Property in Care (PIC) ID:	PIC277
Designations:	Scheduled Monument (SM90157)
Taken into State care:	1931 (Guardianship)
Last Reviewed:	2019

STATEMENT OF SIGNIFICANCE

BROCH OF GURNESS (AIKERNESS BROCH)

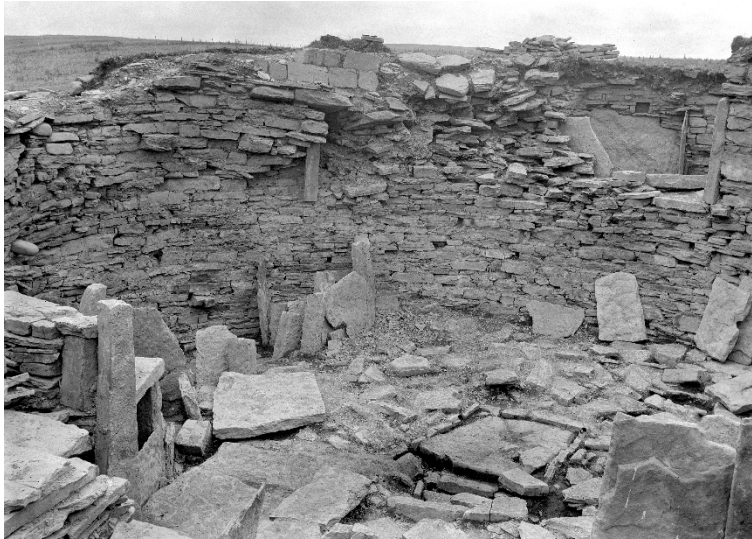
SC 1214992 © Crown Copyright: HES. Gurness, broch interior immediately after emptying (c. 1934) to demonstrate how far today’s neat stonework represents comprehensive reconstruction

Photographs survive which show how comprehensively some of the walling was rebuilt, but written records were sparse, as was the case for excavation. Annotated sketch plans and sections do survive, with lists of finds, though understanding of stratigraphy seems to have been patchy.

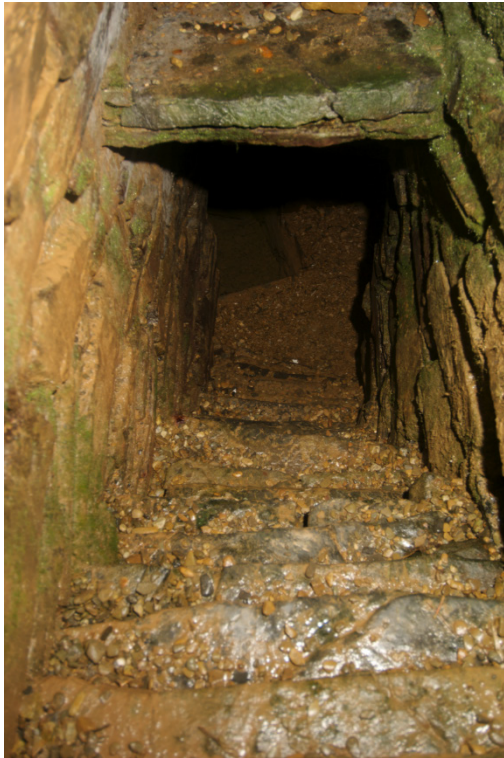
Gurness broch, "well", looking down

- The deep, partly rock-cut chamber or “well” which descends 4m below the broch courtyard, is one of several in Orkney: that at Gurness is only surpassed by that at Mine Howe. It has been suggested that such chambers may be more than wells: possibly spaces in which unknown rituals took place. It has also been suggested that they may pre-date the brochs within which they have been found (with the exception of Mine Howe, which is not below a broch). It may or may not be coincidental that other broch sites known to have such features also tend to have one or more external ditches, although none so clearly visible or large in scale as at Gurness. They also tend to have evidence of metal-working in bronze and/or iron.

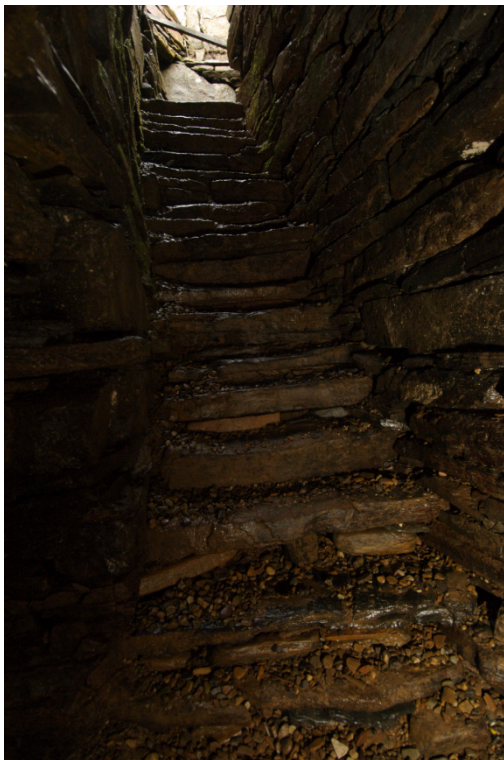
Gurness broch, "well" looking up

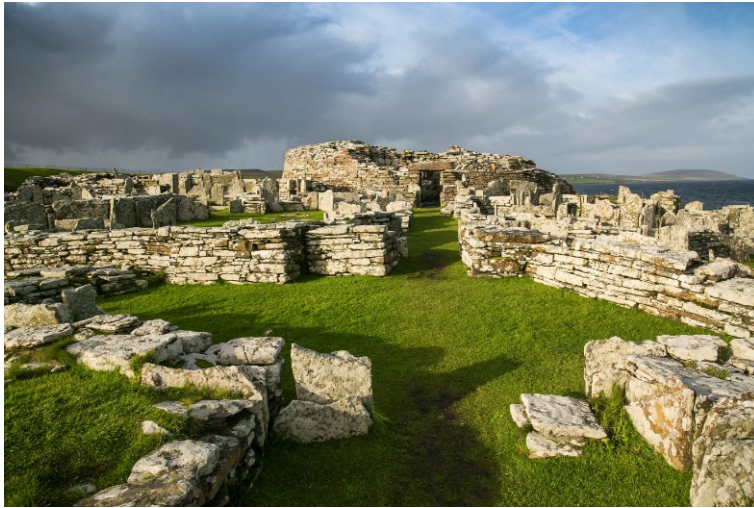
Gurness, entrance way through ditches towards broch

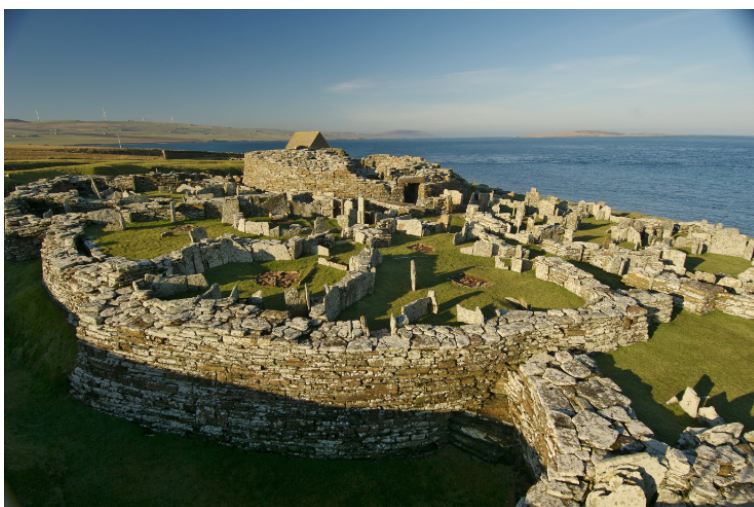
Gurness "village" showing perimeter wall and entrance way
