TECHNICAL
ADVICE
NOTE

CARE AND
CONSERVATION OF
17TH CENTURY
PLASTERWORK
IN SCOTLAND

TECHNICAL
CONSERVATION,
RESEARCH AND
EDUCATION
GROUP

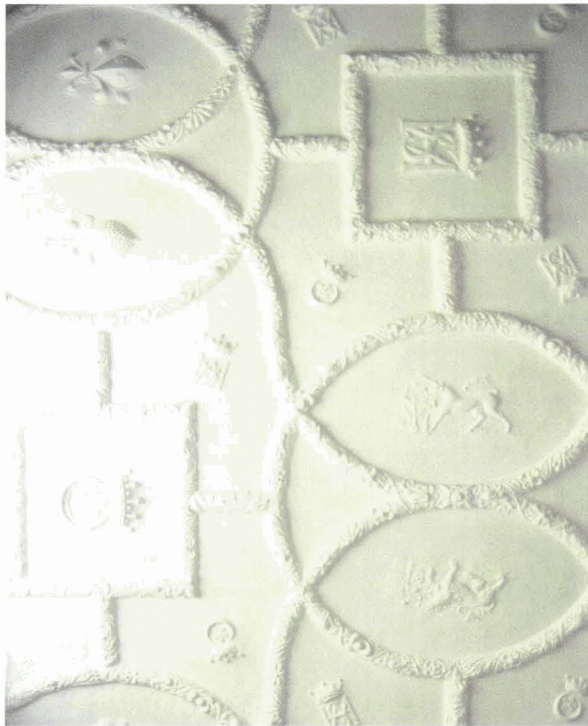
Illus 3. Pinkie House, East Lothian; possibly as early as 1613, the graceful design of this ceiling in the Green room is based on circles and curves, with delicate ribs entirely formed from cast floral enrichment without any underlying run mouldings. © Crown copyright Historic Scotland

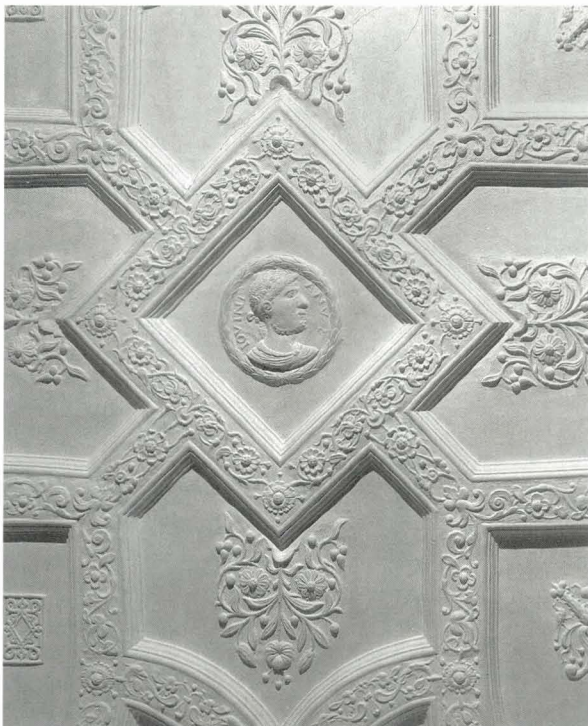
Illus 5. Craigievar Castle, Aberdeenshire; the Blue room ceiling dated 1626 again employs squares, some set diagonally and some set inside quatrefoils, with linking semi-circles. © Crown copyright RCAHMS

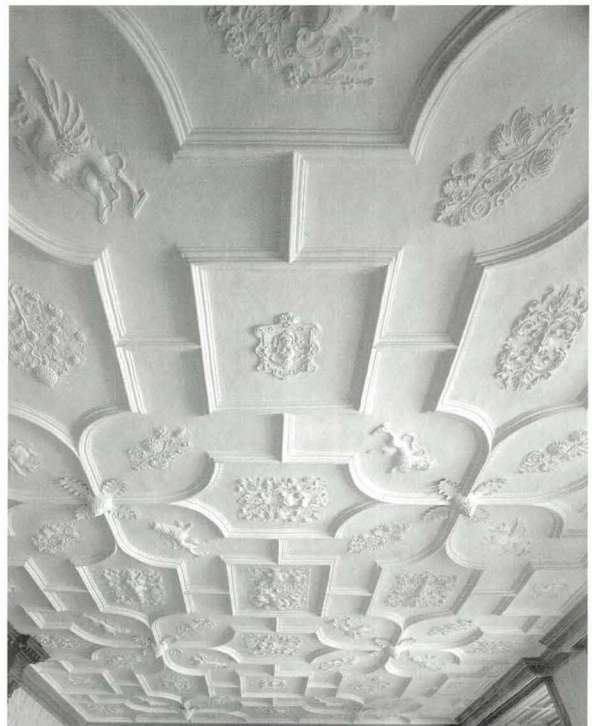
Illus 6. Newbattle Abbey, Midlothian; the library ceiling, probably 1620s or 1630s, with a layout based on a different arrangement of squares and quatrefoils. The run mouldings forming the ribs are narrow and have no additional decoration. © Crown copyright RCAHMS

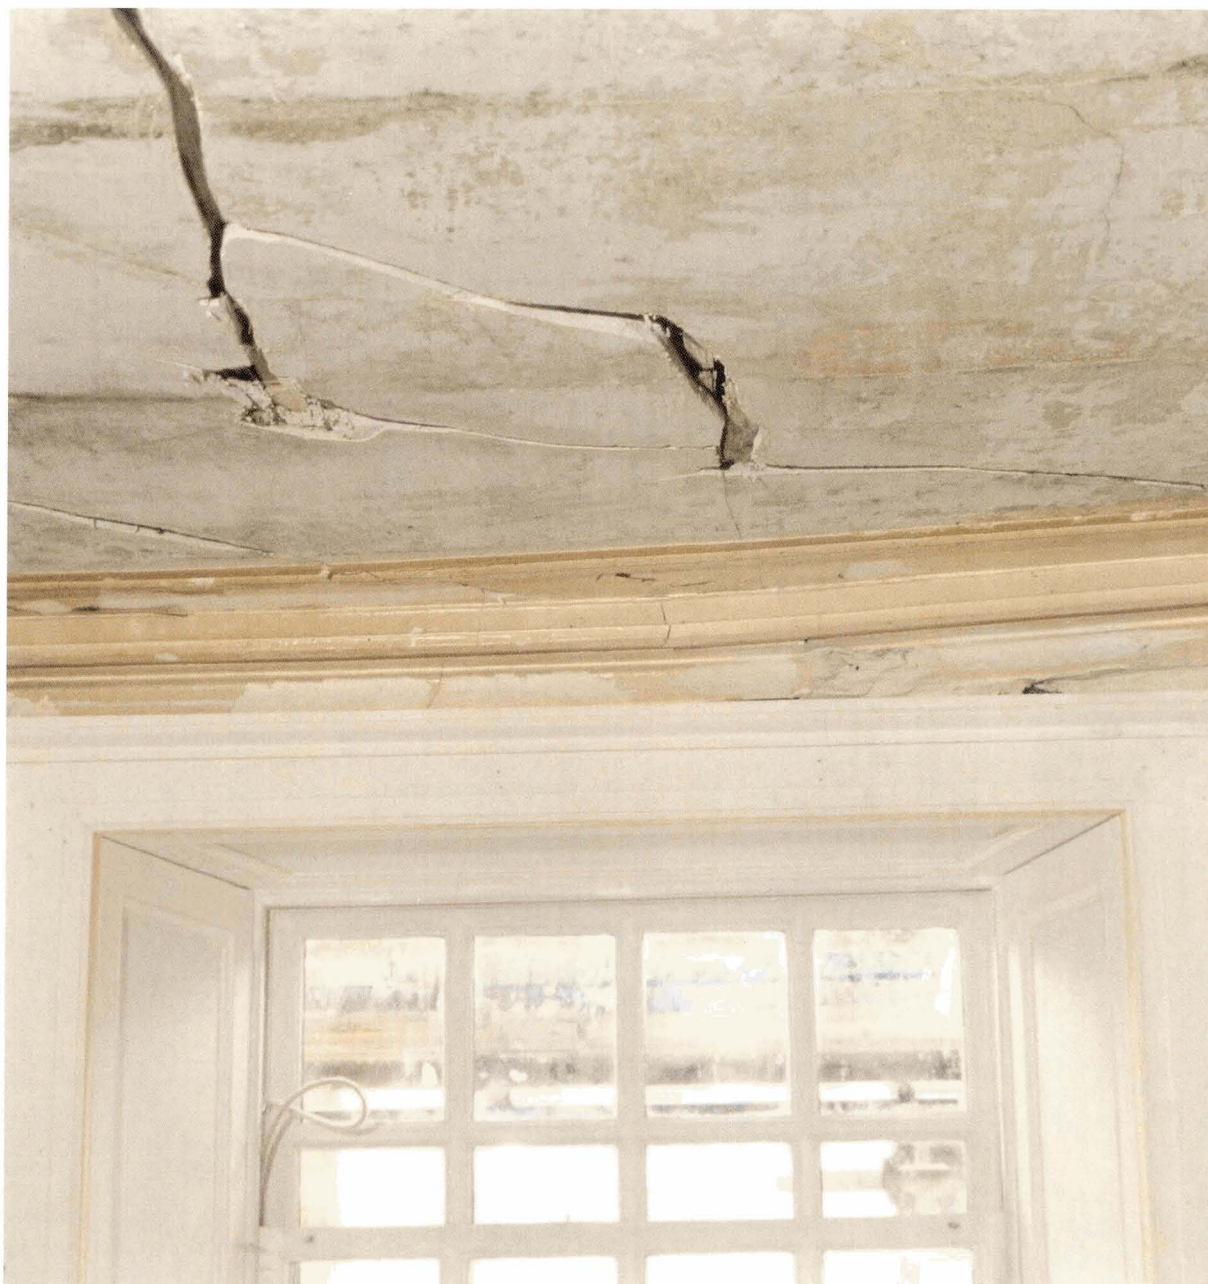
Illus 8. Sandgate, Ayr (later C17 or C18); damaged plaster, with cracks cleaned out ready for refilling. © William McVey

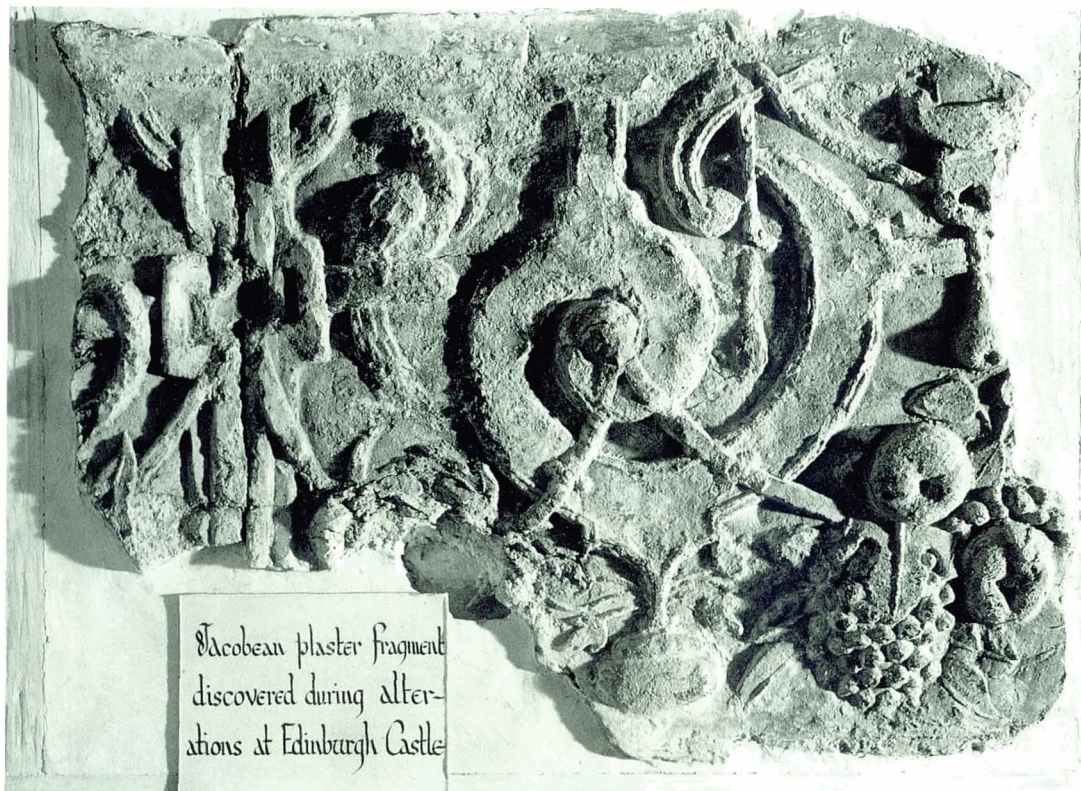
Jacobean plaster fragment
discovered during alter-
ations at Edinburgh Castle

Illus 9. Edinburgh Castle; fragment of a frieze, which was all that remained of the original 1617 plasterwork. It is identical to a frieze at Muchalls. © Crown copyright Historic Scotland

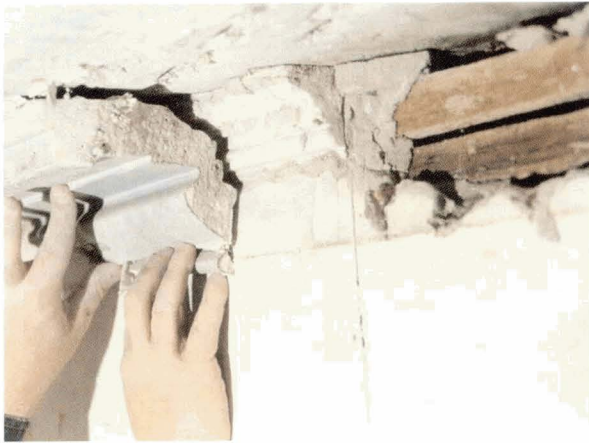
Illus 11. Sandgate, Ayr; there may be vital information hidden behind the plasterwork, as here, where there is an earlier (late C17 or early C18?) cornice behind the visible later one. © William McVey

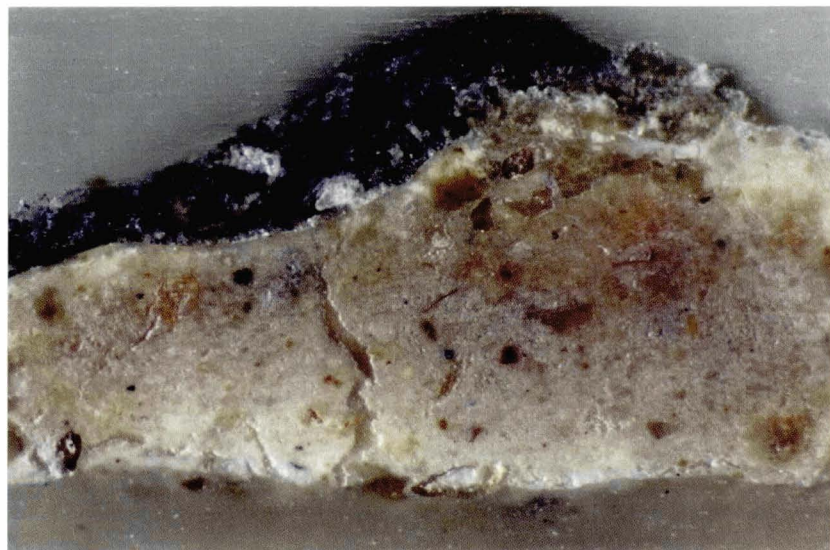
*Illus 16. Cross-section at 100x magnification. Part of the area appears to have been saturated by an oily or waxy substance. The plaster is deeper and darker; it is likely to have been accidentally contaminated during the making of the frieze. The cross-section confirms that discolouration continues below the surface.
© Crown copyright
Historic Scotland*

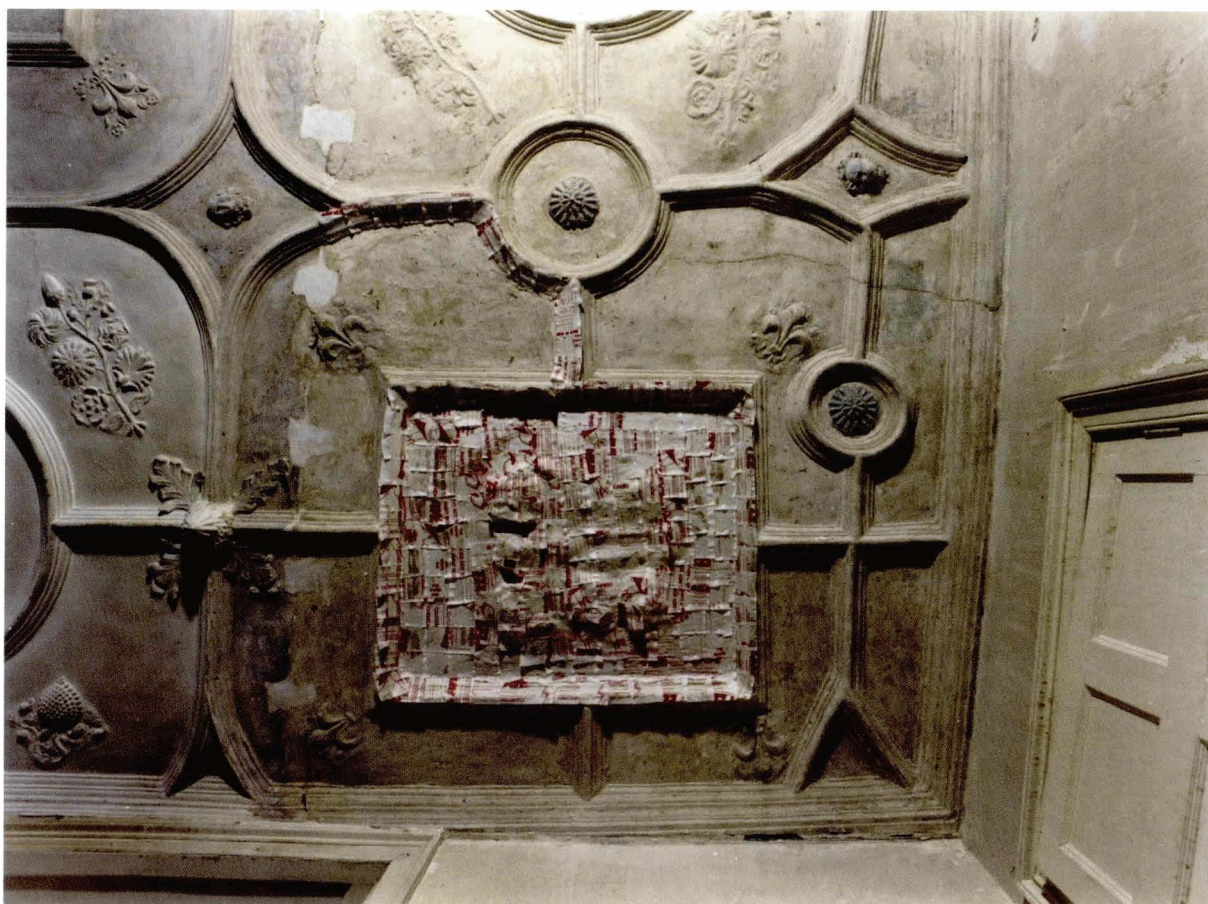
Illus 17. Croft-an-Righ, Edinburgh; damaged plasterwork temporarily supported by water-based adhesive paper.
© Crown copyright Historic Scotland

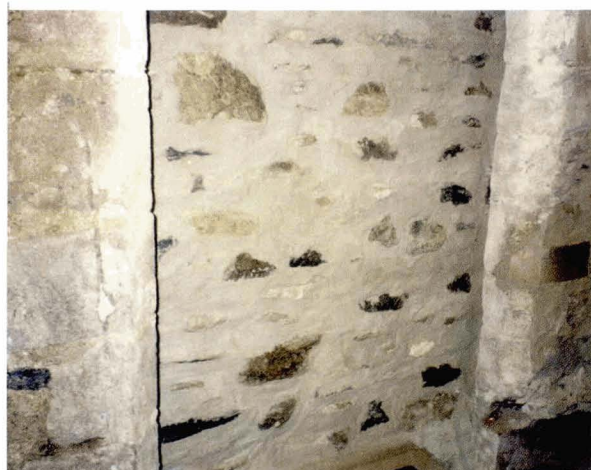
Illus 19. Dubbing out on a rubble stone background to provide a base for application of plaster. © Scottish Lime Centre

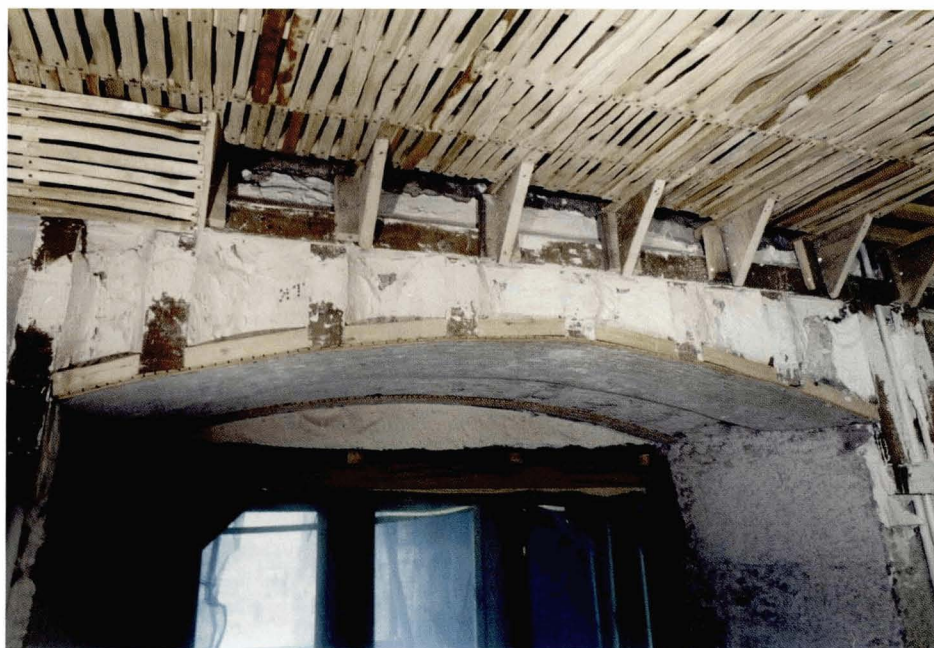
Illus 22. Timber lath background for plaster, with framing built up as the support for a cornice.

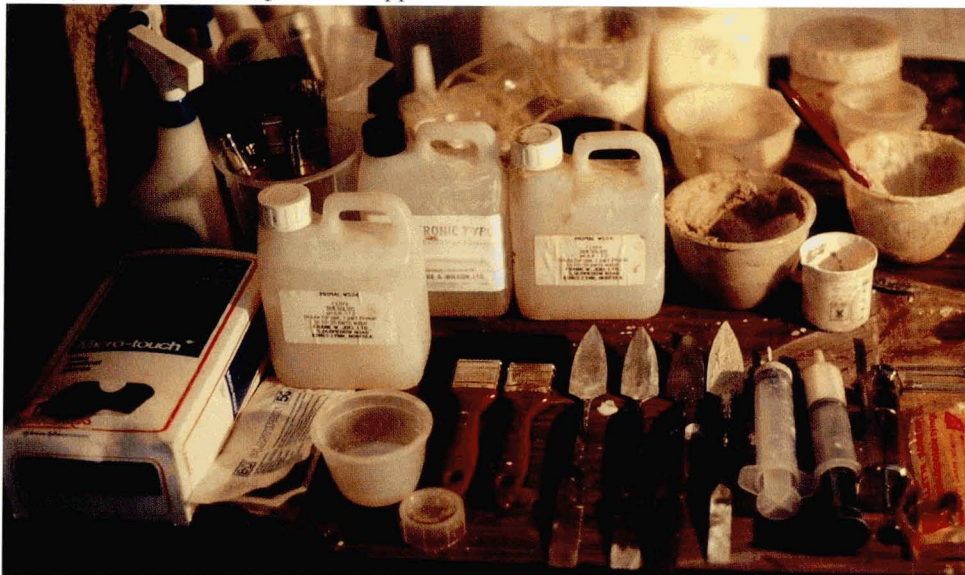
*Illust 23. Materials ready for plaster consolidation by Historic Scotland specialists.
© Crown copyright Historic Scotland*

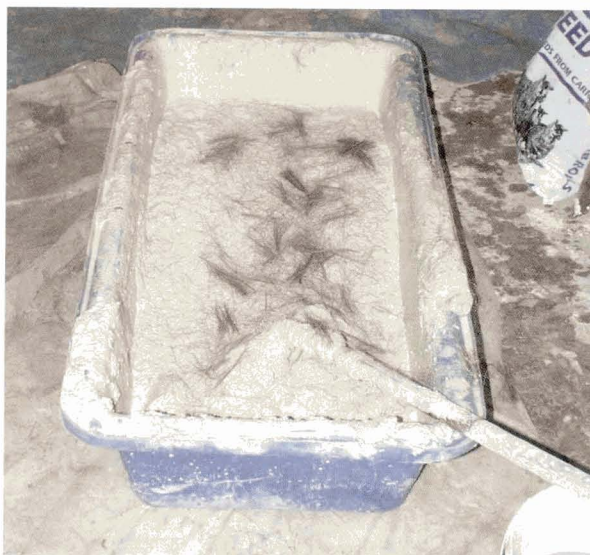
Illus 24. Coarse stuff; lime plaster mix with animal hair ready to be mixed in. © William McVey

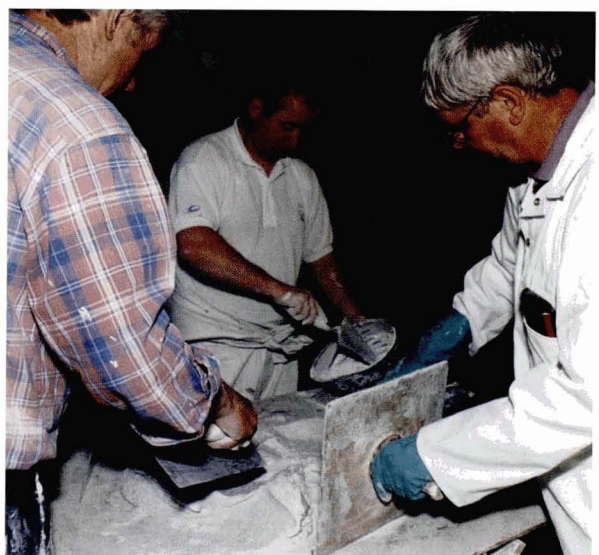
Illust 25. Mixing lime plaster for application. © Crown copyright Historic Scotland

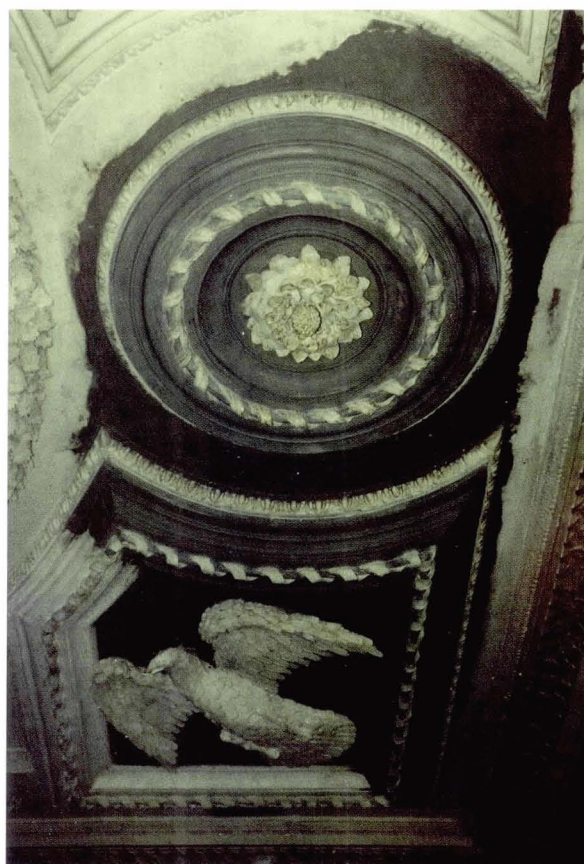
Illus 26. Thirlestane Castle, Scottish Borders; restoration of missing and damaged surface decoration (run mouldings and cast/ modelled applied decorations). The finished ceiling is seen after the repair. © L. Grandison and Son

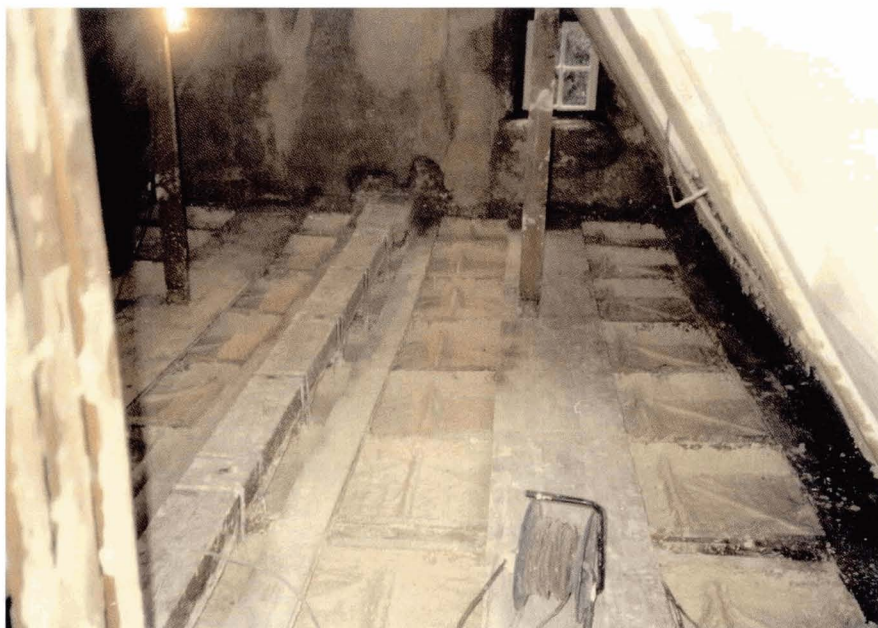
Illus 27 and 28. Crawfordland Castle, East Ayrshire; repairs by William McVey.

Illus 28. Backjacketing ceiling from above. © William McVey

Defects which may be found in lath include timber decay resulting from damp environmental conditions, or insect infestation, as well as physical impact damage. If impact damage has occurred, then it is likely that the plaster finish will also have suffered damage, and will be in need of repair.

Methods of repair, including screw fixing to secure loose lath, and adding mesh to reinforce weak panels are described in TAN 2, Section 3.13. Nailing should be avoided, to minimise any vibration that might cause further loss of security. The selected method should be designed to minimise damage to surviving original material and be appropriate to the original construction. It is important that any patching in of replacement lath is of the same type as the original, to ensure uniform moisture content and response to varying environmental conditions.

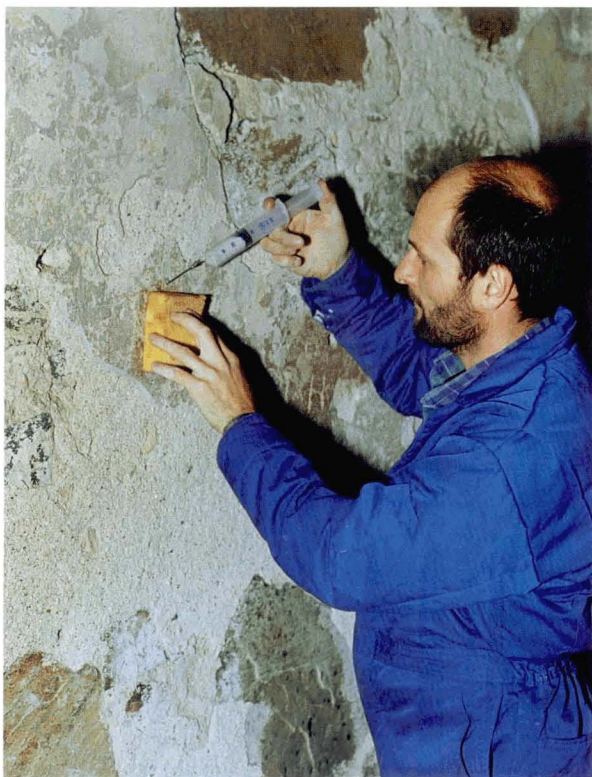
Illus 29. Historic Scotland conservator grouting loose plaster to give a better bond to its backing. © Crown copyright Historic Scotland

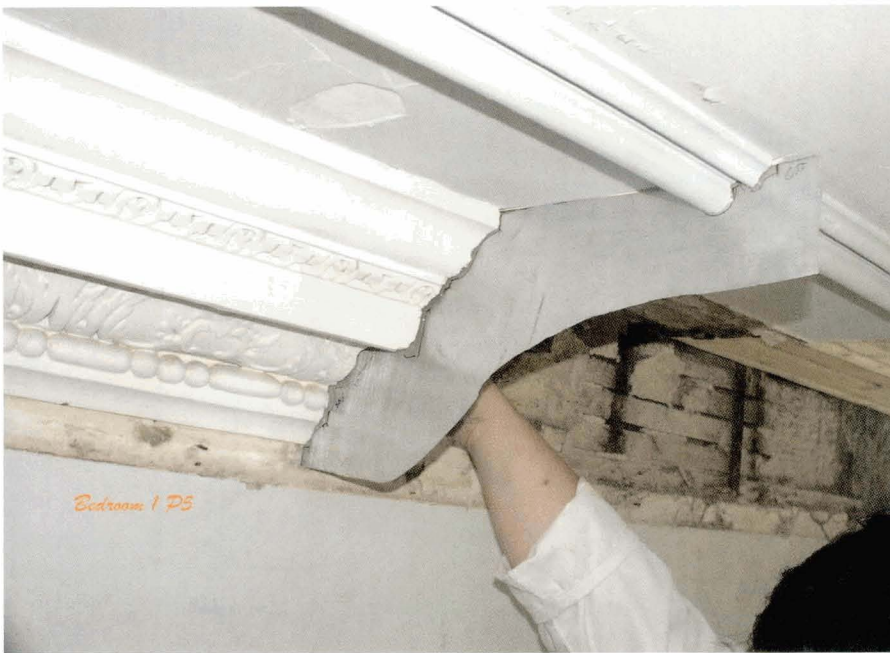
*Illus 31. Taking a profile from the original cornice in order to renew part of it (in this example the plasterwork is much later).
© William McVey*

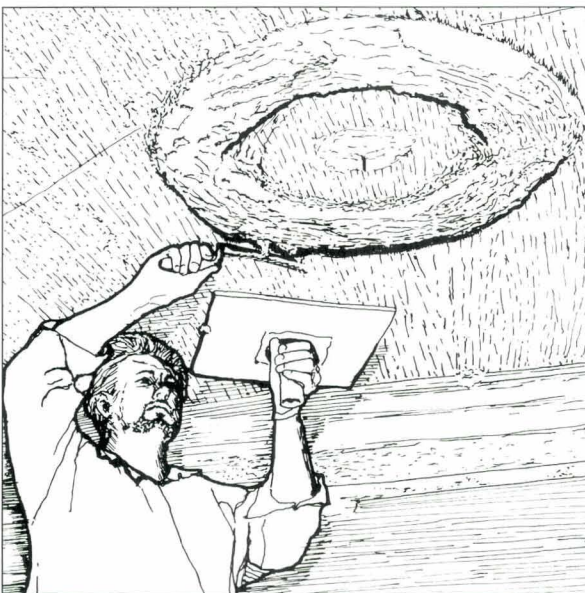
Illus 32. Building up coarse plaster as a base for a circular rib moulding run in-situ; note the central nail acting as a guide. © Crown copyright Historic Scotland/EA Whitfeld

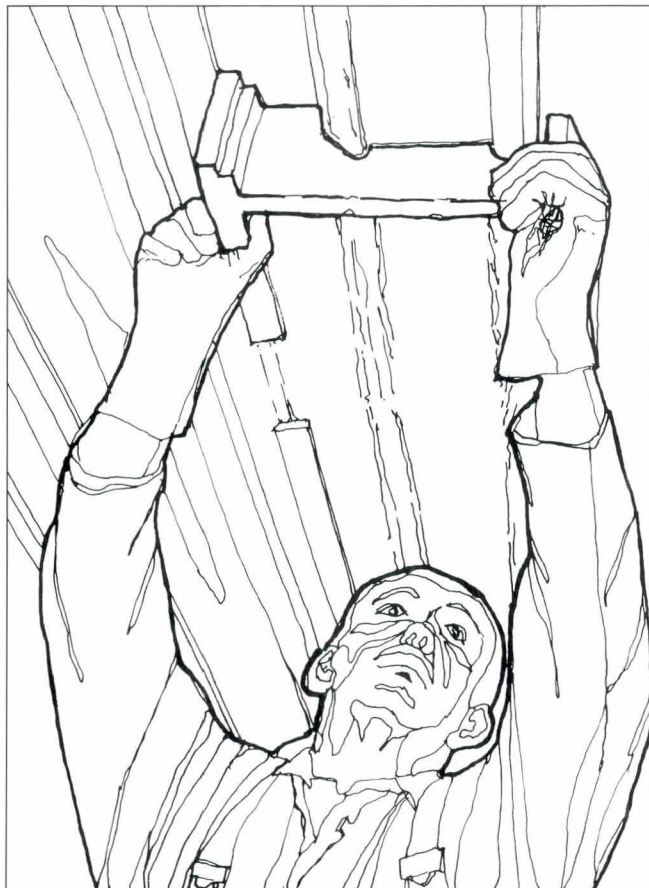
Illus 34. Running base coat for straight in-situ rib with muffled template mounted on a horse, using battens as edge guides. © Crown copyright Historic Scotland/EA Whitfeld

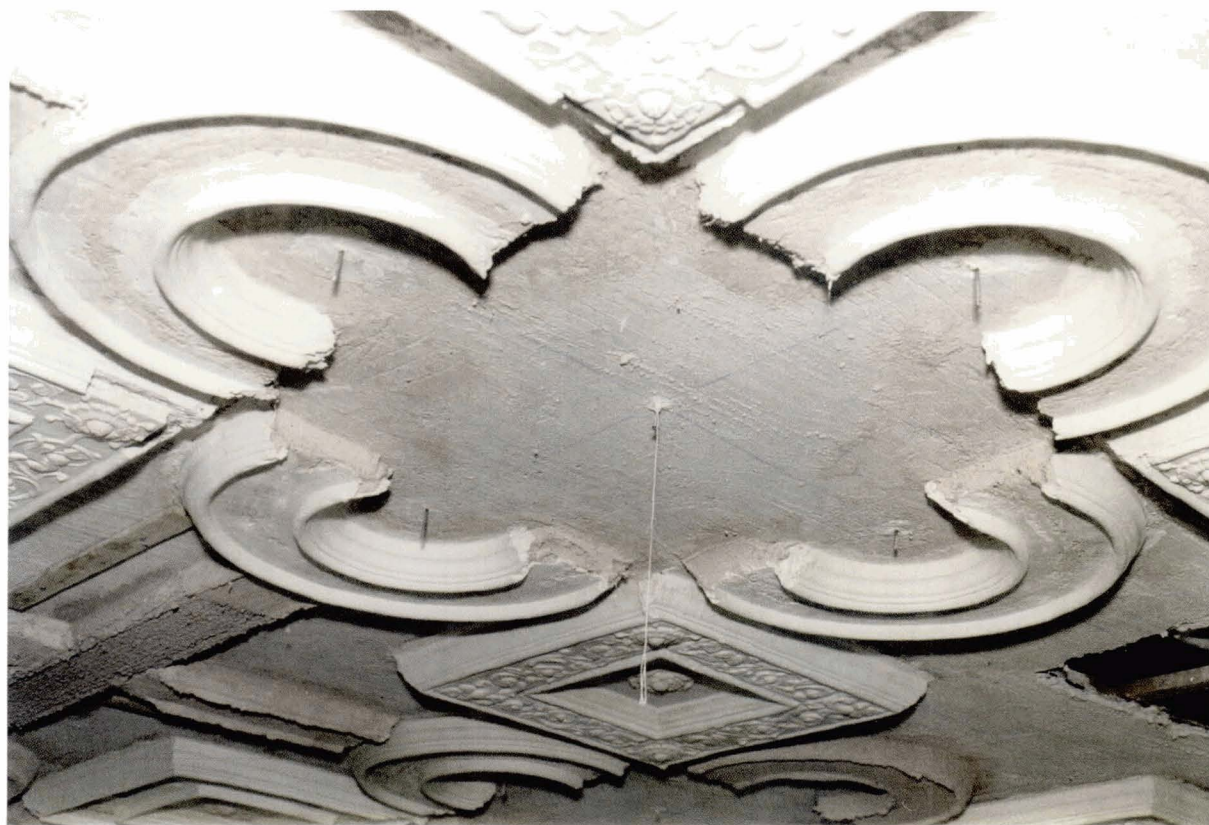
Illus 35. The finishing coat has been added and run in-situ to semi-circular mouldings. Nails and string at centre points provide guidance. © Crown copyright Historic Scotland

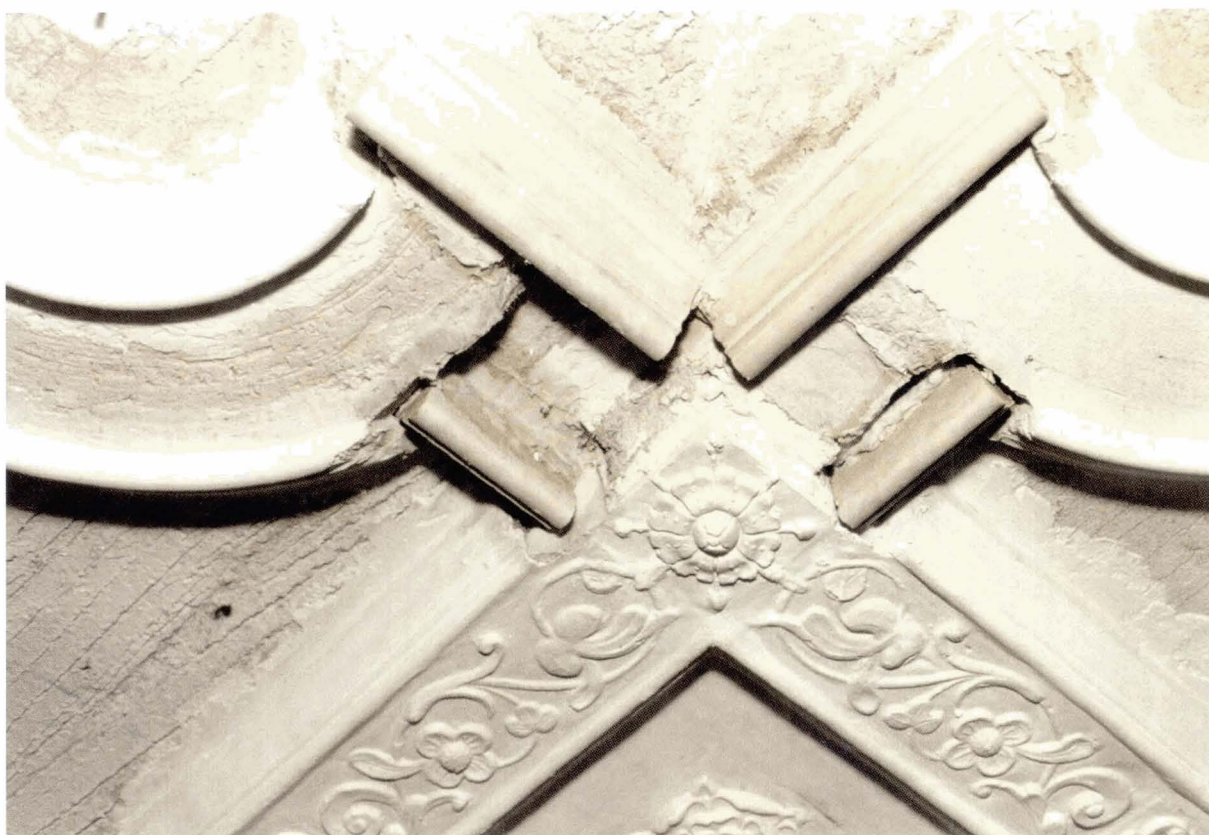
Illus 36. Pre-cast sections of rib have been inserted to link in-situ run ribs. The junctions will be finished by hand.
© Crown copyright Historic Scotland

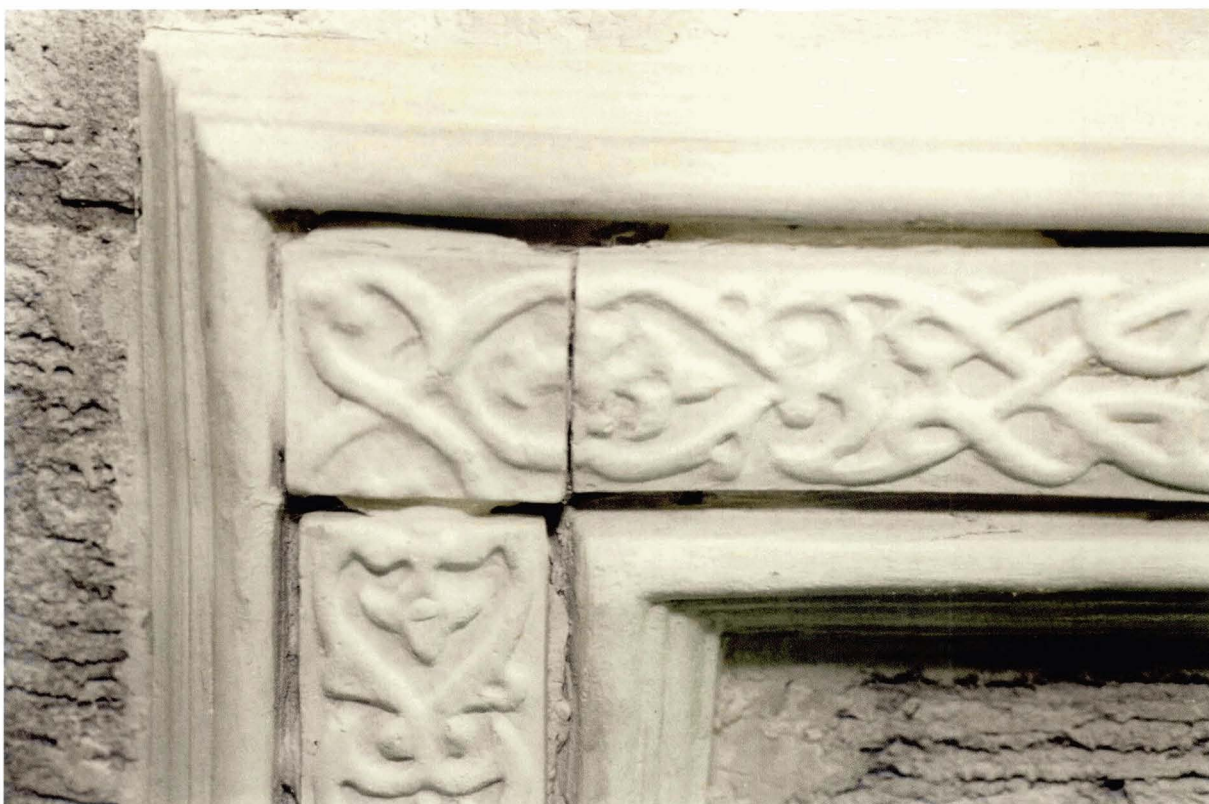
Illus 37. Cast rib enrichment positioned on soffit of in-situ run ribs, using fresh plaster as the adhesive.
© Crown copyright Historic Scotland

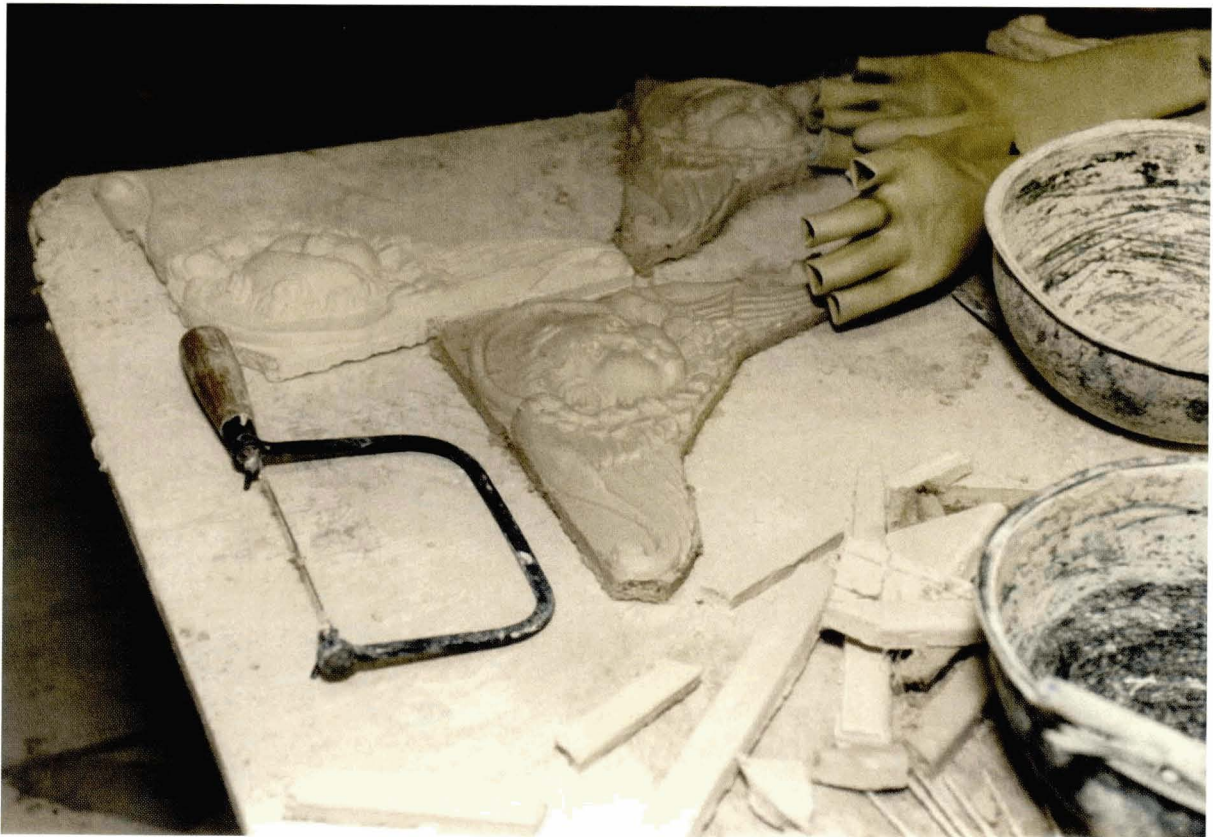
Illus 39. Casting table with casts, rubber gloves, saw and bowls for plaster. © Crown copyright Historic Scotland

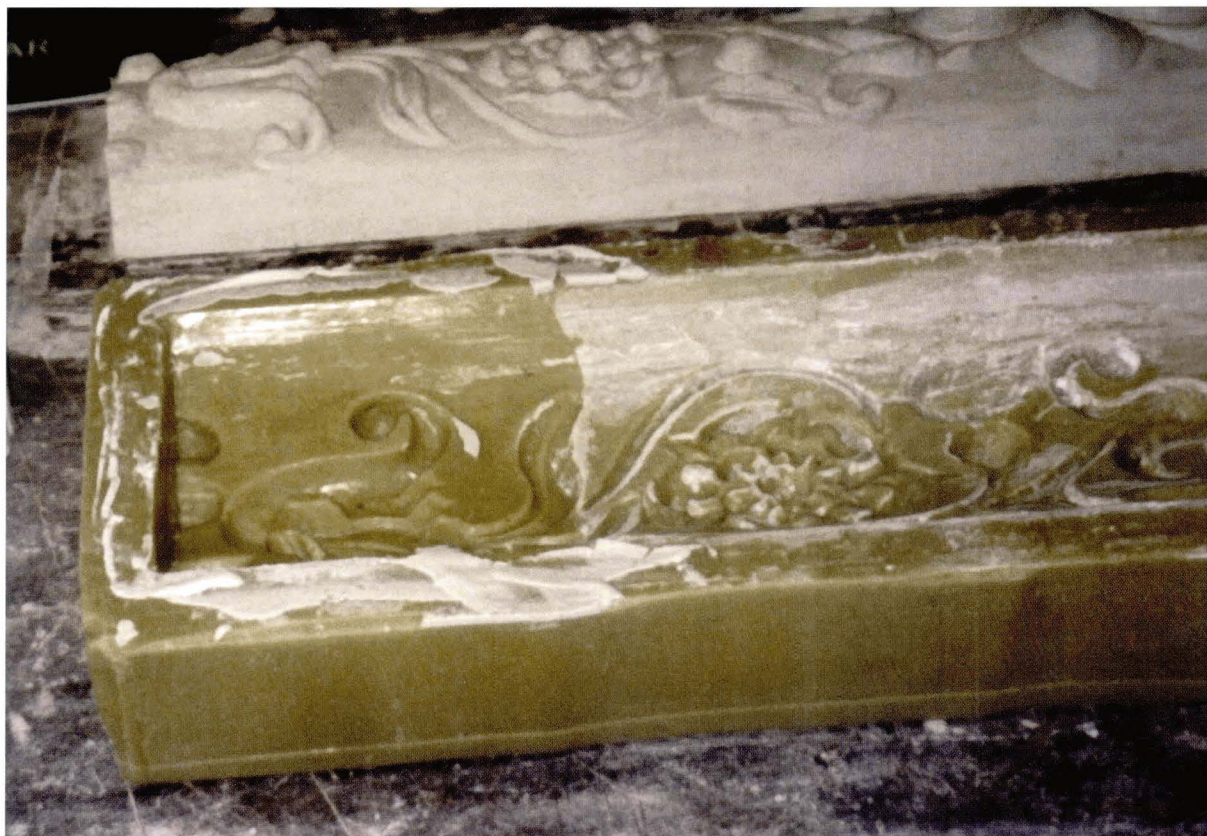
Illus 40. Negative mould and cast. This is a modern flexible mould. Originally wooden moulds would have been used.
© Crown copyright Historic Scotland

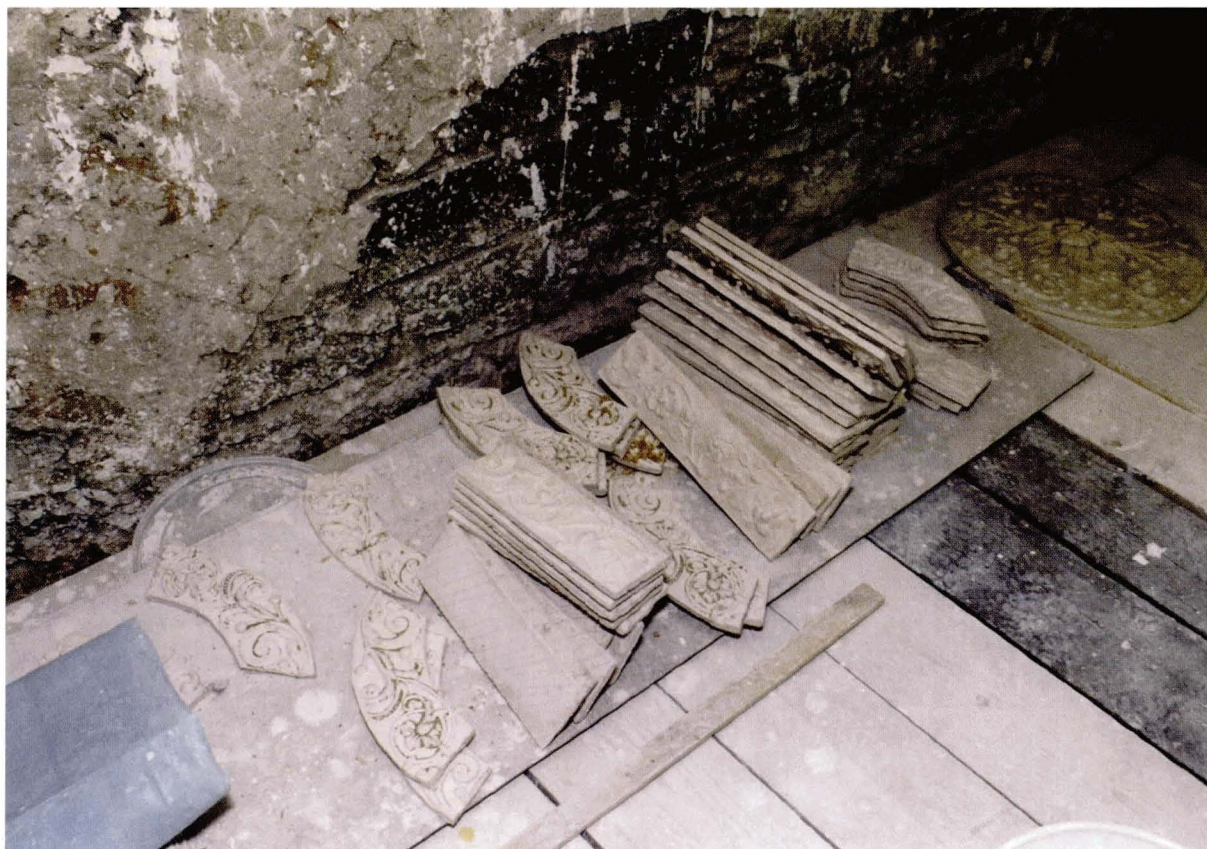
Illus 41. Cast rib enrichments ready for application to the soffit of ribs. © Crown copyright Historic Scotland

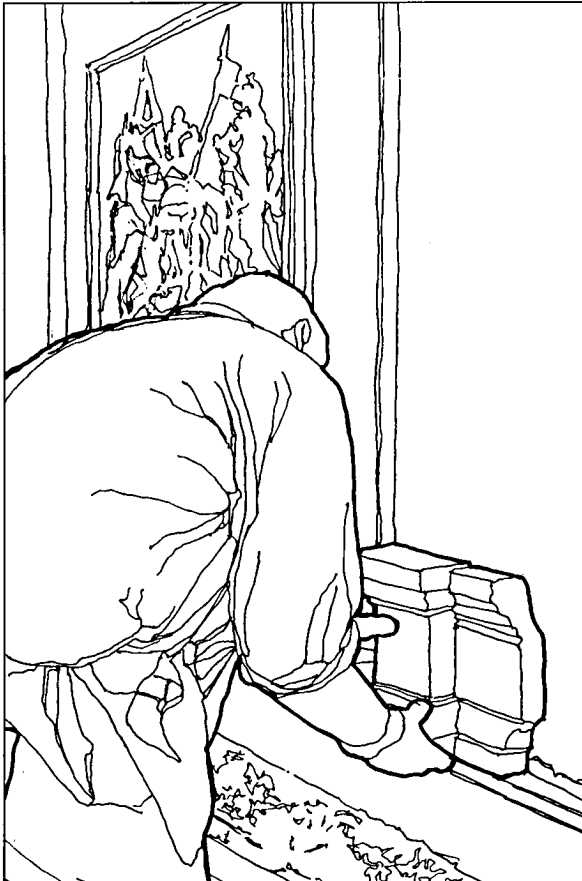
Illus 42. A decorative cast moulding being put into position (from scaffolding) on an overmantel. © Crown copyright Historic Scotland/EA Whitfeld

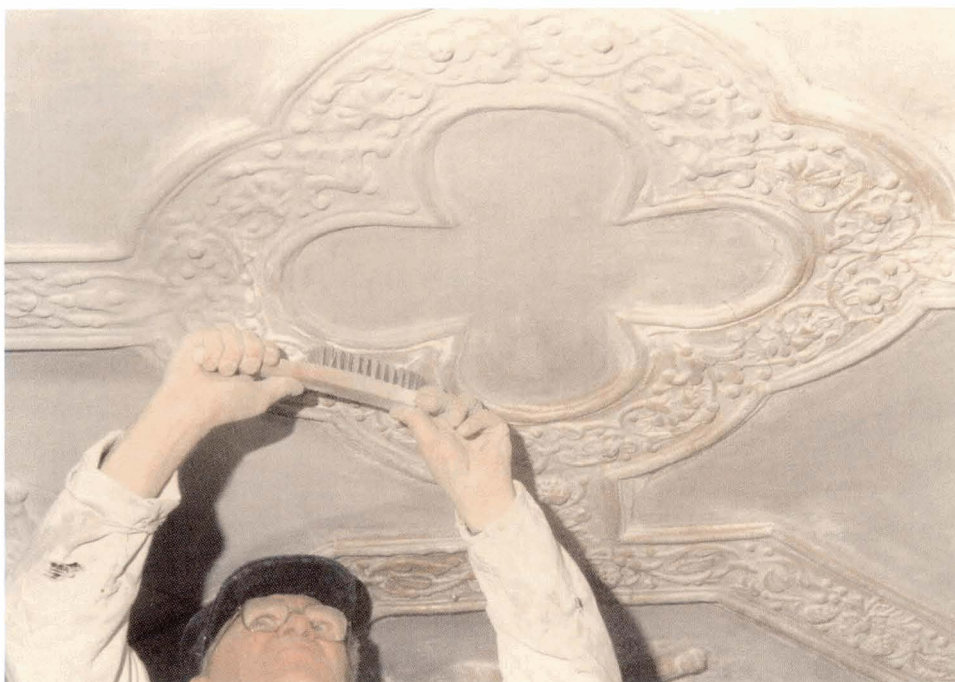
Illus 44.
Crawfurdland Castle,
East Ayrshire;
brushing down the
ceiling to remove dust
and old limewash in
preparation for
renewing limewash.
 © William McVey

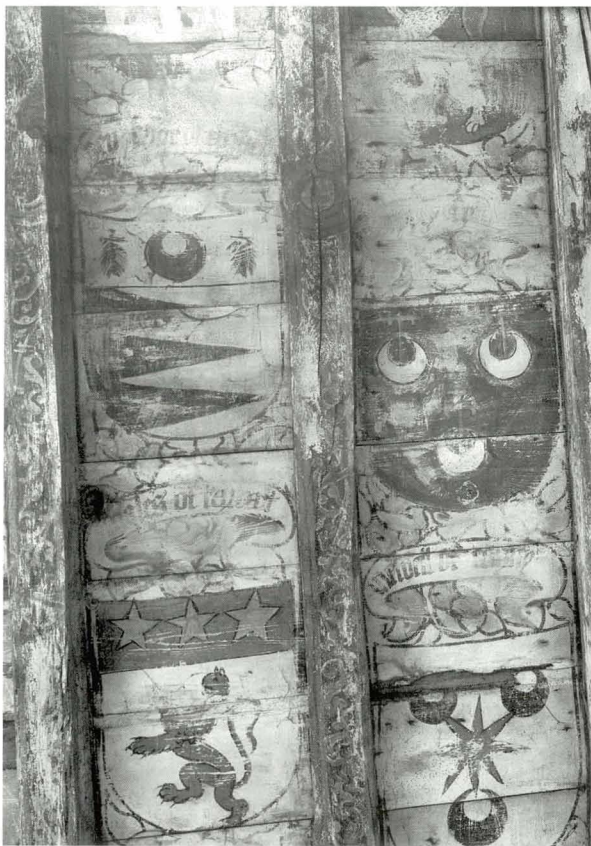
Illus 45. Collairmie Castle, Fife; painted timber ceiling, C16. Many of the motifs used in plaster ceilings had been seen previously on painted timber ceilings; note the coat of arms, stars, crescents, lion rampant, scroll with inscription, and floral decoration, particularly to the ribs. © Crown copyright RCAHMS

Some ornamental details and motifs can be found both on painted ceilings and on plaster ceilings. For instance: peacock and fruit; a long spray with twirl, rose crescent or fleur-de-lys; vase of flowers; dolphin head scroll; double scroll; bird, serpent and squirrel rib enrichment; lion rampant or couchant; lion passant and unicorn; lion mask; rose, thistle, harp, fleur-de-lys, torso (long or short), mermaid, bearded head in profile, star or virgin. The basic models for most of these

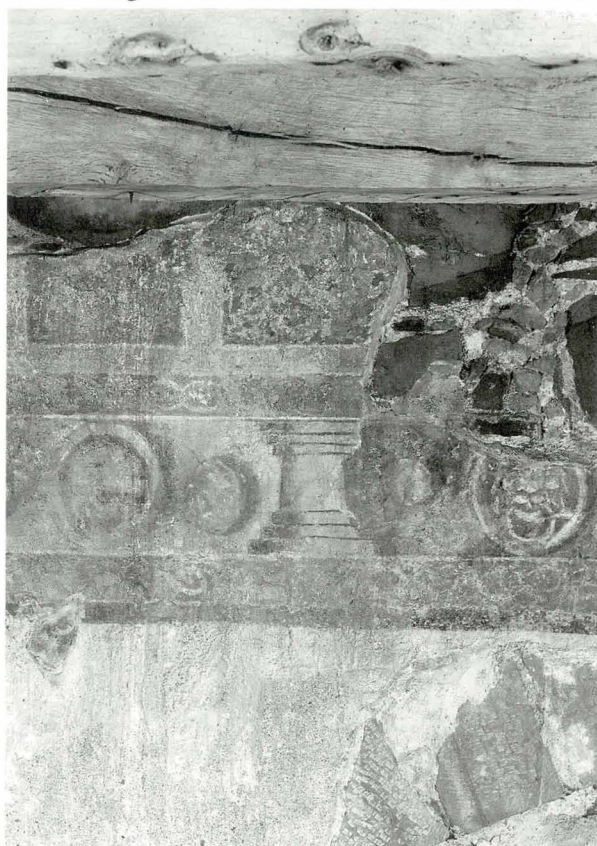
Illus 46. Amisfield Tower, Dumfries and Galloway; late C16 painted decoration on flat plaster showing lion heads and other medallions, framing with columns, floral enrichment etc, motifs which recurred in moulded plasterwork. © Crown copyright RCAHMS

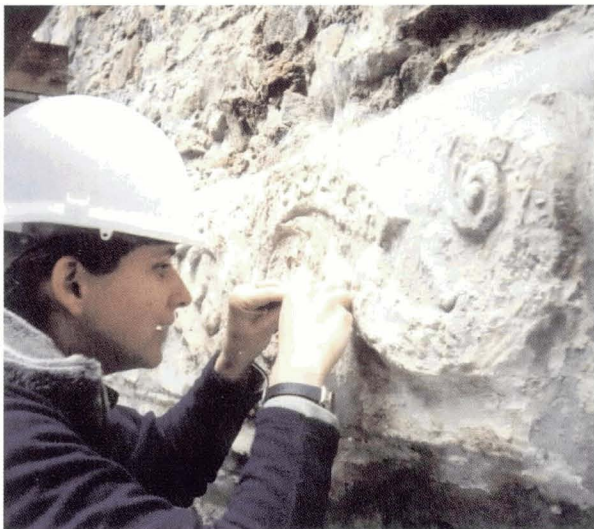
Illus 47. Huntly Castle, Aberdeenshire; this frieze is probably the earliest moulded plasterwork extant in Scotland, said to date from 1602-08. A Historic Scotland specialist consolidates this plaster which is now exposed to the weather. © Crown copyright Historic Scotland

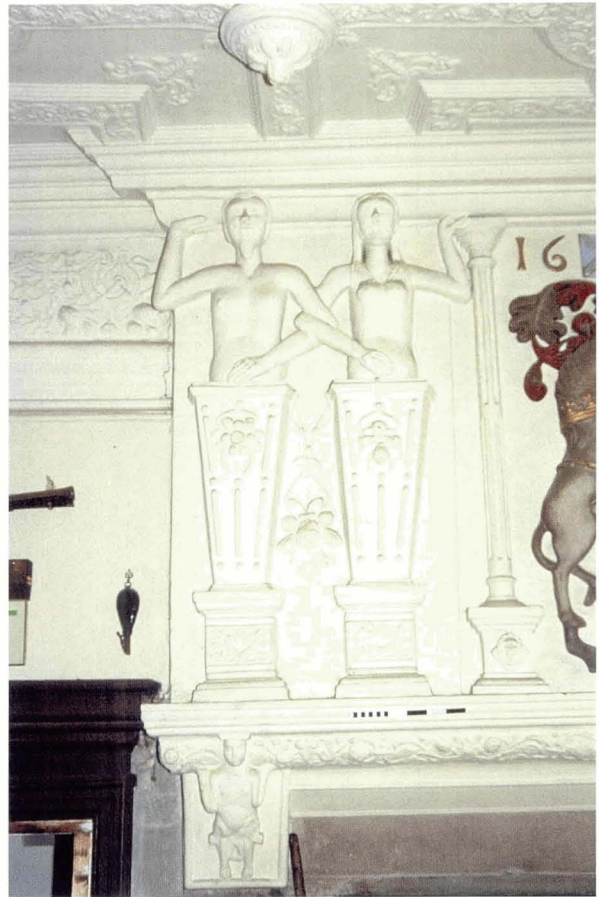
Illus 48. Muchalls Castle, Aberdeenshire; hand modelled figures used on either side of the coat of arms on this overmantel. © Crown copyright Historic Scotland

Some of the earliest English relief plasterwork included hand-sculpted compositions, often classical or biblical scenes. There are no obvious examples of these in Scotland, the nearest parallel being sculpted figures on overmantels, such as those at Auchterhouse, Muchalls (illustration 48) and Craigievar, or unusually, individually modelled ceiling panels as at Saughton Hall (illustration 49). Instead, the use of casts for repetitive decoration expanded, possibly as the potential was realised and then exploited. This was a highly expensive and sophisticated type of work, relying on the skill, training and experience of the individual craftsman (and his team). The early examples, both in England and in Scotland, were in Royal palaces and the great houses of the richest families.

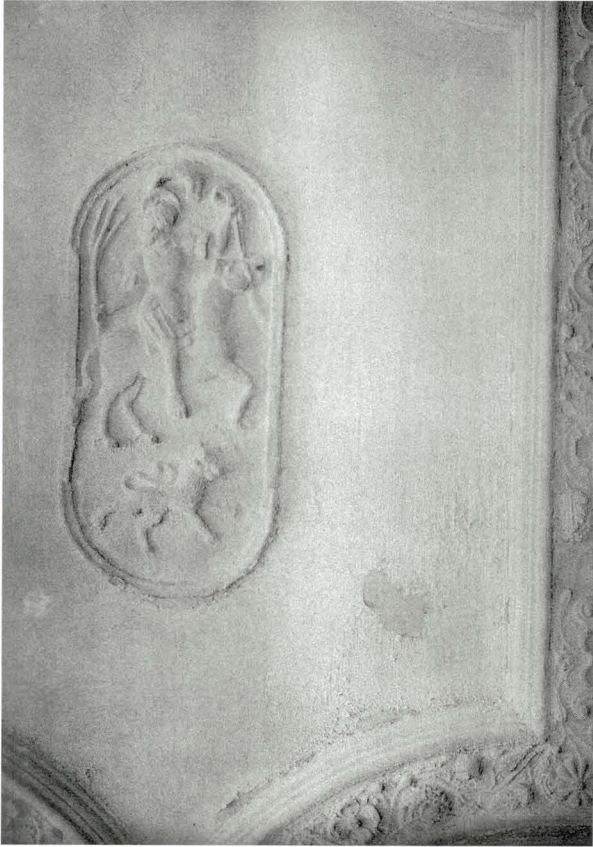
Illus 49. Saughton Hall, Edinburgh; mounted knight with hound, framed and used as a motif. Unusually, this appears to have been hand modelled rather than cast, which was the more common method. © Crown copyright RCAHMS
