TECHNICAL
ADVICE
NOTE

CARE AND
CONSERVATION OF
17TH CENTURY
PLASTERWORK
IN SCOTLAND

TECHNICAL
CONSERVATION,
RESEARCH AND
EDUCATION
GROUP

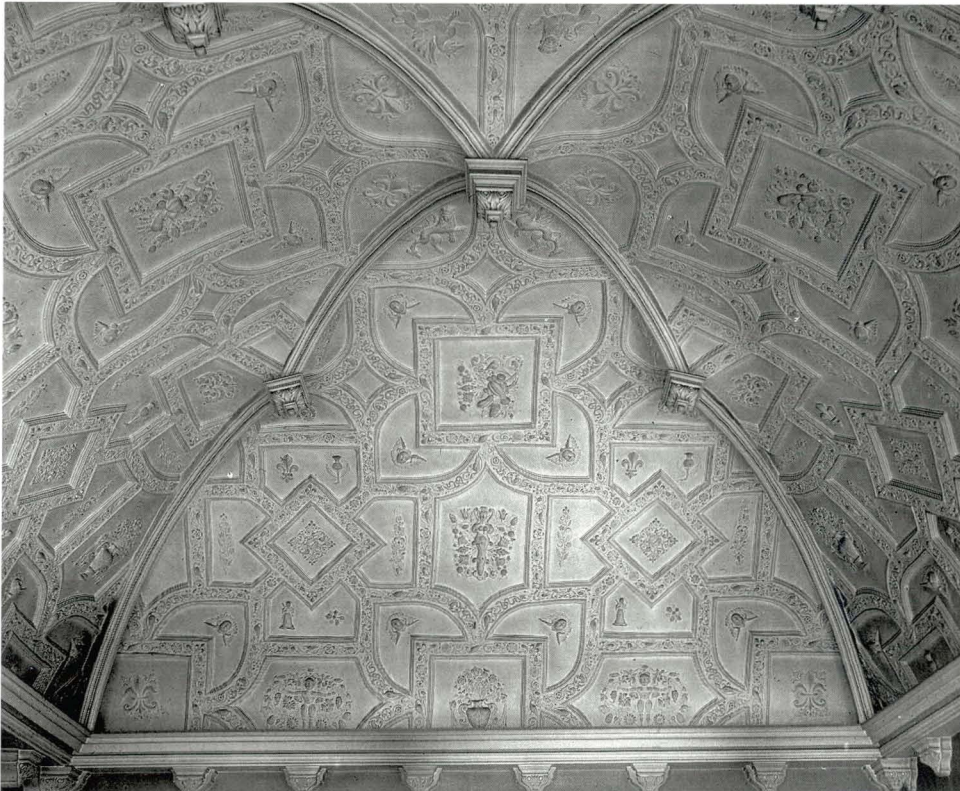
Illus 50. Moray House, Edinburgh; a domed ceiling from a town house of the late 1620s. © Crown copyright RCAHMS

Similar extensive and fine plasterwork is found at Craigievar (1626) and in Moray House (c1628, see illustration 50). Moray House was perhaps the first town house to be furnished with decorative plasterwork, but the next decade saw more town houses treated in this way.

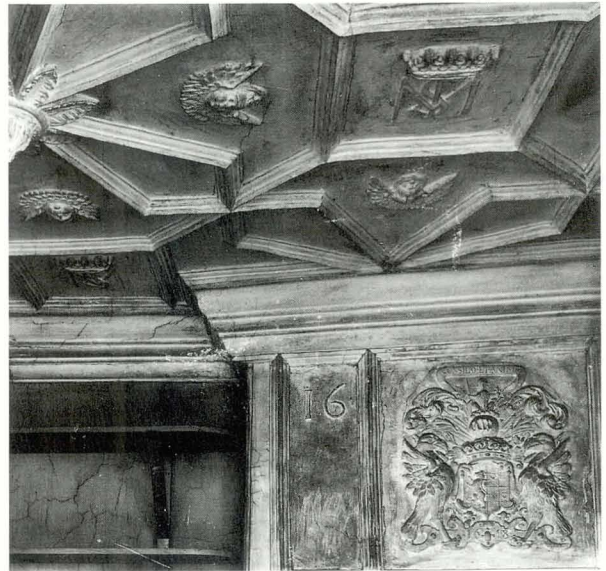
Illus 52. Lennoxlove House, East Lothian; might this fan pattern with a central boss have been imitating medieval fan vaulting? © Crown copyright RCAHMS. Reproduced courtesy of Country Life Picture Library

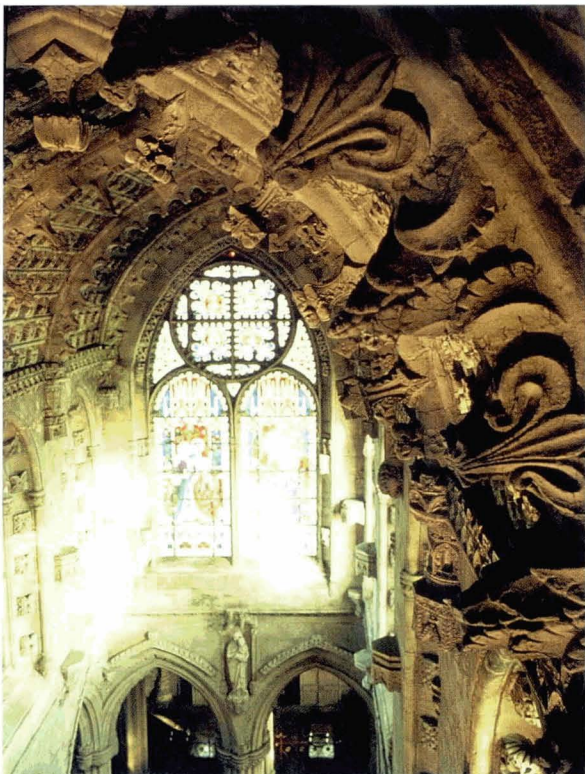
Illus 54. Roslin Chapel, Midlothian; stone bosses and pendants which almost certainly influenced the development of bosses and pendants in plasterwork. © Crown copyright Historic Scotland

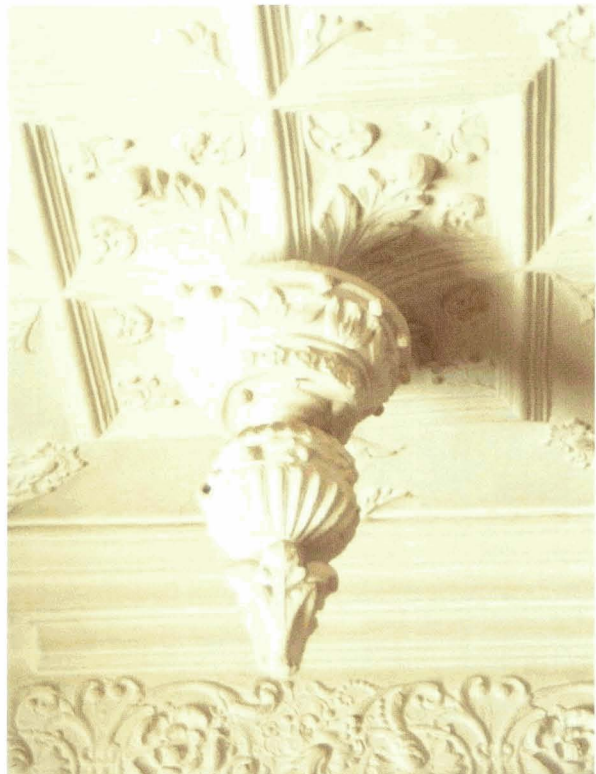
Illus 55. Auchterhouse, Angus; a moulded plaster pendant. © Crown copyright Historic Scotland

Strapwork was much more characteristic of English ceilings, and was only occasionally used in Scotland as a framing device for motifs in the cast reliefs (see illustration 53). Pendants, although they are also found in England, became a particular feature of Scottish ceilings, and appear to have been developed from medieval timber or stone ceiling bosses (see illustration 55).

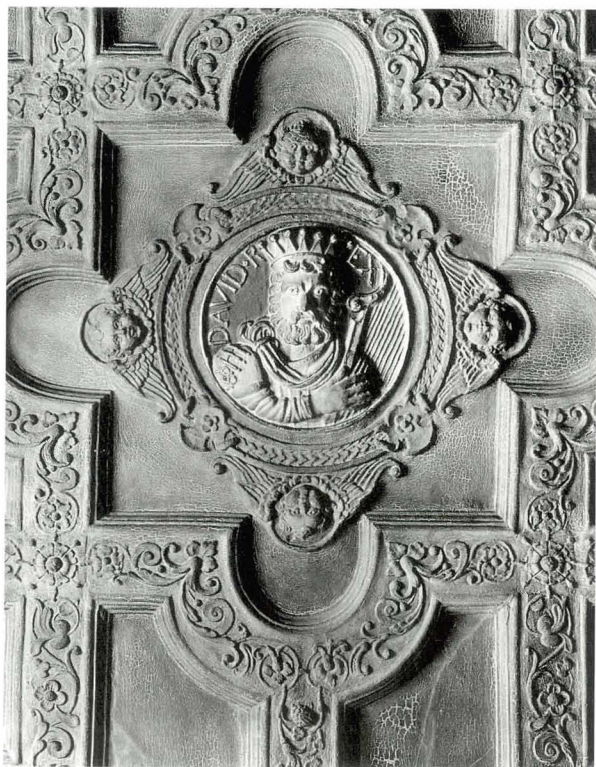
Illus 56. Muchalls Castle, Aberdeenshire; medallion head of King David, one of the nine 'Worthies', framed by strapwork and cherubs (1624). © Crown copyright RCAHMS. Reproduced courtesy of Country Life Picture Library.

The use of portrait medallions (see illustrations 56 and 57) can be traced from portrait heads on metal shields in Greece (c 90BC), on metal and wooden shields in Imperial Rome, and on stone or terracotta medallions in Renaissance Italy. This fashion spread throughout Europe in the 15th century and 16th centuries. Examples in Scotland are the stone medallions on the exterior façade of Falkland Palace (1533) and the wooden ceiling roundels (Stirling heads) at Stirling Castle (c1540). A tempora ceiling representing the nine worthies was made in 1602 for Sir Thomas Burnett of Leys, who later commissioned plaster ceilings with portrait medallions at Muchalls (John Touche, whose articles are at the RCAHMS, went into the subject of portrait medallions and regalia in some depth).

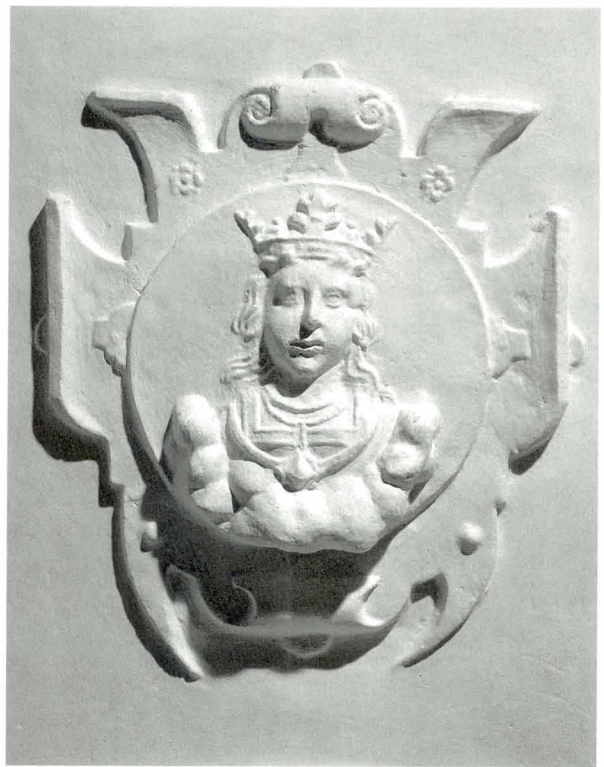
Illus 57. Craigievar Castle, Aberdeenshire; medallion head, thought to represent Queen Margaret, in a strapwork frame (1625). © Crown copyright RCAHMS

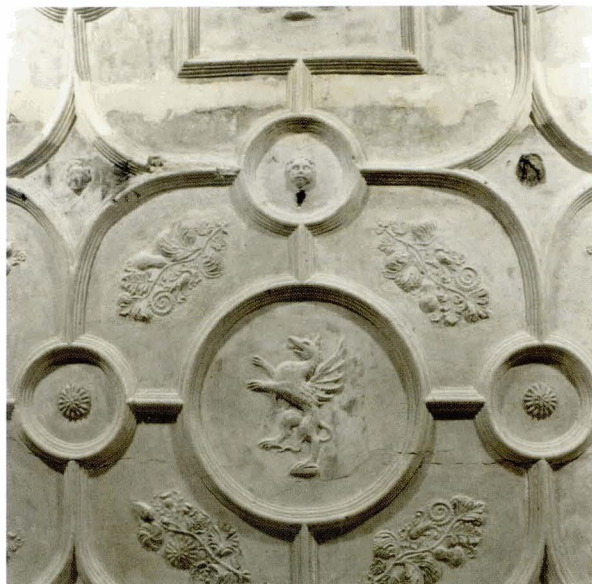
Illus 59. Croft-an-Righ, Edinburgh; the cast for this winged dragon could perhaps have been originally made as a supporter for the English royal arms; similarly the crowned lion shown on the front cover photograph, also at Croft-an-Righ. © Crown copyright Historic Scotland

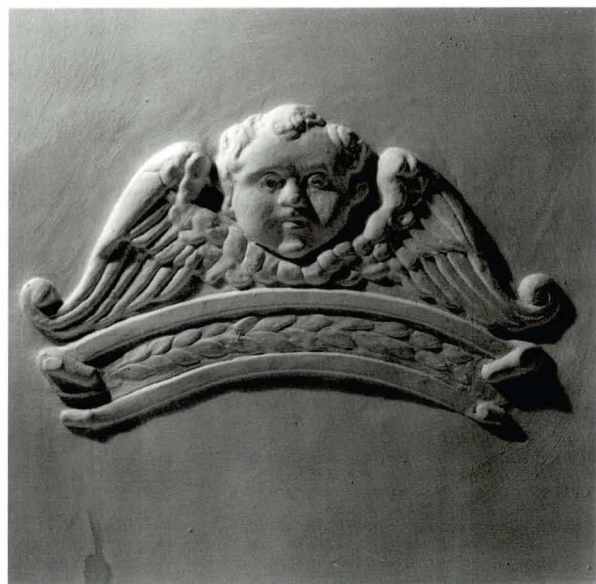
Illus 60. Stenhouse Mansion, Edinburgh; winged cherub's head motif. © Crown copyright Historic Scotland

Other very frequently used motifs were winged cherubs' heads, stars, flowers and fruit, terminal figures, etc (see illustrations 60 and 61).

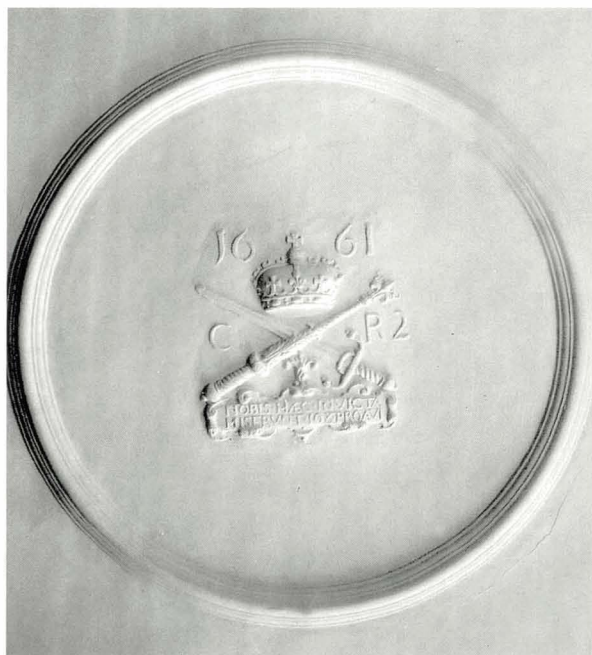
Illus 62. Gorgie House, Edinburgh (1661); royal regalia, adapted from an earlier cast designed for Charles I, to incorporate a 2 for Charles II. © Crown copyright RCAHMS

The next great burst of activity was in response to the end of the Cromwellian occupation of Scotland, and the return of Charles II to his throne. Between 1661 and 1662 there were ceilings and overmantels with decorations which included the royal regalia, installed at Dalry House, Gorgie House, Merchiston Castle, Niddrie House (or Niddrie Marischal), Stenhouse Mansion and probably Woodhall House, all in Edinburgh. There was also plasterwork with royal regalia at Riddle's Court/Close, Lawnmarket, Edinburgh (perhaps 1684). The style of these ceilings is very much in the same tradition as earlier plasterwork; many of the same casts and moulds were used, indeed some were altered crudely to adapt to Charles II instead of Charles I (see illustration 62).

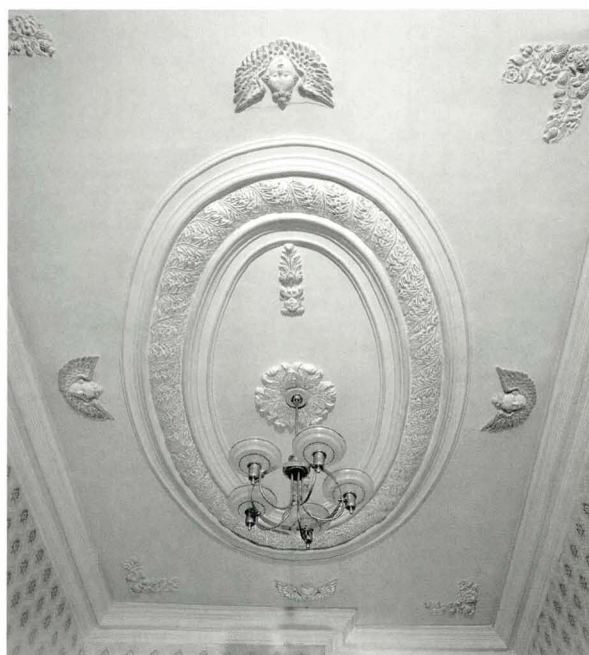
Illus 63. 341 High Street, Kirkcaldy, Fife (c1672); the oval panel was a new fashion, as was the use of a single central panel. © Crown copyright RCAHMS

Evidence of these changes in style can be recognised in many ceilings, despite the individual differences. For instance, the plasterwork at Kirkcaldy (see illustration 63) has an oval central panel – a new shape for Scottish ceilings – and a decorated frame or rib, probably based on a shallow, wide, run moulding, built up with a large quantity of repetitive pre-cast foliate enrichment. The motifs used are traditional, although these versions are sometimes more refined than earlier ones. A similar rib to that at Kirkcaldy, but without any visible run moulding, was employed at Arbutnott probably in the 1660s, which was also a throwback to similar ribs at Roslin (1622).

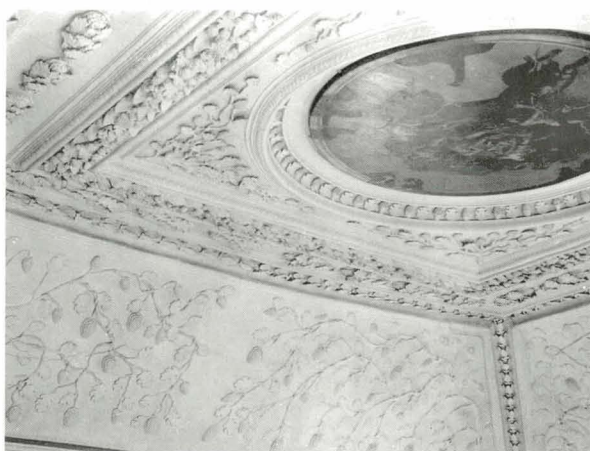
Illus 64. Kellie Castle, Fife (1676); the vine room illustrates changing ideas in plasterwork with its painted central panel and the free-flowing vine motif. © Crown copyright RCAHMS

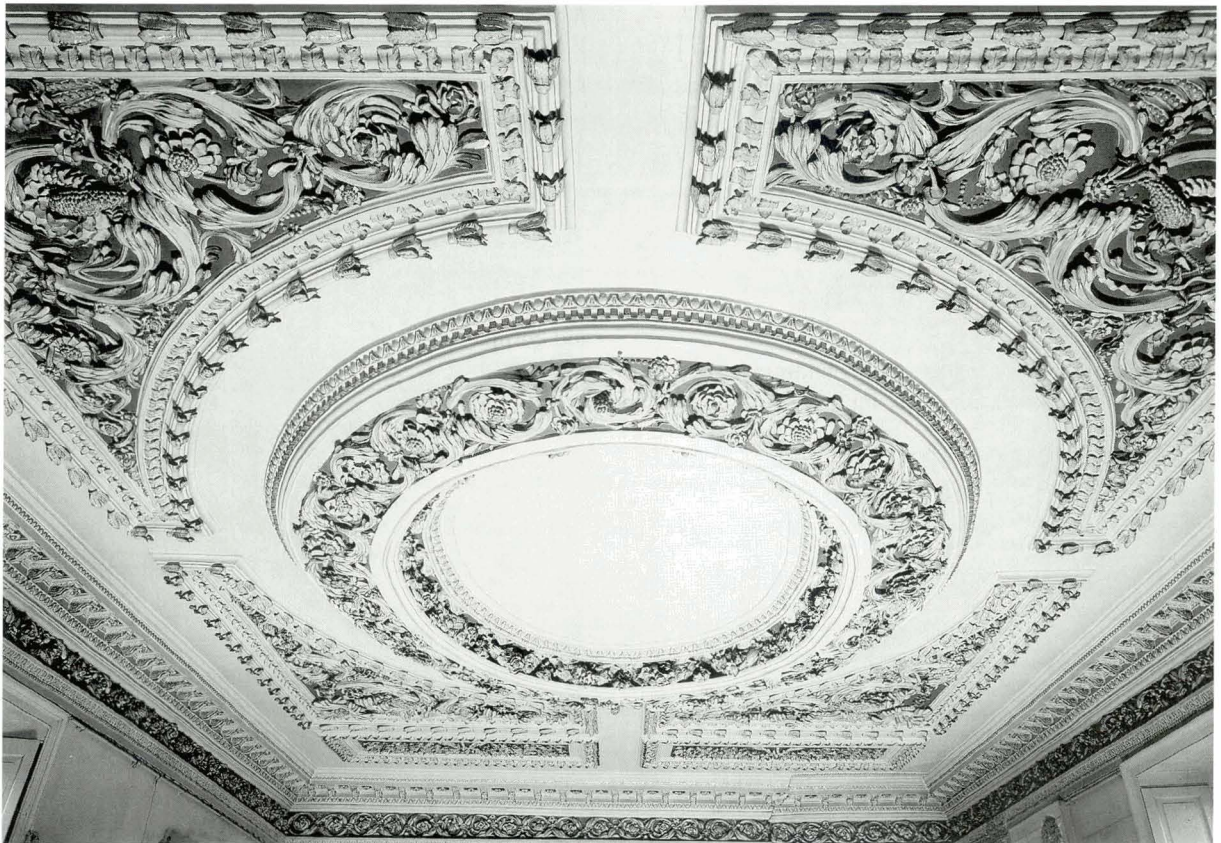
Illus 67. Bannockburn House, Stirlingshire (1680); a baroque style had established itself by this date, replacing the simpler plasterwork of the earlier C17. © Crown copyright RCAHMS

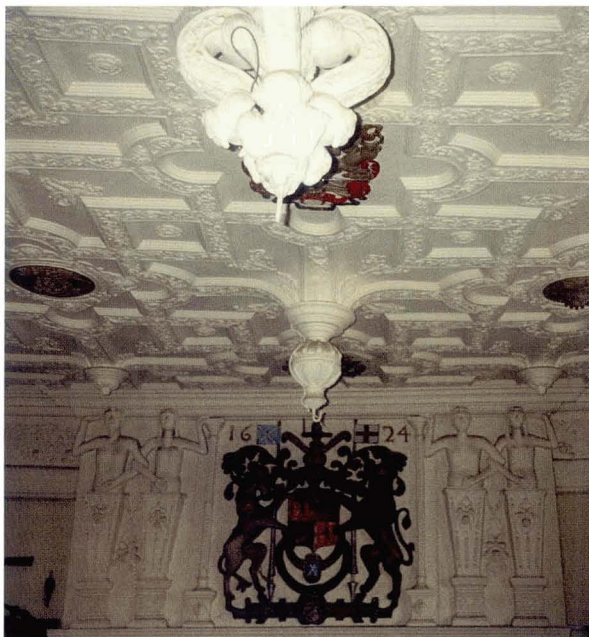
Illus 69 Strapwork with pendants, and fruit and floral decoration, Muchalls Castle, Aberdeenshire © Crown copyright Historic Scotland

The Burnet family remodelled the castle from 1619 to 1627, incorporating older work. Three principal interiors, the laird's study, great hall and dining room, have Renaissance plasterwork of 1624, as lavish as any at this period. The great hall has a rich strapwork frieze and 11 pendants, the central one almost 1m long and hugely elaborate, made of 4 scrolls with protruding human and animal heads. The ceiling is compartmented by wide ribs enriched by fruit and floral decoration. Coats of arms of the Burnets, their relatives and political associates are positioned within ceiling panels and above the windows. Other panels contain medallion heads of Hector, Alexander, David

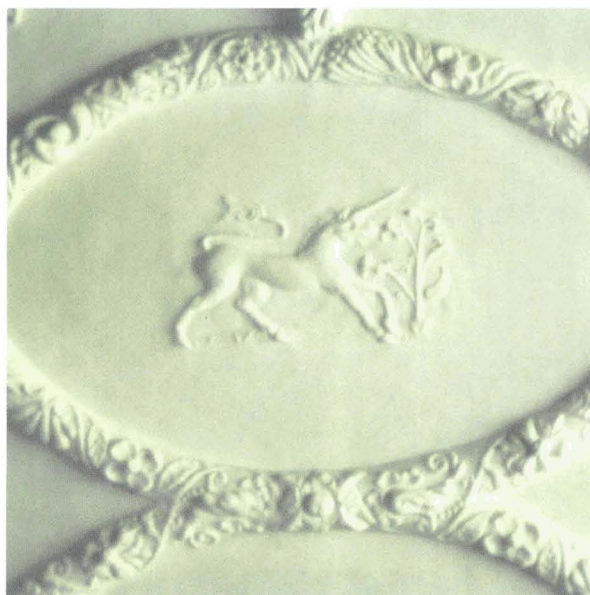
Illus 70 Rounded, cast floral enrichment, Pinkie House, Musselburgh, East Lothian © Scottish Lime Centre

Later 16th century L-plan house, extension started c1613, but not finished until later. The initials AS.ED and AS.MH appear frequently in the decoration (Alexander Seton, chancellor to James VI, who became 1st Earl of Dunfermline in 1605, and his wife Margaret Hay, married 1607). One room on the 1st floor and 3 rooms on 2nd floor have early 17th century plaster ceilings. Earliest plasterwork (copied at Winton) in the green room or hall is said to be 1613, has rounded cast floral enrichment forming ribs (without any run mouldings), forming a pattern of 4 squares and 5 circles linked by ribs, with delicate floral motifs (fleur-de-lys and roses) in outer circles and squares. A portrait medallion in strapwork frame occupies the central circle; the spaces between have terminal figures and branches with thistles, roses, acorns, etc., also crowned monograms and cinquefoil in crescent. The 3 rooms on the 2nd floor have 'probably the finest 17th century plaster ceilings in Scotland' (RCAHMS Inventory). In the King's room (N), ribs are wide and shallow, enriched with a floral

pattern incorporating roses, fleur-de-lys, etc. (similar to Bromley-by-Bow?). There are massive and elaborately wrought pendants; many of the motifs are the same as in the green room, suggesting that the date might be the same, or at least the moulds; however they also include more elaborate scenes such as a lion (or deer, or unicorn?) among foliage. The layout of ribs and panels is more elaborate, and there is a cove and (later?) cornice around the edge. The Seton room (south) has ribs as in the green room, but a more elaborate and sinuous overall design, plus a Seton coat of arms above the fireplace. Both here and in the turret stair and passage, crowned monograms and cinquefoils in crescents recur. Elsewhere in the house there are also plaster ceilings in a later style from c1700 to 1740, with the initials SIHM for Sir John Hay and his wife, to whom it passed in the 1690s. Charles I stayed here, as did Bonnie Prince Charlie. Now part of Loretto School (private).

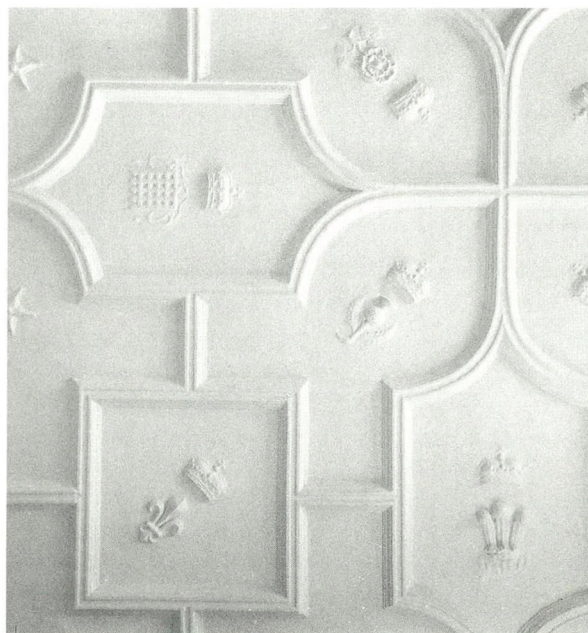
Illus 71 Ribbed and enriched ceiling, Baberton House, Edinburgh. © Crown copyright RCAHMS

Built in 1622-3 by James Murray of Kilbaberton, master of the King's Works. On the principal floor, the office (formally withdrawing room) adjacent to the dining room, has a ribbed and enriched ceiling; narrow ribs with a cast relief in each compartment; stars in the outer panels, the inner have items from the national arms of Great Britain (except the Scottish lion); Prince of Wales (ostrich) feathers, and fleur-de-lys (the Tudor emblems, similarly employed at Winton), thistle, lion, portcullis, harp, rose as at Muchalls and Craigievar (some slipped below a crown). East wing drawing room has plaster cornice enriched with bayleaf garland, possibly late 17th century or early 18th century. Now commercial offices, privately owned.

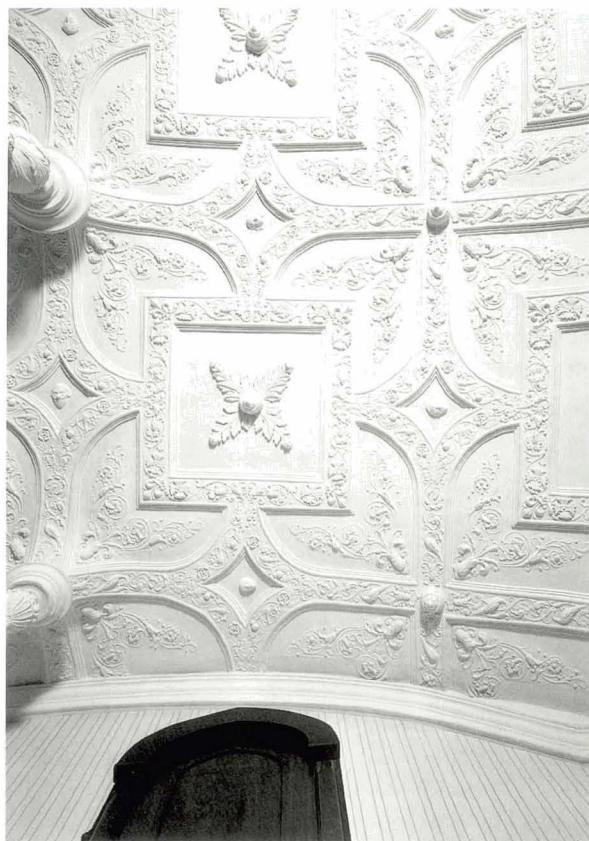
Illus 73 Arched, floreated ceiling in Sea Room, House of the Binns, West Lothian. © Crown copyright RCAHMS
