INFORM

INFORMATION FOR HISTORIC BUILDING OWNERS

Terracotta and Faience

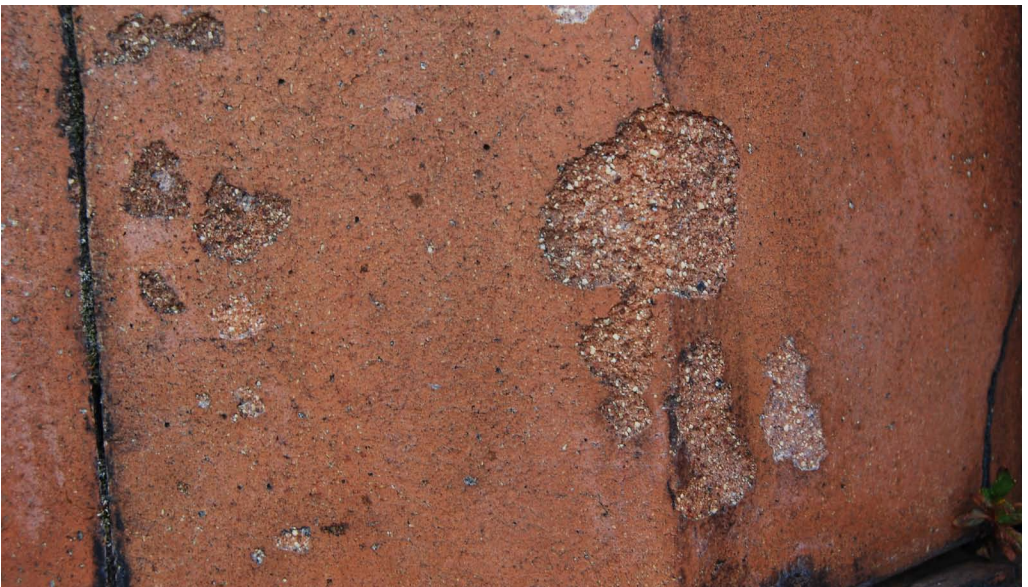
Fig. 2: Spalling has led to the loss of the terracotta fireskin leaving the material vulnerable to further decay

Spalling is caused by water penetrating the material and then migrating back to the surface or freezing in cold weather causing it to expand.

Where the spalling is more serious and there is a substantial deterioration of elements and loss of original fabric it will be necessary to replace these elements. Spalling can cause serious problems if not attended to early as it can lead to further deterioration of both the ceramic material and the anchoring systems which hold it to the building behind.

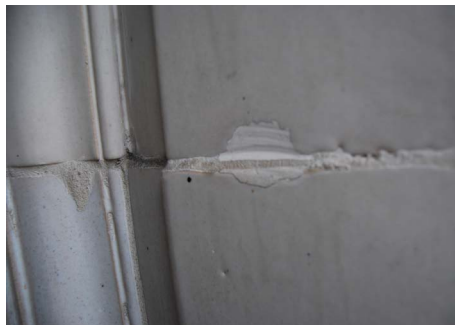
Fig. 3 Small areas of material spalling can be repaired using a fill of hydraulic lime mortar

Where spalling is minor the best solution may be to paint with the same reglazing product as in the case of glaze spalling to prevent water ingress whilst avoiding the expense of replacement.

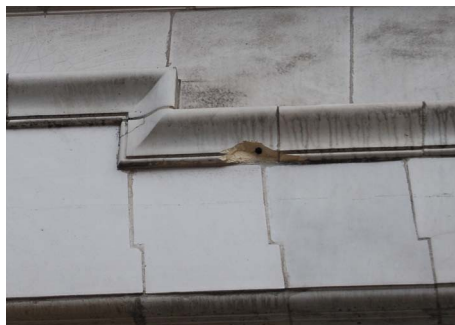
Fig. 4: In this faience clad structure spalling of the material has revealed deterioration of the anchoring system

As these parts of the structure of terracotta and faience architecture are hidden from view such deterioration is often hard to detect unless a serious problem has occurred. Any evidence of displacement of elements, spalling or rust staining should be followed up with a thorough investigation to check for potential failure of anchoring systems. A serious failure of anchoring systems will put the public at risk.

The cause of such deterioration will most likely be water ingress causing a failure of ferrous metal fixings due to saturation and associated decay. When repair is being carried out the source of this water should also be rectified.

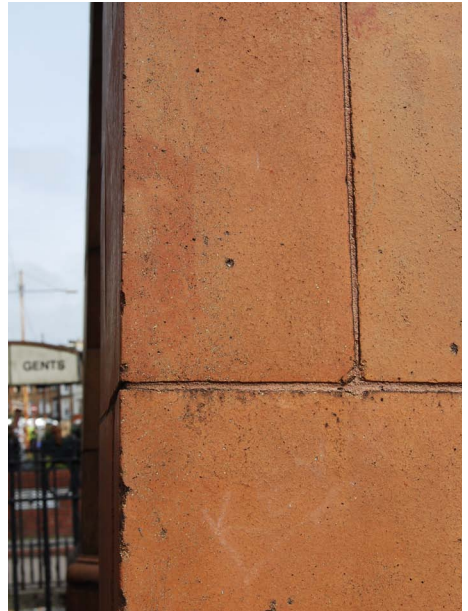
Fig. 6: Re-pointing work should be undertaken using lime based mortars and can be coloured to blend in with the architectural ceramic.

By using lime based mortar, moisture which has penetrated into the structure of the building will be allowed to evaporate through the joints. An impervious cement based mortar should not be used as this will not allow moisture to escape in that way. Likewise, waterproof caulking of joints should be avoided. As well as the binder it is important that a fine sand be used as the aggregate for repointing mortar for architectural ceramics.

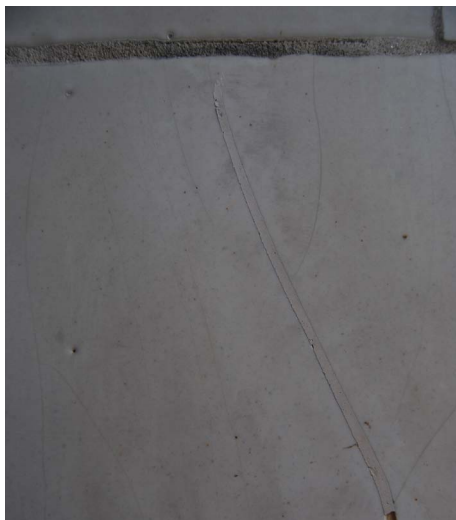
Fig. 8: Missing pointing should be replaced to avoid water ingress and further deterioration

Whilst not appropriate for re-pointing, a waterproof caulking material can be used to fill small holes or cracks which do not warrant the replacement of the element but if left un-repaired, would allow water to penetrate the surface of the material and lead to further deterioration.

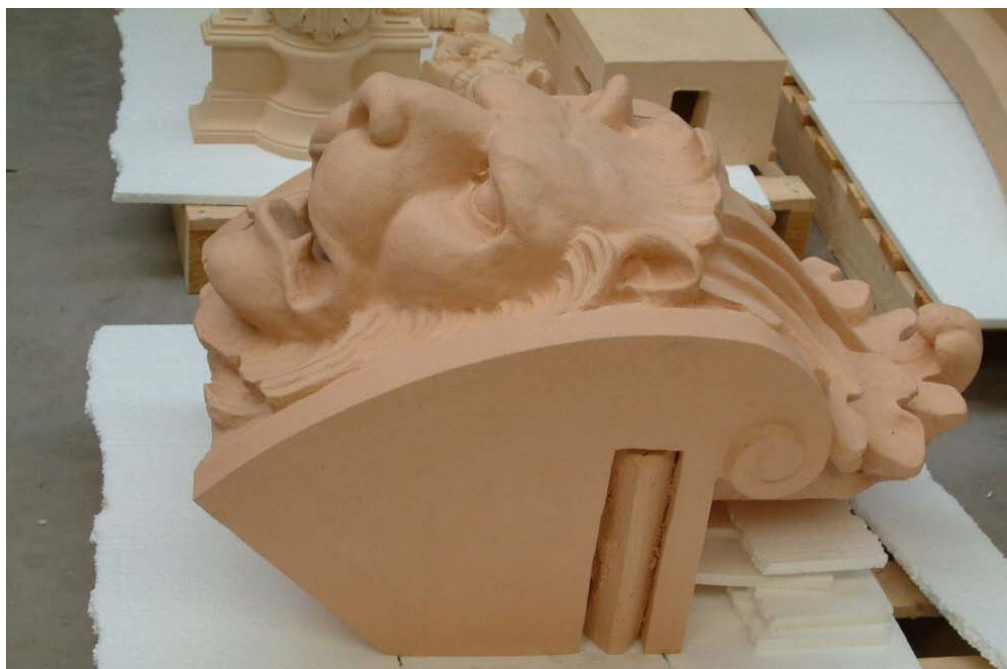
Fig. -9: A replacement terracotta unit manufactured to replace one which had suffered severe deterioration

Replacement units should be anchored using stainless steel or non ferrous fixings rather than the iron or mild steel fixings to reduce possible corrosion in the future. However, it may not be advisable to anchor replacement elements into the same holes which held previous fixings as these may be a source of weakness and a new hole may have to be drilled to take fixings.
