TECHNICAL
ADVICE
NOTE

THE
ARCHAEOLOGY
OF
SCOTTISH
THATCH

by
Timothy G Holden

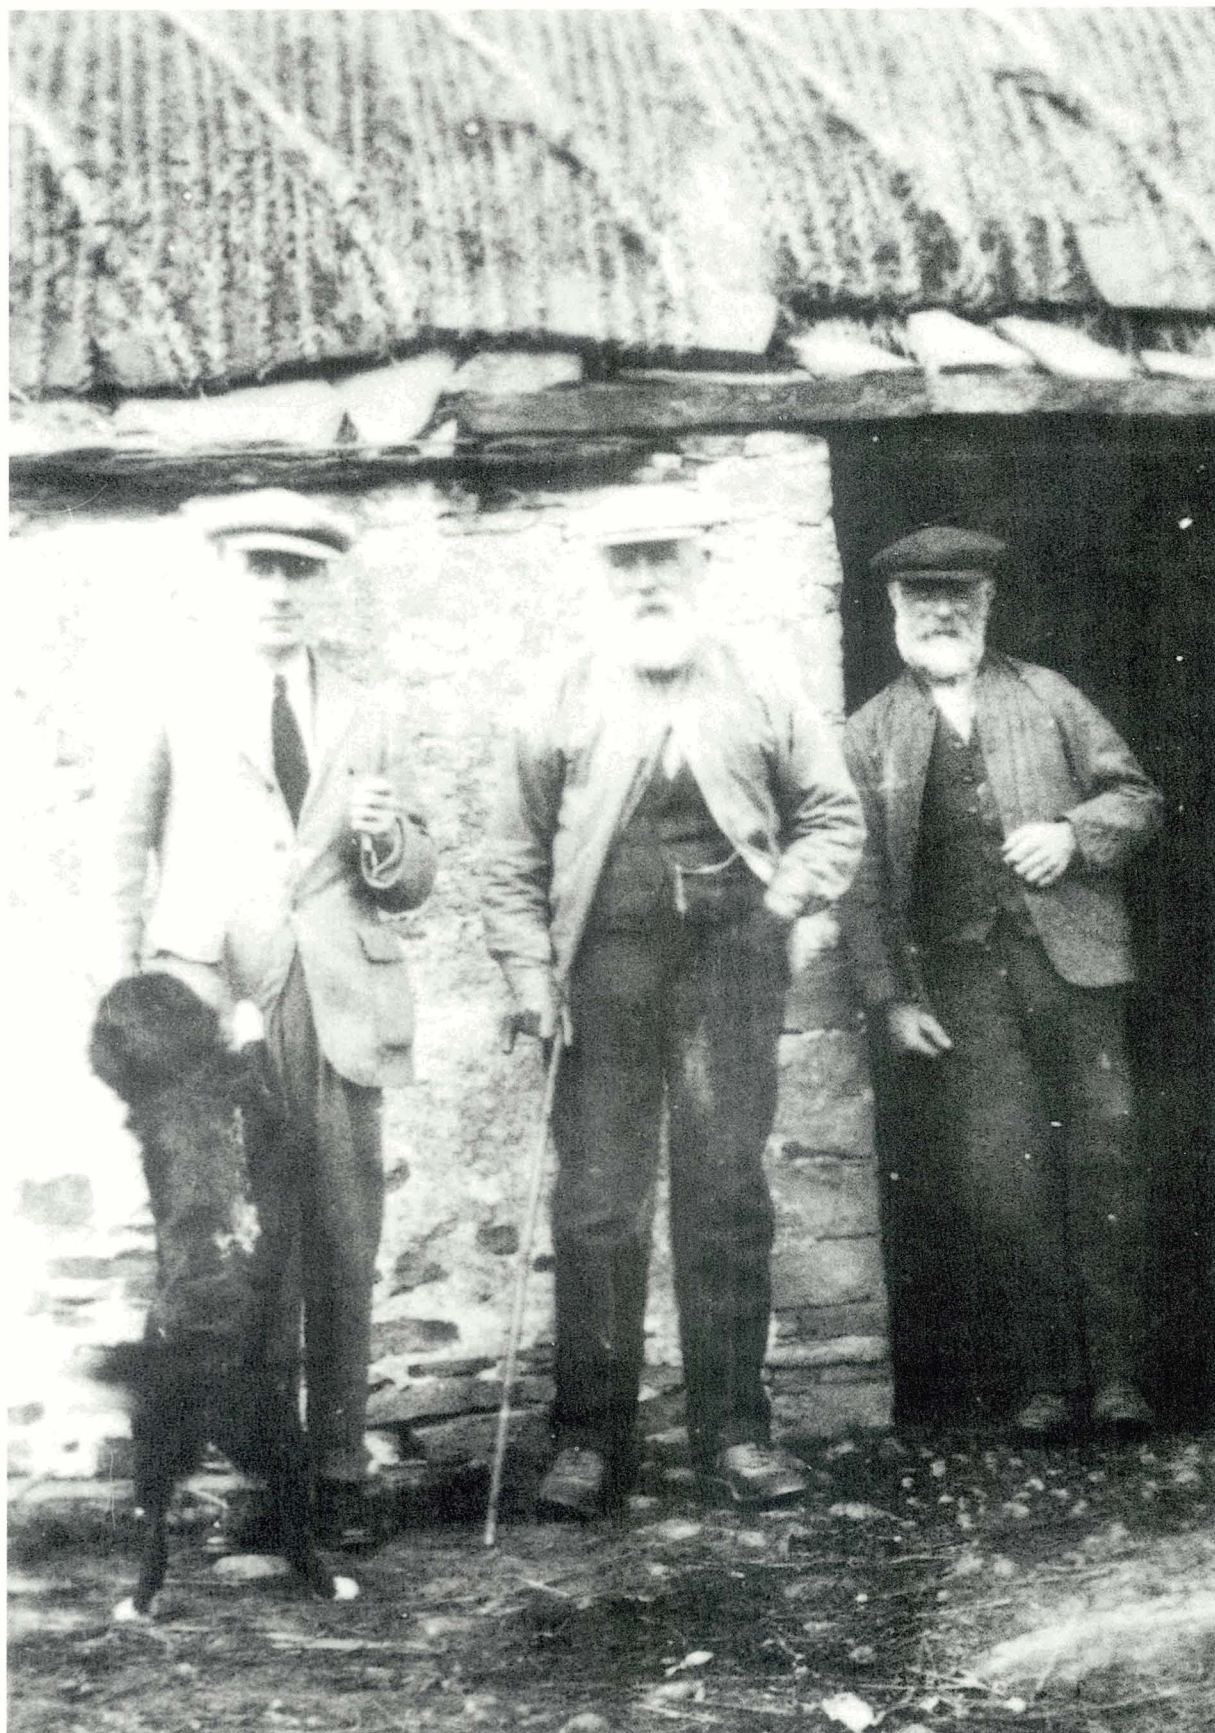
An unusual needle thatch from Orkney with diagonal as well as standard simmens. (National Museums of Scotland C12181).

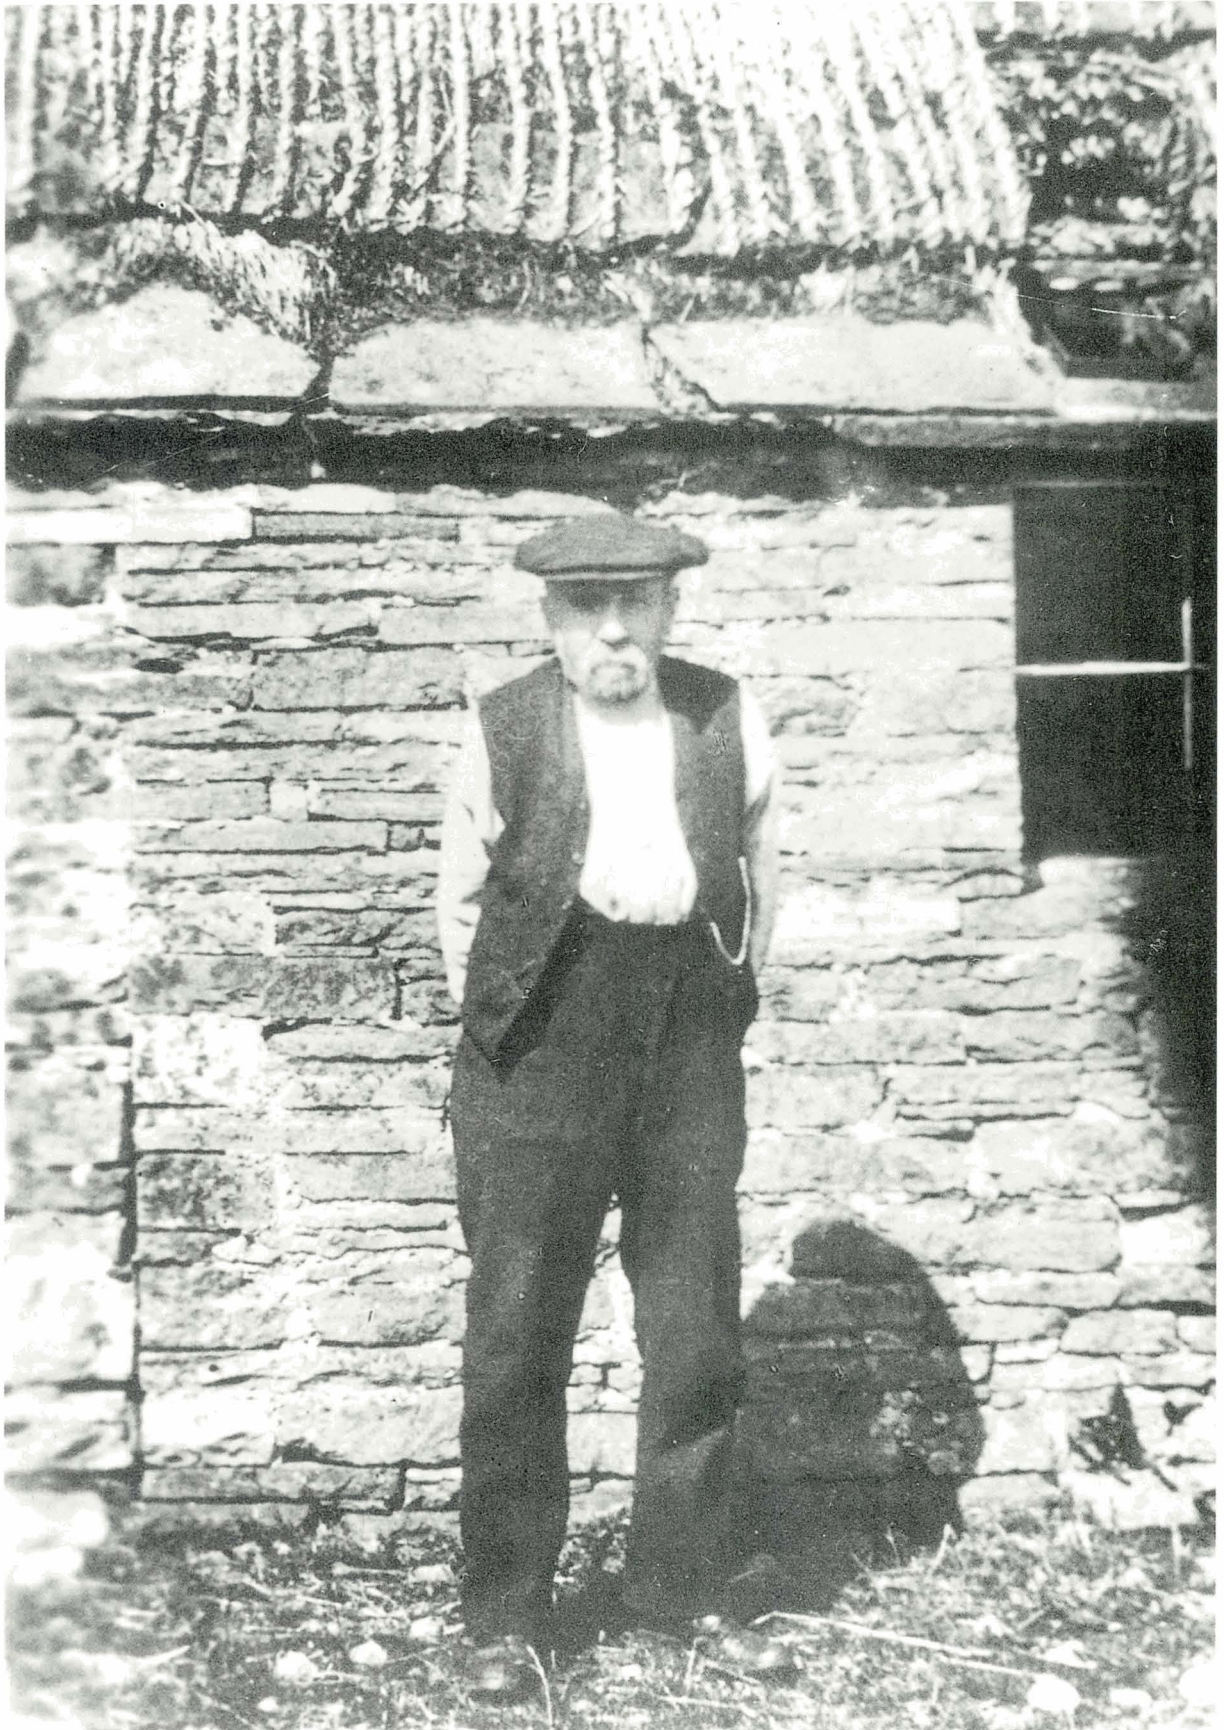
A needle thatch from Faray, Orkney. Note the Orkney flagstone at the eaves and the rooflight over the window. (National Museums of Scotland C8332).

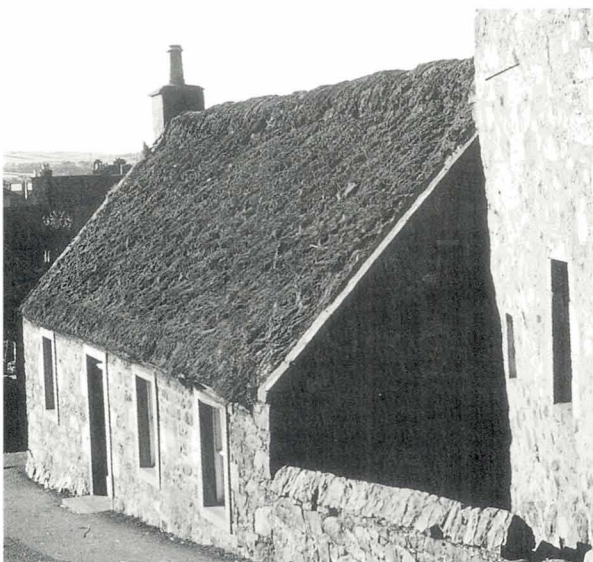
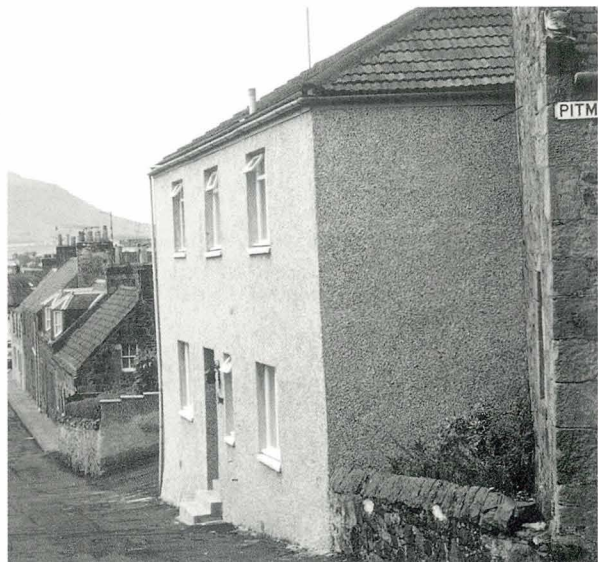
Auchtermuchty, Fife. This roof consisted of a basal turf layer originally with an oat straw thatch. At a later stage short layers of reed were driven through the oat straw. The ridge was capped with a mudwall mix and turf. Before (1974) and after (1980) renovation (B.W.)

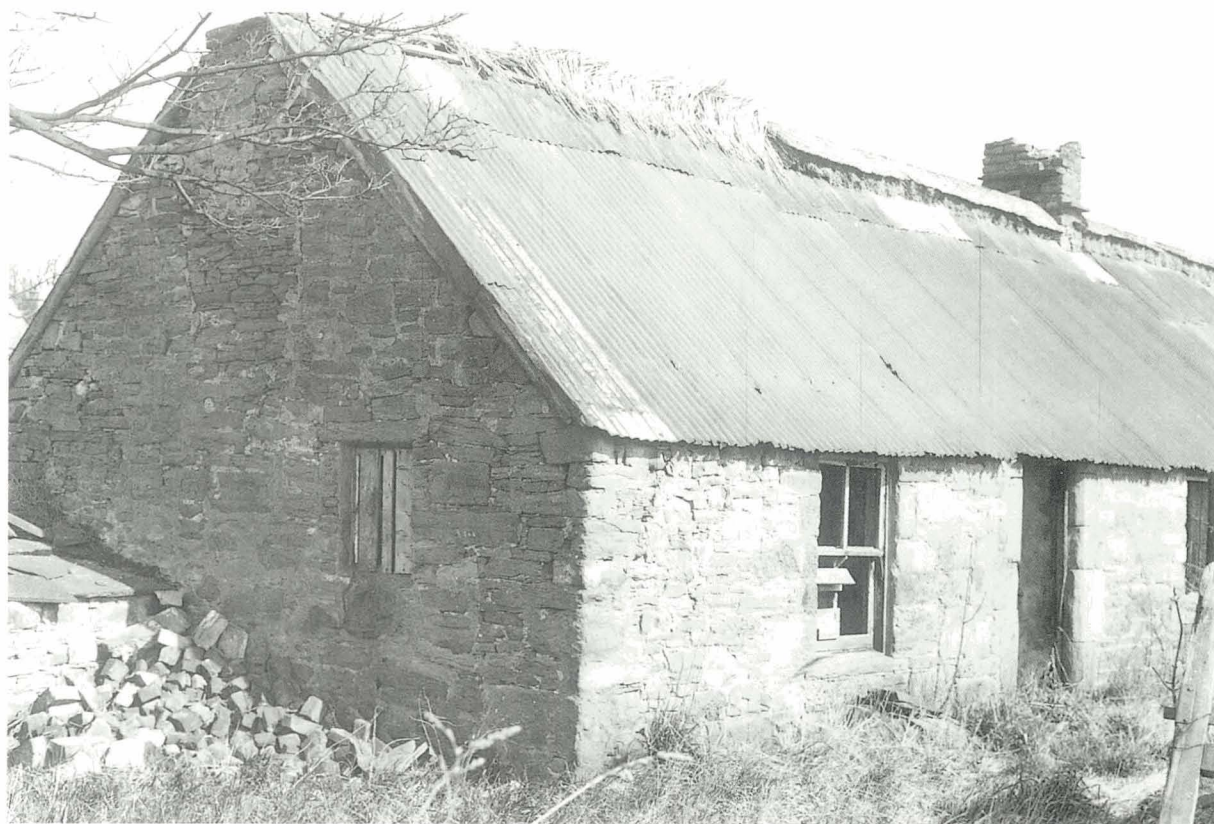
*Thatch is often preserved under corrugated iron or other sheet materials. In this case the thatch was of reed. Murroes, Angus.
(B.W.)*

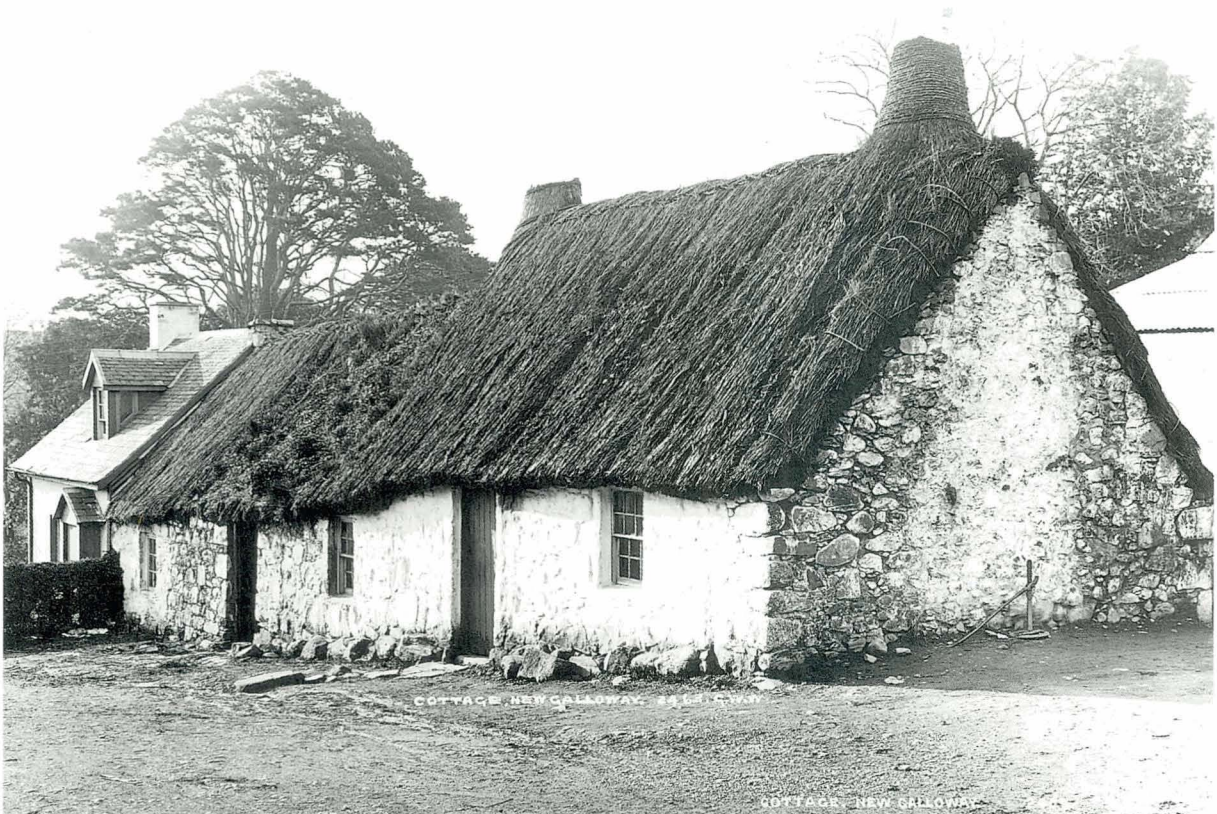
A cottage, New Galloway, Dumfries and Galloway. The dark colour and coarse texture suggest this might be a broom thatch. Note the rolled skewes, roped chimney heads and scob and wand fixings at the ridge.
(G.W.W. Aberdeen University Library E1509)

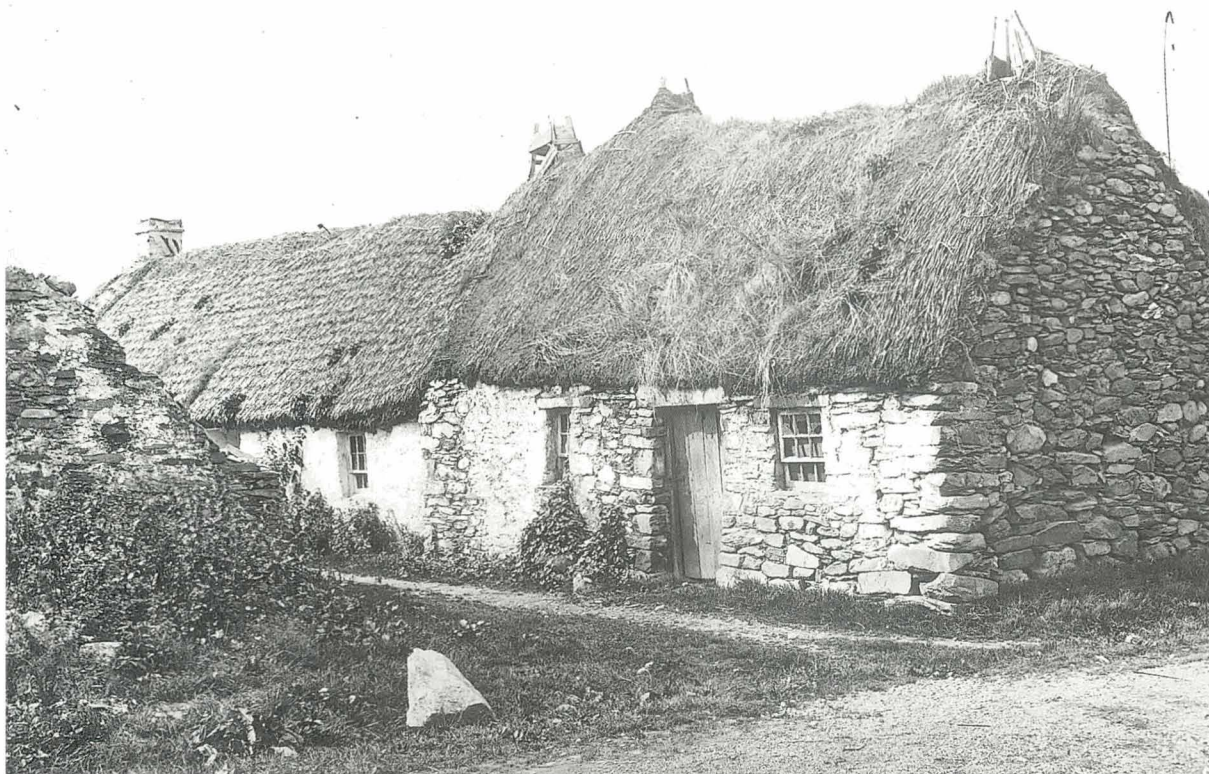
Two Highland cottages, at Luss, Loch Lomond. Different thatching techniques are shown on adjacent buildings. The house on the left is probably a bracken thatch, the horizontal lines being formed by the blackened basal parts of the stipe exposed on the surface. Close to the apex wand and scob have been used as a fixing. The house on the right is in a much poorer condition and appears to have a coarse material such as bracken close to the skewers but other parts of the roof look more like cereal straw. (G.W.W. Aberdeen University Library F4310)

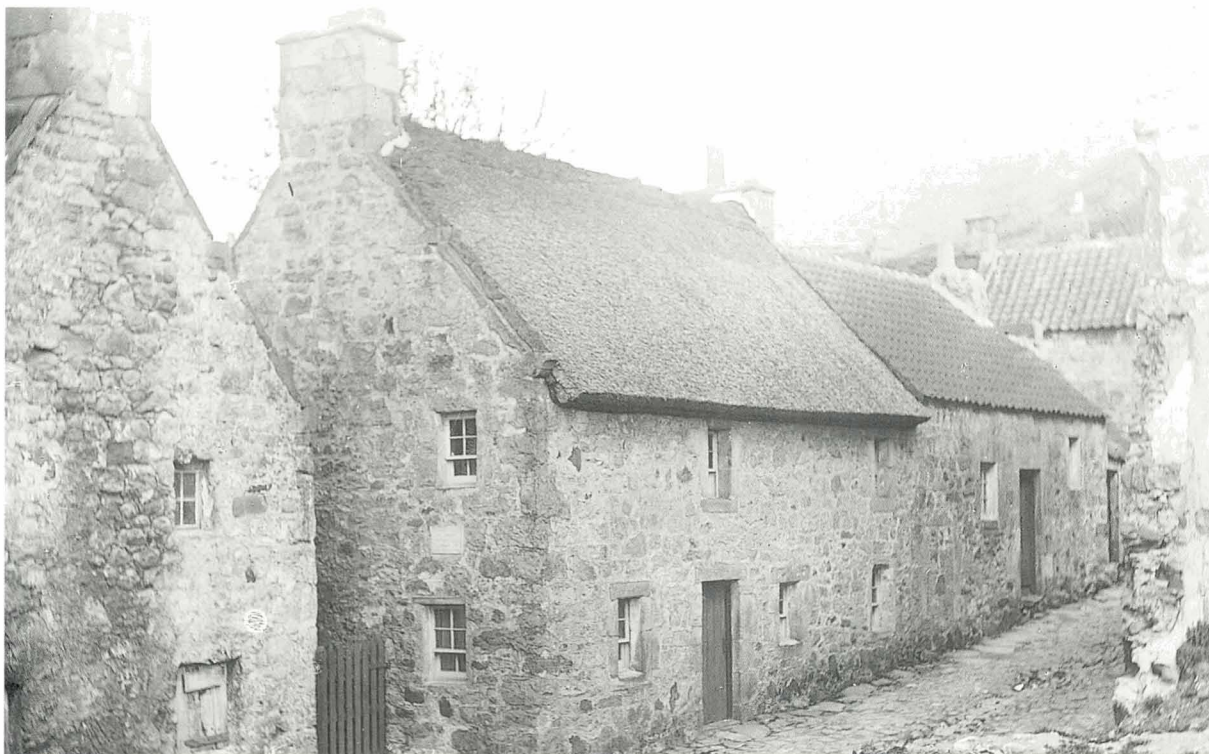
Michael Bruce's Cottage, Kinnesswood, Loch Leven. Probably one of the earliest reed thatches in the area. The reed would have been stitched to the roof and the gable capped with turf. This commonly used roofing style superseded earlier cereal thatches in many east coast towns. Most have now been replaced with pantiles (G.W.W. Aberdeen University Library F5351)

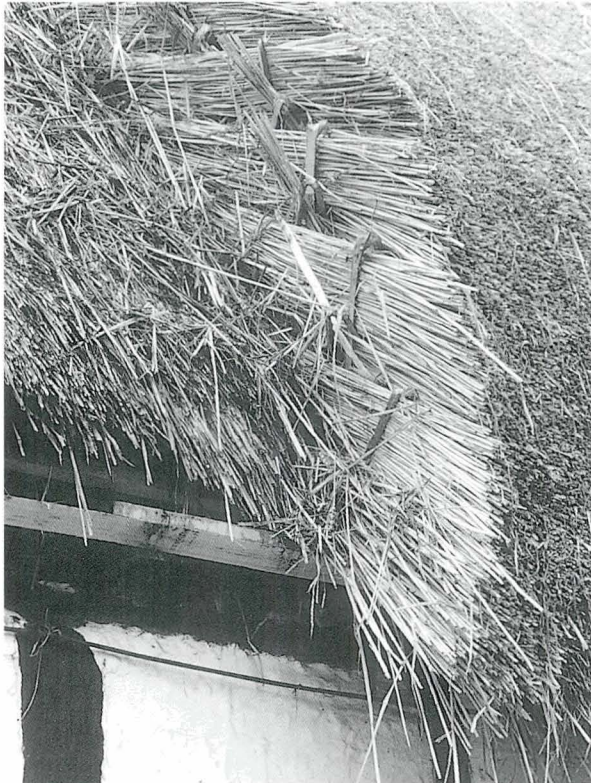
A wheat reed technique, Warwickshire. (B.W.)

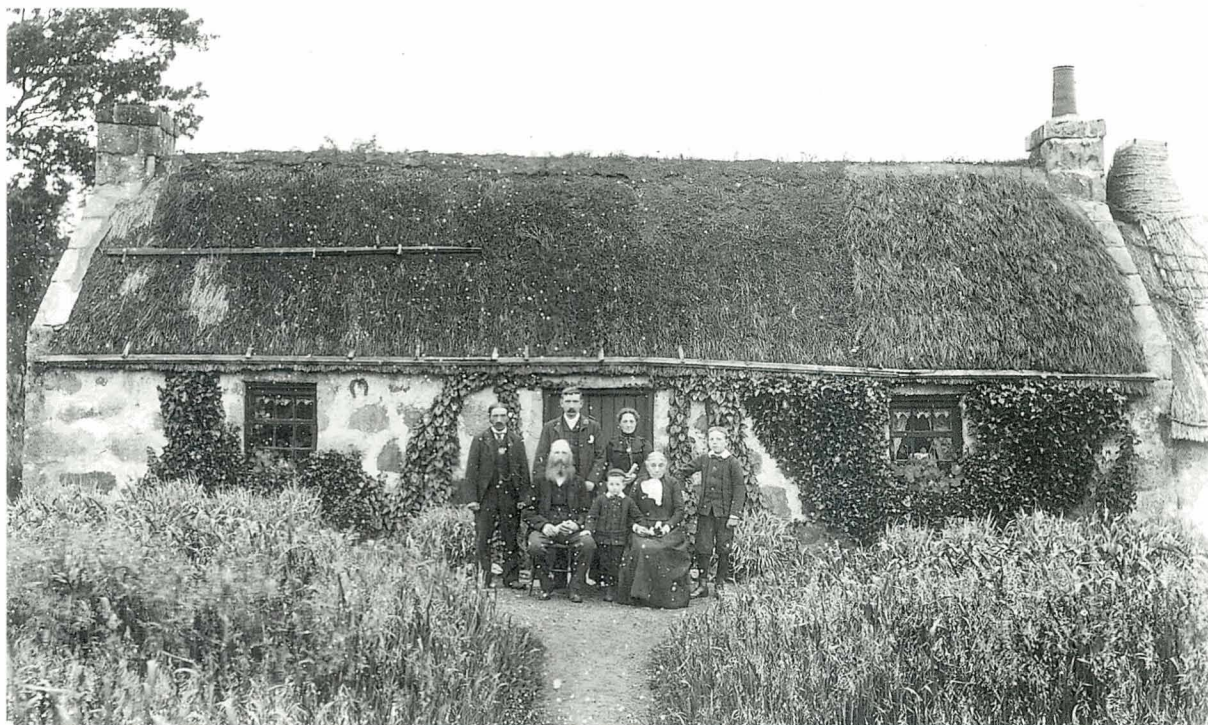
Ardoyne, Aberdeenshire. Possibly a broom thatch held down by chicken wire with a turf ridge. Note the rolled skew and roped chimney and fixings on the older house to the right. (National Museums of Scotland C5041)

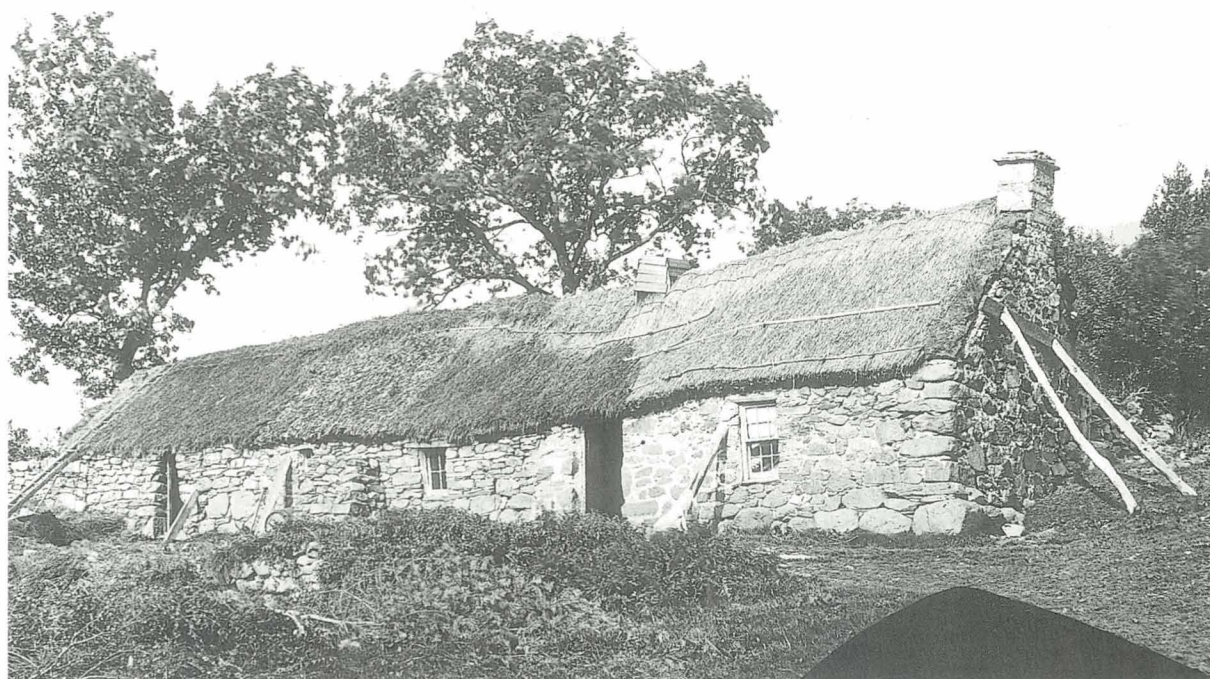
Mrs Ferguson's Inn, Bridge of Turk, Perthshire. These buildings show cereal or rush thatches in different states of repair. Scobed timber wands have been used to fix parts of the roof and stitched timber wands as fixings at the apex. (G.W.W. Aberdeen University Library F2883)

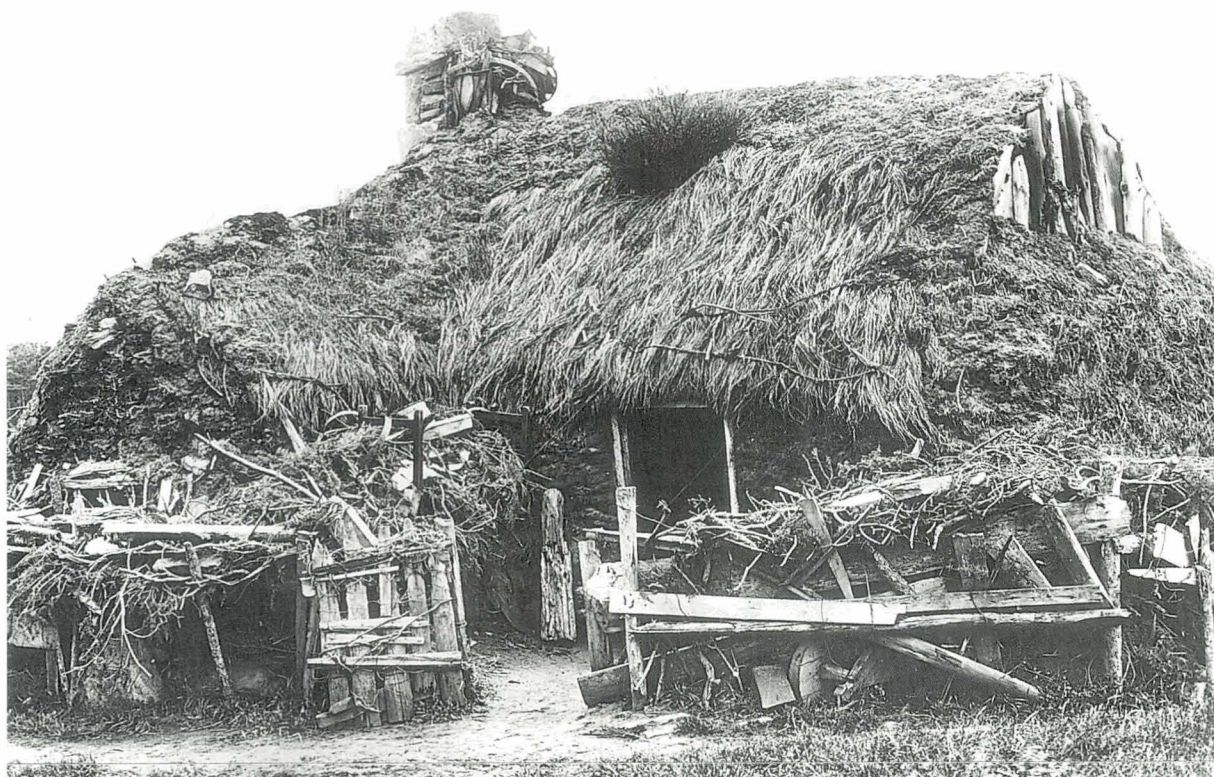
Annie Shaw's Castle, Nairn. This building has been repaired many times. Broom would appear to have been used to fix the roof. (G.W.W. Aberdeen University Library C1184)

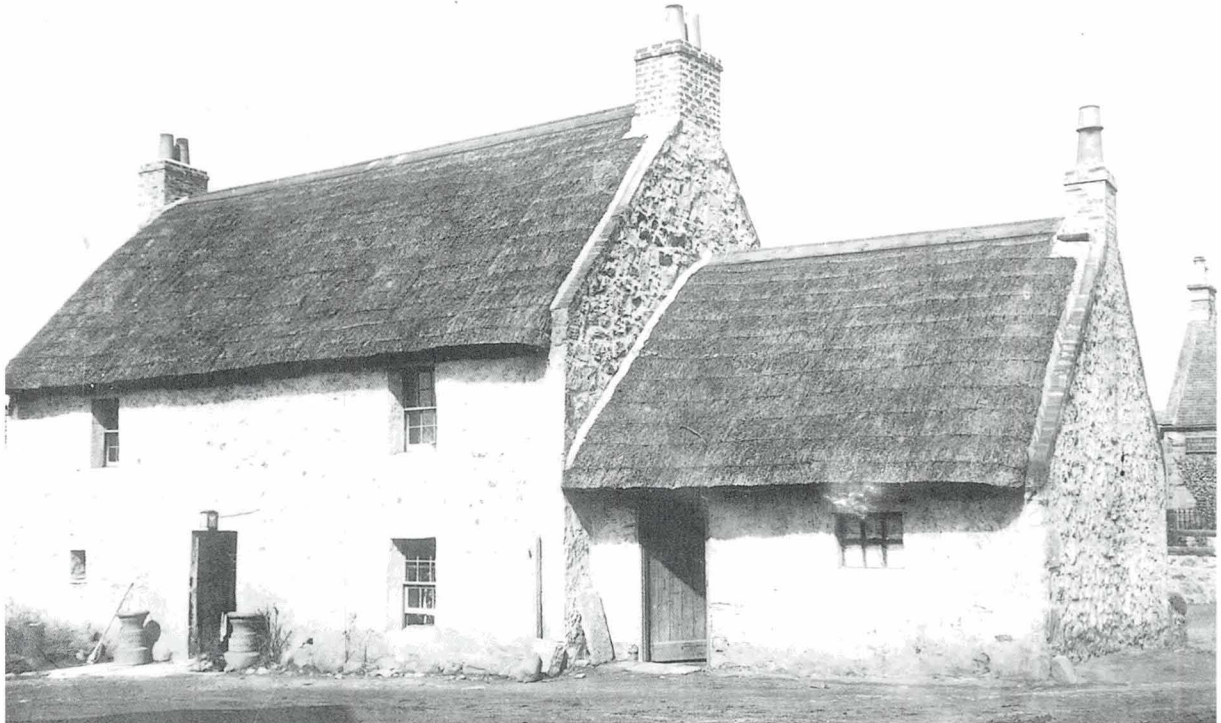
Corstorphine, Midlothian c1900. A cereal or reed thatch on a well-built two storey building. The horizontal lines across the roof are formed by raip and scob fixing. (National Museums of Scotland)

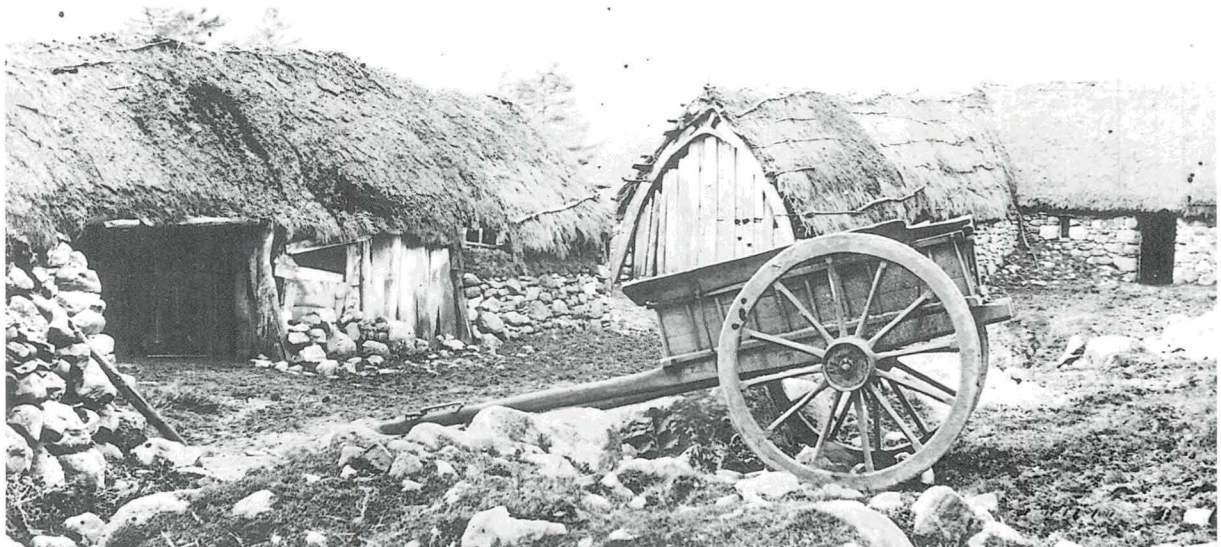
A Highland Steading, Kinlochewe, Wester Ross. A range of thatch types are shown. On the right the main farm house uses a method of secret fixing, the range to its left is secured using timber wands. The cart shed to the left of the photograph may have a deteriorating cereal or rush thatch although there are indications that turves or clay may be exposed at the surface. (G.W.W. Aberdeen University Library 0748)

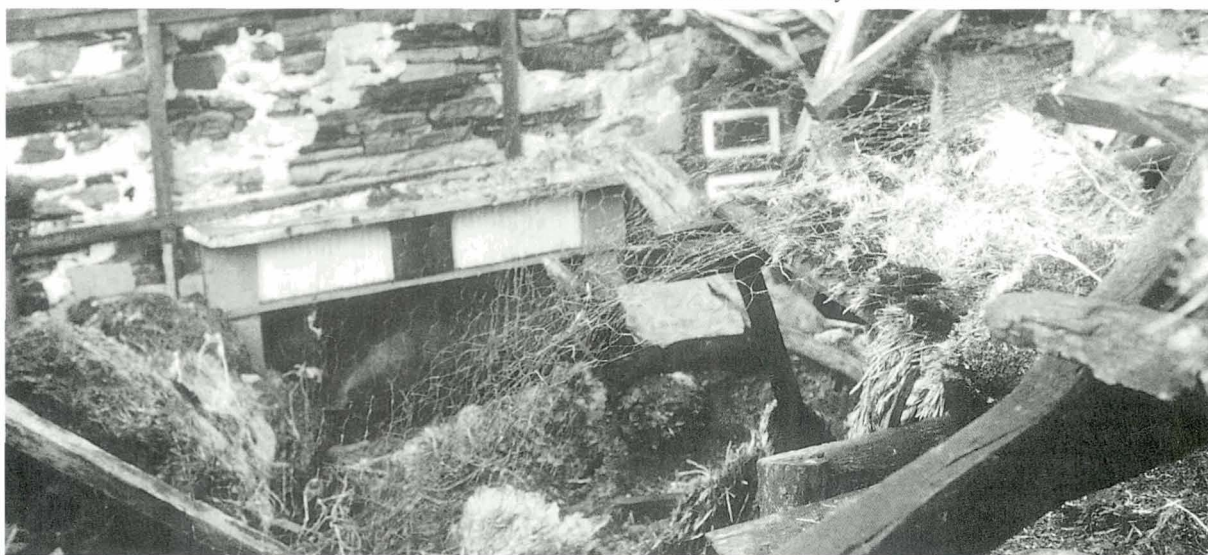
Up to 1m of organic material can accumulate after the collapse of the roof. (Gimps, Orkney 1996 see section 6.4)

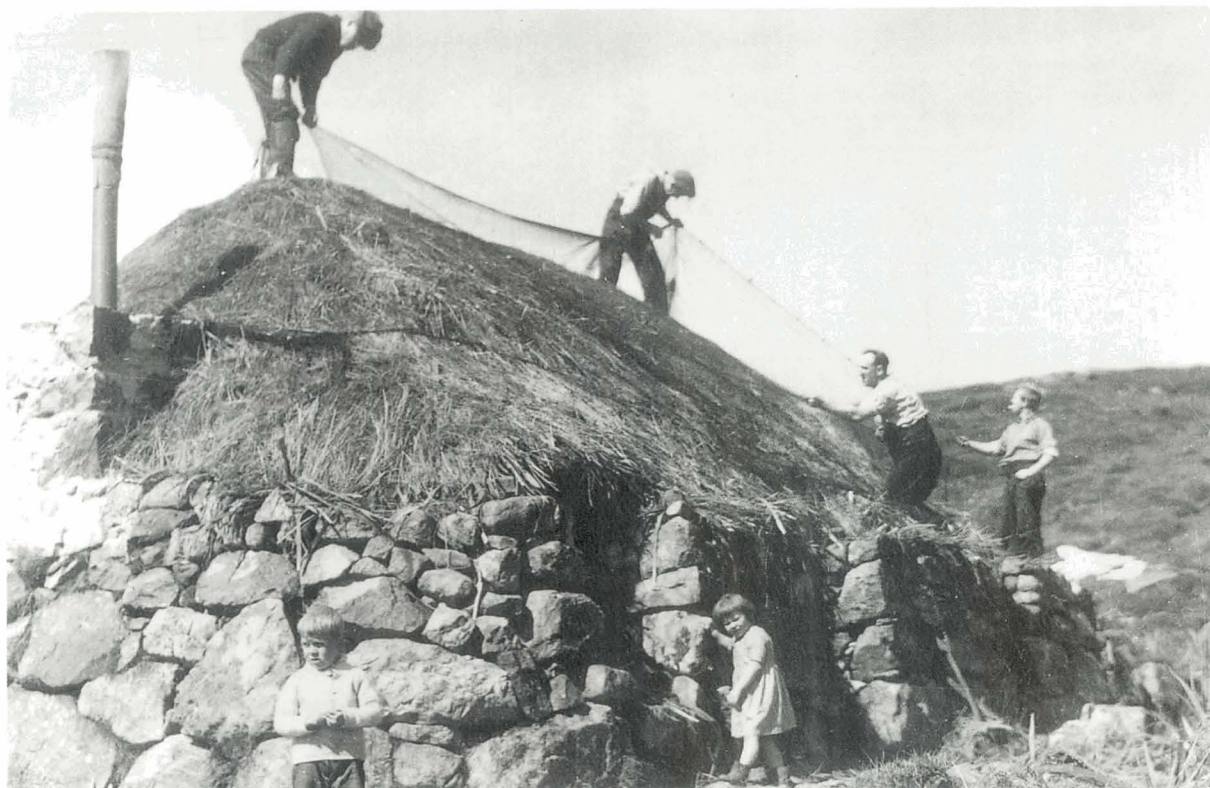
Netting and roping a thatch of cereal or bent on the Uists. (National Museums of Scotland C7684)

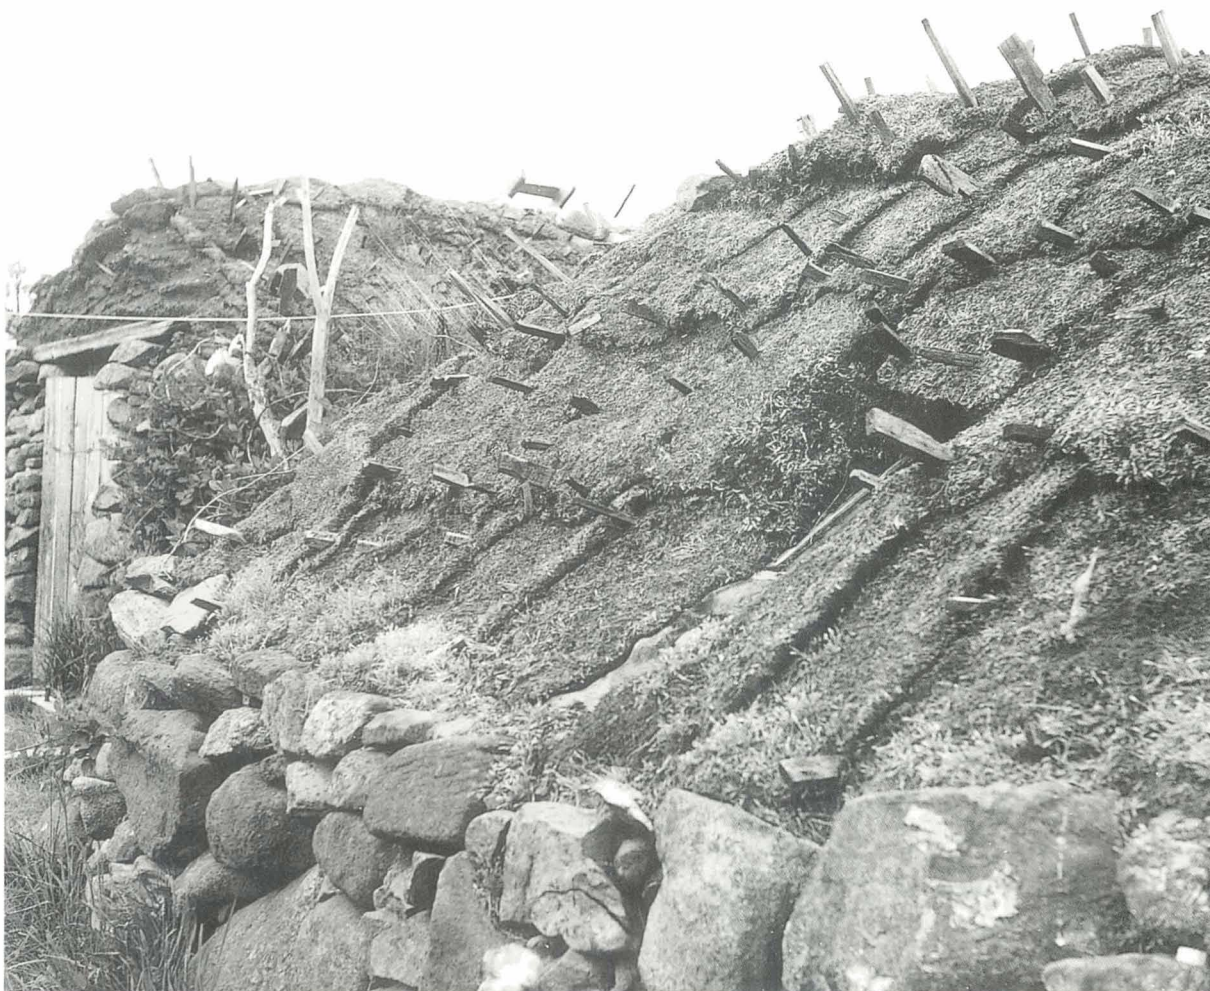
The bull's house on a Muckle Row croft, Orkney. Roof turves retained with wooden pins –1962. (Orkney Library)

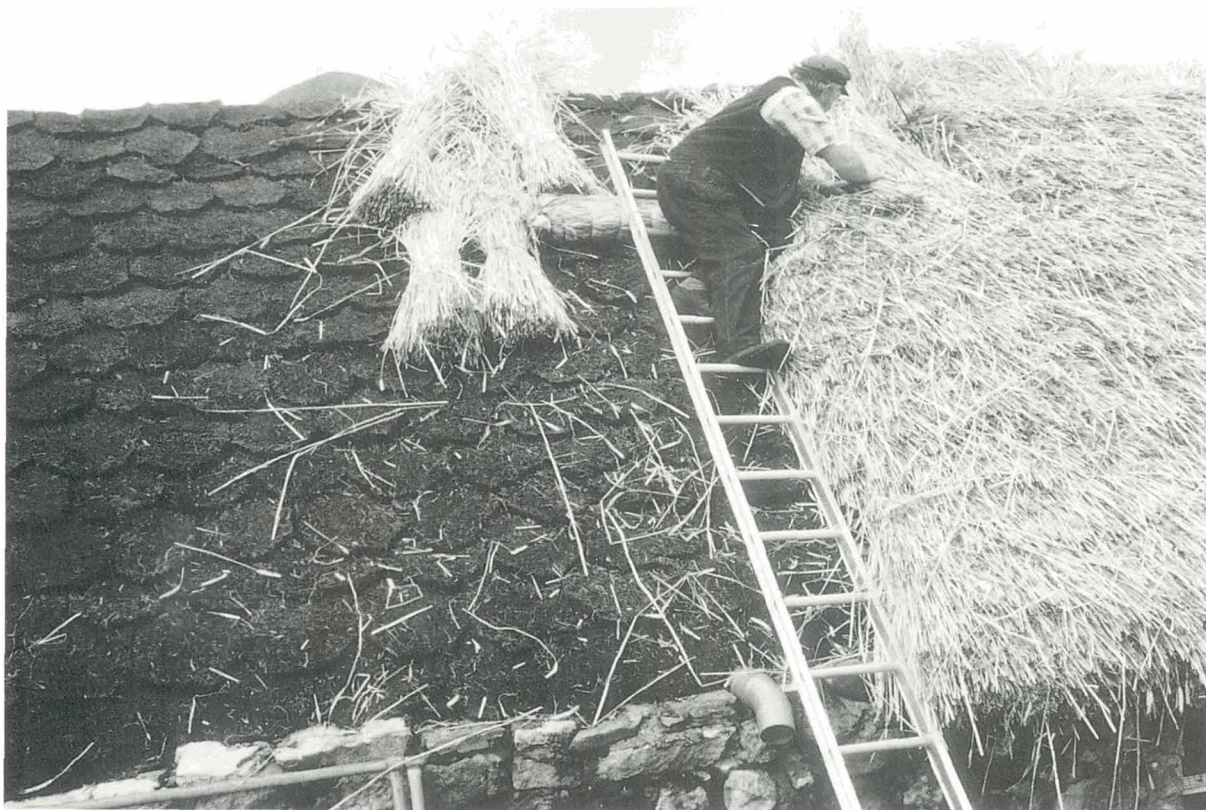
Cereal thatch over turf – Duncan Matherson, Luib, Skye. (B.W.)

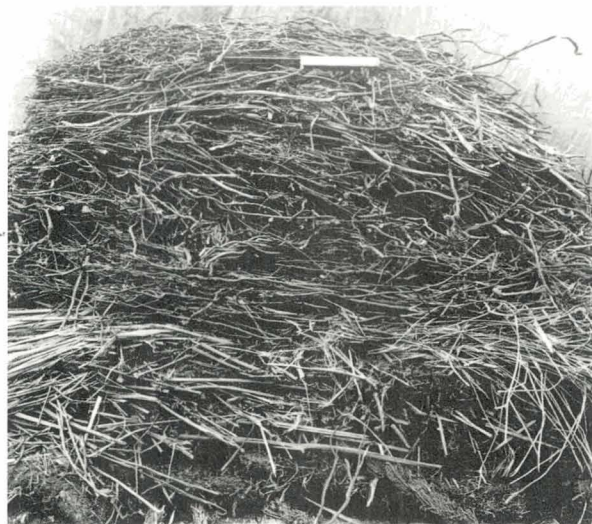
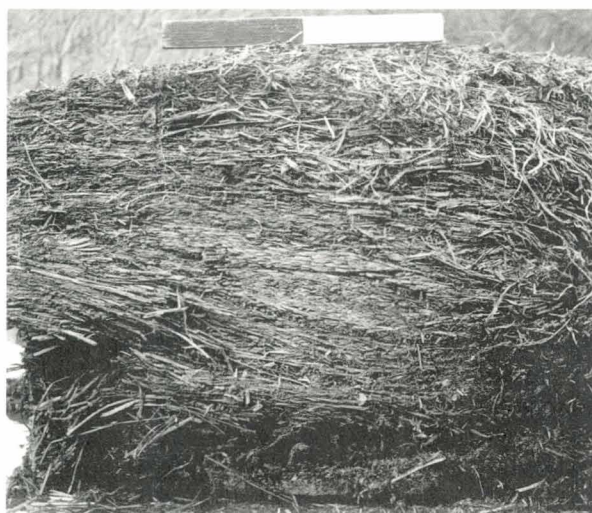
Sections through the thatch block.

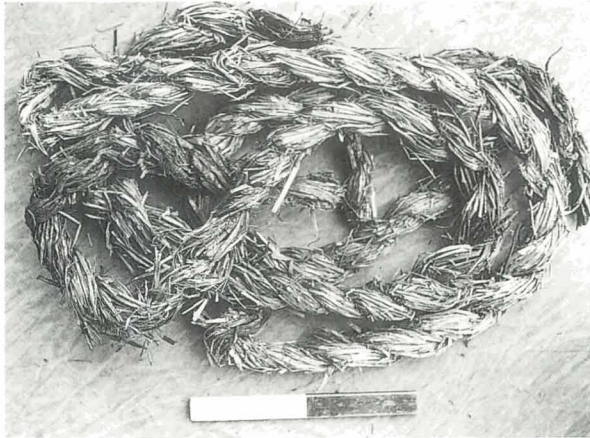
Simmens from the internal surface of the roof.

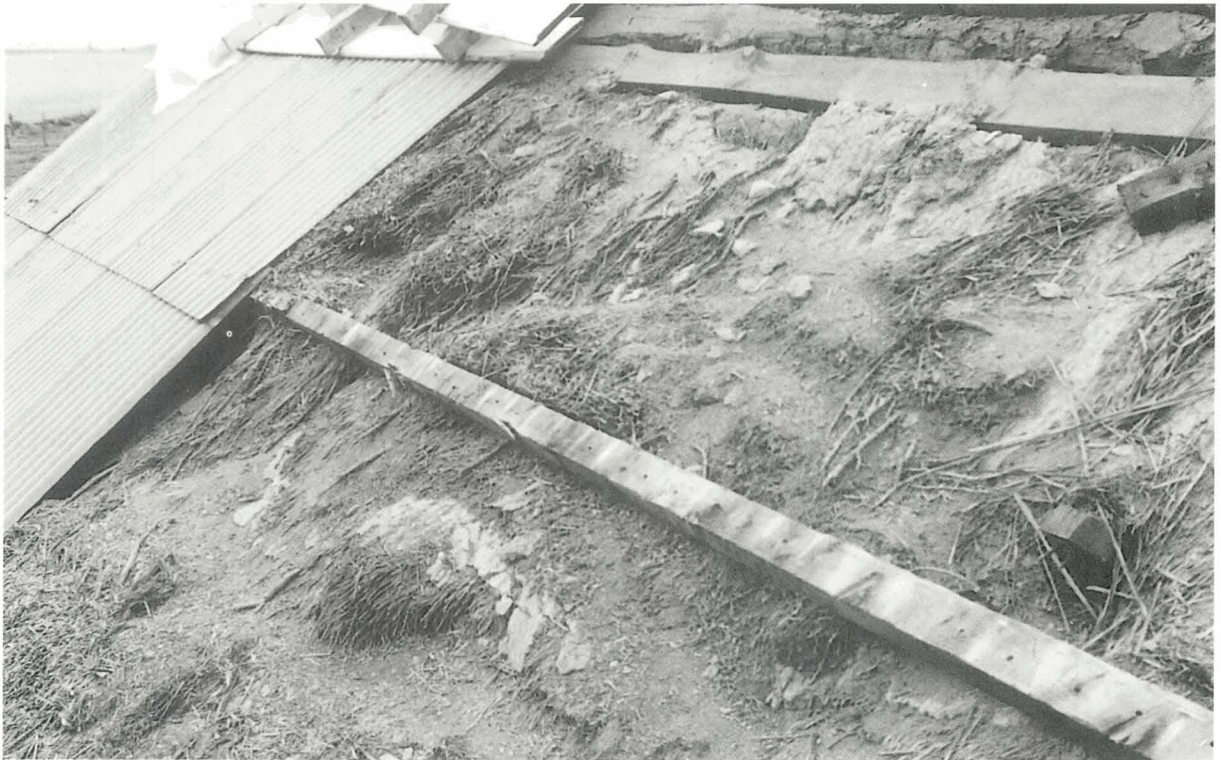
The eroded surface of clay, straw and broom. (T.H.)

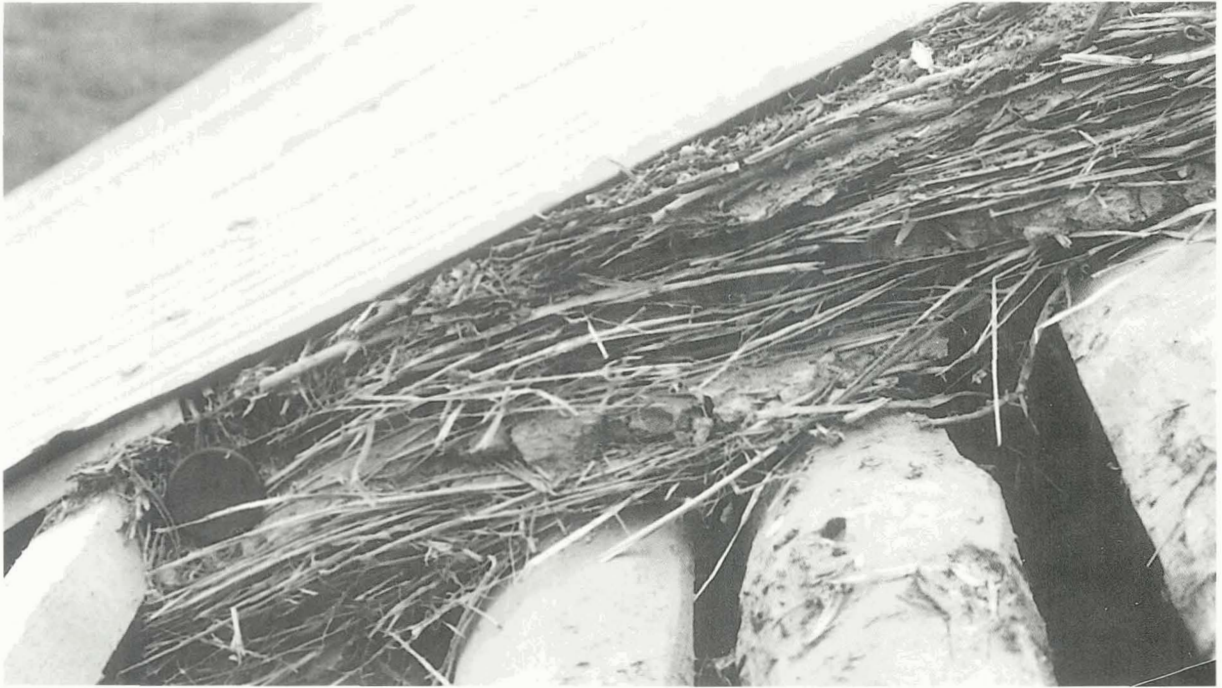
Section adjacent to sampled area. (T.H.)

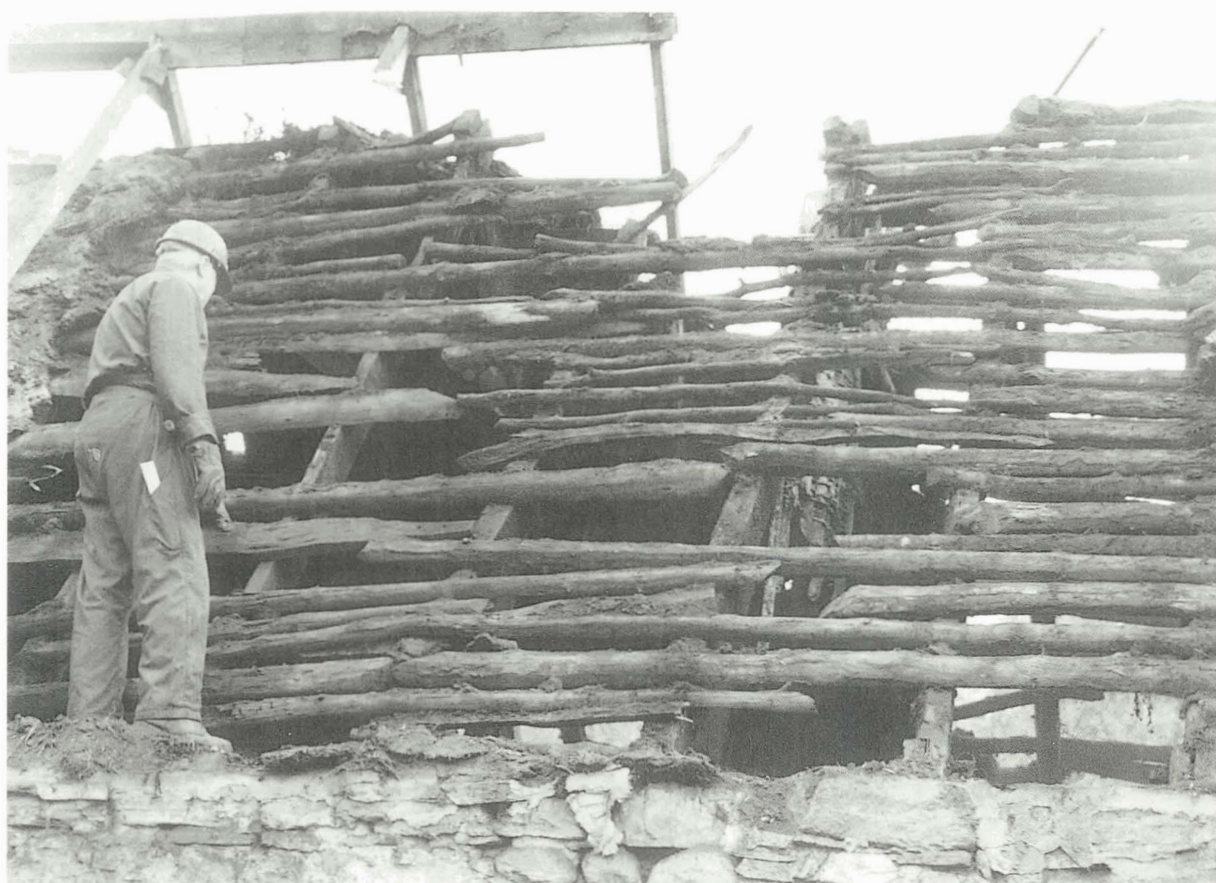
Johan Cottage, roof timbers following the removal of the thatch. (S.Whyman)

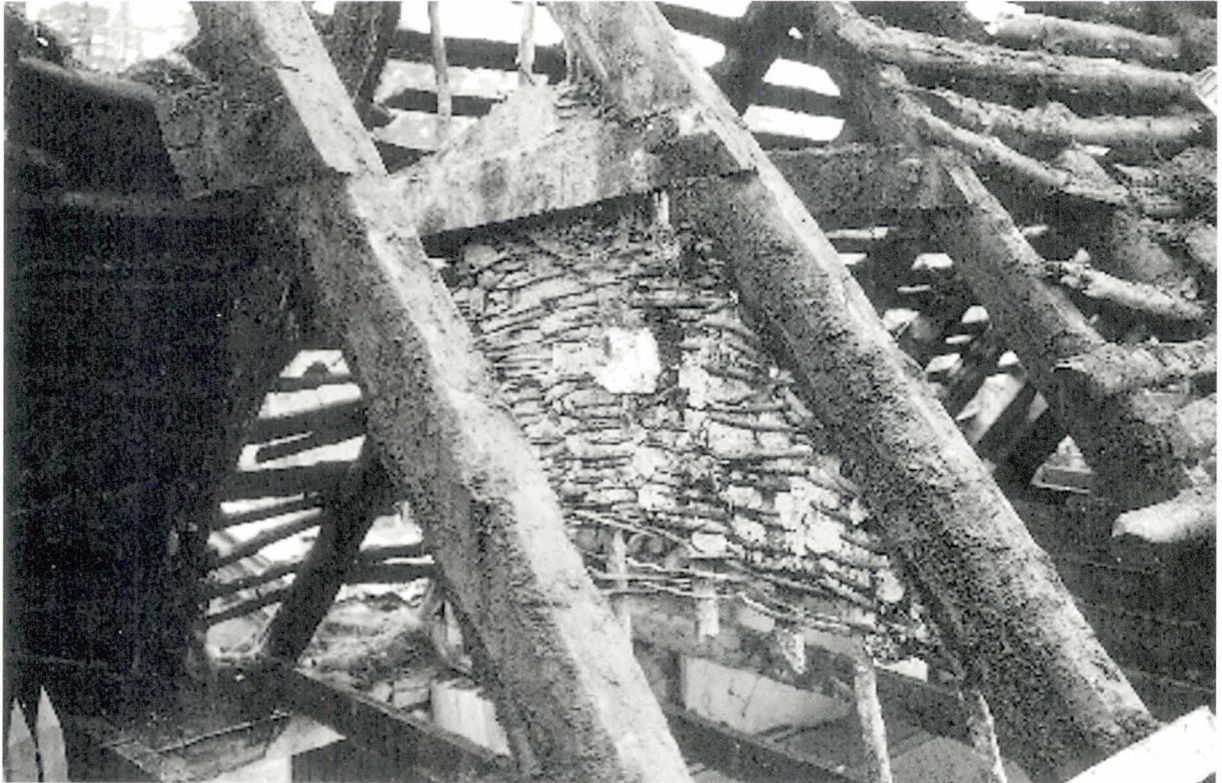
Johan Cottage, roof timbers and wattle panelling. (S.Whyment)
