HISTORIC
ENVIRONMENT
SCOTLAND

Property in Care (PIC) ID: PIC257

STATEMENT OF SIGNIFICANCE

MOUSA BROCH

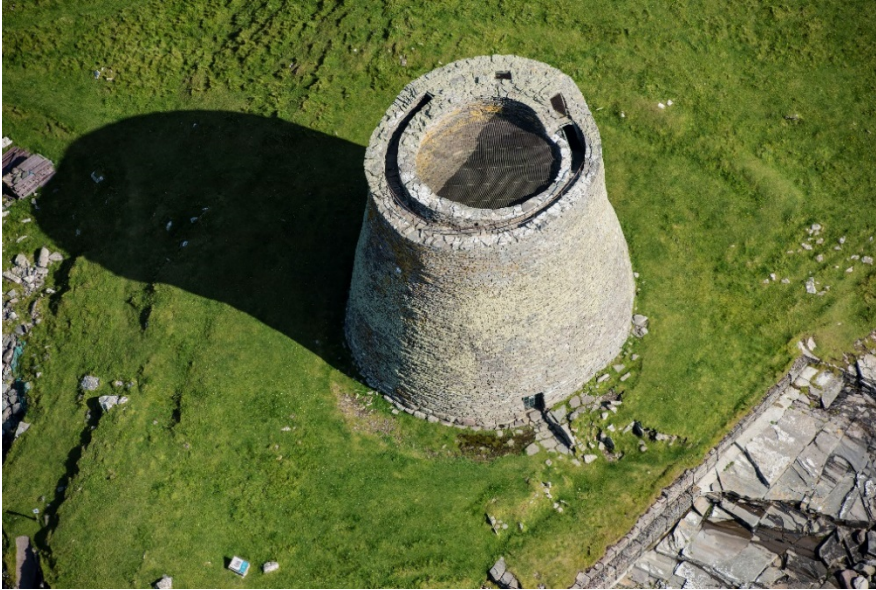
Aerial view, showing interpretation board, remains of structures outside broch entrance, grass-covered remains of wall beyond broch. Note gabions at coast edge and flagstones of foreshore.

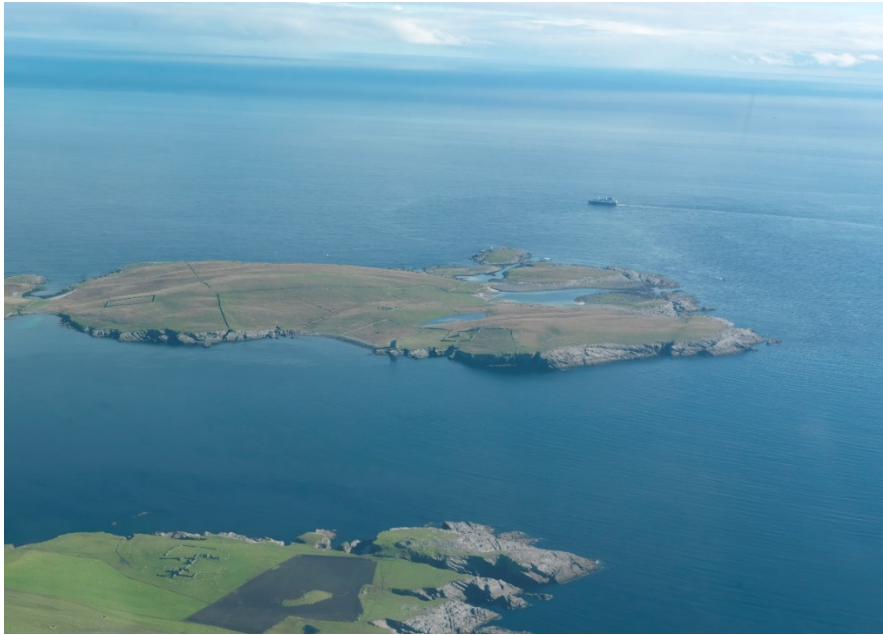
Distant aerial view from WSW: note the broch is on the more sheltered side of the island. The boat landing is towards the left hand (north) end of the island, where the very distinct wall reaches the rocky shore.

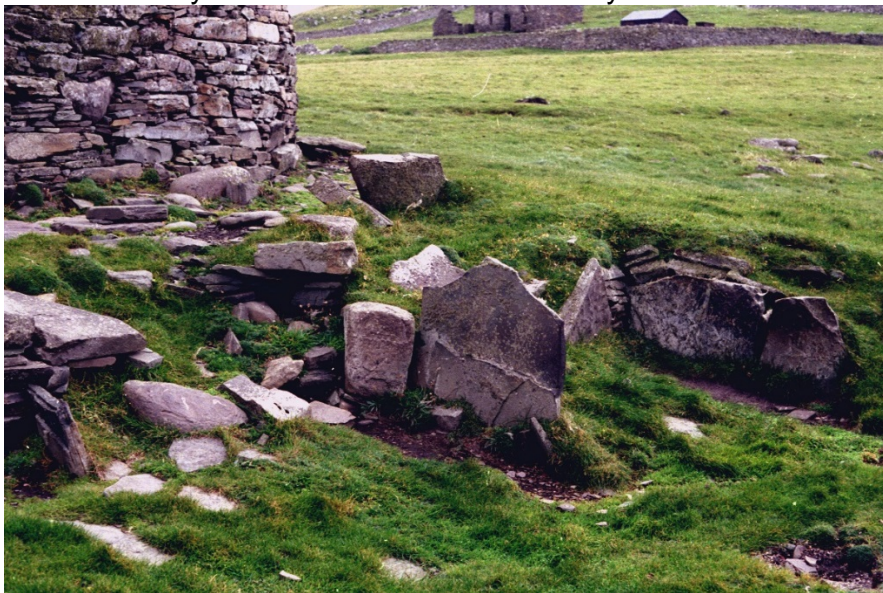
The ruined structures outside the broch entrance. **SC 336040 © Crown Copyright: HES.**

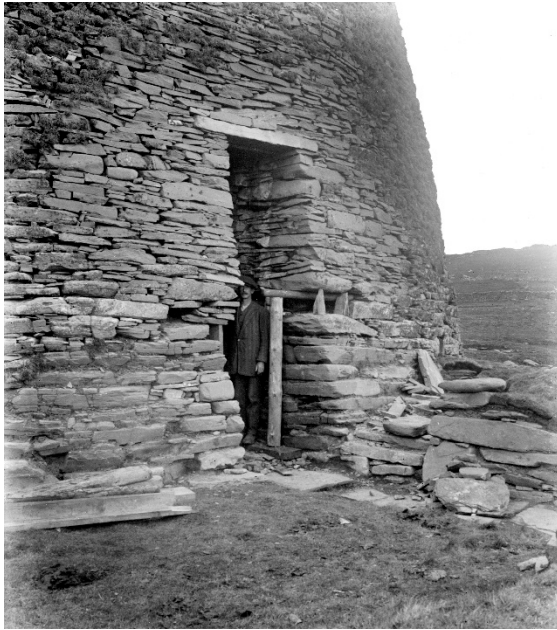
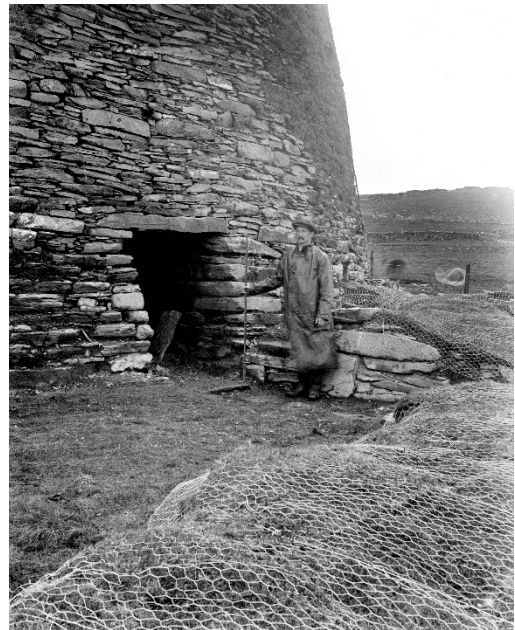
SC 1166524 © Crown Copyright: HES.

Exterior view in 1919 showing before and after rebuilding of wall above entrance.

There seems to have been steady but unspectacular deterioration until 1919, by which time over 1 metre of debris had once again accumulated inside the tower, largely consisting of bird-droppings and smaller fallen stones⁵⁷. In that year, John Wilson Paterson, architect with the Office of Works, arrived on Mousa with a squad of masons, to oversee "certain works of repair" and make an accurate, up-to-date, measured survey of the broch. Paterson unravelled the history of the entrance passage, excavating down to the original entrance level.

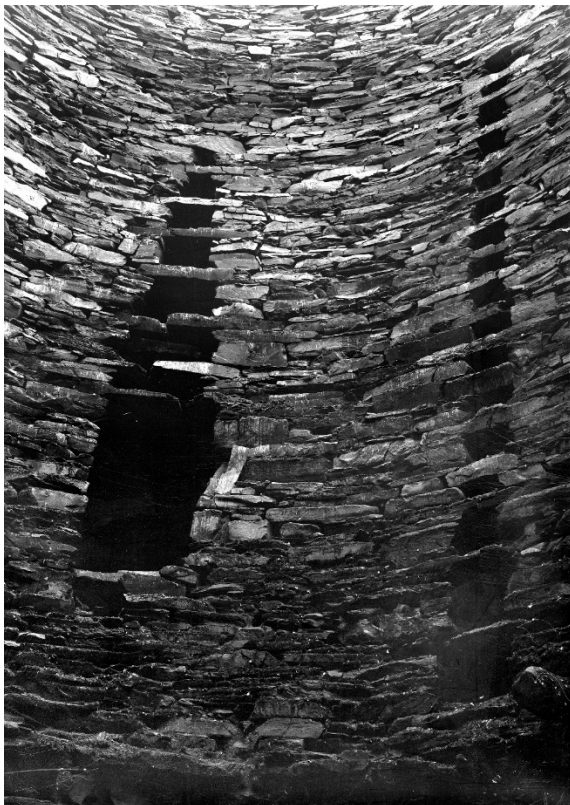
Interior wall-face showing stair landing between first and second gallery levels and ascending "stacked voids". SC 336038 © Courtesy of Historic Environment Scotland.

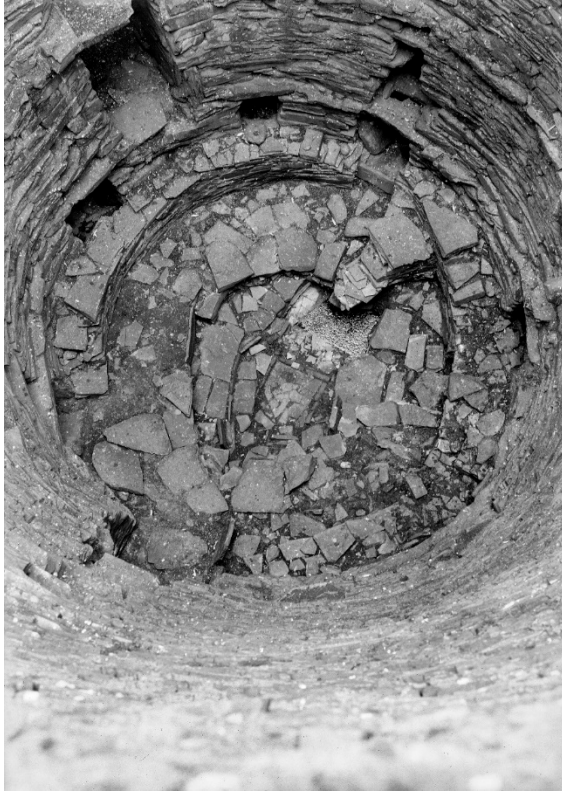
Central space form above, showing stair-foot landing at top left, entrances to wall-base cells, scarcement ledges and later features: bench around inner wall-face, masonry "pier", square hearth (rebuilt) and floor tank (dry). **SC 1224494** © Crown Copyright: HES.

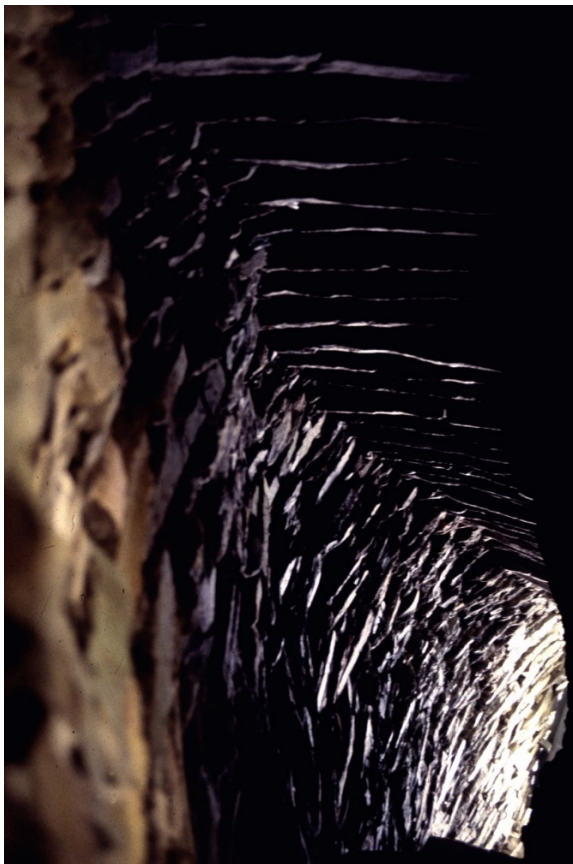
View inside stairway looking upwards. SC 336270 © Crown Copyright: HES.

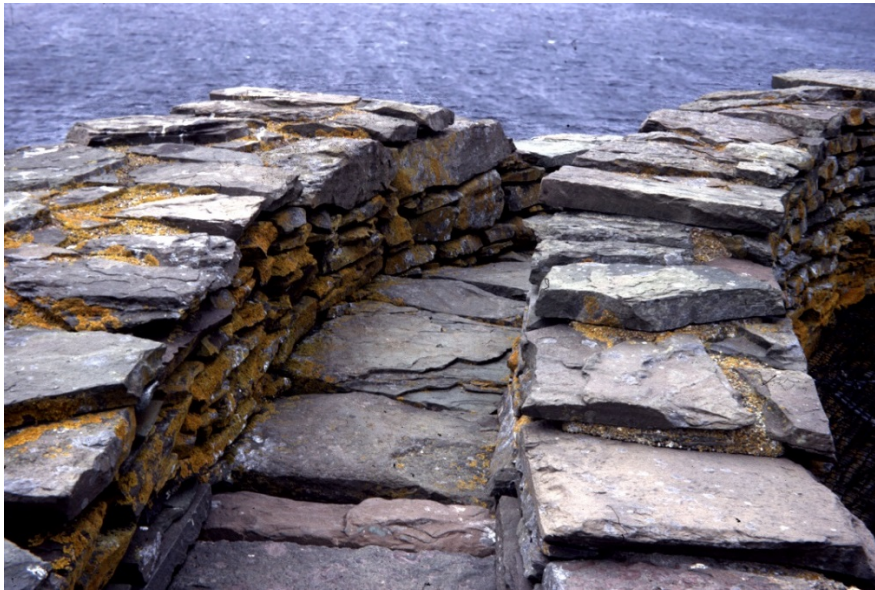
View of wall-head. SC 336236 © Crown Copyright: HES.

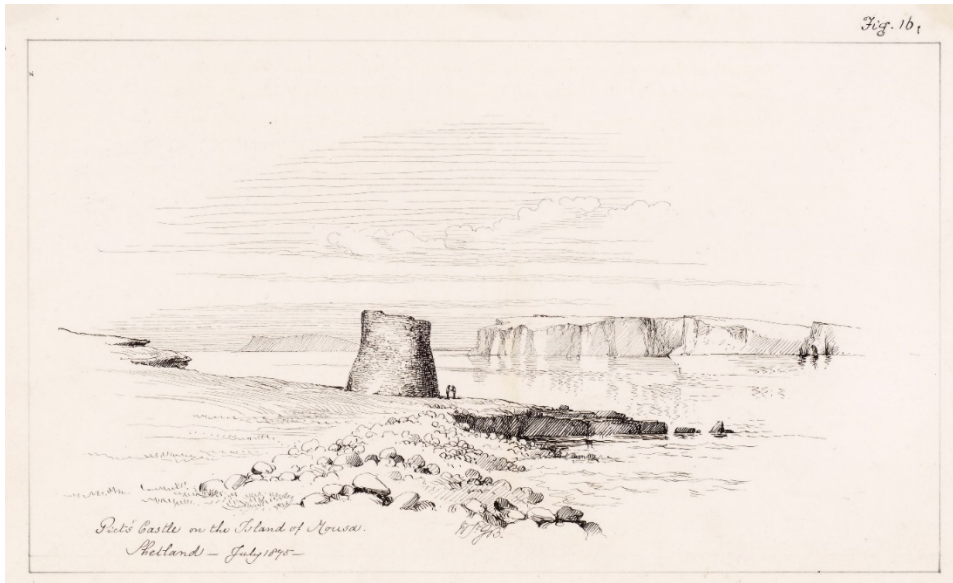
1875 view -note that the figures are slightly too large for true scale. HES collection – DP 1322822

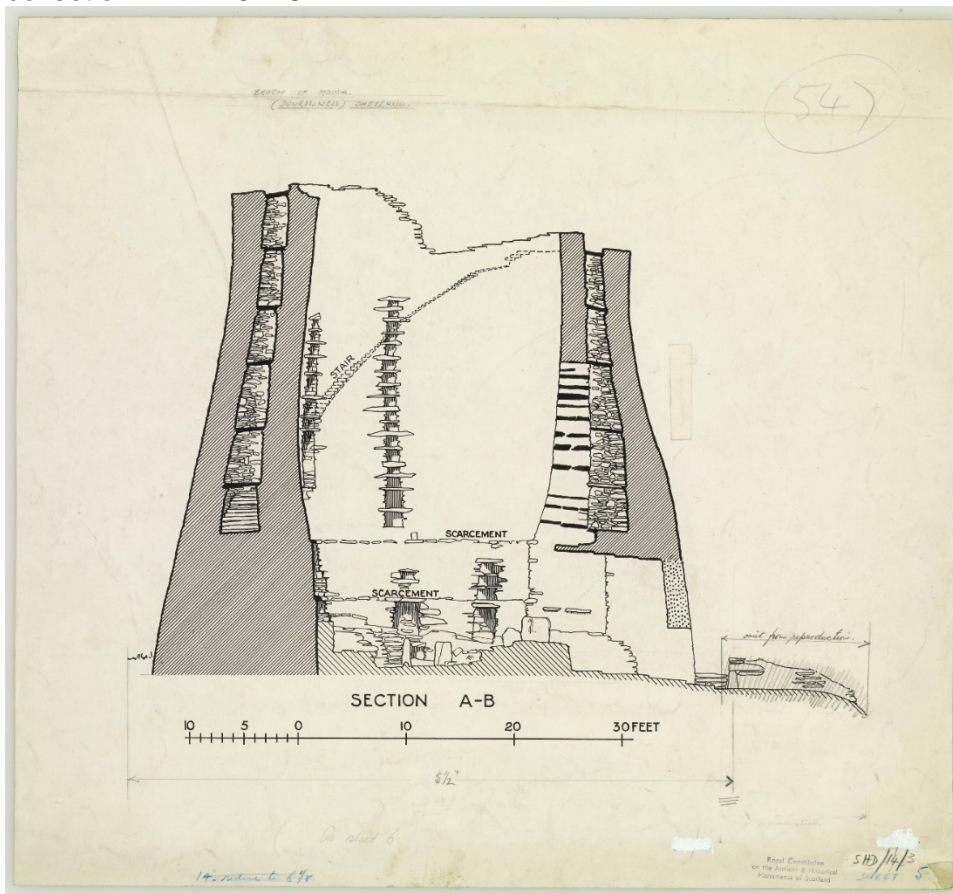
Paterson's section 1919. Compare with Dryden's 1866 version above. HES collection DP 1505509

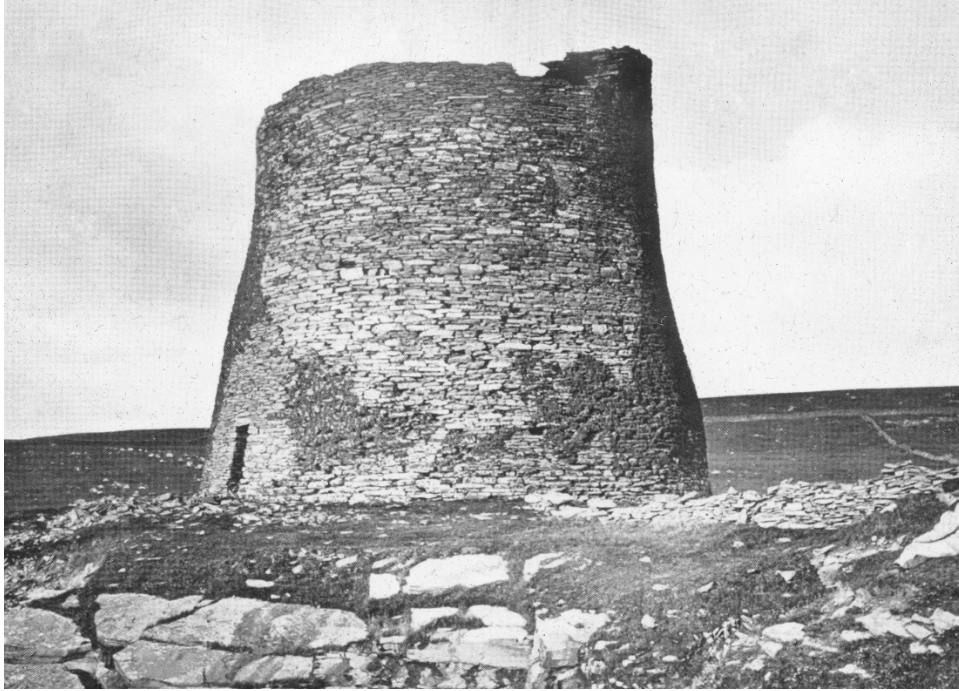
Paterson's 1919 photograph, clearly showing rebuilding above the entrance but still with a considerable amount of consolidation to be done on the walls, and the wall-head work apparently not yet done. HES collection – SC 1330617
