HISTORIC SCOTLAND

INFORM

INFORMATION FOR TRADITIONAL BUILDING OWNERS

Timber Staircases

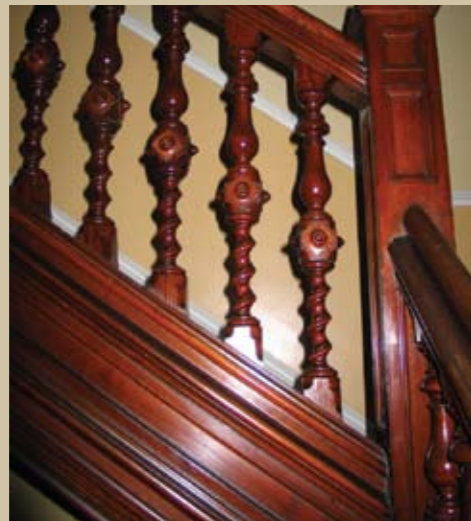
Wooden Balustrade

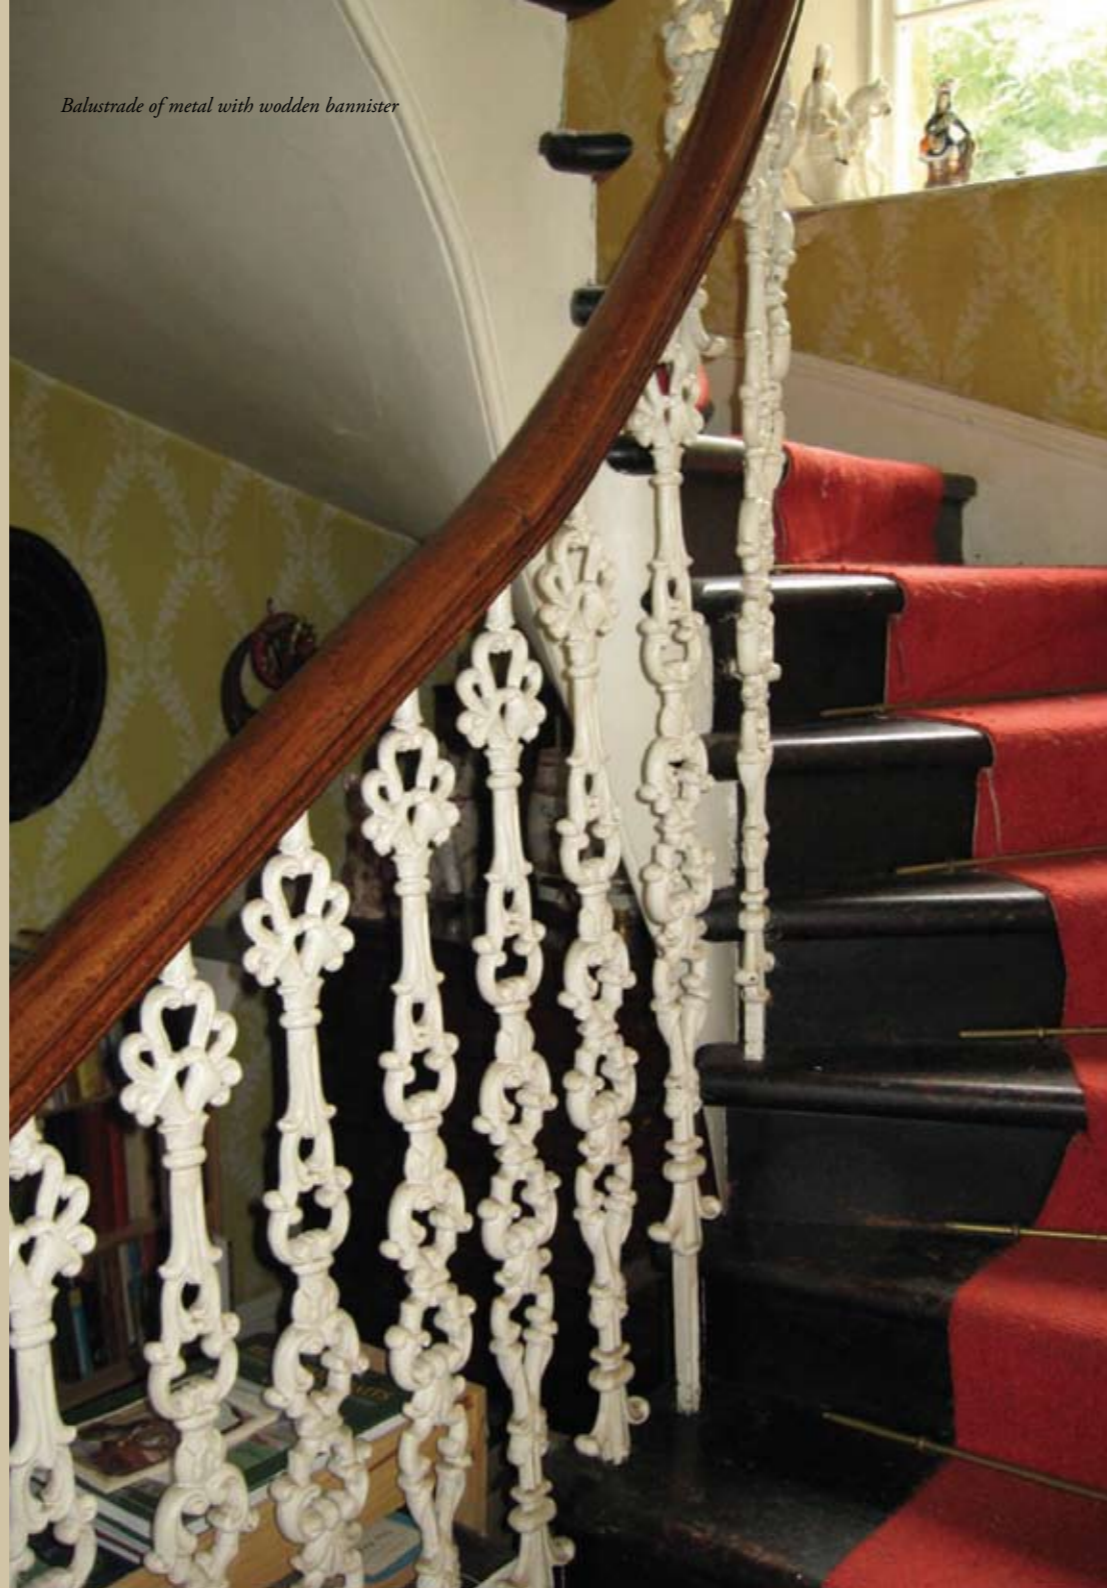
Balustrade of metal with wooden bannister

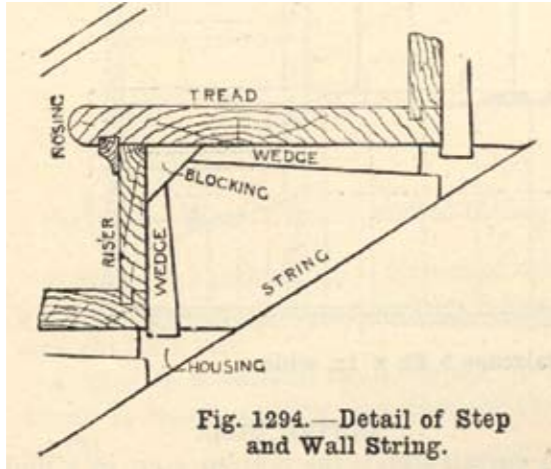
Diagram showing the way a timber staircase fits together

Some of the parts of a timber staircase

Treads and risers are held in place in horizontal and vertical grooves cut into the stringer and then strengthened by the insertion of glued wooden wedges where they meet. The risers are set between consecutive treads and are usually fitted to the treads in a grooved joint, strengthened by small wooden wedges glued to both on the underside. The tread projects slightly over the top of the riser, this is known as the nosing. The stringer which is set against the wall is known as the inner or wall string and that which runs up the outside and holds the baluster, as the outer string. If a stair is over a meter wide it will sometimes have a centre string for support, otherwise triangular blocks of wood are glued and occasionally screwed to the riser and the tread to provide extra stability.

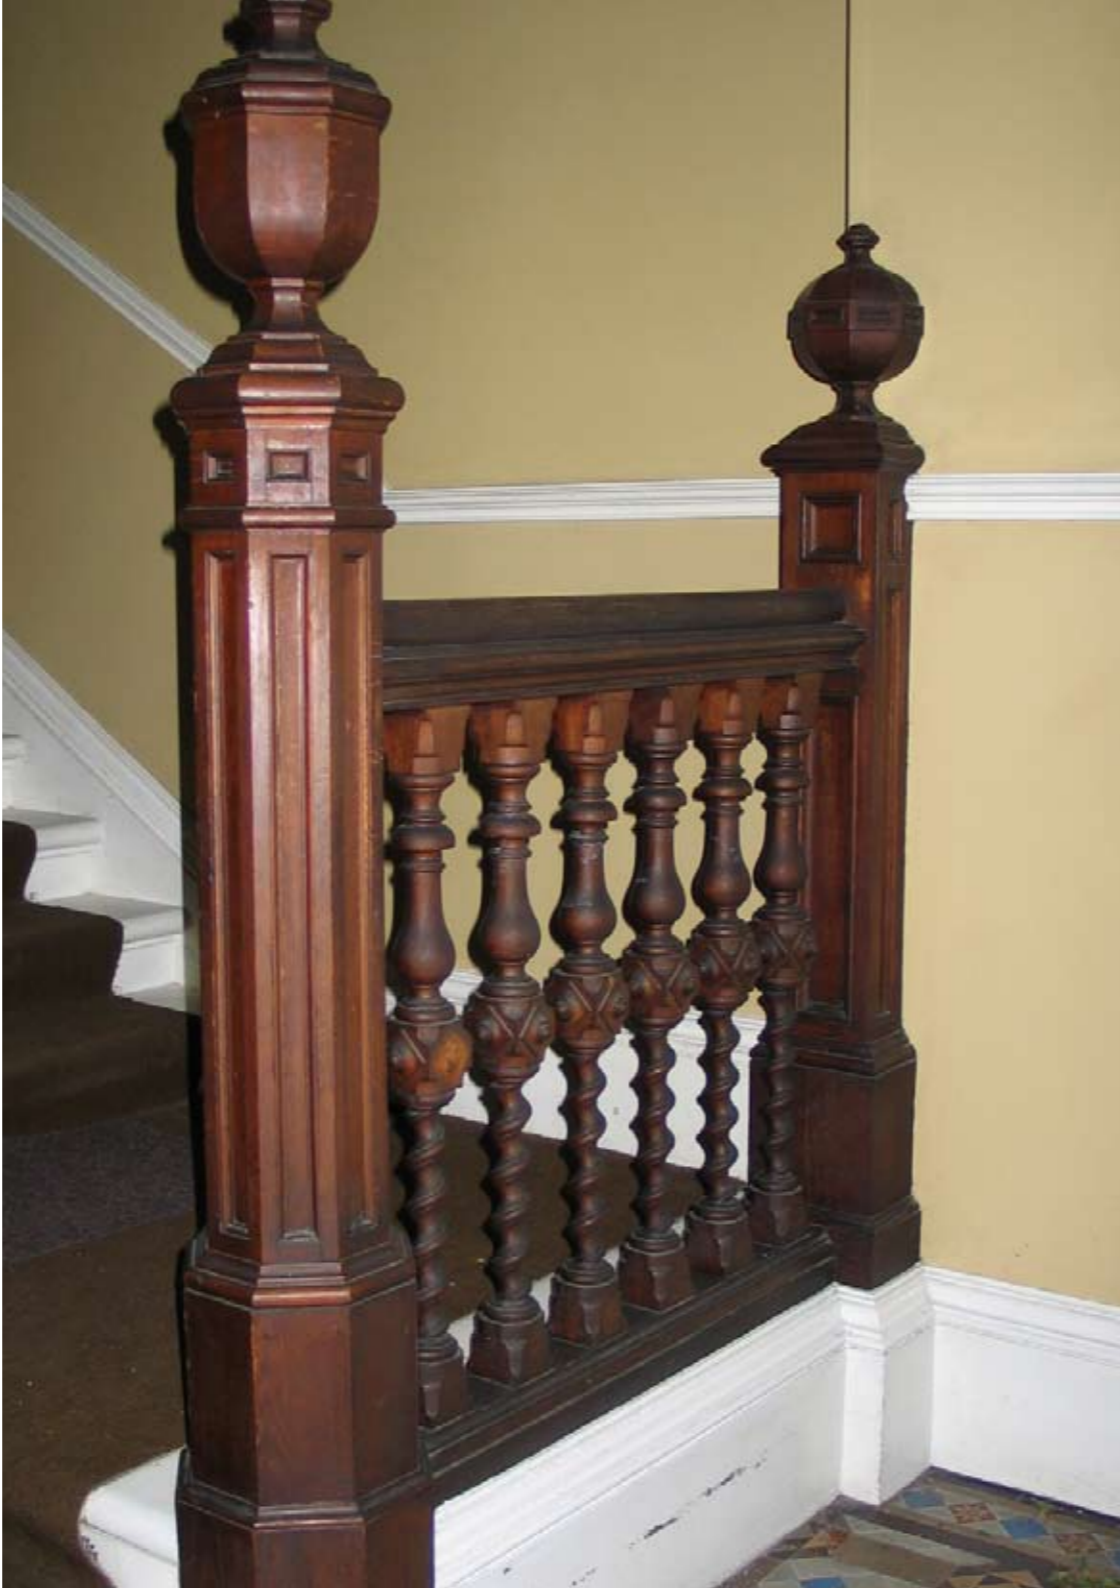
Diagram showing how a Newel post fixes into a floor

Newel posts located at the top and bottom of a flight of stairs or at right angled changes in direction, perform the function of transferring the weight of the stair to the floors and provide secure support for the balustrades. When made from a solid piece of timber they are usually fixed to the floor by nailing them to floor boards. Occasionally they are made up as a hollow box and secured to the floors with threaded metal rods.

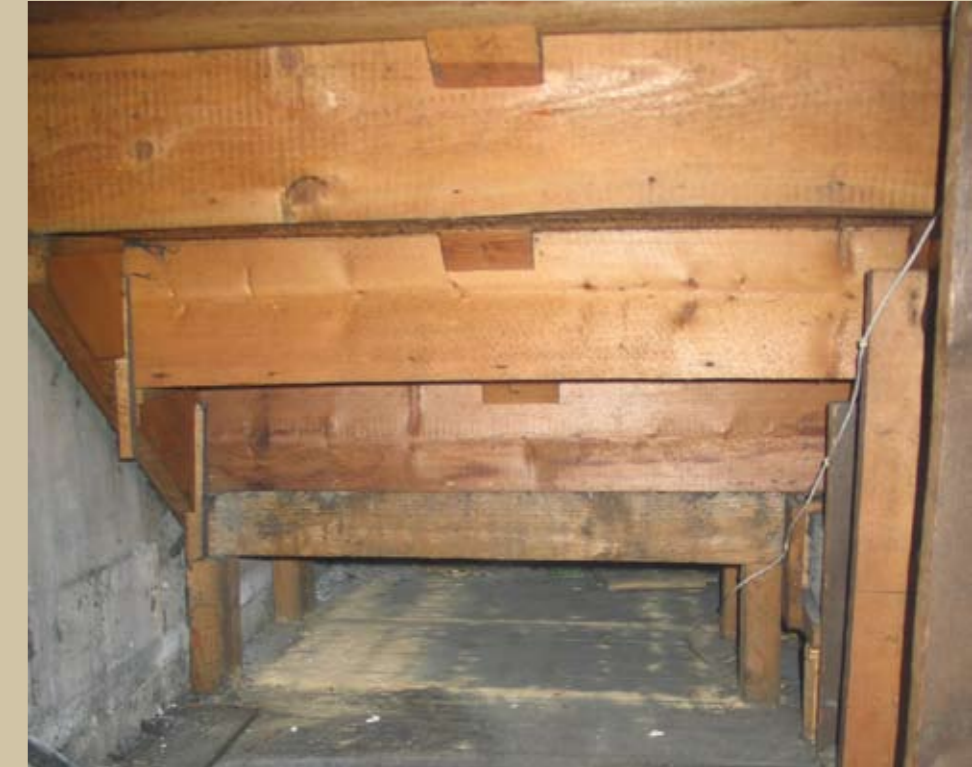
Re-fixed blocks holding tread and risers securely in place

The triangular blocks which hold the treads to the risers can also become loose. If possible the original should be reused although again if this has become damaged a new block can be fashioned to the same dimensions. When refitting such blocks it is important to fit them slightly off where the original was placed so that new screw holes can be located. It is also important to ensure a suitable length of screw is used so as to provide a secure fit but without protruding from the front face of the tread or riser. Before securing any element using screws drill pilot holes in the wood to prevent splitting.
