Property in Care (PIC) ID:	PIC271
Designations:	Scheduled Monument (SM90303) (stone circle only)
Taken into State care:	2005 (Guardianship)
Last Reviewed:	2023

STATEMENT OF SIGNIFICANCE

ROYAL OBSERVER CORPS BUNKER (part of TOMNAVERIE STONE CIRCLE)

THE ROYAL OBSERVER CORPS BUNKER

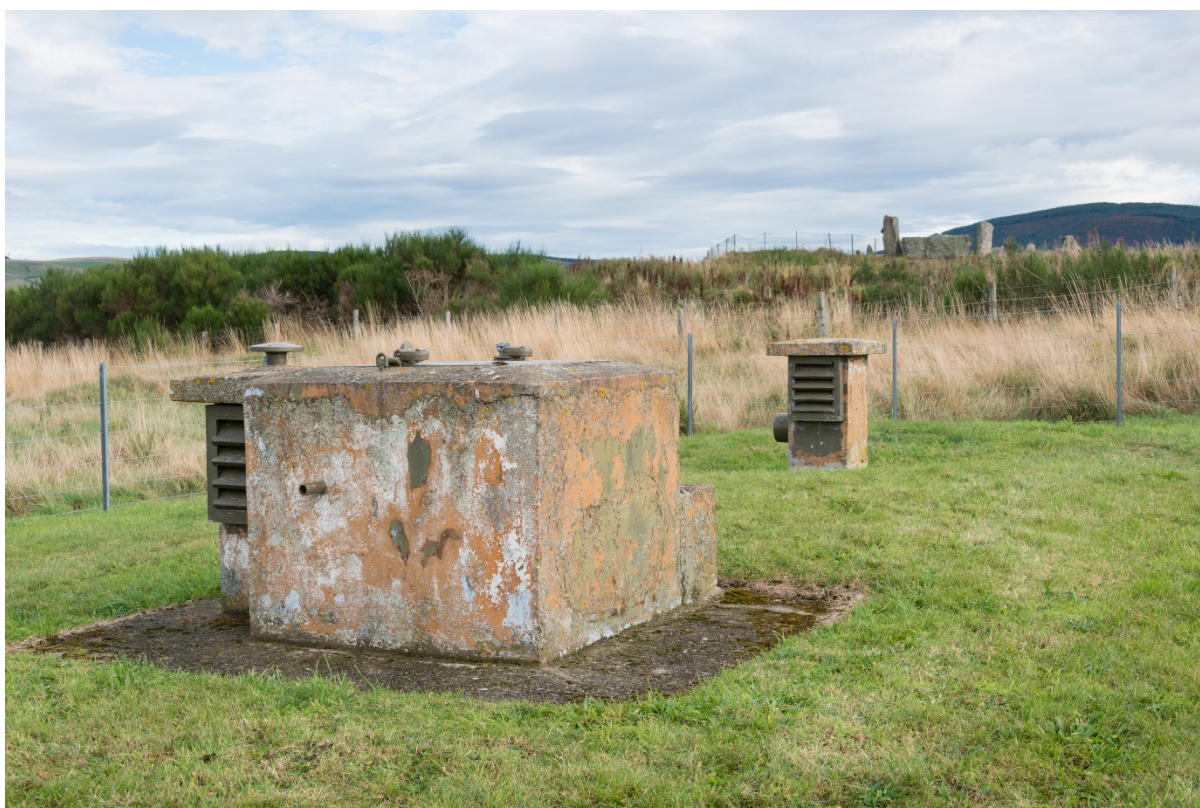
Figure 1: Exterior view of Tomnaverie ROC post with recumbent stone circle in background. © Crown Copyright HES.

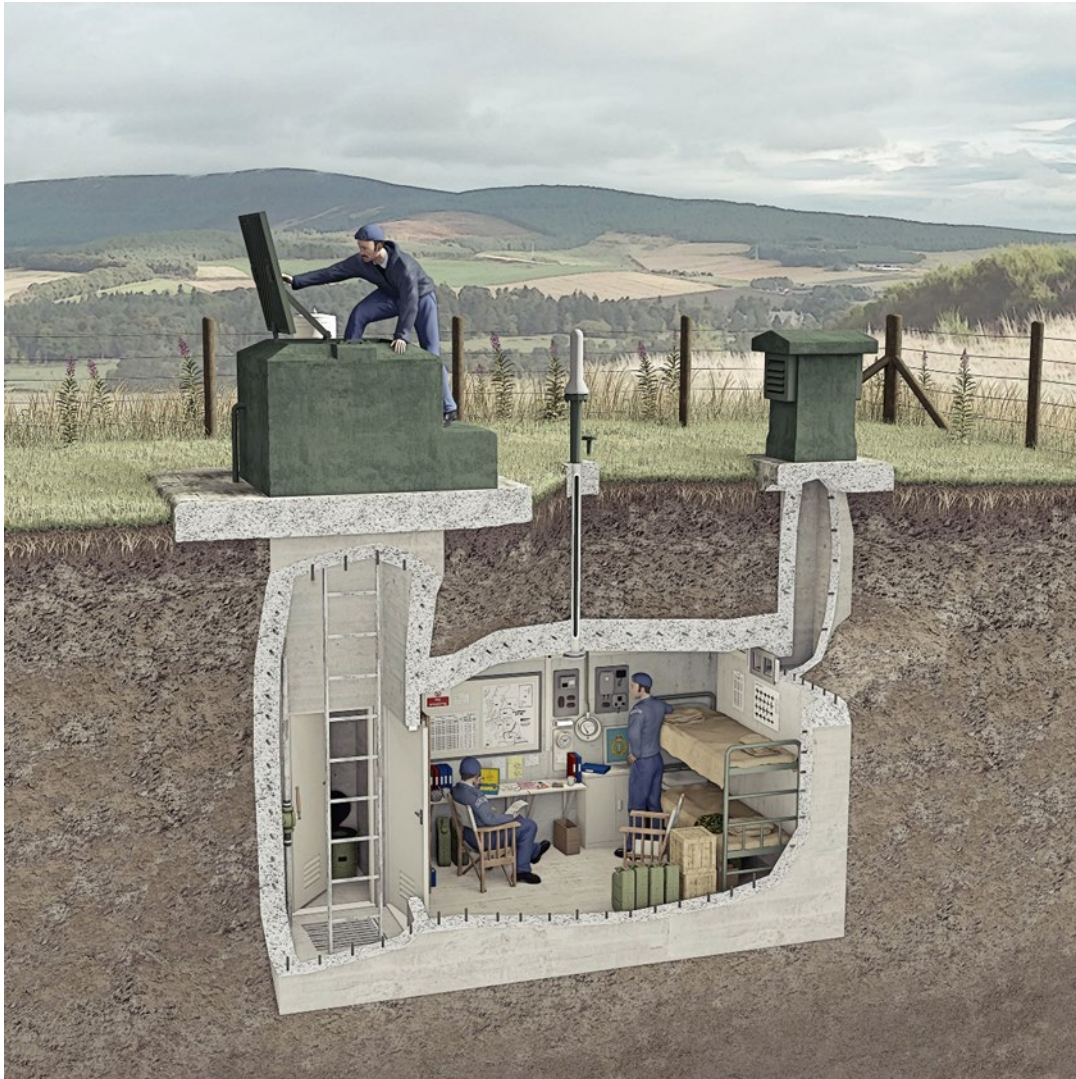
Figure 2: Reconstructed cutaway drawing of Tomnaverie ROC Post showing ROC observers at work.
© Crown Copyright HES

The Home Office specified the protected ROC posts as to be 19ft x 8ft 6in x 7ft 6in (5.8m x 2.6m x 2.3m) high, divided into three parts: a ladder well leading down 15 ft (4.6m) from the entrance hatch, with sump at its base; a small toilet; a main room combining working space and sleeping accommodation for a four-person crew. It would be built in an excavated hole and covered by 3ft (0.9m) of soil. The walls and roof would be over 6in (15cm) thick. A protected underground bunker was trialled at Farnham in 1956 and, with minor changes, was adopted. 1563 posts and 31 group centres had to be built. The programme was completed in 1965. Existing posts had to be surveyed to see if the sites were suitable for the new structures, and if they were not, had to be re-sited. By mid-1958 94 of the new posts were in use, with 110 under construction. The same period saw the extension of the system into the far north-west of Scotland.

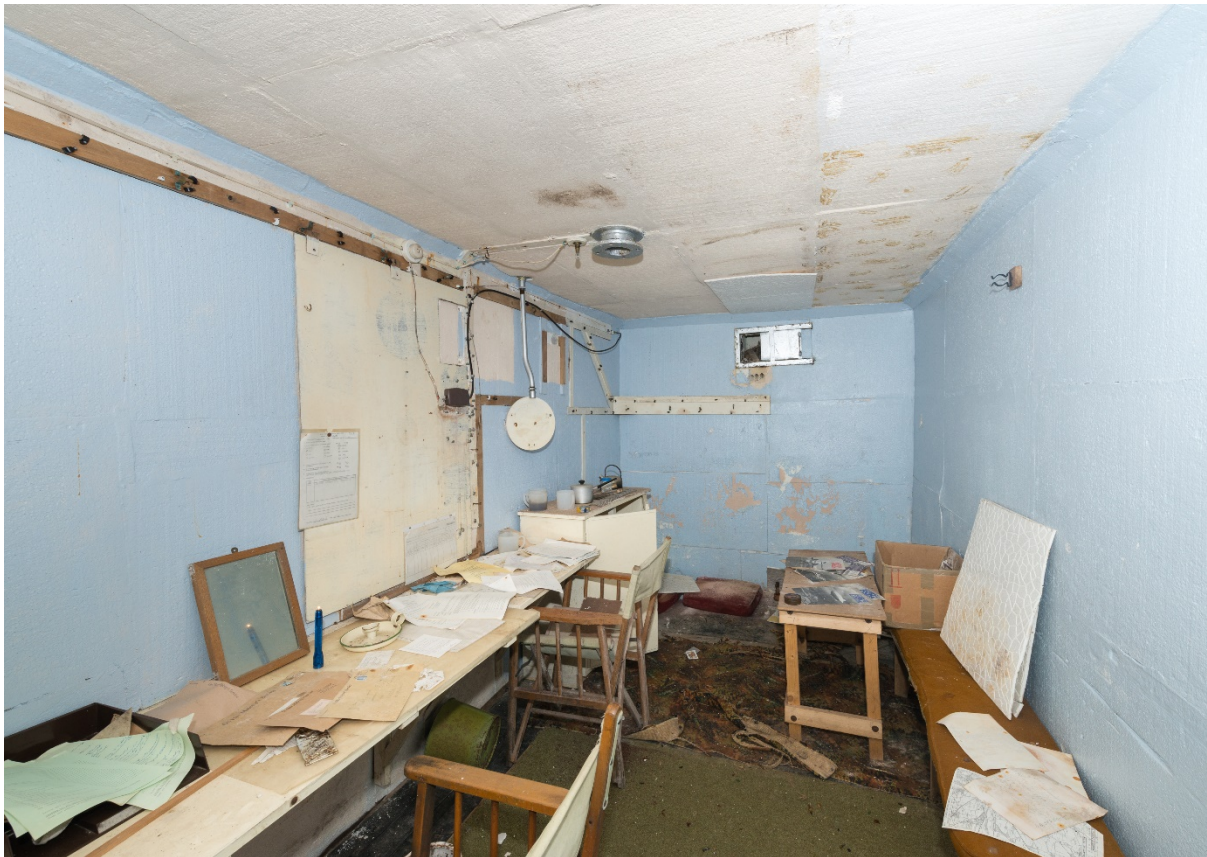
Figure 3: Interior view of ROC post. ©Crown Copyright HES

Upon entering State care, some items within the bunker were removed for their assessment and conservation. The images provided by HES Collections team show that Tarland when emptied had what appears to be a typically random collection of domestic items, stationery, documents and magazines. The rope nets are not commonly mentioned in contents lists. Are they perhaps to aid the transfer of equipment and supplies down the ladder/hatch?

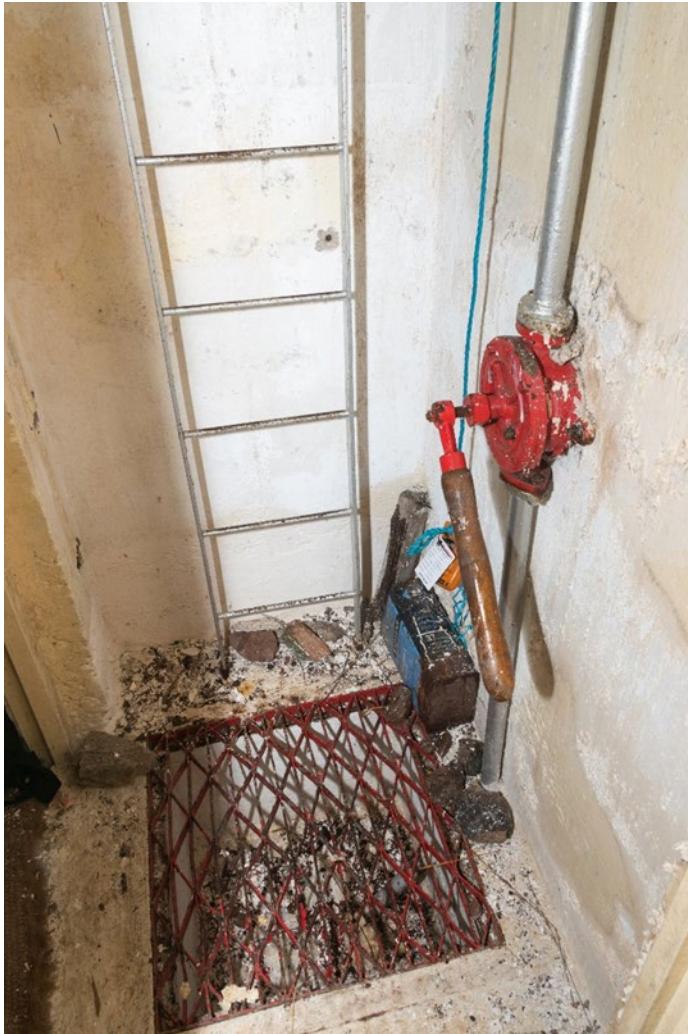
Figure 4: Image of entrance area to ROC post showing the 'shower tray' and hand-pump. © Crown Copyright HES.

The item listed as 'shower tray' (E3092) is visible on some of the photographs of the interior as covering the sump, into which water was to drain, to be pumped out using the hand-pump attached to the wall (both shown in figure 4). It is of the same pattern as a relatively rare security grille of a kind illustrated on page 113 of Dalton,⁹ which were designed to prevent unauthorised access from the surface while the hatch was open for ventilation. Elsewhere, Dalton provides an image of a grille used to cover the sump for water to drain into, but this was of a simpler pattern.
