**Property in Care (PIC) ID:** PIC272 & PIC273

**Designations:** Scheduled Monument (SM90022)

## STATEMENT OF SIGNIFICANCE

# ARNOL BLACKHOUSE NO. 39 AND ARNOL BLACKHOUSE NO.42

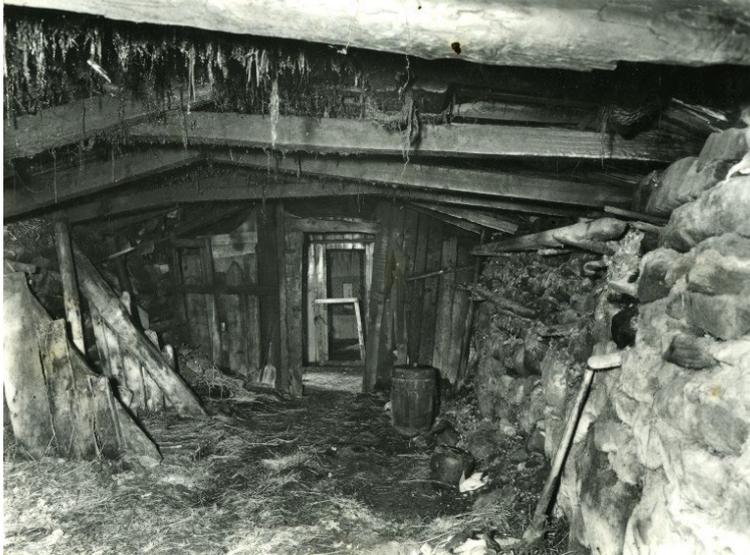
Interior of the byre at No 42 at the time it was taken into care, illustrating the sagging trusses

'When the Blackhouse was taken into care in the 1960s it was in a semi collapsed condition. The local residents at the time advised that, while a small continuous decrease in pitch occurred over the byre (primarily as the best and longest timbers were used over the accommodation for people), the trusses were in a collapsed state and were never meant to be at such a low pitch. This led to saturation of the thatch, rotting it, soaking the byre interior and the sagging of the trusses.

When in the 1980s the collapsed form became so unstable as to require propping and the thatch failing so much a tarpaulin was covering the roof, an attempt was made to replicate the low pitch trusses with new timber but these collapsed. Trusses of a slightly increased pitch were then tried which lasted a few years but with continuing problems of stability and thatch rot they were again replaced in the 1990s with trusses of an increased pitch. There is still a slight decrease in ridge line, from building centre to byre end, as each successive truss has a decrease in angle and this last arrangement is structurally stable, allows fast water run to off over the thatch and is approved by the local residents.'<sup>20</sup>

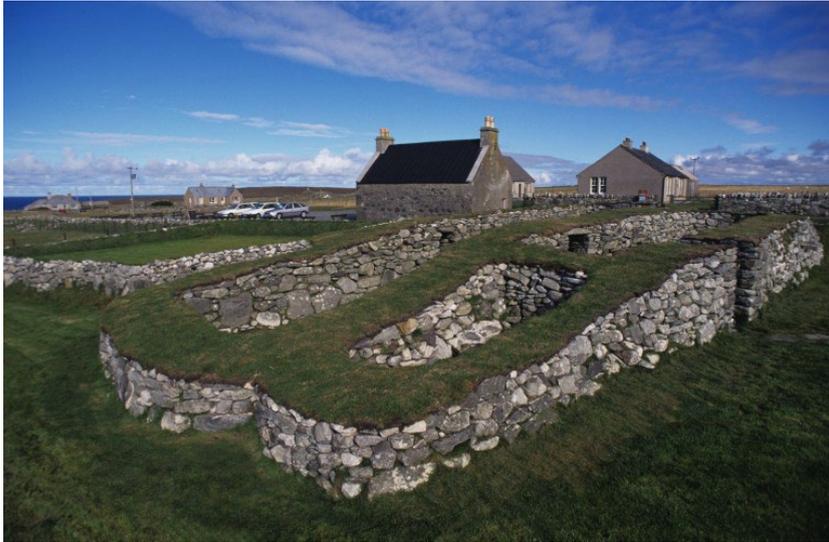
The consolidated ruined blackhouse at No.39, with the whitehouse and the 1960s bungalow (visitor centre) behind it.

The unroofed remains of the blackhouse at no.39 have been analysed and excavated in 1995 leading to the conclusion that although it was only occupied for a relatively short time, it was modified many times. It consists of three parallel units built with random rubble walls packed with earth and clay. The first is the 'fosglan' or entrance porch, which in this case is almost as long as the central housing unit. This leads into the central house, which would have consisted of a living area to the right and byre to the left. The housing area has clearly been extended, adding a window in the gable end as well as extra space. It is built on a slight slope with the living area at the upper end, and the byre (with raised cattle stalls) at the lower end, which allowed water/ animal waste to exit from a small hole (feadan/ toll lodain) at the lower gable end. From the central unit there is a doorway to the third unit (the barn), at the far end of which there is a low opening which would have been a winnowing hole.

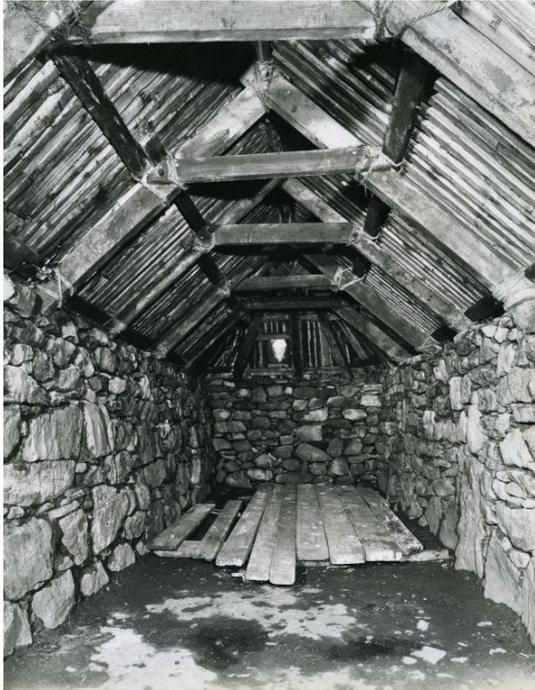
Roof timbers above the barn section of No 42

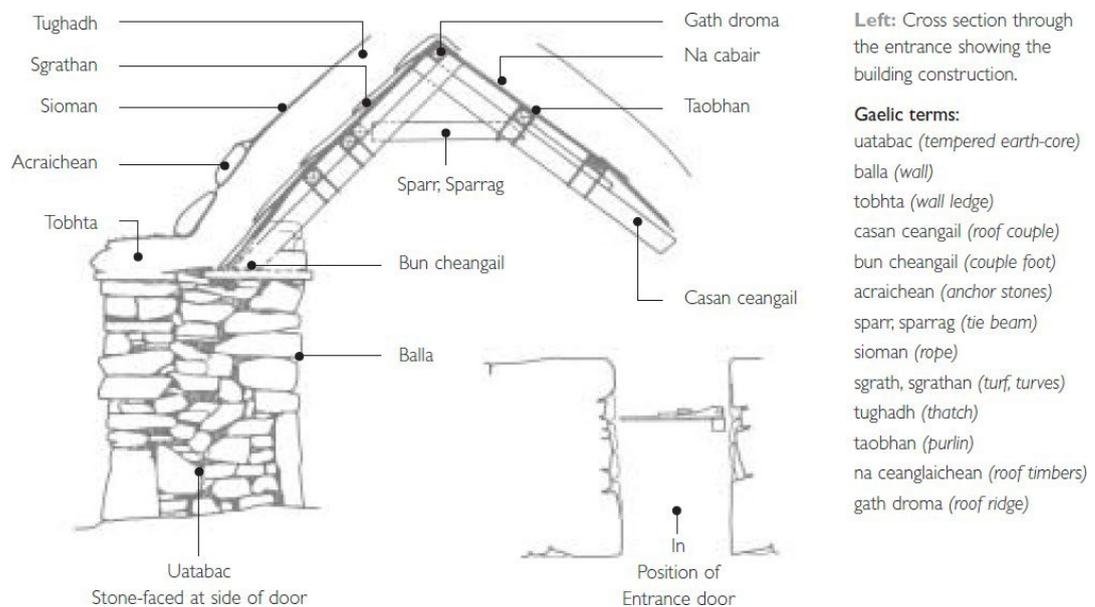
Diagram showing Gaelic terminology of parts of the blackhouse

Detailed and technical notes on the construction of the blackhouse at No. 42 Arnol can be found in *The Hebridean Blackhouse* (HS TAN 5). A summary of the information in the book is given at Appendix 3.

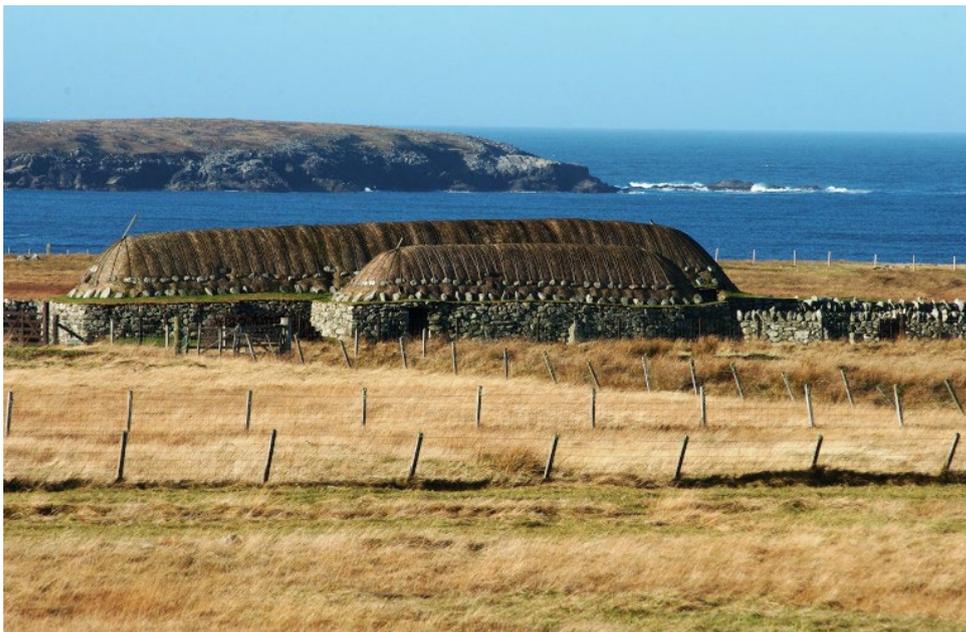
Exterior view of Blackhouse No. 42 from the croft behind the house, illustrating how well it blends into the surrounding landscape

The blackhouses at No. 39 and particularly No. 42 Arnol have an extremely high aesthetic value. Built entirely with natural materials, stone walls and straw thatch, they blend with the landscape and illustrate in many ways the close relationship the people of the area had with the land. The low height and rounded corners provided protection from the strong Atlantic gales to which it was exposed. The enclosures around the buildings are made of drystone, and outside No. 42 there is a peat stack and some haystacks which further enhance the experience.

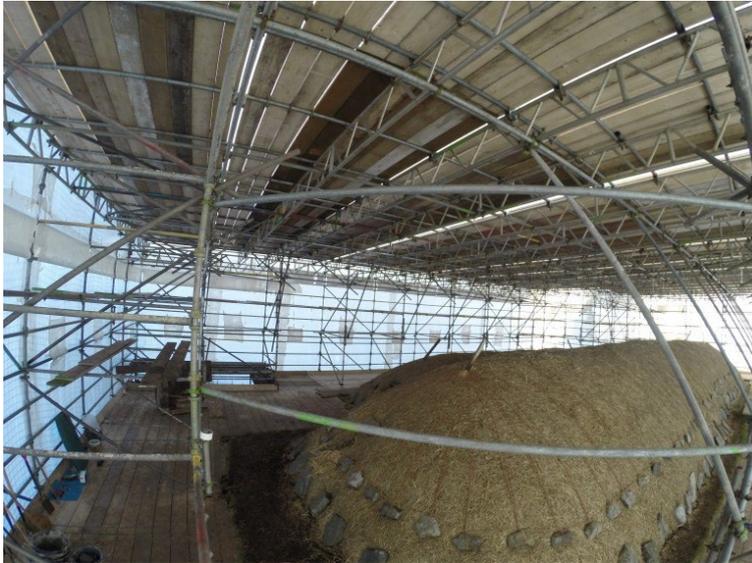
Interior view of the covered scaffolding which was used during the last full rethatching process to protect the collection of artefacts inside among other reasons

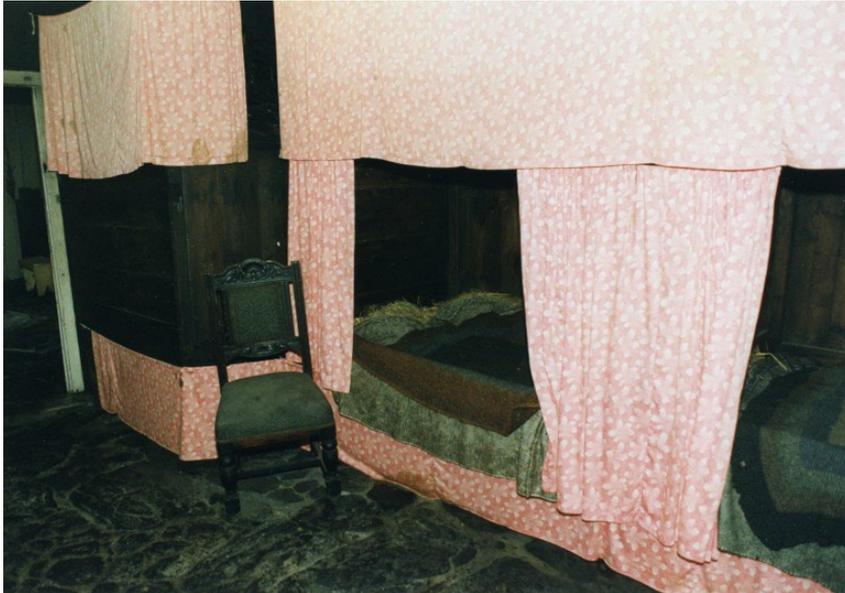
The boxbeds in Blackhouse No 42

There are three box beds in the Blackhouse, laden with blankets. Box beds are typical of any blackhouse.

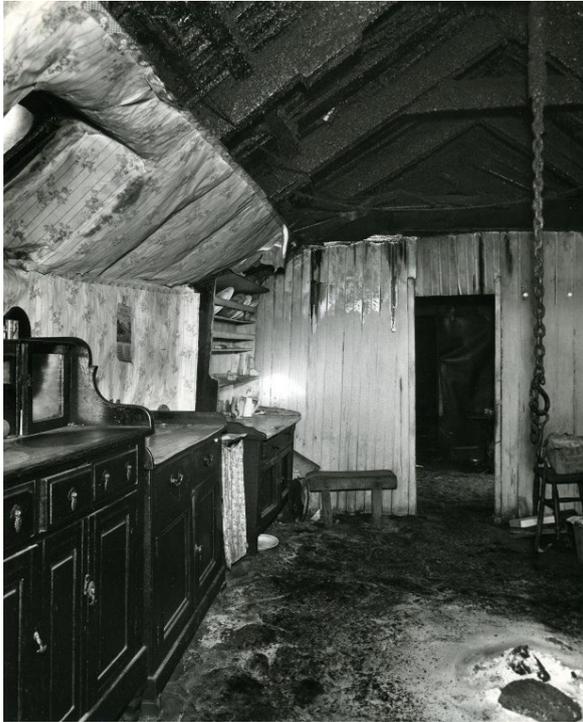
Interior view from living room looking through to porch and byre

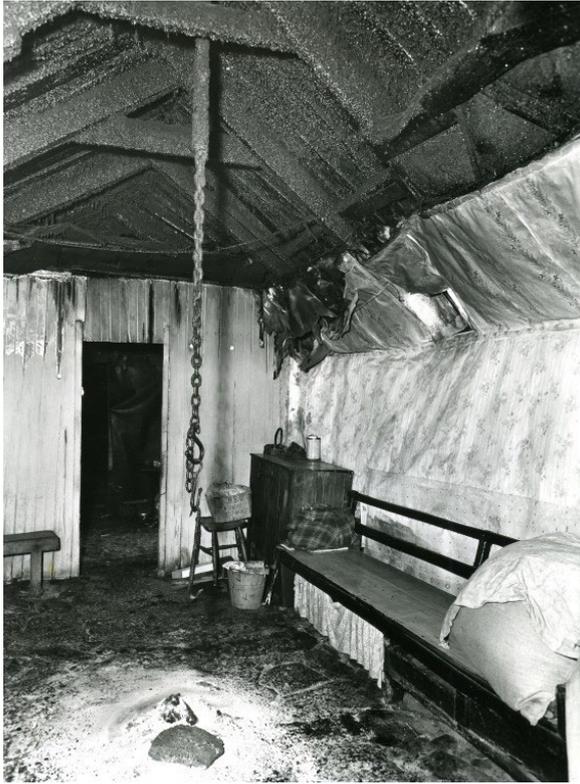
Interior view from living room looking through to porch and byre

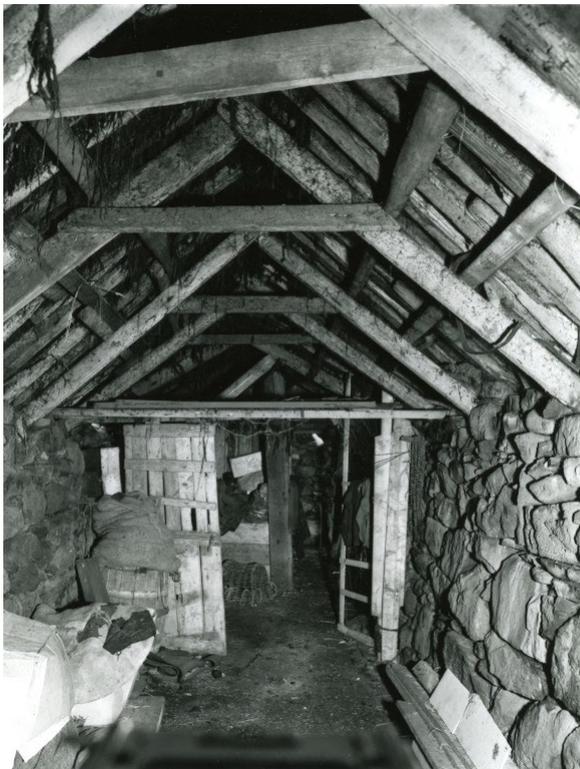
Interior of barn

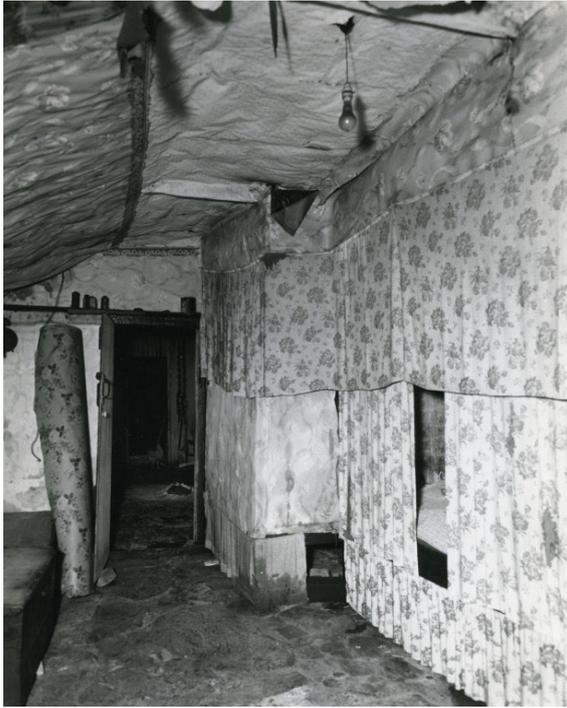
Interior of bedroom and boxbeds (note walls and beds all covered in fabric/paper) looking through to living room

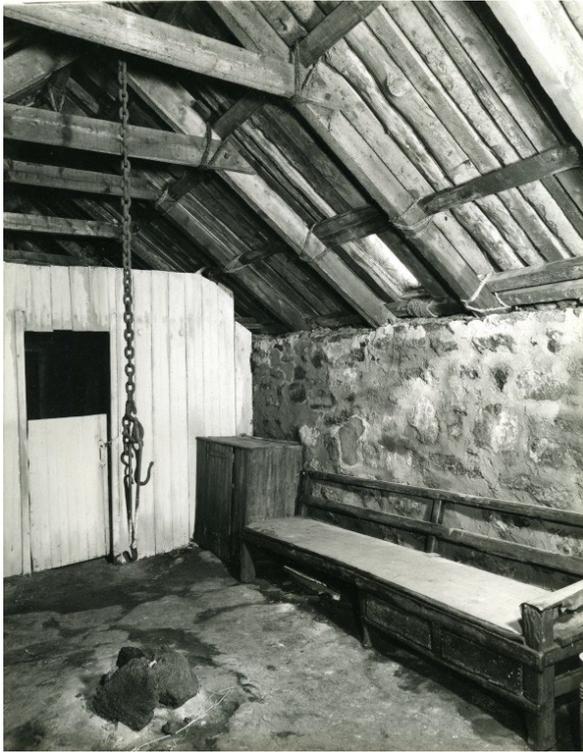
The seise (bench/settle) in living room

The settle at Arnol Blackhouse no. 42 has been made from driftwood and been adapted for storage at one end. The use of driftwood to construct furniture highlights the resourceful nature of a local community where wood was a rare commodity and emphasises the unique nature of these objects. A reused boat tiller in the roof of the blackhouse reiterates this point. Other items made of driftwood include a bench, a stool and one of the dressers. This dresser has been made with an angled top to fit in with the camber of the roof. This unique, eccentric touch can only be appreciated because the dresser has remained within the context in which it was made for.

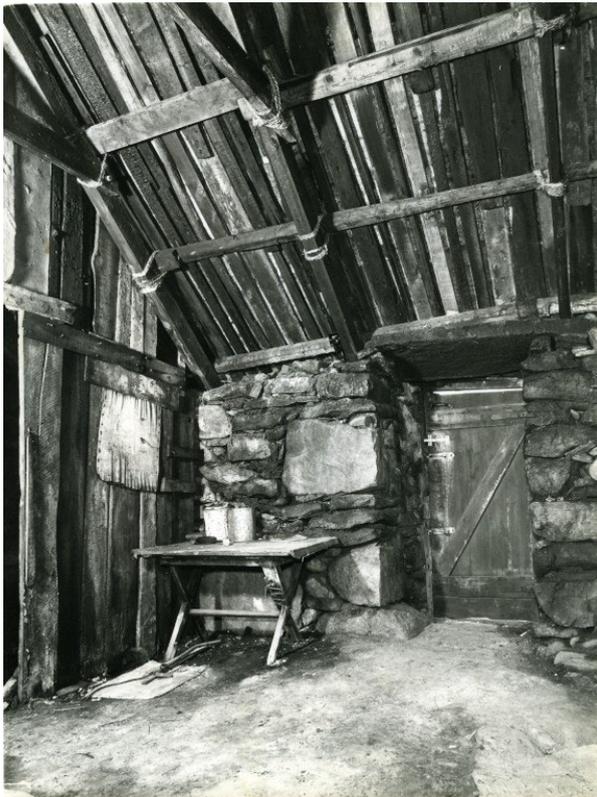
The porch area showing exterior door

barn and a porch area or fosglan. The latter has another door leading outside to the back of the building where the peat stack was kept. It is clearly visible where the barn was shortened at the north end in 1940 following a partial collapse when a World War II sea mine was detonated.
