REFURBISHMENT CASE STUDY 27

HOLM FARM COTTAGE GRANTOWN-ON-SPEY

VENTILATION AND INSULATION IMPROVEMENTS

HOLM FARM COTTAGE, GRANTOWN-ON-SPEY VENTILATION AND INSULATION IMPROVEMENTS

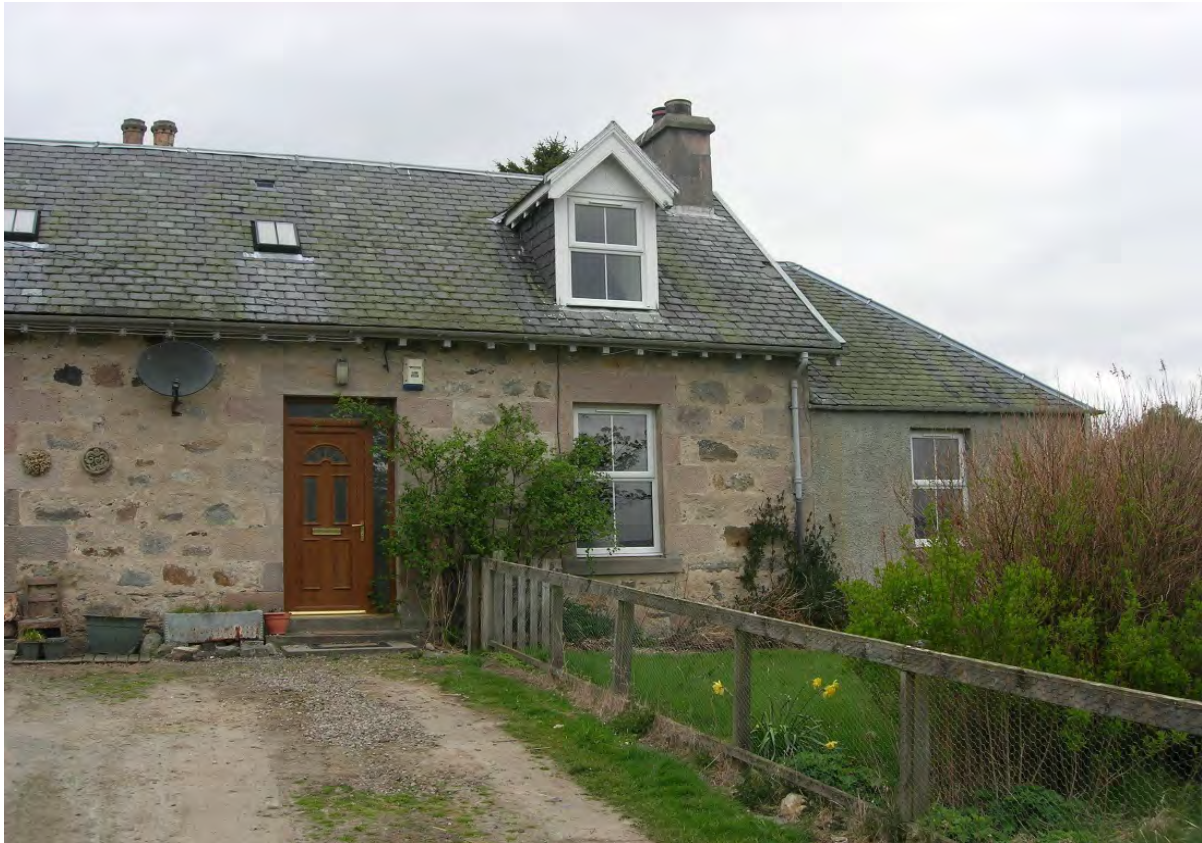
Holm Farm Cottage, located in Grantown-on-Spey, is one of a semi-detached pair of mid-19th century estate cottages on the Reidhaven Estate (Figure 1). The original part of the building is built of rubble walled masonry, with a later cement rendered extension. Both parts of the building are roofed with slate laid onto sarking boards. The building was refurbished in the early 2000s and had lost most of its original internal finishes. The windows were removed and replaced with uPVC double glazing as part of this previous refurbishment work.

Figure 1. Holm Farm Cottage, showing the original building and the modern bathroom extension on the right.

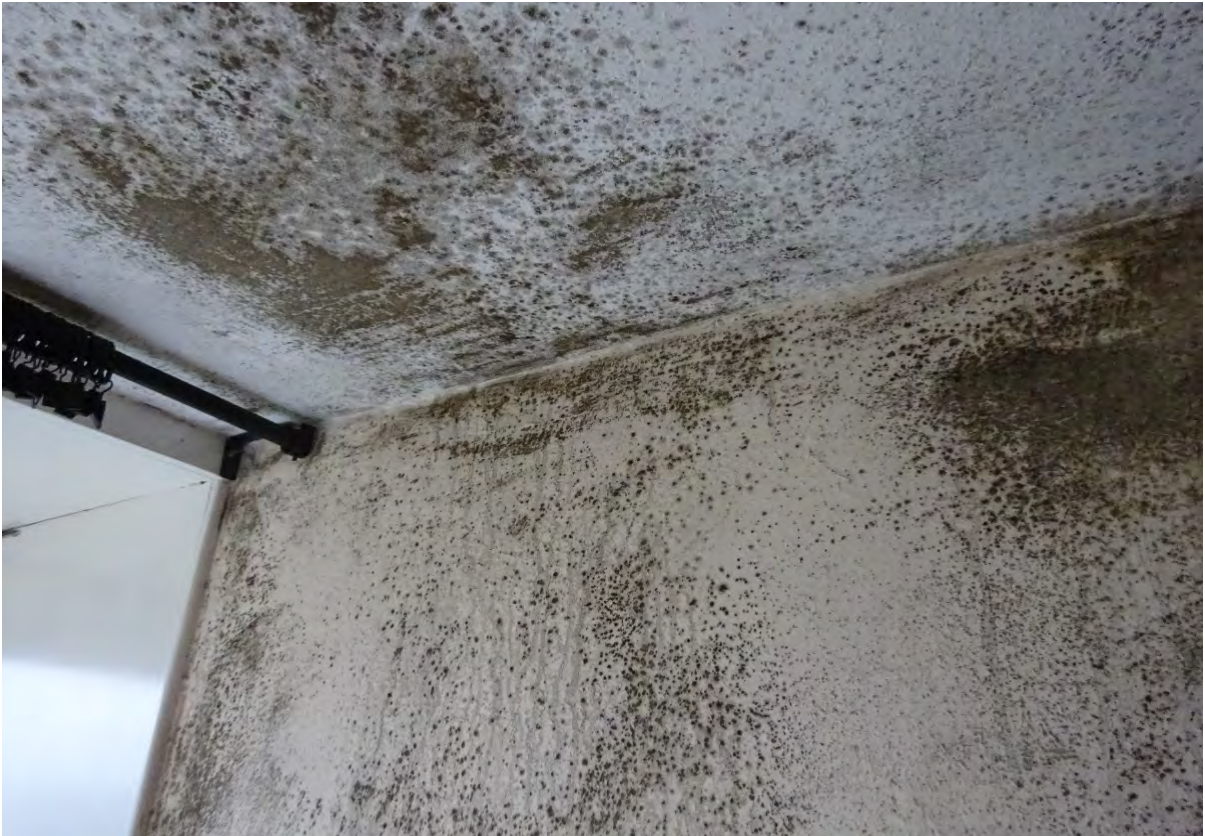
As part of the aforementioned refurbishment, the external walls on the ground floor had been insulated using 100mm thick phenolic foam. Along with uPVC double glazed windows, this insulation resulted in an internal environment with little ability to buffer relative humidity within the building fabric, and which relied on the operation of trickle vents and inadequate extractor fans in the bathroom and kitchen for ventilation. These ventilation measures proved insufficient as mould growth began shortly after the refurbishment (Figure 2).

Figure 2. Previous insulation and ventilation schemes had failed, leading to substantial mould growth throughout the building.

Following removal of the failing internal wall linings and insulation, the walls on the ground floor were framed out and 100mm wood fibreboard insulation fitted. This was finished with plasterboard (not foil backed), ready for a vapour open paint coat to be applied. Issues of access made insulation of the stairwell a difficult operation, but this was overcome and both the pitched roof section and the wall on the ground floor were insulated (Figure 6). The wall on the ground floor was framed out and 100mm wood fibreboard insulation fitted into the frame. Space was more limited in the roof space and here only 40mm thick wood fibreboard insulation was installed. This was fitted in place between existing rafters, a 50mm gap being left between the insulation and the sarking boards of the roof to ensure ventilation was maintained. The roof space insulation was likewise finished with plasterboard. A similar 40mm thick wood fibreboard was used to insulate the dormer cheeks (Figure 7) and roof in the upper floor bedrooms. Lastly, the external gable wall was insulated with 100mm wood fibreboard (Figure 8). Using an insulation material which was permeable to water vapour moisture will help regulate internal relative humidity, allowing moisture to diffuse out of the building through the insulation.

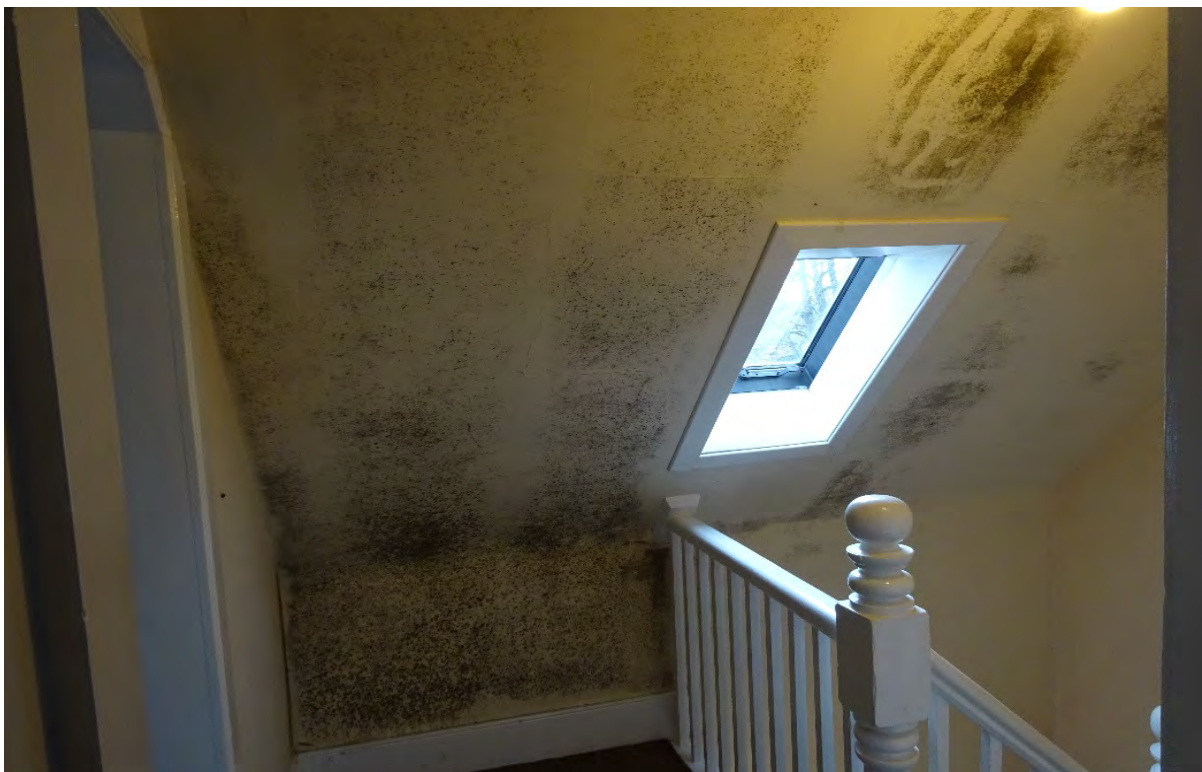
Mould growth was particularly pronounced in the later extension, the bedroom, bathroom, and in the stairwell, even though this area had not been insulated (Figure 3). Following this failure, it was deemed necessary to reverse the retrofit and implement a strategy to both thermally insulate the whole building envelope and tackle the relative humidity which had led to the mould growth. These works principally involved the use of a vapour permeable insulation material to help buffer relative humidity. Mould growth was further arrested by installing a more sophisticated extractor ventilation system to ensure warm moist air, caused by occupancy, could be removed from the building.

Figure 3. Substantial mould growth on the surface of the uninsulated stairwell roof space.

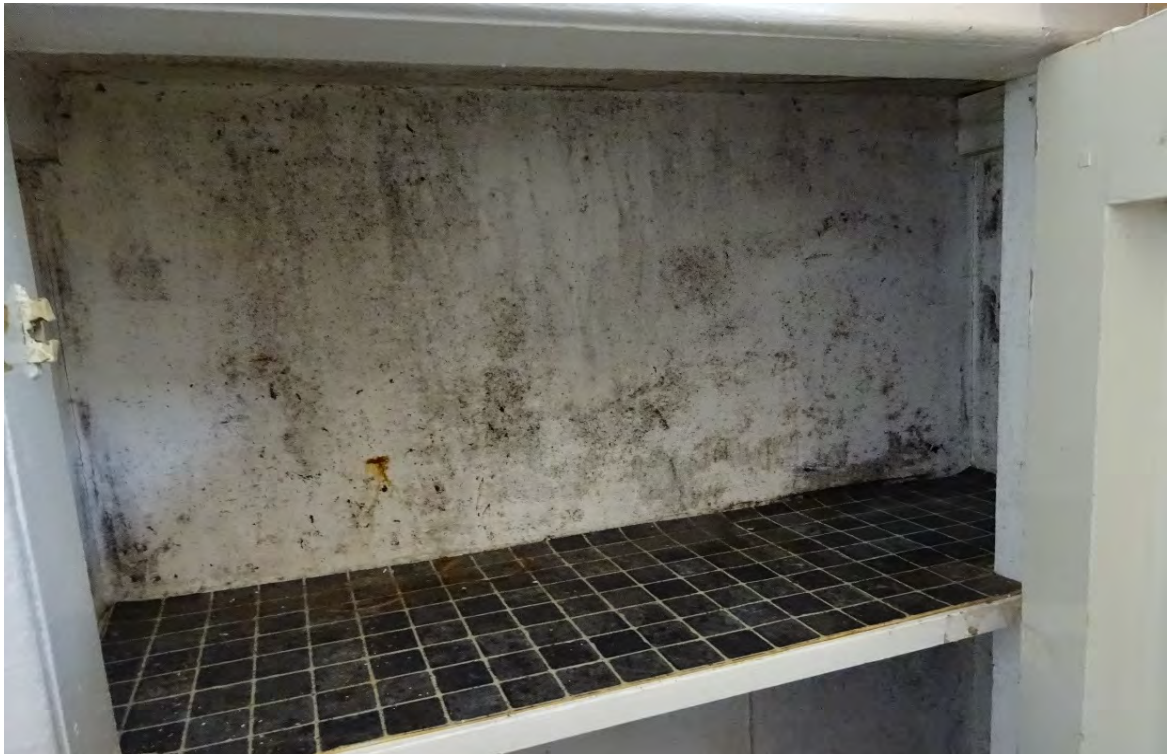
The moisture required for mould to grow in a building can come from many sources, including building defects and leaks. Condensation as a result of high internal relative humidity can also create the conditions for mould to grow (Figure 4). The only effective way to control mould and prevent it re-establishing itself is to remove the source of moisture which has led to its growth in the first place. For more information on managing moisture levels in buildings, see Historic Environment Scotland's INFORM guides [Damp: Causes and Solutions](#) and [Ventilation in Traditional Houses](#).

Figure 4. Mould growth in a press cupboard built into the masonry wall. As the wall is thinner at this point and therefore colder, it is a vulnerable point for condensation and associated mould growth.

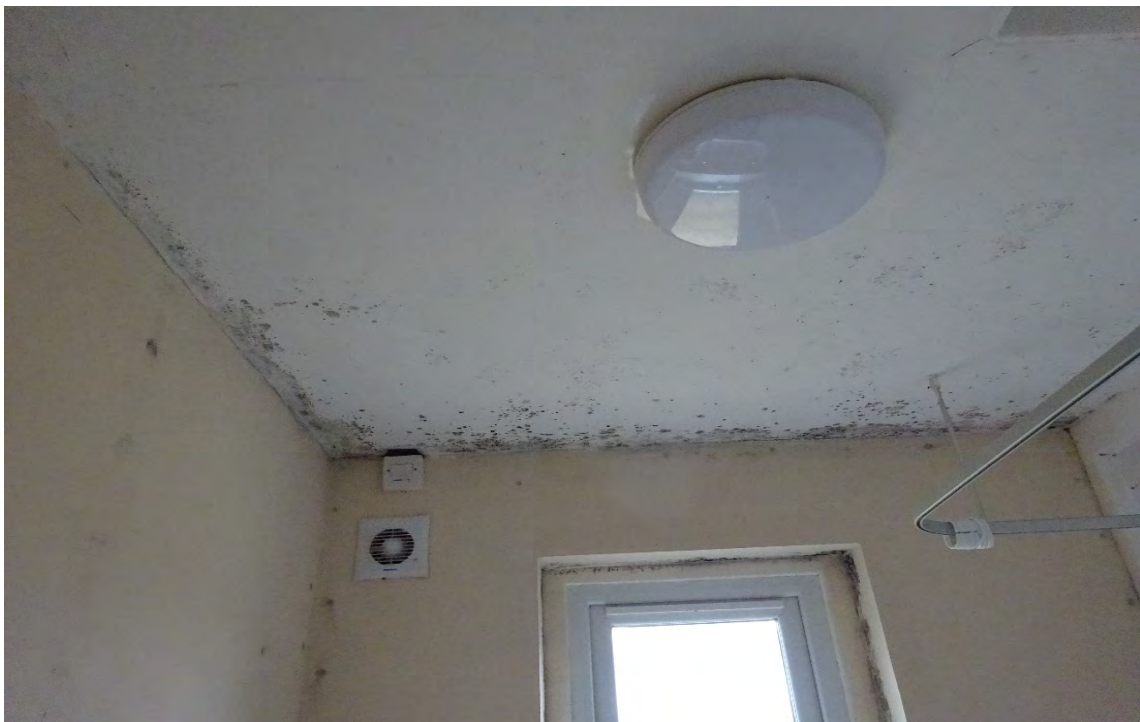
At the cottage the main problem which led to an excess of moisture internally was a lack of ventilation, exacerbated by high internal relative humidity created by occupant behaviour. Examples of occupant behaviour which produce moisture internally include cooking, drying clothes indoors, showers and bathing. Whilst these are all part of everyday life, if vents are not kept open, including trickle vents where appropriate, and extractor ventilation not used correctly, high levels of internal relative humidity can be created (Figure 5). The measures described below were all designed to

Figure 5. Mould growth in the bathroom, note the inadequate extractor ventilation system in the top left of the wall.

A significant factor in the growth of mould in the cottage was deficiencies in ventilation following the previous refurbishment; therefore improving the ventilation was integral to the work. The main element of this was the introduction of a humidistat controlled ventilation system at two points in the building: the bathroom downstairs (Figure 9) and on the stairwell ceiling (Figure 10). These points were strategically chosen as both areas had experienced significant mould growth in the past due to high relative humidity levels. The humidity controlled ventilation should reduce these concentrations of moisture and help prevent mould recurring.

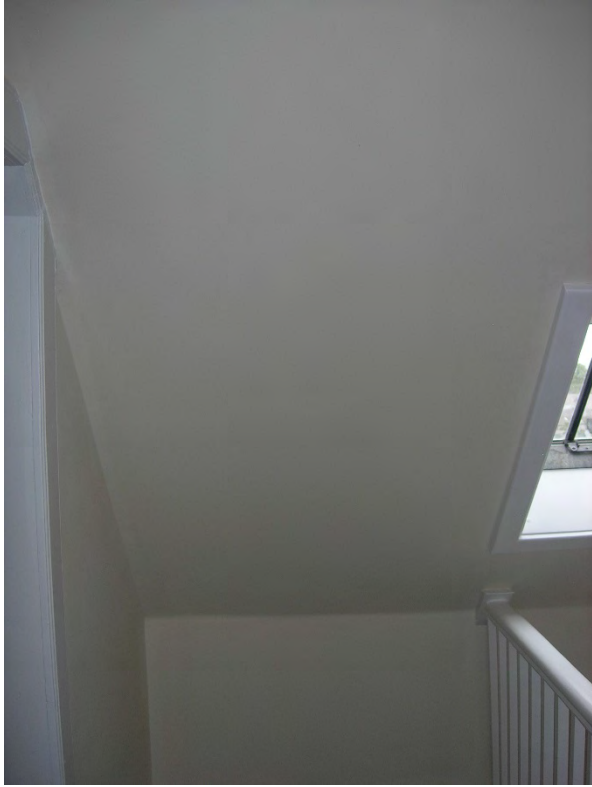
Figure 6. The new insulation was finished with plasterboard. This is the same area of stairwell shown in Figure 2, but following the works.

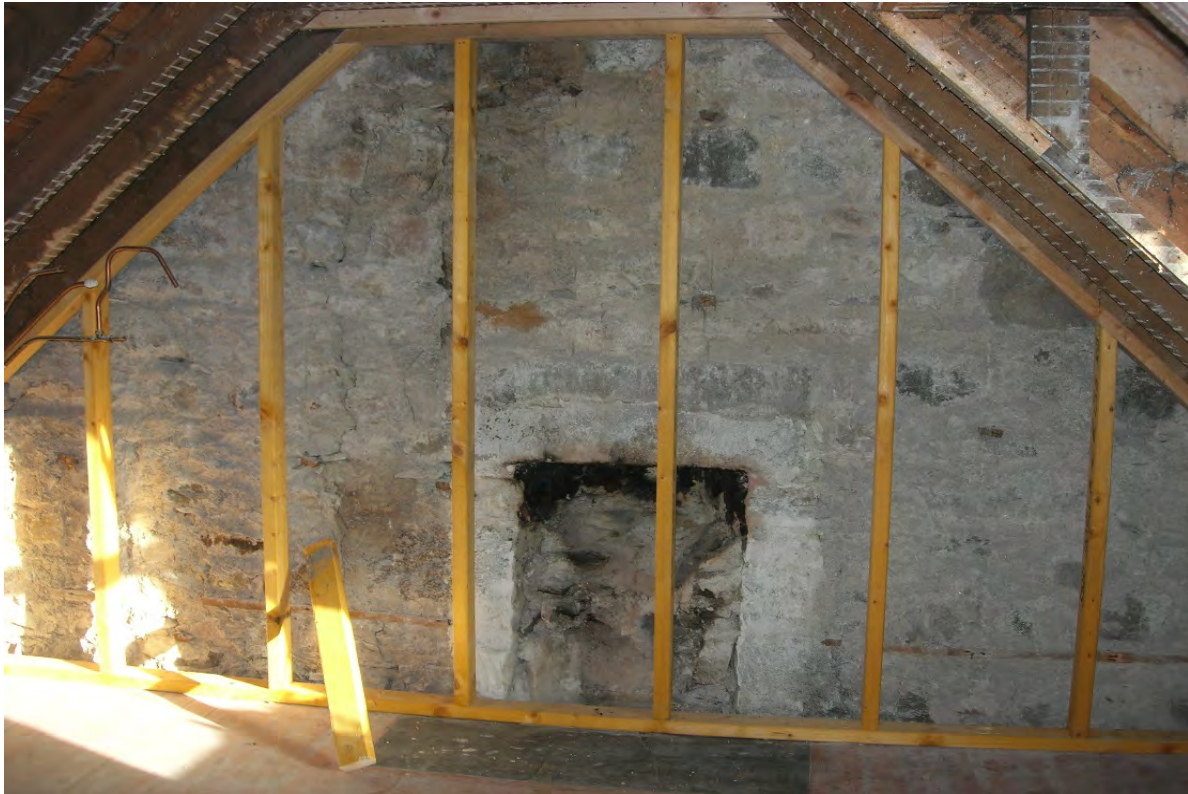
Figure 8. The gable end framed out and ready for insulation, the fireplace was vented to maintain airflow in the flue.

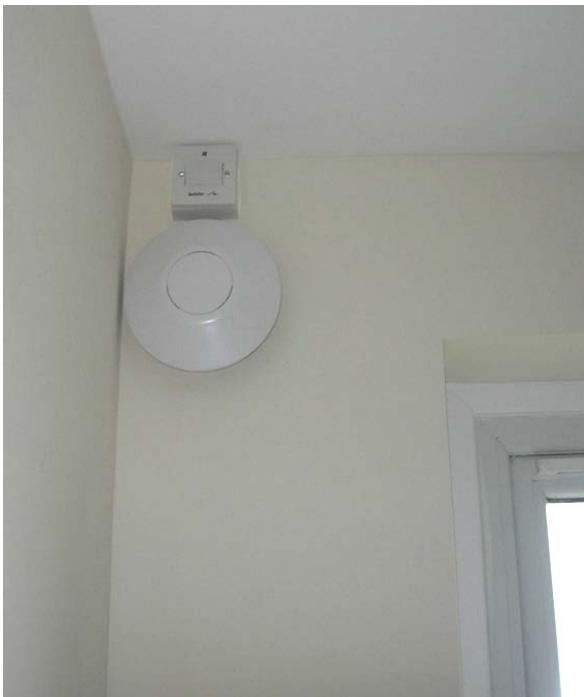
Figure 9. The new humidity controlled extractor ventilation system in the downstairs bathroom.

The extractor ventilation system installed was of the 'Decentralised Mechanical Extract Ventilation' (DMEV) type. A DMEV fan has two modes of operation, a low level "trickle" speed which operates continuously, and a higher "boost" speed which operates when the humidistat shows high levels of relative humidity, turning back to "trickle" when relative humidity is shown to be sufficiently low. The boost function can also be linked to light switches and turned on and off manually.

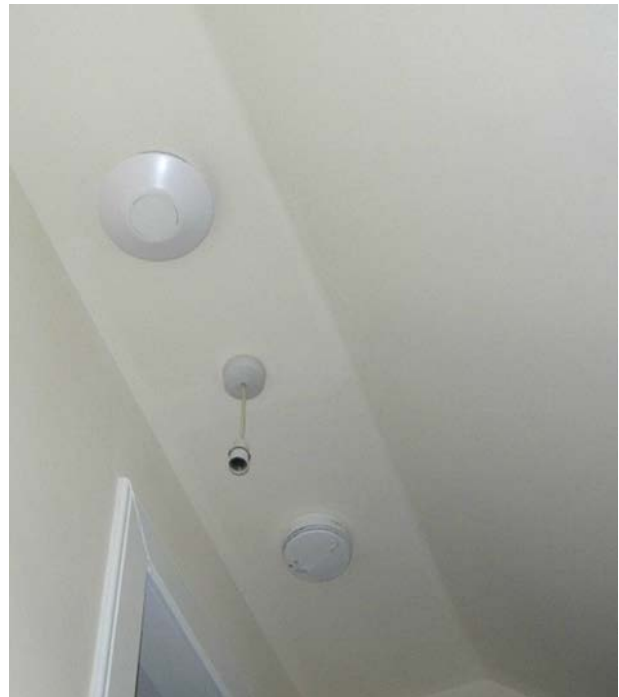
Figure 10. Humidity controlled extractor ventilation system in the stairwell which had previously suffered significant condensation and mould growth.
