INFORMATION FOR HISTORIC BUILDING OWNERS

Exterior Masonry Steps

This INFORM offers owners of buildings information on masonry steps, their different forms and parts, and the repair and maintenance issues that can arise.

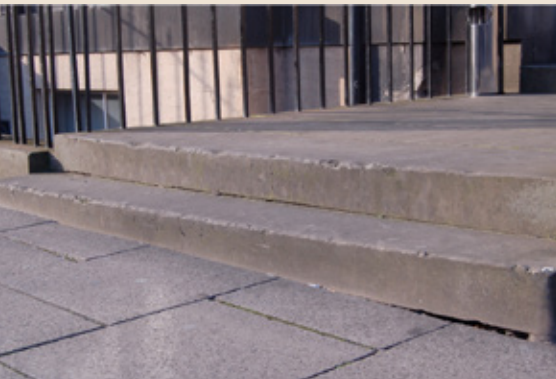
Fig. 1 Simple block step and platt, constructed from large slabs of stone.

The simplest form of exterior step is simply one or more built up masonry blocks, sometimes incorporating a larger slab or 'platt' which forms a threshold at the entrance to a building (Fig.1).

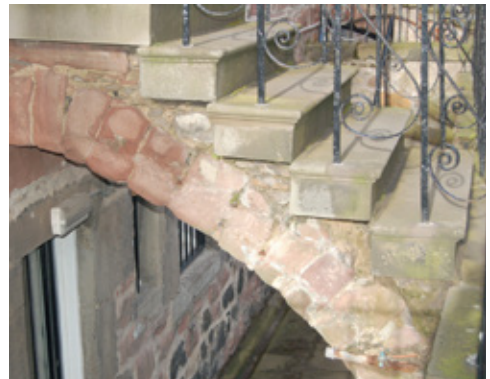
Fig. 2 Rectangular steps built with a supporting arch over a basement, a typical urban detail.

These are the most common type of steps formed of masonry blocks, which are rectangular in section. They are often simply constructed with the front of one step supported on the back of the lower step, but sometimes the step is rebated (secured under) into the one below. The nosing (top edge) of the step is often rounded or chamfered to prevent impact damage, but is sometimes left square. When the steps have to bridge a void, they are built over a supporting arch (Fig. 2). This is a common feature in urban properties that incorporate a basement.

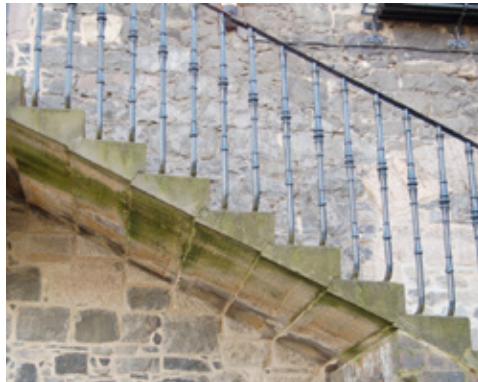
Fig. 3 Spandrel steps.

Spandrel steps are masonry blocks cut in triangular section, so that each step sits on the back edge of the one below, with a diagonal soffit (underside), creating a lightweight and elegant appearance (Fig. 3). Each one is held in place by a rebated joint between the bottom

front edge of the higher step and the top back edge of the lower. Spandrel steps are either built into a wall or supported by masonry or brick.

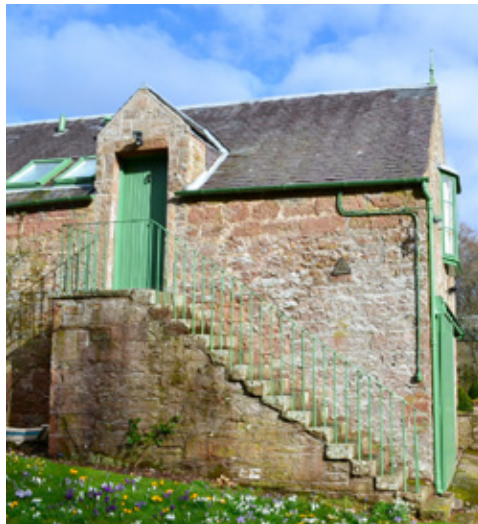
Fig. 4 Outstairs leading to an upper-floor property.

Projecting steps, built on a masonry structure (which may incorporate a store area below the steps), can be found when the upper-level property is either in different ownership or use from that on the ground floor (Fig. 4).

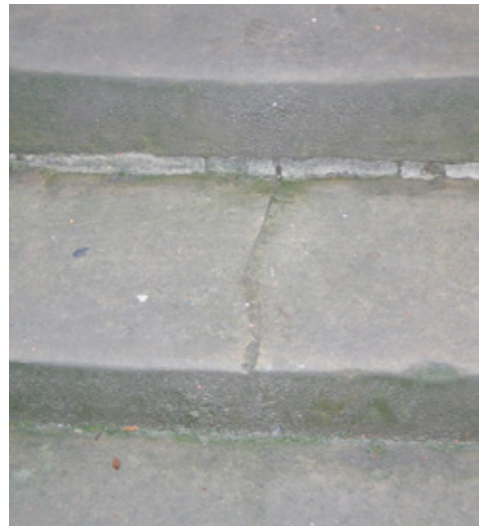
Fig. 5 Evidence of past settlement can be historical and need not be a cause for concern.

External steps can suffer from structural defects which, if left unchecked, can result in serious damage and costly repairs. It is important to regularly inspect them for early signs of these problems. Sometimes evidence of past settlement or cracking is historical and need not be a cause for concern (Fig. 5). If there is evidence of recent structural movement such as treads beginning to come loose, gaps appearing between steps or cracking appearing in the masonry, then further action should be taken.

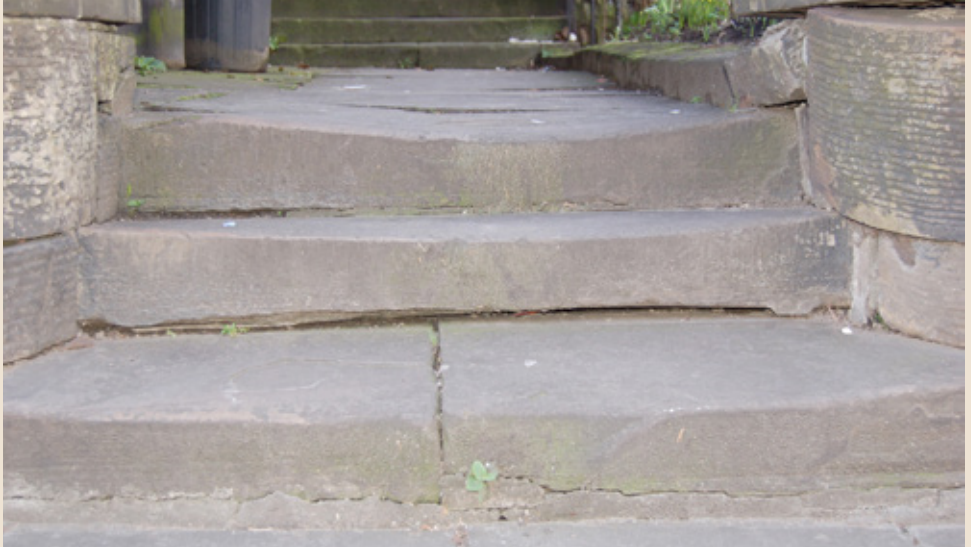
Fig. 6 Open joints can allow water to penetrate leading to masonry decay.

- Biological growths such as mosses, grass and even small shrubs can establish themselves on steps in gaps between treads and the side faces of spandrels. The growth should be carefully removed to prevent the root structures creating further damage and the open gaps repointed with an appropriately specified lime mortar.
- Open joints left between steps and platt slabs also allow water to seep through leaving the underside of the steps saturated with little chance of drying out. Open joints should be repaired as soon as possible to prevent further decay (Fig. 6).

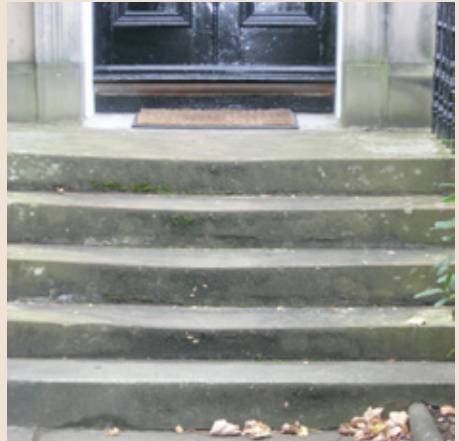
Fig. 7 Some level of wear is normal and acceptable.

Given the traffic which external steps carry over their lifetime it is not surprising that the masonry can become worn. Some wear is normal, and can add considerably to the character of old steps (Fig. 7). Large pieces of stone were often used for steps and platt slabs.

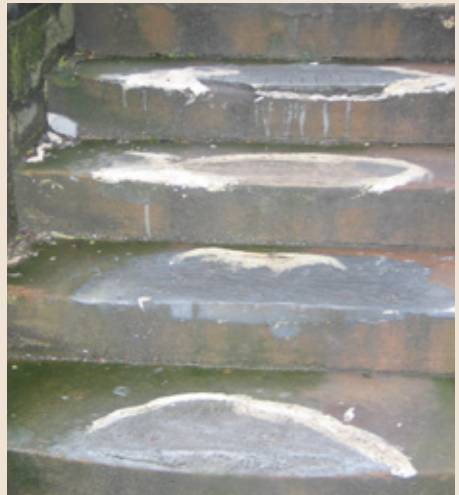
Fig. 8 A poor quality repair using cement.

A cheap repair option involves cement or other proprietary materials being screeded over the existing tread to fill the worn section (Fig. 8). This approach should be avoided; it not only diminishes the visual appearance of the steps, but can lead to an increased risk of decay in the future, as cement is harder and less permeable than natural stone. Some lime-based formulated repair mortars are available specifically for stone step repair and these may be appropriate in some instances.

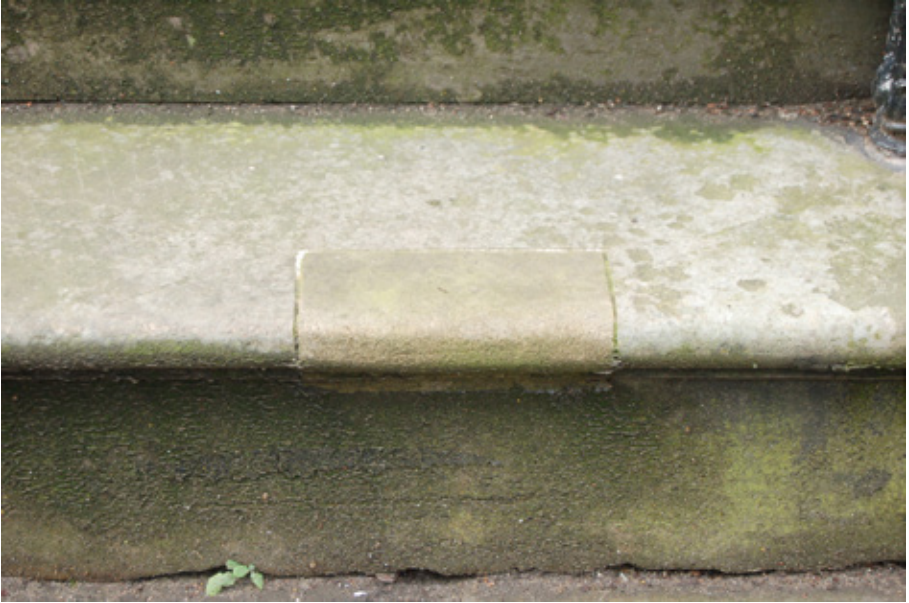
Fig. 9 Stone for indent repairs should be carefully matched to the original.

Parts of a step can sometimes be broken off or fractured due to impact damage. Where there is a clean break, and the original piece of stone has been retained, it may be possible to have an experienced contractor carefully re-secure the broken piece. Where this cannot be done a stone indent may have to be fashioned (Fig. 9).

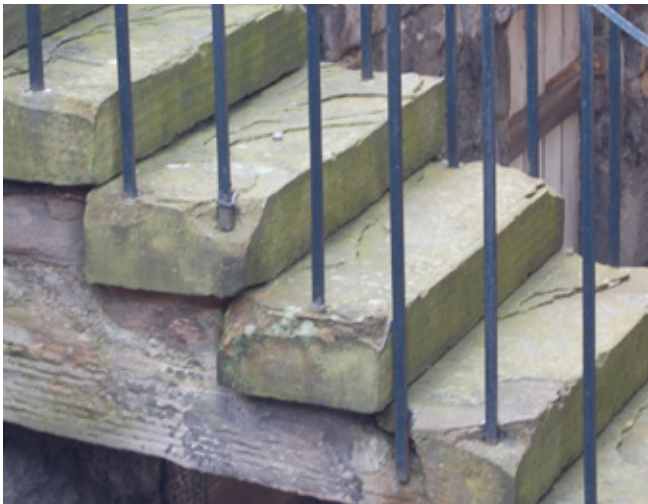
Fig. 10 A lack of maintenance can lead to rusting ironwork and masonry decay.

- Over time the lead caulking can become loose. This can allow water to penetrate the hole into which the balustrade is set, causing corrosion of the metal and/or frost jacking, both of which can cause the surrounding stone to crack (Fig. 10).
- Other parts of the balustrade can also suffer from corrosion and deterioration appearing as: cracked or blistered paint, rust coloured staining and delamination of the surface of the iron.
- Sometimes individual pieces of the balustrade can become damaged or lost. Given the important safety function that a balustrade performs, missing elements should be replaced promptly. Replacement pieces for such elements should match the design and dimensions of the original as closely as possible.
