Property in Care (PIC) ID:	PIC277
Designations:	Scheduled Monument (SM90157)
Taken into State care:	1931 (Guardianship)
Last Reviewed:	2019 (2025 update to include Empire connections)

STATEMENT OF SIGNIFICANCE

BROCH OF GURNESS (AIKERNESSE BROCH)

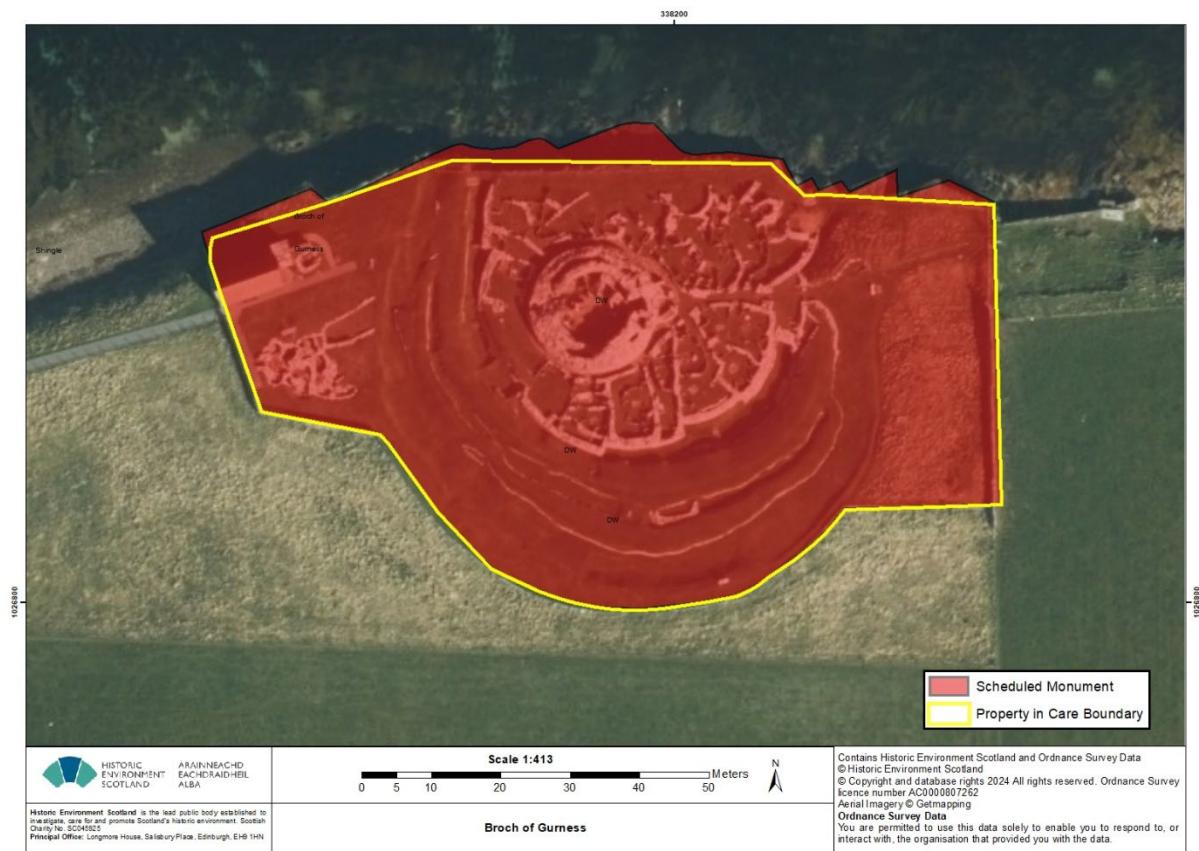
Figure 1: Broch of Gurness Scheduled Area and Property in Care Boundary. For further images, see Appendix 2. For illustrative purposes only.

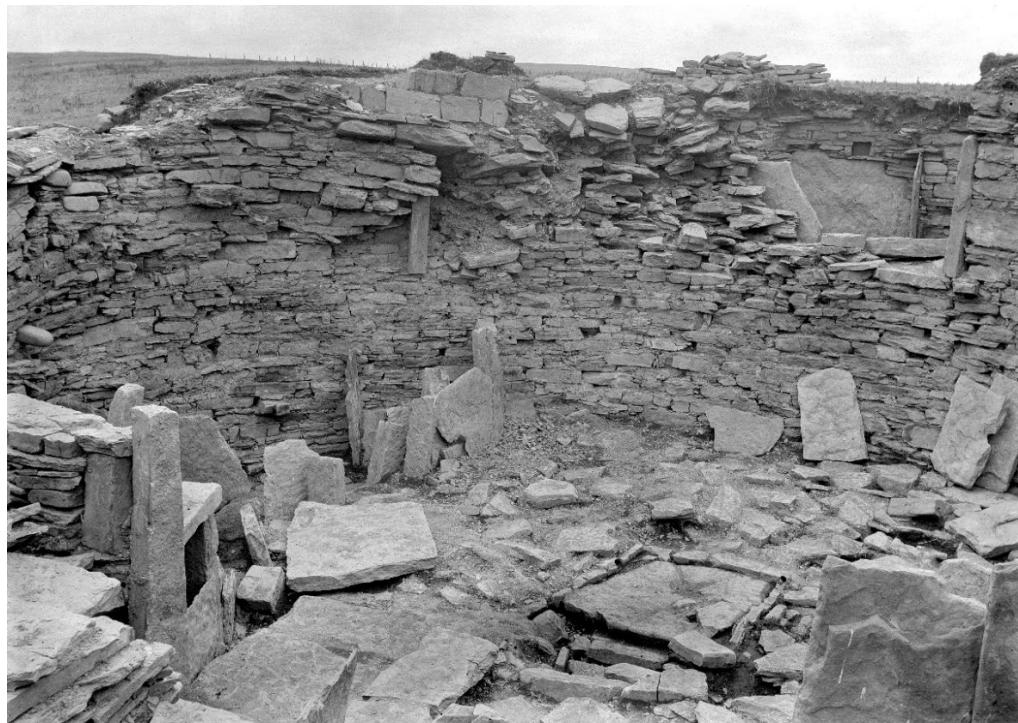
Figure 2: Gurness, broch interior immediately after emptying (c. 1934) to demonstrate how far today's neat stonework represents comprehensive reconstruction (SC 1214992) © Crown Copyright: HES.

Following the extensive works of the 1930s, subsequent consolidation of the site has been largely restricted to keeping the stonework in good condition: in effect, the maintenance of what was done up to 1939 through the replacement of stone pinnings and occasional replacement of stones which have fractured through natural weathering or visitor impact.

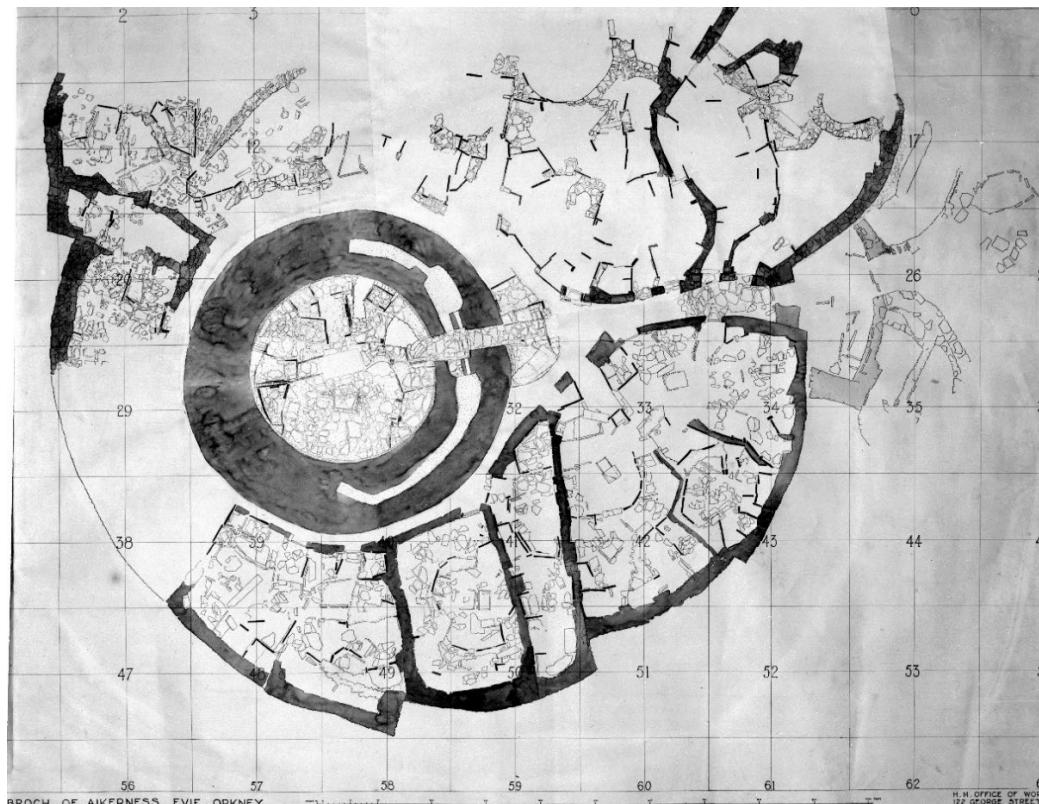
Figure 3: Gurness, the emerging plan (c. 1937) (SC 1217660) © Crown Copyright: HES.

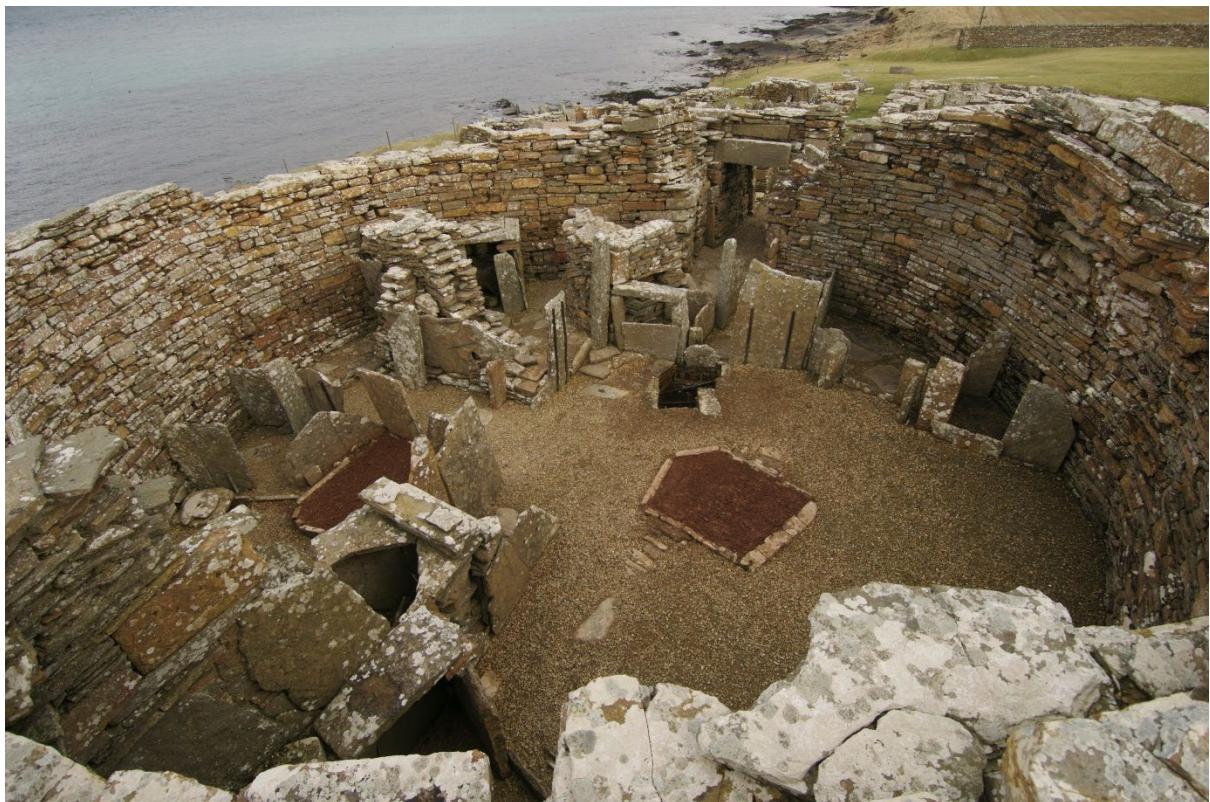
Figure 6: Gurness broch interior (008-001-013-807-R) © Crown Copyright: HES.

Within the broch's interior space are a number of stone compartments and other features, partly constructed of large, upright, slabs; these include two stone stairways which rise towards the broch wall. (These features appear to be secondary insertions. They have all been heavily repaired and in places entirely rebuilt.) A carefully-constructed underground chamber, perhaps a "well", descends for 4m below the floor. This construction (which is now closed by a metal grid) appears to be an early feature, as it was sealed by the layer of paving which underlies many of the internal stone fittings. The precise relationship between the broch and the "well" is not known, because it is by no means certain that the excavators reached the primary floor level of the broch.

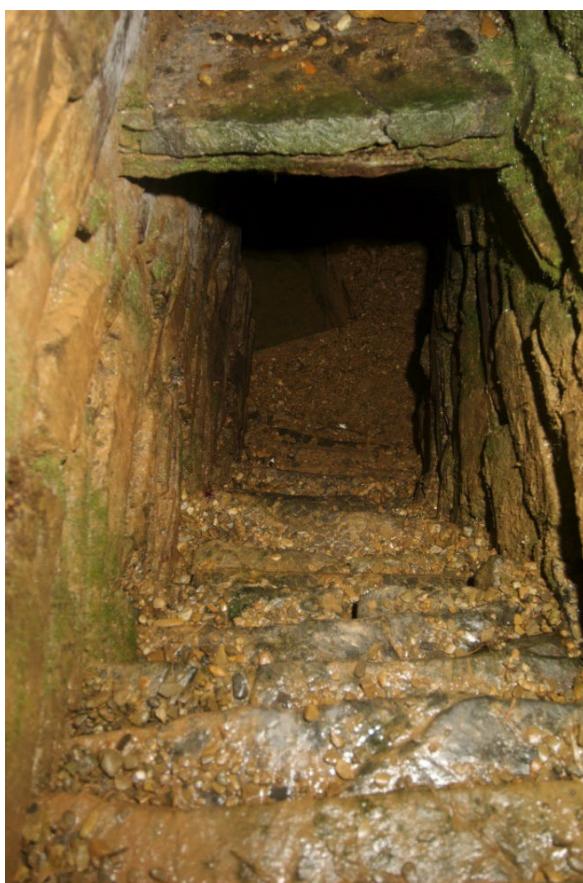
Figure 7: Gurness broch, “well”, looking down (008-001-013-805-R) © Crown Copyright: HES.

- The deep, partly rock-cut chamber or “well” which descends 4m below the broch courtyard, is one of several in Orkney: that at Gurness is only surpassed by that at Mine Howe. It has been suggested that such chambers may be more than wells: possibly spaces in which unknown rituals took place. It has also been suggested that they may pre-date the brochs within which they have been found (with the exception of Mine Howe, which is not below a broch). It may or may not be coincidental that other broch sites known to have such features also tend to have one or more external ditches, although none so clearly visible or large in scale as at Gurness. They also tend to have evidence of metal-working in bronze and/or iron.

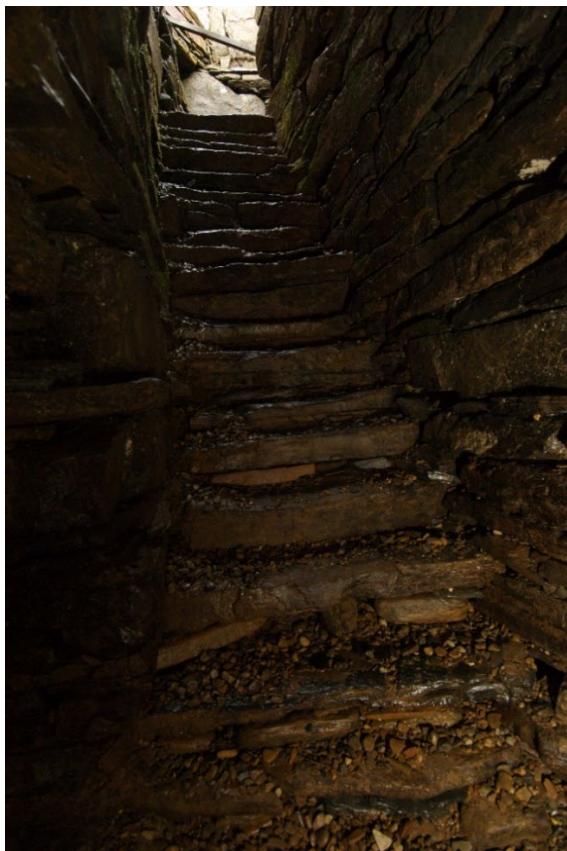
Figure 8: Gurness broch, “well” looking up (008-001-013-803-R) © Crown Copyright: HES.

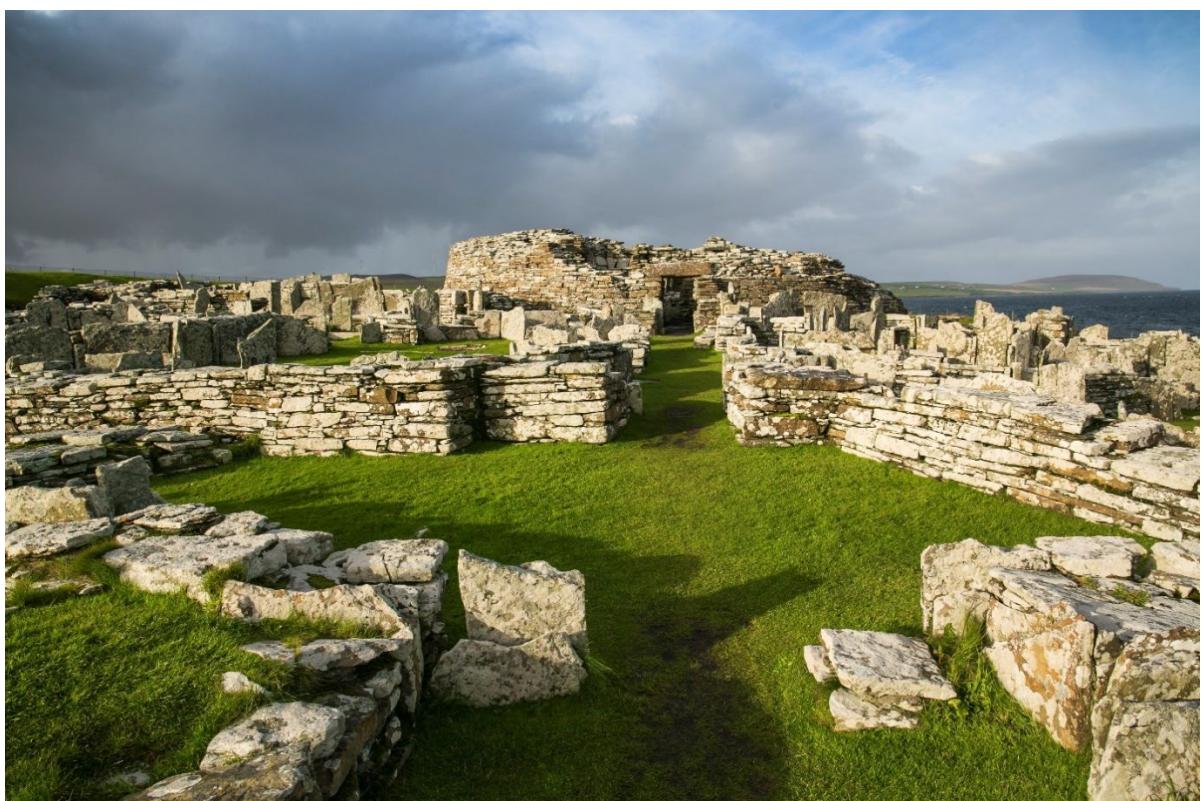
Figure 9: Gurness, entrance way through ditches towards broch (008-000-062-847-R) © Laurence Winram.

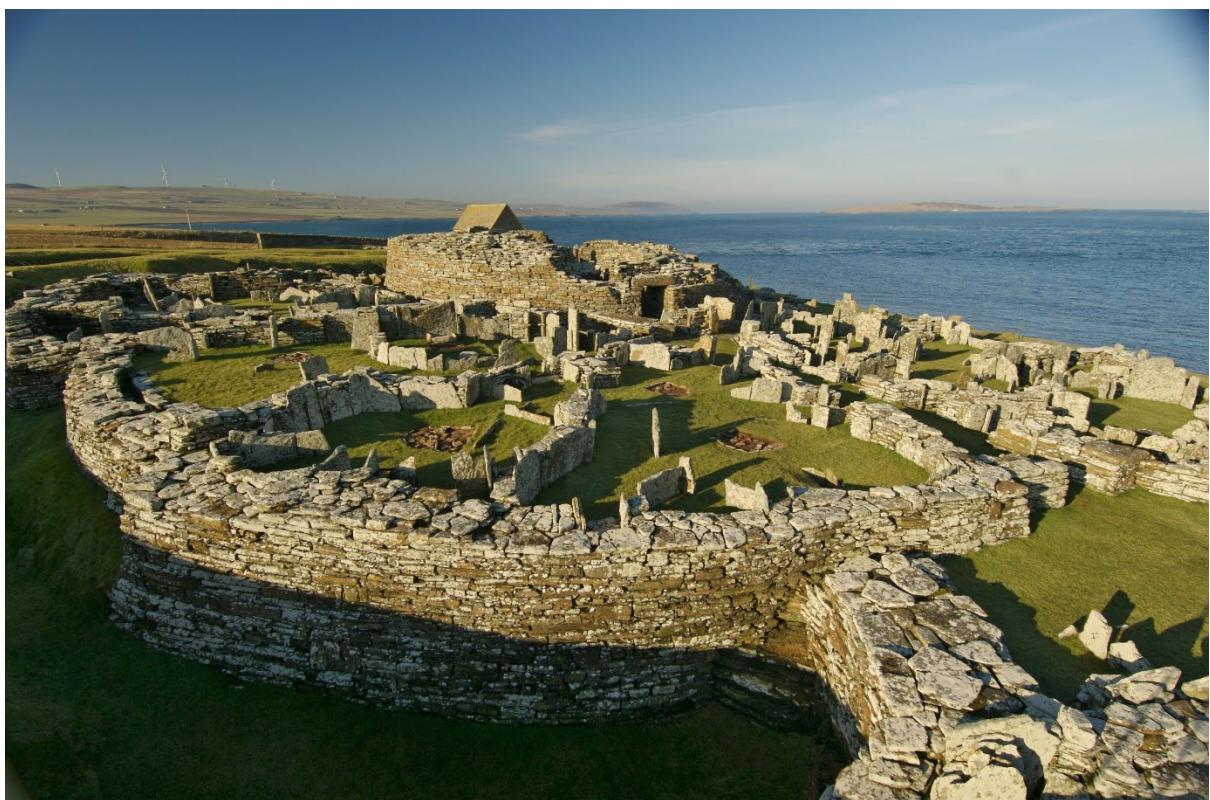
Figure 11: Gurness “village” showing perimeter wall and entrance way (008-001-013-831-R) © Crown Copyright: HES.
