TECHNICAL PAPER 27

HOT-MIXED LIME MORTARS
MICROSTRUCTURE AND FUNCTIONAL PERFORMANCE

HISTORIC
ENVIRONMENT
SCOTLAND

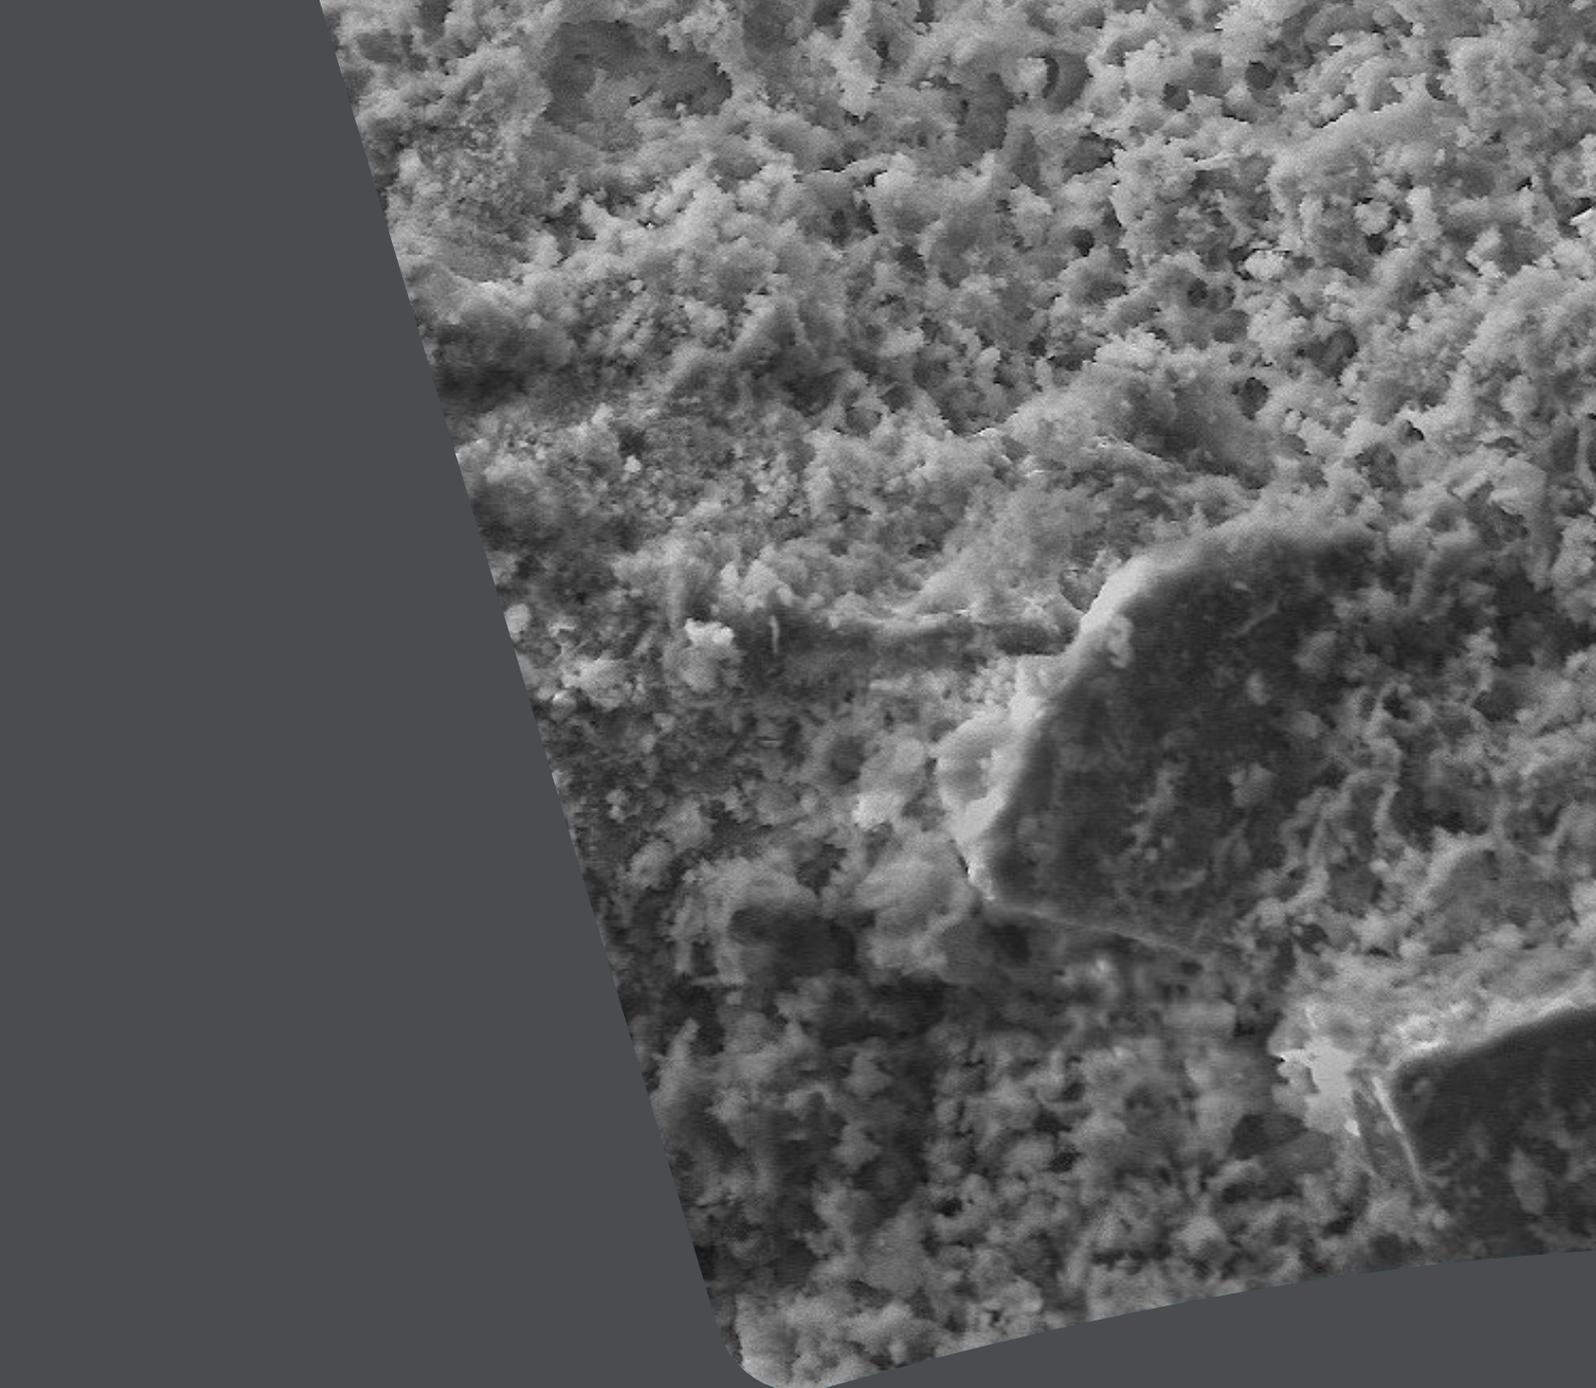
Cover image: Scanning electron microscope (SEM) image of hot-mix mortar showing intimacy of bond between binder and aggregate in historic lime mortar; Kilmahew Castle, Strathclyde.

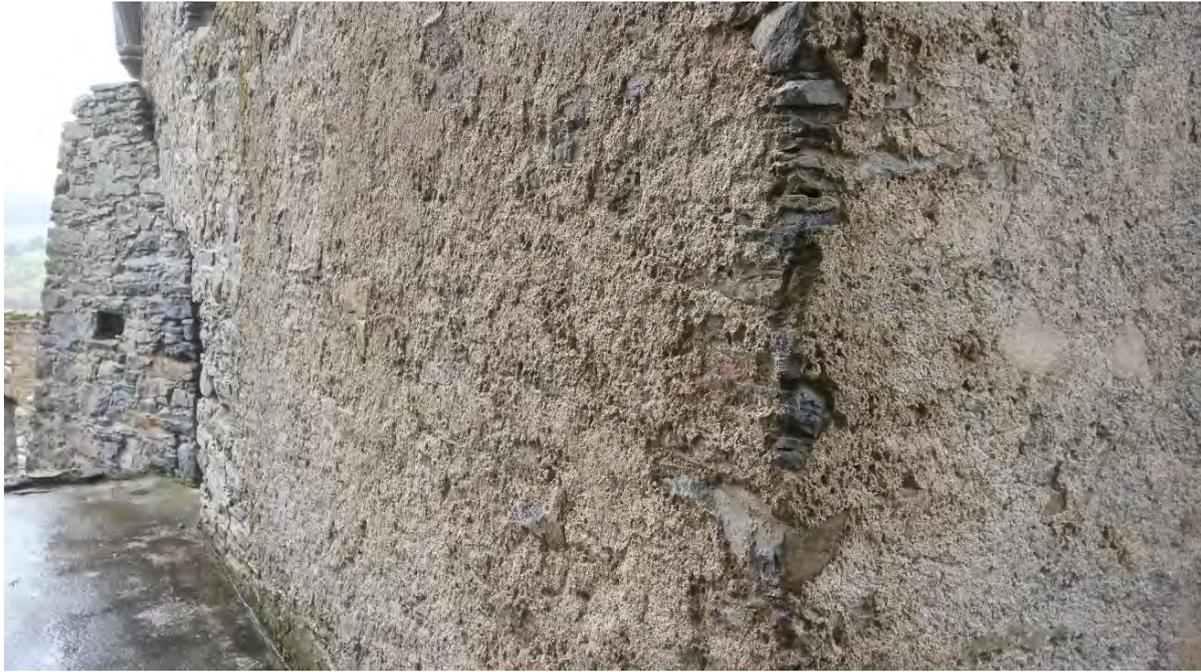
Figure 1: Surviving lime plaster in very exposed conditions at Auchindoun Castle, Grampian.

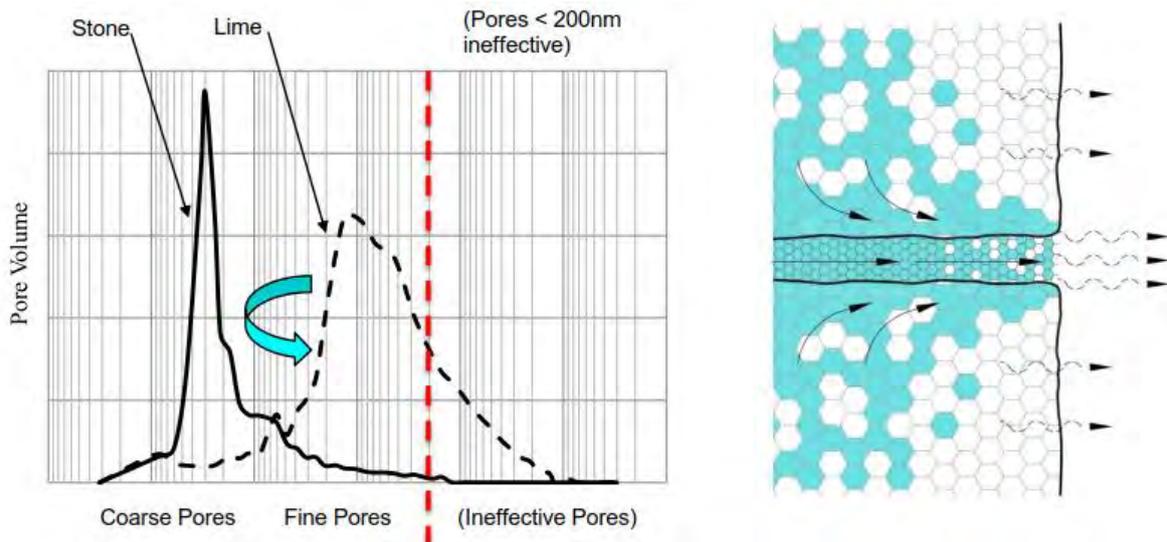
Figure 2: Poultrice mechanics (log scale) and as applied to a 2-D cross-section through a mortar bed joint with inferred water movement pattern (salt advection) (Wiggins 2015).

With these two porous materials of distinctly different pore sizes laid together in the context of masonry joints, and the addition of water (e.g. from wind driven rain, rising damp, condensation or building defects) a poulticing interaction is induced.¹

Narrow pores have a greater capillary draw than broad ones, and so the fine pores of lime mortar draw the water away from the coarse pores of the masonry unit. In doing so, the salt ions held in solution are transported in the body of moving water in a process known as advection (Pel et al. 2010). The lime mortar pointing exploits a capillary drying regime whereby the evaporation front is formed at the surface of the pointing nib, and the evaporative loss is compensated by capillary flow from the body of the wall (Figure 2) (Coussot 2000). The point of evaporation dictates where the salt then precipitates, concentrated in the lime mortar pointing.

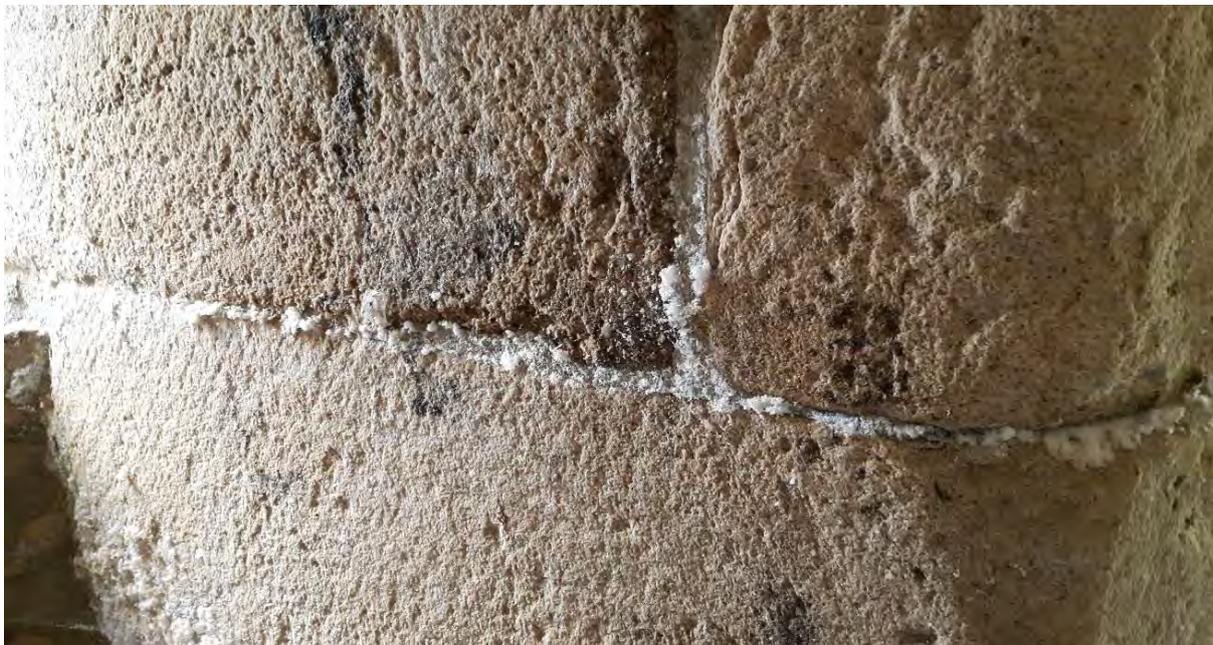
Figure 3: Sacrificial protection in practice - precipitation of soluble salts in mortar joints at Aydon Castle, Northumberland (18th century agricultural buildings).

This interaction is mobilised year round every time the building dries after periods of wind-driven rain. Over the lengthy lifetimes of masonry structures, the mortar acts as a poultrice, offering a pronounced preservation-enhancing function (Figure 3).

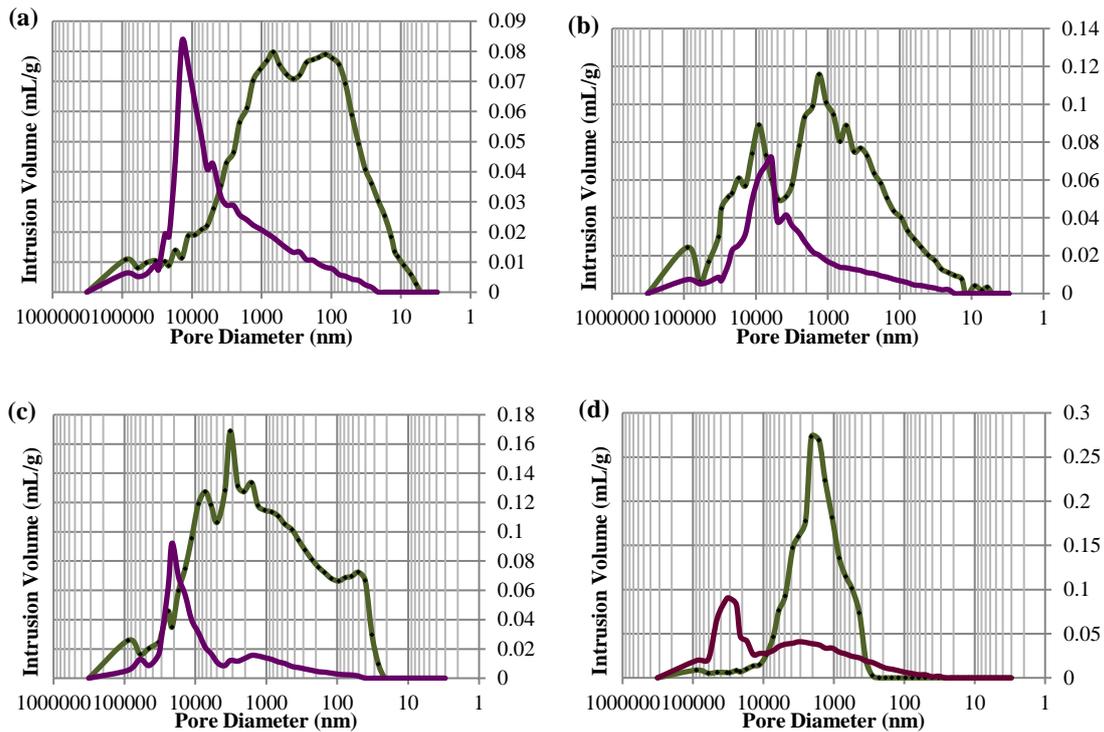
Figure 4: Data pore size distributions of sandstone and lime mortar. (a) Bothwell Castle, South Lanarkshire; (b) Melrose Abbey, Roxburghshire; (c) Newark Castle, Port Glasgow; (d) Saltmarket Tenements, Glasgow. The purple line represents stone, the green line represents lime mortar (Wiggins 2015).

The sandstones in Figure 4 exhibit relatively monomodal pore size distributions with predominant pore size of around 10,000nm and porosities ranging from some 15-25%. The historic lime mortars are substantially higher in porosity than the sandstone; porosities range from some 30-40%. This porosity is well interconnected. The lime mortars exhibit broader pore size distributions than the stone, encompassing both large pores and small pores. Notably, however, a distinct trend throughout is a predominant pore size of around 1,000nm in diameter. This capillary porosity is located within the pore size range attributable to calcitic development i.e. carbonated free lime. Due to the relationship between the predominant pore sizes of the two respective materials, when set together in the context of a mortar joint, pointing, or surface coating (harling), water is wicked away from the coarse-pored stone into the fine-pored lime mortar. This leads to the enhanced preservation offered by lime mortar to the masonry units (e.g. Figure 3).

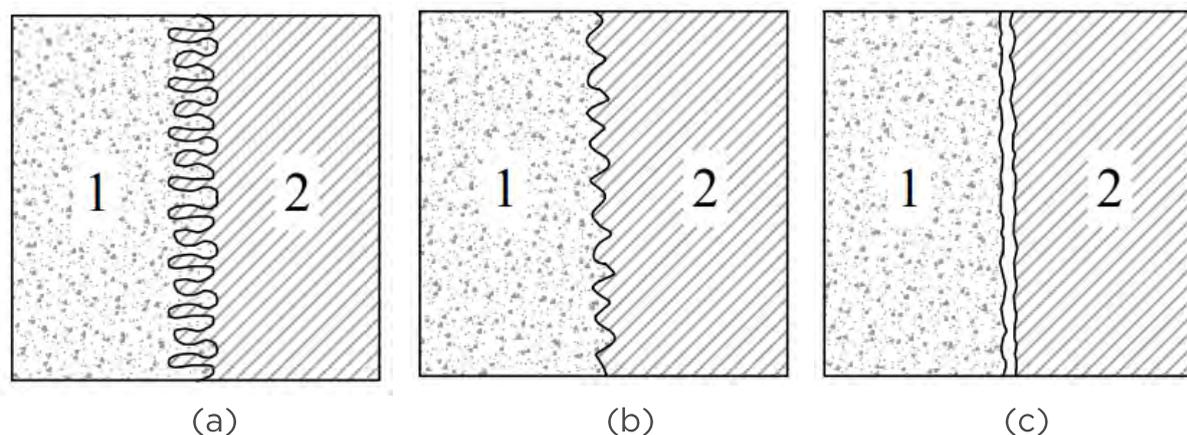
Figure 5: Theoretical variations of bond intimacy and their effect on capillary flow. From left to right: (a) represents hydraulic continuity; (b) represents natural contact; (c) represents an air space formed by shearing of the interface manifesting in interruption to fluid phase movement (Wiggins 2015).

Variation (a) shows 'full hydraulic continuity,' an ideal that is seldom realised in practice. Variation (b) demonstrates the bond between the mortar and masonry unit where there is 'natural contact', despite a demonstrable adherence extension of mineral binder interlinking the pores between mortar and masonry. The pronounced disruption to moisture transport caused by even a small air gap is demonstrated in variation (c) (Haghighat et al. 2003).

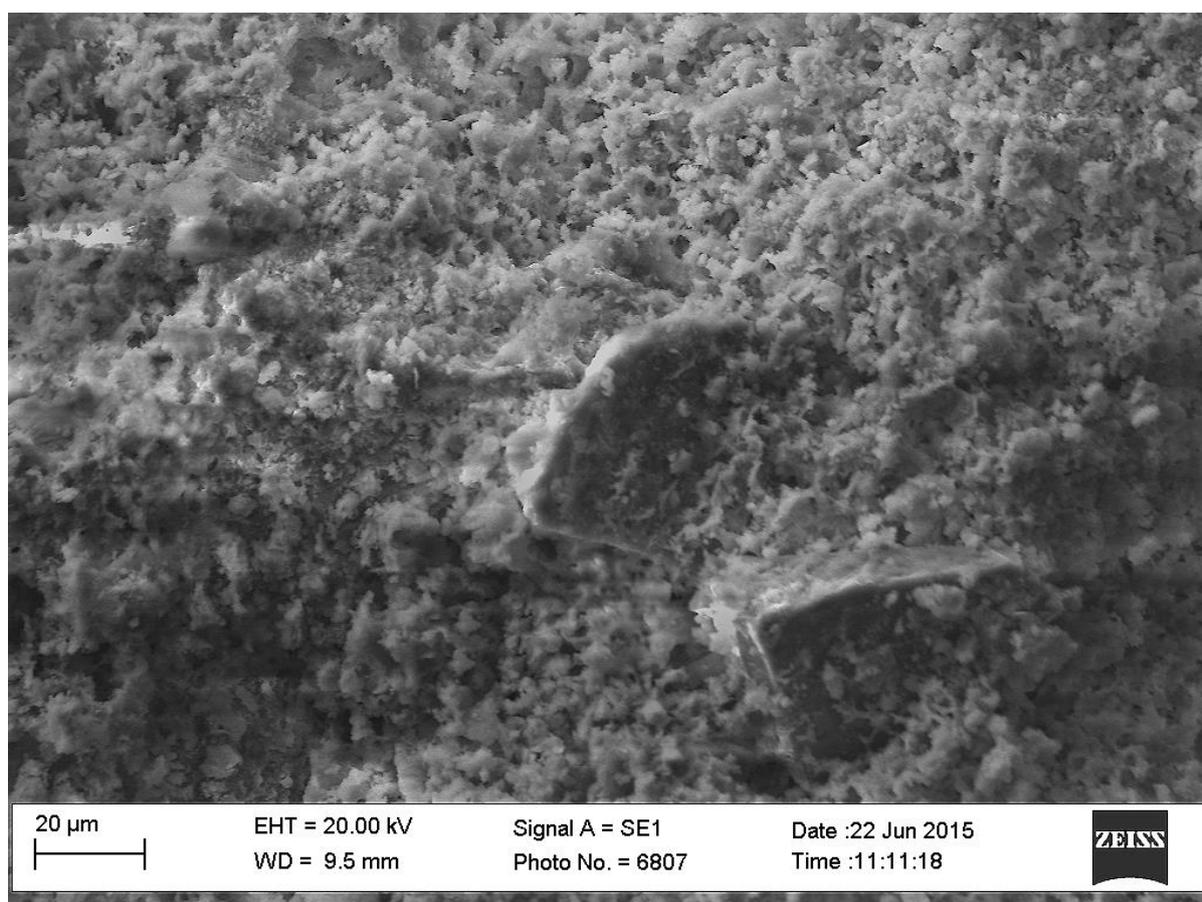
Figure 6: Scanning electron microscope (SEM) image showing microporous nature of binder and intimacy of bond with aggregate in historic lime mortar. Kilmahew Castle, Strathclyde c.1500-1700. Quartz aggregate, binder is calcite rich. Note the scale bar and size of the pores ca. 1 μ m (Wiggins 2015).

Historic lime mortars possess intimate bond capabilities, both with masonry units on the macro-scale, and with the sand aggregate on the micro-scale (Goodwin and West 1980; Bakolas et al. 2000). The intimacy of bond and associated adhesive strength is typically related to the area of surface contact between the binding matrix and the aggregate or substrate. Where binder particles are small and closely arranged, an intimate and strong bond is formed. For a historic lime mortar, known to be binder-rich, an intimate bond can be discerned (Figure 6).

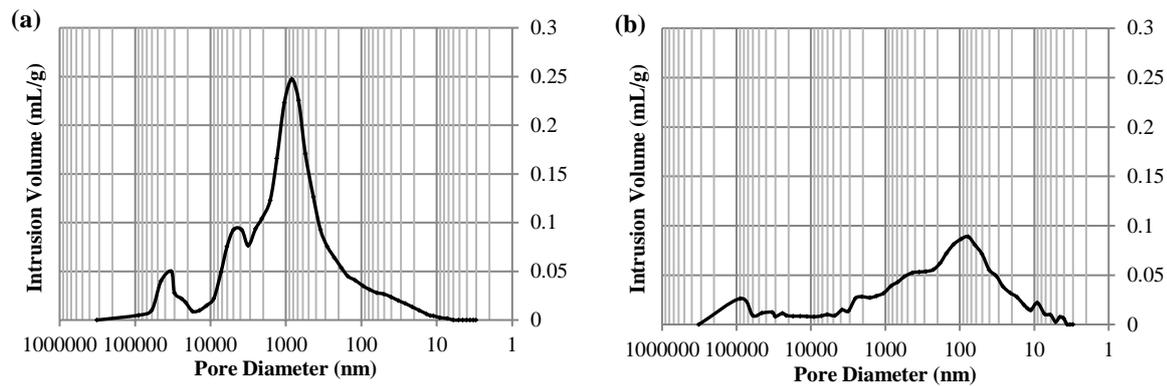
Figure 7: Pore size distributions of (a) historic lime mortar from Balvenie Castle; (b) modern NHL-based lime mortar in use at Urquhart Castle after 2-yr field curing. Note the distinct discord in predominant pore size in addition to the discord in overall porosity (the area under the curve) (Wiggins 2015).
