Property in Care (PIC) ID: PIC259

STATEMENT OF SIGNIFICANCE

NESS OF BURGI

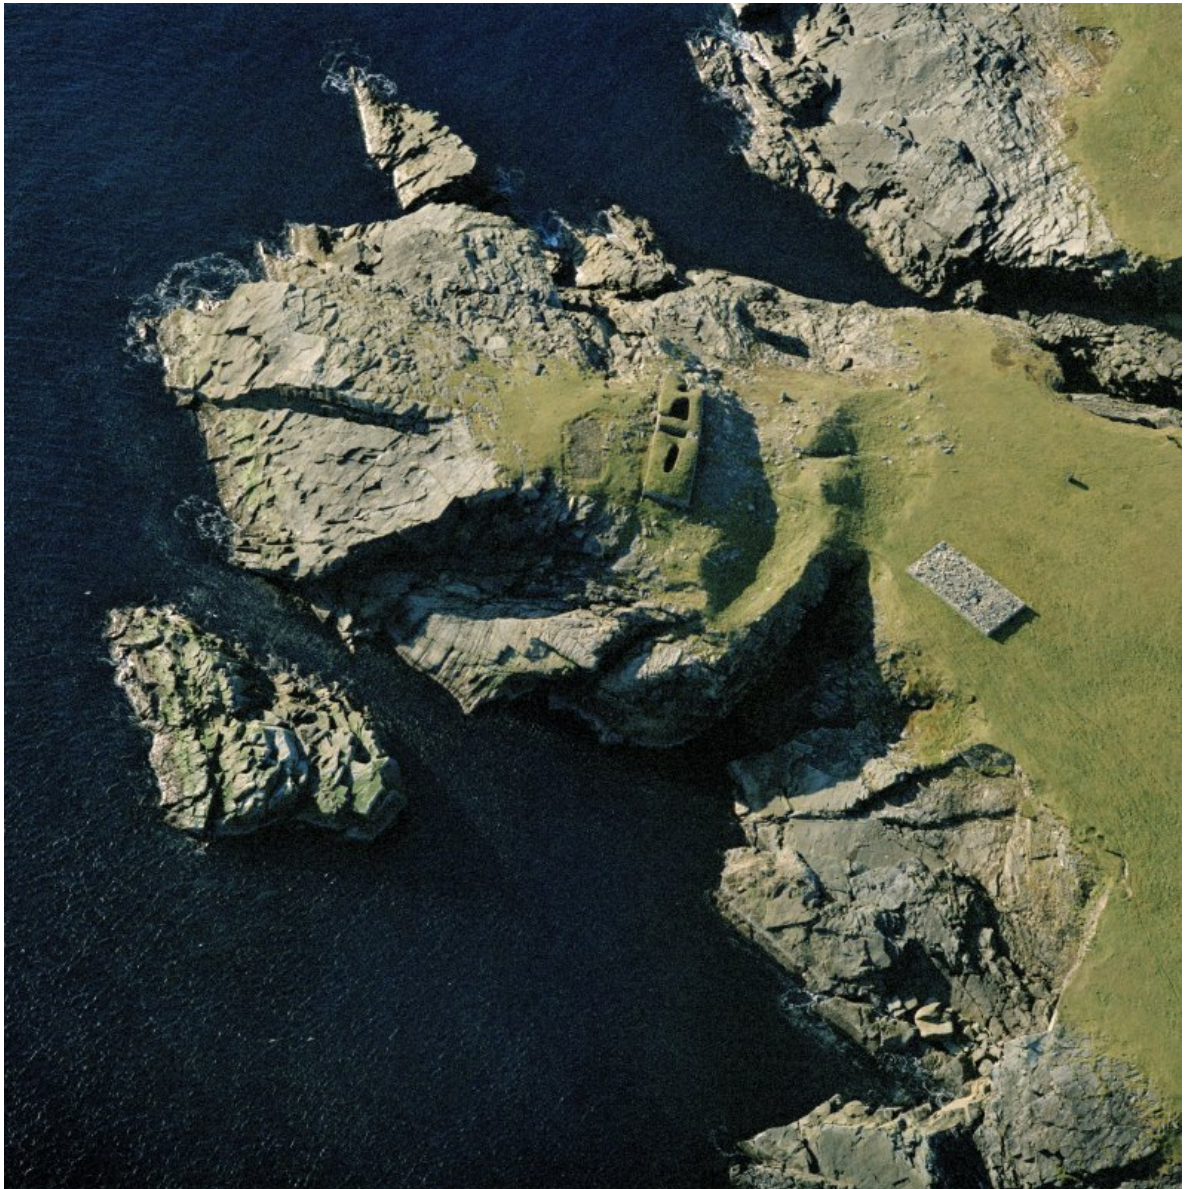
Above: aerial view, south towards top of frame:

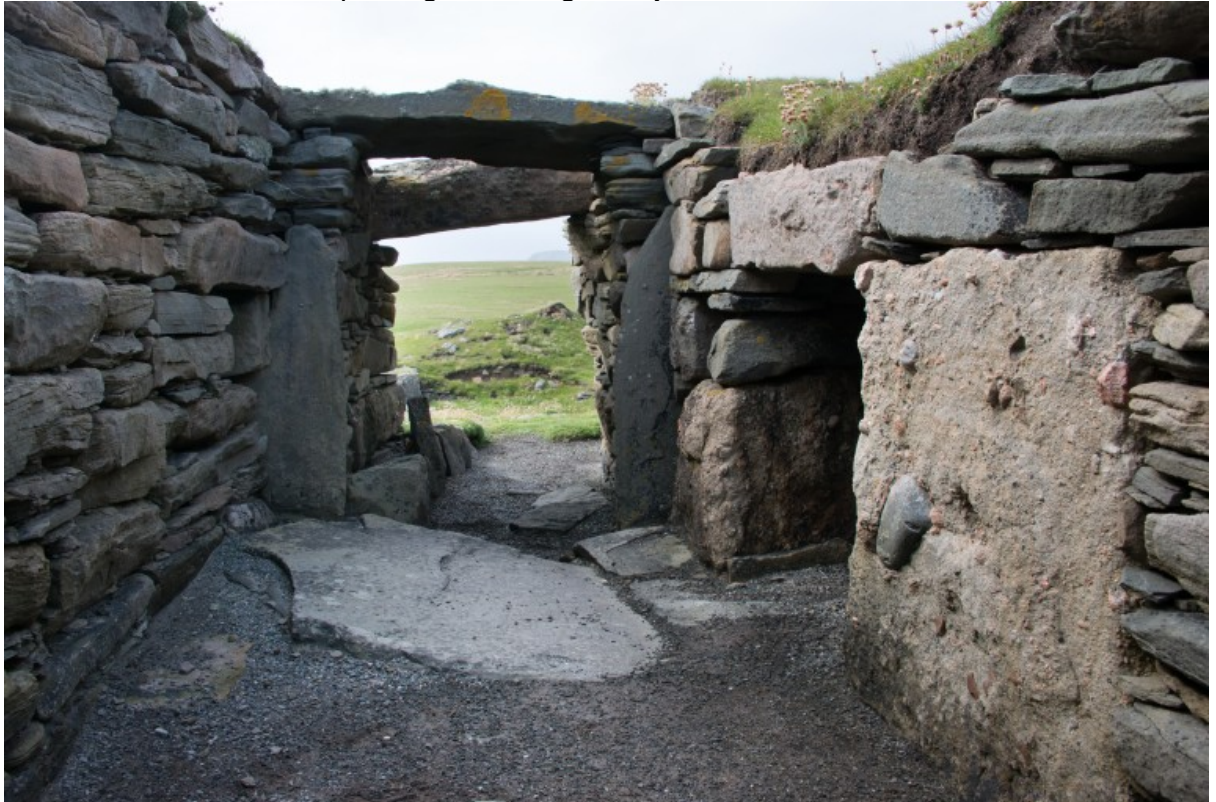
Interior view of entrance passage showing door jambs:

The blockhouse is pierced centrally by a narrow entrance passage, three lintels over this survive *in situ* (or, less likely, had been replaced prior to 1935). This passage is about 1 metre wide as it passes through the outer face of the blockhouse, and widens out at about 1.6 metres in, where a door-jamb and two bar-holes survive. The inner portion of the passage is about 1.3 metres wide.

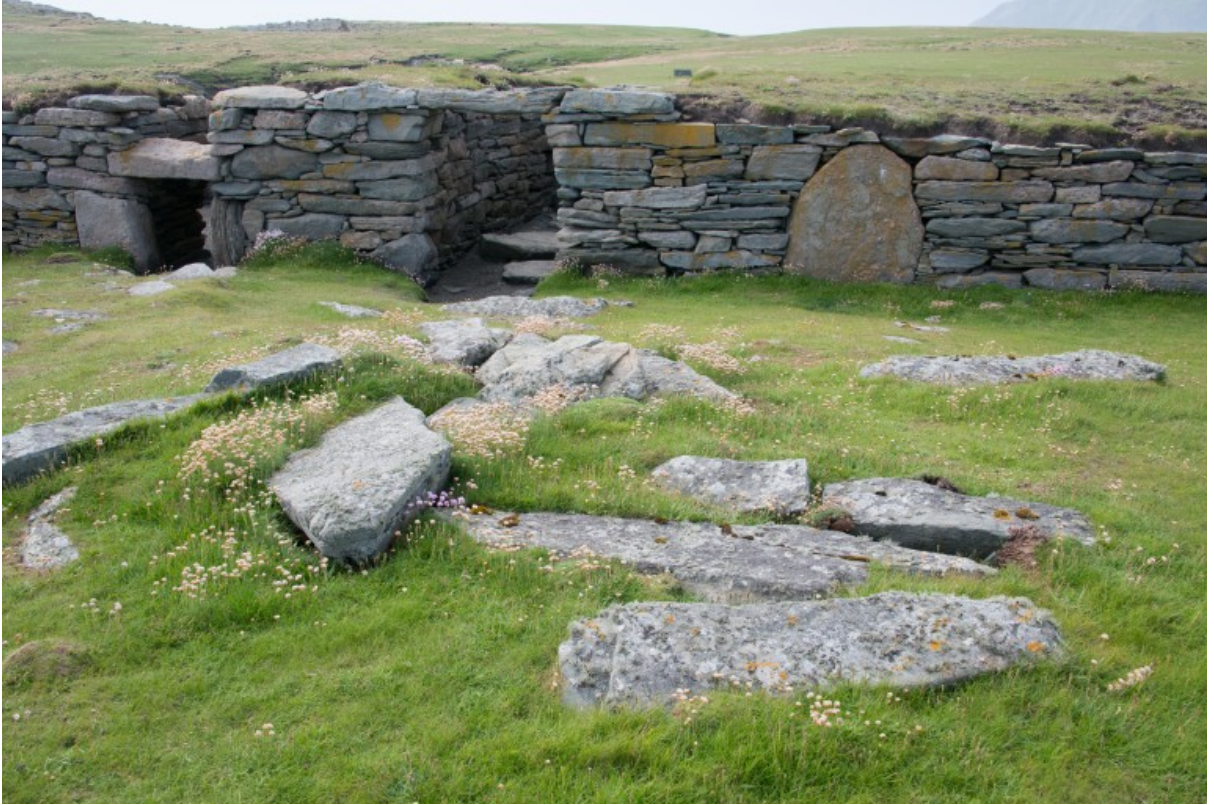
East elevation:

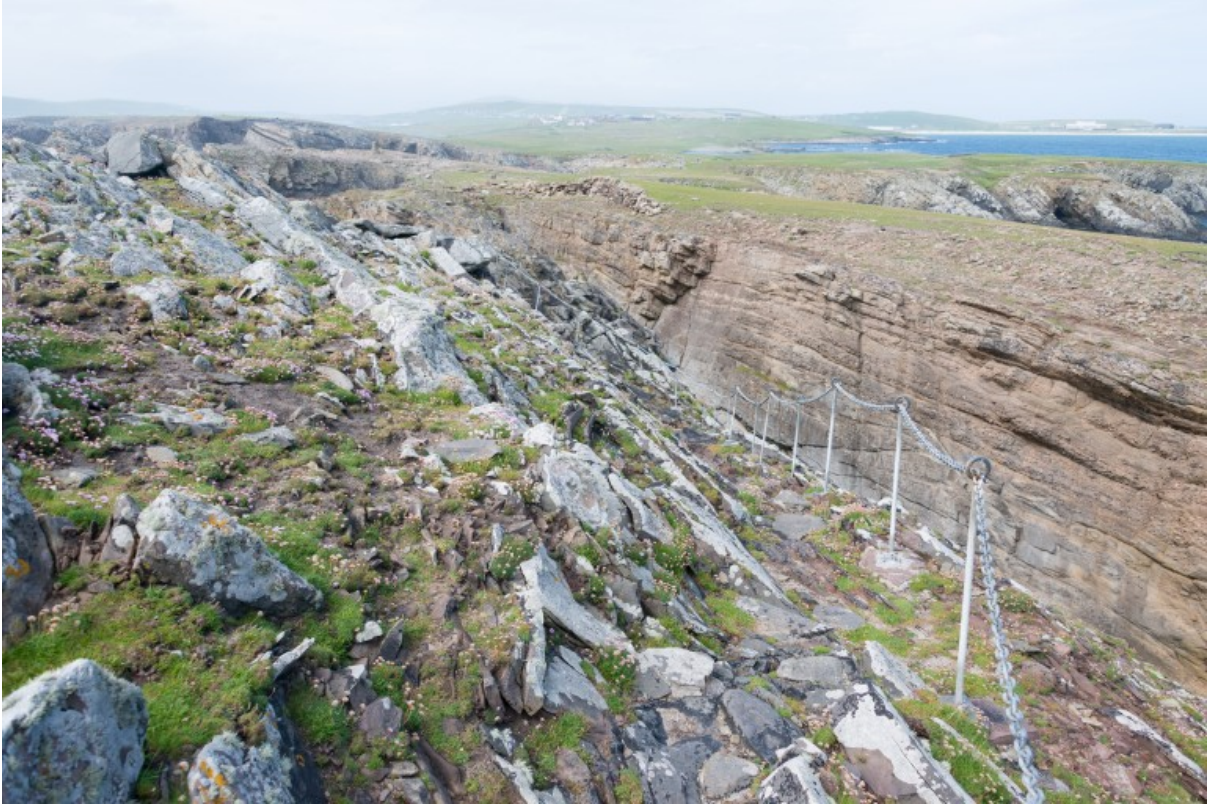
View of approach to site showing rock ridge and safety rail fixing:

On the short rocky slope which forms part of the approach to the promontory on which the site is located, holes were drilled into the rock and metal stanchions inserted, linked by chain or rope to offer support. These decayed over the years, but have now been replaced and are regularly maintained.

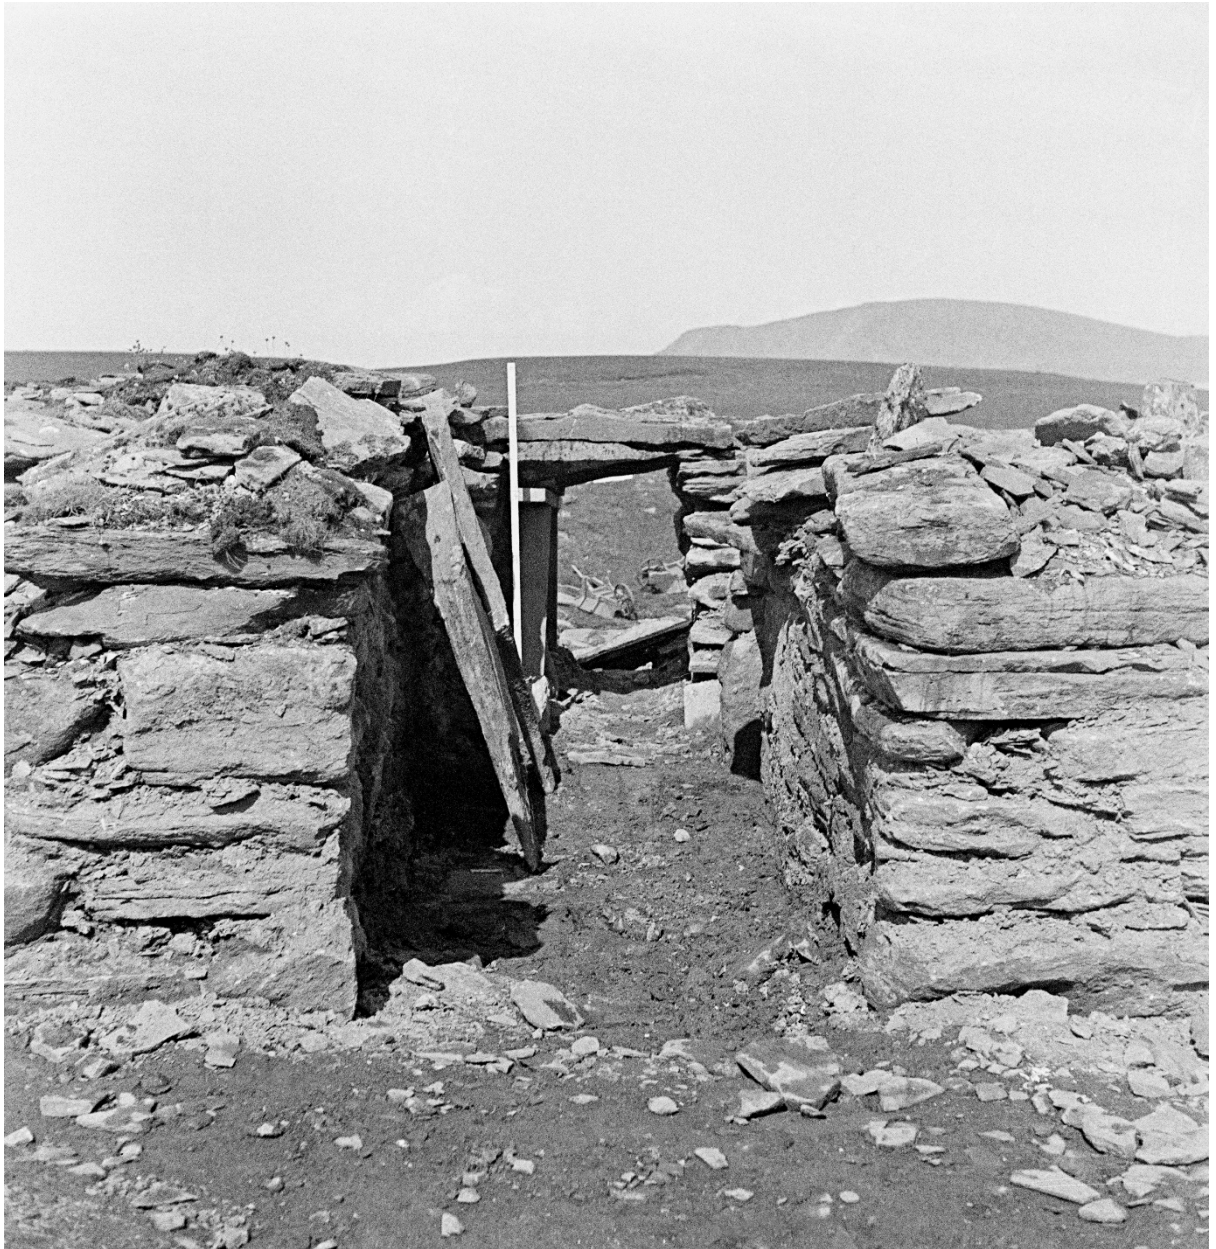
Above: Photograph taken during 1935 excavations: entrance passage looking out:

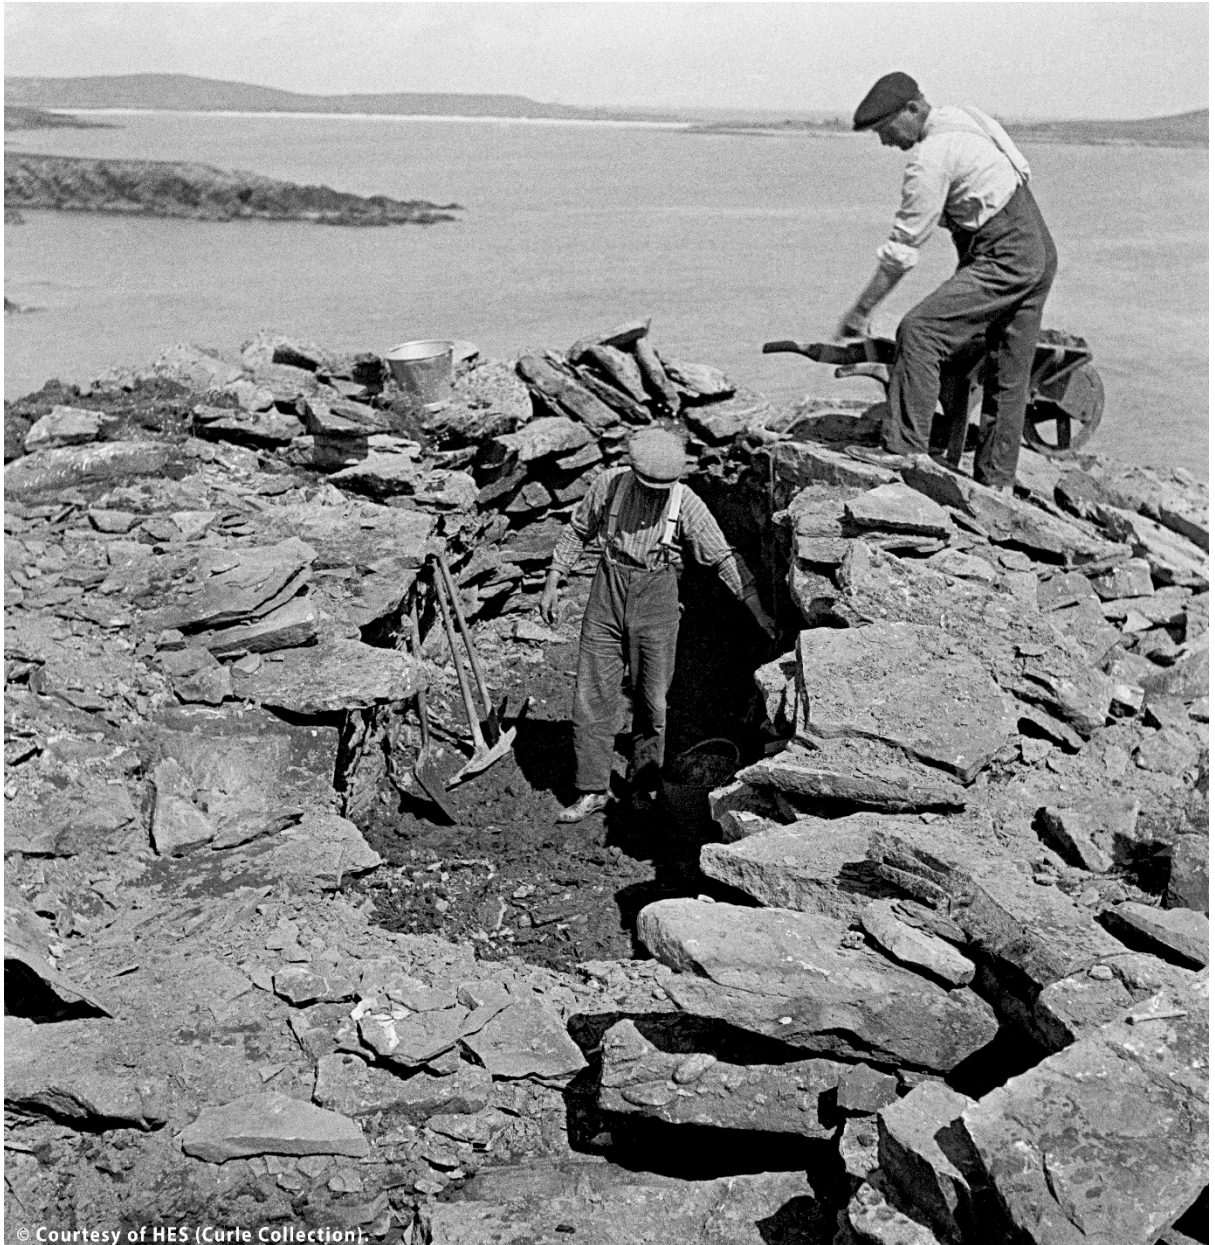
Above: Photograph taken during 1935 excavations: workmen clearing north-east chamber:

Two large hollow chambers are set within the thickness of the masonry. To the north-east of the entrance passage, one such chamber is accessed by a low, lintelled passage off the north side of the entrance passage, four lintels being recorded *in situ* in 1935. This chamber is approximately oval, about 5.5 metres by 2 metres. The walls corbel in slightly at the top and the chamber may originally have been roofed by long lintel stones, examples of which were found within it upon excavation. To the south-west of the entrance passage, the second large chamber is accessed by a doorway from the rear of the blockhouse. Three lintels over its entrance are recorded *in situ* in 1935. This

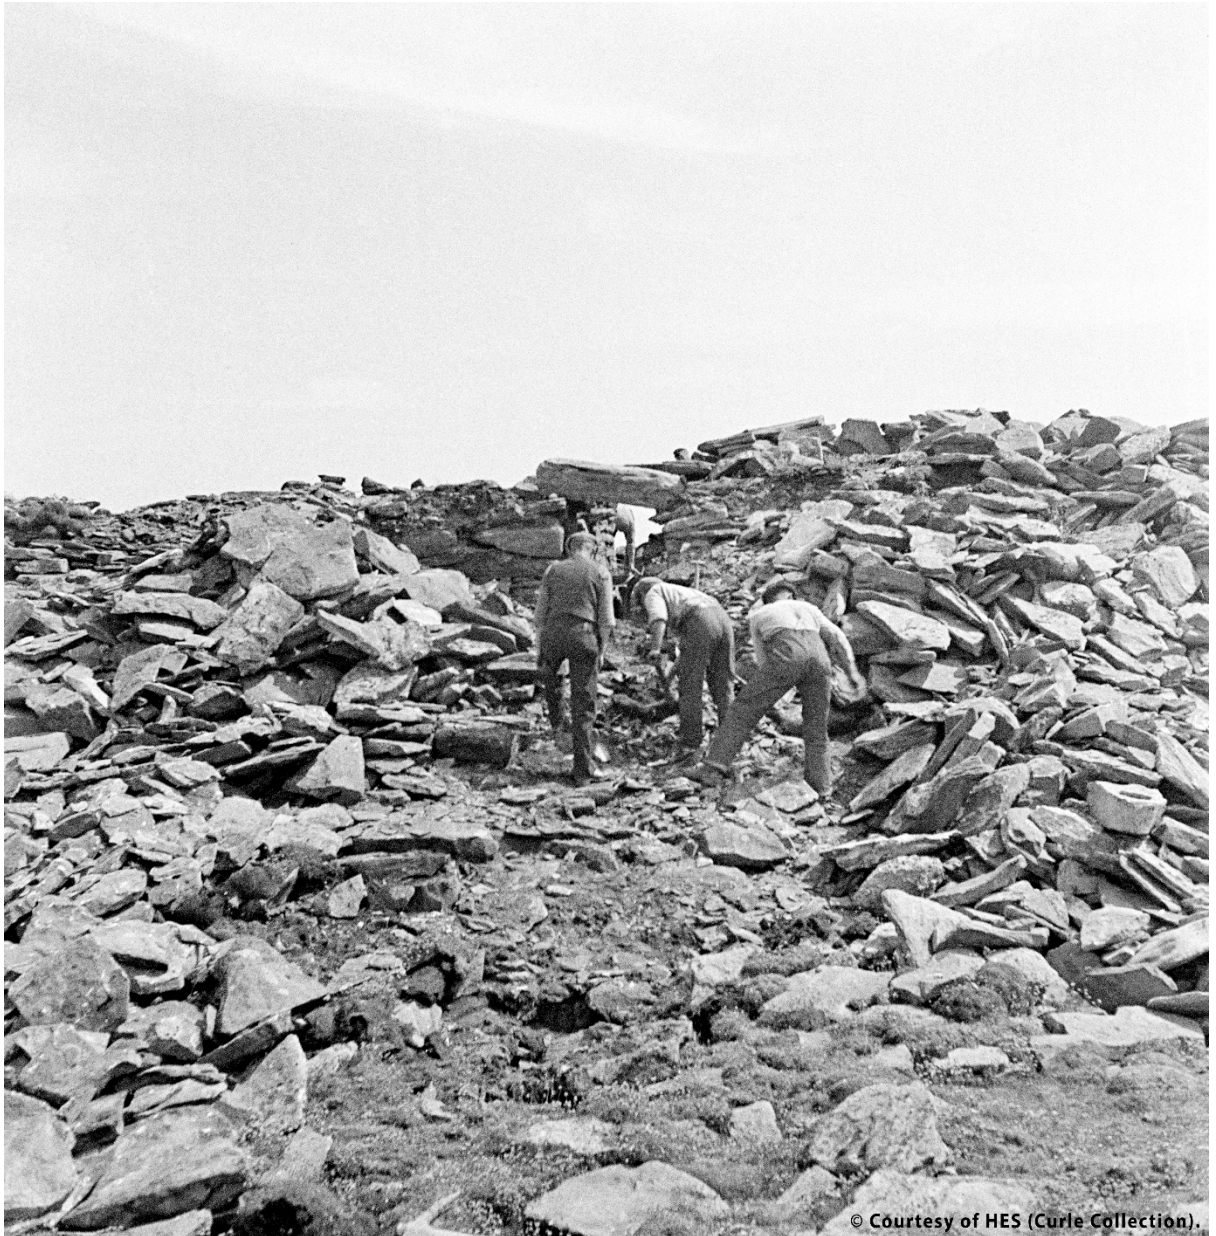
Above: Photograph taken during 1935 excavations: workmen apparently clearing the passageway in outer bank, between piles of stone already removed from the blockhouse:

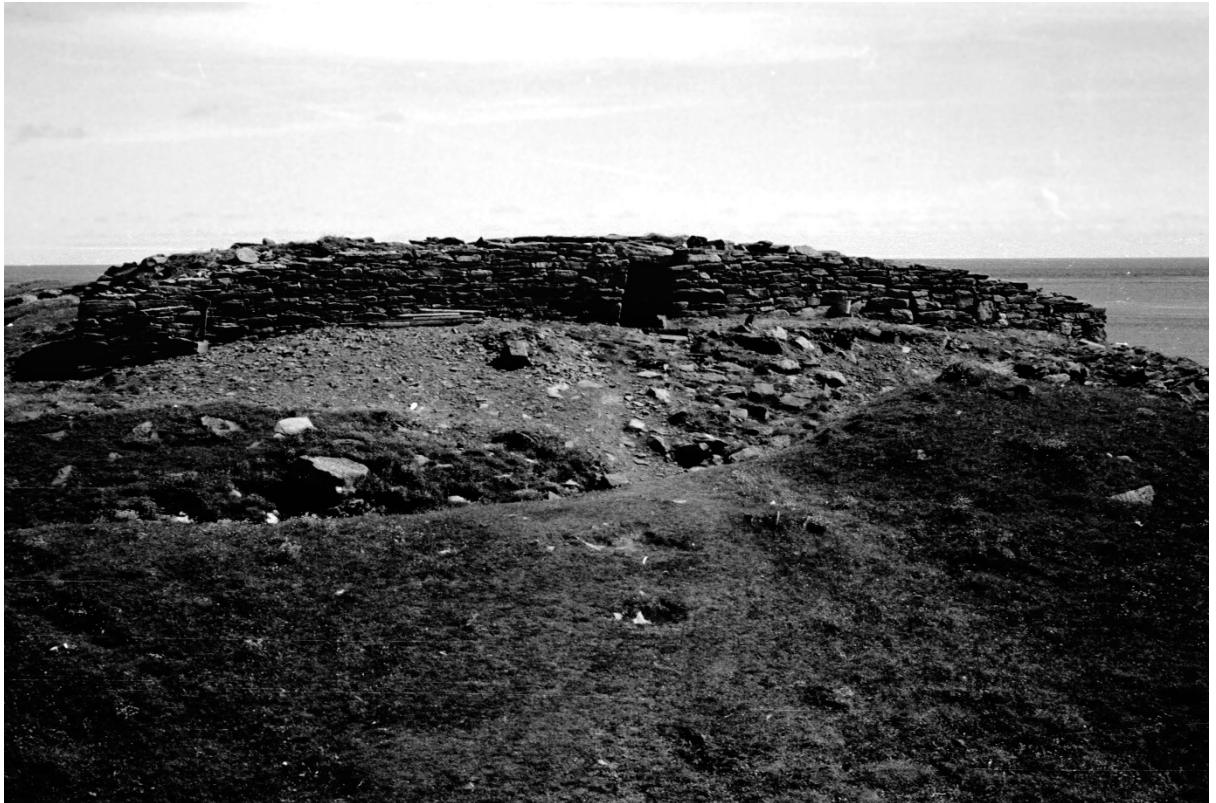
Above: 1971 photo by RG Lamb, showing site soon after stone clearance and consolidation:

The site today is largely as it was left in 1935; some consolidation work was carried out in 1971 and since then only minor works have been undertaken, primarily replacement of pinning stones.
