REFURBISHMENT CASE STUDY 31

HARLAWHILL HOUSE PRESTONPANS

INTERIM REPAIR WORK

HARLAWHILL HOUSE, PRESTONPANS

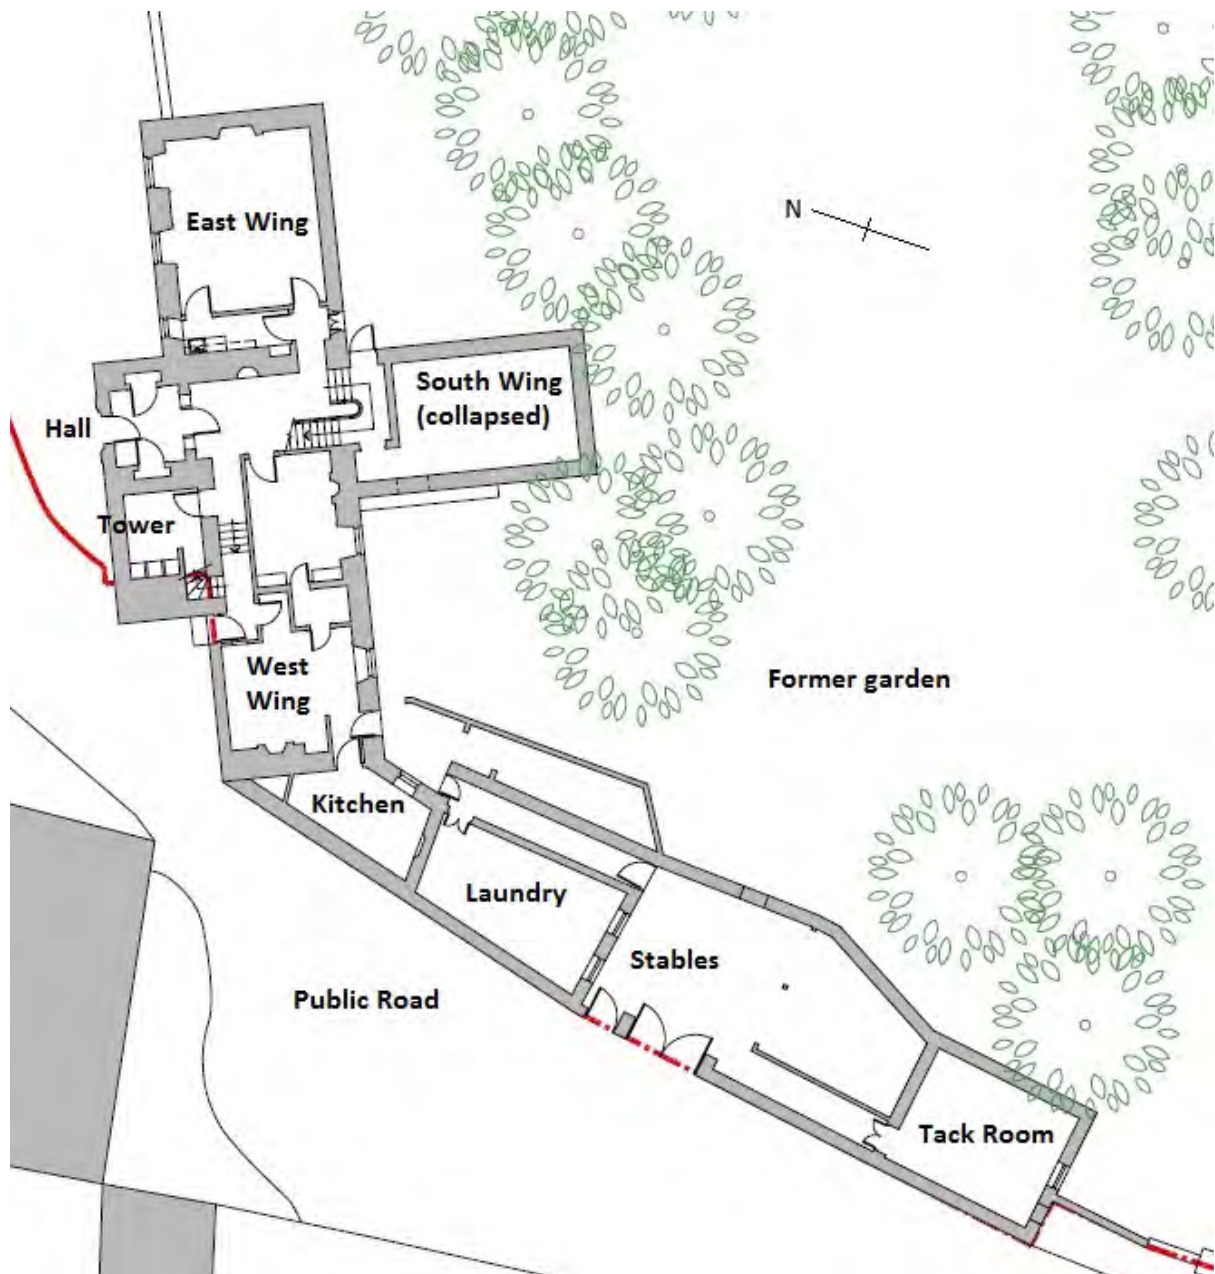
Figure 2. The existing ground plan of Harlawhill House, courtesy of the National Trust for Scotland.

In addition to the main structure of the house, the property has outbuildings consisting of a former laundry, stables and a store, aligned along the north-west boundary wall of the property (Figure 2). The roof of the laundry has partially collapsed at the east end. Neither East Lothian Council nor HES were in a position to allocate funds to its stabilisation.
