# Kirkcudbright

Conservation works to an 18<sup>th</sup> century townhouse

Historic Scotland Refurbishment Case Study 13

Craig Fabian and Laura Dobbie

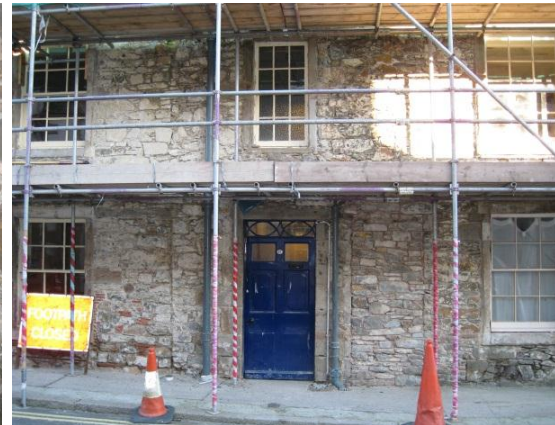
*Fig. 10: Entry door to no. 29 is in-filled with stone, to the right of the existing entry door*

The front door to number 29 (D6 on Fig. 5) was removed and the wall reinstated in whinstone and lime.

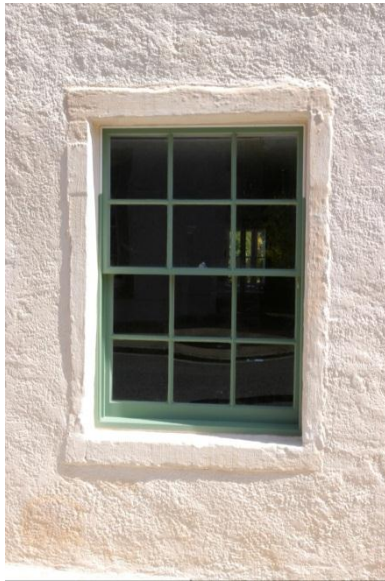
*Fig. 19: New Georgian style window on front elevation, constructed from a template based on existing windows. Note the aged appearance of the stone surround is maintained.*

The existing windows were Georgian and Victorian era single glazed timber-frame sash and case windows. There were also modern PVC windows at the rear, on the utility room addition and in the dormers. The front elevation had a mix of six-over-six Georgian style windows and one-over-one Victorian style windows. Three of the front elevation Georgian style windows were restored and remain in use. Due to the poor condition of a number of others it was determined that replacement was a more viable, cost effective long-term option. On the side and rear elevations of the main house the existing Georgian and Victorian windows were replaced with new bespoke softwood single glazed sash and case windows of a mid 18<sup>th</sup> century pattern. One of the surviving Georgian windows from the front elevation was used as a template for the new windows (Fig. 19).

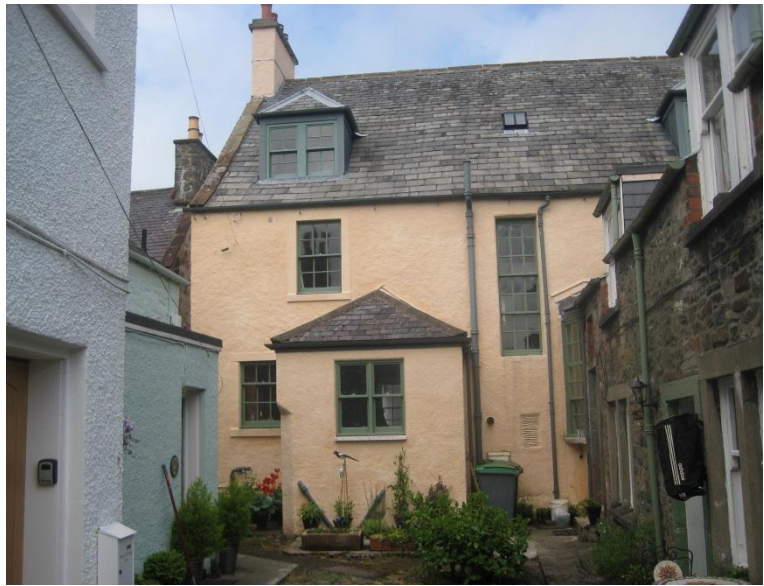
*Fig. 20: The rear elevation after new windows had been installed*

New Victorian style timber single glazed sash and case windows were installed on the front dormers and the rear utility addition, to distinguish these elements as later additions. The rear dormers were upgraded with Georgian style single glazed timber sash windows, as it was decided this was more aesthetically pleasing and in keeping with the other windows on the rear elevation.

A triple sash single glazed window in the rear stairwell was also restored. This 27 pane window is an unusual and interesting feature of the building (Fig. 20).

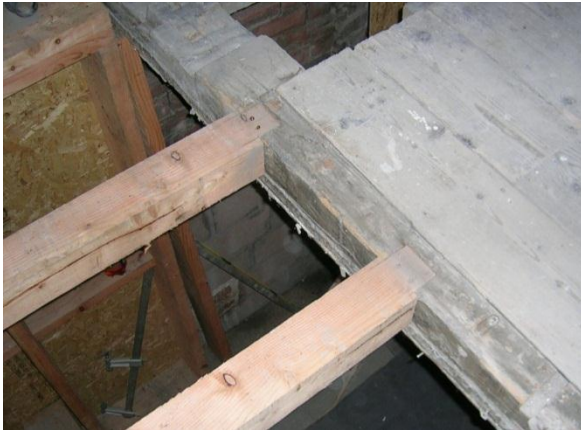
*Fig. 23: Staircase removed from first floor with wood panelling revealed behind*

The late 19<sup>th</sup> century staircase at the front of the house was removed. This required some structural strengthening work as a section of new floor joists had to be installed and tied into the existing floor joists (Fig. 23). This work proved more difficult and time consuming than originally thought, and required the insertion of steel flitch beams (steel plates supporting wood) to support the TV room floor (Fig. 24).

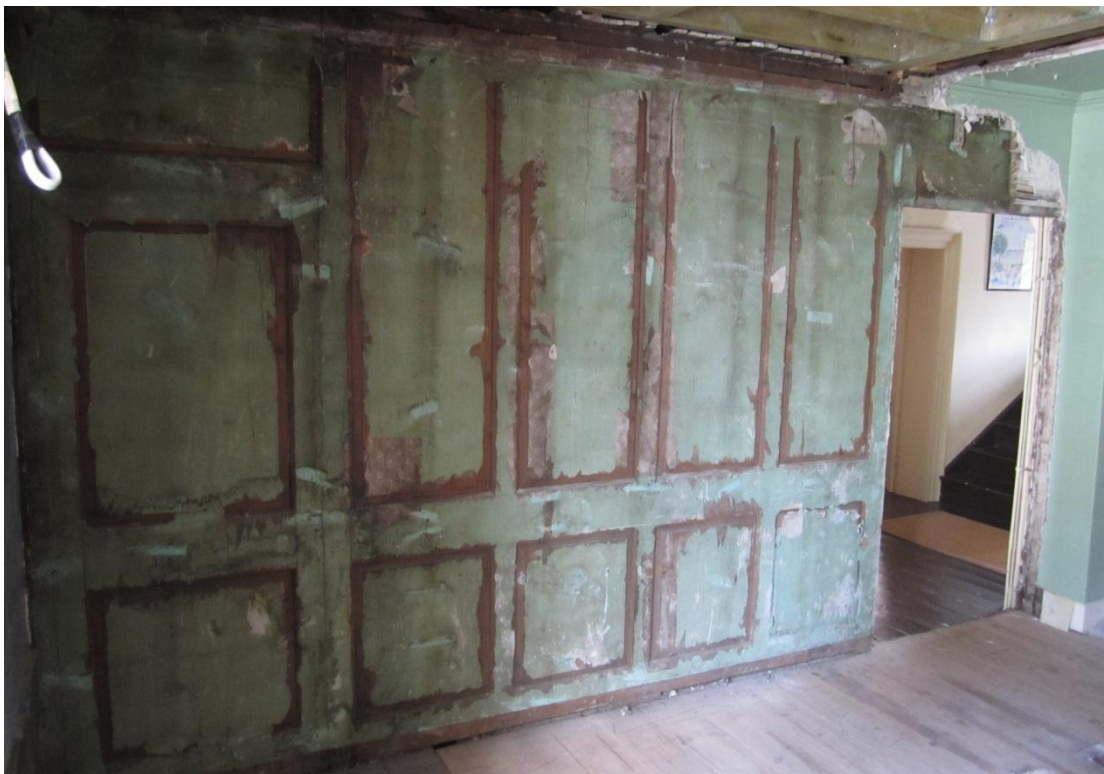
When the staircase was removed from the first floor it revealed a full wood-panelled wall in the 'TV room' (Fig. 25). It is not known what period this panelling dates from. The panelling has never been painted, but was found papered over, which is unusual practice for panelling of this period. This panelled wall has been left exposed in the room as an interesting feature which tells the history of the property.

*Fig. 25: Staircase removal from the first floor revealed a wood panelled wall behind*

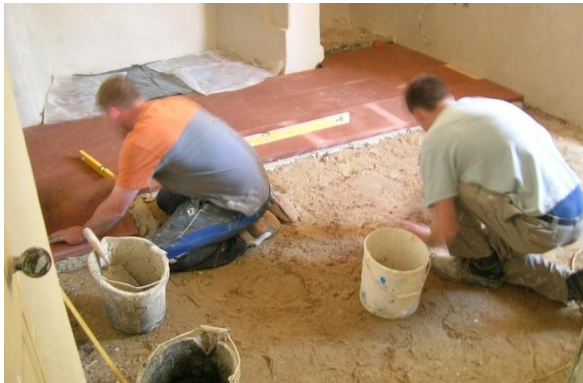
*Fig. 26: Sandstone floor laid on aggregate and sand foundation*

In the 'snug' on the ground floor the existing suspended wooden floor dating from the 1930s was removed, as it was in poor condition and starting to rot in some areas. The room had been used as a kitchen for the number 27 property. The solum (sub-floor) was exposed, uncovering an old cobbled floor beneath (discussed further in the Historical Analysis). The cobbled floor was considered too uneven for present day use by the owner, so a local historian was invited to document and photograph it before it was covered up again. Such documentation is considered good practice. The cobbled floor was covered with an aggregate and sand foundation, onto which a lime mortar bed was poured. Local sandstone flags were placed onto the lime bed, without mortar joints (Fig. 26 and 27). This approach was based on the floor treatment seen in the basement rooms of the nearby Broughton House, a recently restored National Trust property.

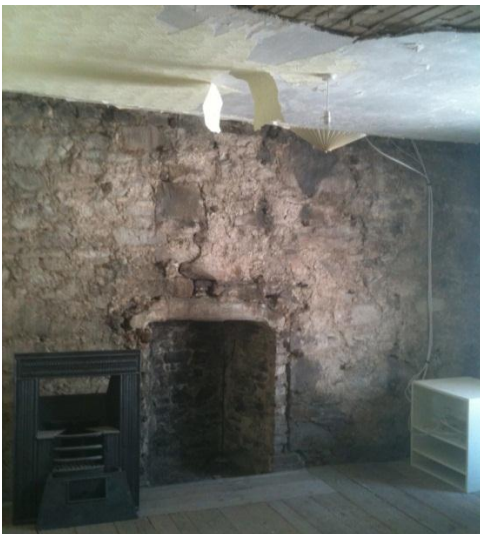
*Fig. 28: Existing hearths were retained in all rooms, but were either plastered over or a fireplace was reinstated.*

When the house was purchased there were eight open flues still in use, though four had been capped during the removal of the chimney. Under the refurbishment works several of these were taken out of use, though all the flues were retained in-situ. The decommissioned flues were kept open to provide ventilation and prevent dampness, and the existing hearths were retained (Fig. 28). Three of them provide ventilation for the kitchen and bathrooms. Three operational fireplaces were kept at ground floor level in the dining room, sitting room and snug. A stove was added in the snug (Fig. 29).

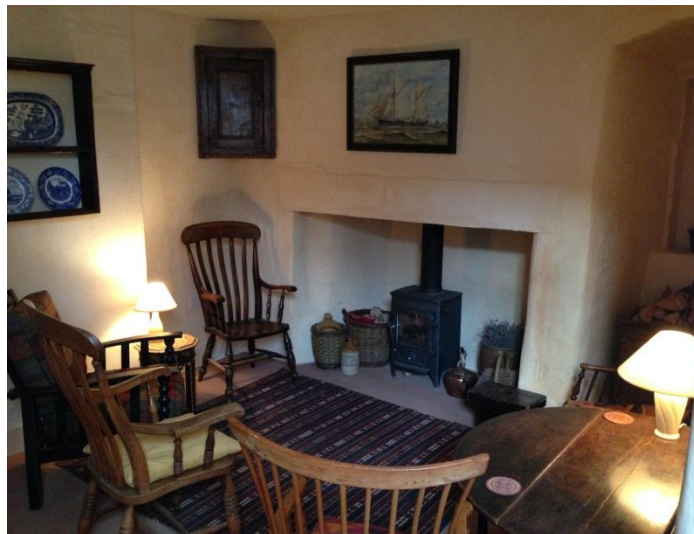
*Fig. 29: New stove in the existing hearth in snug*

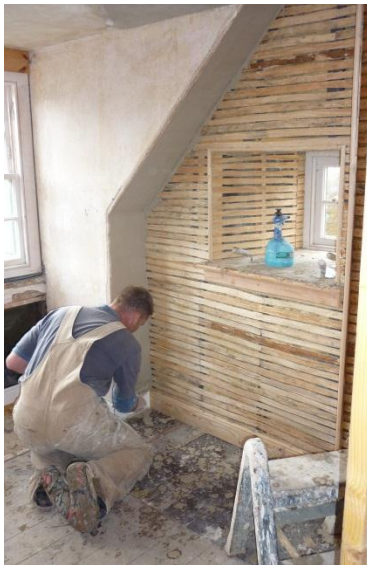
*Fig. 30: Application of lime plaster to timber lath*

The owners were committed to using lime plaster and pigmented lime-wash on the interior walls. It is likely that some rooms in the house, particularly the service rooms to the rear, were lime-washed, but it is difficult to know the original wall finishes throughout. Lime plaster was applied to new timber lath in some rooms (Figs. 30, 31 and 32), but this was not possible in all locations. The lime plaster is vapour open, and together with the lath, allows a degree of air and moisture movement, which is compatible with traditional mass masonry walls. Some external walls were repaired internally with plasterboard on studs, gypsum plaster and emulsion paint, due to budget constraints. In the snug to the rear of the property, the existing stud lining was removed and the walls were lime-washed over lime plaster 'on the hard' (directly onto the masonry wall).

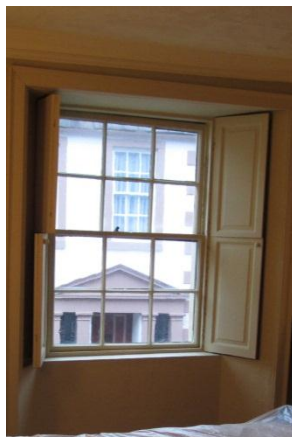
*Fig. 33: Existing shutters retained throughout*

Much of the original interior timber was conserved, repaired and reused, for example old architraves were used on new doorways, and the existing front door was restored. All surviving window shutters were also retained and/or refurbished (Fig. 33). Ironmongery was also cleaned and reused (Figs. 34 and 35).

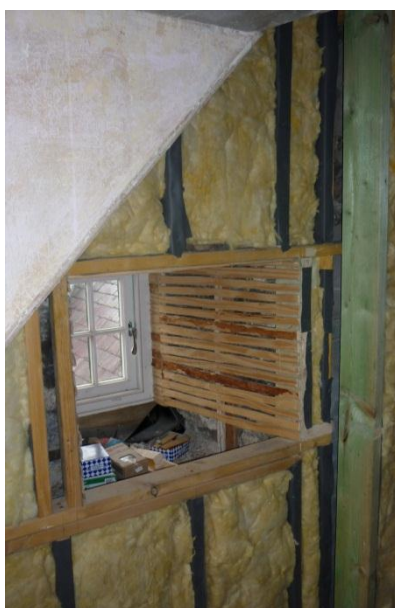
*Fig. 36: Mineral wool insulation installed between studwork prior to application of lath and plaster*

While much of the work in the project concerned alterations and reinstatement, the owners were keen to incorporate as many energy saving measures as possible. To reduce heat loss through the windows, the owners are using the refurbished shutters effectively, regularly closing them to keep in heat. Mineral wool was installed behind new lath and plaster in some rooms, and between stud framing where walls were built out (Fig. 36). This work was carried out early in the project, and since that time the owner has begun to investigate and use more sustainable, environmentally friendly insulation products such as sheep's wool and wood fibre board. Sheep's wool insulation was added in the cooms when the roof slate and sarking was removed, and the owner also intends to insulate the loft space with sheep's wool. Wood fibre board insulation was installed in the ceiling spaces (Fig. 37). These latter products suit traditional buildings due to their 'breathable' (vapour open) characteristics, and the installation of this type of insulation has proved very satisfactory to the owner to date.

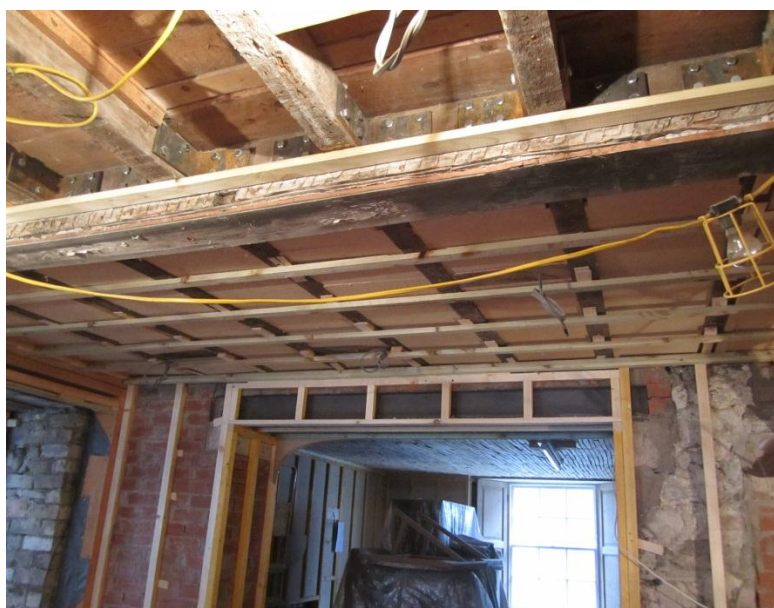
*Fig. 37: Wood fibre insulation board installed in ceiling space above the dining room serves as acoustic and thermal insulation.*

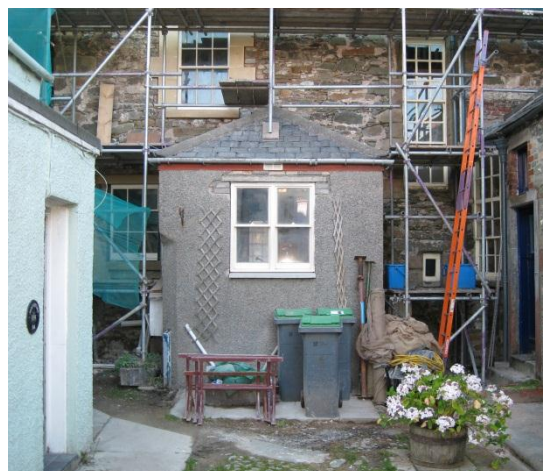
*Fig. 56: Utility addition to rear of property. Built in circa. 1970.*

A small single story, brick extension with cement render finish was added to the rear during the 1970s (Fig. 56) to provide a utility room. It has a pitched slate roof.
