Downie's Cottage, Braemar

Repairs and upgrades to a Highland cottage

This publication should be quoted as:
Historic Environment Scotland
Refurbishment Case Study 22

Roger Curtis

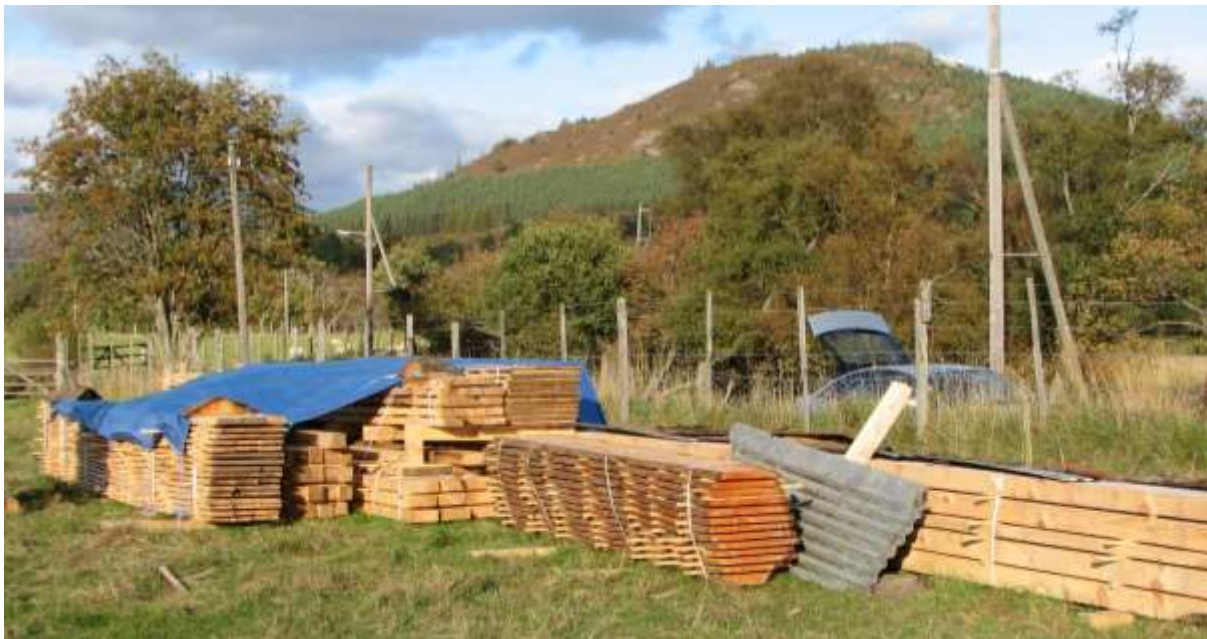
The stand of Douglas Fir and Spruce that had enclosed the site for 60 years had become unstable and subject to windblow, and was felled. The timber was of good quality, and converted to planks and other dimensions with a portable 'Miser Saw' giving some useable timber (Figure 14). There was an aspiration by the client to utilise this material in the repairs to the byre and the construction of a new property close by; unfortunately for reasons relating to building warrant compliance requiring the certification of timber used in construction this proved unfeasible. However, this timber was used for non-structural repairs to the property. The use of local timber in construction is a current issue, and with appropriate grading and certification it is possible, although in this case time and resources did not allow it.

Figure 14. Sawn baulks of timber from the cleared trees.

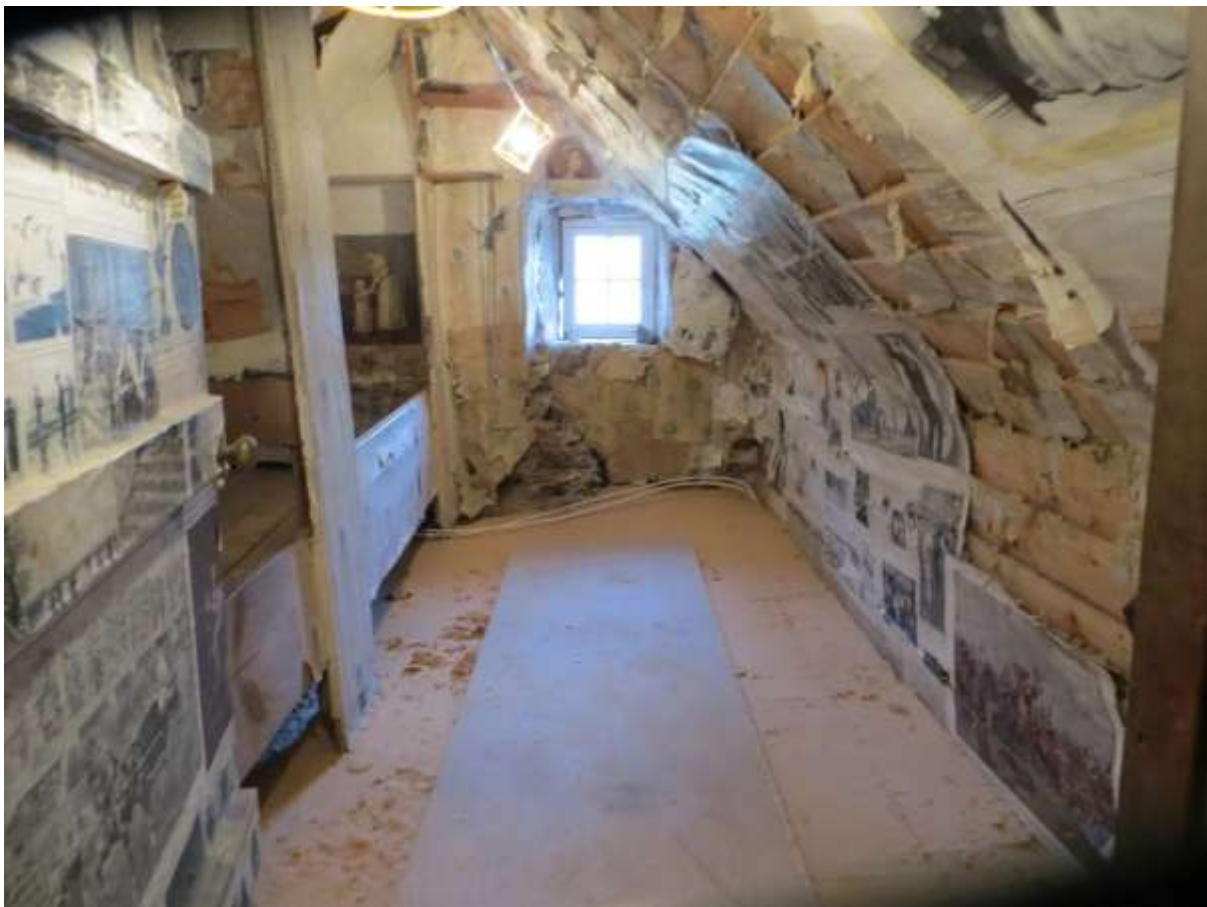
Figure 26. Wood fibre insulation laid on top of the floor in the attic rooms.

This area of the building was largely left as it was to be used for storage. A layer of wood fibre insulation was laid on top of the existing floor (Figure 26) to give a thermal break between the inhabited floors below and the cooler space above. The existing lapped boards, with their covering of paper illustrations, were left in situ. The door giving access to the stair was repaired and used to close off the attic.

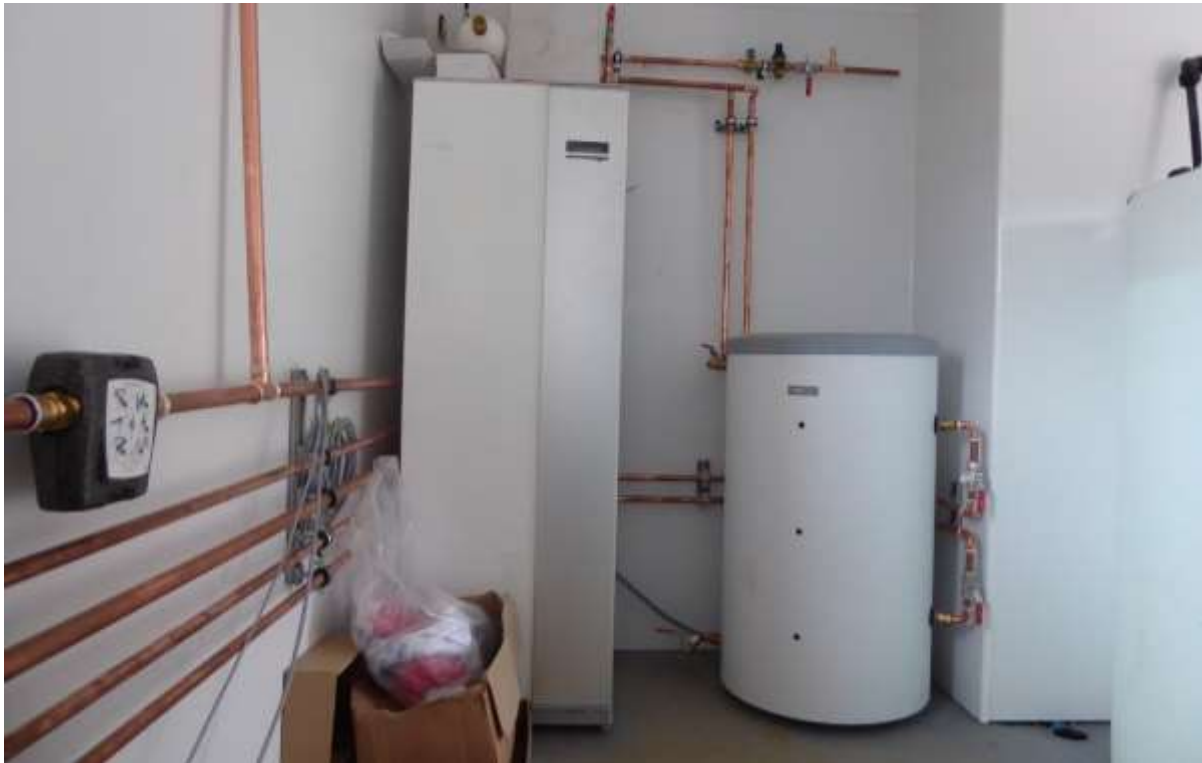
Figure 29. The heat exchanger and other equipment in the restored byre.

Due to the size of the croft being too small to fit the plant, the heat pump unit and associated tanks and vessels were located in the restored byre building close by, with insulated pipework linking the buildings (Figure 29). The system works by extracting thermal energy stored in the earth and this is collected by fluid circulating through underground pipework. The system specified required 400 metres of collector loop to be buried approximately 1.2 metres below the surface. This is now a standard specification, although involves large plant and equipment. The trenches

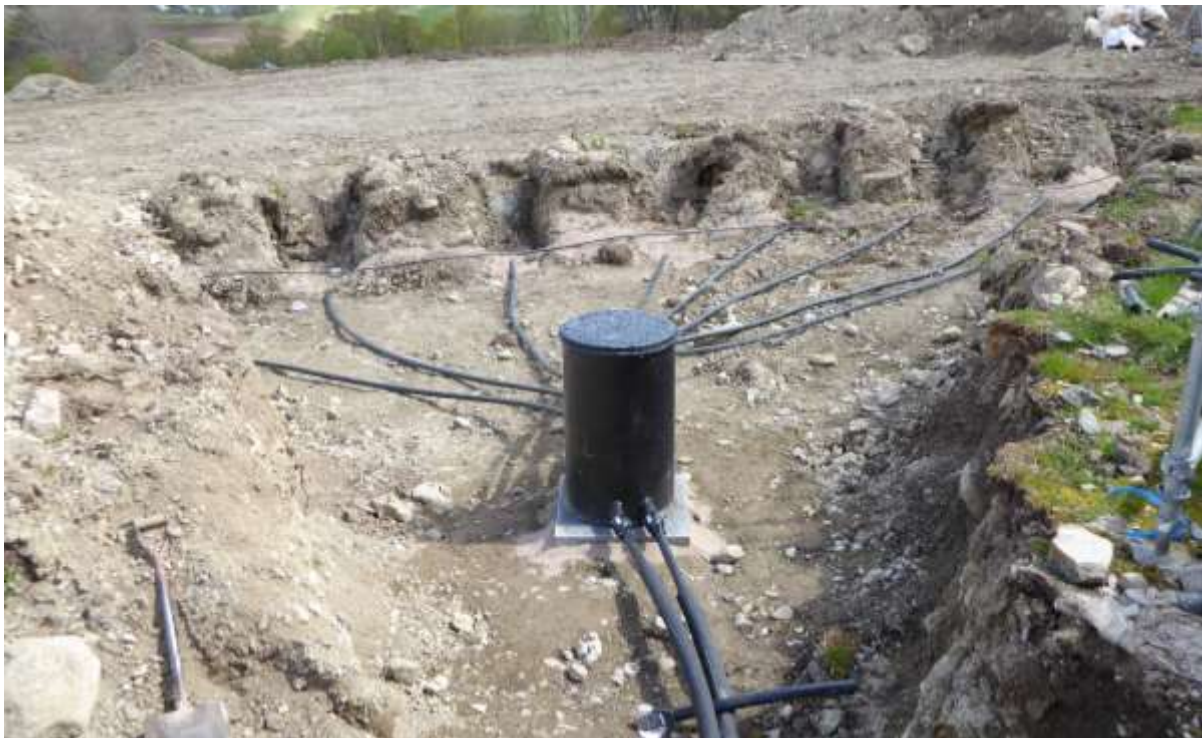
Figure 30. The junction or collector for the ground source heat pump coils laid in the field to the north east of the croft house.

were dug in the field to the north east of the croft house (Figure 30). In some circumstances there will be considerations regarding buried archaeological remains; an assessment of the site indicated that this was most unlikely. In this instance, nothing was encountered.

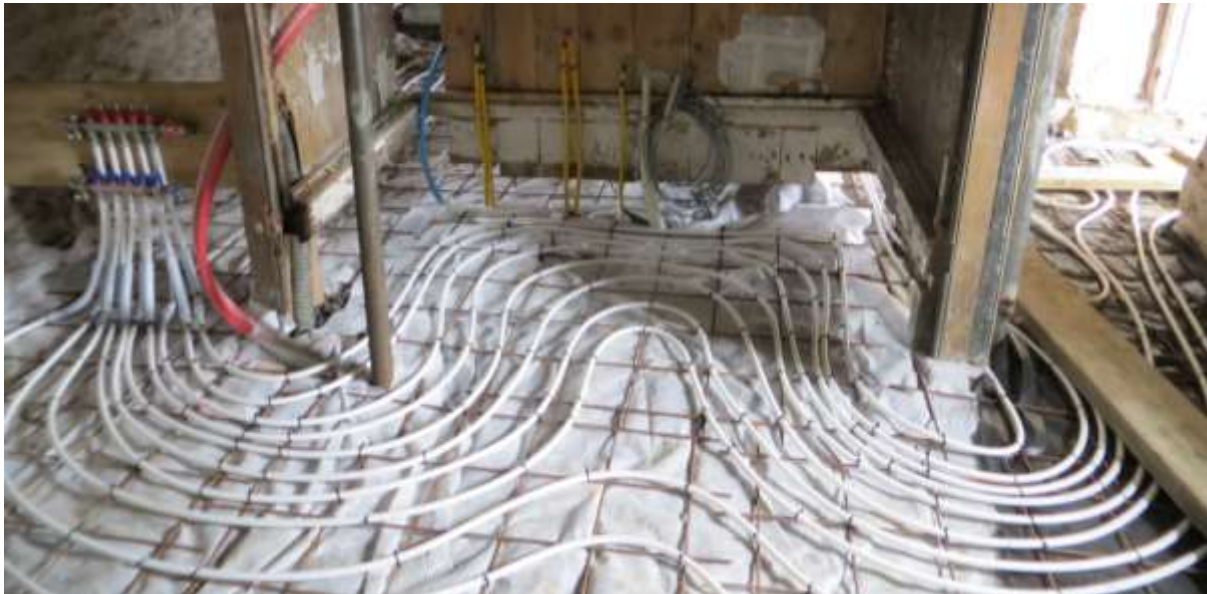
Figure 31. The heating coil fixed in place prior to the final lime concrete layer.

The underfloor heating matrix for the ground source heat pump was fixed to steel reinforcing mesh as the proprietary fixings supplied would not sit accurately on the lime concrete insulation layer (Figure 31). A smooth lime concrete floor slab was then laid encapsulating the heating coils.

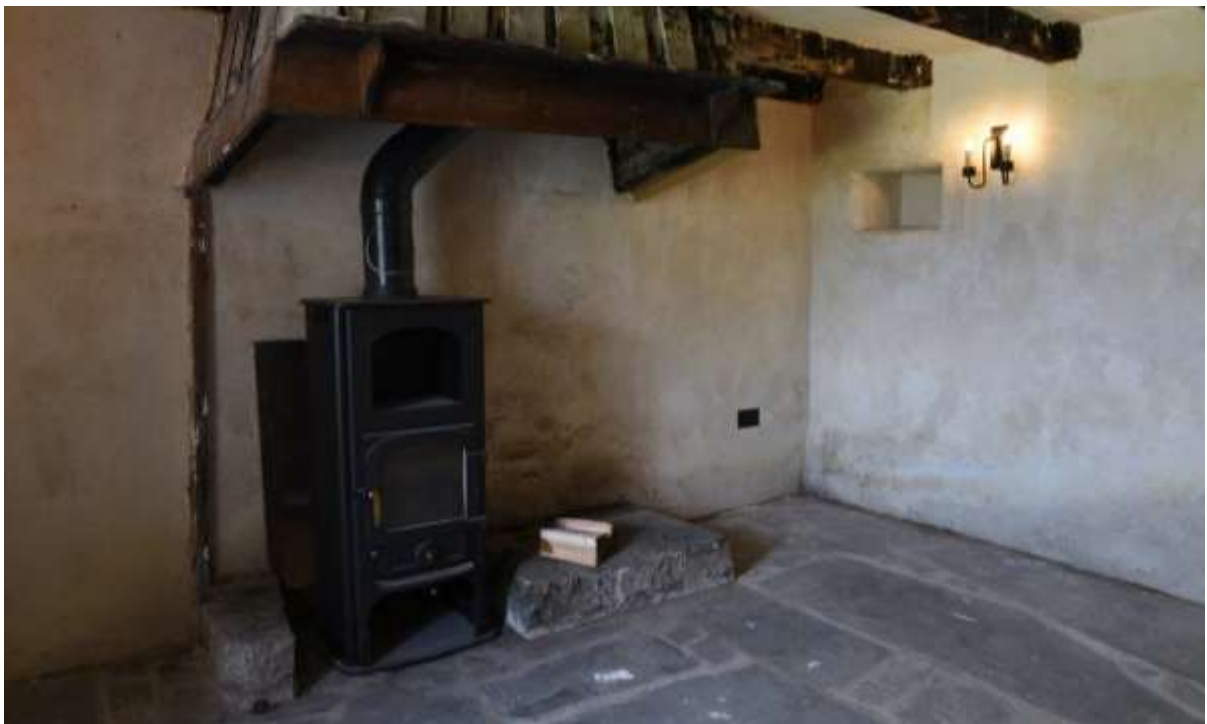
Figure 32. The new wood burning stove in the hearth below the hanging lum

The client also wanted to augment the under floor heating with a wood burning stove that could raise the temperature quickly in the kitchen if required. This was located in the kitchen, on the footprint of the hearth below the hanging lum (Figure 32). A modern double skinned flue was fitted within the existing timber of the hanging lum. This allowed the safe use of a fire in the building.

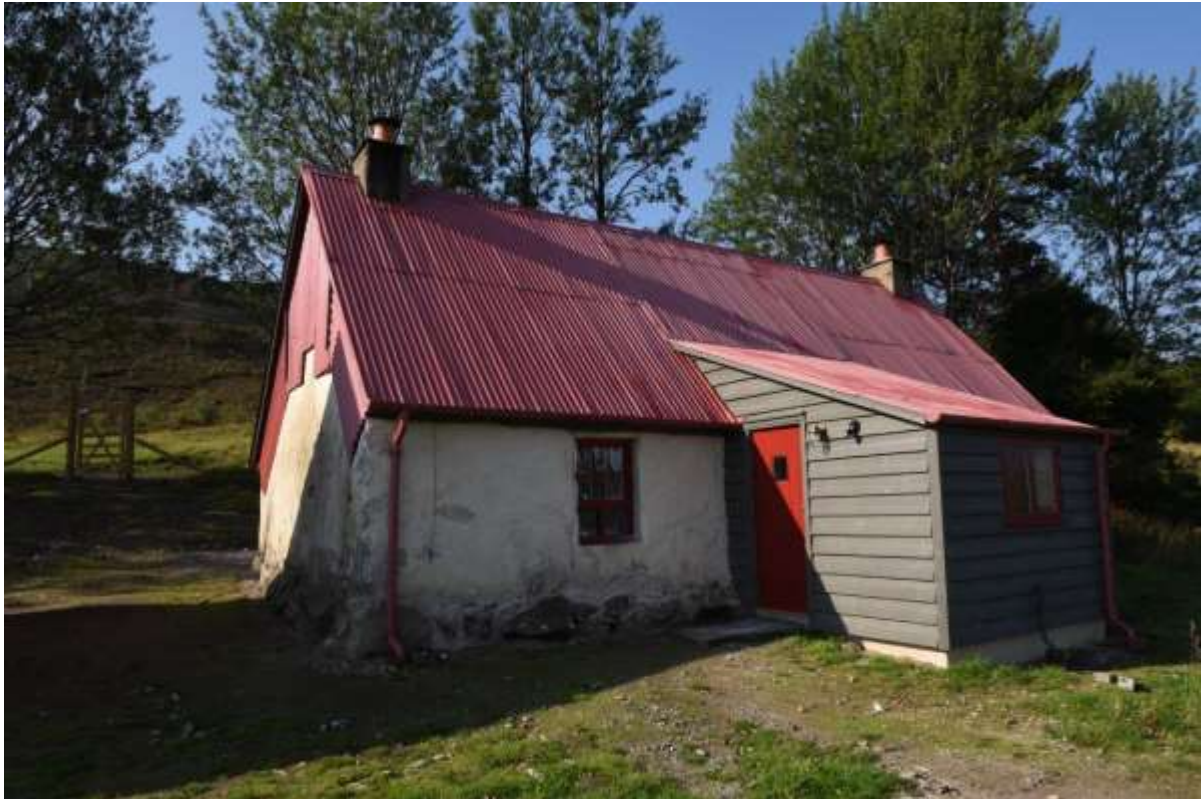
Figure 33. The croft house viewed from the southeast in September 2016 following completion of works in July of that year.

The building has been successfully upgraded and brought back into use. Damaged and defective items have been repaired and improved using traditional materials and techniques. Historic finishes have been retained while modern services have been

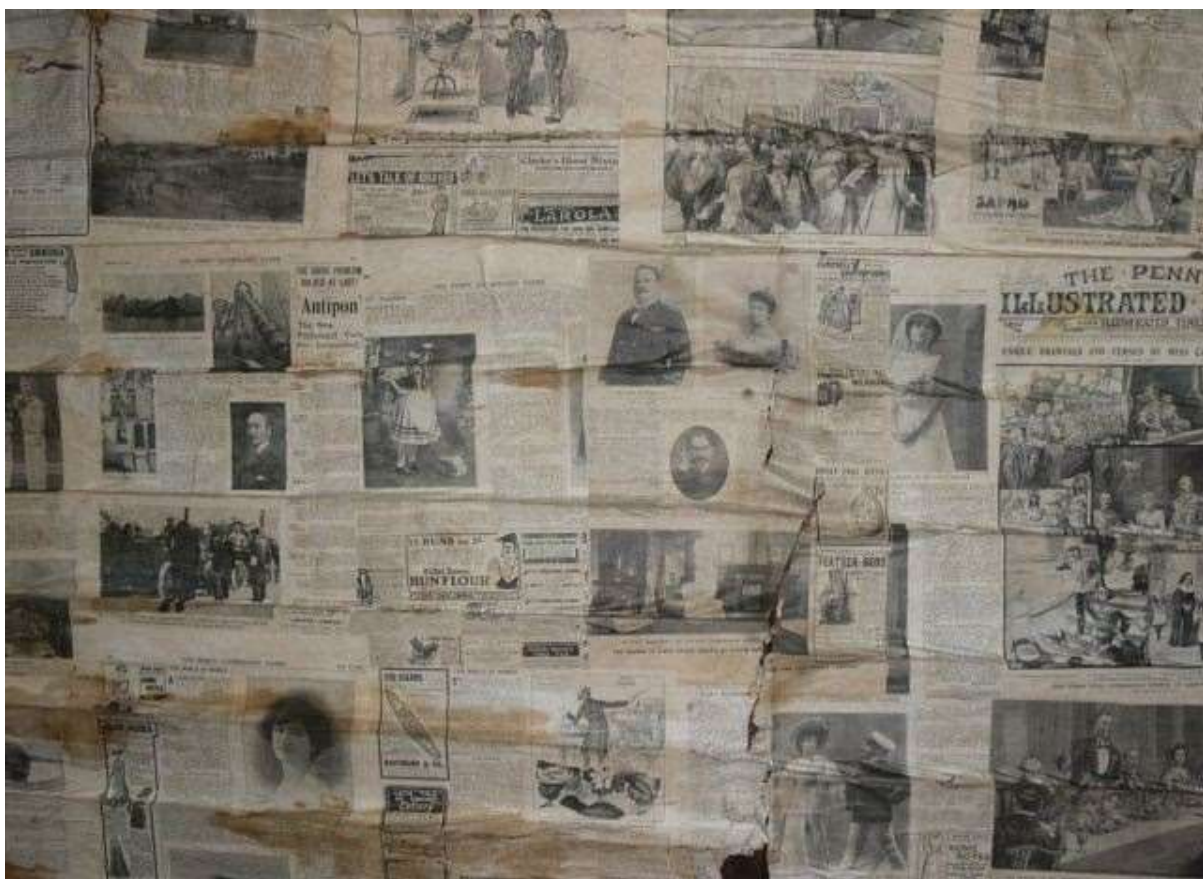
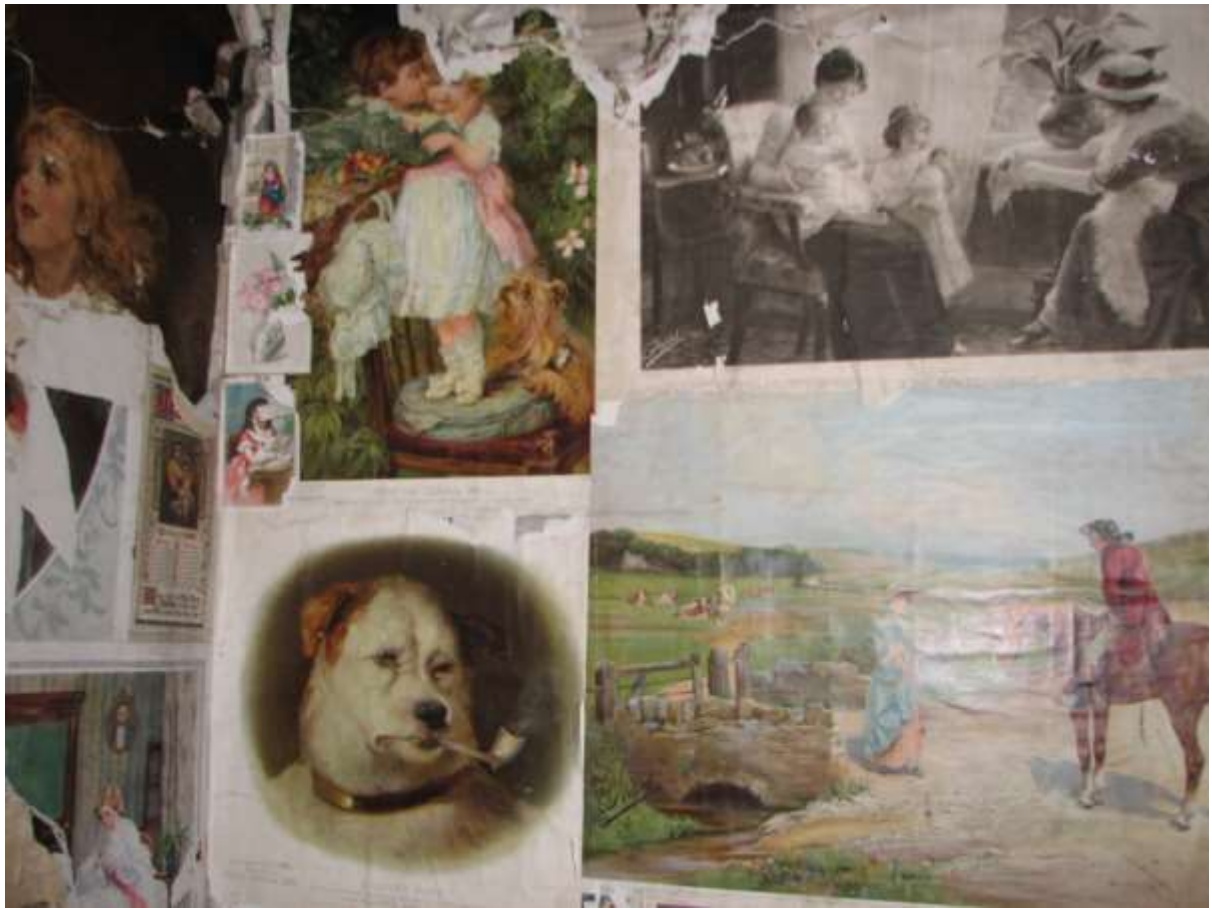
Cuttings and images from the 'Illustrated London News' used as internal wall coverings at stairwell partition
