Kirkton of Coull, Aberdeenshire

Thermal Improvements to a 19th century farmhouse

Historic Scotland Refurbishment Case Study 16

Roger Curtis

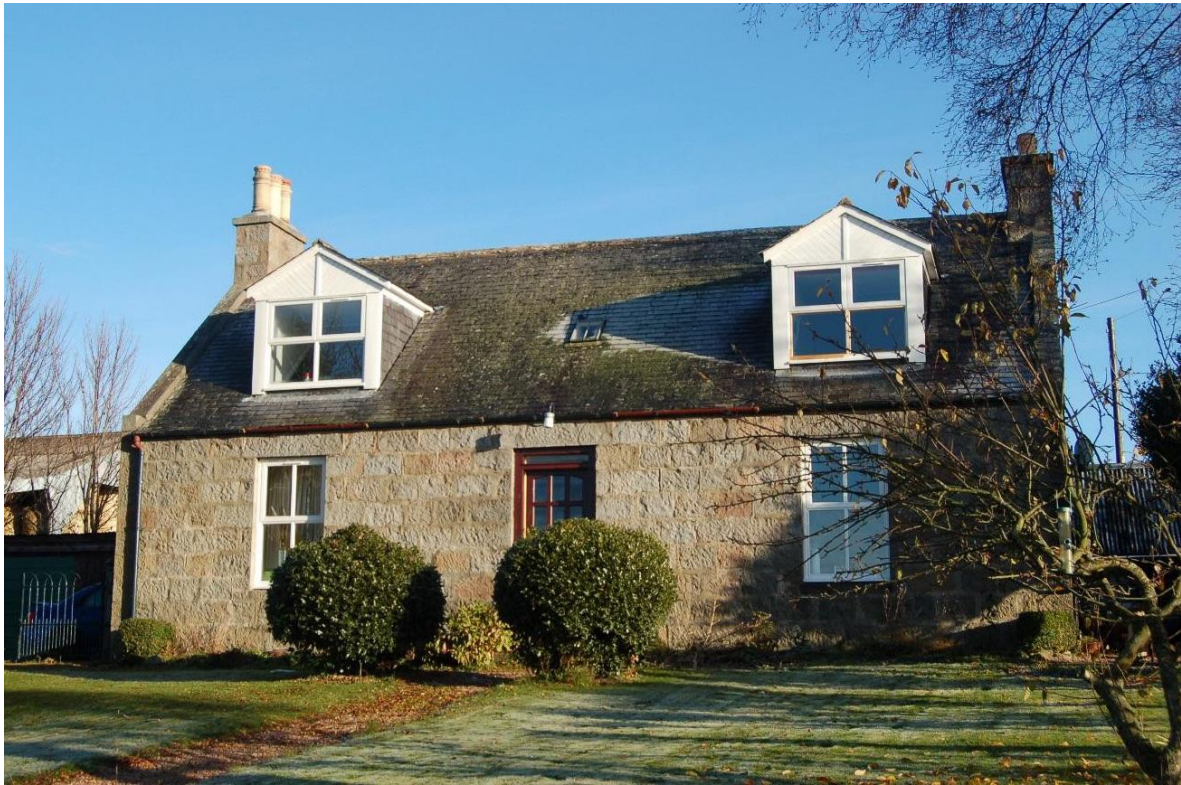
Figure 1: *Kirkton of Coull farmhouse, Aberdeenshire*

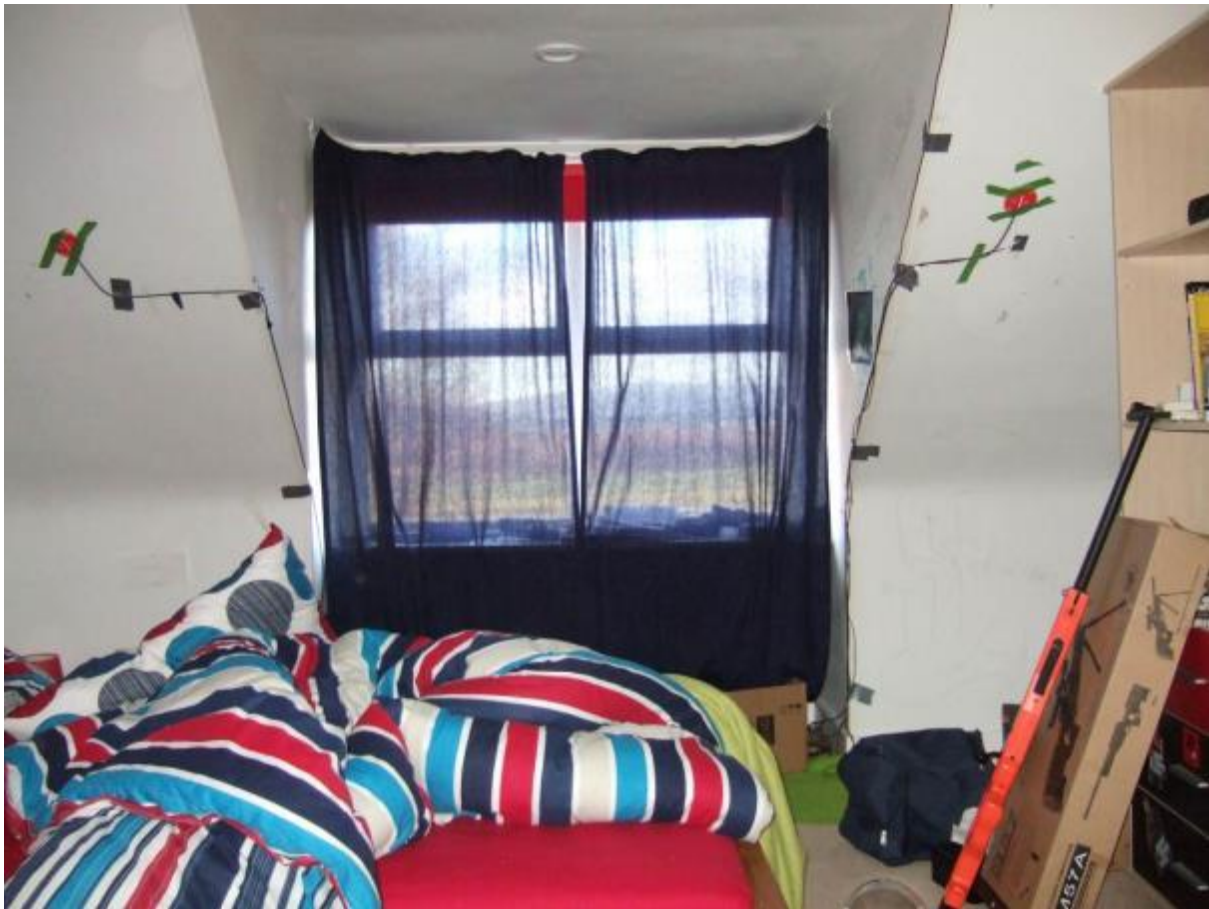
Figure 4: Heatflux plates sited either side of the dormer used to assess heat flow for in situ U-value measurement

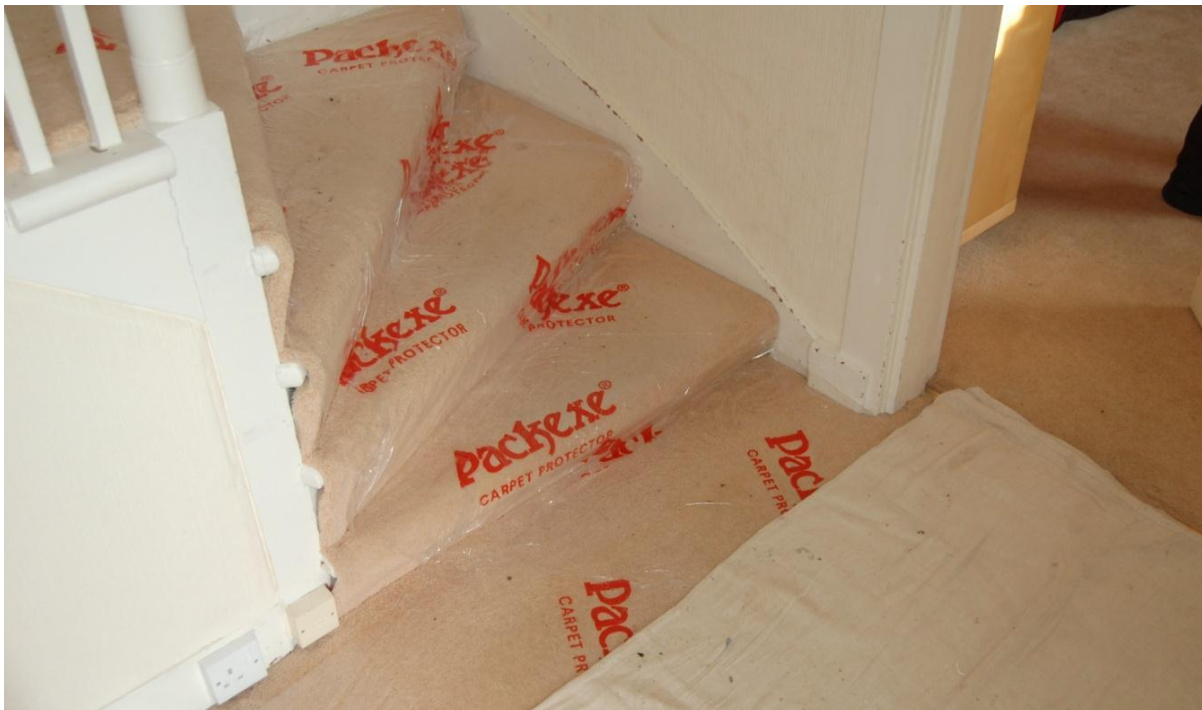
Figure 6: *Protection of carpets during the works*

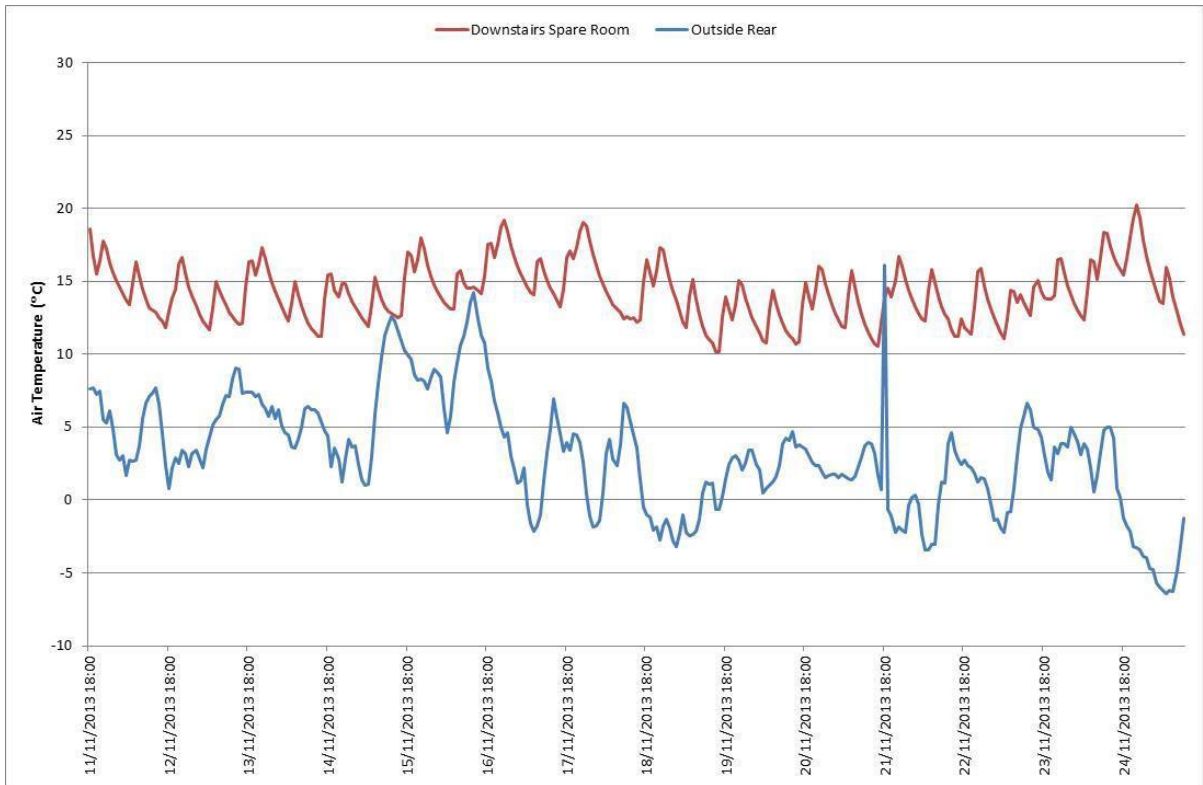
In addition to assessing relative humidity in the filled wall cavity, monitoring of the air temperature in the downstairs bedroom pre- and post-intervention was carried out. Comparison of pre-intervention (Fig. 12) and post-intervention (Fig. 13) internal and external temperatures showed a reduction in the temperature fluctuation due to the insulation and improved air tightness of the space. The insulation to the timber floor would also have contributed to the reduction in temperature variation recorded in May 2014 (Fig. 13). The temperature ‘spikes’ in Figures 12 and 13 show occasional warm days, where internal and external temperatures converged. This end of the building (the south west gable) is fully open to afternoon sun, and

Figure 12: Monitoring before the works, showing internal and external air temperatures in the downstairs bedroom

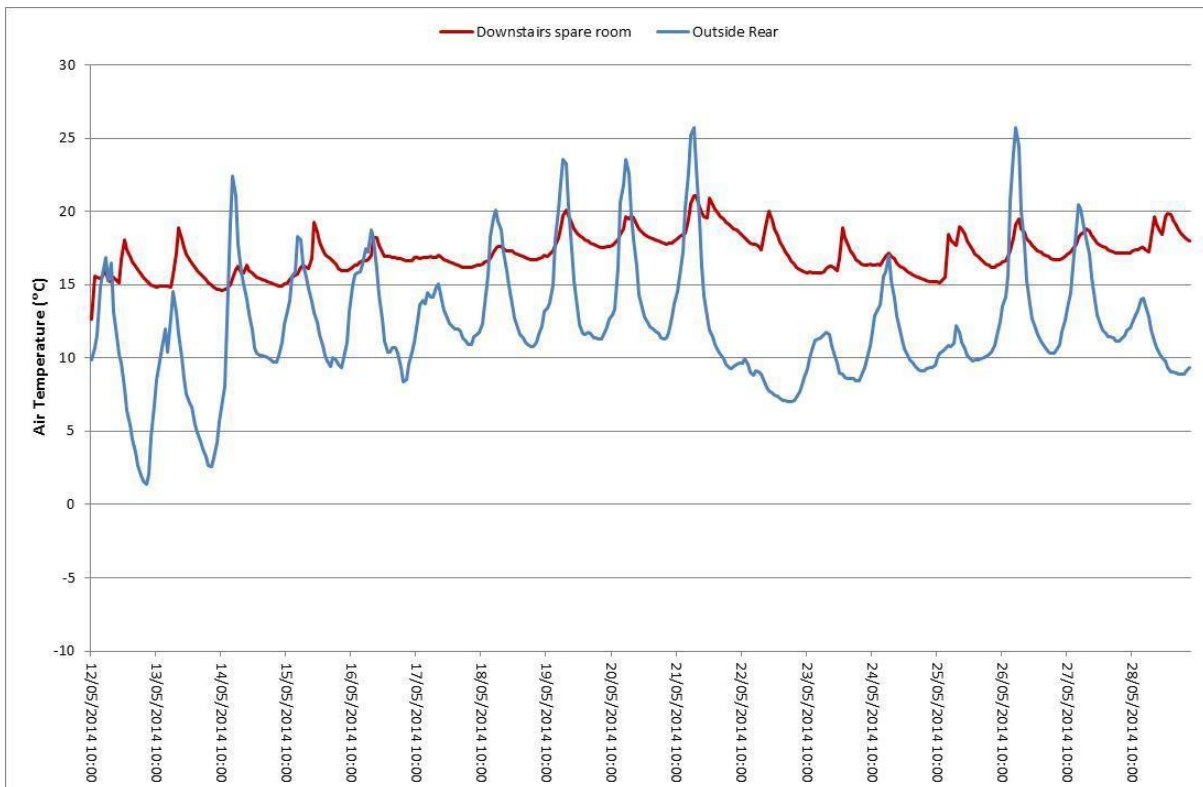
Figure 13: Monitoring after the works, showing the internal and external air temperatures in the same downstairs bedroom

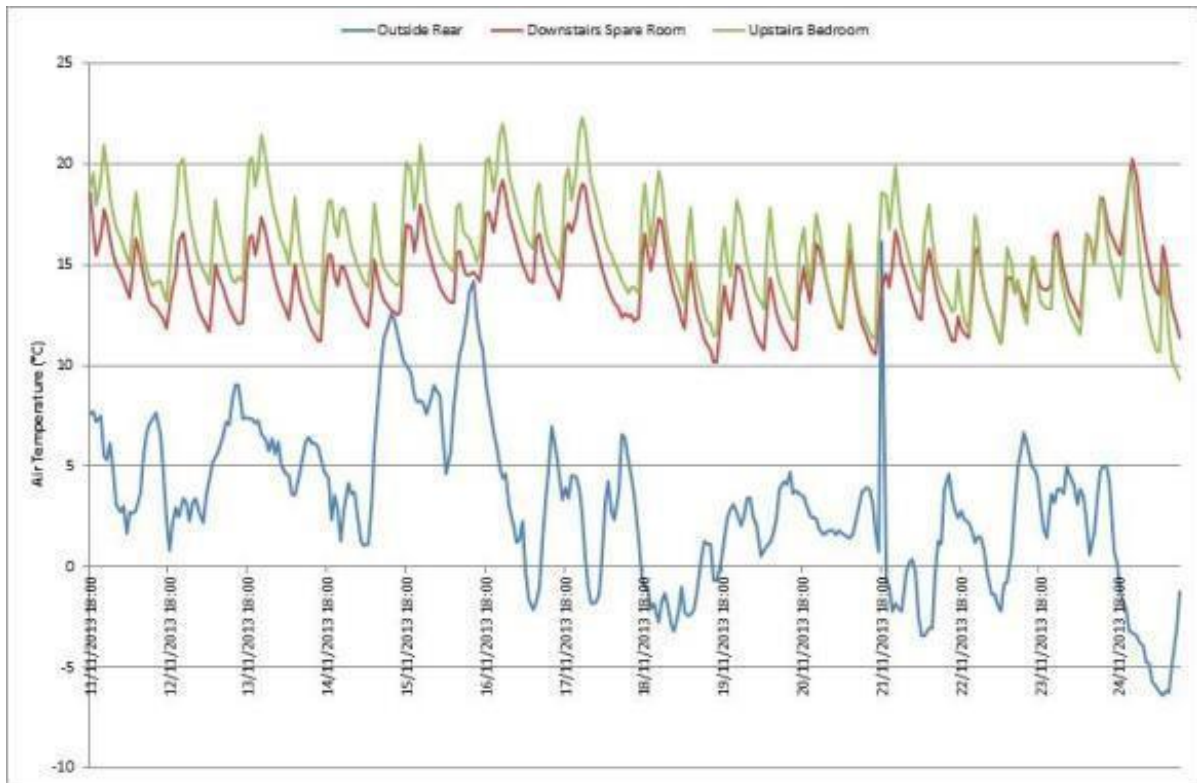
Restrictions on how the monitoring was done, and the time of year, meant that direct comparisons with each room was not possible (the post-intervention monitoring was done in May), but the results show that that temperatures in the first floor bedroom fluctuated less over the diurnal cycle, indicating that the wood fibre board insulation to the coombs, and the solid wall insulation, had introduced a degree of thermal stability or buffering into what was previously a thermally much more responsive and less well insulated structure. Before intervention, the red and green lines in Figure 16 indicate a substantial variation in temperature, at times up to 10° Celsius.

Figure 16: The red and green lines show the temperature fluctuations in the upstairs and downstairs bedrooms before the work, and the blue line shows the outside air temperature

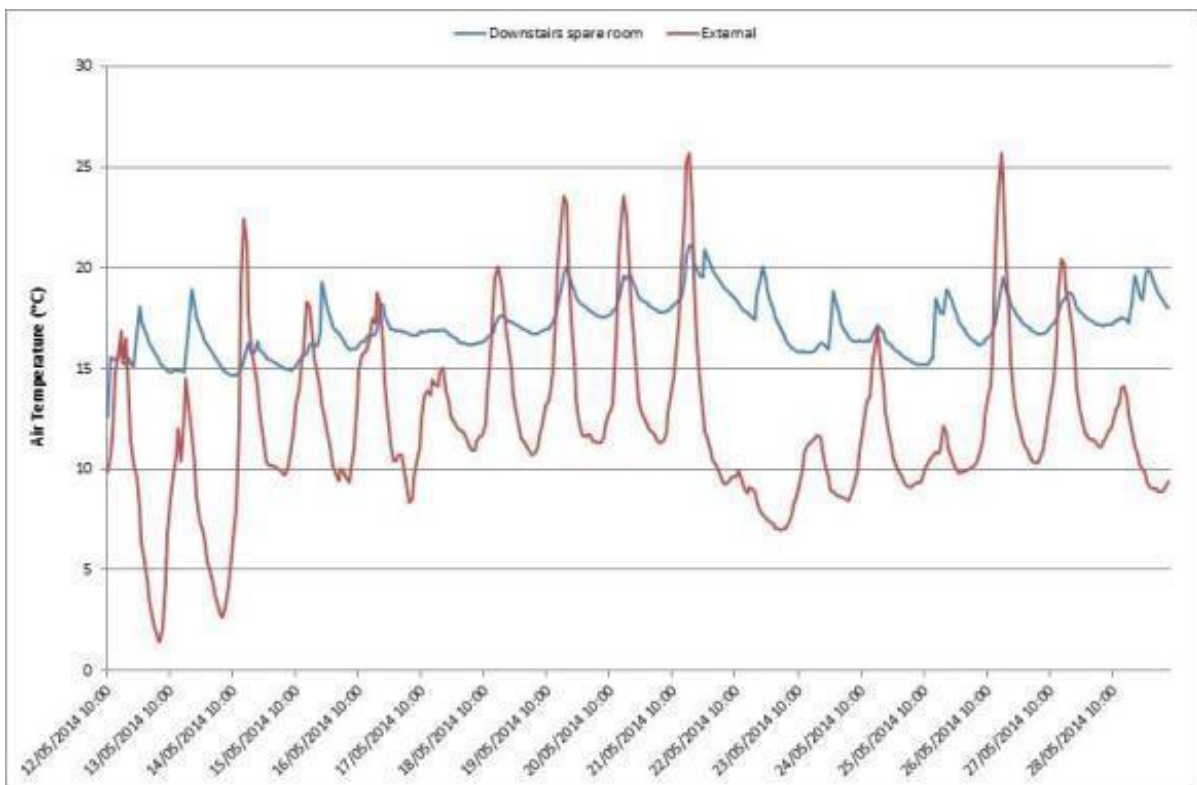
While the roof slopes themselves were well insulated before the works with the blown cellulose, the adjacent areas of the dormers, parts of the coomb and the masonry of the gable were not insulated at all. This resulted in air leakage and thermal loss from the gables and the adjacent areas. The refurbishment works addressed these areas, giving a much tighter thermal envelope to the upper parts of the building, and a reduction in the fluctuation in the temperatures in the upstairs bedrooms. This can be seen in reduced temperature ranges shown on the blue line in Figure 17.

Figure 17: Room temperature fluctuations in the downstairs bedroom after the works. The blue line showing the internal temperature is in a much narrower temperature band.

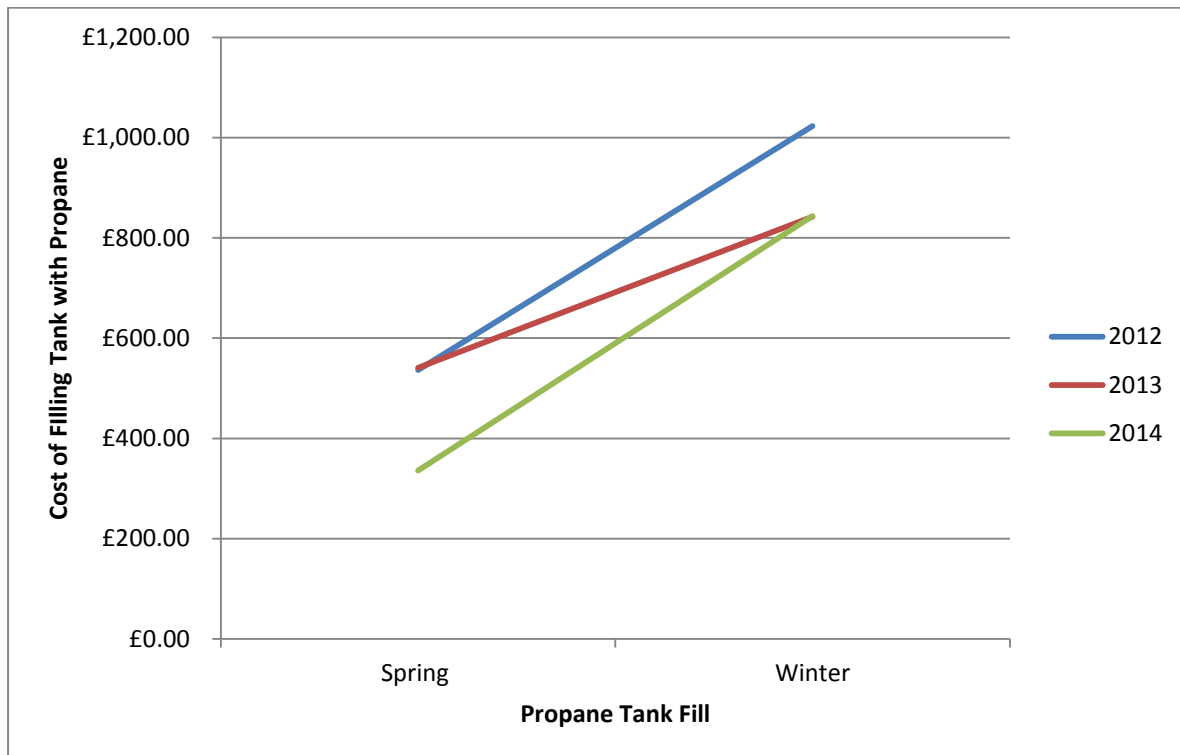
Following the completion of the works in March 2013, the billed energy usage was recorded. In 2014, the year after all of the works had been completed, a total of £1179.62 was spent on LPG, approximately 25% lower than the amount spent in 2012 (Fig. 19). This is a considerable reduction in the heating utility bills as a result

Figure 19: Comparison of heating utility bills over a three year period
