THE
INVESTIGATION,
REPAIR AND
CONSERVATION
OF THE
DOULTON
FOUNTAIN,
GLASGOW GREEN

2 | Case
Study

TECHNICAL
CONSERVATION
GROUP

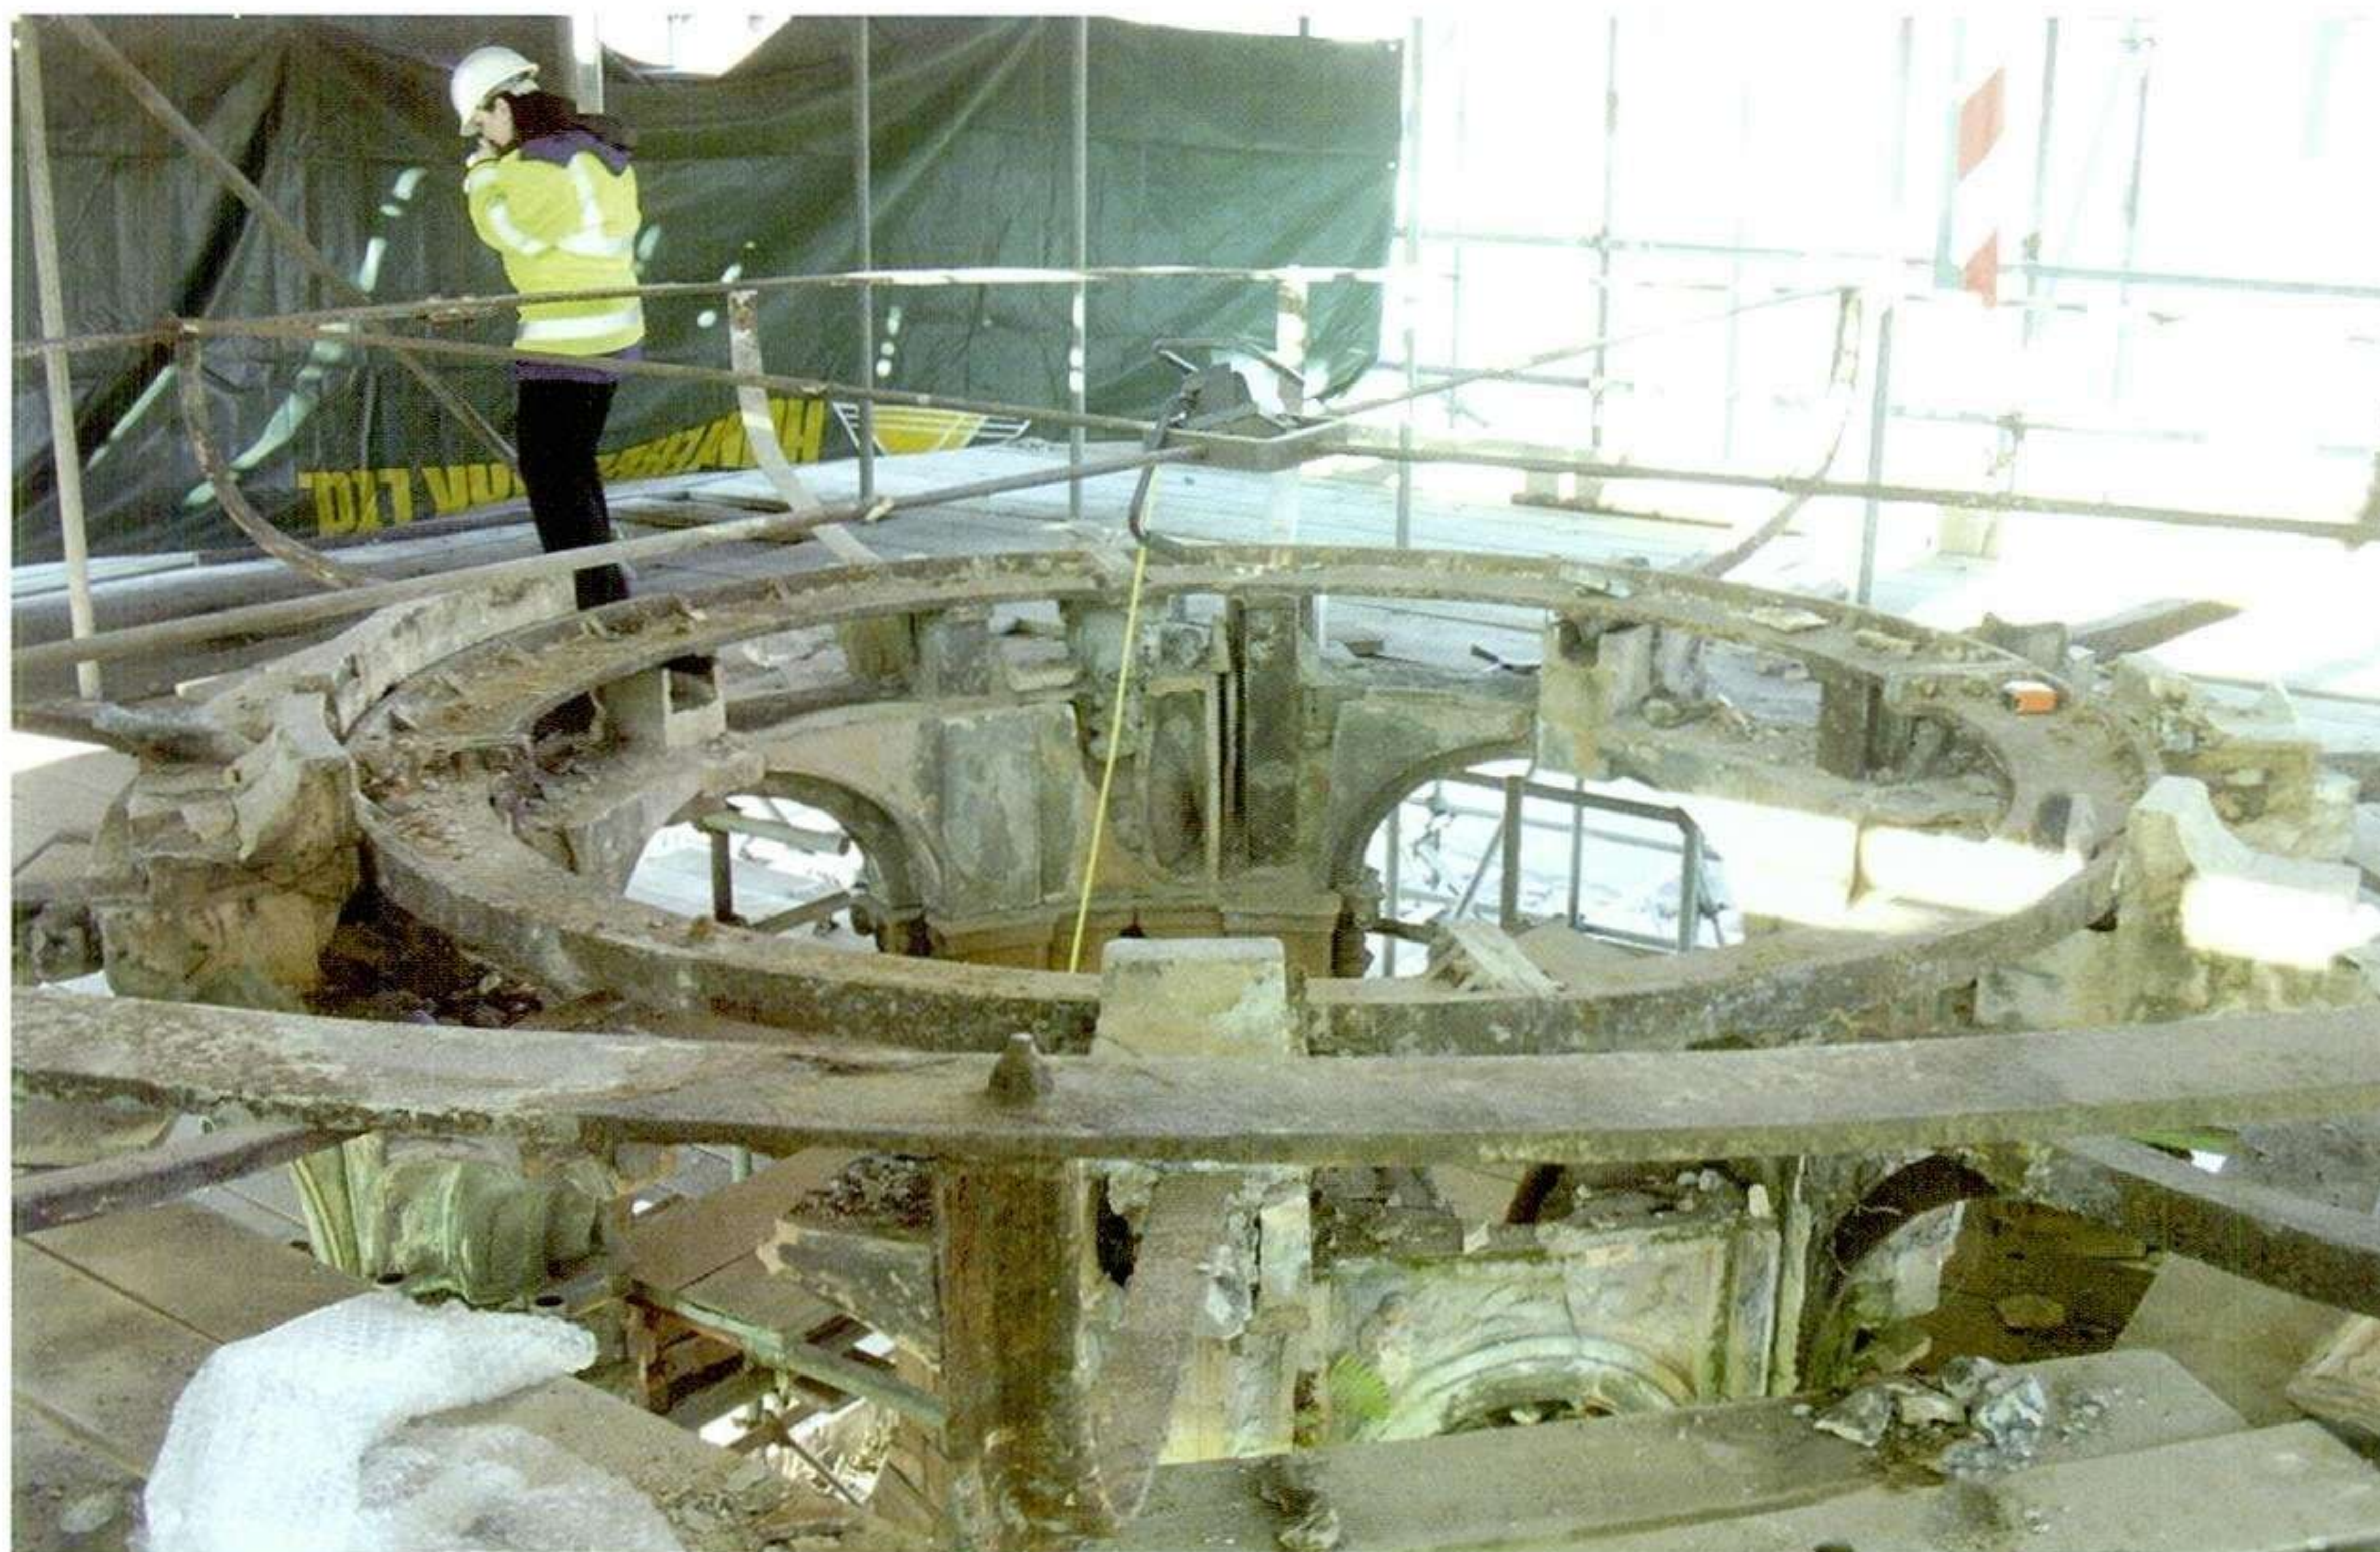
The cast iron and wrought iron frame of the cantilevered basin, exposed and prior to dismantling.

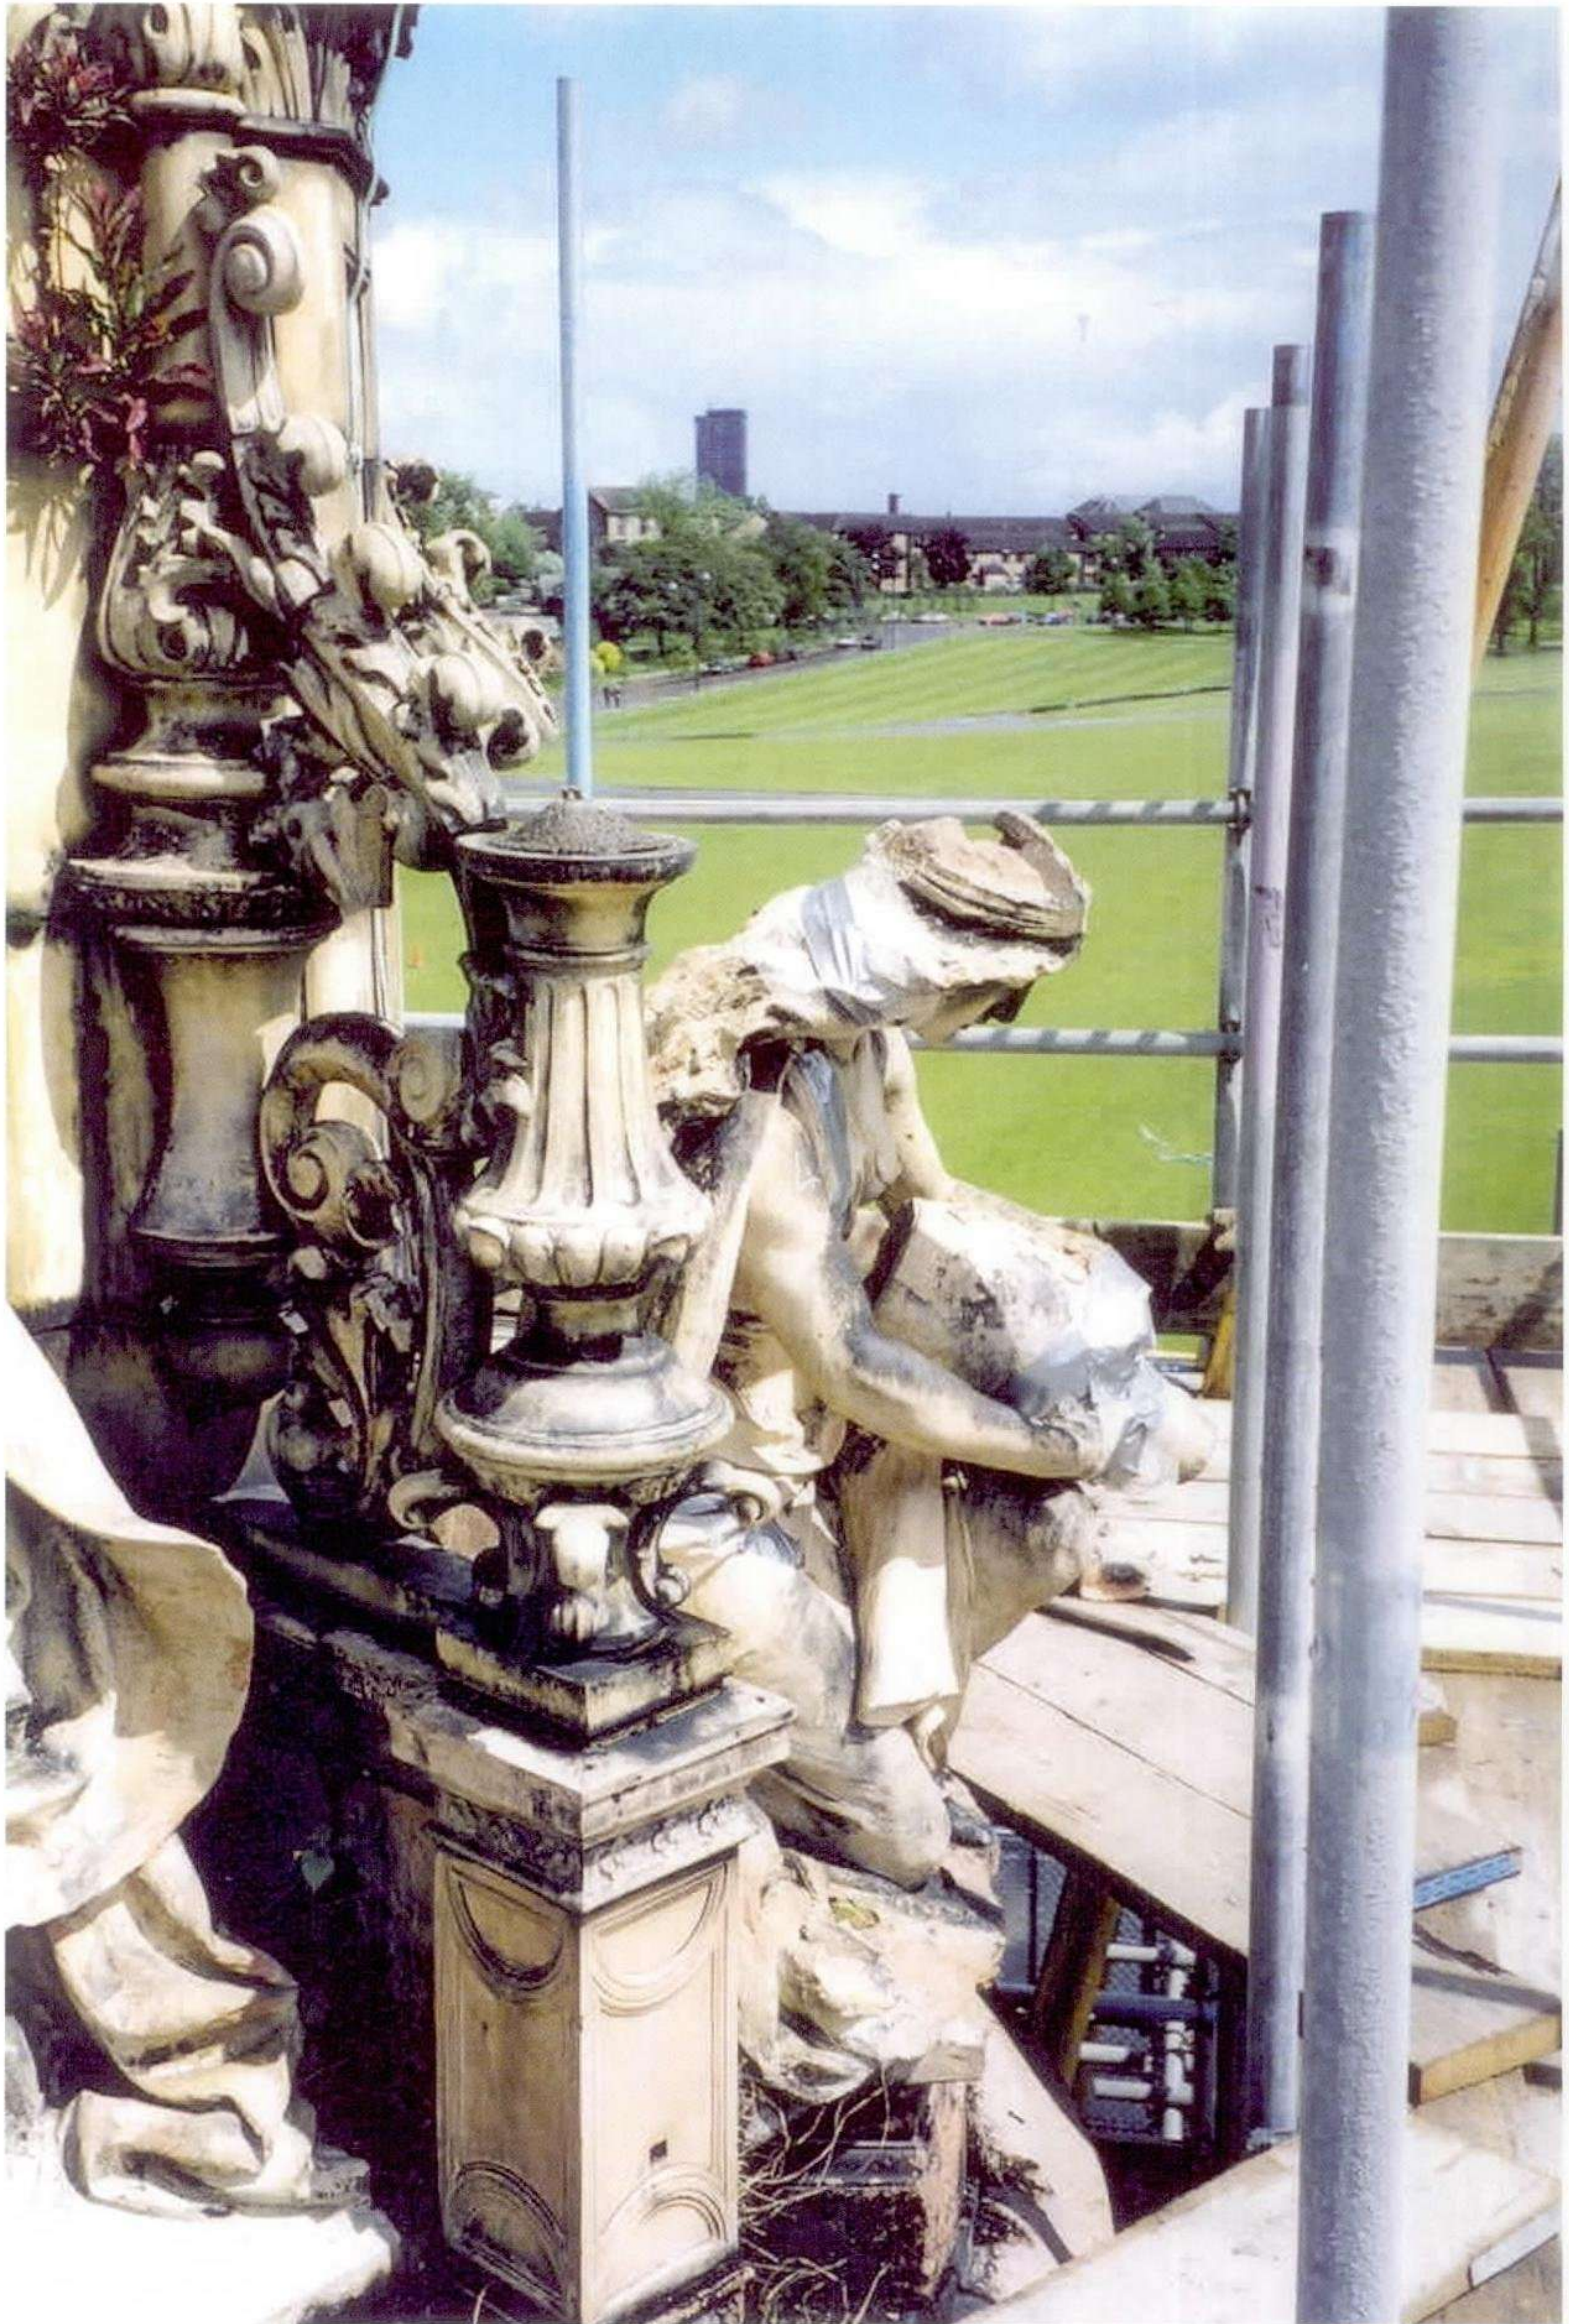
The delicate process of removing the water bearers sculptures began with stabilisation of delicate surfaces.

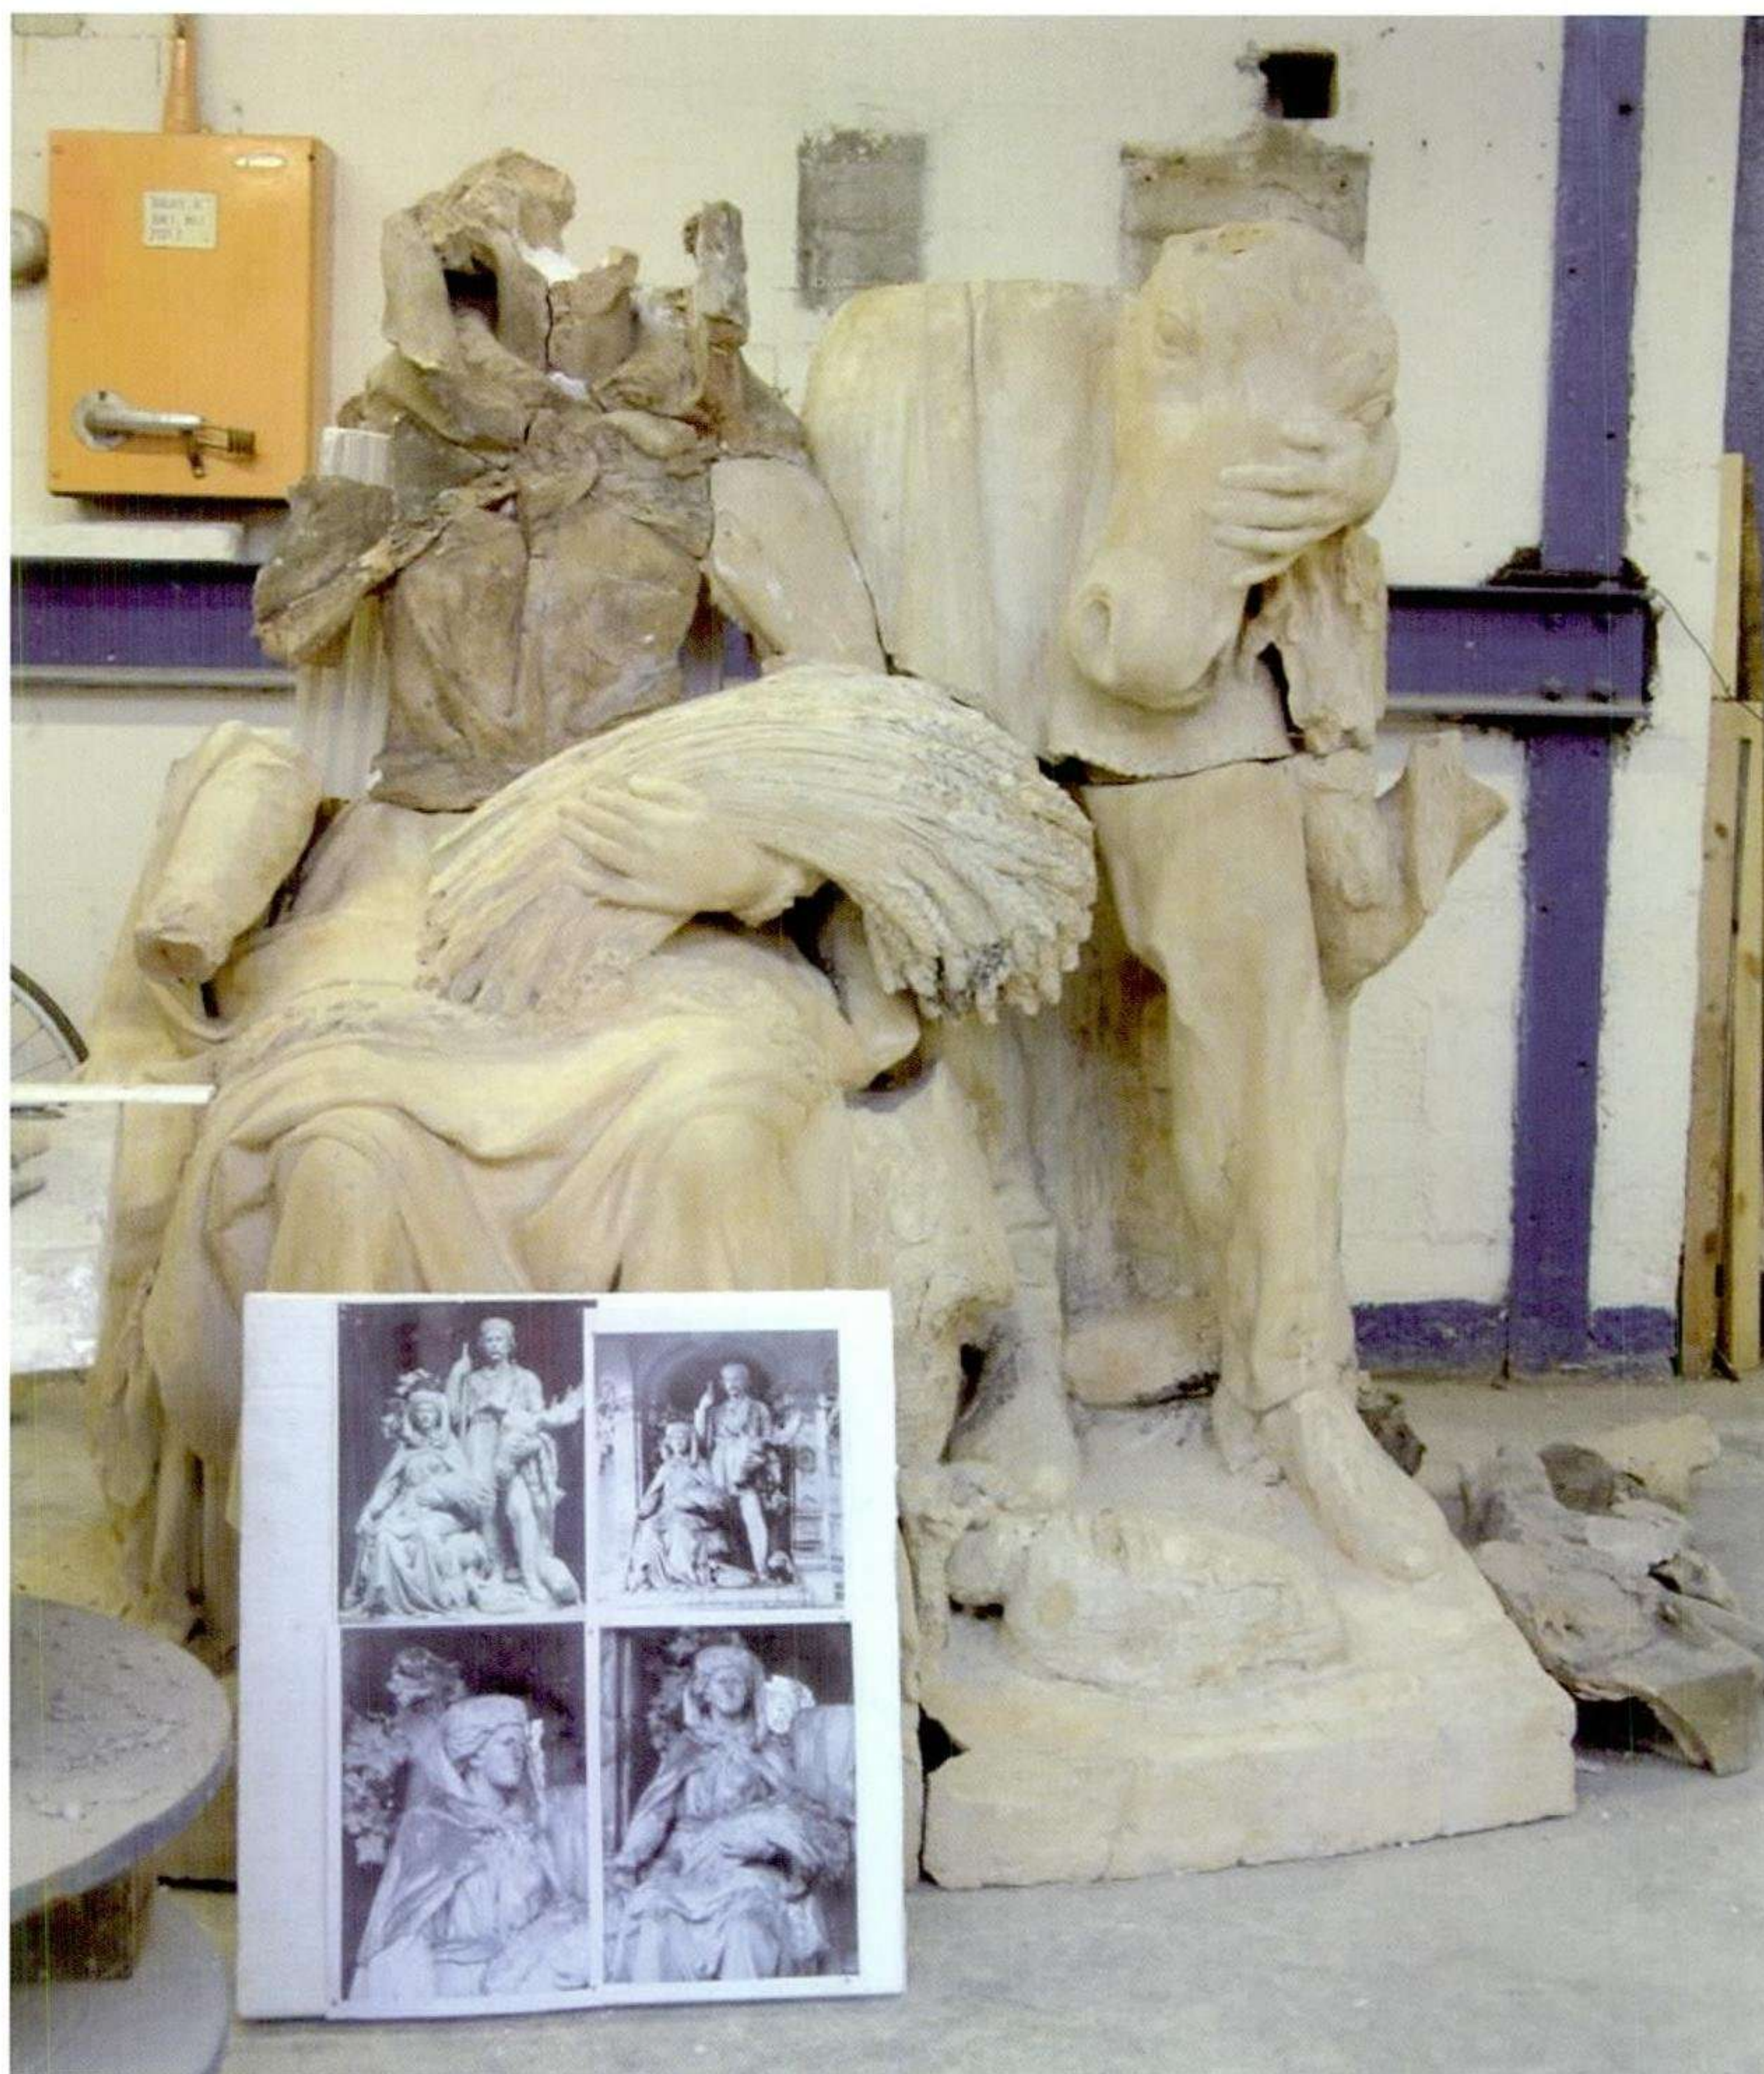
The remaining fragments of the Canadian lady's torso have been reassembled and documentary evidence collected in preparation for modelling of the new piece.

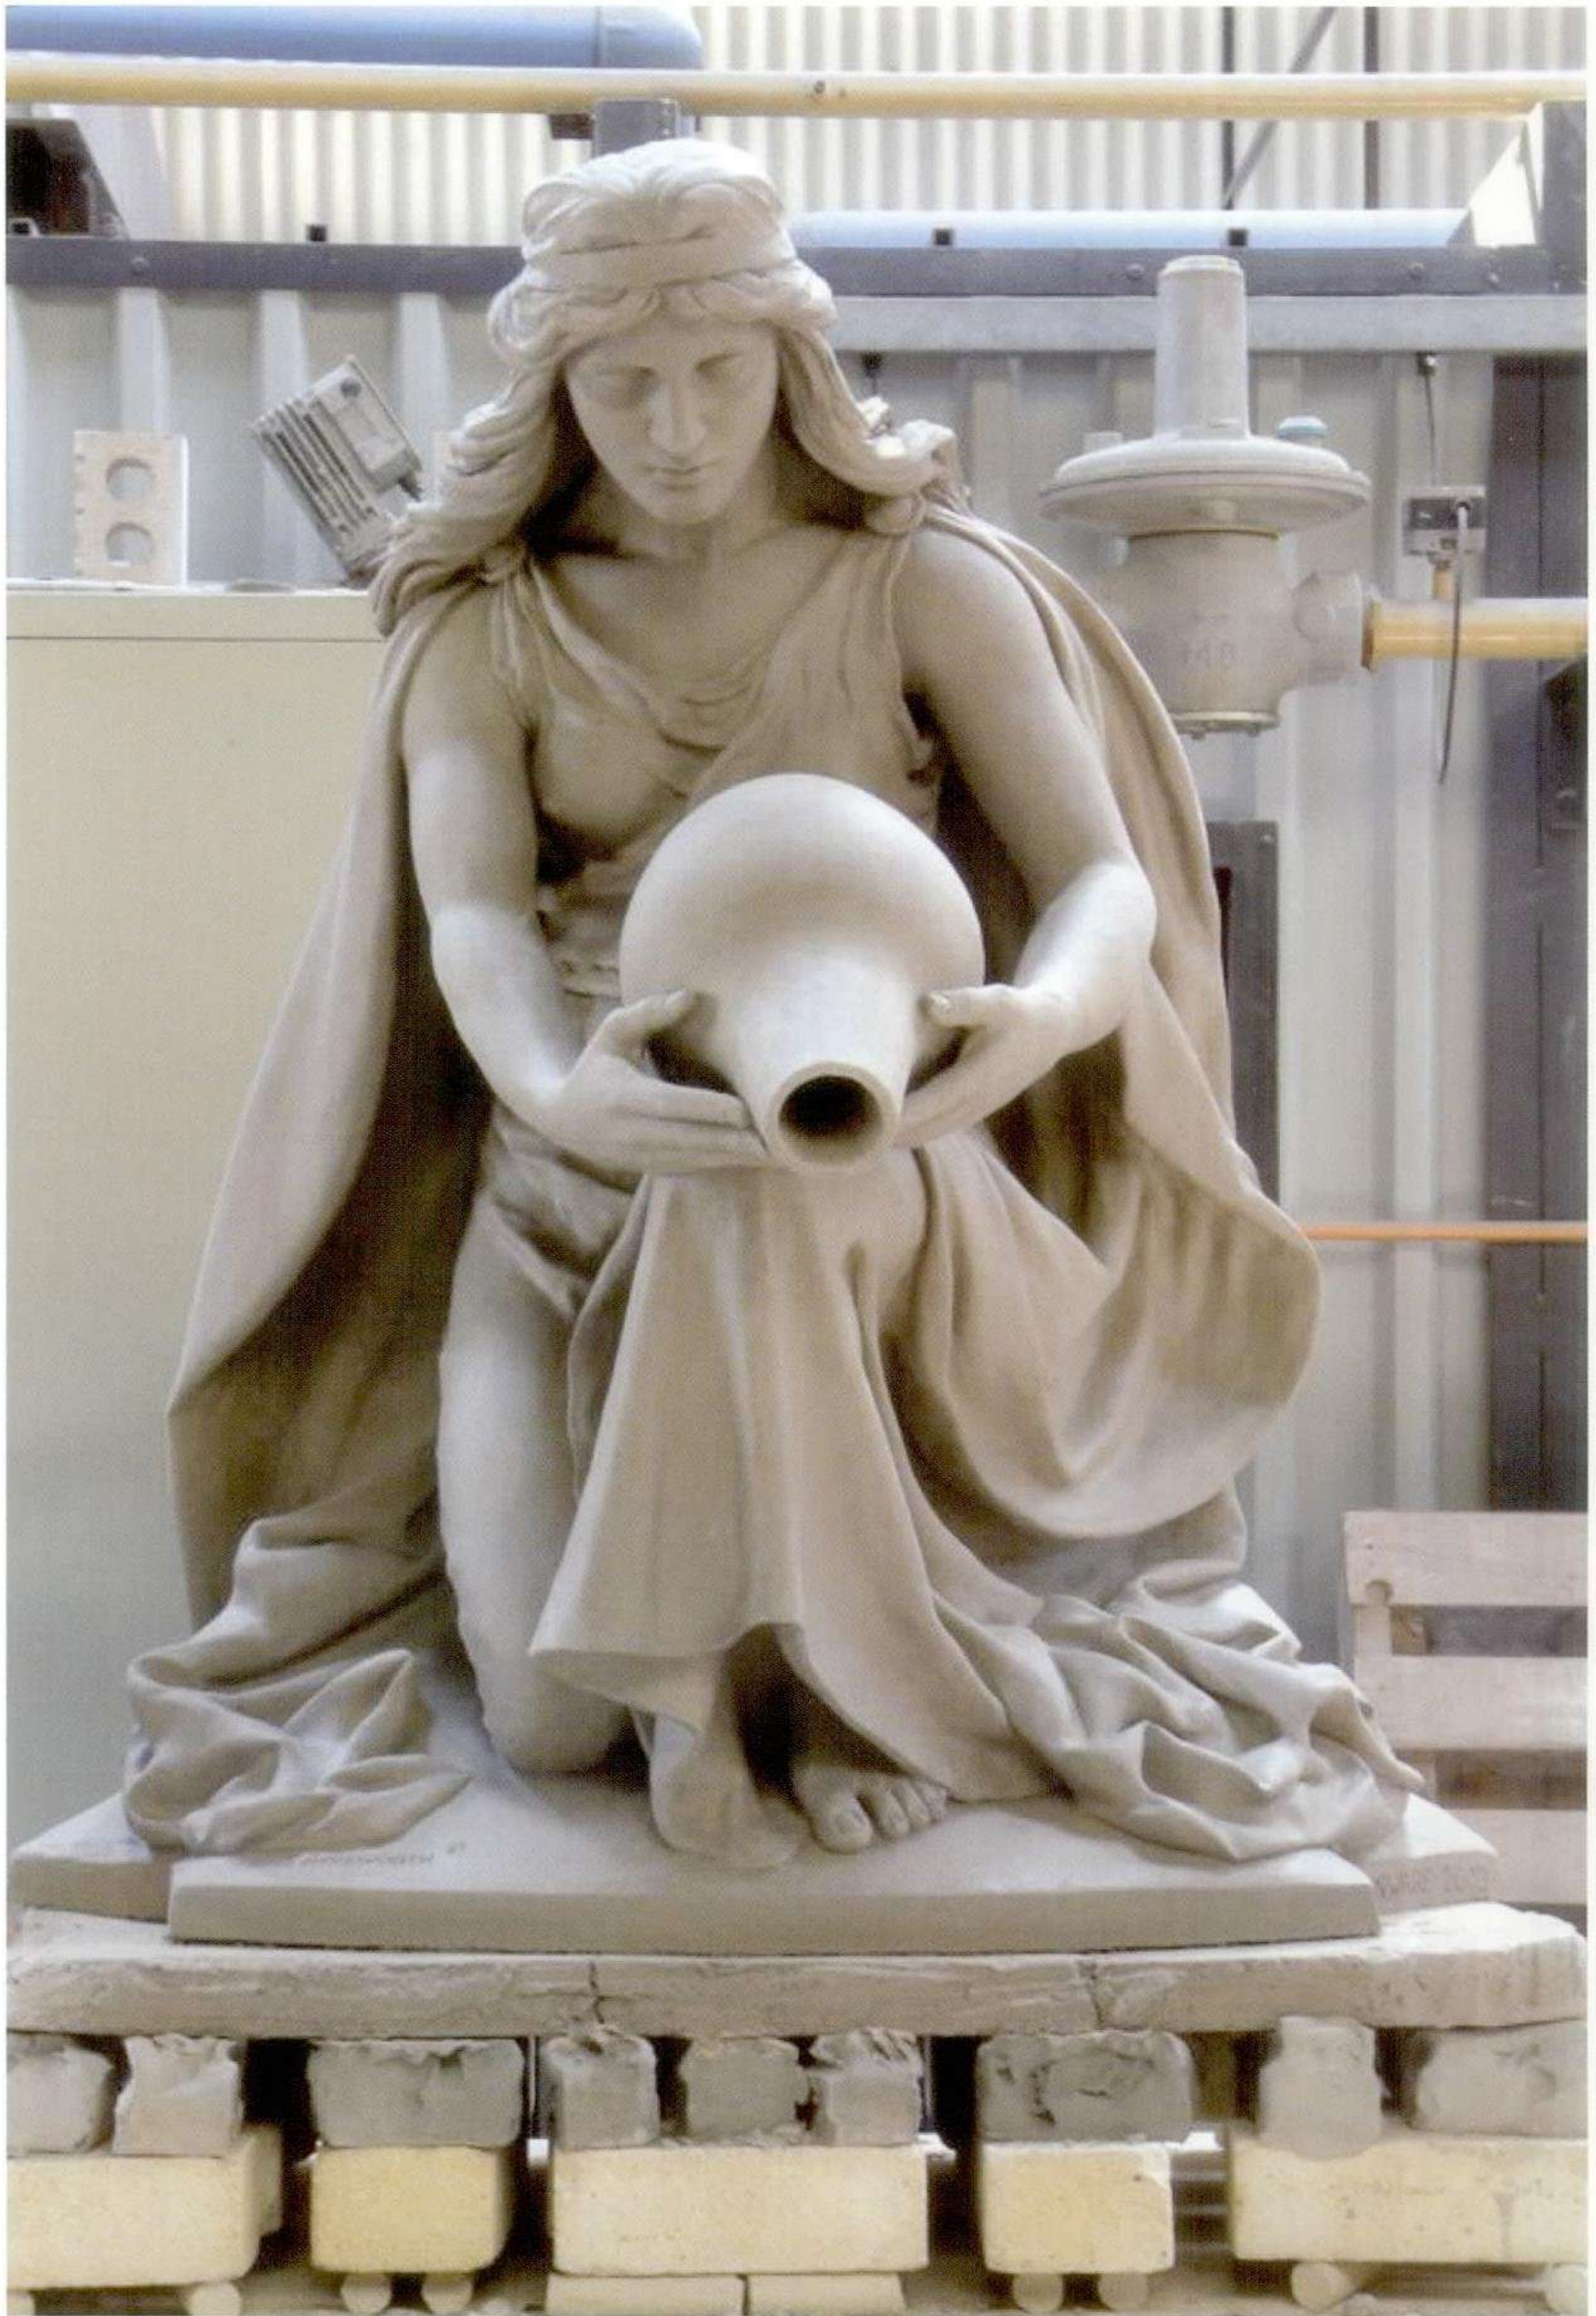
The finished sculpture of Water Bearer No. 3 dries out on a sacrificial base and multi directional rollers designed to control drying-out shrinkage.

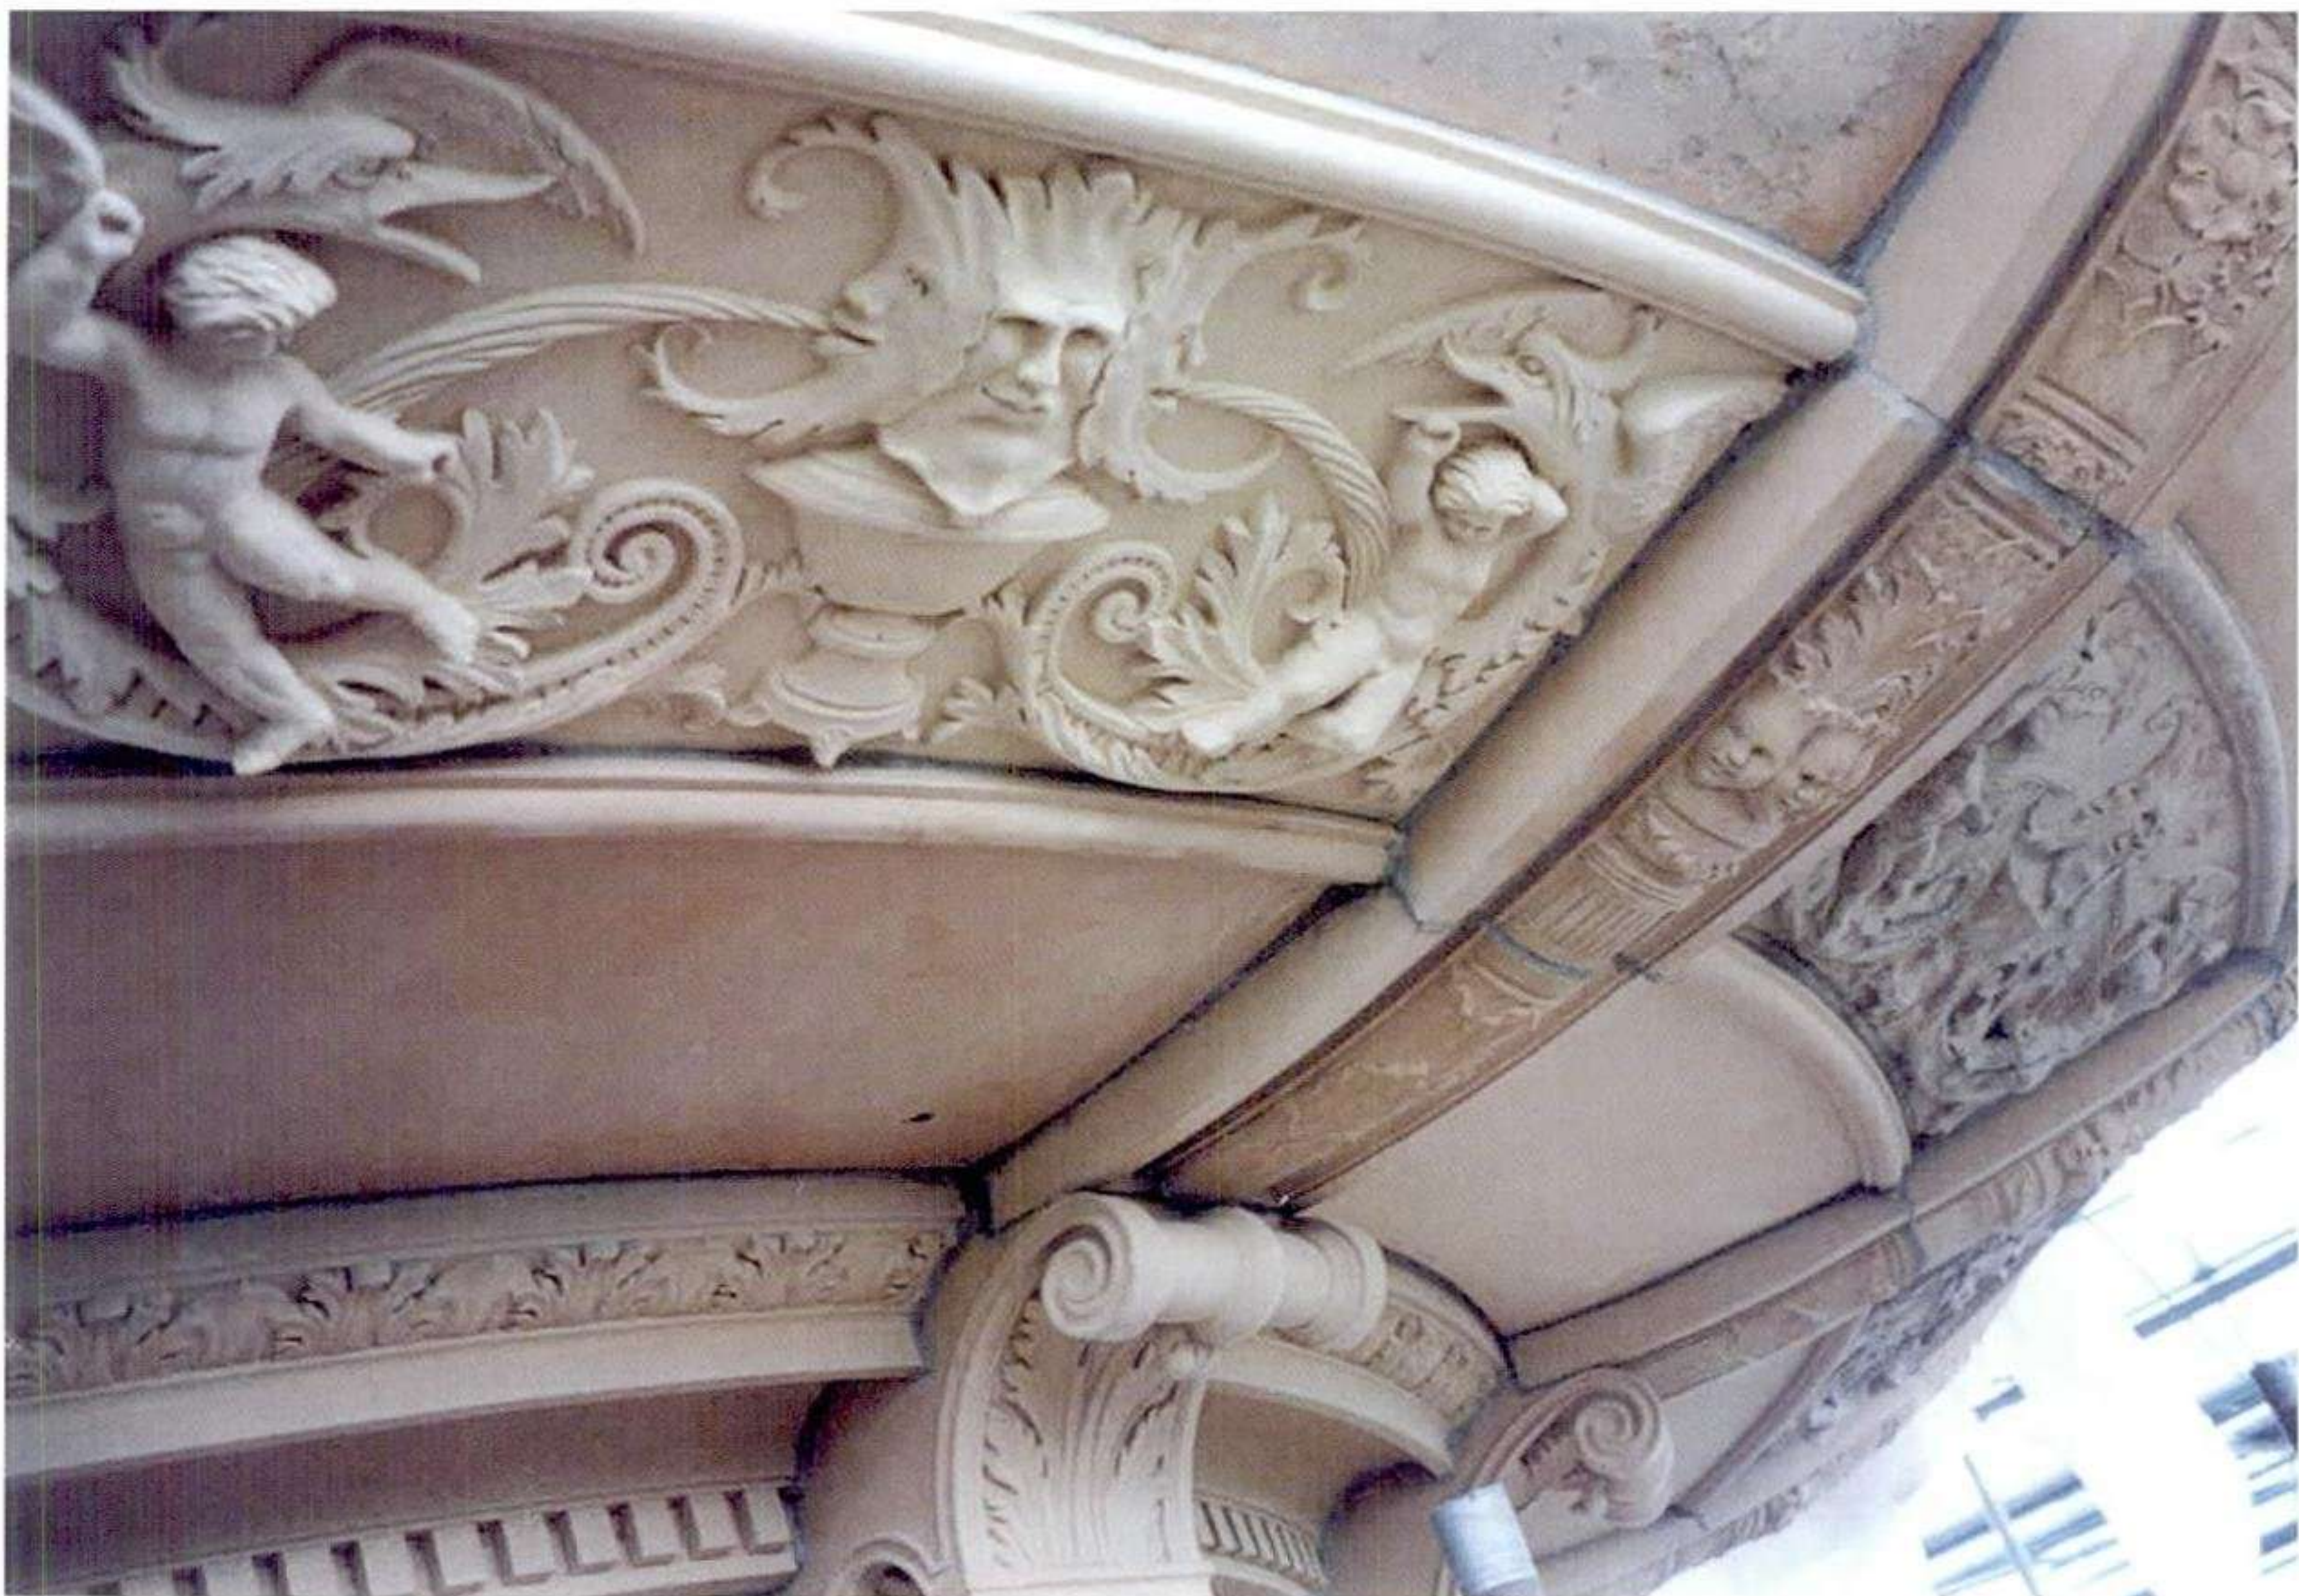
The pieces of the cantilevered basin were four different colours. Replacement terracotta reflected this diversity.

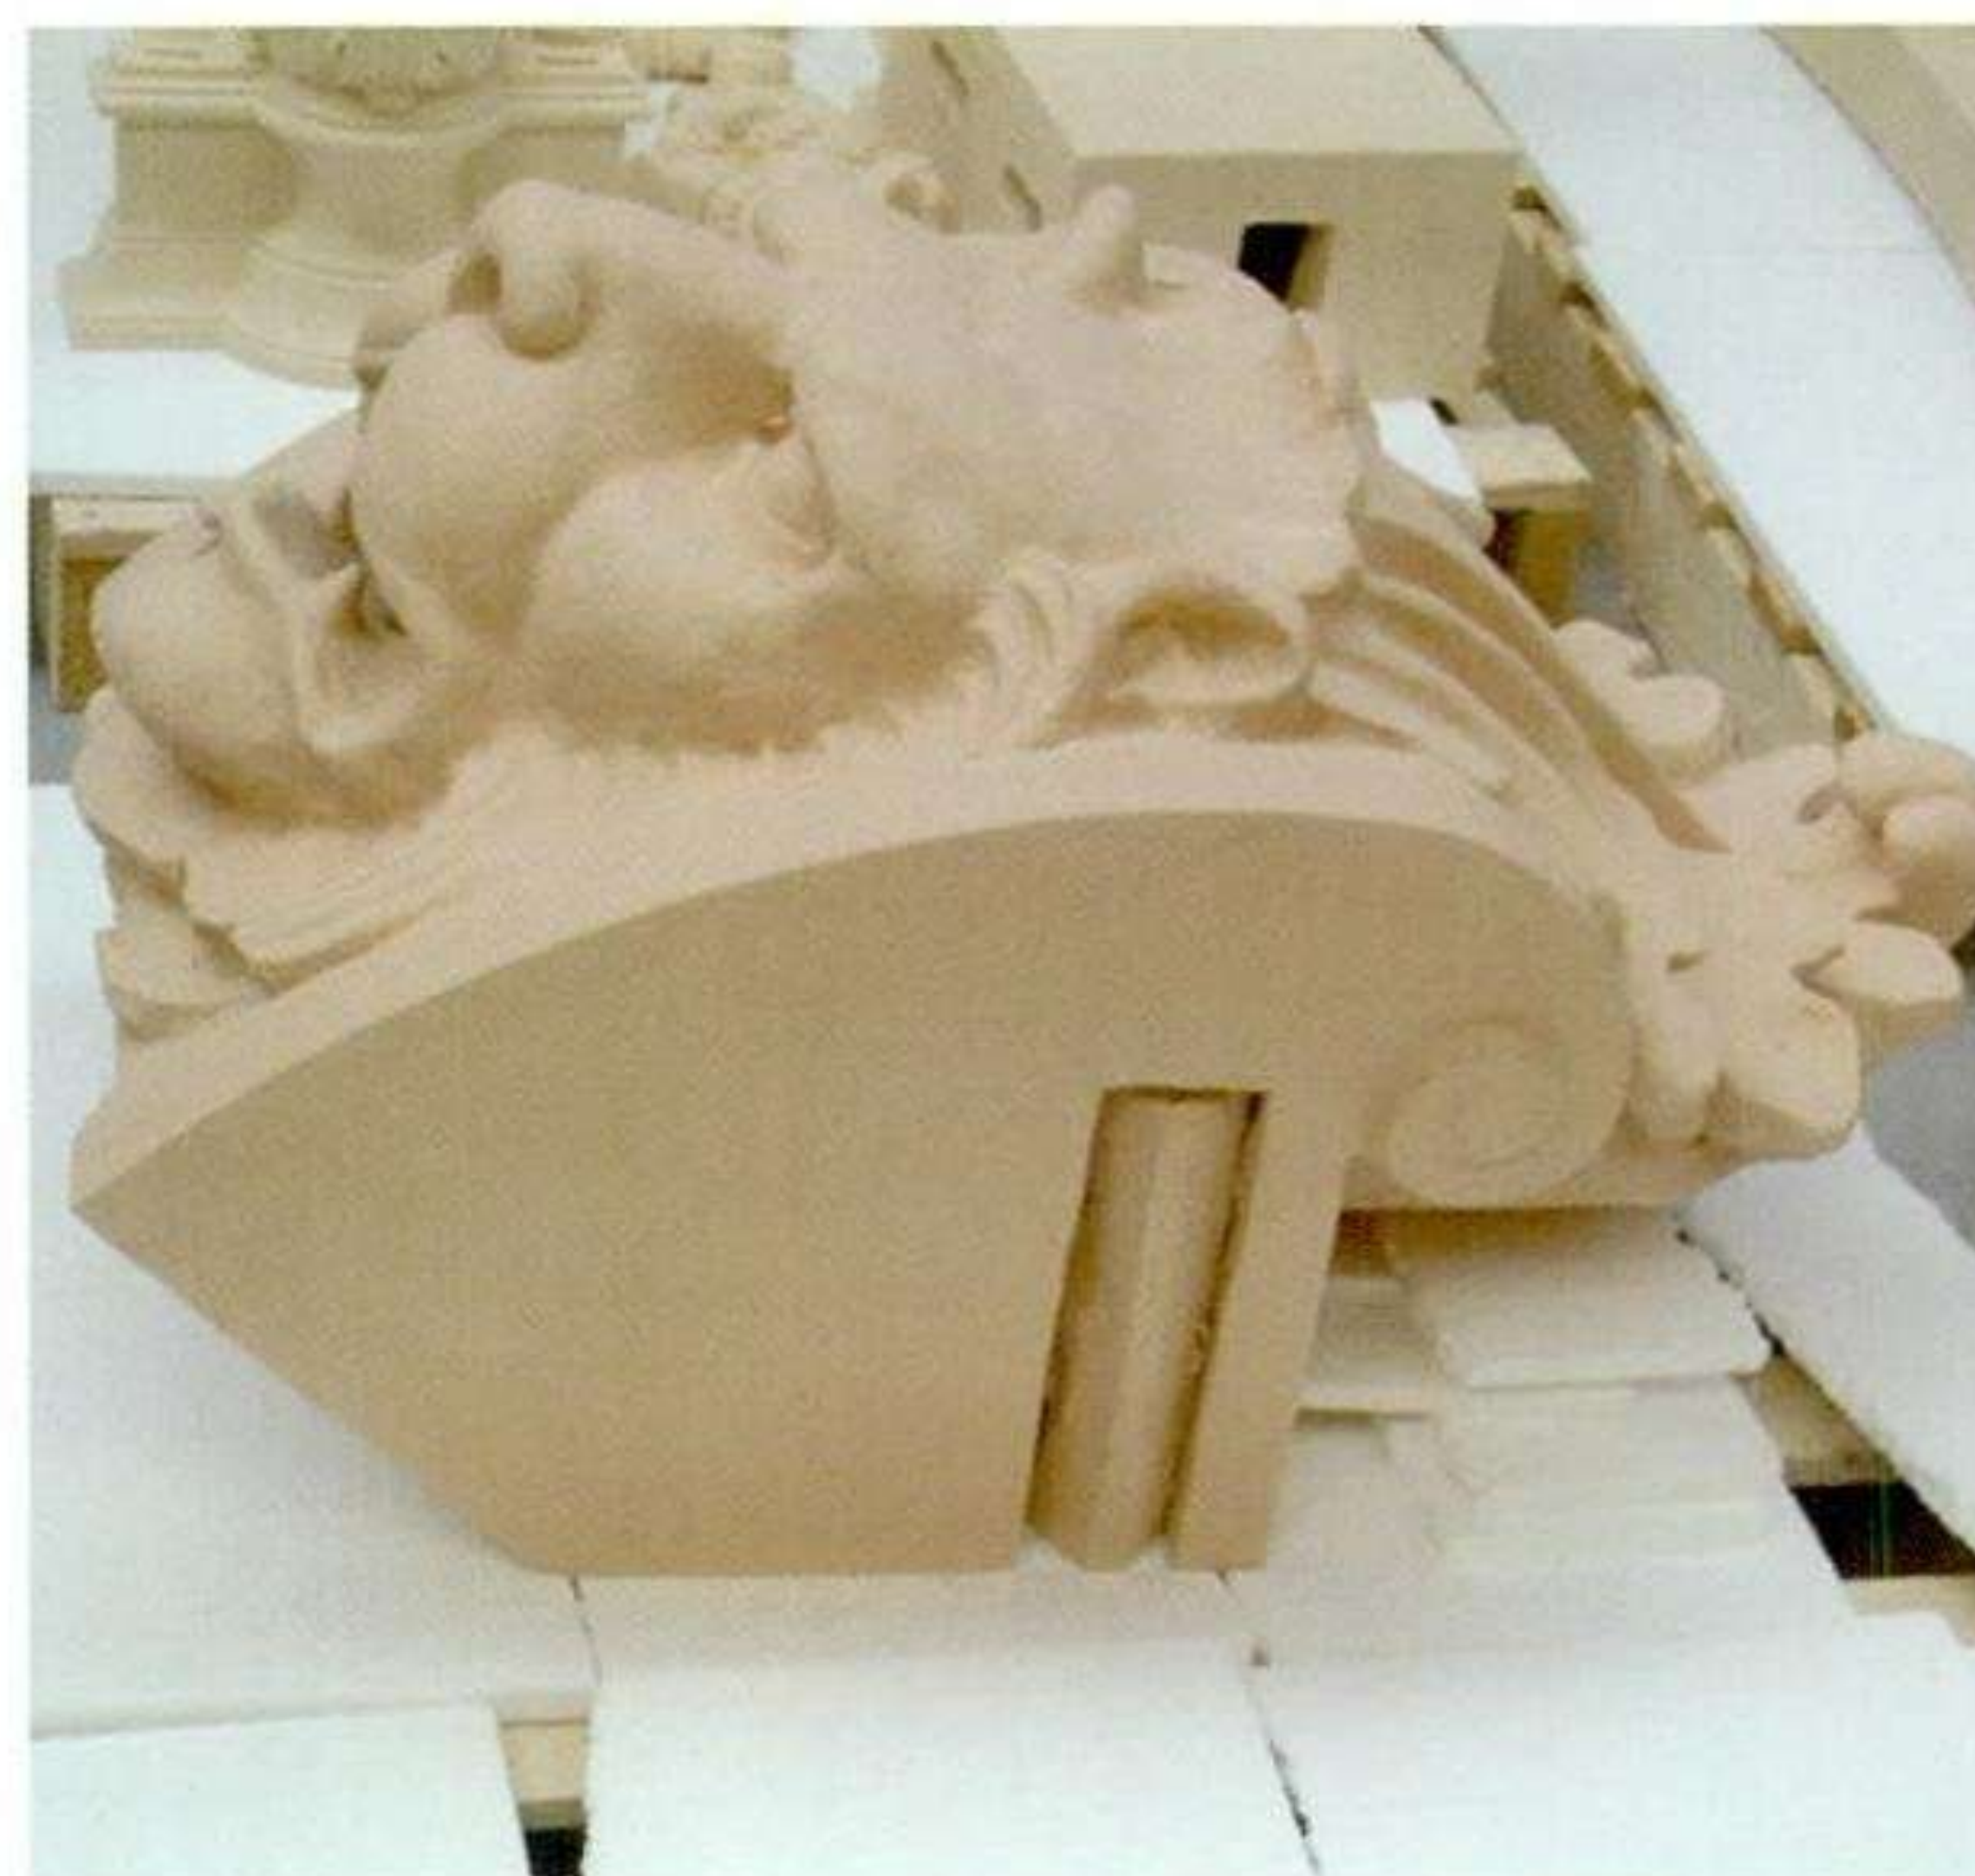
A fired lion head for the cantilevered basin.
