THE
INVESTIGATION,
REPAIR AND
CONSERVATION
OF THE
DOULTON
FOUNTAIN,
GLASGOW GREEN

2 | Case
Study

TECHNICAL
CONSERVATION
GROUP

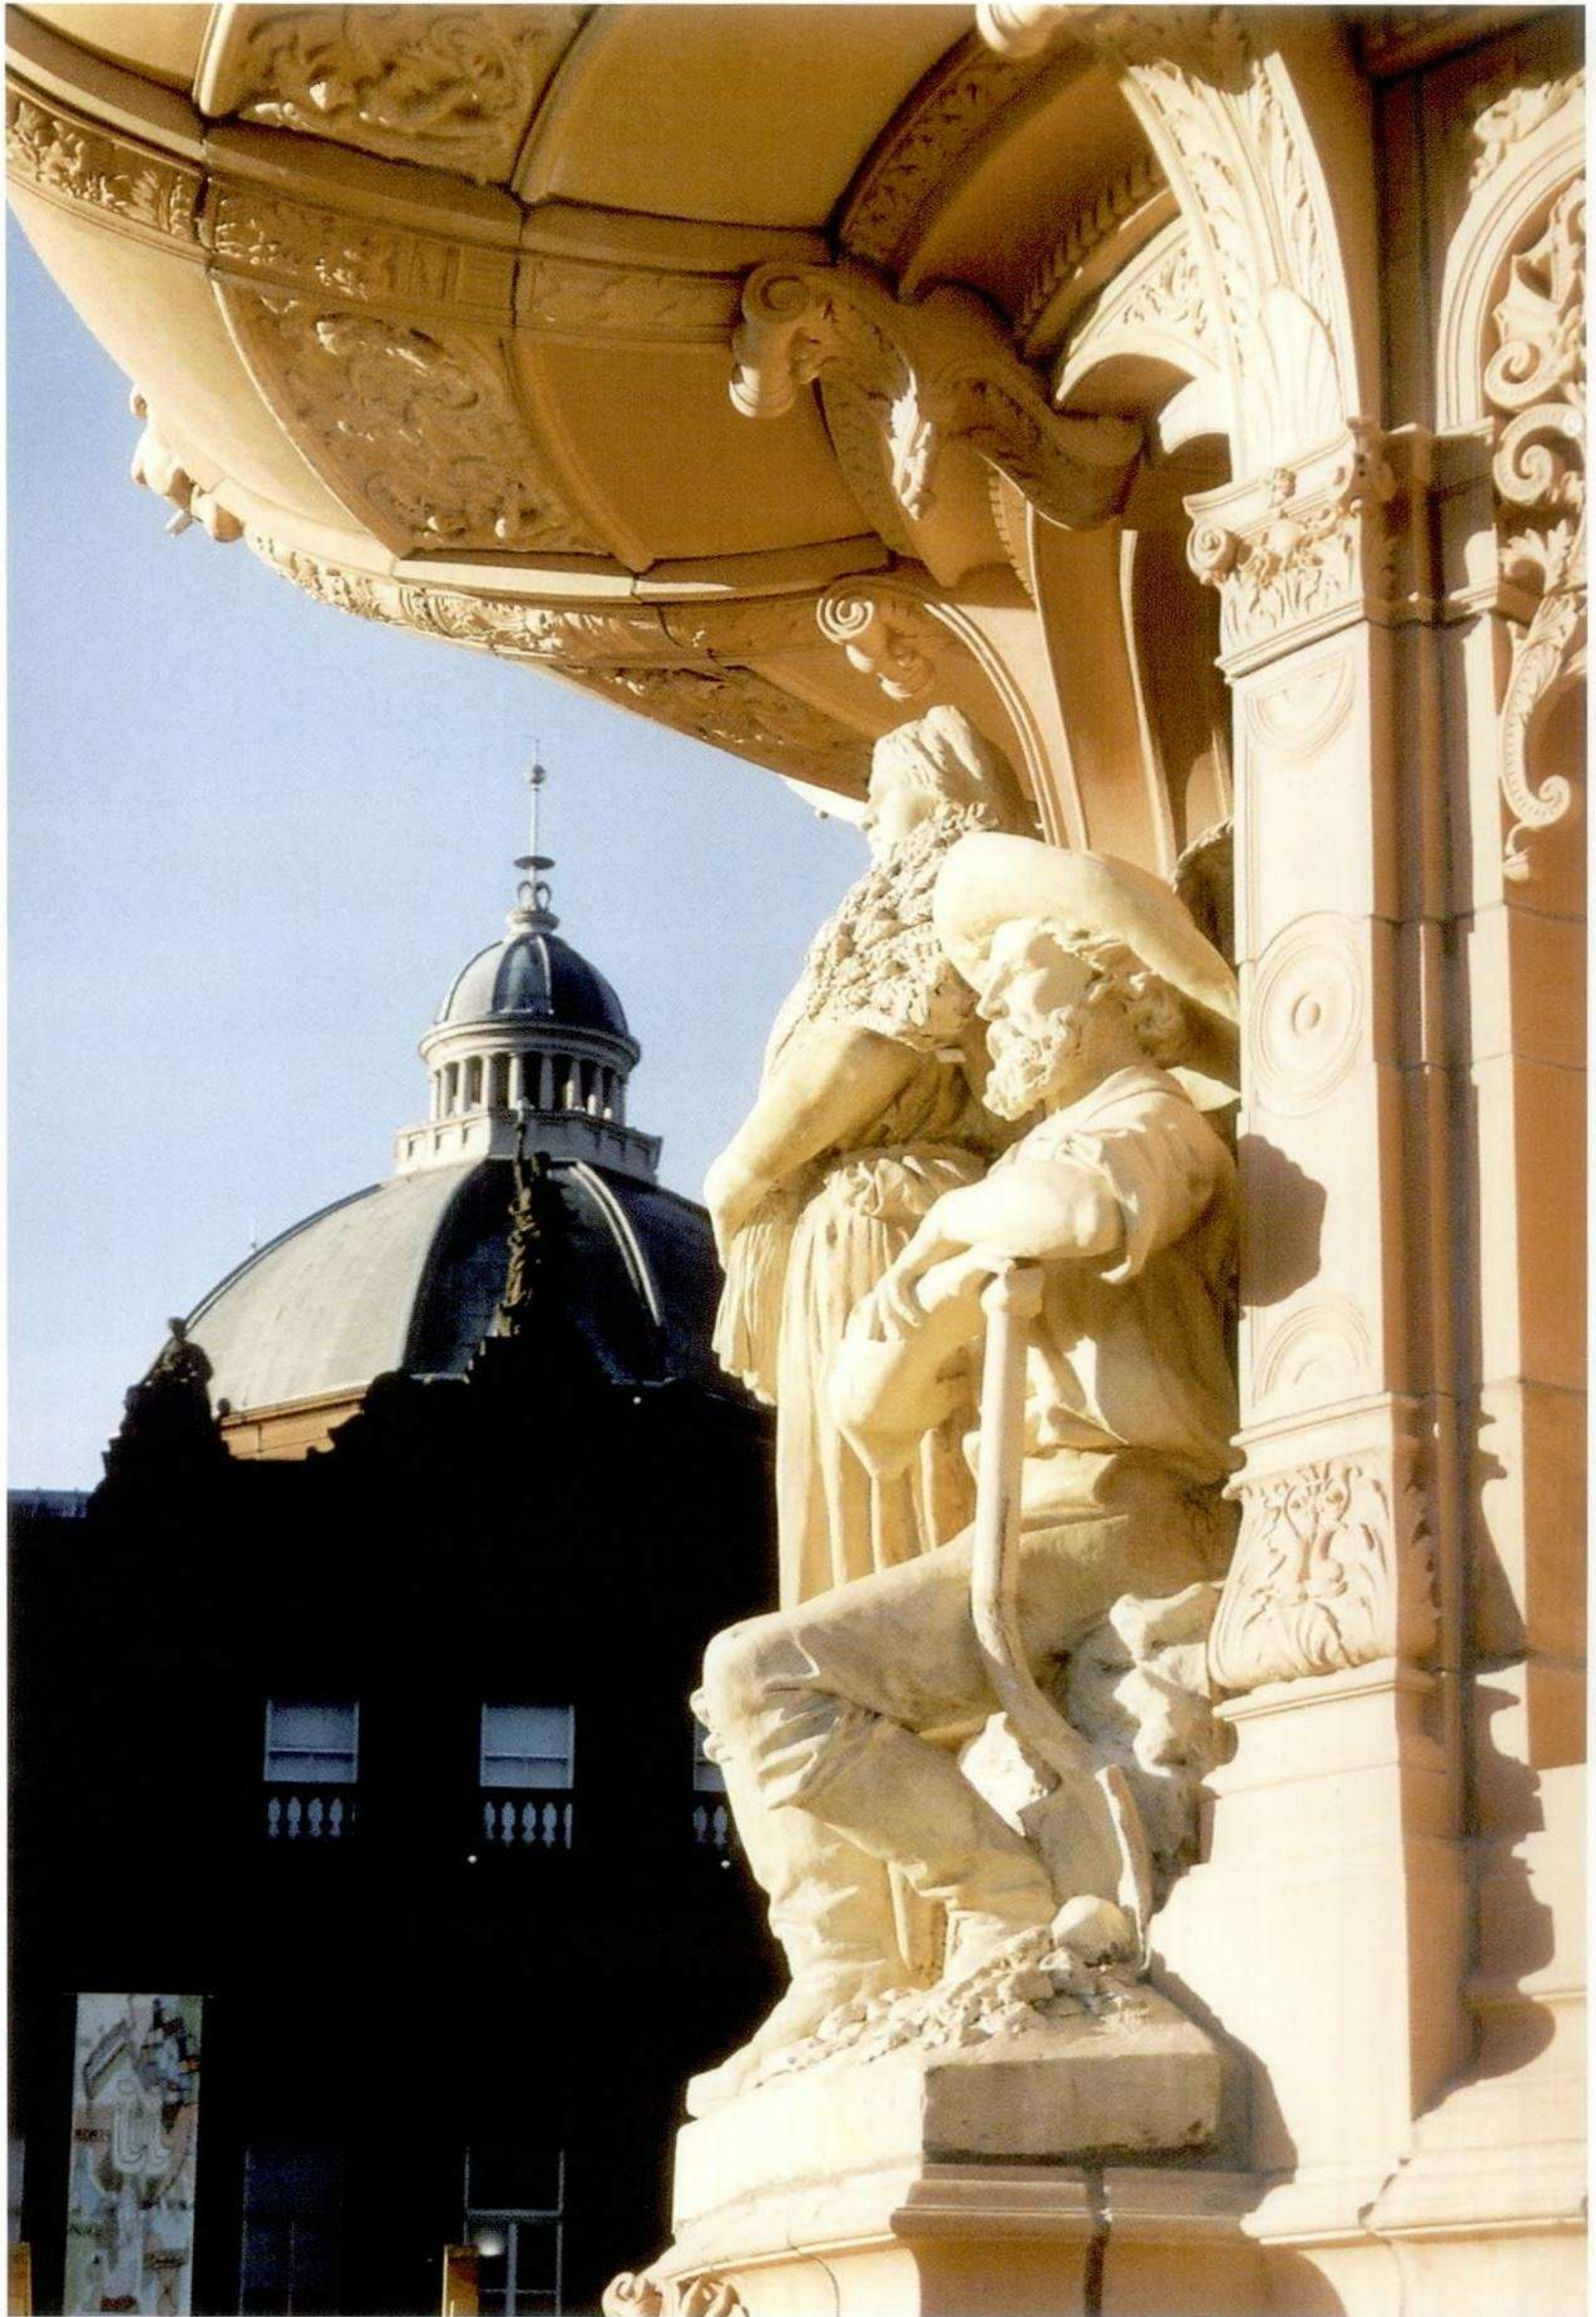
The restored Australia group shelters in its niche under the cantilevered basin.

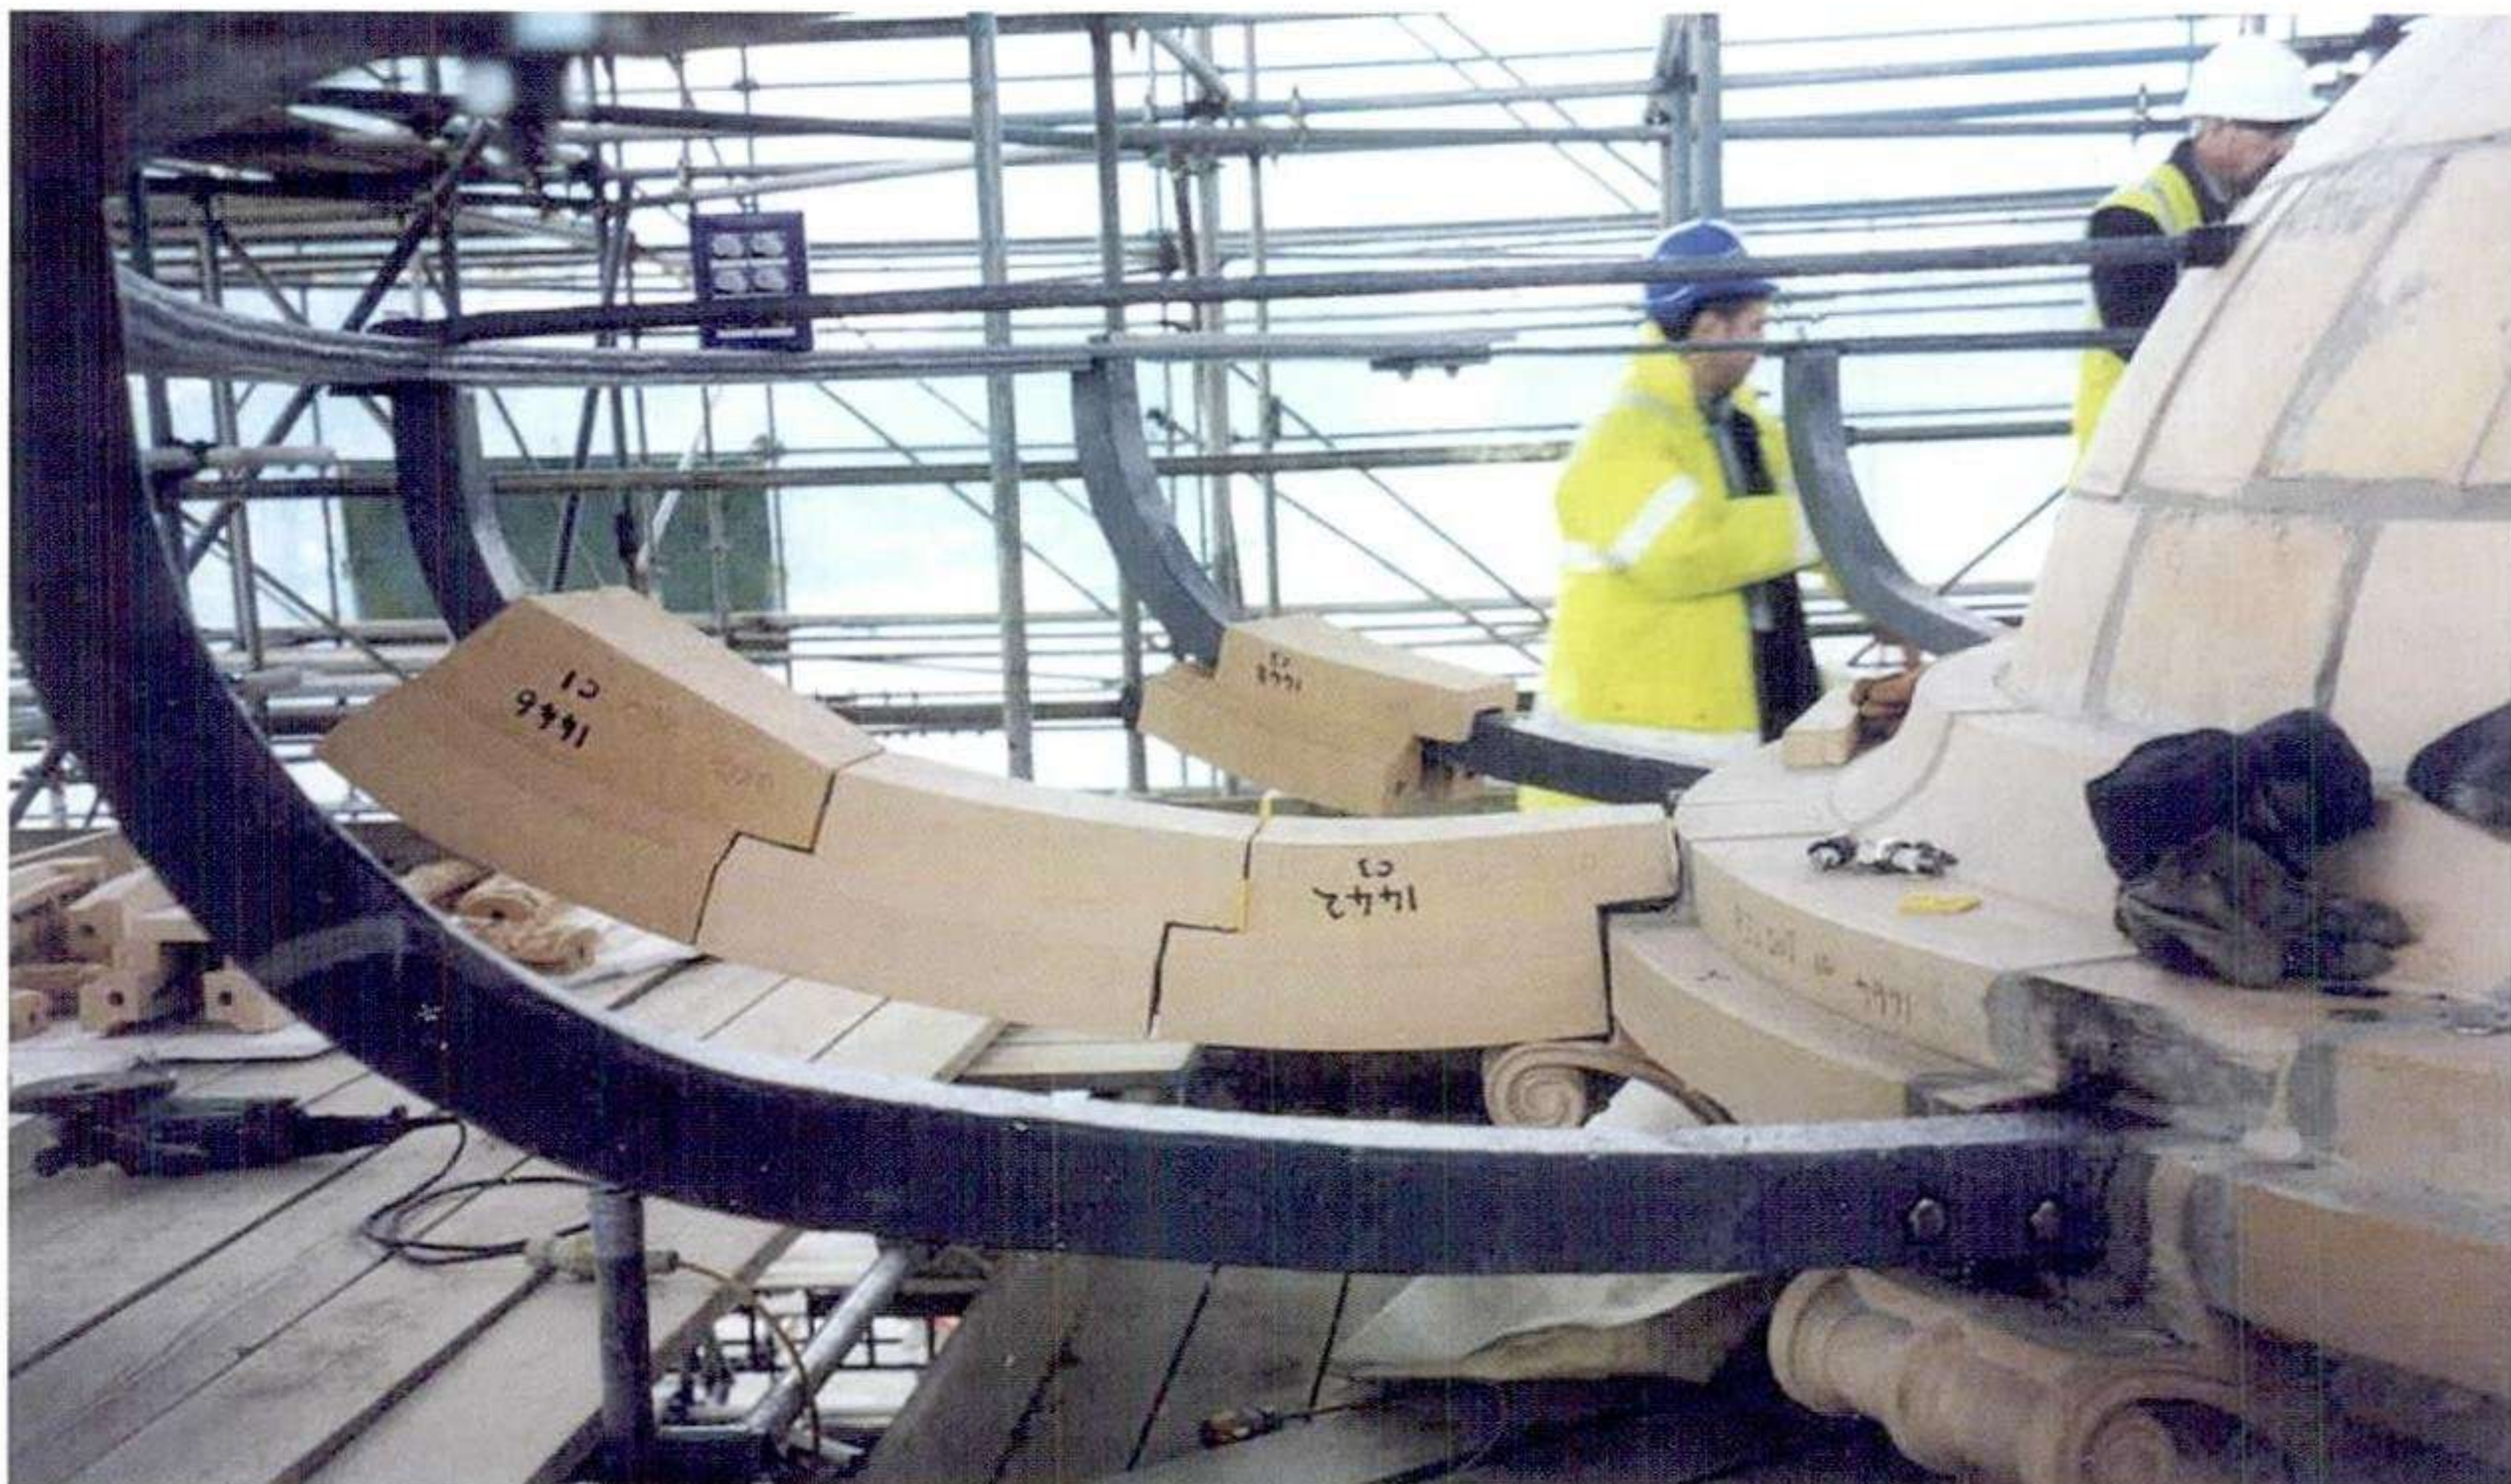
Reconstruction of the cantilevered basin began with the saddle blocks to the structural arms.
