HAA OF SAND, SHETLAND

HOT-MIXED MORTAR RE-HARLING AND ADAPTING A GABLE END WALL

This publication should be quoted as:
Historic Environment Scotland
Refurbishment Case Study 25

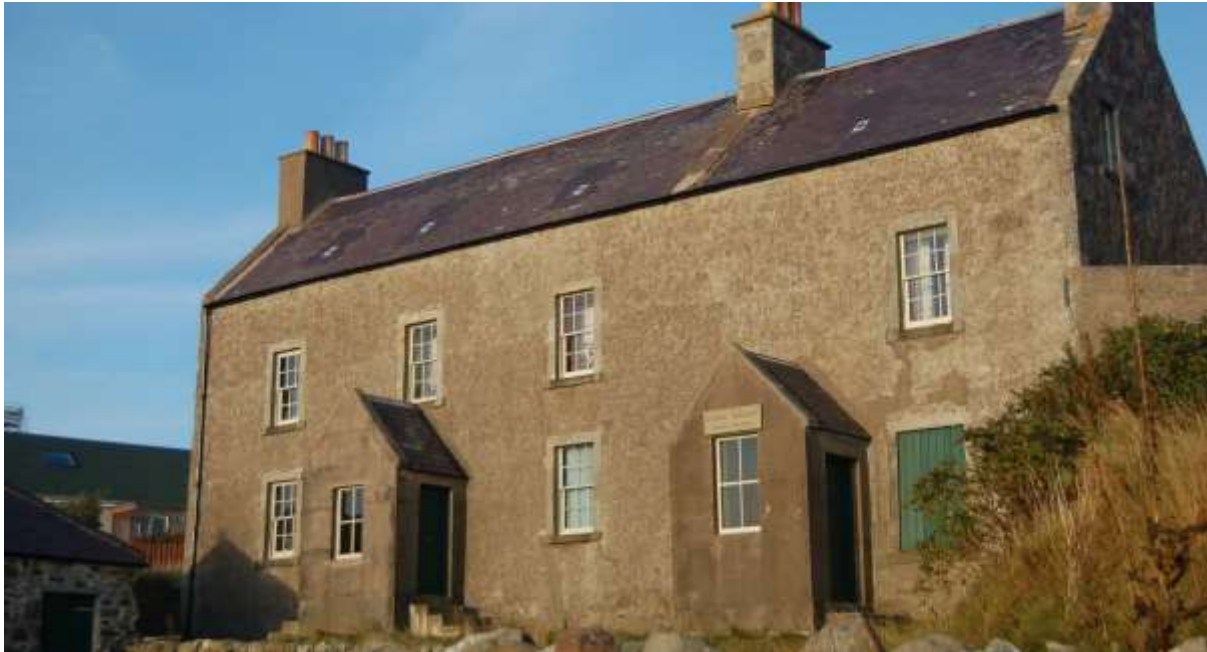
The approach taken to specifying the re-harling work was informed by research into the existing historic lime finishes in Shetland, including documentary research (Tait, 2012), site inspections and lime mortar analysis. The evidence suggested that traditionally, buildings in Shetland were not routinely harled and lime washed, but

finished instead with a relatively thin slaister harl, using lime-rich mortars and local aggregate (Figure 12).

Figure 12: Brae House, Shetland, where the historic lime-based harl survives.

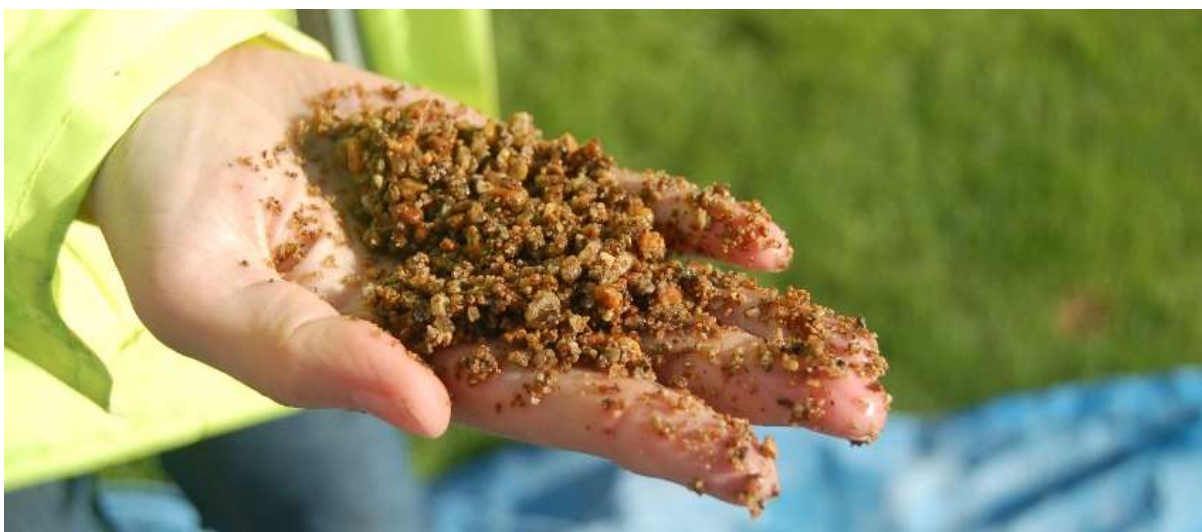
Figure 15: Sand and aggregate from the beach similar to that present in the original harl.

Following the analysis, a specification was prepared for the lime harling finish, based on a gauged NHL and quicklime binder, hot-mixed with local beach aggregate (Figure 15). Whilst the removal of sand or aggregate from the foreshore is not permitted, the owner of Haa of Sand fortuitously had access to a sea-loch on the estate, and crofting rights to remove small amounts of materials for use on the croft itself. It is recognised that this is not a solution that can be generally replicated, and therefore an alternative mix using a carefully graded commercial aggregate, based on crushed granite sand and shell was also approved.
