REFURBISHMENT CASE STUDY 33

ST ATHERNASE CHURCH LEUCHARS

GROUND WORKS IN AN HISTORIC GRAVEYARD

ROGER CURTIS

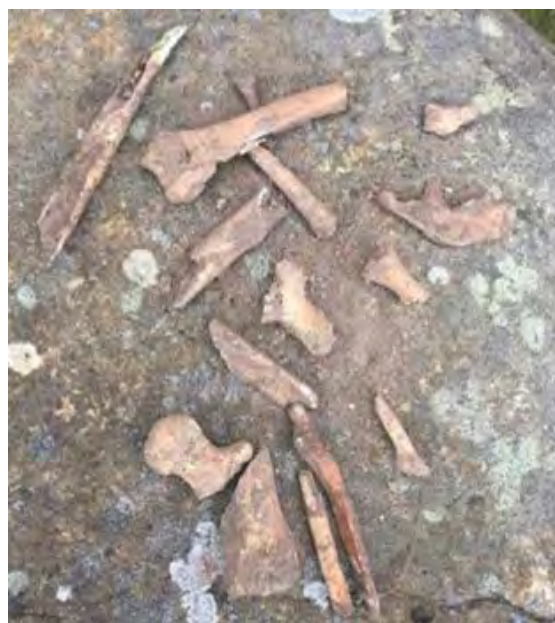
During the surveying work, trial pits to the north and south of the nave were made to check the levels of the foundations (Figure 8). These excavations produced several bone fragments (Figure 9). After taking advice from the minister, the bones were returned to the ground once survey works were complete. A further hole was dug at the southeast corner of the nave where the downpipe enters the ground at the junction with the chancel. The excavations confirmed that ground levels had risen considerably. In addition to drainage deficiencies, the wet earth in contact with the wall was causing damp to penetrate the building at low level.

Figure 9. Bone fragments uncovered during the investigation work.

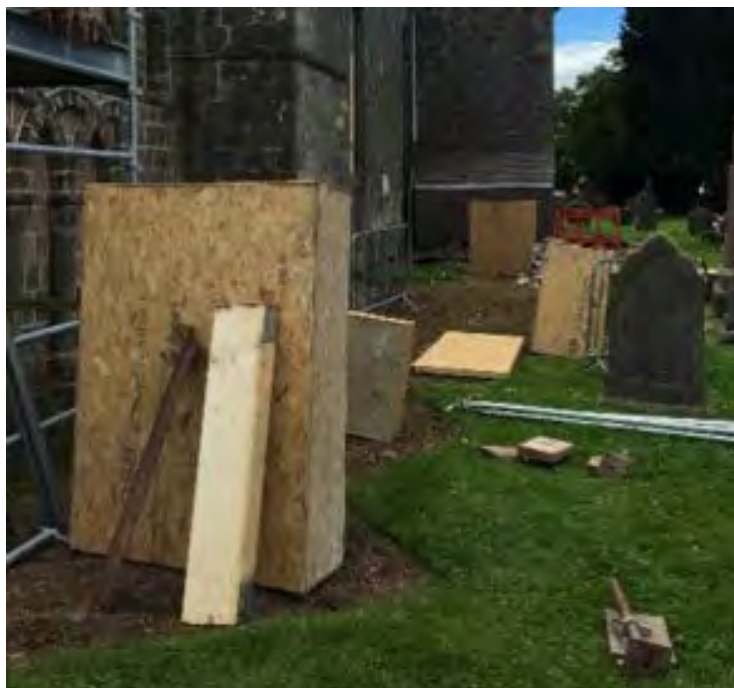
Figure 13. Timber enclosures in place to protect memorials from damage.

After a standard tender process, Laing Traditional Masonry was appointed as principal contractor. The church was closed for the duration of the refurbishment project as the building was surrounded by scaffolding and access was hazardous. The congregation used other churches and venues within the presbytery for worship. Using the wayleave granted by Fife Council, the contractor was able to occupy and use specified areas of the site. The site compound was set up in a parking area by the west entrance to the graveyard, clear of any planned works. Site facilities were provided by the client in a temporarily vacated building on site. Protection of grave markers and headstones was necessary, and this was done by securing timber enclosures over exposed memorials for the duration of the contract (Figure 13).

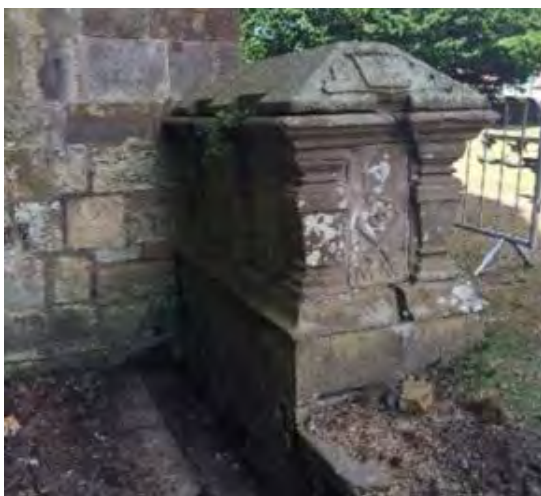
Several stone memorials had to be re-sited before works could start. One headstone that was close to the excavations and porch had to be moved to avoid the new embankment that was created as a result of the groundworks. The sarcophagus tomb on the north side of the church, placed close to the nave wall (Figure 14) also needed to be moved as it

was preventing the lowering of the ground levels. The tomb's inscription is dated 1726, but it was apparent from records and photographs that its location close to the nave was not its original one. Therefore, it was unlikely that there would be any human remains within or below it. Its position unusual, and the large profiled stone capping channelled water directly against the abutment with the church walls and prevented the continuation of the banking along the nave to the chancel. It was decided to re-locate the tomb away from the church, close to the edge of the graveyard. The construction of the sarcophagus tomb and its various component parts was recorded as it was being dismantled, before being re-erected using traditional masonry techniques in the new location (Figure 15).

Figure 14. The sarcophagus tomb in its original location.

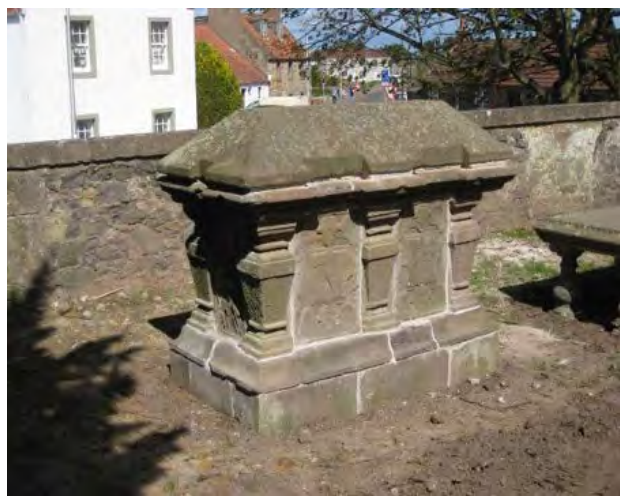
Figure 15. The sarcophagus tomb in its new location.

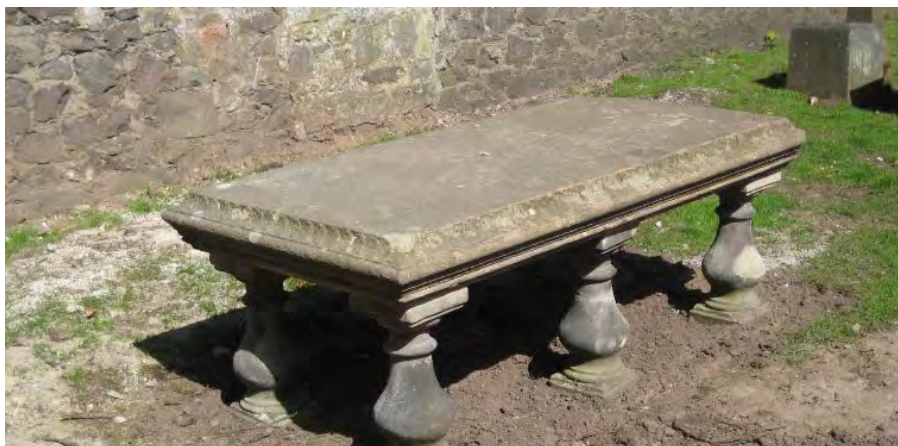
Figure 16. One of the table tombs in its new position.

Two table tombs to the north of the nave were also moved to accommodate new drainage routes and allow undulations and dips in the surface of the graveyard to be filled with dispersed soil. The tombs were recorded to allow like-for-like reconstruction and relocated to the north edge of the graveyard (Figure 16).

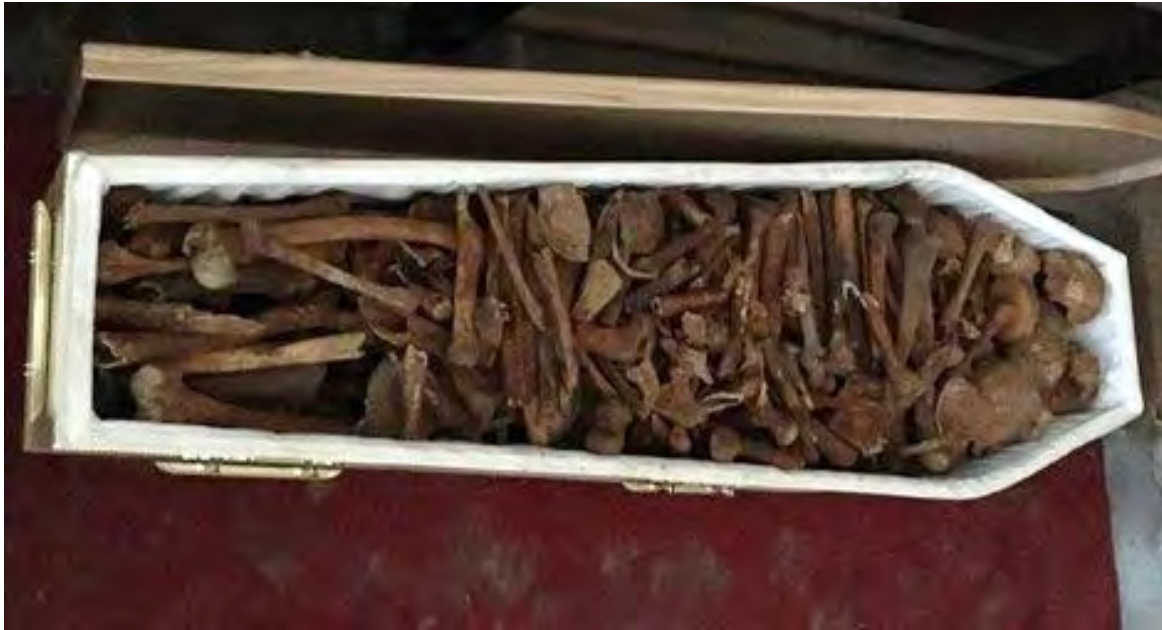
As expected, the excavations revealed extensive human remains. The remains were carefully collected by the contractor, as per the method statement, and then washed and dried in the church. The church's project team, including the minister, decided that the remains should be placed into a wooden coffin provided by a local undertaker (Figure 18). This coffin was stored in the apse before being removed to the undertaker's facility for custody once excavations were complete.

Figure 18. Bones recovered during the excavations were washed and placed in a coffin in the apse pending re-burial.

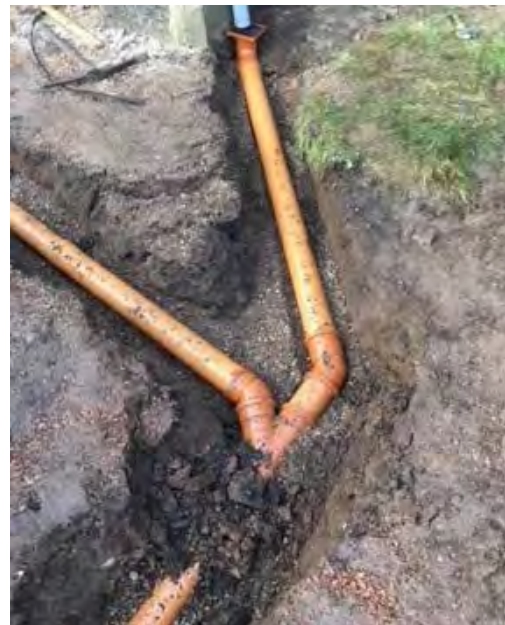
Figure 22. The new drain route from the southwest corner of the nave.

Drainage specification: The new drainage around the church comprises 100mm diameter PVCu pipes laid to fall in a granular pea bed. They have rodding eyes at ground level at every change of direction to facilitate future access and cleaning (Figure 21). The new drainage was photographed throughout the installation (Figure 22) and the locations recorded on a site plan.

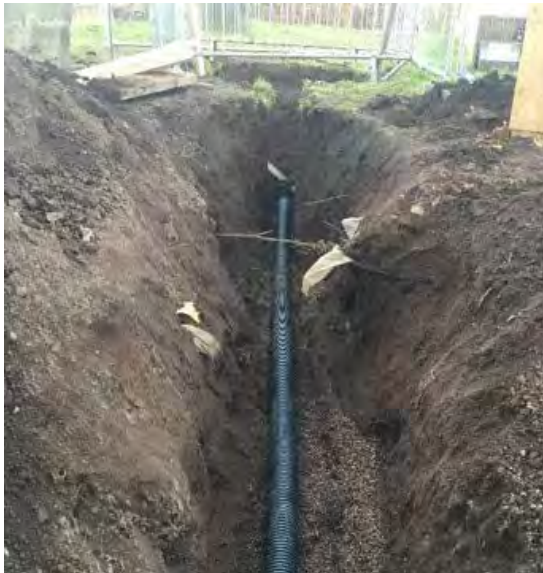
These deep tracks in the graveyard were costly and work progressed slowly due to the risk of damaging buried services (Figure 23). In some places the depth being dug was deeper than 1.4m so the trenches had to be shuttered. Signage and protection was set up for public safety. Human remains were encountered during this stage of the works, typically at a depth of 2m. These were handled following the protocols outlined in Section 5.4 above. The surplus earth following backfilling was checked for human remains then dispersed around the churchyard in accordance with the protocols agreed for the work around the nave.

Figure 23. The new drain track from the apse to the soakaway.

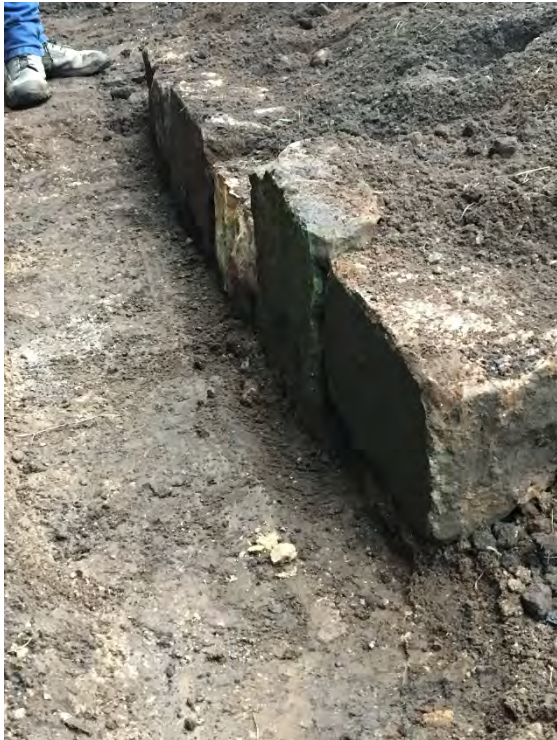
Figure 25. Reused stone edging by the nave.

stone from local sources, and bedded on the scraped formation without foundation (Figure 25). The joints and larger voids were filled with packed earth and small stones, and a curved line was formed around the apse (Figure 26). The gradient of the slope down to the edging was made as shallow as space would permit (approximately 35°) to allow Fife Council to cut the grass.

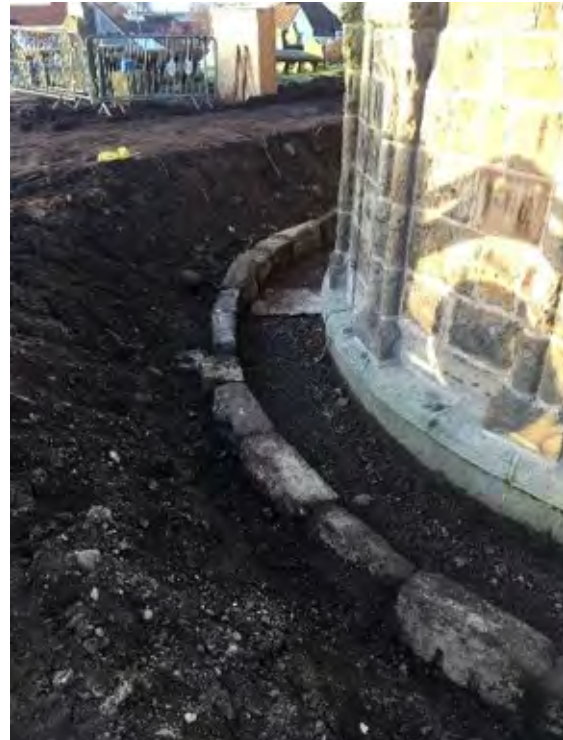
Figure 26. Stone edging around the apse.

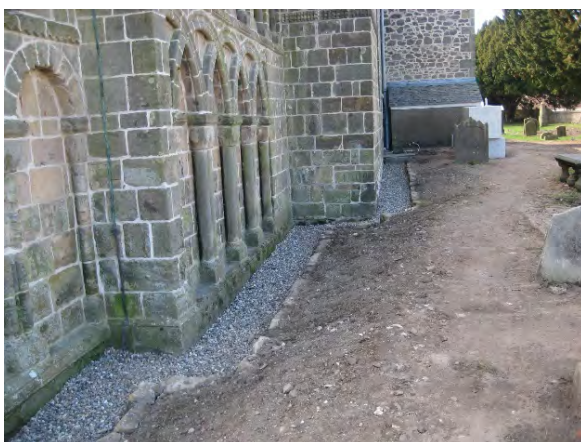
Figure 27. The finished gravel and edging on the north side of the church.

A 150mm layer of gravel at 20mm diameter was laid on perforated mesh between the church walls and the stone kerb to prevent plant growth. This created a continuous detail that was consistent in appearance along the length of the nave and the apse (Figures 27 and 28).

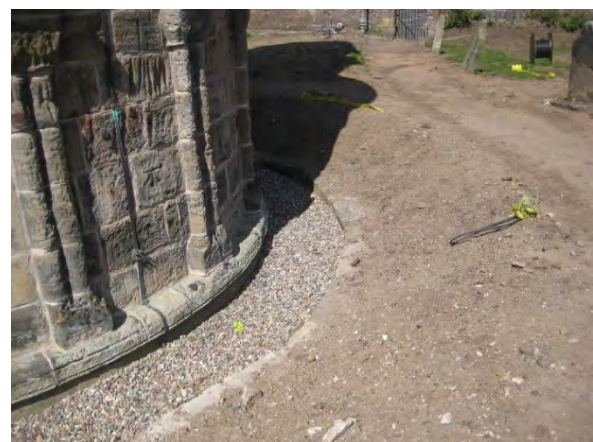
Figure 28. The finished gravel and edging around the apse.
