# ANGUS FLAGSTONE ROOFING – VOLUME I: LITERATURE REVIEW AND CASE STUDIES

HISTORIC  
ENVIRONMENT  
SCOTLAND

Principal Author: Sara Carruthers MCIOB, BSc (Hons), MA (Conservation, IoAAS), Certified Building Conservation Specialist (CIOB)

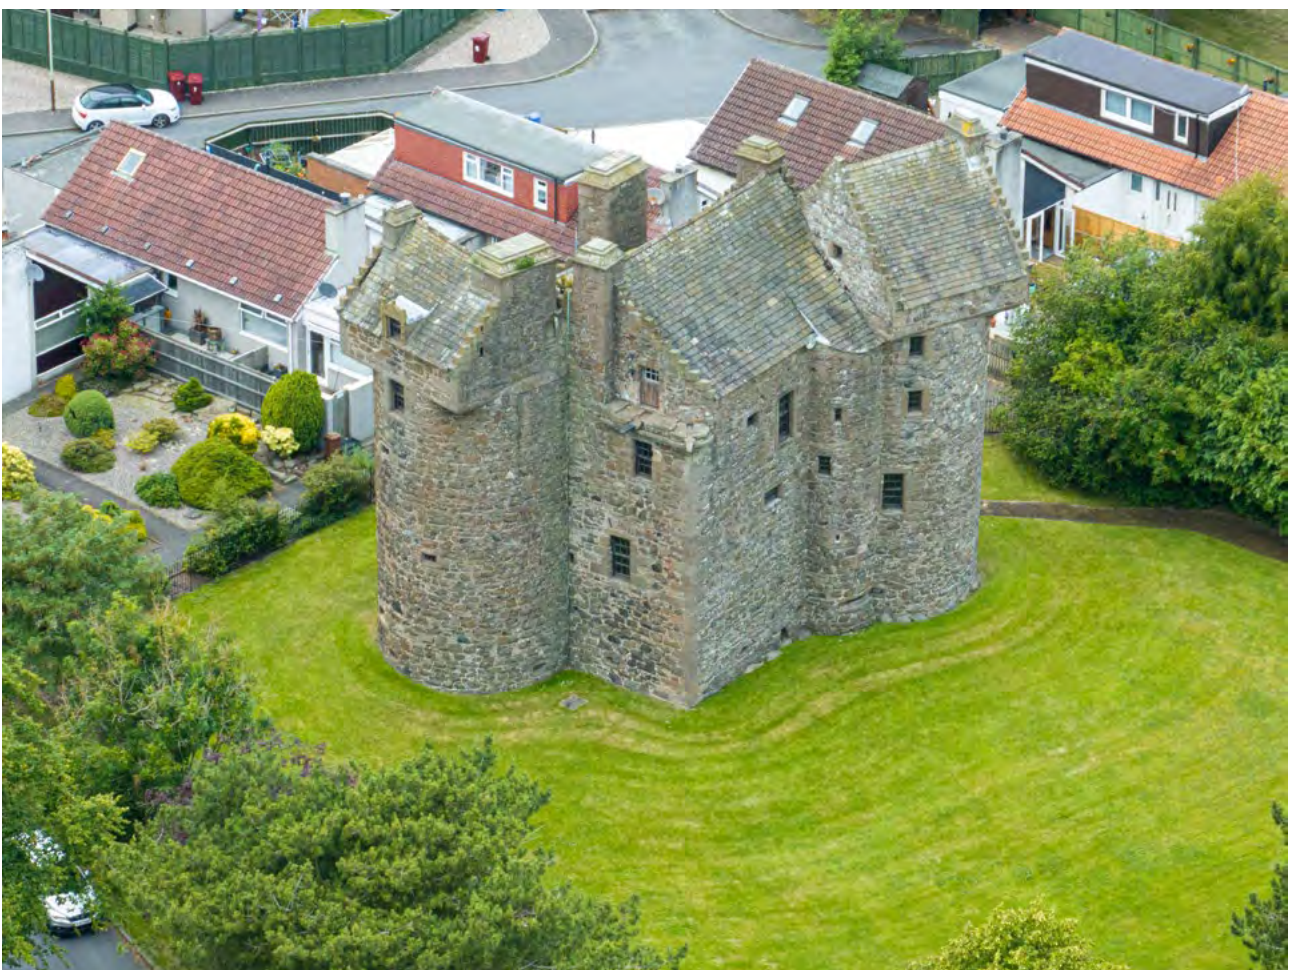
A few doocots, tolbooths and mausolea, dating from before 1700, have flagstone roofs which may retain original fabric. Claypotts Castle in Dundee also has an early flagstone roof, although it is unclear when the roof was last relaid.

Figure 10: Claypotts Castle, Dundee.

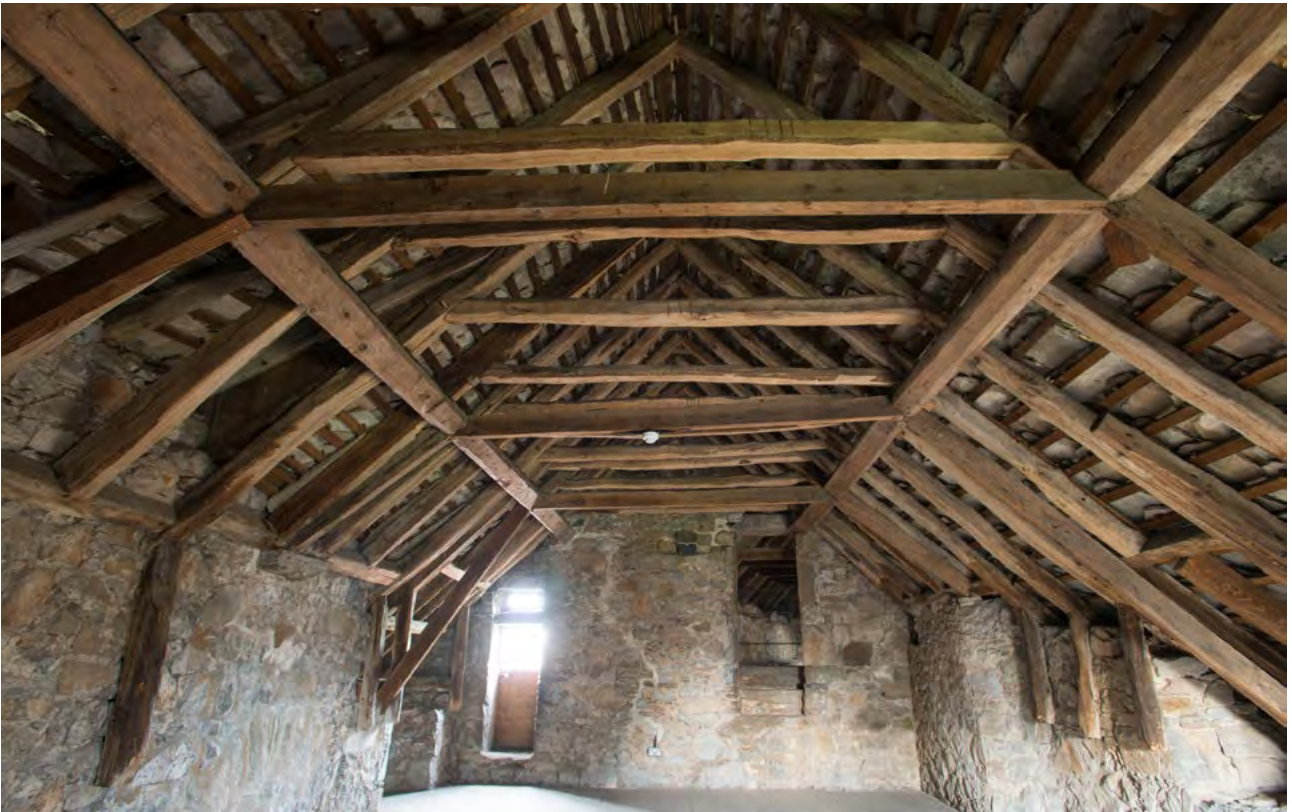
Claypotts Castle in Dundee, known for its very early roof structure, and the Abbott's House at Arbroath Abbey are both still pegged, as are many of the ruinous buildings observed where the substructure is exposed.

Figure 14: The interior roof structure of Claypotts Castle, Dundee.

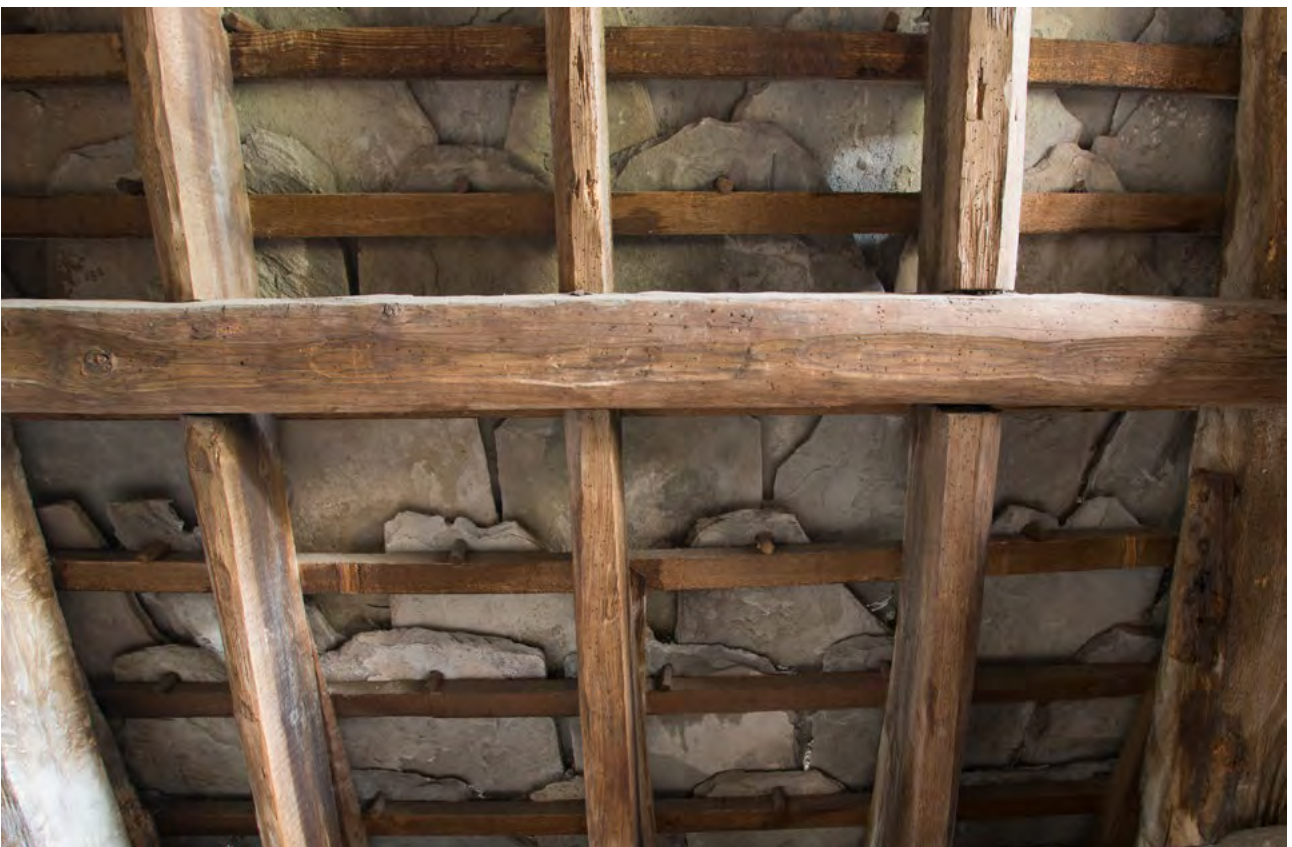
Figure 15: Batten and peg method of laying flagstone, Claypotts Castle, Dundee.

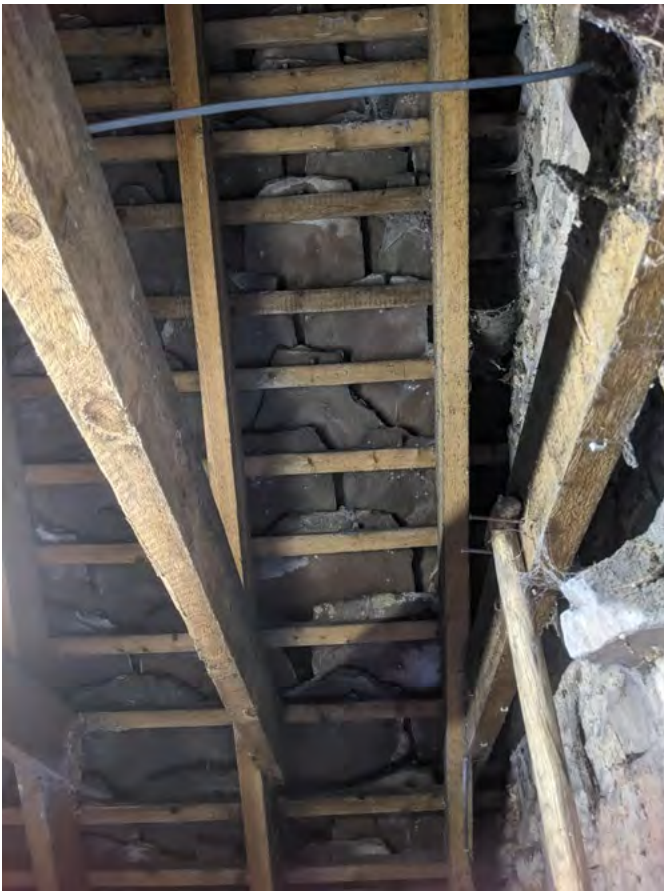
Figure 16: Batten and peg method of laying flagstone on an outbuilding at Templeton Farm, Angus. © Sara Carruthers.

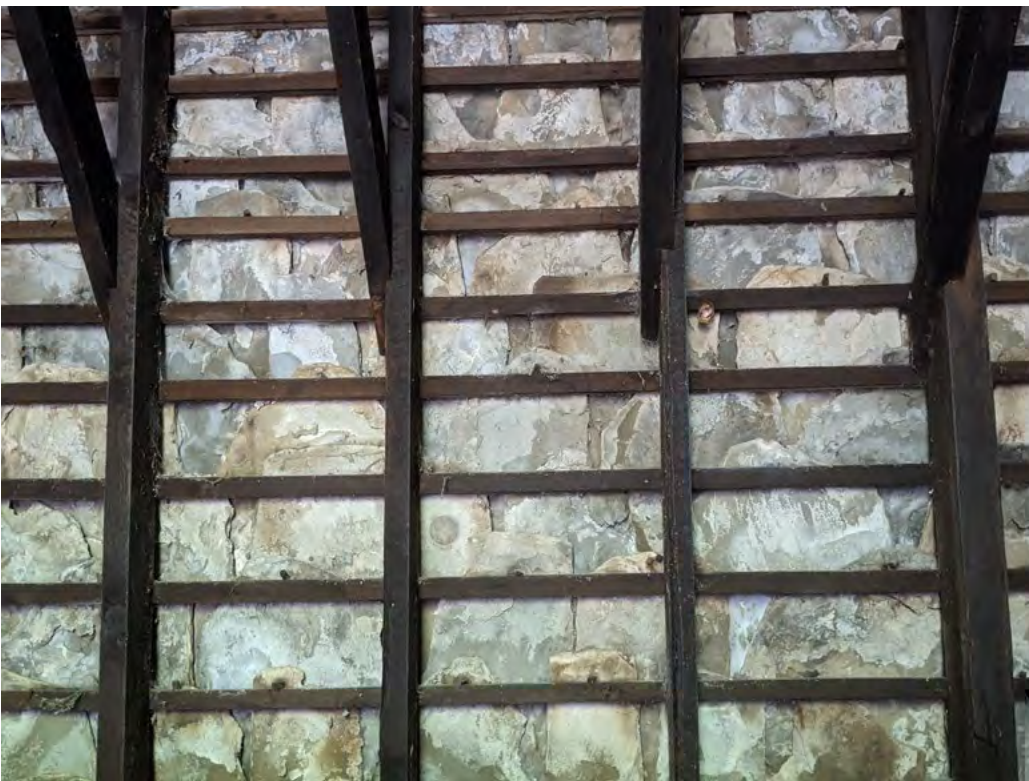
Figure 18: Interior showing the batten and peg method of laying flagstone at Tealing Doocot, Angus. © Sara Carruthers.

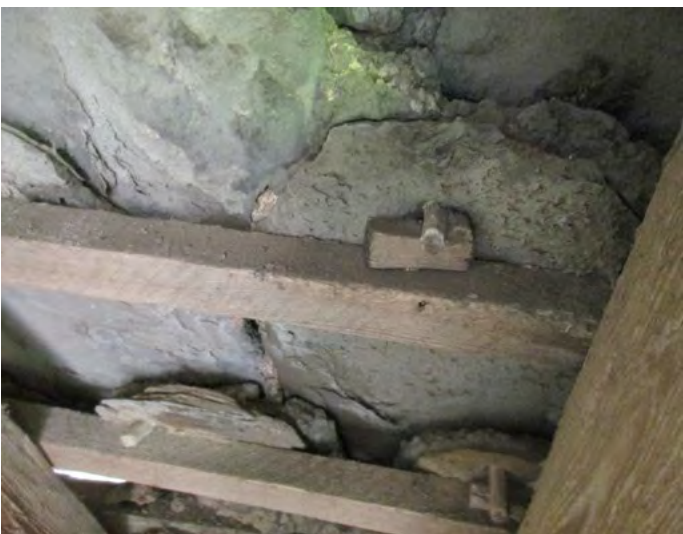
Figure 21: Historic pegs, packers and lime mortar bedding at Pittenweem Tolbooth, Fife. © Arc Architects.

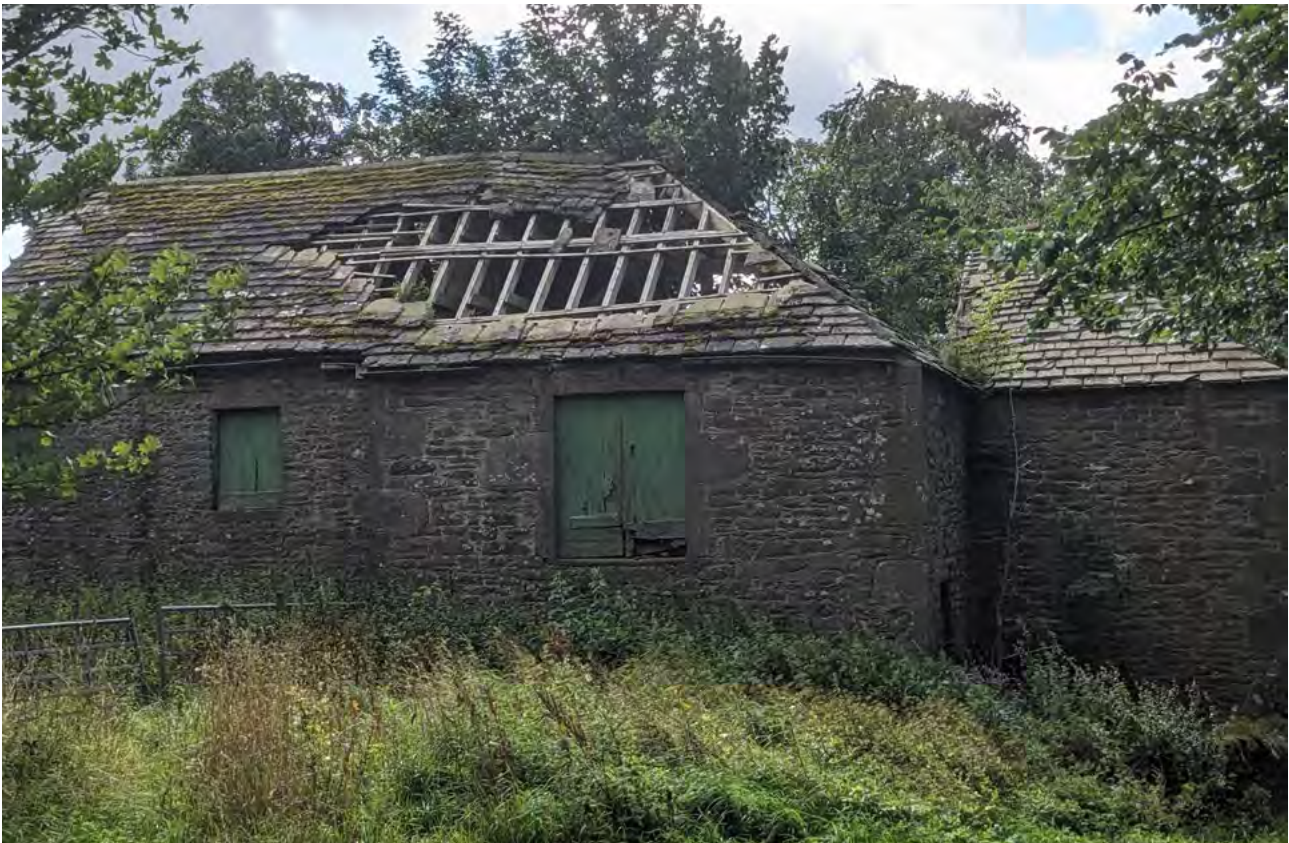
Figure 23: South Balluderon Mill and Steading, Tealing, with the formation of battens and slates visible. © Sara Carruthers.

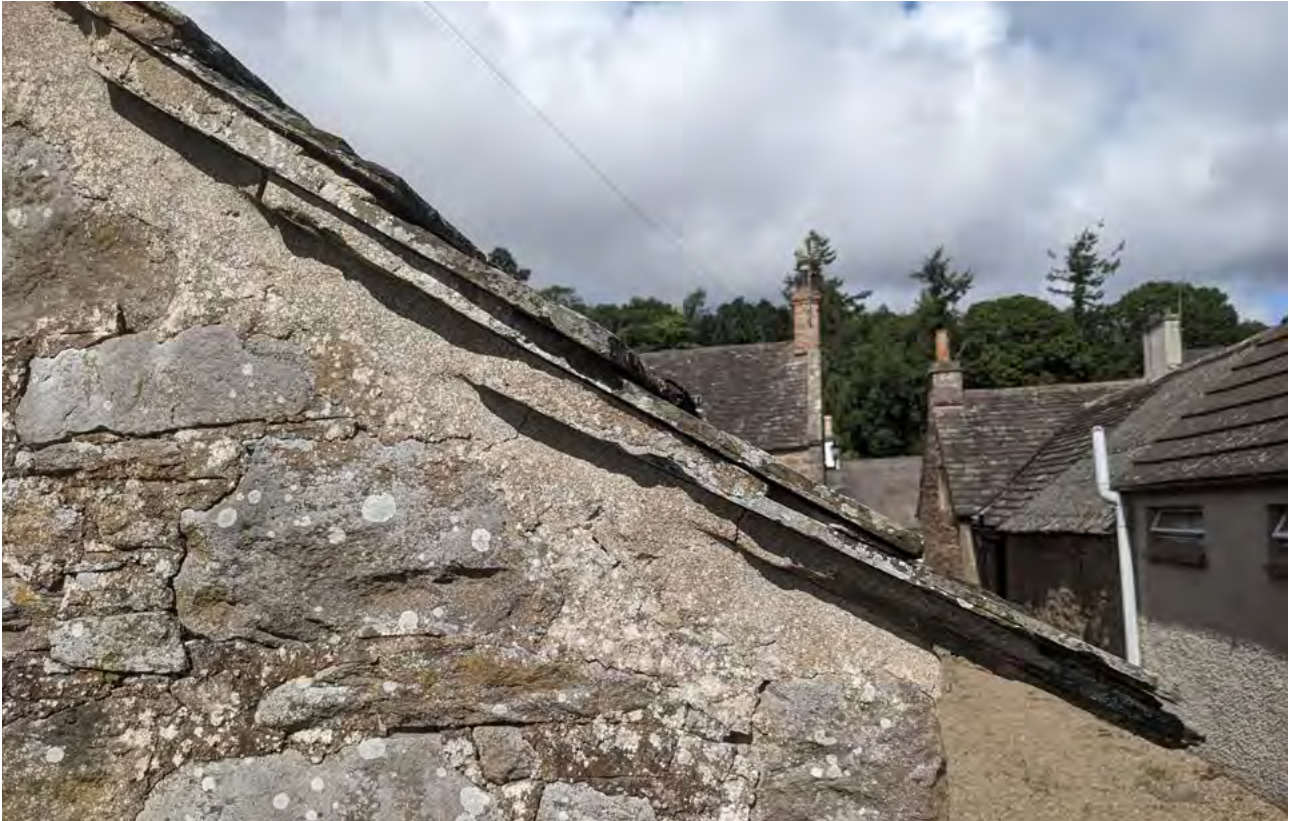
Figure 30: Detail of lapping and verge in Back Dykes, Glamis, Angus. © Sara Carruthers.

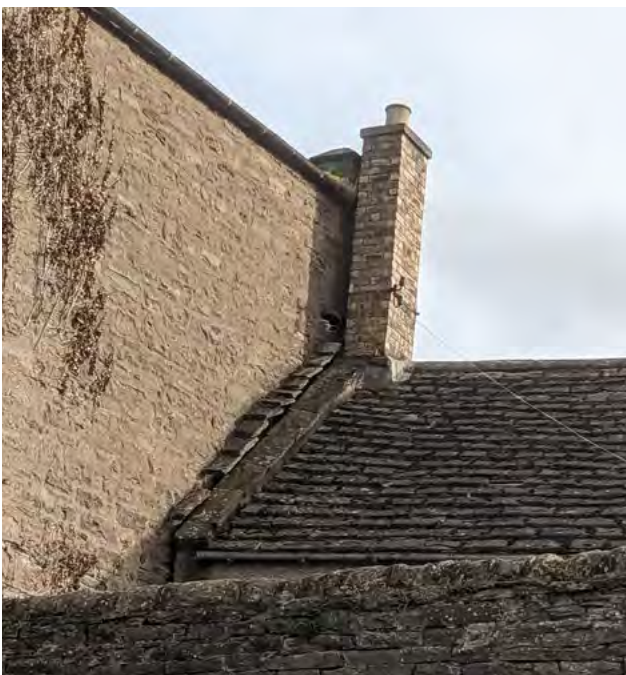
Figure 31: Stone flashings in St James Road, Forfar. © Sara Carruthers.

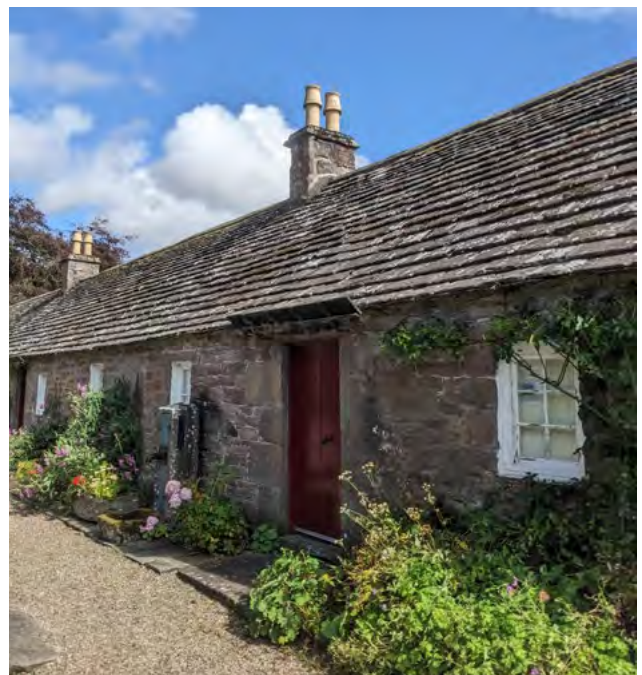
Rainwater disposal is via cast iron rhones and downpipes or by roofs being designed to drip at the eaves, occasionally with an overstop above doorways, as shown in Figure 32.

Figure 32: Eaves with an overstop in Kirkwynd, Glamis. © Sara Carruthers.

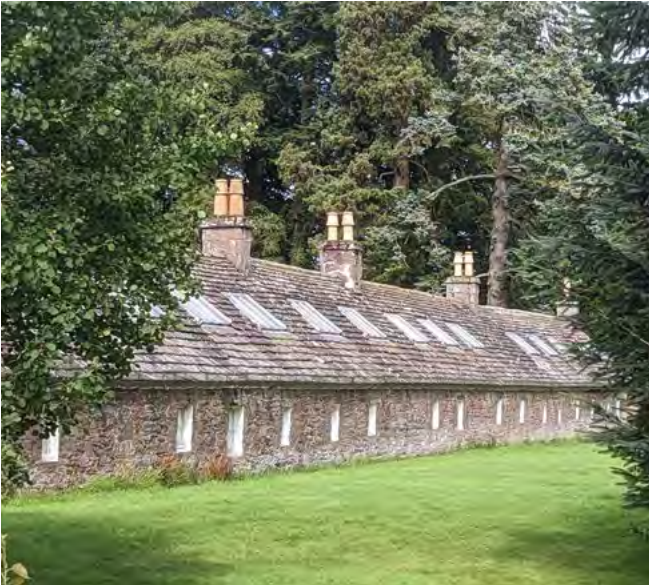
Figure 33: Rooflights in Kirkwynd , Glamis.  
© Sara Carruthers.

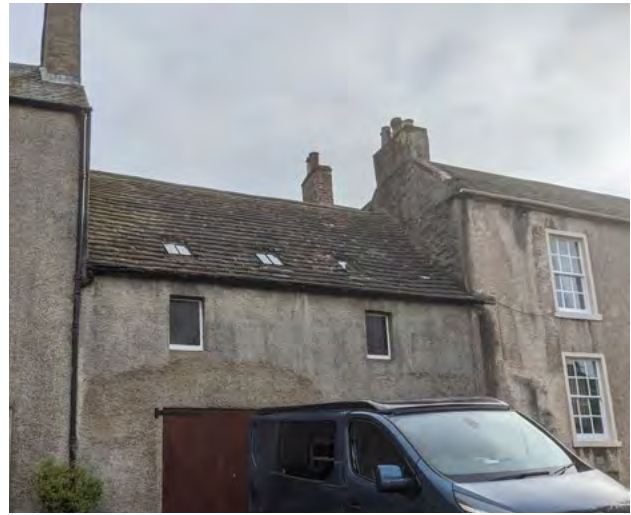
Figure 34: Rooflights in Little Causeway, Forfar. © Sara Carruthers.

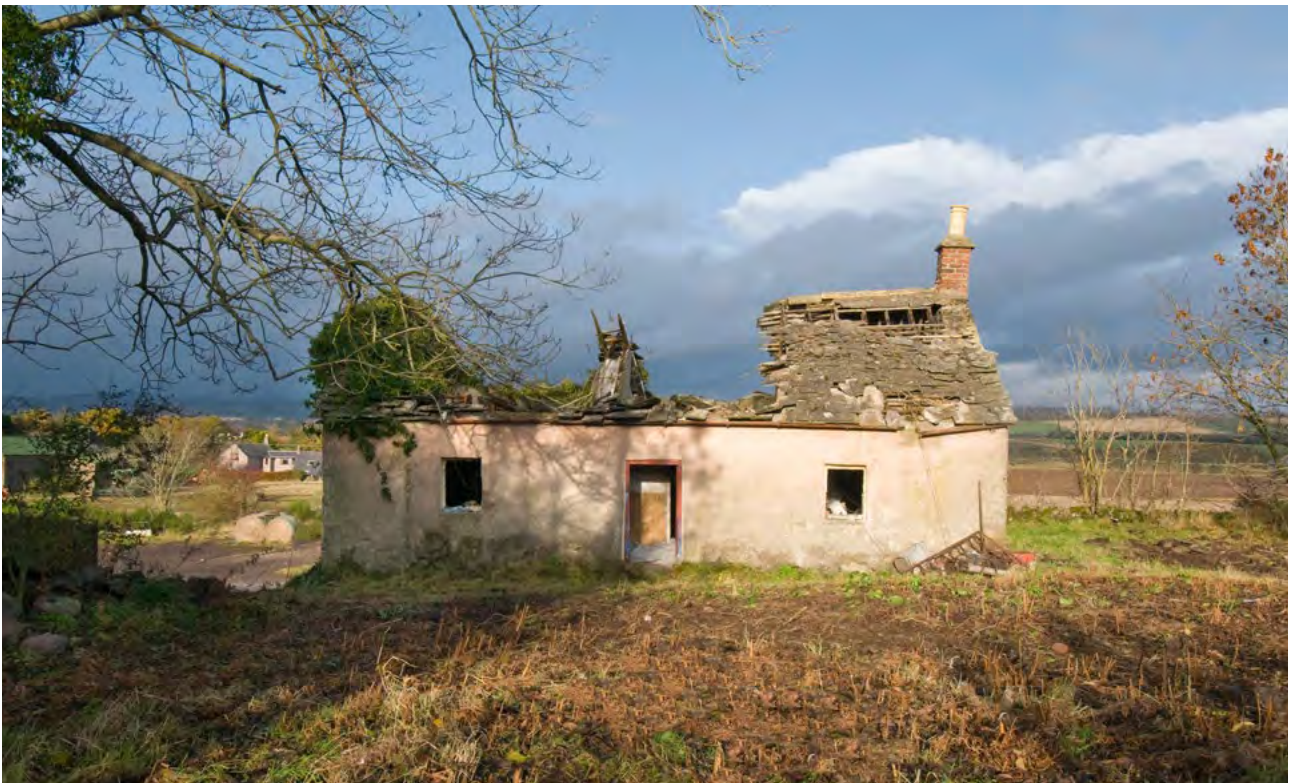
Figure 39: The Davidson Cottage before restoration. © Davidson Legacy.

Owner Mike Sinclair shared his experiences of restoring the cottage roof. The cottage mainly consisted of field stone and clay mortar walls (also known as boule and clay) with an Angus flagstone roof. It was unimproved and without services when the last occupant left in 2002. The ruinous roof likely dated from the 1840s, when the eaves height was raised to incorporate an upper floor. It consisted of pegged flagstone slates of random widths and reducing courses, hung on battens on A-frame couples of half-round cabers forming the rafters. The yellow earthenware ridge tiles were potentially a later replacement and contemporary with the early 20th-century brick chimneys. The roof was removed prior to restoration.

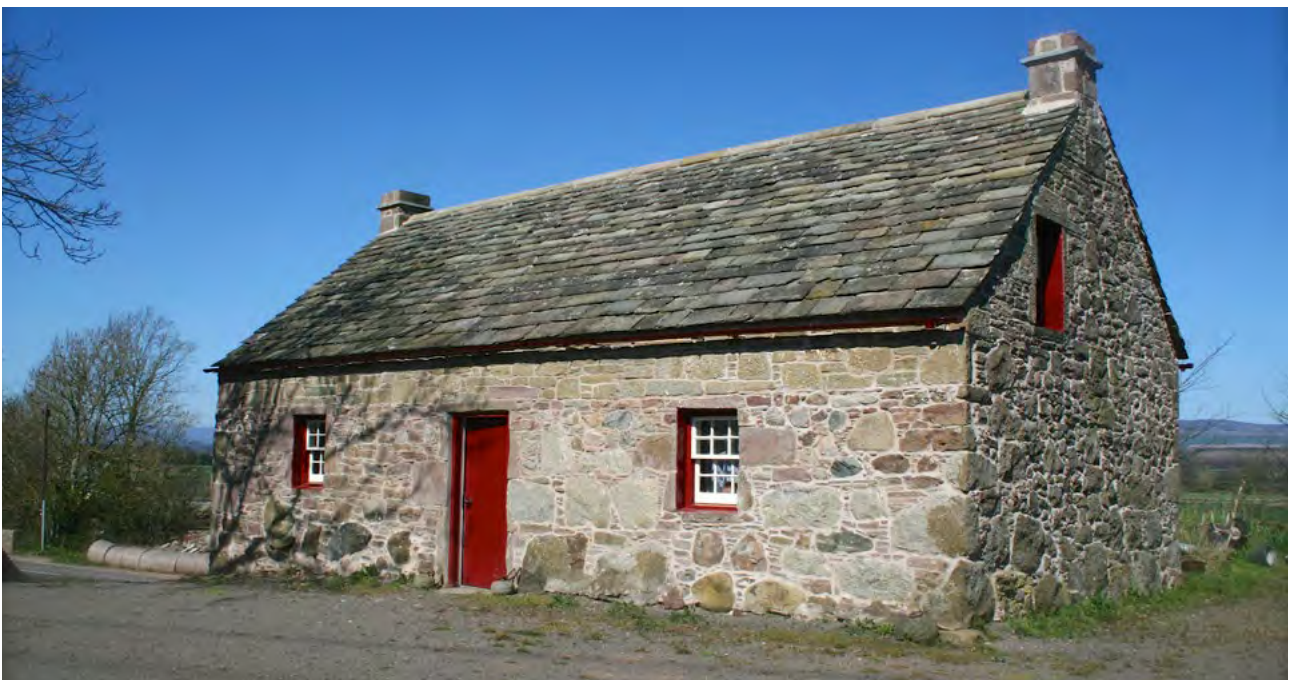
Figure 40: The Davidson Cottage in 2012 after restoration. © Davidson Legacy.

A roofer with previous experience of roofing with flagstone, gained while working with Ardle Construction Ltd under Ian Cumming, carried out the re-roofing work on The Davidson Cottage. The couples were replaced to a similar design but using C24 timber, sarked, covered in a breathable roofing fabric and the flagstone drilled and fixed onto the sarking with 3-inch clout nails. Second-hand Carmyllie flagstone ridges were sourced from Invercauld.

When new, flagstone slates were sorted into matching lengths and thicknesses to allow an even course to be hung on each batten. Owing to the limited source and range of sizes available of second-hand material, nailing onto sarking maximised the number that could be reused. Variations in length can be taken up at the head, so an even tail is left exposed. Each slate was bedded on a weak lime mortar to give stability, and the finished roof ‘settled’ satisfactorily over a few months.

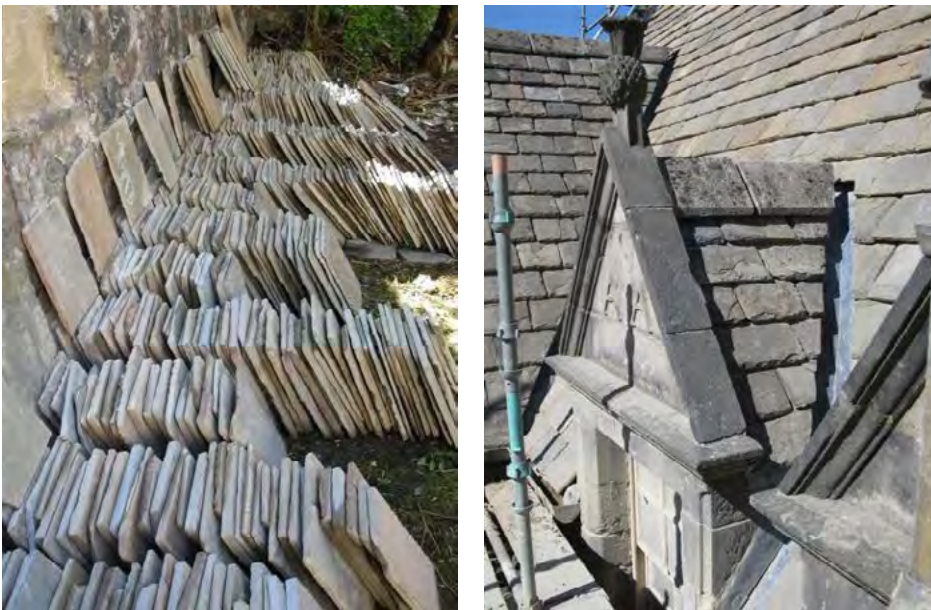
In 2009, Simpson & Brown Architects were engaged to coordinate roof repairs. The Angus flagstone roof covering had deteriorated to such an extent that the level of reuse possible was quite minimal. Simpson & Brown, along with the Scottish Stone Liaison Group, identified Pitairlie Quarry in Angus as a source of stone to make up the shortfall. They worked with Denfind Stone, the quarry owner, to produce suitable roofing material. The roof of Acheson House now comprises mostly new stone.

Figure 41a and b: Acheson House during re-roofing. © British Geological Survey.

The variable sized flagstone slates were laid in diminishing courses, double-lapped and head-nailed with copper nails. These were laid on breathable membrane and on tongued and grooved horizontal sarking. Larger slates were double-nailed and abutments had lime mortar fillets. In general, the publicly visible slopes were laid with flagstone and the other slopes with Westmorland slate. The existing mixture of stone and concrete ridge pieces were re-bedded with Code 4 lead soakers under the joints.<sup>62</sup> The main contractor for this work was Scotia Roofing.<sup>63</sup>

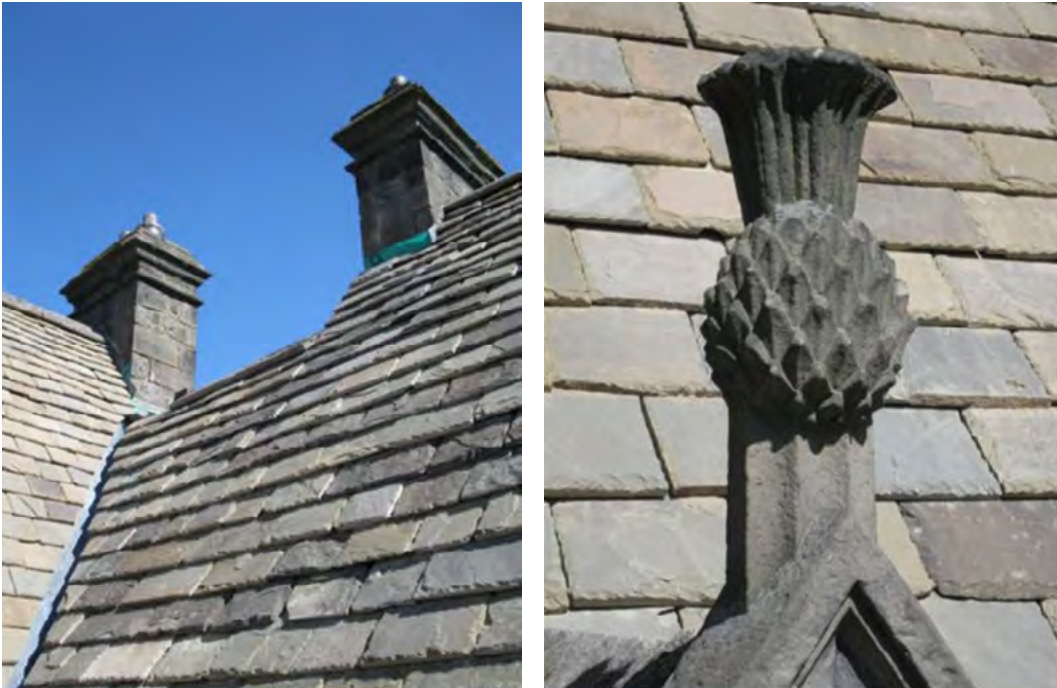
Figure 42a and b: Acheson House roof after new stone was laid. © Denfind Stone Ltd.

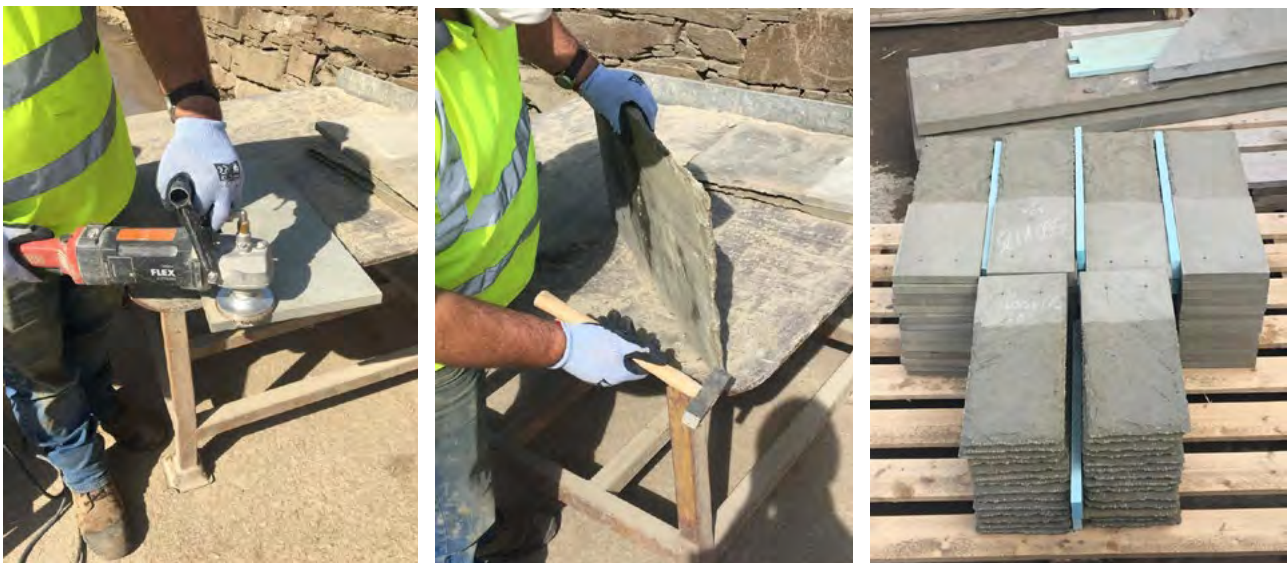
Figure 45a, b and c: Flagstone being hand finished at Pitairlie Quarry by Denfind Stone, and as delivered. © Douglas Binnie.

The flagstone is hand finished by flaming the top surface. This removes the top 2mm of stone and provides a more variable appearance and texture, imitating a riven effect. This process has now been mechanised. The cut edges are buffed with a grinder and axed with a slater's hammer to recreate the chamfers on a traditional flagstone slate. They are then pre-drilled with two 5mm diameter holes in each top corner, each 50mm in from the head and sides.

The quarry could provide 20mm-thick slabs, although they cannot provide them to the full size of the largest historic flagstone slates because of the stone available at the quarry. For St Athernase, a total of 1,250 flagstone slates were supplied in one length (600mm) and three widths (175mm, 250mm and 350mm).

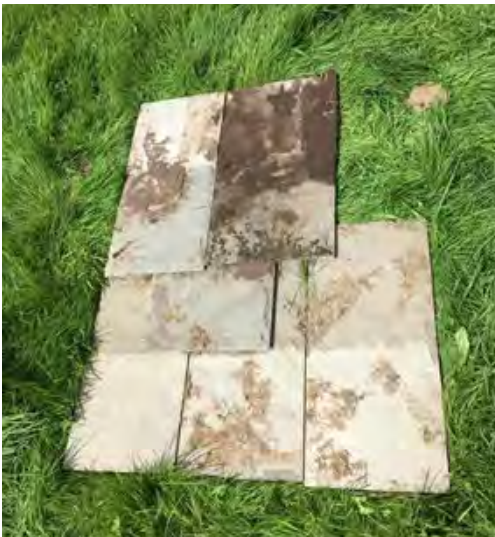
Figure 46: Samples of new Pitairlie flagstone slates.  
© Douglas Binnie.

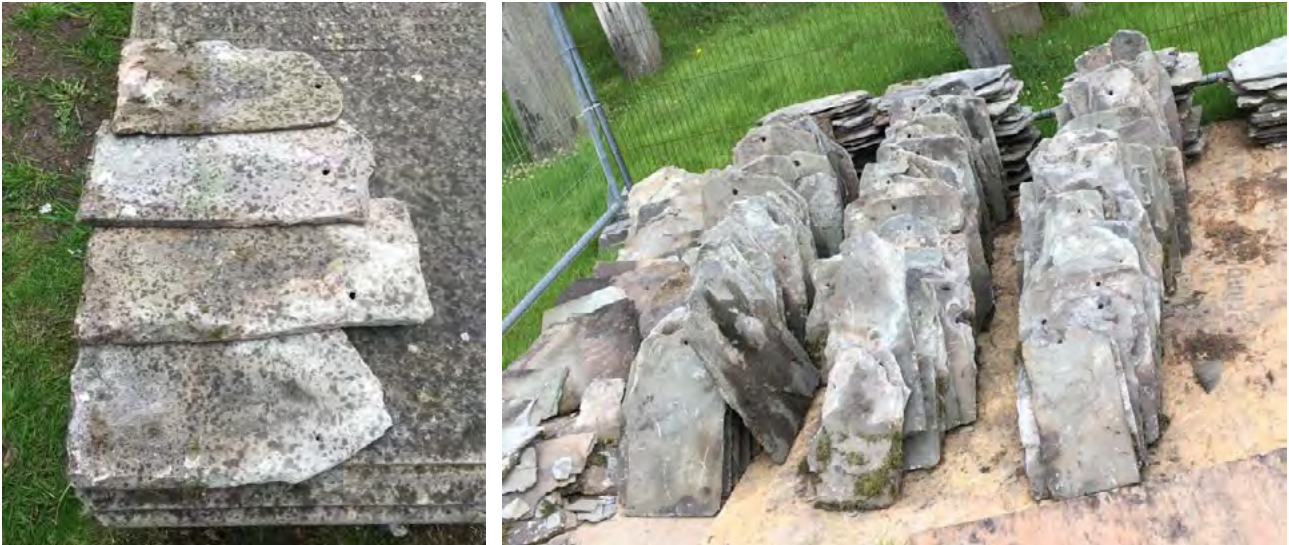
It was initially agreed that the new flagstone would be used to cover the rear face of the roof and the existing ones reused on the front face. Once stripped, only about 10% of the existing slates were reusable, and so the roof was entirely re-slatted with new. The original flagstone was reused on the small porch roof and on internal cill repairs, with the remainder kept on site as spares. As the roof was stripped, the existing flagstone slates were discovered to be highly variable and in very poor condition. It is likely that they were second-hand already. They were variously single- or double-nailed, shouldered or with a squarer head and laid on bituminous felt on sarking, fixed with slater's nails.

Figure 48a and b: Two images showing a selection of the pre-existing flagstone slates. © Douglas Binnie.

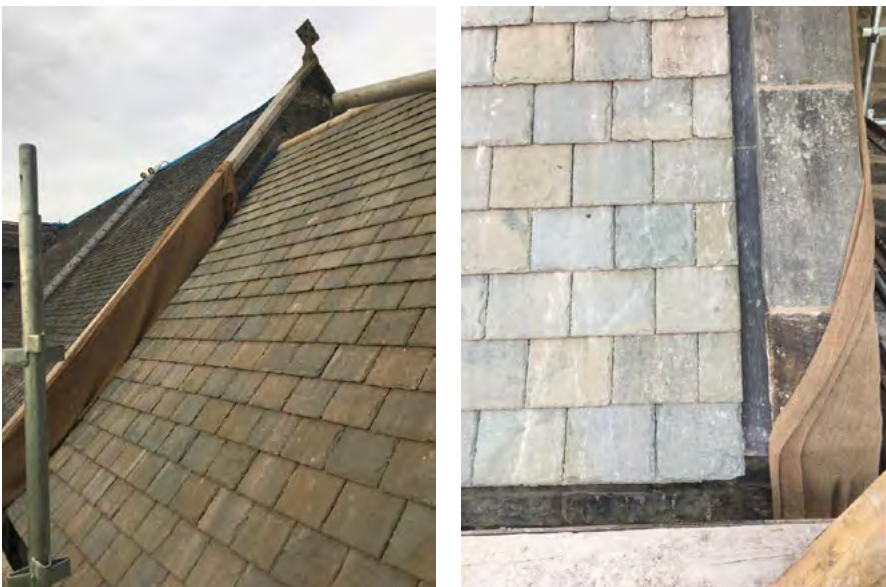
Figure 49a and b: The completed roof of St Athernase. © Douglas Binnie.

On site, the existing sarking was repaired, a breathable membrane laid and lead secret gutters created to replace the cement fillets. The flagstone was fixed with two stainless steel 40mm annular ring shank nails per slate. This was supplemented by an occasional bed of hydraulic lime mortar behind the nail holes, providing an additional fixing assurance while allowing them to bed flat. This contrasts with the traditional practice of lime beds on top of the slate head.

The ridge was replaced with new Cullalo stone from Aberdour in Fife. The flagstone was laid in diminishing courses and laid on each pitch in thirds to evenly load the roof. It was observed that joints in the roof structure opened up after stripping the roof and retightened once re-slatted. The project was completed in 2018.

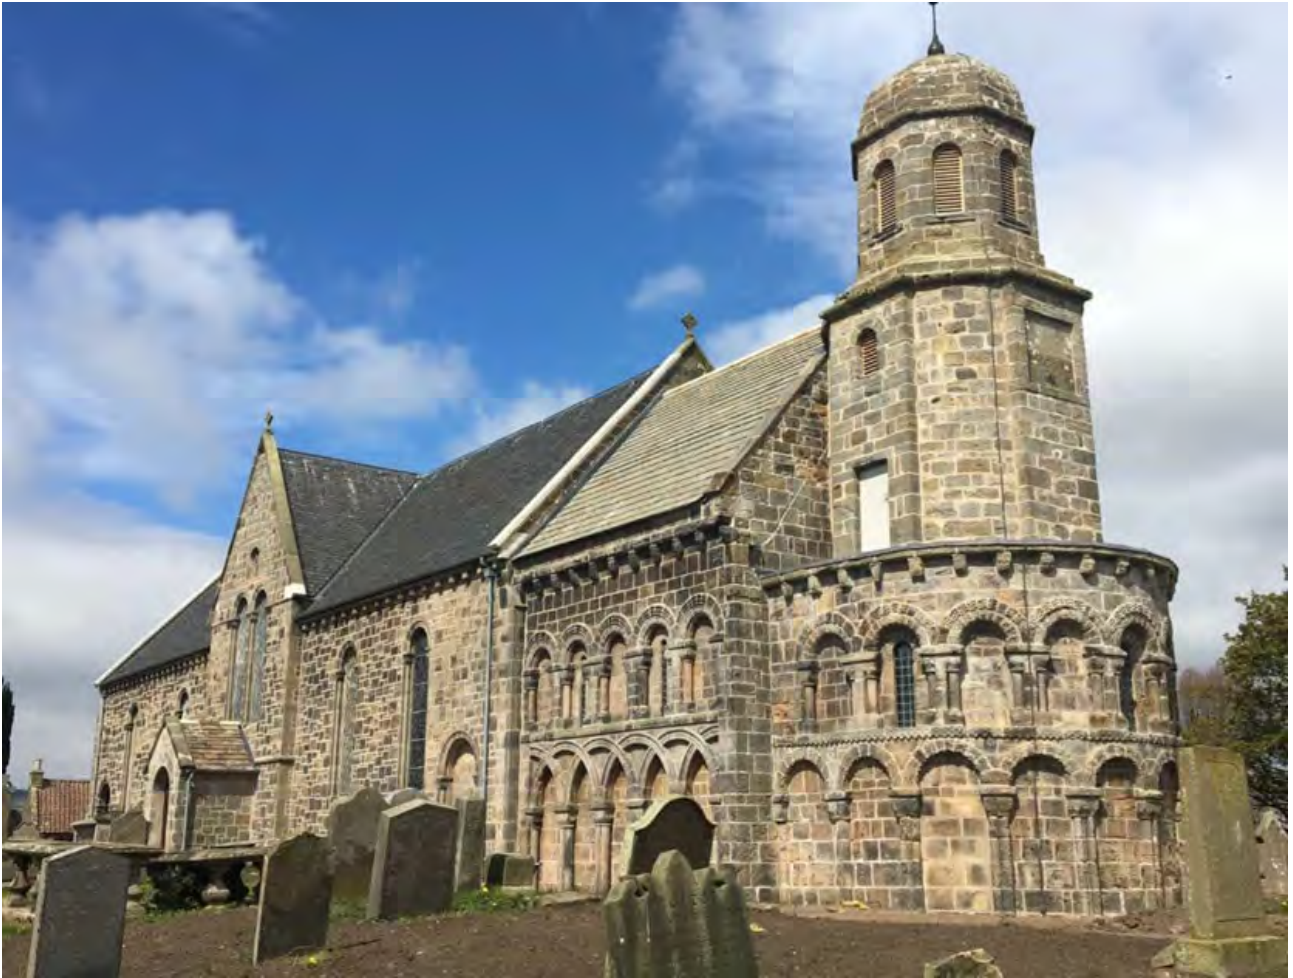
Figure 50: The completed repairs at St Athernase, showing the flagstone roof on the chancel. © Denfind Stone Ltd.

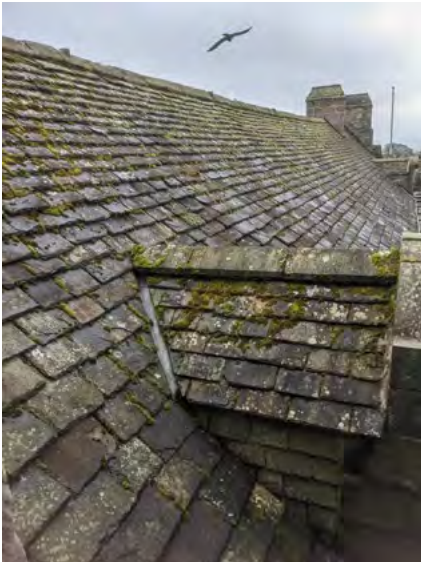
The South Range of Falkland Palace dates from the 16th century, but the form of the current roof dates from the 1890s – although it contains earlier fabric. The South Range has a flagstone roof, which records show was altered and re-covered in the 1890s. This restoration during the 1890s is considered the reference point for maintaining the fabric by the National Trust for Scotland (NTS). The NTS has carried out various roof repairs since it took over care of the Palace in 1952 and the extent of these is still under investigation. Maintaining the integrity of this roof is critical as the chapel, including a painted ceiling and panelling, is immediately below.

Establishing the extent and method of replacement required is a key issue for NTS. The south elevation is easily accessible from the parapet wall walk, but the north elevation would need scaffolding, and this would inform repair decisions.

Figure 53: The flagstone-roofed south elevation of the South Range, Falkland Palace. © Sara Carruthers.

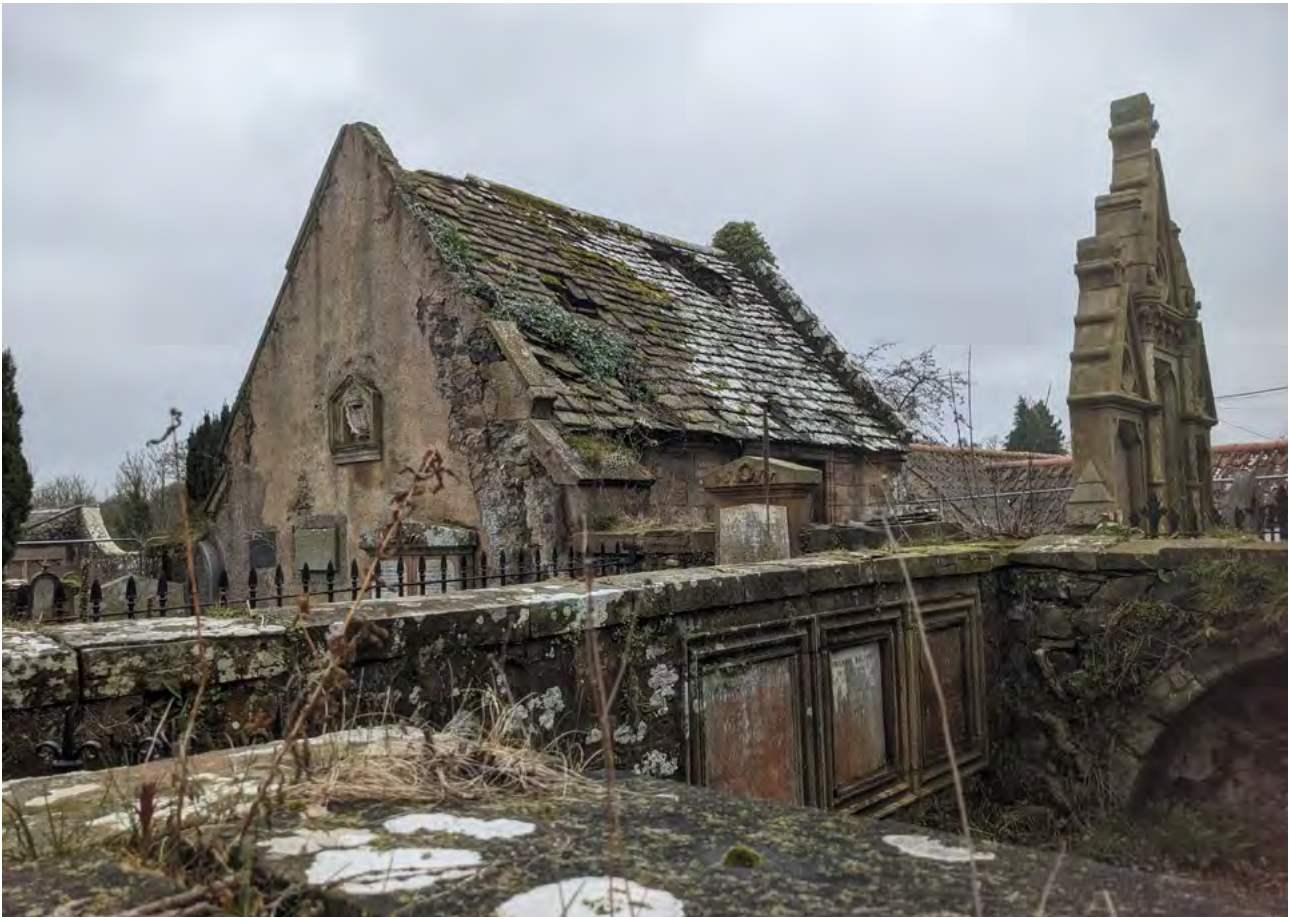
The morthouse is formed from the north aisle of the church. It was built after 1690 and repaired in 1831, and it houses various burial niches. It is in very poor condition and is at risk of collapse. Fife Council instigated a repair scheme to be carried out in 2024.<sup>65</sup>

Figure 56: Monimail Morthouse. © Sara Carruthers.

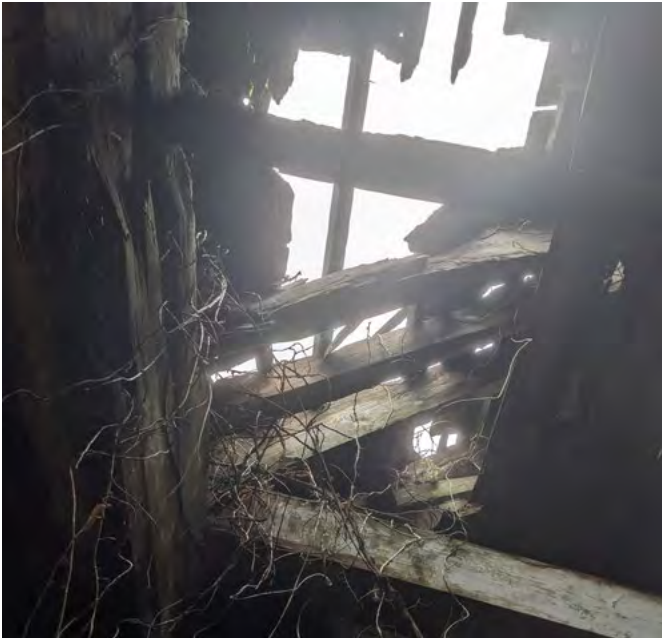
The roof on the morthouse is made up of flagstone slates, pegged, with some nailed or nailed through pegs. They are on split battens, on worked rafters, supporting a timber barrel vault. Roofs of this age are now rare survivors and, although patched, retain evidence of historic roofing practice. This building is a rare combination of being in the care of a public body with a commitment to conservation best practice and having a relatively untouched historic fabric. The potential for retaining historic elements of the roof is limited owing to its condition, but detailed recording while dismantling and retention of the maximum of historic fabric in the repaired structure would be very valuable.

Figure 57: The roof structure of Monimail Morthouse, showing worked rafters and battens. © Sara Carruthers.

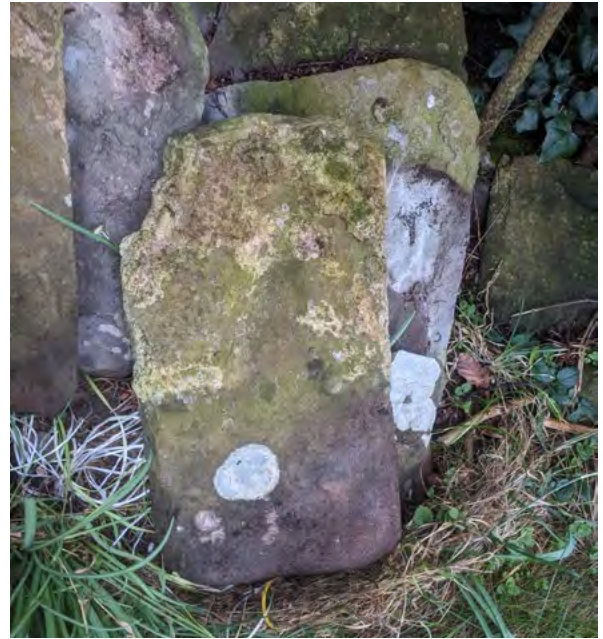
Figure 58: A flagstone slate from the roof, showing the remains of a peg in the single head hole and traces of mortar bedding. © Sara Carruthers.
