REFURBISHMENT CASE STUDY 34

SOUDEN KIRK SOUTHDEAN PARISH

INTERIM REPAIRS

INTERIM REPAIR WORKS AT SOUDEN KIRK

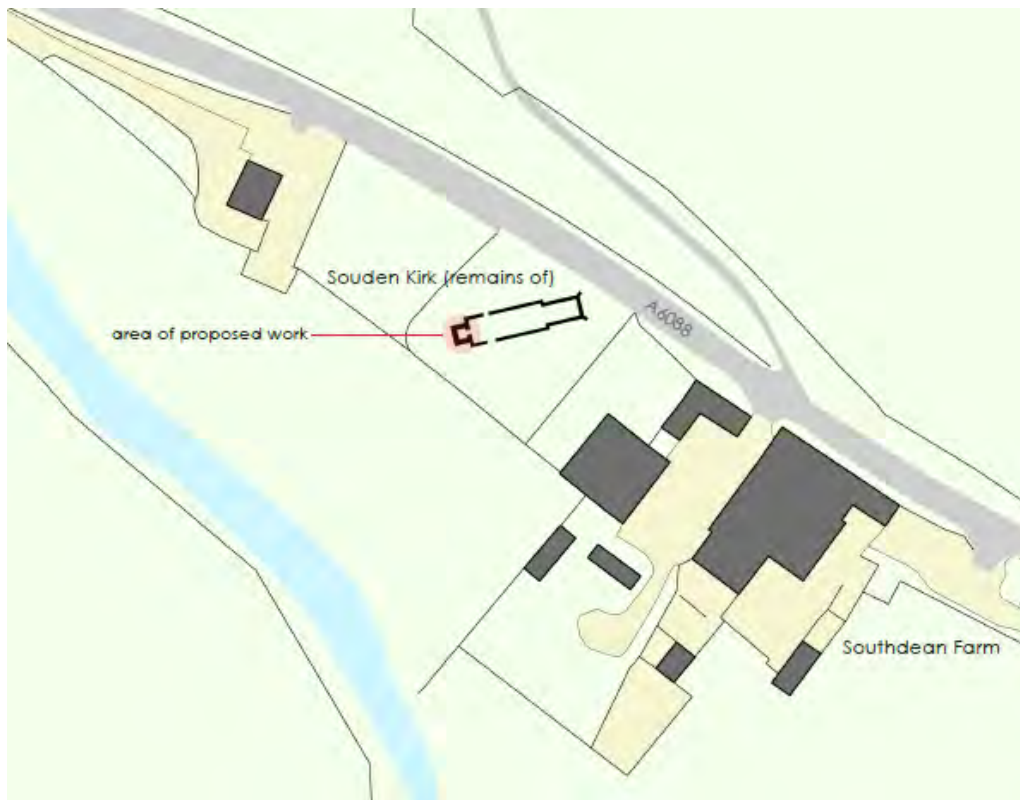
Figure 1. Site plan showing the church plan and area of proposed works

The works described in this document sought to address the key defects in a specific part of the building using simple materials and techniques (Figure 1). The works were done to a basic specification, but subsequent inspection has shown the soft capping and the felt work to have been largely effective in minimising water ingress into the monument. The works were delivered by volunteers with modest supervision and minimal cost, showing that the custody of a certain type of building or monument does not need to be expensive, and such interim repairs can ‘buy time’ while a more formal scheme is developed. As the custody of many buildings and sites is transferred from Local Authorities to community groups, this example may offer ideas to those responsible for properties that some works can be delivered locally by volunteers with suitable permissions and supervision.
