# THE STONE OF DESTINY

CONDITION ASSESSMENT, SCIENTIFIC ANALYSIS AND **DIGITAL DOCUMENTATION** 2023

HISTORIC SCOTLAND

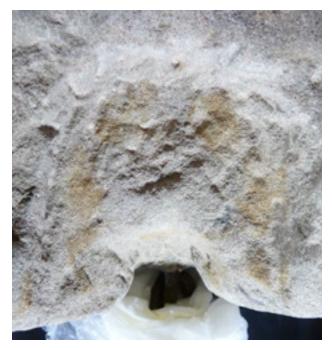
Fig 7. Dexter face socket (2016).

A watercolour wash applied to the repair in 1996 is still serving its function to disguise the previously applied cement mortar (1950). Traces of the mortar located in the dexter socket do not show any changes.

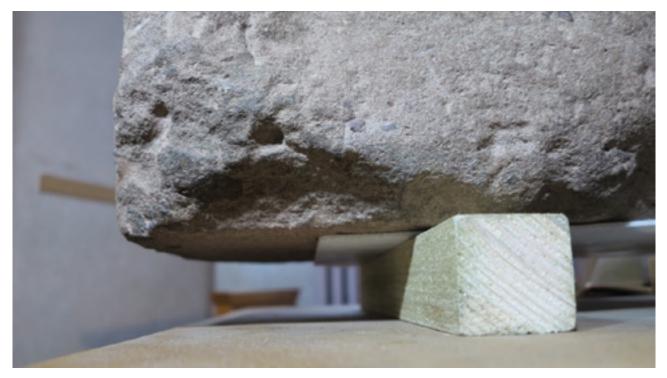
Fig 19. Lower left corner of the front face (2023).

A small, resinous, semi-transparent yellow-white residue was spotted on the lower left corner of the front face (Fig 19). It was also visible as a glowing spot under UV light (Fig 20). The nature and location of the residue may suggest a **deposit** of substances used for decorating or protecting the wooden Coronation Chair (eg varnish), which could have been grazed during previous de-installations of the Stone from the chair. Westminster conservators informed the team of the presence of 'orpiment', a hazardous substance previously used on the chair that required PPE and risk management procedures when handling. The potential for this substance leaving residue on the Stone should be considered not only for condition assessment and conservation purposes, but for health and safety reasons for any future interactions with the Stone.

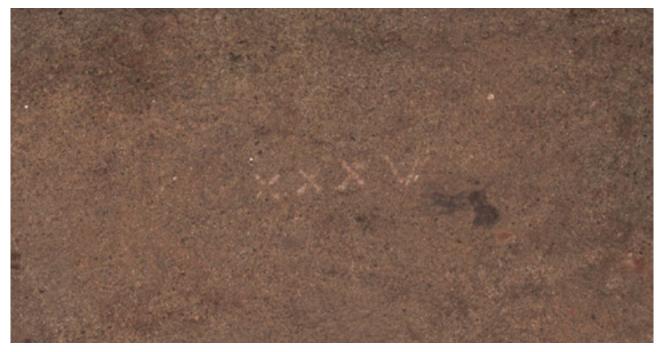
Fig 32b. Close-up of the incised numbers/letters (macro image).

Near the edge, between the bottom face and the back face, a previously undocumented earlier incised inscription has been noticed. The sharply incised inscription represents Roman numbers or letters: XXXV or XXXVX,<sup>10</sup> with the last X being slightly shallower (Figs 32a, b and c). The inscription appears to be relatively modern, possibly 20th century, and though there is no record of its purpose, it is conceivable that the marking may have been added to help identify the Stone or a part of it. The two occasions which seem most likely are: (1) during the Second World War when the Stone is thought to have been concealed for its safekeeping, or (2) in the 1970s when concerns were heightened following a second (failed) attempt to remove the Stone from Westminster Abbey. The visible number could possibly be part of an **accession system**.

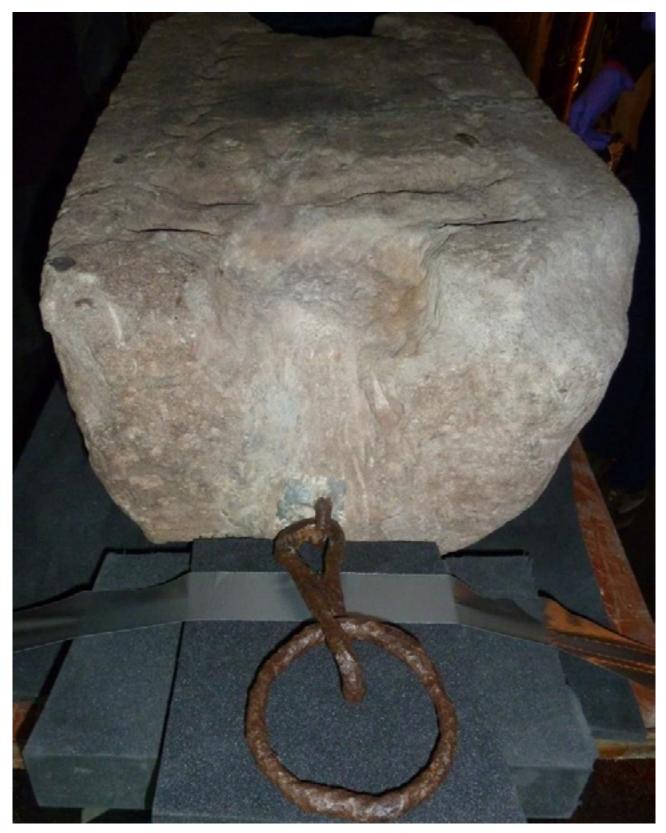
Fig 33. Sinisted end face of the Stone of Destiny with iron ring extended and supported (2016).

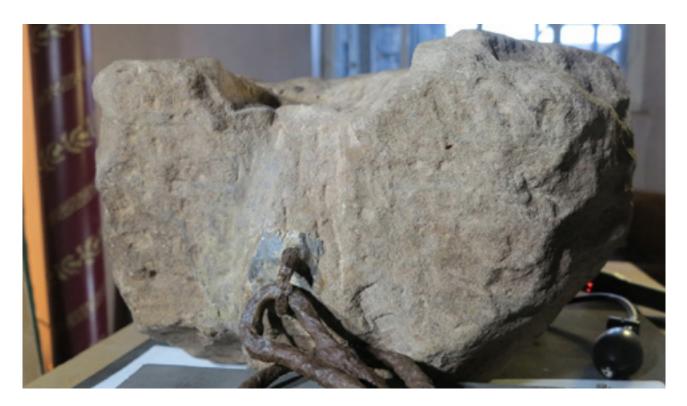
The condition of the surface of the sinister end face is stable (Figs 34 and 35). No significant signs of any active disintegration have been observed, and the reversible colour wash still serves its function to disguise inexpertly applied mortar over the repair joint.

Fig 34. General photo showing the ring and link lowered on the soft padding (2023).

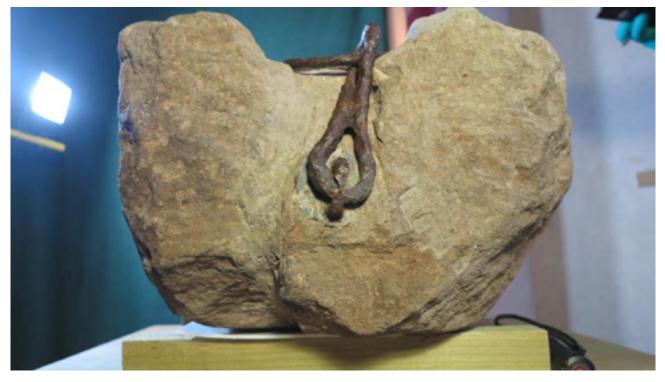
Fig 35. General photo showing the ring and link rested in the socket (2023).

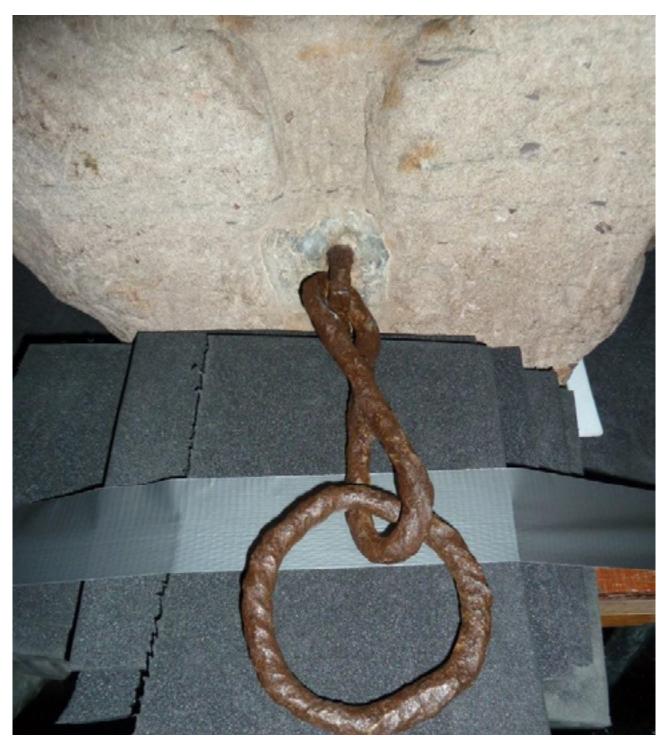
The condition of the surface of the dexter end of the Stone is stable (Fig 40). The iron staining, already identified in 2016, caused by the corrosion of iron elements located in the socket dedicated to them has neither intensified nor expanded (Figs 39 and 41). Similar observations were made of the iron staining inherent to the Stone and present on the right lower corner of the left end face (Figs 42 and 43).

Fig 39. General photo of the dexter end face (2016).

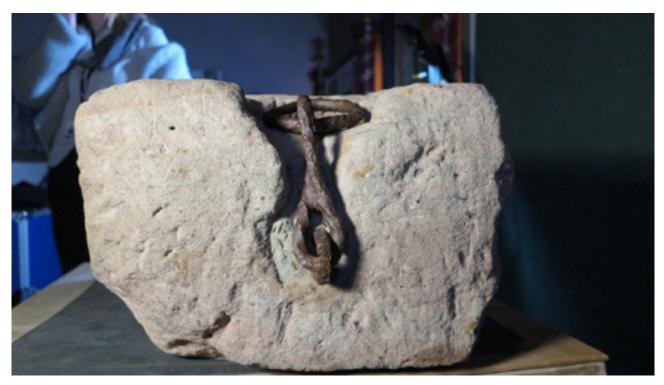
Fig 40. General photo of the dexter end face (2023).

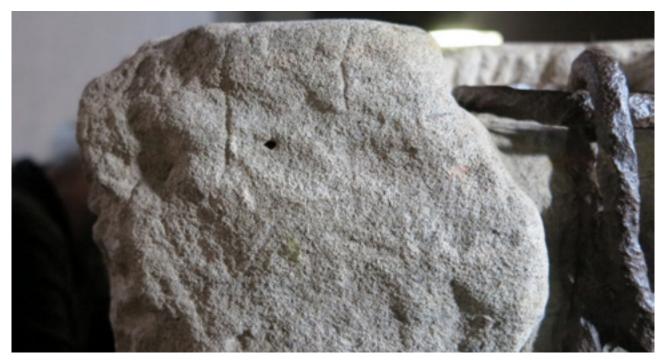
The resinous, semi-transparent yellow-brown substance is most probably organic, deposited onto the area under the two lines incised on the left top corner of the left end face. It was observed under UV light (Figs 44-46). The residue showed fluorescence of similar colour and intensity as the deposit on the left lower corner of the front face of the Stone (Fig 20).

Fig 45. The same area as Fig 44, photographed in 2023.

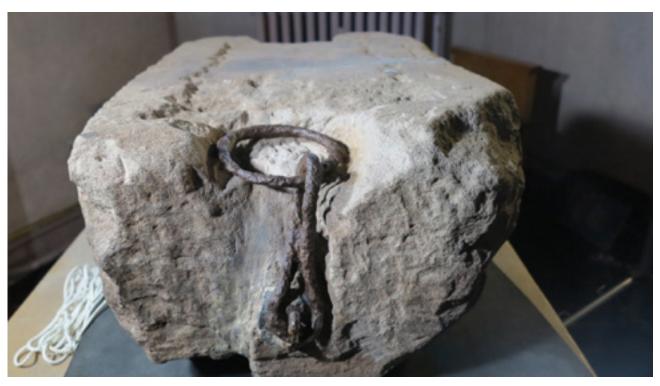
Fig 48. Ironwork and lead plug located on the sinister face (2023).

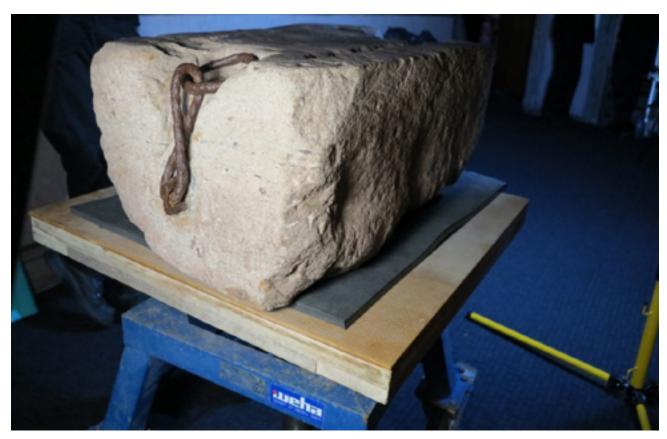
The condition assessment also revealed small areas of flaking iron corrosion and a previously undocumented crack in the staple on the dexter side of the Stone. Overall, the fragile nature of the iron staples makes them the most vulnerable to damage of all elements of the Stone. In case of any examination or movement of the Stone, these must be carefully protected (Figs 49 and 51).

Fig 50. Ironwork and lead plug located on the right (dexter) face (2023).

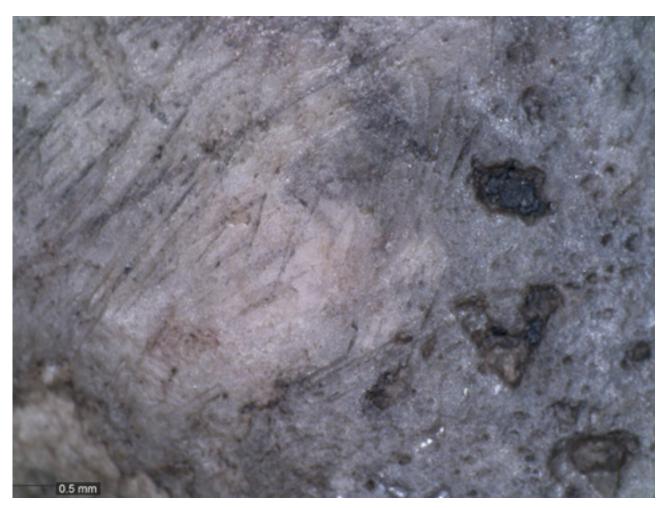
Detailed observations in Figure 2 of one large quartz pebble (location 1155 in Fig 1a) highlighted numerous narrow scratch marks, measuring between 0.02–0.006 mm in thickness. These scratch marks appear to be post-depositional and are unlikely to be geological in origin. They could relate to in-service abrasion of the Stone post-extraction from the quarry, or to abrasion from tools used to shape and hone the Stone.

Fig 2. Microscope image of scratch marks on a large pebble on the top surface of the Stone of Destiny.

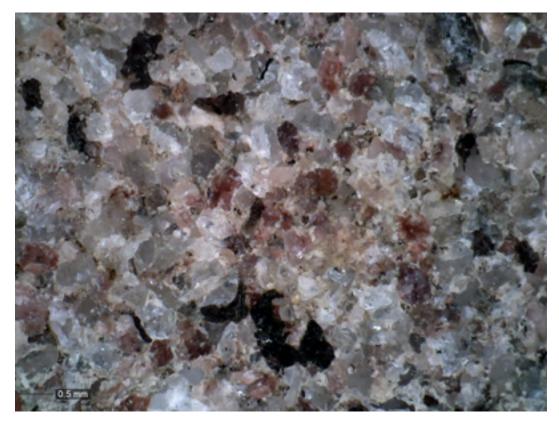
Fig 4b. Sample area 503. Smooth area of stone on the top surface. Note the relatively open mineral texture and absence of intergranular geological material.

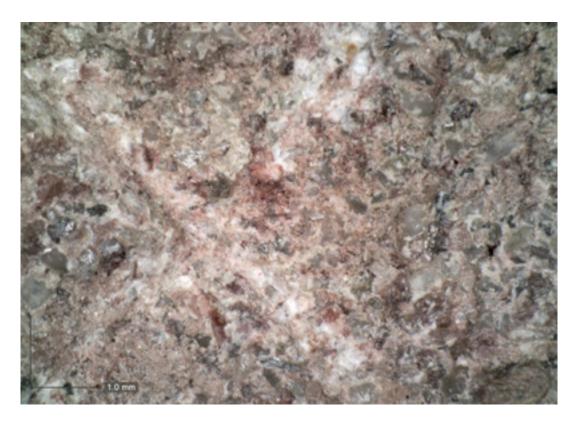
Fig 11. Microscope image of the middle of the three 'x' incisions. Location shown in Fig 1c.

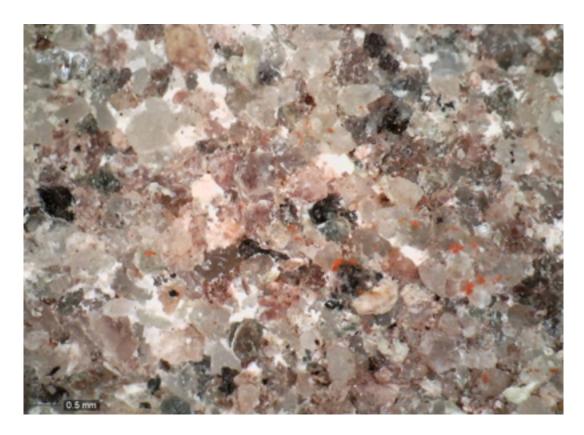
Five locations (near pXRF analysis positions 485, 487, 488, 490 & 493. See Fig 1f) on the base of the Stone of Destiny had small patches of an unknown red material (Fig 12). They appear visually distinct from the geological composition of the Stone and display a different red hue to iron-bearing minerals observed elsewhere in the Stone. These red deposits were varied in size, shape and distribution. There were no obvious anomalies in the pXRF data corresponding to their presence on the Stone. The source of this red material is unknown.

Fig 12. Sample analysis area 487 showing an accumulation of deposited red material (centre right of image).

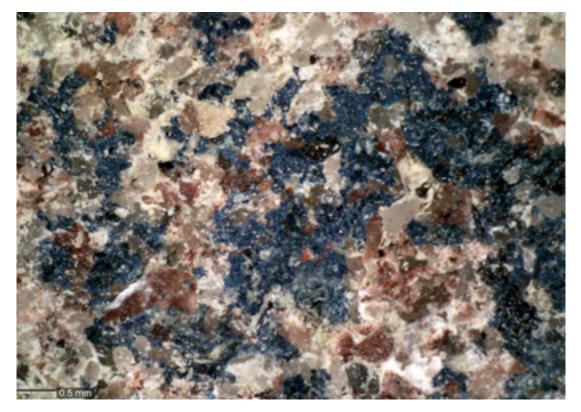
Comparatively large patches of blue material were present on the dexter face and base of the Stone (Fig 13). The patches of blue are different in texture to the red material and may represent paint transfer from tools previously used to move/transport the Stone in the 20th century.

Fig 13. Blue deposited/transferred material on the base of the Stone of Destiny.
