REFURBISHMENT CASE STUDY 37

HOLYROOD PARK LODGE EDINBURGH

THERMAL UPGRADE WORKS TO A 19TH CENTURY
LODGE HOUSE

HISTORIC
ENVIRONMENT
SCOTLAND

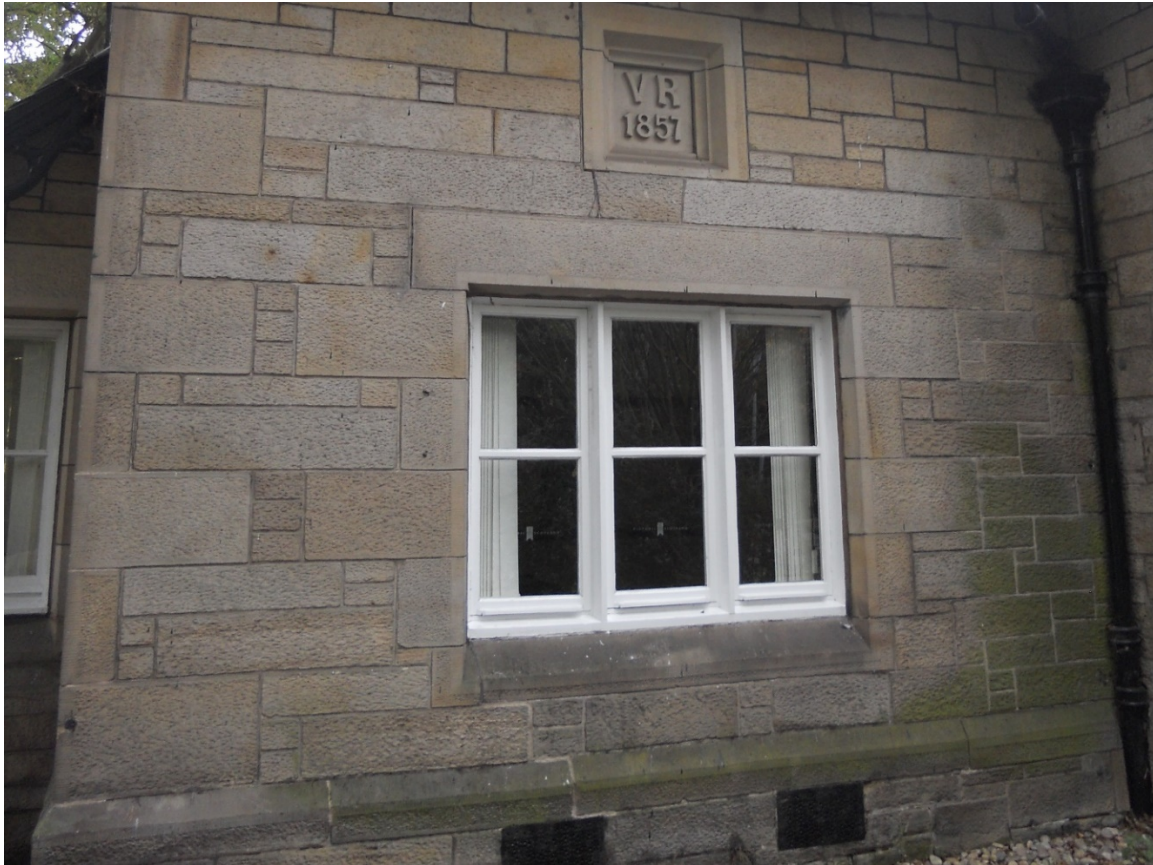
(single-glazed casements) were installed (Figure 3). However, the internal work was more conventional, with modern decorative finishes and details. The floors were covered in a hardwearing commercial carpet; the original timber floorboards remained underneath and in reasonably good condition, although the ground floor room to the east had dropped by several inches in one corner (Figure 4).

Figure 3. Single-glazed windows from the 1990s works.

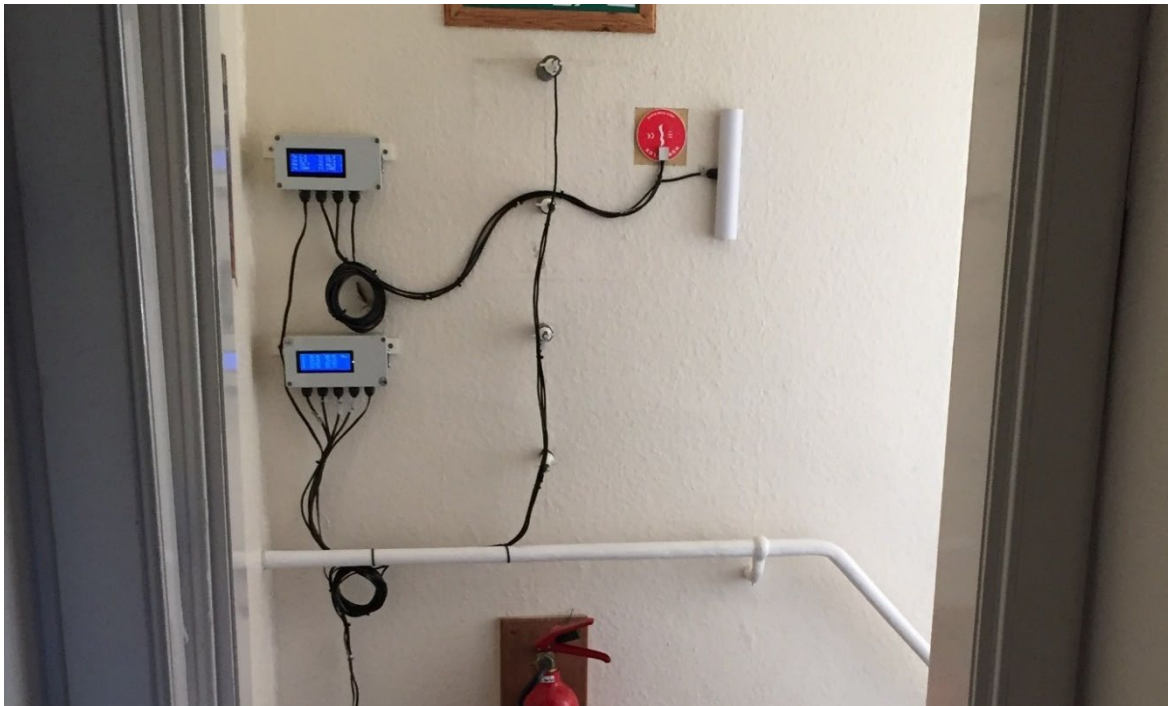
In addition to the assessment of the U-values of the masonry walls, measurements were taken of the relative humidity and temperatures of the west elevation. This was done with a series of probes installed at four different depths at the top of the stairwell on the west wall (Figure 9), which would allow a humidity profile to be established in the solid wall. Understanding the humidity in solid walls is important, as consideration must be given to any effects of added insulation which might affect the dew point within the wall thickness. A condensation risk assessment is necessary to understand if there is a risk in the use of certain insulation techniques and the potential for condensation to cause dampness. This

Figure 9. The in-situ U-value and humidity measuring equipment in place at the top of the stairwell. Note the four probes measuring humidity within the wall.

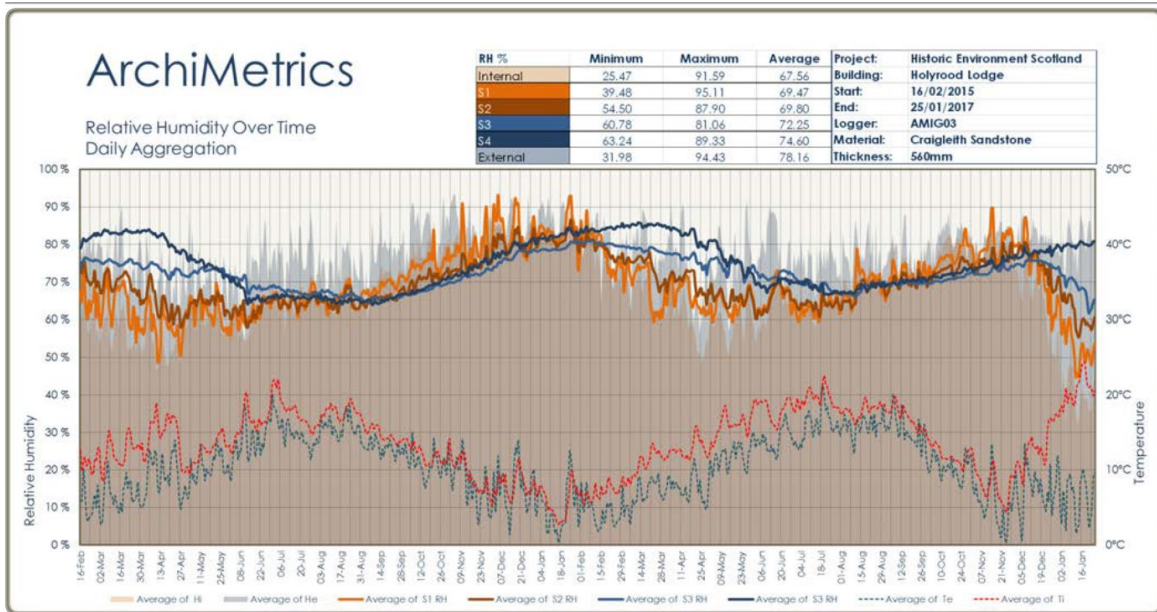
Figure 10. Graph of relative humidity over a 2-year period, February 2015 – January 2017.

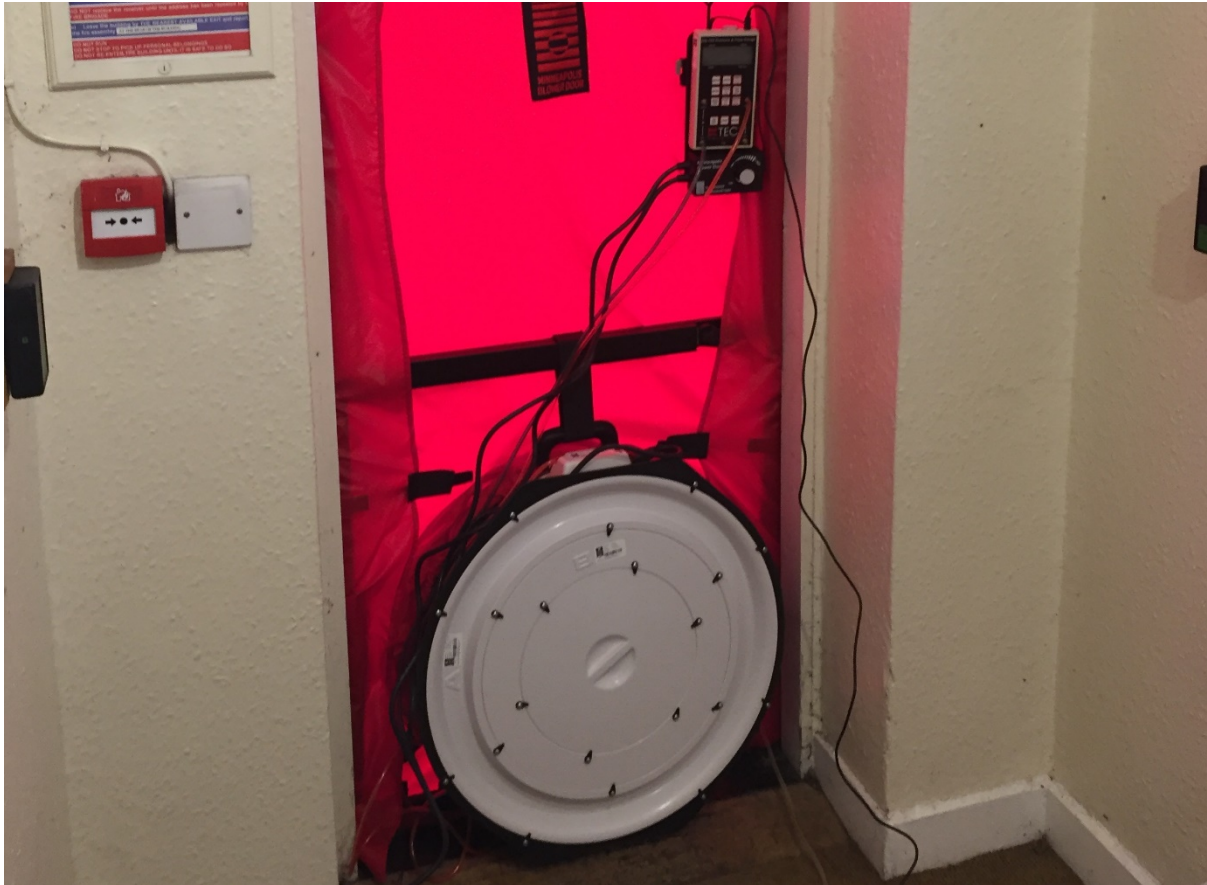
In order to assess how the works improved the air tightness of the lodge, multiple pre-intervention air pressure tests were carried out in Winter 2017 (Figure 11). Not all of these tests conformed to the standard procedure, deliberately so, and were designed to establish how leaky the building was in different states. This included identifying how the building performed when it was ‘in service’, which is different from the condition a building is in when it is tested for compliance purposes. Three of our series of tests, however, equated to the standard compliance test, where only the windows were un-taped, flues and other openings in the fabric were closed off, and a de-pressurising fan was used in accordance with BS EN 13829:2001. The result achieved was an average of 15.29 m³/h/m². This is a typical figure for an unimproved building, and provides a useful benchmark to counter the quote that older buildings are exclusively draughty. The pre-intervention air leakage results are compared to post-intervention data in section 11.4.

Figure 11. The fan on the back door for the air pressure test in Winter 2017.

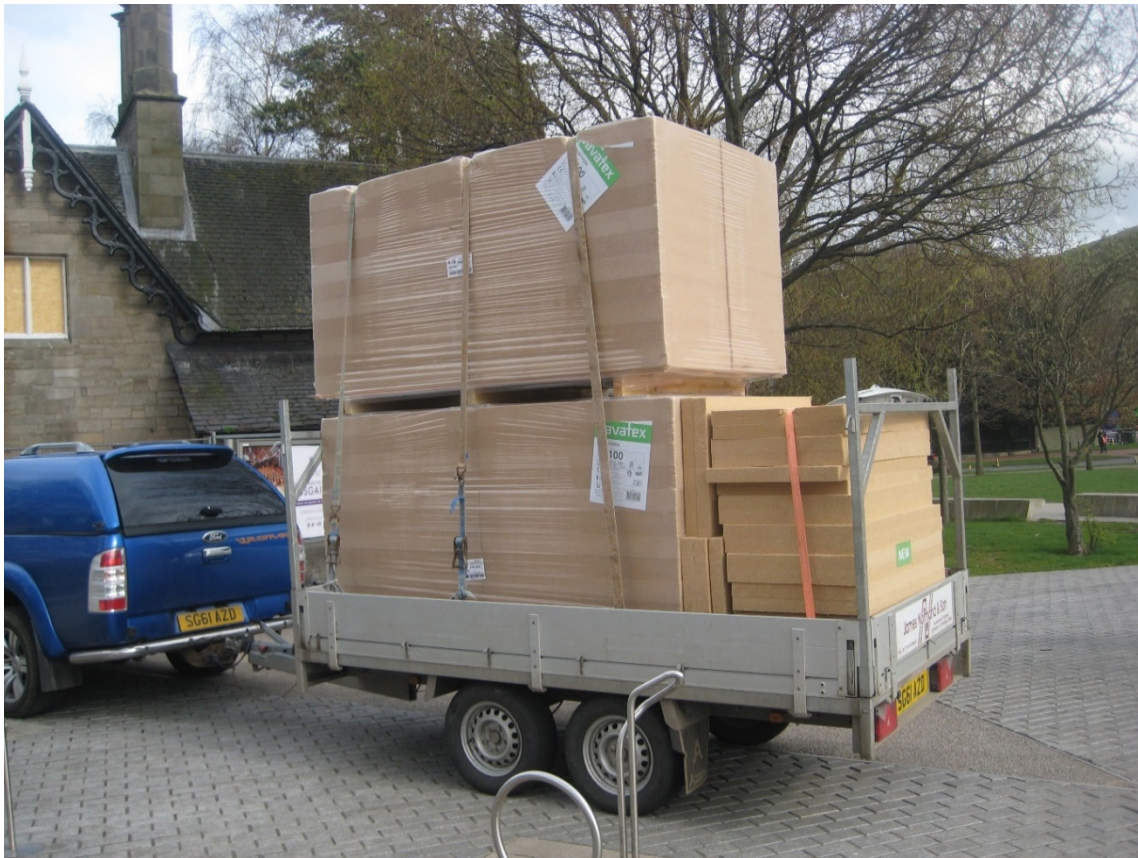
Figure 15. The wood-fibre insulation batts for use in the floor and the roof spaces.

Following the repair and upgrade of the timber joists on the ground floor, wood-fibre insulation was fitted between the joists. The wood-fibre insulation is a semi-rigid batt, 100mm thick, specified for use in the floors and the attic spaces, allowing a single product bulk buy (Figure 15). The wood-fibre board was cut into the required lengths with a wide toothed

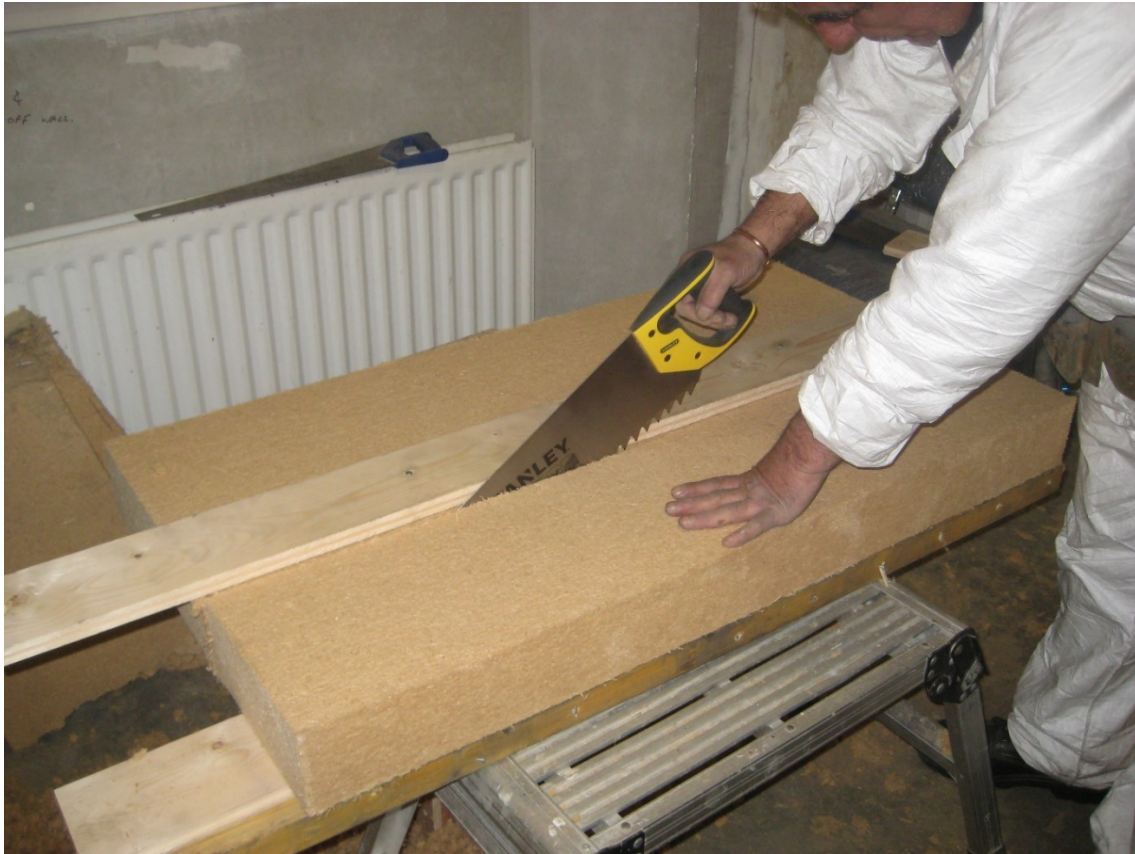
Figure 16. Cutting the wood-fibre board with a wide toothed hand saw.

hand saw, not seen very often today, this type of saw is able to effectively cut fibrous materials without the teeth clogging up (Figure 16).

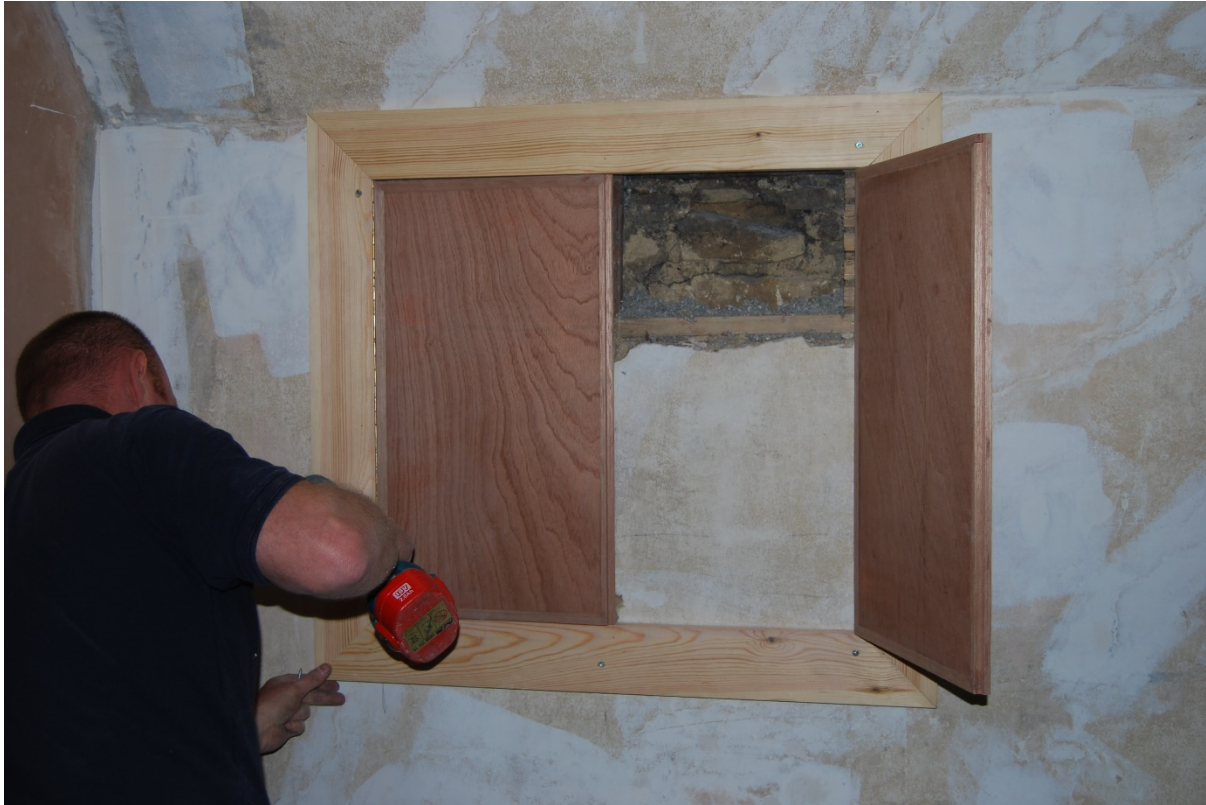
Figure 19. Fitting the interpretation panel to show the blown cellulose fibre behind the lath and plaster.

Whilst blown wall insulation remains an effective option for upgrading lath and plaster walls, further evidence is needed to show that there are no damaging effects on the building fabric. To assist with this, the in-situ monitoring at the stairwell will allow for a continued assessment of the effects of these thermal upgrade measures to be made available. Visitors can also see what has been done with the blown insulation, through an inspection wall panel in the meeting room on the first floor (Figure 19).

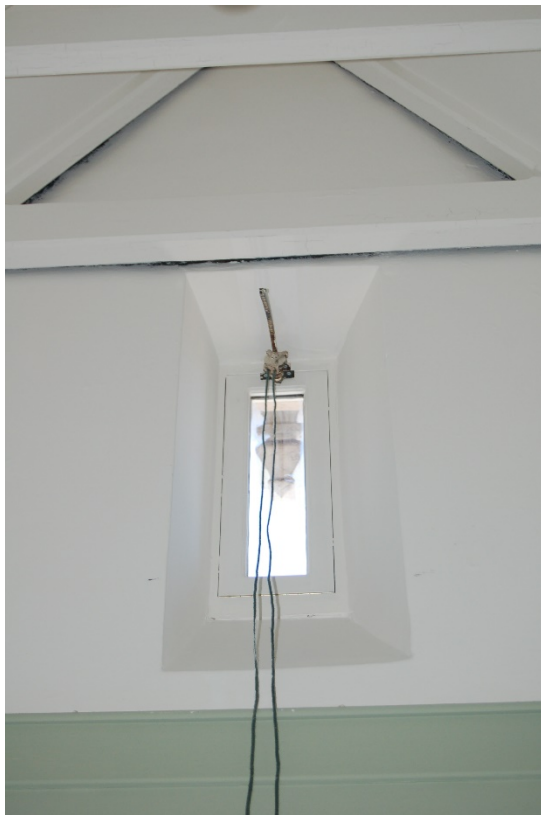
Figure 25. Internal view of the opening light.

For security reasons, and due to the nature and pattern of use of the building, it was decided that most windows on the ground floor of the lodge would be kept closed. To ensure the proper flow of air through the ground floor areas however, a small quarter light at high level in the north hall was modified to be operable with a pulley (Figure 25). This simple device does not have any power or electrical requirements, making it simple to maintain. Its height and size made it a low security consideration (Figure 26).

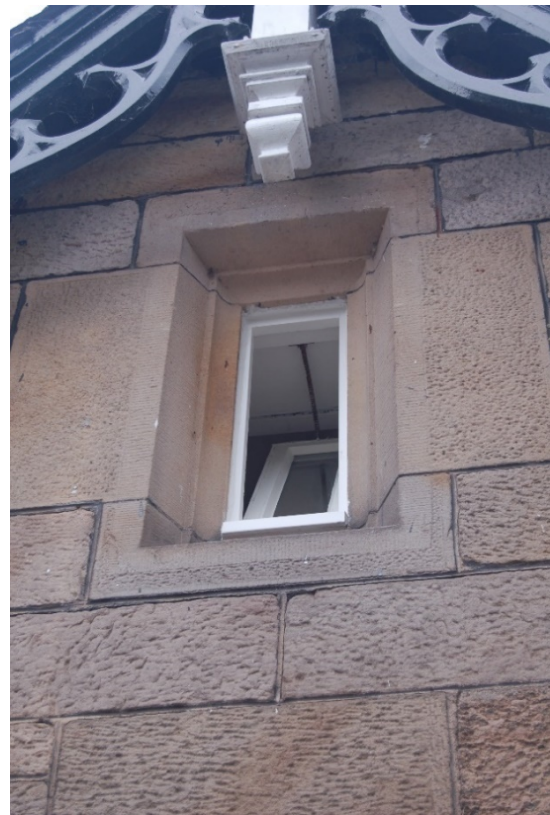
Figure 26. External view of the light, shown fully open.

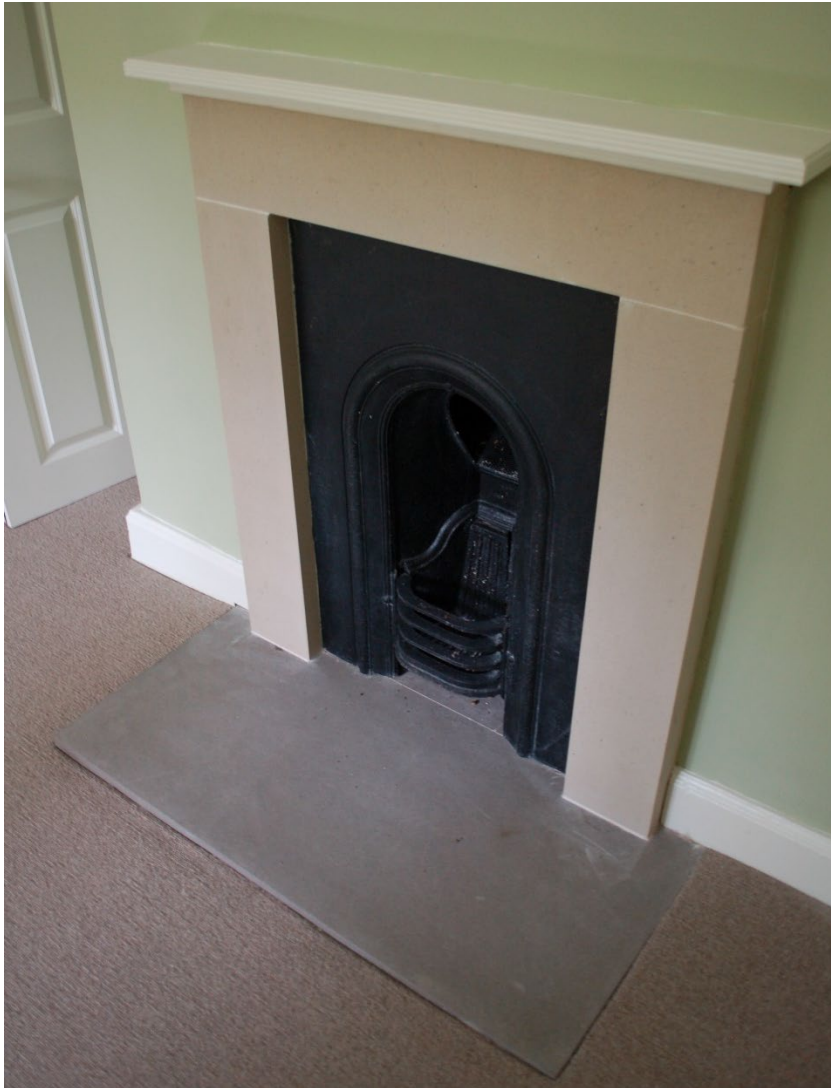
Figure 28. The re-instated chimney piece and hearth in the meeting room.

When the room is in use, in conjunction with a small opening of the window, this is considered an adequate means of air extraction. Dimensions and sizes of the masonry surround were taken from another lodge in the park, and a cast iron inset and grate supplied from an architectural salvage retailer. As the width of the room had been narrowed by the creation of a new door at some stage in the past, the opening was made slightly narrower to better match the proportion of available width. However, a reasonably sympathetic assembly was achieved (Figure 28). The hearthstone had become uneven and loose and required re-bedding. This was set to be nearly flush with the timber floor, allowing a 10mm up stand to account for the thickness of the carpet. Traditional hearth stones are always level with the floor; raised hearths are a modern adaptation.

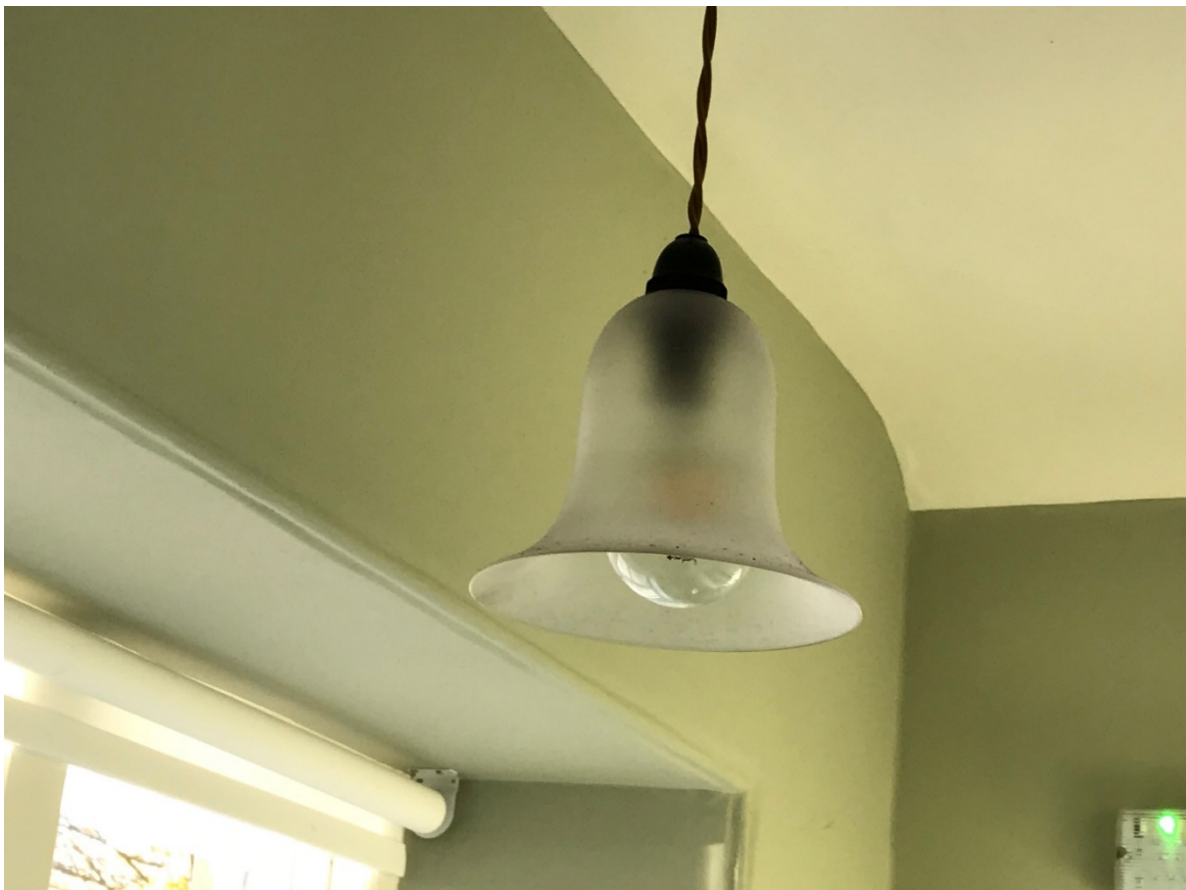
Figure 29. New light fittings of traditional pattern contributed to the improvement in amenity at the Lodge.

To improve the visual amenity of the lodge, the lighting for the stairwell and the upstairs rooms was re-modelled with new but traditional pattern fittings and pendants in brown Bakelite (Figure 29). These were more appropriate for a domestic scale building than the large luminaires that had been installed in earlier works. LED bulbs were used, but attention was paid to achieving the correct 'colour temperature' to give a soft warm light. The temperature selected was 7500 Degrees Kelvin. In many cases, a bulb temperature over 7500 can be too bright for traditional interiors, unless there is a specific need. Some LED bulbs can give rise to a cold blue light, caused by this higher frequency of emitted light. This can affect perception of colour and personal comfort.

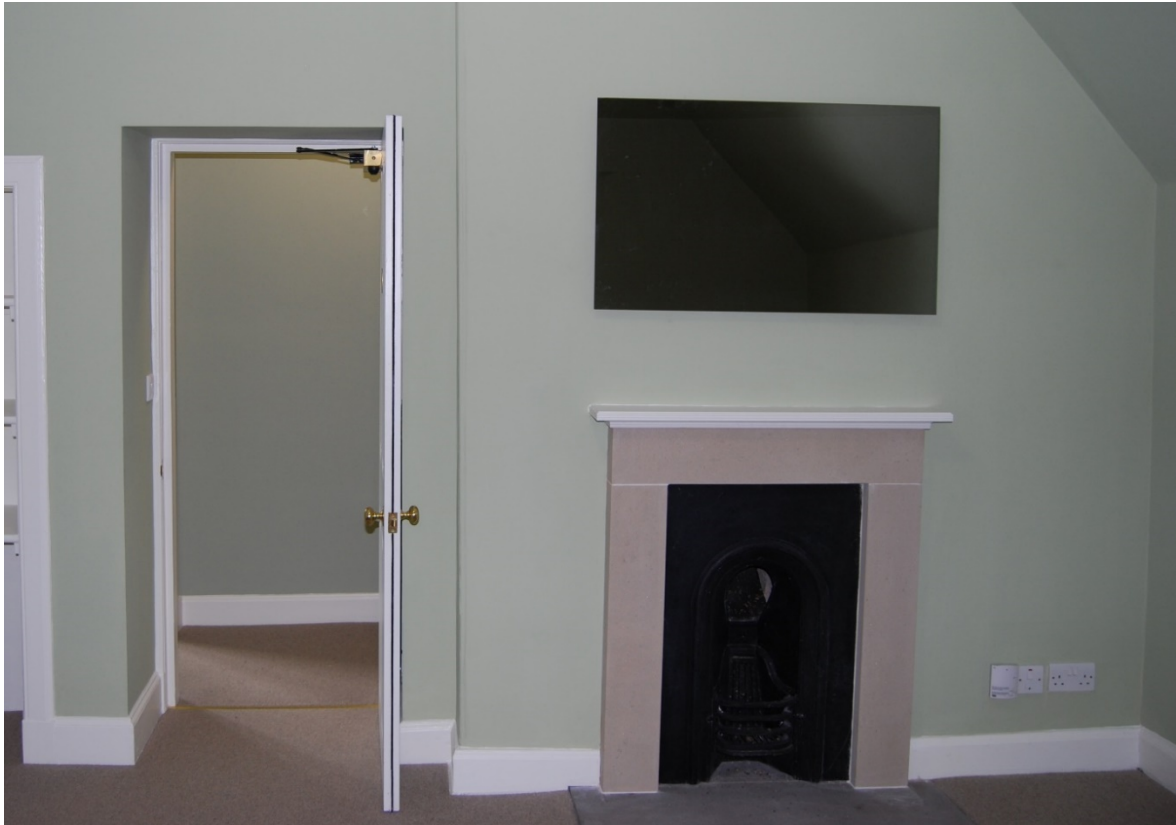
Figure 31. The infrared heating panel over the chimneypiece in the meeting room.

The lodge was heated by a conventional wet system, with a relatively modern condensing boiler. Due to this and for reasons of cost, it was decided to leave this in place. Some radiators were moved to allow for the reflooring and shopfitting works. New installations were made to give localised heating in two locations with a new form of electrical heating. An infrared heating panel was placed over the re-instated hearth in the upstairs meeting room (Figure 31) and another on the ground floor retail space by the shop counter area. Radiant heat is delivered by the panel through the infrared radiation heating the objects it falls on and not the air itself. While it cannot be called a low energy heat source, it delivers thermal comfort more directly and often allows comfort with lower air temperatures. These systems suit large spaces where only localised heat is needed, and airtightness is hard to achieve. The panels are controlled by a thermostat mounted on the wall close by.

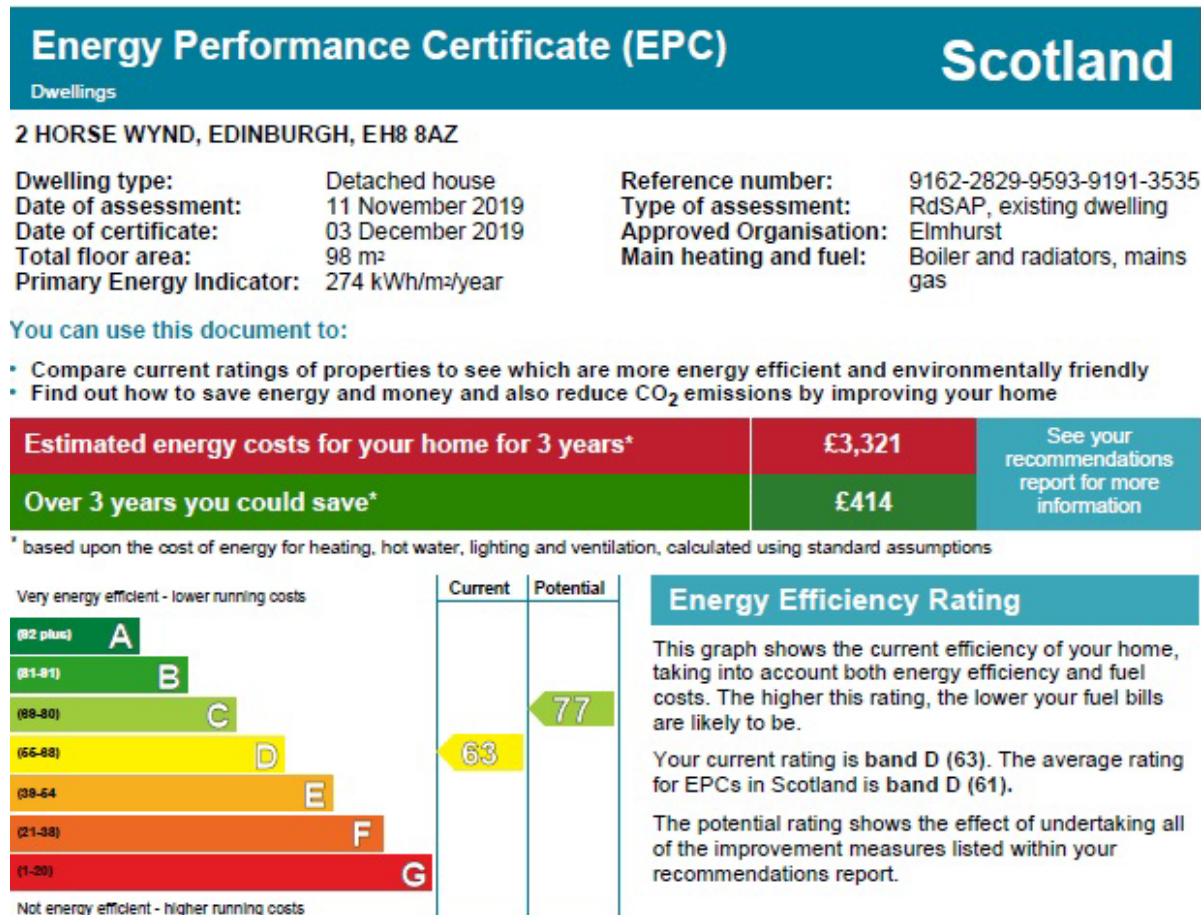
With the works completed, a post-intervention EPC assessment was carried out by the same assessor. This followed all existing Rd SAP conventions and was supplemented by documented evidence on insulation added to parts of the building that would not normally be visible. In this case, the product information on the installed measures, which were retained as part of the Health and Safety File (a requirement of the CDM regulations), were invaluable. The file was handed over to the EPC Assessor, who was able to ascribe the right values to insulation thickness etc. The 'extended data' entry options were selected for the room in the roof data entry. Specifically, this consisted of careful measuring of all the components of the room in the roof: the 'flat ceiling' above, the 'vertical walls', the sloping ceilings of the cooms and the gable walls. It also accounted for all known thicknesses of insulation from the recent refurbishment. Details on the boiler, the heating controls, hot water provision, secondary heating and lighting were also included. The details of the double glazing were entered, as well as chimney details. This new EPC assessment gave a SAP rating of 63, the upper part of EPC Band D (Figure 37). While not ideal, this is a good score for a 19th century building. With

further work, the EPC predicted that a score of 77, the upper part of Band C, could be achieved.

Figure 37. The EPC for the Lodge post refurbishment.
