GARDEN BOTHY, CUMNOCK

UPGRADES TO WALLS, FLOORS, WINDOWS & DOOR

Historic Scotland Refurbishment Case Study 8

MOSES JENKINS

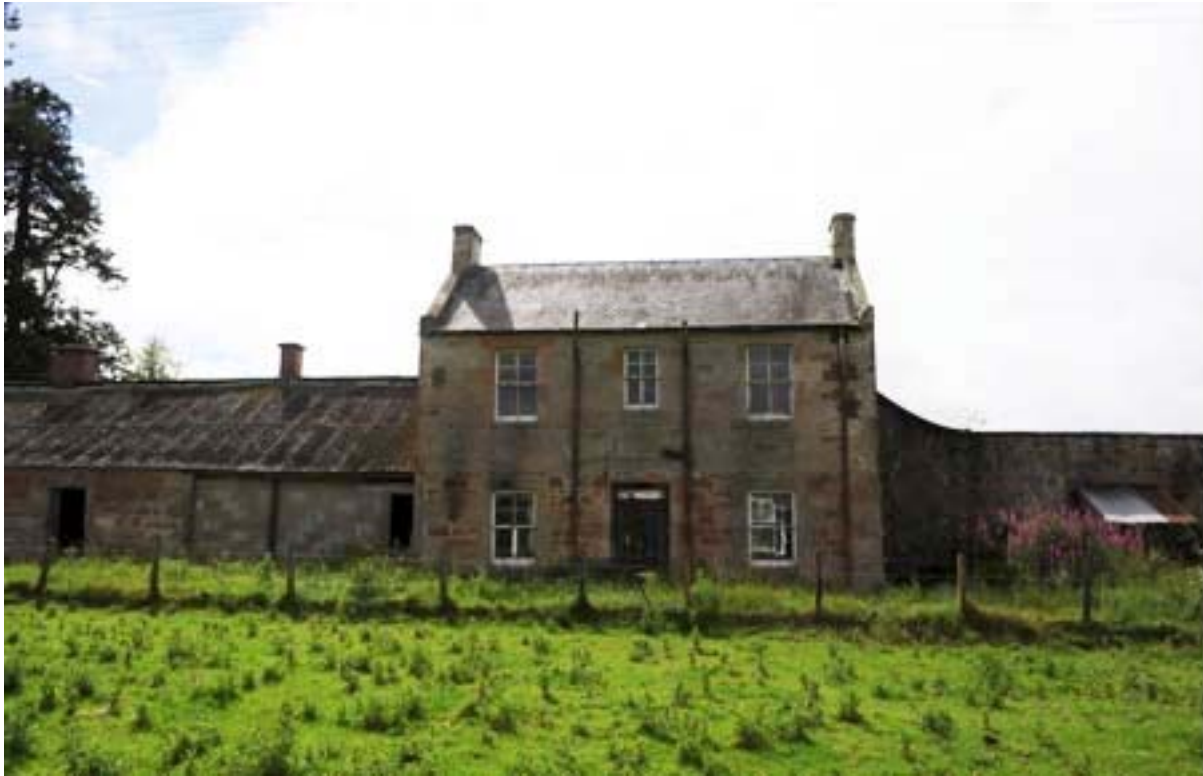
The property, whilst not derelict by any means, had suffered the effects of at least five years of inoccupation and many years of limited maintenance prior to this. This had led to water ingress at several points and subsequent damage to building fabric. The measures taken to rectify these problems are discussed in section 4 (*Enabling Works*).

Fig. 1. The Garden Bothy, Dumfries House Estate, East Ayrshire, prior to upgrades
