SCOTSTARVIT TOWER COTTAGE, CUPAR

THERMAL UPGRADES & INSTALLATION OF RADIANT HEATING

This publication should be quoted as:
Historic Scotland Refurbishment Case Study 7

JESSICA SNOW

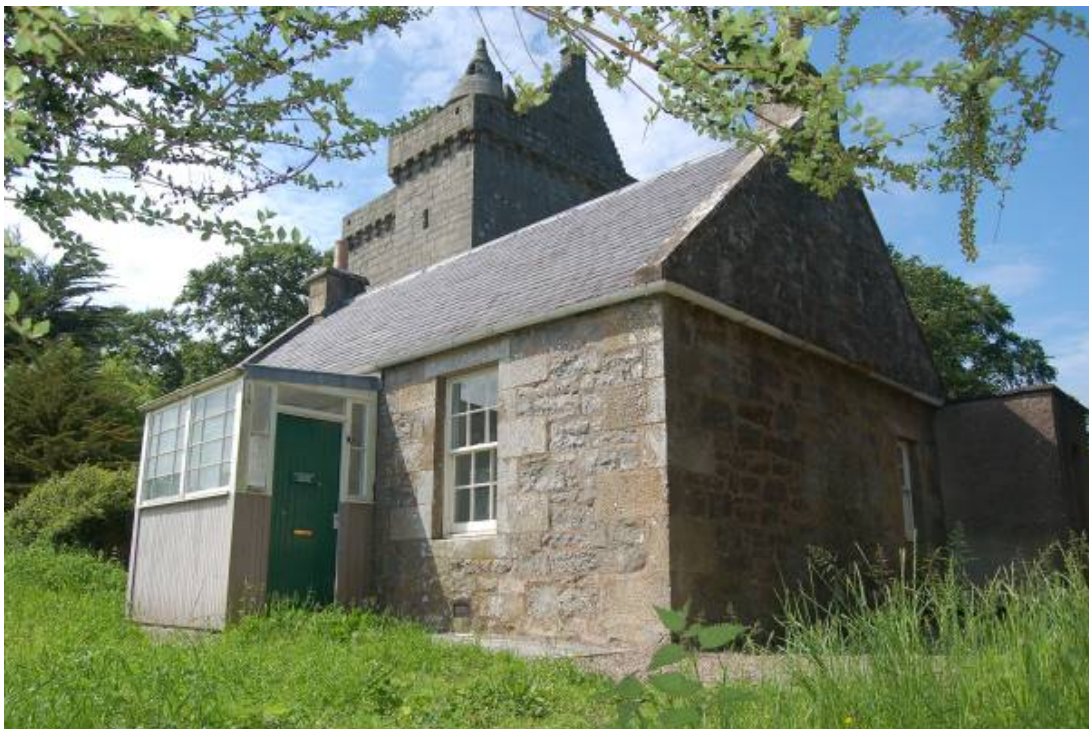
Fig. 1. Scotstarvit Cottage

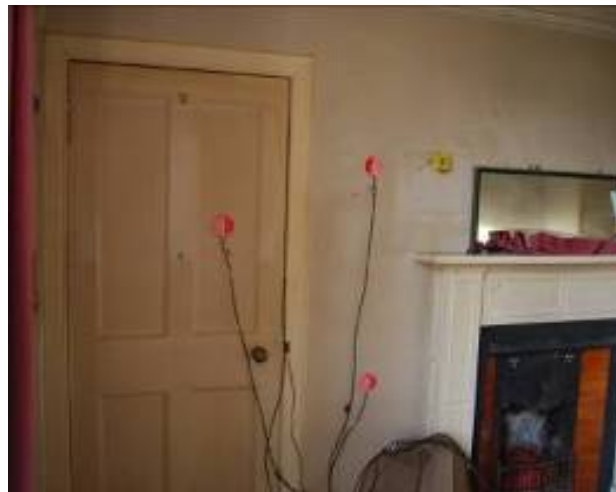
The thermal performance of the unimproved elements was measured prior to the works by Edinburgh Napier University and consisted of in situ U-value measurements of the floor, wall and the ceiling, using the standard heat flux plate and associated equipment (Fig. 2). As glazing of the type found at the cottage had been tested before, the windows were omitted from the testing process. The relative humidity value for the void behind the existing plasterboard was also tested. These measurements allowed a baseline pre-intervention figure to be calculated, from which the effectiveness of the upgrade works could be measured (Table 1). The techniques for measurement and analysis are described in Historic Scotland *Technical Papers 10 and 17*. The results are similar to other in situ measurements that Historic Scotland has monitored in traditional built fabric and as such need no discussion.

Fig. 2. The U-value of various elements being tested using heat-flux sensors

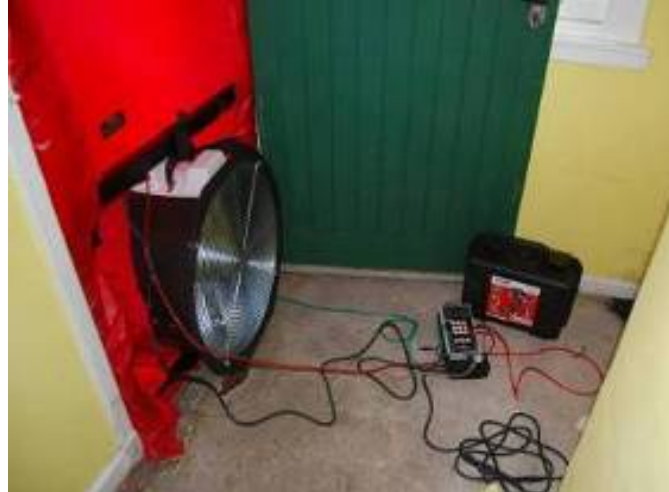
The property was also tested for air leakage, using a blower door test (Fig. 3). This returned a result of 16.9 m³h⁻¹m⁻² @50Pa. This level of air leakage can be compared with the *Scottish Building Standards Technical Handbook Domestic* for new dwellings which has a recommended maximum leakage rate of 10 m³h⁻¹m⁻² @50Pa (see section 6.2.4). The air leakage testing and results are described in full in Appendix 1.

Fig. 3. Blower door testing to measure the air tightness of the unimproved building

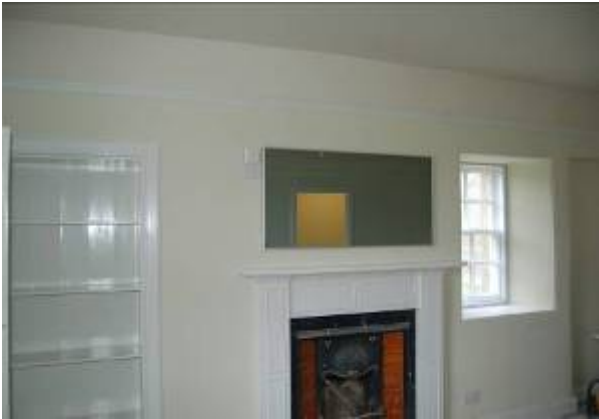
Fig. 19. The redecorated living room showing radiant heated mirror above fireplace

and 22), with a heated mirror selected for the living room and bathroom (see Fig. 19). Unfortunately the mirror is a smoked glass, so is not ideal as a bathroom vanity mirror, although it is adequate in most other situations.

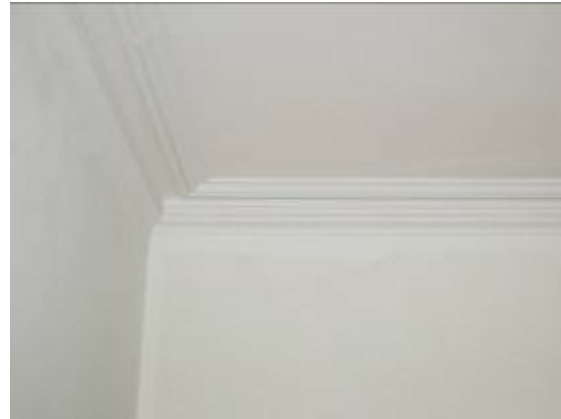
Fig. 20. The property was redecorated with clay paint

Whilst internal plaster and timber linings were retained, the finishes were stripped back to bare plaster, removing degraded layers of modern paint and paper. The property was then repainted throughout using vapour permeable clay based paint (Figs. 19 and 20). As well as being non-toxic and low in VOCs, a clay-based paint allows any moisture present within the fabric of the building to be dispersed into the internal atmosphere where it can be removed by ventilation.

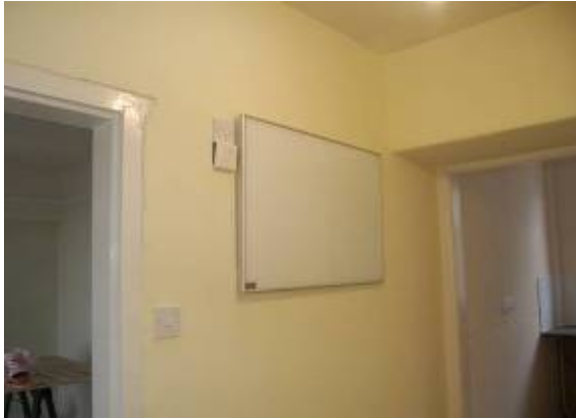
Fig. 21. Radiant heating panel in hallway

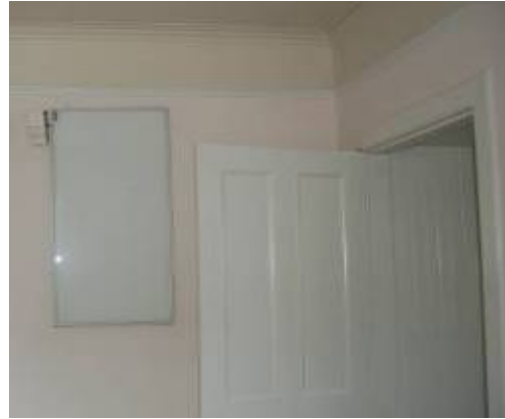
Fig. 22. Radiant heating panel in bedroom

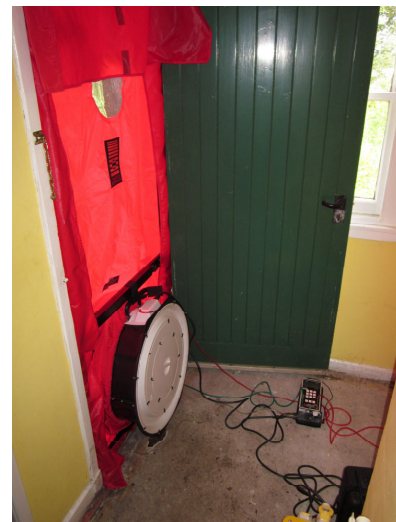
Right: Blower door in situ at Scotstarvit Tower Cottage

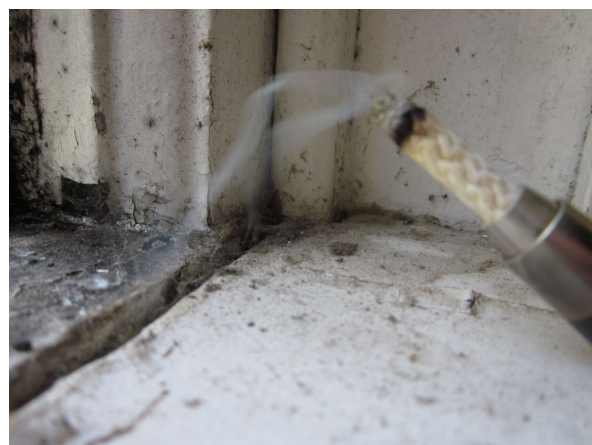
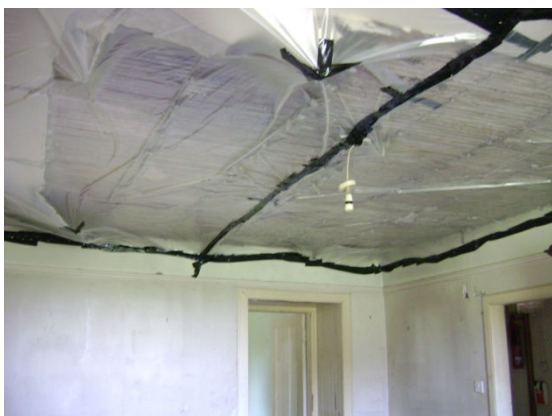
Below: Smoke pen in use on one of the windows at Scotstarvit Tower Cottage

| Part of building | Room | Area | Description | Comments |
|---|---|---|---|--|
| General | | Windows | Gaps around windows and via sash box | Visible air leakage using smoke pen. Draught proofing or other improvement required. |

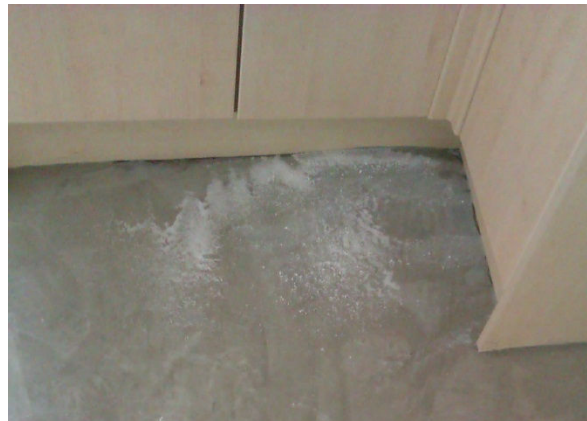
Overview of ingress identified under test conditions (please note that on this occasion, the air flow around skylight in the passage was not checked). Most of the air flows were relatively minor:
