A Survey of Thatched Buildings in Scotland

Thatch Survey of Scotland
2014-15

A photographic survey of thatched buildings in Scotland, surveyed between May 2014 and August 2015 by Zoe Herbert (SPAB Scotland Officer), on behalf of the Society for the Protection of Ancient Buildings.

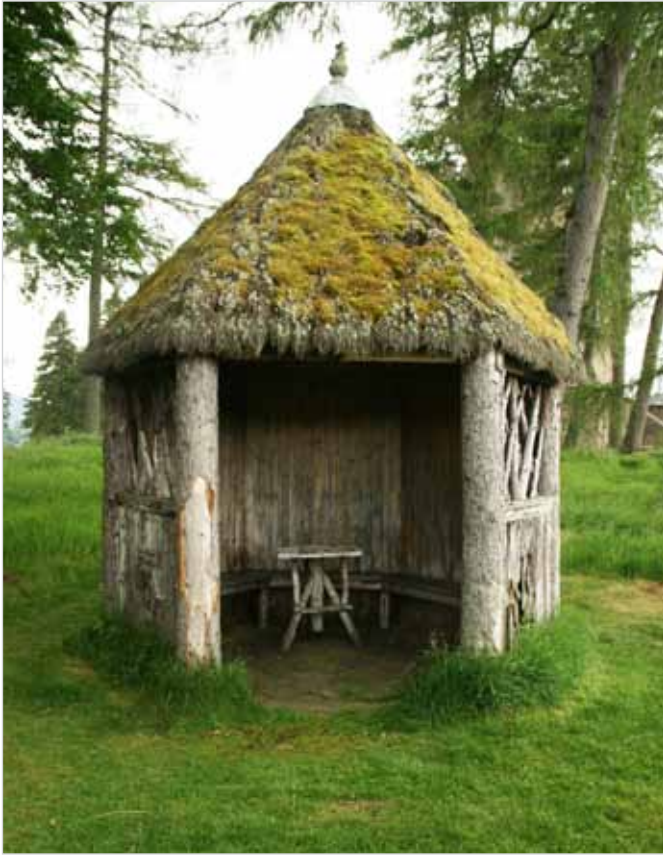
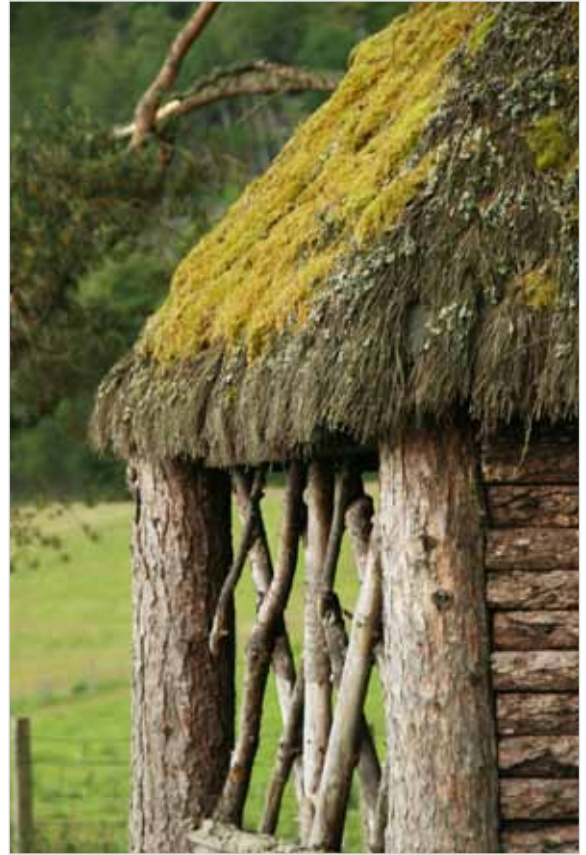
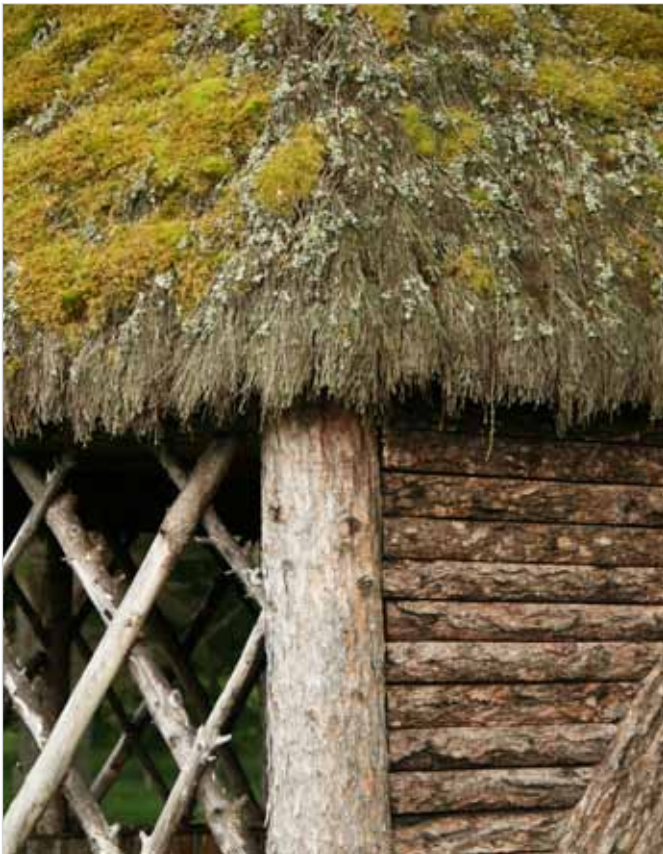
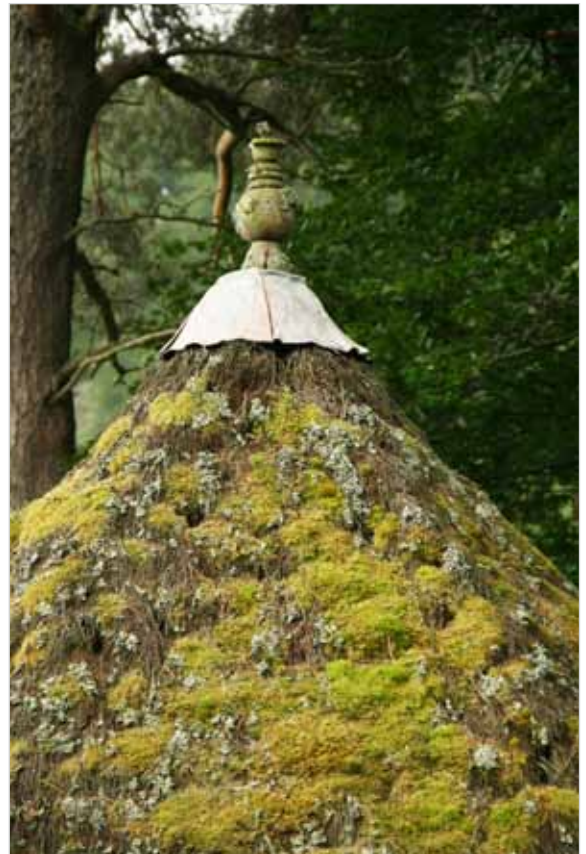
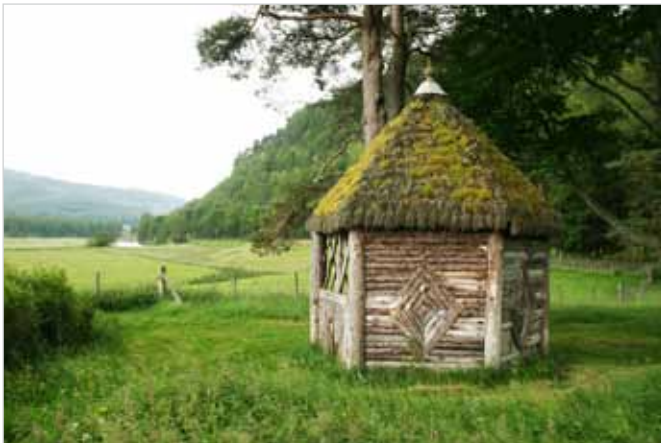
Braemar Castle – Aberdeenshire

Local Council: ABERDEENSHIRE
 Grid Reference: NO 15664 92373
 Date of Visit: 10/07/2015
 Thatch Type: Heather
 Ridge Type: n/a
 Condition: Fair

Additional Notes: The summerhouse is listed as an ancillary structure within the listing of Braemar Castle, and the listed building description reads '*round rustic timber summerhouse with conical thatched roof to W*. The timber summerhouse, of unknown date, has a hexagonal heather thatched roof, which has been capped at the apex with lead and a decorative timber finial. The heather itself, whilst intact, is covered in a large amount of mossy vegetation growth across a large percentage of the roof surface. The thatch has been left uncovered and appears to be fixed to the roof using metal pegs and wire. The roof interior of the structure has been covered over

with modern timber panelling, and there appears to be a membrane, which looks like felt, directly underneath the heather. Braemar Castle is now a museum and the summerhouse is open to the public for access.

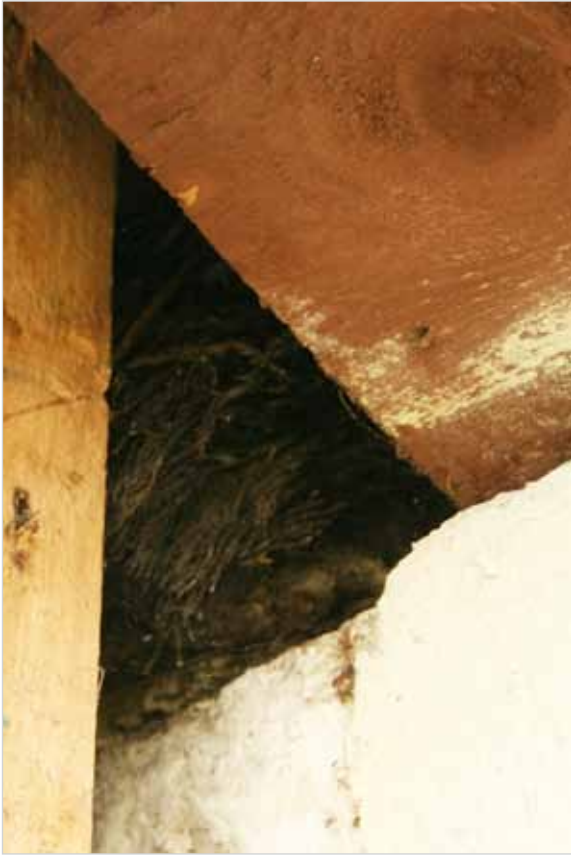
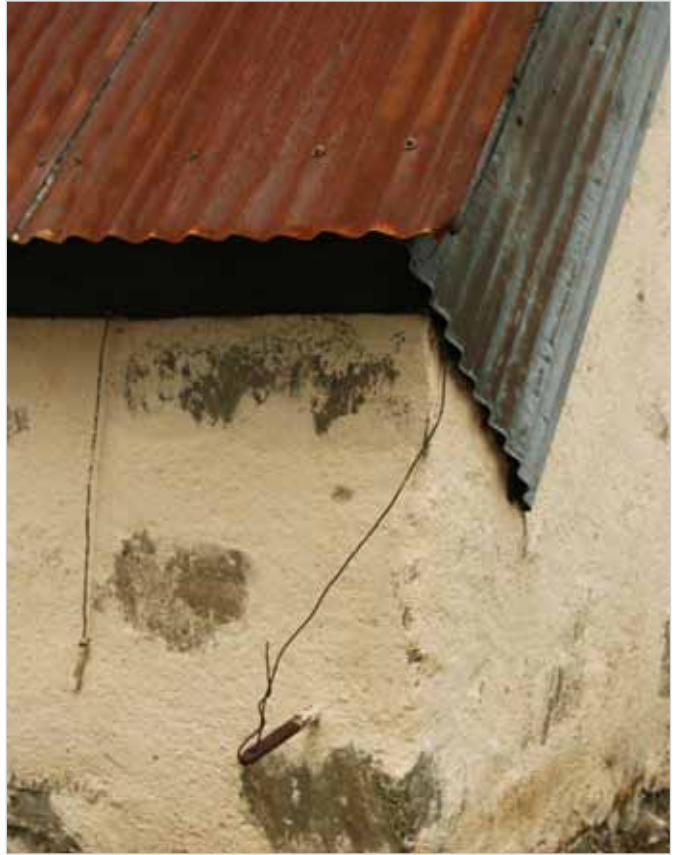
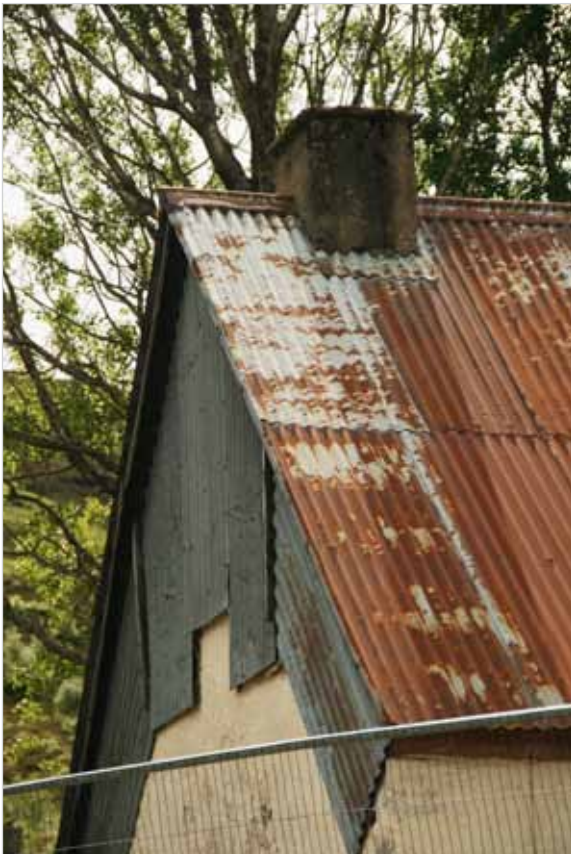
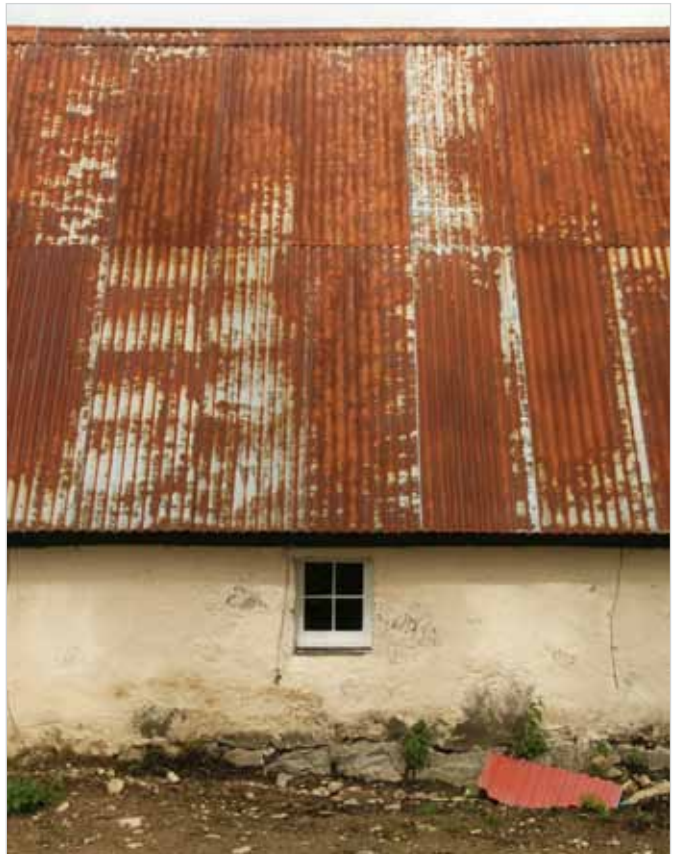
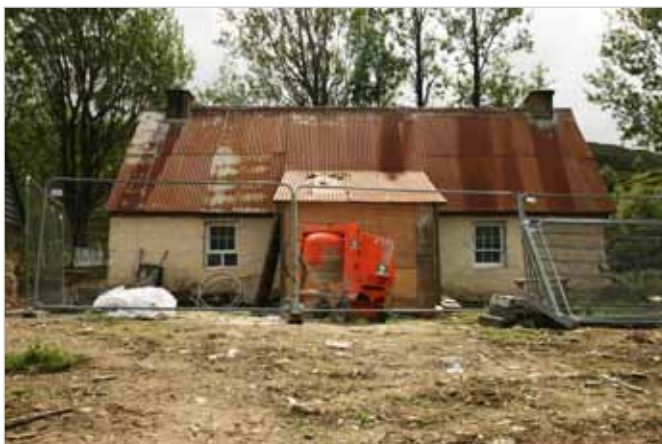
Tomintoul Croft – Aberdeenshire

Thatch Type: Heather
 Ridge Type: Unknown
 Condition: Unknown

Additional Notes: Early to mid 19th-century crofting cottage with existing heather thatched roof underneath a corrugated iron covering. The heather thatch has been largely undisturbed since the corrugated iron roof covering was put in place at the turn of the 20th century therefore the exact condition of the thatch is unknown. Small sections of the heather are visible from various locations within the interior of the building, from behind the timber boarding, and in one location on the exterior at the eaves where the cottage joins the porch extension. The owners recall seeing an old photograph of the cottage before the corrugated iron was installed, that showed

the heather thatch being covered in timber boards. The thatch has been secured by wires that come down underneath the eaves and attach to the external wall surface by metal pins. The cottage is currently being renovated and turned into a holiday let; however, the thatch and corrugated iron will be retained.

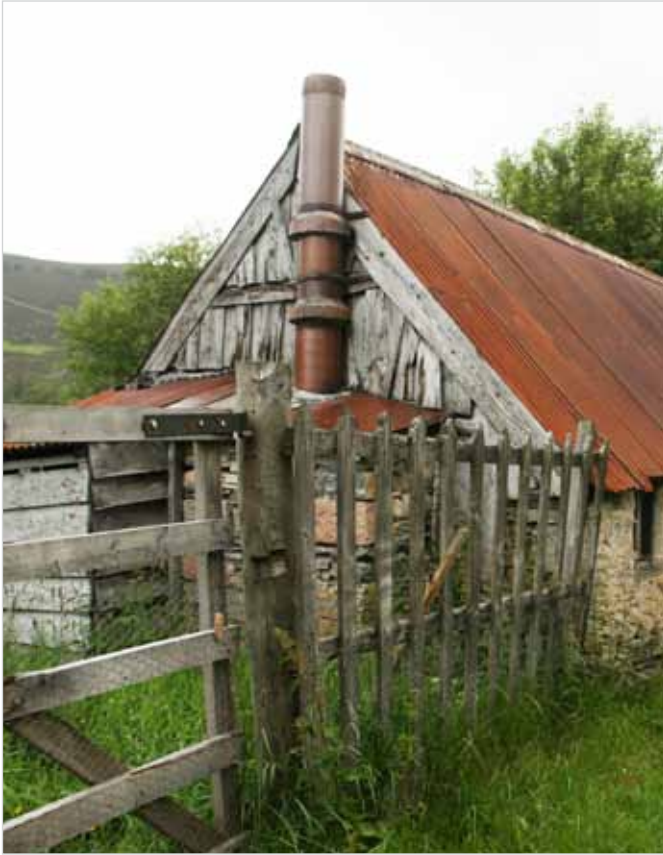
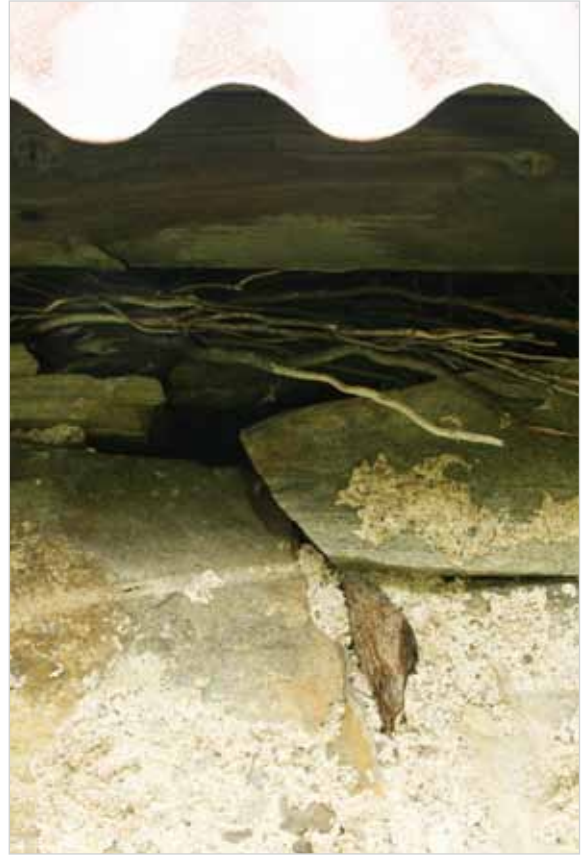
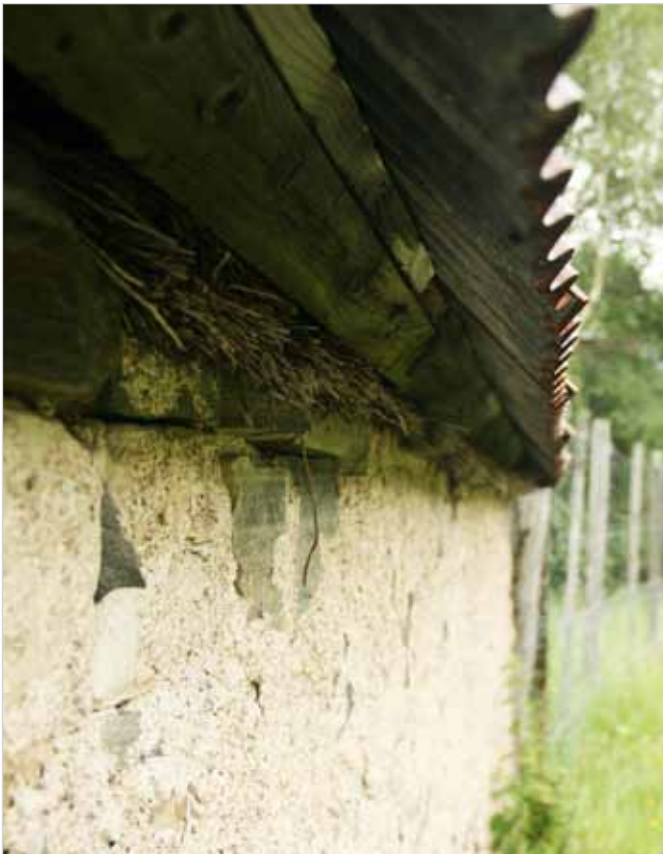
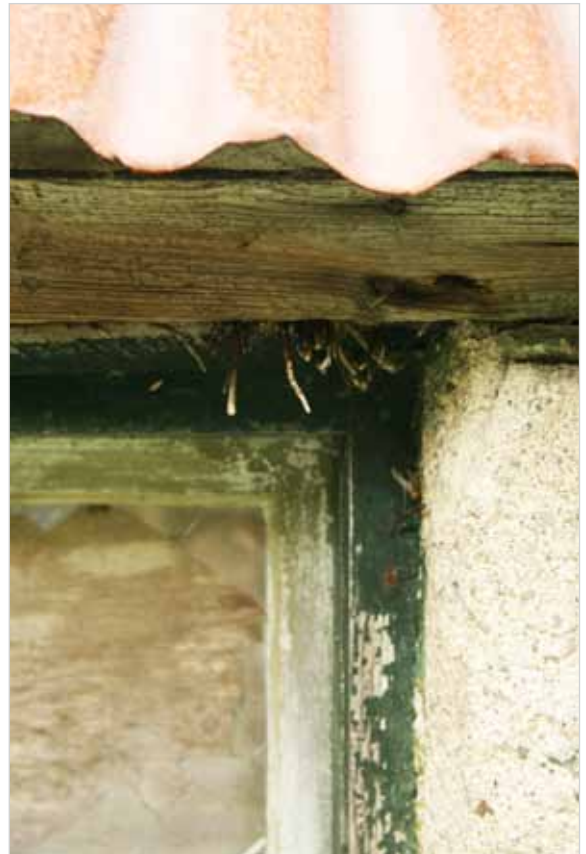
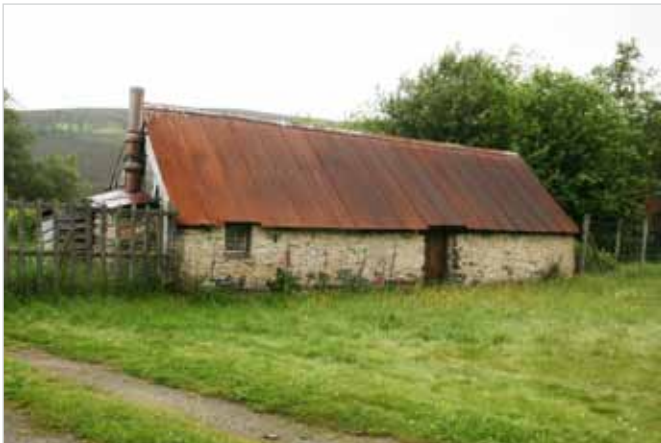
Former Smithy – Aberdeenshire

Additional Notes: This mid 19th-century former smithy building is listed as having a corrugated iron roof with thatch insulation. The grid reference shown in the listing for this building is incorrect and identifies a more modern structure to the west of this one (grid reference NO 08981 89302), however, the listed building description notes that the building has a 'low rubble lean-to' and 'single metal flue' to the west gable. It also describes a 'small deepset window to far left, single low door near centre' on the south (front) elevation. Whilst internal access could not be gained upon visiting, some thatching material could be seen from underneath the corrugated iron

covering, all along the eaves. It is unclear exactly what type of thatch it is; however, it looks to be either heather or bracken. Buildings of similar type and construction next door to this one were found to retain heather thatch underneath their corrugated iron roofs.

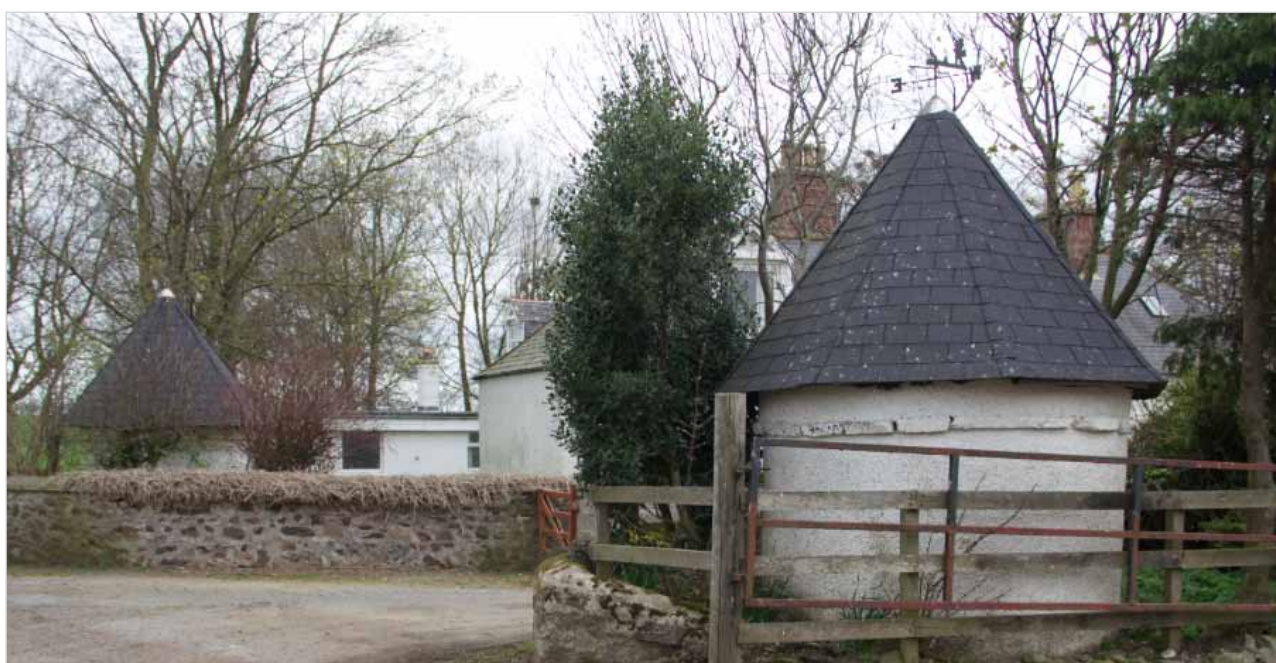
Address: Waddies Cottage

Additional Notes: Early 19th-century cottage, listed as having a roof of 'corrugated-iron over thatch', and the notes of the listing description read '*remnants of a thatched roof, probably straw over divots, can be seen between rafters and battens*'. The building is currently derelict and there is no longer any thatch left on the roof. What appears to be either a temporary roof or the base layer of a new roof is currently in place whilst restoration and extension work to the rear takes place. The listing description for this building should be updated accordingly.

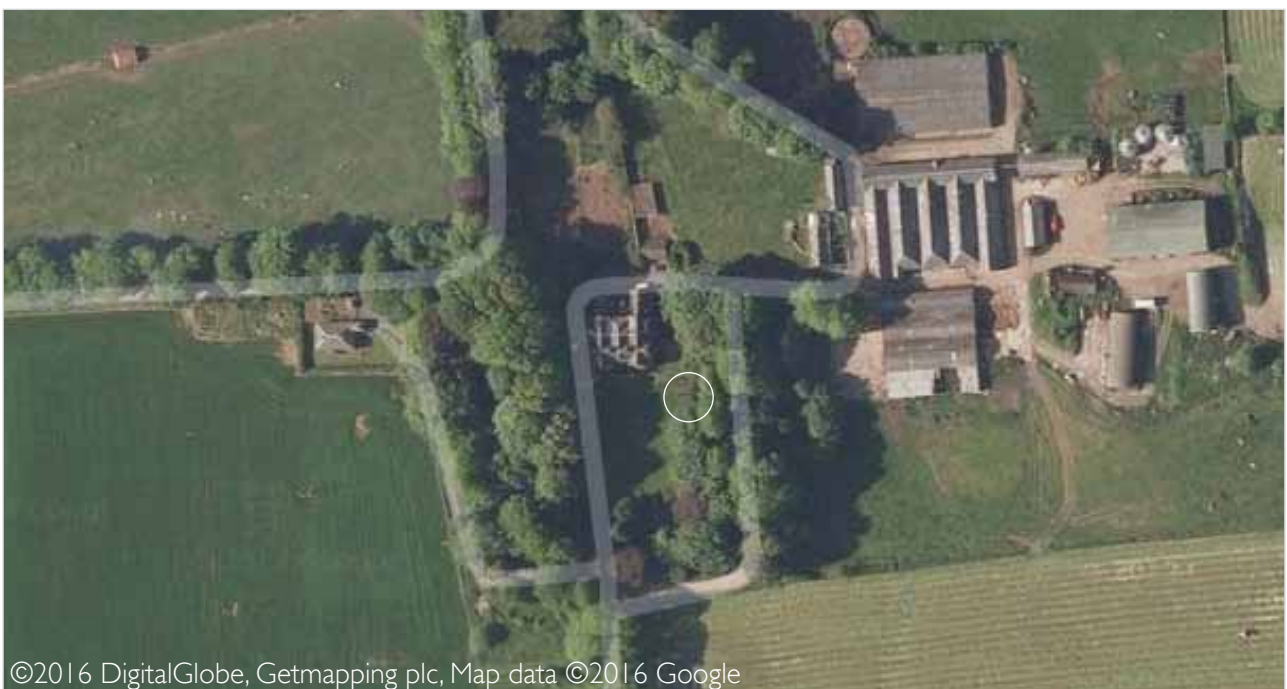
Additional Notes: Listed as part of a group with Pitpointie Farmhouse, the listing description reads '*Single storey, rectangular-plan game store SE of house. Rubble, dilapidated thatch roof. Door at W, window at S. Interior has stone slab shelves*'. The building has deteriorated further since being listed and is now in a ruinous condition with no thatch or roof structure remaining. The owner stated that it has been completely un-thatched for at least the last 20 years. The listing description should be updated accordingly. No photographs were recorded during the site visit as a result of the ruin almost not existing and being heavily overgrown.

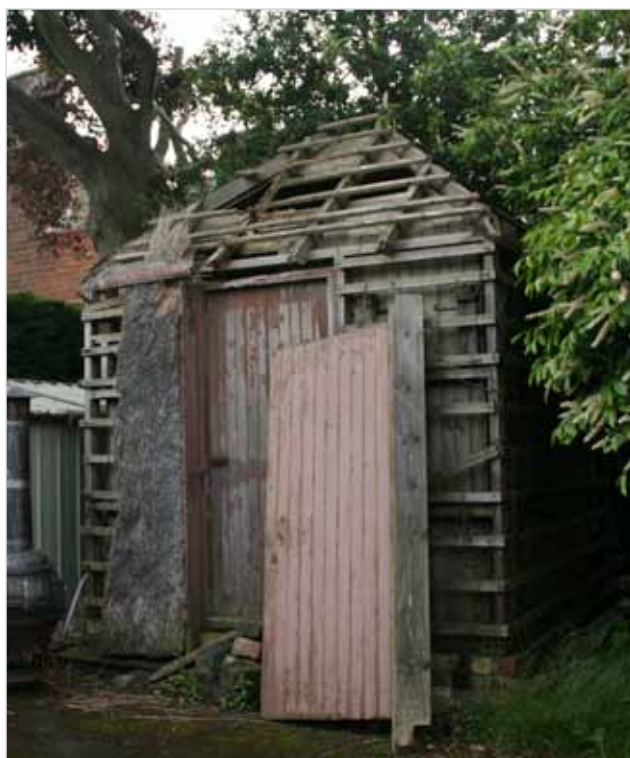
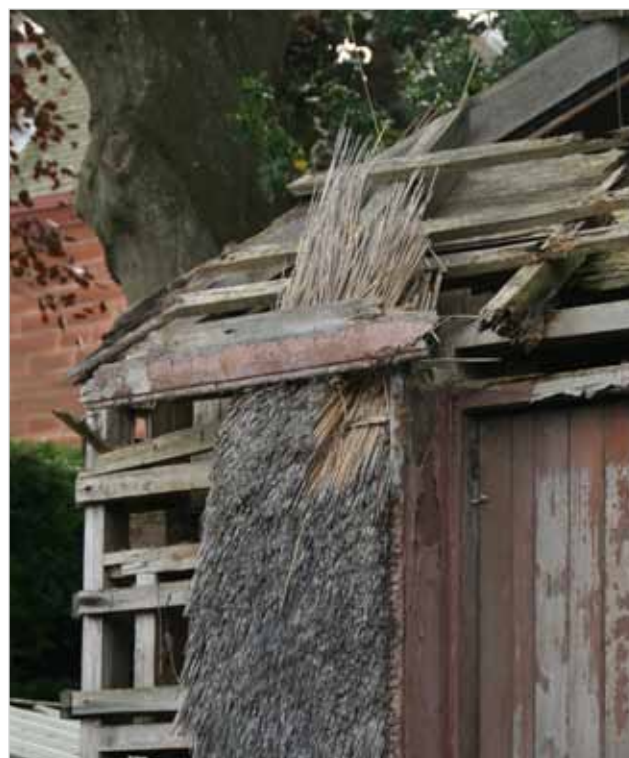
Address: Tigh-na-muirm House

Additional Notes: Part of a group listing with Tigh-na-muirm House, the listing description describes the structure as 'Single-storey, square-plan, brick clad in wired thatch, with thatch pyramidal roof; single door; lead vents at S ground level, louvred vent at roof apex'. The owner stated he had been removing the reed thatch from the building for the last 18 months with the necessary permissions, and plans to remove the small amount of remaining thatch, and begin to repair and reclad the structure, in the near future.

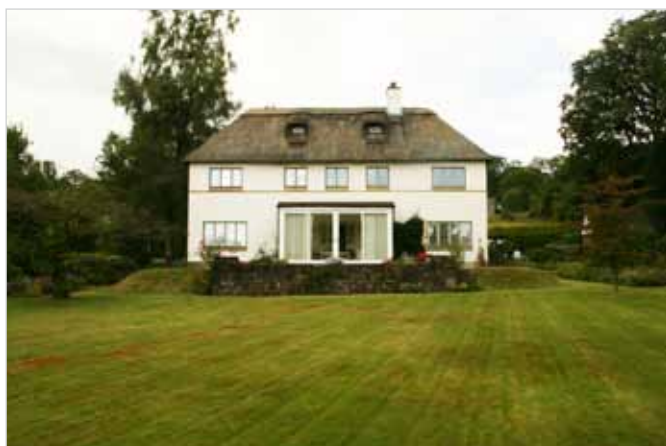
Ardlarich – Argyll & Bute

Thatch Type: Reed
Ridge Type: Concrete
Condition: Good

Additional Notes: Arts and Crafts style two-storey house, dated 1937. The roof is thatched in reed and has a concrete ridge. The owner stated that the house was last re-thatched in around 1996-98 by thatcher Peter Brugge, who is based in Cheshire, England. The thatch is netted only below the concrete ridge and directly below the dormer windows, whilst the rest of the thatch has been left uncovered. Repairs to the thatch on the house and the re-thatching of the lychgate, which took place around two years ago (2012), were done using the same company as the previous re-thatch (Peter Brugge). At this time, the roof was treated with a copper powder spray

to stop vegetation growth. The thatchers also repaired minor damage caused by birds and also completely re-thatched the lychgate in reed as it was in poor condition. Currently, there are a few dislodged pieces of reed in places and a number of small patches of mossy vegetation growth across the surface of the thatch.

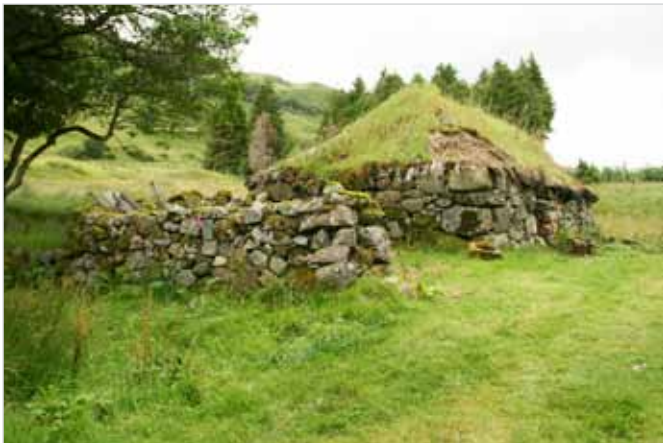
Building G – Argyll & Bute

Thatch Type: Bracken
 Ridge Type: Thatched (Bracken)
 Condition: Poor

Additional Notes: Reconstruction cottar's house, part of the Auchindrain open-air museum of a traditional Scottish Highland farm township. The building is part of a group listing with 22 other structures. Historic maps have shown a building on this site in both 1789 and 1871, however, by 1946 the building on this site was abandoned and roofless. In the early 1980s, the building was excavated and was then ultimately reconstructed to simulate a cottar's house from the early 19th century. The building was given a cruck-framed roof that was covered in bracken thatch. Since this time, the building has been deliberately left unused and abandoned, and the thatch

left to deteriorate, as apparently a township would have always had some unoccupied buildings. The bracken thatch, which appears to have a continuous bracken ridge, is in a poor condition and is heavily overgrown with grassy vegetation.

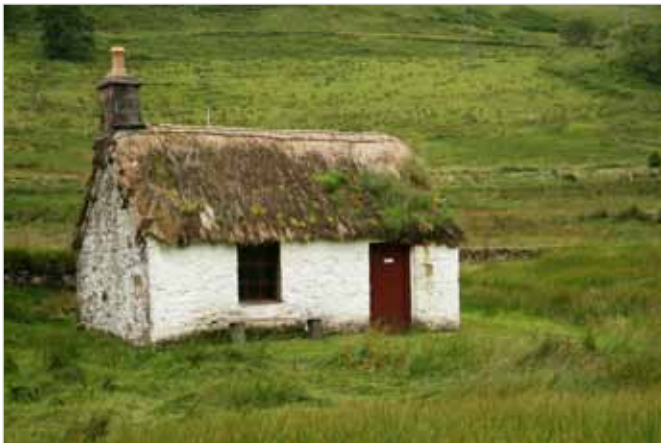
Building M, Bell a'Phuill's House – Argyll & Bute

Address: Building M, Bell a'Phuill's House
 Auchindrain Township
 Furnace
 Inverary
 Local Council: ARGYLL & BUTE
 Listing Category: A
 Date Listed: 20/07/1971
 Listed Building Number: 6798
 Canmore ID: 23412
 Building Type: Cottage
 Use: Museum
 Grid Reference: NN 03079 03142
 Occupancy: Occupied
 Date of Visit: 06/08/2015
 Buildings At Risk: n/a
 Thatch Type: Rush
 Ridge Type: Thatched (Rush)
 Condition: Fair

Additional Notes: Small traditional cottage, now part of the Auchindrain open-air museum of a traditional Scottish Highland farm township. The building is part of a group listing with 22 other structures all from the late 18th and 19th centuries. Bell a'Phuill's House, as it is now known, was occupied by 1841 as a dwelling. It was lived in until the death of Isabella McCallum (Bell a'Phuill) in 1915 but thereafter fell into disuse, and by 1946 was roofless and derelict. The building was repaired and re-roofed in 1975, and has been regularly re-thatched since. It is thatched in rush, as this material grows in abundance around the site, and was last re-thatched in 2011, receiving

a top-dressing in 2012. The ridge appears to have been thatched more recently than the rest of the roof, which has an amount of mossy and grassy vegetation growth across the surface of the thatch. The ridge has been scobed with two horizontal lines of thin branch.

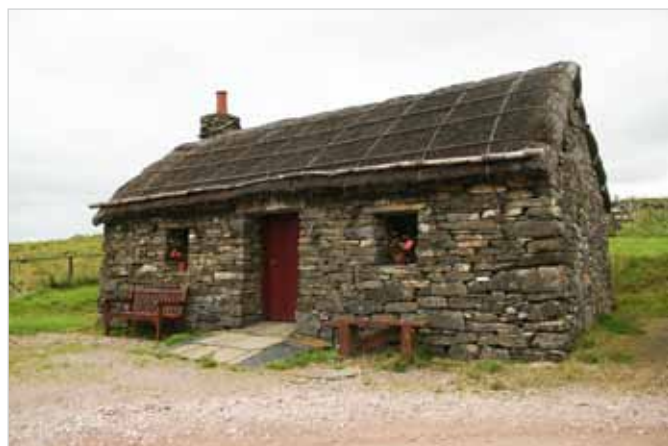
Taigh Iseabal Dhaibh – Argyll & Bute

..... Good

Reconstruction of a late 19th century cottar's house, completed in August 2002 to demonstrate typical island living of the past. It forms part of the Lismore Gaelic Heritage Centre, who according to the walls of the cottage were built by local people from the Isle of Lismore, whilst the roof beams were erected by a man from Argyll and the roof thatched by Jeremy Cox from Castle Douglas. Some of the reeds for the roof came from nearby Balnagowan Loch, with the rest from Perthshire. The majority of the turfs that were used as an underlay between the reed and the wooden roof beams were dug on site, from the land behind where

the building stands. The reed is netted, including over the thatched ridge, which is held down by ropes. The ropes that are positioned vertically are weighted at the eaves by single wooden logs and then pegged into the stone directly below the eaves using metal tools. The horizontal ropes are pegged into the stone at the gable ends, also using old metal hand tools.

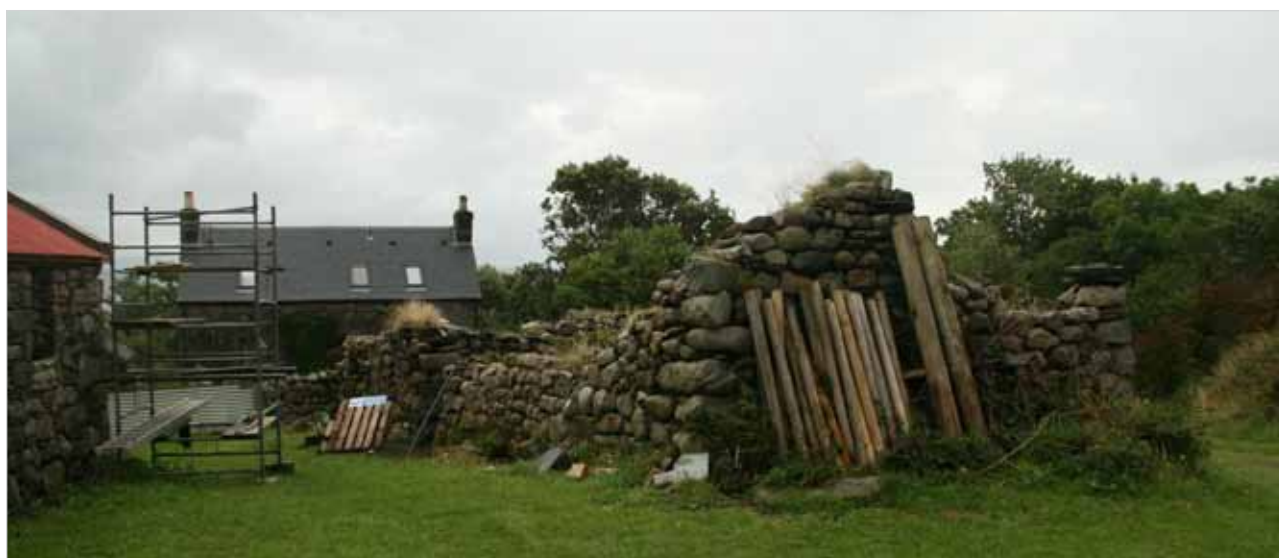
Additional Notes: Part of a group listing, the former byre is listed as having a thatched roof. It has been on the Buildings at Risk (BAR) Register since 2010 (BAR reference number 4600) and inspection notes from 2009 read 'External inspection finds the building a ruined shell in an advanced stage of decay. Images taken by Canmore show the building complete with thatched roof and in use as a byre, in 1974'. BAR recorded upon inspection in 2012 that there were no significant changes though 'vegetation ha[d] increased'. Upon visiting the building, the degraded thatching material could be seen on the ground within the building shell. Some of the building's timber roof trusses could also be seen lying on the ground next to the building, however, these were also heavily deteriorated. No thatch remains intact. The owner stated that plans were being made to restore the byre.

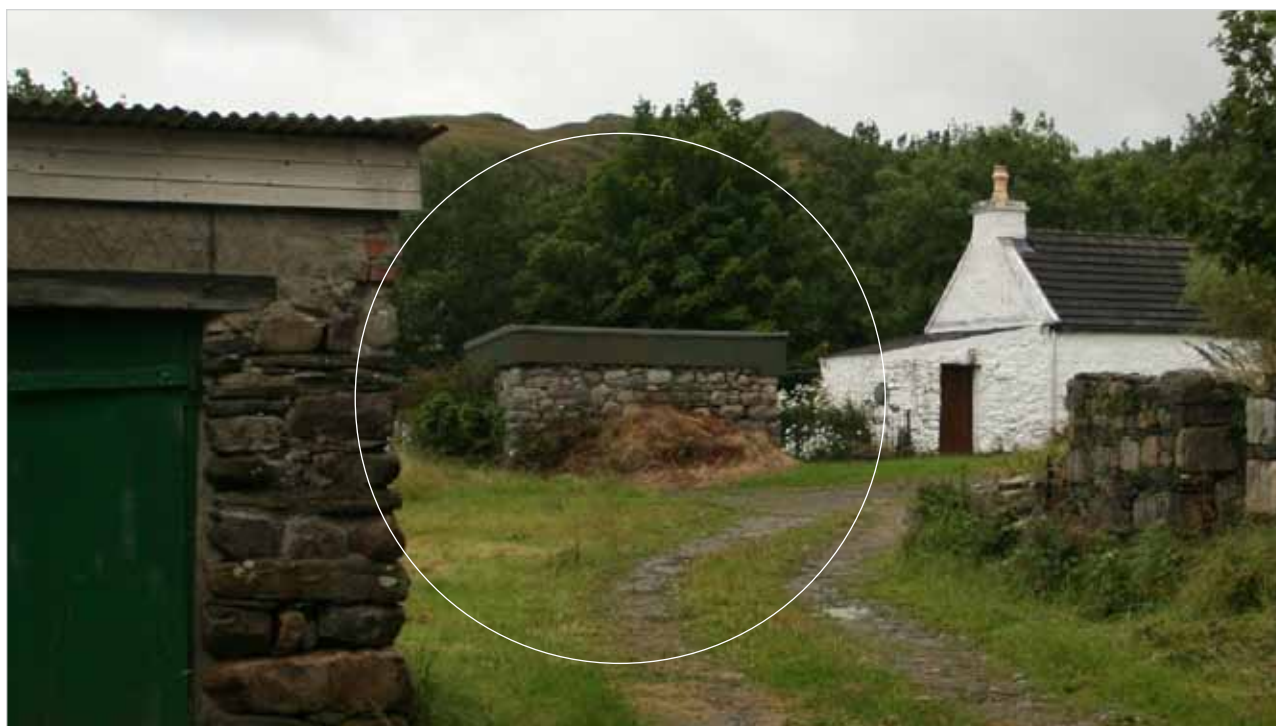
Additional Notes: The former byre under the group listing with Keils Cottage was formerly thatched. The listed building description reads 'Byre to east, now partially ruined. Single bay remains. Dry-stone walls, dressed quoins remain at north. Infill wall on ruined gable end with remnants of lum. Very rough roof trusses, thatched roof. What is left of the building has been re-roofed and no thatch remains. It is unclear whether the building is still being used in any way.....

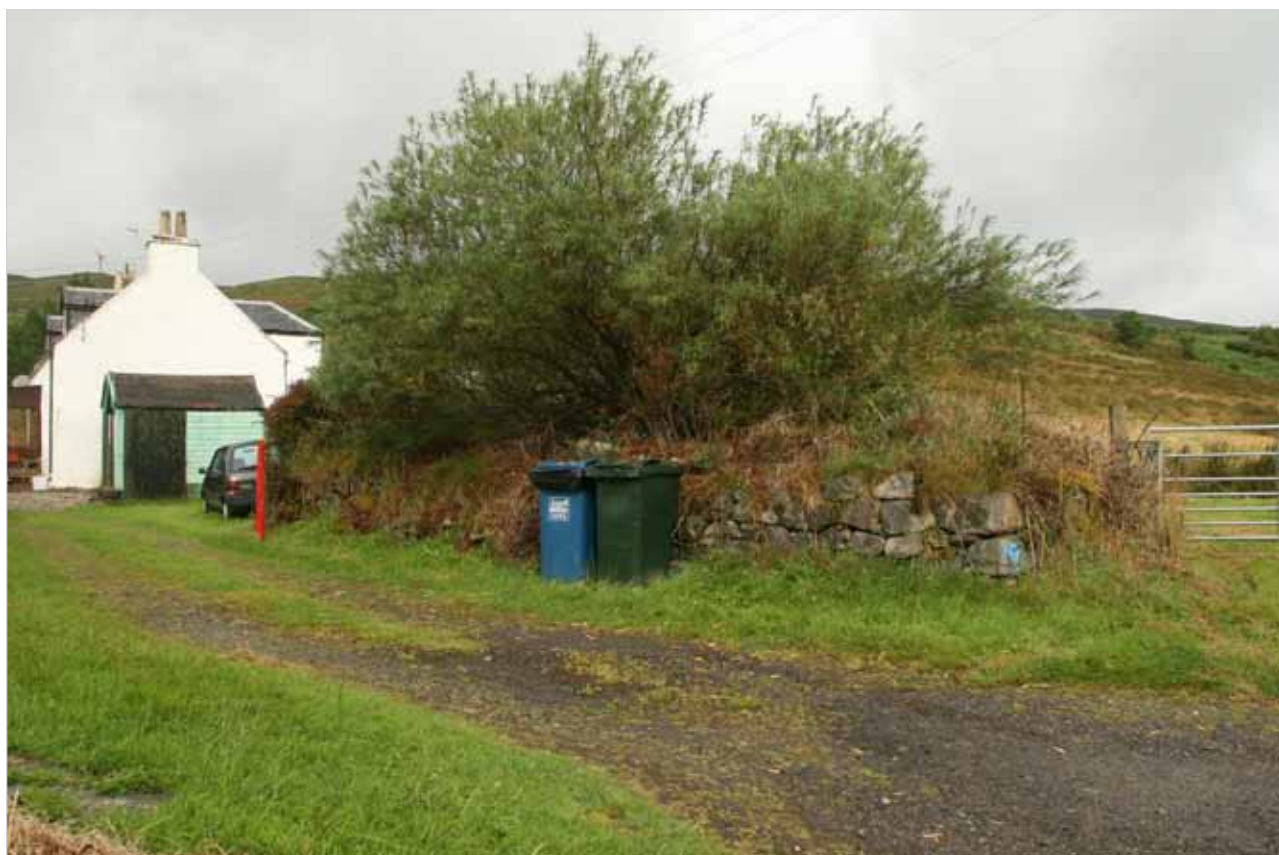
Additional Notes: Listed building description reads '*Probably early 19th century. Single cell store with entrance on gable end. Dry-stone walls. Thatched roof.*' The building is now a roofless ruin and is heavily overgrown with vegetation. The building's shell only survives up to a few feet in height and none of the roof structure remains.

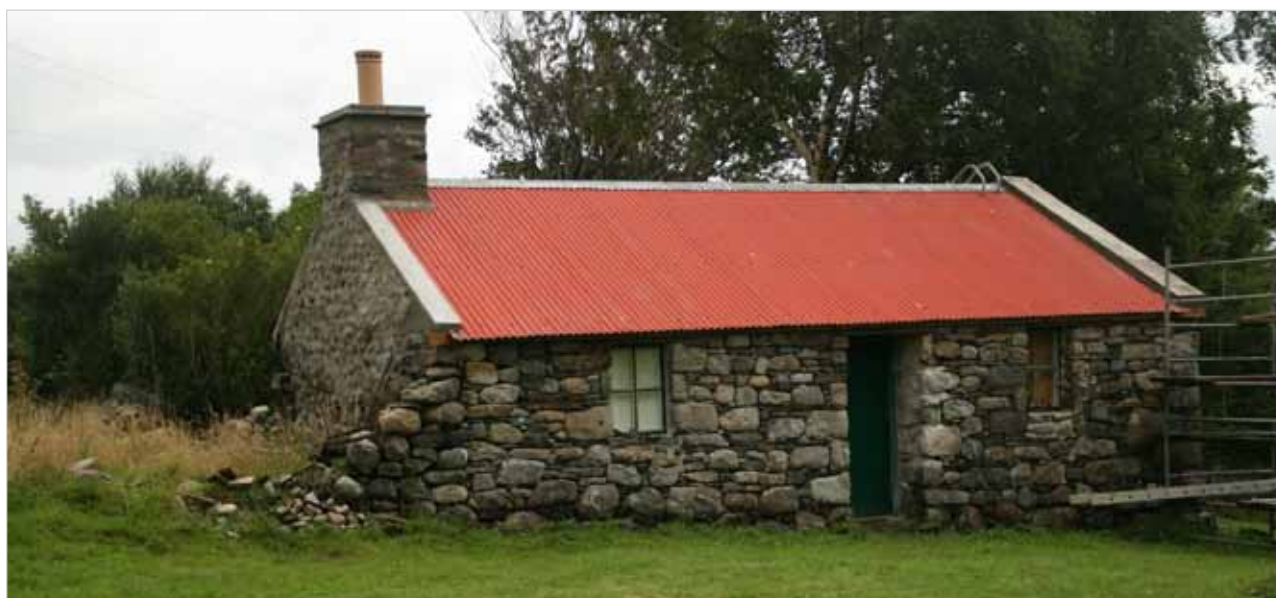
Additional Notes: The building was added to the Buildings at Risk Register in 2010 (BAR reference number 4601) and was last inspected by BAR in 2012. In 2009 the building was recorded as '*a ruined shell in the slow process of collapse*', however it was moved to status 'Restoration in Progress' by 2012 after having '*partial wallhead consolidation and the insertion of a new door and window*'. Since then, the building has been restored further and a corrugated iron roof has been installed. The building is now weather tight and is being used as a store and workshop by the owner. The listing description for the building, which states that it has a thatched roof, should be updated accordingly.....

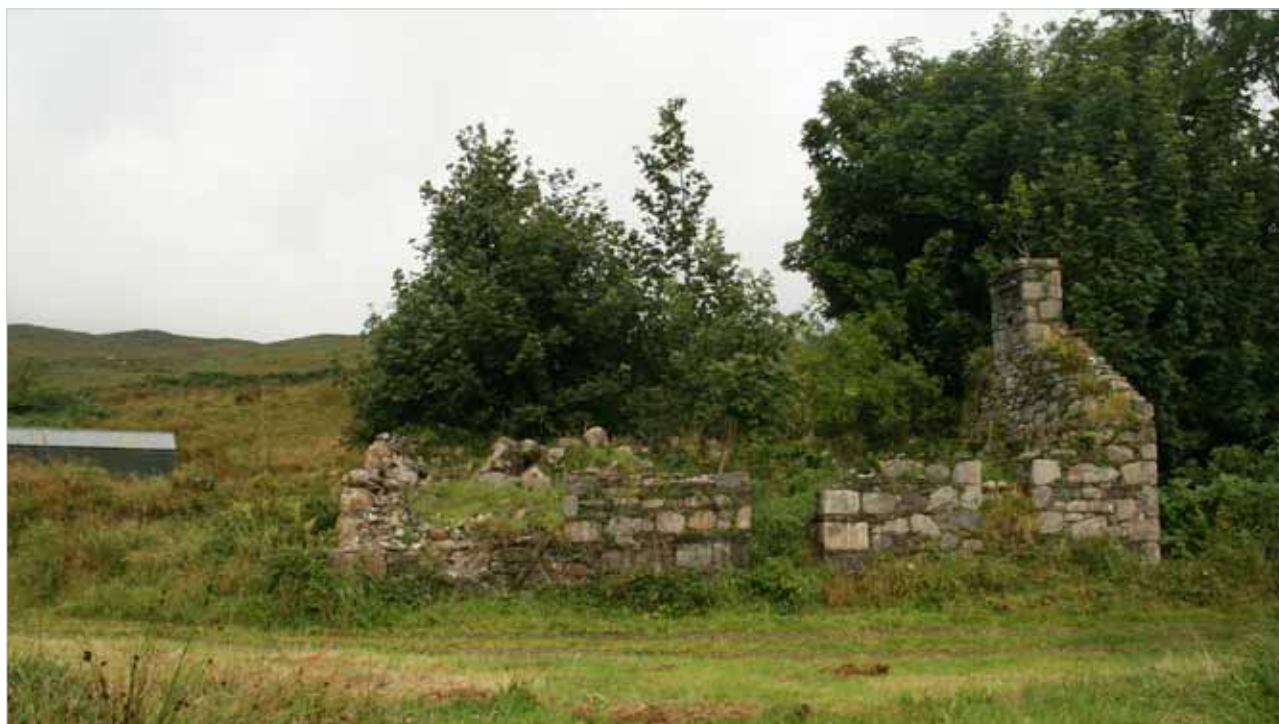
Additional Notes: Early 19th-century single-storey cottage, which has been on the Buildings at Risk (BAR) Register since 2010 (BAR reference number 4603). BAR inspection notes from 2009 and 2012 describe the building as 'a roofless shell'. Comparing images from BAR inspections in 2012 to the current condition, the building has deteriorated even further, with the south gable and chimney stack having collapsed. The listing description for the building, which states that it has a thatched roof, should be updated accordingly.....

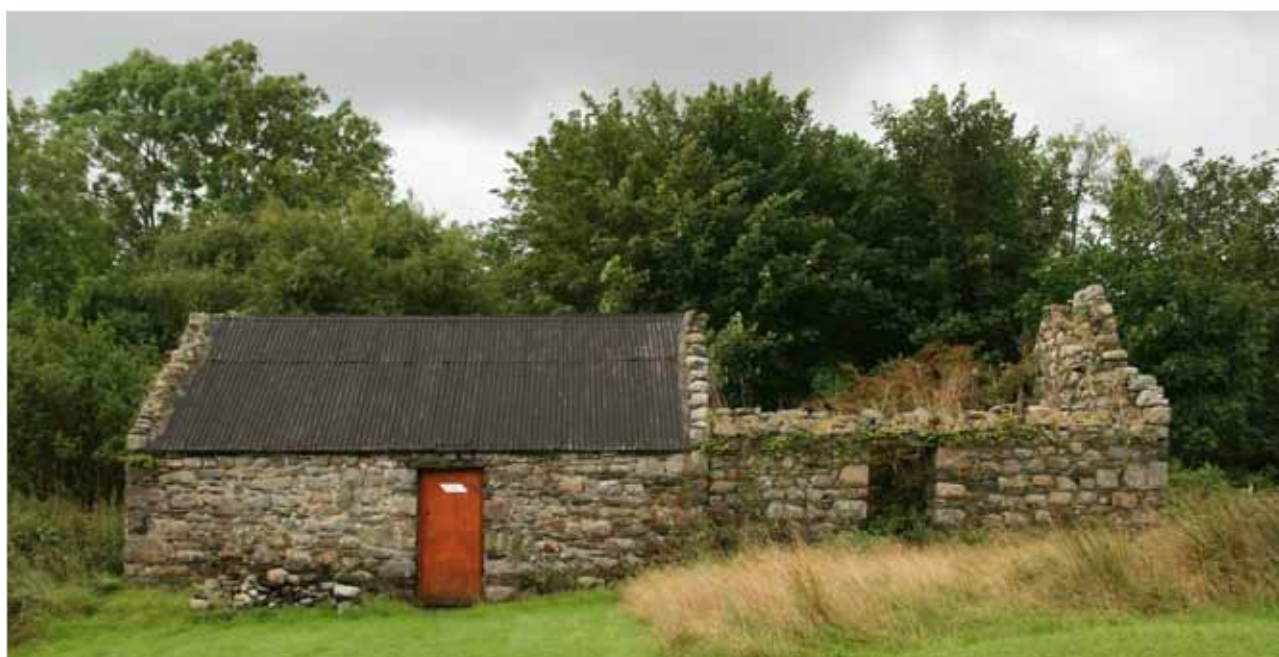
Additional Notes: Mid 19th-century byre with two compartments. Listed building description reads '*Pitched roof, formerly thatched, now corrugated iron*'. It has been on the Buildings at Risk (BAR) Register since 2010 (BAR reference number 4598). BAR inspection notes from 2009 read '*one part of the building re-roofed and in use as a store, the remainder though is a roofless shell and deteriorating*'. There has been no significant change since this description and there is no sign of any thatch remaining. It was previously in use as a farm building but is now partially used as a store. Signage on the door of the east compartment reads '*I. Bull Lane*'.

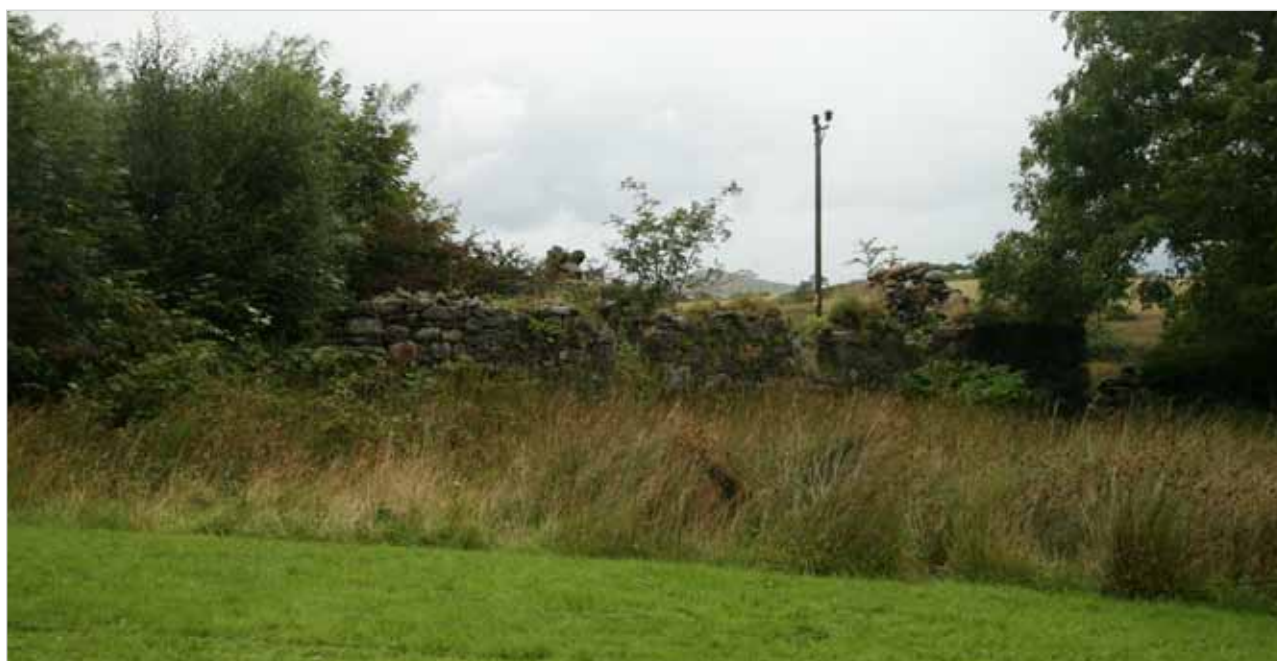
Additional Notes: The listed building description reads '19th century byre, half now ruined. Rubble-built with roughly dressed quoins and jambs. Entrance with window to west on south elevation. Surviving part thatched. The building is now a complete ruin and none of the roof structure or thatch remains. The building has been on the Buildings at Risk Register since 2010 (BAR reference number 4602) and upon inspection in 2009, BAR noted that 'External inspection finds the formerly thatched building now in an advanced state of collapse', with no significant changes recorded in 2012.

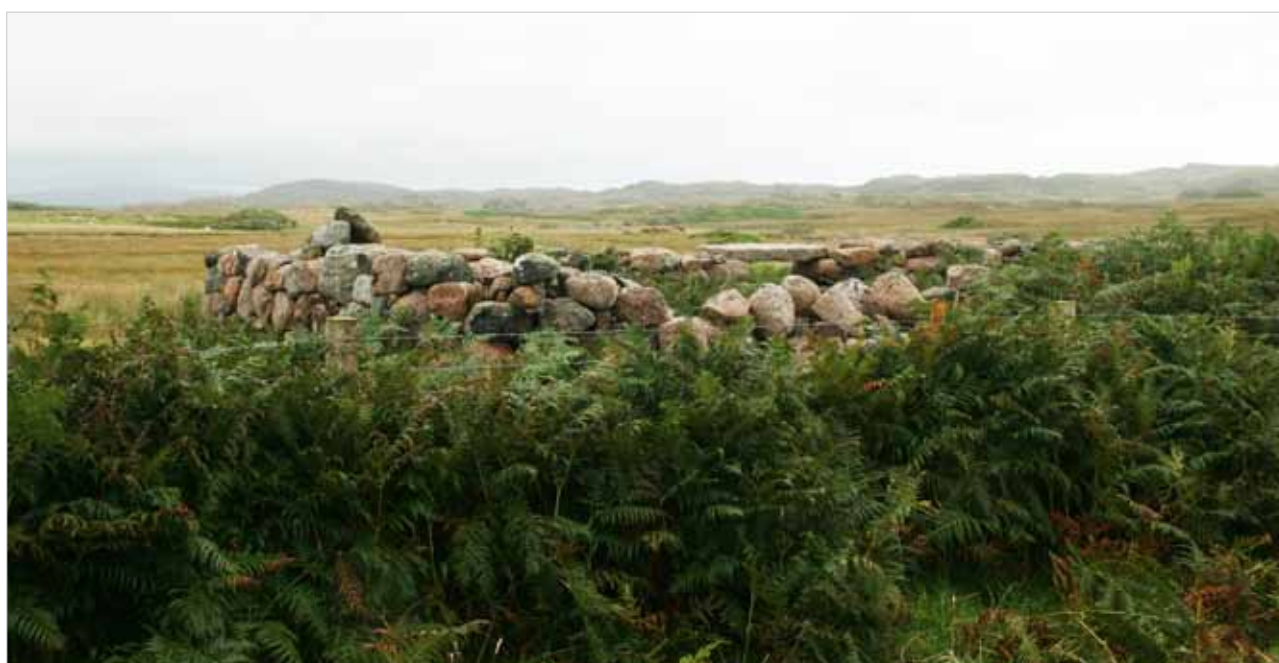
Additional Notes: The listed building description reads '*Small Highland cottage (Skye type). Straw-thatched roof with piended ends. Chimney-vent at W end*', however, the listing notes simply read '*derelict*'. The building is now a ruin, the rubble walls survive up to around the height of the door lintel and the whole site is overgrown with vegetation. Canmore records from a visit to the building in 1980 note that the '*Thatched cottar's house [...]* probably dates from the first half of the 19th century; it was occupied until about 1968, but has deteriorated rapidly since that date'.
