A Survey of Thatched Buildings in Scotland

Thatch Survey of Scotland
2014-15

A photographic survey of thatched buildings in Scotland, surveyed between May 2014 and August 2015 by Zoe Herbert (SPAB Scotland Officer), on behalf of the Society for the Protection of Ancient Buildings.

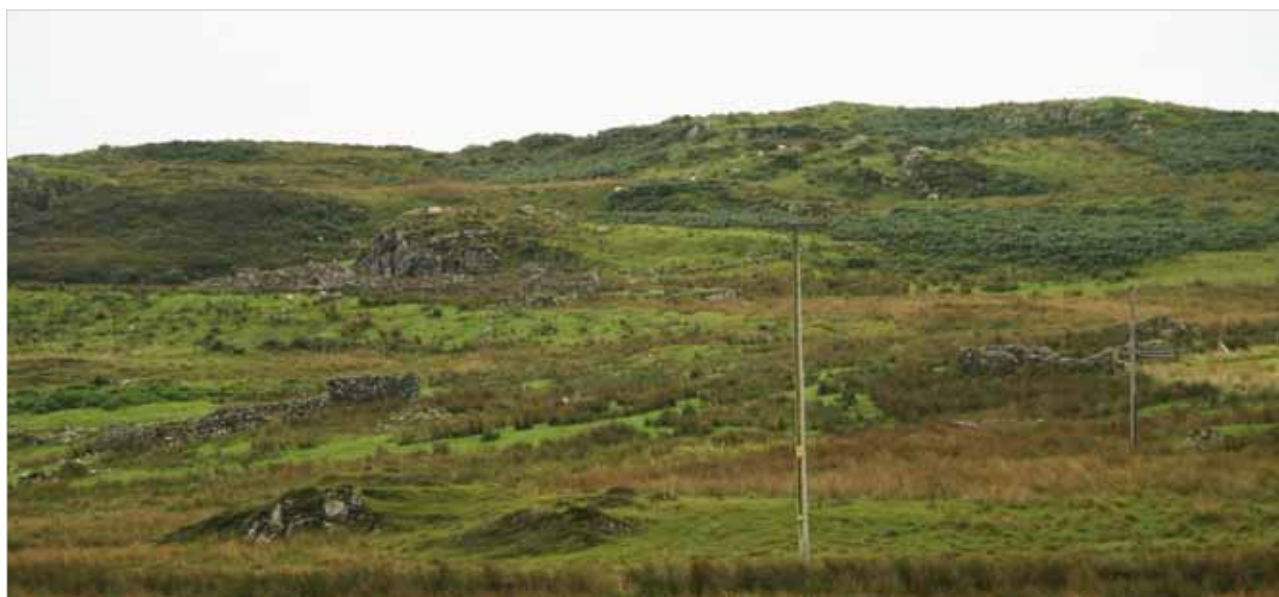
Additional Notes: Due to the highly ruinous nature of the site and the adjacent ruined buildings, it is unclear exactly which building footprint relates to this building, however, no thatch remains on the site. The building was surveyed in the Argyll & Bute District Council Thatched Buildings Survey of Tiree, Coll & Mull in 1985 (Entry Number 26, named 'Bra Cottage'). Here it is noted as being '*The last thatched building left on Mull*', and at the time was thatched in rushes with a muran grass ridge and a turf underlay. The materials were apparently cut from the Island and the building was last re-thatched by the owner six years prior (circa 1979). The listing description for the building, which states that it has a thatched roof, should be updated accordingly.....

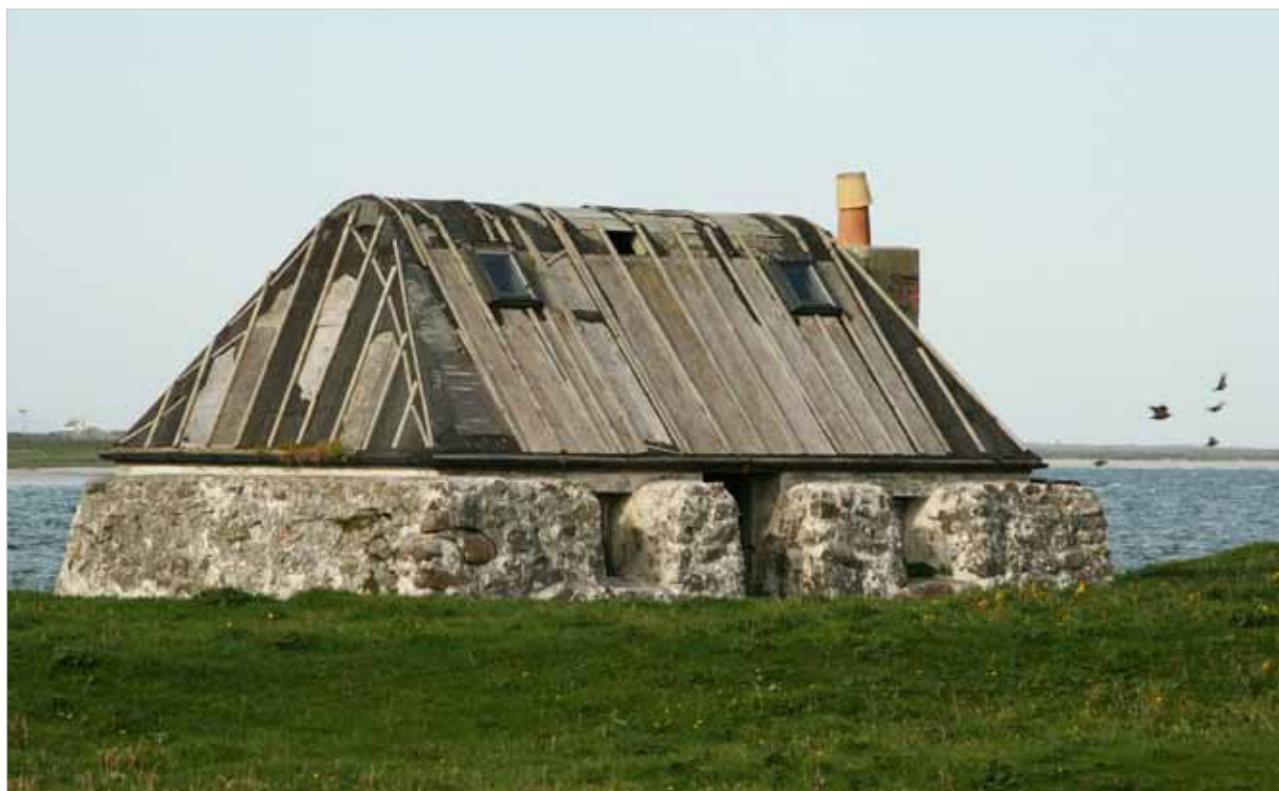
Additional Notes: The listing description for the property reads '*19th century traditional single storey 3-bay cottage with centre door, rubble-built, wide eaves ("tobhta"), 1 gable end stack; piended tarred felt roof with small skylight*'. It does not state whether the building was originally thatched, although this is probable. The building is currently on the Buildings at Risk Register (BAR reference number 3881).

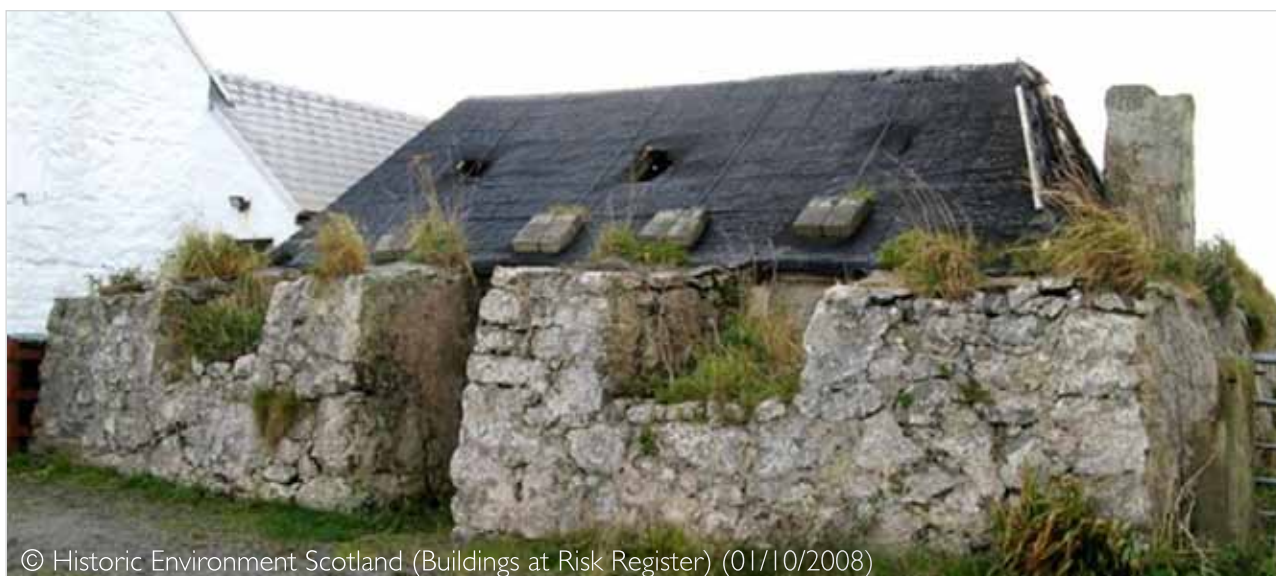
Additional Notes: The listed building description reads '19th century traditional single storey cottage 3 bays with centre door. White-washed rubble with square angles, wide eaves ("tobhta"); gable end stacks: piended green felt roof', however, the notes section states 'felt replaces thatch'. This confirms that there was once thatch on this building; however, web-based satellite imagery confirms there is no longer any thatch left. The building has been on the Buildings at Risk (BAR) Register since 2009 (BAR reference number 3894) and site visits by BAR note that the roof structure and felt was removed at some point between visits in 2008 and 2012. No photographs were recorded during the visit.

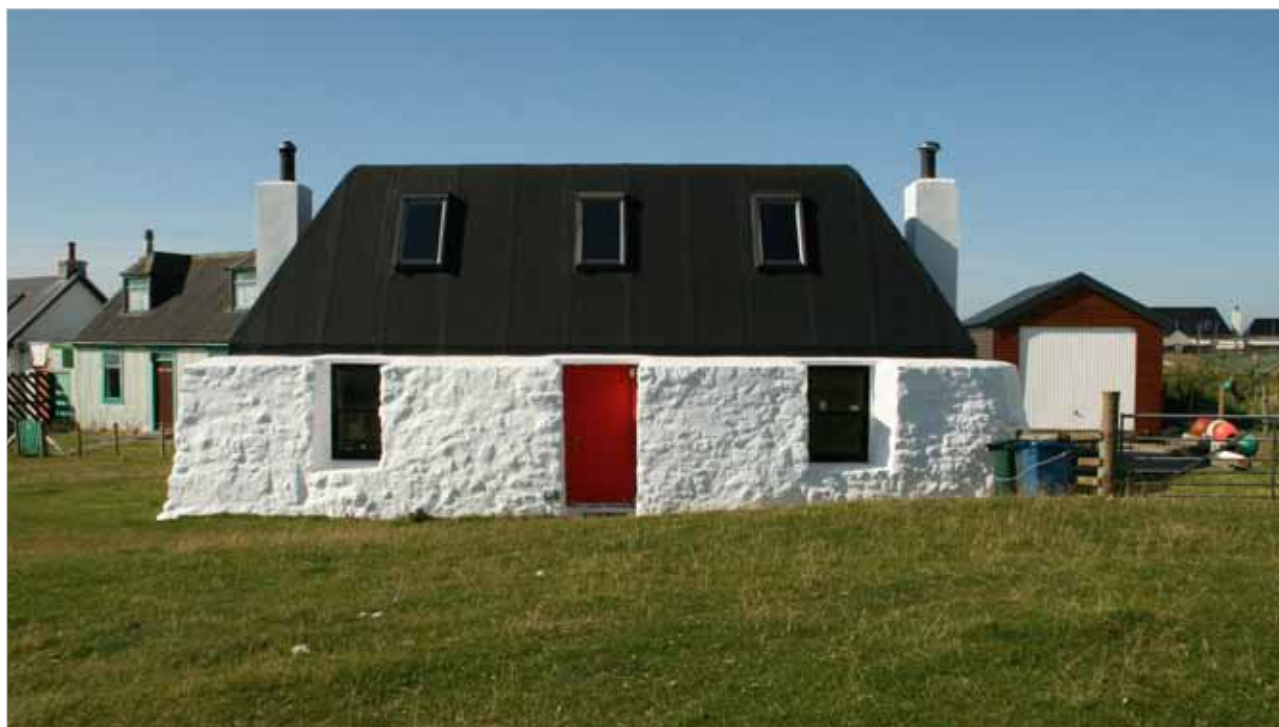
Additional Notes: 18th-century cottage, listed as having a '*piended thatched roof*'. The building is no longer thatched, and now has a tar felt roof with sky lights. This building is entry number 21 in the Argyll & Bute District Council Thatched Buildings Survey of 1985, where it is reported to have been '*long derelict and roof has fallen in*'. According to the 1985 survey it was last occupied in 1969 and maintenance to the roof had ceased during the 1970s. The listing description should be updated accordingly.....

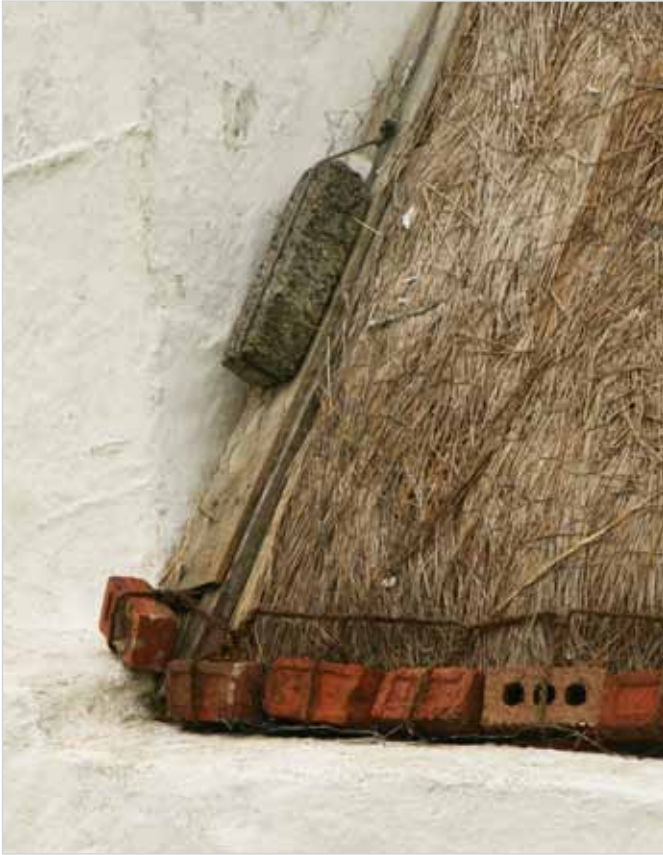
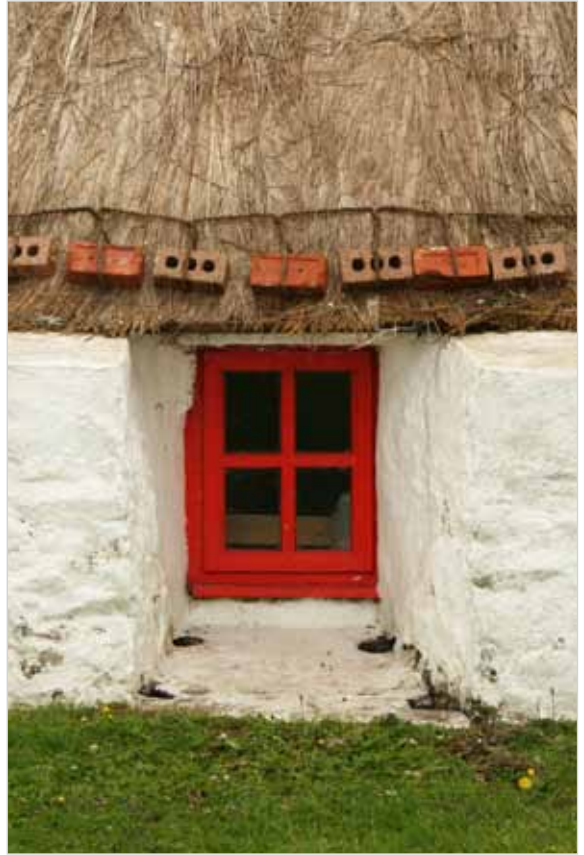
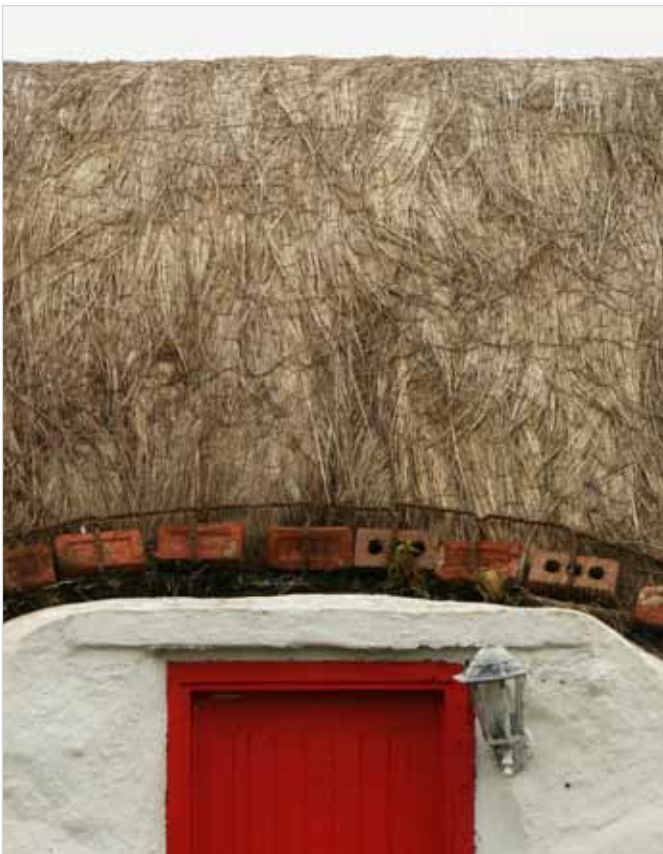
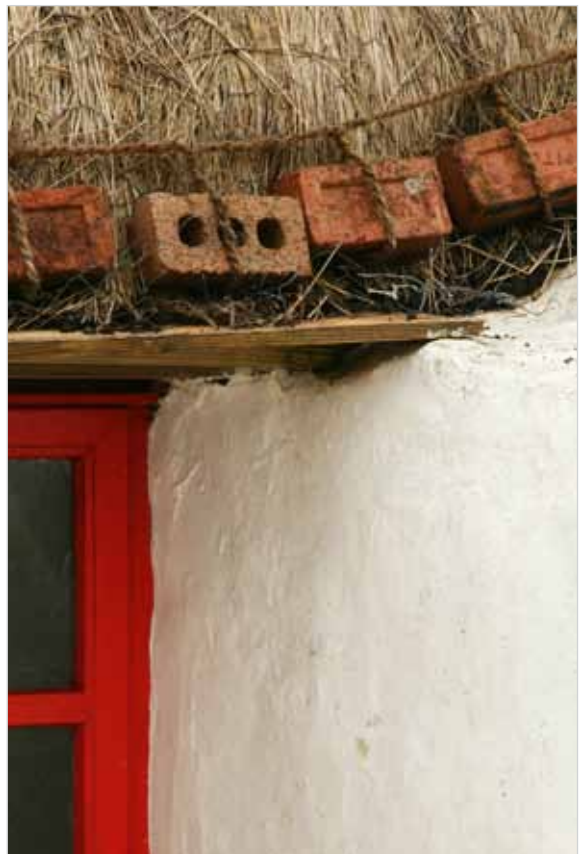
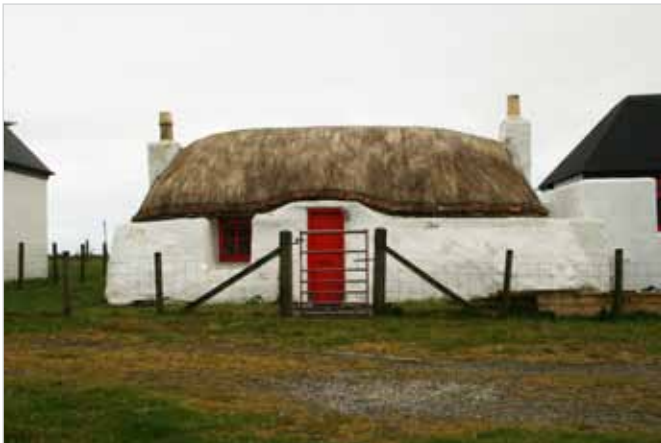
Pierview Cottage – Argyll & Bute

Condition: Good

The roof is currently thatched in marram with a continuous marram-thatched ridge. The entire roof has been netted, including across the ridge, which has been weighted down using a string of bricks and thin ropes around the roof just above the wallheads, including above openings but not around the chimney stacks. The netting has been weighted around the chimney stacks with planks of wood, held down by breeze blocks and thin ropes, to provide additional protection at this slightly more vulnerable junction of the thatch. A wooden board has been

installed above the window opening on the front elevation only.

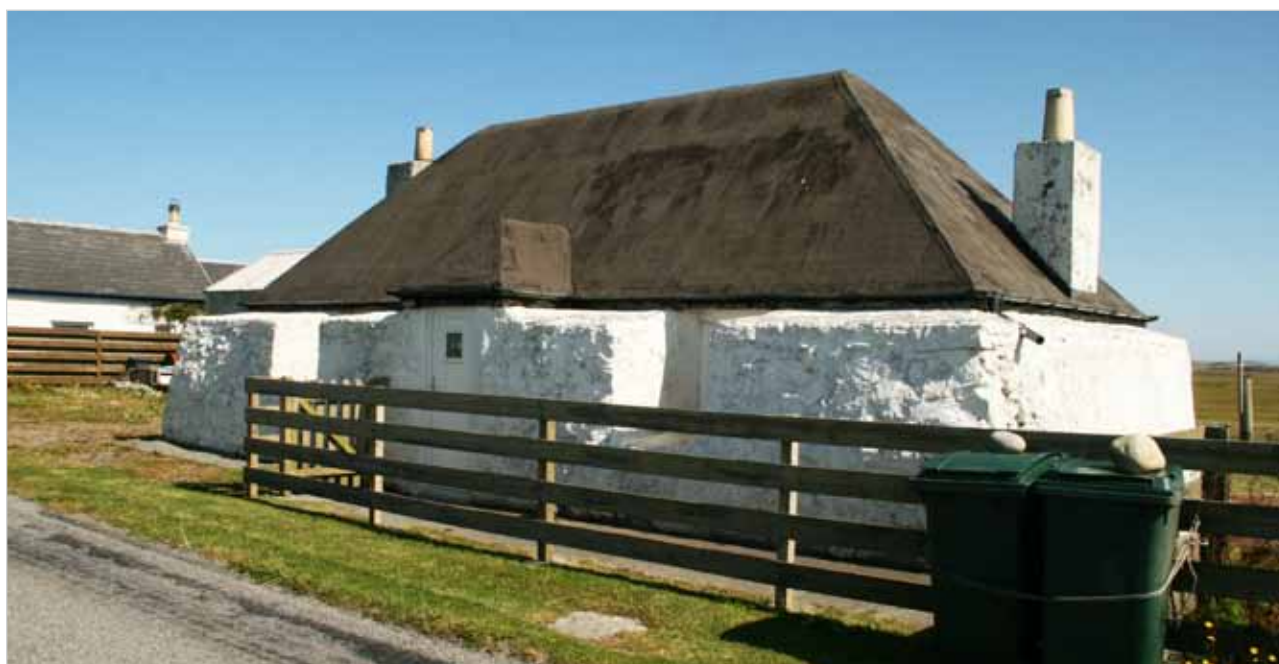
Additional Notes: The building at the location associated with the listing now has a black top roof and is no longer thatched. It has also had a modern extension added to the back. Its listing description reads '*19th century, traditional single storey 3 bay cottage: rubble, partially cemented, white-washed: wide eaves ("tobhta"); gable end stacks: piended thatched roof*'. The building is noted in the listing as being entry 7 in the Argyll & Bute District Council Thatched Buildings Survey (1985), however, this information appears to be incorrect (the property at 3 Kilmoluaig is entry 7).

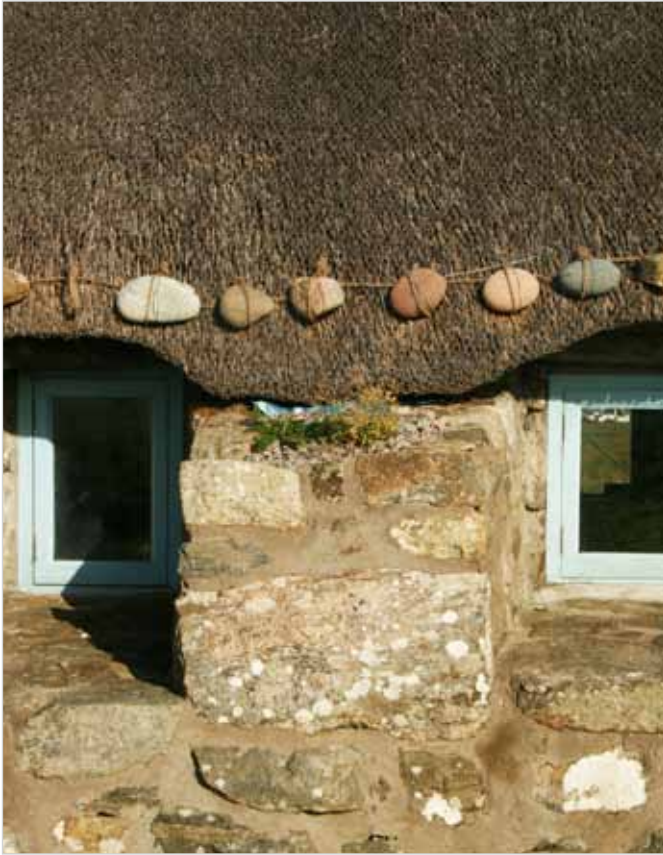
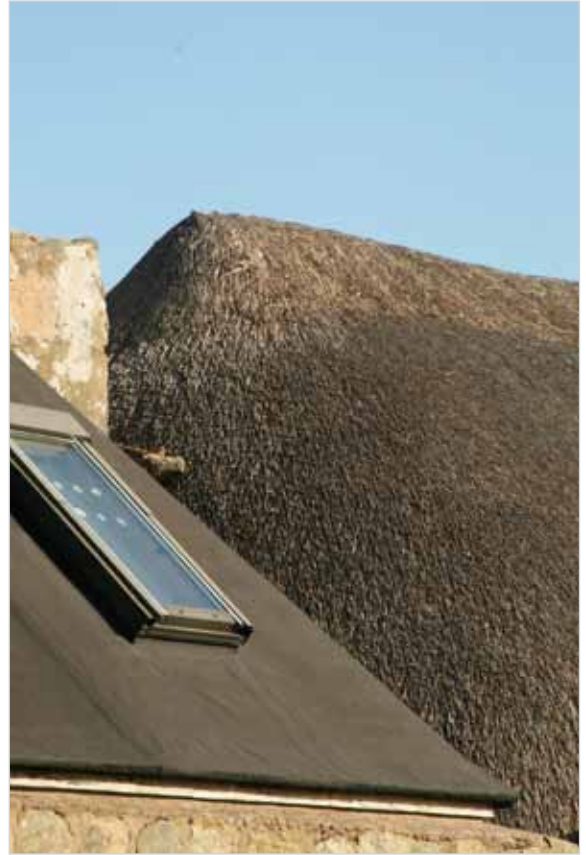
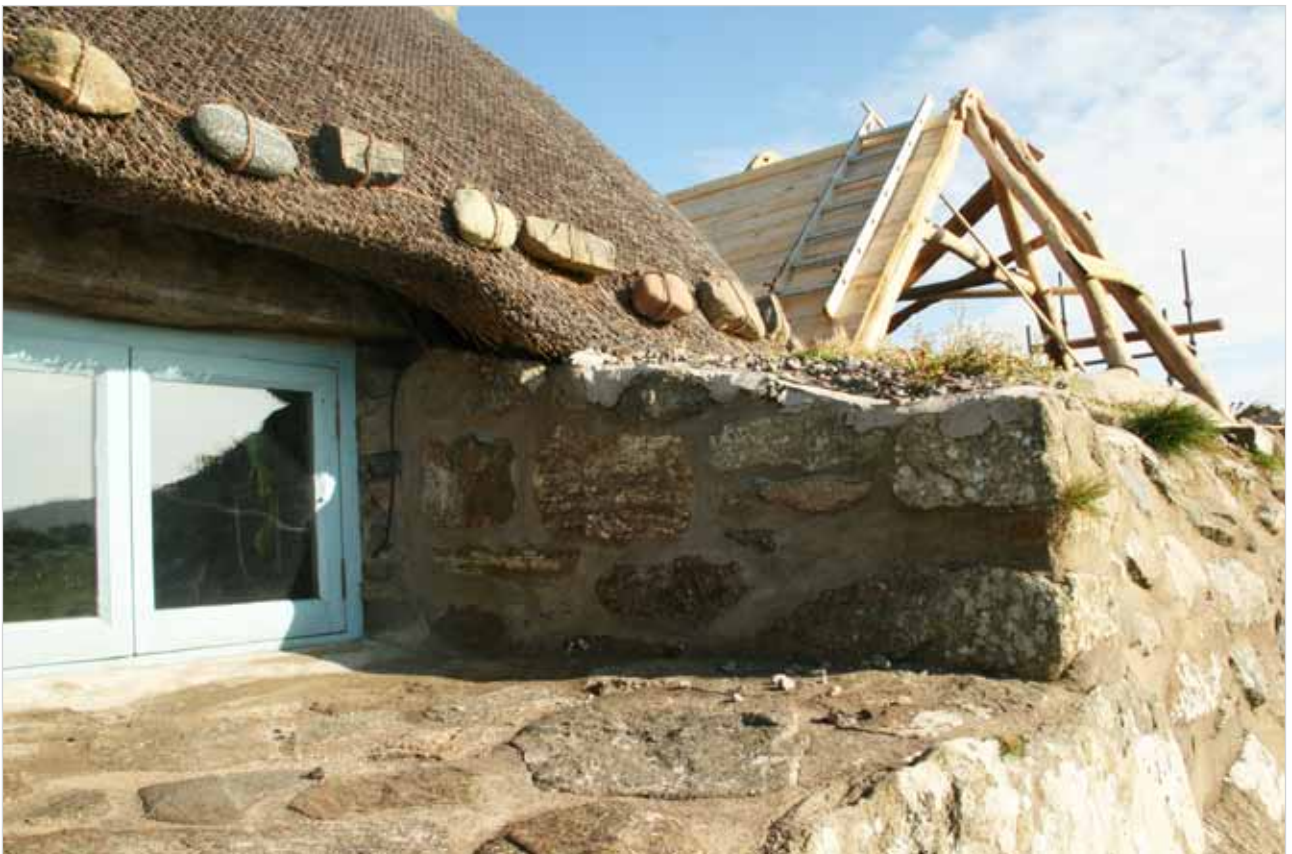
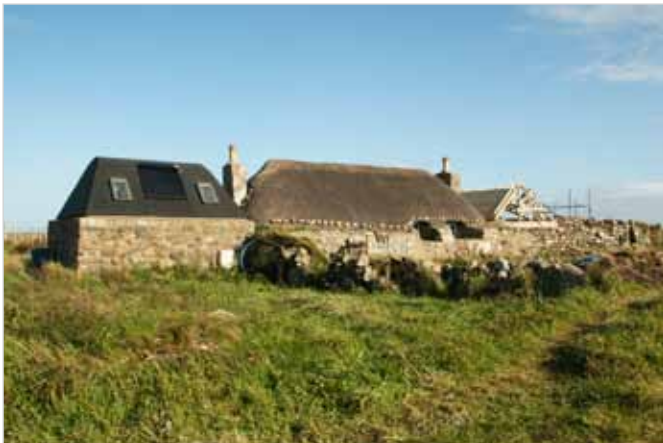
Cnoc Bhiosta – Argyll & Bute

Thatch Type: Unknown
 Ridge Type: Thatched
 Condition: Good

Additional Notes: This early 19th-century cottage is listed as being flanked by byre/barn at each gable end and having '*piended thatched roofs to cottage and one barn; tarred felt to second*'. The barn to the north has a felt roof, whilst the barn to the south is in a ruinous condition, though the owner is in the process of restoring the south barn and building a new roof. The main cottage remains thatched. The whole roof, including across the ridge, has been netted and weighted down using thin ropes and stones. The stone weights run around the entire circumference of the building just above the wallhead, openings and around the chimney stacks at either end.

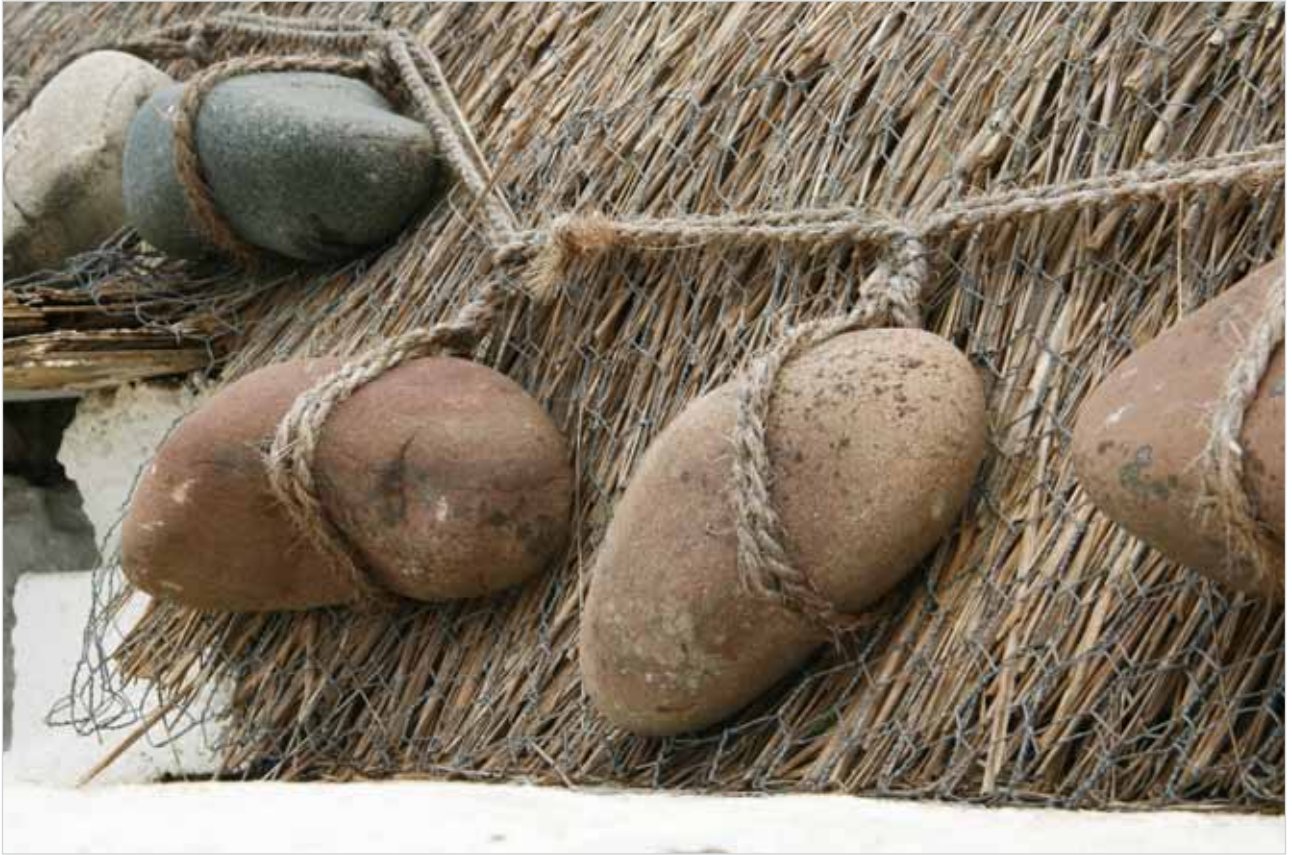
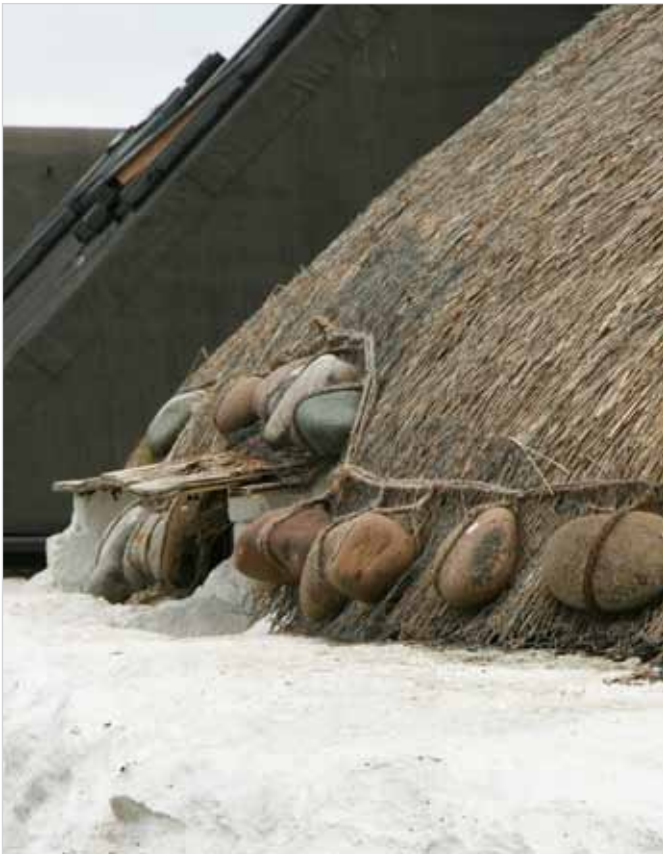
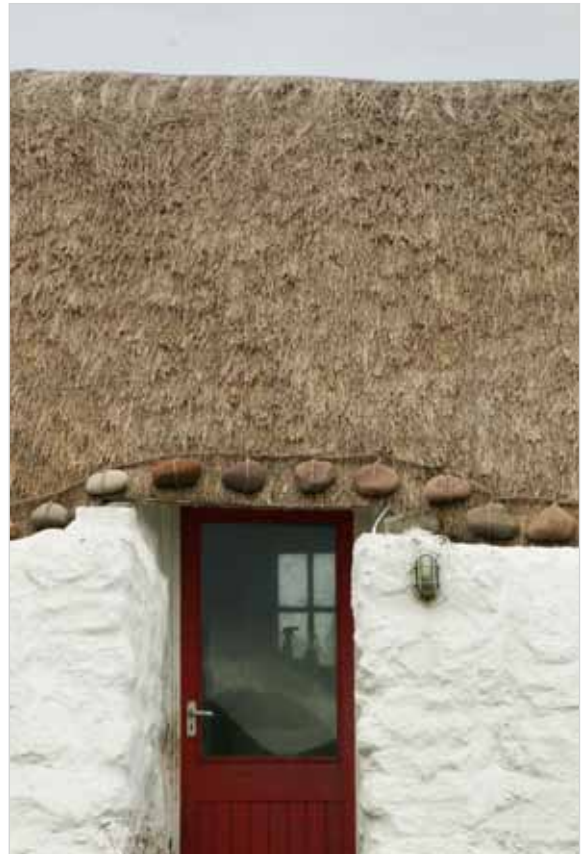
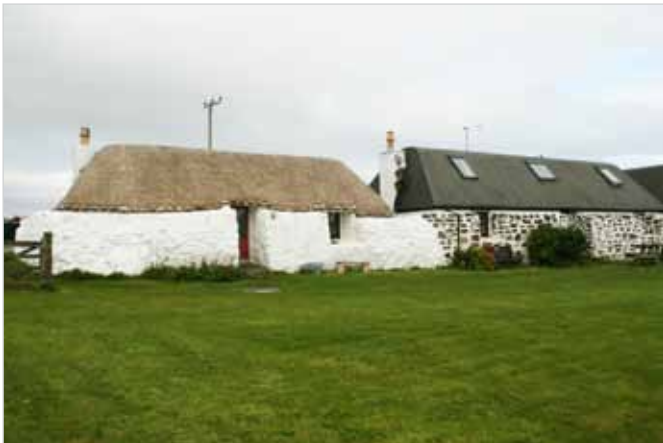
3 Kilmoluaig – Argyll & Bute

Thatch Type: Marram
 Ridge Type: Thatched (Marram)
 Condition: Good

Additional Notes: From what can be understood of the listing description and accompanying notes, there were, at the time of listing in 1981, two thatched roofs at this site. The 19th-century cottage is listed as having 'piended thatched roofs', and the listing notes read '*original dwelling renovated and re-roofed in substantially traditional fashion in 1981. Adjoining byre demolished and now thatched dwelling in substantially traditional style built on site.*' Exactly which other roof was thatched at this time is unclear; however, now only the roof to the south cottage is thatched, in marram with a continuous marram ridge. The entire roof has been netted, which has

been weighted down with stones and thin ropes just above the wallhead, openings and around the chimney stack to the south gable. Wooden boards have been installed above the door and window openings.

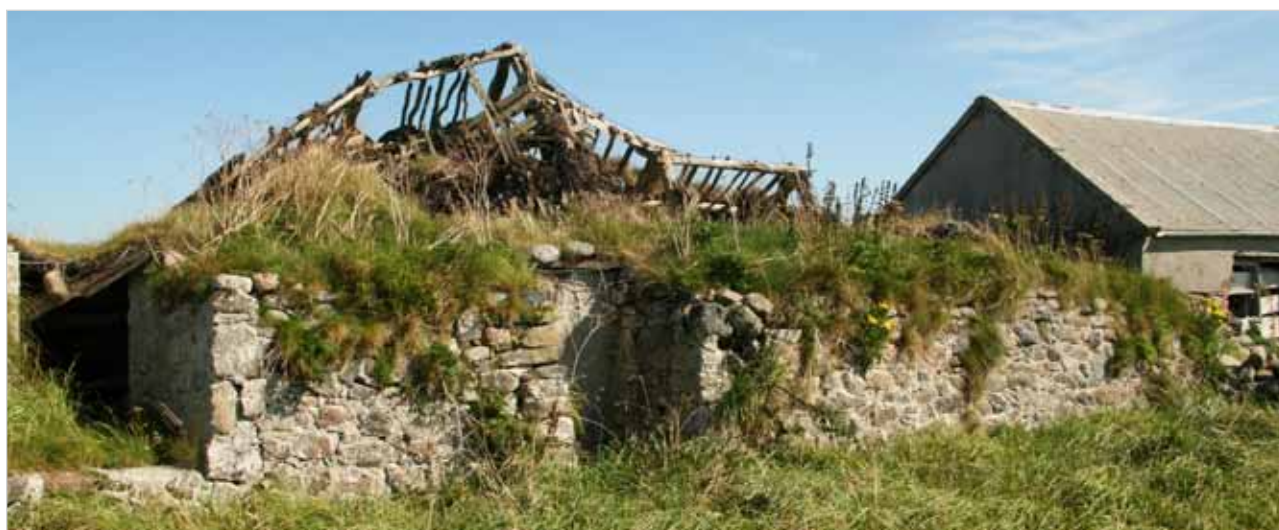
Buildings At Risk: Yes

Additional Notes: Listing description reads '*Earlier 19th century traditional single storey 2 bay cottage. Single chimney to north gable: piended thatched roof with thatch overhanging eaves. Corrugated iron roofed extension to west*'. Noted in the Thatched Building Survey of Tiree, Coll and Mull (1986) as being recently re-roofed and re-thatched in 1983-4, and only recently vacated by a family at that time but in use as a store, with apparently an interconnecting passage to the new build through the south gable. The roof structure has mostly collapsed, along with the thatch. There remains some highly deteriorated evidence of thatching material as well as netting, and what remains is heavily overgrown with vegetation. It has been on the Buildings at Risk Register since 2009 (BAR reference number 3875).

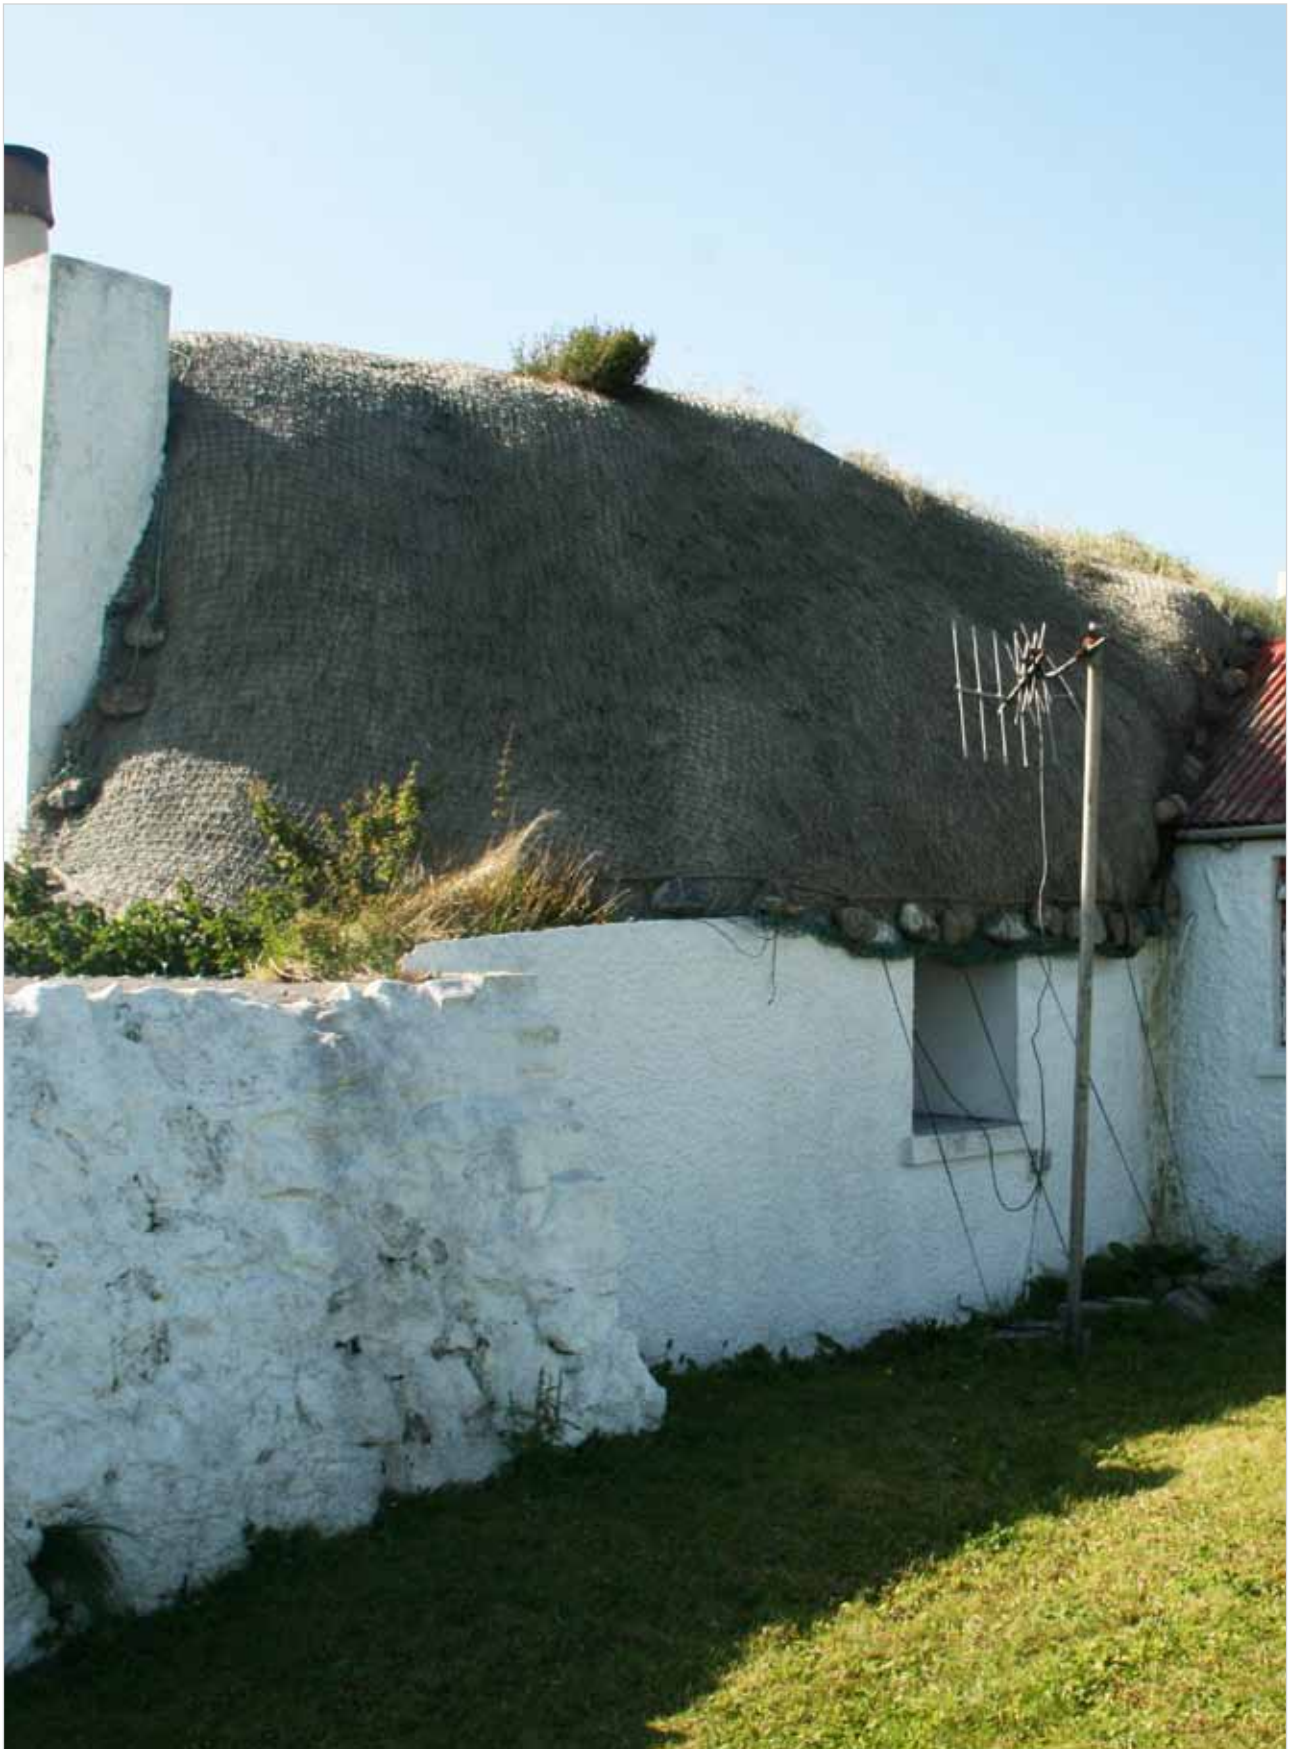
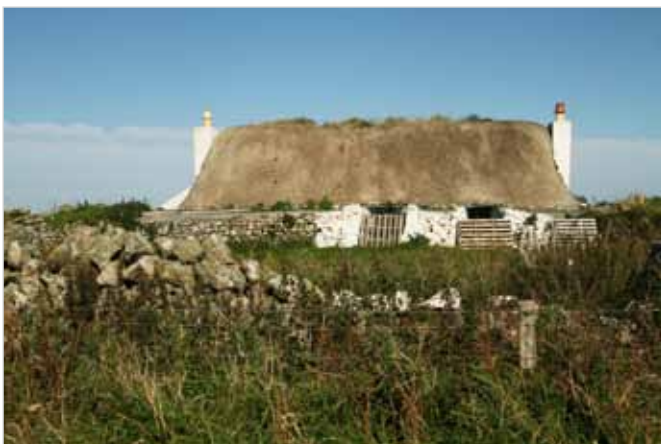
7 Balevullin – Argyll & Bute

..... Fair

19th-century cottage listed as having a 'thatched piended roof with 'modern gabled porch'. The roof is thatched in marram with a continuous marram ridge. The entire roof has been netted with fishing net, including across the ridge, which has been weighted down with stones and thin rope just above the wallhead and around the chimney stacks and adjoining porch roof. Additional weighting has been installed on the front (east) elevation in the form of breeze blocks placed upon the ground and attached to the base of the netting by string. The thatch itself is in good condition; however, there is some grassy vegetation growth along the ridge and where the thatch meets the wallheads.

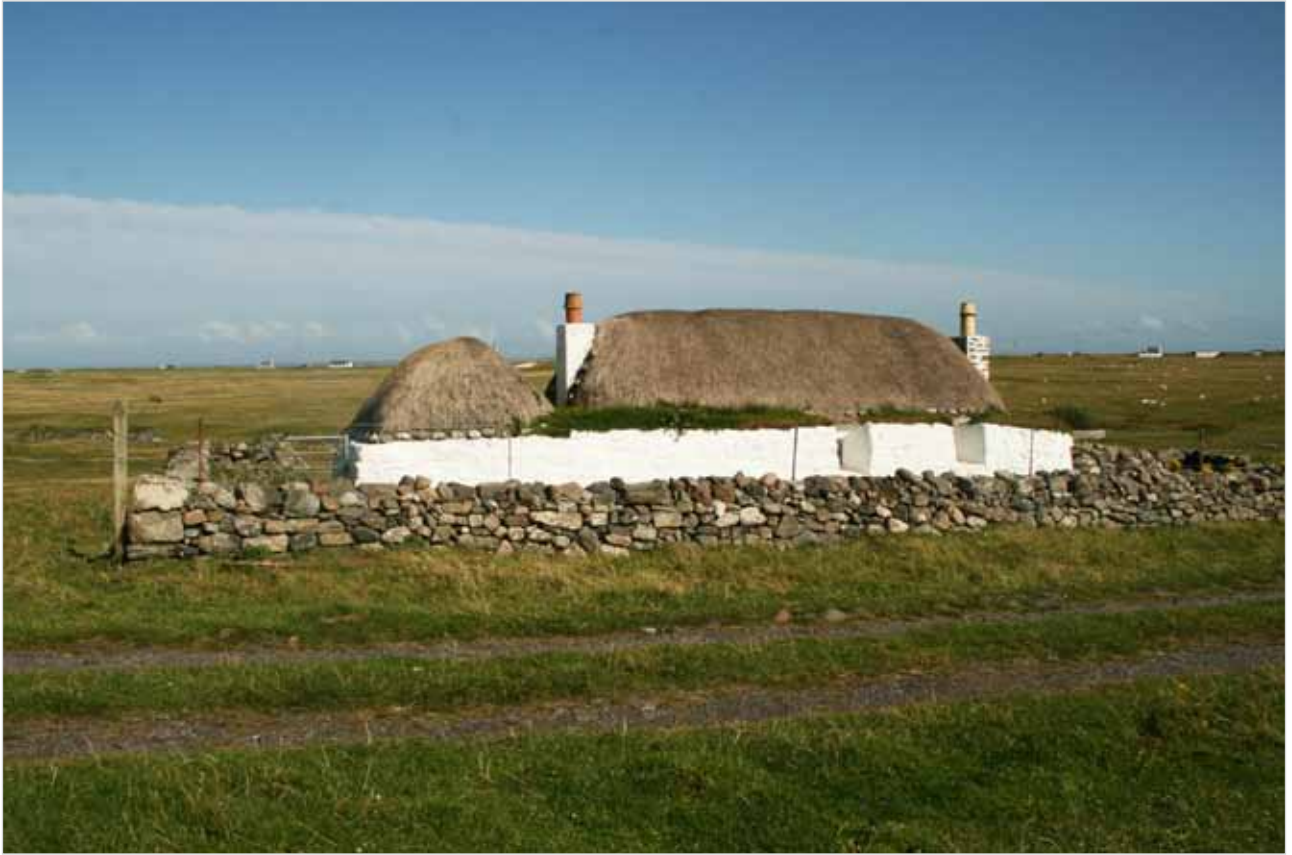
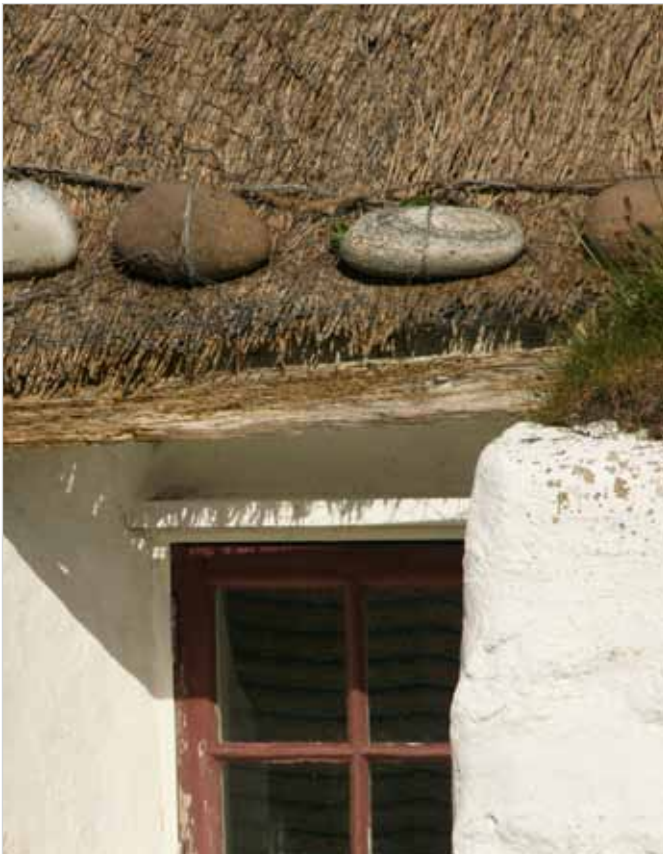
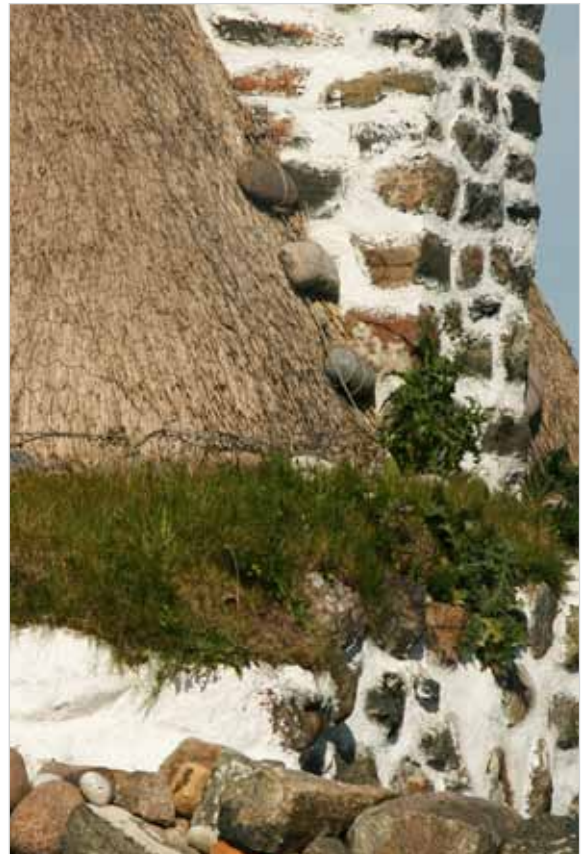
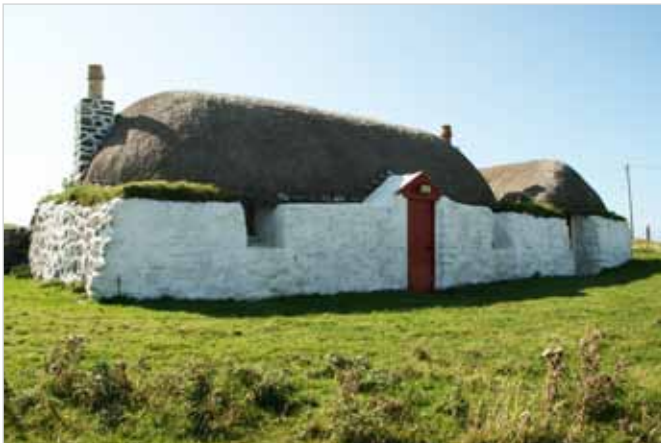
Balevullin Cottage – Argyll & Bute

19th-century cottage with adjoining byre to the north, both listed as having a 'thatched piended roof'. The roofs of both the cottage and barn are thatched in marram, each with a continuous marram ridge. Both roofs have been completely netted, including across the ridge, which has been weighted down with stones and thin ropes just above the wallheads and openings, and down the sides of the chimney stacks of the cottage. Turf has been placed upon the wallheads around part of the cottage and barn, whilst some parts of the wallheads have been left exposed. The notes of the listing entry record that the 'cottage [was] modernised

in 1982' and the barn was 'restored in traditional fashion in 1985'.

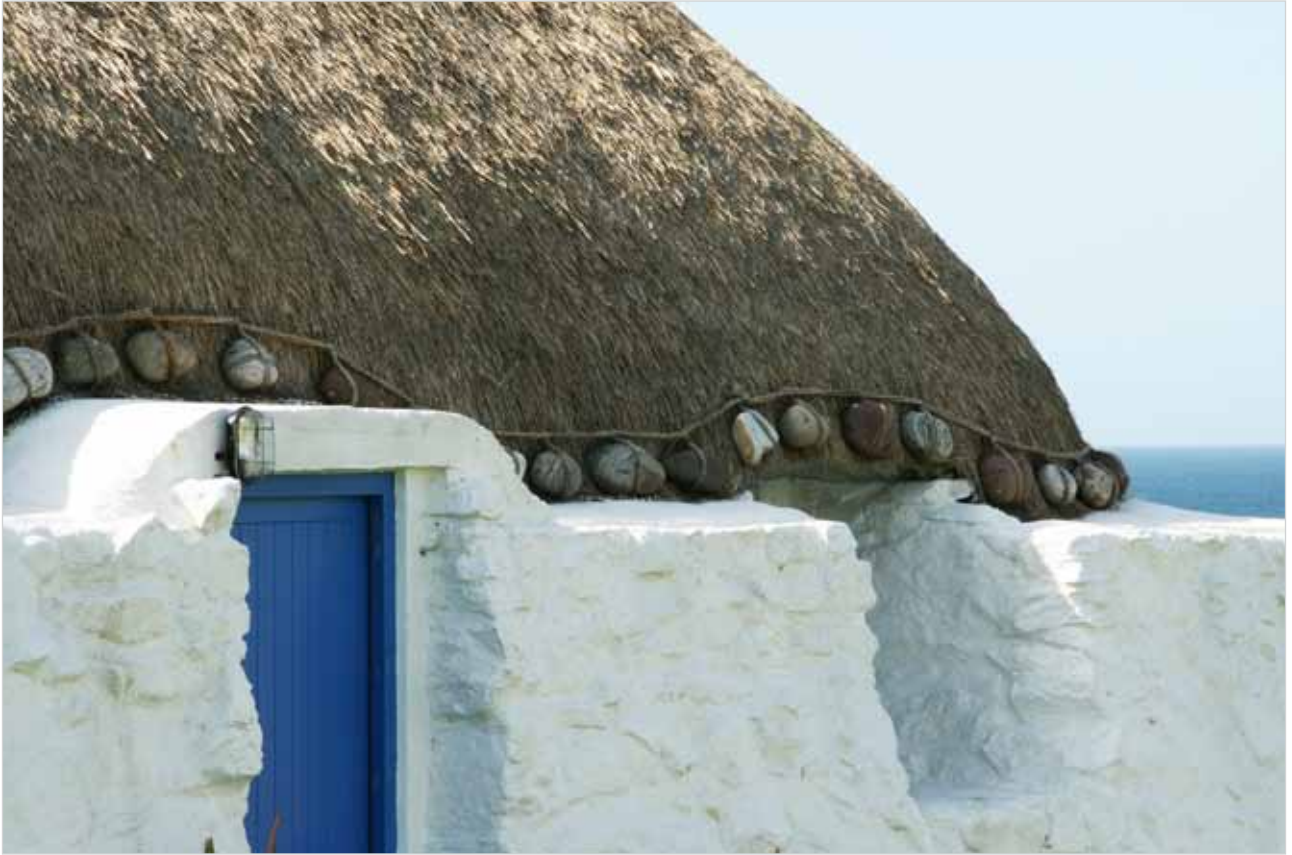
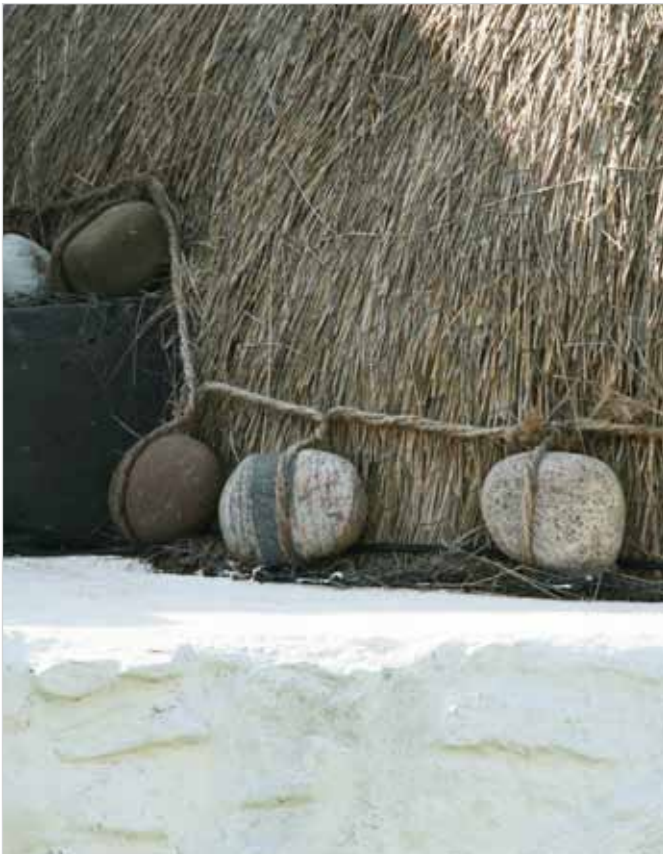
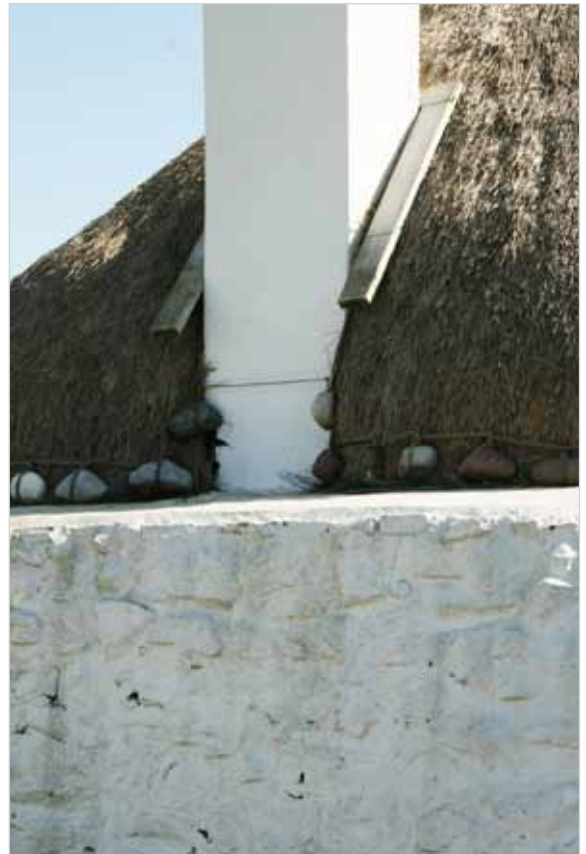
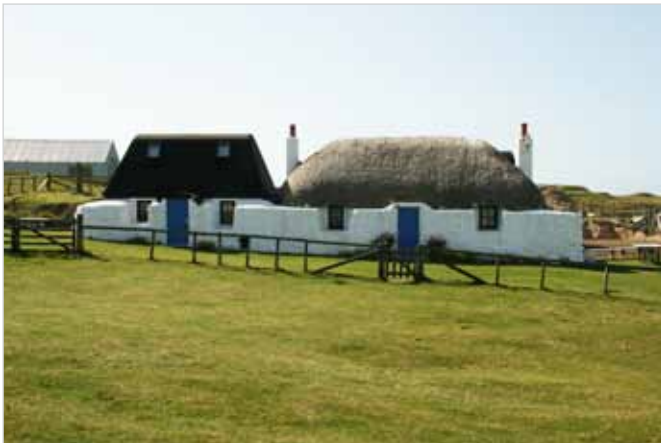
Creag Chrom – Argyll & Bute

19th-century cottage listed as having a 'piended thatched roof', with the listing notes reading 'cottage has been diminished in length adjoining shed not included in list'. The roof of the adjoining shed is tar felted, whilst the roof of the cottage is thatched in marram with a continuous marram ridge. The entire roof has been netted with a medium gauge netting, which has been weighted down just above the wallhead by rope and stones. The stones continue above the window and door openings, and across a section of the tar-felted roof of the adjoining shed. The stones do not go around either chimney stack; they run along the base of the south

stack whilst planks of wood have been used to weigh down the netting around the north stack, tied to the netting with string.
