A Survey of Thatched Buildings in Scotland

Thatch Survey of Scotland
2014-15

A photographic survey of thatched buildings in Scotland, surveyed between May 2014 and August 2015 by Zoe Herbert (SPAB Scotland Officer), on behalf of the Society for the Protection of Ancient Buildings.

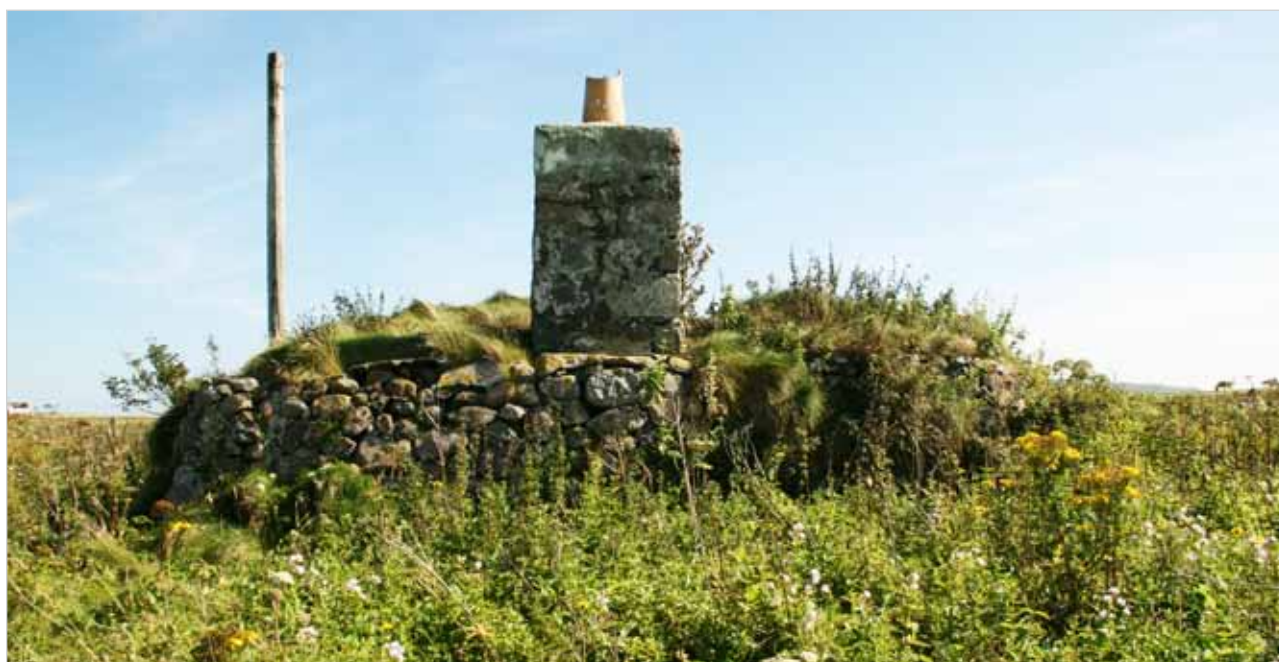
Address: Kilkenneth Cottage

Additional Notes: 19th-century single-storey cottage, listed as being thatched. The building, however, is now in a ruinous condition and no thatch remains. It has been on the Buildings at Risk (BAR) Register since 2009 (BAR reference number 3876) with inspection notes from this time stating the roof had already collapsed. The building is entry number 9 in the Argyll & Bute District Council Thatched Building Survey of Mull, Coll & Tiree (1986) where it is noted as having been derelict for many years with the roof being in an advanced stage of decay. The listing description should be updated accordingly.

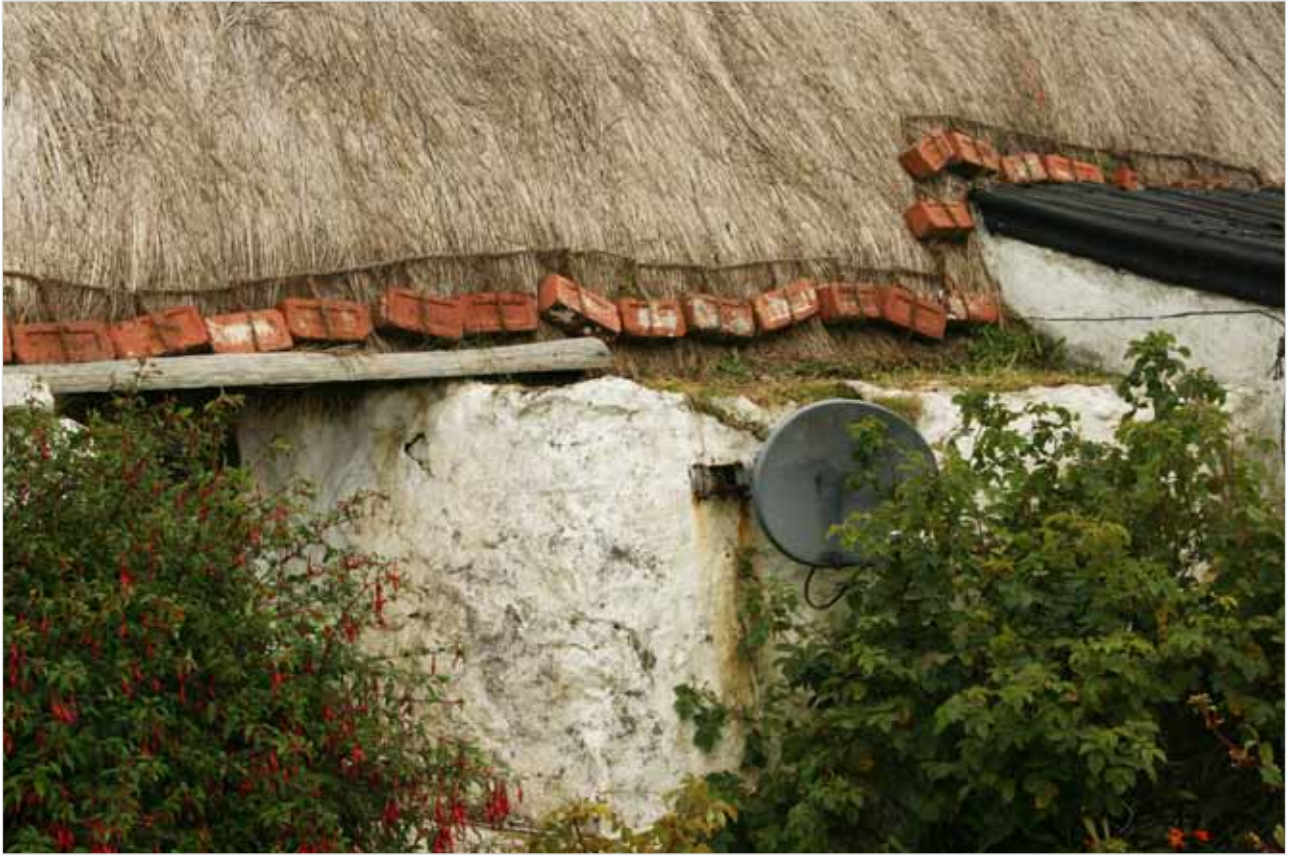
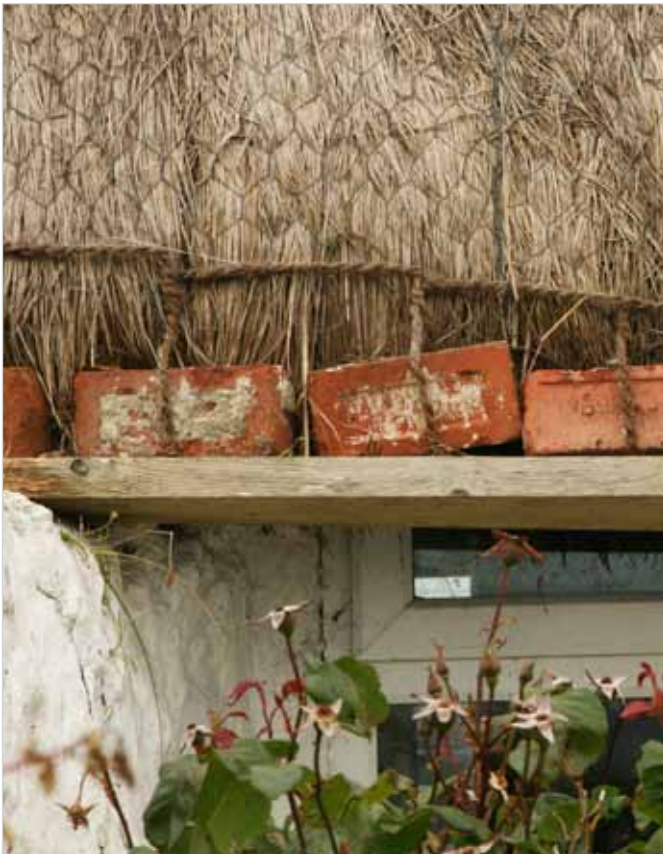
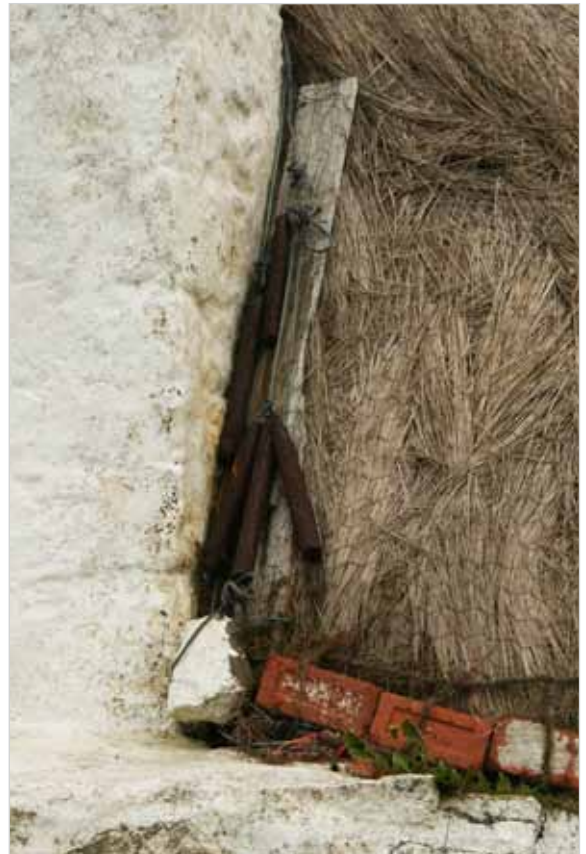
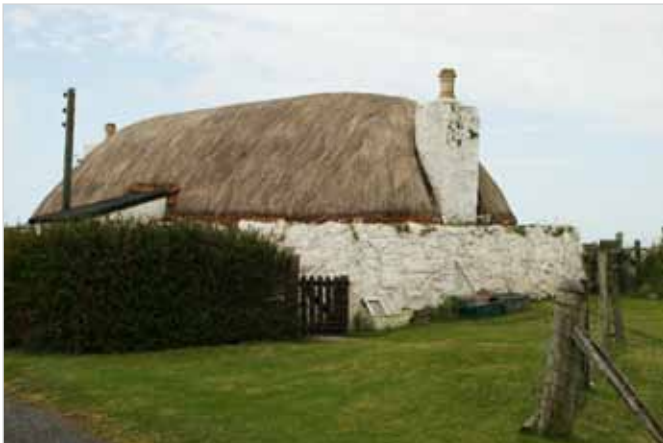
Clachan Dubh – Argyll & Bute

Thatch Type: Marram
 Ridge Type: Thatched (Marram)
 Condition: Good

Additional Notes: 19th-century traditional cottage with 'small wood and corrugated iron porch'. The building is thatched in marram and has a continuous marram ridge, which has been netted all over, including across the ridge. The netting has been weighted with bricks and thin ropes, which sit just above the wallhead. The bricks are also used above openings and above the roof of the porch. Down the sides of the chimney stacks at either end, planks of wood have been placed underneath the netting, which have been weighted down with metal poles tied with string to the outside of the netting, providing further protection to this slightly more vulnerable junction

of the thatch. Wooden boards have been placed upon the wallheads across the window openings. The grid reference identified by the listing and by Canmore is slightly inaccurate as it indicates a small cluster of farm buildings on the same site to the north of the cottage. This should be updated.

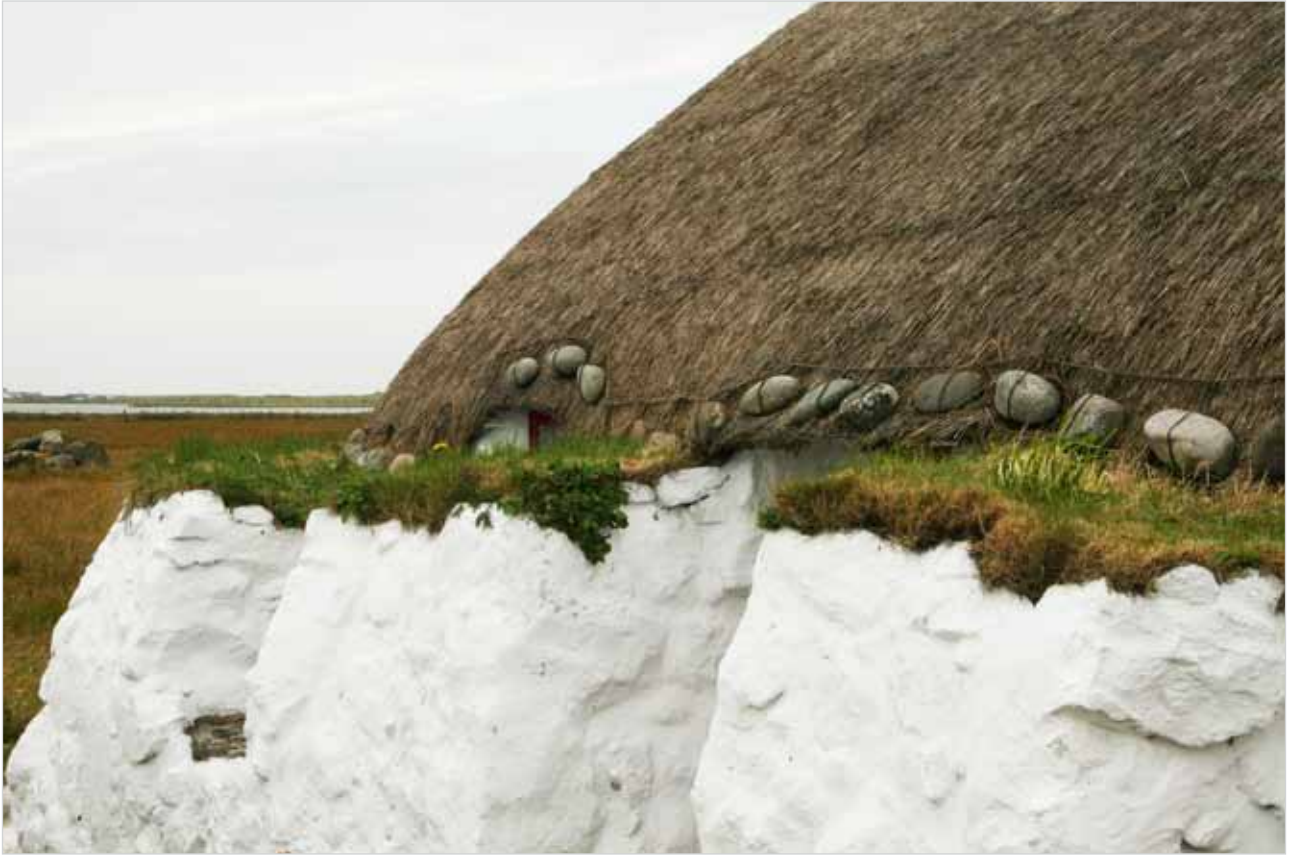
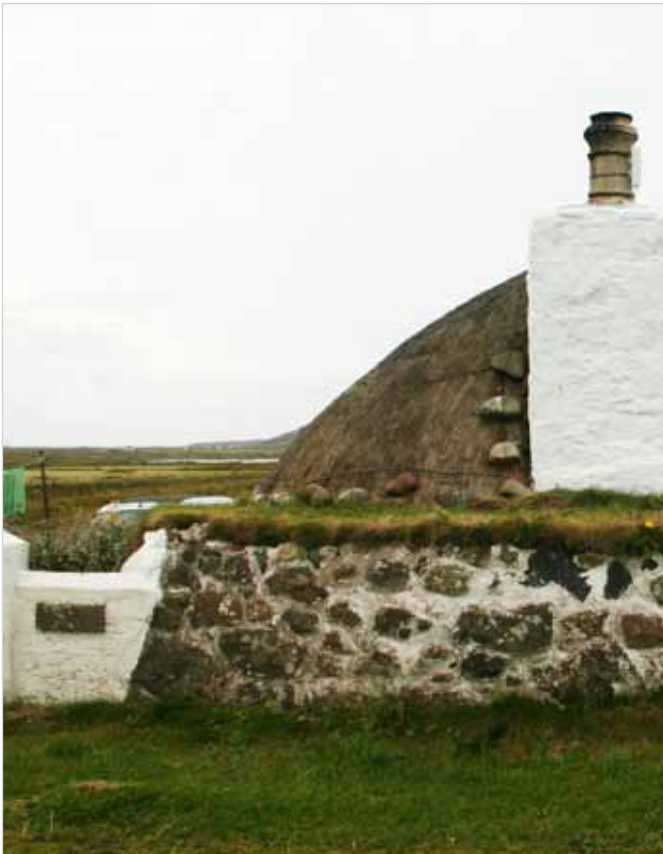
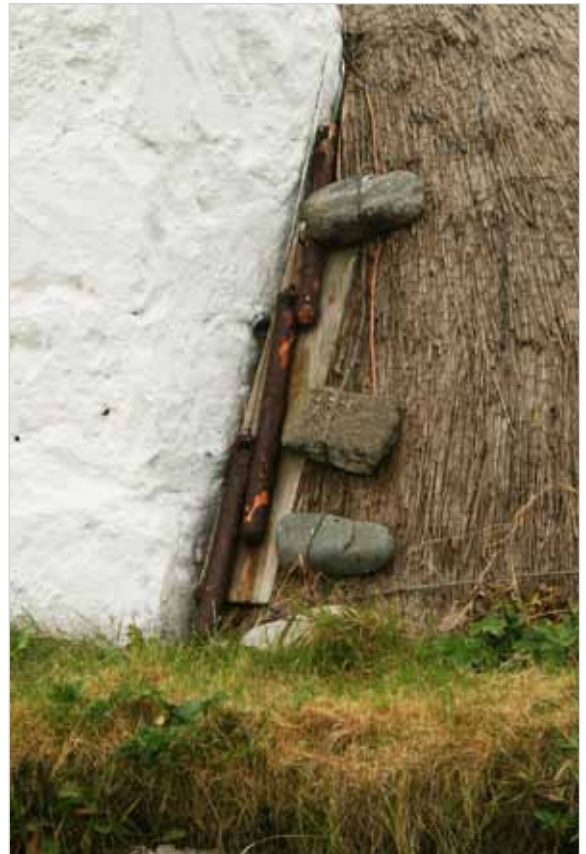
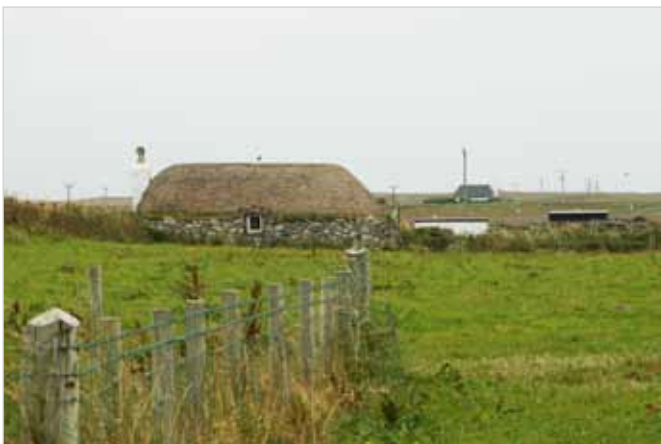
Drovers Cottage – Argyll & Bute

Condition: Good

Additional Notes: Small 19th-century cottage listed as having a '*piended thatched roof*'. The roof is thatched in marram, the traditional material used on Tiree, and has been netted all over, including across the continuous marram ridge. The netting, which has a wide gauge, has been weighted down by stones secured to the netting by thin ropes, running just above the wallhead and above the window and door openings around the entire circumference of the building. The stones and rope also run around the edge of the chimney stack on the north gable, but here additional weights have been used in the form of cast-iron weights. These weights appear

to be used primarily to hold in position planks of wood that have been placed vertically on either side of the chimney stack, presumably put in place to protect this slightly more vulnerable junction of the thatch.

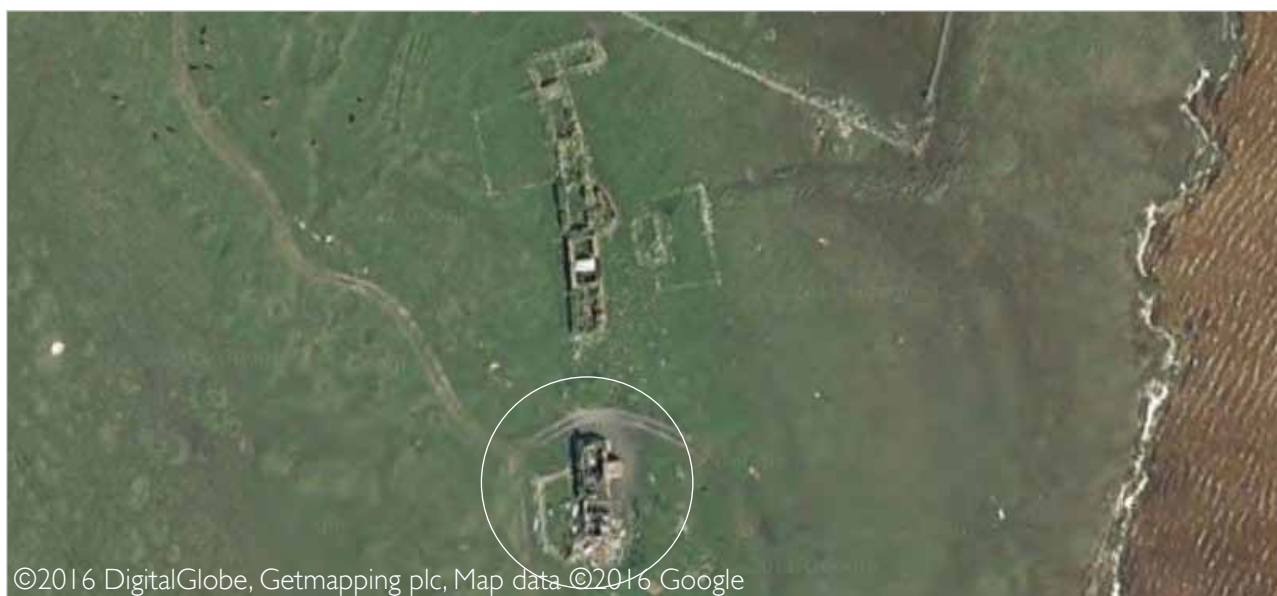
Address: Hector McNeill's Croft

Additional Notes: Listed building description reads '*19th century traditional single storey 3 bay cottage: limewashed rubble: thatched piended roof*'. Access to this building was not possible when visiting Tiree, however, no thatch could be seen from the main road nearby or from web-based satellite imagery. The building has been on the Buildings at Risk (BAR) Register since 2009 (BAR reference number 3891). The report from the last BAR inspection in 2012 reads '*the external walls and both chimney stacks survive but the thatch roof has collapsed filling the interior. The walls remain largely intact but the walls of the adjacent buildings are ruinous*', confirming that no thatch remains.

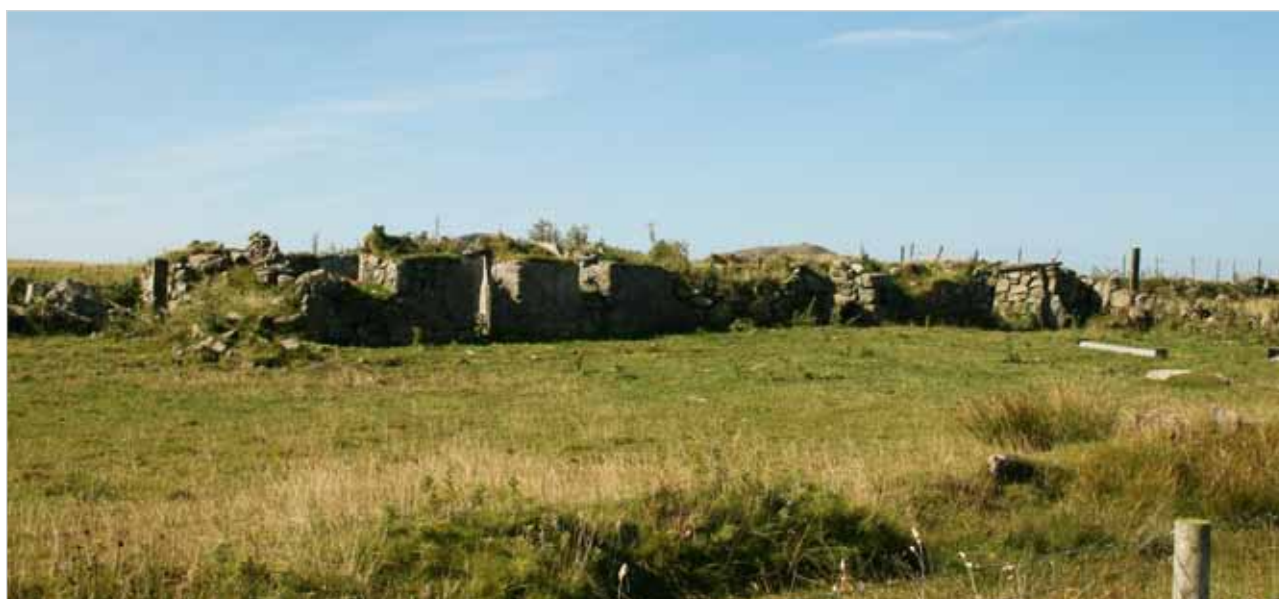
Address: John Henderson's Cottages

Additional Notes: Both the North and South cottages under this listing are ruins and have been on the Buildings at Risk (BAR) Register since 2009 (BAR reference numbers 3874 and 3873). The listing description reads '18th century Highland (Lewis type). Double walls. Piended byres at ends. Piended thatched roof, however the listing notes state '2 properties. Now unoccupied. N. one is in poor condition'. They were catalogued during the Argyll & Bute District Council Survey of Thatched Buildings on Tiree (1985), at which time it was 'noted as being thatched and in good condition, and in use as a store/barn by a neighbouring crofter'. The listing description should be updated accordingly.....

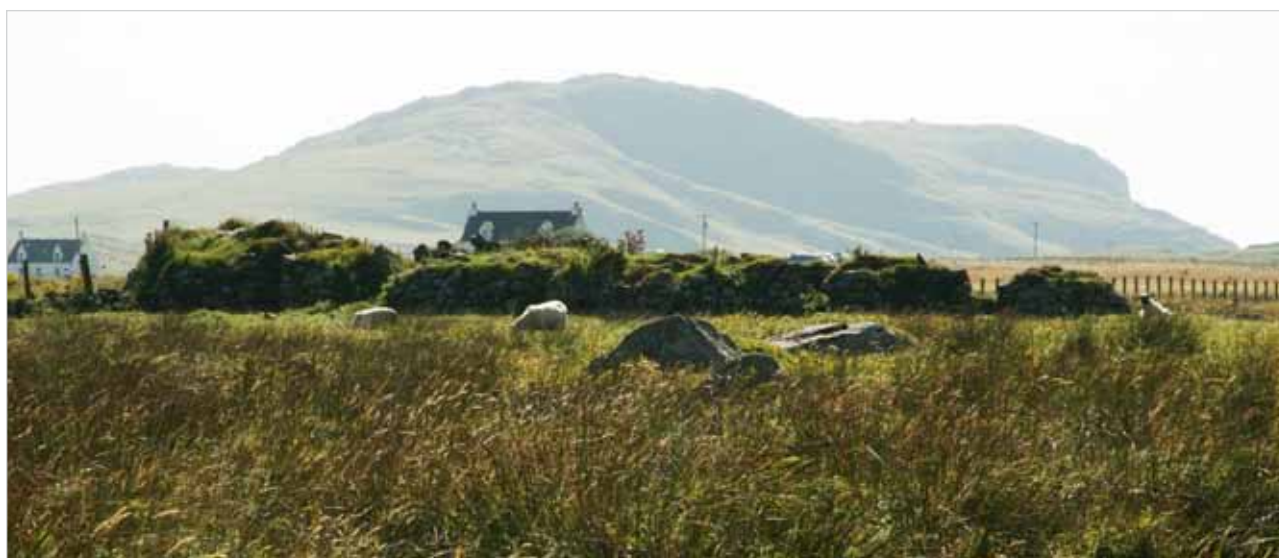
Address: 3 Moss
..... Isle of Tiree Listing Category: B
..... Date Listed: 26/01/1981
..... Listed Building Number: 17860
Local Council: ARGYLL & BUTE Canmore ID: 233868
Building Type: Cottage
Use: n/a
Grid Reference: NL 95940 43732 Occupancy: Ruin
Date of Visit: 27/08/2014 Buildings At Risk: Yes

Additional Notes: 19th-century cottage, listed as having a '*piended thatched roof*'. This building is entry number 16 in the Argyll & Bute District Council Thatched Building Survey (1985) and in another survey by John Wilson Associates (February 1986). In 1985, the property is noted as being in use as a holiday home and last being thatched the year previously, however, in the 1986 survey it is noted as being '*unoccupied*', and the condition of the thatch is described as being '*poor becoming overgrown with weed*'. Also in 1986 the thatch is noted to have been weighted with '*stones on hemp rope - some missing*'. Currently the building is a ruin and has been on the Buildings at Risk (BAR) Register since 2009 (BAR reference number 3877). BAR inspections in 2008 and 2012 also note the buiding to be a '*ruinous shell*'. The listing description should be updated accordingly.

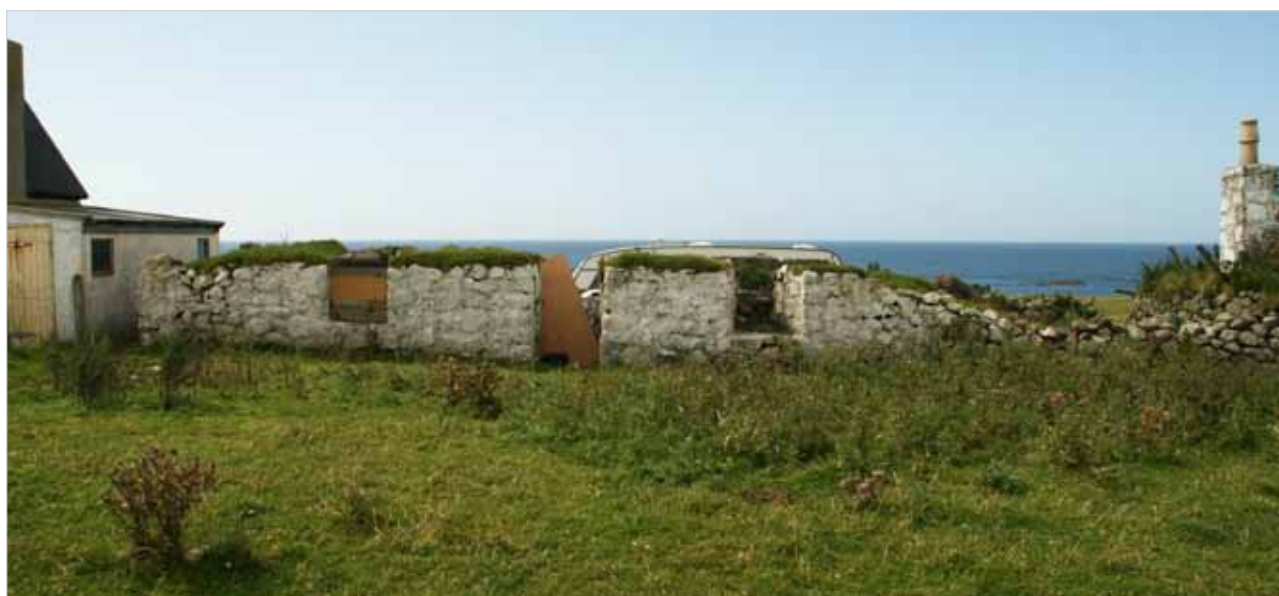
Address: The Terrace
..... (Centre Cottage) Listing Category: B
..... Sandaig Date Listed: 26/01/1981
..... Isle of Tiree Listed Building Number: 18475
Local Council: ARGYLL & BUTE Canmore ID: 252047
Building Type: Cottage
Use: n/a
Grid Reference: NL 94020 43245 Occupancy: Ruin
Date of Visit: 28/08/2014 Buildings At Risk: n/a

Additional Notes: This 19th-century cottage was listed in 1981 as part of a group listing along with the cottage to the north of this. It is listed as having a '*piended thatched roof*', with the listing notes reading '*The Terrace is unusual row of 3 traditional thatched cottages*'. The building has been on the Buildings at Risk (BAR) Register since 2012 (BAR reference number 5290), at which time it was recorded as being '*ruinous*'. The building was once part of a row of three traditional thatched cottages, this one being the central – the north cottage is still thatched but is in a derelict condition and the south cottage now has a tar felt roof. The listing description for this building should be updated accordingly.....

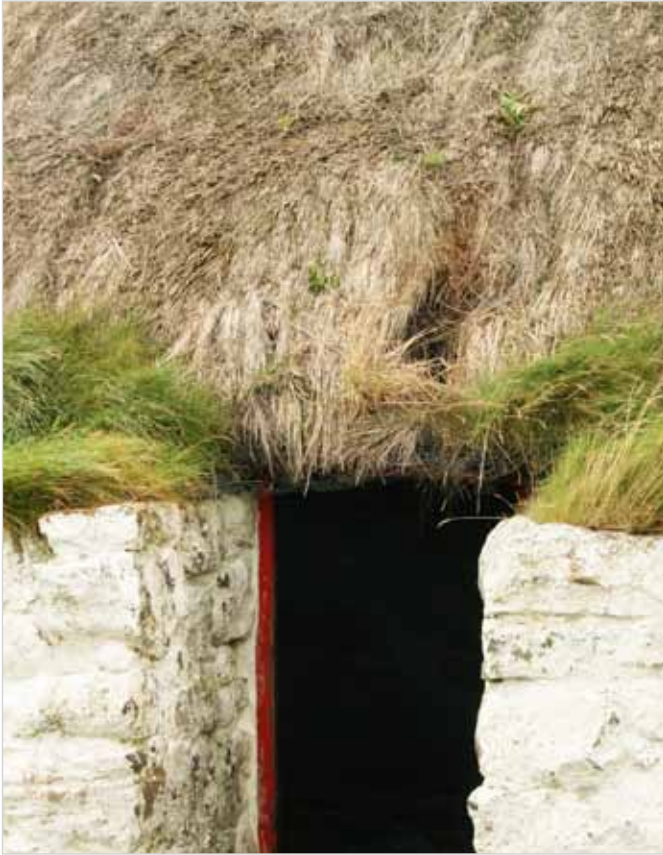
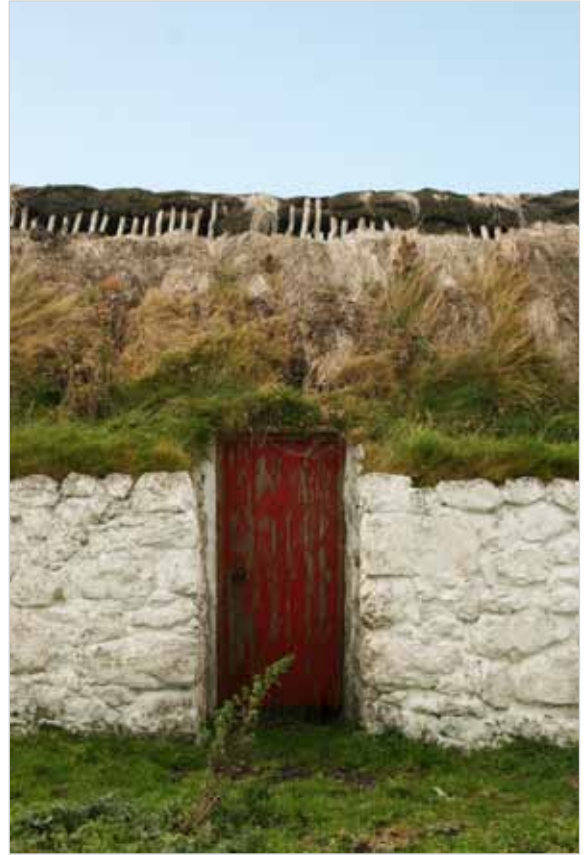
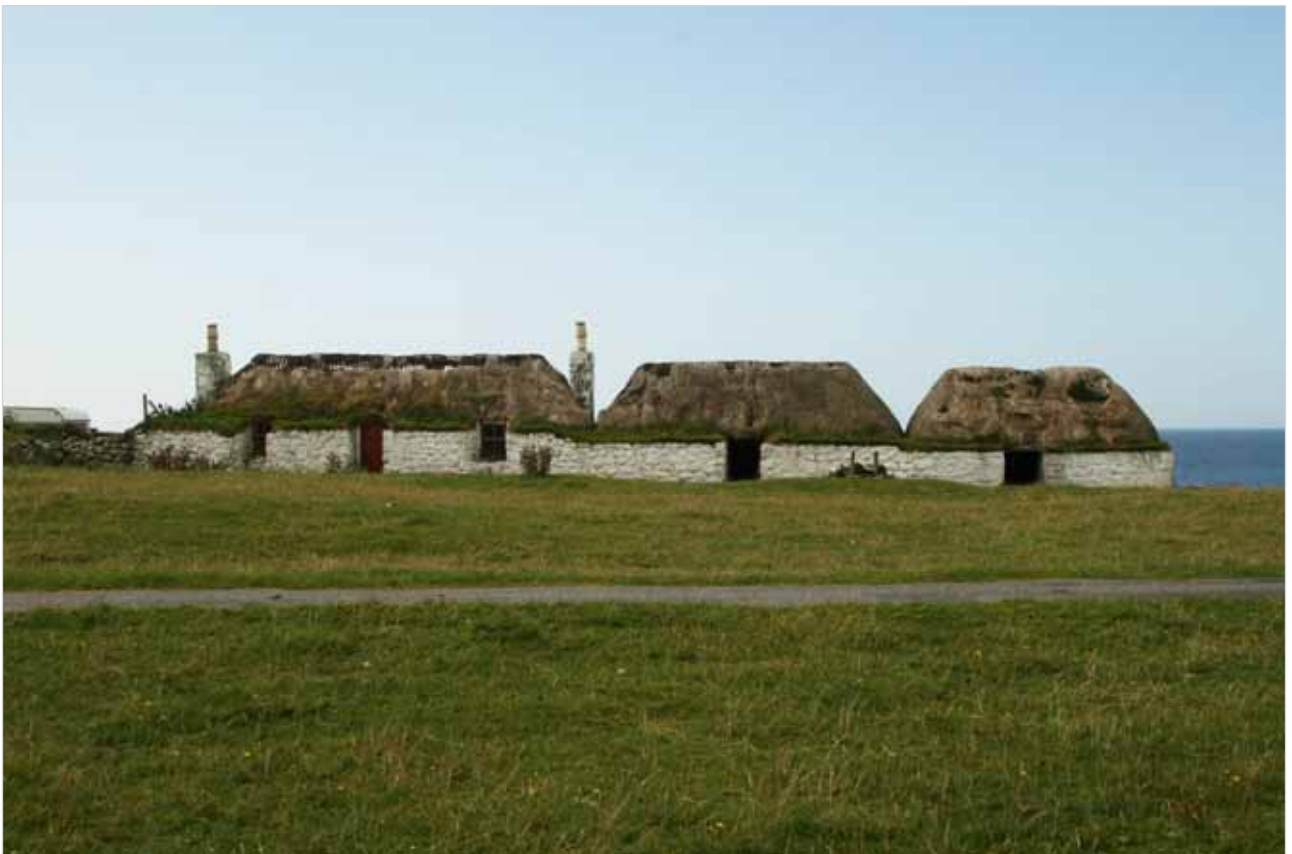
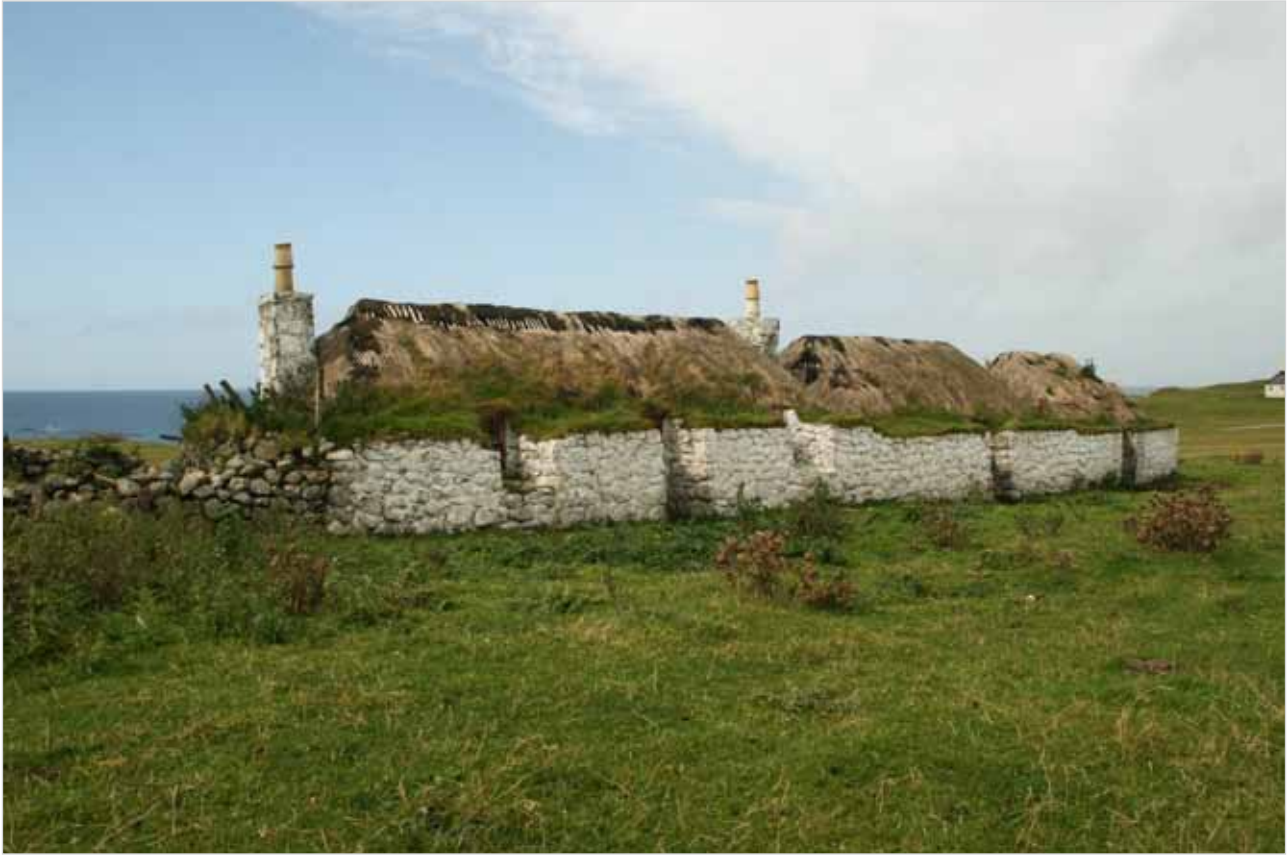
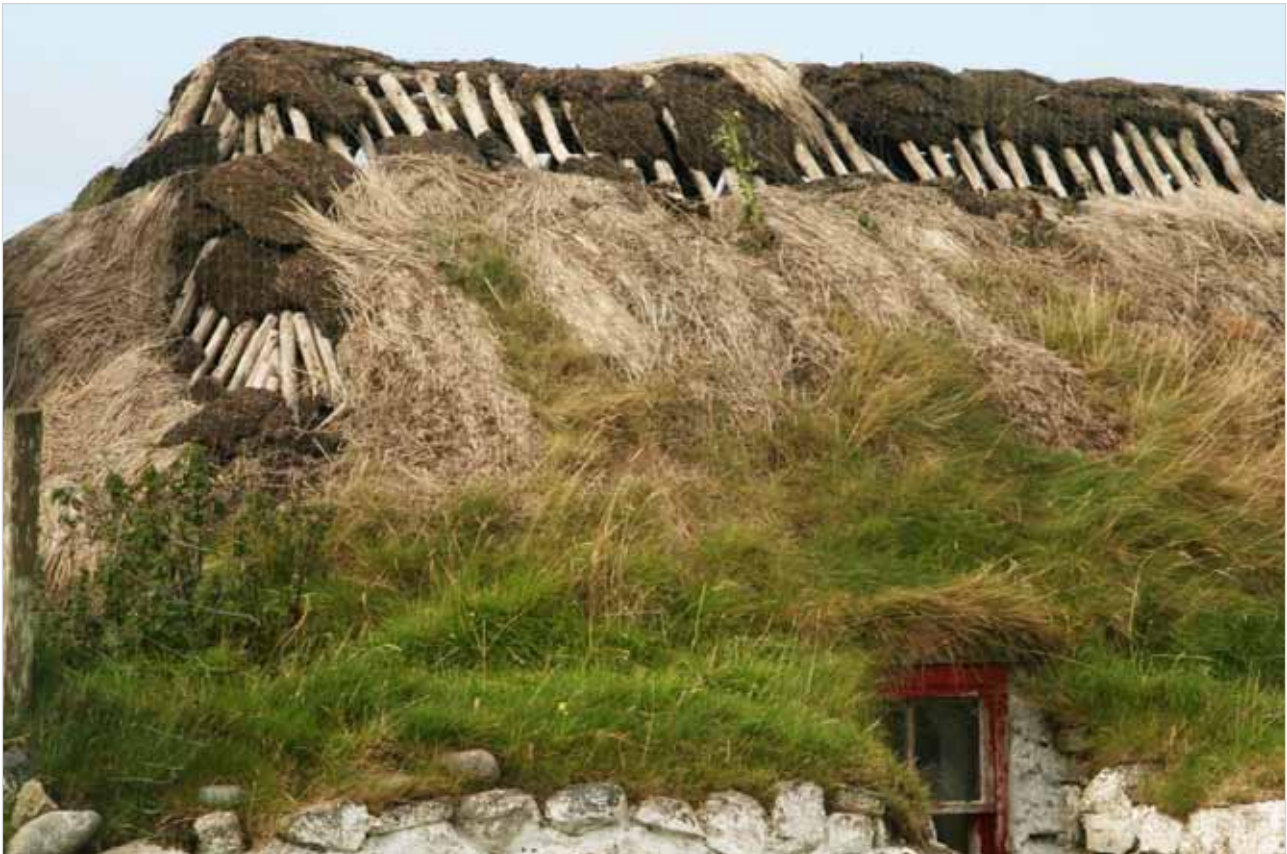
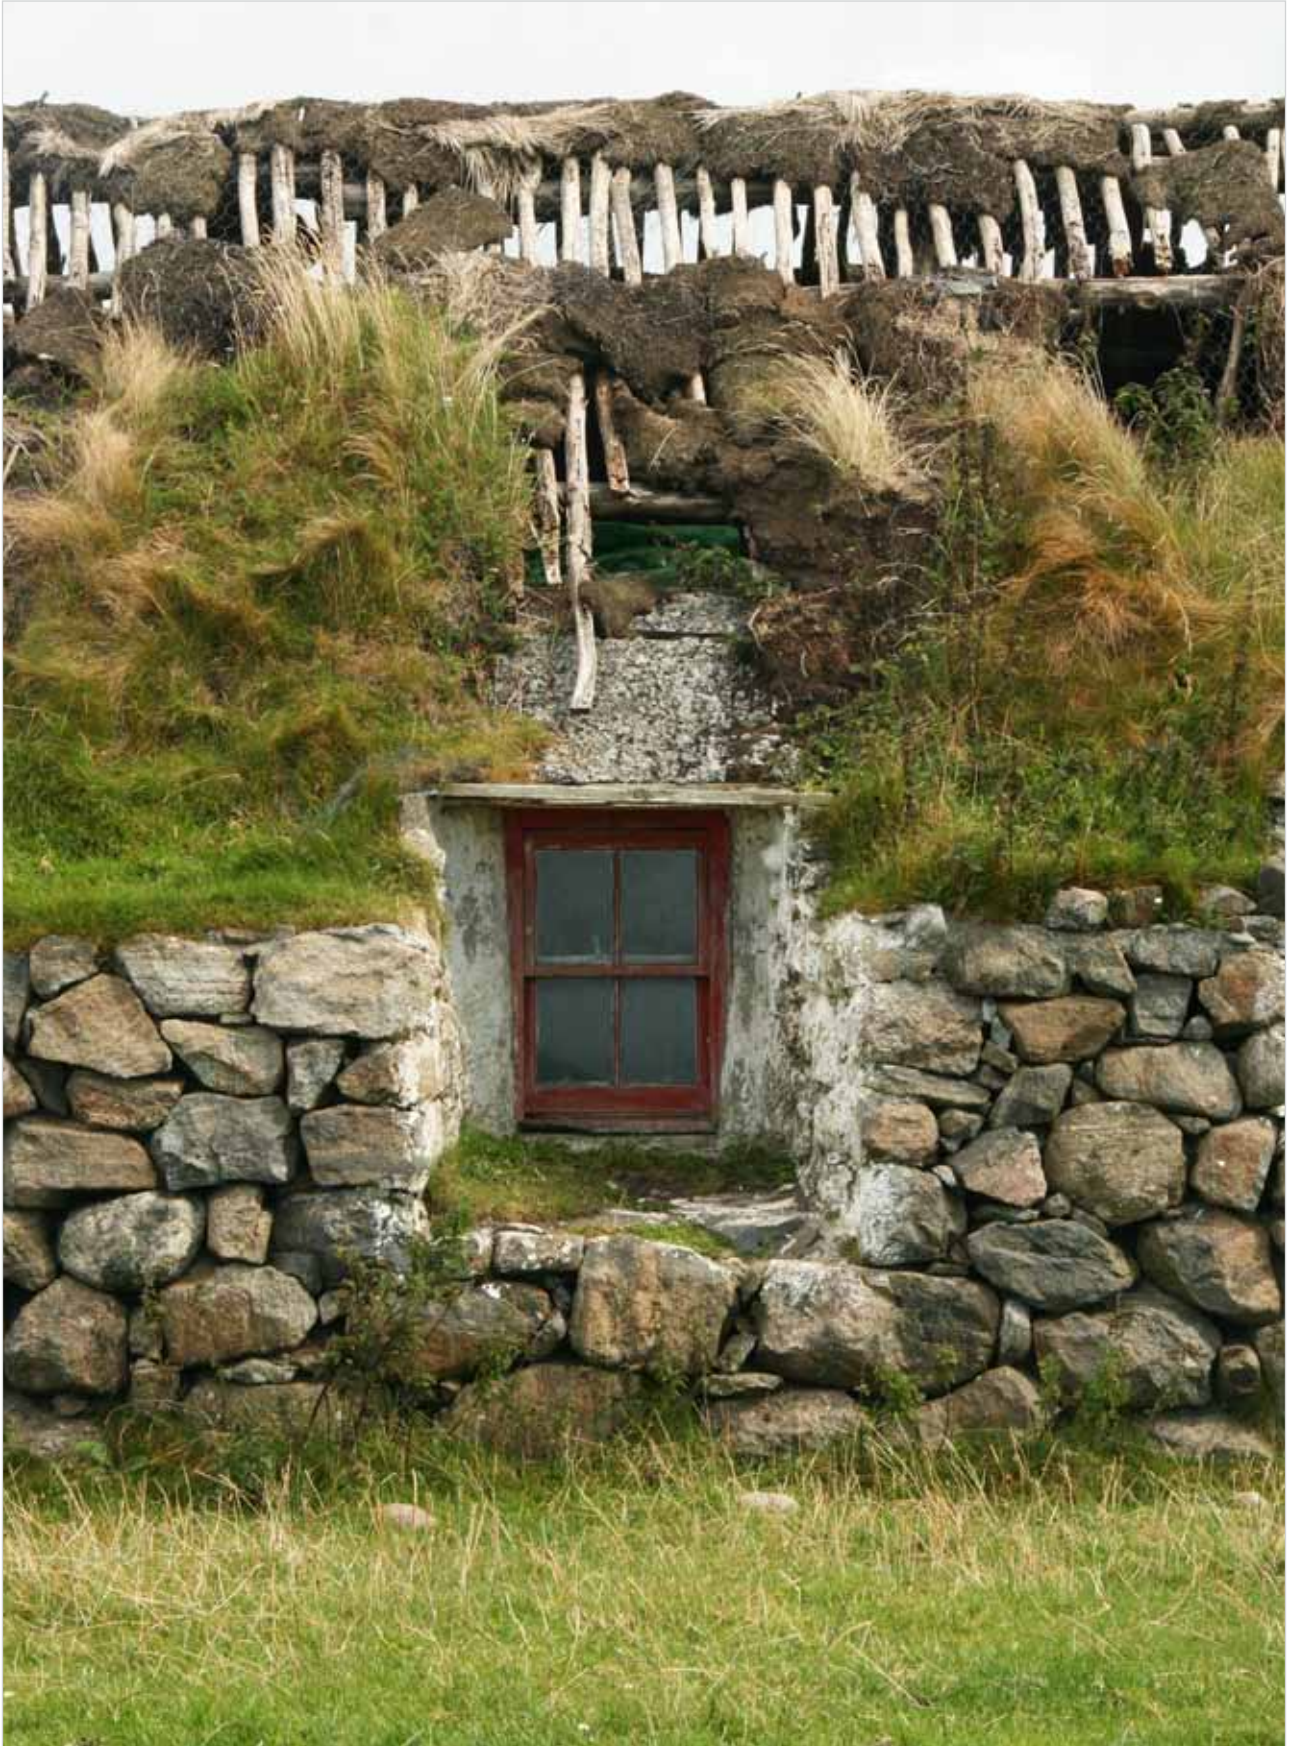
The Terrace (North Cottage) – Argyll & Bute

Thatch Type: Marram
Ridge Type: Thatched (Marram)
Condition: Poor

Additional Notes: 19th-century cottage with adjoining barn and byre to the north. All three buildings were listed in 1981 as having piended thatched roofs, as part of a group listing with another cottage to the south. This cottage is the northern most in a row of three traditional cottages, all originally, and at the time of listing, with thatched roofs (the central cottage is now a ruin and the southern cottage has a tar felt roof). The cottage, barn and byre are in a derelict condition and the thatched roofs have deteriorated significantly. The roofs are thatched in marram and appear to have had continous marram ridges, though this has been lost in most places. There is visible evidence of having been netted, though, due to the overgrown nature of the turf upon the wallheads, no weighting devices can be seen to be holding the netting in place. There are large holes in the thatch, with much of the marram missing, exposing the turf underlay and the interior of the building. The cottage, barn and byre have been on the Buildings at Risk (BAR) Register since 2012 (BAR reference number 5408), at which time the roof was also recorded as having '*holes on their west facing thatched roofs*' and being '*currently disused*'. According to BAR notes, the building was last in use as a museum and by 2012 full Planning Permission and Listed Building Consent were being sought to change the use to two dwellings and a store. The current status of these applications is unknown.

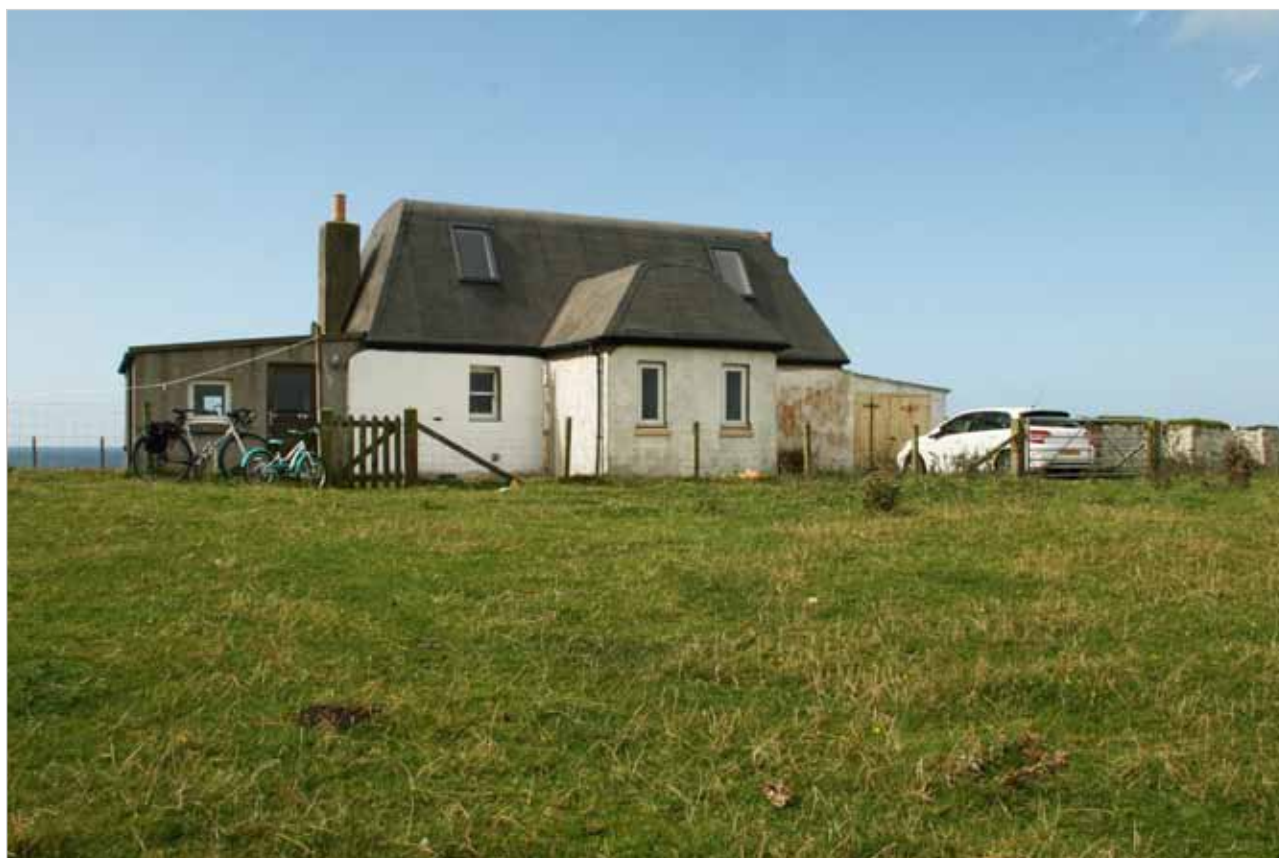
Additional Notes: Circa 1930 cottage, the southernmost in a row of cottages called 'The Terrace'. It was listed in 1981 as having a '*piended thatched roof with overhanging eaves*'. The building now has a tar felt roof and no thatch remains. The listing description for this building should be updated accordingly.
