A Survey of Thatched Buildings in Scotland

Thatch Survey of Scotland
2014-15

A photographic survey of thatched buildings in Scotland, surveyed between May 2014 and August 2015 by Zoe Herbert (SPAB Scotland Officer), on behalf of the Society for the Protection of Ancient Buildings.

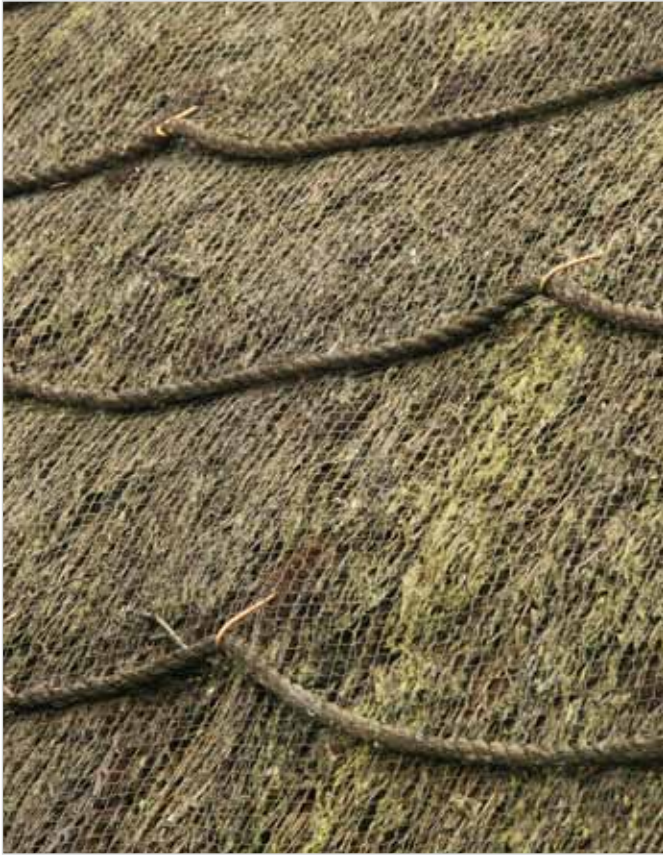
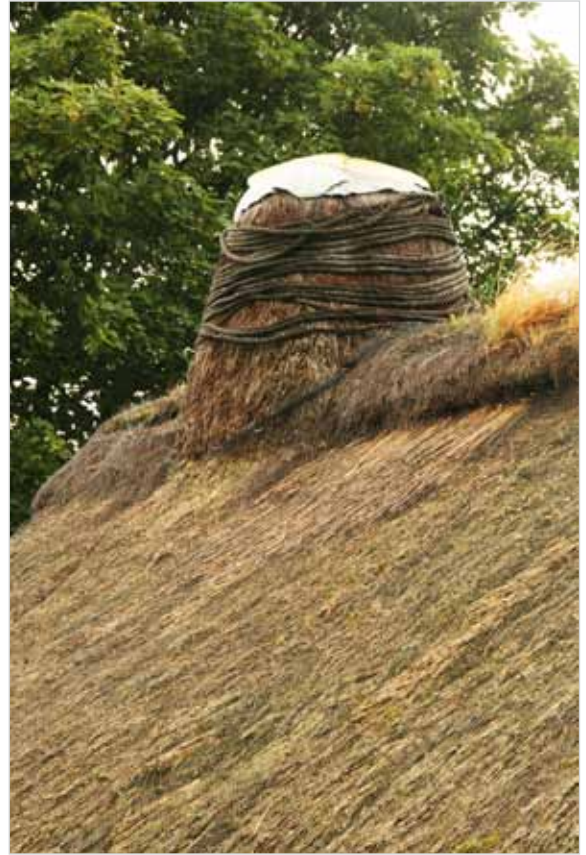
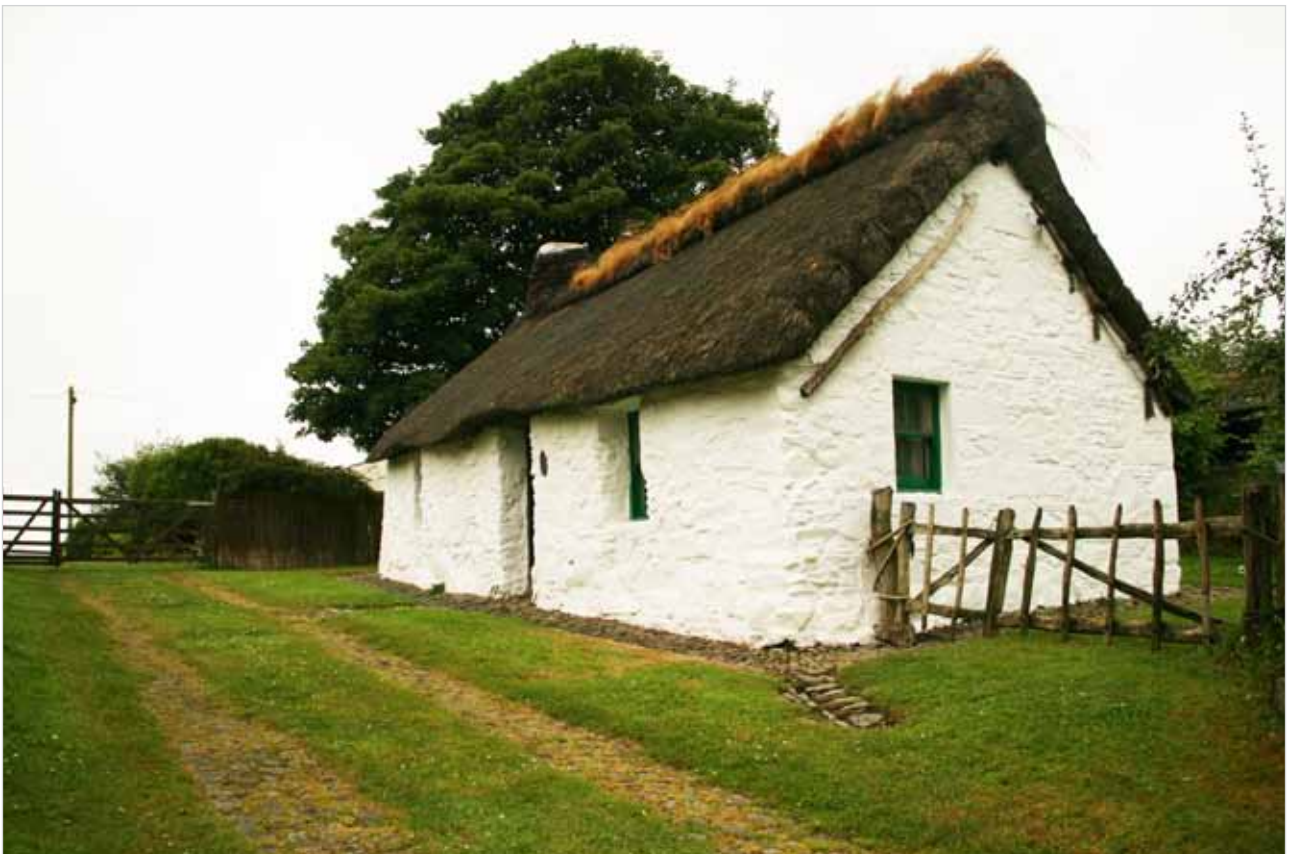
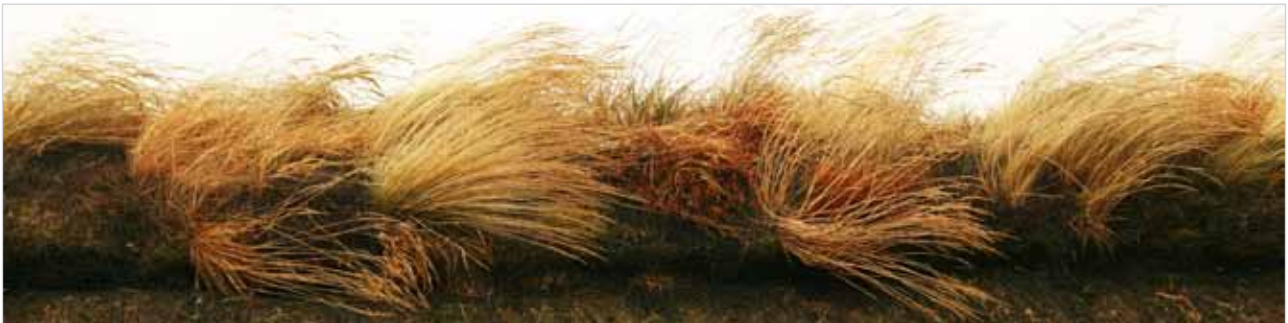
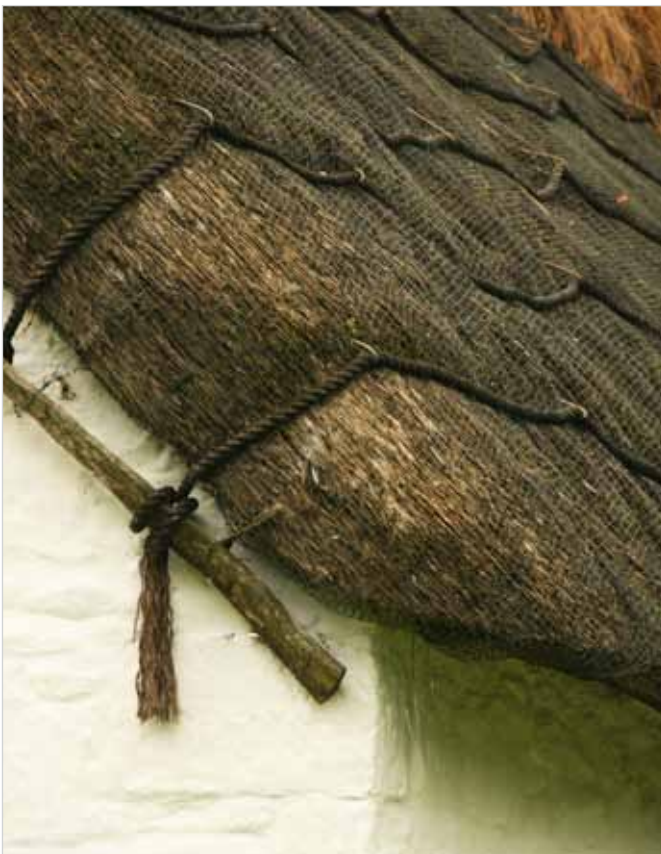
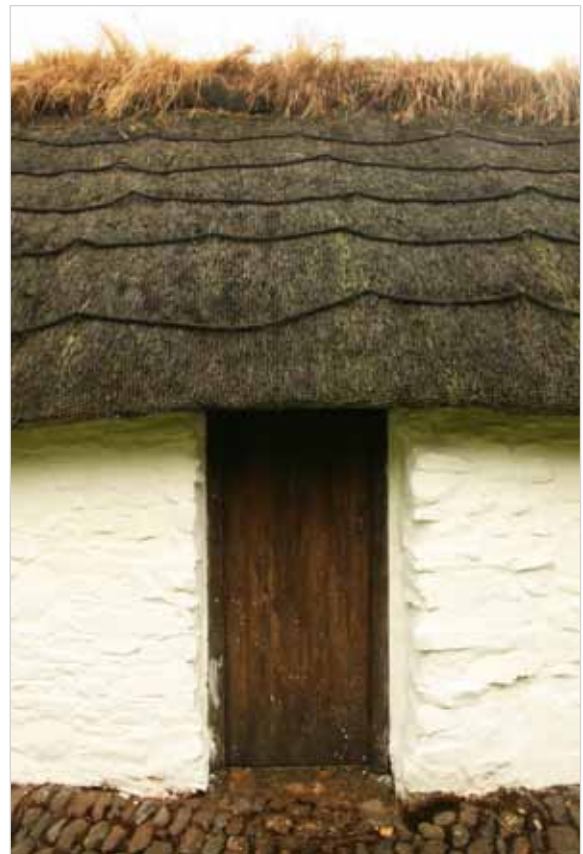
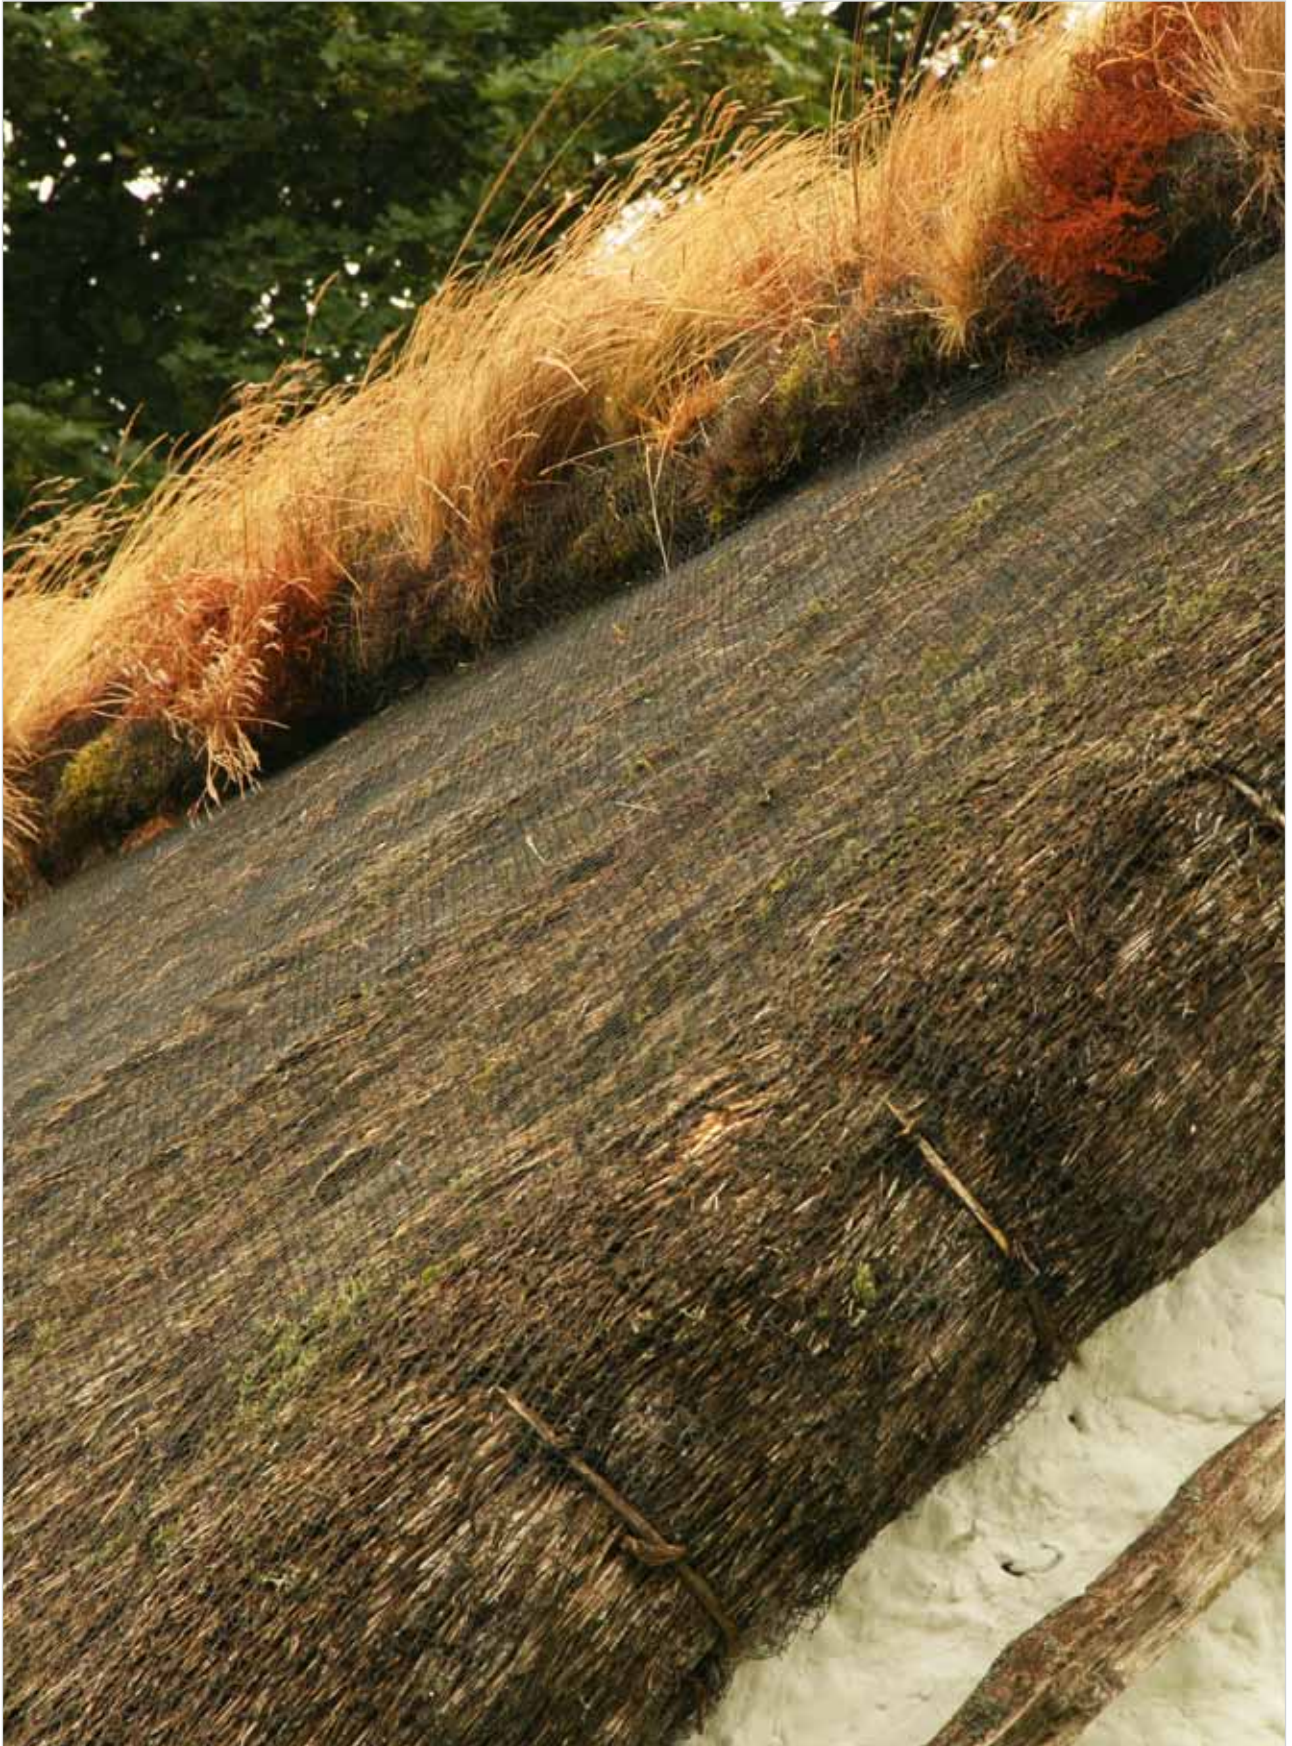
The Cruck Cottage – Dumfries & Galloway

Thatch Type: Rye Straw
Ridge Type: Thatched (Heather and Turf)
Condition: Fair

Additional Notes: Single-storey cruck-frame cottage, largely rebuilt in the first half of the 19th century. It was damaged by fire in 1956 and was restored and re-thatched in 1960. Major restoration work was also carried out in 1991-93, however, by 2003 the thatch had deteriorated quite badly in places and so the top layer of thatch was removed, along with some of the rotten timbers. It was then covered with a new layer of rye straw and the chimney was re-thatched in heather and secured with rope. At this time the ridge was also finished with woven straw. By 2012 several areas on the front of the roof were showing signs of rot and so repairs were carried out in November of that year. The ropes securing the thatch at the front were found to be rotten and were removed. This time, the ridge was repaired using heather turf. It was estimated at the time that these repairs would keep the roof watertight for at least another four years (circa 2016), at which time a total re-thatch would be required. Due to the high cost of rope, it was decided that replacement ropes for the front of the roof could not be justified at the time and would be replaced instead during the complete re-thatching. The Cruck Cottage Heritage Association that has been set up locally carries out the basic year-to-year maintenance and repair to the building. All the restoration work in recent years has been carried out and/or organised by thatcher Jeremy Cox, based in Castle Douglas. (Information provided by the Cruck Cottage Heritage Association.) The cottage

is currently used as a museum and although it is well maintained, the building itself is occupied fairly infrequently, especially during the winter season. The entire thatch has been netted, including over the ridge, however, the ridge has grown through the netting and is only partially visible. As described, the ropes have been removed from the front elevation of the roof; however, they are retained on the back elevation and around the chimney. The ropes have been secured to the surface of the thatch with what appears to be hazel. The ropes are fastened to slim timbers that have been fixed to each of the gable ends. The thatch underneath the netting has a large amount of mossy vegetation growth and the surface of the thatch is rather uneven. As stated by the Heritage Association, the cottage is due for a complete re-thatch within the next year or two.

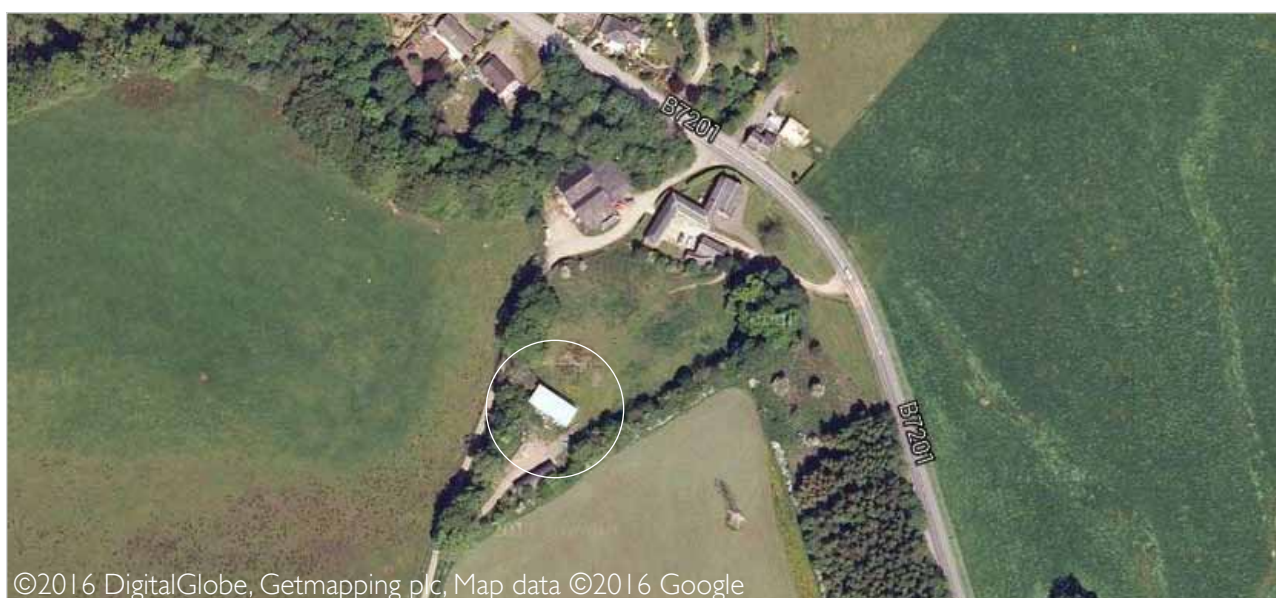
Address: Priorslynn Cruck-Framed Byre

Additional Notes: Late 18th-century clay-walled and cruck-framed agricultural building. Whilst the listing description for this building reads '*roof originally thatched, now covered with corrugated iron*', none of the thatch remains. This is confirmed by text excerpts on Canmore (Stell, G. (1972c), '*two cruck-framed buildings in Dumfriesshire*', *Trans Dumfriesshire Galloway Natur Hist Antiq Soc*, 3rd, vol. 49, 1971-2) and from Buildings at Risk (BAR) Register inspection notes, from when it was added to the Register in 1999 (BAR reference number 1771). The building currently has a corrugated iron roof covering, which is in poor condition, and a secondary temporary roof constructed over the building for protection.

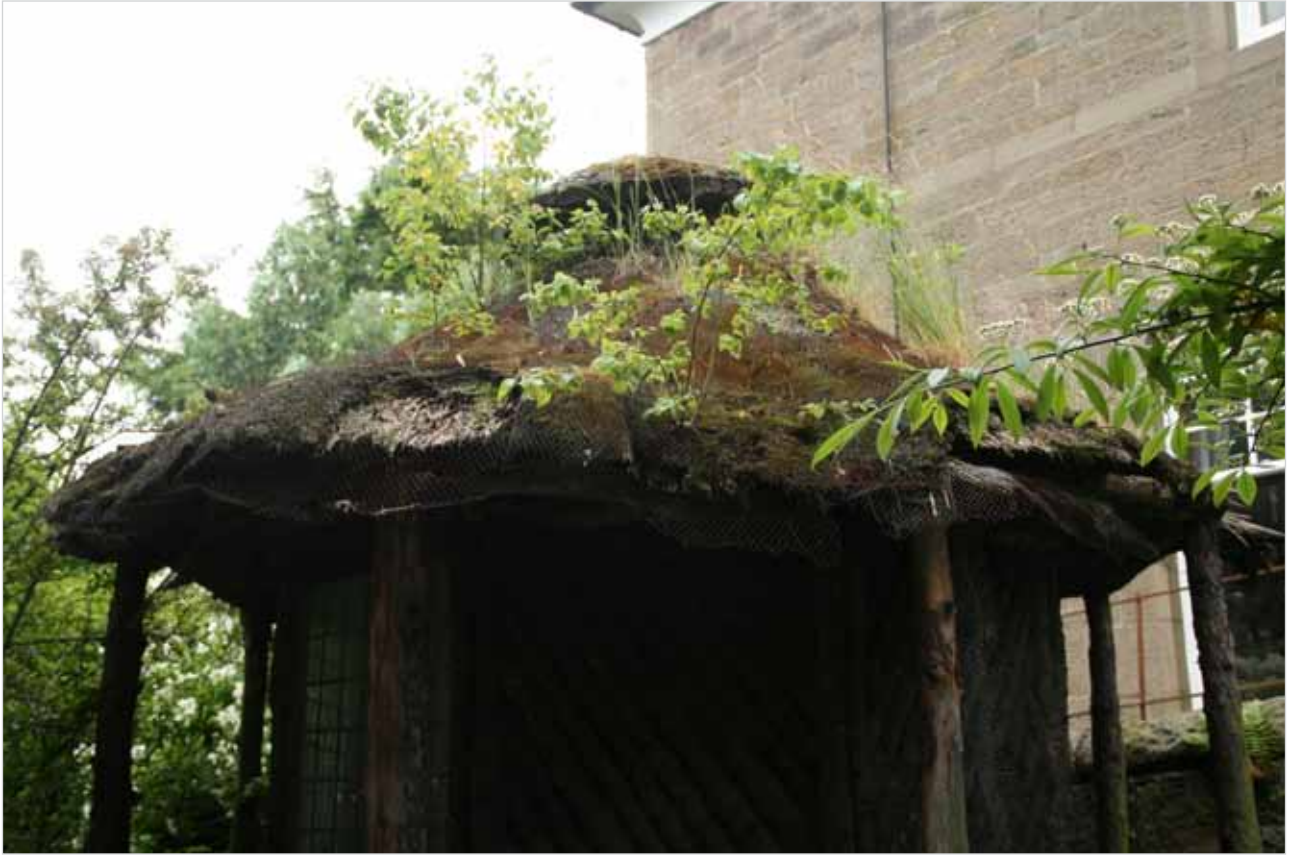
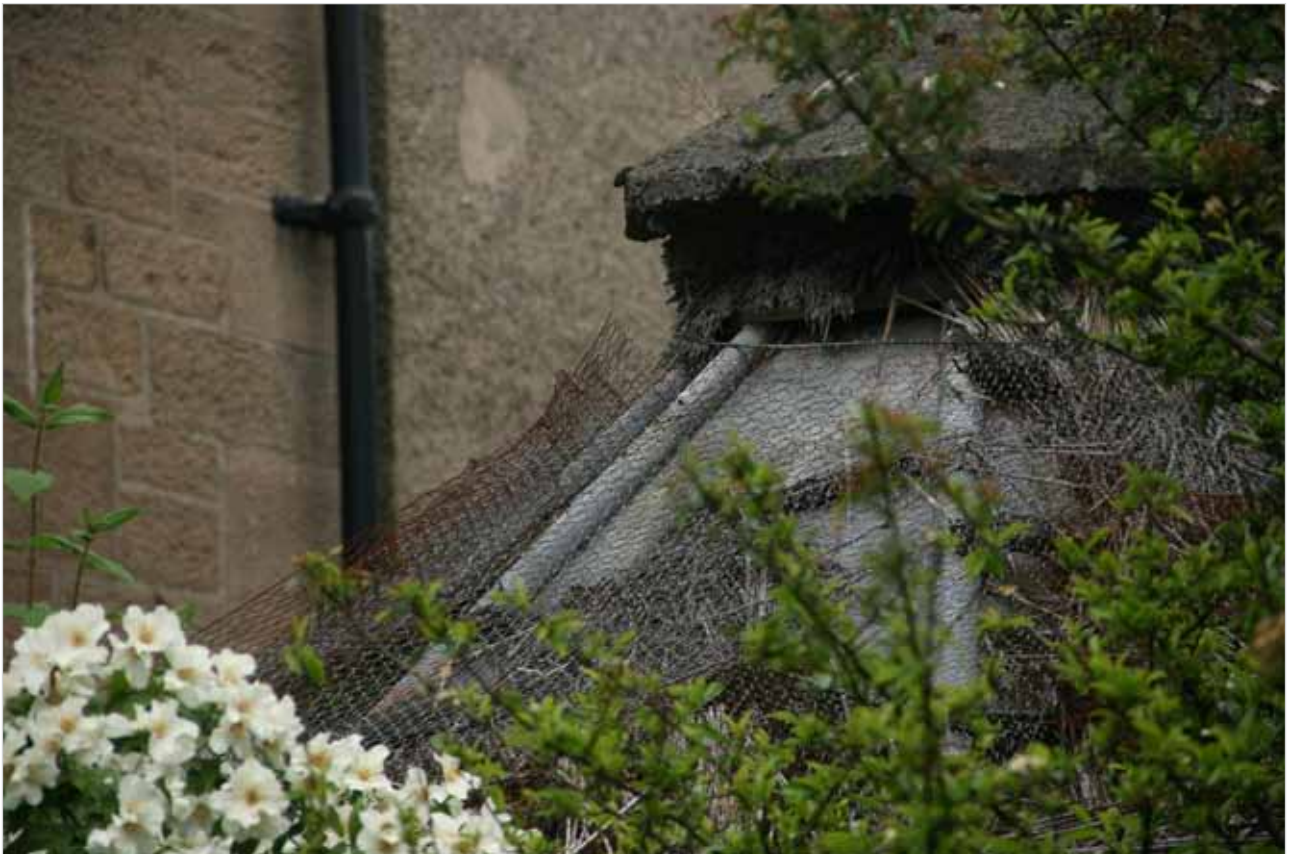
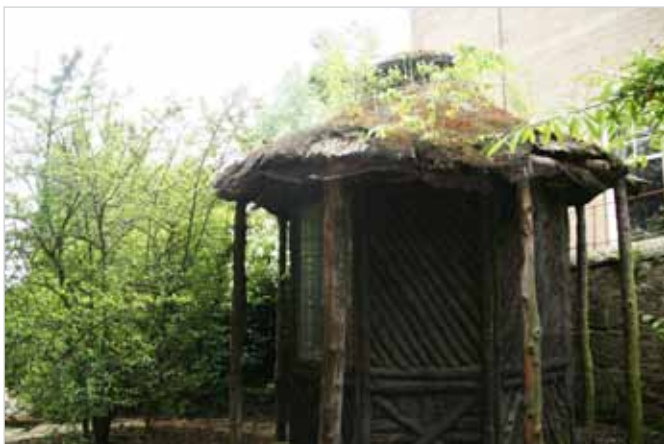
Pinemount – Dundee

..... Poor

Circular timber structure with conical roof, glazed window openings, door and timber wall panels, in the garden of a house under the same listing. The listing description states 'Possibly by J M Robertson circa 1890'. The owner stated that the property had been purchased around three years ago and the intent is to completely restore the structure, including the thatch, which is currently in a fairly bad condition, at some point this year. The roof on the structure is in a particularly poor condition, with the thatch being missing or loose in most places, and has a large amount of vegetation growth. The thatch has been netted all over, but this has

been dislodged and removed in places, apparently by birds who often nest there. In some places where the thatch is missing you can see a lead sheeting, but it is uncertain whether this covers the entire roof underneath the thatch. The roof has a concrete capping.

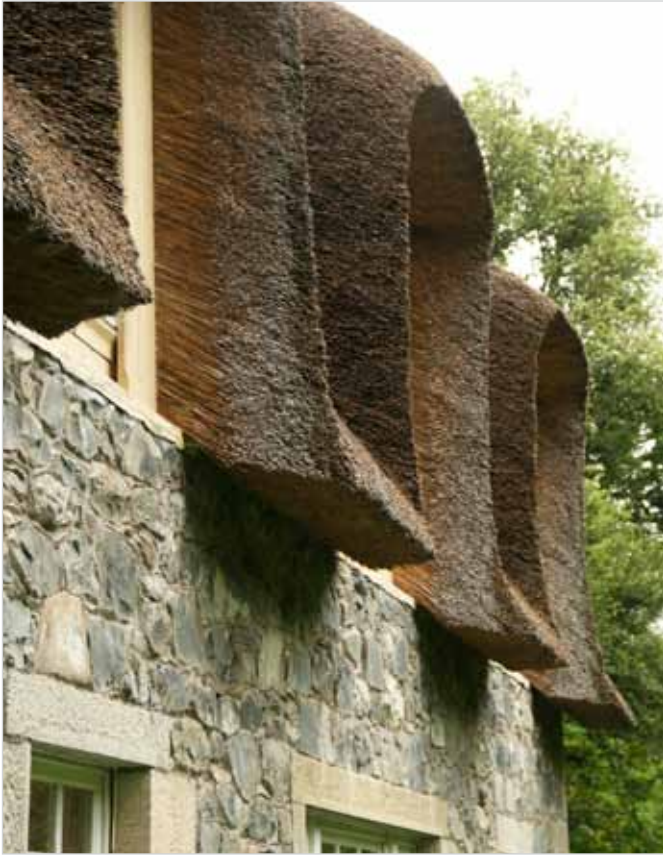
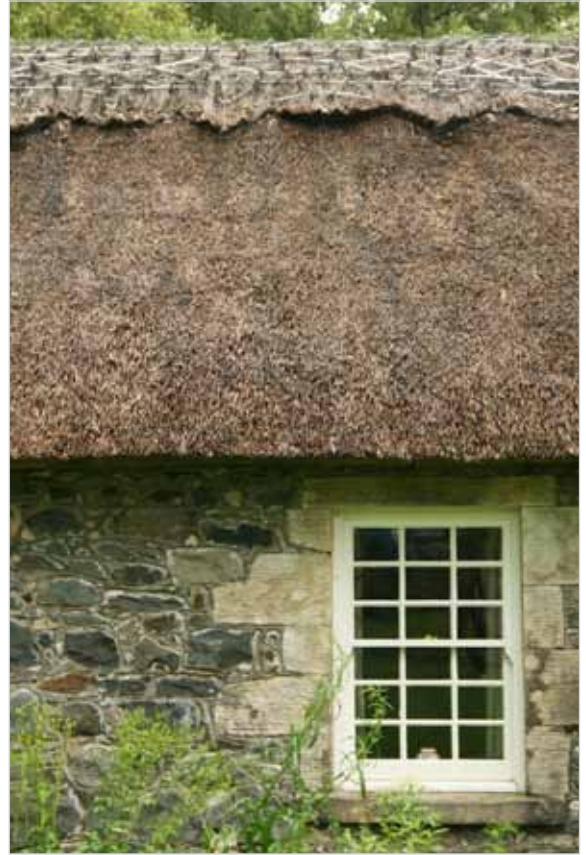
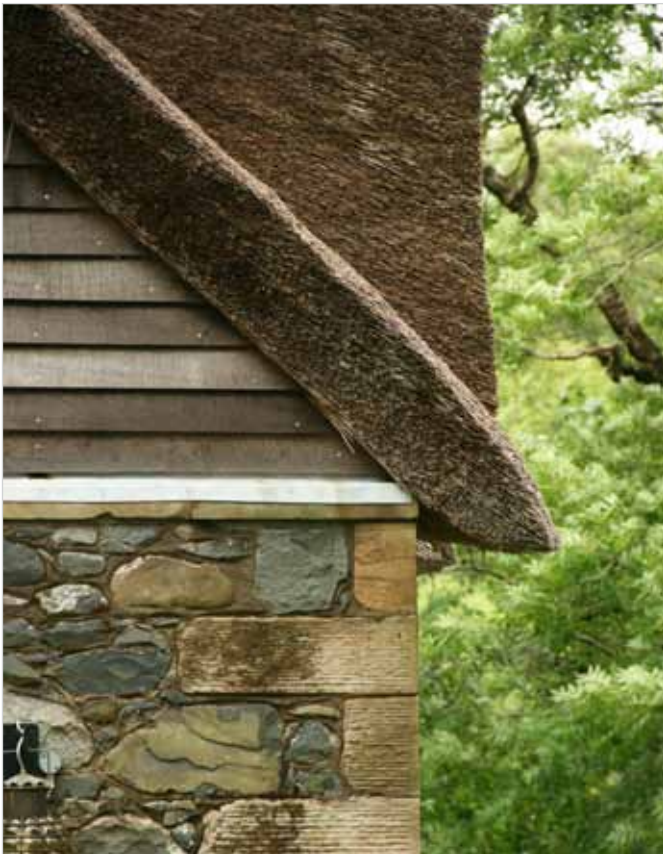
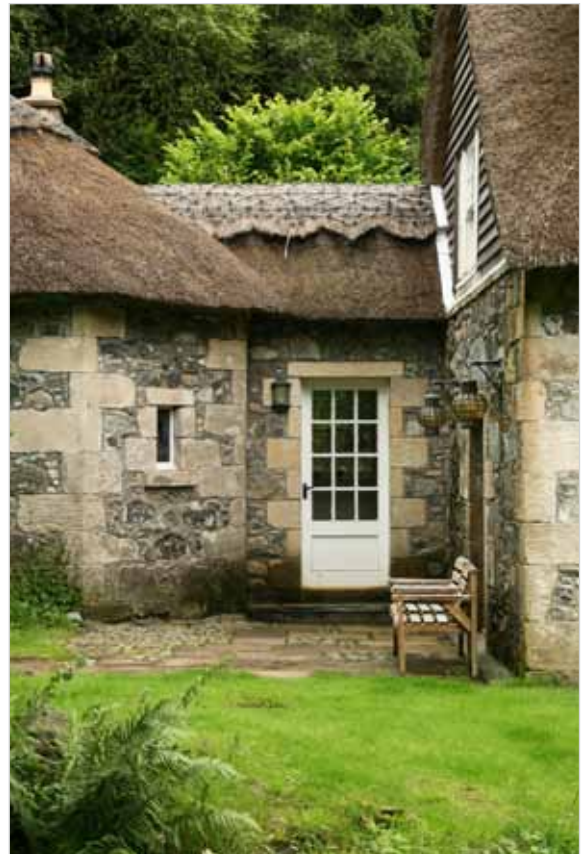
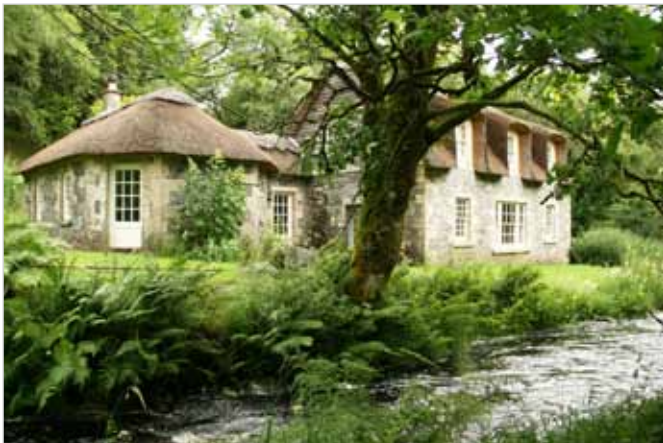
Forget Me Not Cottage – East Ayrshire

Additional Notes: Large restored two-storey cottage with single-storey wing to the west, which is currently in use as holiday accomodation. The roof has a reed sculpted raised ridge, which has been scobed using hazel spars and has been netted. The rest of the reed-roof has been left uncovered. The roof of the main building has three large dormer windows along the front elevation of the building. The thatch is in good condition, however, the ridge is in need of some maintenance.

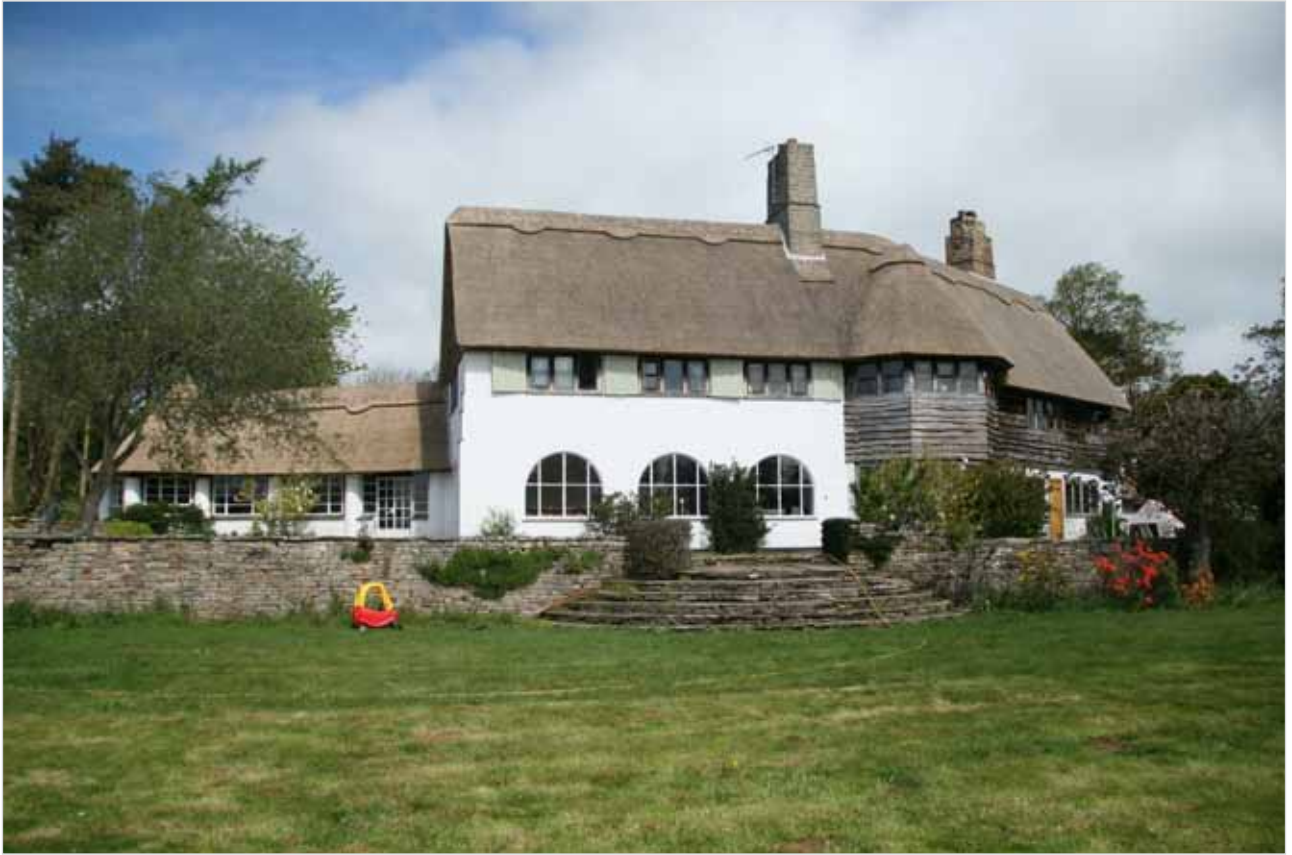
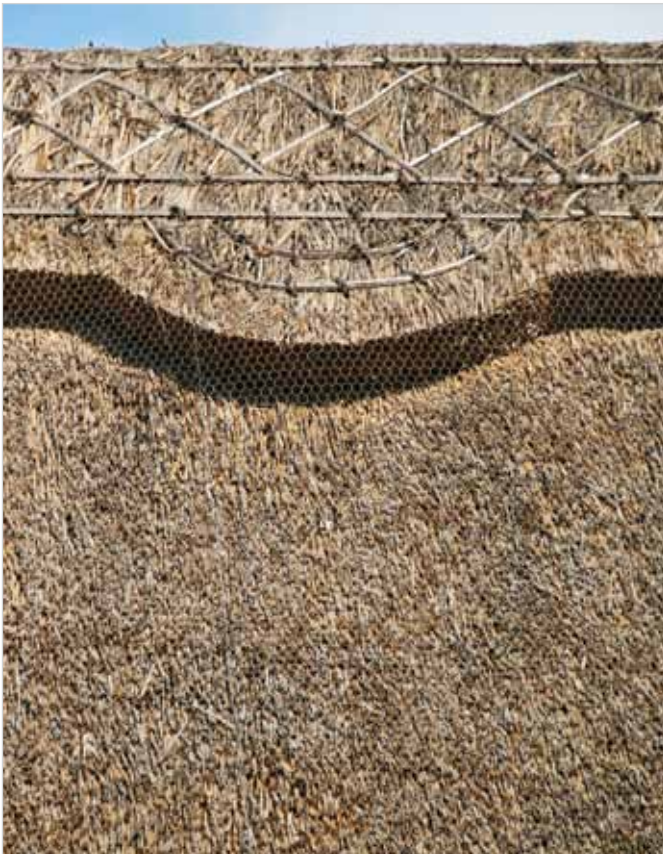
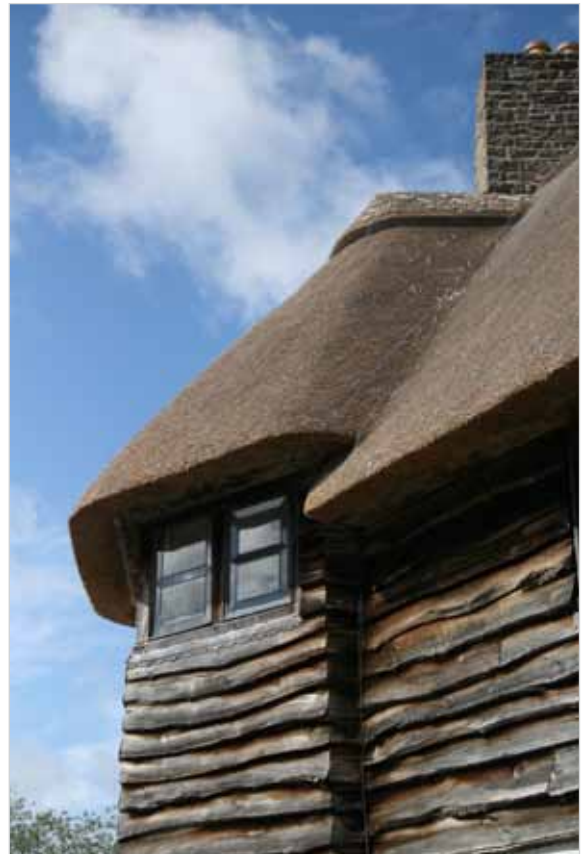
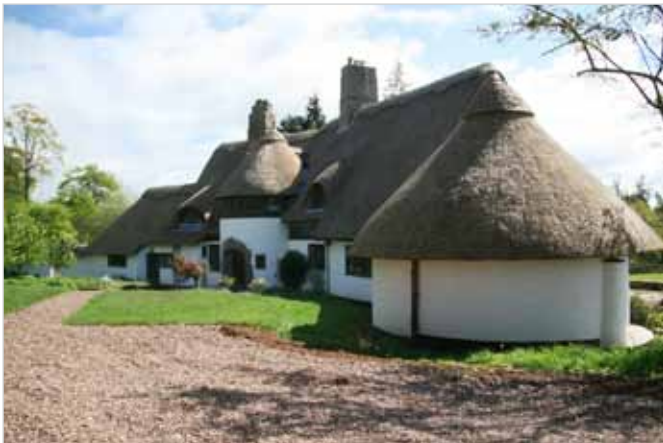
Bolton Muir – East Lothian

Condition of Thatch: Good

Additional Notes: Arts and Crafts style single-storey plus attic mansion, built in 1930. Attached to the main building is a single-storey plus attic piend lodge, with flanking garage entrance with thatched coping and drum piers with conical thatched caps. The current building owner states that the building has been re-thatched within the last six months using Norfolk reed. The ridge is thatched, sculpted decoratively at the base and scobed with what appear to be hazel spars. The entire roof is netted, including over the ridge.

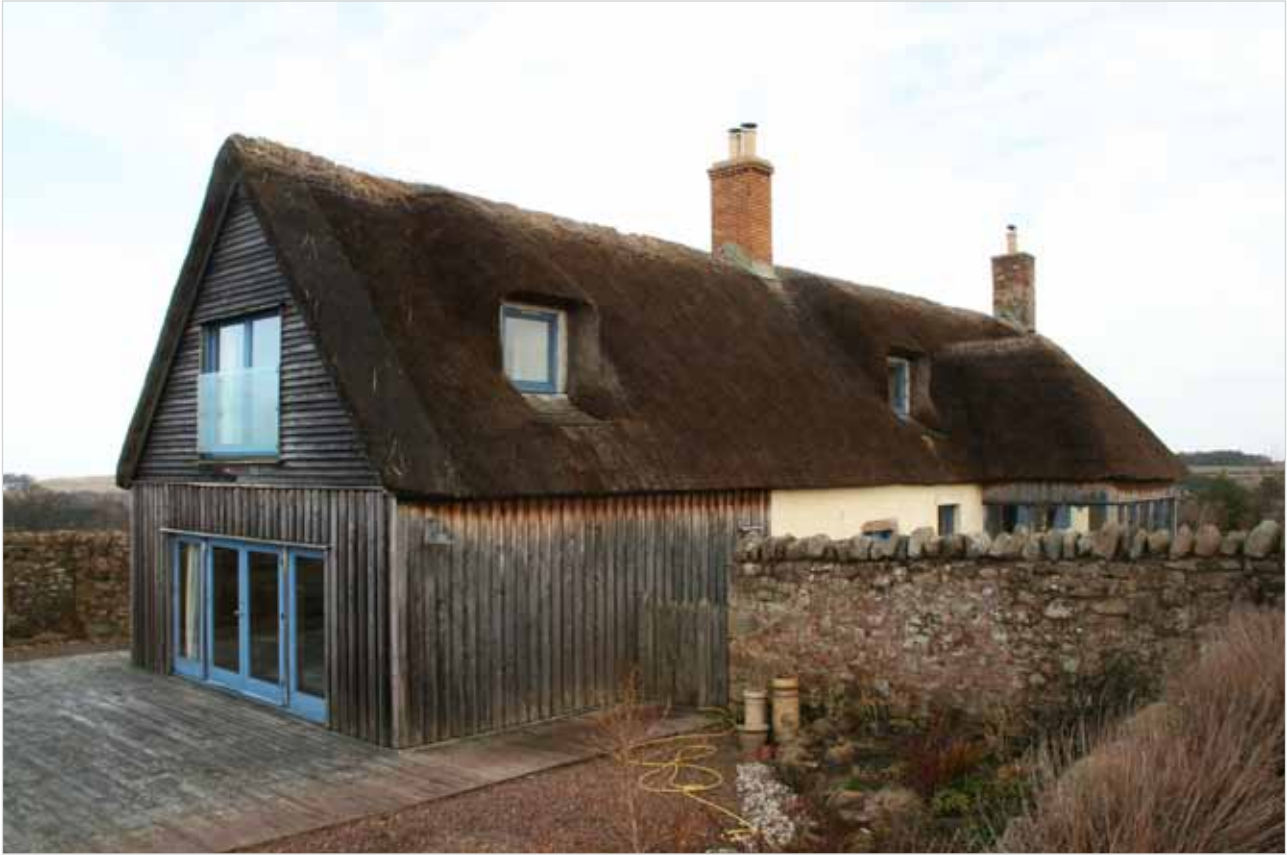
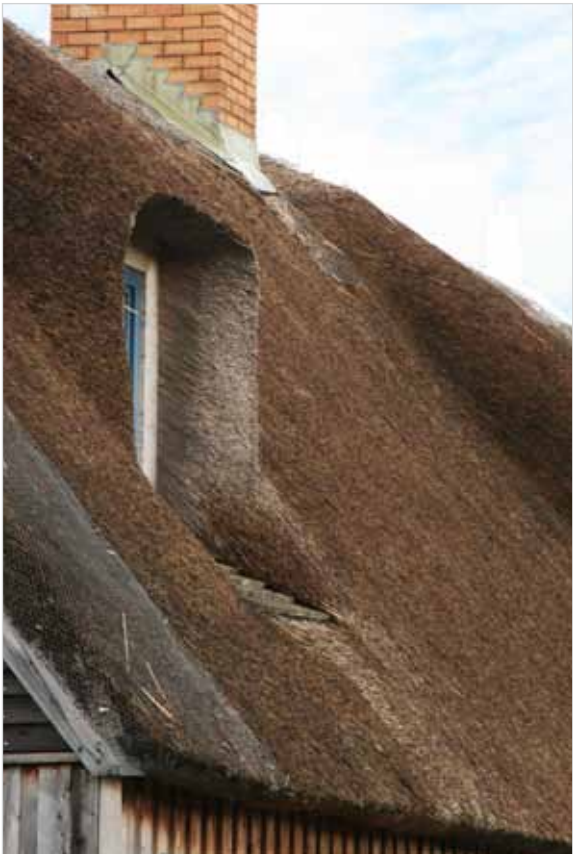
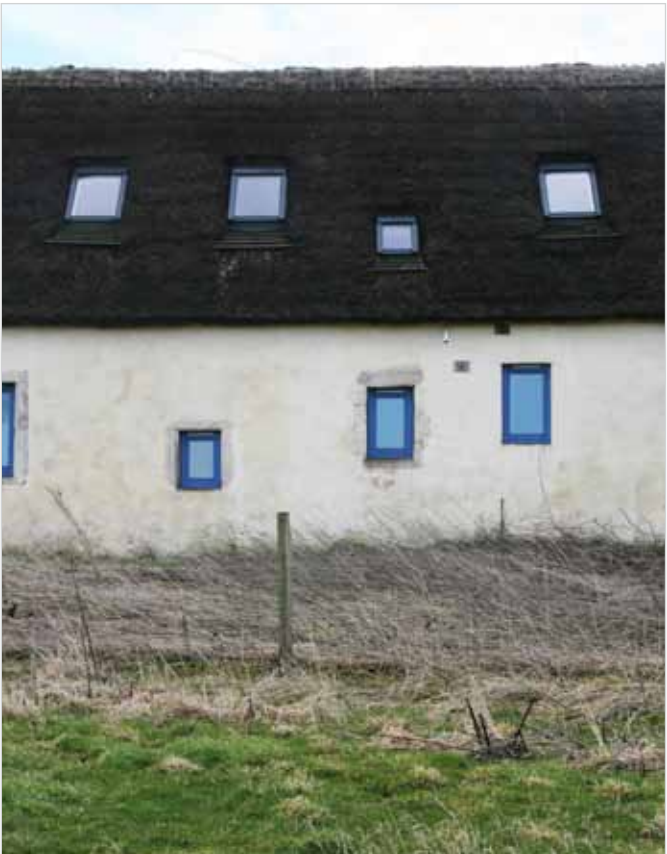
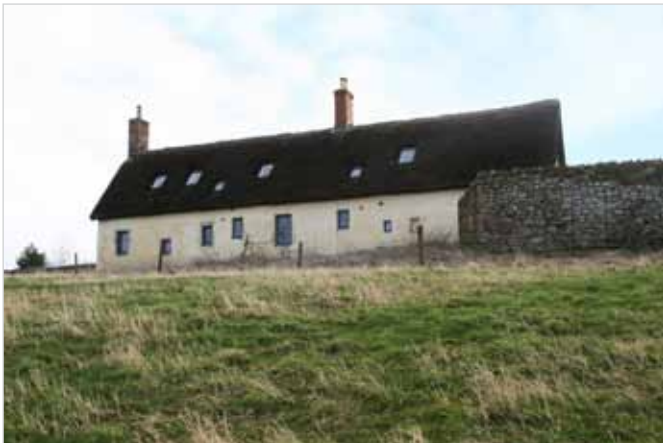
Park Cottage – East Lothian

The cottage, which was previously derelict, was restored in 2004 by Benjamin Tindall Architects. The building was thatched during the restoration, having previously been slated. The thatcher for the project was Scotland-based Adam Cooper, who thatched the roof using reeds from Poland and the ridge with rye straw. The ridge is scobed with hazel spars and, having previously been left uncovered, was netted in 2010/11 after storms and wind had caused the ridge to deteriorate. At this time, the skewers at the west end were also netted to prevent further deterioration and some of the thatch below the left dormer window was repaired. This

work was also carried out by Adam Cooper. The ridge is due to be repaired and the whole roof netted this summer by thatcher Peter Brugge of Northern Thatchers, who completed the recent thatch work at nearby Bolton Muir.

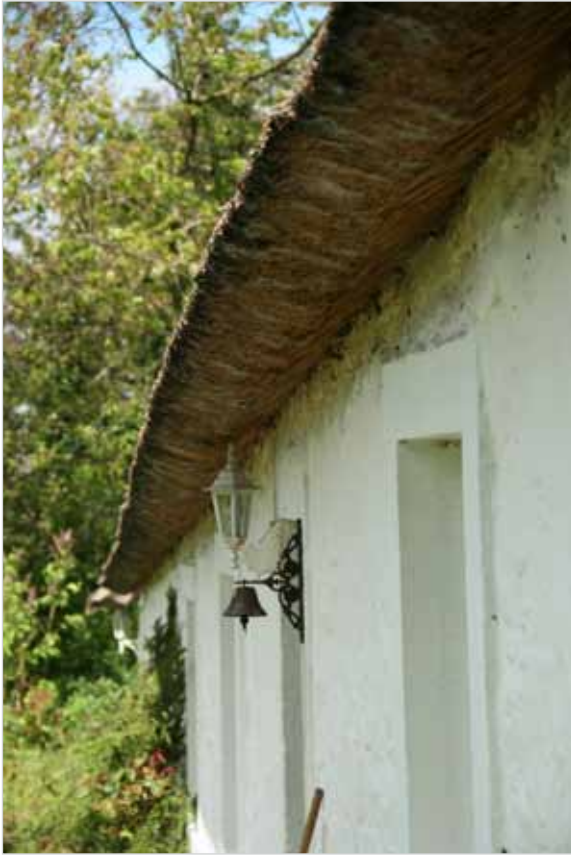
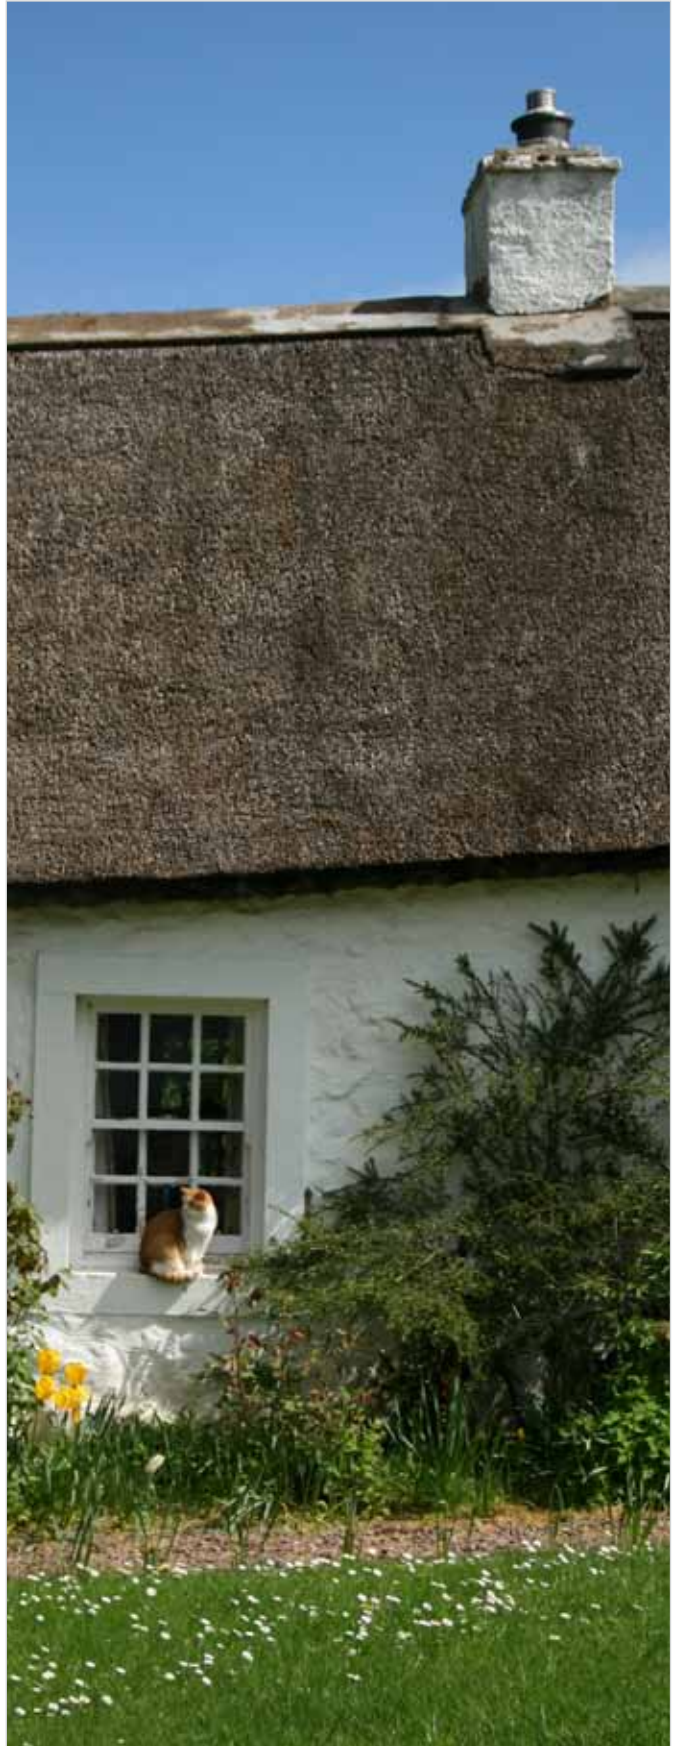
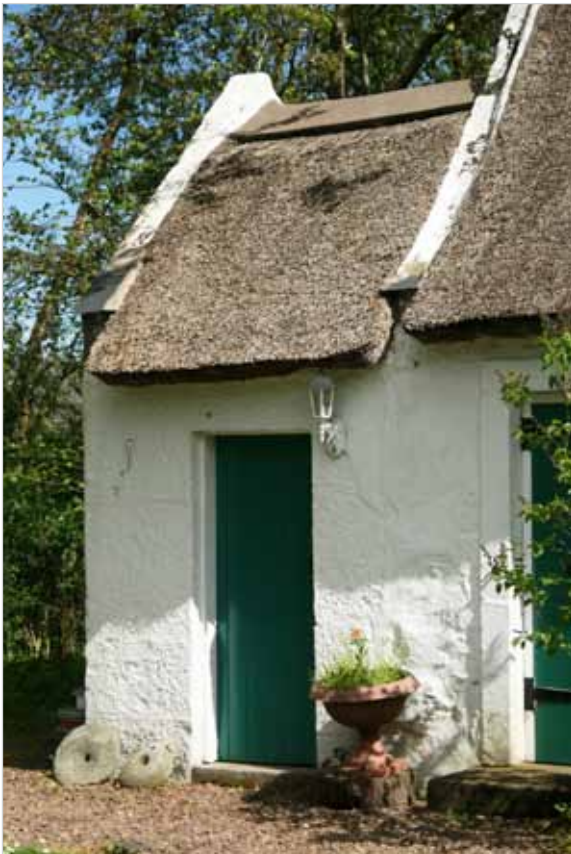
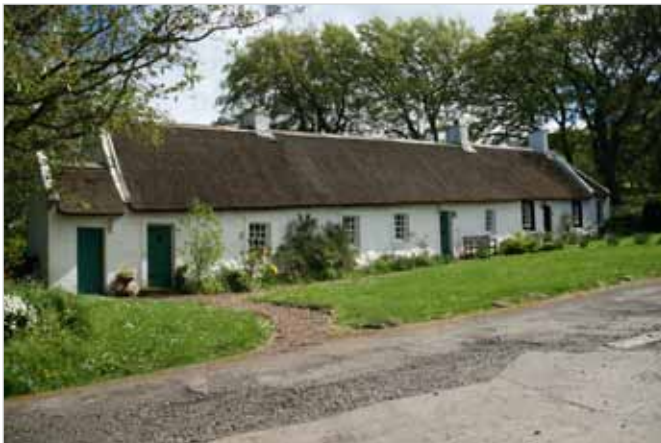
9-10 Swanston Village – Edinburgh

Thatch Type: Reed
 Ridge Type: Concrete
 Condition of Thatch: Good

Additional Notes: 18th-century single-storey cottage building, comprising two properties, with a continuous thatch roof and concrete ridge spanning. It is noted on the listed building entry that it would have once consisted of three cottages, with the current number 9 originally being two properties. There are two small later extensions at either end of the building that are also thatched. The listing states they were restored in 1959-62 by J Wilson Paterson for Edinburgh Corporation. The owner of number 10 noted that the whole building had last been thatched in Norfolk reed in around 2007. None of the thatch is netted. The cottages are part of the small village

of a group of thatched buildings in Swanston on the outskirts of the City of Edinburgh, which has a total of six 18th-century thatched-roof buildings (see entries 060-064 of this survey for the other five entries).
