A Survey of Thatched Buildings in Scotland

Thatch Survey of Scotland
2014-15

A photographic survey of thatched buildings in Scotland, surveyed between May 2014 and August 2015 by Zoe Herbert (SPAB Scotland Officer), on behalf of the Society for the Protection of Ancient Buildings.

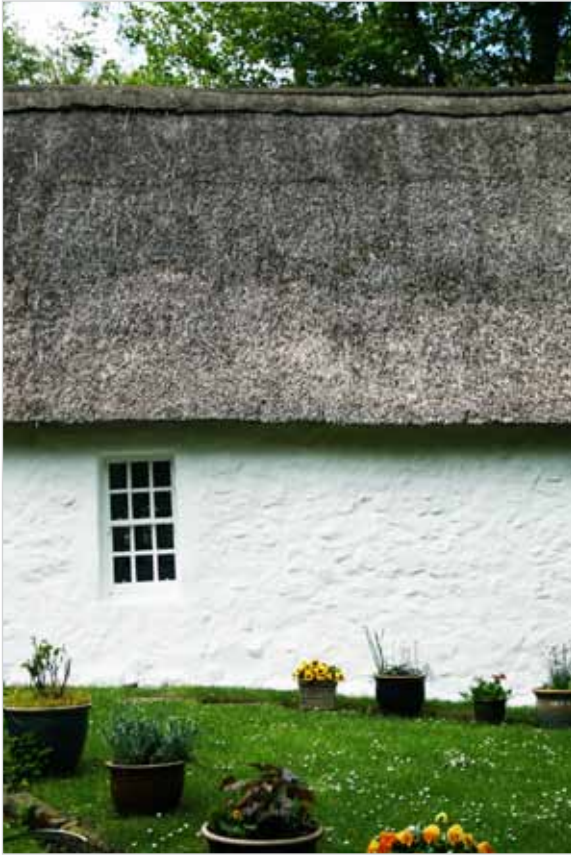
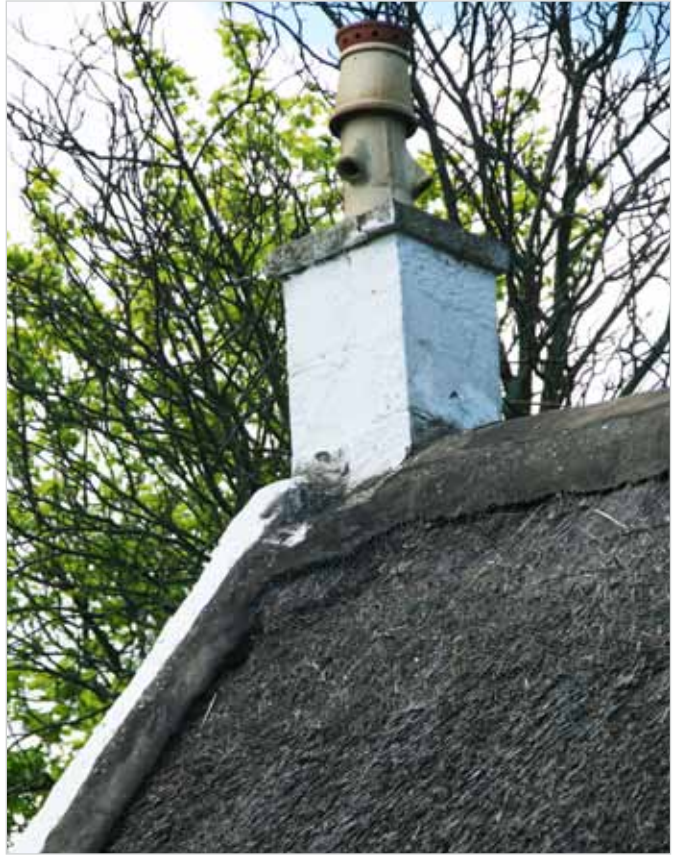
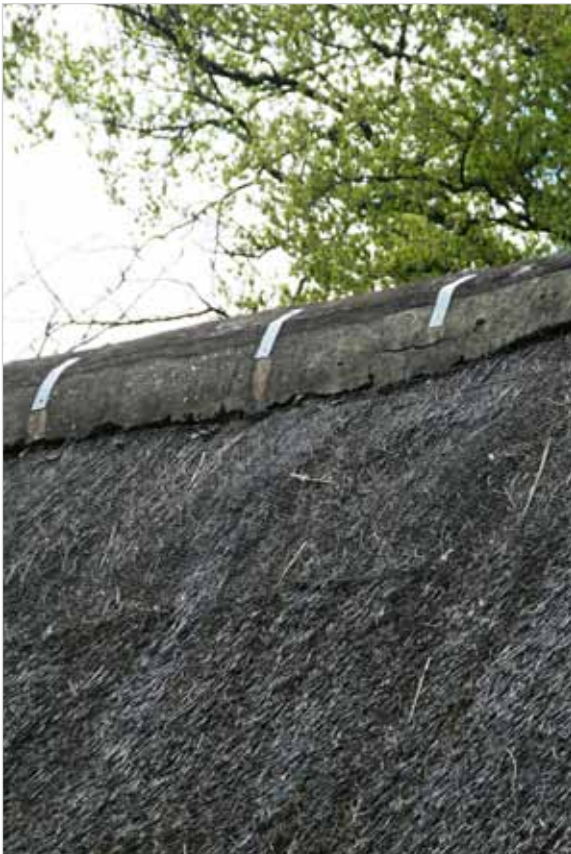
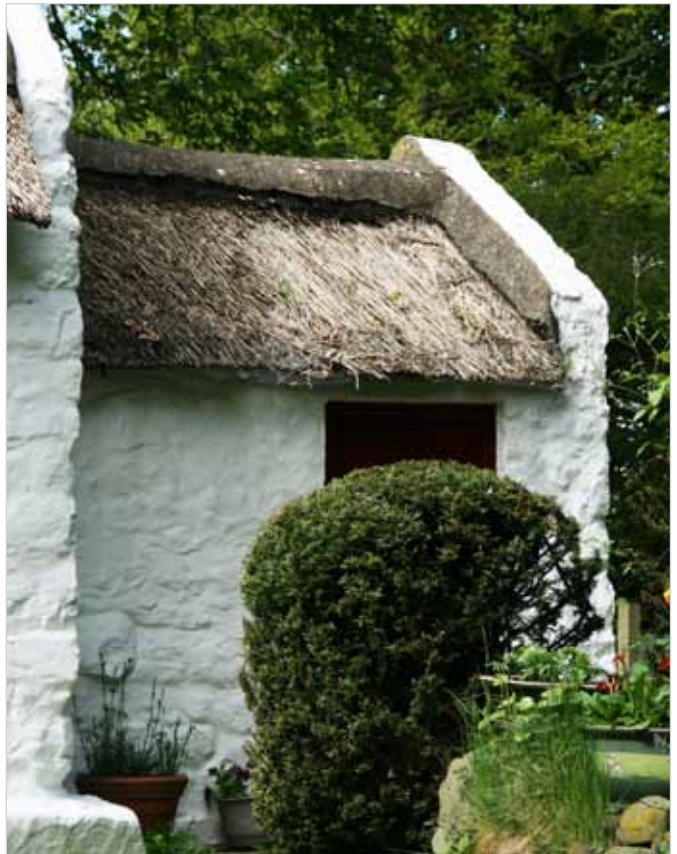
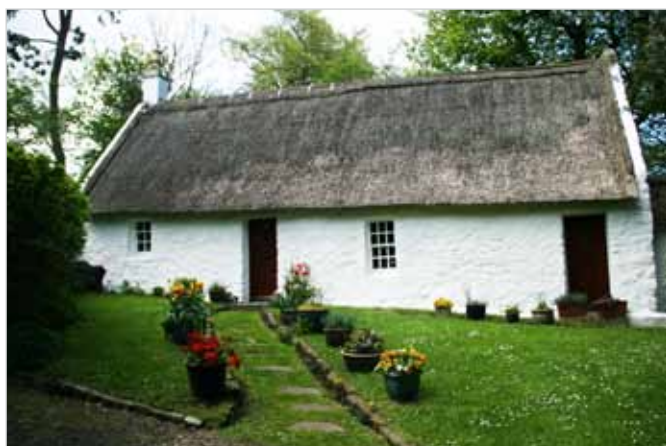
11 Swanston Village – Edinburgh

Thatch Type: Reed
 Ridge Type: Concrete
 Condition of Thatch: Fair

Additional Notes: 18th-century cottage, listed as being 'restored by J Wilson Paterson for Edinburgh Corporation 1959-62'. The cottage has a small gabled extension to the north, which has also been thatched. The concrete ridge has experienced some deterioration, so much so that six metal ties have been installed along the front, presumably where significant cracks were present. The thatch is only partially netted, for a few feet below the ridge, with the bottom section being left uncovered. The thatched extension appears to have been entirely netted at one time; however, this looks to have been cut away in the centre as only a small strip of netting is

left around the sides. The thatch has deteriorated slightly in places; there are a few loose reeds throughout and the thatch has sunk away from the ridge at the top and at the concrete skews, though this could be partly due to deterioration of the ridge at the same time. Part of a group of thatched cottages of the same period (see surveys 059 and 061-064).

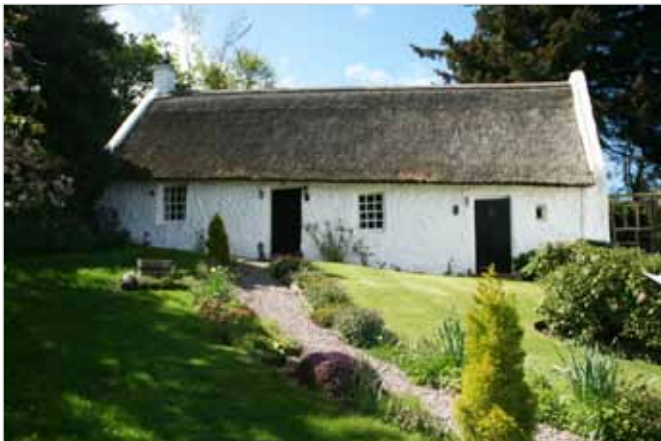
12 Swanston Village – Edinburgh

Additional Notes: 18th-century cottage, listed as being 'restored by J Wilson Paterson for Edinburgh Corporation 1959-62'. The owner states that the roof was last thatched approximately eight years ago using a Tay reed. The thatch remains in a good condition, as does the concrete ridge, with only a small patch of mossy vegetation growth near the top of the thatch visible on the front elevation. The thatch is netted below the ridge only, for about a foot in width. The rest of the thatch is left uncovered. Part of a group of thatched cottages of the same period (see surveys 059-060 and 062-064).

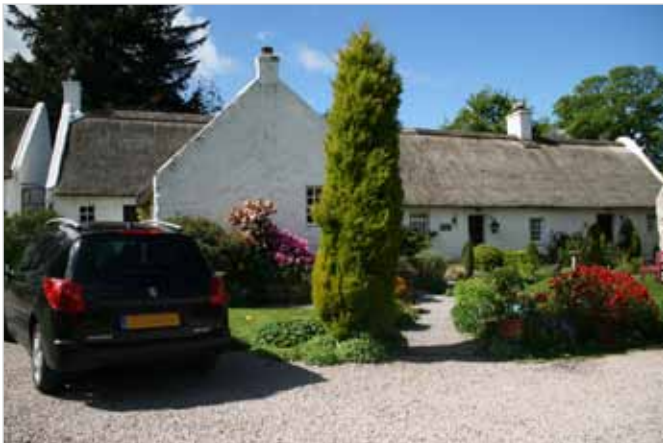
13 and 14 Swanston Village – Edinburgh

18th-century cottage, previously a terrace of two cottages (numbers 13 and 14 Swanston Village, as is listed) but now appears to have been modified to form a single property. The cottage is listed as being 'restored by J Wilson Paterson for Edinburgh Corporation 1959-62'. A short wing projects from the main cottage building, from the front (east) elevation, which is thatched in the same manner as the rest of the building. The concrete ridge appears to have been repaired, as a section in the middle looks to have been entirely replaced. There has also been a repair to the thatch, in the top right corner of the principal elevation on the main cottage,

where the ridge and skews meet. The entire thatch has been netted up to the ridge. There is a large amount of mossy vegetation growth along a section of the ridge as well as the top section of thatch. Part of a group of thatched cottages of the same period (see surveys 059-061 and 063-064).

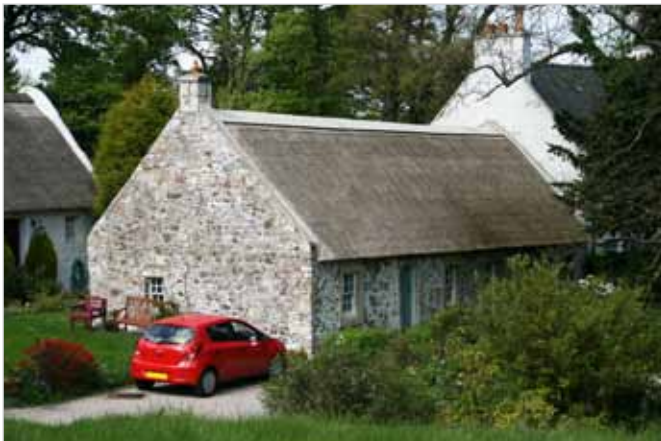
15 Swanston Village – Edinburgh

Additional Notes: 18th-century cottage, listed as having 'slight alterations' and being 'restored by J. Wilson Paterson for Edinburgh Corporation 1959-62'. The skews of the building are lower than the depth of the thatch and a cement fillet has been put in place to secure the thatch at the skews. The listed building description reads 'raised skews', so it would appear the skews or level of the thatch has been altered since the date of listing. The thatch is extremely neat and is left entirely uncovered, and the concrete ridge appears in a new condition. Part of a group of thatched cottages of the same period (see surveys 059-062 and 064 for the other entries).

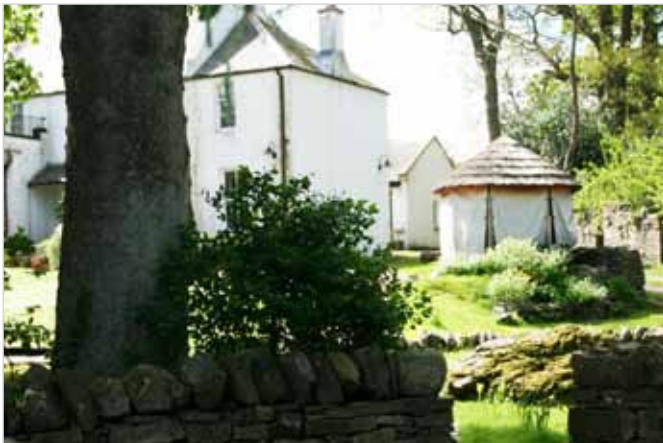
The Old Schoolhouse – Edinburgh

In the front garden of 'The Old Schoolhouse', which is located next to a number of thatched cottages (see entries 059-063) in the village of Swanston, is a small thatched gazebo. It appears to be a modern structure, thatched in what looks to be reed. The conical thatched roof is stepped, with six layers overlapping one another, and has a small cap on the apex of unknown material.

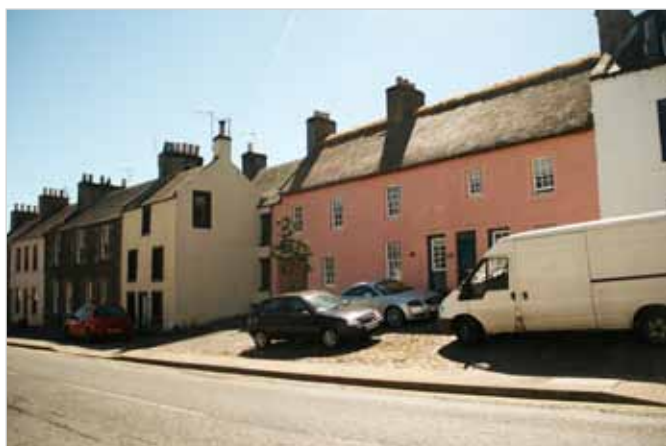
165-173 High Street – Fife

Additional Notes: 18th-century, two-storey block currently comprising two flats. On the front (south) elevation there are two visible repairs to the thatch directly below each chimney stack. On the back (north) elevation there are seven repair patches, below each dormer window, ventilation pipe and chimney stack. The repairs have been thatched in reed, like the rest of the roof, however, they have been secured to the roof using a different technique and have been scobed with what appear to be hazel spars. One of the current tenants stated that the repairs, which include a concrete barrier, were carried out in order to stop roots growing into the thatch.

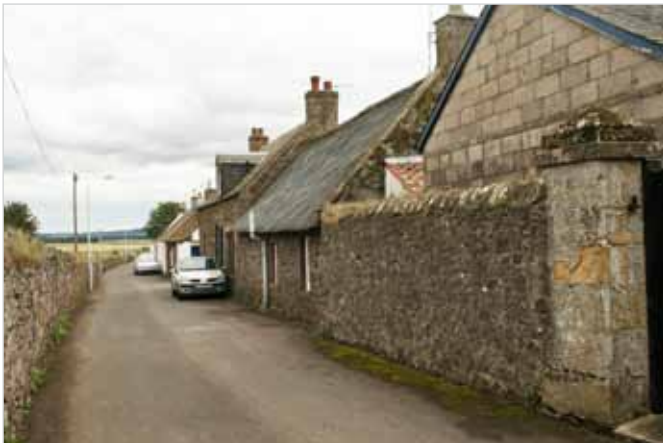
11 Bow Road – Fife

Thatch Type: Reed
 Ridge Type: Thatched (Heather)
 Condition of Thatch: Fair

Additional Notes: 18th-century cottage, with 19th-century alterations. It was re-thatched in 1991 with the aid of a Historic Environment Scotland Thatched Buildings Maintenance Grant, and this would appear to be the last time the building was thatched. The entire thatch is netted, including over the ridge, which is held in place with metal pegs secured into the thatch. The thatch has deteriorated somewhat and the level of the thatch is uneven throughout; however, the netting is still intact and there are no signs of any major vegetation growth or significant damage other than a few loose reeds. The ridge appears to be thatched in heather; however, due to the ridge being netted and its condition, this cannot be said for certain.

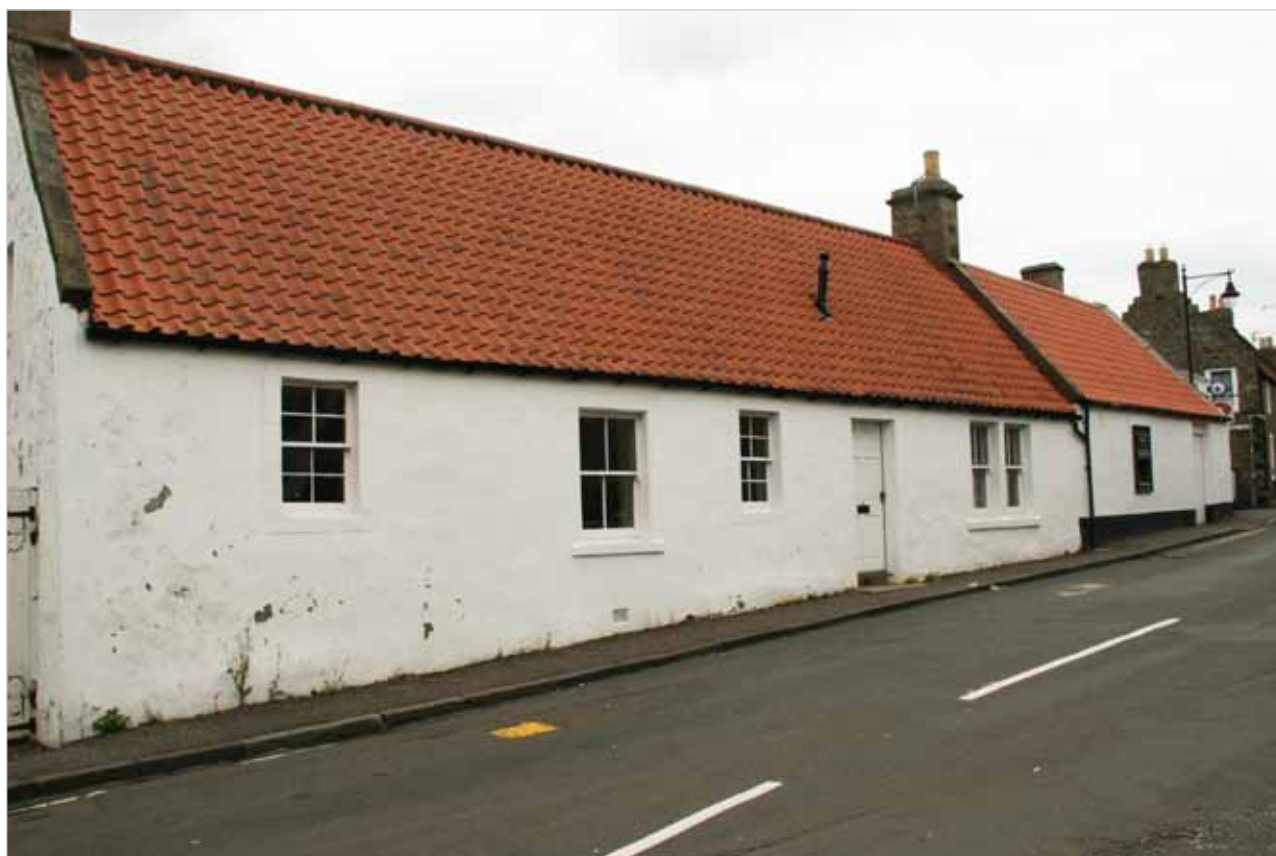
Additional Notes: 18th-century cottage, listed as being thatched. The building at the location for this listing is not thatched and has a pantile roof. The height of the skewers would suggest it was possibly once thatched. The listing description for this building should be updated accordingly.

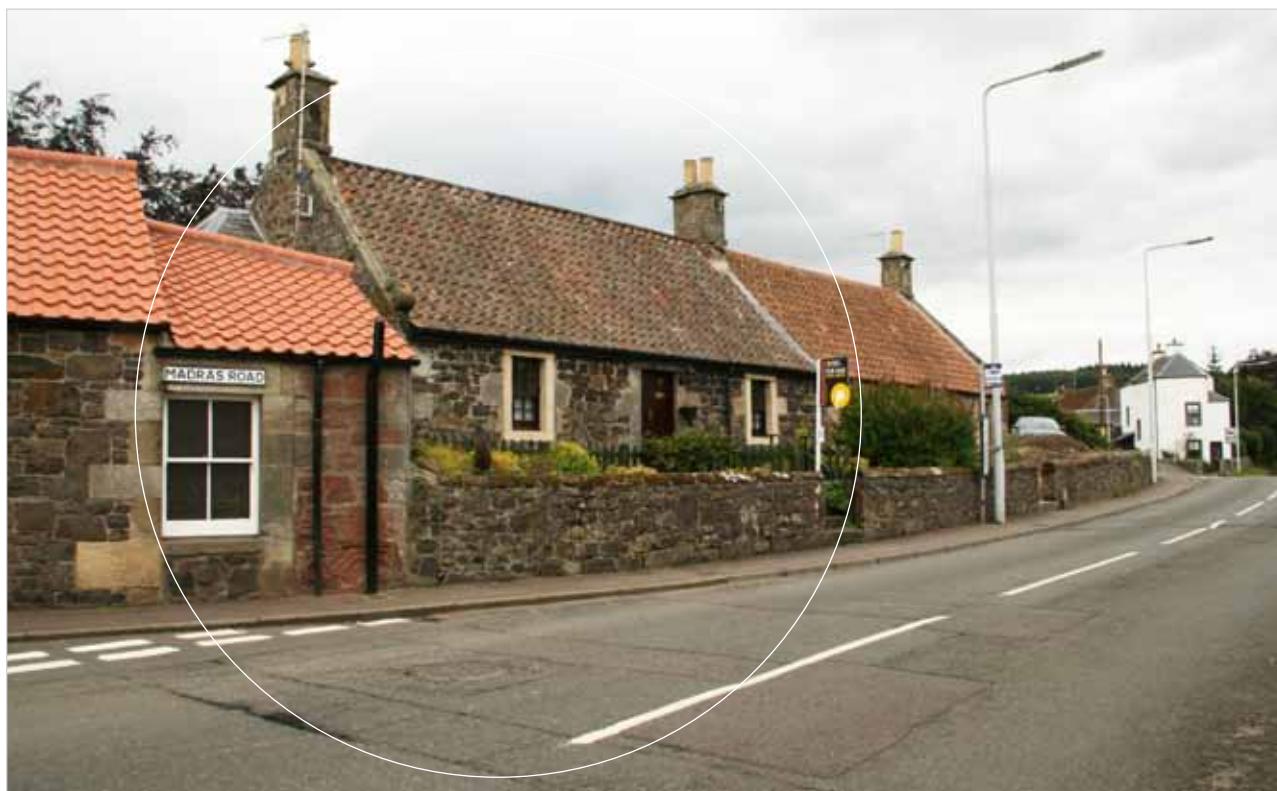
Additional Notes: Pair of late 18th-century cottages, listed together. The southern cottage is listed as being 'thatched with scrolled skewputt', whilst the northern cottage (right in the image below) is listed as having 'Roman tiles'. The southern cottage is no longer thatched and now has a pantile roof. The listing description for the southern cottage should be updated accordingly.

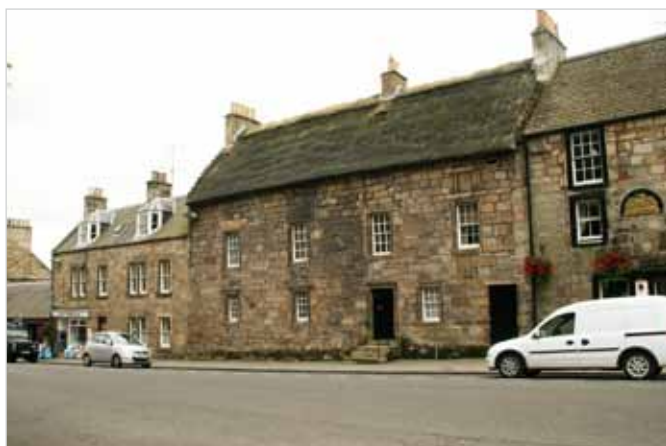
Moncrief House – Fife

Thatch Type: Reed
Ridge Type: Thatched
Condition of Thatch: Fair

Additional Notes: The building, which according to the listing description is 'dated NMAO 1610 at lintel', is comprised of two storeys with a dormerless attic. The roof is thatched in what appears to be reed, however due to the poor condition of the thatch it is difficult to determine for certain. The thatch has suffered deterioration, leaving the surface quite uneven. The whole thatch, including what appears to be either a turf or heather ridge, is netted. There are many loose pieces of thatch on the roof, some of which are only remaining in place due to the wire netting, and there is a large amount of visible mossy vegetation growth throughout. The raised

ridge is continued at a lower level directly below the central chimney stack, as well as below the chimney stack to the east. The cement fillet used between the thatch and the crow-stepped skewers has deteriorated. On the rear (south) elevation there is an interesting angular shape to a section of the eaves.

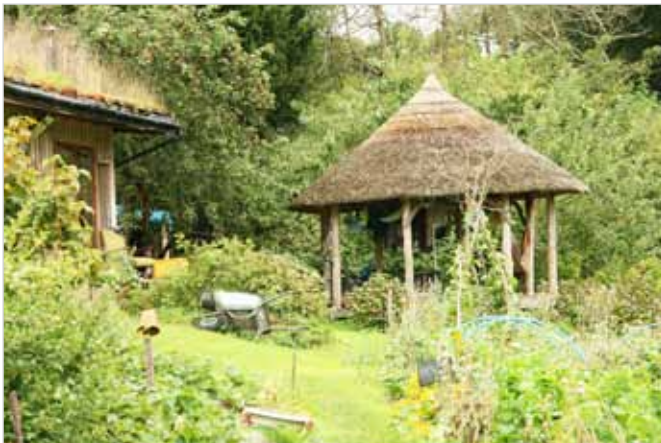
Monimail Gazebo – Fife

Additional Notes: Timber gazebo of modern construction with conical thatched roof in the grounds of the Monimail Tower Project. The structure was built and thatched by Scottish-based thatcher Jeremy Cox, who is based in Castle Douglas and completed work in the nearby village of Collessie where there are a number of thatched cottages (see entries 076-080). The thatch is tied together at the apex and secured with three rows of hazel scobing. As well as the thatched gazebo, there is also an older thatched hut in the grounds of Monimail Tower. The hut is fairly inaccessible due to surrounding vegetation and appears not to be currently in use; however, the

thatched roof, which has some mossy vegetation growth on the surface, remains intact. It appears to be thatched in either reed or straw and is thought to have once been used as a chicken hut.

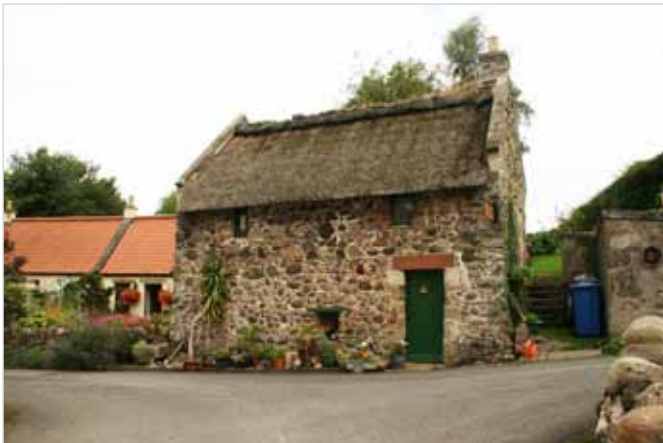
Thatch Type: Reed
 Ridge Type: Thatched (Turf)
 Condition of Thatch: Good

Additional Notes: Late 18th-century two-storey former village wash house, restored in 1995-98 by the current owner, who uses the building as an art studio. The restoration work was carried out by Fife-based Arc Architects. The building was thatched in reed and given a turf ridge, which is netted. In some places, the turf has grown quite extensively along the ridge. Due to the building's use and the need for additional natural lighting, the lower half of the roof on the north elevation has been glazed. The thatch, which other than along the ridge is not netted, is in a good condition; however, there is a small amount of mossy vegetation growth across the surface

of the thatch throughout. There is a single-storey brick extension to the north, which has a pantile roof.

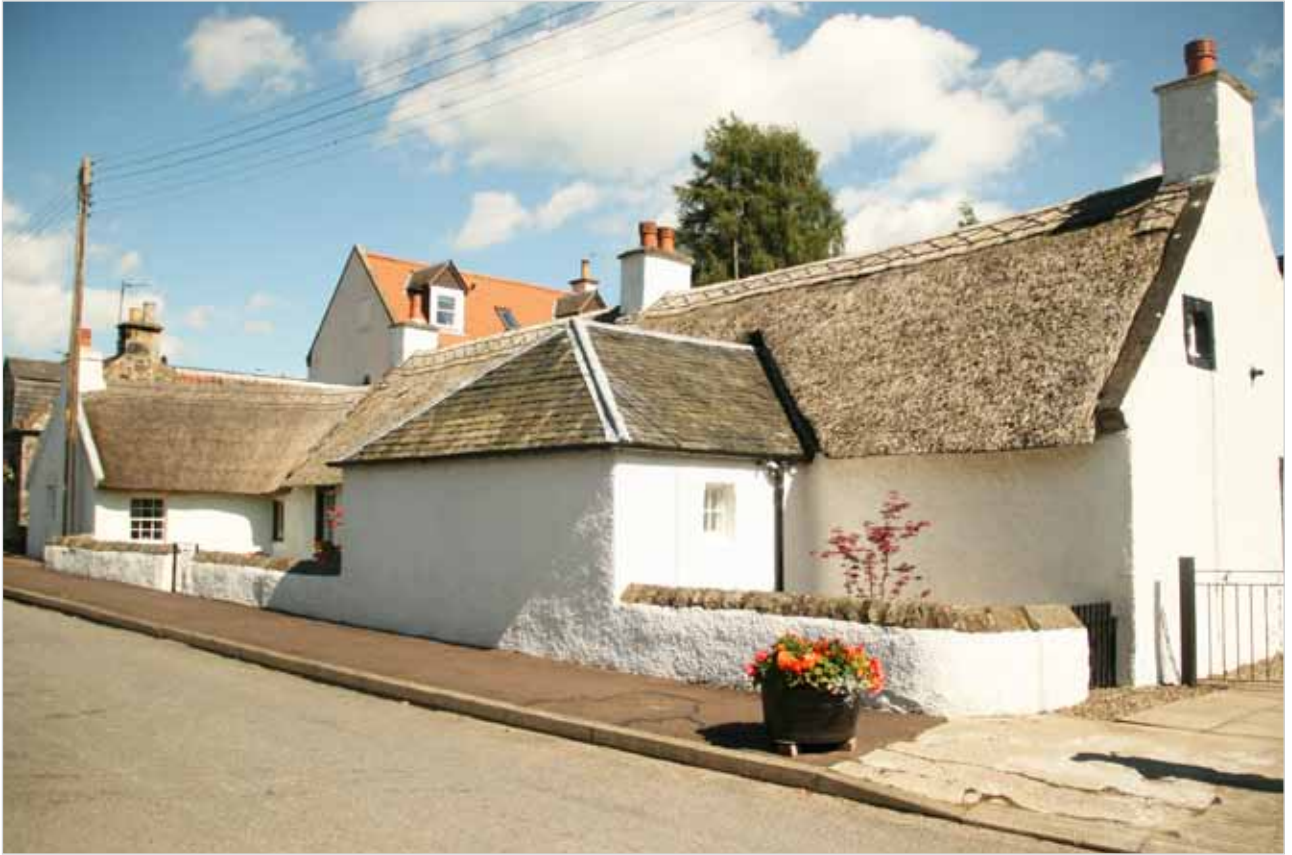
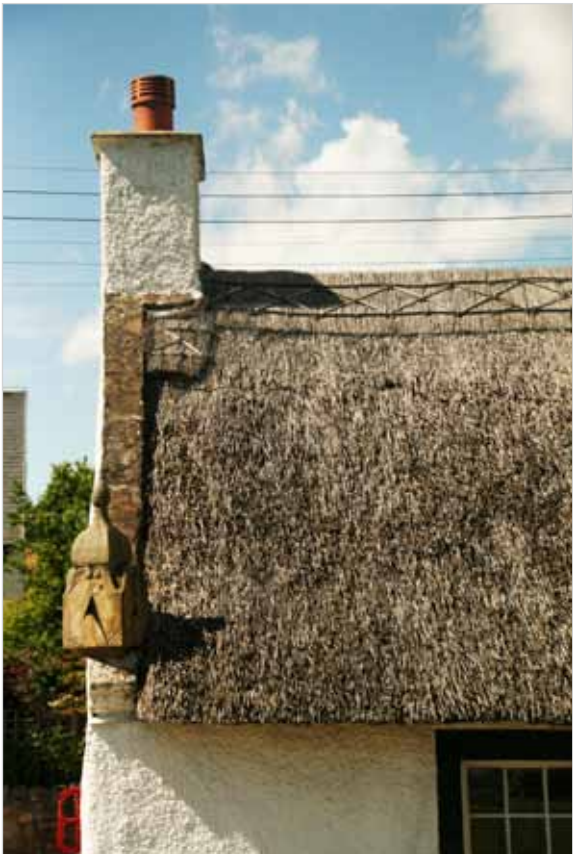
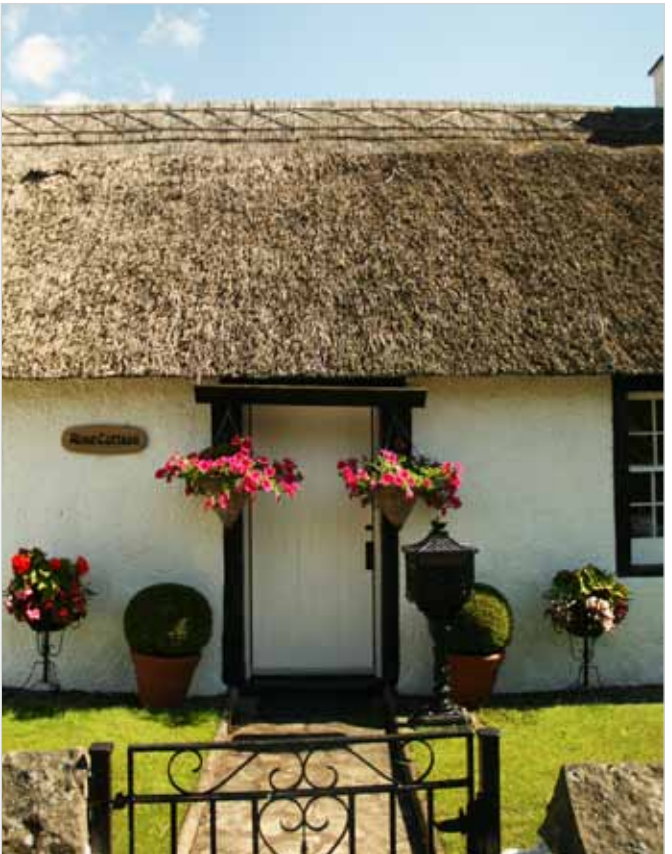
Rose Cottage – Fife

Thatch Type: Reed
 Ridge Type: Thatched (Reed)
 Condition of Thatch: Good

Additional Notes: 18th-century L-plan single-storey cottage, originally three weavers' cottages, now one property. The roof is thatched in reed; a mixture of Tay reed from earlier thatching and reed from Poland in more recent years. A section of the ridge was last re-thatched around 2012-13, whilst the rest of the ridge was last re-thatched around ten years ago. The ridge is netted, as well as directly below the ridge for around a foot, whilst the rest of the thatch remains uncovered. The ridge is scobed, using bramble spars diagonally and rubber horizontally. The small patches of scobing directly below the chimney stacks are scobed using only bramble. The thatch is in

..... a good condition and has been well maintained.
 Central section has had a single-storey extension
 wing built to the north, the roof of which is slated.
 The cottage is located in a small village with four
 other thatched properties in close proximity (see
 entries 076 and 078-080).

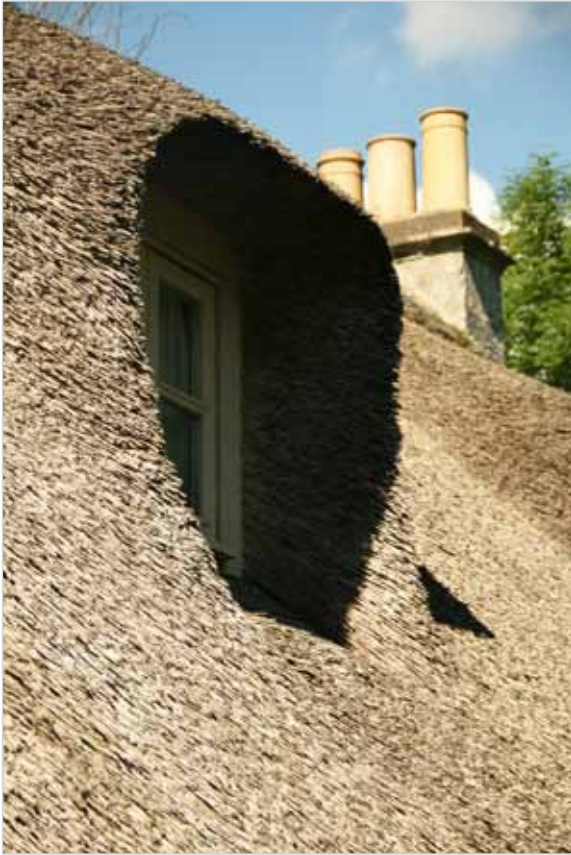
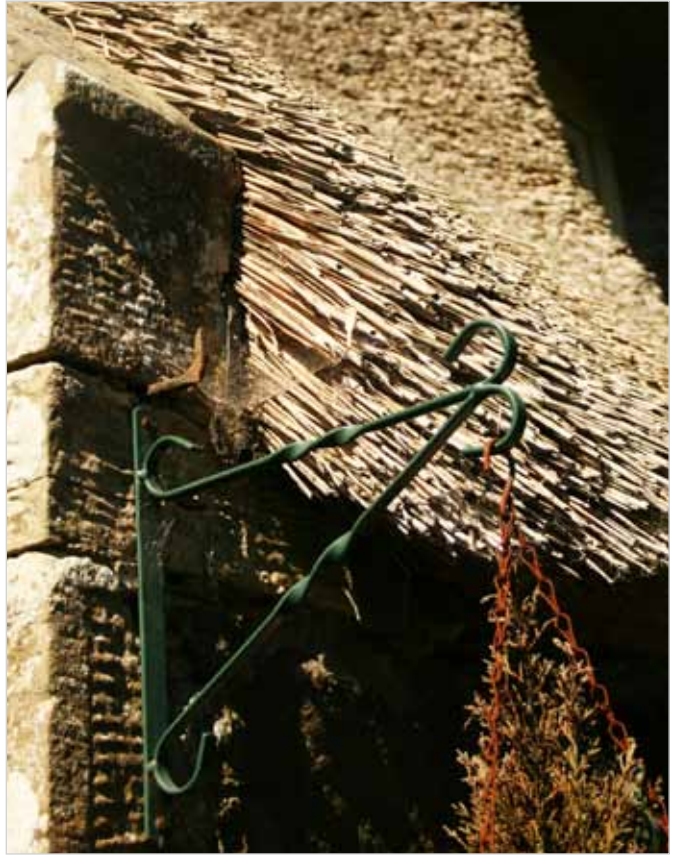
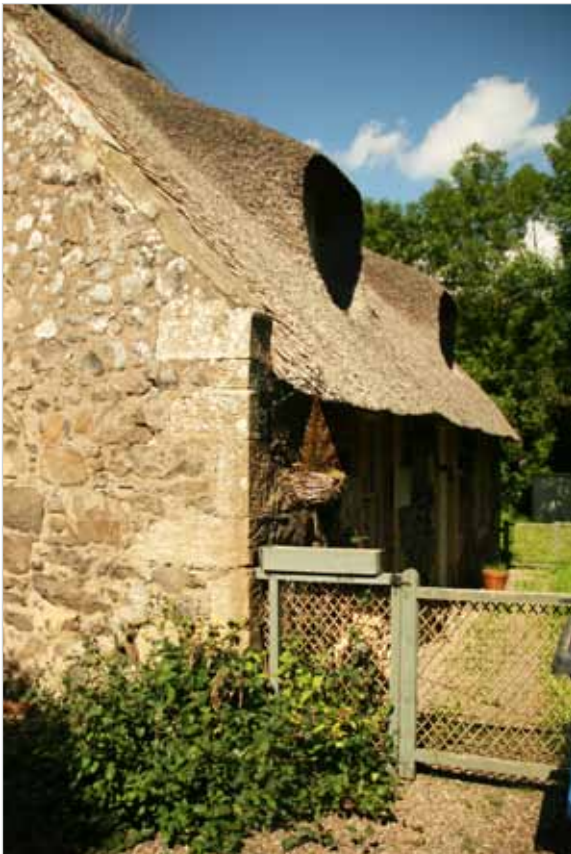
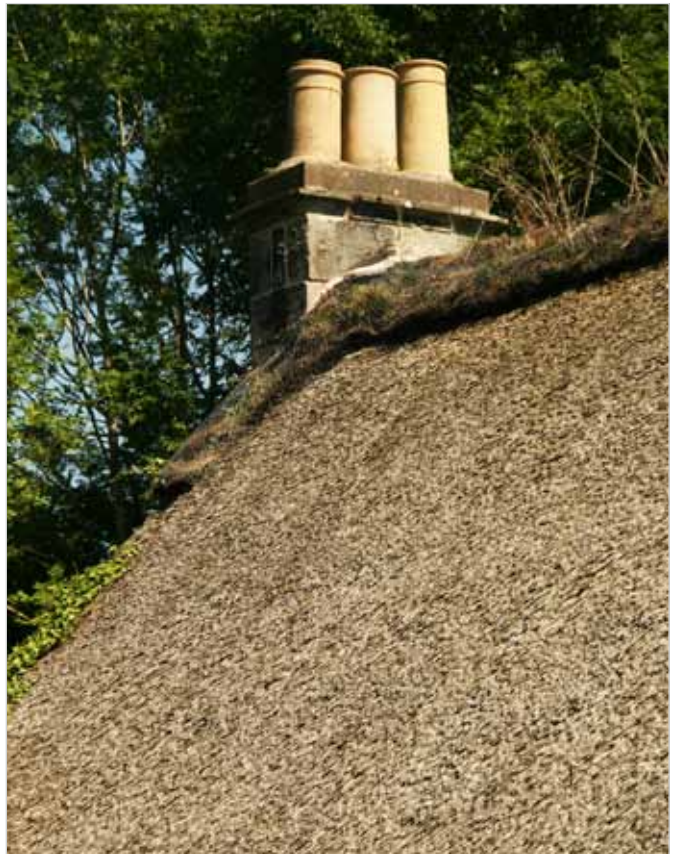
Southview Cottage – Fife

Condition of Thatch: Good

Additional Notes: Late 18th-century cottage, single-storey with an attic and listed as having a 'felt tiled roof and being 'recently renovated'. The listed building description notes read '*Former Parish School, Unsympathetic roofing material*', which could perhaps explain a later decision to thatch the roof in reed. On the south (principal) elevation, there are two attic dormer windows within the thatched roof. The netted turf ridge is slightly overgrown with vegetation, whilst the rest of the thatched roof, which has been left uncovered, is in a good condition. On the north (back) elevation, ivy has grown up the gable, under the eaves, and onto the thatch. According to locals,

the cottage was last restored circa 2011, when it is believed to have also been re-thatched.

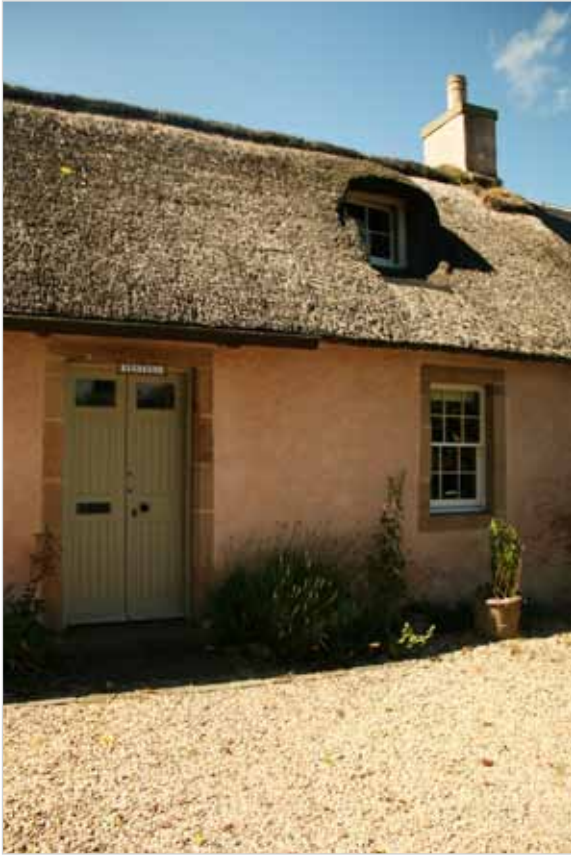
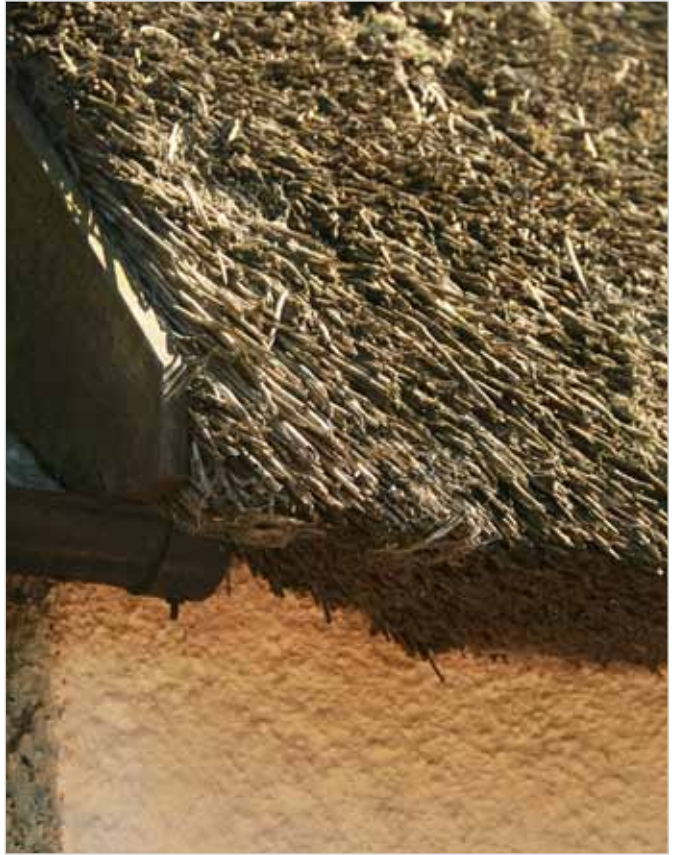
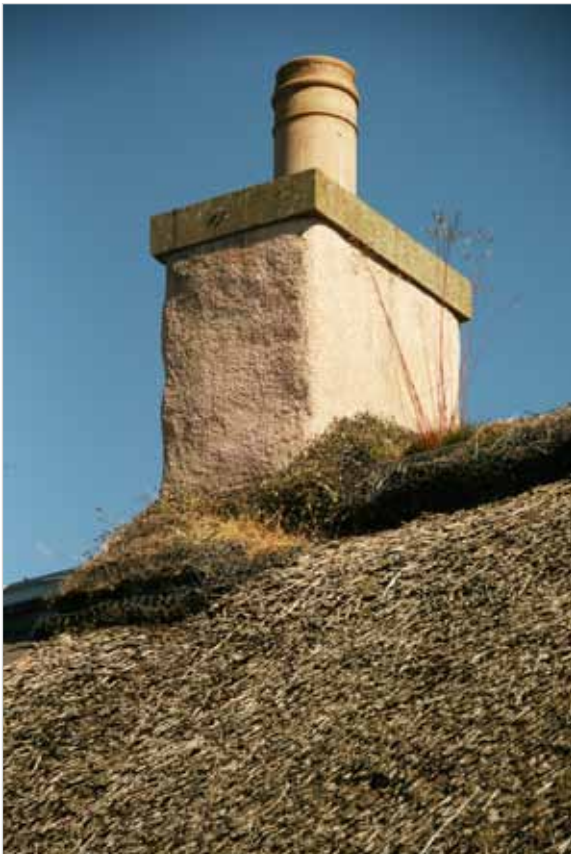
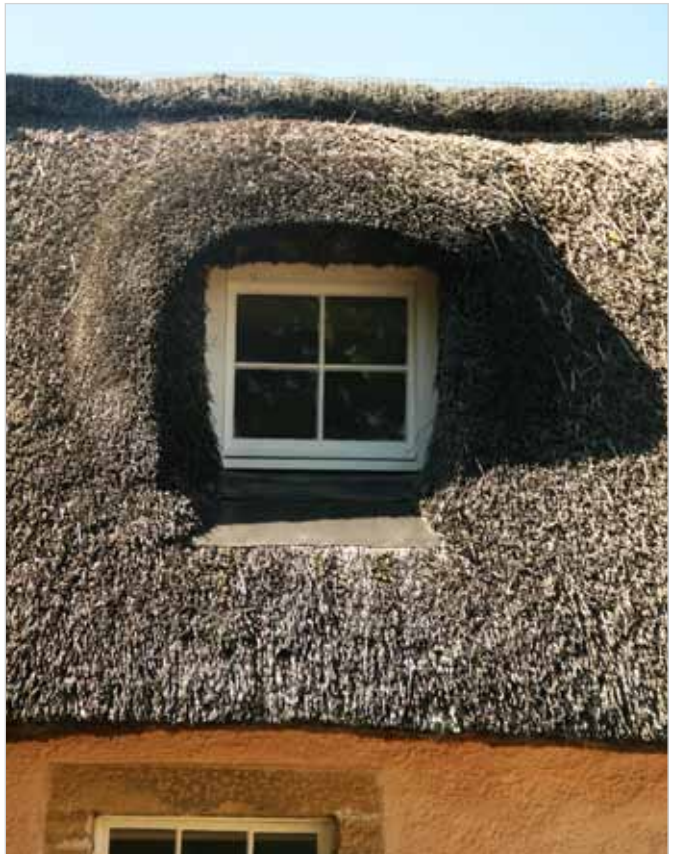
West End Cottage – Fife

Local Council: FIFE
 Listing Category: B
 Date Listed: 29/06/1978
 Listed Building Number: 2474
 Canmore ID: 260904
 Building Type: Cottage
 Use: Residential
 Grid Reference: NO 28477 13163
 Occupancy: Occupied
 Date of Visit: 10/07/2014
 Buildings At Risk: n/a
 Thatch Type: Reed
 Ridge Type: Thatched (Clay and Turf)
 Condition of Thatch: Good

Additional Notes: The cottage was restored by Arc Architects, and the description from their website reads
 'This 18th century "B" listed cottage, prominently located in the conservation village of Collesie, was restored
 for a local developer in 1998. Derelict, but with some of the original thatch and pine roof remaining, the house
 required a complete restoration. The roof structure was carefully repaired and a Tay reed thatch roof reinstated
 with eyebrow dormers and a clay and blueberry turf ridge' (<http://www.arc-architects.com/conservation/West-End-Cottage.htm>). It is unknown whether any re-thatching or maintenance/repair has taken place since the

restoration in 1998. The ridge is netted, whilst the rest of the thatch is left uncovered. The ridge has compacted slightly in places and has some minor vegetation growth. Where the adjoining cottage to the east has been slated, a timber bargeboard has been used to contain the thatch. A snow board has been installed above the front door.

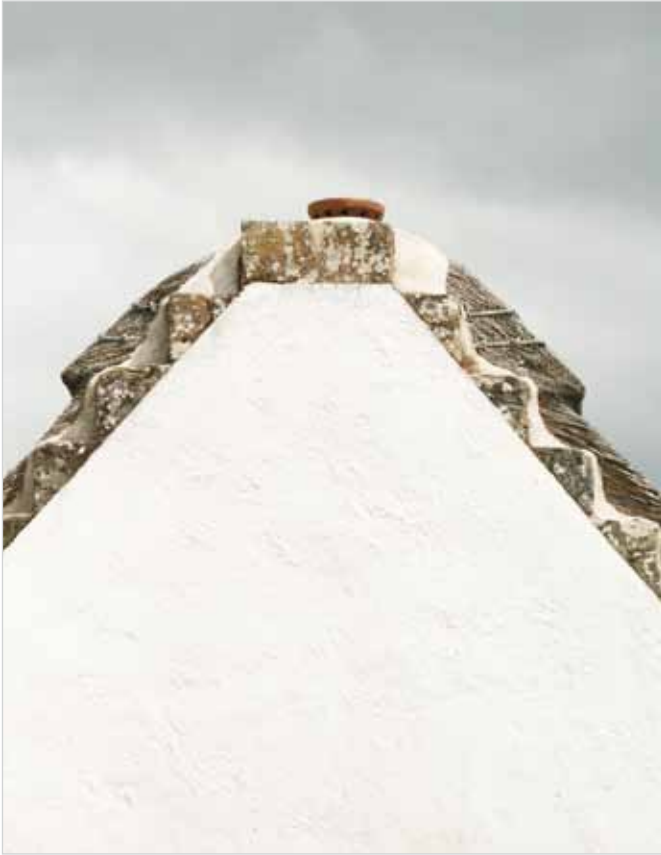
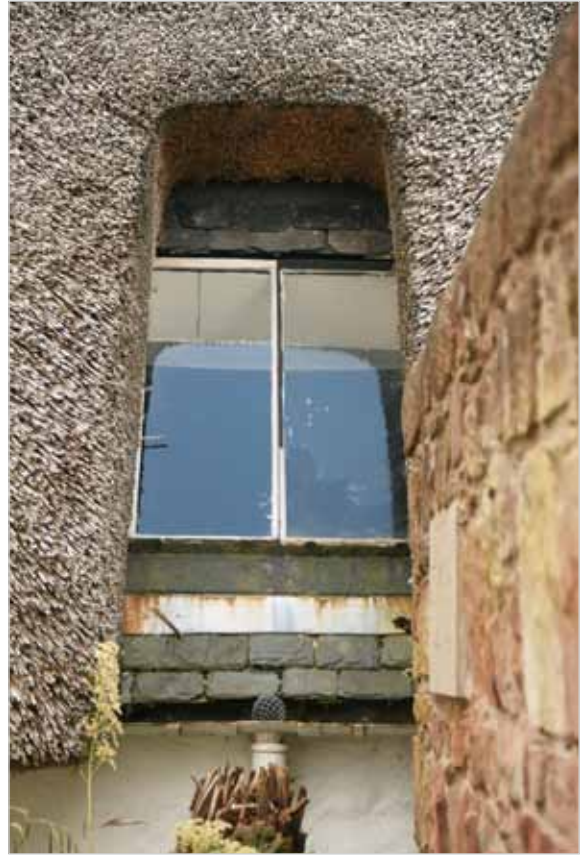
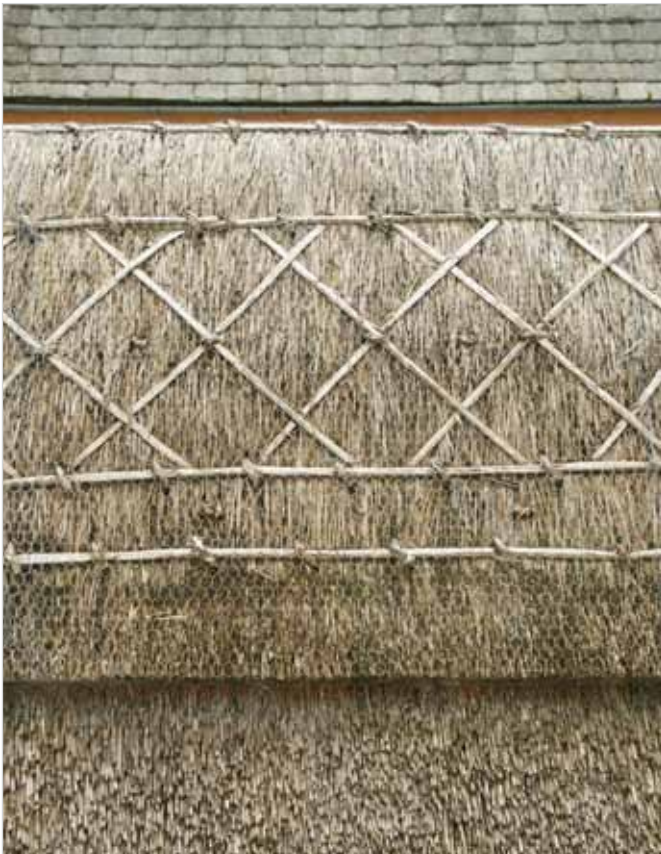
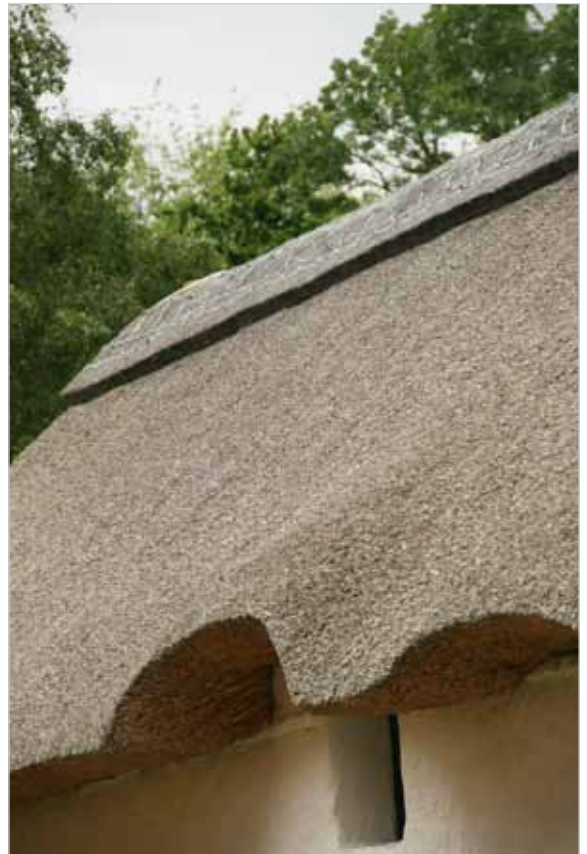
Hugh Miller's Cottage – Highlands

Thatch Type: Reed
 Ridge Type: Thatched (Straw)
 Condition of Thatch: Good

Additional Notes: Early 18th-century two-storey cottage, made famous by being the birthplace of geologist Hugh Miller. The cottage is owned by the National Trust for Scotland and is part of the Hugh Miller's Birthplace Museum. The building was last re-thatched in 2010, in reed with a straw ridge, by thatcher Graham Carter. According to NTS literature on display in the building, the roof would have been thatched in turf topped with straw, or in heather. The longevity of the reed is why they chose this material for its last thatching. The straw ridge has been scobed with hazel spars, and extended decoratively below the chimney stack to the north. On

the south-east (front) elevation the thatch has been sculpted at the eaves above the three first-floor window openings, whilst on the north-west (rear) elevation there are two recessed window openings within the thatch, below which the roof has been slated to the eaves. The roof has been netted along the ridge only, whilst the rest of the thatch has been left uncovered.

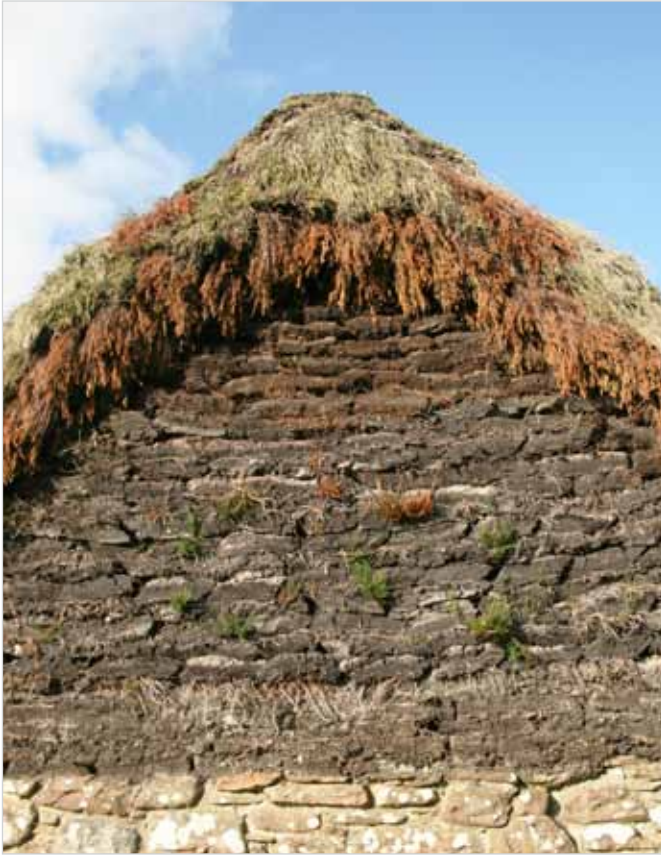
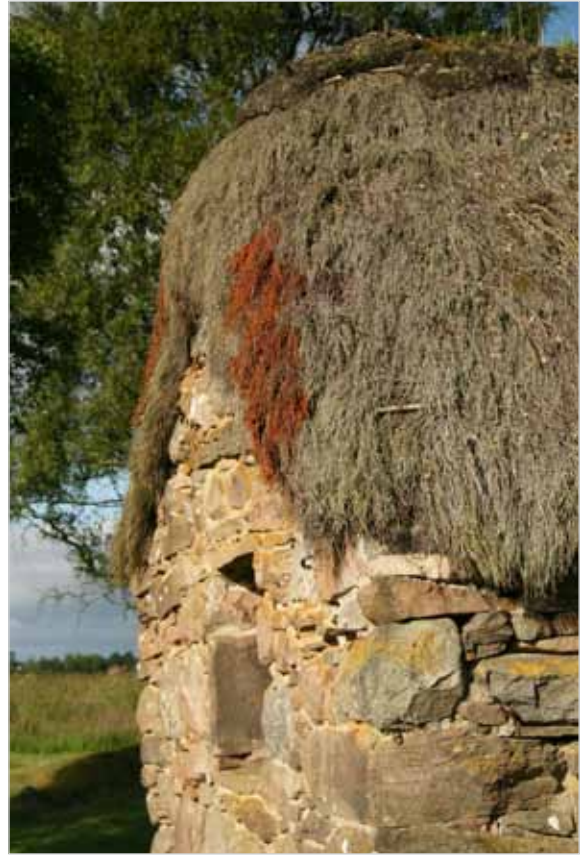
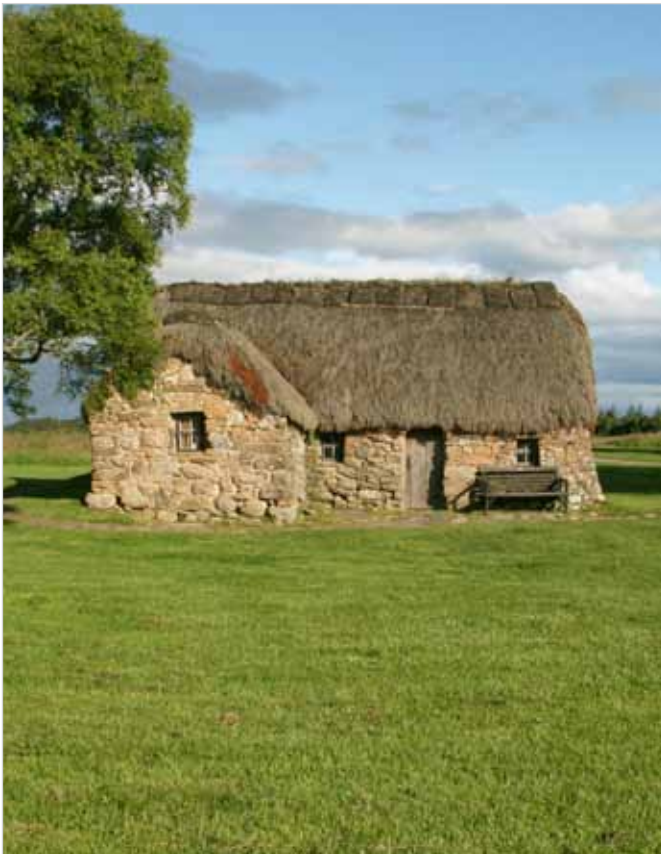
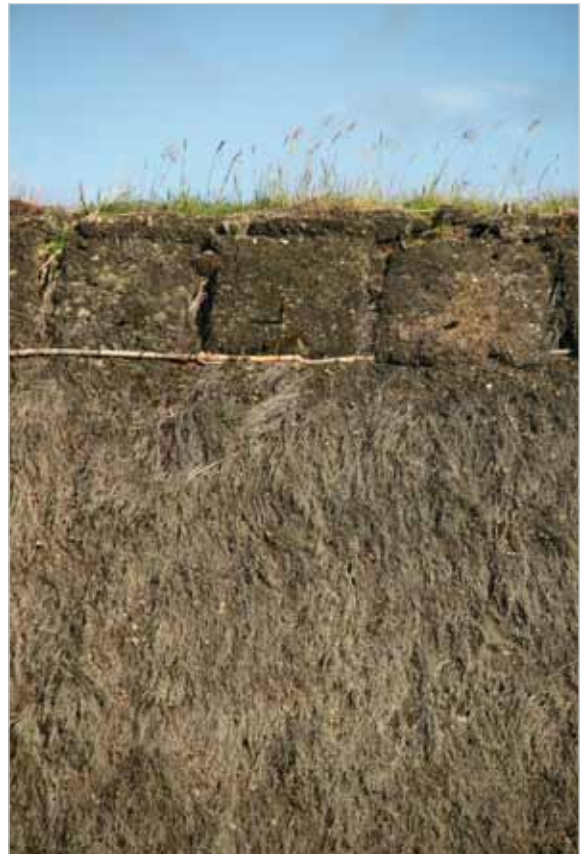
Old Leanach Farmhouse – Highlands

Thatch Type: Heather
 Ridge Type: Thatched (Turf)
 Condition of Thatch: Good

Additional Notes: Mid 19th-century cottage, located on the site of the Battle of Culloden and now part of the National Trust for Scotland museum complex. The listing description for the building states that it has a 'piended heather thatched roof (c. 1982 re-thatch)'. Across the top of the ridge and down the sides, turf has been placed in rectangular tiles and pegged to the roof with wooden pegs. Thin wooden branches have been secured to the thatch directly underneath the turf on the ridge in places, it would appear to add further support to the turf and stop them from slipping. The thatch has been left uncovered, and there are metal hooks secured into

the stone below the eaves that are currently not being used, which would suggest the thatch was tied down using these hooks at some point in the past. Also known as Old Leanach Cottage.
