A Survey of Thatched Buildings in Scotland

Thatch Survey of Scotland
2014-15

A photographic survey of thatched buildings in Scotland, surveyed between May 2014 and August 2015 by Zoe Herbert (SPAB Scotland Officer), on behalf of the Society for the Protection of Ancient Buildings.

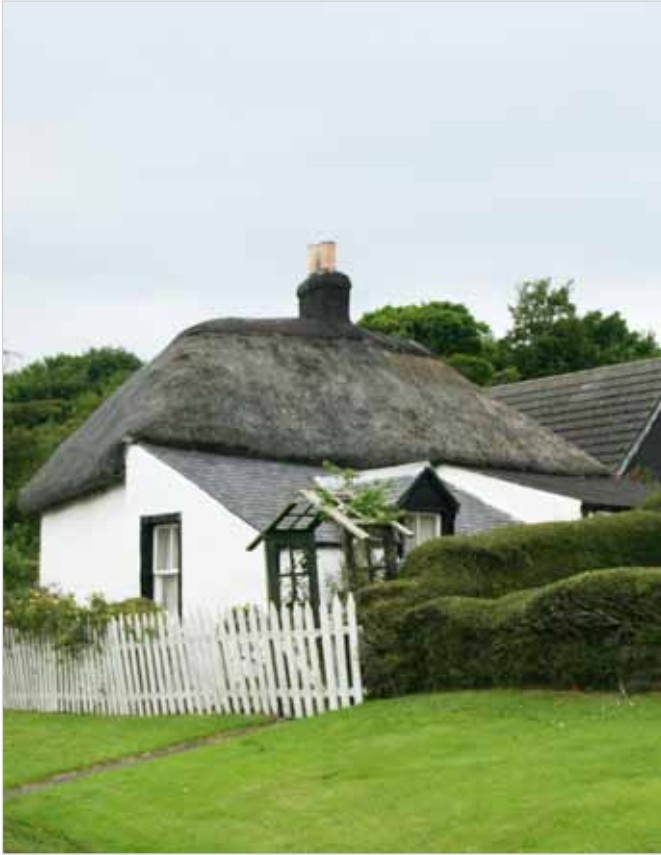
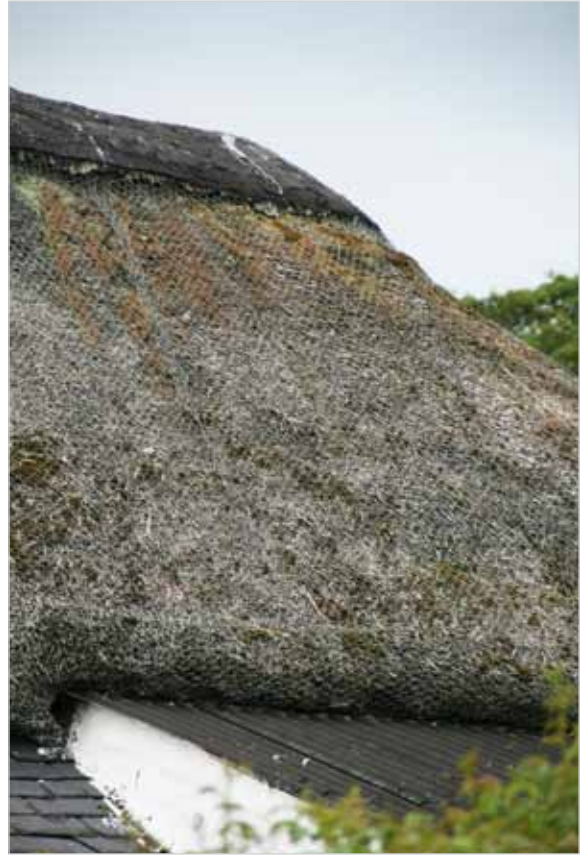
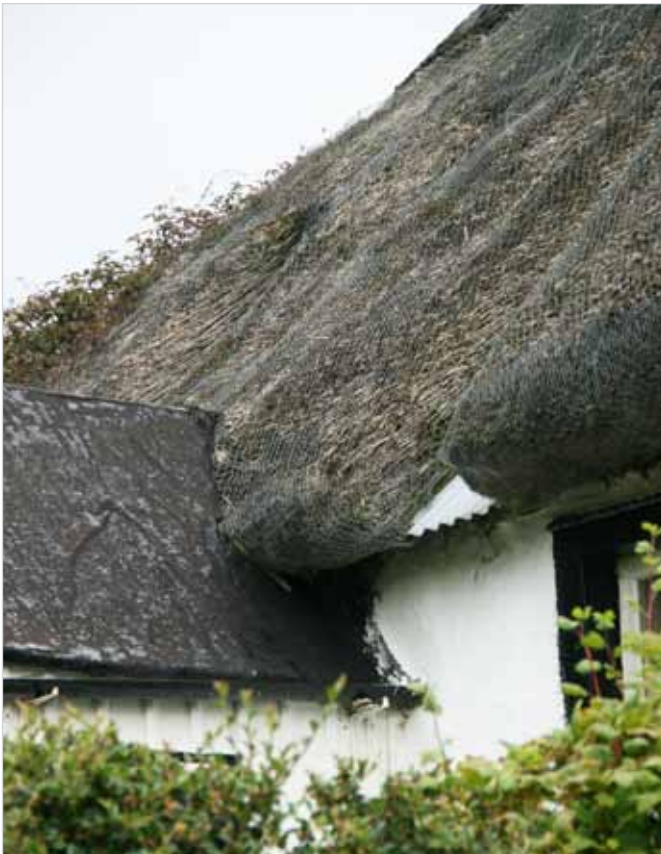
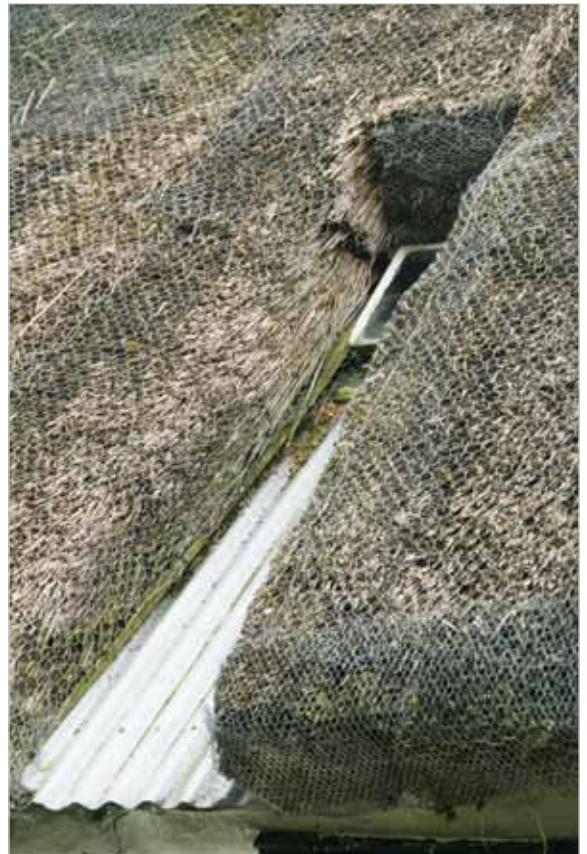
Windyhill – Highlands

Thatch Type: Reed
Ridge Type: Concrete
Condition of Thatch: Fair

Additional Notes: Circa 1800 single-storey cottage with later single-storey extension across the full length of the rear elevation. The rear extension, as well as the gabled 19th-century porch to the front elevation, does not have a thatched roof. The cottage has a single chimney stack in the centre of the concrete ridge and a steeply pitched thatched roof. On the front elevation there is a pair of small attic windows, one on either side of the entrance porch. Below the attic windows the roof is not thatched and instead has been covered with a strip of corrugated iron that extends from the bottom of the window to the eaves. The thatch has been entirely

netted, from the base of the concrete ridge to underneath the eaves. There is an amount of mossy vegetation growth across the surface of the thatch, particularly on the rear elevation. To the left of the front elevation, one of the plants from the garden has grown up onto the building and is spreading across the thatch.

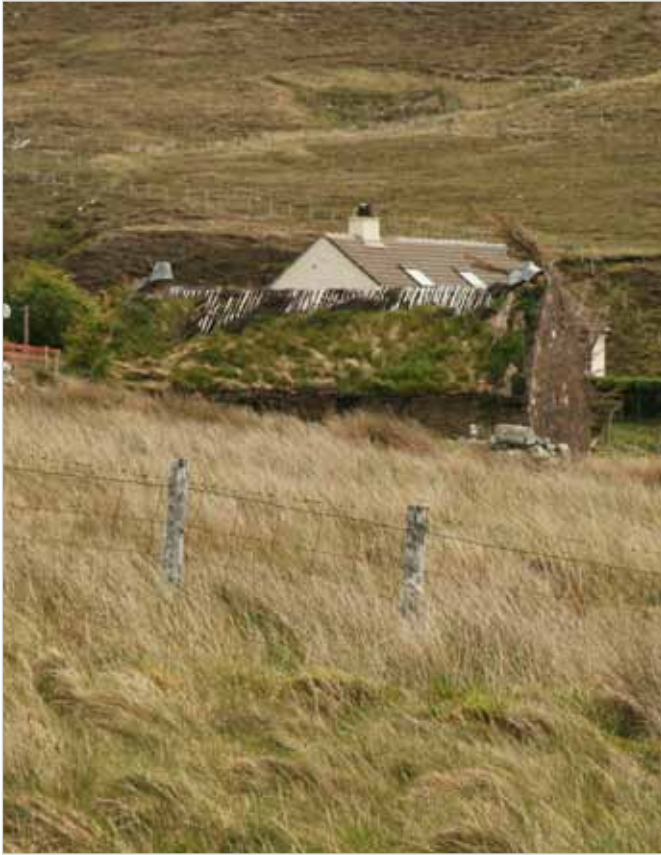
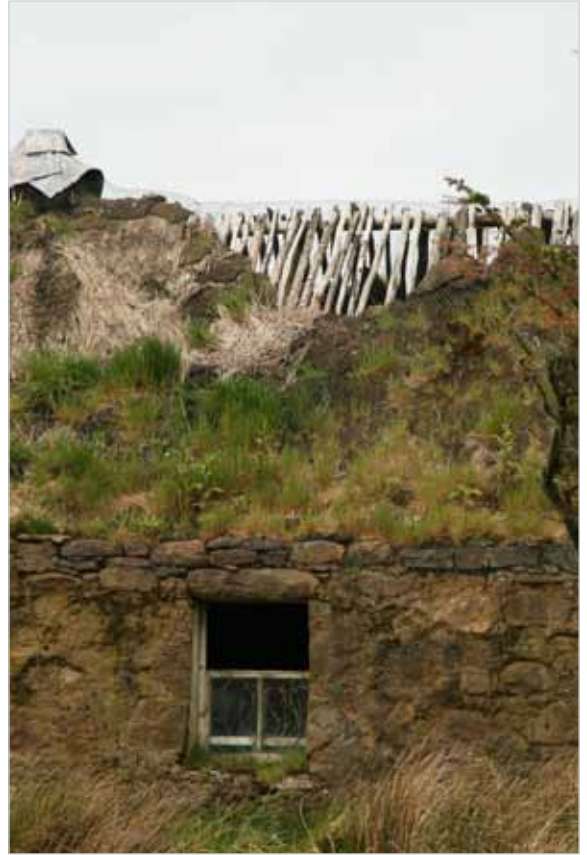
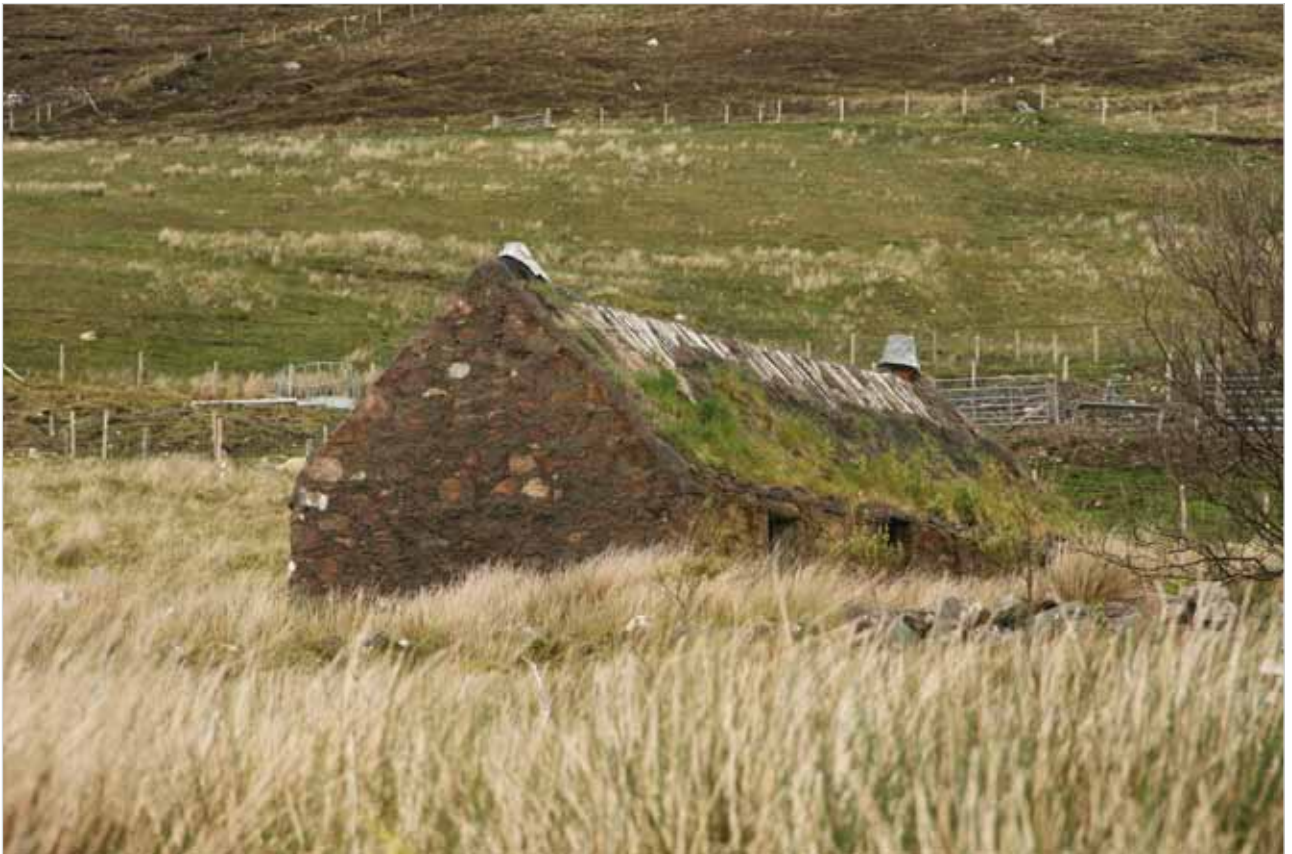
11 Melvaig – Highlands

Condition of Thatch:

Mid/late 19th-century three bay cottage. The building is currently not being used and is in a derelict condition. The thatched roof, along with what appears to be a layer of turf underneath the thatch, is only partially intact and what remains is heavily overgrown with grass and other vegetation growth. The thatch has been almost entirely lost across the ridge and there are large openings exposing the interior of the building to the elements. The listed building description states that the thatch is 'now covered with felt', however, there is no visible evidence of this on the roof. The thatch was netted and this appears to still be in place across the

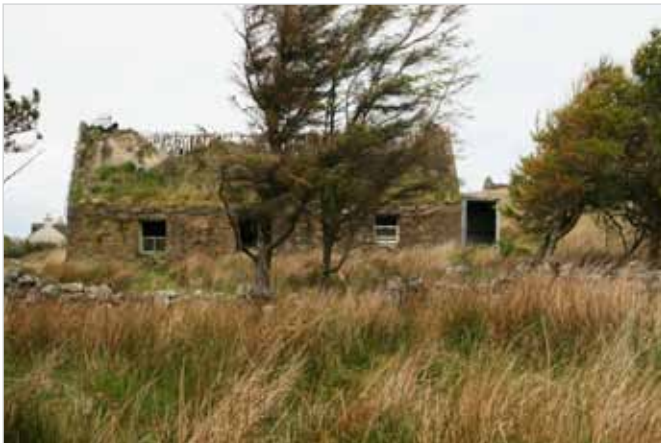
roof; however, there is no visible sign of any stone weights or ropes keeping the netting in place.

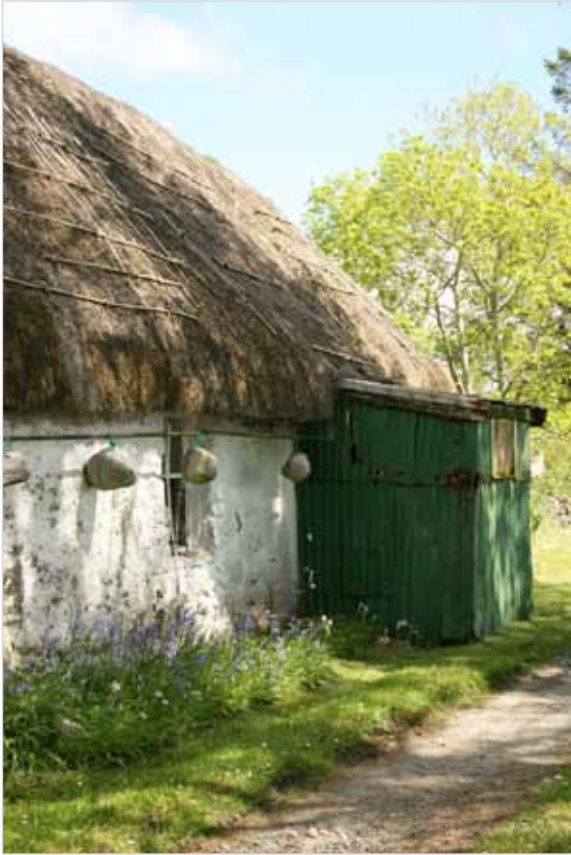
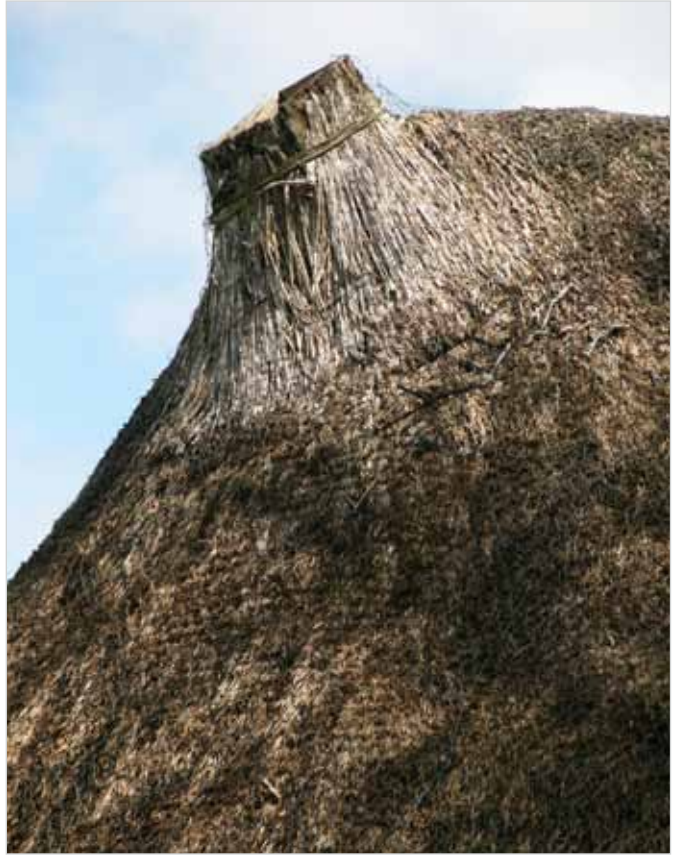
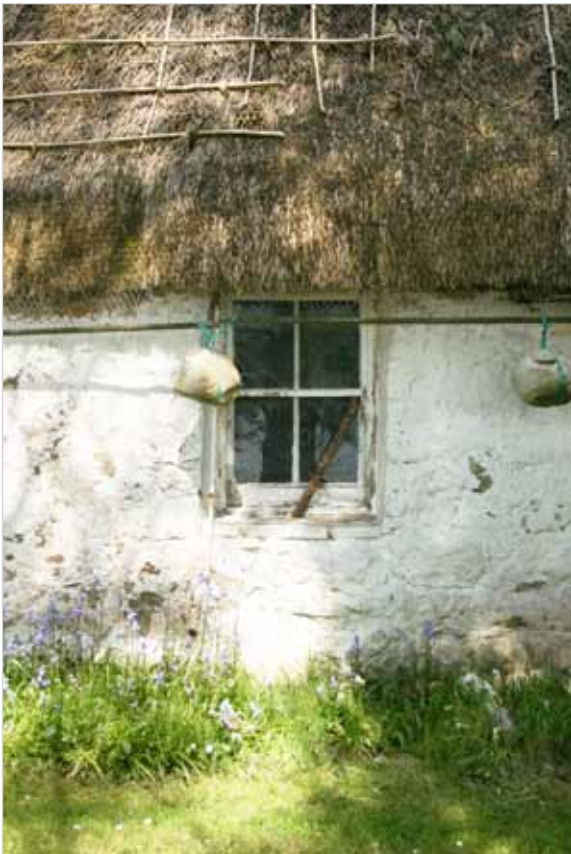
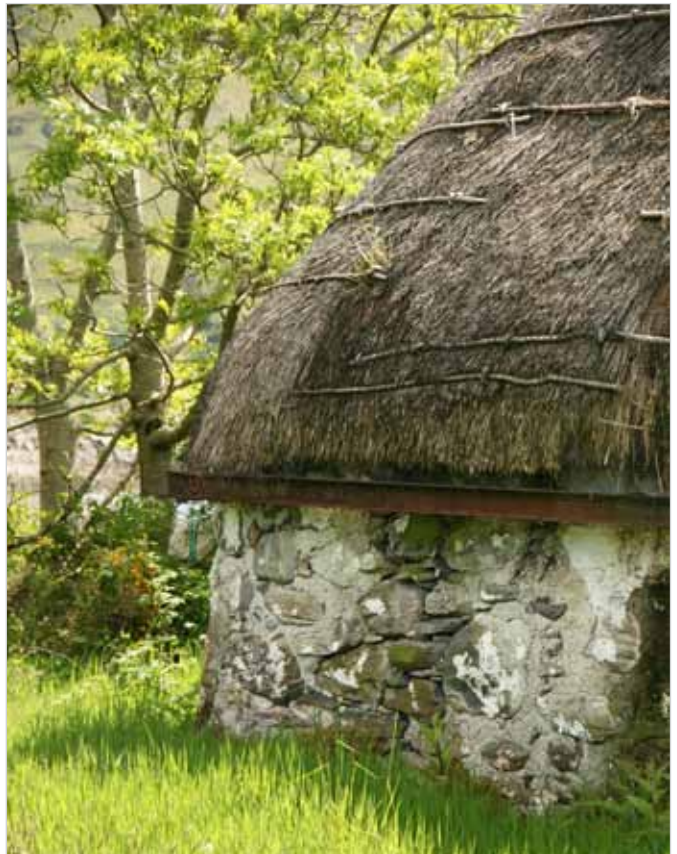
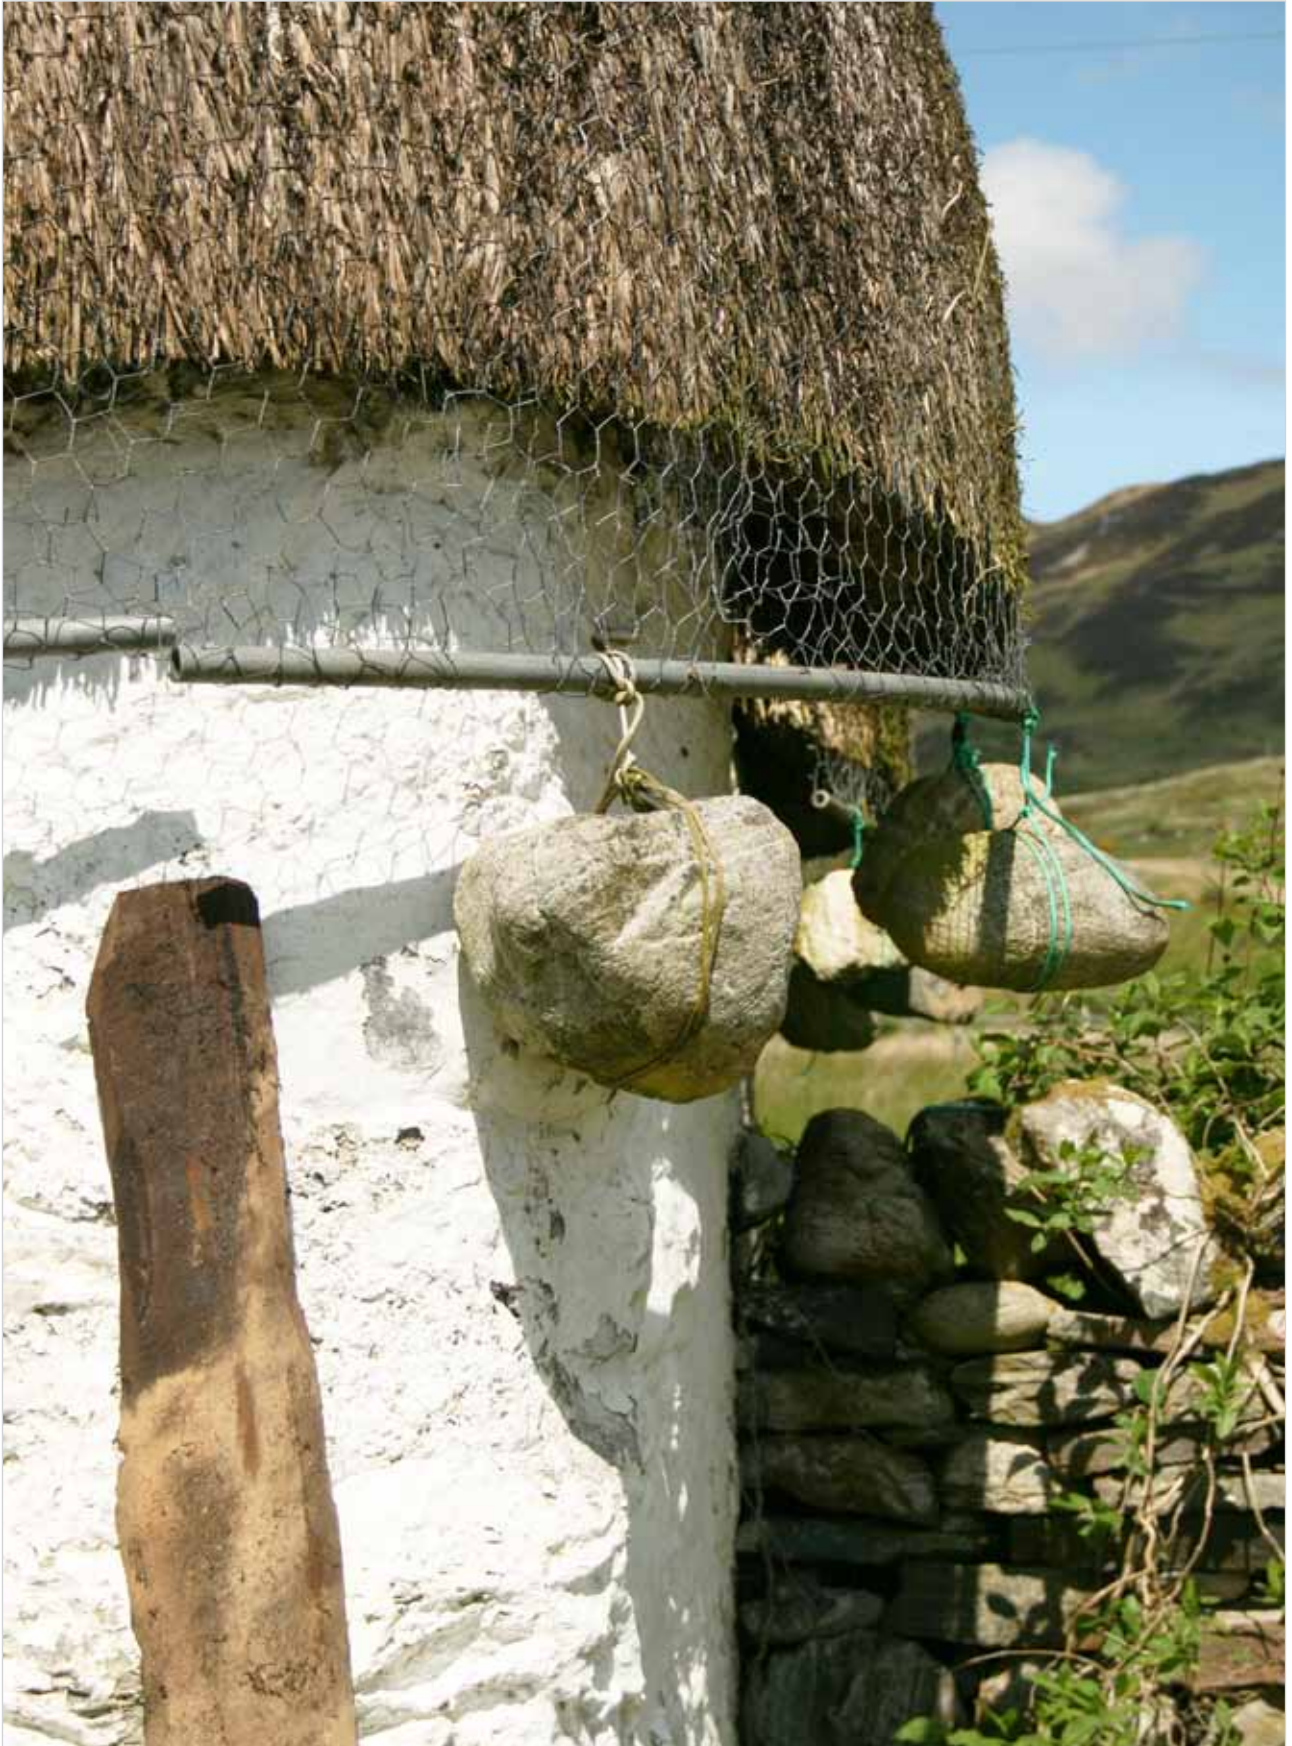
I2 Lower Ardelve – Highlands

Thatch Type: Rush
Ridge Type: Thatched (Rush)
Condition: Poor

Additional Notes: 19th-century cottage with later central projecting corrugated iron porch to front elevation.

The cottage is listed as having a roof of '*rush and/or straw thatch with some heather at eaves, pinned at ridge and eaves with bent hazel wands*', though according to Mary Myers in her book *Western Seaboard: An Illustrated Architectural Guide* (2008), the roof, '*originally of rushes and heather*', was '*re-thatched with rushes pinned with hazel wands in 1996*'. The building has been on the Buildings at Risk (BAR) Register since 1998 (BAR reference number 876), and since then BAR has documented its deterioration as well as a series of ongoing repairs in its vacant state. The thatch has some vegetation growth throughout, patches of both moss and grass. The roof is entirely netted, and has had a number of timber branches secured horizontally across the surface of the thatch by hazel, a few of which have become loose and slipped down the roof. The netting is weighted at the eaves, by metal poles that have been hooked into the holes of the netting. The metal poles then have stones hanging from them, secured to the poles by string. Along the back elevation, two sections of the netting have been weighted by two steel beams attached to the base of the netting at the eaves, which do not have any stones hanging from them. At the west end of the ridge there is a straw-thatched wooden capping to the lum, which has been bound with twine.

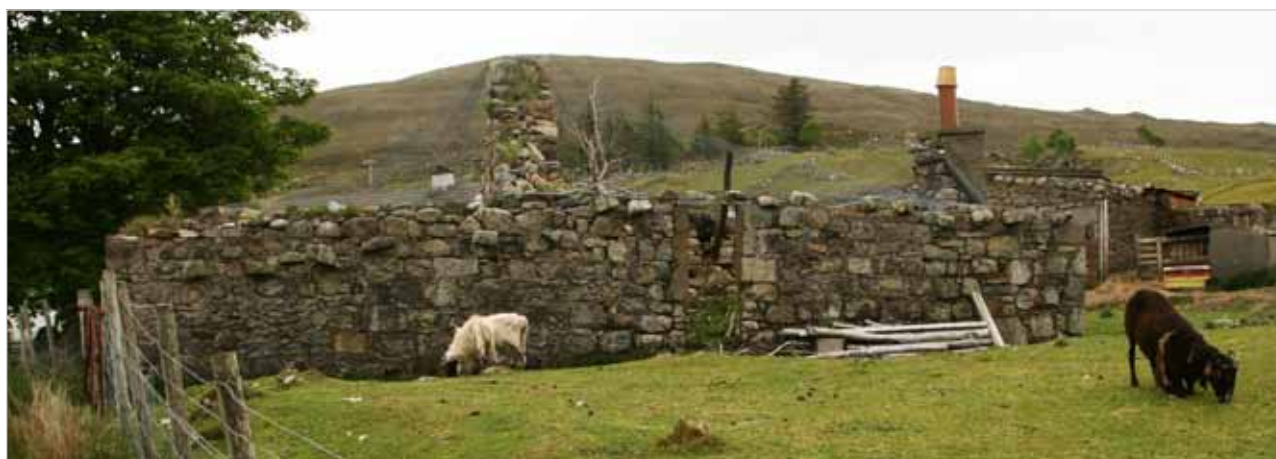
Additional Notes: Mid/late 19th-century cottage, originally used residentially and then more recently as a museum. The building was listed in 1971 and the listing description reads that the building has '1 gable end chimney (renewed) to left' and a 'piended thatched roof'. The cottage is now a roofless ruin and has been on the Buildings at Risk (BAR) Register since 2002 (BAR reference number 2828). In 2002, *The Aberdeen Press and Journal* reported that the building had closed as a museum two years ago when a piece of timber fell from the roof and injured a visitor. Also in 2002, upon BAR inspection, the thatched roof was found to have deteriorated, with the roof trusses collapsing at one end. There are still visible signs of the netting, stones and metal ties that once weighted down the thatch, as well as some material on the wallheads that could be the remains of the thatch.

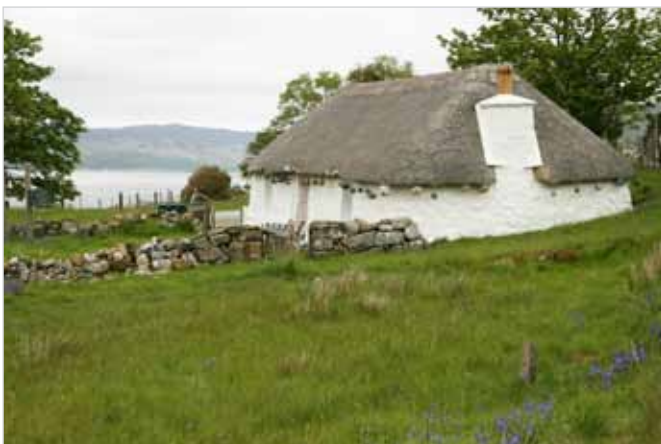
19th-century cottage listed as having a '*piended thatched roof*'. The cottage, which is now the last thatched building in the village of Luib, has been renamed and restored as a holiday let. The roof appears to be thatched in reed with a continuous straw ridge, and the ridge has been scobed with two horizontal rows of straw, secured to the ridge by entwined straw. The roof is entirely netted, including across the ridge, which has been weighted by stones hanging from the netting by wire at the eaves. Additionally, the netting has been secured by metal pegs that have been driven into the roof. Above the door and window openings on the front elevation

of the cottage, the stones have been secured to the netting just above the eaves, as opposed to hanging below.

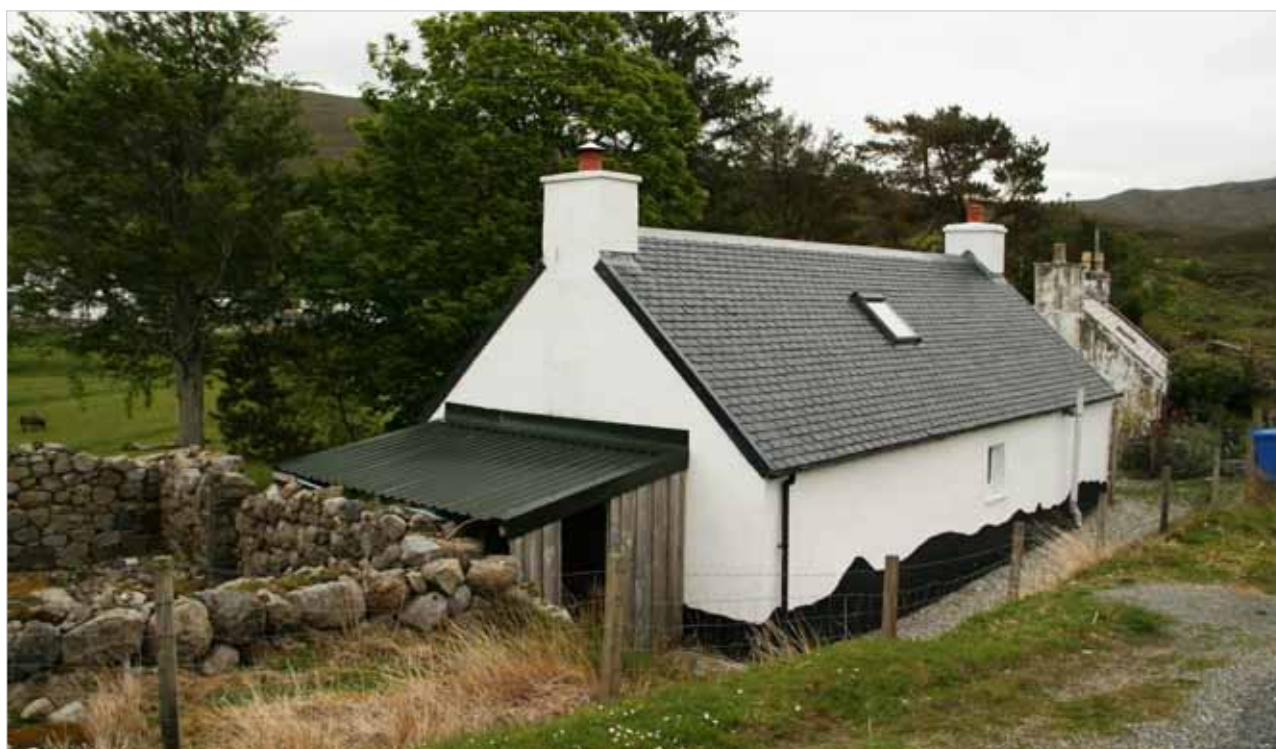
Additional Notes: Mid 19th-century cottage, listed in 1971 as having 'gable end chimneys' and a 'piended thatched roof', however, the listed building description notes, of unknown date, read 'uninhabited; condition deteriorating'. The building has been repaired at some point and the thatched roof has been removed, replaced with slates. There is the ruin of what appears to be a small byre located a few metres to the north-west of the cottage, which exists to only a few feet in height. The listing description for this building should be updated.

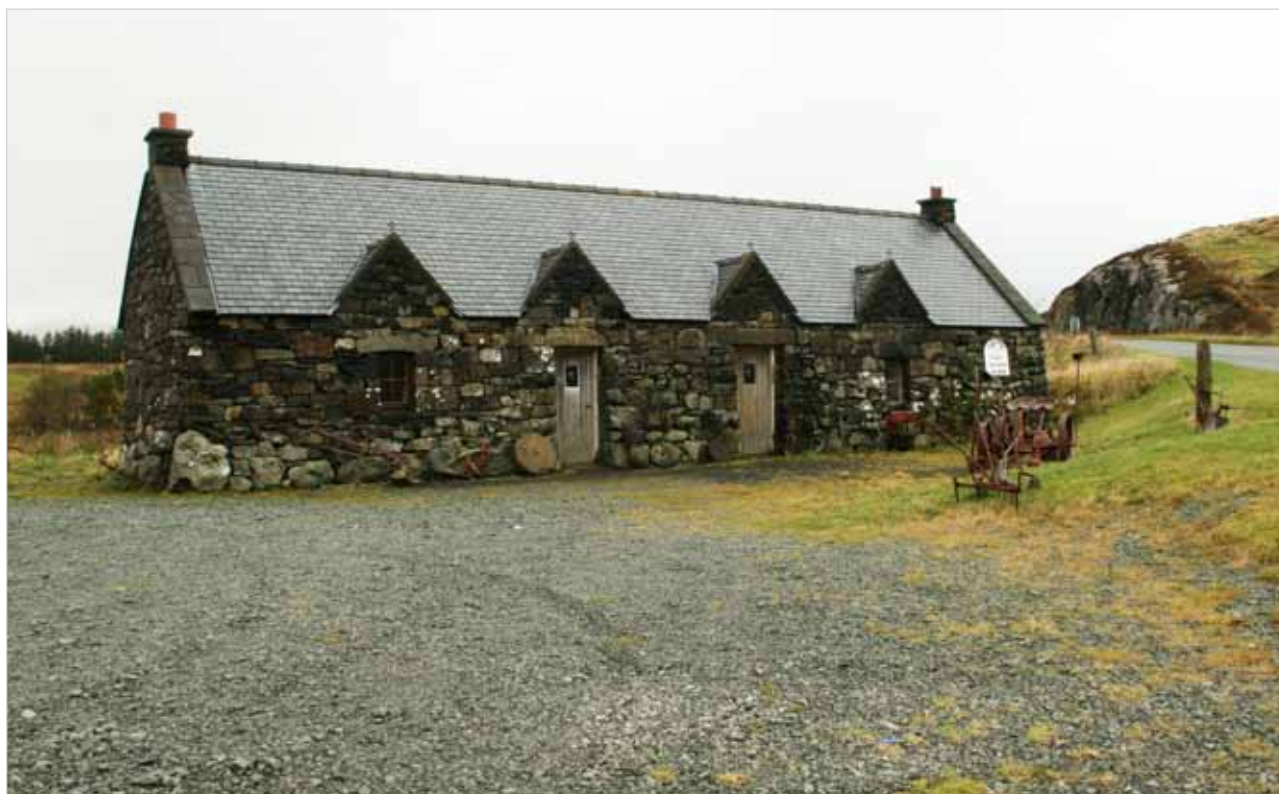
Additional Notes: The signage on the front of the museum reads 'Taigh Tasgaidh Museum'. The listed building description reads '19th century traditional Skye house, single storey, 3 bay with centre door; rubble, rounded corners; end stacks; piended thatched roof. The building no longer has a thatched roof; the entire roof is slated. The listed building description should be updated accordingly.....

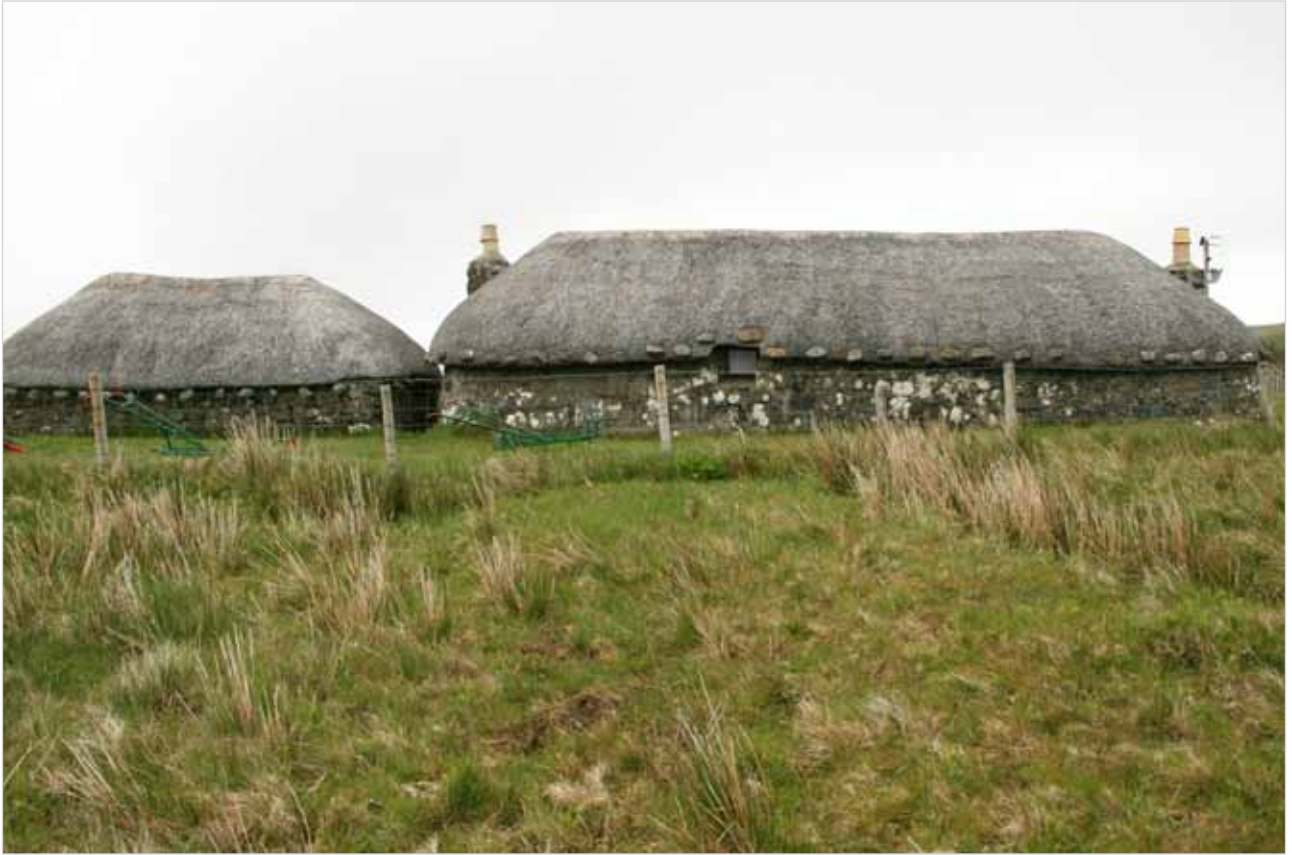
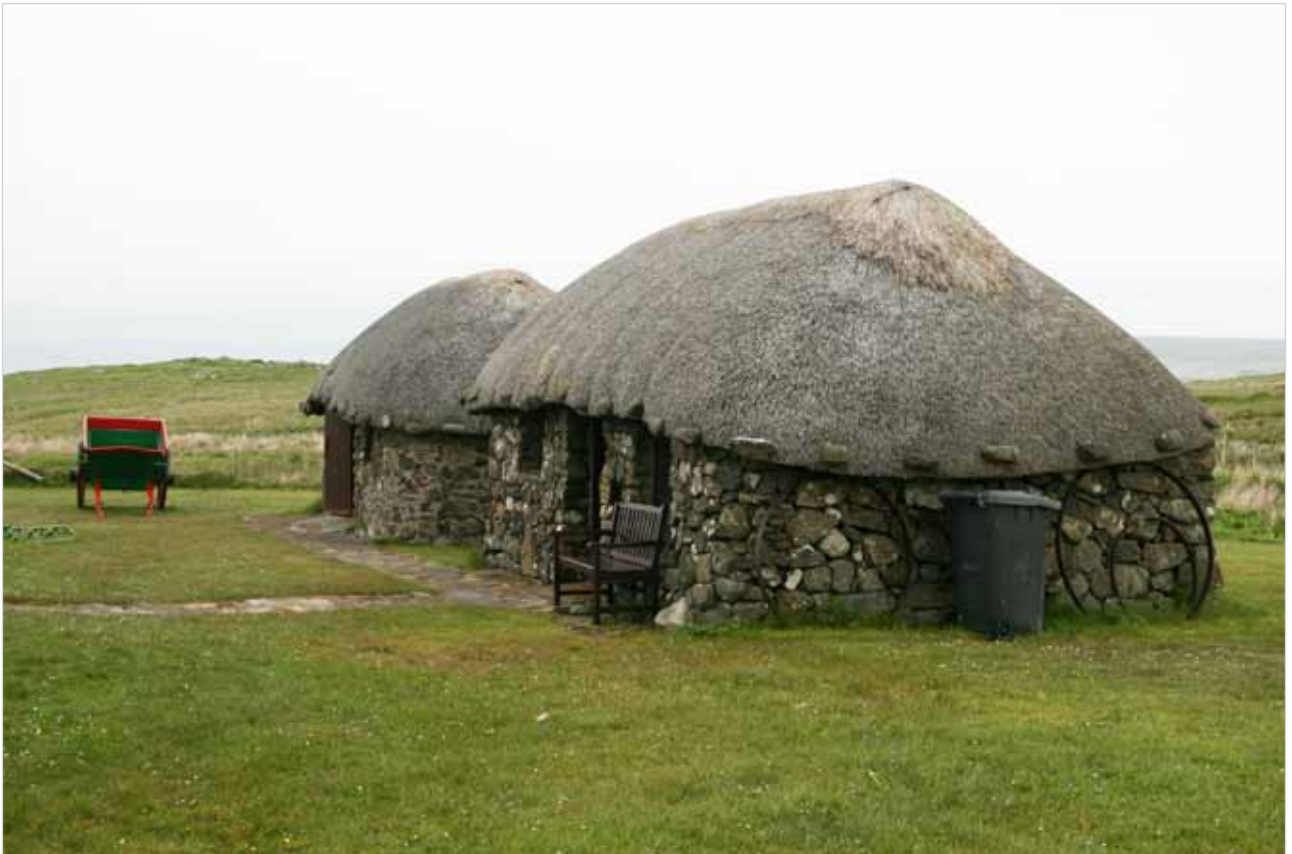
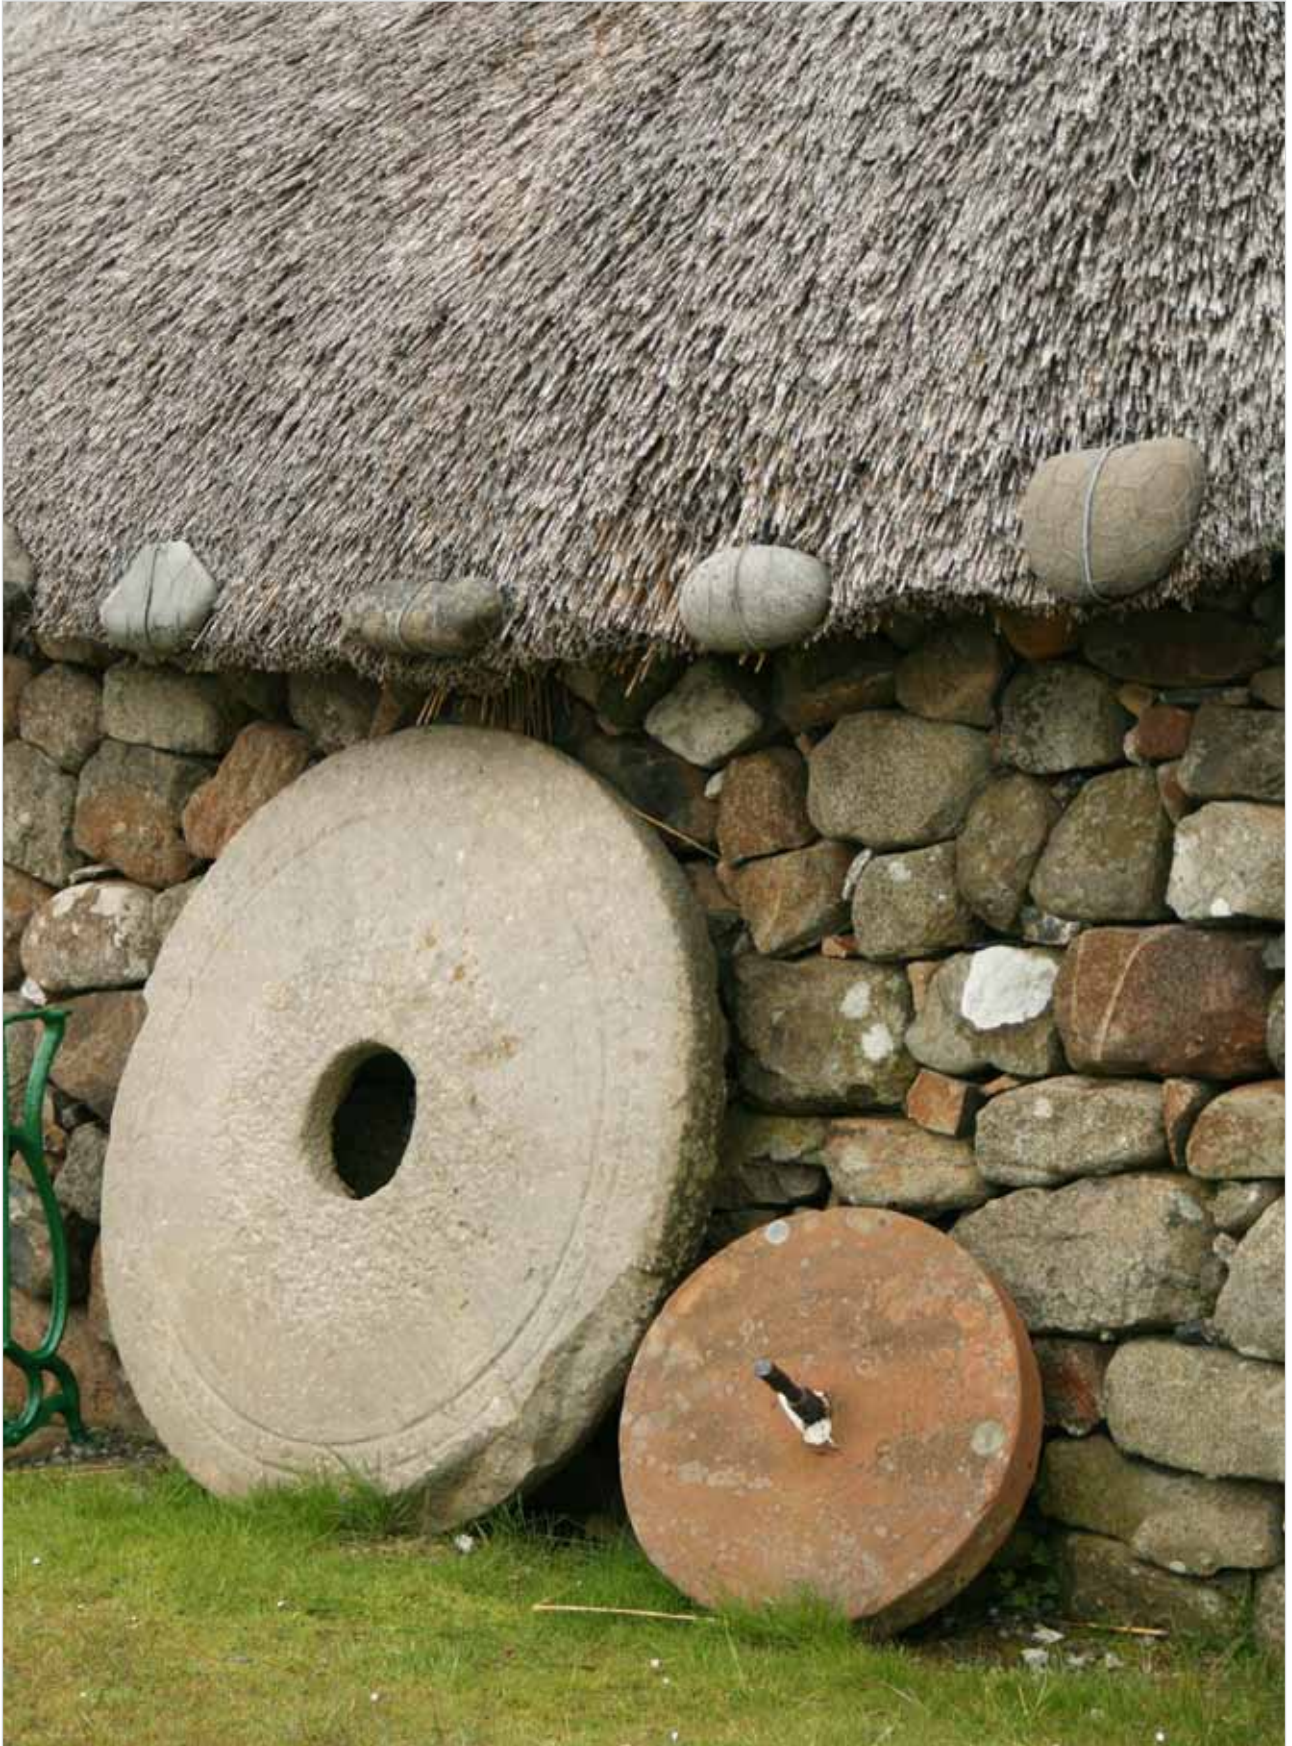
Skye Museum of Island Life – Highlands

Thatch Type: Straw
Ridge Type: Thatched (Straw)
Condition: Good

Additional Notes: Listed as a group of four 19th-century buildings 'comprising dwelling, smithy, tailor's workshop and weaving house', however, there are currently seven buildings at what is now the Skye Museum of Island Life (formerly, and listed as Osmigarry Croft Museum). According to an excerpt on Canmore, the museum includes 'various later 20th century re-creations' and a 'group of three original thatched buildings is preserved at the southern end of the complex' (Miers, M. (2008), *The Western Seaboard: an illustrated architectural guide*. Edinburgh), which would account for the additional buildings. All seven of the structures have straw thatched roofs with continuous straw ridges. The roofs have all been entirely netted, including across the ridge, which has been weighted along the eaves with stones secured to the netting by wire. On two of the most westerly of the buildings, the stones hang from the eaves, whilst on the five other buildings they are hung slightly above the eaves, resting on the thatch. According to the listing description notes, the dwelling, part of the original four listed buildings, was 'lived in up to 1958'. Mary Miers states in her book that the group of three original thatched buildings originate in circa 1790, but are of 'traditional 19th century Skye vernacular appearance'.

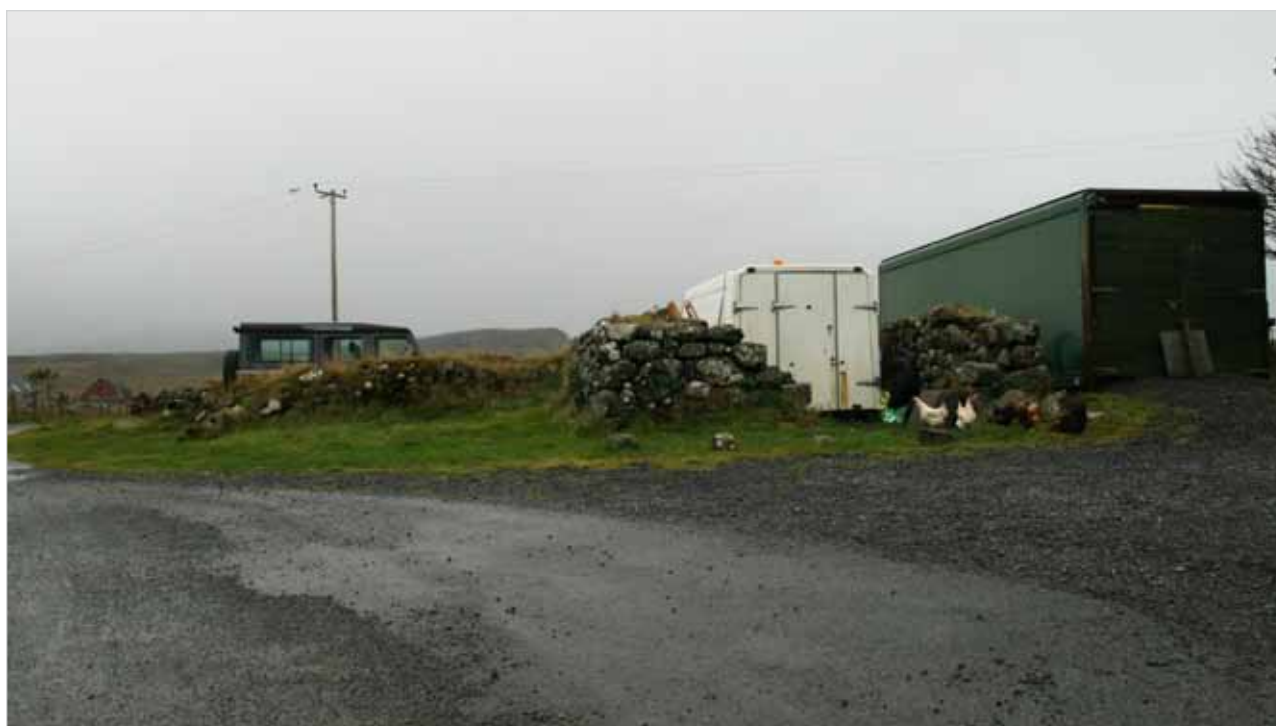
Additional Notes: The listed building description reads 'Later 19th century, traditional Skye dwelling of long-house type. Single storey. Thick, battered walls, piended thatched roof. The listing notes read 'now used as byre and for hens'. All buildings at this location are now ruins and no visible evidence of any roof structure or thatch remains. The ruins are currently being used to store vehicles and their walls reach only a few feet off the ground. The listing description should be updated accordingly.....

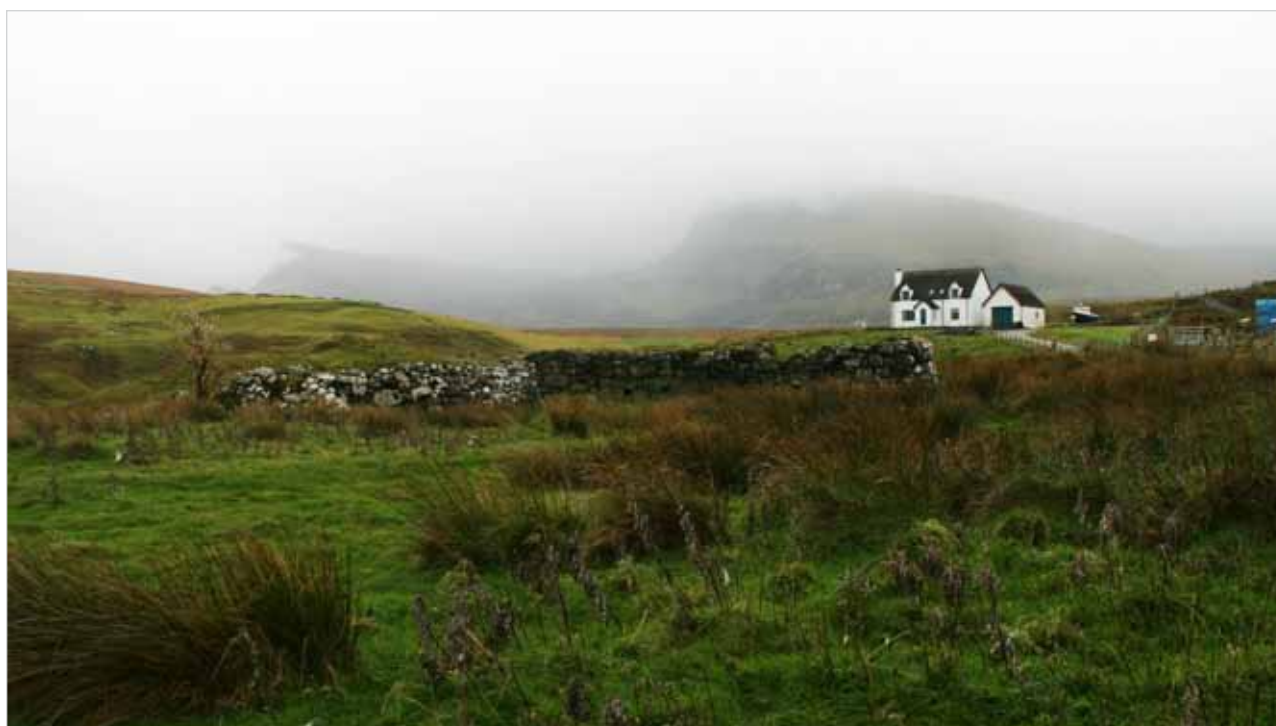
Additional Notes: Pair of byres, listed in 1982 as being thatched and noted as being 'in use'. The listed building description reads '19th or early 20th century, pair traditional Skye byres, one single bay, one 2 bay. Rubble, round corners, piended thatched roofs'. Both byres are now roofless ruins, their walls reaching only a few feet from the ground. No visible evidence of any thatch or roof structure remains. The listing description should be updated accordingly.

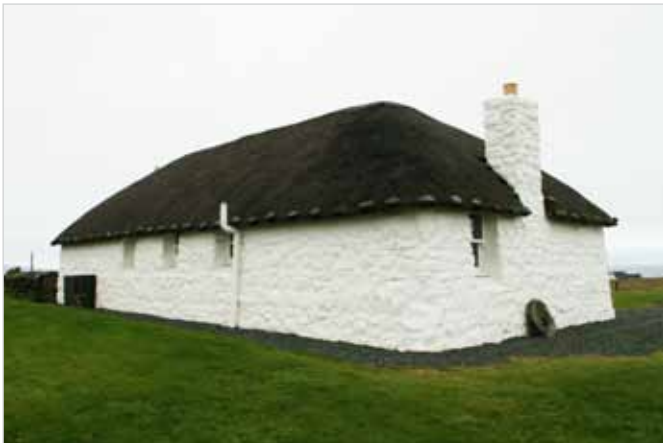
Condition of Thatch: Good

Additional Notes: Single-storey thatched cottage, currently in use as a holiday let. The website advertising the property states that the building was restored by architects Rural Design, who are based on the Isle of Skye. The website also states that the building is a 'restored blackhouse' that was originally built by the church as a reading room. The reed-thatched roof, with continuous thatched ridge, is entirely netted and is weighted by stones along the eaves and around the chimney stacks. The stones are secured to the wire netting using metal wire.

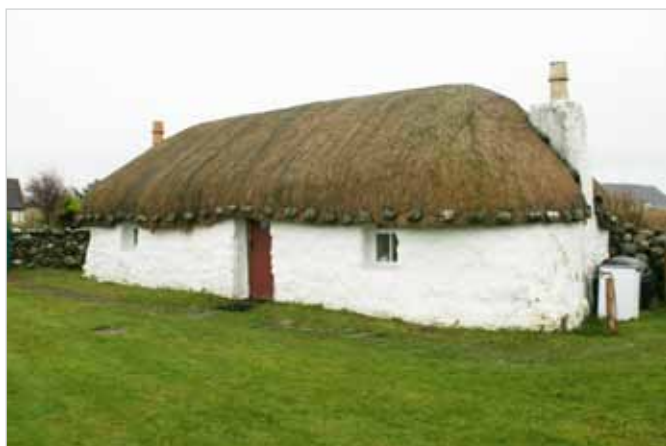
Additional Notes: 19th-century cottage, listed as '40 Bornesketaig' but more commonly referred to as Beaton's Cottage. At the time of listing in 1971, the listing description notes state that the building was lived in and in a 'quite excellent condition', however it was restored and is now owned by the National Trust for Scotland, who let out the building as holiday accomodation. According to an excerpt on Canmore, the cottage was re-thatched in rushes in 1999, and was 'reconstructed internally for holiday accommodation' (Miers, M. (2008), *The Western Seaboard: an illustrated architectural guide*. Edinburgh). The rush-thatched roof, with continuous rush

ridge, is entirely netted. The netting is weighted just above the eaves and around the chimney stacks at either end with stones that have been secured to the netting with wire. There is a small amount of algae-like growth across the surface of the thatch, but this is minimal. N.B. Thatch was repaired in July 2015.

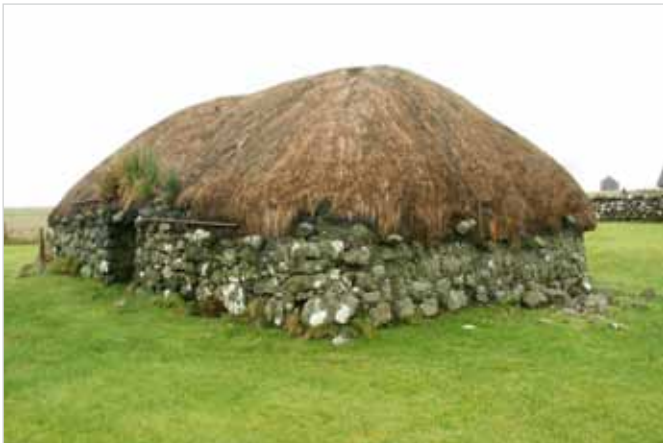
Additional Notes: Single-storey byre, part of a group listing with a 19th-century croft building (Beaton's Cottage). Both buildings are owned and managed by the National Trust for Scotland, the croft being let out as holiday accomodation. The rush-thatched roof of the byre has a continuous thatched ridge and is entirely netted. The netting is weighted at the eaves with stones, tied to the netting with wire. In three locations around the building a metal pole has been used to weigh down the netting at the eaves, onto which some of the stones have been tied. There is a small amount of vegetation growth across the surface of the thatch, particularly above

one of the door openings, where there is a large patch of grass growing from the thatch just above the eaves. N.B. The north ridge was completely re-thatched and the south ridge repaired in July 2015. Treated for woodworm, September 2015.
