A Survey of Thatched Buildings in Scotland

Thatch Survey of Scotland
2014-15

A photographic survey of thatched buildings in Scotland, surveyed between May 2014 and August 2015 by Zoe Herbert (SPAB Scotland Officer), on behalf of the Society for the Protection of Ancient Buildings.

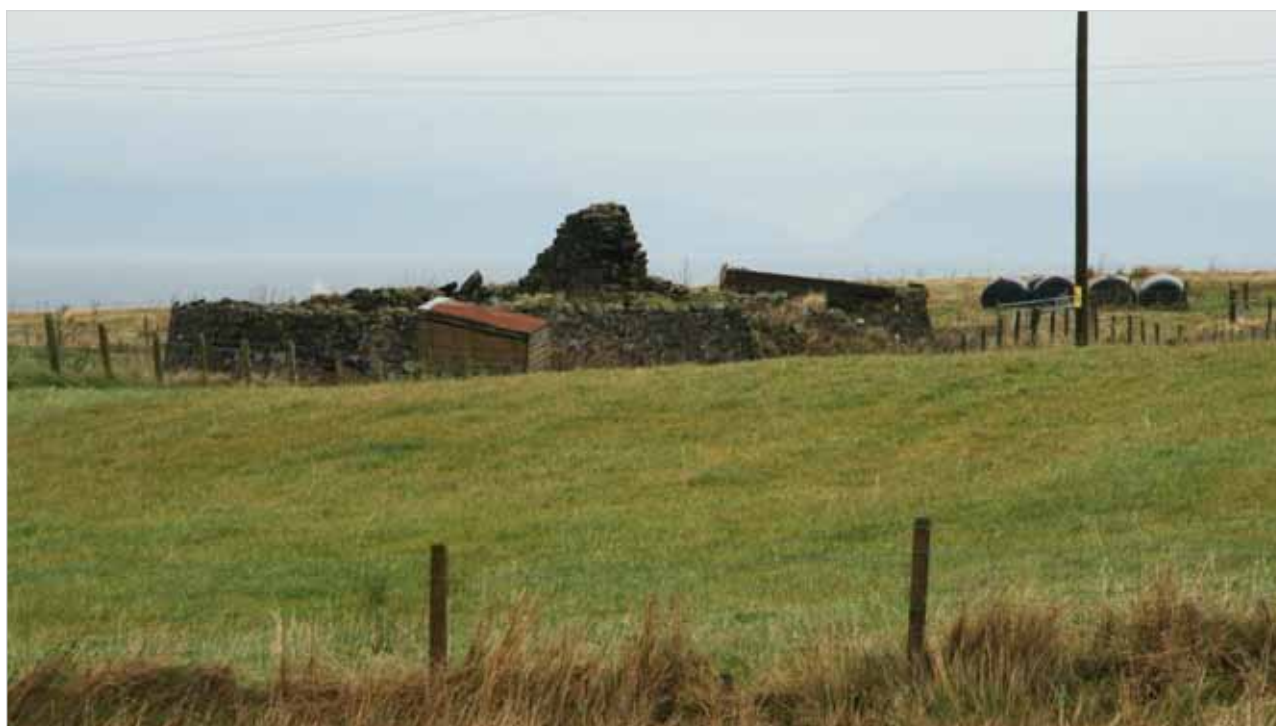
Additional Notes: The listed building description for this building reads '*Traditional 19th century Skye house; rubble, rounded corners. Long elevations roughly SW and NE. Single storey, 2 long bays with entrance at right. 2 windows rear. 2 near centre ridge chimney pots; piended thatched roof.* When it was listed in 1971 it was noted as being '*lived in*'. The building is now a ruin and no visible evidence of any roof structure or thatch remains. The listing description for this building should be updated accordingly.

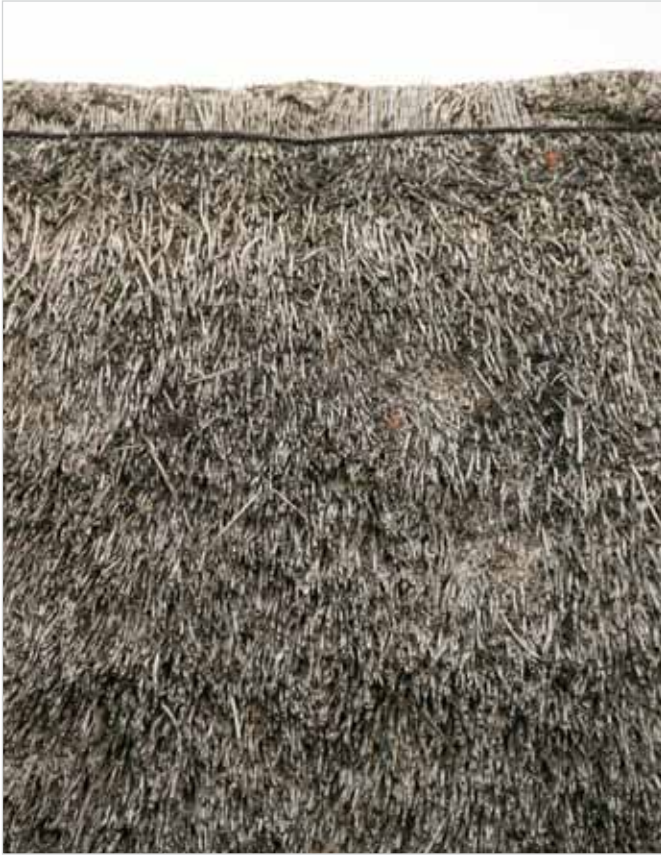
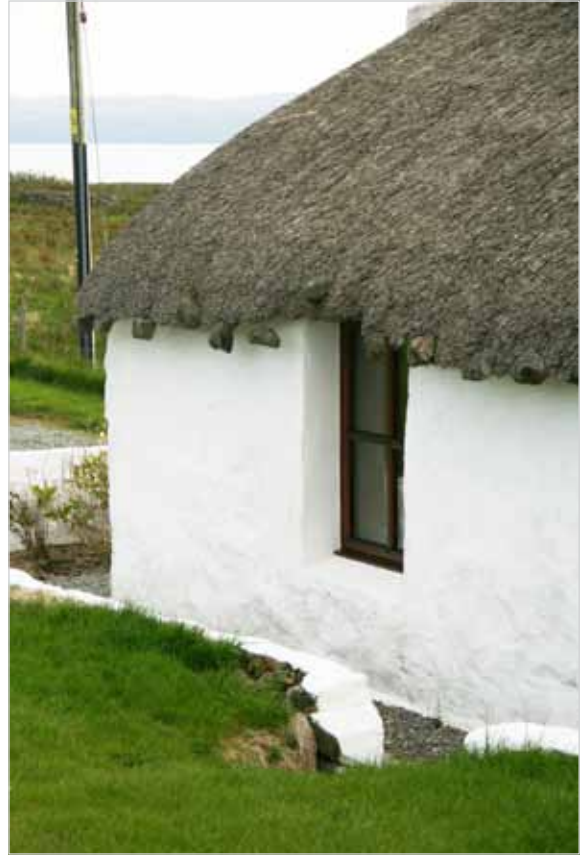
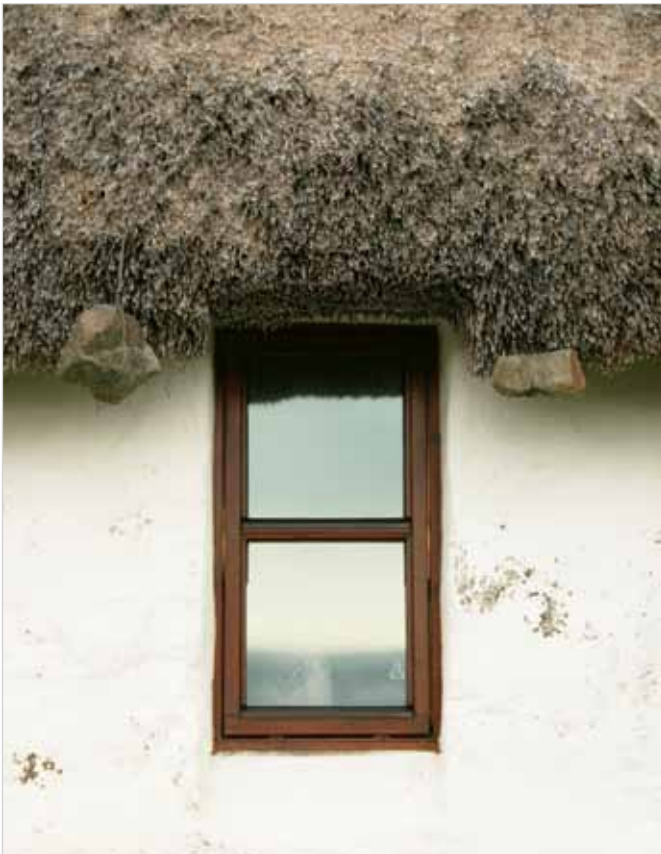
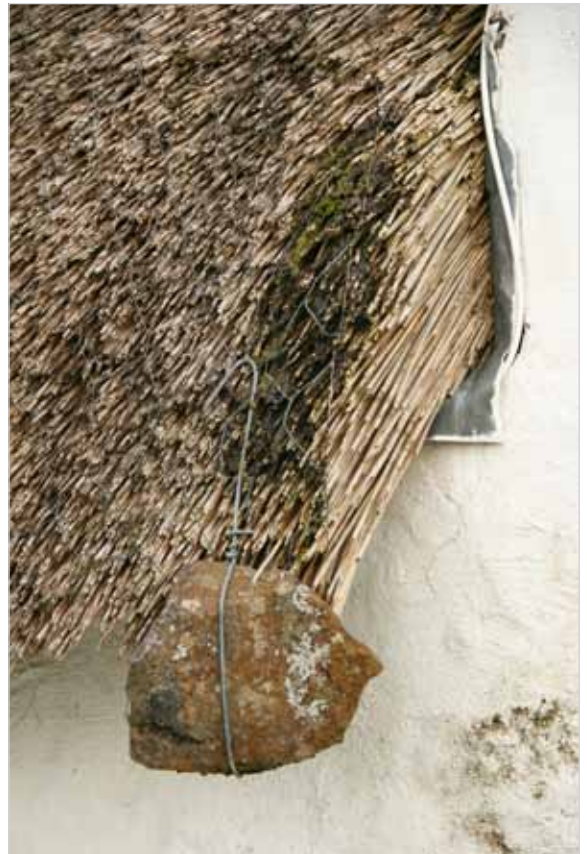
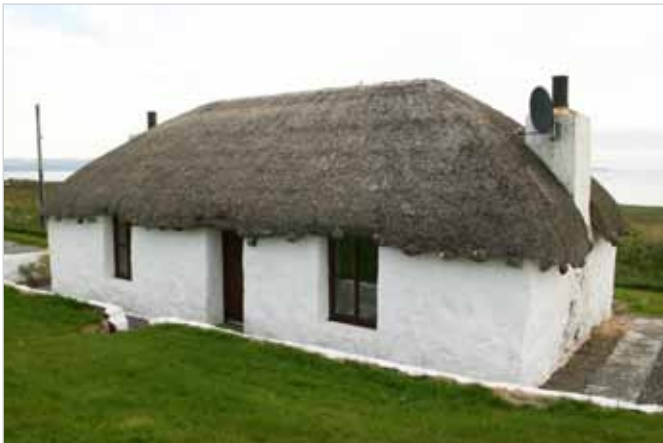
Lawrie's Cottage – Highlands

Modernised thatched cottage, currently let out as holiday accomodation. The roof is thatched in what appears to be either reed or straw and has a continuous thatched ridge. The ridge, which has been secured with metal wire pegs, has a single row of horizontal scobing made from metal. The entire roof has been netted, including across the ridge. The netting has been weighted along the eaves with stones, which have been secured to the netting along the eaves by metal wire. The stones hang slightly off the edge of the eaves, except from above the door openings where the stones have been secured slightly above the eaves. There are

a few patches of mossy vegetation growth across the surface of the thatch, but this is not extensive.

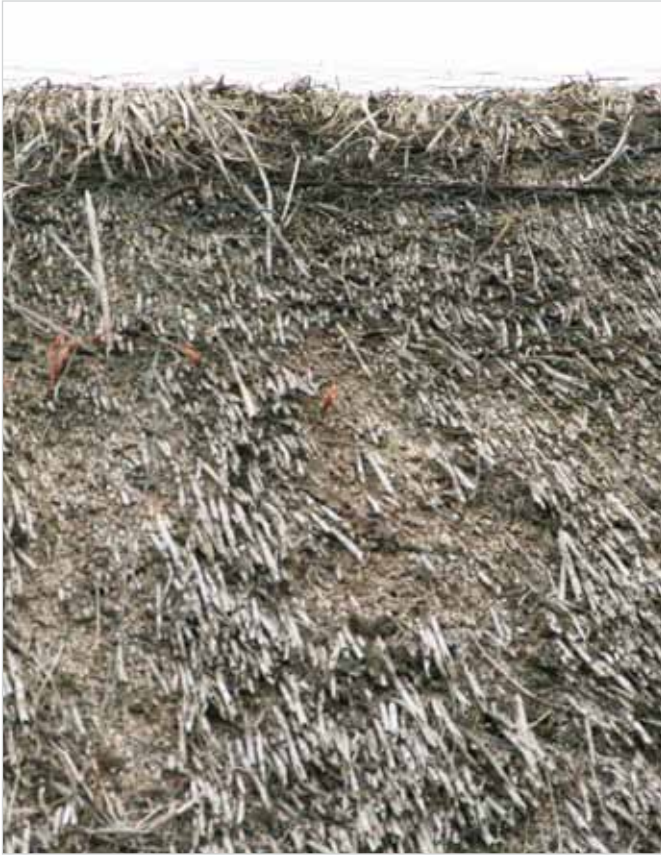
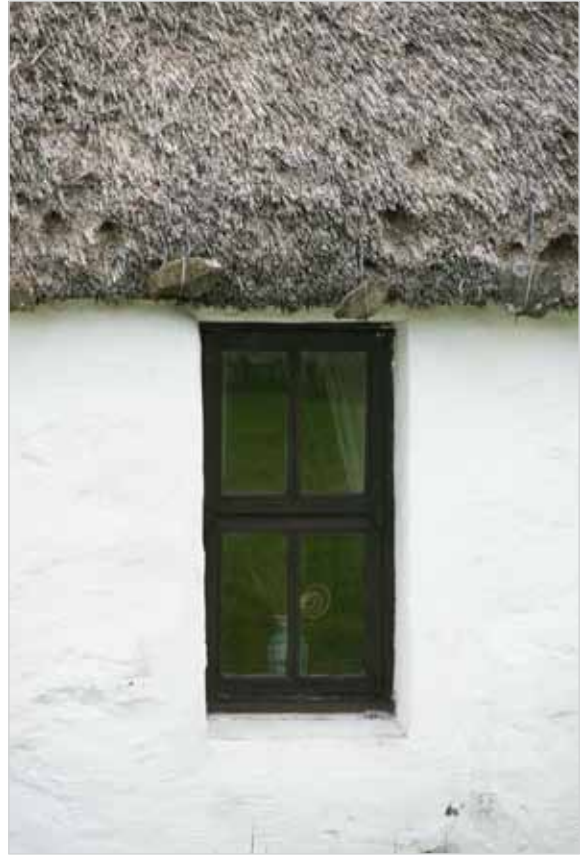
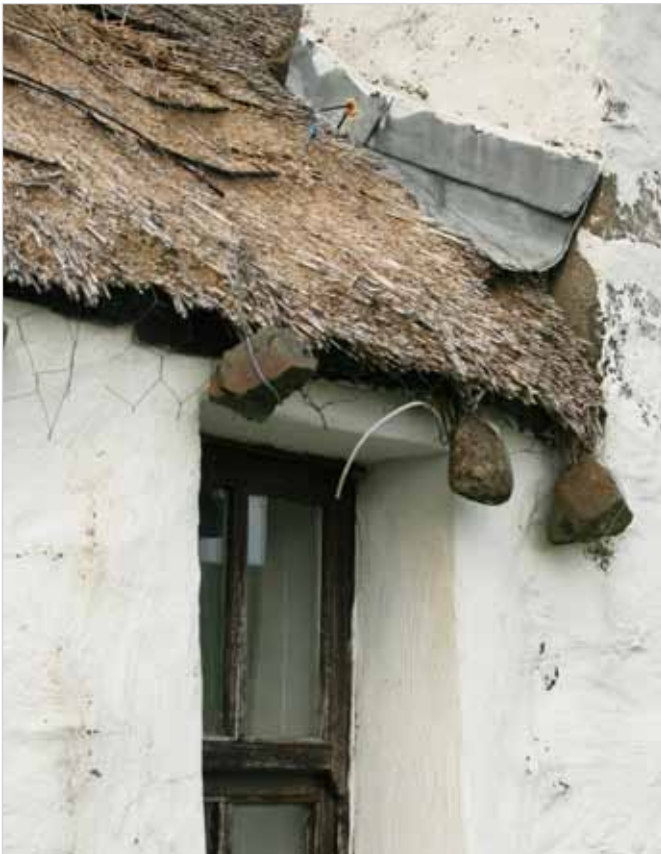
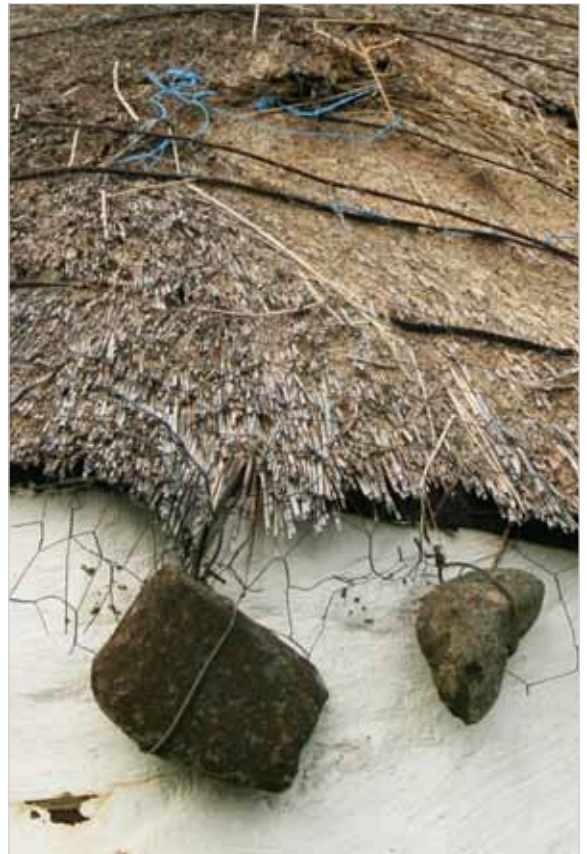
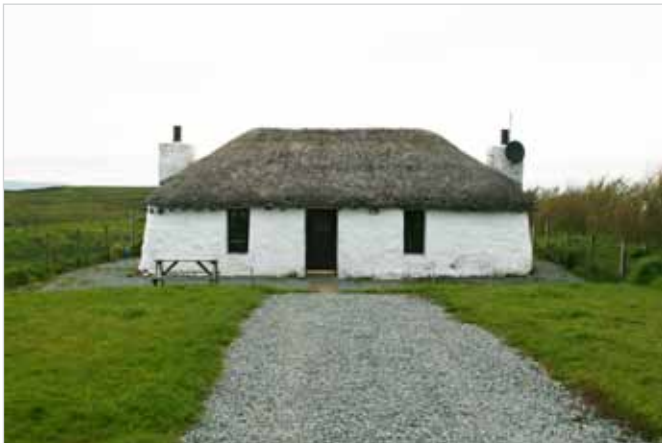
Thatched Croft – Highlands

Modernised thatched cottage, currently let out as holiday accomodation. The roof is thatched in what appears to be either reed or straw and has a continuous thatched ridge. The ridge has a single row of horizontal scobing made from metal. The entire roof has been netted, using a particularly large gauge wire net, which has been weighted along the ridge using stones secured to the netting by wire. In some places, the thatch has deteriorated somewhat and where this is particularly bad, additional wire netting has been placed horizontally across the thatch to try and keep the thatch in place. In addition to some of the thatch being loose

in places, the thatch has also compacted in others. There is also a small amount of mossy vegetation growth on the surface of the thatch in places; however, this is not extensive.

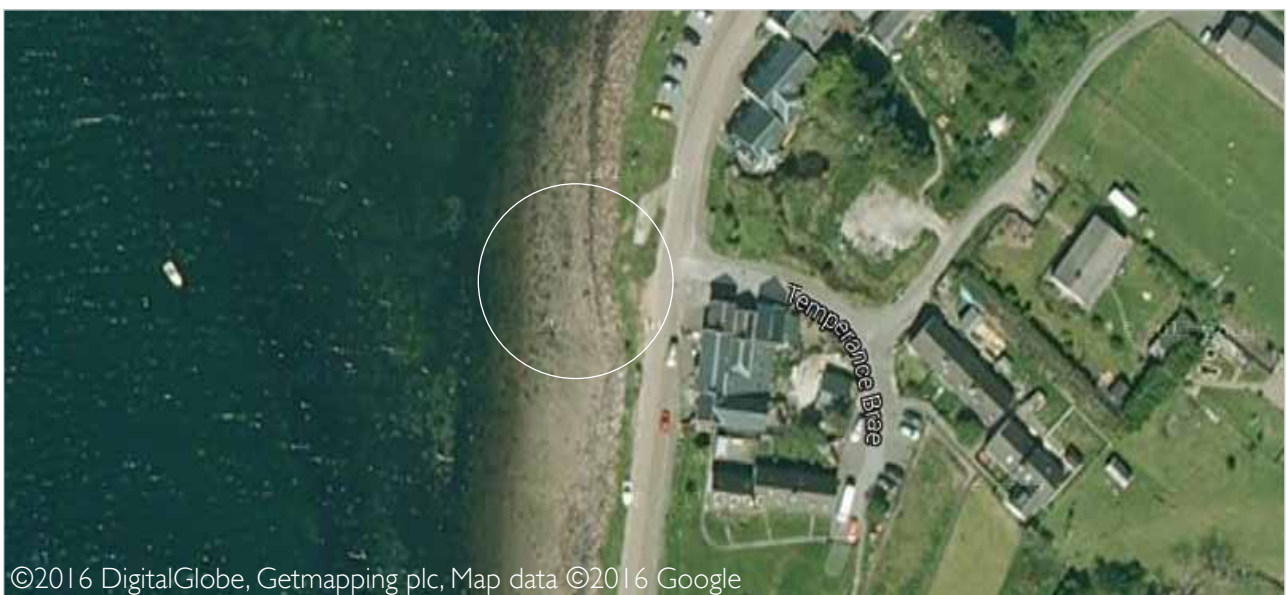
Additional Notes: Although this cottage has been included on previous surveys of thatched buildings in Scotland, and has a record on the Canmore database, the building no longer exists. The site upon the shore in Shieldaig that it is recorded to have occupied has now been taken over by the beach and no visible remains of the cottage can be seen. There are photographic images held by Canmore that show the building in 1976. At this time, the heather-thatched roof was still partially in situ, although there were large openings exposing the interior of the building. A photograph of the interior shows that the ridge and a large amount of thatching material had fallen in by this time and the building appears derelict.

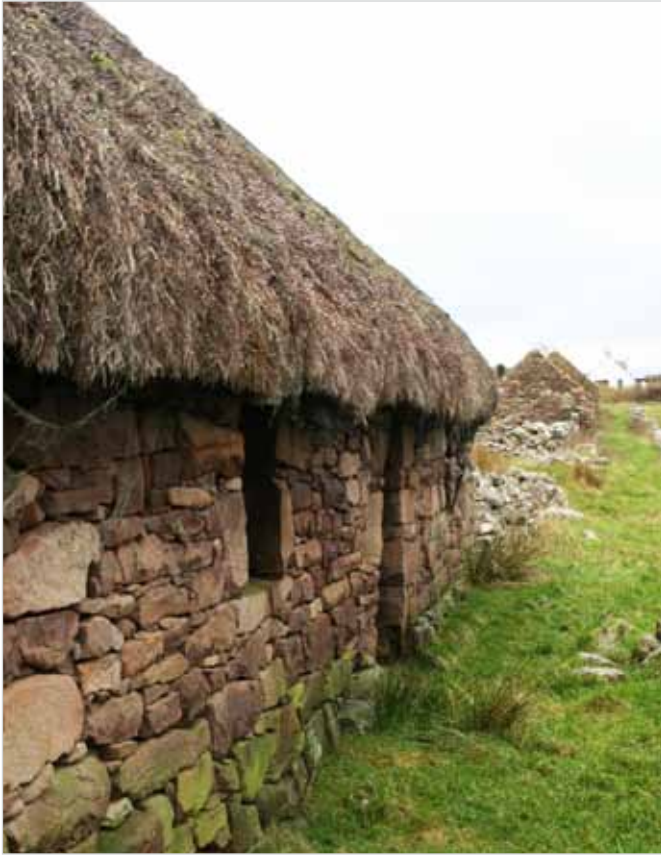
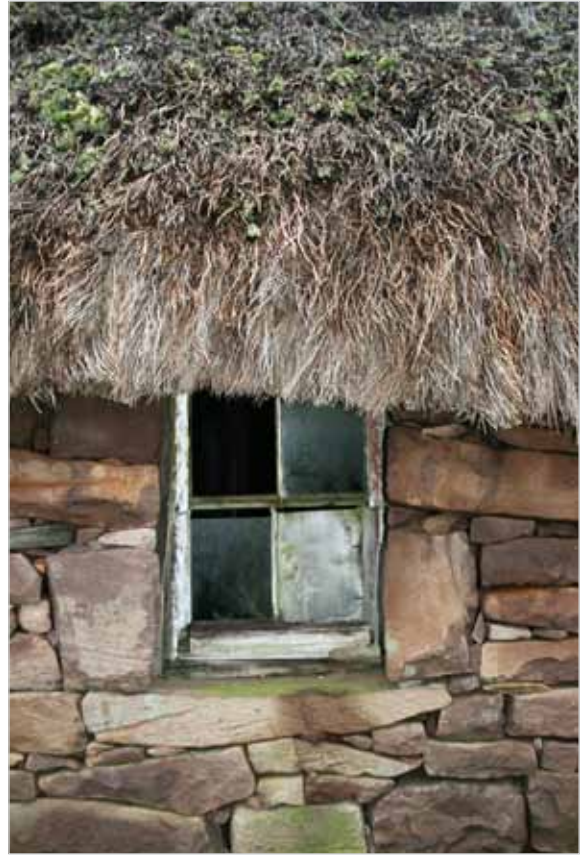
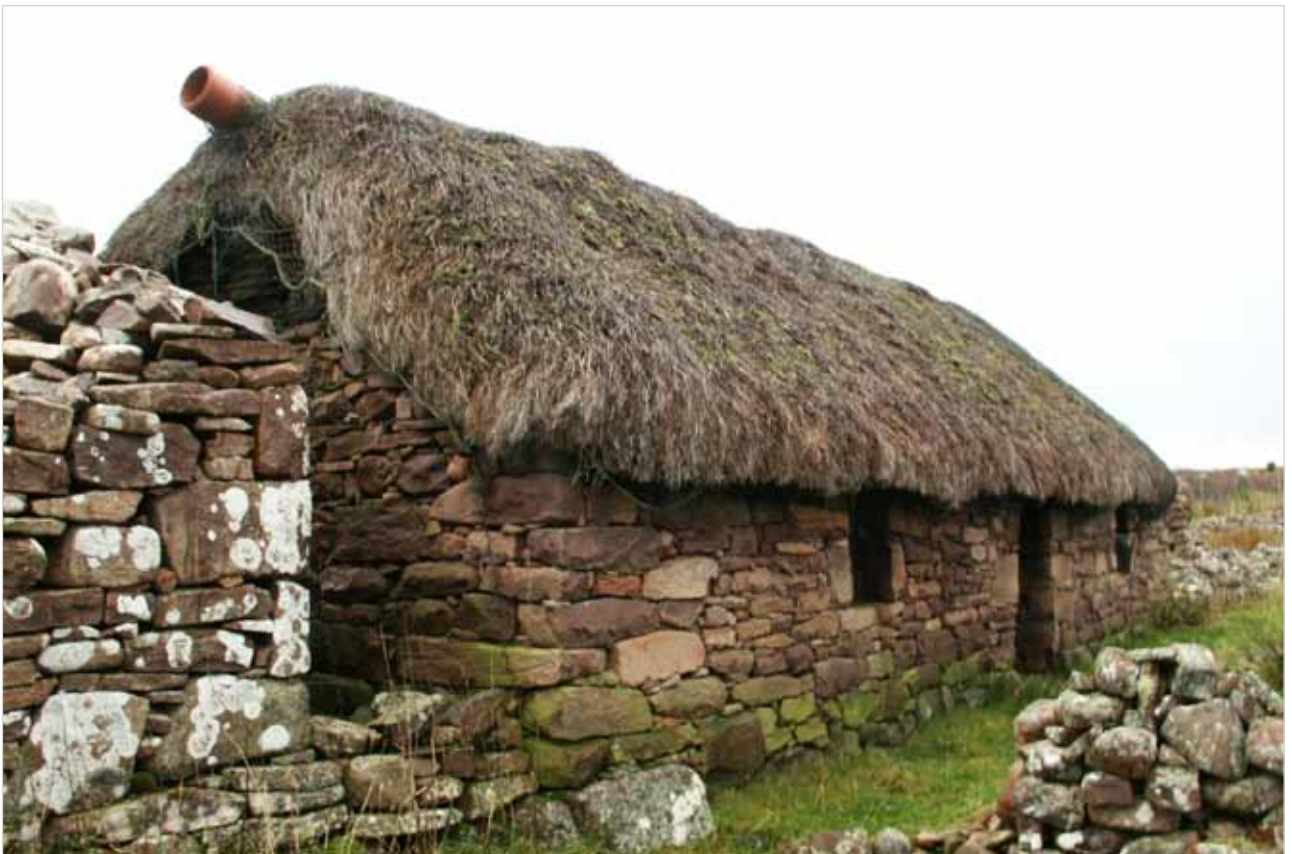
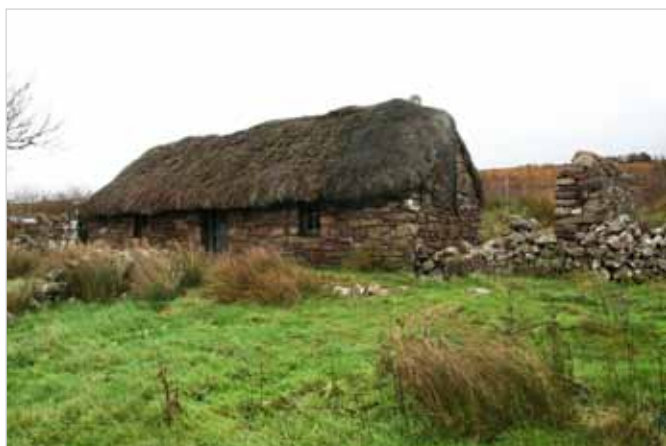
Lonbain Thatched Cottage – Highlands

Condition of Thatch: Fair

Lonbain, a linear settlement of cottages, the rest of which are in a ruinous condition. The cottage is listed as

drainpipes project at each rounded apex to serve

as flues'. The building appears to be derelict and

the site. N.B. Scheduled for complete re-thatch

and structural repair in Spring 2016.

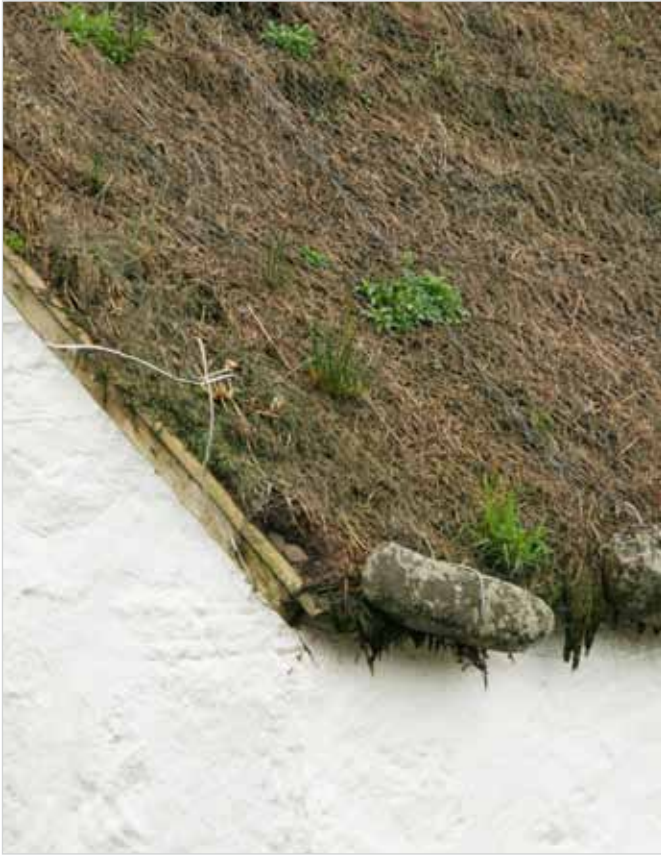
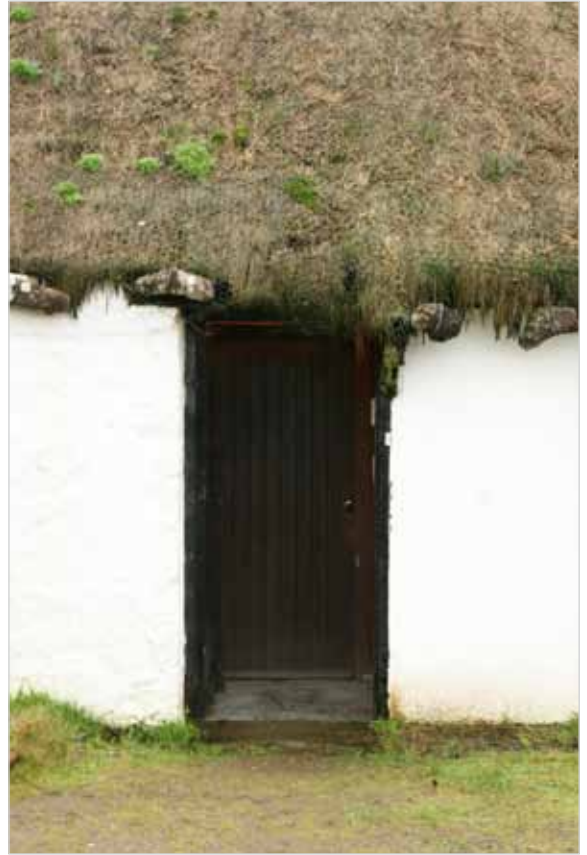
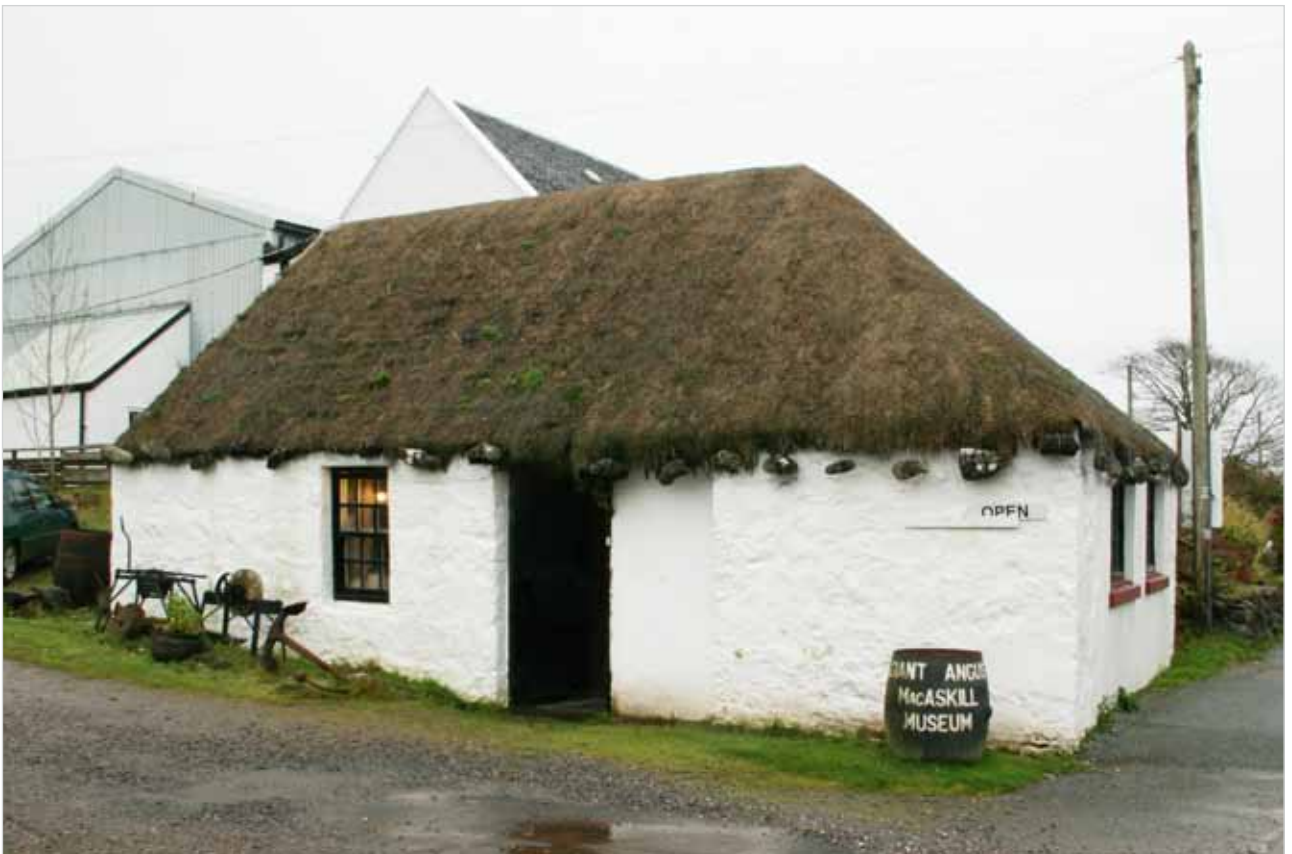
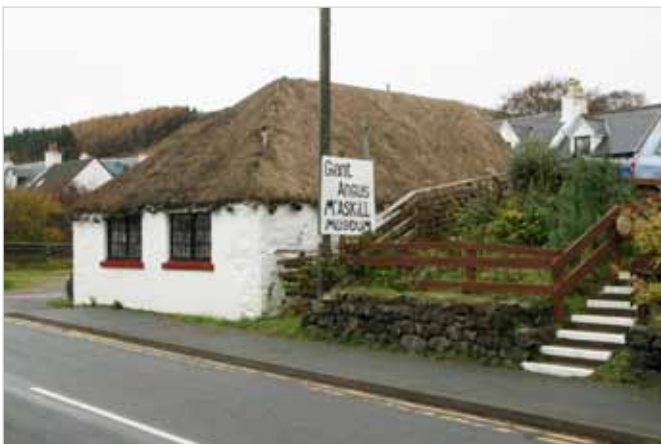
Giant Angus MacAskill Museum – Highlands

Renovated croft building, currently used as a museum dedicated to Angus MacAskill and established in 1989. The roof of the building has a top-coat of straw thatch, with a continuous straw ridge. The thatch is missing in a few patches across the roof, particularly down the skewes and along the ridge, exposing what appears to be timber and a corrugated roof covering. Underneath the missing thatch along the ridge, much of the metal ridge beneath can be seen. The roof has been entirely netted, including across the ridge, and weighted at the eaves by stones hung from the netting by wire. There is some vegetation growth in places across

the surface of the thatch and patches of thatch missing throughout, exposing the roof structure underneath.

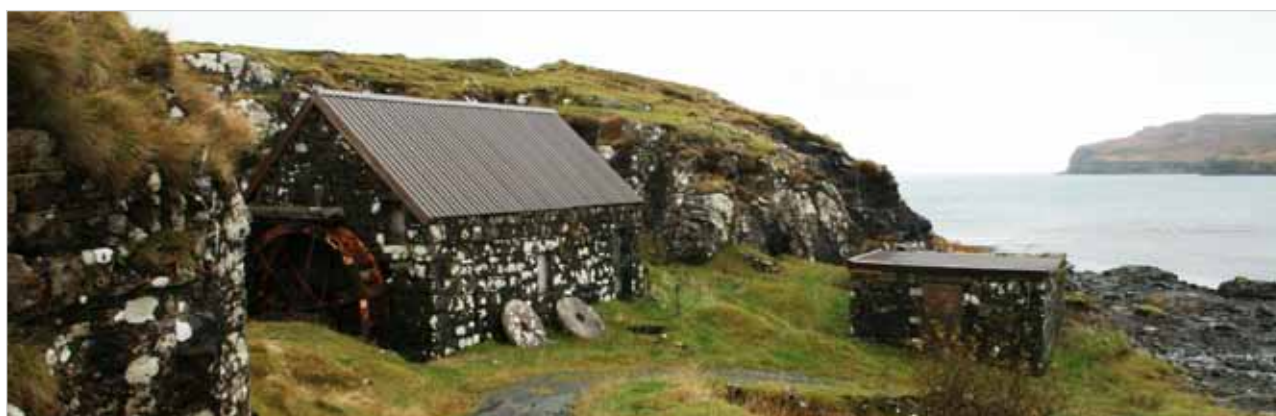
Additional Notes: The thatched roof of the Glendale Watermill Museum collapsed in 2009 following many years of neglect due to low visitor numbers. The mill was first opened as a museum in the 1970s following restoration. It now has a corrugated roof, and whilst all the mill equipment has been removed, the door remains unlocked for visitors to look around the building of their own accord. Both the mill and adjacent kiln building are listed as being thatched, their listed building description reading *'said to be mid 18th century; restored 1972. Pair of buildings of coursed and caulked, roughly squared rubble with thatched roofs; some iron pins remain in north mill gable to which the thatch was fastened. Mill: simple rectangular building with wheel to south gable and west wall built into side of hill [...]. Detached kiln: Small square (renewed) chimney to north; piended thatched roof.* The kiln building now also has a flat corrugated iron roof. A photograph on the Glendale website shows both structures thatched in 2002. The listing description for the buildings should be updated accordingly.....

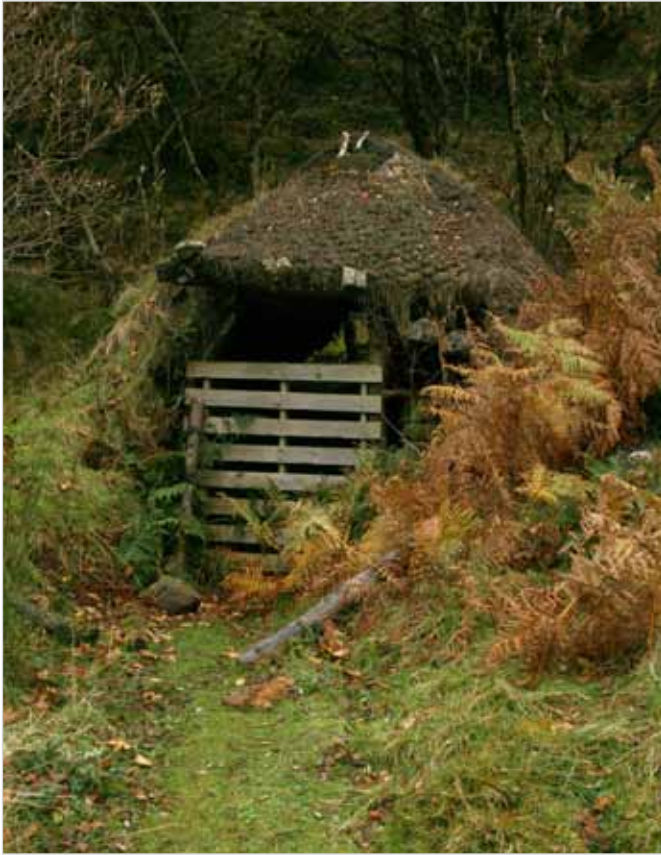
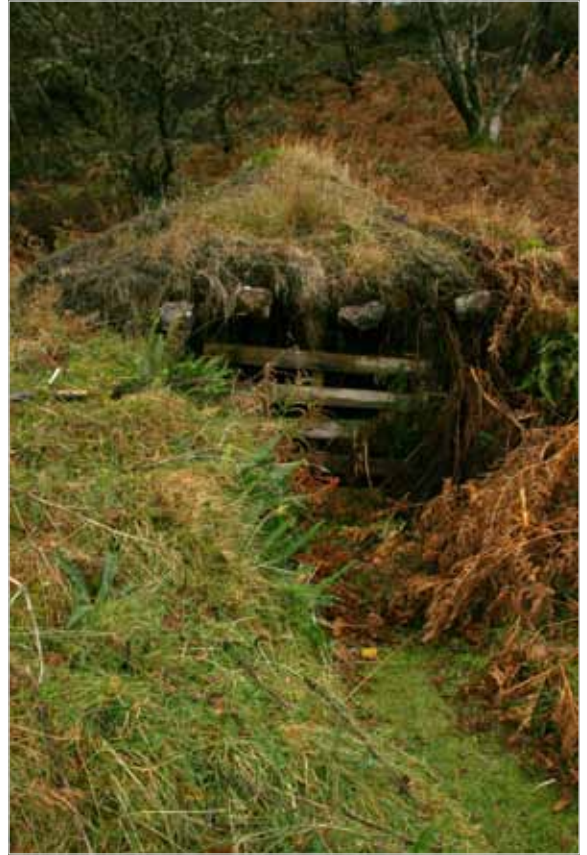
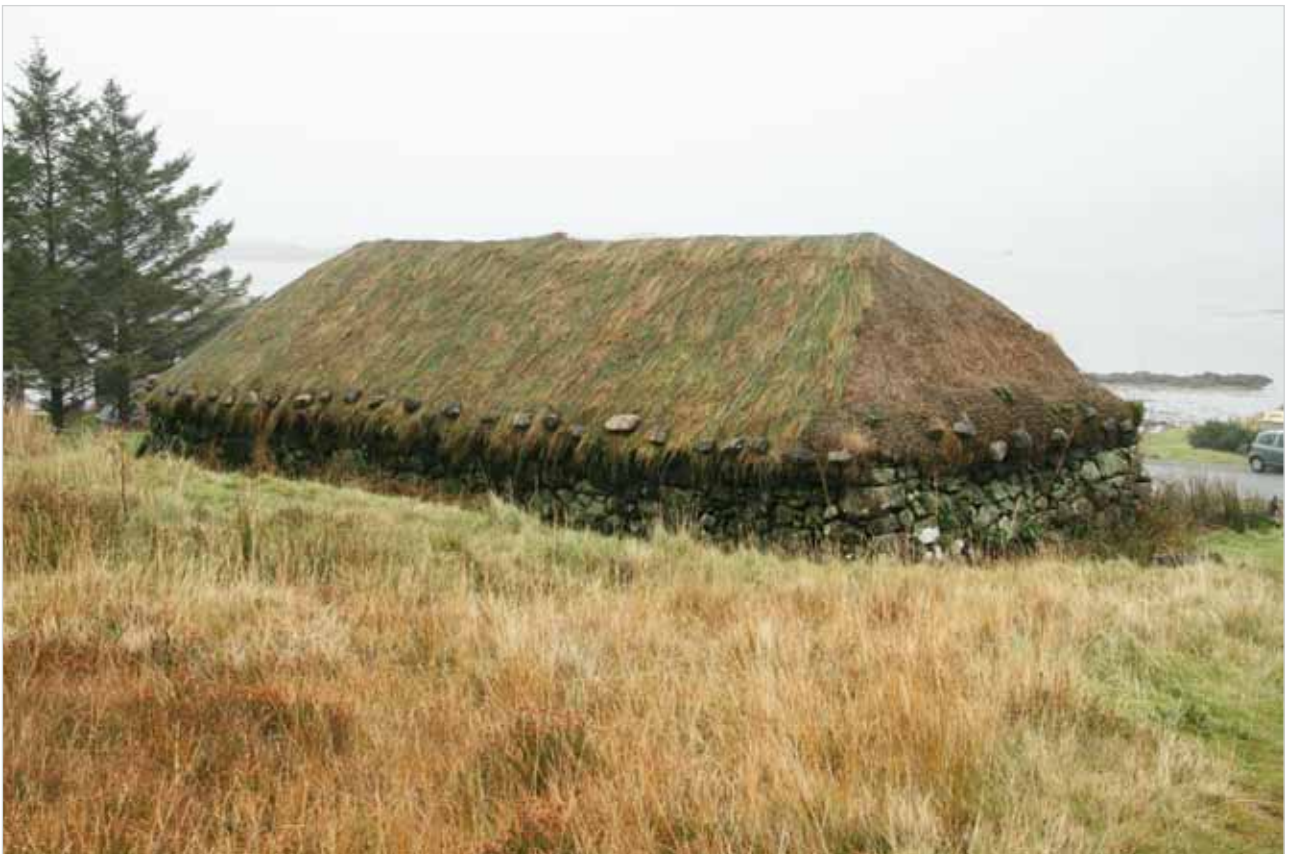
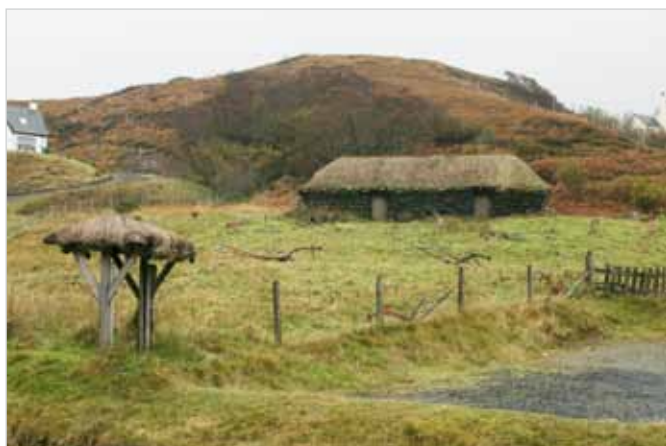
Colbost Croft Museum – Highlands

Late 19th-century croft house listed with former still behind the house. Additionally, there is an outbuilding a few metres away from the still, which was supposedly used as a store. All buildings now form the Colbost Croft Museum, which was established in 1969 by local Peter MacAskill, who also established the Giant Angus MacAskill Museum in Dunvegan. The cottage is thatched in what appears to be either rush or marram, and appears to currently be having another layer of thatch installed as a top coat. The ridge is thatched continuously across, and the entire roof has been netted. The netting has been weighted down at the eaves using

stones, secured to the netting with wire. There is a fair amount of vegetation growth to the surface of the thatch, particularly along the front elevation, which also has an amount of algae-type growth on the thatch. The thatched roofs of the outbuildings, which appear to be thatched in the same manner, are heavily overgrown with vegetation.

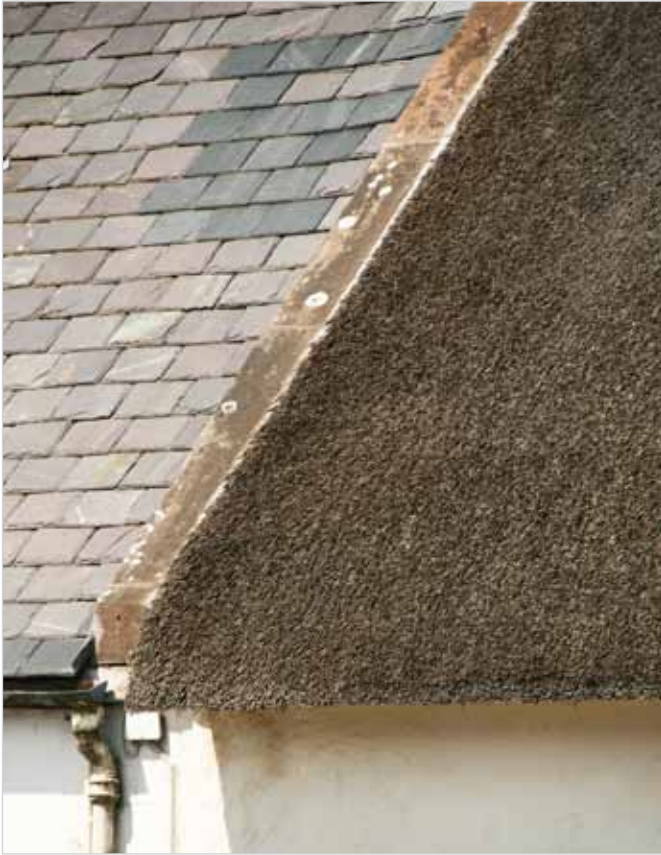
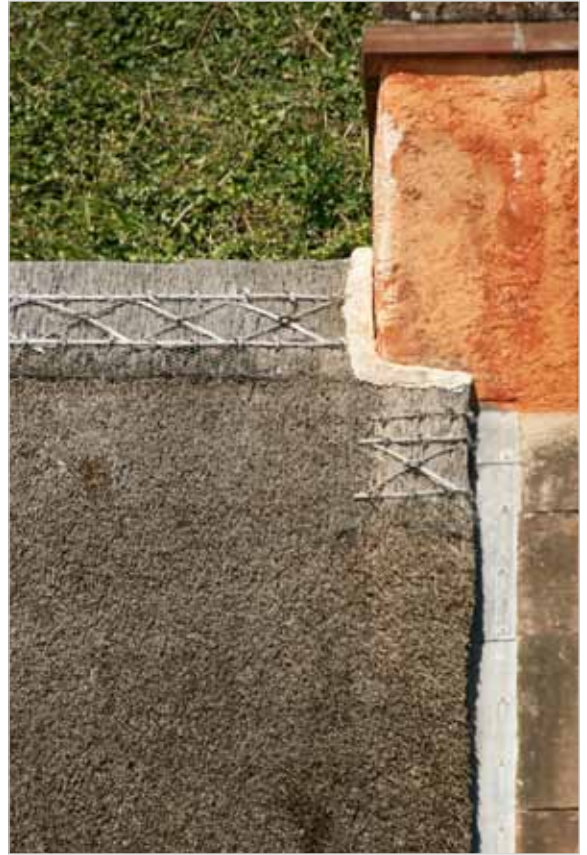
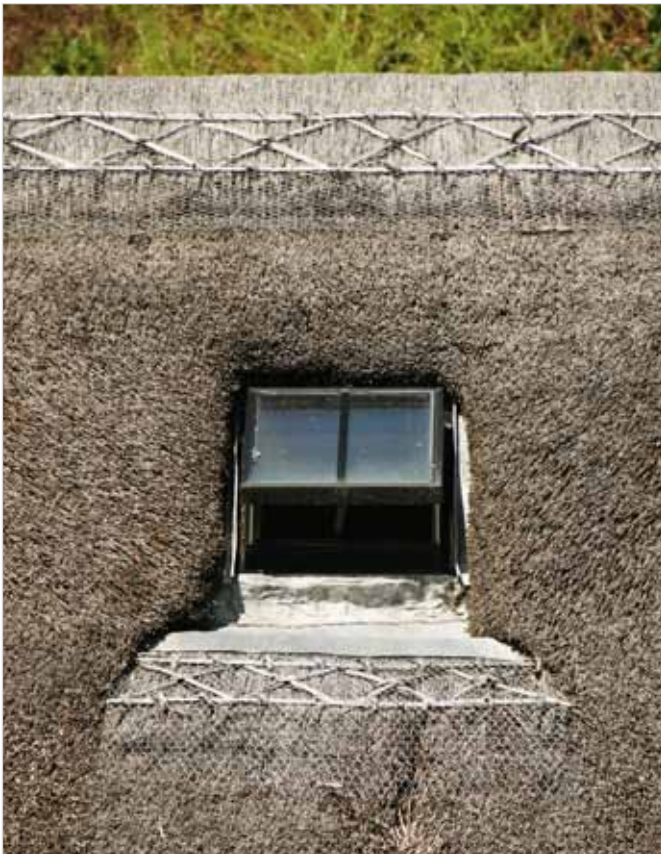
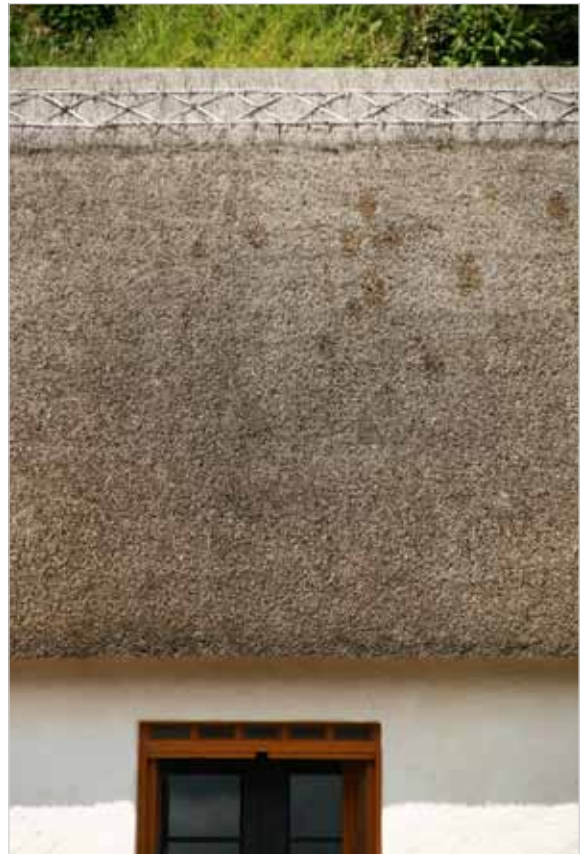
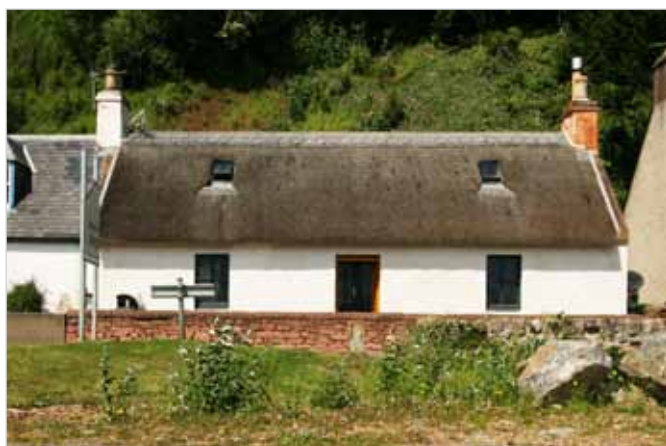
Rye Cottage – Highlands

Thatch Type: Reed
 Ridge Type: Thatched (Reed)
 Condition of Thatch: Good

Additional Notes: Group listing of two late 19th-century cottages, the one at 29 High Street listed as having a slated roof, and that at number 30 listed as having a corrugated iron roof. The cottage at number 30 now has a reed-thatched roof but whether there was thatch underneath the corrugated iron at the time of listing is unknown. The building was restored and used as a holiday let in the last couple of decades and appears to have had a completely new roof covering installed at this time. The ridge of the roof, which is slightly raised, has been scobed using hazel spars. There are two attic windows on the front elevation, and the thatch below these openings

has also been scobed with hazel spars, as well a small patch of scobing underneath the chimney stack at the north east gable end. The roof has been netted along the ridge and over the patches of scobing only, while the rest of the thatch has been left uncovered. The listing description should be updated accordingly.

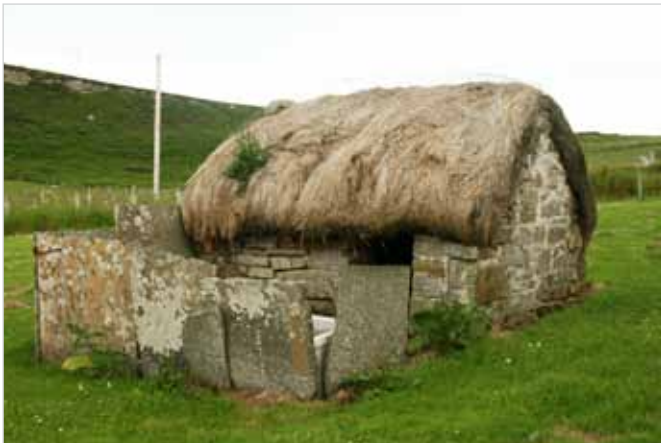
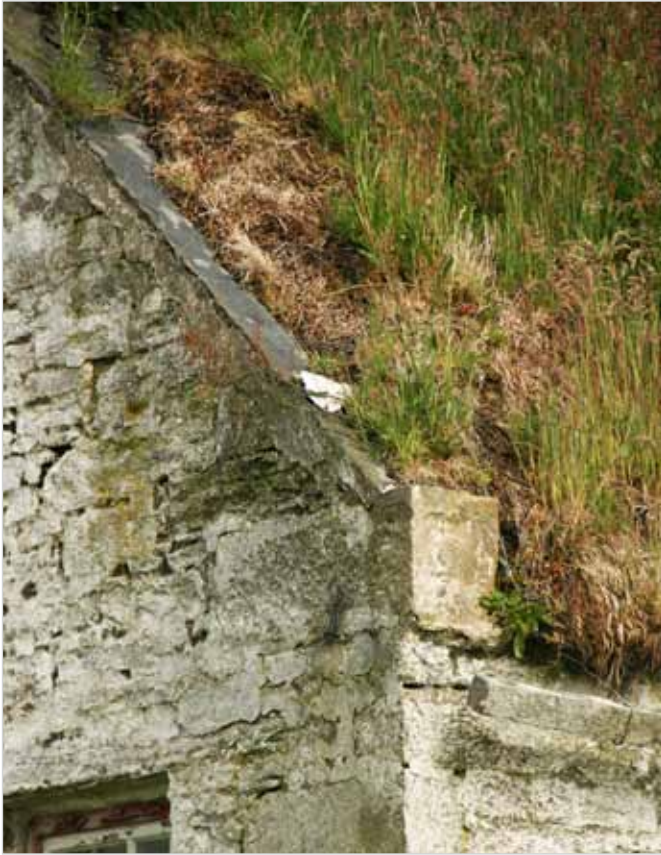
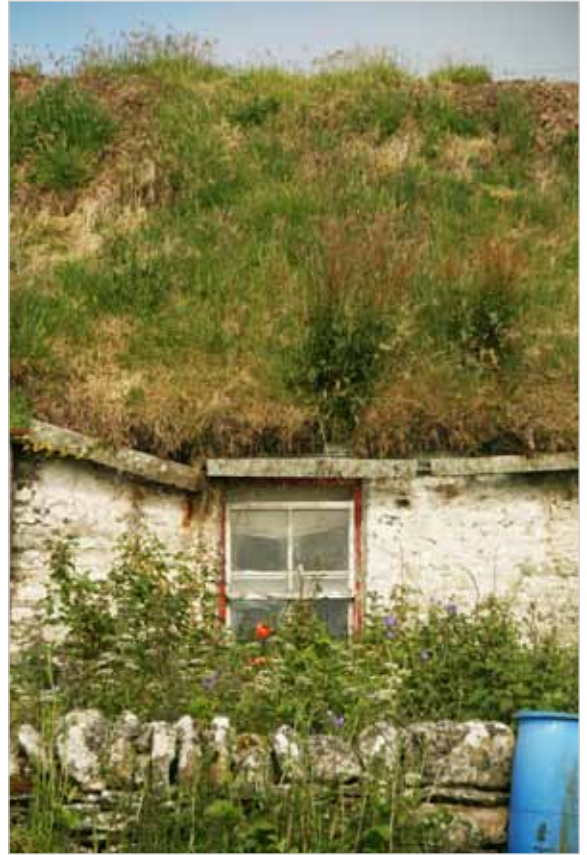
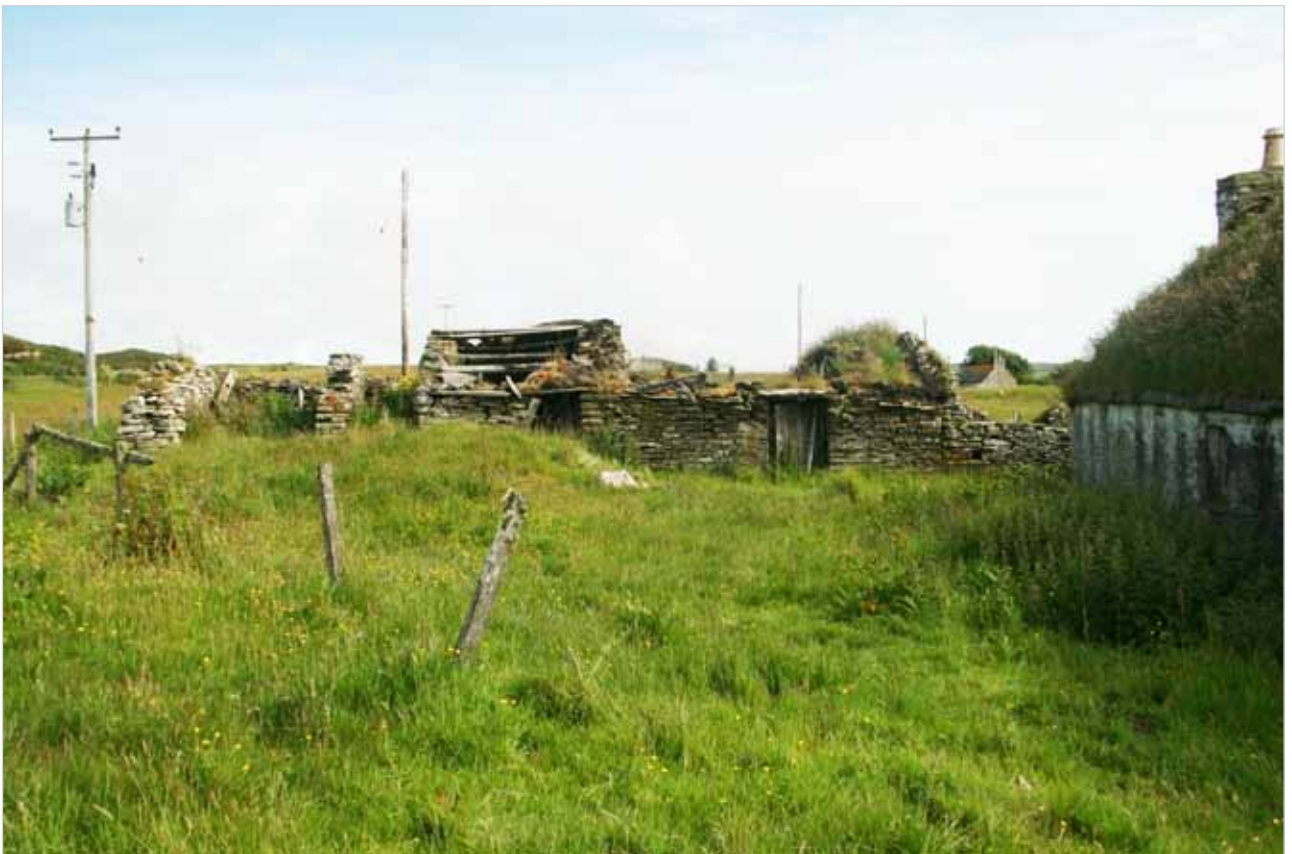
Group listing of a mid to late 19th-century croft house, with adjoining outbuildings and detached pig house and privy. The croft is also known as Mary Ann's Cottage, after the last owner and occupier of the buildings, and is now open to the public as a museum. Only the pig house is listed as having a thatched roof, which is currently thatched in marram. The small structure has a continuous marram ridge, and the entire roof has been netted, including over the ridge. The netting has not been weighted in any way; instead it has been nailed into the mortar joints along the gables but left unsecured along the eaves. The netting along the ridge is slightly higher

than the thatch, indicating that the thatch may have experienced some compaction. There are a few patches of grassy vegetation growth across the surface of the thatch, as well as an algae-type growth across the surface of the rear elevation.
