A Survey of Thatched Buildings in Scotland

Thatch Survey of Scotland
2014-15

A photographic survey of thatched buildings in Scotland, surveyed between May 2014 and August 2015 by Zoe Herbert (SPAB Scotland Officer), on behalf of the Society for the Protection of Ancient Buildings.

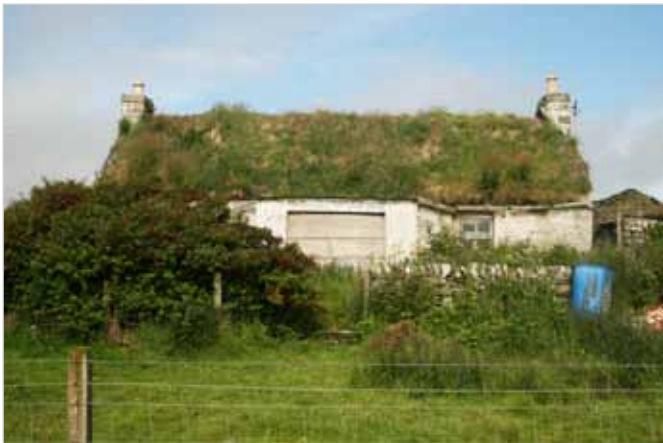
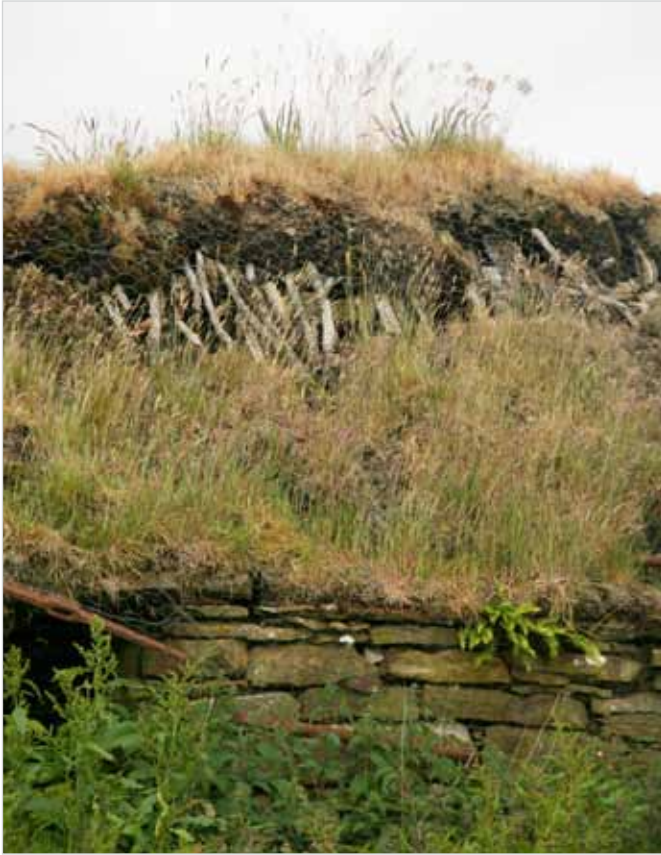
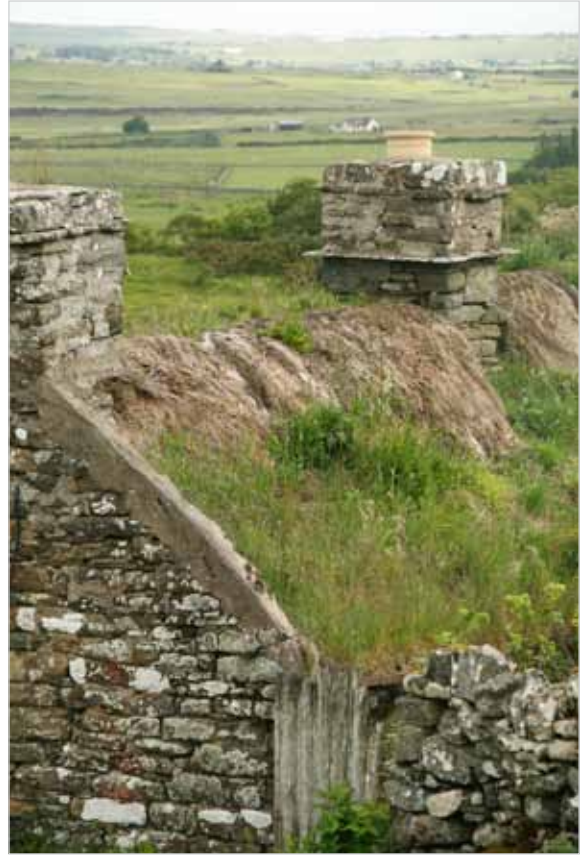
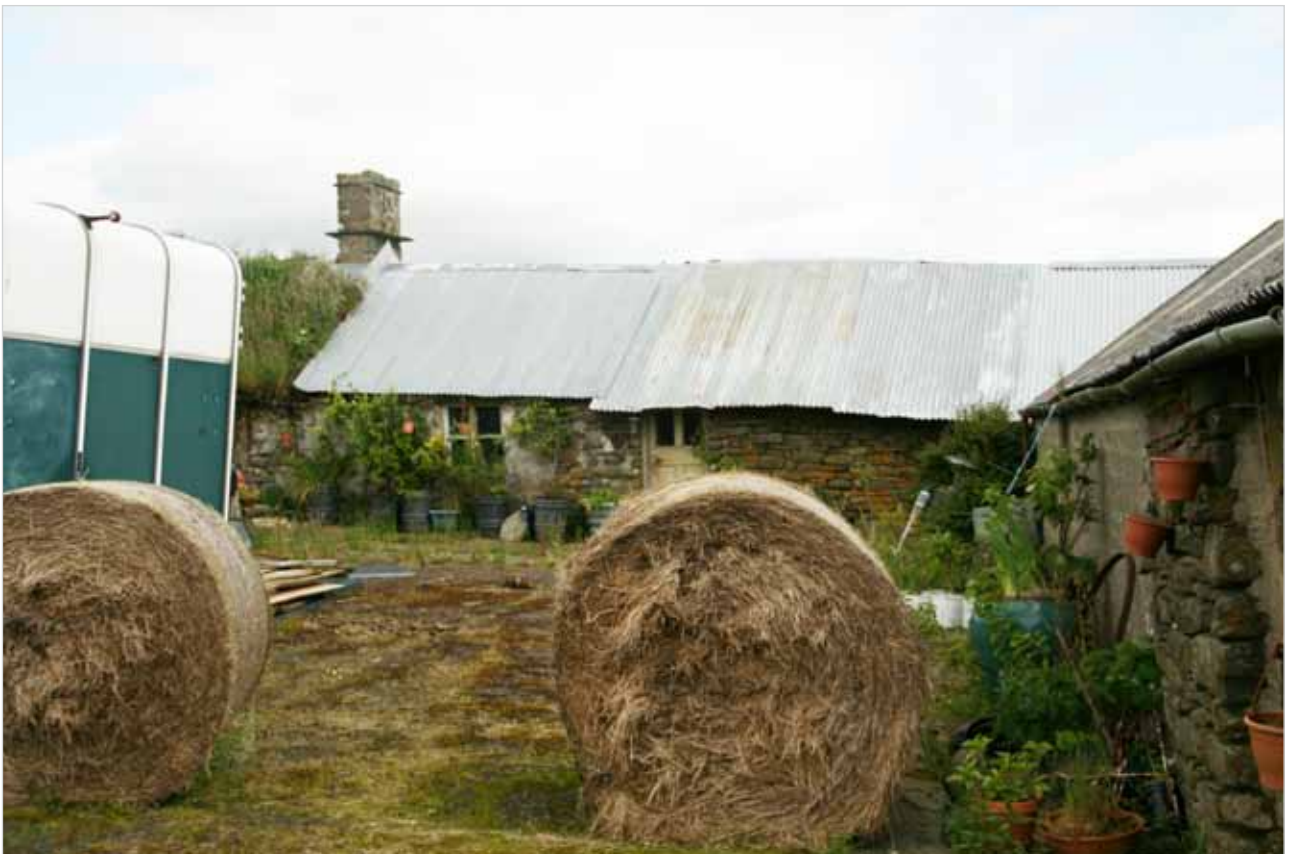
Mr James Sinclair's House and Steading – Highlands

Thatch Type: Rush
 Ridge Type: Thatched (Rush)
 Condition of Thatch: Poor

Additional Notes: Mid 19th-century house with steading at a right angle to the north. Both the house and steading are listed as having a 'rush thatched roof'. According to the listing notes, the owner who lived there at the time of listing, Mr James Sinclair, was a thatcher who re-thatched nearby Laidhay Croft Museum in the 1970s. The steading to the north is now a ruin and the thatched roofs have collapsed. The house retains its rush-thatched roof; however, it is heavily overgrown with vegetation and the building is vacant. The roof is entirely netted, and weighted at the eaves with long stone slabs secured to the netting with wire. A few of the weighting stones have become dislodged and slipped partially.

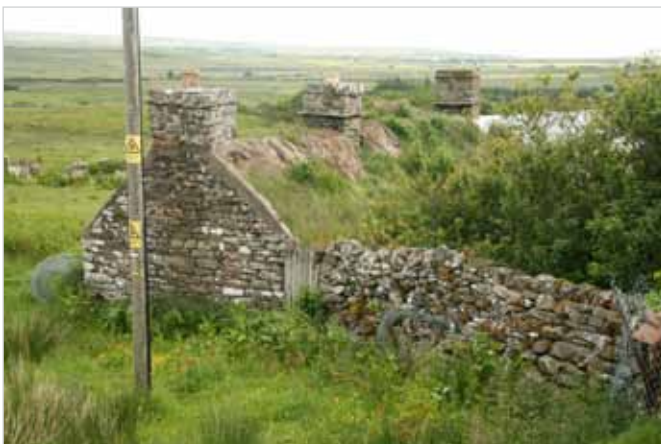
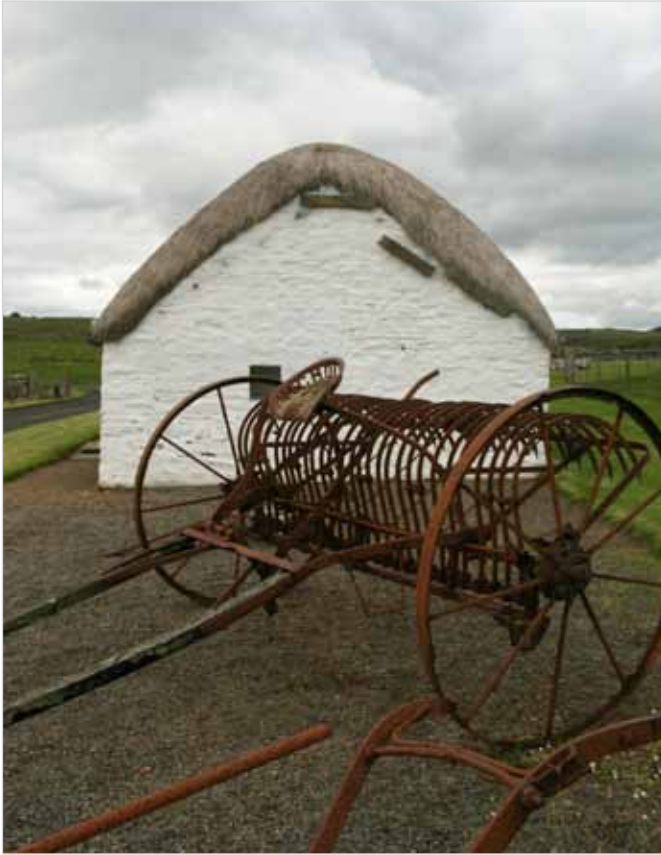
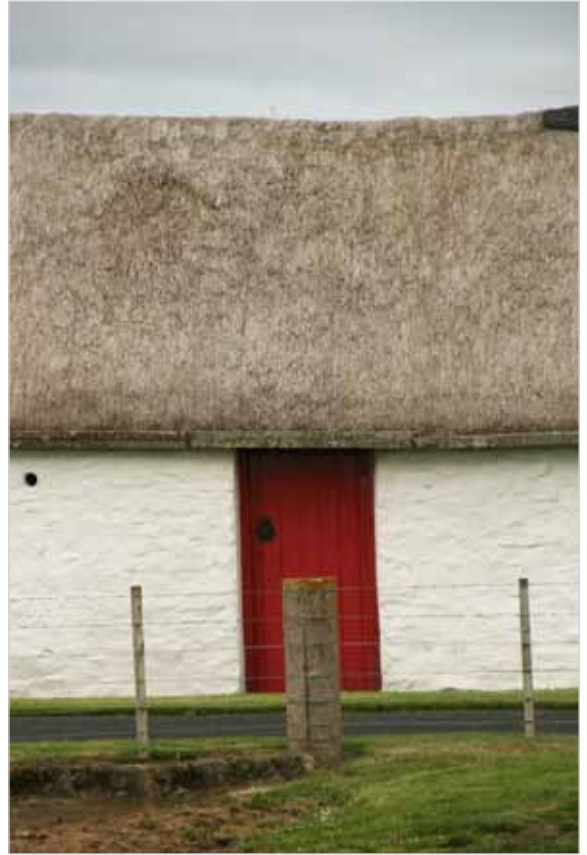
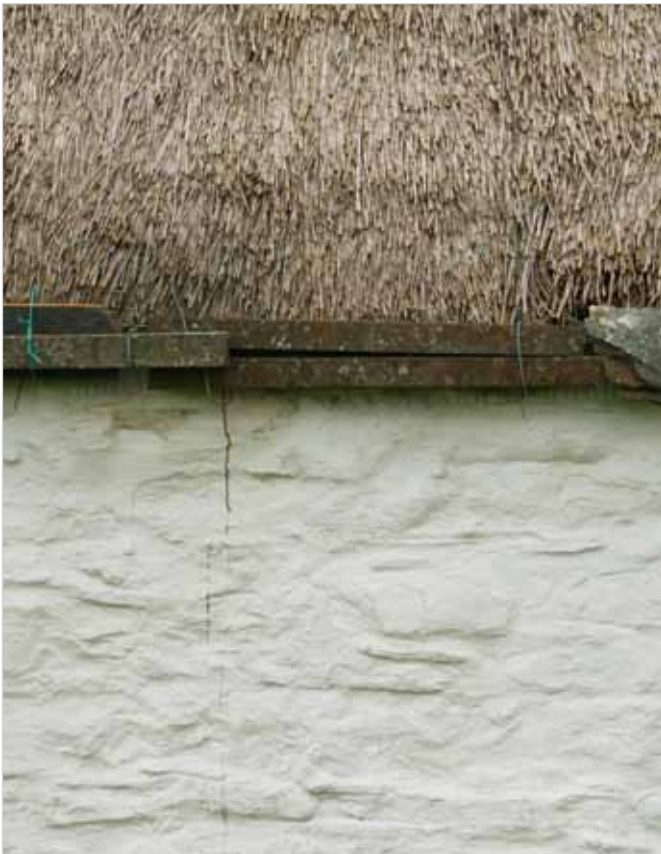
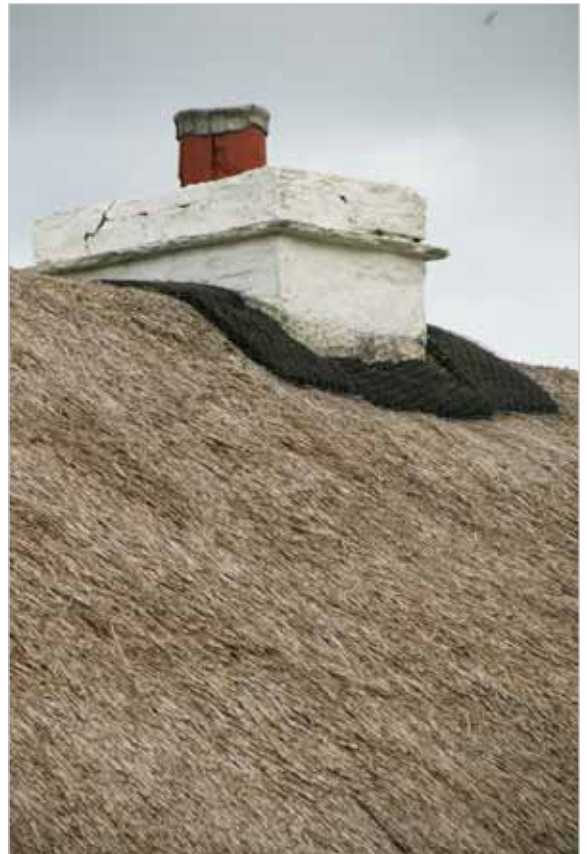
The Corr – Highlands

Address: The Corr
 Latheron Listing Category: C
 Wick Date Listed: 28/11/1984
 Listed Building Number: 7935
 Local Council: HIGHLANDS Canmore ID: 93288
 Building Type: Croft Complex
 Use: n/a
 Grid Reference: ND 20250 35707 Occupancy: Derelict
 Date of Visit: 13/07/2015 Buildings At Risk: Yes
 Thatch Type: Rush
 Ridge Type: Thatched (Rush)
 Condition of Thatch: Poor

Additional Notes: Early 19th-century croft complex, consisting of longhouse, byre, barn and stable range, hen house, wash house and cart shed. The listed building description states that the dwelling, hen house and workshop range all have rush-thatched roofs. The buildings have been vacant for some years now, and have been on the Buildings at Risk (BAR) Register since 2008 (BAR reference number 3623), at which time it was already recorded that the thatched roof was in poor condition and suggested it did '*not appear to have been maintained for several years*'. The roofs of the ancillary buildings to the south west of the longhouse have large

areas of thatch missing, exposing the interiors of the buildings. Part of the longhouse range has been covered with a temporary corrugated iron covering, whilst the section to the west remains uncovered. The thatch that can be seen on the longhouse is heavily overgrown with vegetation.

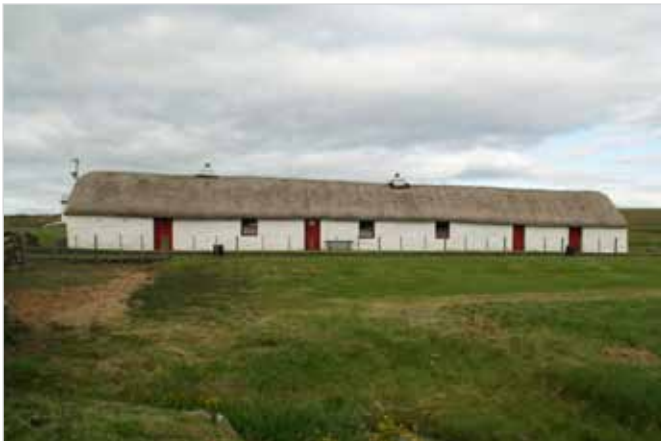
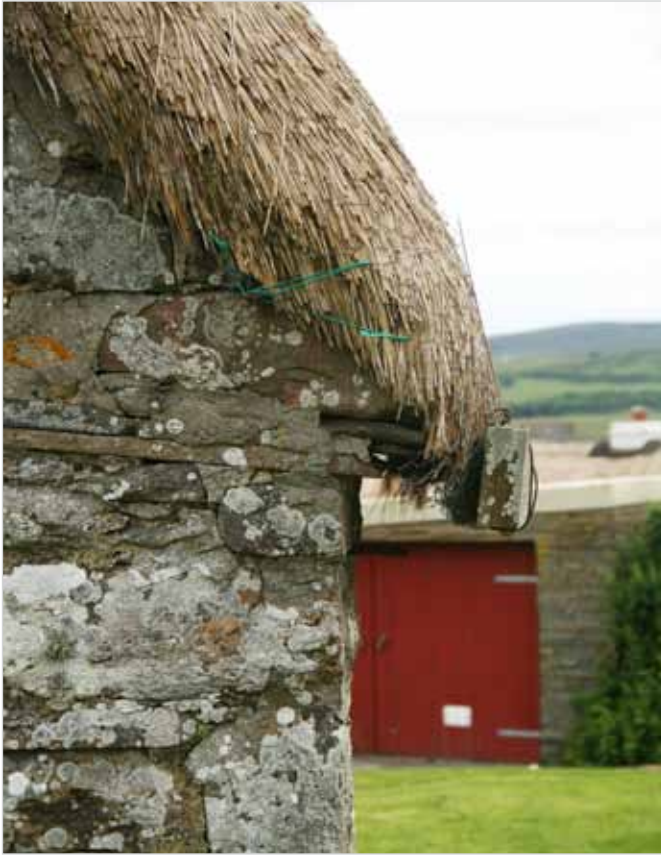
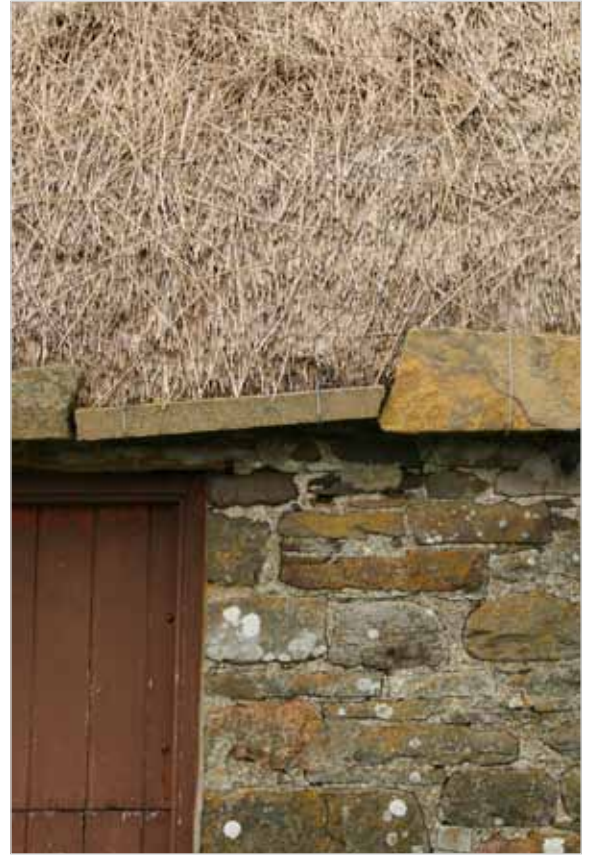
According to the listing, the building is thatched in rush. It has a continuous thatched ridge and the entire roof has been netted, including across the ridge. The netting is weighted along the eaves with long slabs of stone and concrete, which have been secured to the netting with string and wire. At the gables, the netting has been fixed into the gable wall with metal pegs, and stones have been hung from the netting in places for additional weighting. The

building has two chimney stacks along the ridge, around the base of which have been placed tiles of what appears to be turf that is held in place by the netting. There is some minor weed growth on the surface of the thatch in places, but otherwise the roof is in a well-maintained condition.

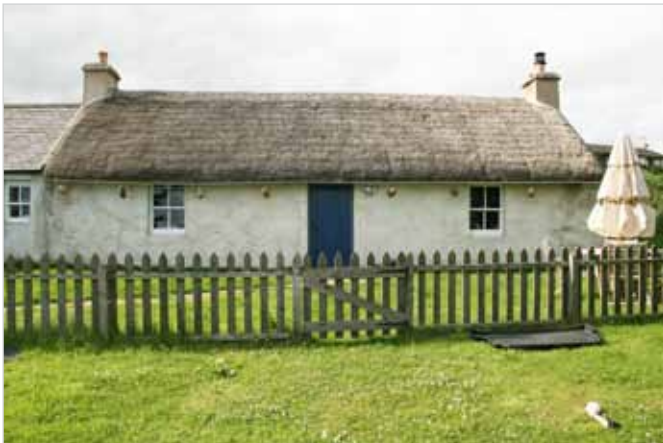
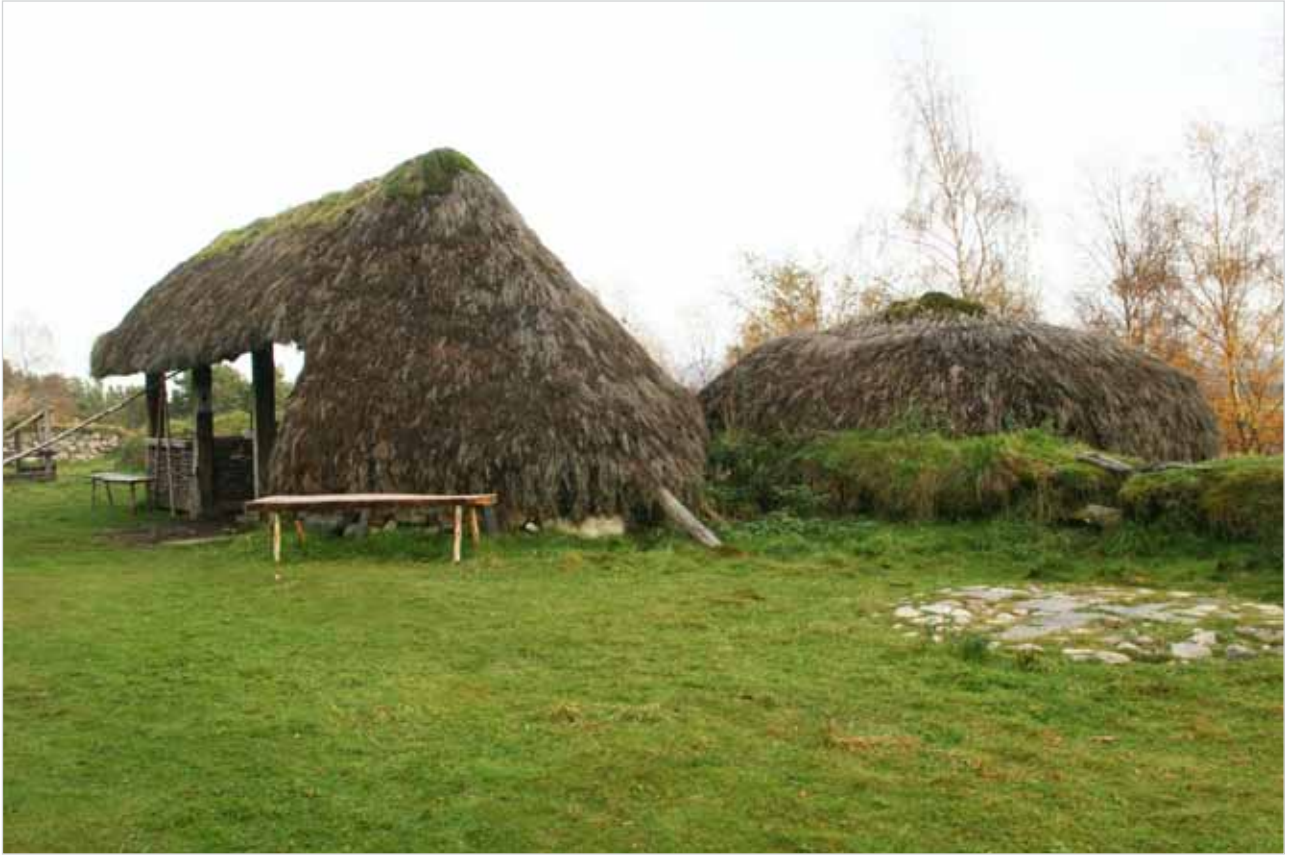
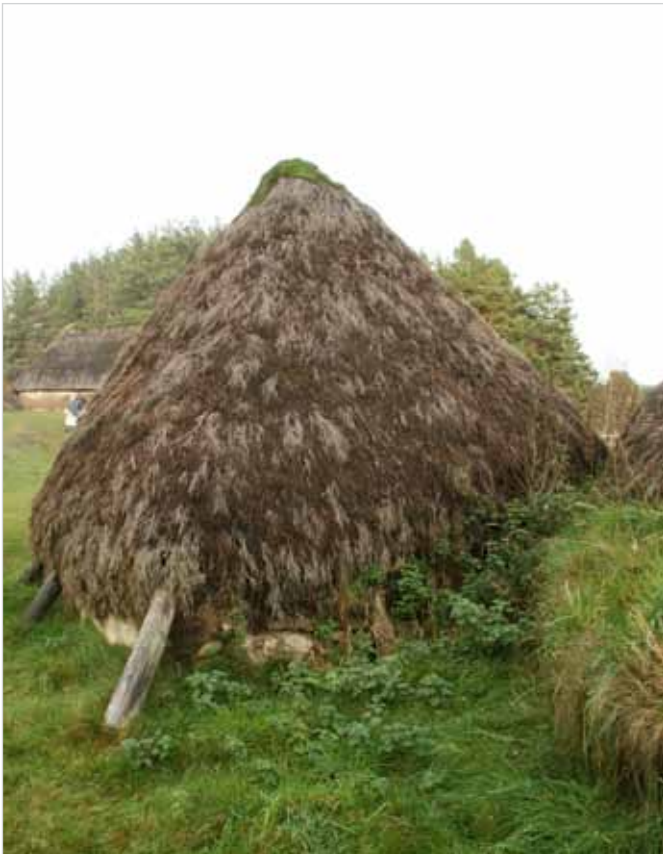
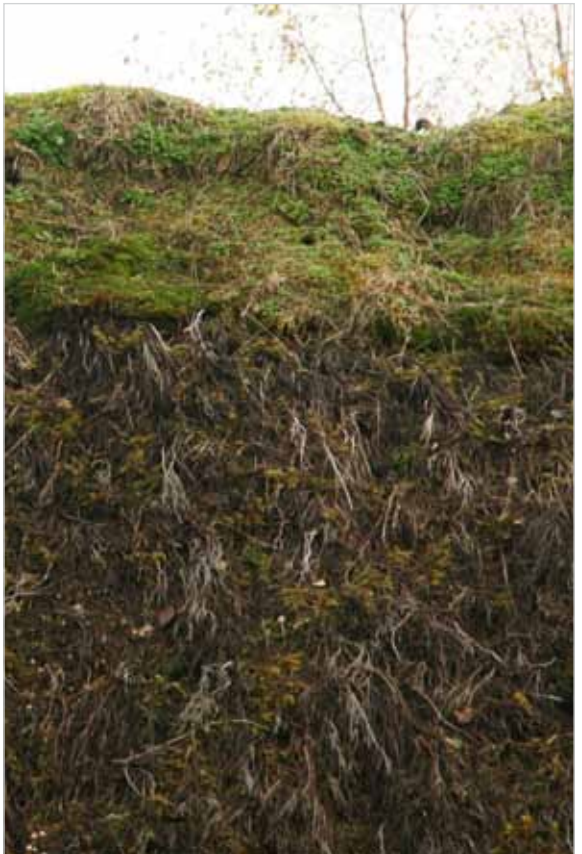
Probably late 19th-century cottage, listed as having a roof of 'marram thatch over turf. The roof is no longer thatched in marram, and has been replaced by what appears to be straw. The ridge is thatched in the same material, which has also been scobed using horizontal hazel spars. The entire roof is netted, including over the ridge, and has been weighted at the eaves with thin timber battens and stones. The timber battens have been secured to the netting by being passed through the netting's holes. The stones have then had small holes drilled through them and tied to the netting around the timber battens with wire, which then hang below the

eaves and keep the netting in place. The addition to the west gable of the cottage is listed as having a corrugated iron roof; however, this part of the roof is now slated.

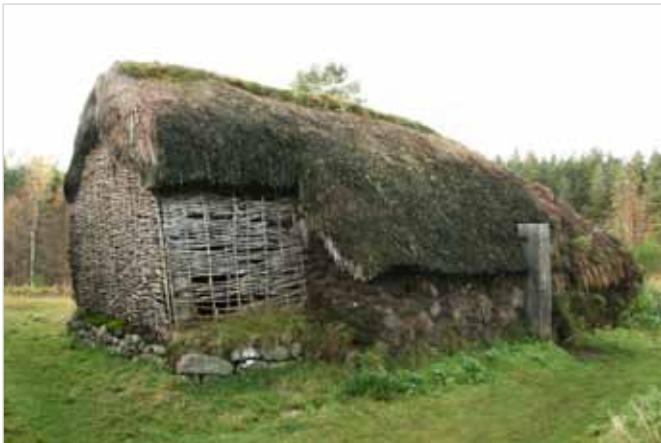
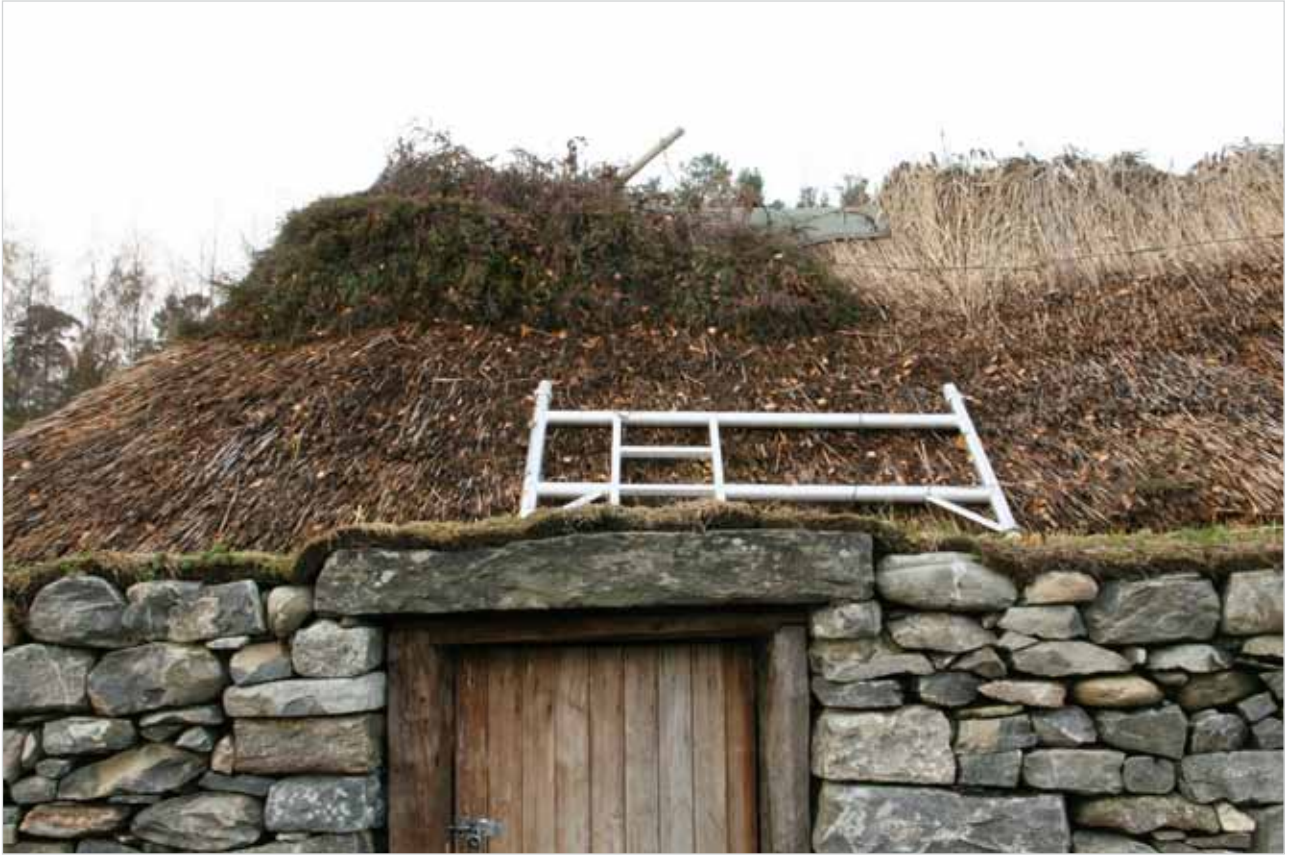
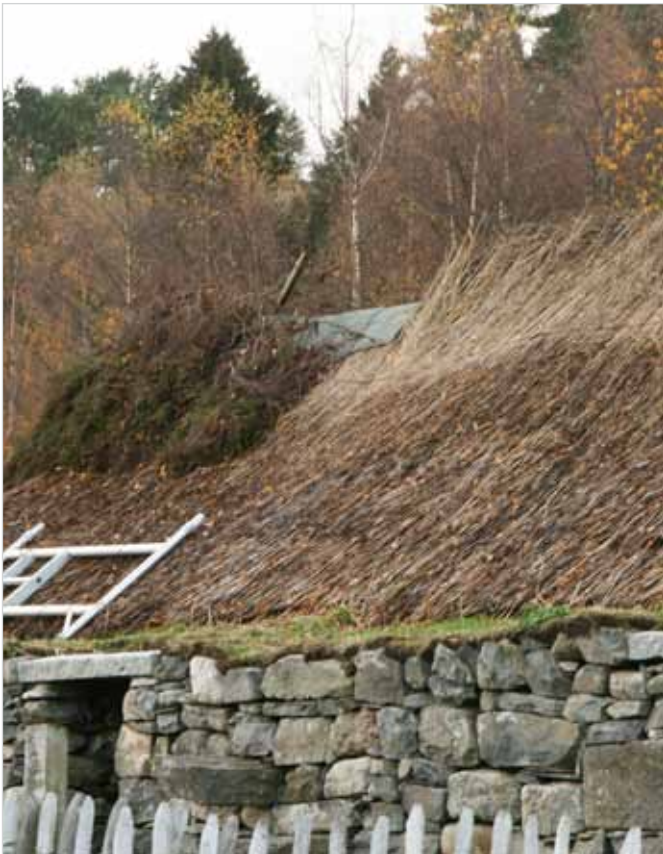
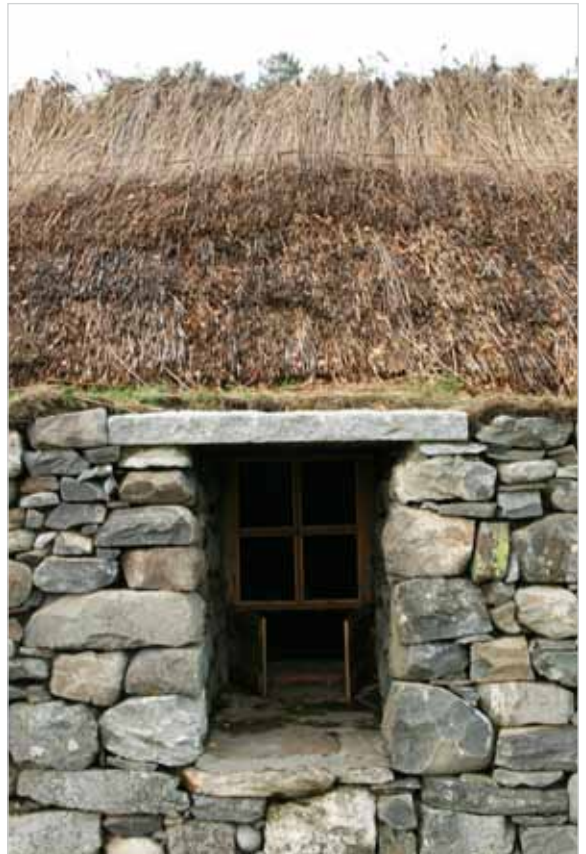
Part of a reconstruction at the Highland Folk Museum of an early 1700s Highland township. The roof is thatched in predominantly bracken and has a turf-thatched ridge. The roof has been left uncovered and has some mossy and grassy vegetation growth across the surface of the thatch throughout. The thatch at the north end of the building is in a poorer condition than the south end and has some small areas of thatch missing and substantially more vegetation growth.

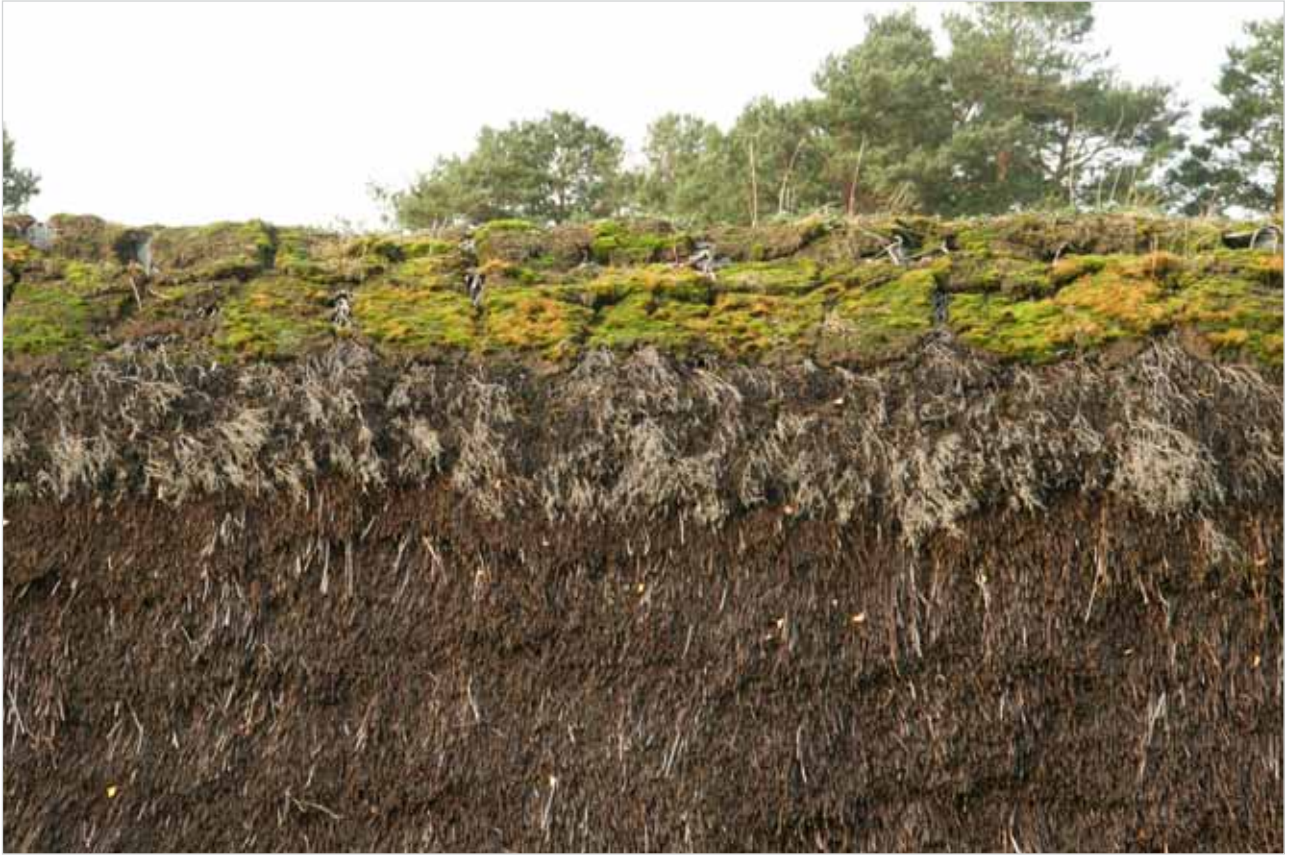
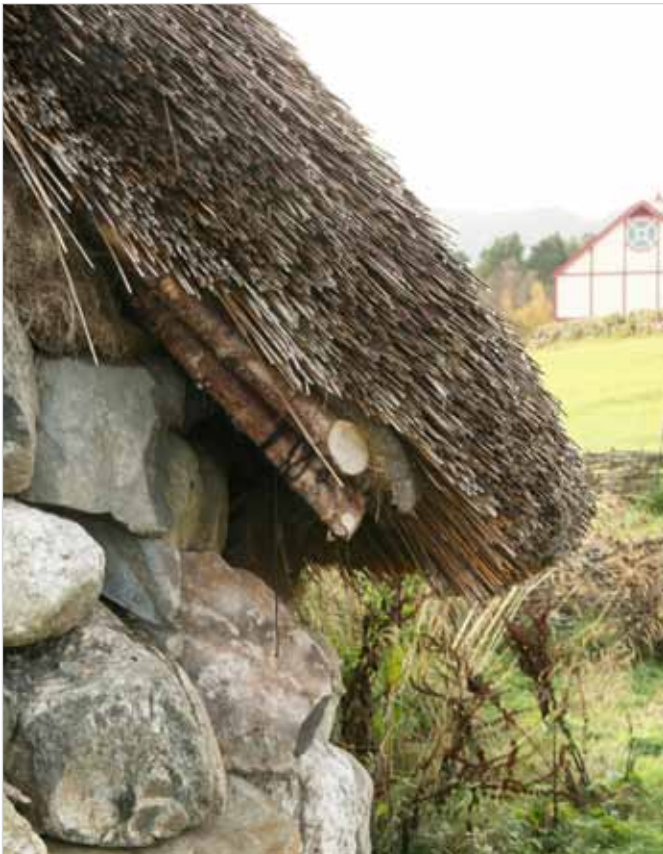
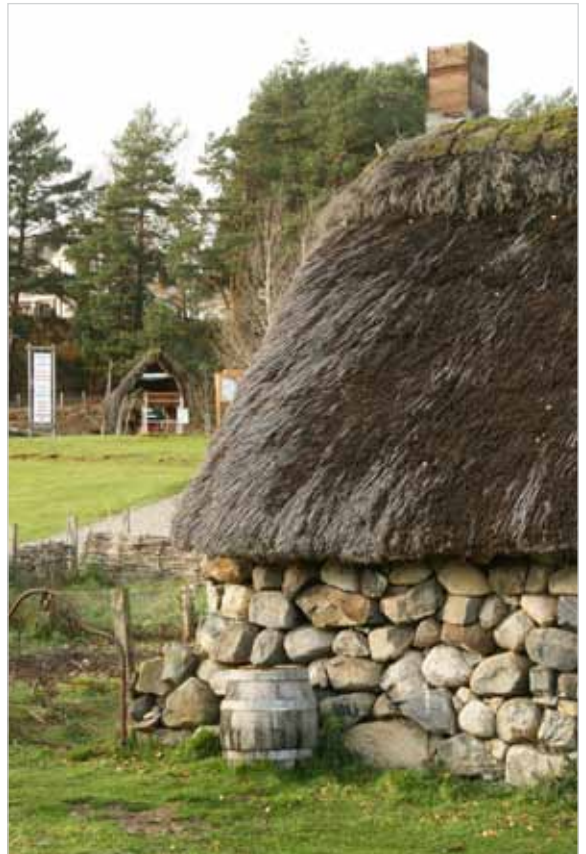
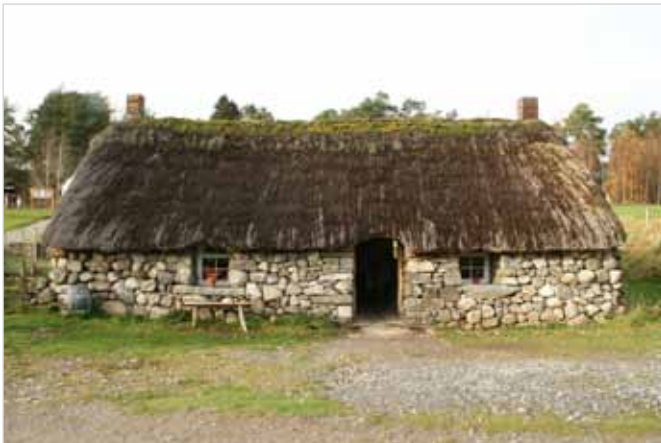
The Highland Cottage – Highlands

Condition of Thatch: Good

Additional Notes: The building was inspired by a circa 1890 photograph of a Highland cottage in Grantown, recreated and interpreted for the same period. It is part of the Highland Folk Museum in Newtonmore, and according to the guidebook the house was '*probably "home" built in the early 1800s*'. Also noted in the guidebook, the roof is described as being covered with '*cabers, turf and heather thatch*'; however, the roof is currently thatched in what appears to be reed or straw, with a layer of heather underneath a layer of turf across the ridge. The entire roof has been left uncovered.

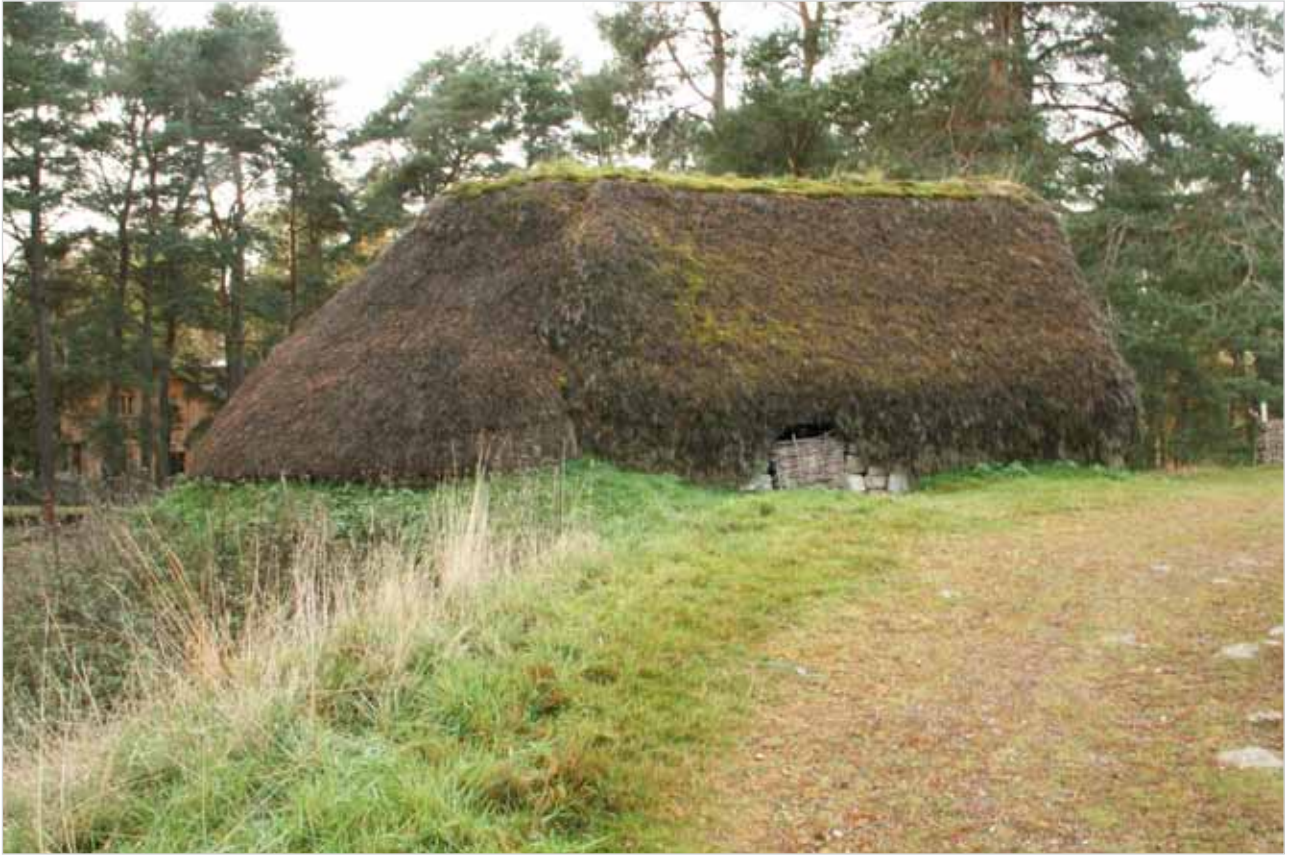
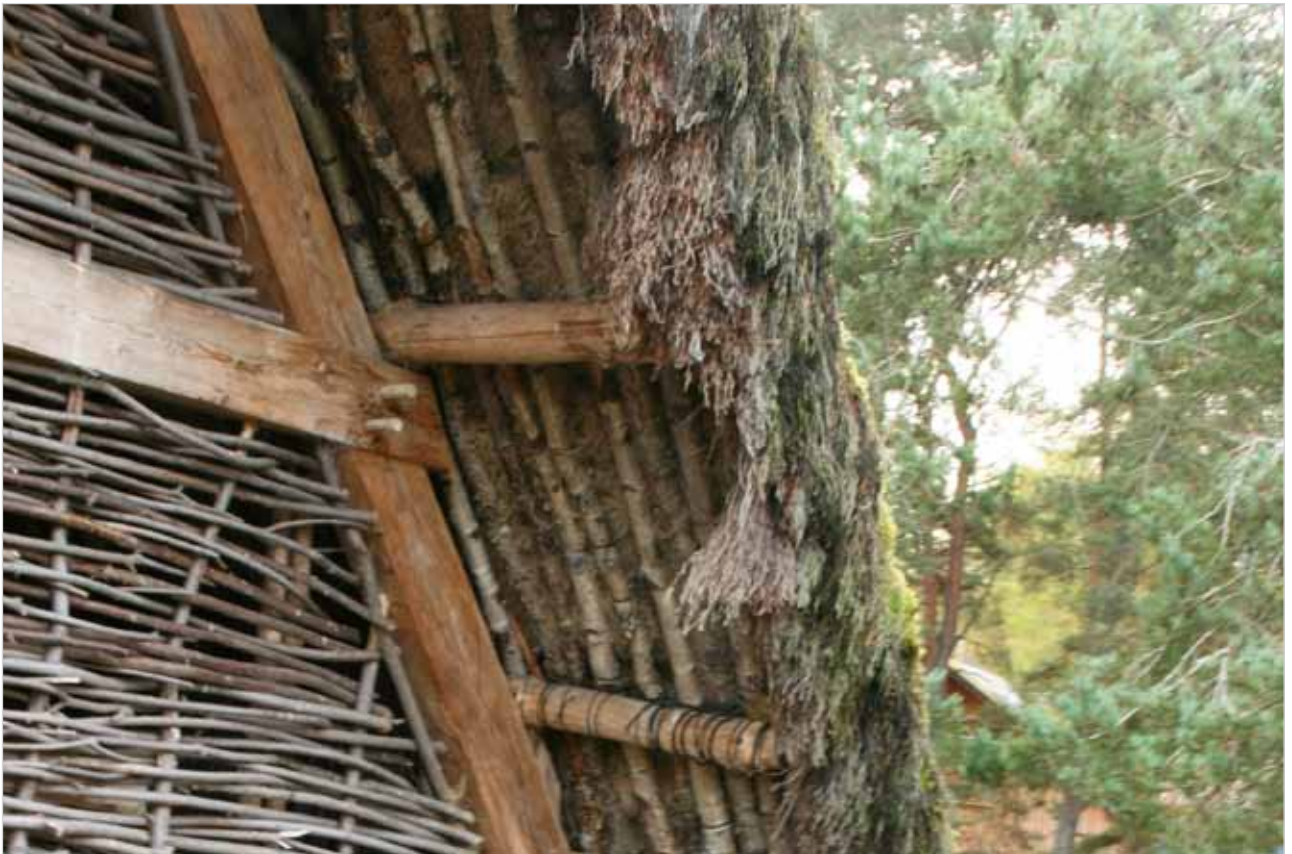
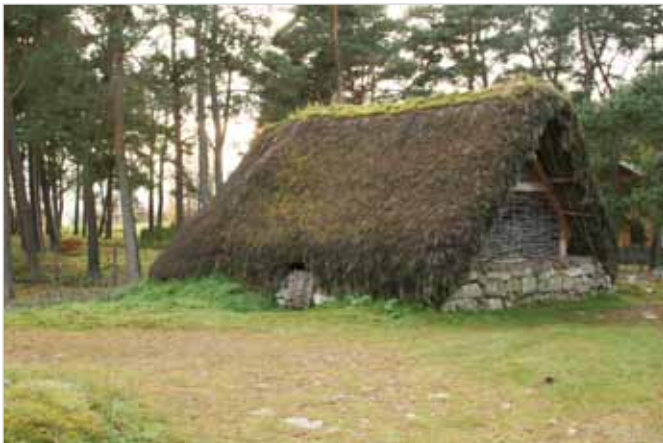
Kiln Barn – Highlands

Condition of Thatch: Good

Additional Notes: Part of a reconstruction at the Highland Folk Museum of an early 1700s Highland town-
 ship. The structure of the building is made entirely of timber and has a roof thatched in heather with a turf ridge.
 The entire roof has been left uncovered and allowed to flourish of its own accord. There is a small amount of
 mossy and grassy vegetation growth across the surface of the thatch. The eaves of the roof come down very low
 and almost reach ground level.

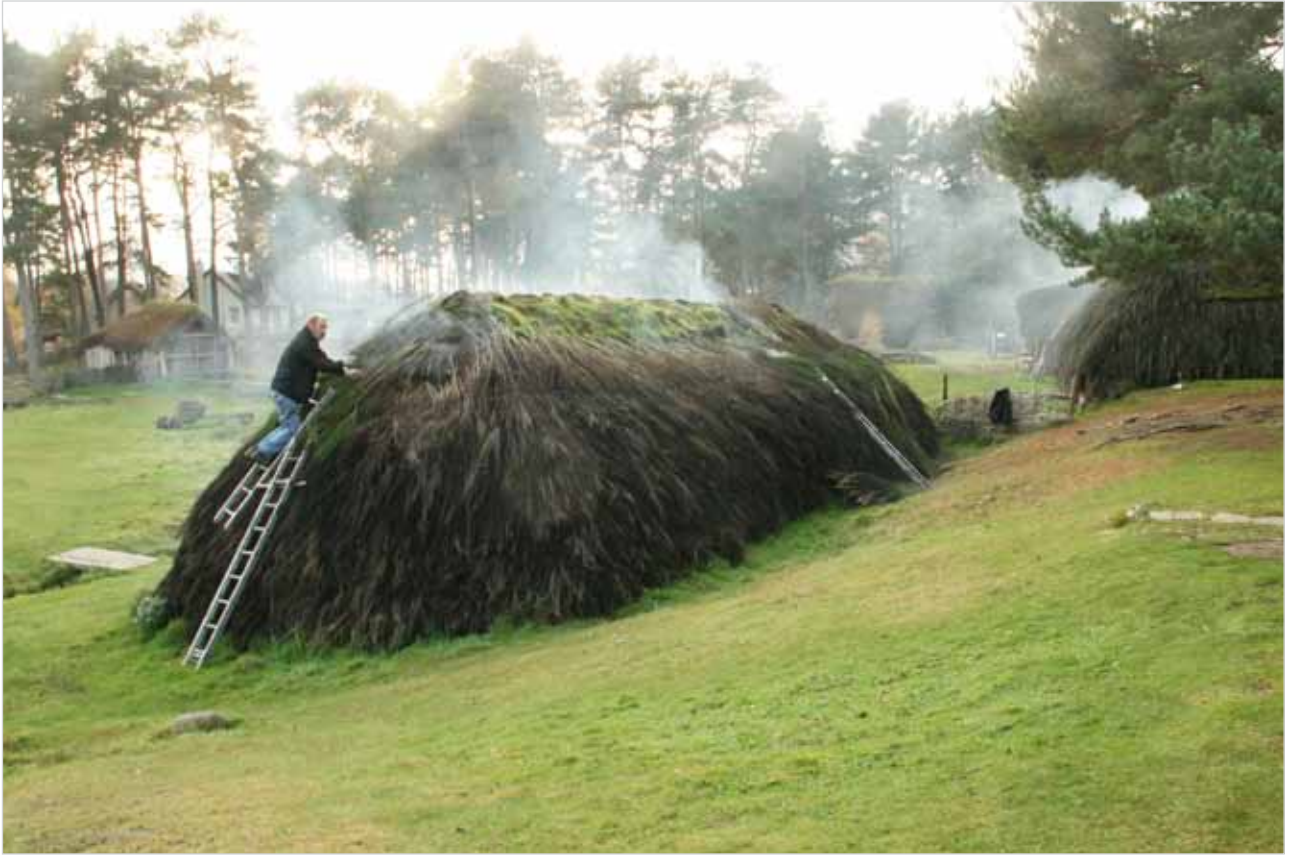
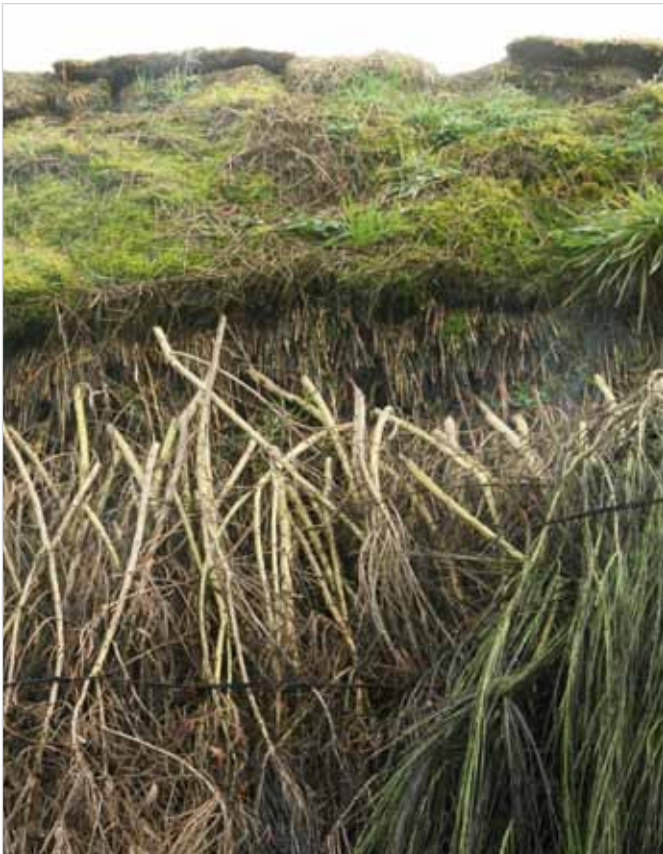
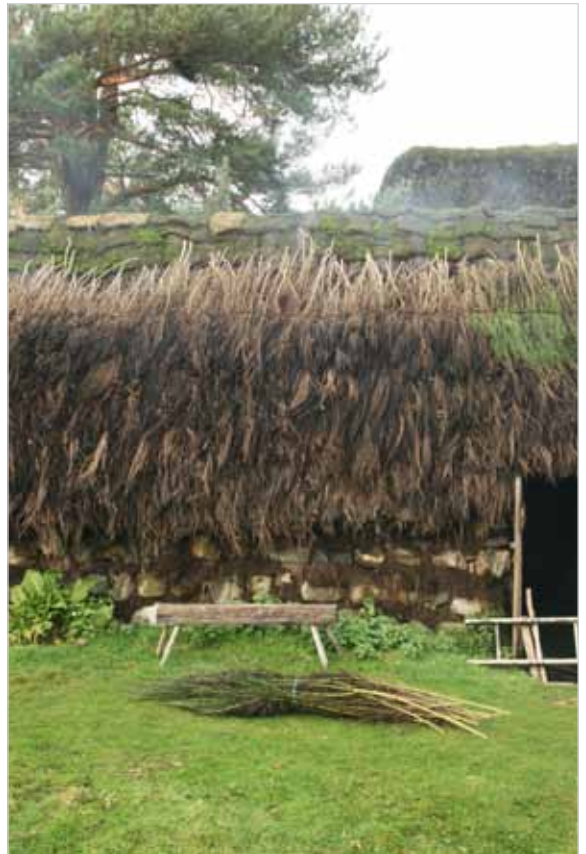
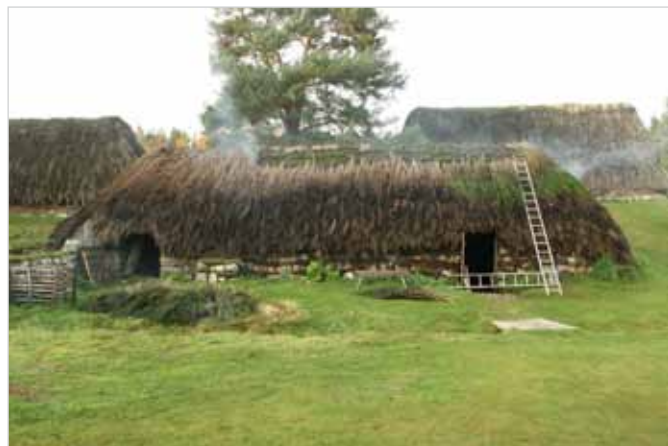
Stockman's House – Highlands

Condition of Thatch: Good

Additional Notes: Part of a reconstruction at the Highland Folk Museum of an early 1700s Highland township.

The building was in the process of being re-thatched upon visiting by staff at the open-air museum. The roof is thatched in broom and has a turf ridge. The roof has been left uncovered. The thatch appears to be secured to the roof in bundles with string.

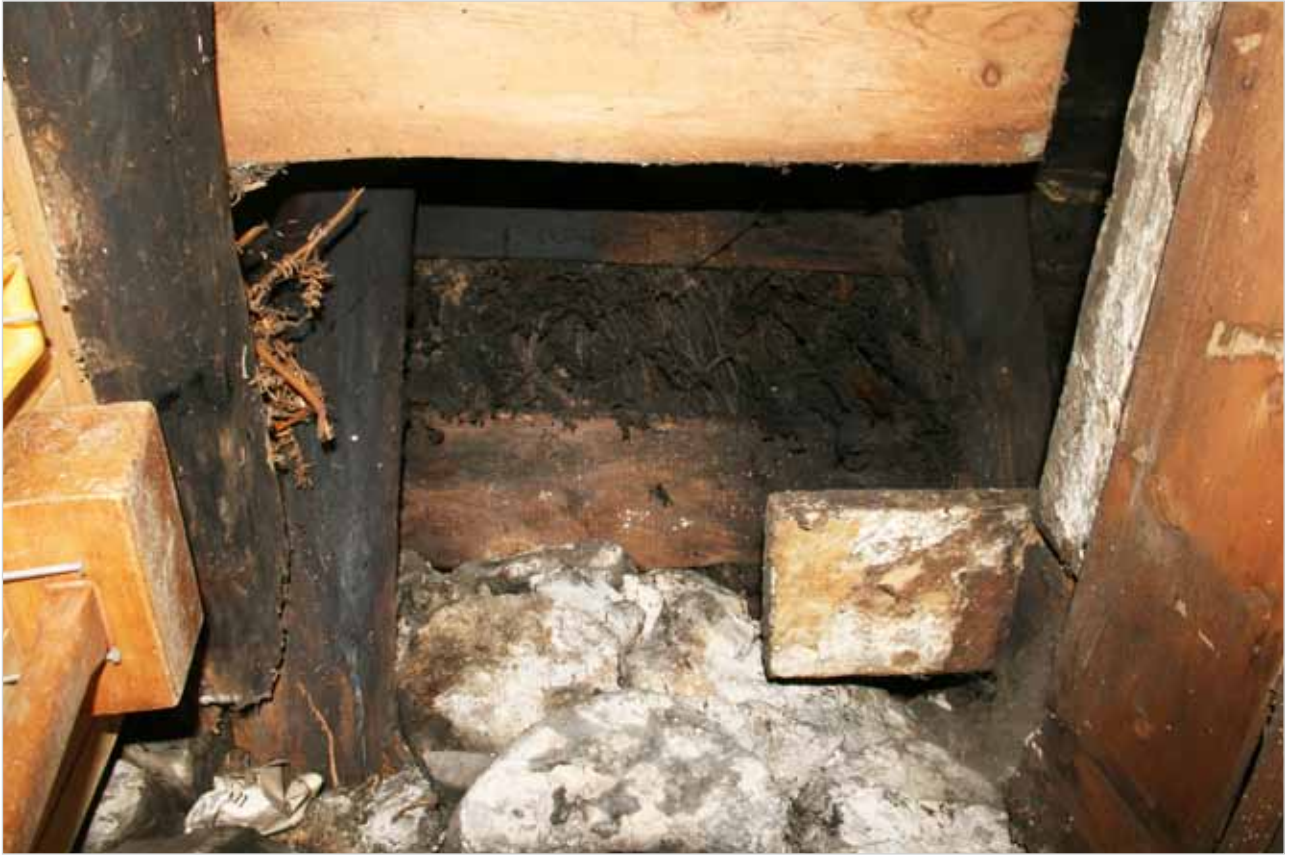
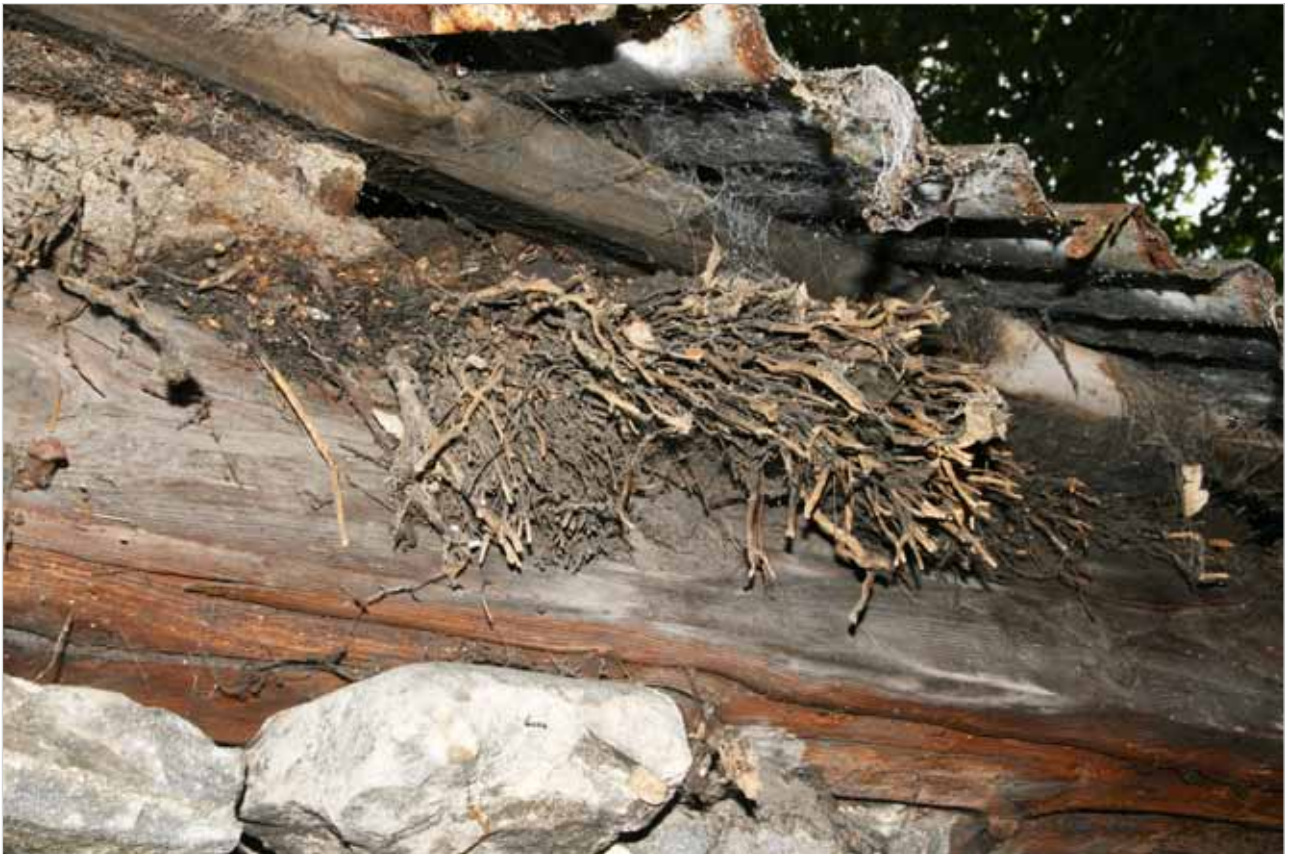
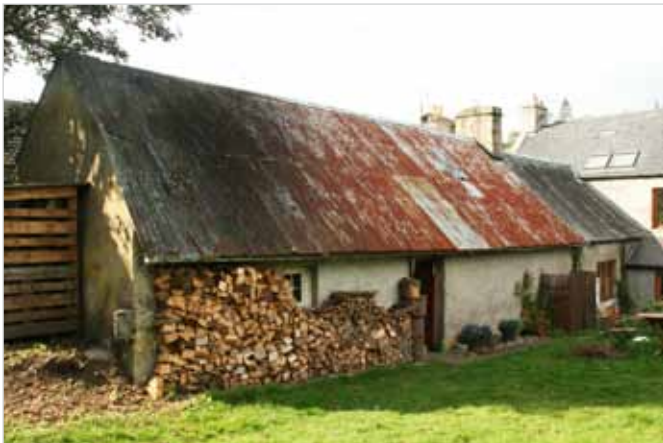
Monaliadh – Highlands

Thatch Type: Bracken and Heather
 Ridge Type: Unknown
 Condition of Thatch: Unknown

Additional Notes: The listed building description reads '*Earlier 19th century, single storey, irregular 3-bay cottage, now forming rear wing to Monaliadh [...] corrugated iron roof covers surviving thatch*'. The current owners, who live in the adjoining building (the house is called Monaliadh, which is of later 19th-century origin than the rear wing and not included in the same listing), have owned the building for approximately three years. In this time, it has remained in use as a shed/store. The corrugated iron roof is still in place over the surviving thatch, which is thought to be a mixture of bracken and heather. Evidence from internally and from underneath the eaves

externally would support this. The exact condition of the thatch is unknown, as is the thatching technique or the construction and material of the ridge (if this still exists).
