A Survey of Thatched Buildings in Scotland

Thatch Survey of Scotland
2014-15

A photographic survey of thatched buildings in Scotland, surveyed between May 2014 and August 2015 by Zoe Herbert (SPAB Scotland Officer), on behalf of the Society for the Protection of Ancient Buildings.

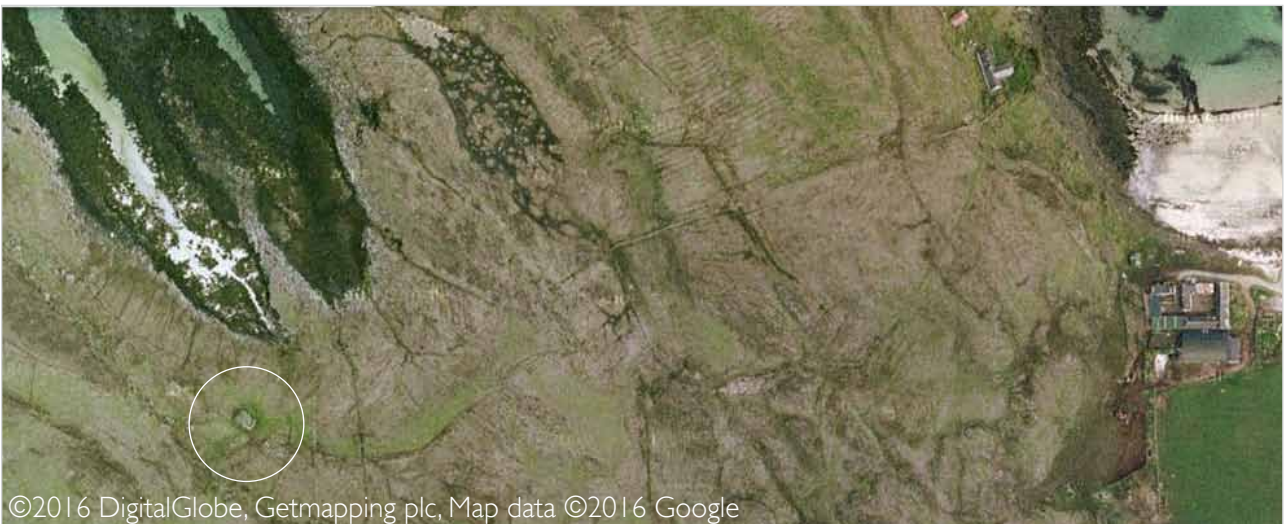
Additional Notes: This building was not surveyed due to discovering that the building has a turf or sod roof. The building had been a ruin until the late 1960s when it was restored. There is some uncertainty over when the roof covering was changed from being thatched; the current tenant took occupancy of the building in 1988, at which time the roof was turf. It was listed in 1985, however, as having a '*piended rush thatch roof over turf divots held down with fishing net and a variety of weights and stones*'. It would appear that at some point between being listed in 1985 and the current tenant moving into the cottage in 1988 the rush had either degraded or blown away, and the bare turfs had developed to be the predominant roofing material. Further research into this building is required and the listing description should be updated accordingly.

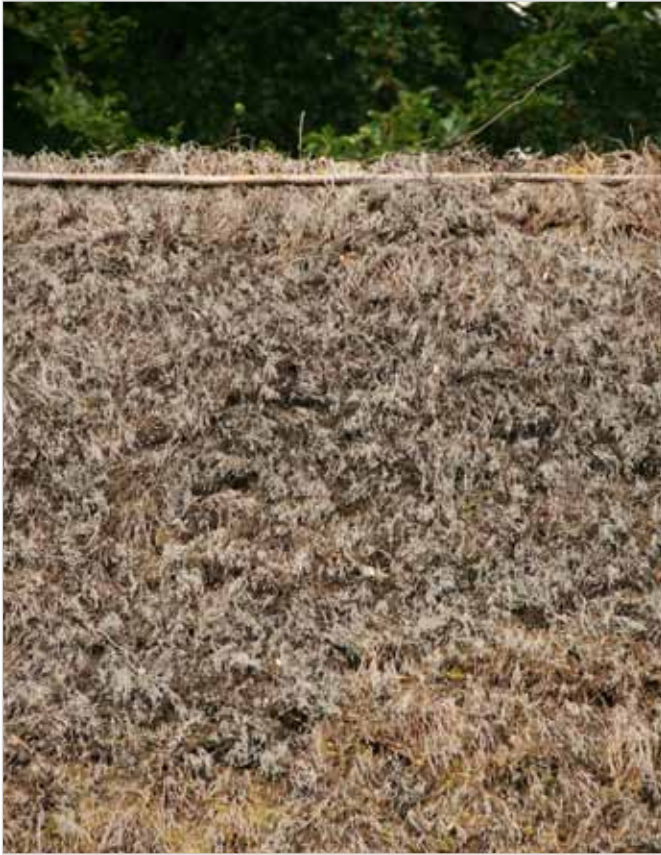
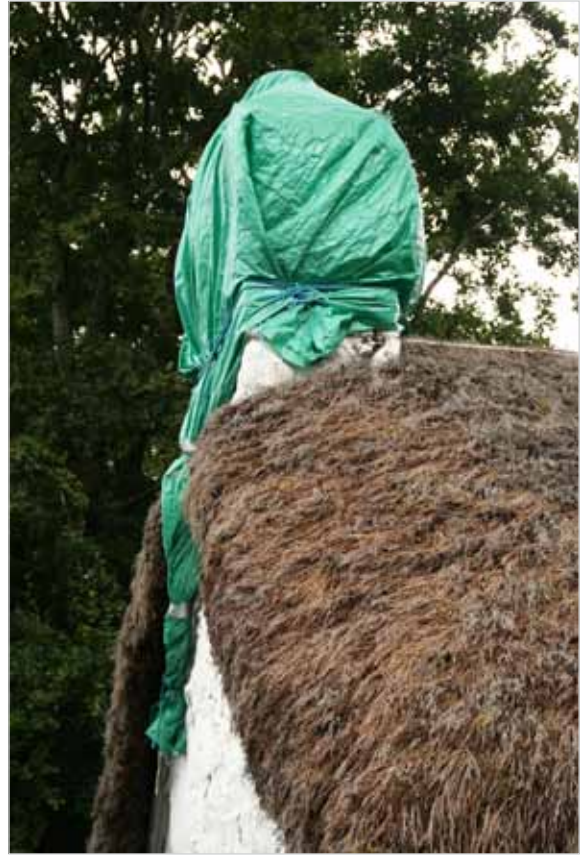
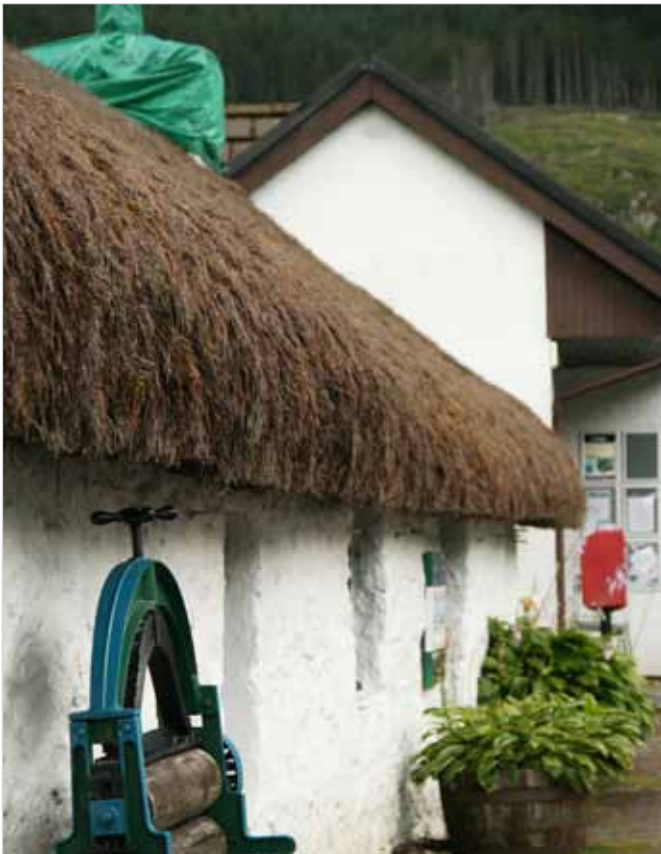
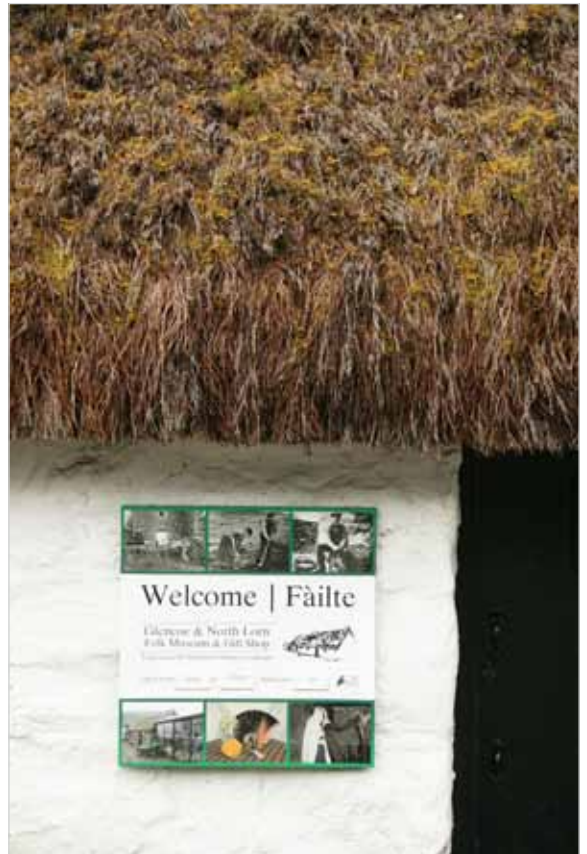
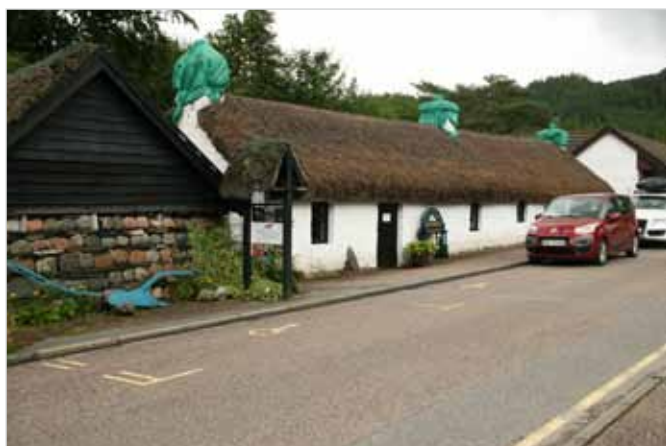
Glencoe and North Lorne Folk Museum – Highlands

Condition of Thatch: Good

Additional Notes: Earlier-mid 19th-century pair of adjoining single-storey cottages, currently in use as part of the Glencoe and North Lorn Museum. An excerpt of text on Canmore states that the cottages were last lived in until the 1950s, and '*restored from dereliction, re-thatched with heather and converted to a museum*' in 1971 (Miers, M. (2008), *The Western Seaboard: an illustrated architectural guide*. Edinburgh). Whilst the cottages are listed as being '*earlier-mid 19th century*', the text on Canmore states that the cottages date from circa.1700. The roof of the building is thatched in heather, which has been left uncovered, and has a continuous heather ridge.

The top layer of thatch along the ridge has been secured with a single row of metal wire, which has been covered with a row of thin wooden branches. There is a small amount of mossy vegetation growth across the surface of the thatch in places. According to the museum's website, the last re-thatching of the roof was completed in January 2014.

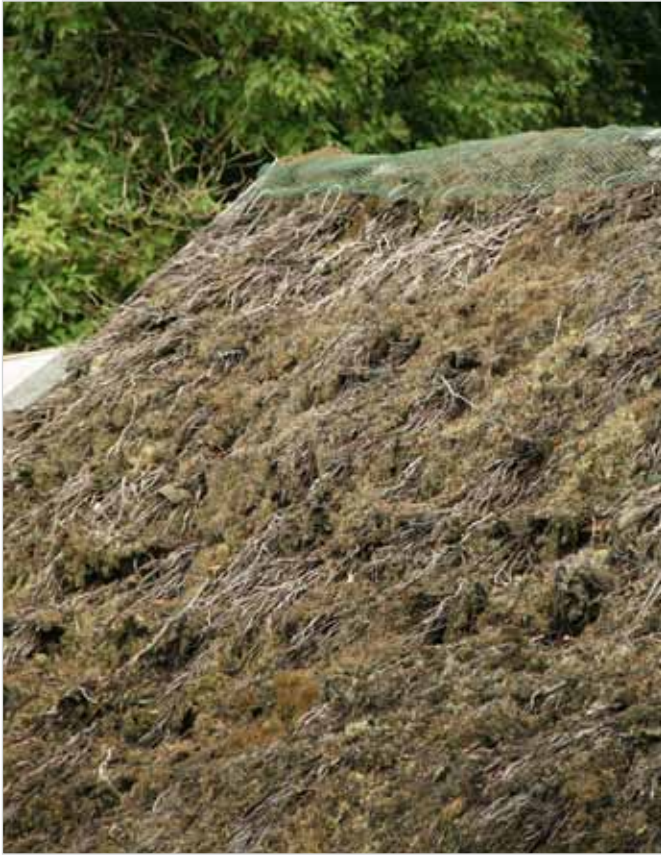
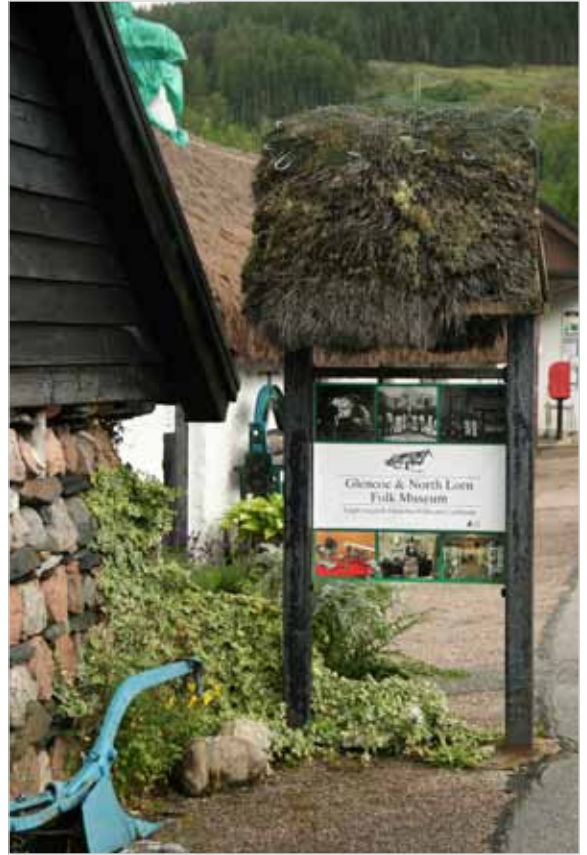
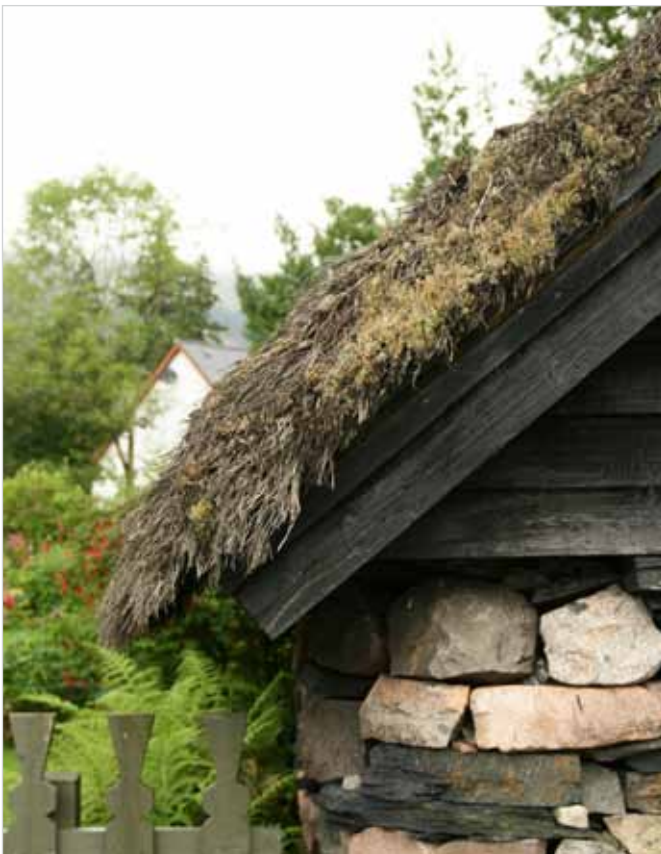
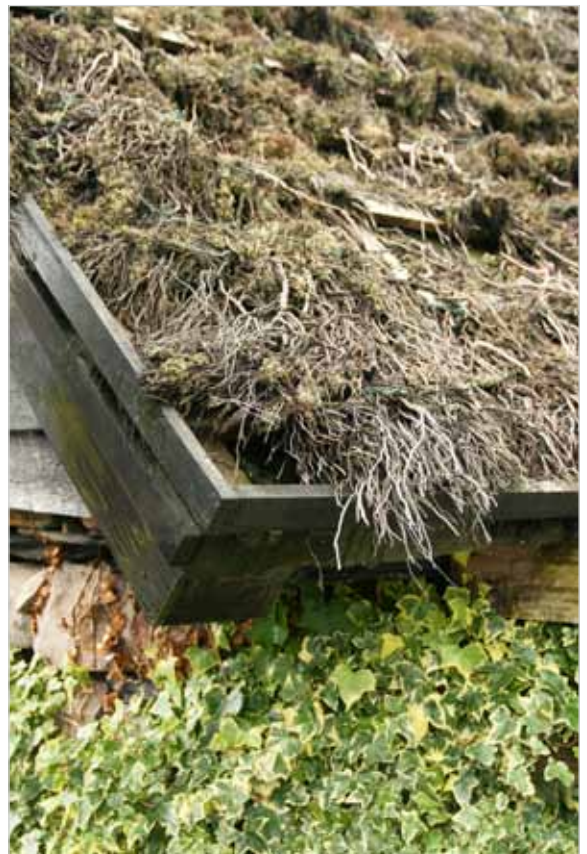
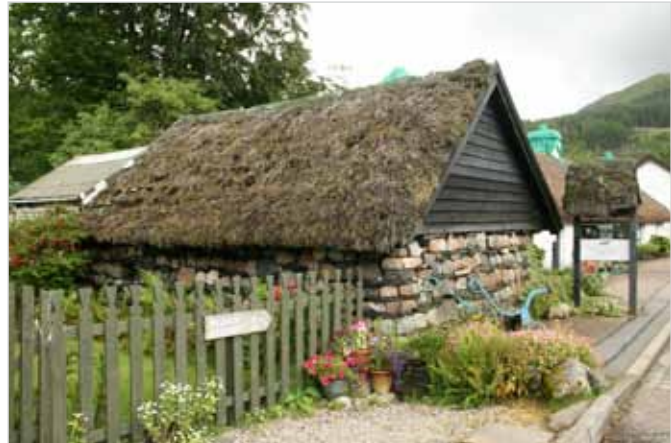
Massacre Room – Highlands

..... missing throughout the thatch, which is exposing the roof structure beneath, and there is an amount of mossy

..... vegetation growth across the surface of the heather. Next to the byre is a street sign that has a pitched heather-

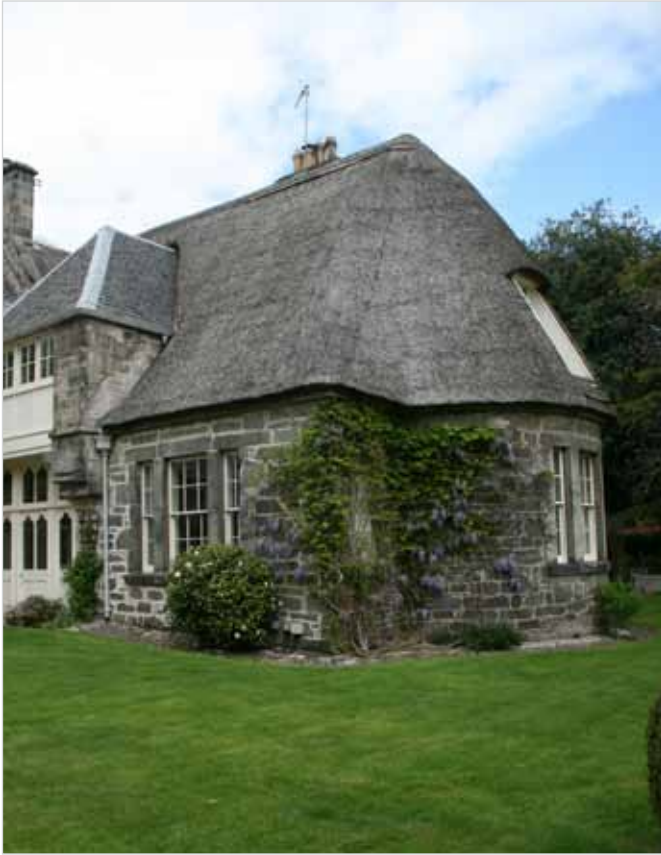
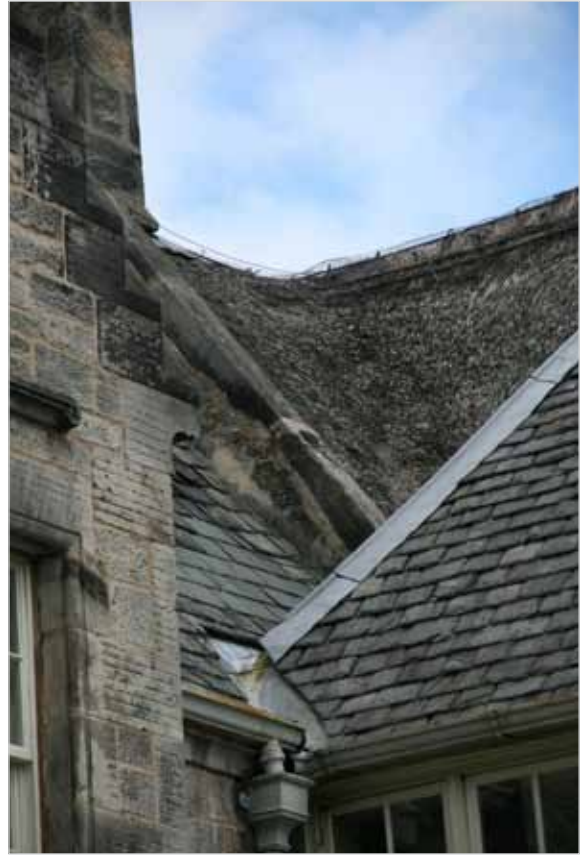
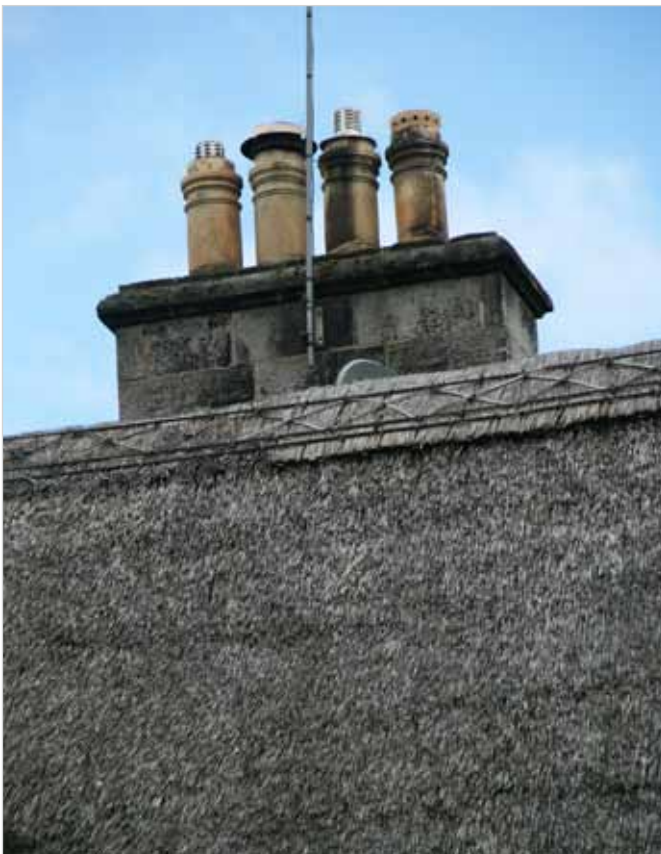
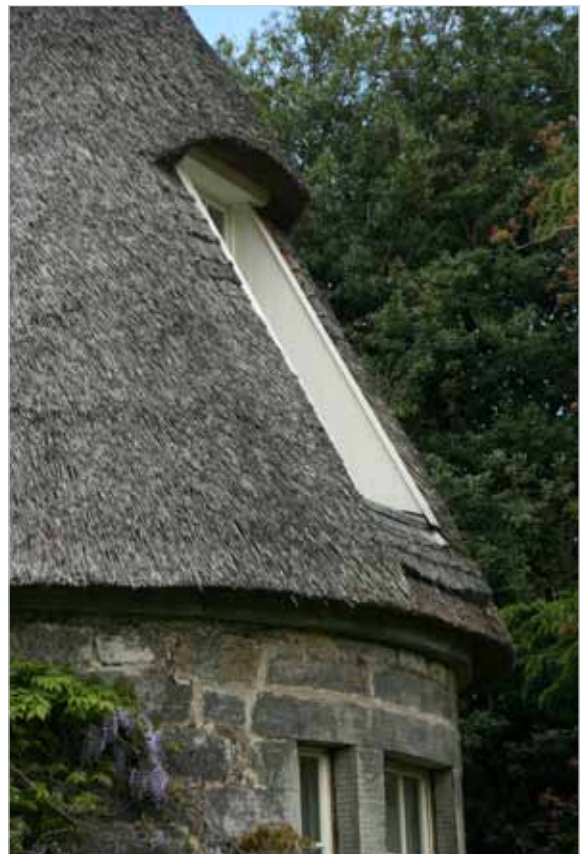
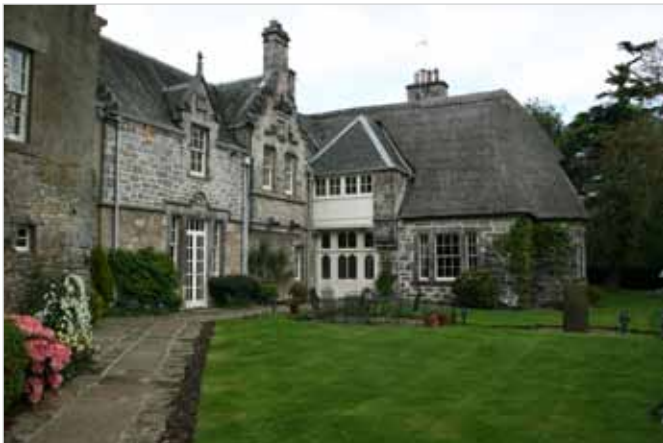
Barony House – Midlothian

Circa 1781 L-plan thatched extension to earlier 18th-century cottage. The wing, located at the east of the building, is currently thatched in reed and was last re-thatched approximately 12 years ago (around 2002). The thatch is netted in some places, and the thatched ridge, which is scobed with hazel spars and fixed with metal rods and wire horizontally, is entirely netted. The ridge has deteriorated slightly since it was last thatched, sagging away from the netting in places. To the south, the wing has a rounded hip with a central recessed dormer window just above the eaves, which has scobed detailing directly below the window and underneath the sculpted thatched hood at the dormer cheeks.

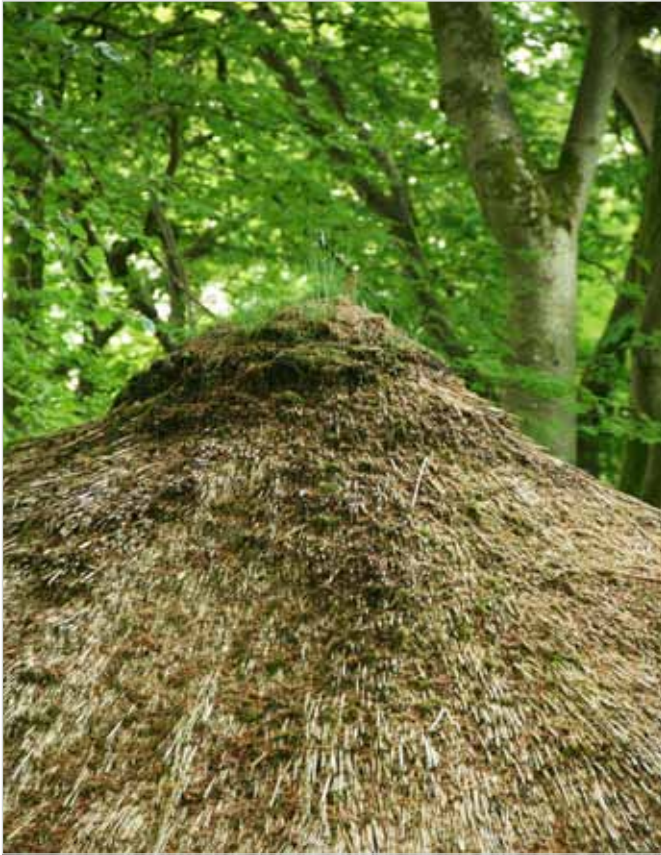
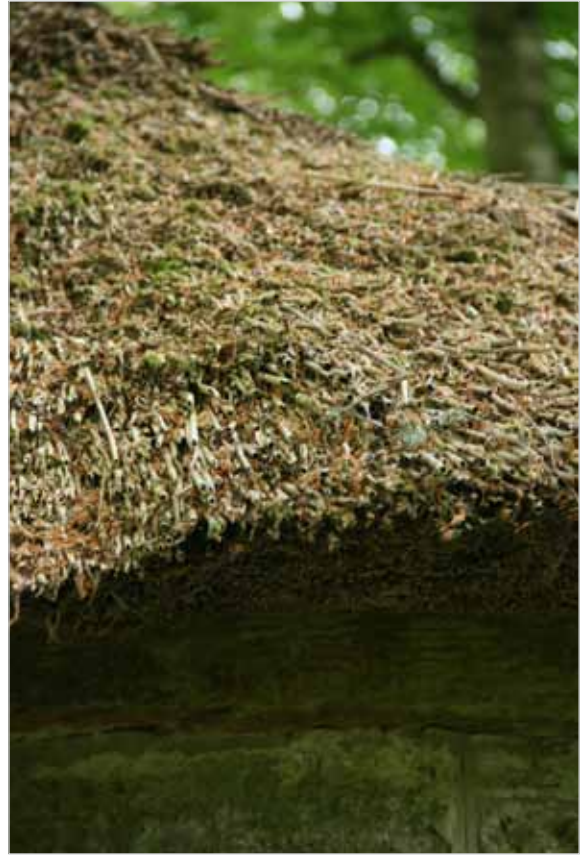
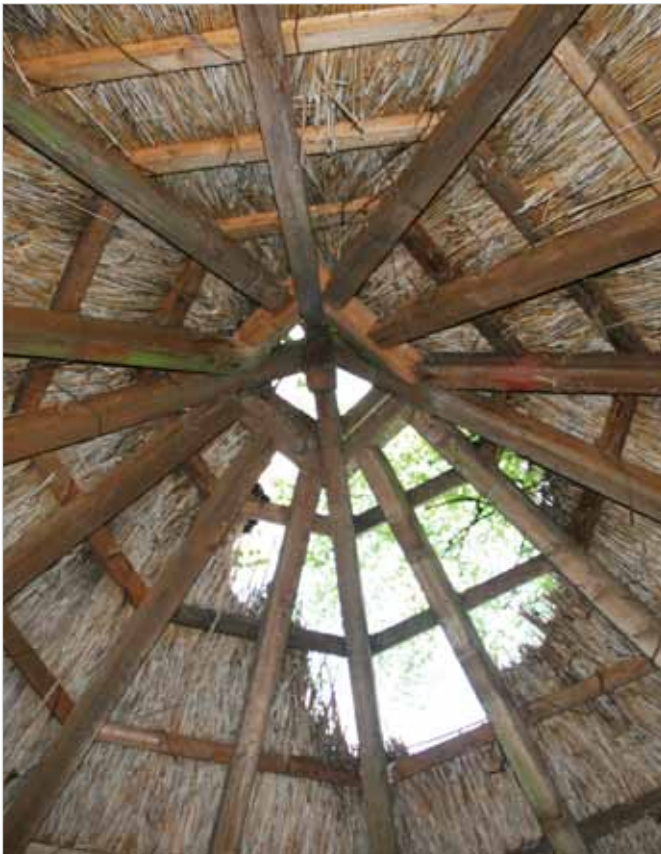
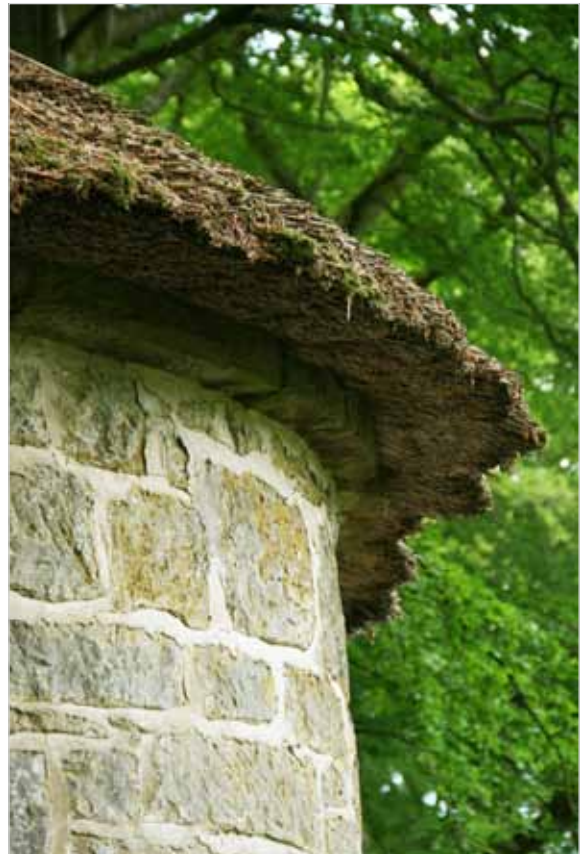
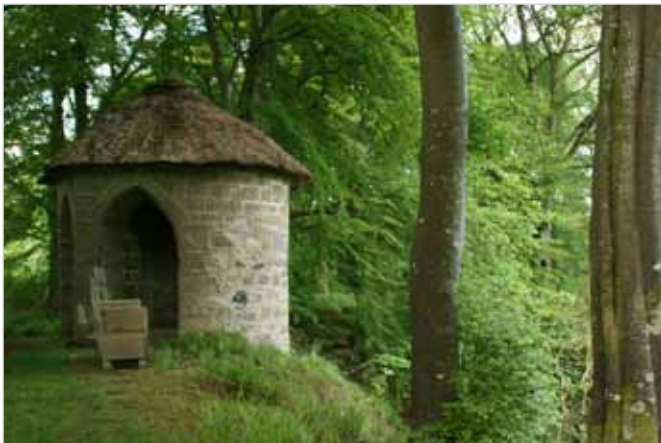
Rustick Hut – Midlothian

Late 18th-century circular ashlar stone structure with conical thatched roof. There are pointed arch openings and a pointed window that overlooks the North Esk river to the south. The roof appears fairly sound when viewed externally, however, upon entering the structure a large opening is visible in the thatch above, exposing the interior of the building to the elements. The remaining thatch is in a reasonable condition, with some mossy vegetation growing throughout across the surface of the thatch. The timber elements of the roof, and the building in general, are currently in a stable condition, but the roof is likely to deteriorate if it is not repaired

soon. Although listed as being an 'outbuilding', the structure currently has no apparent use. The thatch is not netted.

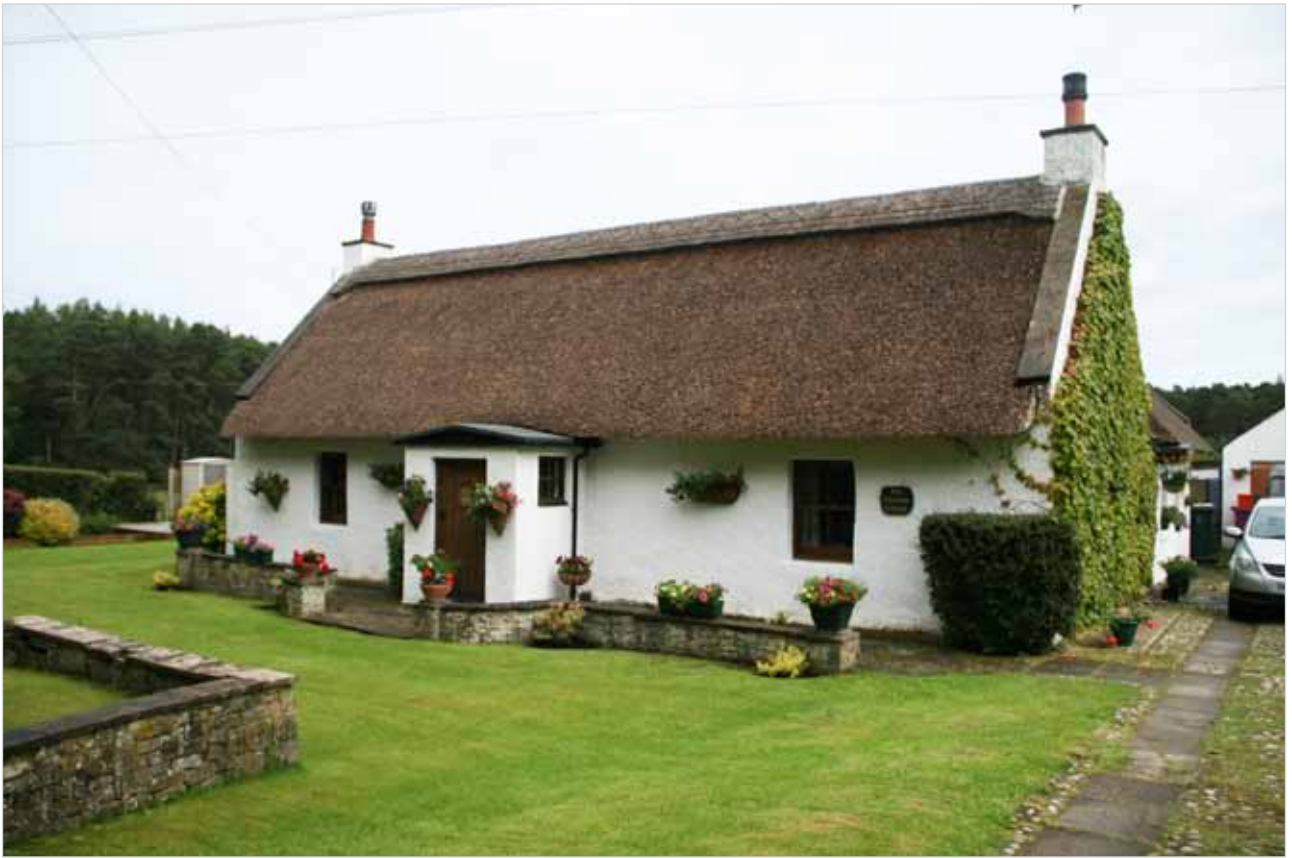
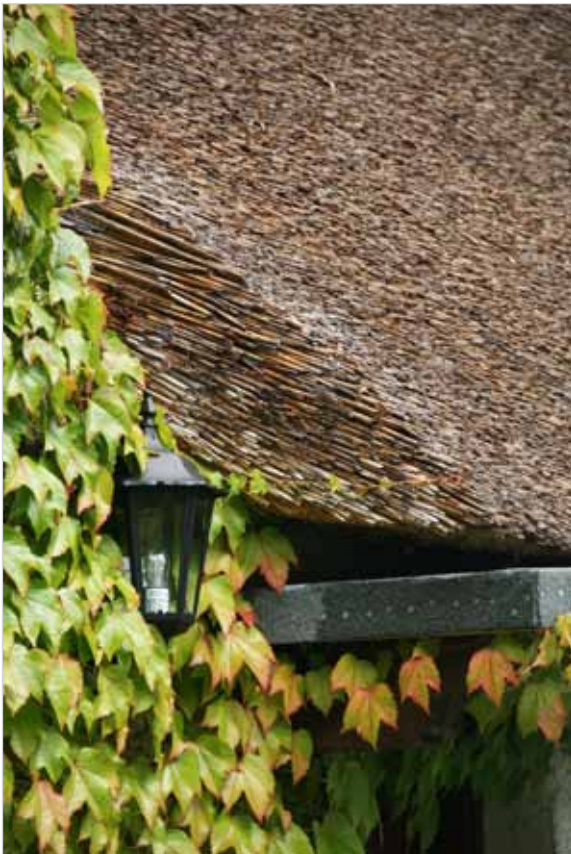
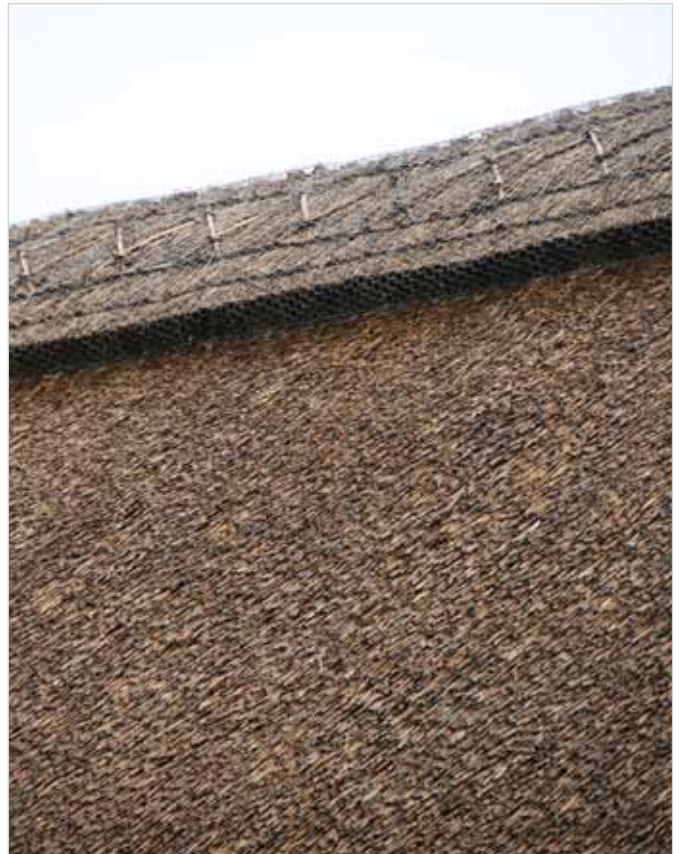
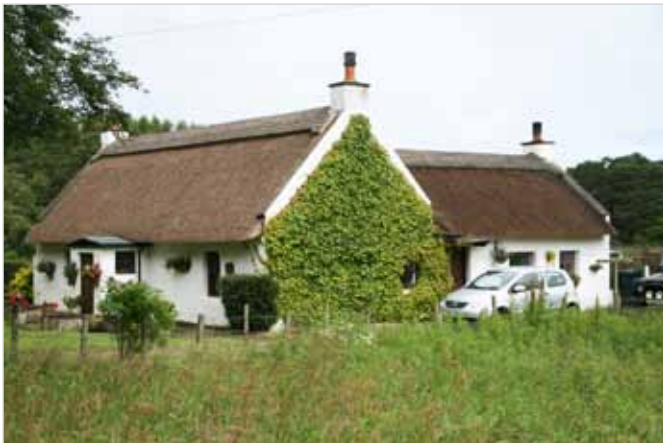
Loch Na Bo Croft – Moray

Additional Notes: Listed building description reads 'Early/mid 19th century. Single storey 3-bay cottage with wing to rear forming L plan', with the listed building description notes stating it was thatched by 'John Brockie circa 1970'. According to the owners the building was last re-thatched two years ago (2012) in reed by a thatcher from Castle Douglas. The raised thatched ridge is scobed with hazel spars and is also netted, whilst the rest of the thatch is uncovered. The building has concrete skew copes that partially overlap onto the thatch. The thatch overhangs deeply at the eaves and is sculpted slightly to allow room for the roof of the entrance porch.

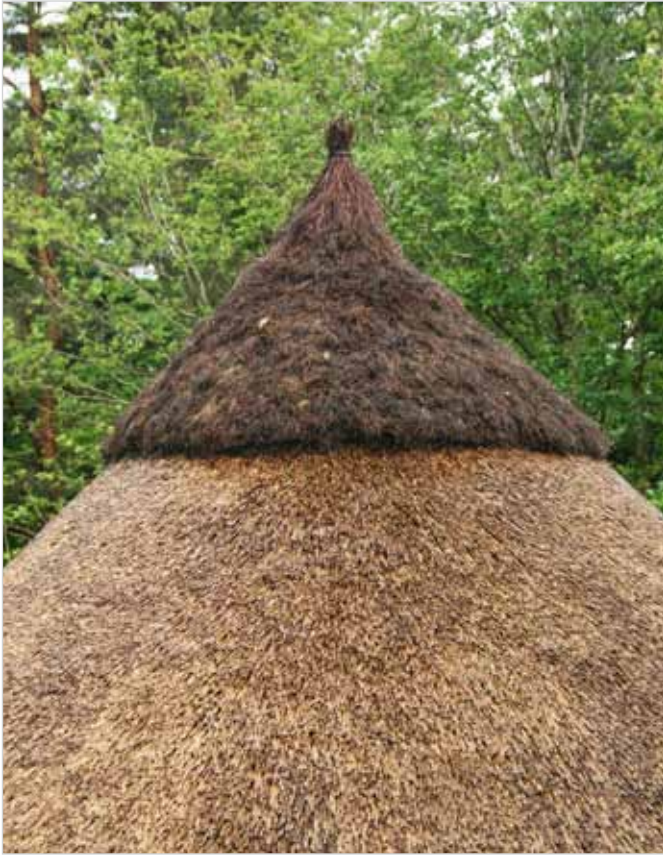
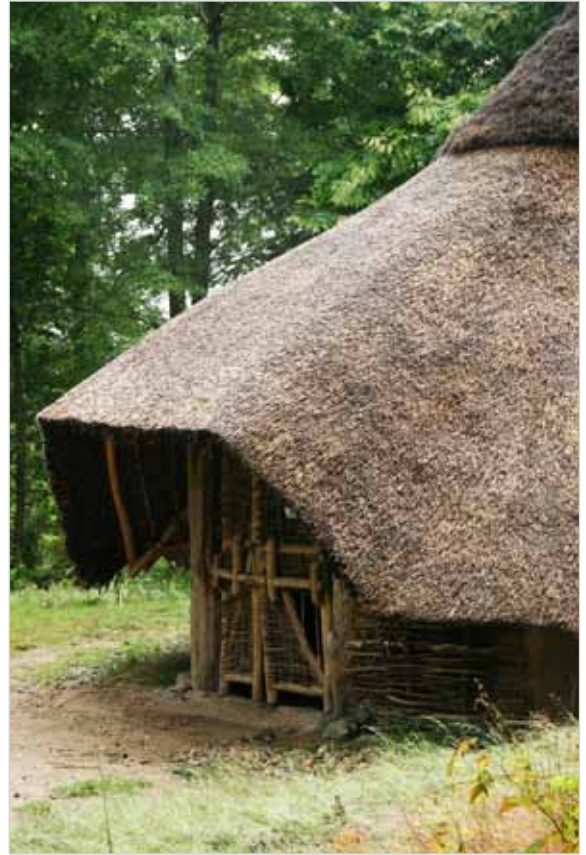
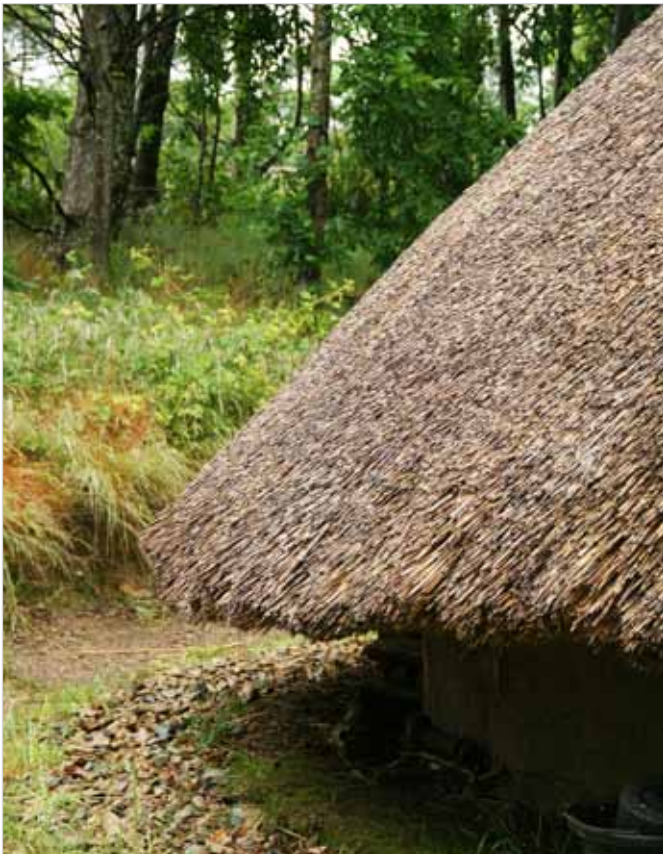
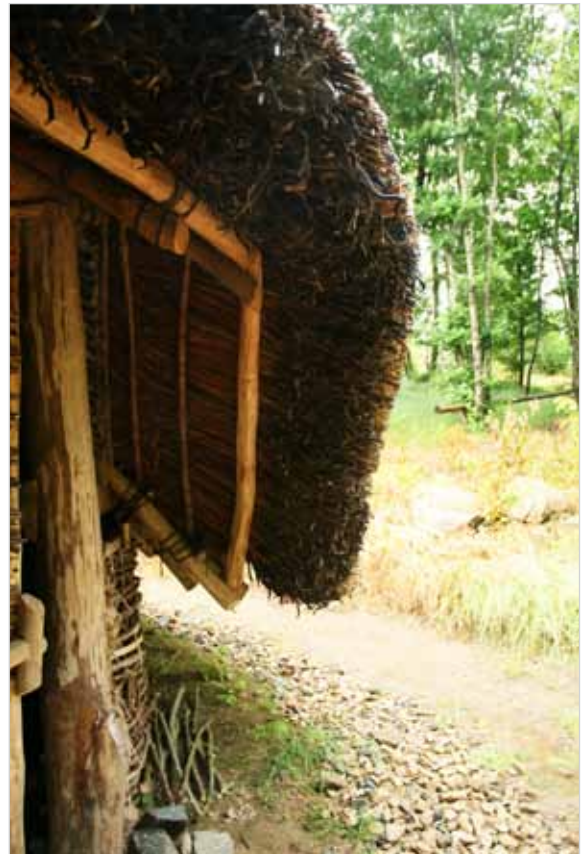
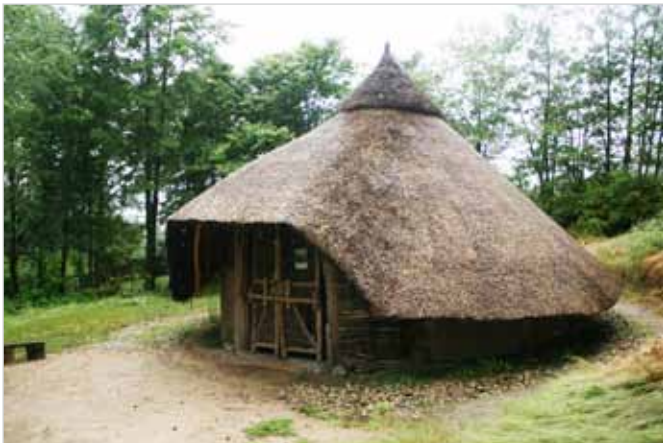
Bronze Age Replica Roundhouse – North Ayrshire

Additional Notes: Replica Bronze Age roundhouse built in the grounds of Brodick Castle in 2012, thatched by Jeremy Cox. The structure is used for educational purposes and is currently open once a week for visitors to learn about ancient crafts and Bronze Age life. The conical roof is thatched in bracken as a base layer, and then in reed on top. The apex of the roof has a further layer of heather thatch and is tied at the top with thin bracken. The eaves of the roof have a deep overhang and the thatch roof is curved and heightened around the entrance opening. Visible from underneath the eaves, the thatch is laid onto horizontal wooden beams that are in turn tied

to the primary roof beams. The thatch is then tied to the roof structure using what appears to be natural ropes or bracken.

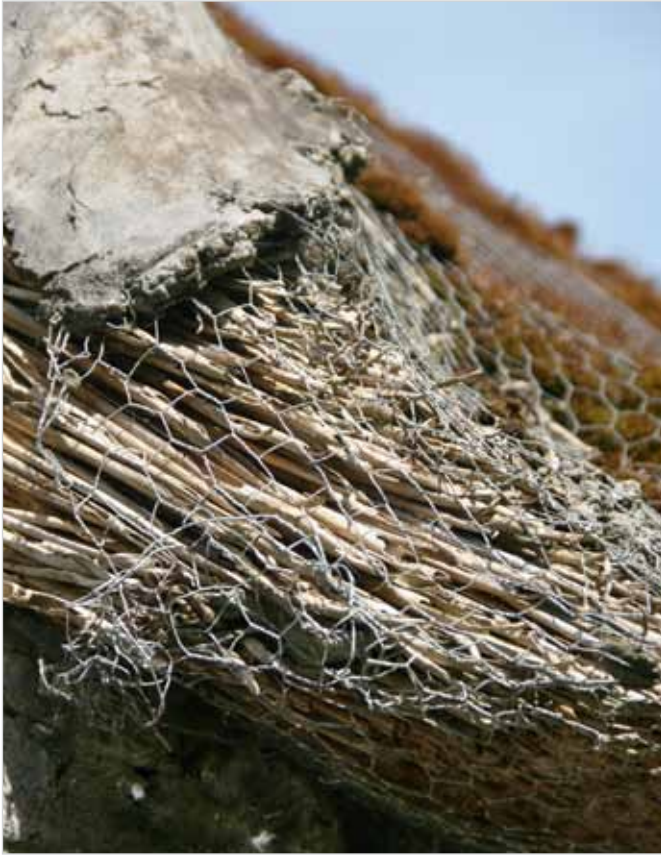
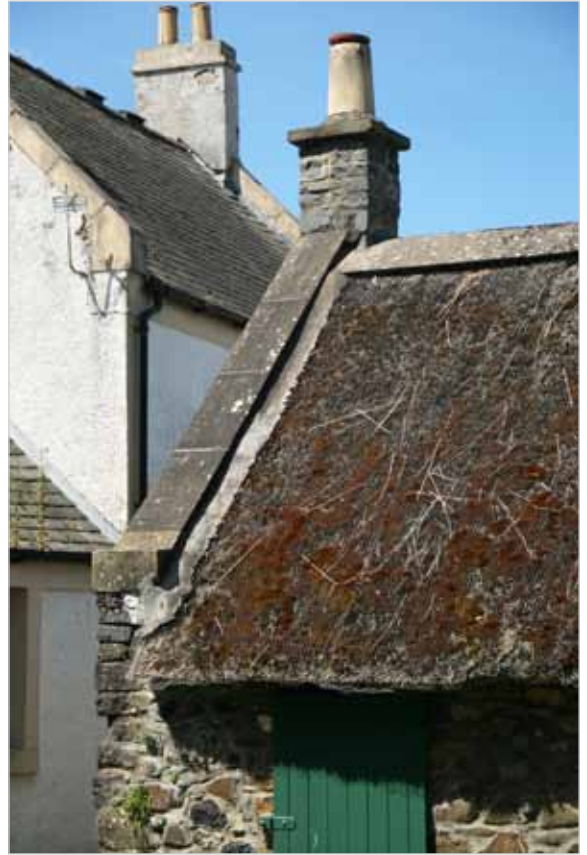
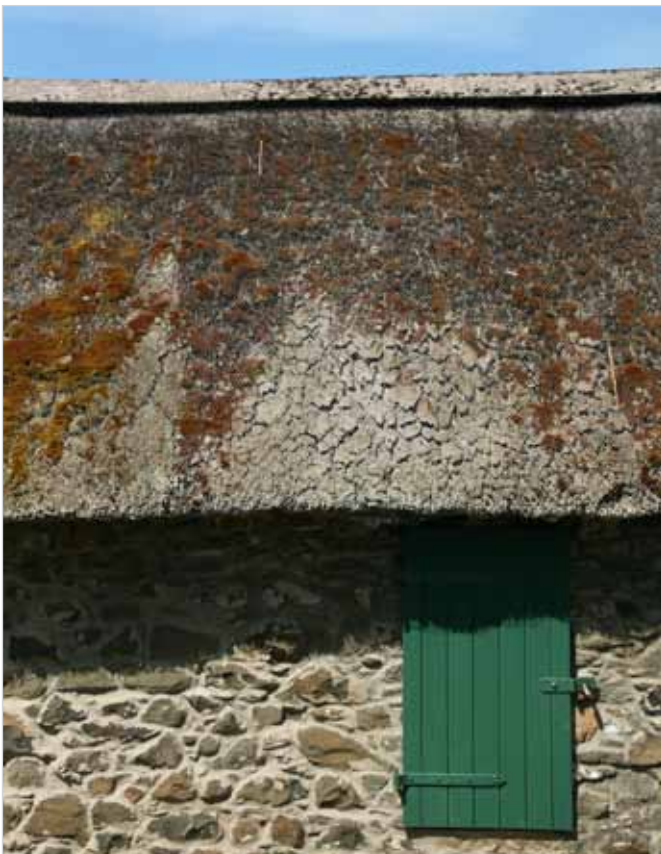
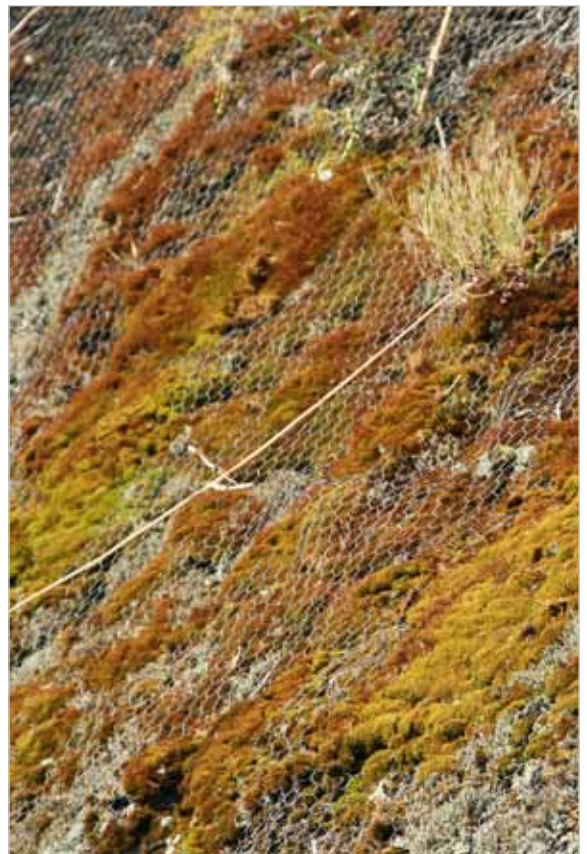
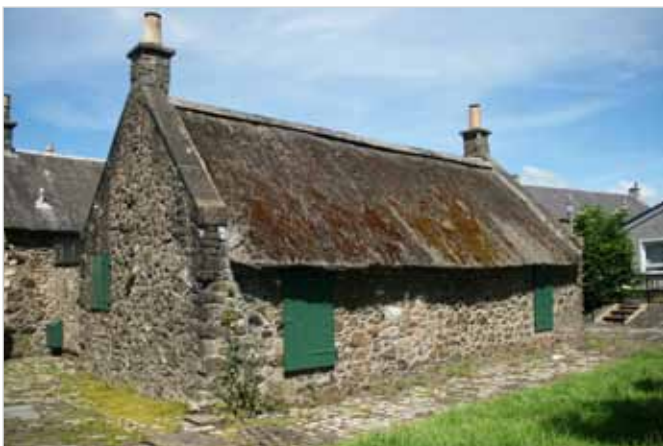
The Heckling Shop – North Ayrshire

Condition of Thatch: Poor

Additional Notes: Single-storey cottage currently owned by the local authority and let out commercially. The current tenant stated the building is used for storage, however they have been advised that the building will be returned to its former use as a museum/educational centre at some point in the near future. The building was last used as a museum in 2010. The thatch is fairly decayed in places and there is a large amount of vegetation growth throughout. There is also a large amount of loose reed, particularly on the west pitch of the roof. There are cement fillets between the thatch and the skewers. The thatch is netted all over and held in place with metal pegs.

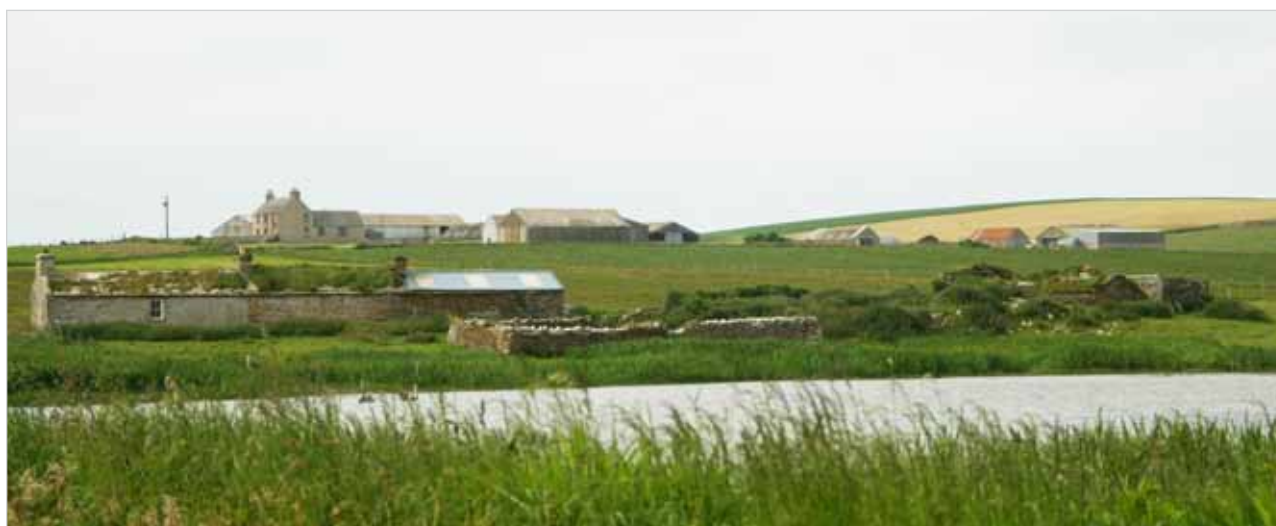
Additional Notes: 19th-century long low crofting range, comprising two cottages and a barn/byre to the west. The 'left cottage' in this group listing is listed as having a turf thatch roof, whilst the right cottage and barn/byre buildings are both listed as having 'remains of stone flags' to their roofs. It is unclear exactly which is the group of buildings in the listing, as the list entry describes a group of structures that are to the north-west (Grid Reference HY 24792 17725) of those shown in the Buildings at Risk (BAR) entry for the property (Grid Reference HY 24840 17709). The buildings to the north-west are roofless ruins, whilst those to the south-east (BAR reference number 2835) still have their roofs, though they are in 'poor condition'. The exact buildings should be confirmed and the listing description updated accordingly.

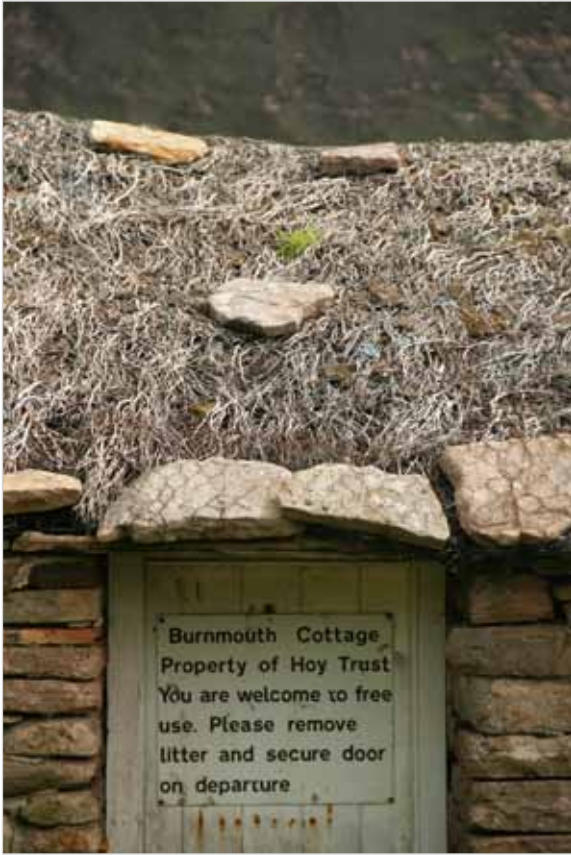
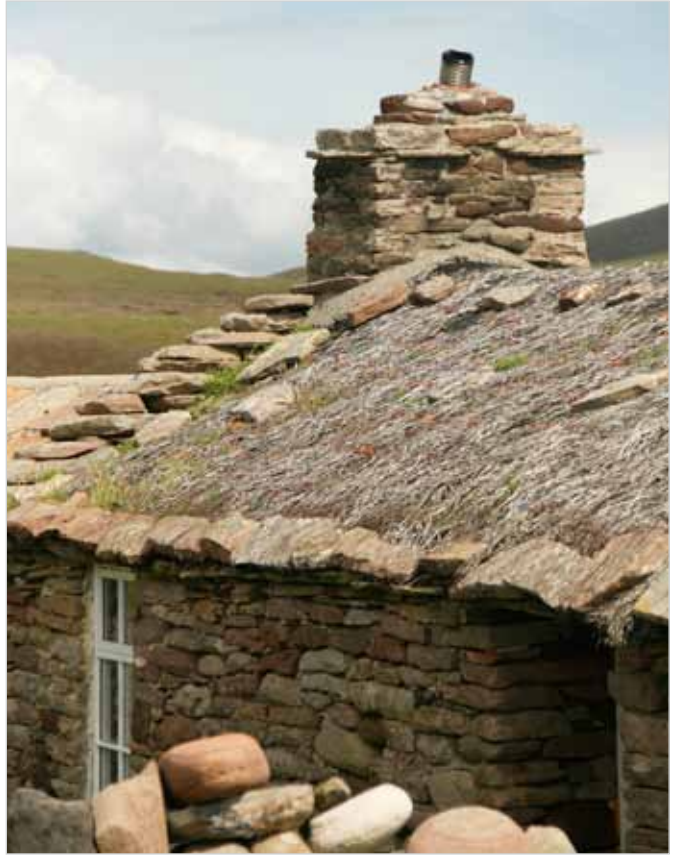
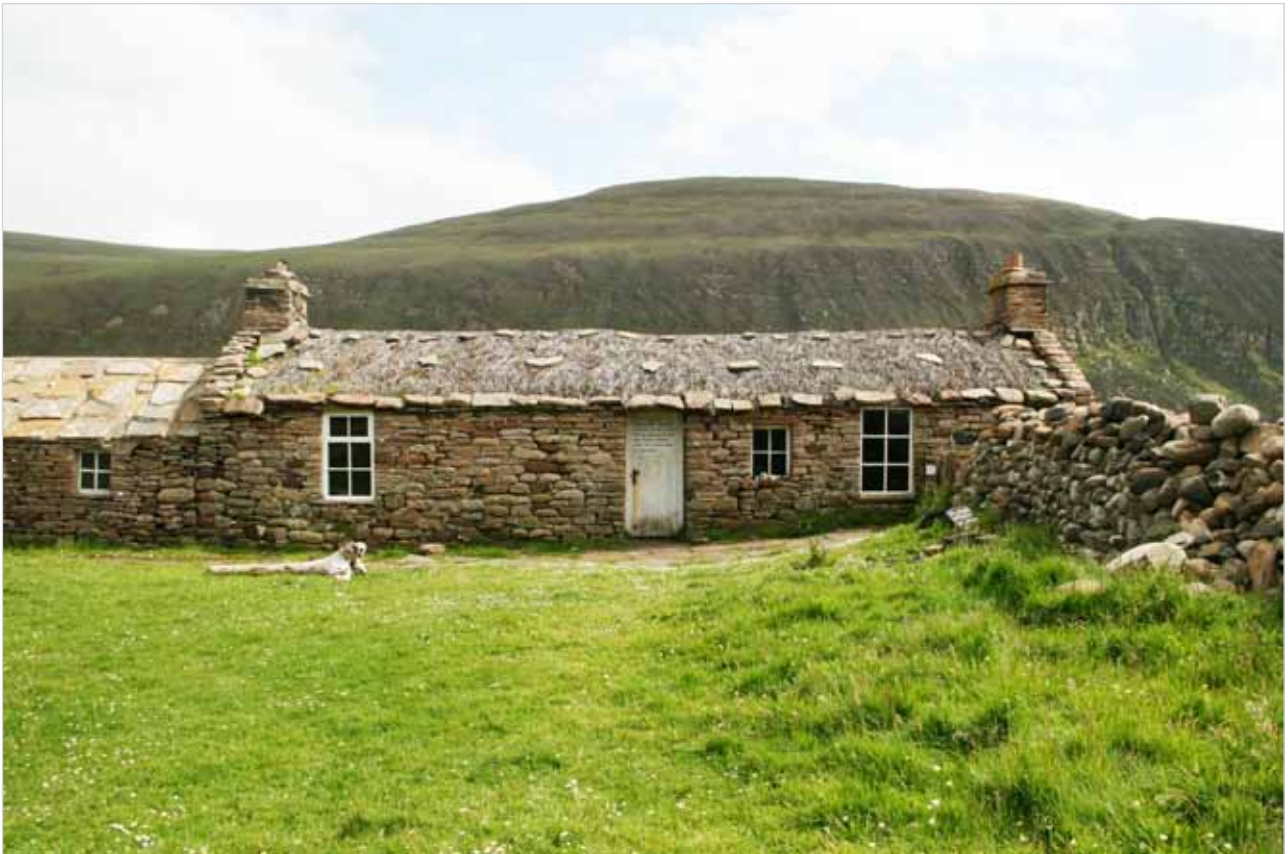
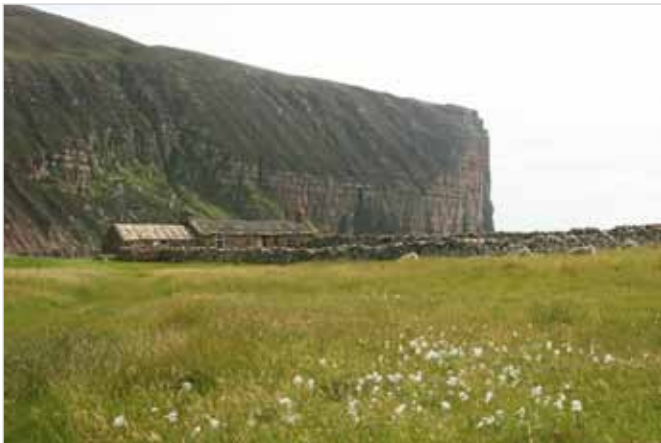
Burnmouth Hostel – Orkney Islands

Thatch Type: Heather
 Ridge Type: Thatched (Heather)
 Condition of Thatch: Good

Additional Notes: Early 19th-century single-storey bothy with adjoining lower protection to north east gable. The bothy has a heather-thatched roof, with a continuous heather ridge. The thatch is netted and weighted with stones along the ridge, in a row along the centre of the thatch and secured to the eaves. There is a small amount of mossy vegetation growth across the surface of the thatch. Both the main building and the NE projection, which has a flagstone roof, are open publicly as a bothy. The notes of the listing description reads '*this long low building displays two important and traditional roof types peculiar to Orkney. The main block is heather thatched; the roof of the lower projection comprises large flagstone overlaying a timber frame. Reinstated by the Hoy Trust as a bothy for visitors.*'
