A Survey of Thatched Buildings in Scotland

Thatch Survey of Scotland
2014-15

A photographic survey of thatched buildings in Scotland, surveyed between May 2014 and August 2015 by Zoe Herbert (SPAB Scotland Officer), on behalf of the Society for the Protection of Ancient Buildings.

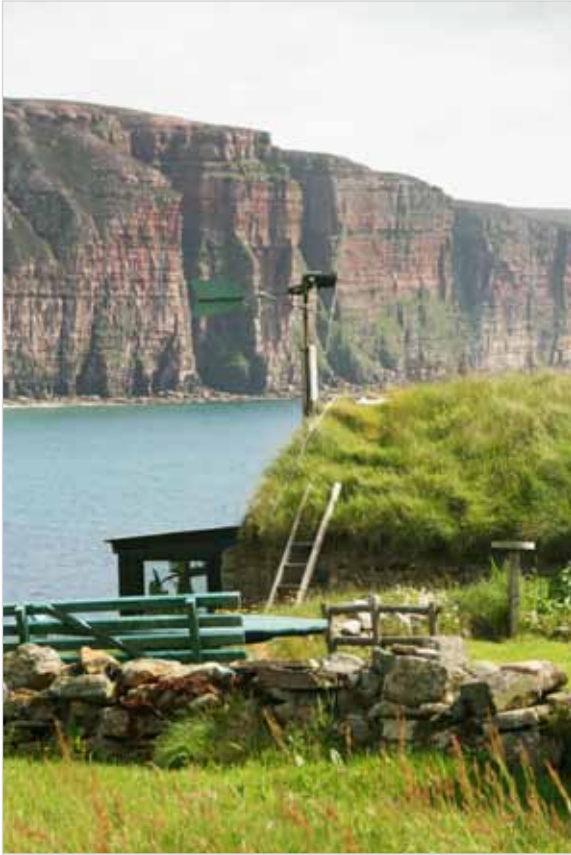
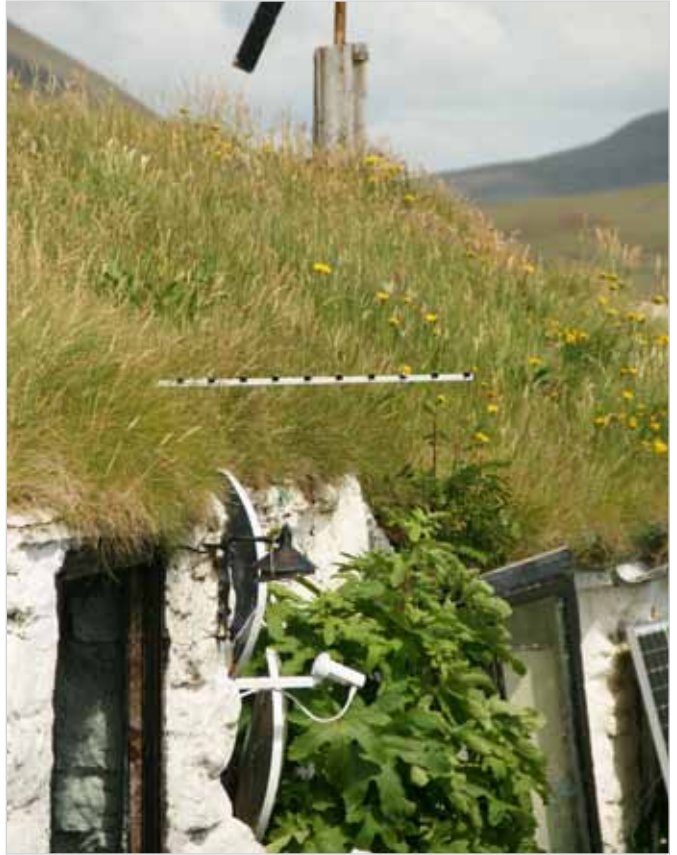
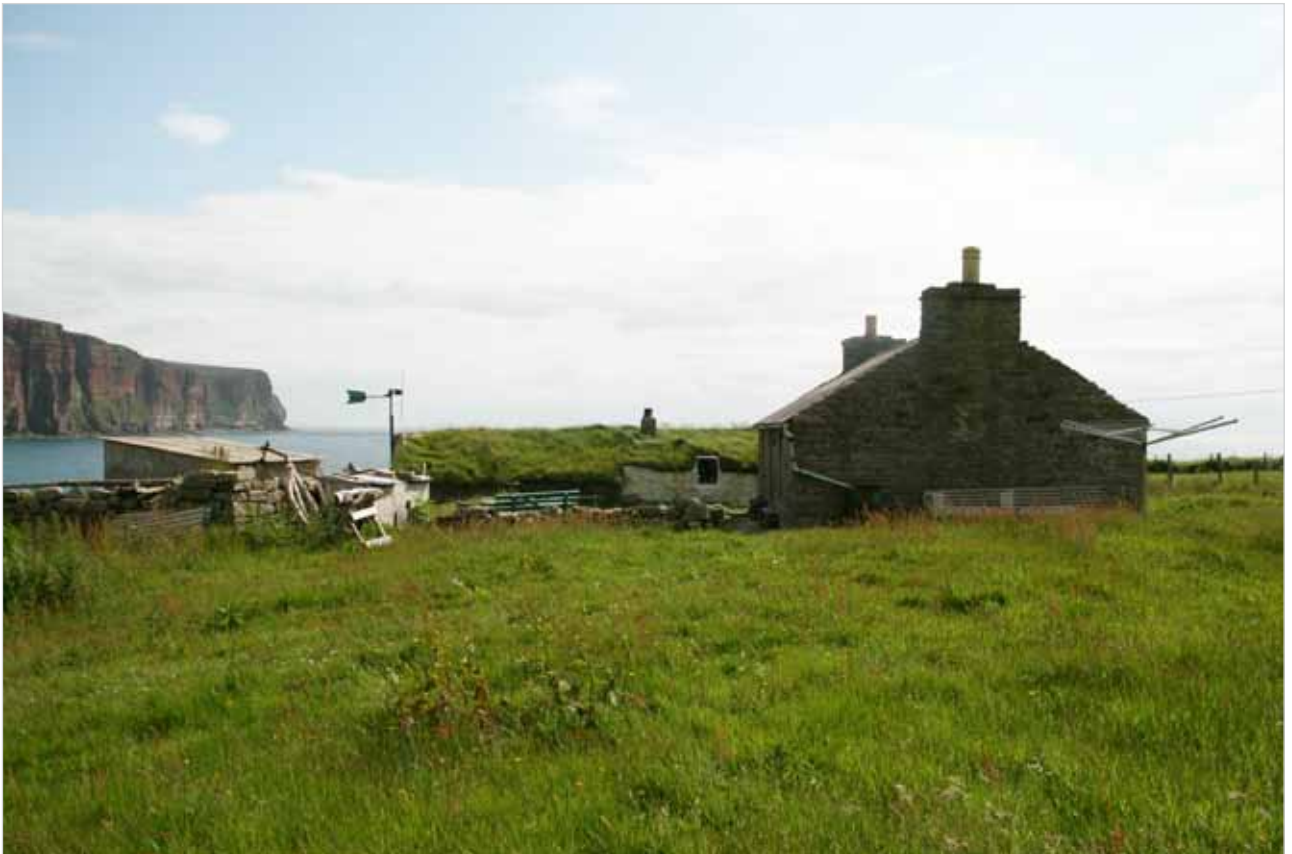
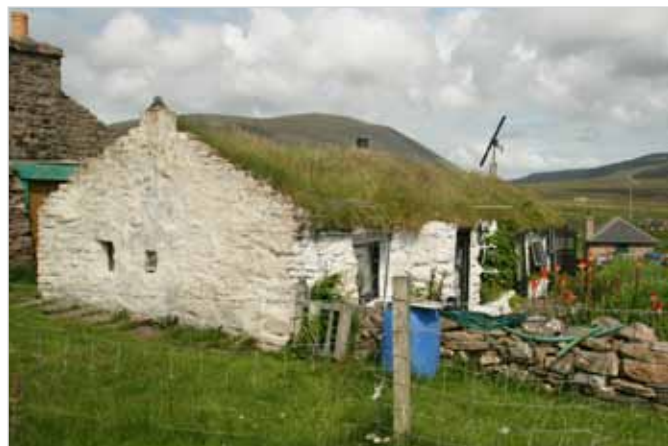
Muckle House – Orkney Islands

Condition of Thatch: Good

Additional Notes: Late 19th-century single-storey cottage with a turf-thatched roof and a central ridge chimney stack. The turf thatch is flourishing and has a number of different grasses and flowers growing in it. Turf is a traditional roofing technique in Orkney and this is one of only a few examples left on the islands.

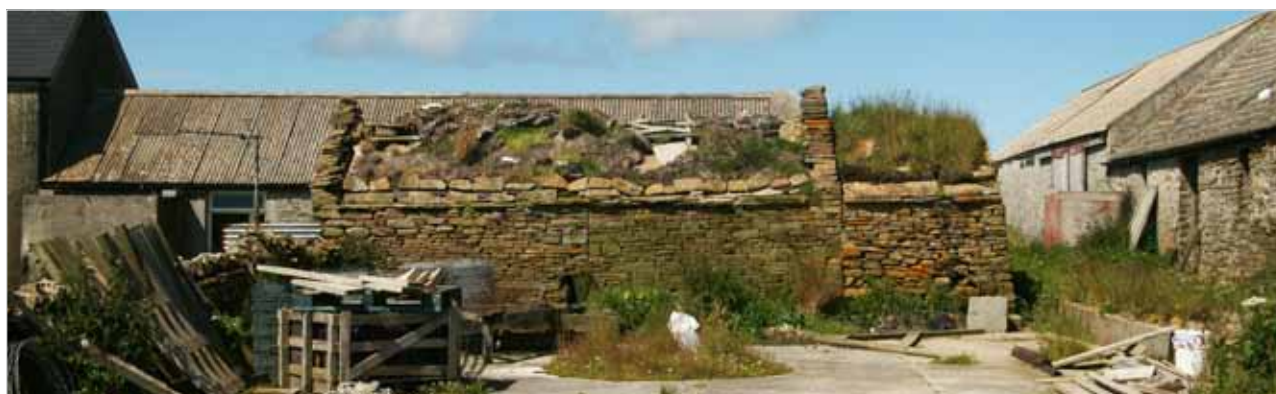
Address: Boloquoy Farm

Additional Notes: Early to mid 19th-century farm complex, listed as a group. The farm cottages to the east of the main farmhouse, the detached byre to the east and the parallel byre to the west are all listed as having thatched roofs (some with turf and some with straw). The only visible evidence of any thatch at the site is on the 'parallel byre' (pictured below). It is described in the listing description as having a 'turf thatched roof to left, straw thatch to right, secured at eaves with bendlin stanes'. In fact, the roof to the west is thatched in straw, and that to the east is thatched in turf. Both roofs of this building are in a poor condition and there are many holes in the thatch exposing the interior of the building, as well as a large amount of vegetation growth throughout. There is visible evidence of netting as well as small stone slabs used along the eaves to secure the netting. You can also see some of the flagstone slabs that were placed underneath the thatch, a tradition on Orkney. The listing description for this building should be updated accordingly.

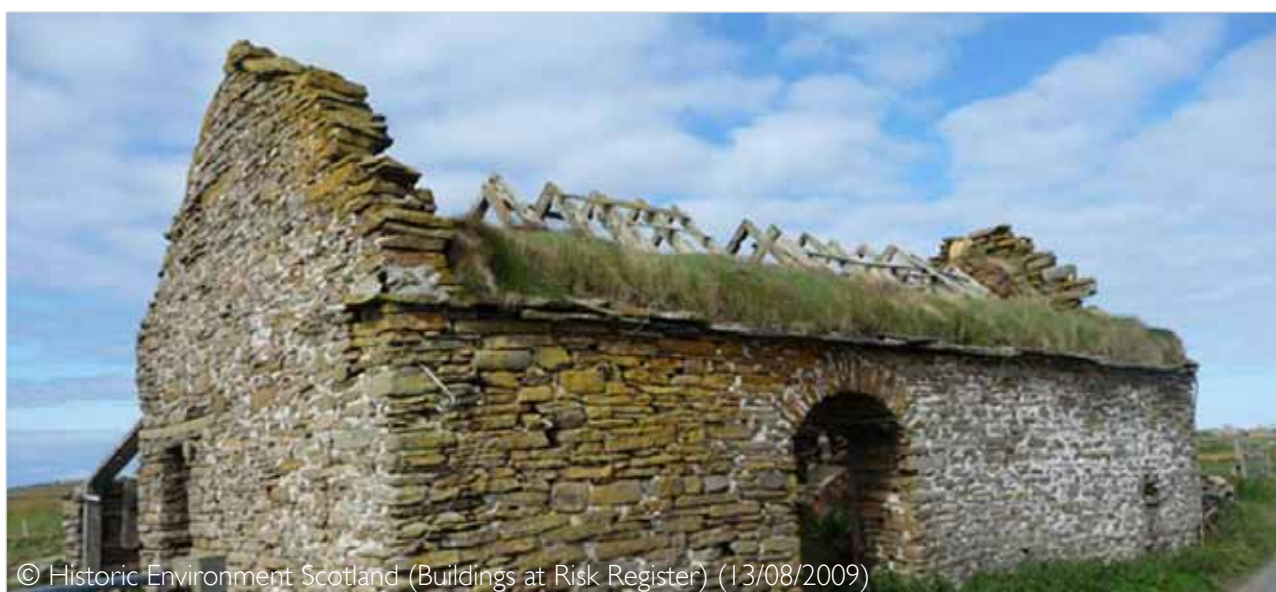
Additional Notes: Early 19th-century watermill, listed in 1999 as having '*remnants of flagstone and turf-thatched roof*'. It was placed on the Buildings at Risk (BAR) Register in 2009 (BAR reference number 4131), at which time it was noted by BAR to be in a ruinous condition. In 2011, the status of the building on the BAR register was changed to '*Restoration in Progress*'. A phone call was made in July 2015 to the planning department in Orkney Islands Council, where it was reported that the building had been restored and confirmed the building was no longer thatched. It was stated that the watermill now has a flagstone roof, also a traditional roofing technique in Orkney. No site visit was made. The listing description for the building should be updated accordingly.

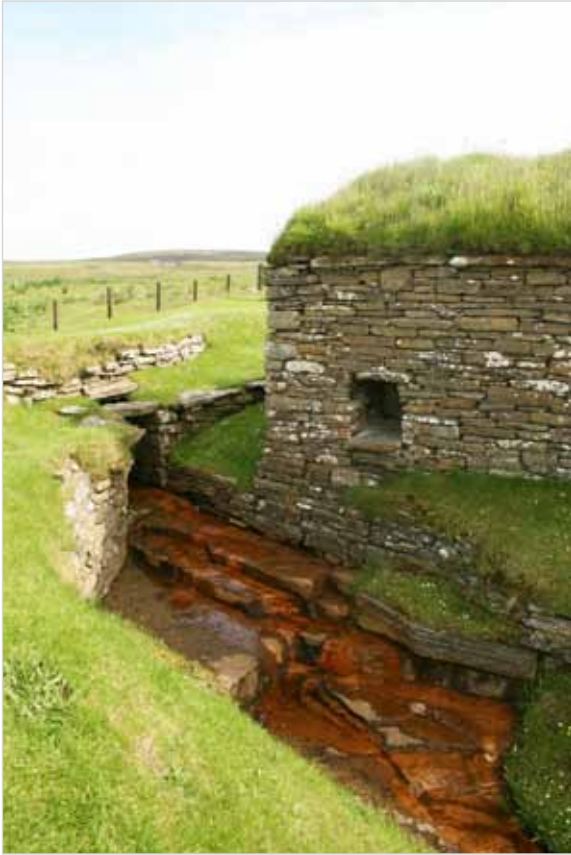
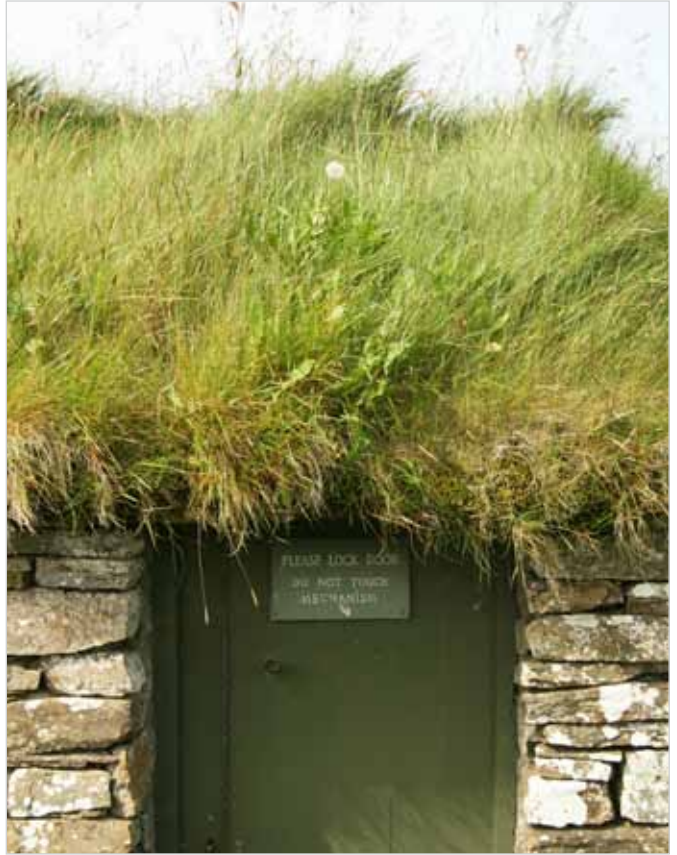
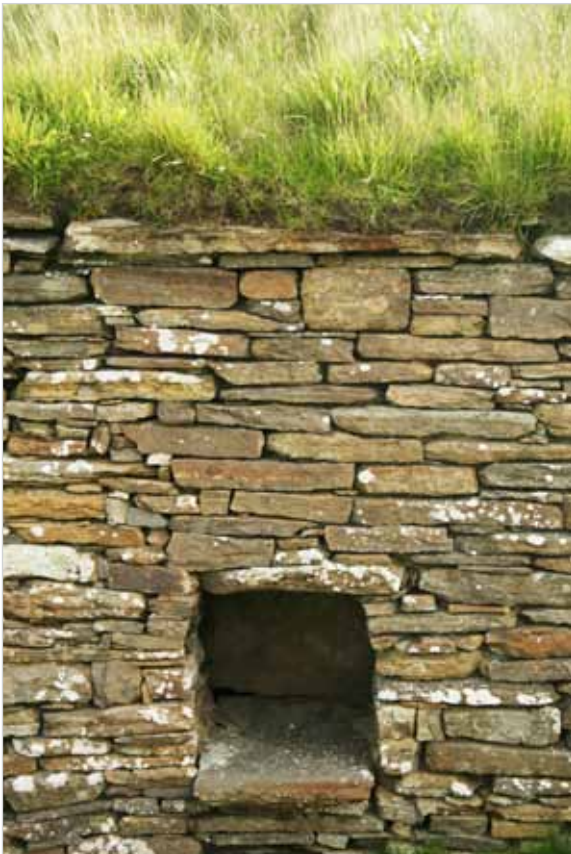
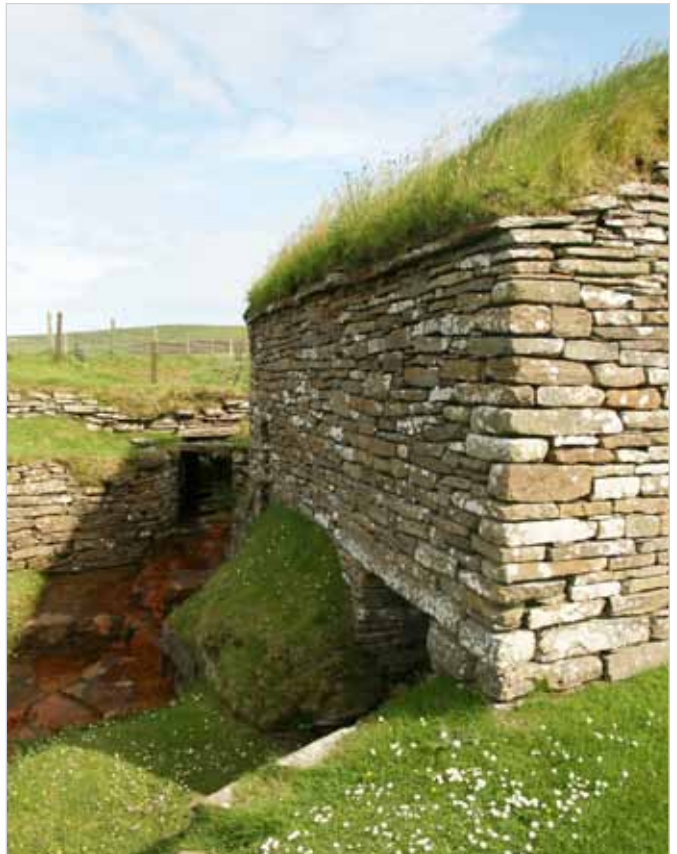
The Click Mill – Orkney Islands

Thatch Type: Turf
 Ridge Type: Thatched (Turf)
 Condition of Thatch: Good

Additional Notes: Circa 1825 small oblong mill; according to the listing notes it is the 'last surviving working example in Orkney of a primitive type of mill more numerous represented in Shetland and Faroes'. The building has a flagstone roof covered with turf, a traditional roofing technique in Orkney, which is thatched continuously across the ridge. The thatch has been left uncovered. The mill, which is in working condition, is open to the public and is in the guardianship of Historic Environment Scotland.

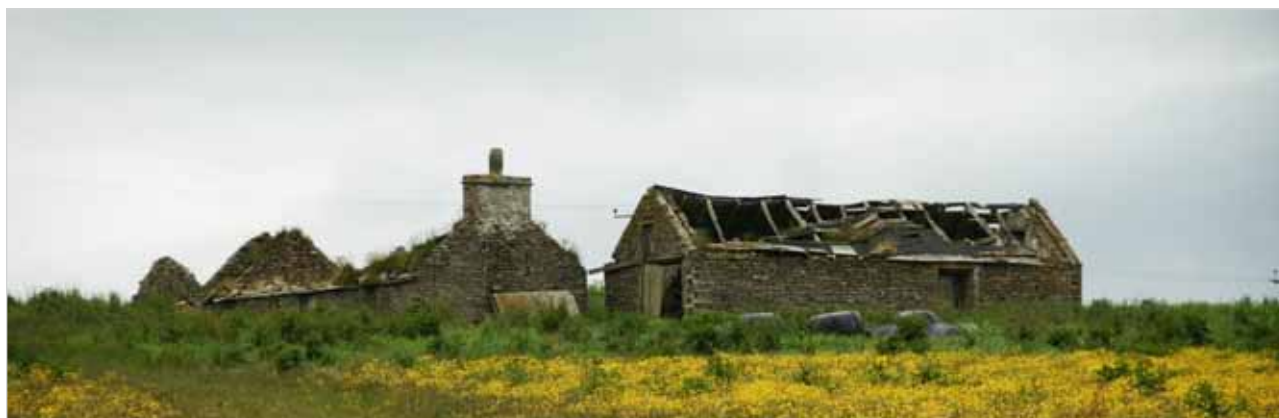
Address: Scarpigar Farm Buildings

Additional Notes: The longhouse range, bothy and barn/byre range, which form part of this group listing of mid 19th-century farm buildings, are listed as having a mixture of turf and straw-thatched roofs, some also with flagstones. The longhouse range, seen in the foreground of the image below (behind the black barn), has a flagstone roof to the south (left) and the remains of a thatched roof to the north (right). The condition of the thatch is uncertain due to the large amount of vegetation growth, however, the building appears to be derelict and there are large openings in the roof exposing the interior of the building. There is visible evidence of netting still intact. Whilst only part of the byre range could be seen upon visiting, which was roofless, the Buildings at Risk (BAR) Register would confirm that the building is a roofless ruin and that no thatch remains. The longhouse range has been on the BAR Register since 2009 (BAR reference number 4149), as has the barn/byre range (BAR reference number 4150). The bothy now has a flagstone roof.

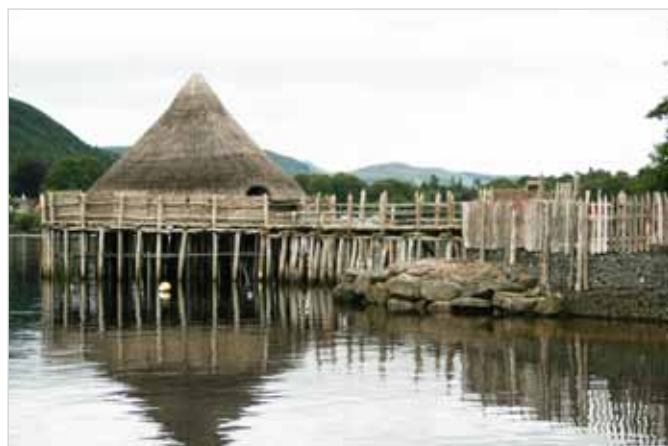
The Scottish Crannog Centre – Perth & Kinross

Condition of Thatch: Good

which is a replica of a crannog and uses traditional construction techniques and materials, has been left uncovered. Above the door openings to the south, the thatch has been sculpted along the eaves to allow entry.

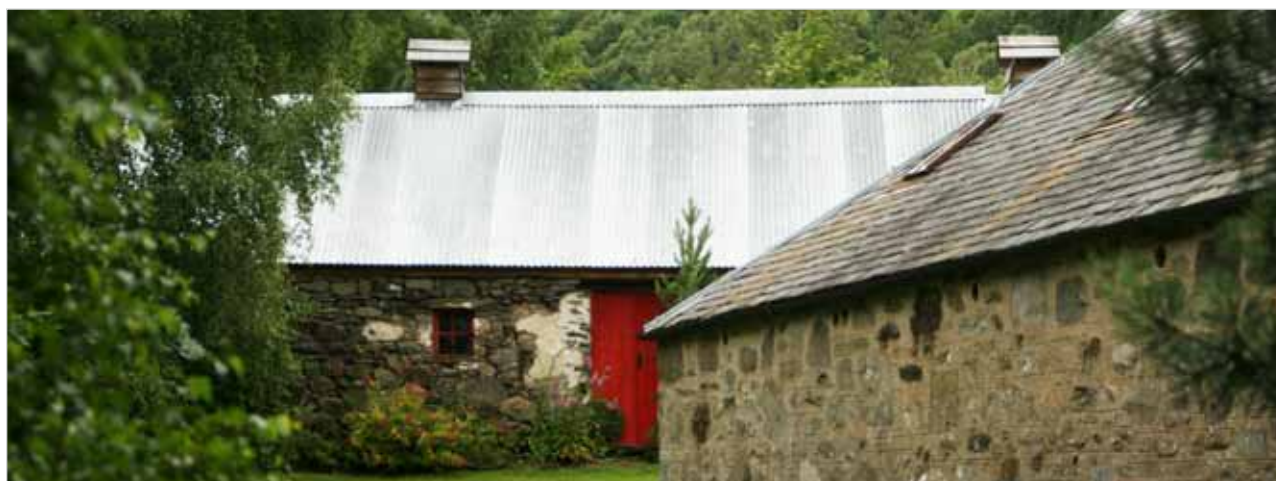
Additional Notes: Mid 18th-century or earlier longhouse, which was restored in 1992 and in 1997. According to the listing description, the thatch was reinstated in 1992 by Duncan Matheson, who installed a roof of 'rye straw and heather divots'. The listing notes also state that the thatch was renewed in 1997. During the renovation work in the 1990s, corrugated iron had been removed from the roof and the thatch was reinstated; however, corrugated iron has been installed again on the roof, presumably covering the thatch underneath. Internal access could not be gained upon visiting and therefore the condition of the thatch could not be determined. Further investigation into the status of the thatch should be undertaken. The grid reference held by Historic Environment Scotland in the listing record and on Canmore (NN 81688 49248) needs to be corrected, as they both identify the adjacent farm buildings to the south.

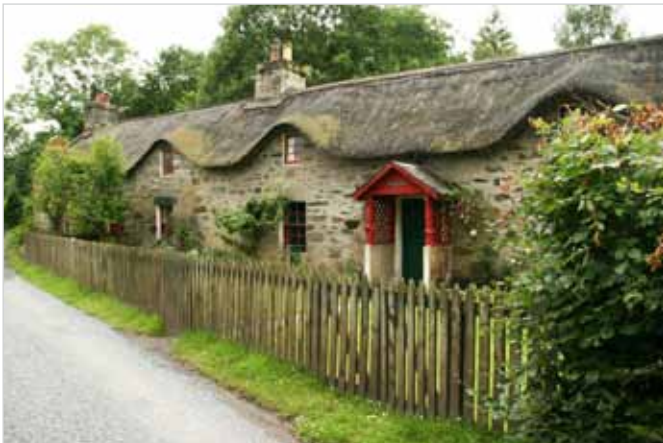
Crachan Cottages – Perth & Kinross

Condition of Thatch: Fair

Additional Notes: Circa 1835 single-storey with attic row of cottages, altered after a fire circa 1990. The cottages are listed as having 'thatched roof with striking thatched eyelid dormerheads over attic windows'. The reed-thatched roof, which is entirely netted, has a concrete ridge that extends below each of the chimney stacks at both the gable ends and along the ridge. There is an amount of mossy vegetation growth across the surface of the thatch, which is particularly dense across the dormerheads and along the eaves, and there are loose pieces of thatch throughout that have been held to the roof by the netting.

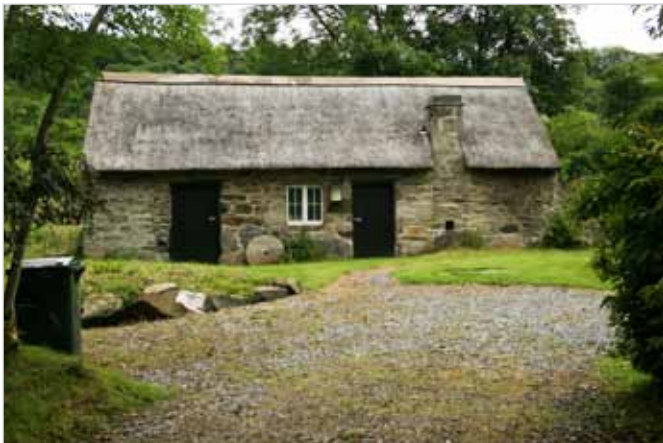
Former Smithy – Perth & Kinross

Condition of Thatch: Good

Access to the building could not be gained upon visiting; however, the front elevation of the building could be seen from the road. The rectangular former smithy has a chimney stack to the front elevation of the building. The thatch, which appears to be reed, has been entirely netted and appears to have been boxed in at the skewers with timber.

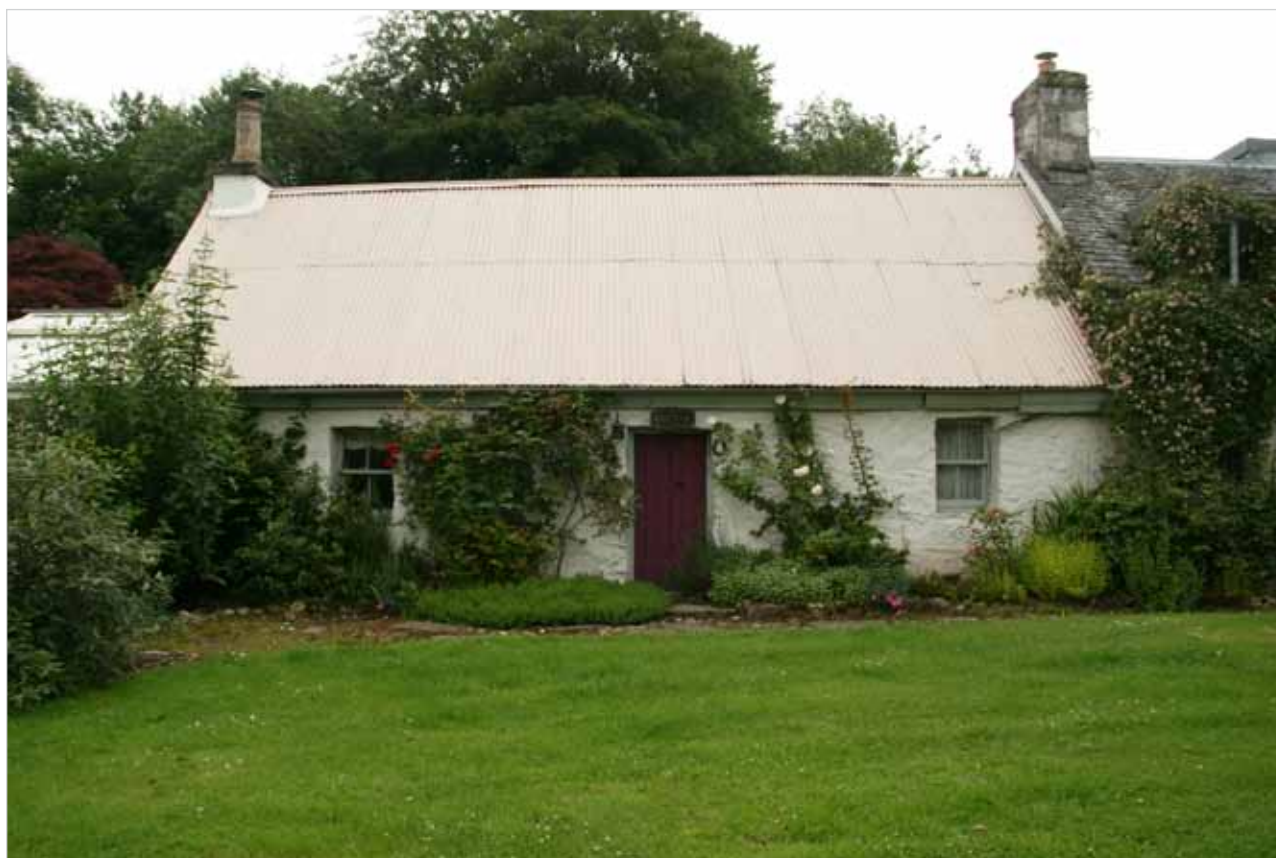
Additional Notes: Probably 18th-century cottage, listed as having a '*remarkably intact*' thatched roof under-
neath the corrugated iron covering. Internal access could not be gained and therefore the status and condition
of the thatch could not be confirmed. Further research into this building is required.

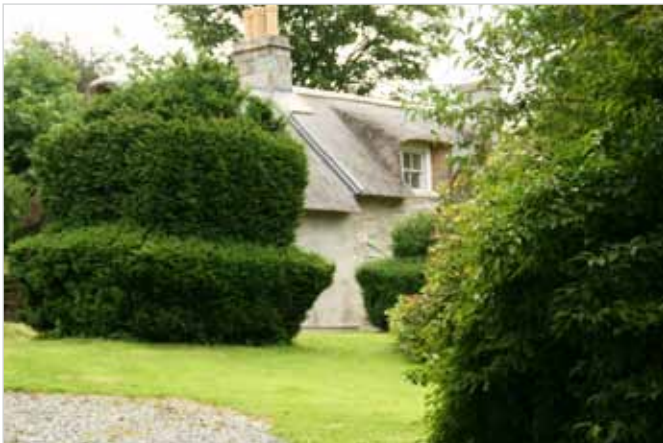
Smithy Cottage – Perth & Kinross

Condition of Thatch: Good

when viewing the building using web-based street view. It can therefore be assumed that the current thatched roof is a relatively modern installation, which its condition would confirm.

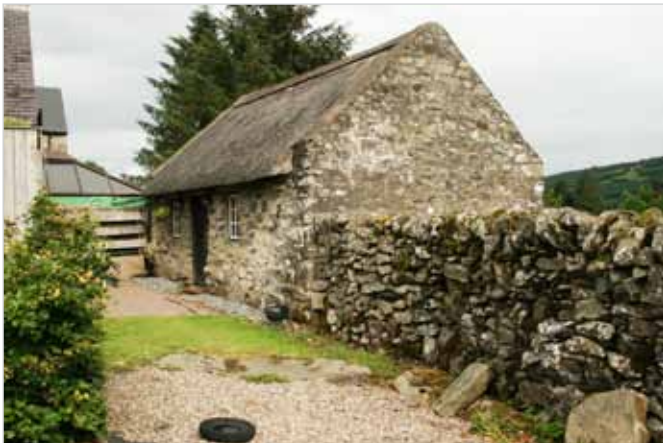
The Bothy – Perth & Kinross

Condition of Thatch: Good

Additional Notes: Part of a group listing of 18th-century cottage, barn and bothy. The bothy is listed as being 'converted to dwelling circa 2000' and having a 'replacement thatch with concrete ridge and skewes'. The thatch, which appears to be straw, has been entirely netted, right up to the ridge, skewes and eaves. There is an amount of mossy vegetation growth on the surface of the thatch, as well as along the concrete ridge.

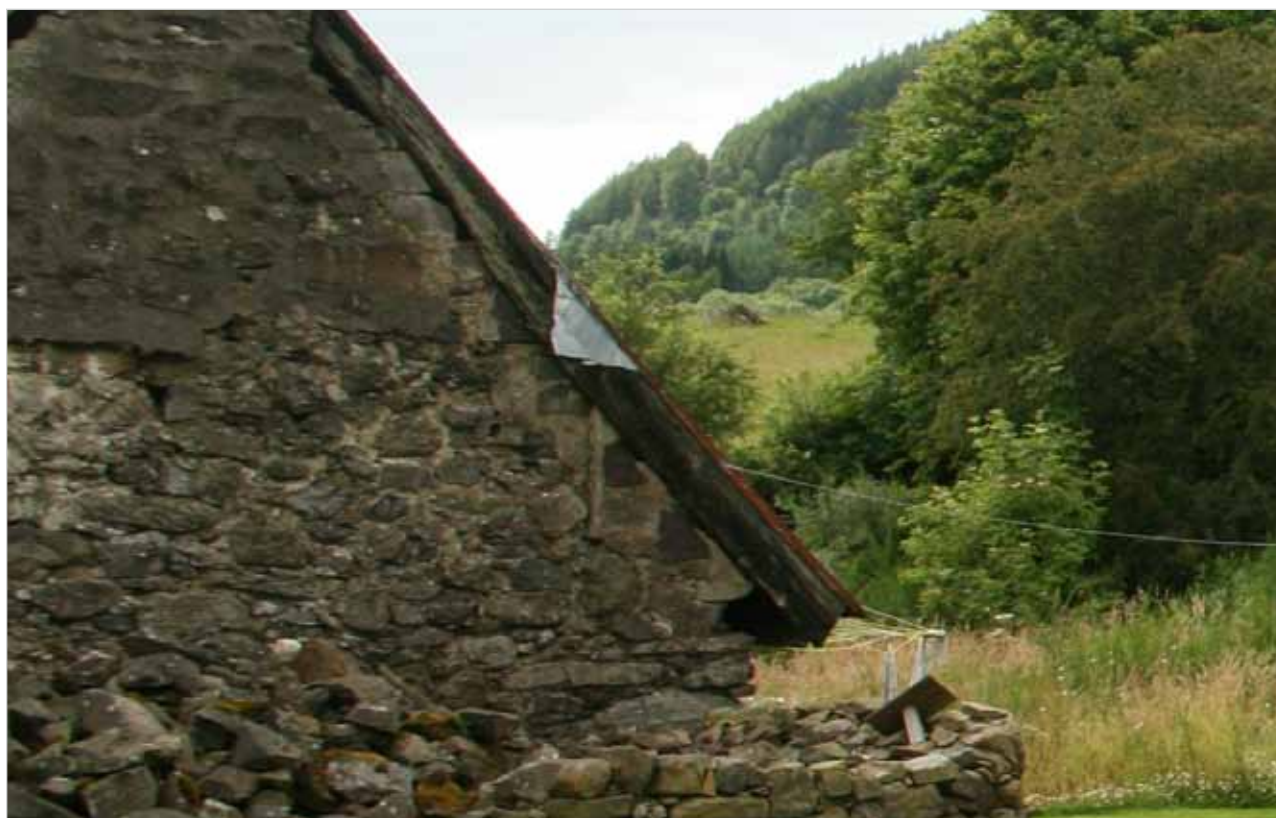
Additional Notes: Probably early 19th-century single-storey cottage, listed as having a '*thatched roof under corrugated iron*'. The grid reference recorded by Historic Environment Scotland in the listed building entry and that held on Canmore related to a different building to that described in the listing description (Grid Reference NN 85398 49883). The building in question could not be found in the adjacent sites either. Further research into the location of this building is required and the location should be updated accordingly on the listing and Canmore records.

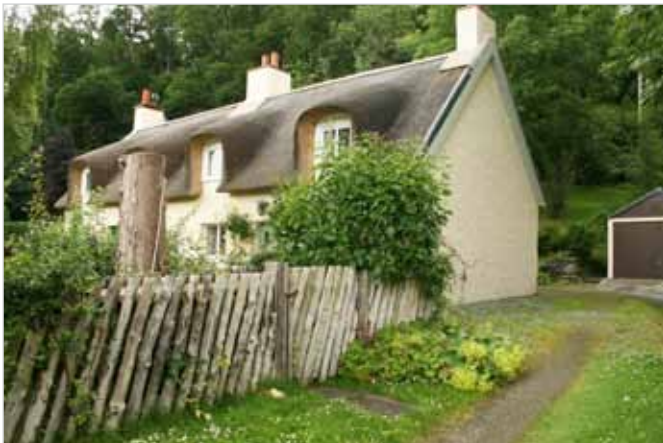
Kirkton Cottages – Perth & Kinross

Thatch Type: Reed
 Ridge Type: Concrete
 Condition of Thatch: Good

Additional Notes: 1889 single-storey building with attic and four dormer windows on the front elevation, listed as having a thatched roof in an 'English traditional manner' by architect J.M. Maclaren. The roof is thatched in reed and has a concrete ridge, which extends below each of the three chimney stacks. The thatch is entirely netted and has been boxed in with timber and lead flashings at the skewes. The cottages are part of the small village grouping of thatched buildings in Fortingall, which are Group Category A Listed (see entries 164 and 165).

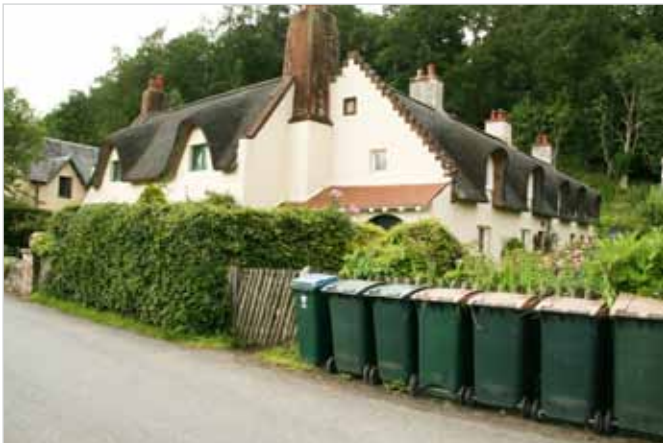
Mclaren Cottages – Perth & Kinross

Thatch Type: Reed
 Ridge Type: Concrete
 Condition of Thatch: Good

Additional Notes: 1889 'L plan block harled and thatched, single-storey and attic with 2 storey projecting wing', listed as having a thatched roof in an 'English traditional manner' and by architect J.M. Maclaren. There are two dormer windows to the roof of the south elevation and five dormer windows to the roof of the east elevation. The reed-thatched roof, which is entirely netted, has a concrete ridge that extends below each of the five chimney stacks. The cottages are part of the small village grouping of thatched buildings in Fortingall, which are Group Category A Listed (see entries 163 and 165).

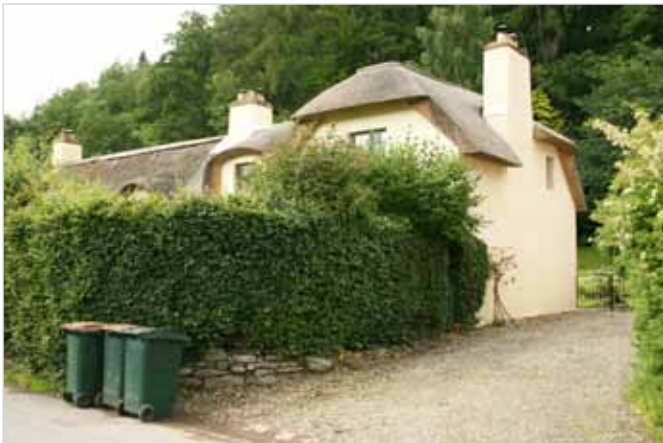
Mr Menzies' Cottage – Perth & Kinross

Circa 1835 single-storey with attic building, listed as being '*harled and slated*'. The building, which is separated into two residential properties, currently has a thatched roof with dormer windows. The entire roof is thatched in reed, has been netted and has a concrete ridge. The roof to the east property has been re-thatched in the last few years and had a new concrete ridge installed. The thatch to the roof of the west property, having been re-thatched less recently than the east property, has an amount of mossy vegetation growth to the surface of the thatch. The cottages are part of the small village grouping of thatched buildings in Fortingall, which

are Group Category A Listed (see entries 163 and 164).

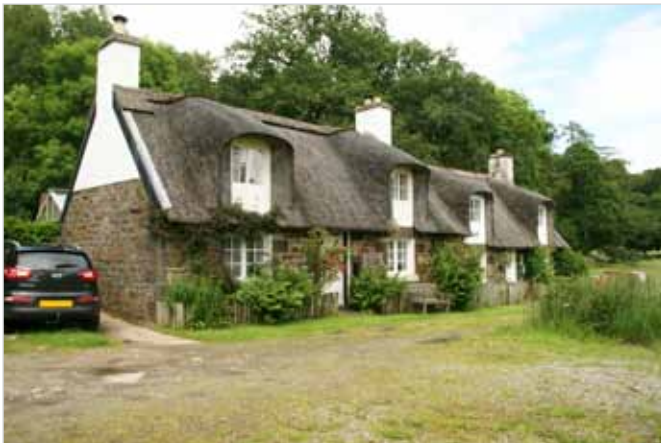
East Cottage – Perth & Kinross

Condition of Thatch: Good

Additional Notes: Circa 1900 single-storey cottage with attic and four dormer windows on the front elevation, listed as being thatched and by architects Dunn & Watson. The east half of the building has been stepped down to lower level to accommodate the topography of the site. The reed-thatched roof has a concrete ridge, which is raised above the dormer windows to accommodate the curve in the structure. The ridge also extends directly below each of the three chimney stacks, one at each gable end and one along the ridge. The thatch has been entirely netted and has been boxed in with timber and lead flashings at the skewes. There is an amount of

..... mossy vegetation growth along the ridge, as well as a small amount across the surface of the thatch underneath the netting.

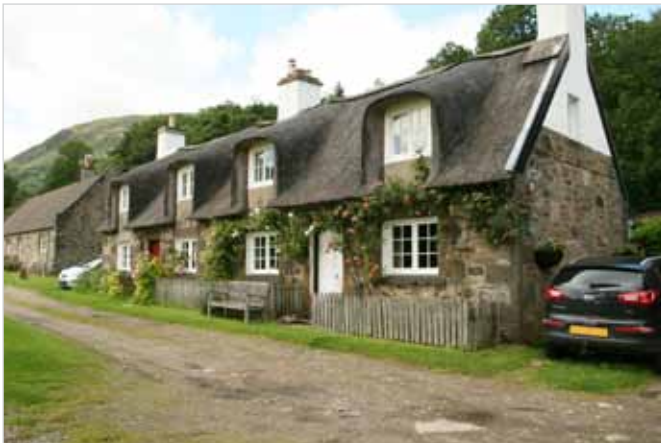
West Cottage – Perth & Kinross

Condition of Thatch: Good

Additional Notes: Circa 1900 single-storey cottage with attic and four dormer windows on the front elevation, listed as being thatched and by architects Dunn & Watson. The reed-thatched roof has a concrete ridge, which is raised above the dormer windows to accommodate the curve in the structure. The ridge also extends directly below each of the three chimney stacks, one at each gable end and one along the ridge. The thatch has been entirely netted and has been boxed in with timber and lead flashings at the skewes.

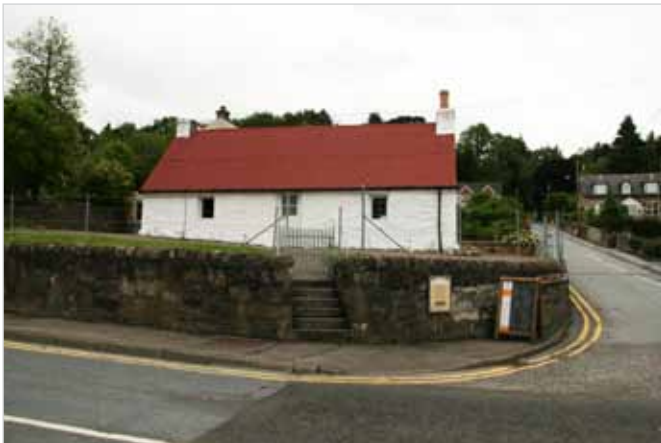
Sunnybrae Cottage – Perth & Kinross

Late 18th to early 19th-century cottage, listed as having thatch surviving underneath its corrugated iron roof. Historic Environment Scotland bought the building in 1998 after the death of its last owner and according to the website it has 'carried out an extensive programme of conservation, archaeological excavation and research, which has illuminated the intriguing history of this building and its inhabitants'. The building is currently closed to visitors, and the interior was therefore not inspected. The listed building notes read 'thatch (much repaired) consisting of variety of materials, layers include cereal straw, some light grey clay,

grassy turves (laid grass side down), rye straw and broom twigs. Supporting cabers of small-diameter pine and birch'.

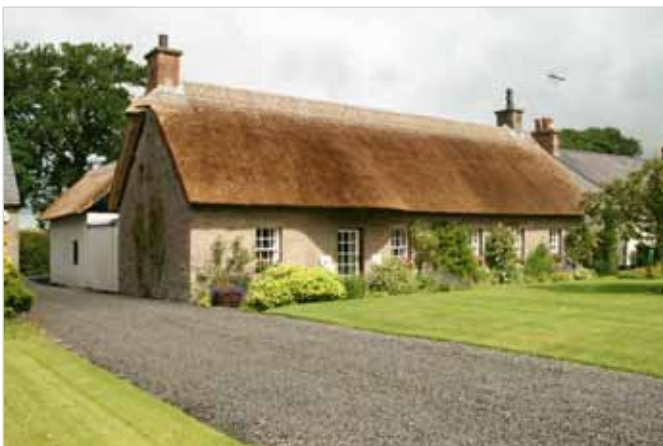
Mercat Green Cottage – Perth & Kinross

Condition of Thatch: Good

Additional Notes: Late 18th-century cottage, listed as having a 'roof thatched with corrugated iron over'. The cottage appears to have been extended to the north-west and renovated, has had the corrugated iron covering removed and a new thatched roof installed since being listed. The roof is thatched in reed with a straw ridge. The ridge, and below the chimney stacks, has been scobed with hazel spars and has been netted, whilst the rest of the thatch has been left uncovered. There is an extension wing to the rear of the building, projecting west from the north end, and an additional detached building to the south end, which is connected to the main cottage

by a single wall. Both of these additional buildings have been thatched in the same way as the main cottage.

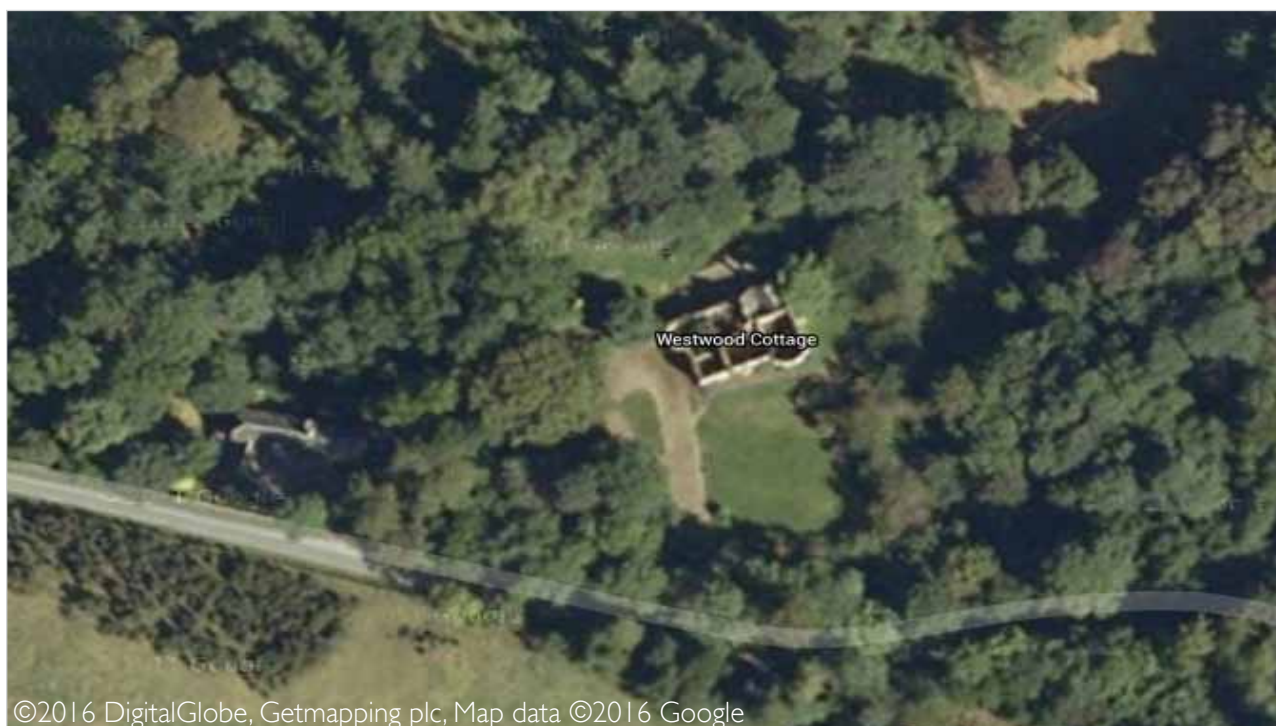
Additional Notes: Circa 1825-30 cottage with later addition to the west, listed as being a 'Large thatched 2-storey cottage ornee'. The cottage is now a ruin and no thatch remains. The site is heavily overgrown so the exact condition of the building could not be determined, however, the owner of a property nearby confirmed that the roof was destroyed in a fire. The roofless condition of the building can be confirmed on web-based satellite imagery. The listed building description for the building should be updated accordingly.

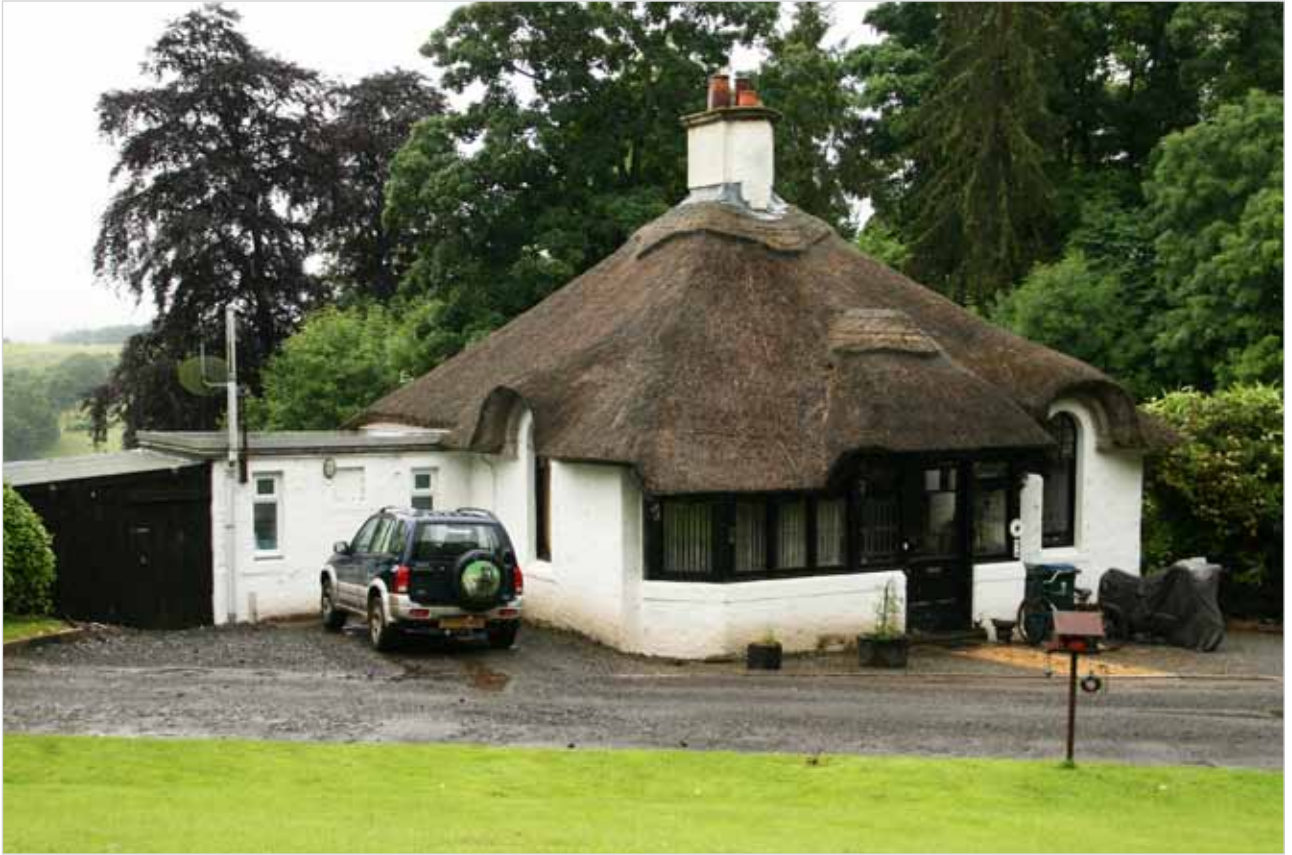
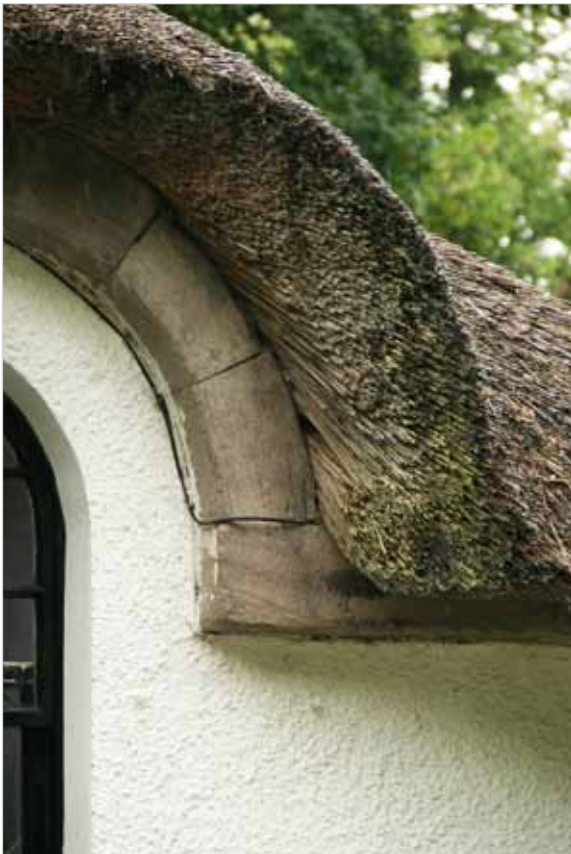
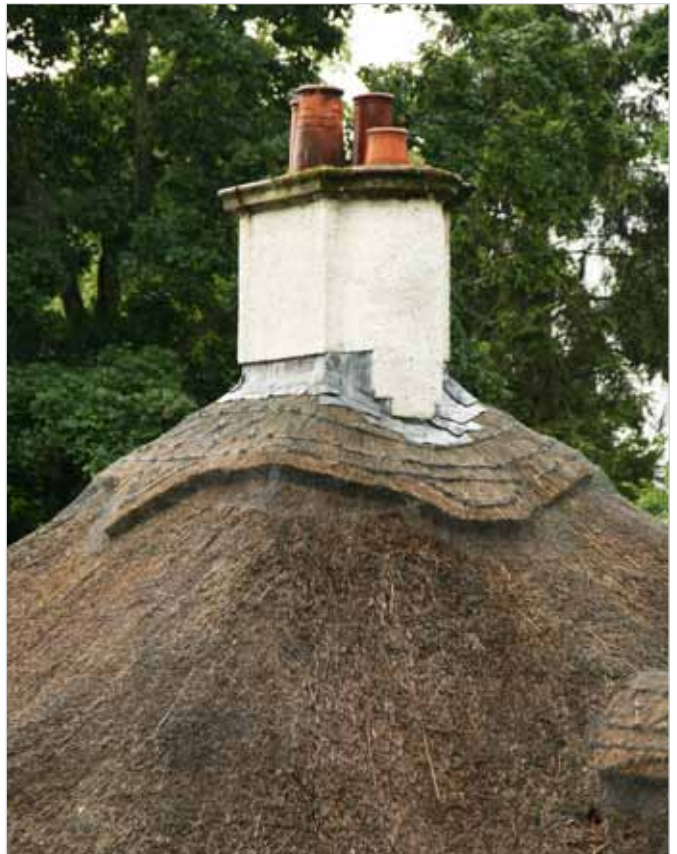
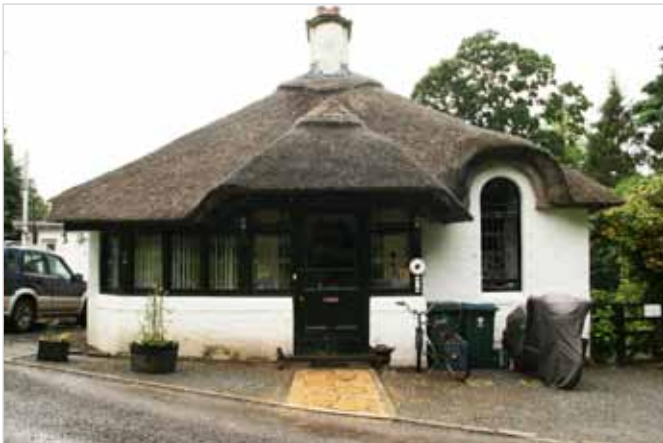
Balthayock Lodge – Perth & Kinross

netted whilst the rest of the thatch has been left uncovered. There are some loose pieces of thatch in places;

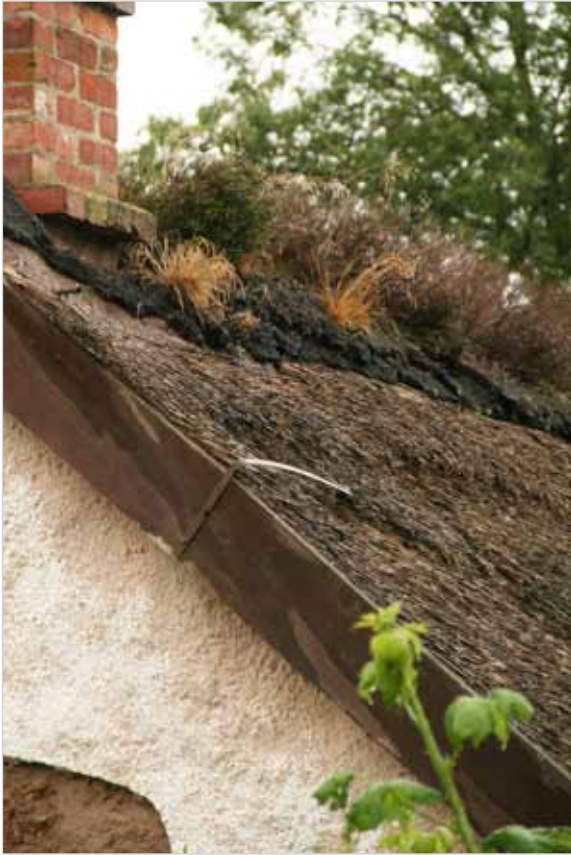
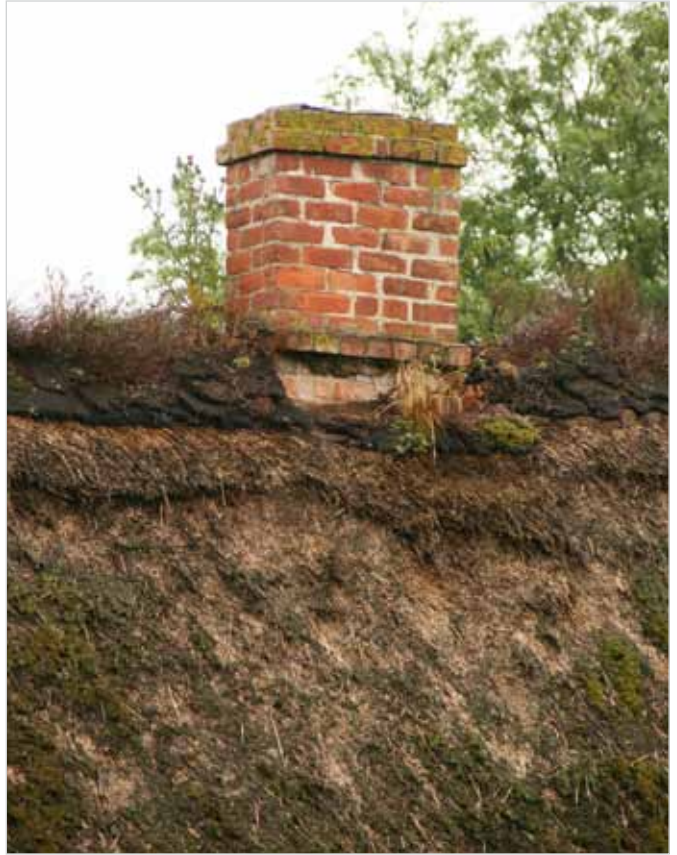
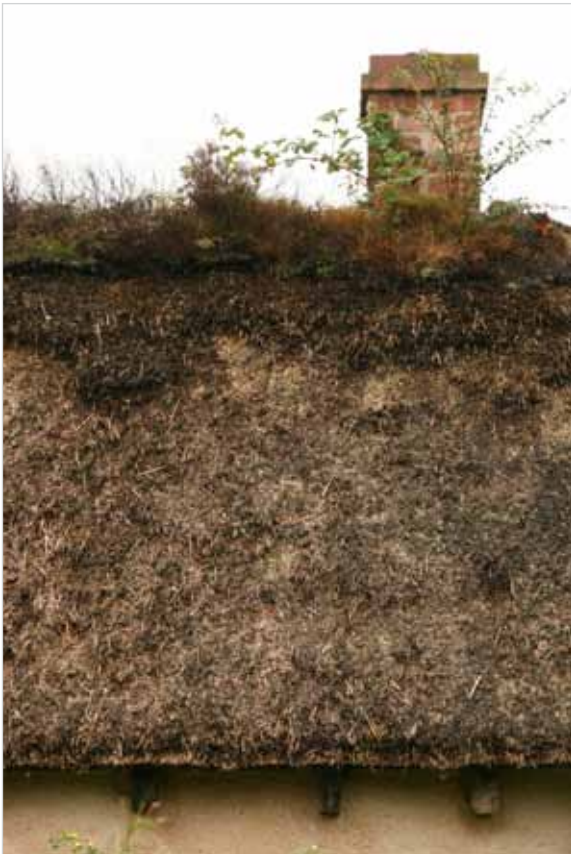
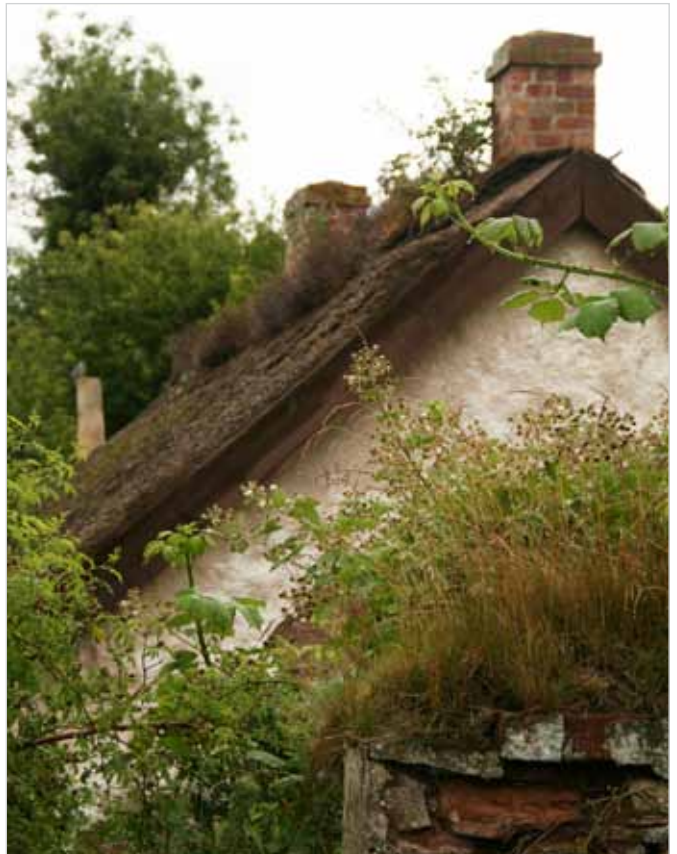
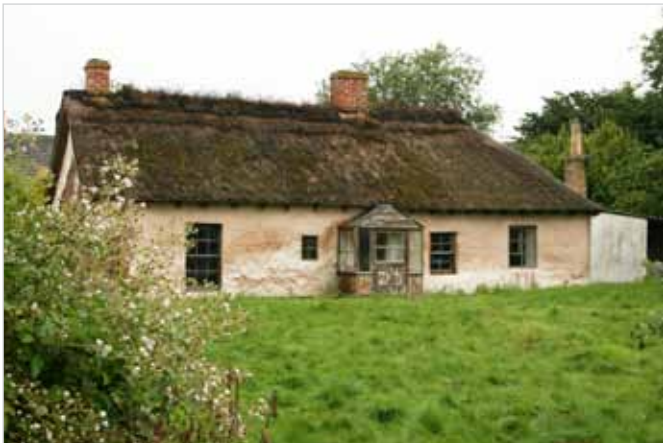
Cottown Schoolhouse – Perth & Kinross

Thatch Type: Reed
 Ridge Type: Thatched (Turf)
 Condition of Thatch: Poor

Additional Notes: 18th-century clay-walled former school building, listed as having a thatched roof. The building has been on the Buildings at Risk (BAR) Register since 1991 (BAR reference number 312), at which time it was recorded that the 'thatch requires attention' and that the building was occupied until 1985. In 1994, BAR recorded that the building had been acquired by the National Trust for Scotland and a restoration project was in progress in partnership with Historic Environment Scotland and Perth and Kinross Heritage Trust. In early 2011 the building was heavily flooded and it was recorded by BAR that the roof is 'in need of extensive repair and

there are dense growths of brambles'. The roof is currently in much the same condition and has a large amount of mossy vegetation growth across the surface of the thatch, as well as vegetation growth in the turf ridge. The thatch has been left uncovered and is boxed in at the skewes with timber. The thatch is also supported underneath the eaves with timber.
