A Survey of Thatched Buildings in Scotland

Thatch Survey of Scotland
2014-15

A photographic survey of thatched buildings in Scotland, surveyed between May 2014 and August 2015 by Zoe Herbert (SPAB Scotland Officer), on behalf of the Society for the Protection of Ancient Buildings.

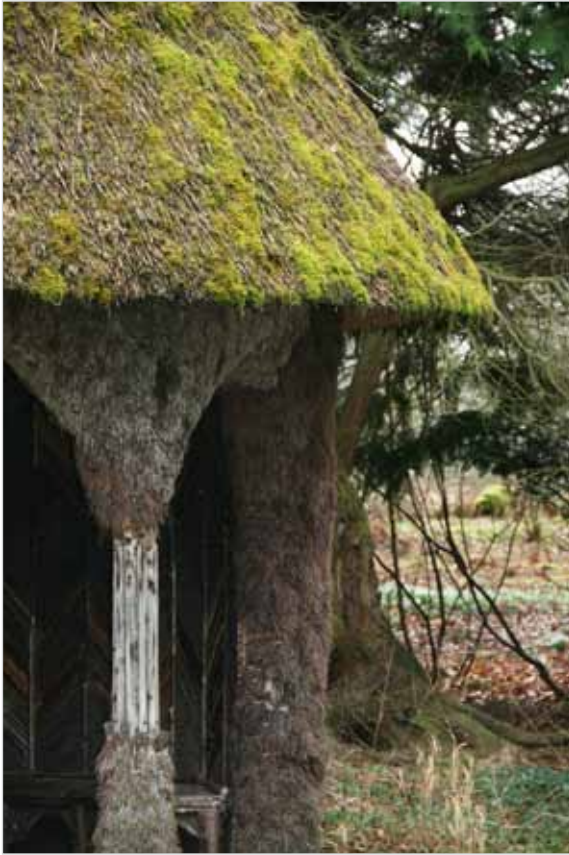
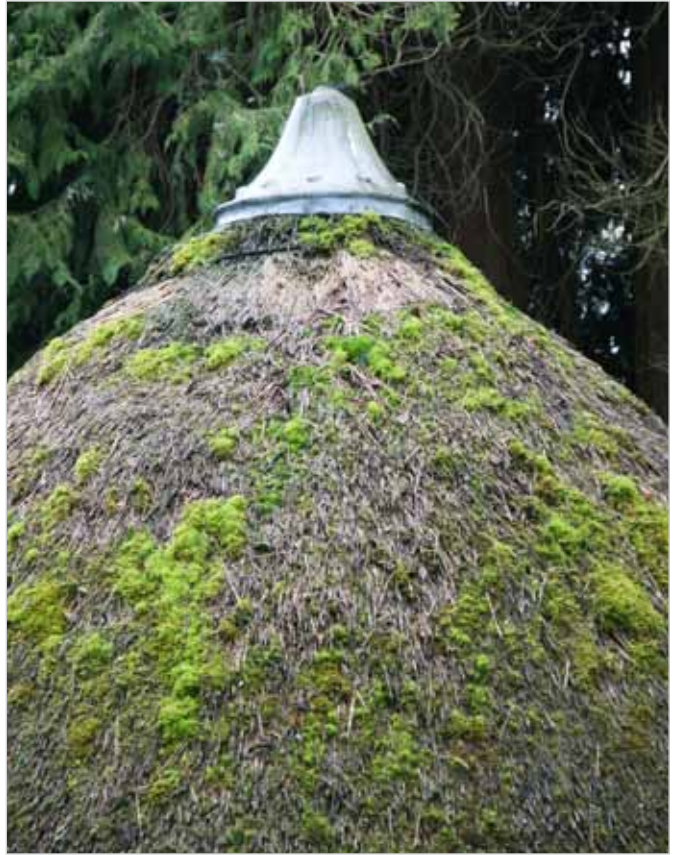
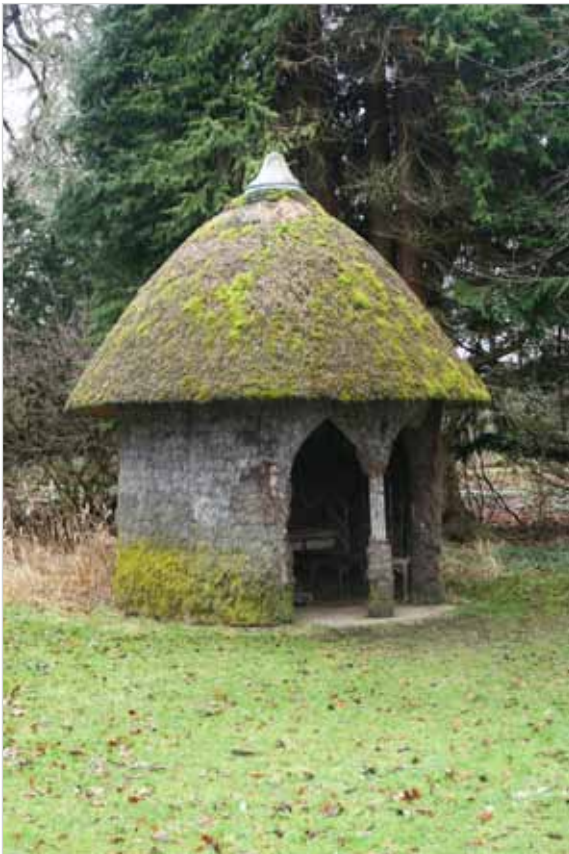
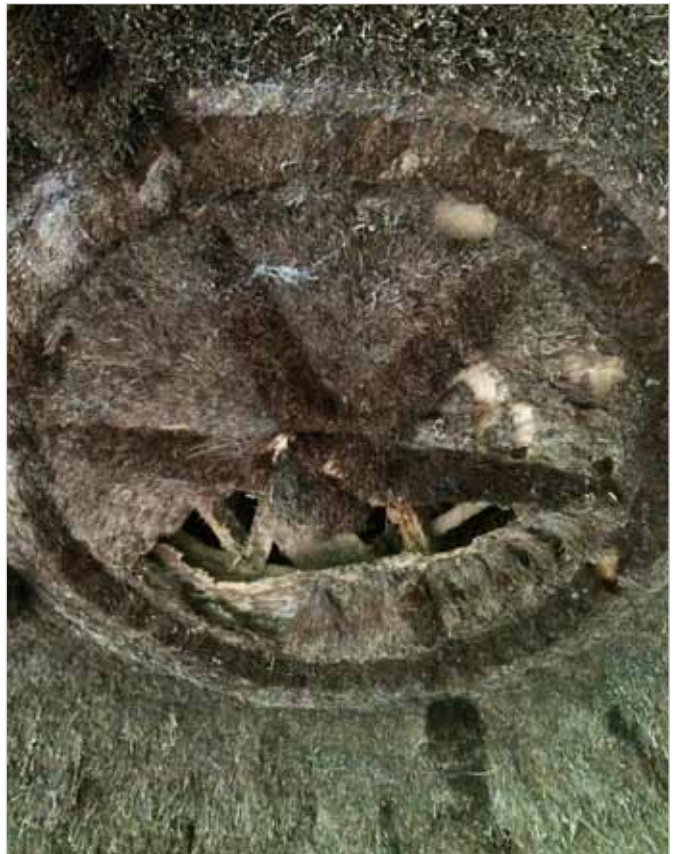
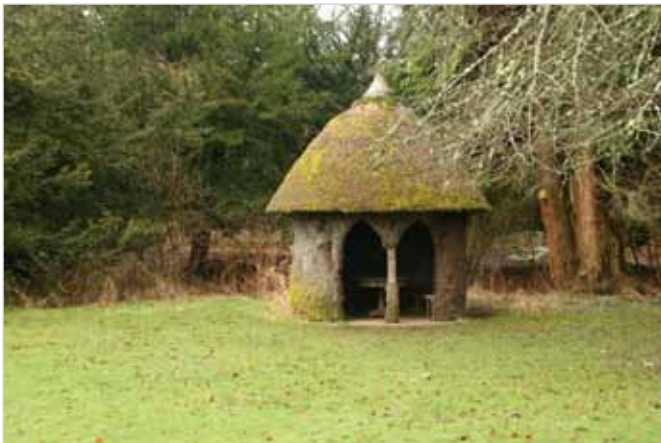
Heather Summerhouse – Scottish Borders

Thatch Type: Reed and Heather
 Ridge Type: n/a
 Condition of Thatch: Fair

Additional Notes: Dated 1834, circular plan summerhouse with conical roof located within the grounds of Traquair House. Internally, the walls are lined with its original willow or hazel twigs and it has a heather-thatch ceiling with contrasting star detail and ribs. There is some damage to the heather-thatch ceiling, which has exposed some of the roof structure above. The summerhouse has two pointed arch openings, and the external walls are clad in heather, last re-thatched in 1990. There is some damage to the heather externally, with two substantially sized holes exposing the timber wall structure beneath, as well as a few minor patches of damage to the thatch.

There is also a large amount of mossy vegetation growth on the external walls along the bottom section of the walls. The conical roof is thatched in reed, and capped in metal at the apex. The thatch has been left uncovered and many of the reeds are loose. There is also a large amount of mossy vegetation growth across the surface of the roof.

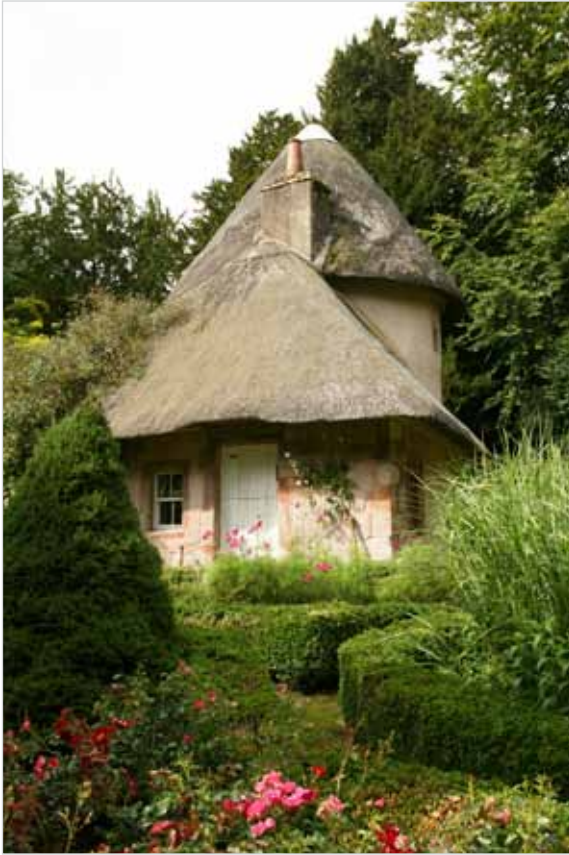
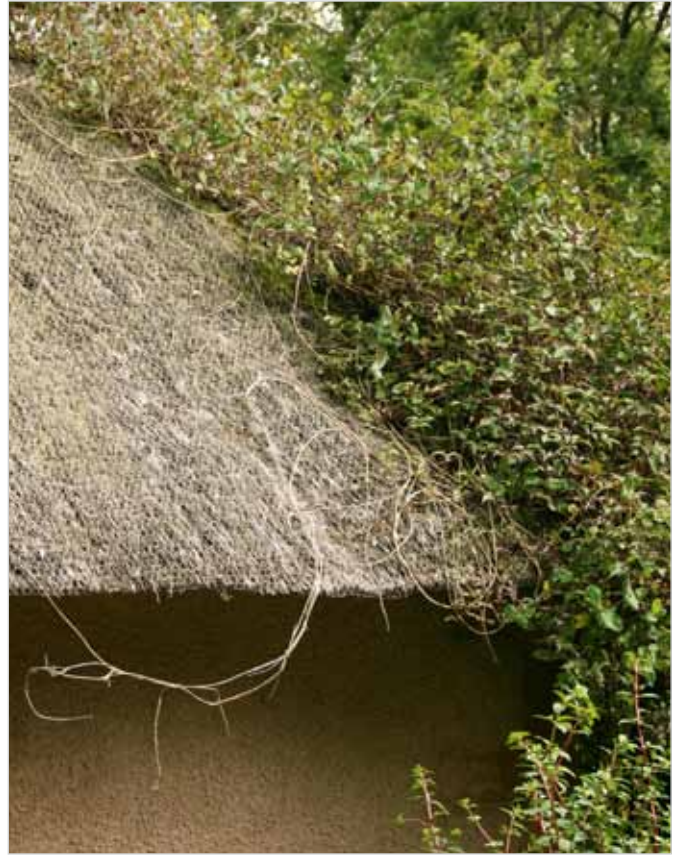
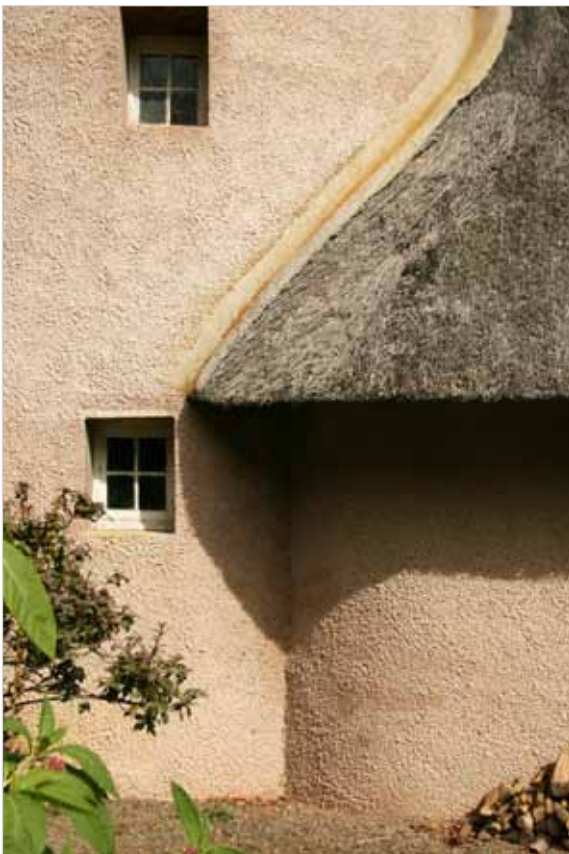
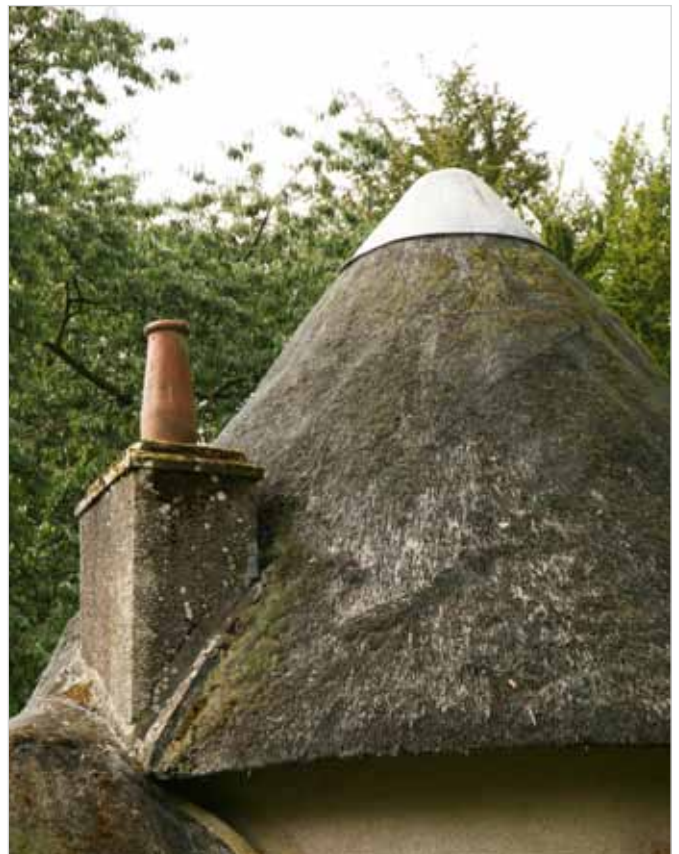
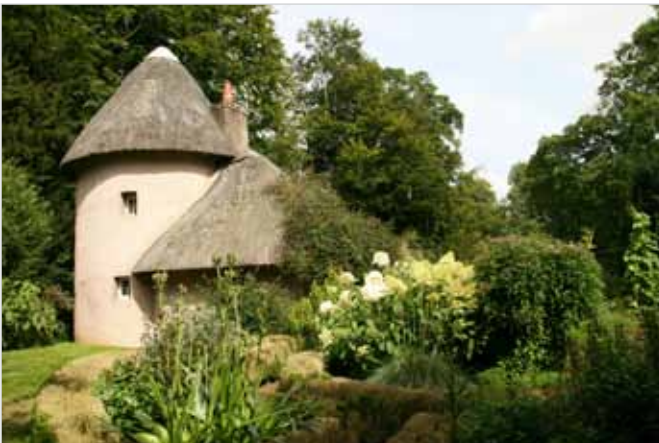
Norman Cottage – Scottish Borders

Condition of Thatch: Fair

Additional Notes: The listing description for this building simply reads 'cottage orne in park'. A section of text on Canmore states that the building is late 19th-century. The building, which is also known as 'Old Cottage', currently has a thatched roof to both the main block and the wing to the south. The main block is a circular two-storey structure with a conical thatched roof, whilst the wing has only one storey and a steeply pitched roof. Both sections of the roof are thatched in reed, which is entirely netted. The apex of the conical section of thatch is capped in metal, whilst the lower section of roof has a short ridge of concrete at the point that

it meets the chimney stack. There is some mossy vegetation growth across the surface of the thatch throughout, and vegetation from the garden below has begun to grow up onto the thatched roof of the wing.

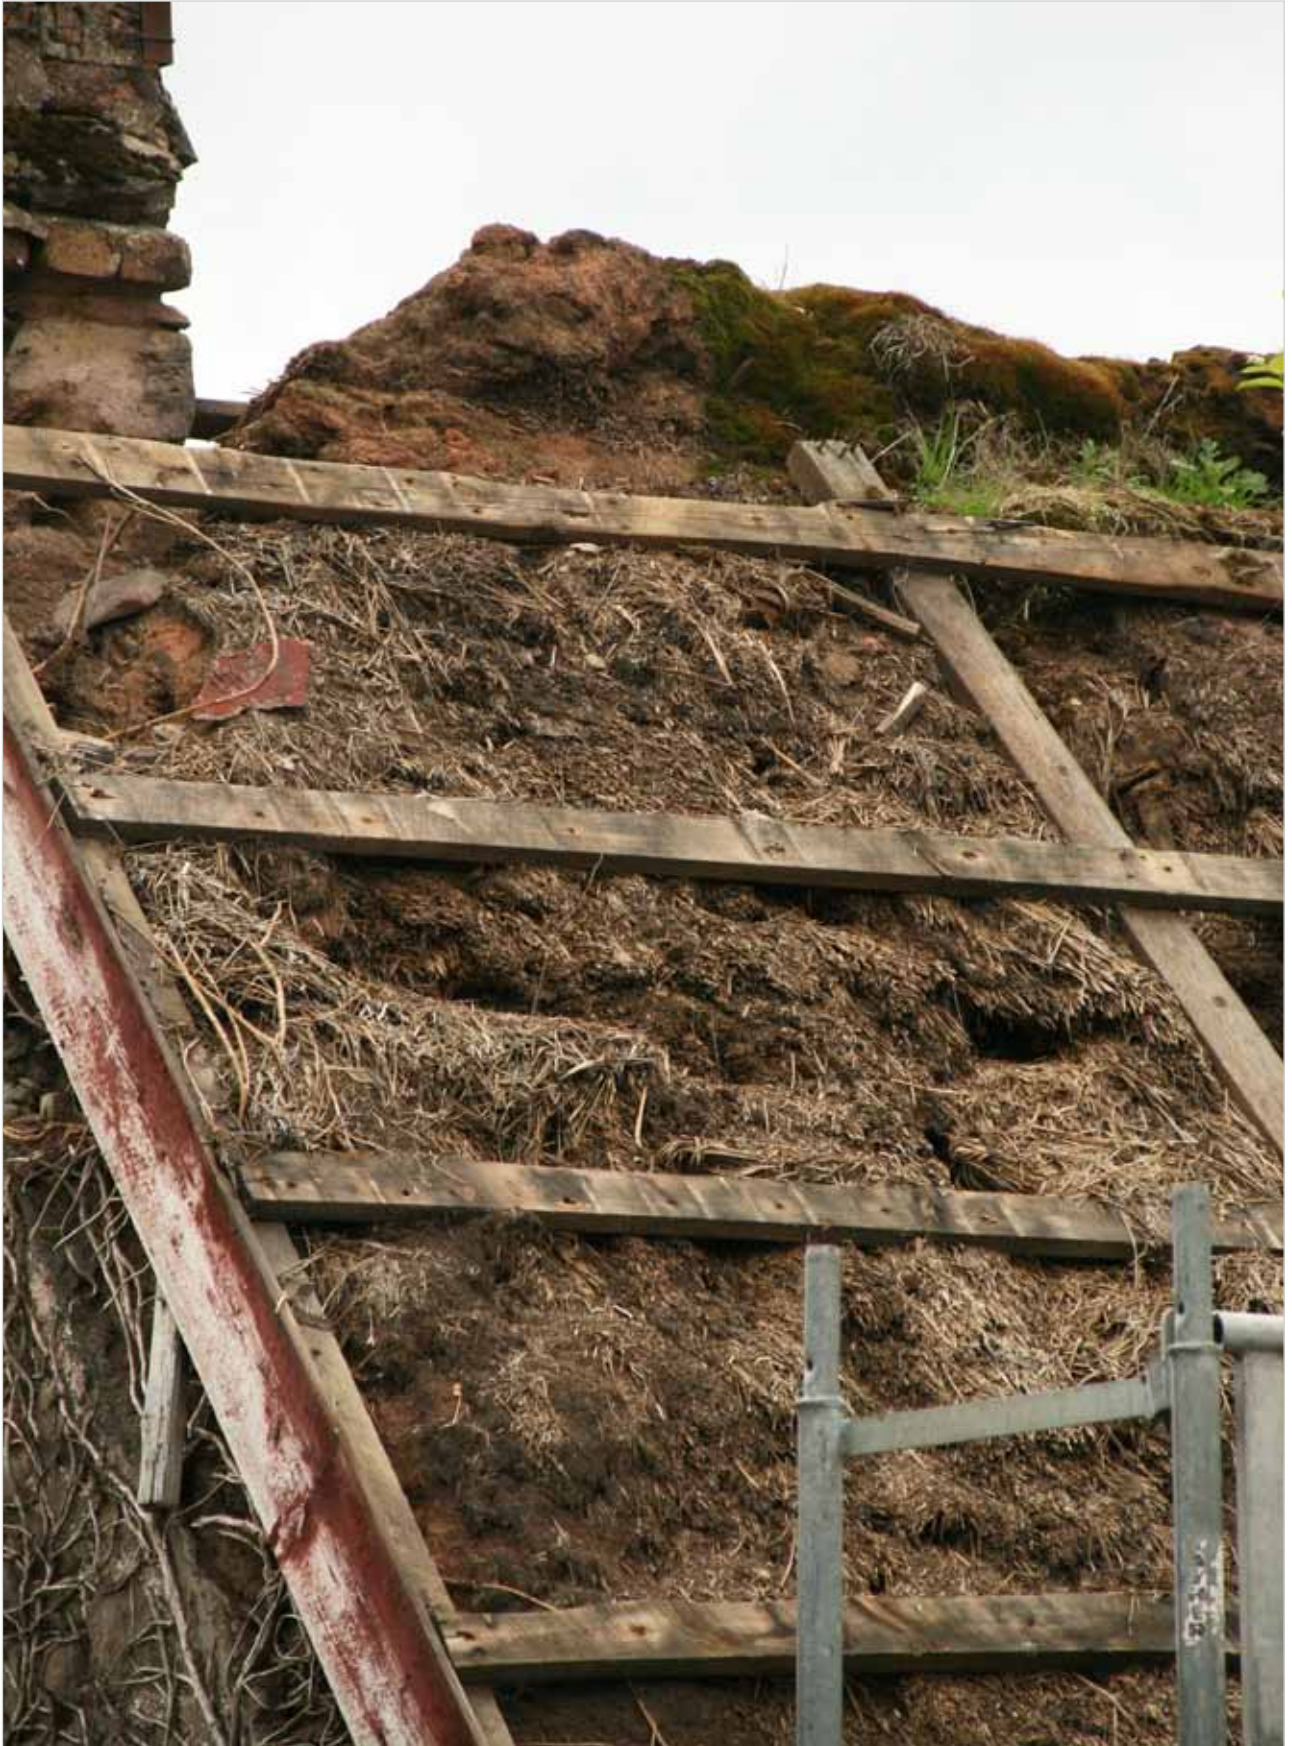
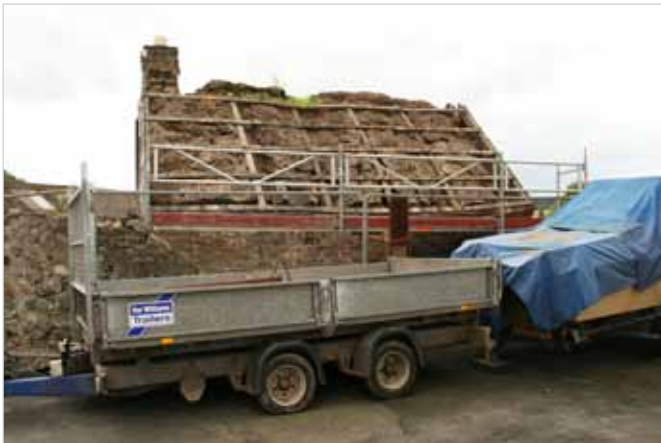
Fluther's Cottage – Scottish Borders

The building, which is listed as 'retaining original thatched roof beneath subsequent corrugated iron roof and "boxed" barge-boarding at eaves', was added to the Buildings at Risk (BAR) Register in 1994 (BAR reference number 2015). Planning applications for change of use, alterations and extension to the building submitted in 2013 were accepted in June 2015. The planning application was to alter the building from a store to a dwellinghouse. Work has now started on alterations to the building and upon site visit the corrugated iron roof had been removed, exposing the thatch underneath. Due to the condition of the thatch, it is unclear

what type of material the thatch is. The planning application states 'retaining original thatched roof beneath subsequent corrugated iron roof and "boxed" barge-boarding at eaves'.

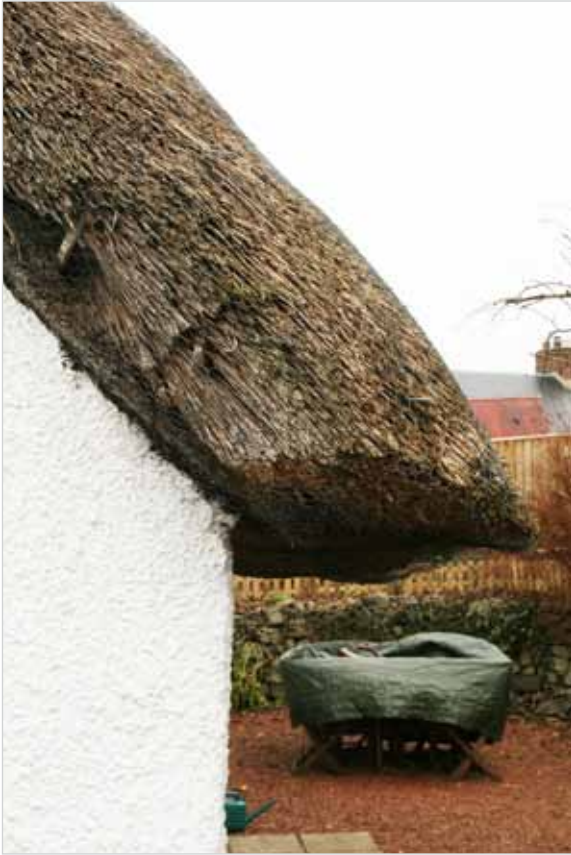
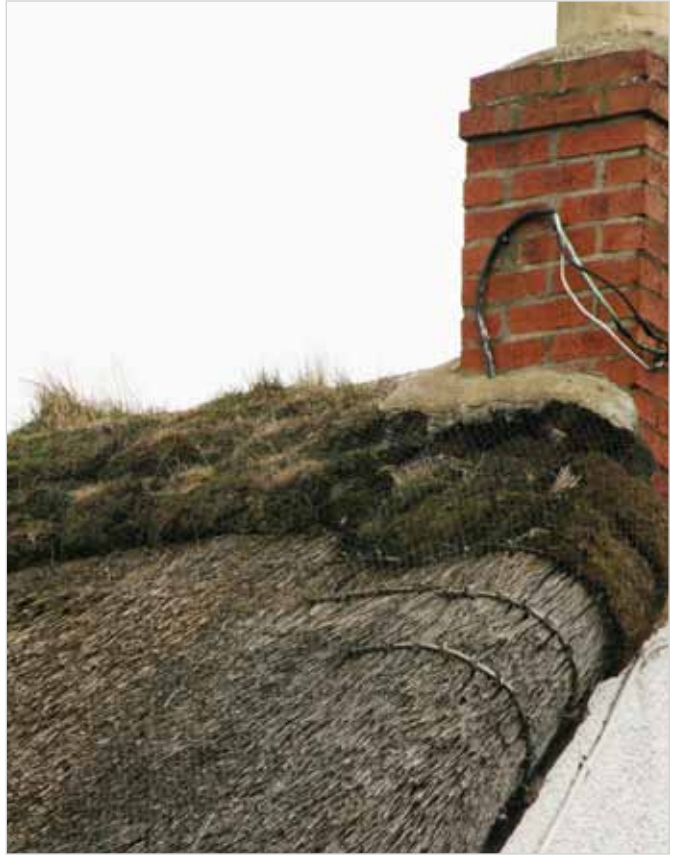
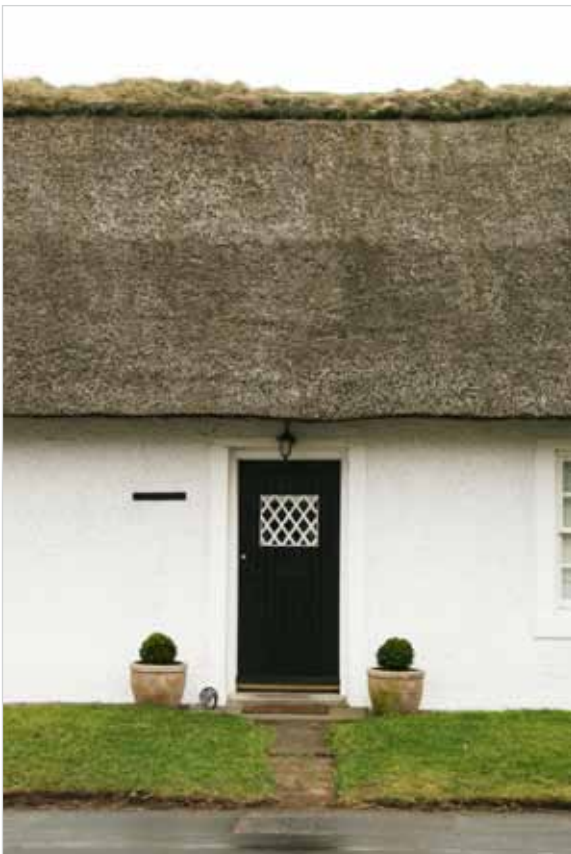
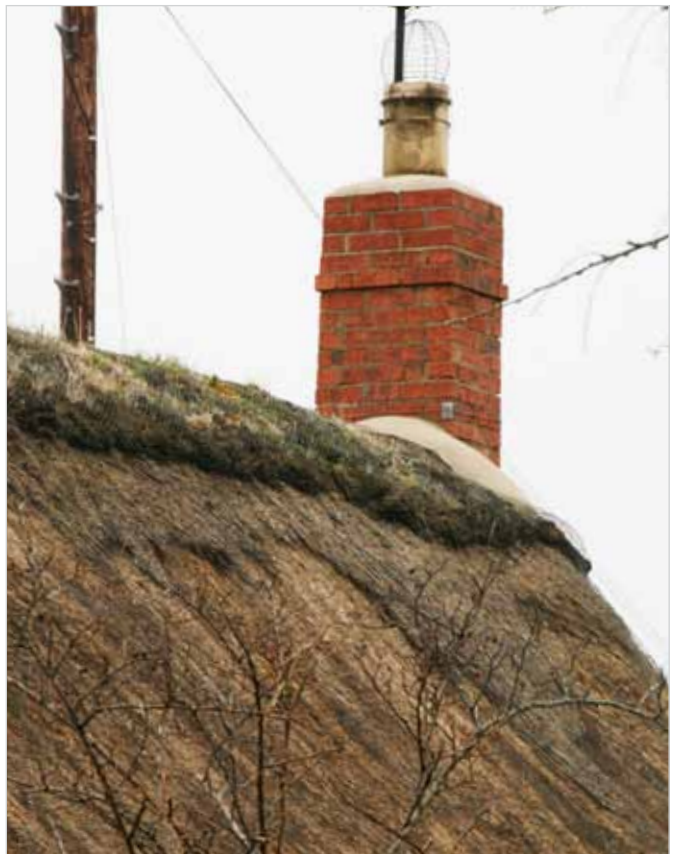
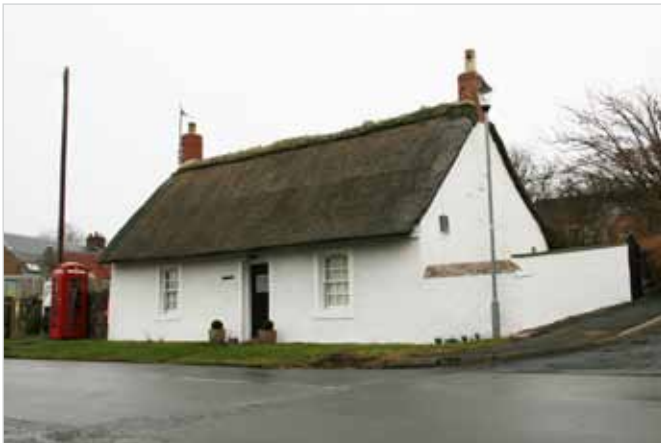
Late 18th-century single-storey cottage, currently used as a holiday rental, is listed as having a 'thatched roof with scalloped ridging'; however, the ridge is no longer scalloped. It is unclear whether the ridge is thatched in turf or whether this is extensive vegetation growth. The entire thatch, including the ridge, is netted. What appear to be repaired patches are visible directly below the chimney stacks on both the north and south ends on the front (NW) elevation, which have been scobed using hazel. There is also a patch of repair below the south chimney on the rear (SE) elevation, again using spars. The thatch on the front elevation is in good condition;

however, on the rear elevation the surface of the thatch appears to be slightly damaged in places.

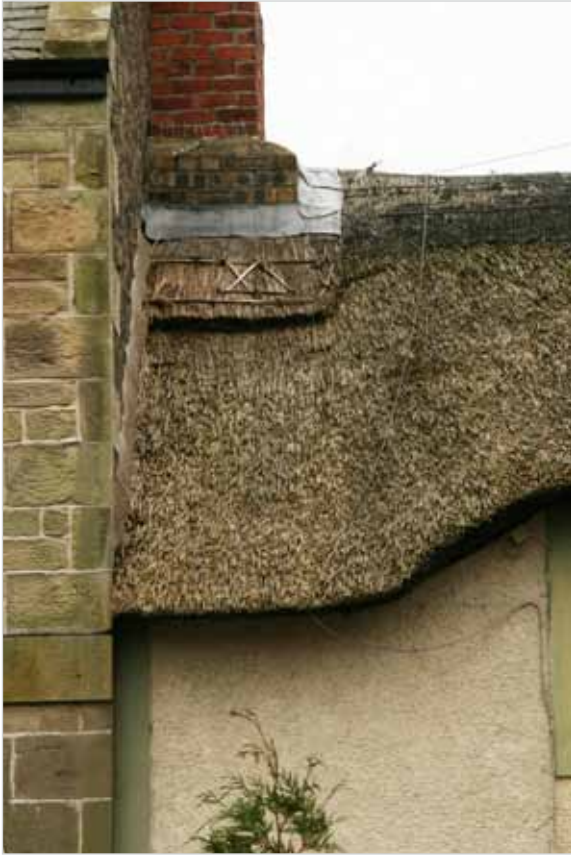
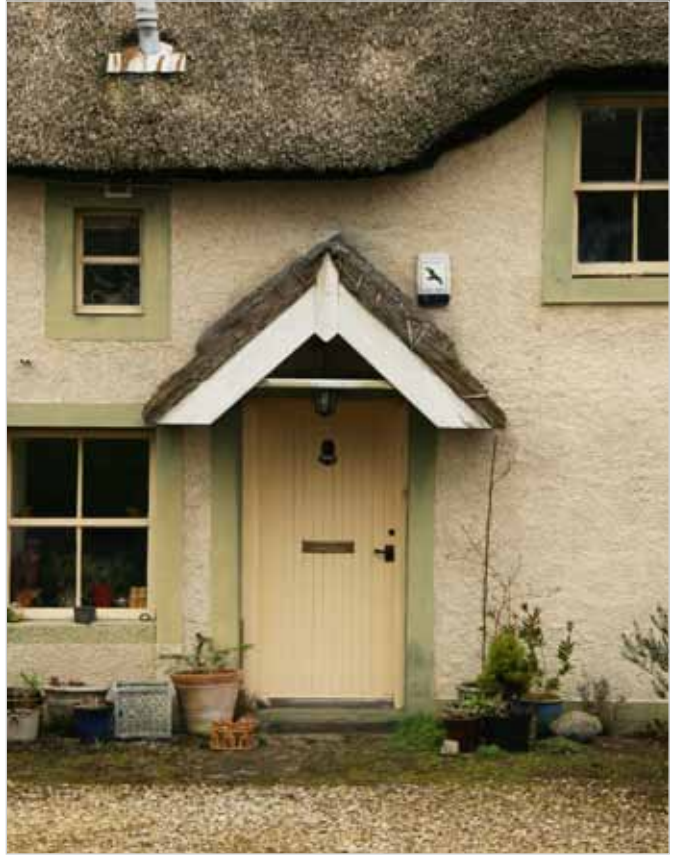
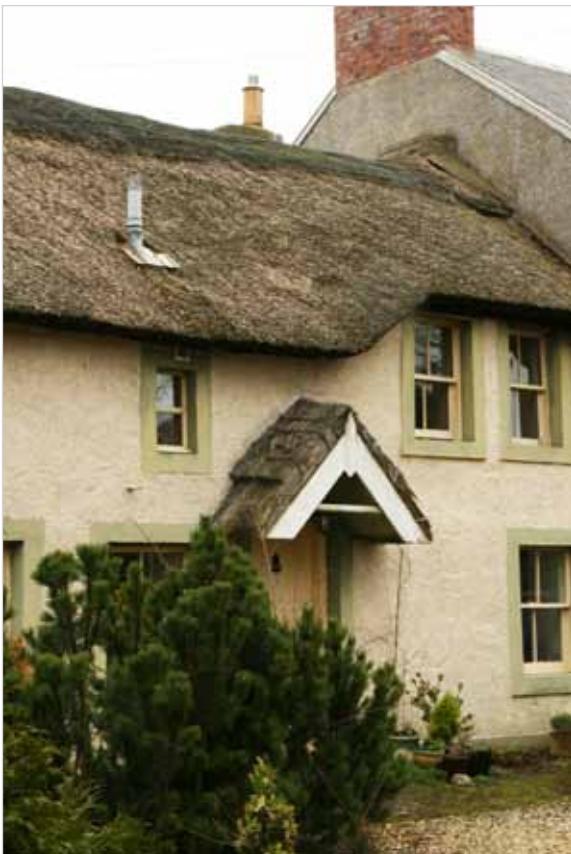
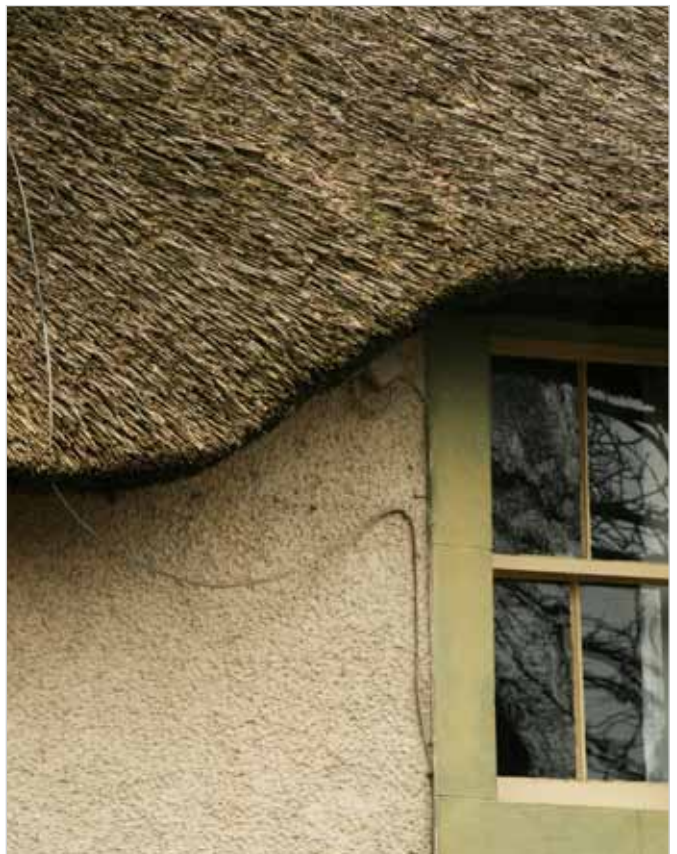
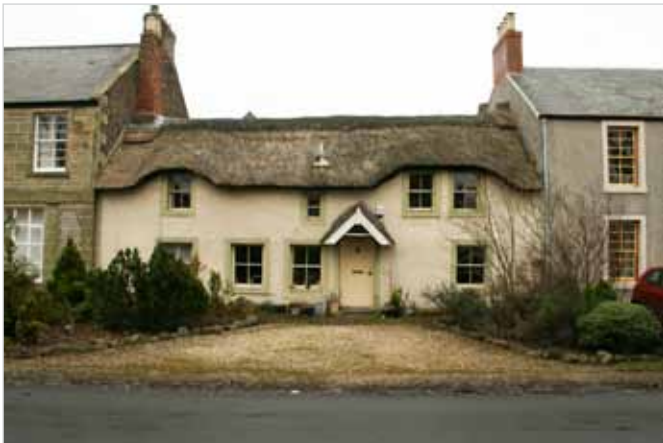
Thatched Cottage – Scottish Borders

Address: Thatched Cottage
..... High Street
..... Town Yetholm
.....
Local Council: SCOTTISH BORDERS
.....
Grid Reference: NT 82001 28056
Date of Visit: 19/02/2015
Thatch Type: Reed
Ridge Type: Thatched (Reed)
Condition of Thatch: Good

Additional Notes: Mid to late 18th-century single-storey with attic cottage, located in a village with a number of other thatched cottages. The entrance doorway has a reed-thatched gabled canopy above it, scobed with hazel spars and partially netted. The thatch forms dormer hoods to the three upper-storey windows on the west (front) elevation. The ridge, which is netted and scobed with hazel spars, has a substantial amount of mossy vegetation growth present and the scobing has come away from the ridge in some places. The ridge is continued below both the north and south chimney stacks at a lower level; however, the scobing is in better condition and

more defined below the northern stack. Only the ridge and entrance canopy are netted. The thatch has a small amount of mossy vegetation growth throughout. On the rear elevation, the roof and ridge are both thatched in the same manner as on the front.
.....
.....

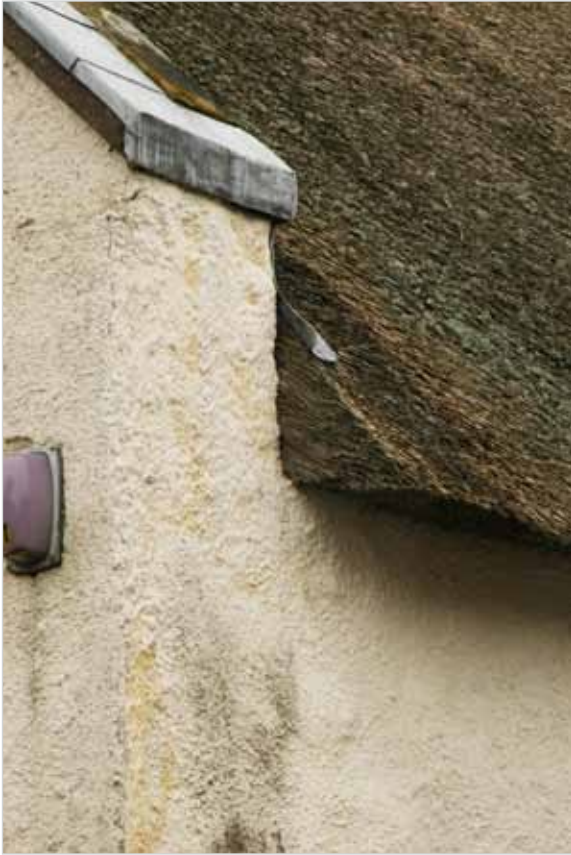
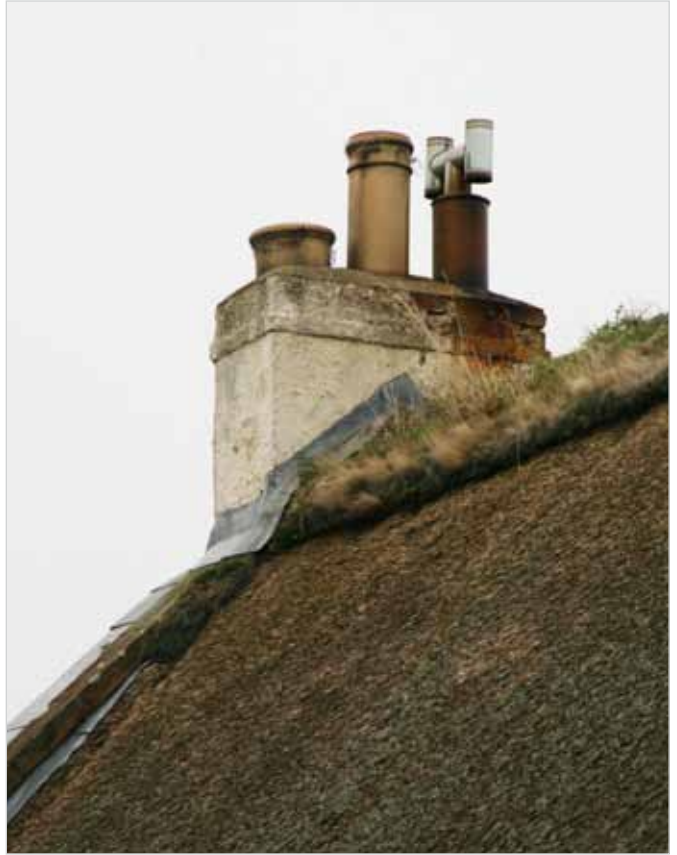
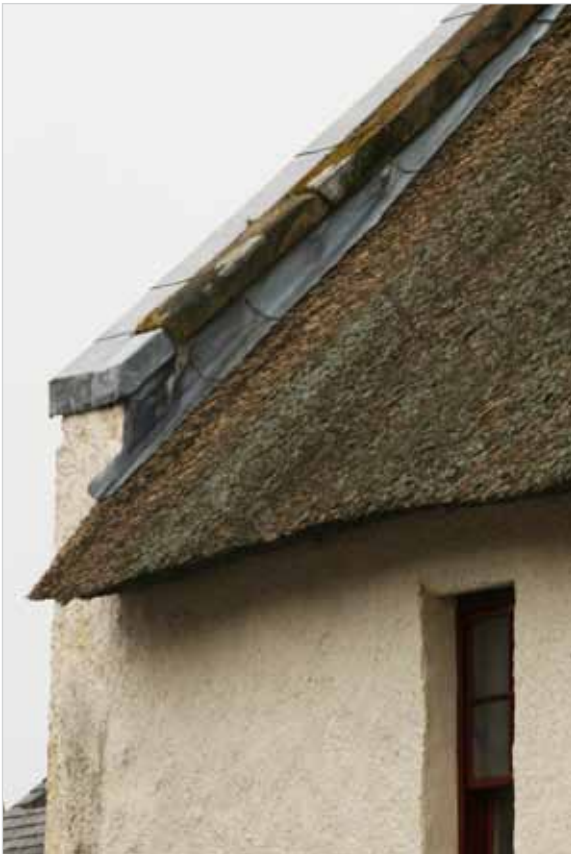
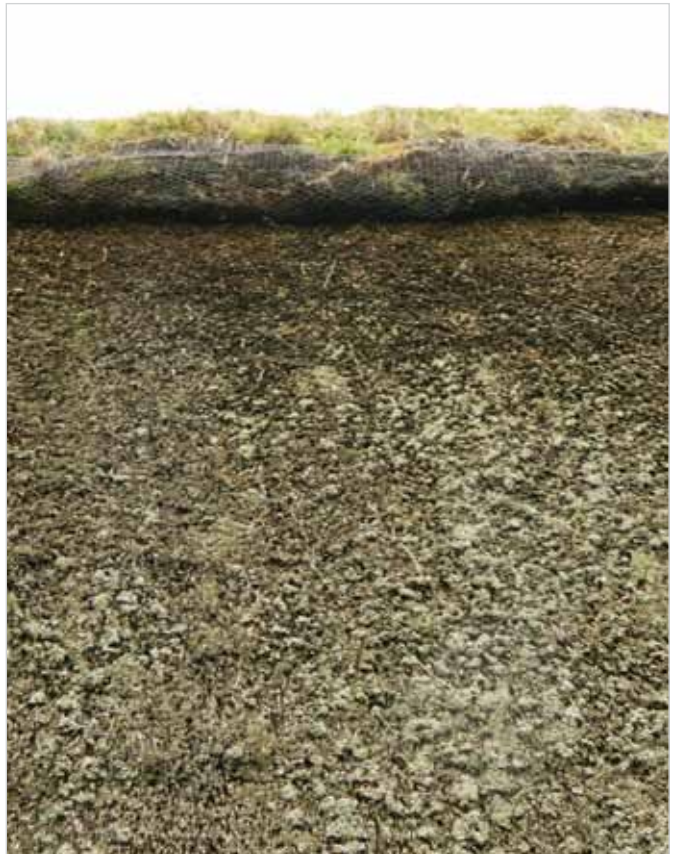
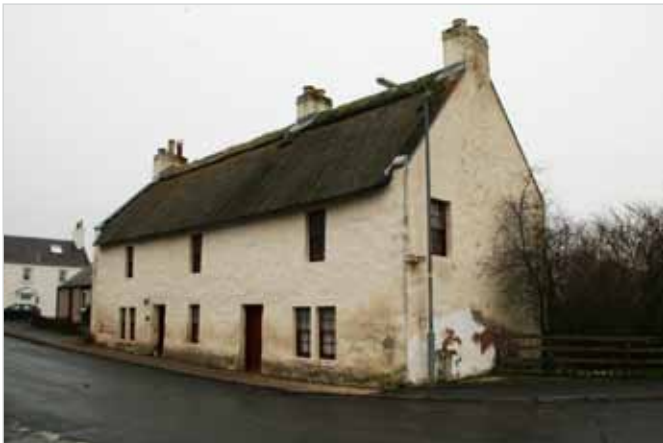
Myrtle Cottage – Scottish Borders

Thatch Type: Reed
 Ridge Type: Thatched (Turf)
 Condition of Thatch: Good

Additional Notes: Early to mid 18th-century two-storey block comprising two cottages. The building has a steeply pitched reed-thatched roof with a turf ridge. The thatch is fairly shallow and is lower than the height of the skewers. The surface of the thatch has a large amount of mossy vegetation growth throughout. The turf ridge, which is continued below the three chimney stacks at a lower level, is netted, whilst the rest of the thatch is left uncovered. The turf has slightly grown through the netting at the ridge; however, it is in a good condition otherwise and remains intact. The building is located directly opposite another thatched cottage (Rose Cottage) and in

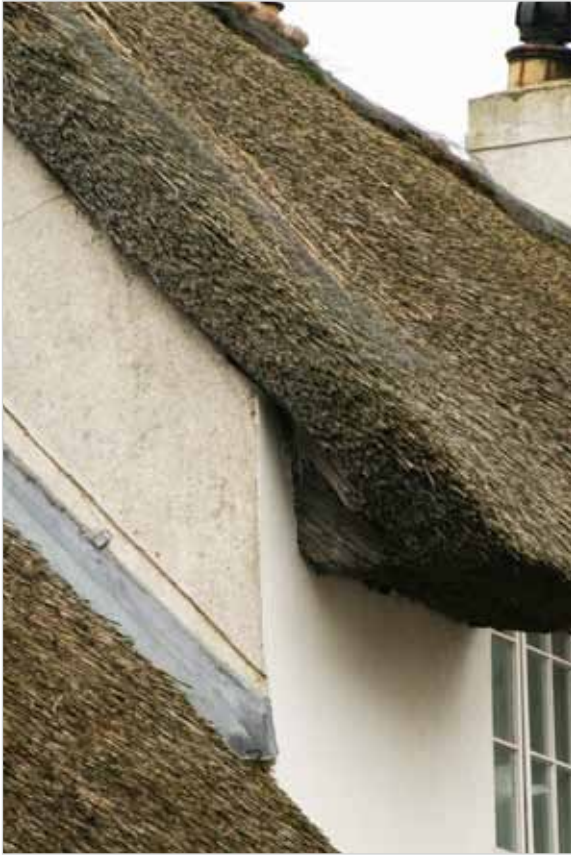
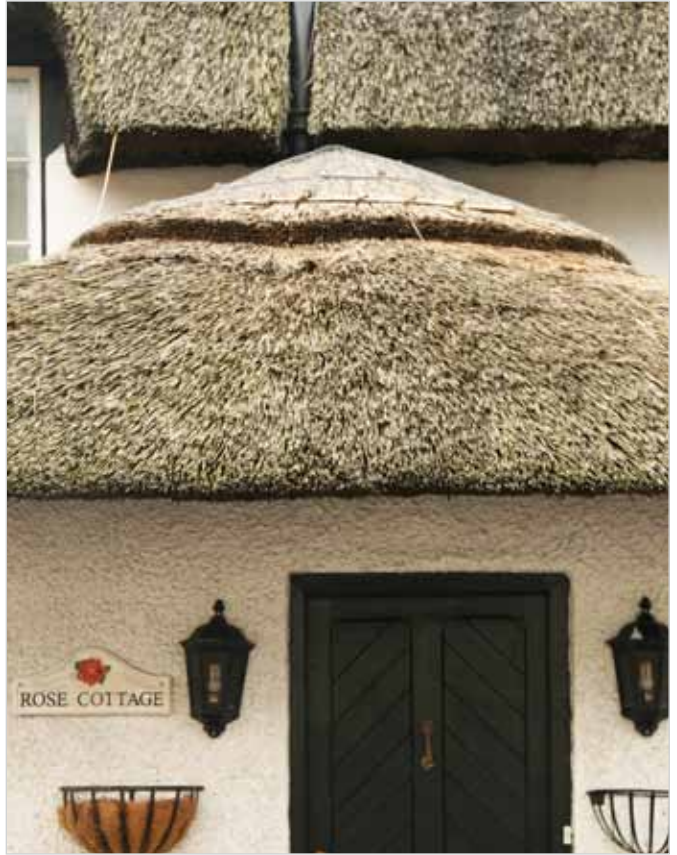
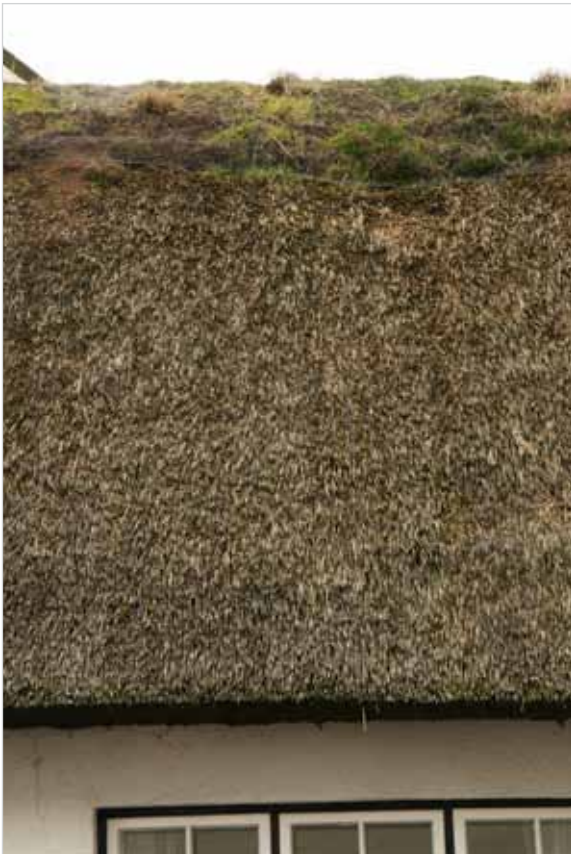
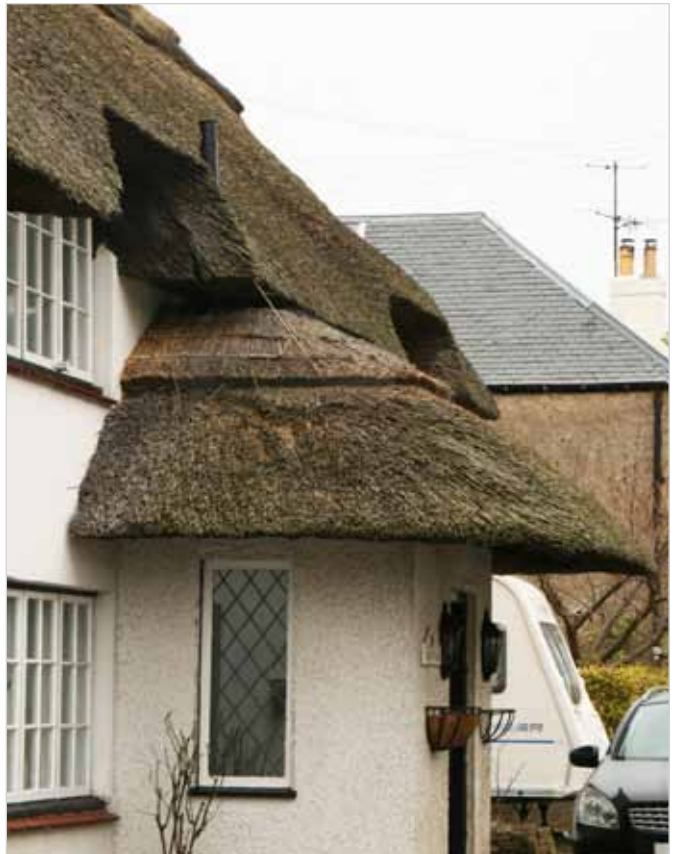
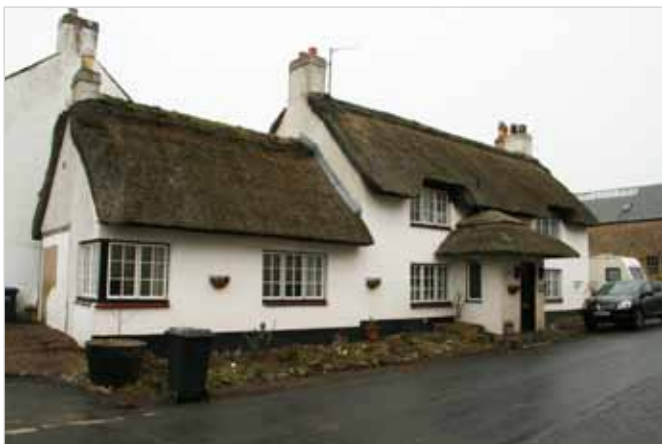
Rose Cottage – Scottish Borders

Thatch Type: Reed
Ridge Type: Thatched (Turf)
Condition of Thatch: Good

Additional Notes: Mid to late 18th-century, two-storey thatched house with single-storey wing to south, and mid 20th-century alterations. The south wing is thatched in reed and has a turf ridge, which is extended at a lower level directly below the south chimney stack. Both the ridge and skewes are netted, whilst the rest of the thatch has been left uncovered. The roof of the main building is thatched in the same way; however, the thatch is hooded above the first floor window openings. The turf ridge along both sections of the roof has slightly deteriorated in places. The entrance porch on the east elevation has a pyramidal thatched roof with overhanging eaves, the raised

ridge of which is netted and thatched in reed and scobed using hazel spars. The rest of the porch roof is left uncovered. The condition of the thatch as a whole is generally good, with only a few loose strands of reed in places.
.....
.....
.....
