A Survey of Thatched Buildings in Scotland

Thatch Survey of Scotland
2014-15

A photographic survey of thatched buildings in Scotland, surveyed between May 2014 and August 2015 by Zoe Herbert (SPAB Scotland Officer), on behalf of the Society for the Protection of Ancient Buildings.

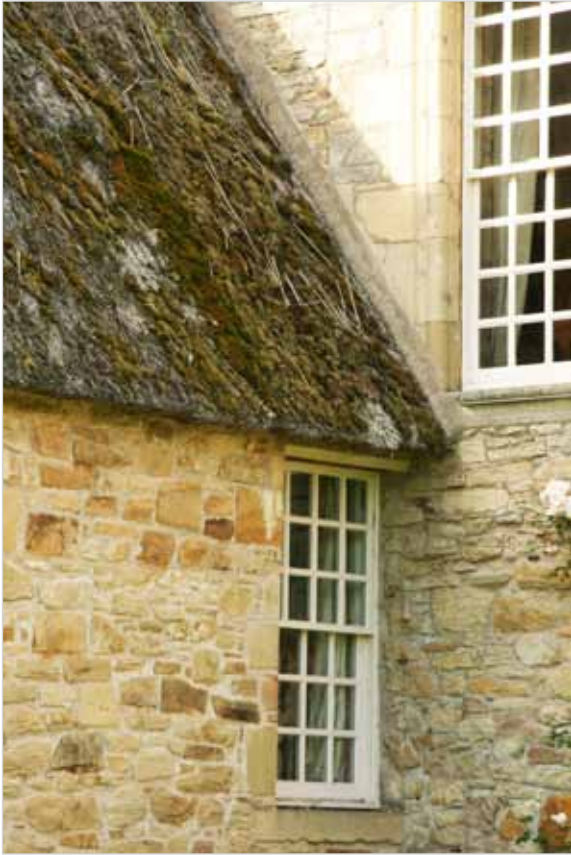
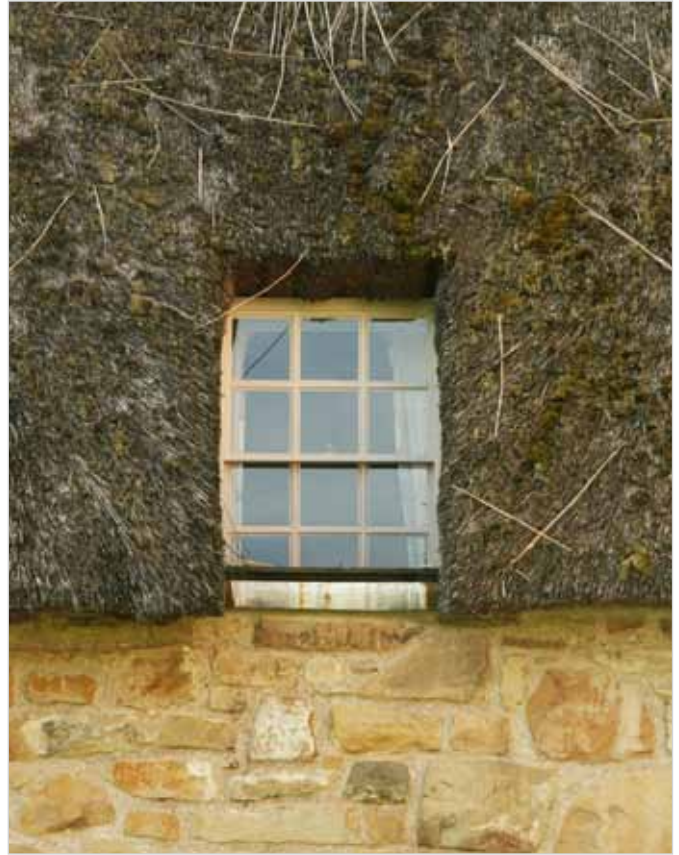
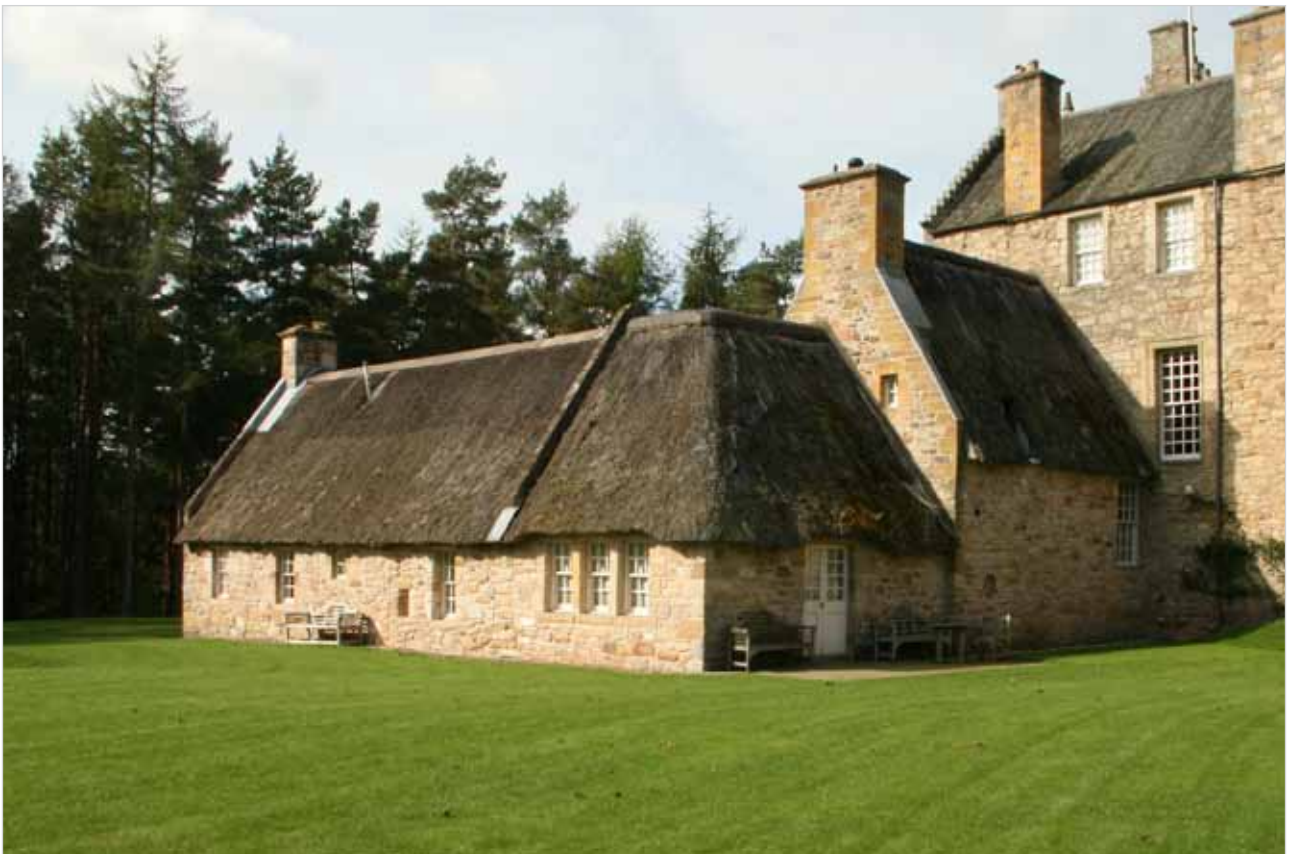
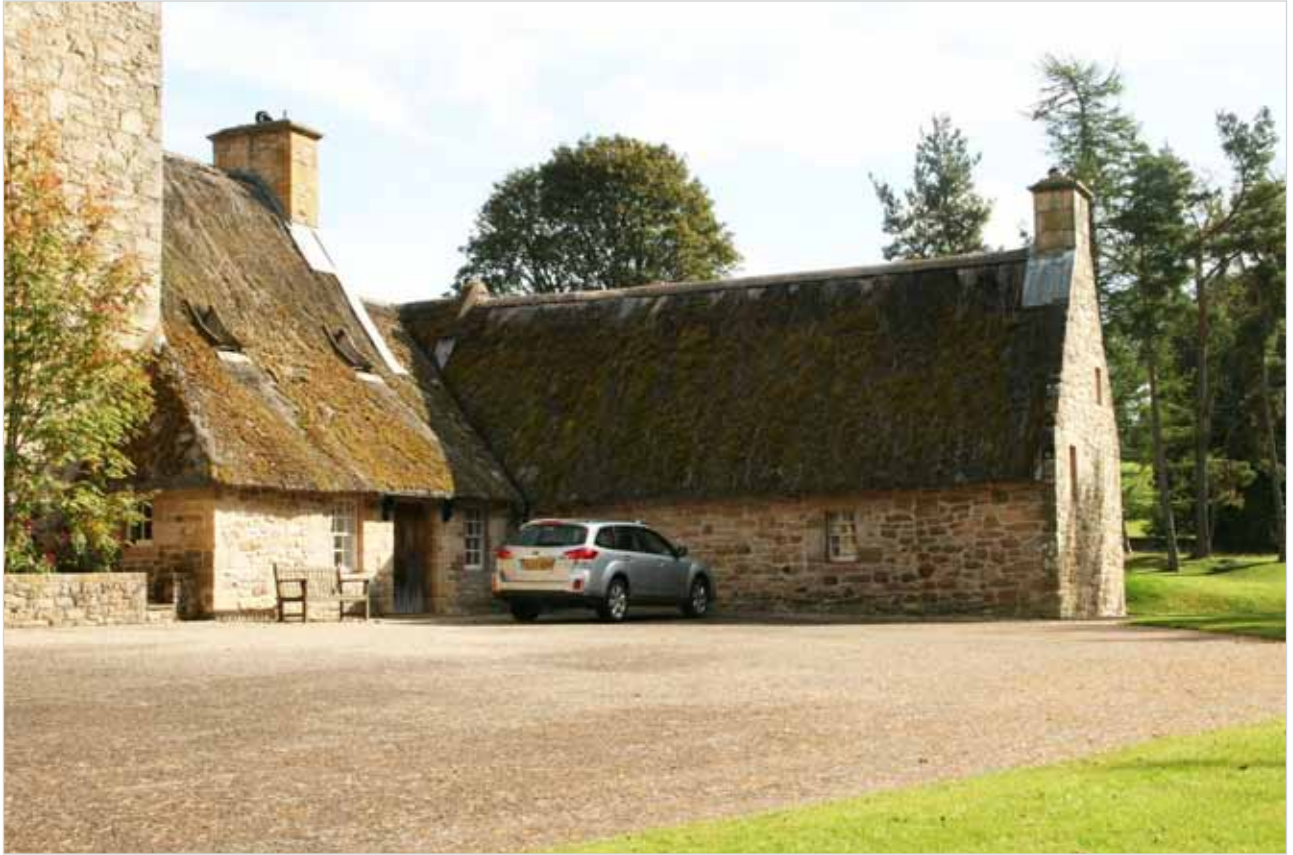
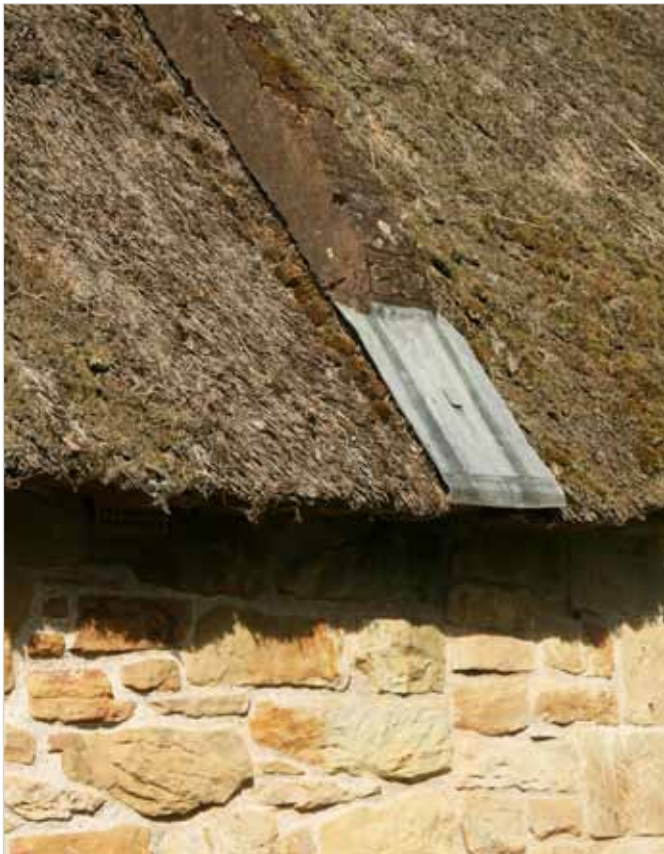
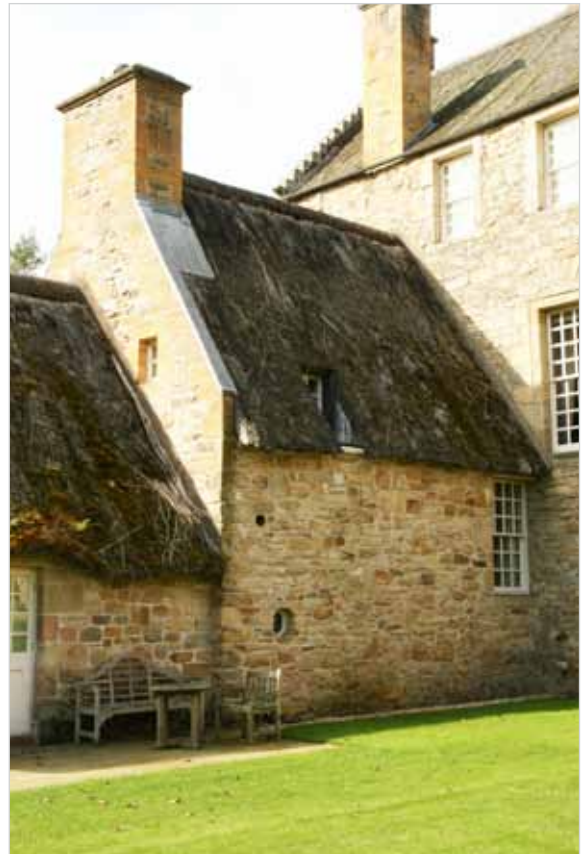
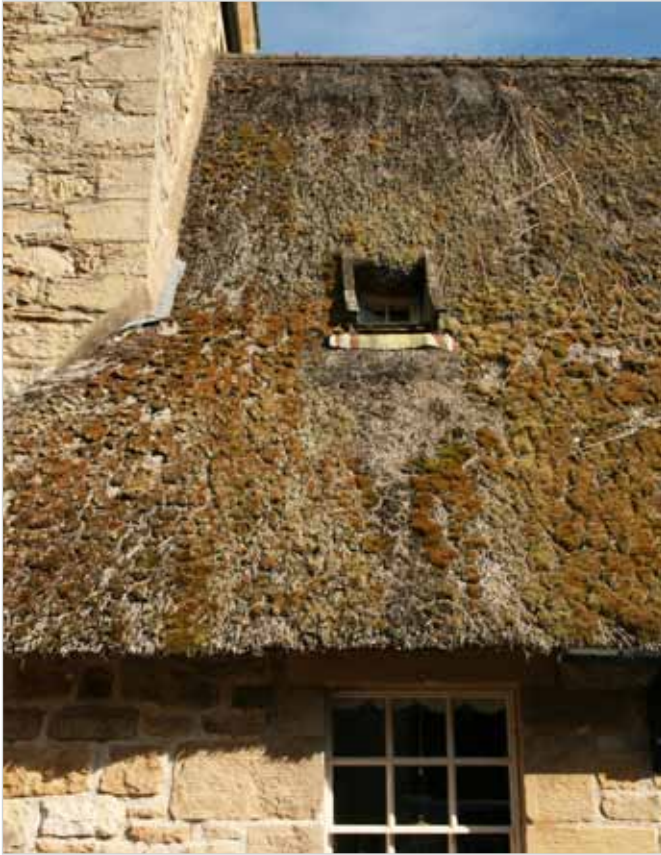
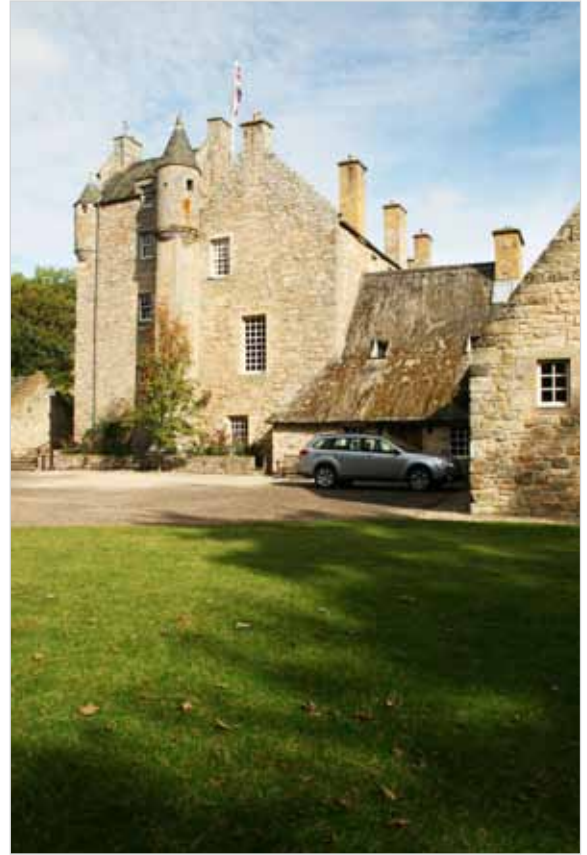
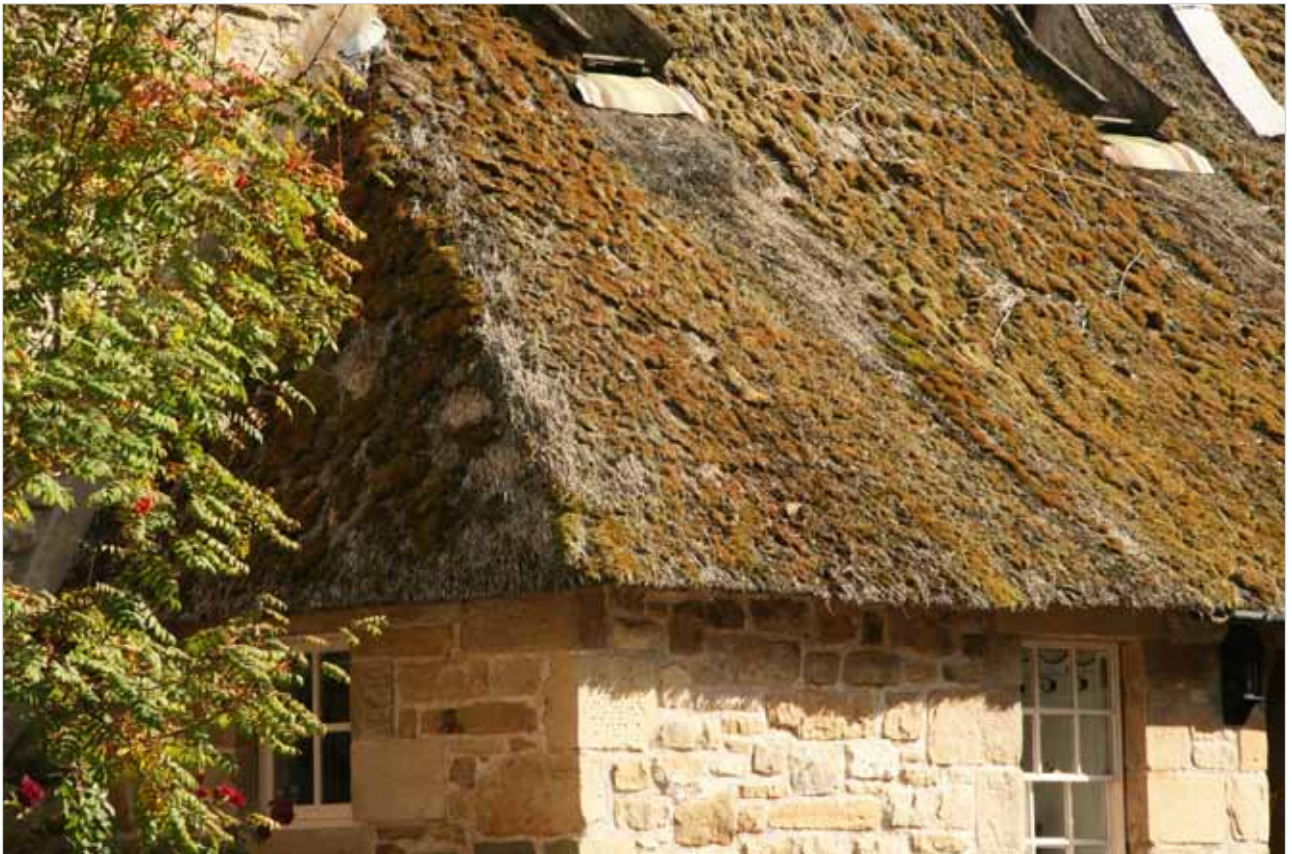
Ferniehirst Castle – Scottish Borders

Thatch Type: Reed
Ridge Type: Concrete
Condition: Fair

Additional Notes: Ferniehurst Castle was built in the late 16th century and it is the single-storey L-plan former kitchen wing to the south that is currently thatched. Simpson & Brown Architects were hired in 1987-90 to renovate these buildings, which were roofless at the time. In July 2014 a planning application was submitted by the owners (Lothian Estates) to remove the thatch on the building and replace it with Scottish slate. It was supported by examples of other outbuildings on the estate that were also roofed in Scottish slate. In October 2014 the planning application was granted permission, subject to a number of conditions regarding the materials and finishes used on the re-roofing. There are two window openings set into the thatched roof, two facing south-west and one facing north-east. The L-plan wing appears to have been extended at some point and this would explain the concrete cope that is present partway along the roof. None of the thatch has been netted. Some areas have had lead flashings installed, directly below the chimney stacks, copes and window openings. The eaves have been moulded slightly above some of the window openings on the south elevation and above the door opening on the east elevation. The thatch is in fairly poor condition, with many loose reeds on the surface of the roof, a large amount of mossy vegetation growth and general deterioration throughout. Work to remove the thatch is likely to begin soon and the wing will be slated.

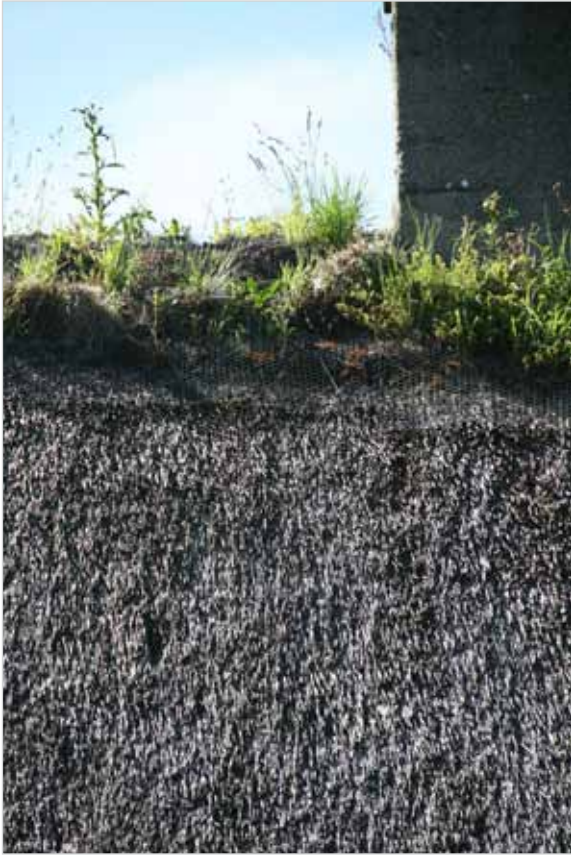
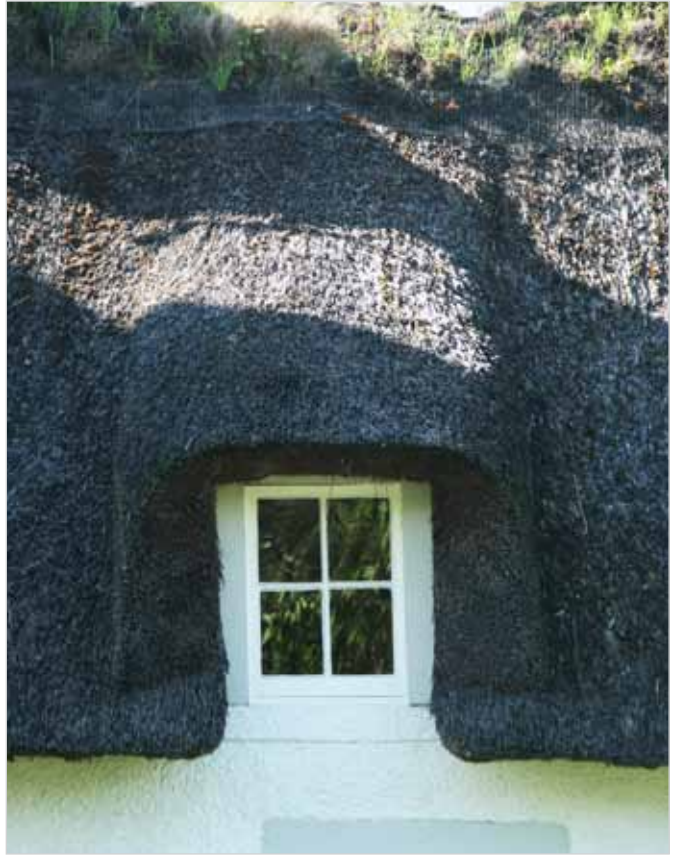
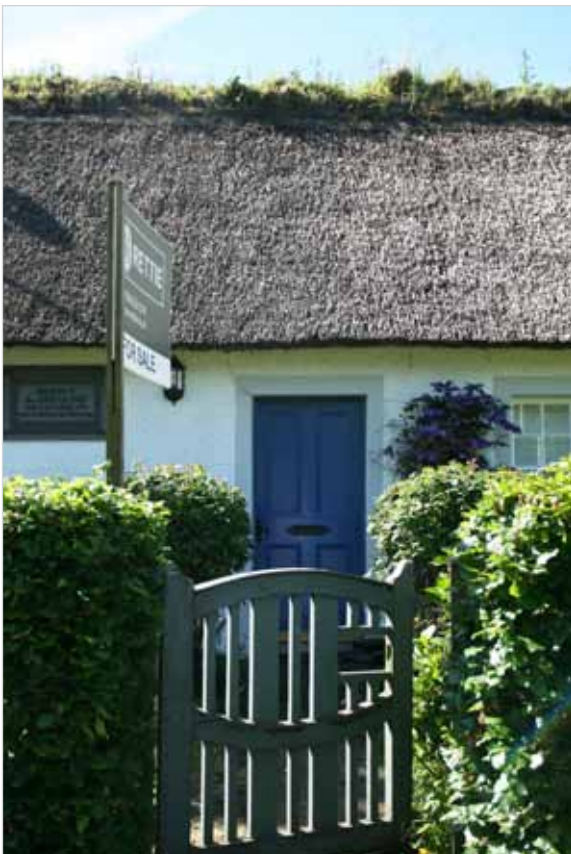
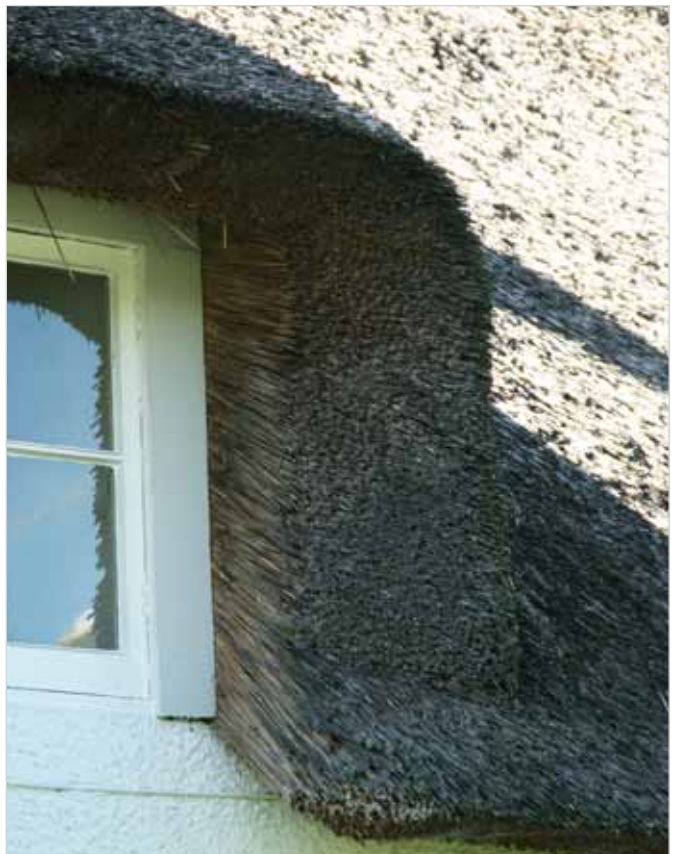
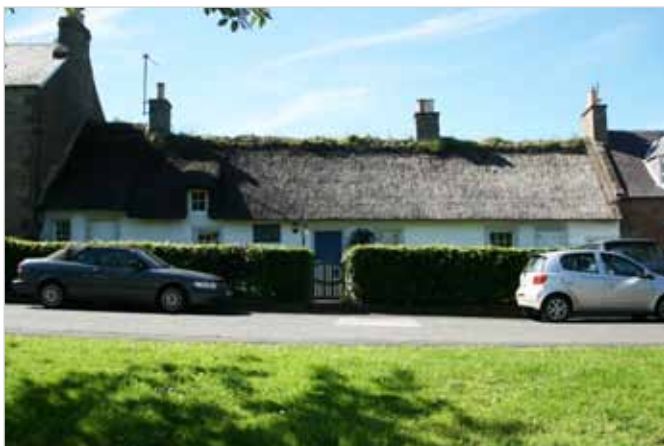
Leyden's Cottage – Scottish Borders

Thatch Type: Reed
 Ridge Type: Thatched (Turf)
 Condition of Thatch: Good

Additional Notes: Single-storey cottage with attic conversion, listed as being a 'restored property of the Edinburgh Border Counties Association' and having a thatched roof. The listed building description does not give an indication of when the cottage was built or when the mentioned restoration took place; however a plaque on the front of the building reads 'Birthplace of Dr. John Leyden Born 8th September 1775'. The roof is thatched in reed, with what appears to be the remains of a turf ridge. Whilst the ridge has become slightly 'wild', it is contained within its netting. The rest of the thatch is left uncovered. The building is listed as having 'one square raised

dormer'; however, the building currently has three dormer windows, one in the front elevation and two in the back elevation. The thatch is raised and sculpted around the dormer window openings. At the time of surveying, the building was up for sale.

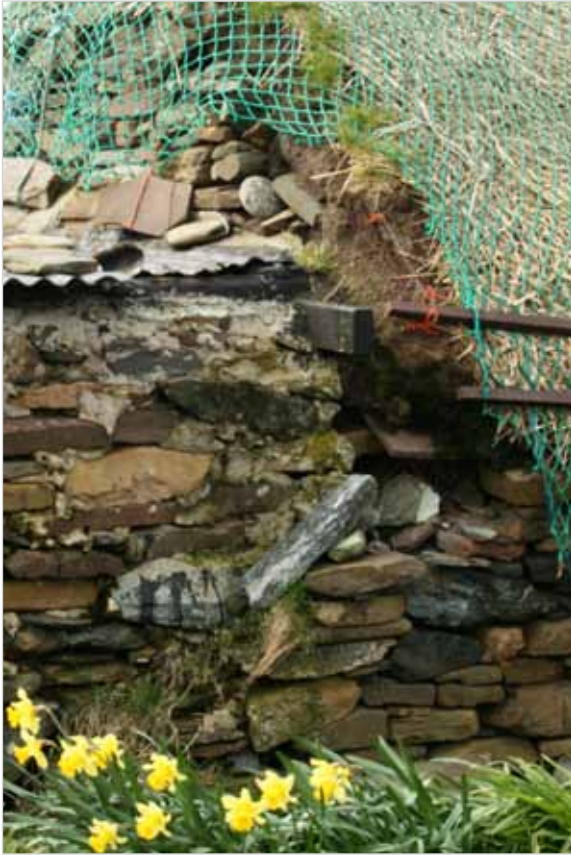
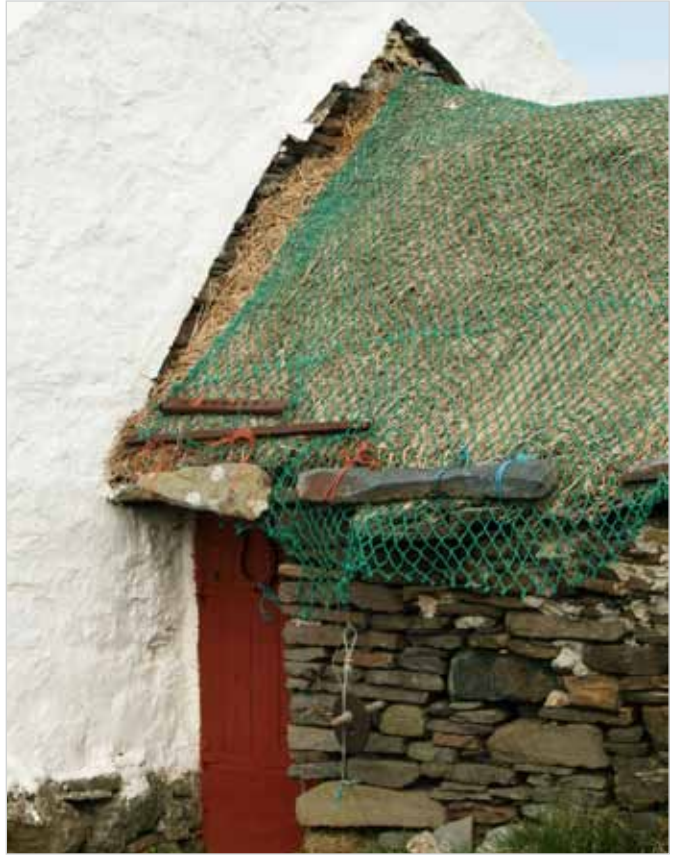
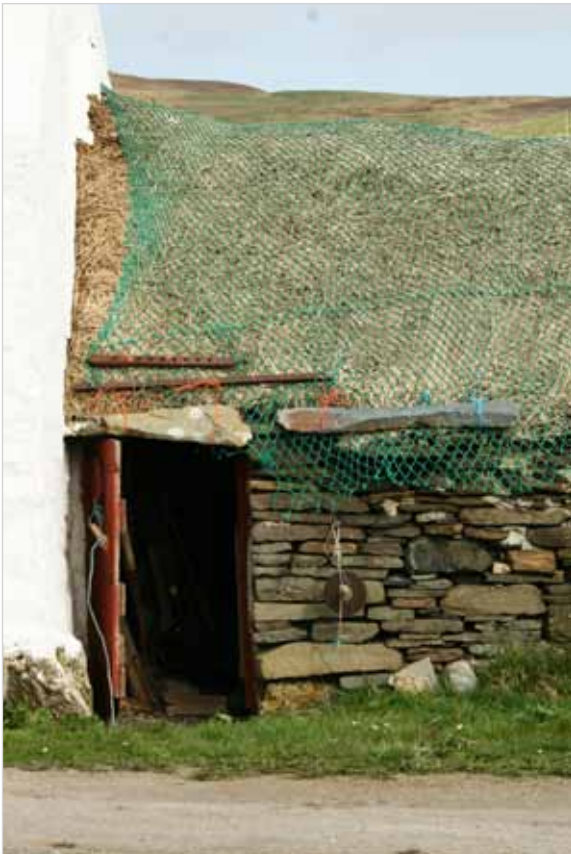
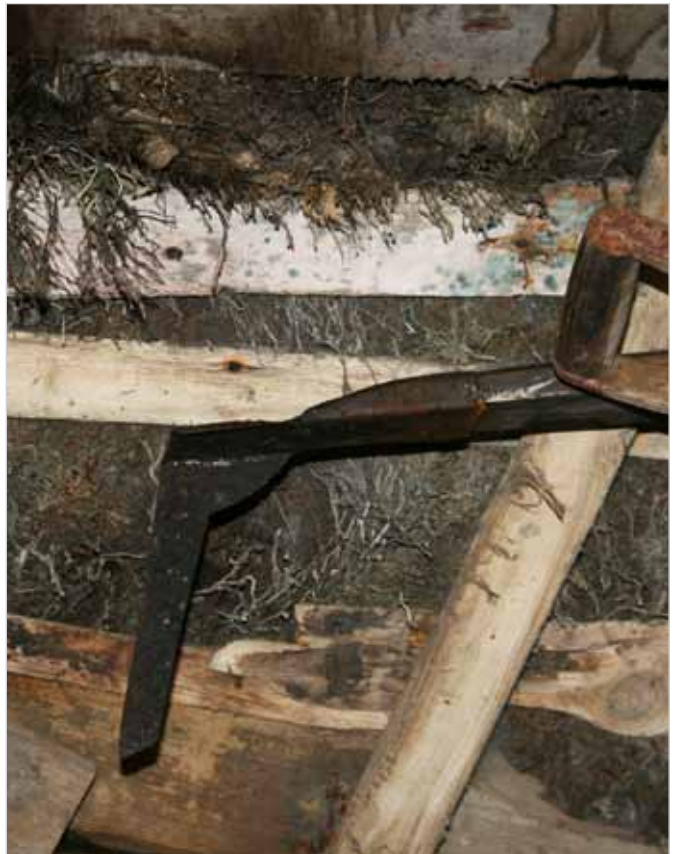
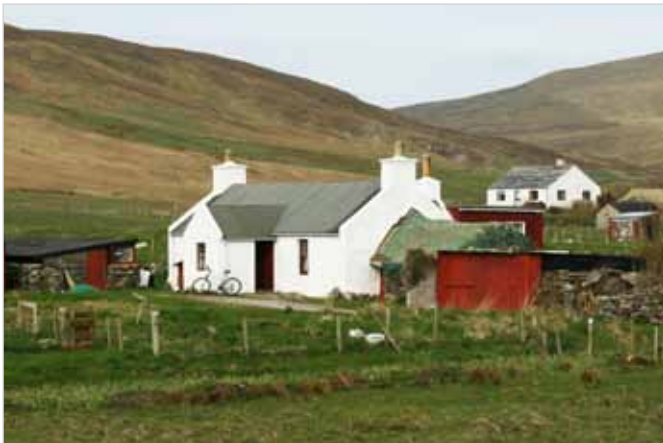
Villians Crofthouse – Shetland Islands

Single-storey flagstone rubble wing adjoining single-storey crofthouse to the north-east gable. Previously all were thatched; however, now only the wing retains its straw-thatched roof, and is currently used as an outbuilding for storage. A top-coat of thatch was last installed in 2014 by the owner of the building. Bale straw from Lerwick was used, however, previously the owner grew straw on his land and used this to thatch the roof. The owner stated that the roof needs a new layer of thatch every year. The layers of straw have been laid upon a underlay of turf, which can be seen through the roof structure internally. The thatch has been netted

with fishing net and weighted along the eaves using stones and metal poles, which have been secured to the netting with string. There is some minor vegetation growth in places and some visible shrinkage in the height of the thatch. Locals stated that traditionally buildings on Shetland were thatched using black oat straw.

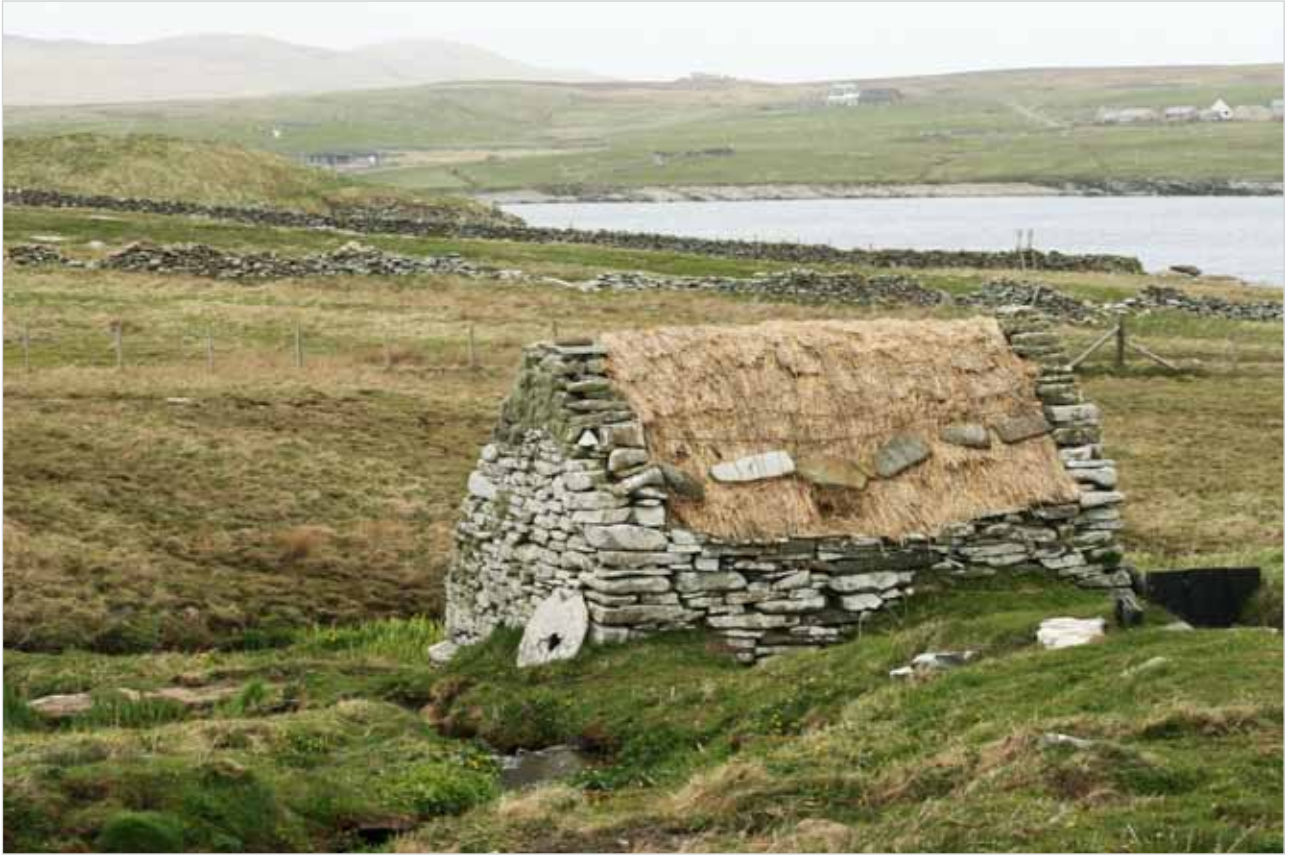
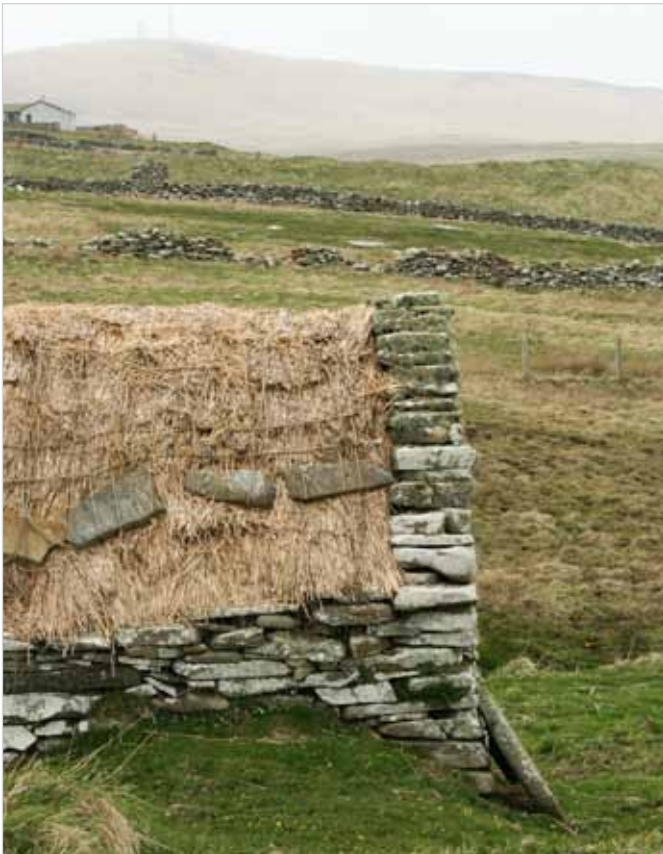
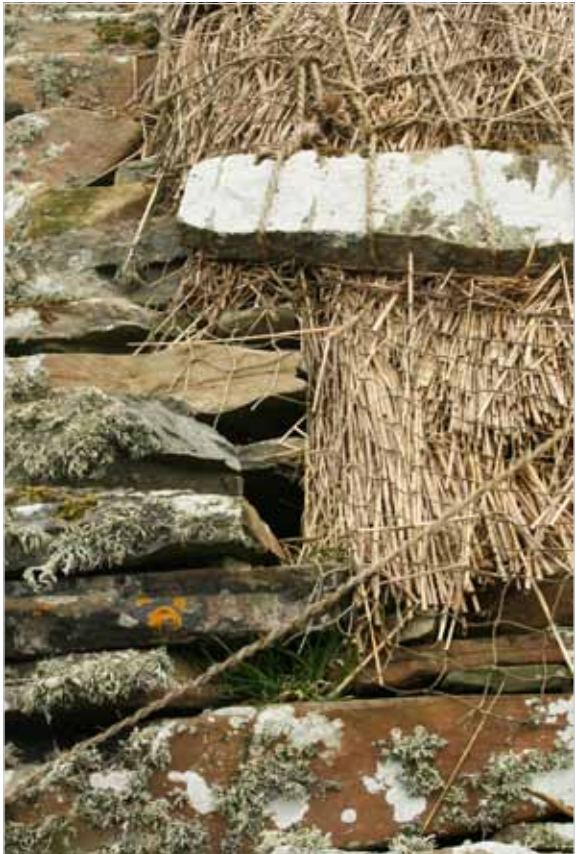
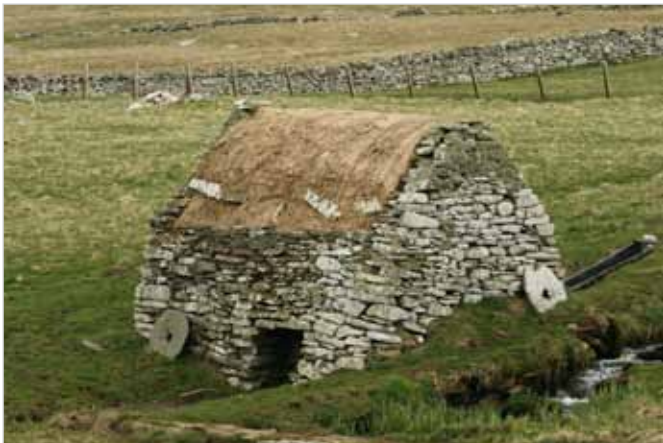
Southvoe Water Mills – Shetland Islands

Additional Notes: Later 19th-century mill, originally one of a group of three mills located along the same burn. The north mill of the three mills at Southvoe retains a straw-thatched roof, whilst the other two mill buildings are now ruins. The mills are associated with the crofting settlement at Southvoe, which is now the Shetland Croft House Museum (also thatched, survey number 194). The mill is now part of, and maintained by, the Shetland Croft House Museum; however, the building is no longer used as a working mill. The thatch is netted using fishing net, which is weighted down using stones tied to the netting with string, placed at about a foot above the

eaves on both the front (north) and back (south) elevations. Whilst the condition of the straw is good, there are a number of small openings in the thatch, along the skewers and at the eaves, exposing a small amount of the buildings' interior. The roof is continuously thatched in straw across the ridge.

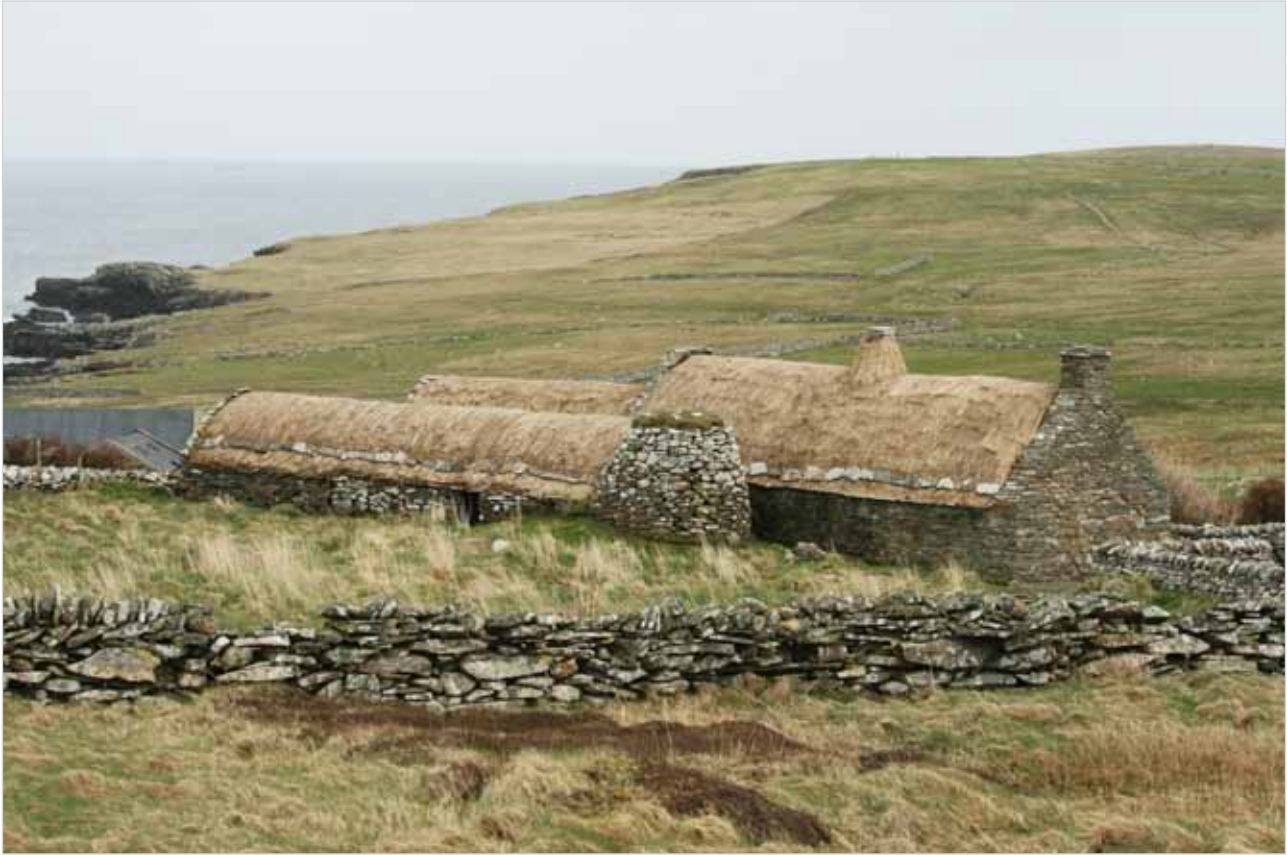
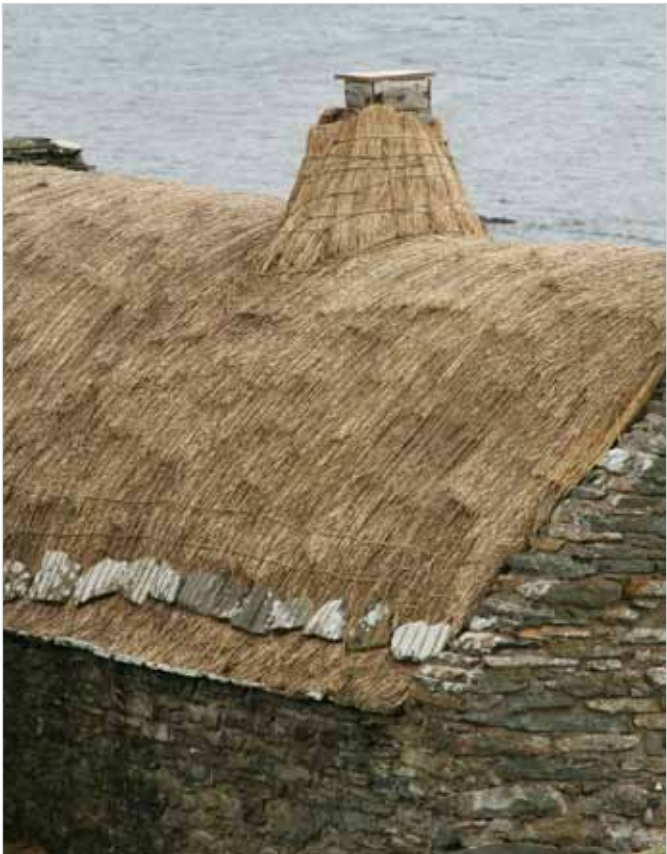
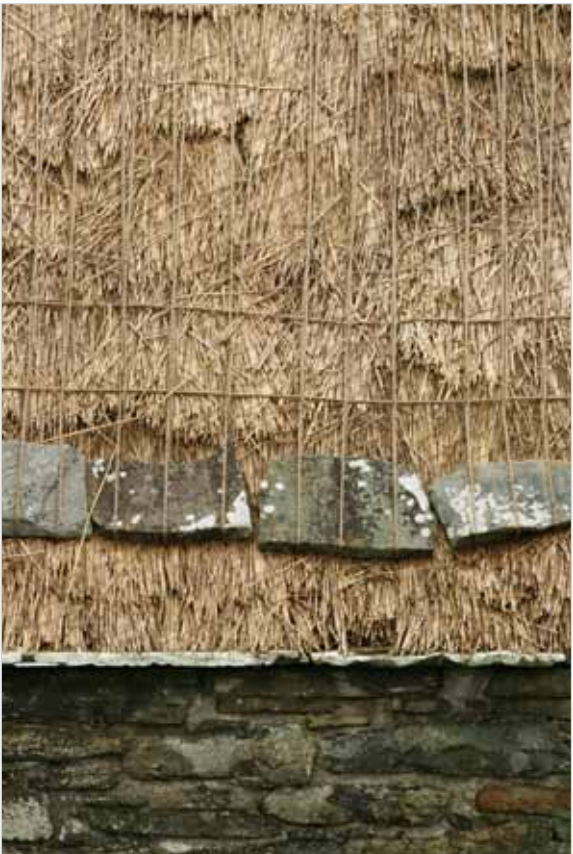
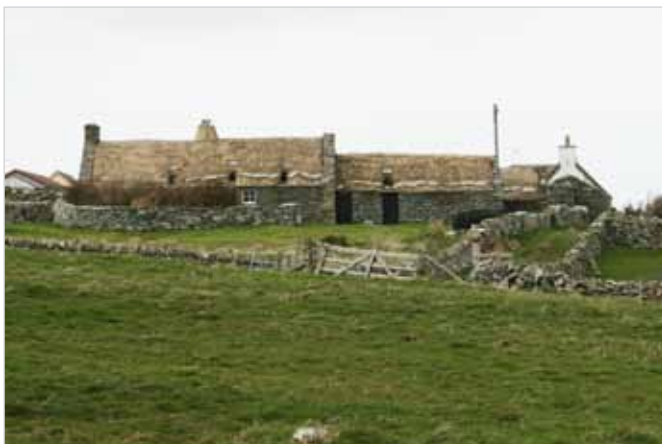
Shetland Croft House Museum – Shetland Islands

with thin ropes that extend across the ridge, and stones tied with rope at around a foot above the eaves and

window openings. The thatch on the chimney stack has been tied with string; however, it has not been netted.

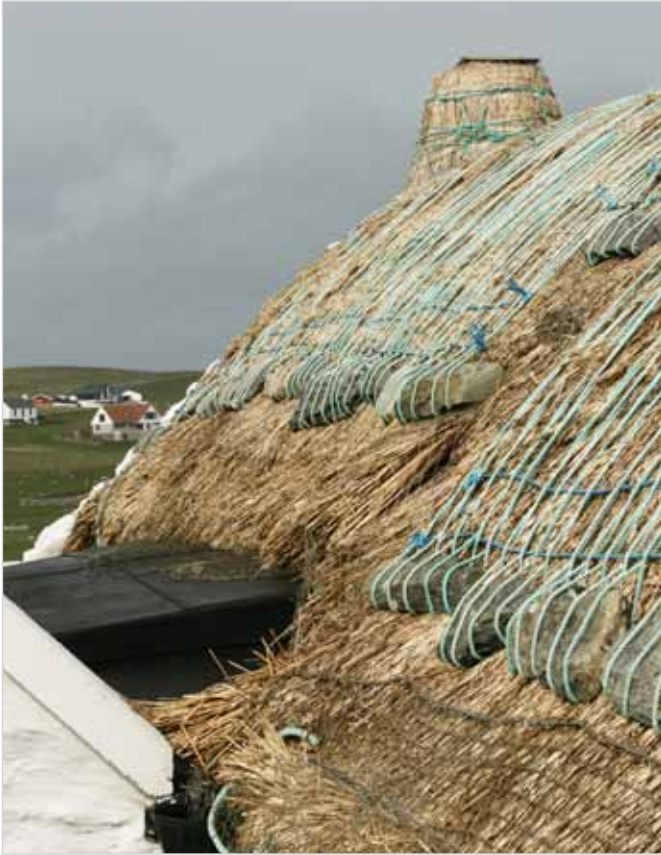
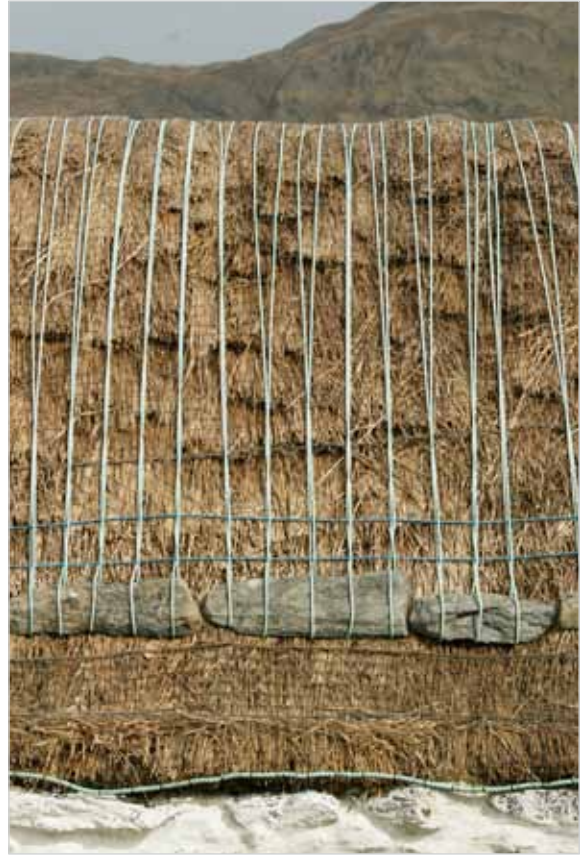
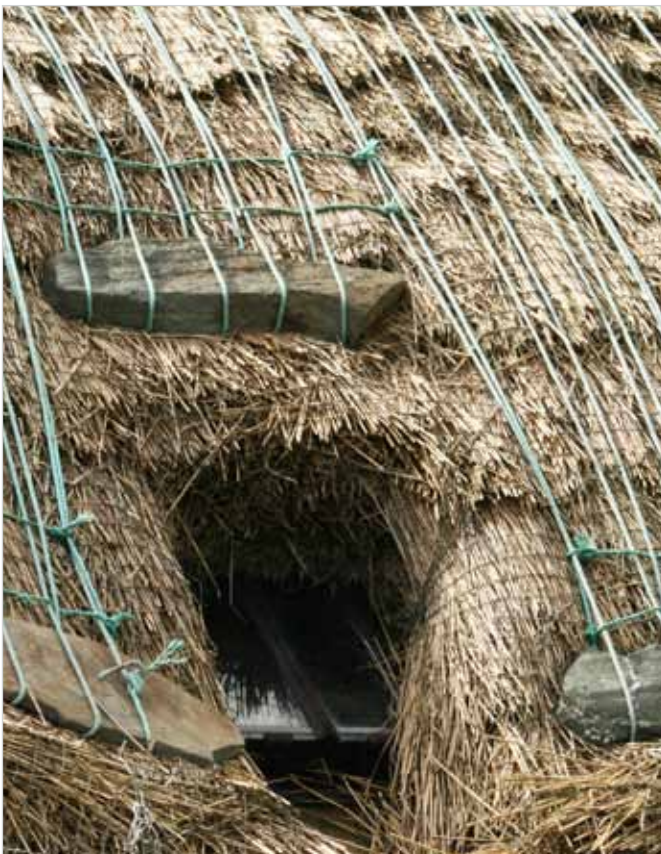
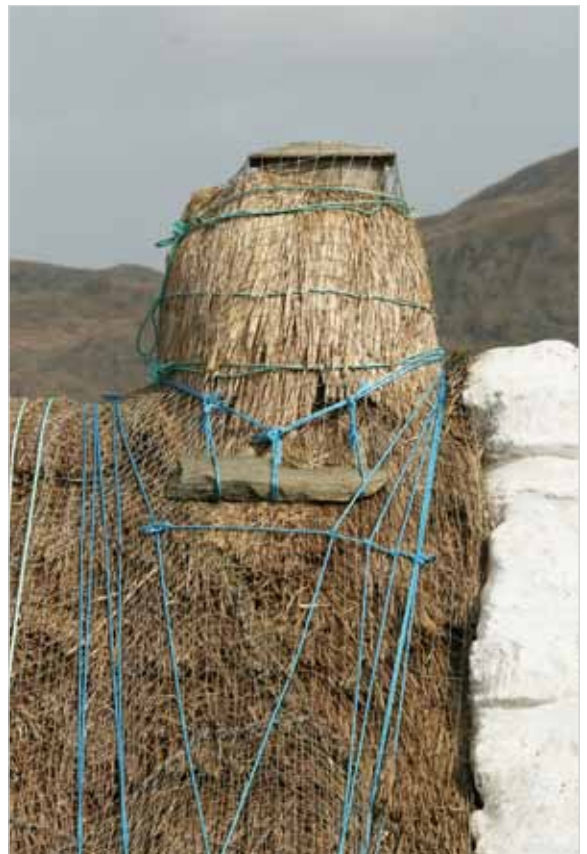
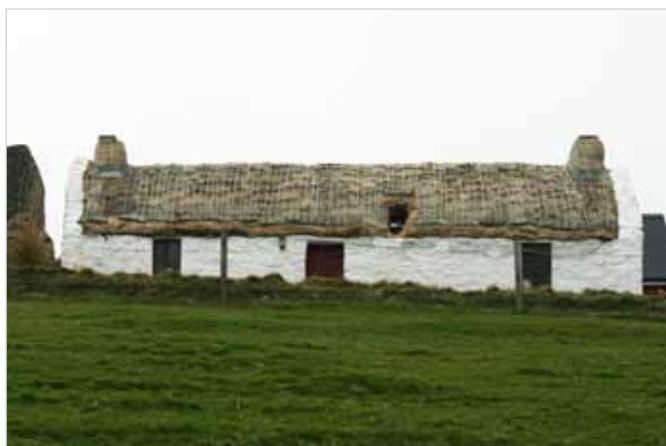
Easthouse Croft – Shetland Islands

Additional Notes: North cottage, part of a group listing of late 19th and early 20th-century crofting settlement currently used as a museum. The south cottage now has a tar-felted roof, whilst the north cottage is listed as having a 'taekkit (thatched) roof with linkstanes and cast-iron skylights at eaves; rigin (ridge) terminated at gables with thatched lums'. The roof is thatched in straw, a traditional thatching material on the Shetland Islands (traditionally black oat straw). The thatch also covers the chimney stacks (lums) and continues across the ridge. The thatch is entirely netted using fishing net, which has been weighted with string and stones. The string wraps

around the lums and has been used across the ridge and tied to the stones that sit just above the eaves. The straw appears to be slightly loose in small patches across the roof; however, the roof structure or interior does not appear to be exposed in any way. The roof of the adjoining wing to the west is felted.

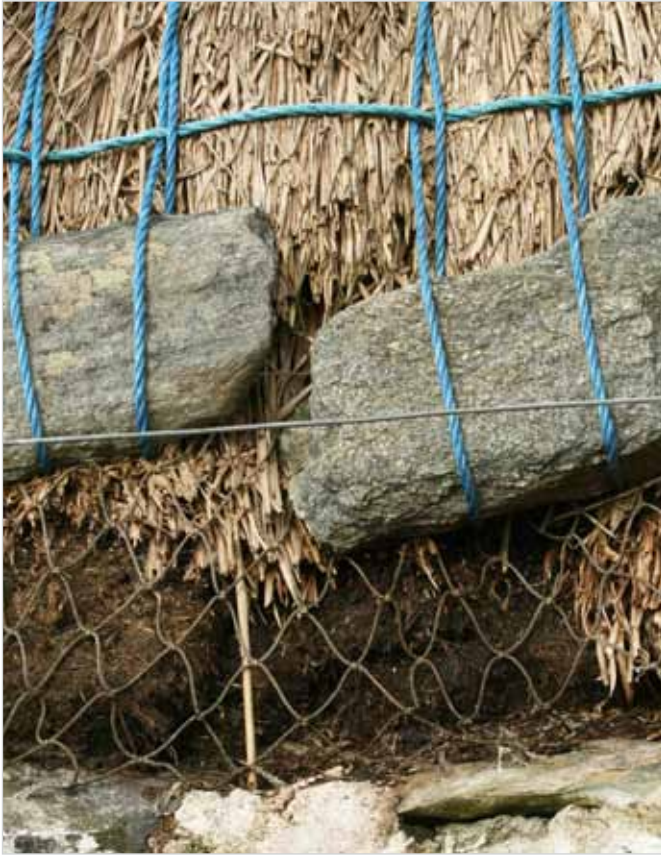
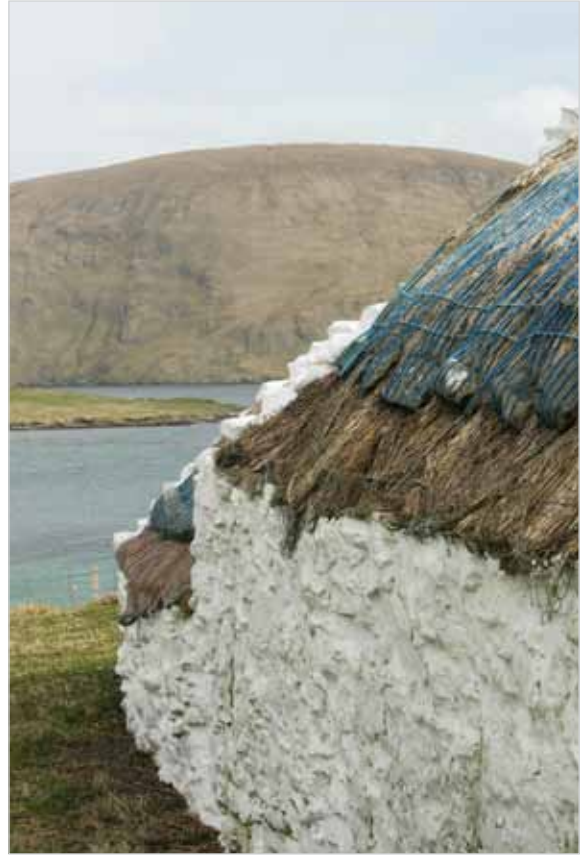
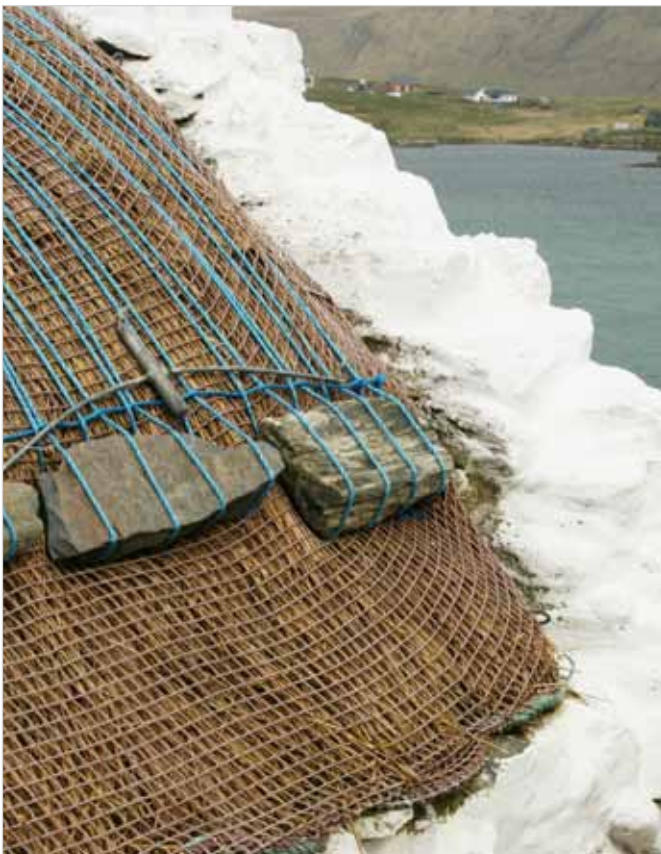
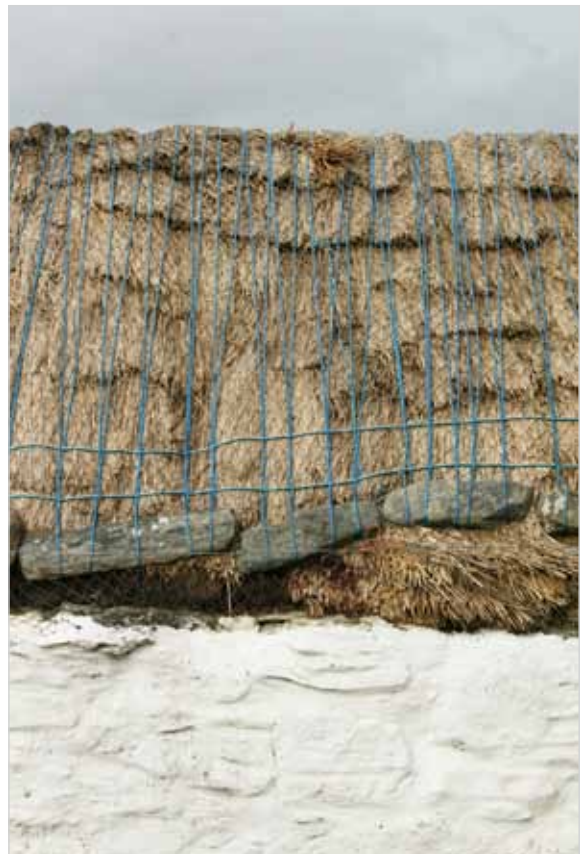
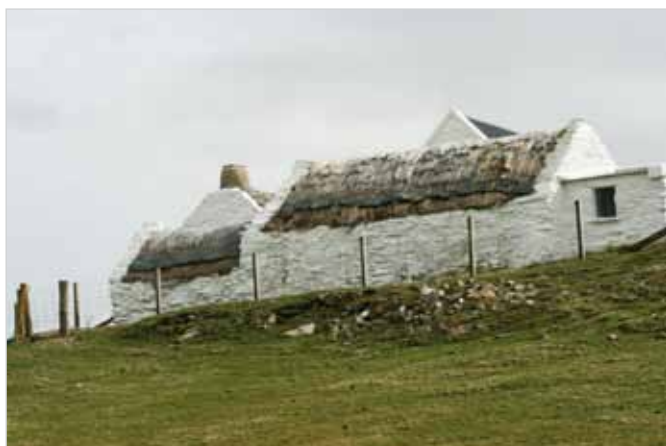
Easthouse Byre and Pig Sty – Shetland Islands

Additional Notes: Byre and pig sty, part of a group listing along with late 19th and early 20th-century crofting settlement, currently used as a museum. The listing notes read 'a now rare example of a crofting settlement, currently unrestored (1997), with its various outbuildings and thatched roofs surviving'. The listing description states that both the byre and pig sty have a turf roof at the time of listing in 1997; however, they are currently thatched in straw. The straw is held in place by fishing net, which has been weighted by strings that extend across the ridge and are tied to stones that are placed just above the eaves. The straw has become slightly dislodged

and sagging in places, with small sections of a turf underlay becoming exposed in sections along the eaves and down the skews of both roofs. An additional metal wire has been used below the stones to further secure the netting at the eaves. Whilst the adjoining hen house to the west of the byre is listed as having a felted roof, it currently has a corrugated iron roof.
