A Survey of Thatched Buildings in Scotland

Thatch Survey of Scotland
2014-15

A photographic survey of thatched buildings in Scotland, surveyed between May 2014 and August 2015 by Zoe Herbert (SPAB Scotland Officer), on behalf of the Society for the Protection of Ancient Buildings.

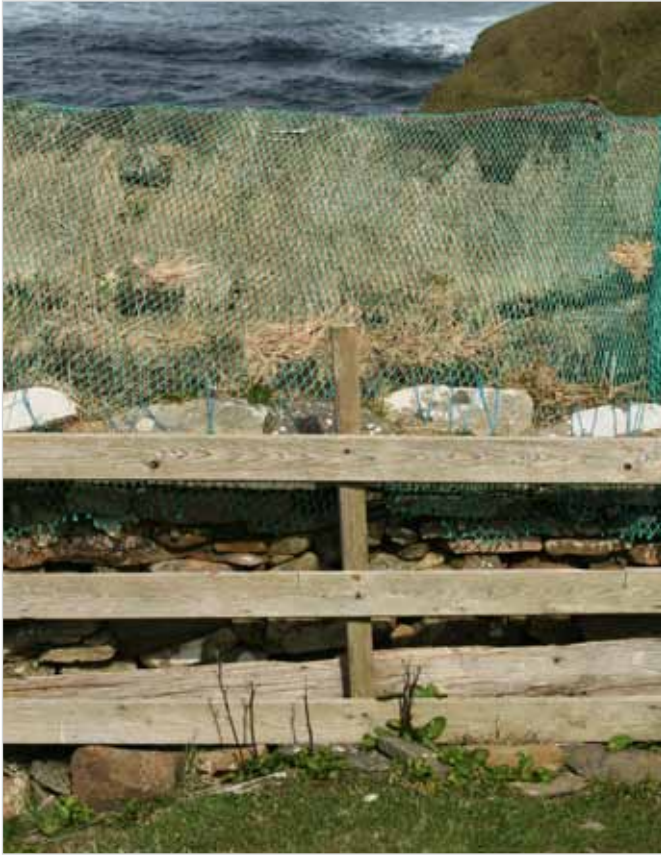
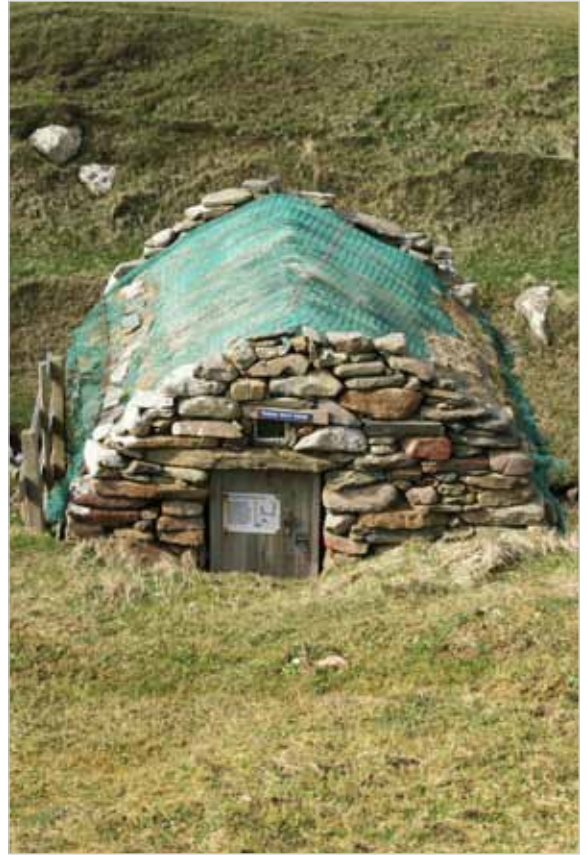
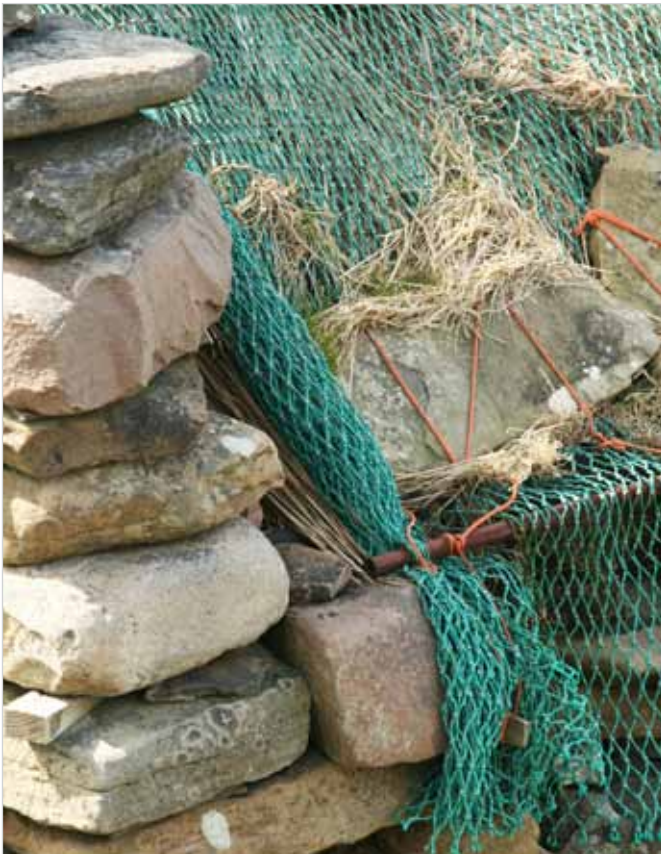
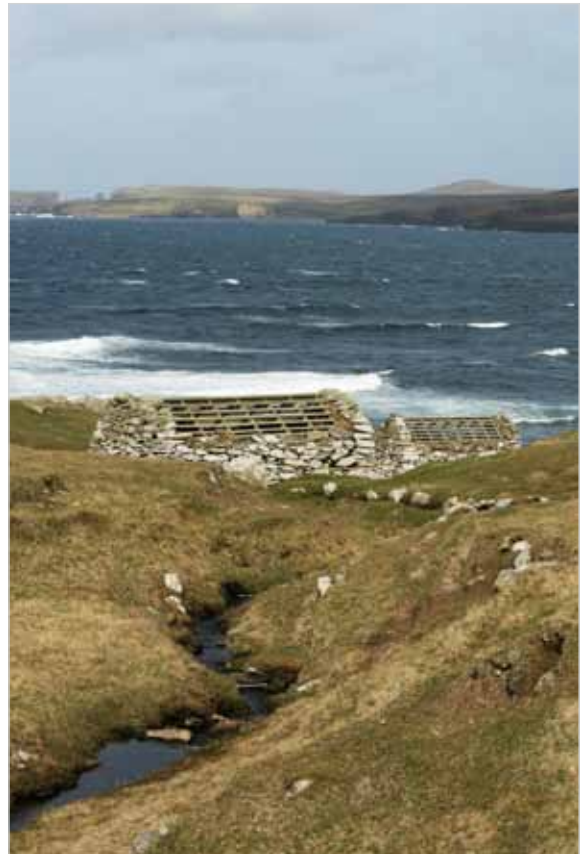
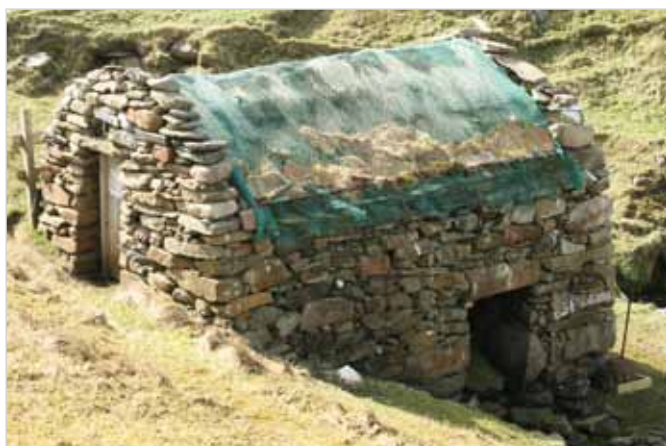
Huxter Mills – Shetland Islands

Additional Notes: One of three later 19th-century mills situated by a stream and on a hill sloping to the west. All three mills were originally thatched, the listed building description stating the '*thatched roofs [were] secured by simmonds and linkstones*'. The lowest mill (north-west) is the most recent to have had a thatched roof, which, according to a local person, was last thatched a few years ago by the Shetland Croft House Museum, who maintain the buildings. Whilst there is visible evidence of thatching material still in situ on the north-west mill building, most of the thatched roof is now missing. Evidence of a turf underlay and straw top coat can be seen. A layer of fishing

net has been installed between the thatch and the top coat of thatch, which has mostly been lost. The thatch was weighted using string, stones and metal poles at the eaves, which are still in situ. The notes of the listed building description read '*these recently restored mills were last used during the Second World War*'.

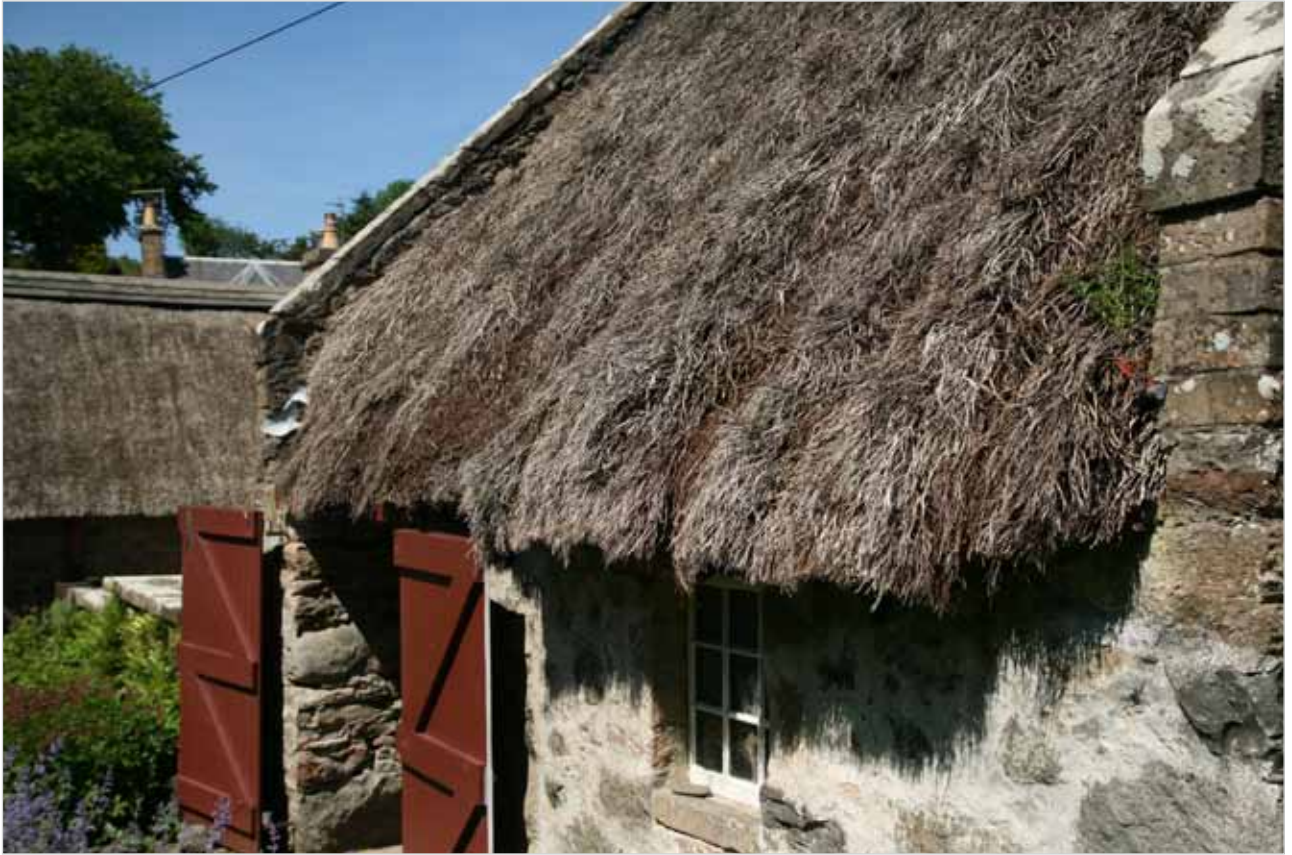
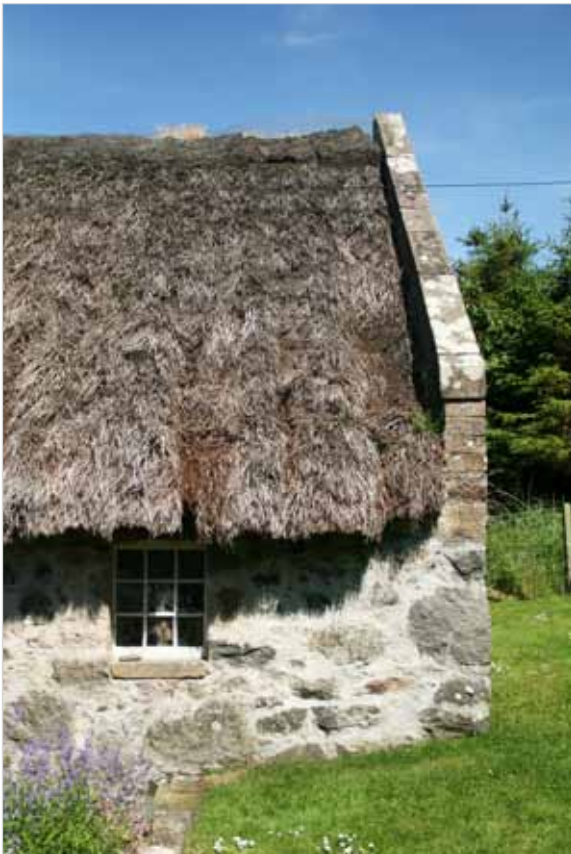
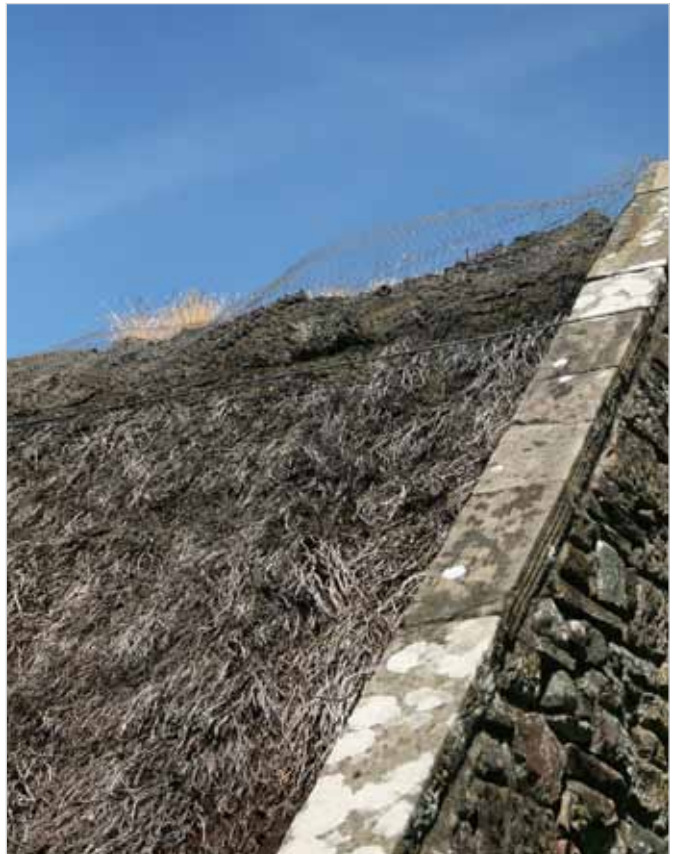
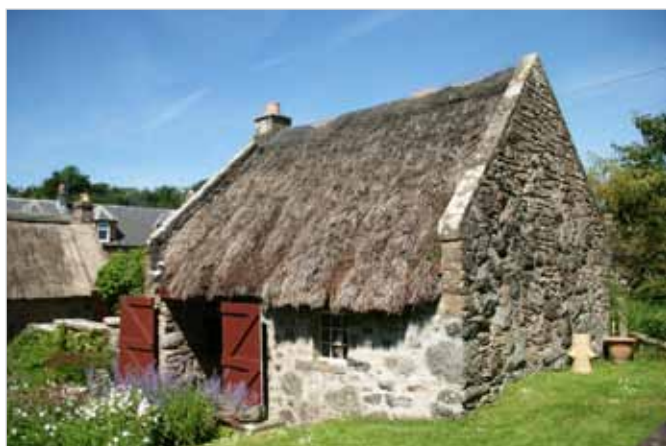
The Ale House – South Ayrshire

The building known as the 'Ale House', is located in the back garden of the National Trust for Scotland-owned property Souter Johnnie's Cottage. Whilst Souter Johnnie's is listed, there is no mention in the listing description of a cottage in the garden, however; the 'life size figures of Tam O'Shanter', which are currently kept inside the Ale House as part of the museum collection, are mentioned. The Ale House was last thatched in 1998 and currently the heather is in a fairly poor condition. The thatch has apparently deteriorated significantly in the last six months, over the 2013/14 winter period. Patches of heather are missing in places and a few holes have

begun to appear in the thatch, exposing the roof structure below. The ridge has also deteriorated significantly, visibly demonstrated by the difference in height between the ridge and the netting. The ridge is netted, whilst the rest of the thatch is left uncovered. The building is due to be re-thatched during the coming year.

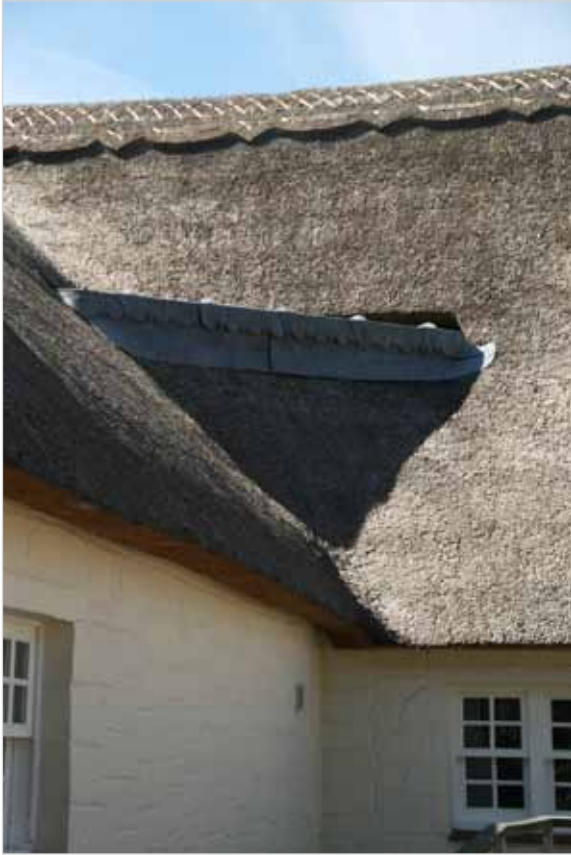
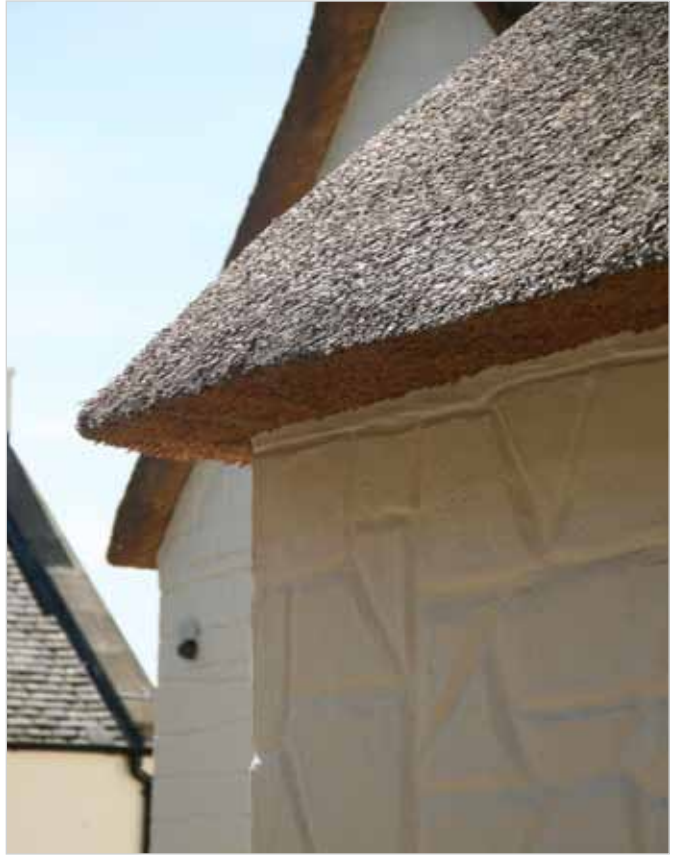
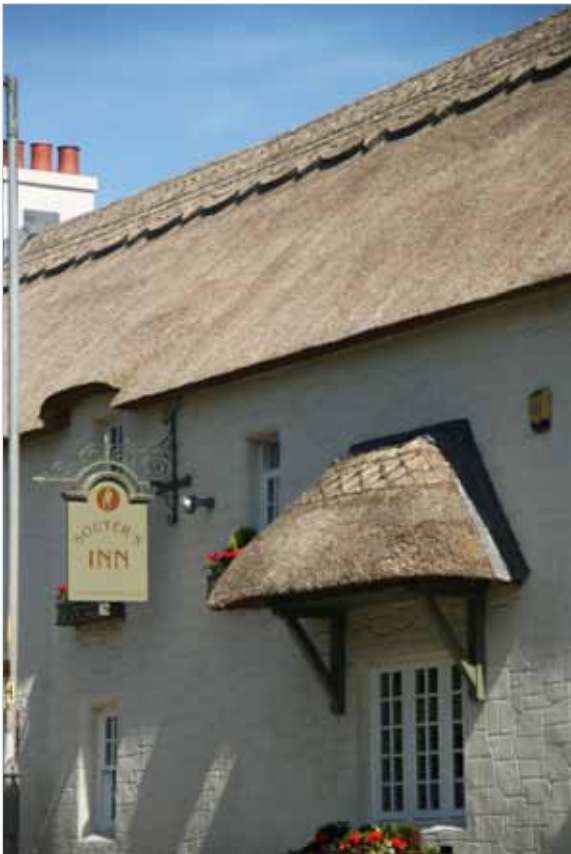
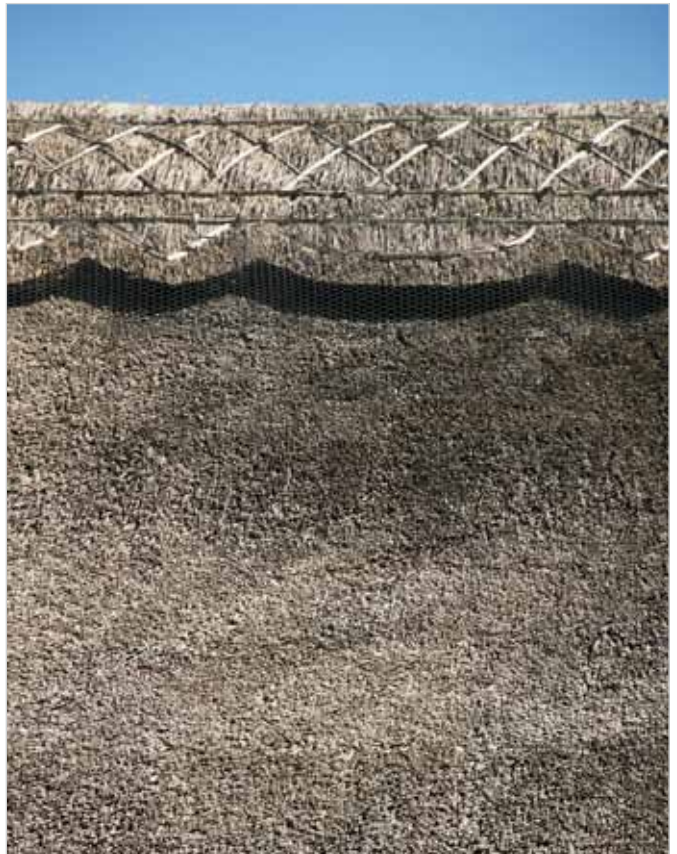
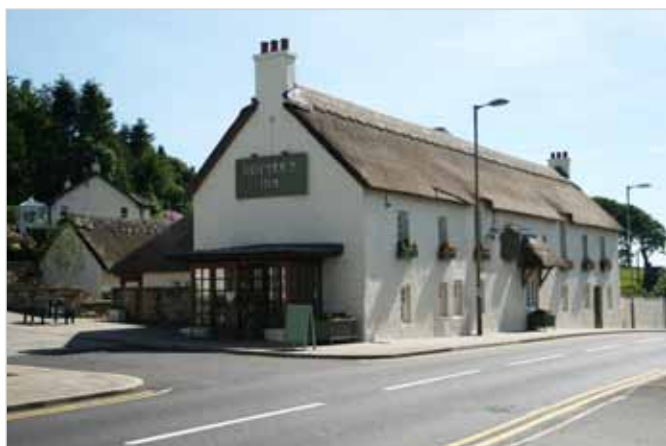
Souter's Inn – South Ayrshire

Additional Notes: Restaurant building, apparently built on the site of the old school house where Robert Burns studied in 1775. The building was first thatched, following refurbishment, around five years ago, circa 2009. However, in early 2012 the thatched roof of the building caught fire and much of the thatch was destroyed. During the incident a section of the roof also collapsed. Following the fire, the damage to the building was repaired and the roof was re-thatched in 2013. The thatcher was based in England and the reed came from Belgium. A fireboard has been installed underneath the thatch and a magma spray has been used on top to prevent fire. The

raised ridge is scalloped, and scobed using hazel spars. The ridge is netted whilst the rest of the thatch is left uncovered. On the north elevation, the roof is hooded at the eaves above two first-floor window openings. There is also a thatched awning above a ground-floor window on the north elevation, which is scobed and netted at the top.

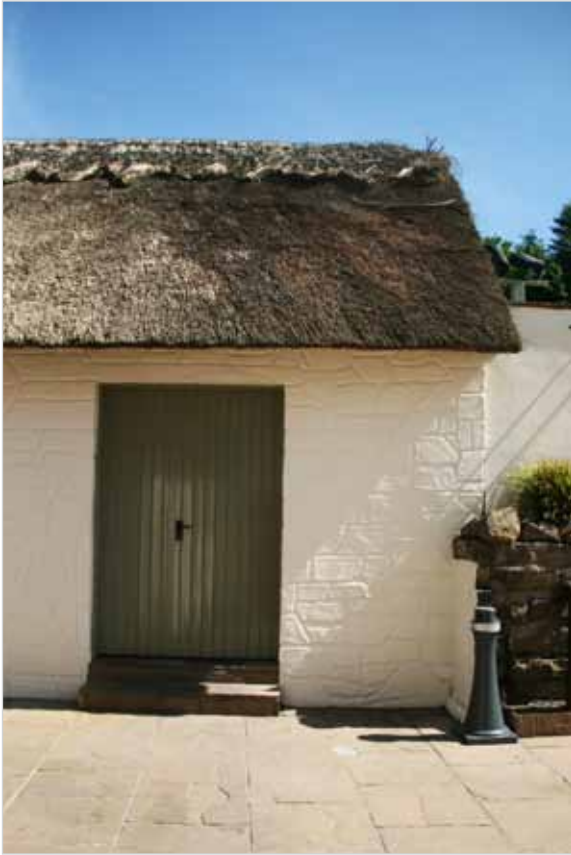
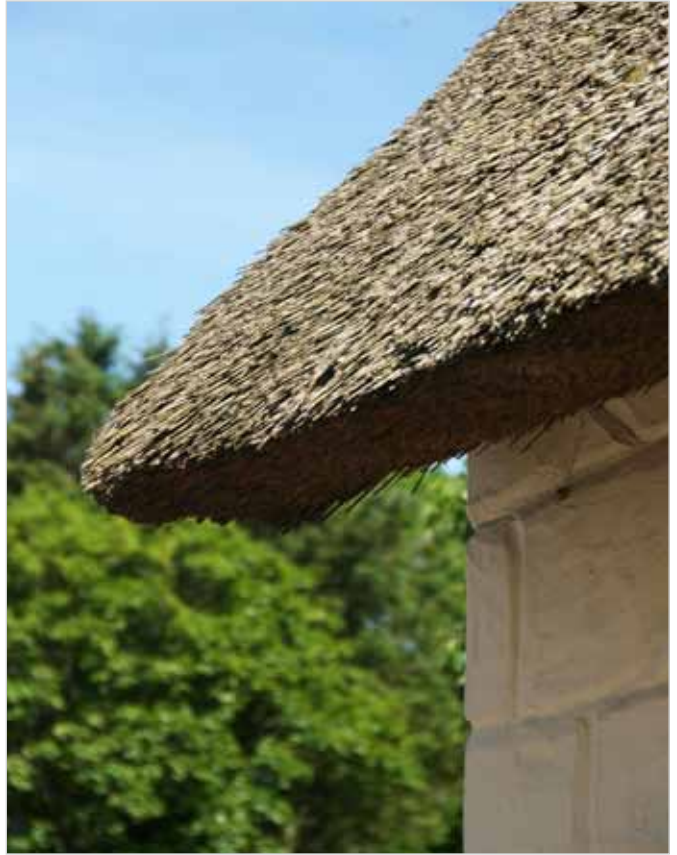
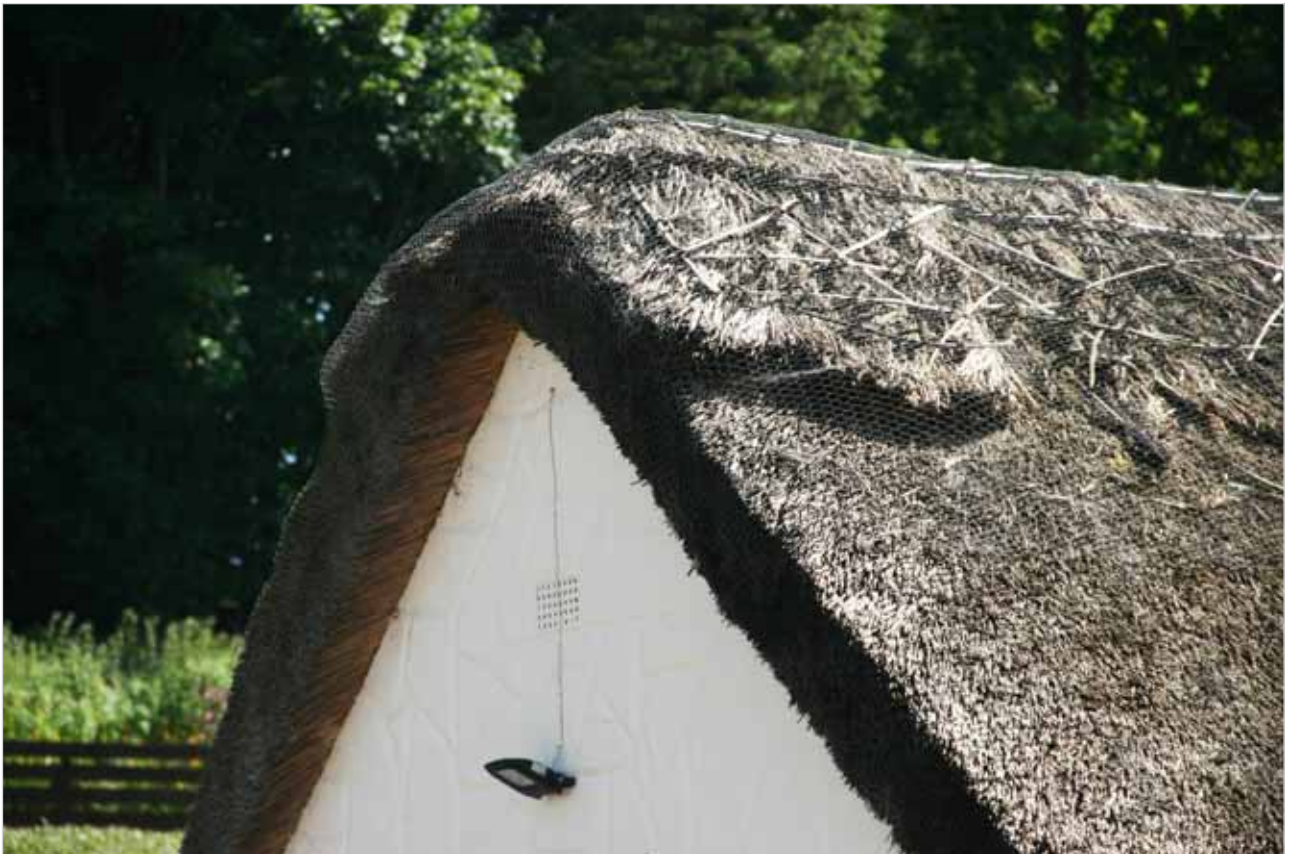
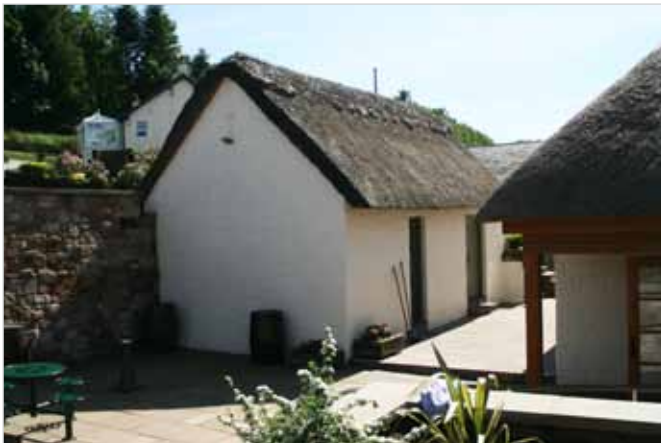
Souter's Inn Larder – South Ayrshire

Condition of Thatch: Fair

Additional Notes: The building was thatched circa 2009. In April 2012 the thatched roof of the main building of Souter's Inn caught fire (Survey Number 201). According to the owner, the larder building is located between the part of the roof that was on fire and the car park where the fire engines needed to park in order for the hoses to reach the fire. The hoses needed to be taken over the roof of the larder and subsequently the scobed ridge of the building was damaged. The ridge, and just below the ridge, has since been netted to protect the damaged thatch or any of the hazel spars from the becoming dislodged and falling off. Due to the high cost of re-thatching

Souter's Inn after the fire, the ridge on the larder building was not deemed urgent at this time. The roof remains watertight despite the damage. The owners plan to have the ridge fixed at some point next year. The thatch below the ridge is in good condition and has only a very small amount of mossy vegetation growth in places.

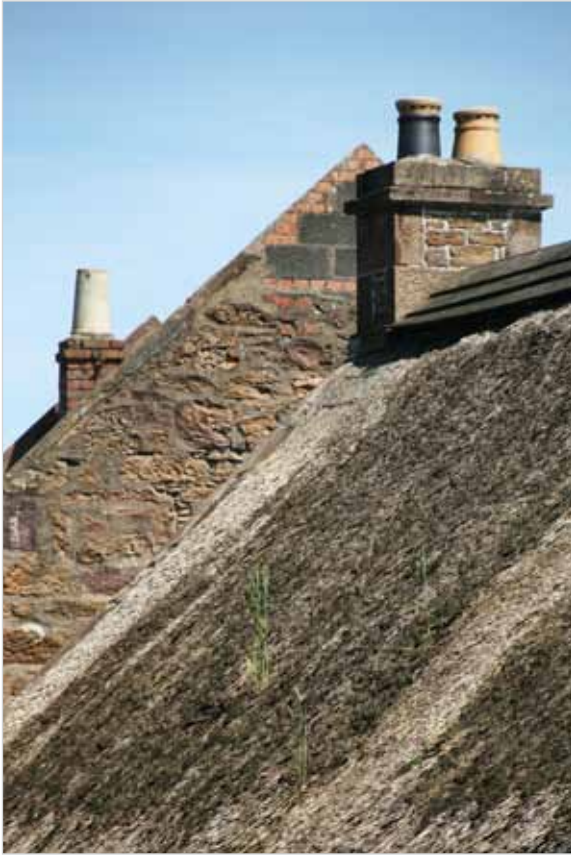
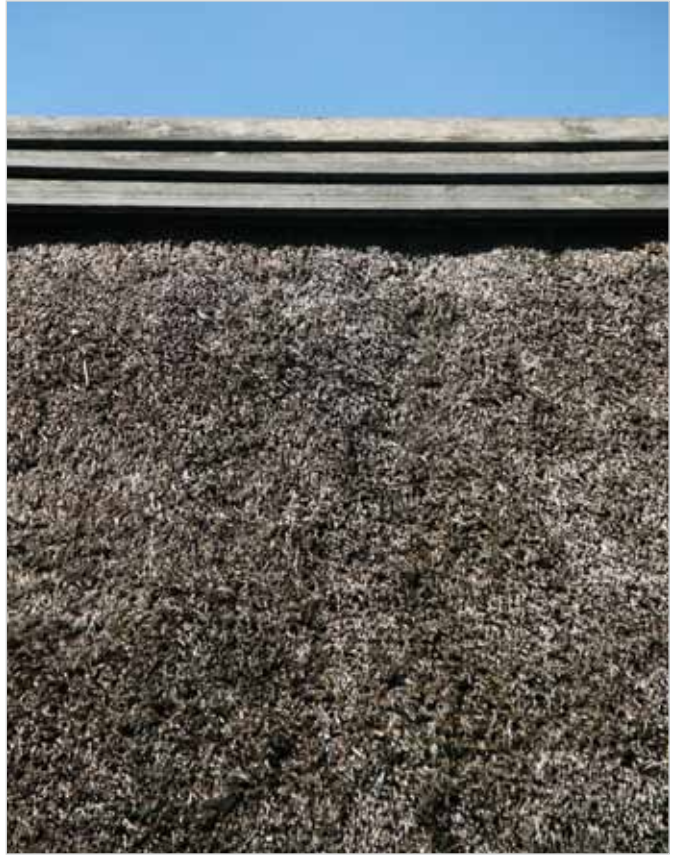
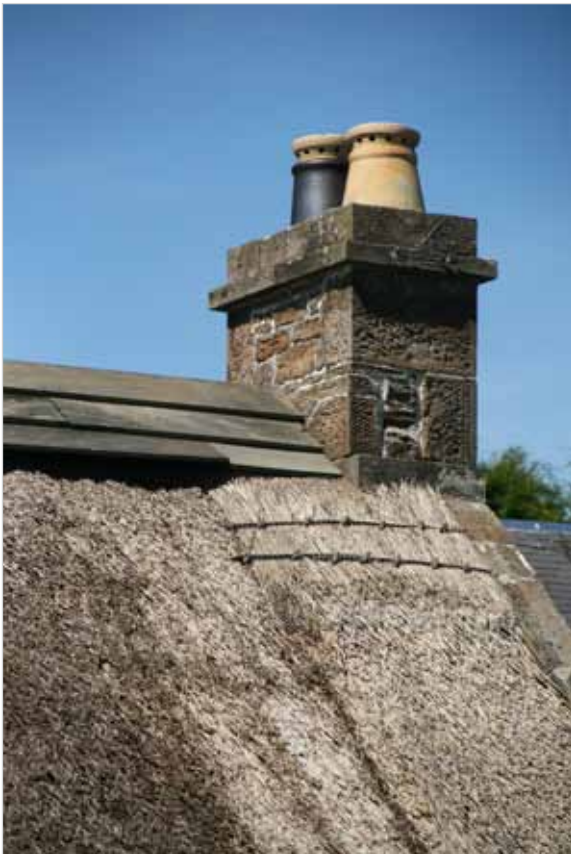
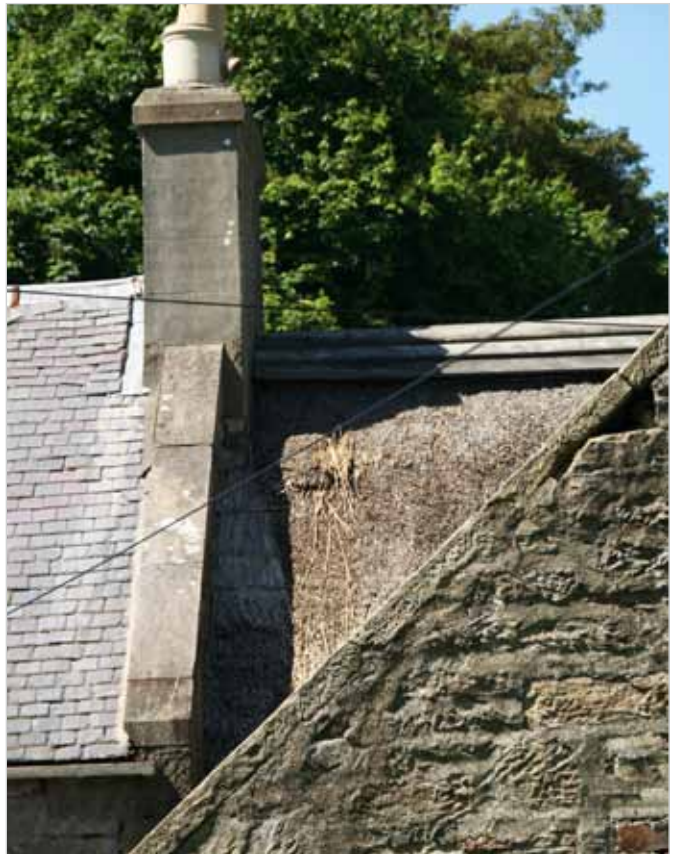
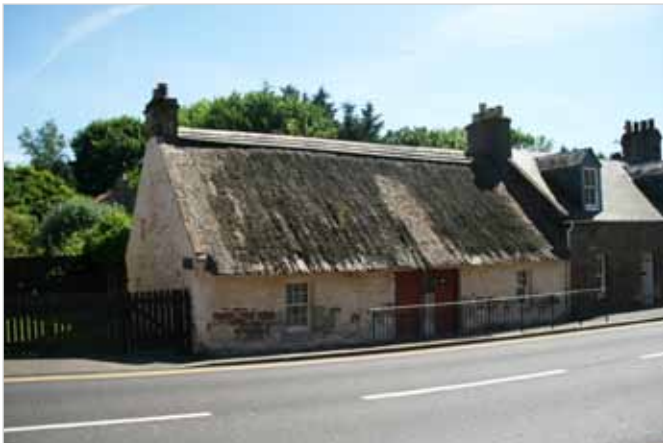
Souter Johnnie's Cottage – South Ayrshire

Condition of Thatch: Fair

..... When the thatchers were re-thatching the roof at nearby Souter's Inn in 2013, two repairs were made to the roof

..... of Souter's Cottage, one directly below each of the chimney stacks. The repair patches are scobed using hazel spars

..... 2013 repairs. There is some deterioration to the

..... the north elevation, where some small plants have

..... begun to grow out of the straw.

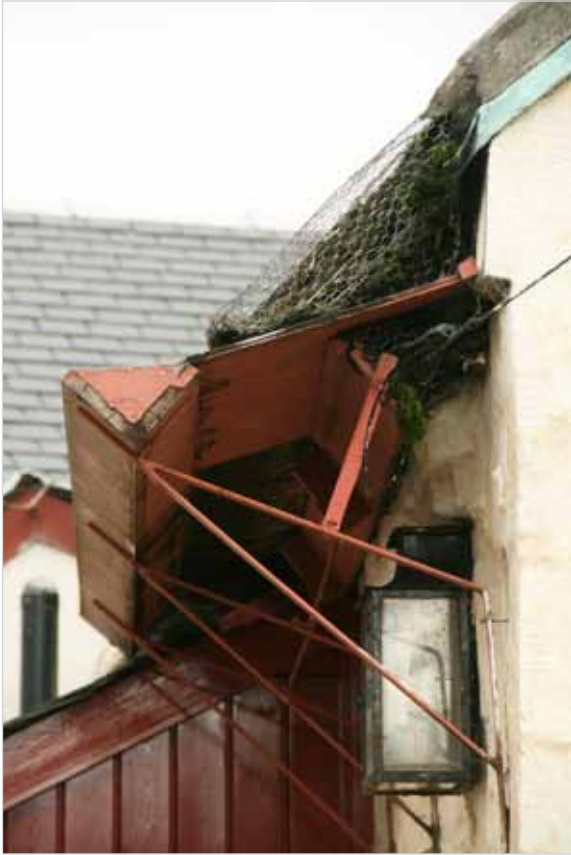
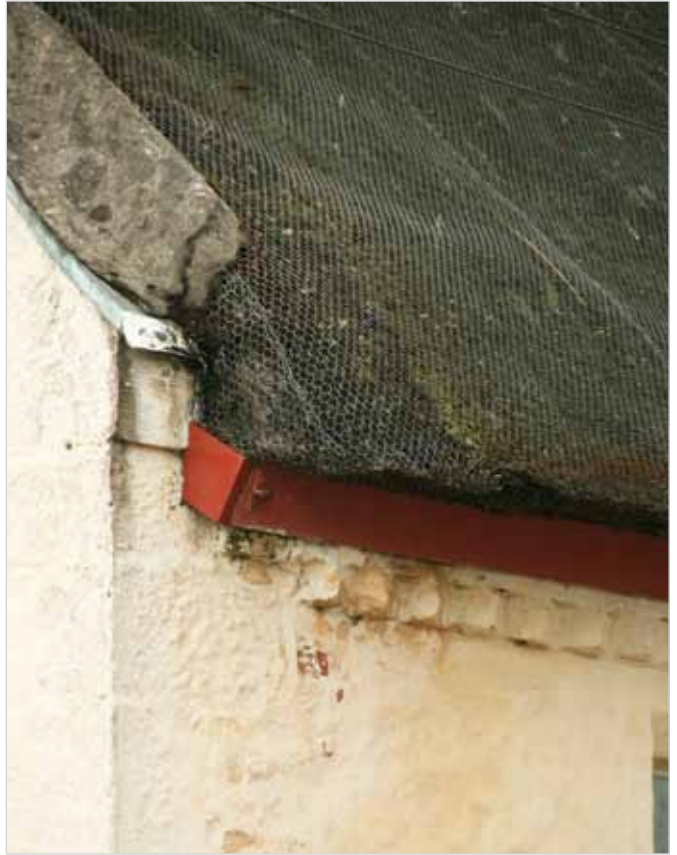
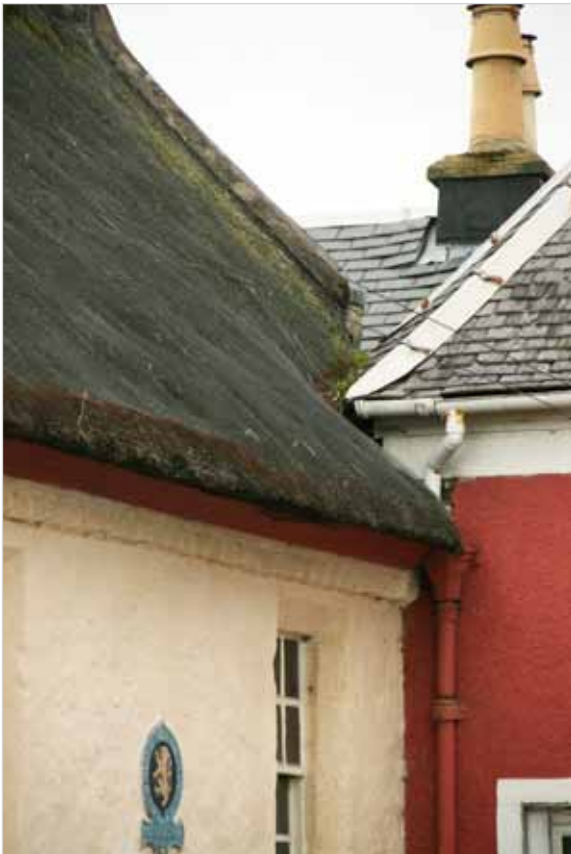
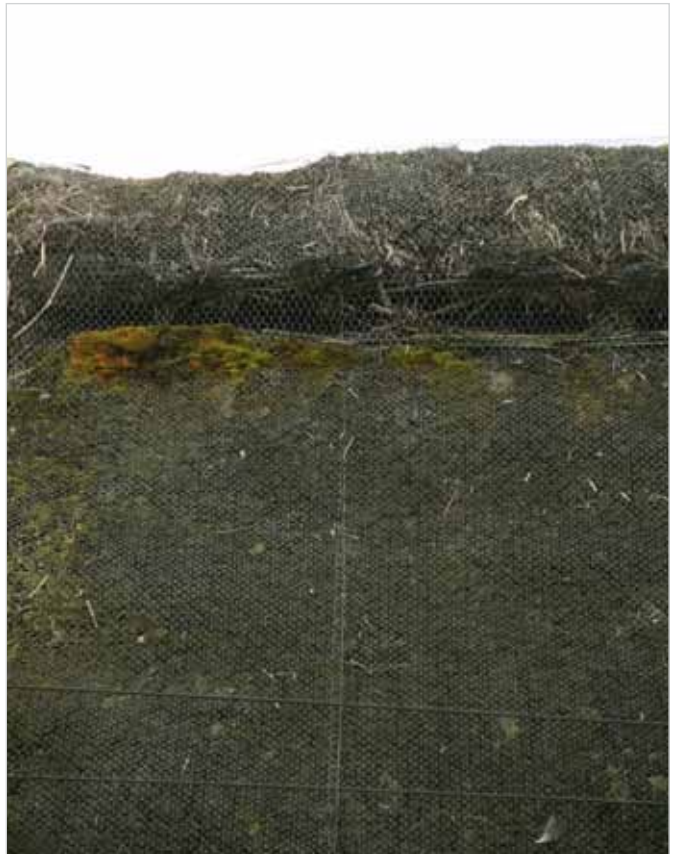
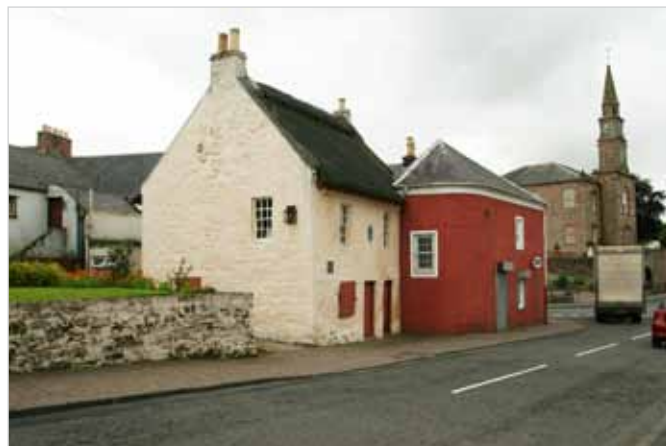
Burns Bachelors' Club – South Ayrshire

Condition of Thatch: Fair

underneath the eaves. The thatch has deteriorated

somewhat and the surface of the thatch is uneven.

some loose pieces of thatch, particularly along the

ridge.

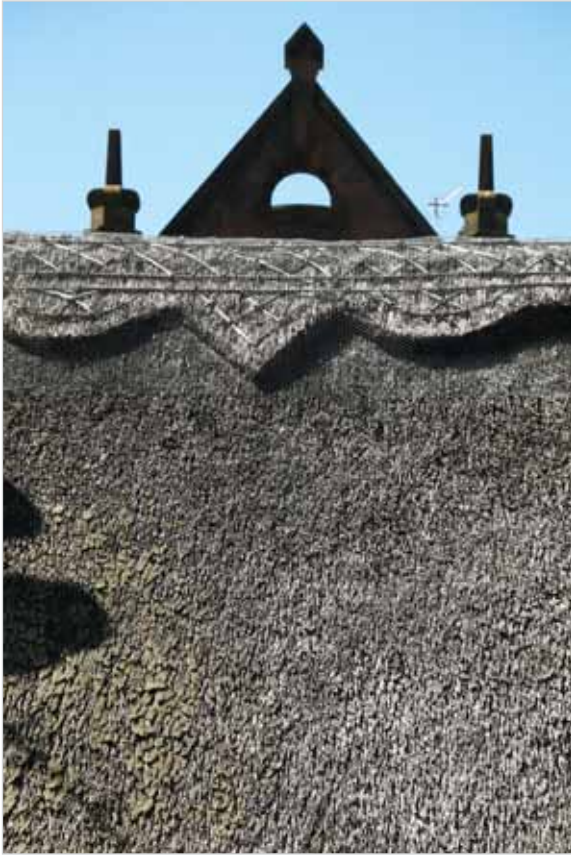
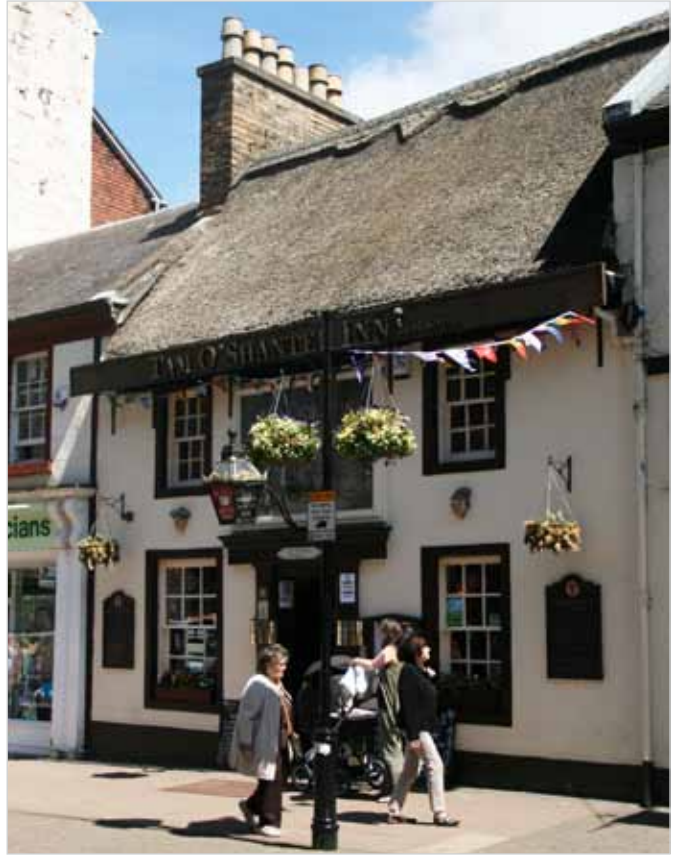
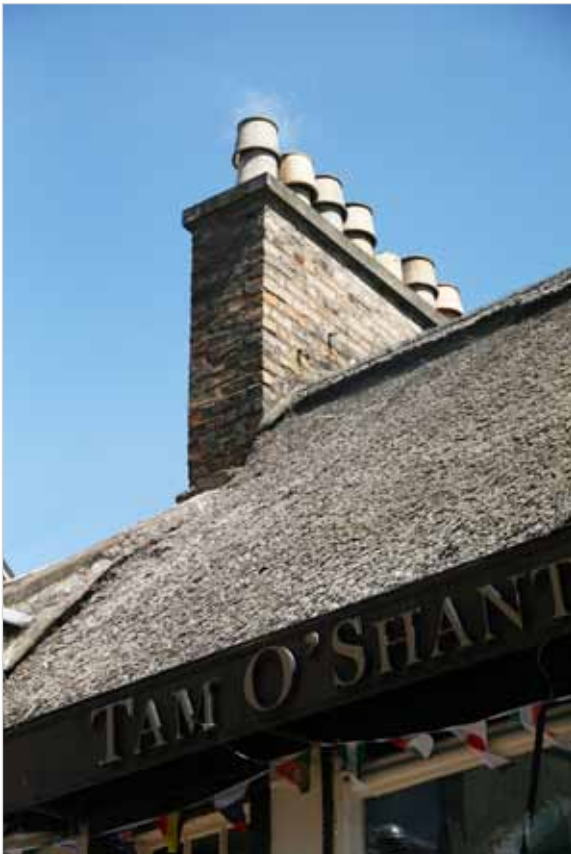
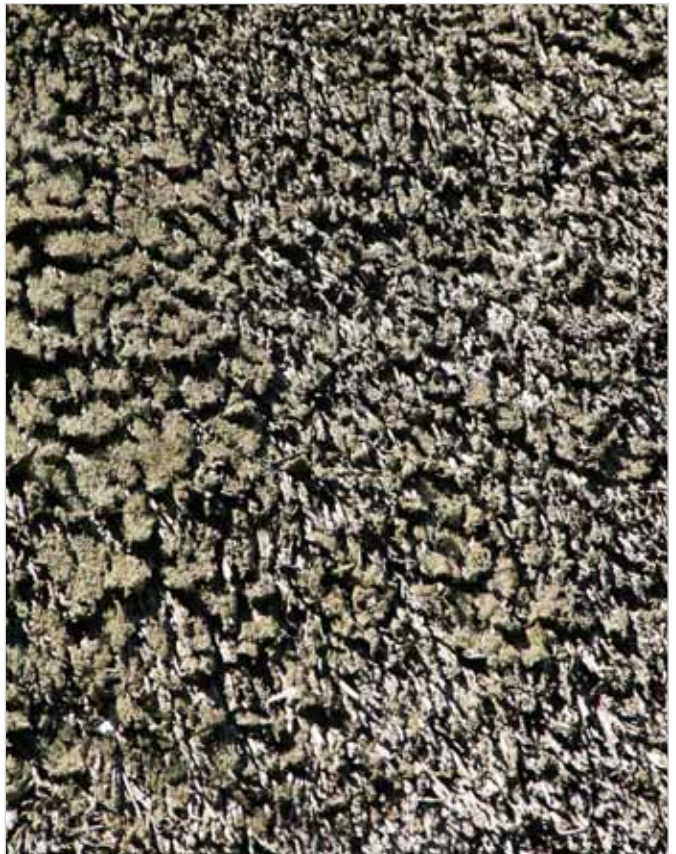
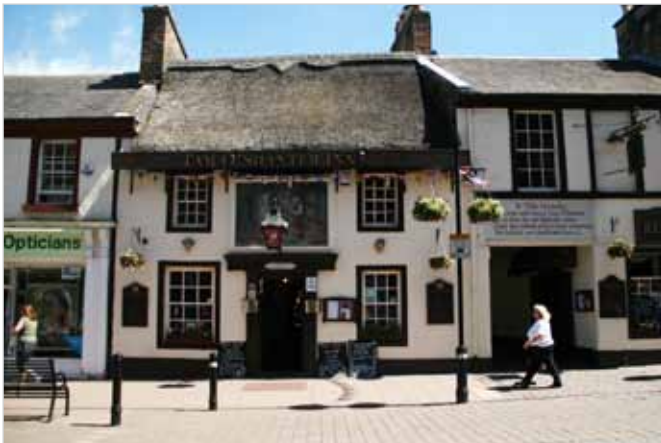
Tam O'Shanter Inn – South Ayrshire

Condition of Thatch: Fair

Additional Notes: Two-storey inn rebuilt in 1808. Decorative, sculpted scobed ridge with hazel spars and horizontal metal wires/rods held in place by metal pegs. Listed as having a 'reed roof' and 'turf ridge'; however, both the roof and ridge are now thatched in reed. Only the ridge is netted, the rest of the thatch is uncovered. There is a fair amount of mossy vegetation growth throughout the thatch and some compaction/decay in places, most evident at the abutment to the later adjacent buildings.

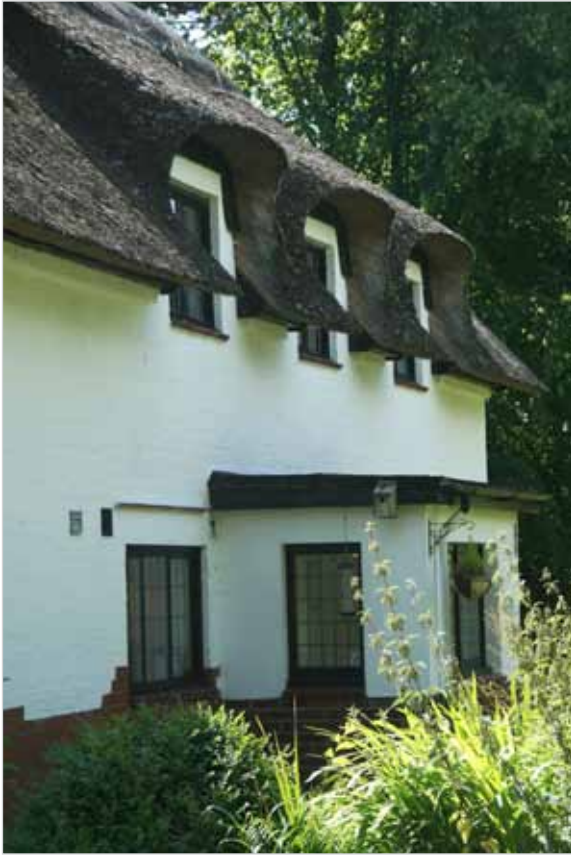
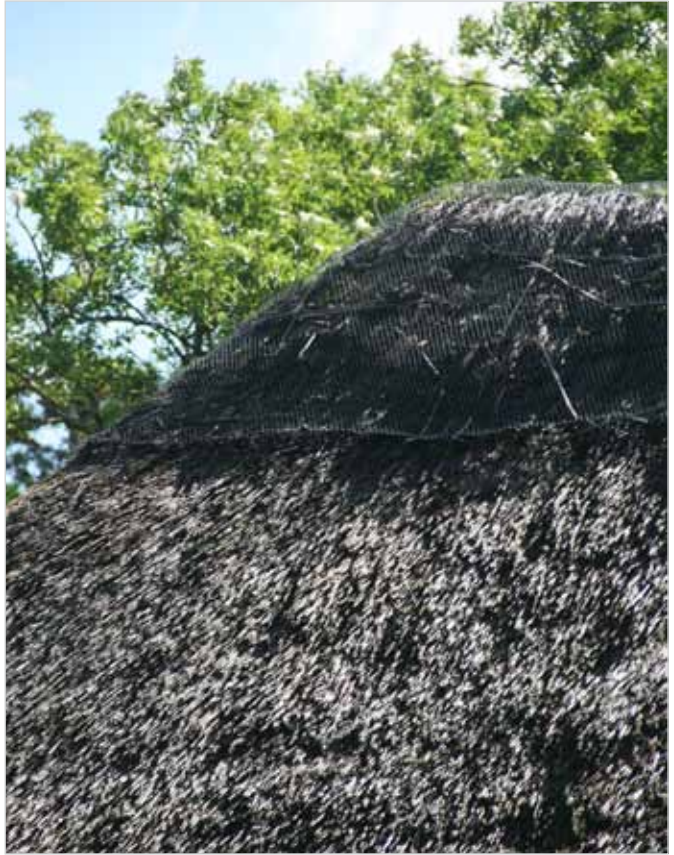
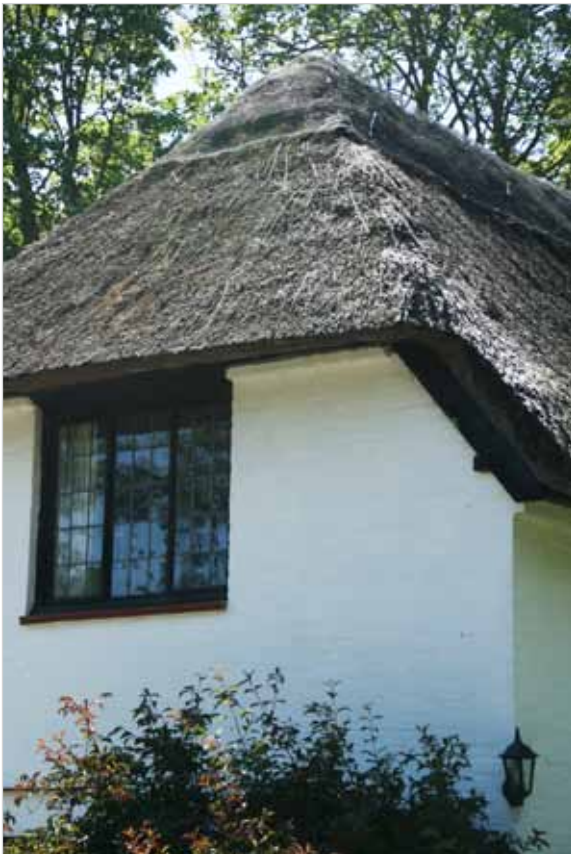
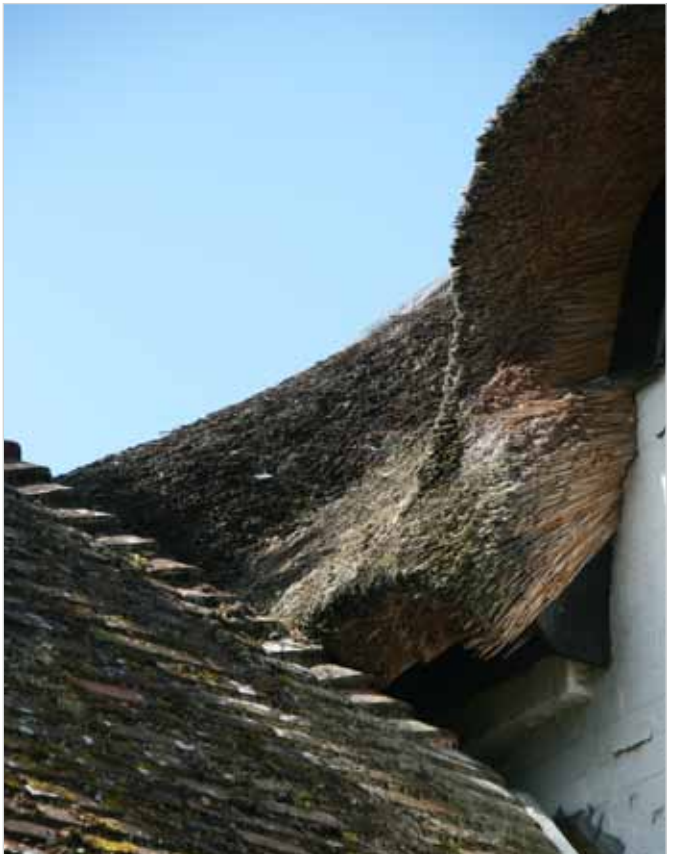
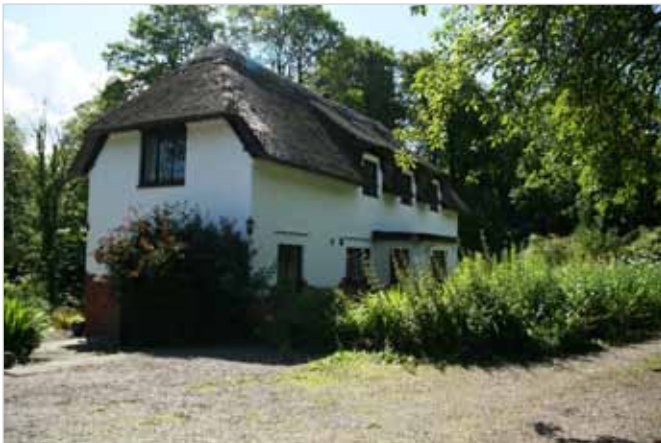
Doonbank Cottage – South Ayrshire

Condition of Thatch: Good

Additional Notes: The building is currently thatched in water reed, from Perthshire, and the ridge is thatched in straw. The roof was last thatched by a thatcher from Yorkshire around ten years ago (circa 2004). The owner of the building stated that the ridge is intended to be re-thatched again at some point in the next year. The ridge is netted whilst the rest of the thatch is uncovered. The thatch has a large overhang at the eaves and is moulded around the first-floor dormer windows on the east and west elevations. The thatch is in a good condition and has minimal signs of deterioration. The ridge, however, has deteriorated somewhat more, and much of the thatch

..... appears loose underneath the netting. The scobing has also come away from the ridge in many places.

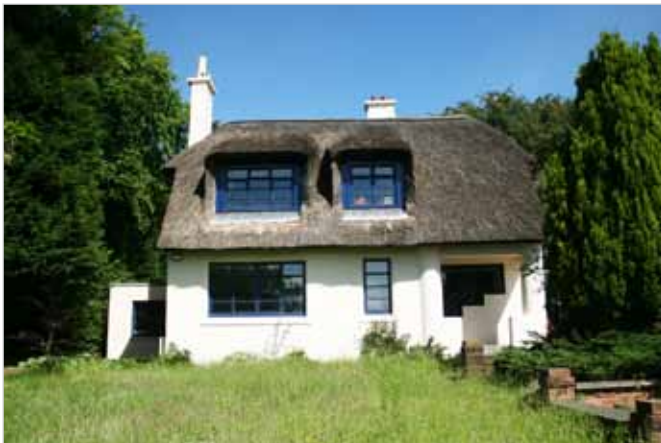
L-plan thatched bungalow with attic storey, and according to the listing description built circa 1935. The building has two attic dormer windows on the south-east (front) elevation and two in the north-east elevation. The thatch is netted directly below the raised concrete ridge, for approximately one foot, whilst the rest of the thatch is uncovered. The thatch is in good condition, although perhaps a little untidy in places with a few loose pieces of reed. A tenant of the building believed it had last been thatched in the late 1980s and had recently been advised by the owner that it was due to be re-thatched at some point within the next

two years. The building is currently being let to an architecture practice.

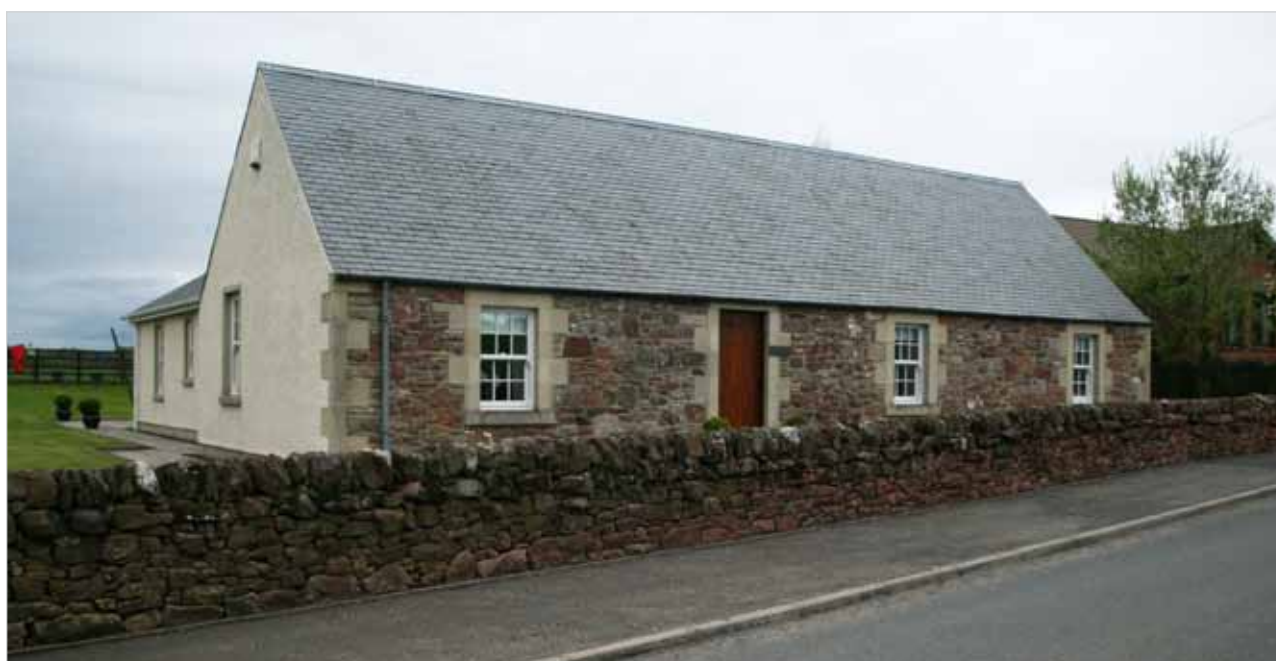
Additional Notes: The listing description for this property states that it is '*thatched beneath a corrugated sheet metal covering*', and that the thatch is visible internally beneath the sheeting. The building appears to have been renovated and extended since being listed (the building plan from Canmore is different to the current plan), and is now slated. The property is now called 'View Kern', according to signage on the front of the building. Unable to locate planning application documents to ascertain what, if any, of the original building was retained. Further research into this building is required and the listing description should be updated accordingly.
