A Survey of Thatched Buildings in Scotland

Thatch Survey of Scotland
2014-15

A photographic survey of thatched buildings in Scotland, surveyed between May 2014 and August 2015 by Zoe Herbert (SPAB Scotland Officer), on behalf of the Society for the Protection of Ancient Buildings.

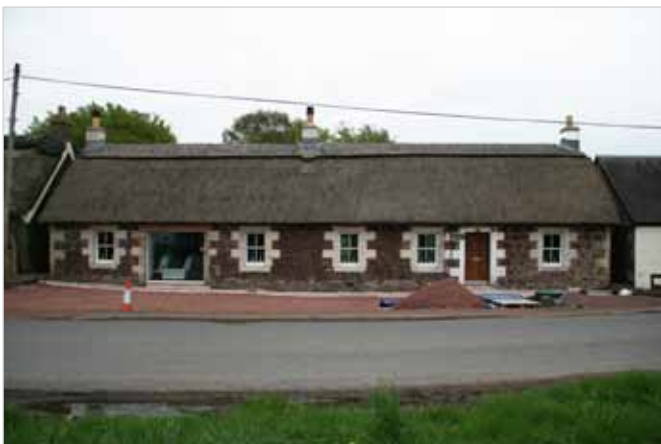
Part of a group listing, which comprises a row of seven single-storey early 19th-century cottages (82-94 Covington Road), all of which would originally have been thatched. Of the properties within the group listing only two currently have any visible thatch remaining (82 and 86 Covington Road), whilst three properties are thought to be thatched underneath their corrugated iron roofs (see survey entries 212-214). The building appears to have recently been renovated and re-thatched, and has been named 'Covington Smiddy' according to the signage on the front door. It has a raised reed thatch ridge, which is scobed and fixed with hazel

spars. The ridge is netted in wire whilst the rest of the thatch is uncovered.

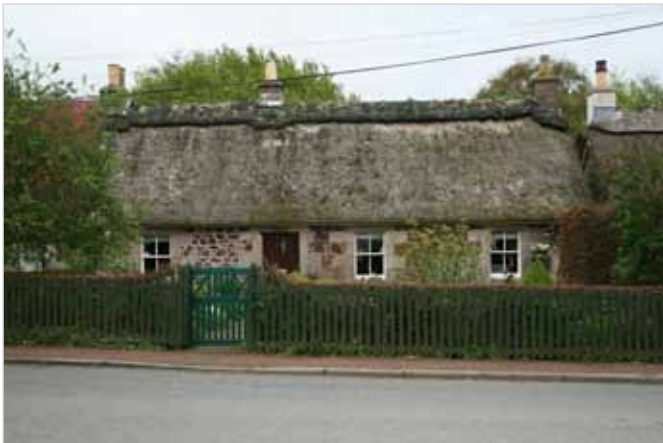
Condition of Thatch: Fair

Additional Notes: Part of a group listing of seven early 19th-century single-storey cottages, all originally thatched. This building is one of only two buildings in the group listing that remains visibly thatched. 82 Covington Road (entry 210) being the other. Historic Environment Scotland listing records show that the thatch was replaced in the early 1990s, possibly the last time the building was re-thatched. There are signs of vegetation growth throughout and small patches of missing/sunken thatch in places. The raised thatch ridge is fairly overgrown and it is difficult to see from ground level exactly what material the ridge is made from due to vegetation growth. The

ridge is netted, whilst the rest of the thatch is left uncovered.

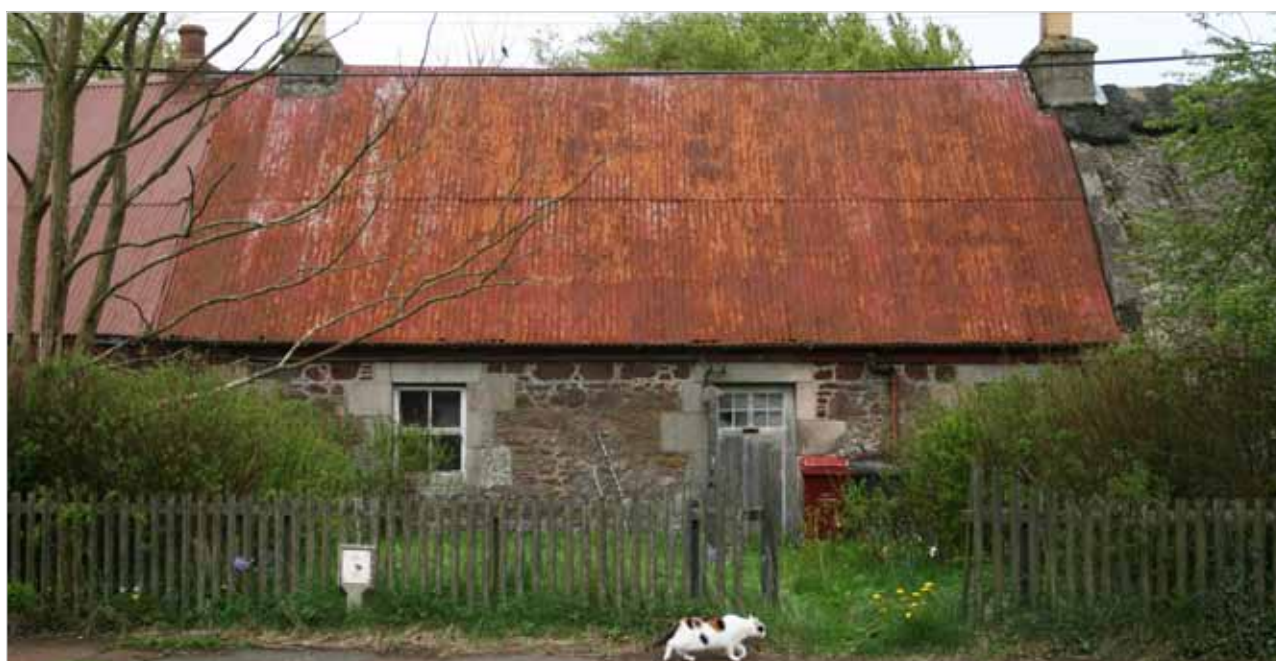
Additional Notes: Early 19th-century three-bay cottage, from a group listing, believed to still have thatch underneath the corrugated iron roof. The building has been on the Buildings at Risk (BAR) register since 2014 (BAR reference number 4807). The building is thought to have been vacant for some years and local authorities have been unable to contact the owners. The corrugated iron remains in place (on visible front elevation) but it is in poor condition. Further research into this building is required and the listing description should be updated accordingly.

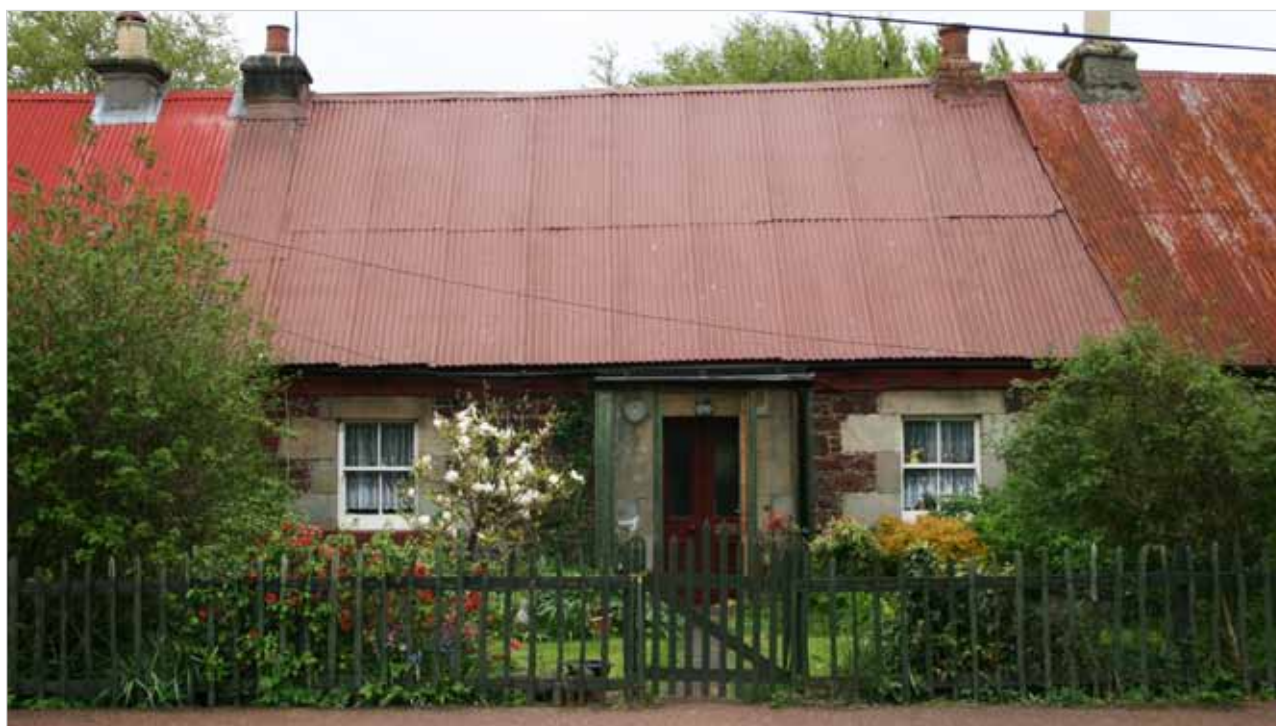
Additional Notes: One of seven early 19th-century, single-storey cottages that forms part of a group listing in the village of Covington, South Lanarkshire. All of the cottages in the listing were originally thatched, though there is no mention of any thatch remaining underneath the corrugated iron in the listing description (only number 86 Covington Road is mentioned as being thatched). Further research into this building is required to ascertain whether any thatch remains underneath the corrugated iron roof.

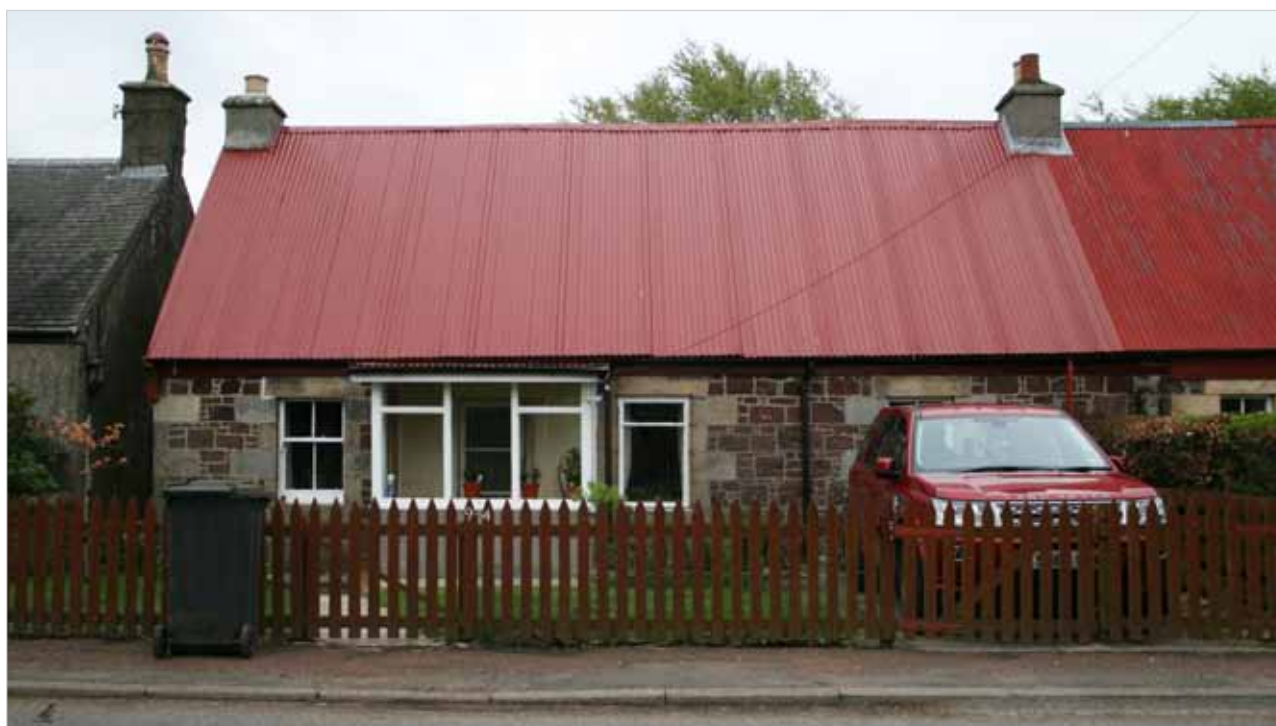
Additional Notes: One of seven early 19th-century, single-storey cottages that forms part of a group listing in the village of Covington, South Lanarkshire. All of the cottages in the listing were originally thatched, though there is no mention of any thatch remaining underneath the corrugated iron in the listing description (only number 86 Covington Road is mentioned as being thatched). Further research into this building is required to ascertain whether any thatch remains underneath the corrugated iron roof.

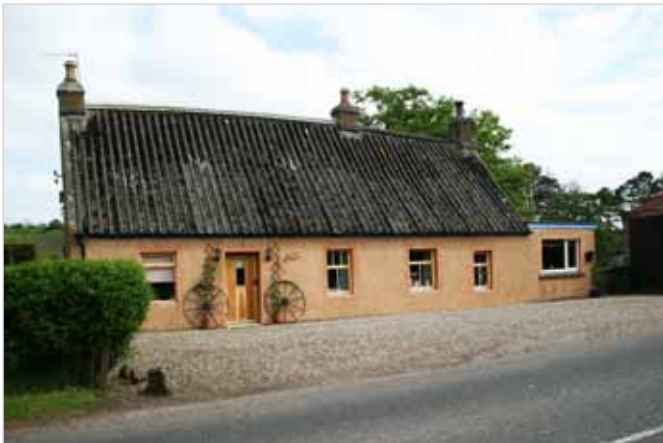
Thatch Type: Straw
 Ridge Type: Unknown
 Condition of Thatch: Unknown

Additional Notes: Single-storey mid/late 18th-century cottage building retaining original thatch underneath a corrugated asbestos sheeting carried on a raised brick eaves course. The building owner states that the roof has a heather underlay with straw on top, however the notes in the listing description states '*the thatch is probably straw, laid vertically and stitched over turf divots*'. The thatch is visible internally within the roof space, but it is difficult to ascertain the condition. There is no thatch visible externally. The asbestos roof appears in a good condition and looks to be protecting the thatch from the external elements. The building owner had looked into

removing the asbestos roof and re-thatching the building in the past, but this had always been too costly to be viable.

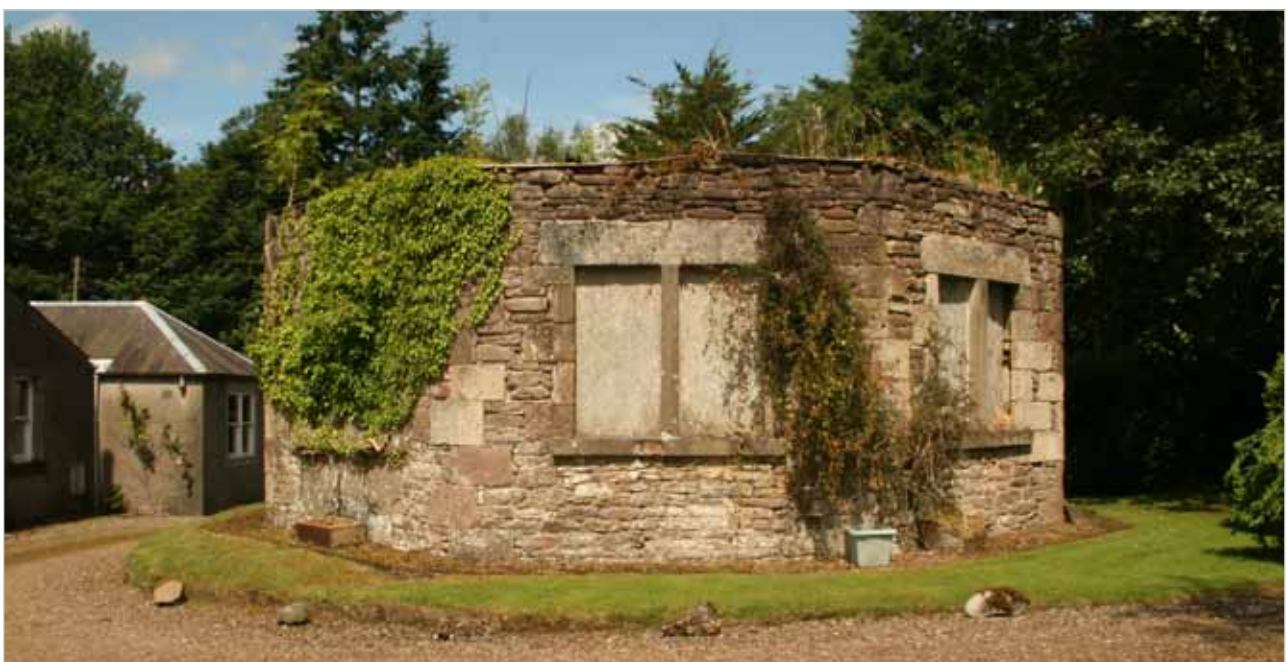
Additional Notes: The owner has lived in the adjacent house for around 30 years and stated that when she moved in, the Octagon was dangerous, particularly the roof. At this time, around half of the thatch had already come off and they later removed the chimney, and subsequently the roof, as it was too dangerous. The last of the thatch came off the building at least 20 years ago. The listing description states that the building [had] a 'steep thatched roof' and is circa 1900. The structure is now a roofless ruin. The listing description for the building should be updated accordingly.

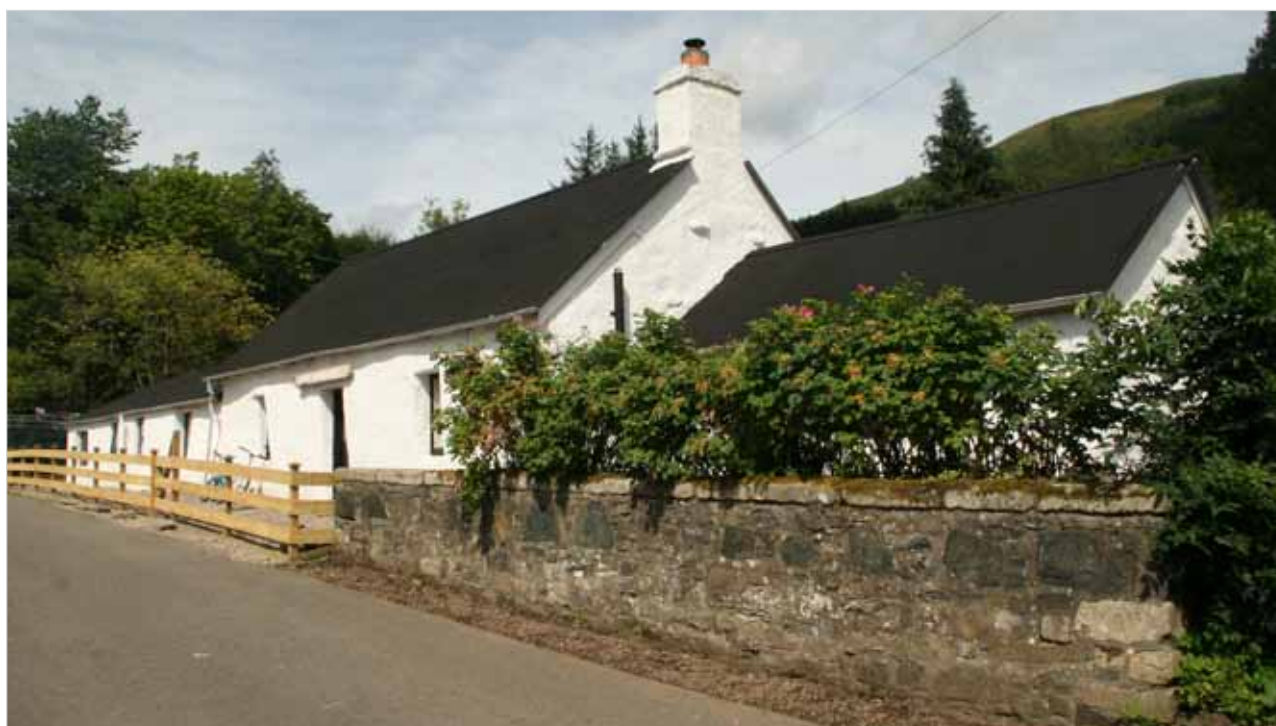
Additional Notes: Single-storey, cruck-framed cottage, probably late 18th-century in origin, with later lower extensions adjoining each gable end. The listing description states it has '*heather thatch under turf under [a] corrugated iron roof*'; however, there appears to be no thatch remaining (the owner confirmed there is no visible sign of any thatch externally or internally). The location of the building according to Canmore was incorrect and needs updating, and the listing description should also be updated accordingly.....

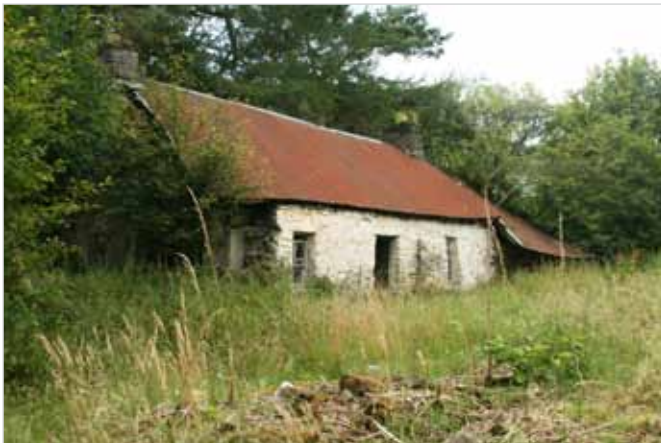
It retains its original thatch, which is currently under a roof of corrugated iron, and is thought to have last been occupied in the 1950s. The cottage has been on the Buildings at Risk (BAR) Register since 1994 (BAR reference number 966) at which time it was 'in a very dilapidated state'. Since then the building and thatch has deteriorated further. It was last visited by BAR in 2012 when it was noted the 'building [is] subject to slow general decay'. Due to the buildings' condition, it is unclear what the current condition of the thatch is, though there are signs of straw

visible externally from underneath the corrugated iron roof at the eaves.

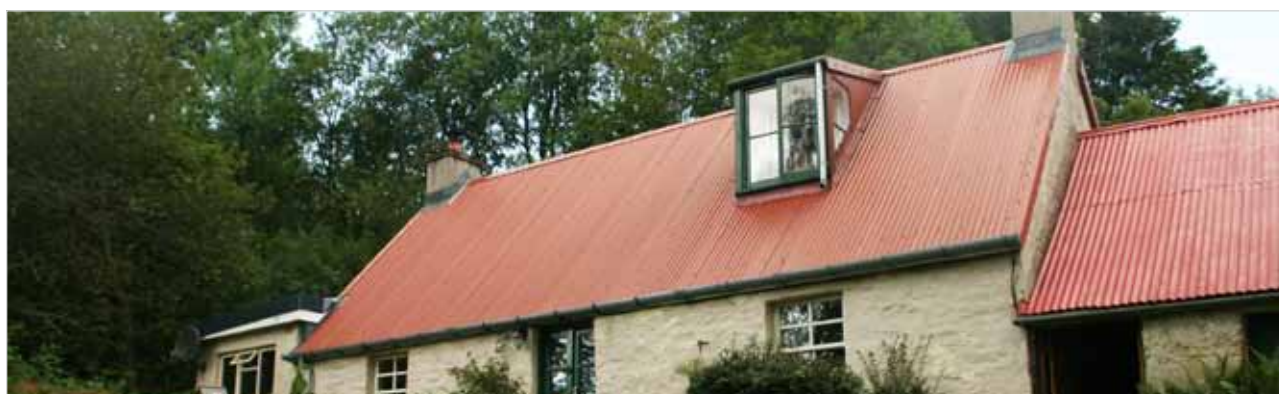
Additional Notes: Single-storey, three-bay, cottage with a corrugated iron roof. It has later byre additions to the north-east end. The cottage is thought to have been built during the early 19th century and the listing description states that it retains straw thatch underneath its corrugated iron roof, but the building owner stated that, due to damage obtained from a large tree falling onto the roof from the north five years ago (2009), very little thatch now remains. When the contractors came to fix the roof they discovered the thatch was extremely damp due to previous leaking from the corrugated iron. Many of the beams had also become rotten due to the damp thatch being sat upon them, and so the majority of the thatch which was damaged was removed and the rotten roof beams were replaced. The new corrugated iron roof is in good condition and appears to be sufficiently protecting any remaining thatch underneath, though this cannot be said for certain and the owner does not know for sure how much thatch remains.

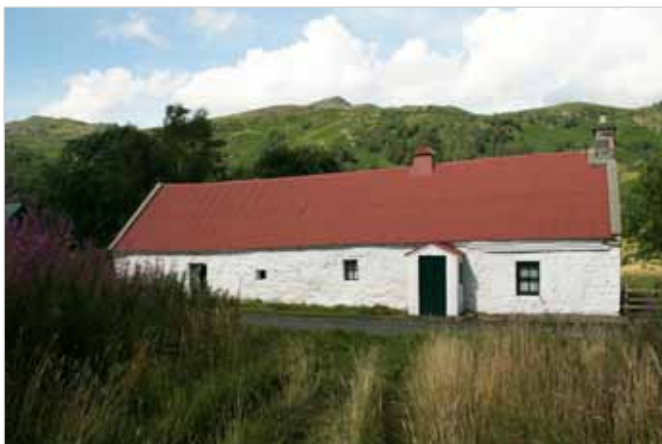
Thatch Type: Bracken and Straw
 Ridge Type: n/a
 Condition of Thatch: Good

Additional Notes: Listed as a late 18th to early 19th-century 'cruck-framed cottage and byre under continuous roofline', owned by the National Trust for Scotland since 1992. The building retains early thatch, which was raked back in the 1940s and covered with a corrugated iron roof. There is visible evidence externally of both straw and bracken thatch from underneath the wooden soffit that runs along the eaves of the building. The roof of this building was the subject of an archaeological investigation in 2011, when the corrugated iron roof was temporarily removed (*Moirlanich Longhouse, Killin - Assessment of the Thatched Roof for the National Trust for*

Scotland', Holden, 2011). The report reveals areas of bracken, rush, rye straw, wheat straw and cereal straw thatch, which cover a substratum of turf laid vegetation side down. Turf is also used as a packing material at the skewes. The presence of wooden pegs throughout suggests the thatch was fixed to the roof using a 'crook and caber' technique.

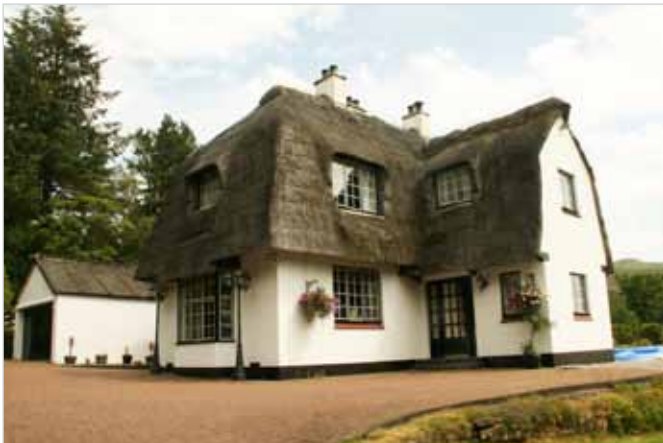
Drumwhim – Stirling

Thatch Type: Reed
 Ridge Type: Thatched (Reed)
 Condition of Thatch: Fair

Additional Notes: Listed as a '1930s English vernacular style' arts and craft house with a thatched roof. The thatch is reed and the owner stated it was last thatched around 20 years ago. There are signs of scobed thatch detailing underneath the windows, but this has significantly come away in most places. The thatch is netted all over, including over the thatched ridge, where it is higher than the thatch by perhaps a foot or so, demonstrating how much the thatch has compacted. There are patches of vegetation growth and loose thatch in places throughout. The thatch is held in place by horizontal metal poles and metal pegs in some places.

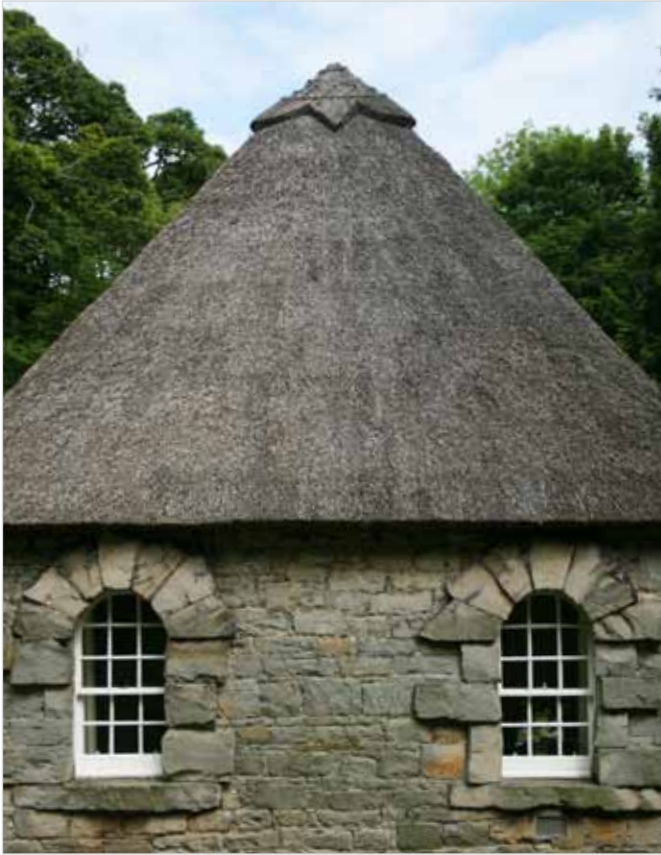
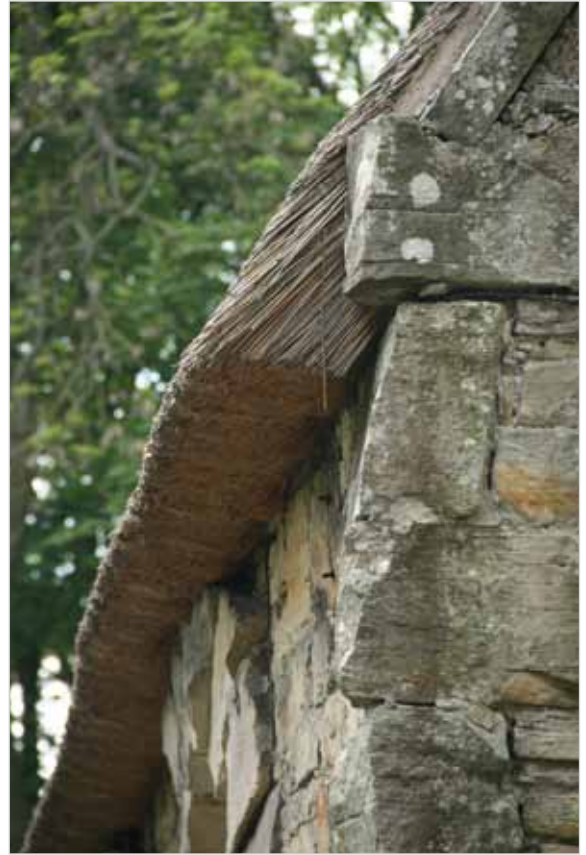
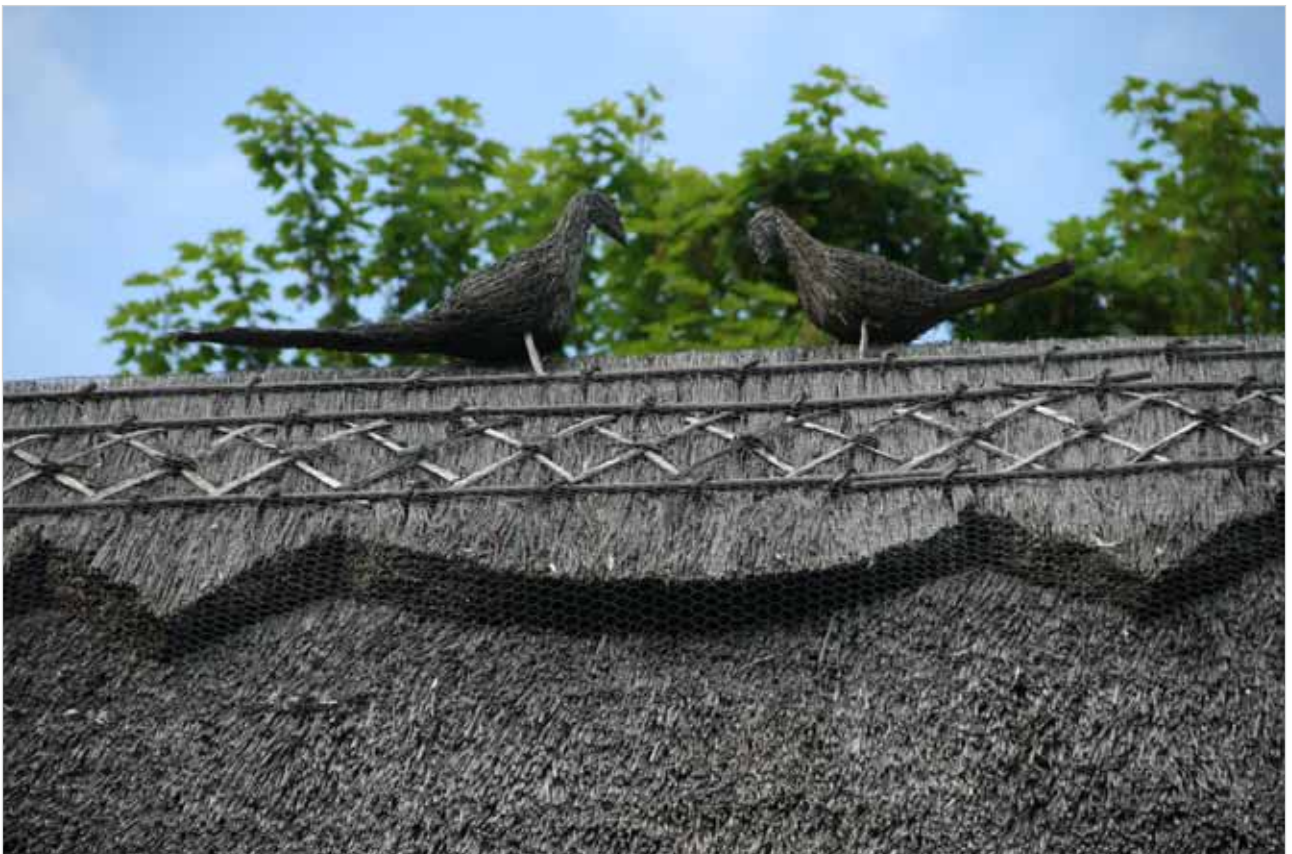
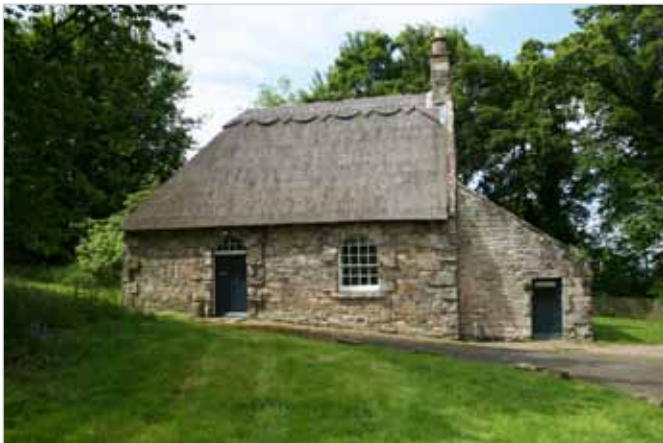
Obelisk Cottage – West Lothian

Thatch Type: Reed
 Ridge Type: Thatched (Reed)
 Condition of Thatch: Good

Additional Notes: Possibly 18th-century cottage, thatched on the north, west and south elevations only, and piended on the west end. Both the building and thatch are in a good condition, with the building currently being used as a holiday let by the Hopetoun House Estate, within which it is located. There are two decorative bird sculptures fixed to the top of the ridge in the centre, made from thatch and netting. The thatched ridge is decoratively sculpted, scobed and netted.

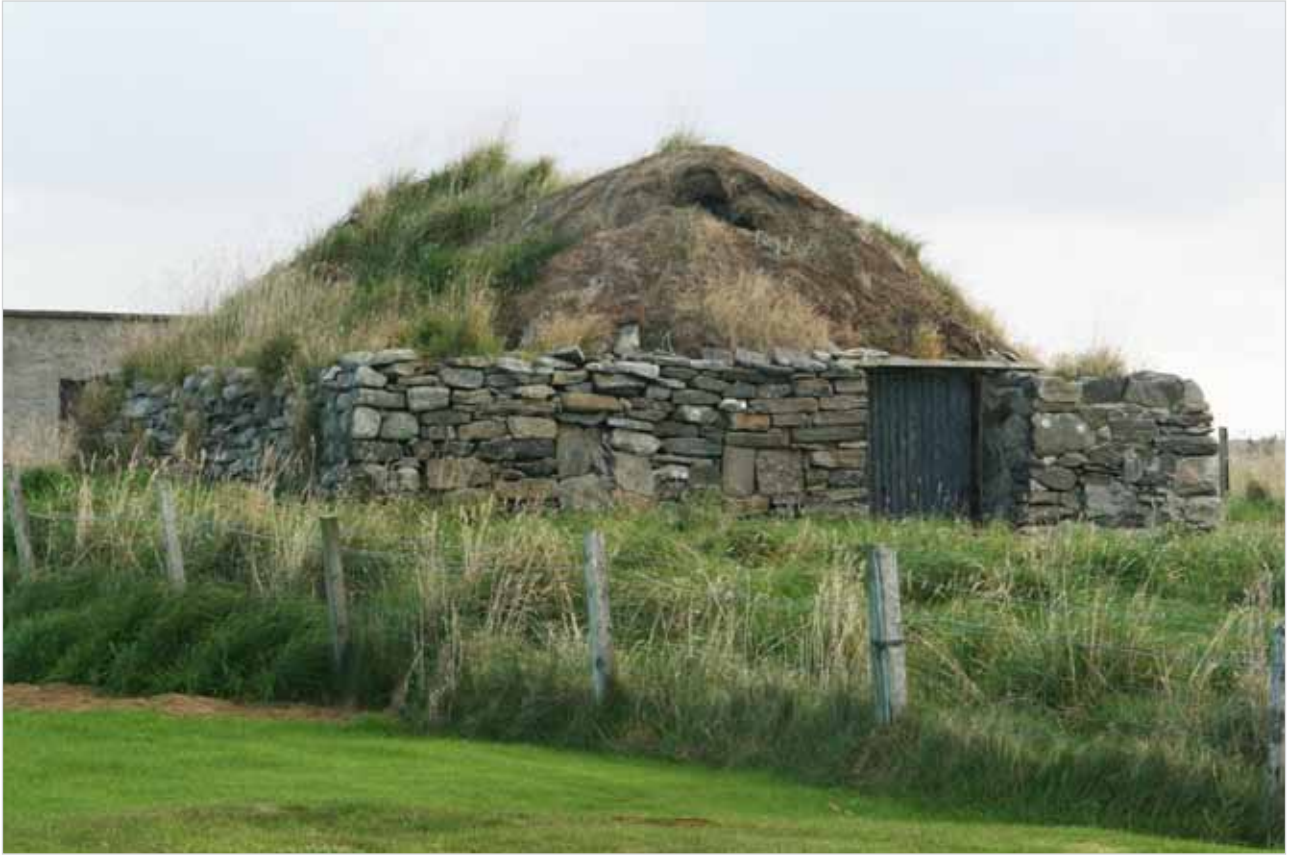
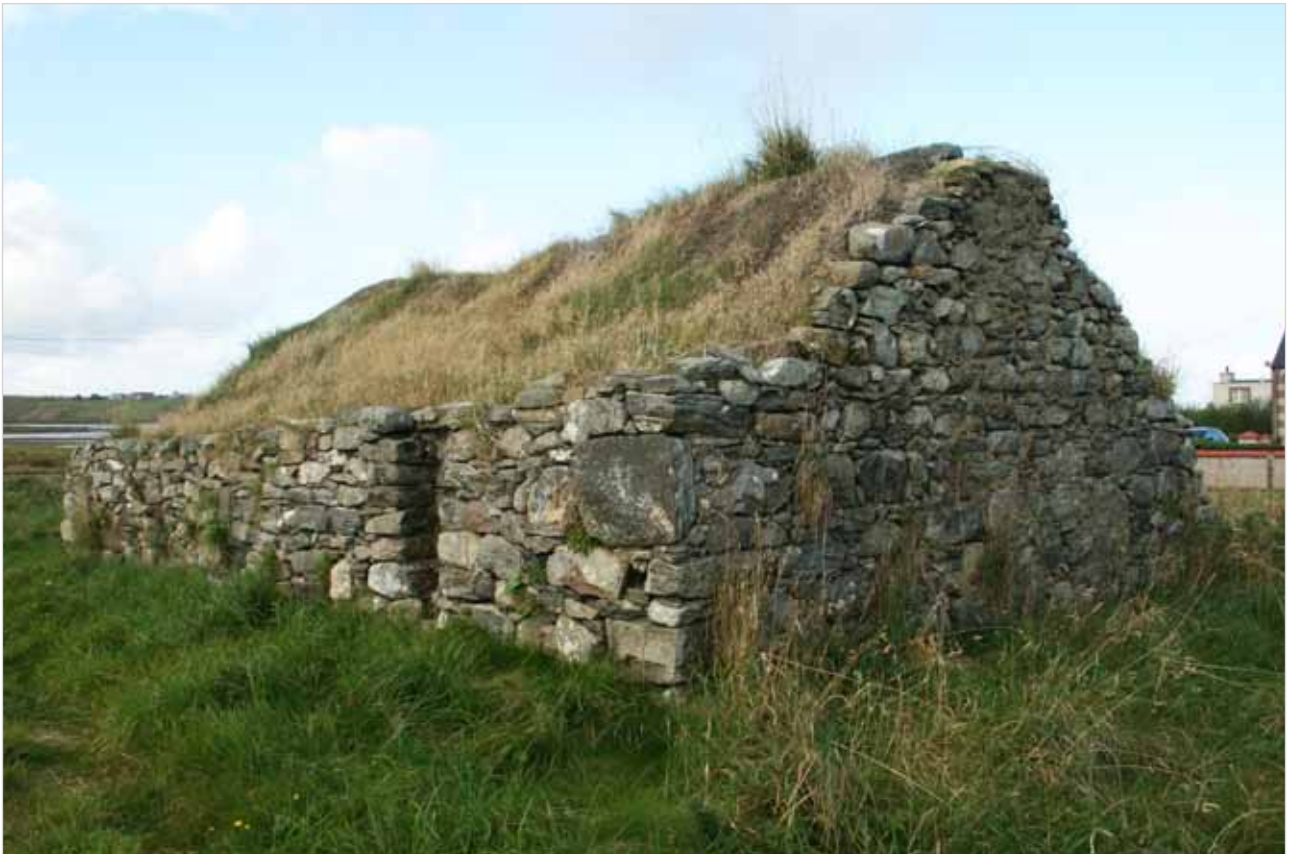
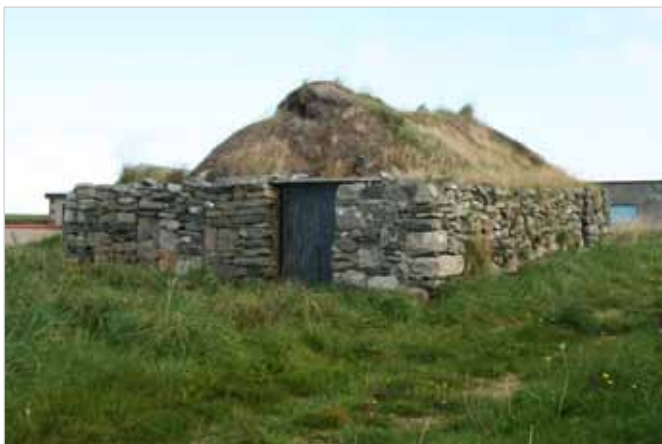
10 Lower Barvas – Western Isles

Condition of Thatch: Poor

Massive rubble-built walls; thatched with muran. South west gable is open, with garage doors, where cottage formerly extended much further'. The south-west gable has been partially blocked up since being listed. The

building is currently without use – according to locals, the owner, who lived in the adjacent house, passed away within the last year and it was he who used to re-thatch and maintain the building. The roof of the structure is

now in particularly poor condition; the thatch is overgrown with vegetation and entirely missing in places, exposing the roof structure beneath. There is evidence of wire netting visible underneath the vegetation, as well as evidence of weighting stones and ropes visible along the wallhead.

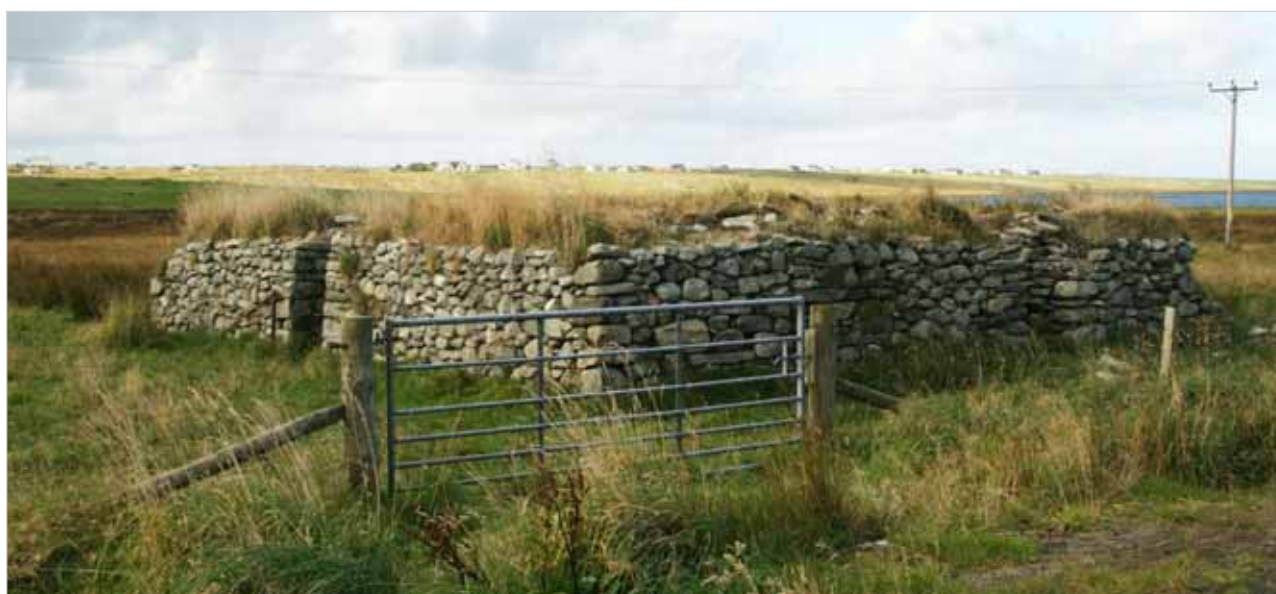
Additional Notes: The listing description reads '*Hebridean-type thatch-roofed building*', however, this building is now a roofless ruin. It has been on the Buildings at Risk (BAR) Register since 2010 (BAR reference number 4757) and BAR inspection at that time noted '*external inspection finds the formerly thatched building now in an advanced state of decay*'. Photographs taken during the same visit by BAR in 2010 show the roof to be collapsed yet with some of the roof structure and thatch attached still visible. This is no longer the case and the roof has entirely collapsed into the shell of the building. The listing description for the building should be updated accordingly.

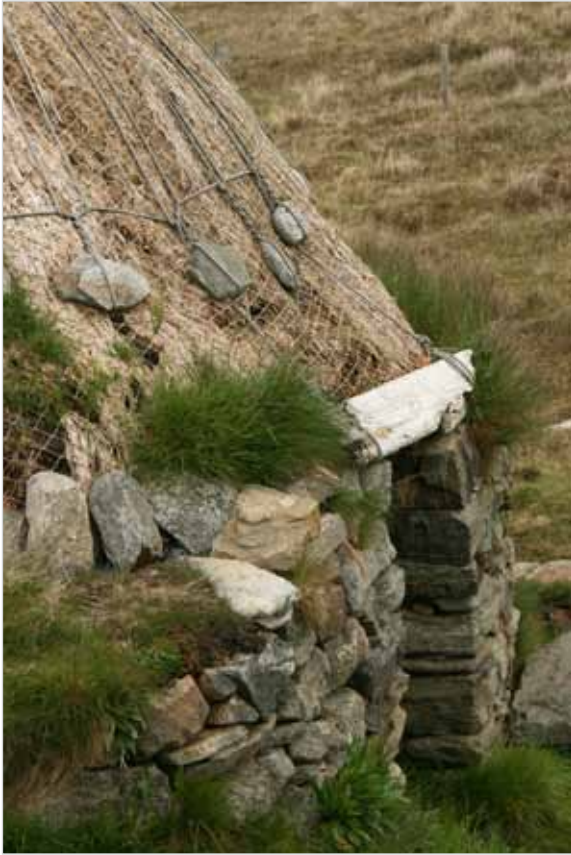
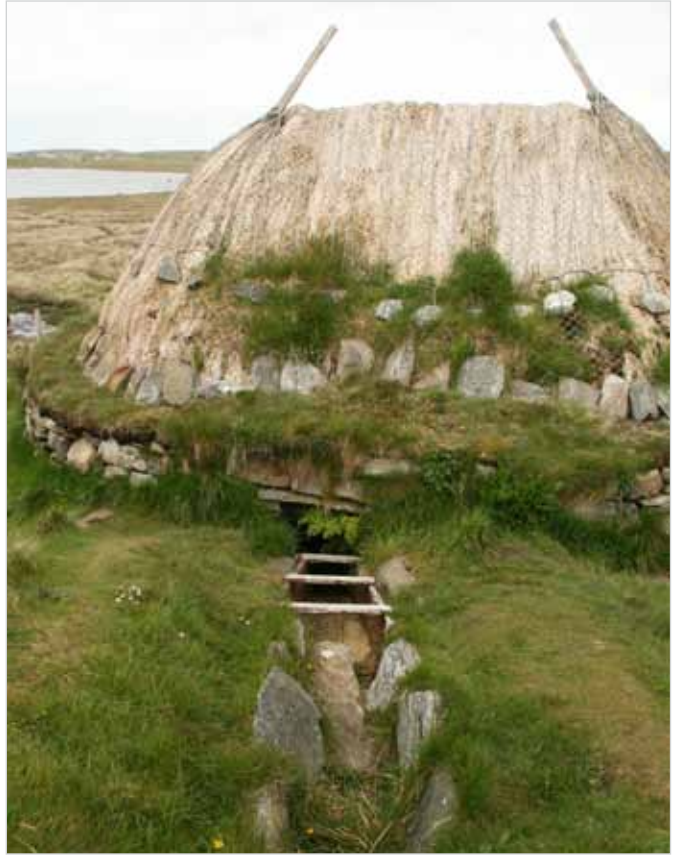
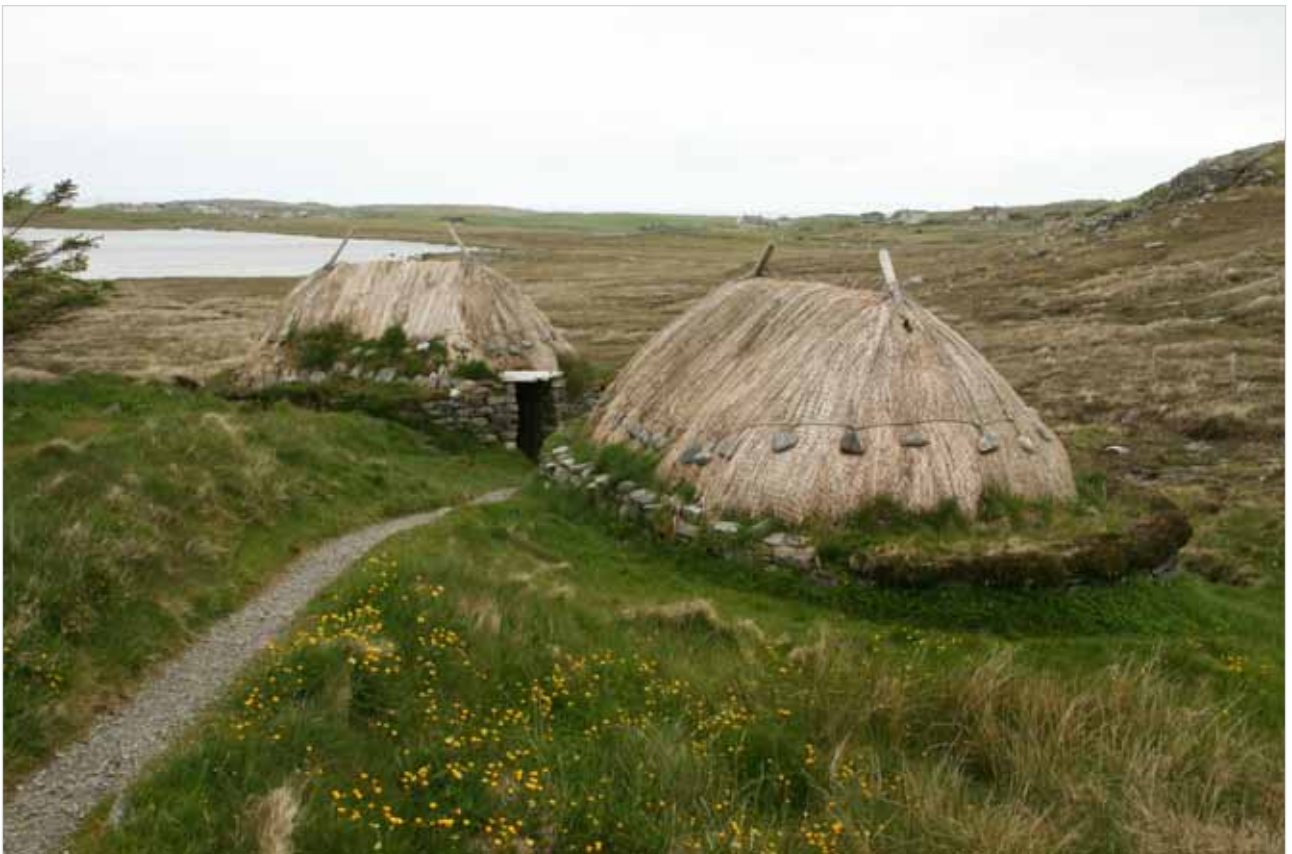
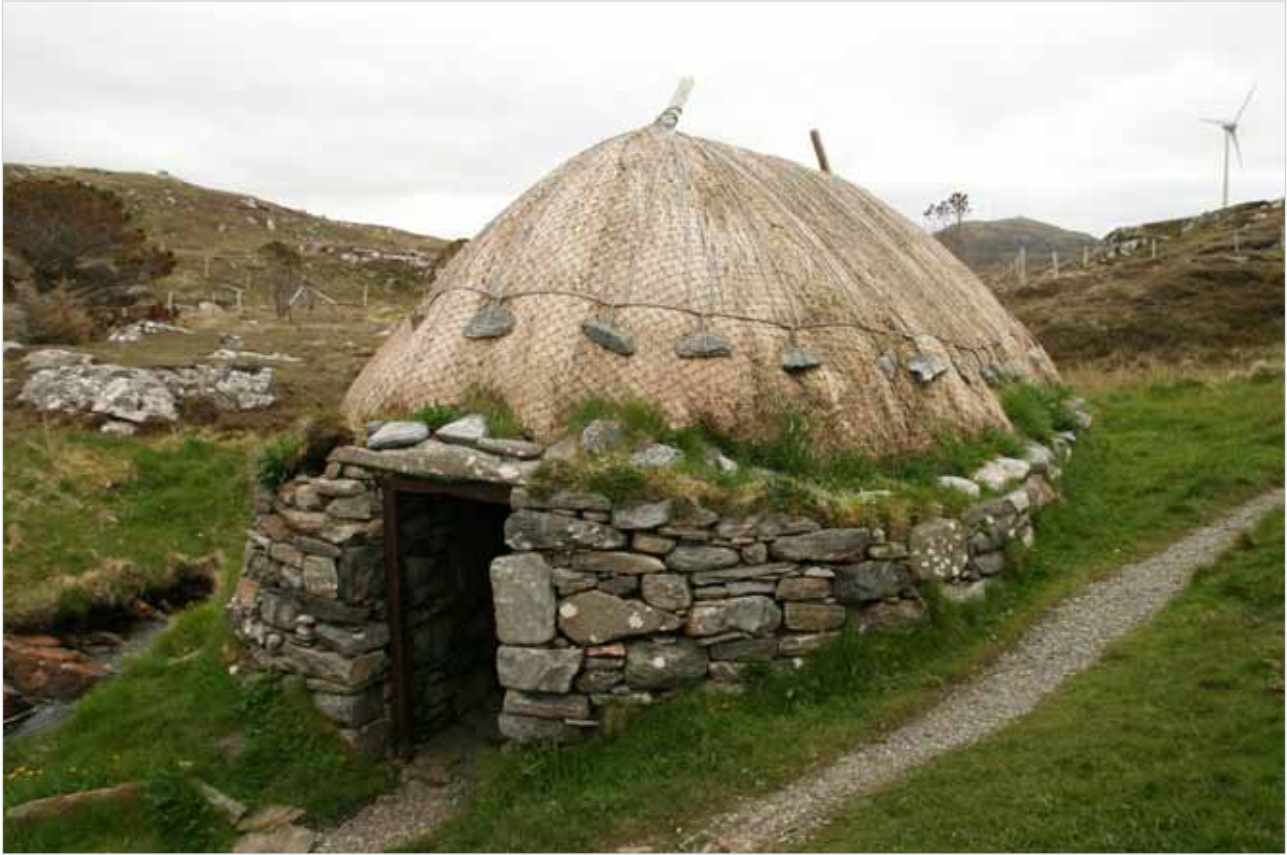
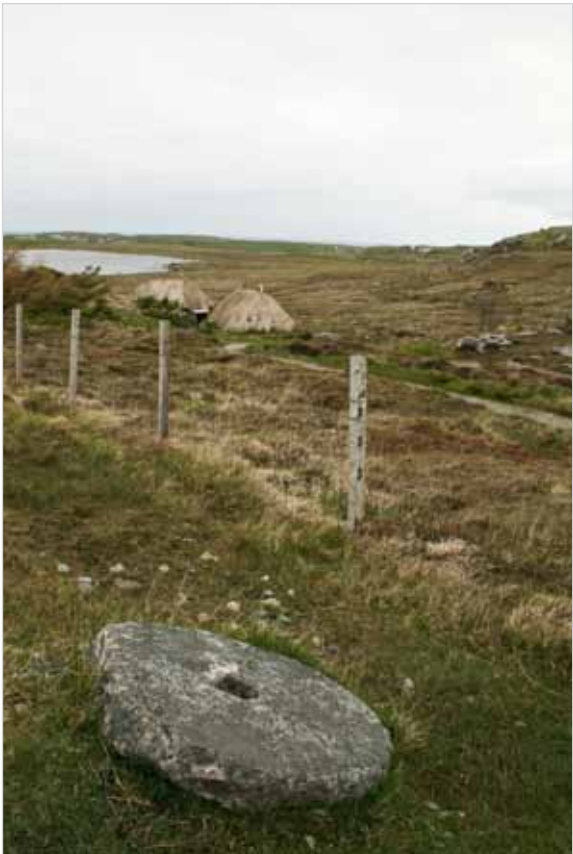
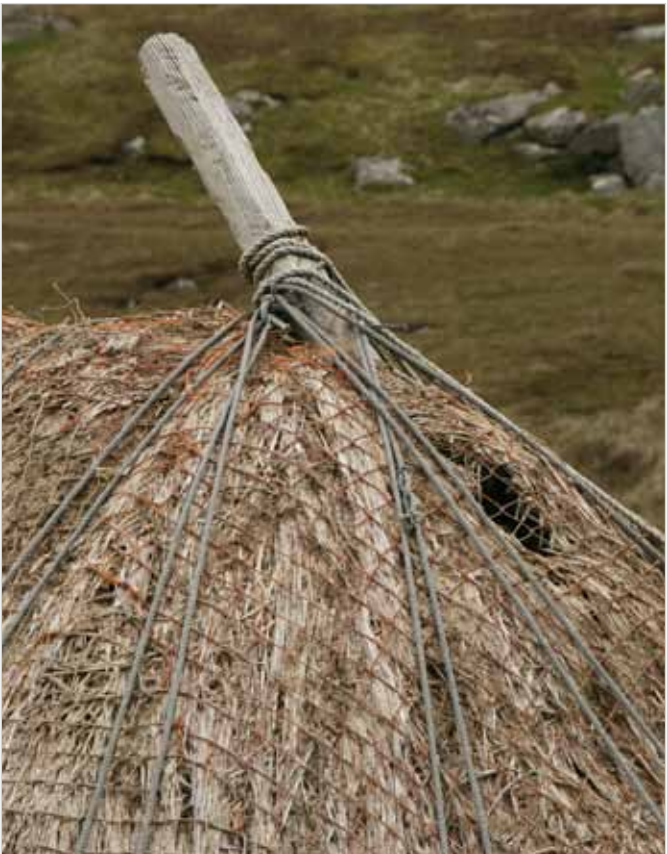
Norse Mill and Kiln – Western Isles

Thatch Type: Straw
 Ridge Type: Thatched (Straw)
 Condition: Fair

Additional Notes: An excerpt of text on Canmore explains that these two structures are a '*traditional thatched horizontal click mill and drying kiln*' that were used until the 1930s. The buildings were restored in the late 1960s but again fell into disrepair until they were '*reconstructed in 1996 by Stuart Bagshaw & Assocs. for the Norse Mill Society*' (Miers, M. (2008), *The Western Seaboard: an illustrated architectural guide*. Edinburgh). Both structures are oval in shape and have a straw-thatched roof with a continuous straw ridge. The roof has been entirely netted, including across the ridge, which has been weighted down with stones and rope. There is a continuous string of stones around the middle of the roof horizontally, attached to vertical ropes that pass over the ridge and down the other side. Twin 'horns' protrude from either end of the ridge and are used to secure some of the ropes for weighting the stones. The netting is additionally weighted by stones placed on the edge of the netting along the wallhead, which is additionally weighted with turf. In some places, the turf from the wallhead has begun to grow up onto the straw thatch, particularly upon a lower area of the south elevation. The buildings are not occupied but are open to the public for viewing as an example of a once common building type on the Western Isles.
