A Survey of Thatched Buildings in Scotland

Thatch Survey of Scotland
2014-15

A photographic survey of thatched buildings in Scotland, surveyed between May 2014 and August 2015 by Zoe Herbert (SPAB Scotland Officer), on behalf of the Society for the Protection of Ancient Buildings.

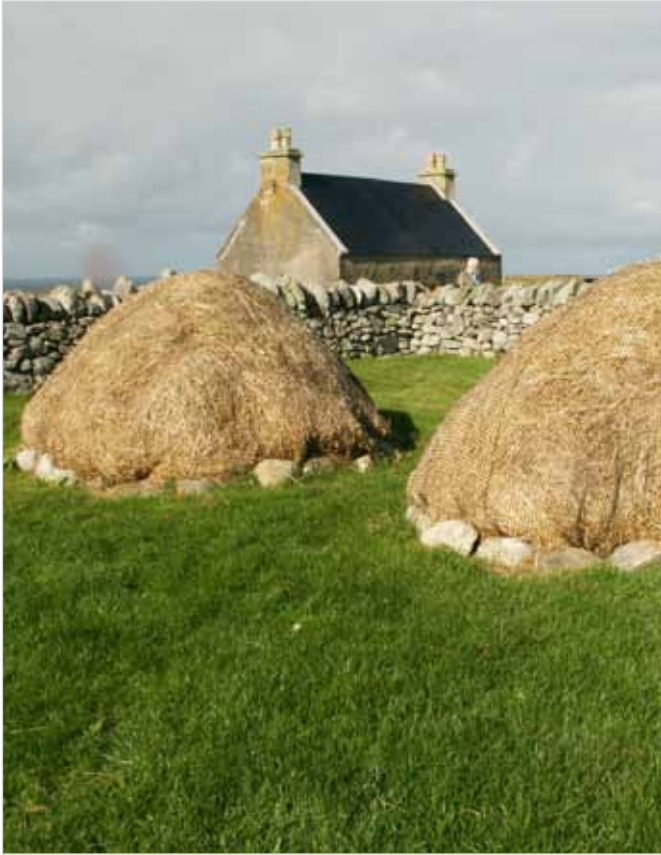
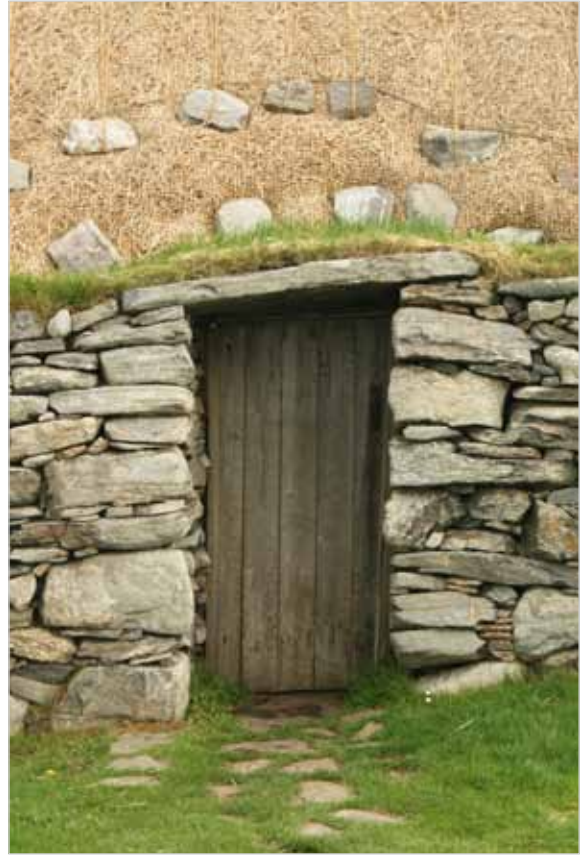
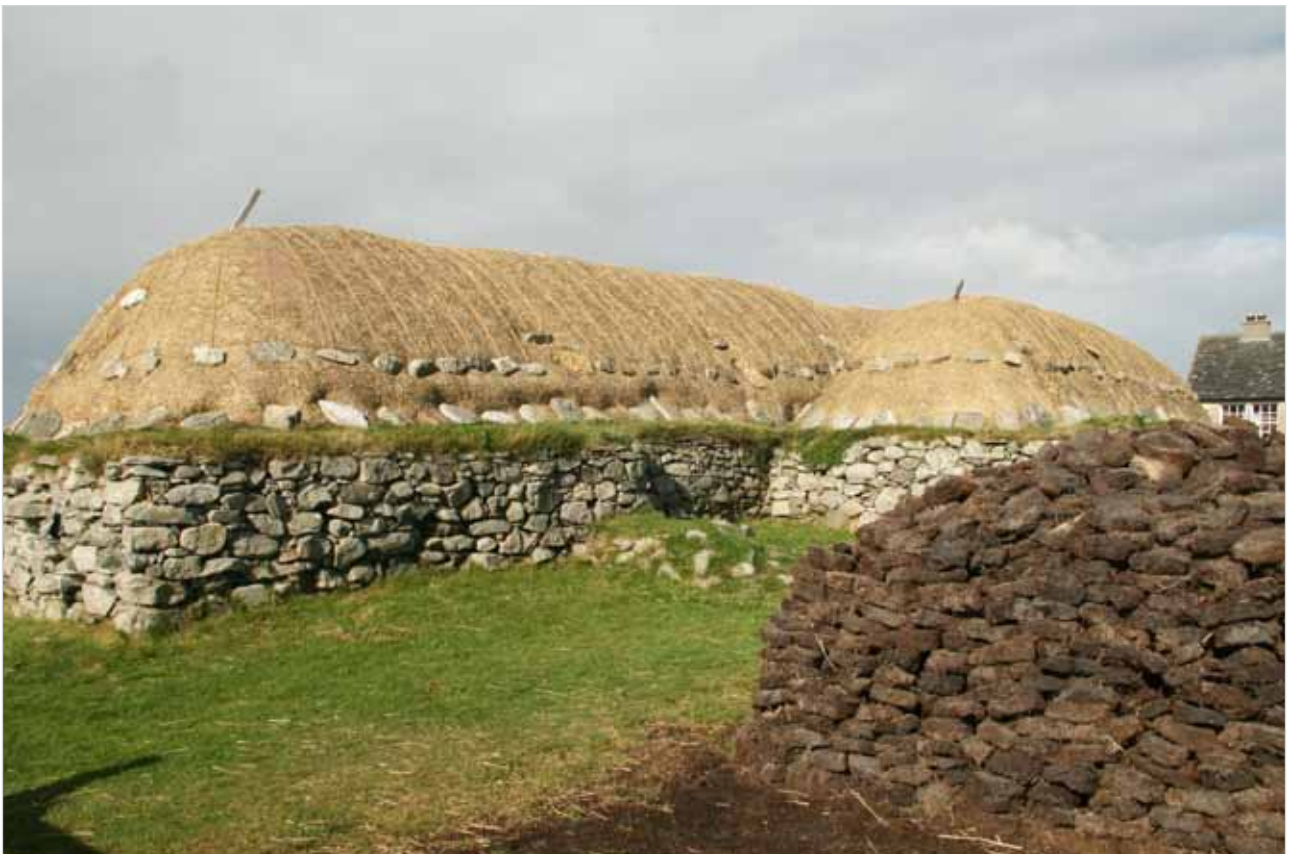
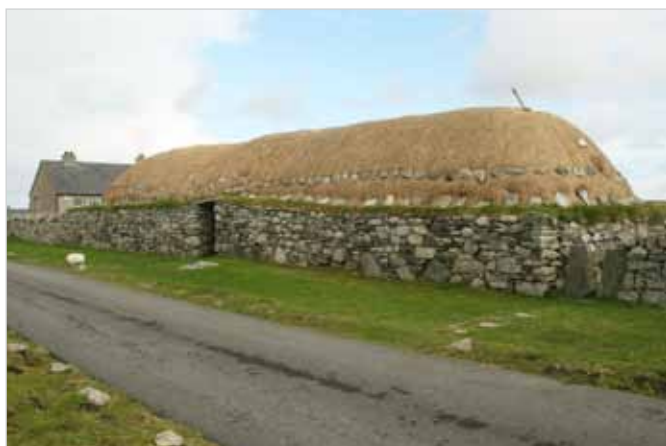
The Blackhouse – Western Isles

Local Council: WESTERN ISLES
 Postcode: HS2 9DJ
 Grid Reference: NB 31069 49238
 Date of Visit:
 Thatch Type: Straw
 Ridge Type: Thatched (Straw)
 Condition of Thatch: Good

Additional Notes: This property is in the care of Scottish Ministers and comprises a thatched blackhouse, byre and adjoining barn, open to the public as an exhibition of a once common building type and way of life. The blackhouse was built circa 1880 and was last occupied in 1964. The main blackhouse range incorporates a byre at one end, and has an adjoining parallel barn range at the rear. Both roofs are thatched in straw, with a continuous straw ridge. The thatch has been entirely netted, including across the ridge, which has been weighted down with stones and ropes that run vertically down the roof and across the ridge. At either end the ropes are secured to

timber 'horns' that protrude through the thatch. The netting is also weighted along the wallhead with stones that are placed on the edge of the net as well as by the turf laid on the wallhead. There are two small straw thatched outbuildings to the north, which have been netted and weighted with stones.

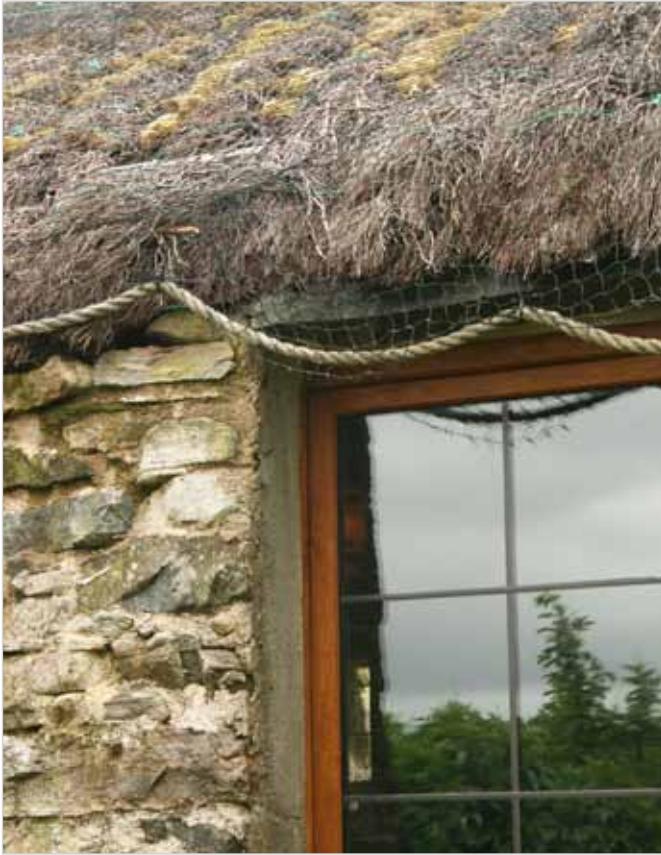
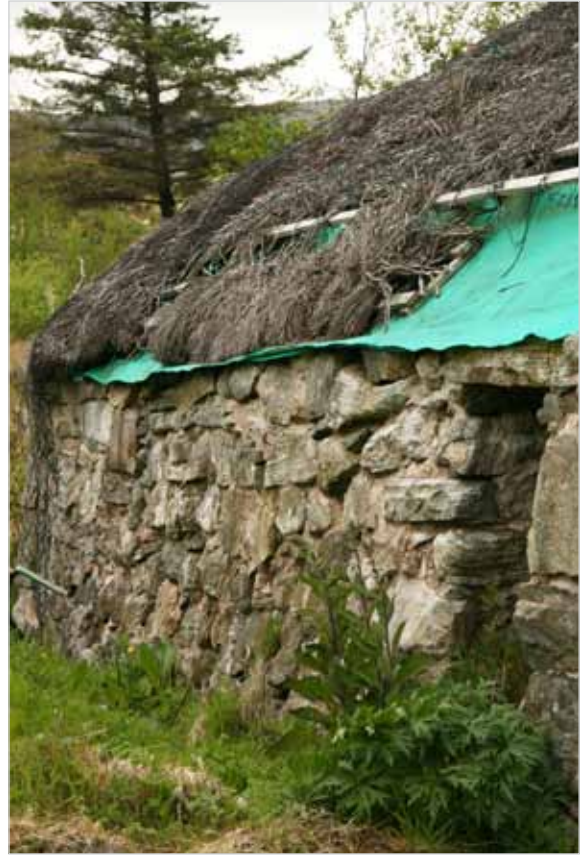
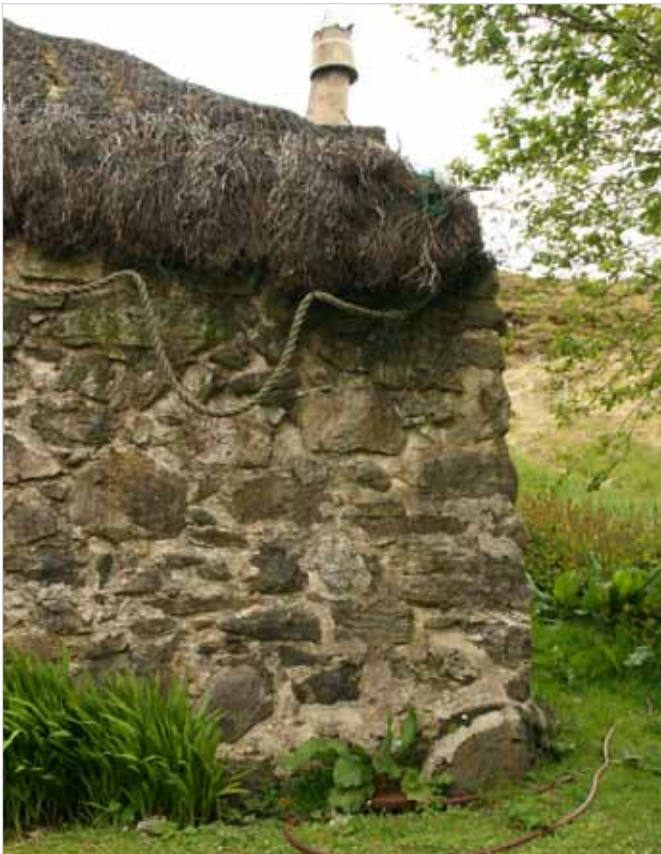
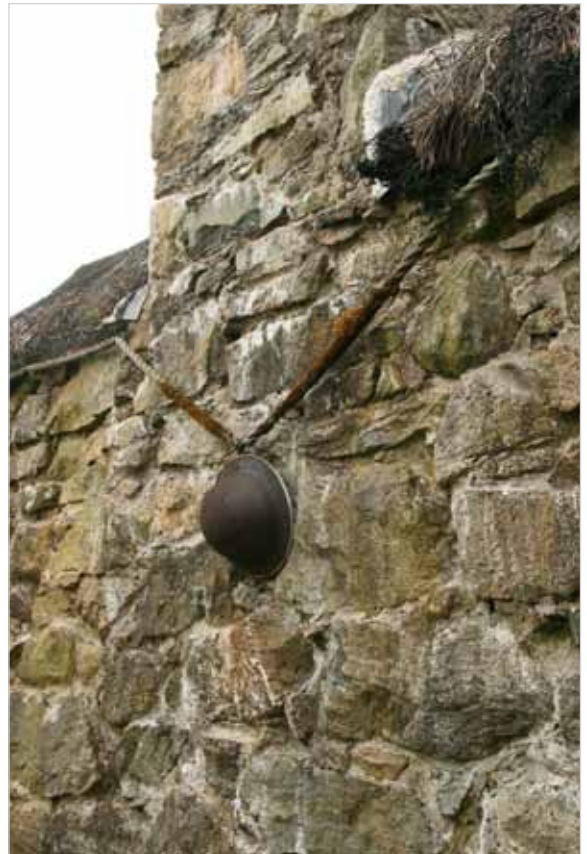
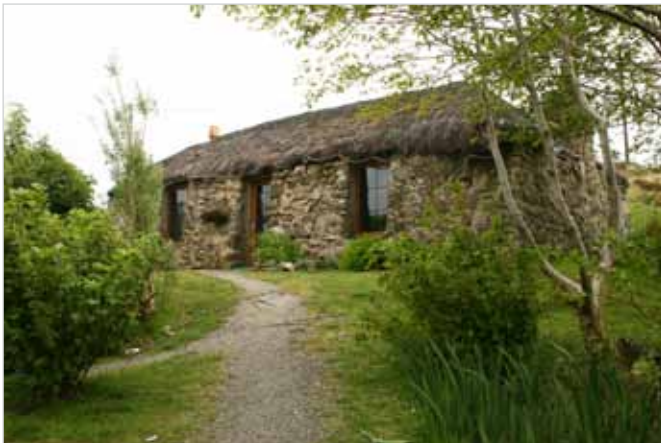
Lickisto Blackhouse – Western Isles

..... Fair

Cottage building of unknown date, located within a camp site and used for cooking and common room facilities for guests. The roof is thatched in heather and has a continuous heather ridge. The roof has been entirely netted, including across the ridge, which has been weighted along the ridge by rope passed through the holes in the net. The net has been secured to the wall at either gable end by metal pegs. The thatch on the rear elevation is substantially missing and exposes much of the roof structure and plastic sheeting beneath. Across the surface of the remaining thatch there is some mossy vegetation growth throughout.

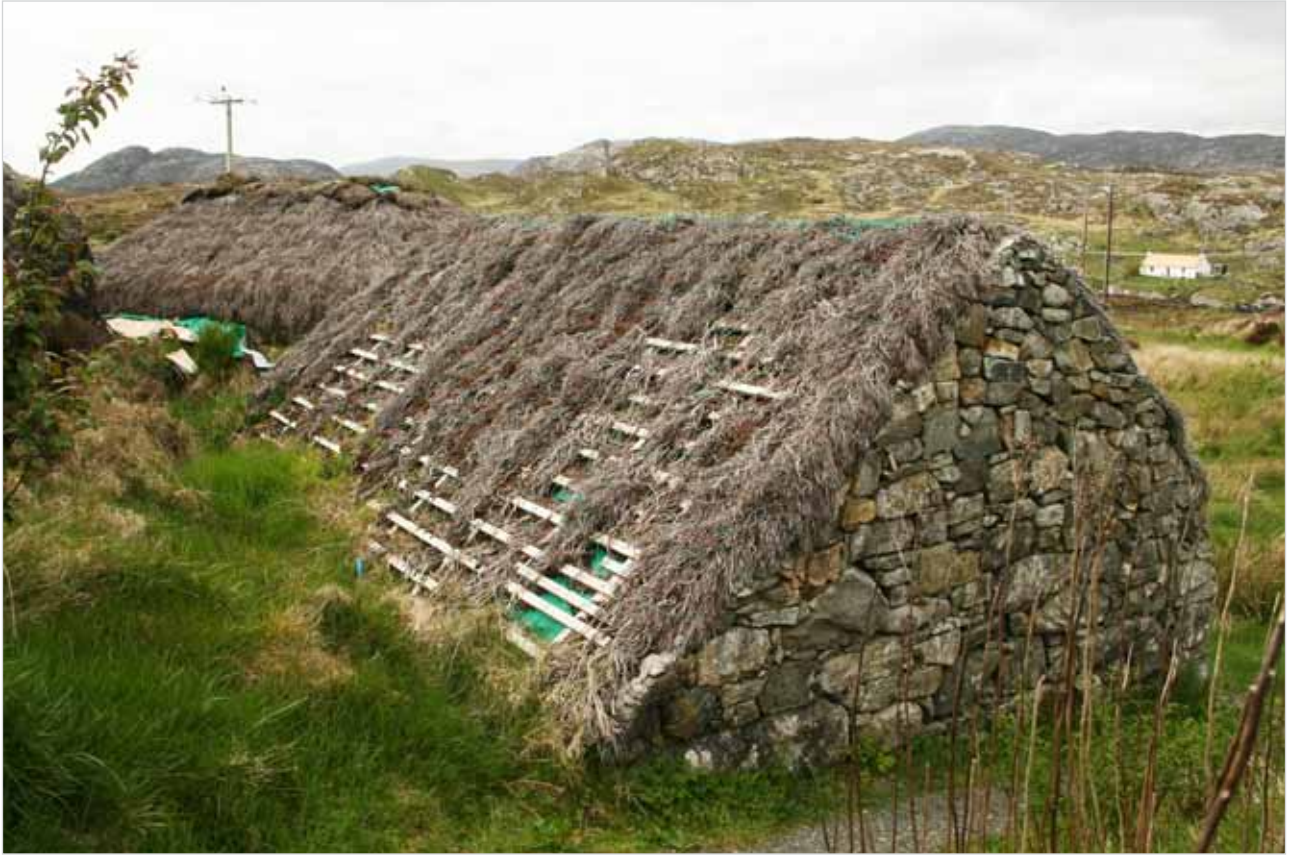
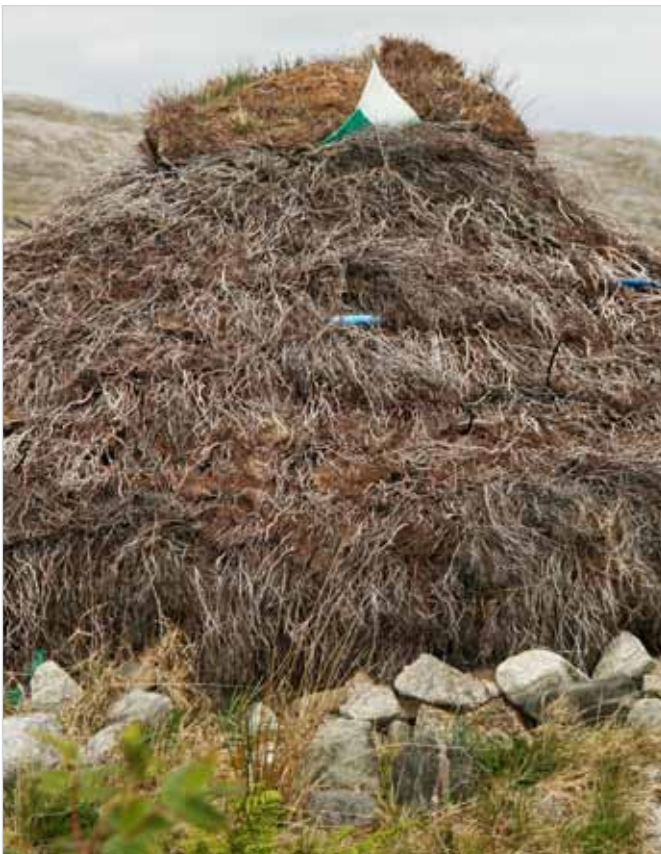
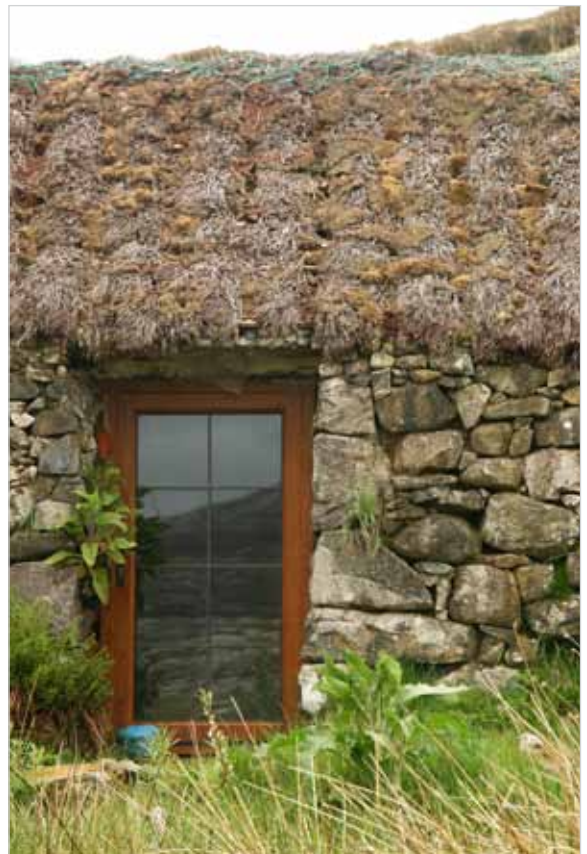
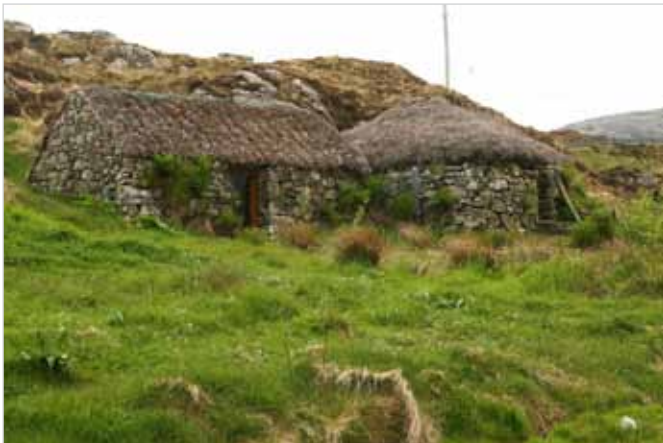
Lickisto Byres – Western Isles

Pair of byres of unknown dates, located within a campsite. The west byre is used as a toilet block for guests, whilst the east byre is used partially for storage and is not open to the public. Both buildings are thatched in heather, and the east byre has a continuous heather ridge whilst the west byre has a turf ridge. Both roofs have been left uncovered and the thatch appears to be secured to the roof by metal wiring on the west byre and string on the east byre. The rear elevation of the east building is in poor condition and much of the thatch is missing, particularly lower down, which is exposing the roof structure and plastic sheeting underneath. There

is also some mossy vegetation growth across the surface of the thatch throughout both roofs.

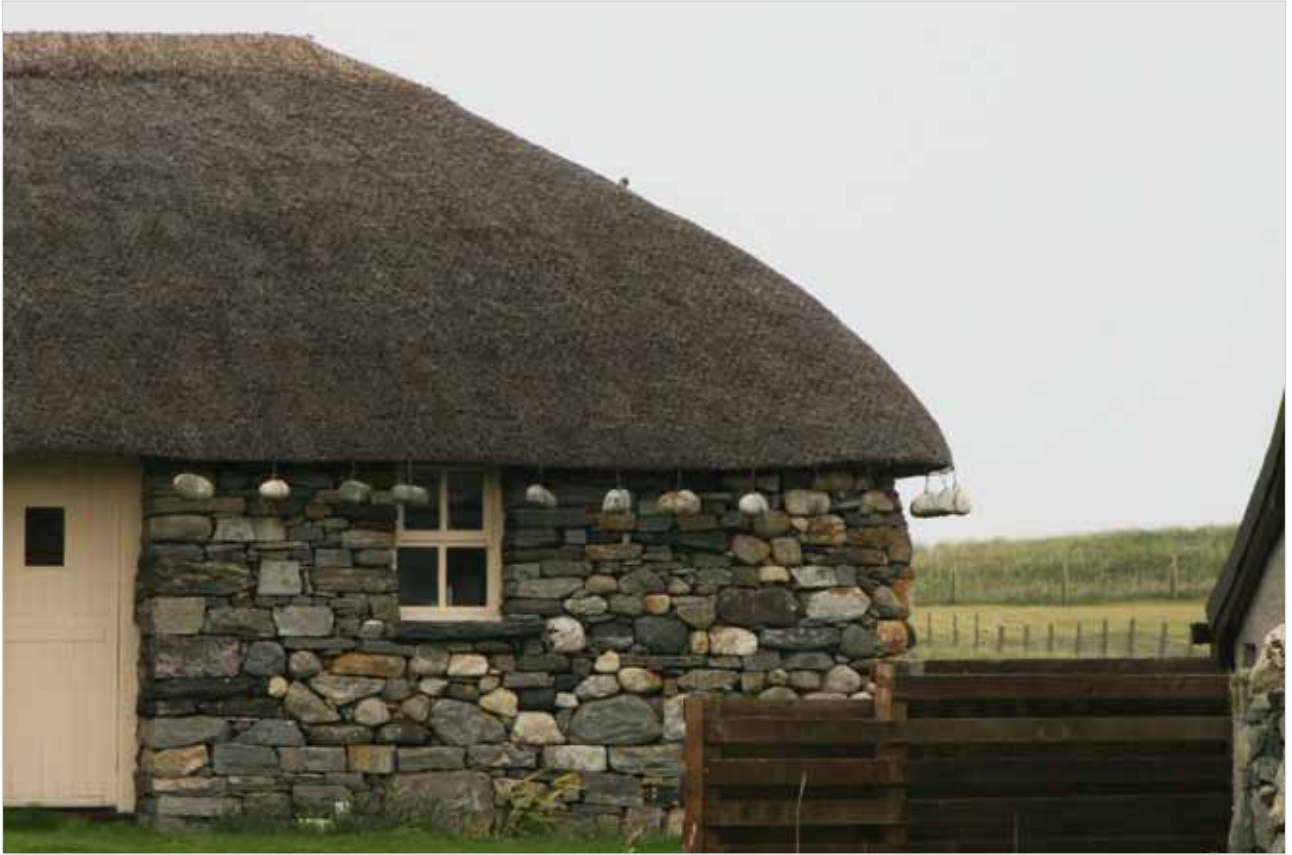
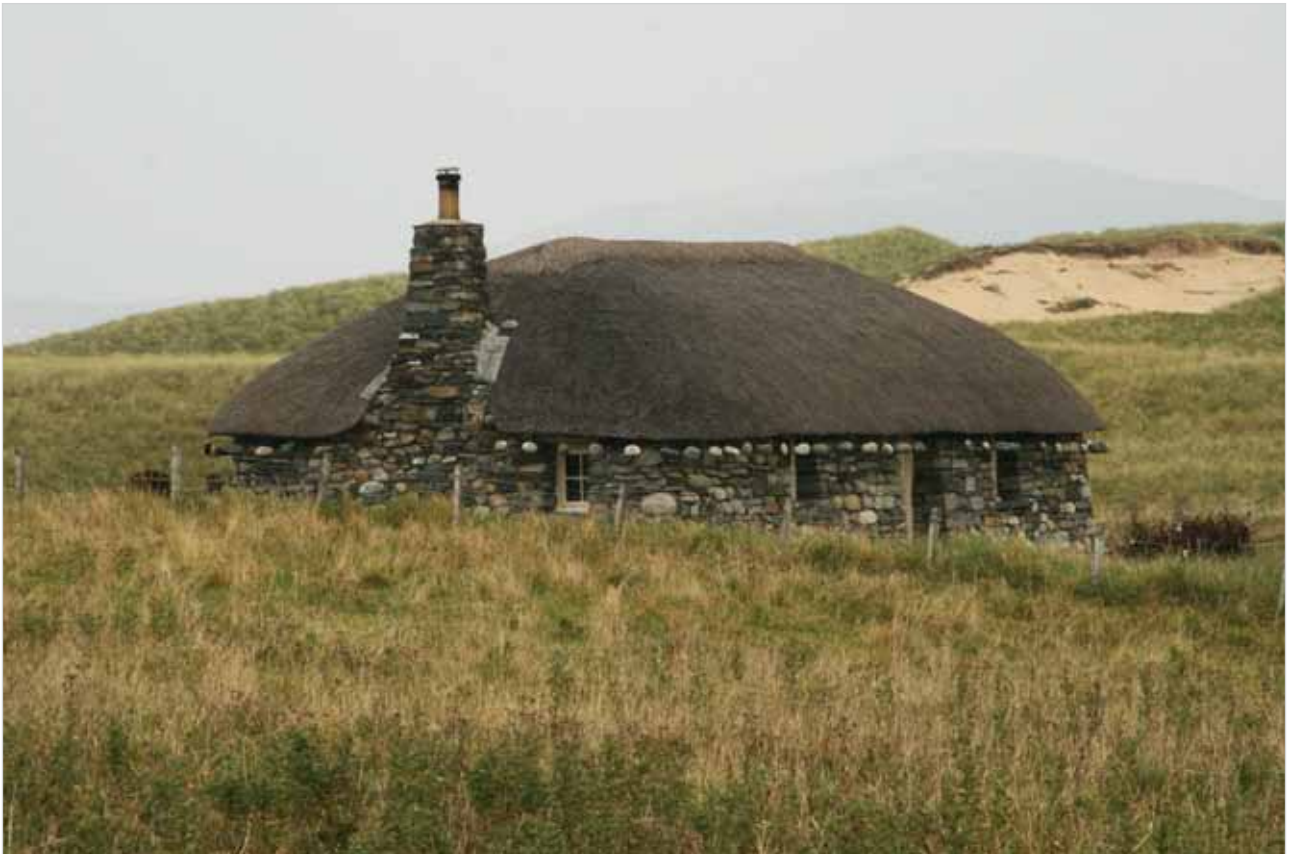
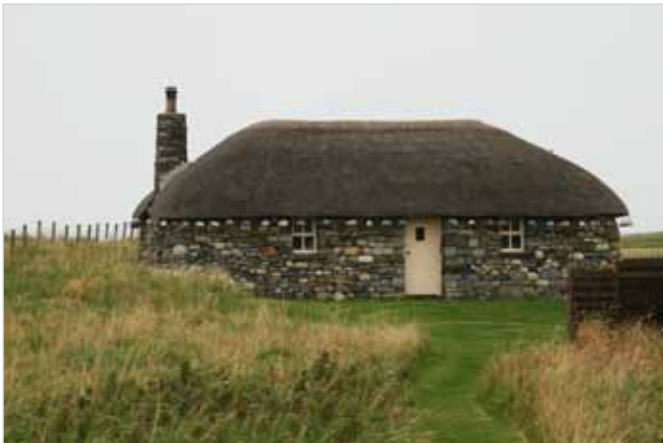
Borvemor Blackhouse – Western Isles

..... Good

According to the website for Borvemor Cottages, the Blackhouse property, which is used as holiday accomodation, was built in 1993 using the traditional dry-stone walling technique. The website also states that the property was completed in only four months and 'subsequently received the Pinnacle Award from The Dry Stone Walling Association of Great Britain (DSWA)'. The entire reed-thatched roof is netted, including across the ridge, which has been weighted down at the eaves using stones that have been attached to the netting by metal wire. The building has one chimney stack at the west end of the building, which has lead flashings between the base of the stack and the thatch.

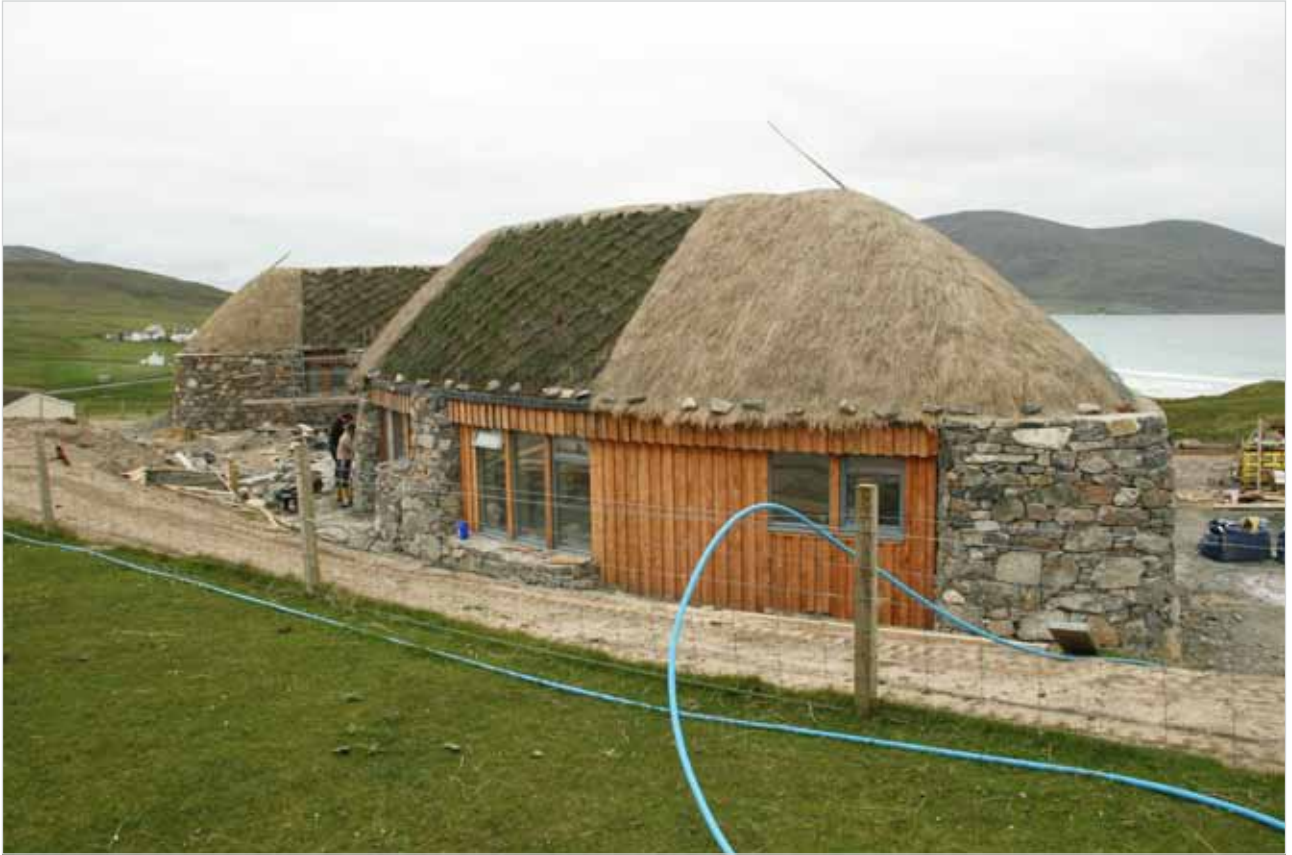
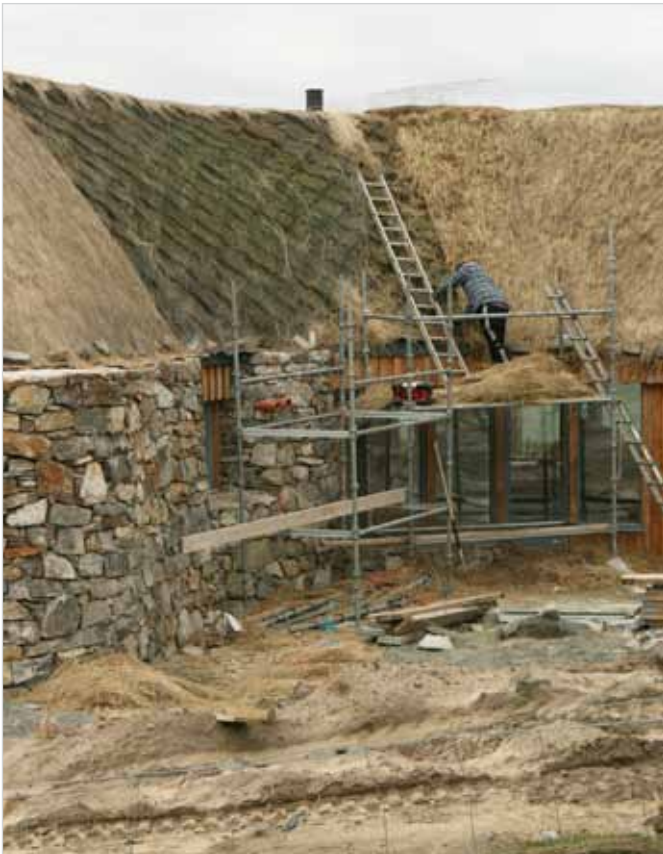
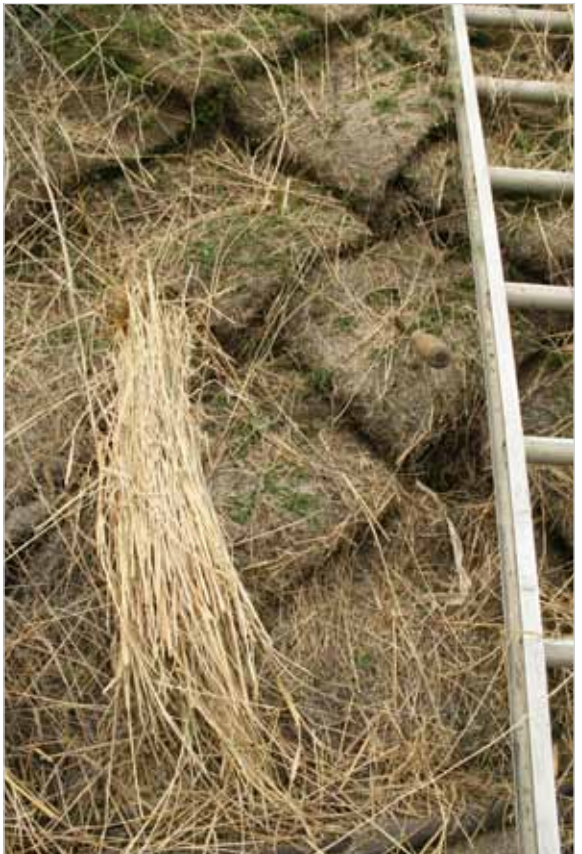
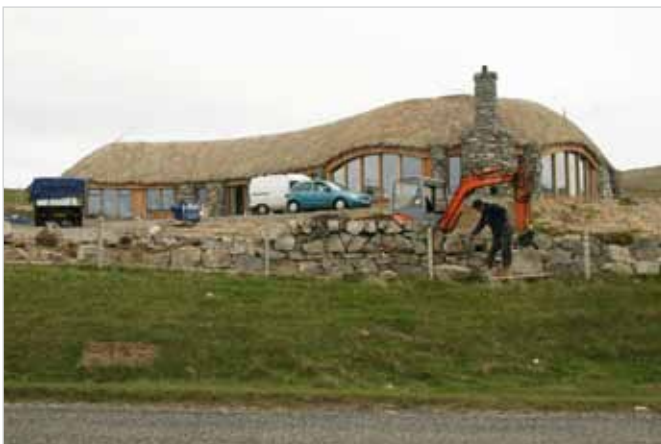
Oran na Mara – Western Isles

Condition of Thatch: Good

..... will be the final method of weighting is unknown.

..... The pitch of the roof varies throughout due to the curvature of the building.

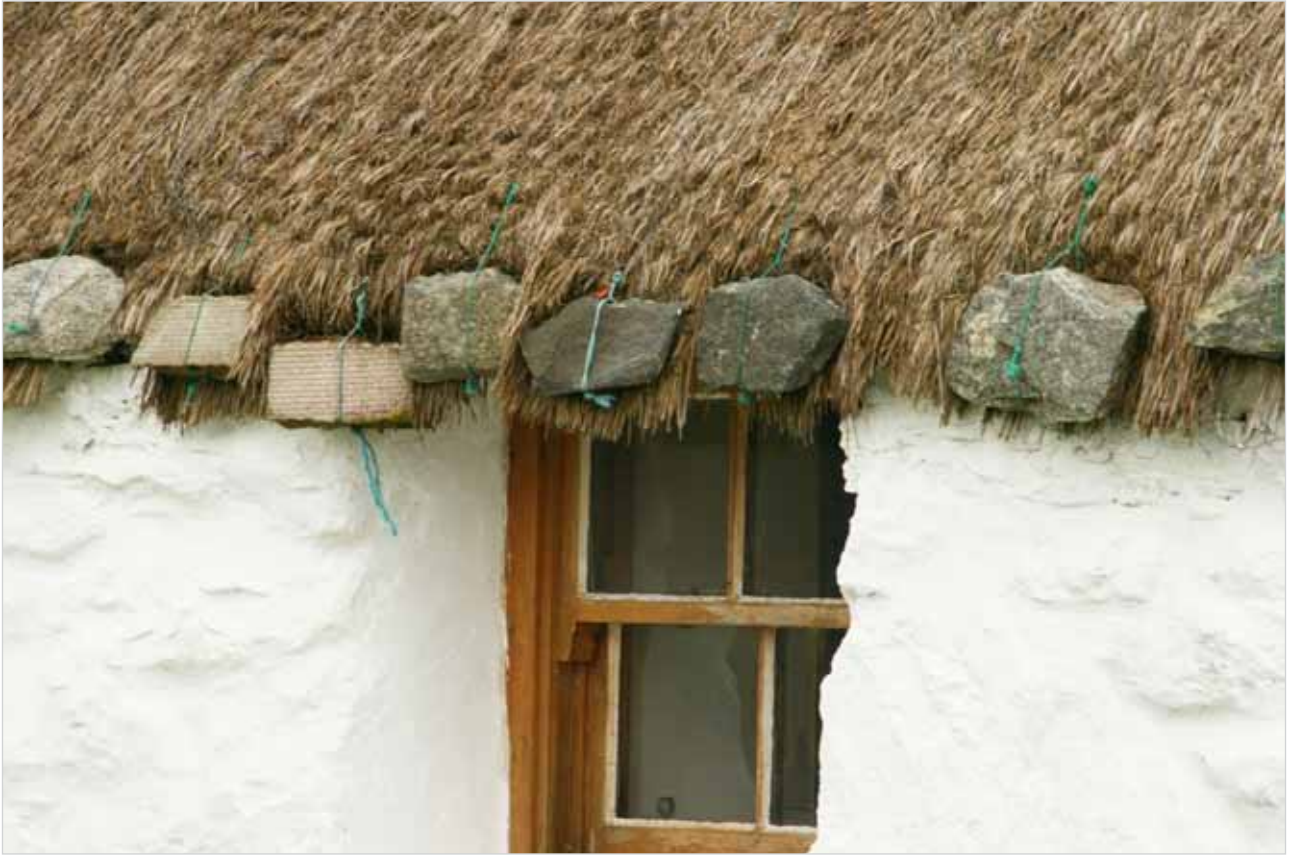
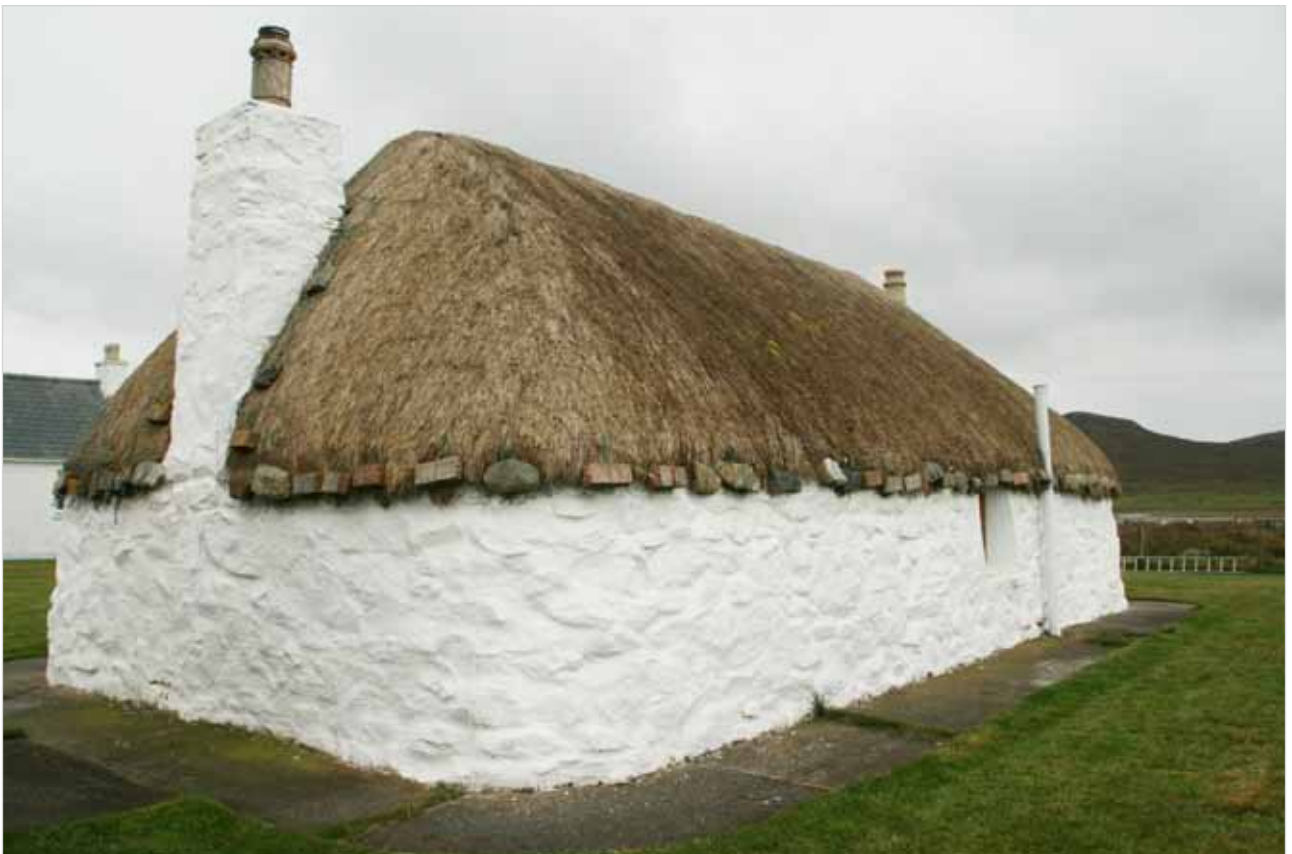
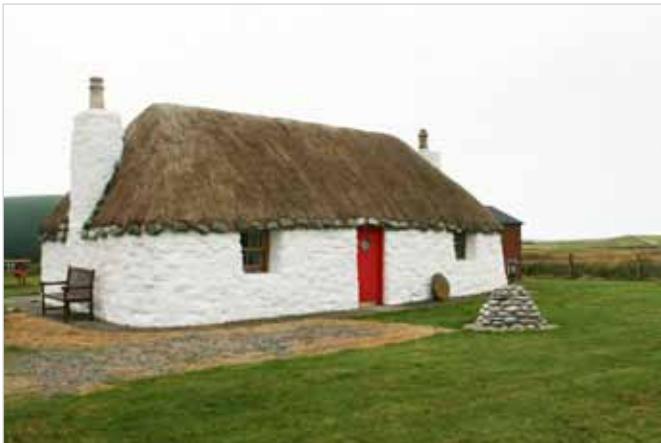
Tigh na Boireach – Western Isles

Thatch Type: Marram
 Ridge Type: Thatched (Marram)
 Condition of Thatch: Good

Additional Notes: According to the website advertising the building, the cottage was built in the 1920s and in 1995 was renovated for use as holiday accomodation. The marram-thatched roof of the cottage has a continuous marram ridge, and the entire roof has been netted with a large gauge netting. The netting is weighted along the eaves with stones and bricks tied to the netting with string. The string of stones is continued around the chimney stacks at either gable end. There are a few small patches of mossy vegetation growth on the surface of the thatch; however, this is not extensive.

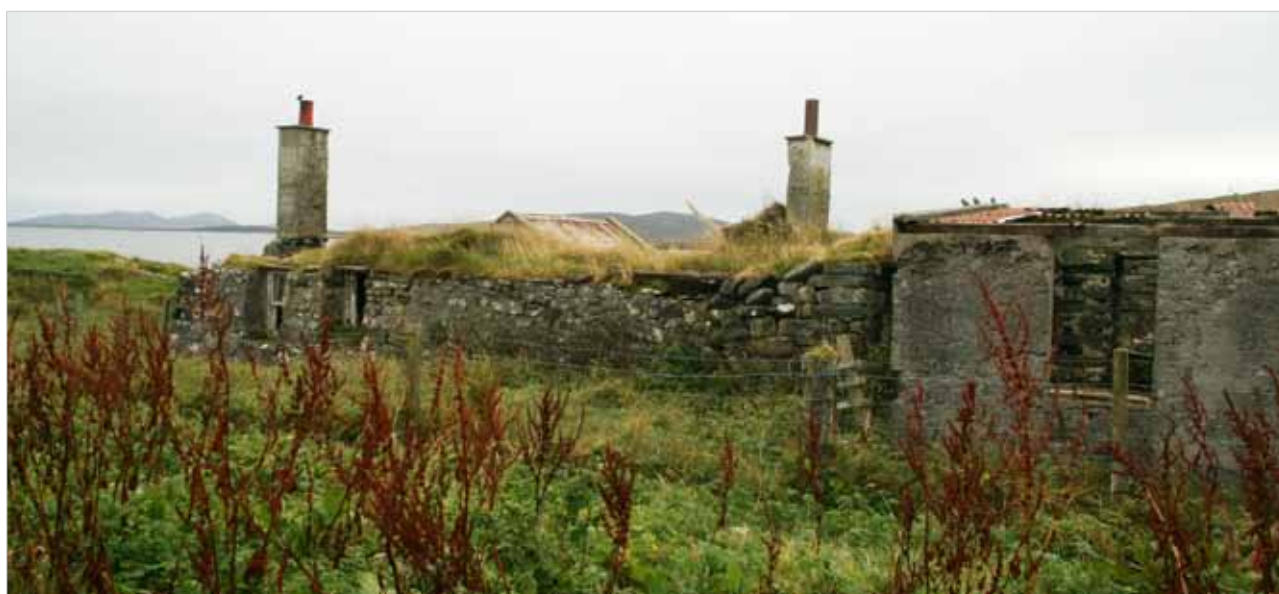
Additional Notes: This pair of likely 19th-century adjoining cottages are listed as having '*muran* thatch roofs, secured with netting and ropes, [and] stone weights over inner wall head'. The buildings are now derelict and the roofs have fallen in on both the north and south cottage. Both cottages have been on the Buildings at Risk (BAR) Register since 1999 (BAR reference numbers 3742 and 1866) after BAR inspection in 1998 found the cottages to be abandoned and ruinous. By inspection in 2009, BAR had recorded the roofs of both cottages to have collapsed. Some evidence of thatching material remains within the shell. The listing description for the cottages should be updated accordingly.

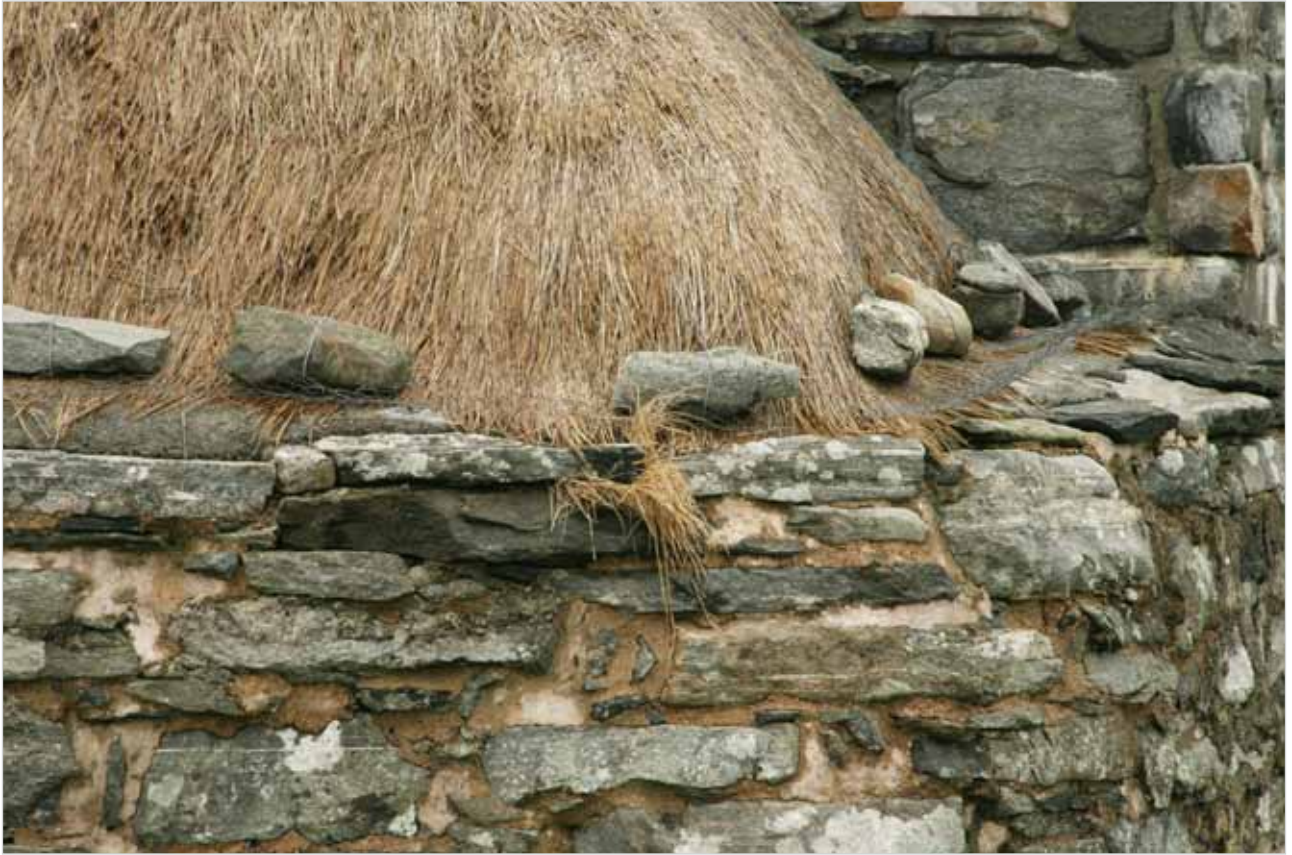
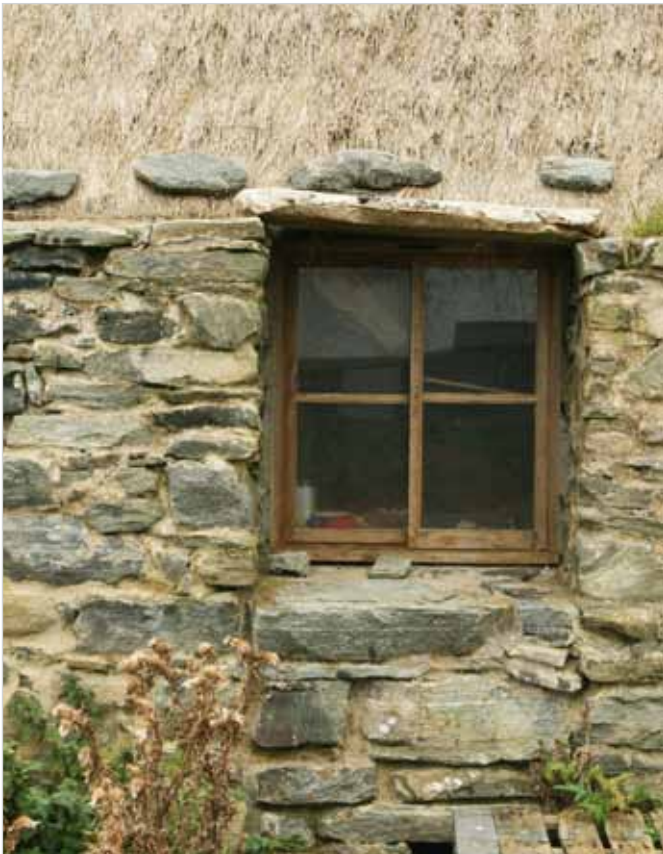
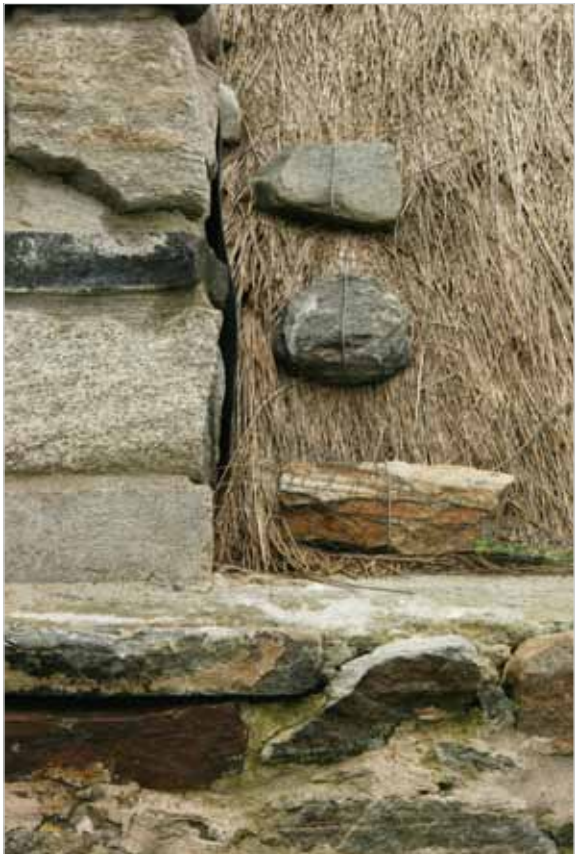
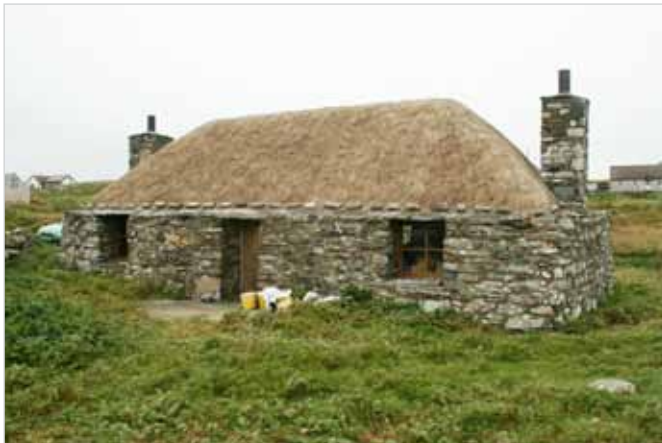
Cnoc an Dundion Thatched Cottage (East Cottage) – Western Isles

Good

Probably 19th-century cottage, listed as having a 'muran thatch roof, secured with ropes and netting, stone weights over inner wall head'. The building has been on the Buildings at Risk (BAR) Register since 1998 (BAR reference number 1856), at which time it was recorded by BAR to be derelict and the roof was collapsing. In 2009, BAR recorded upon inspection that the cottage was a roofless ruin, but by 2010 it was recorded that 'planning permission and listed building consent has been granted for renovation of cottages to provide a residential unit and a studio'. The renovation of the adjacent cottage was complete upon visiting (survey

number 242); however, this cottage is still being renovated internally. It has a marram-thatched roof with a continuous marram ridge. The roof is entirely netted, and weighted along the eaves with stones, secured to the netting by wire. The BAR register and the listing description should be updated accordingly.

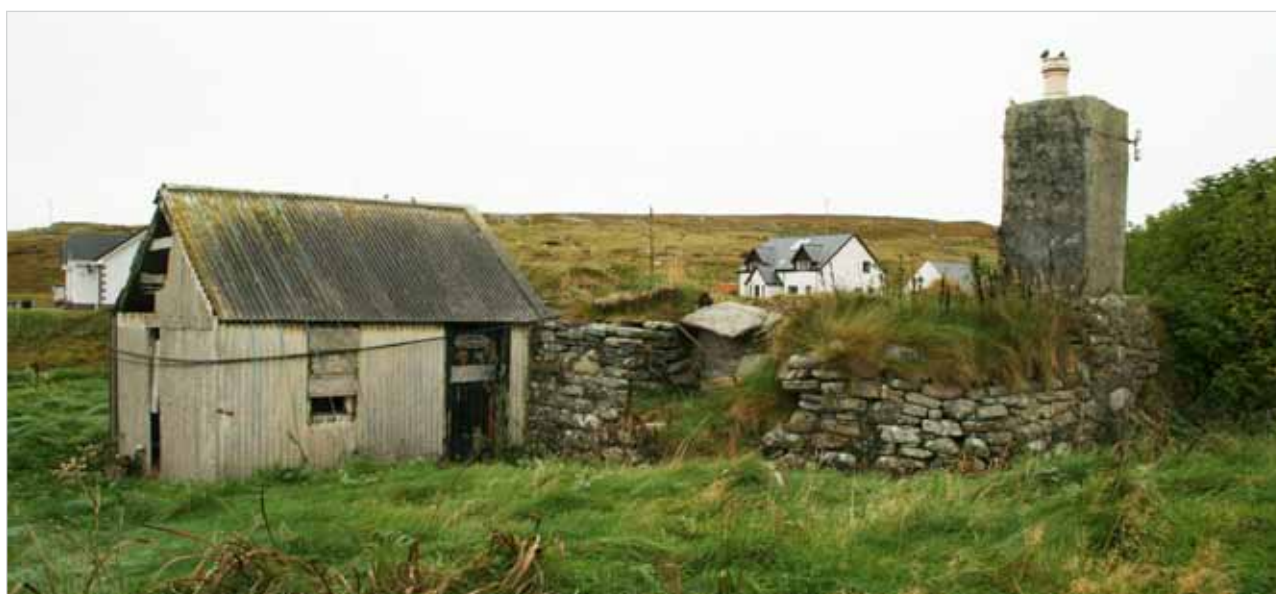
Additional Notes: Probably 19th-century cottage, listed as having a '*muran thatch roof secured with ropes and stone weights above wall head*'. The building has been on the Buildings at Risk (BAR) Register since 2010 (BAR reference number 4756), at which time it was recorded that '*external inspection finds the former thatched cottage, now a ruinous state, though some components survive*'. Most of the remaining thatching material that was recorded and photographed by BAR as still surviving in 2010 has now disappeared or become heavily overgrown with grassy vegetation, and no other signs of any roof structure are visible from external inspection. The listing description for this building should be updated accordingly.....
