A Survey of Thatched Buildings in Scotland

Thatch Survey of Scotland
2014-15

A photographic survey of thatched buildings in Scotland, surveyed between May 2014 and August 2015 by Zoe Herbert (SPAB Scotland Officer), on behalf of the Society for the Protection of Ancient Buildings.

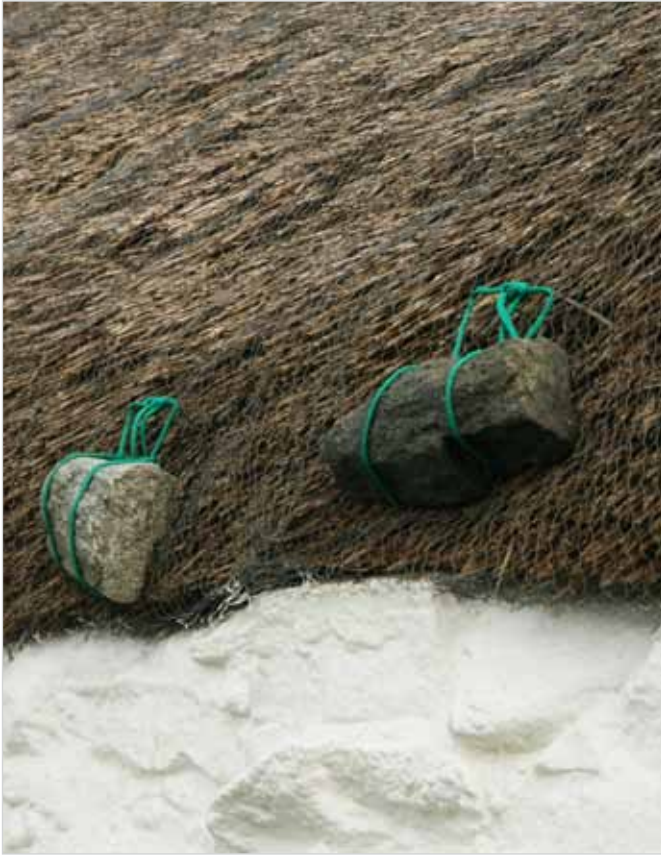
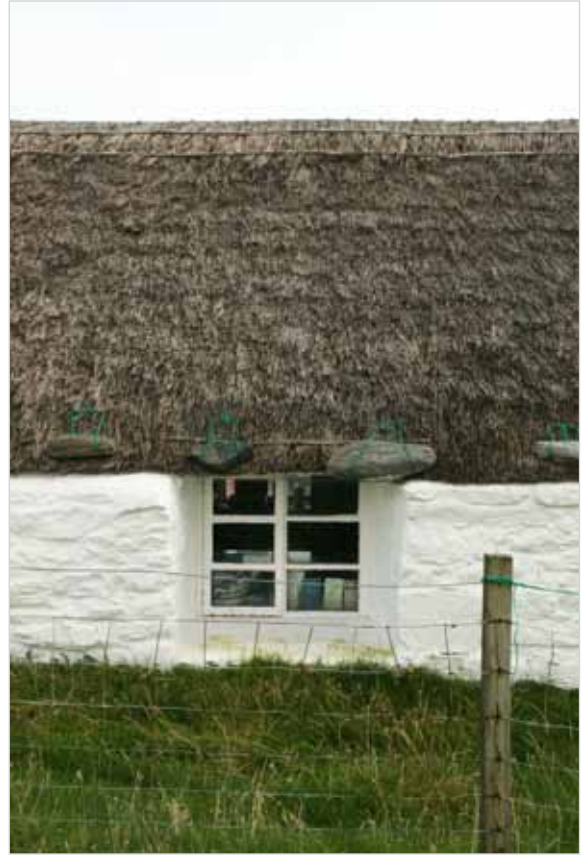
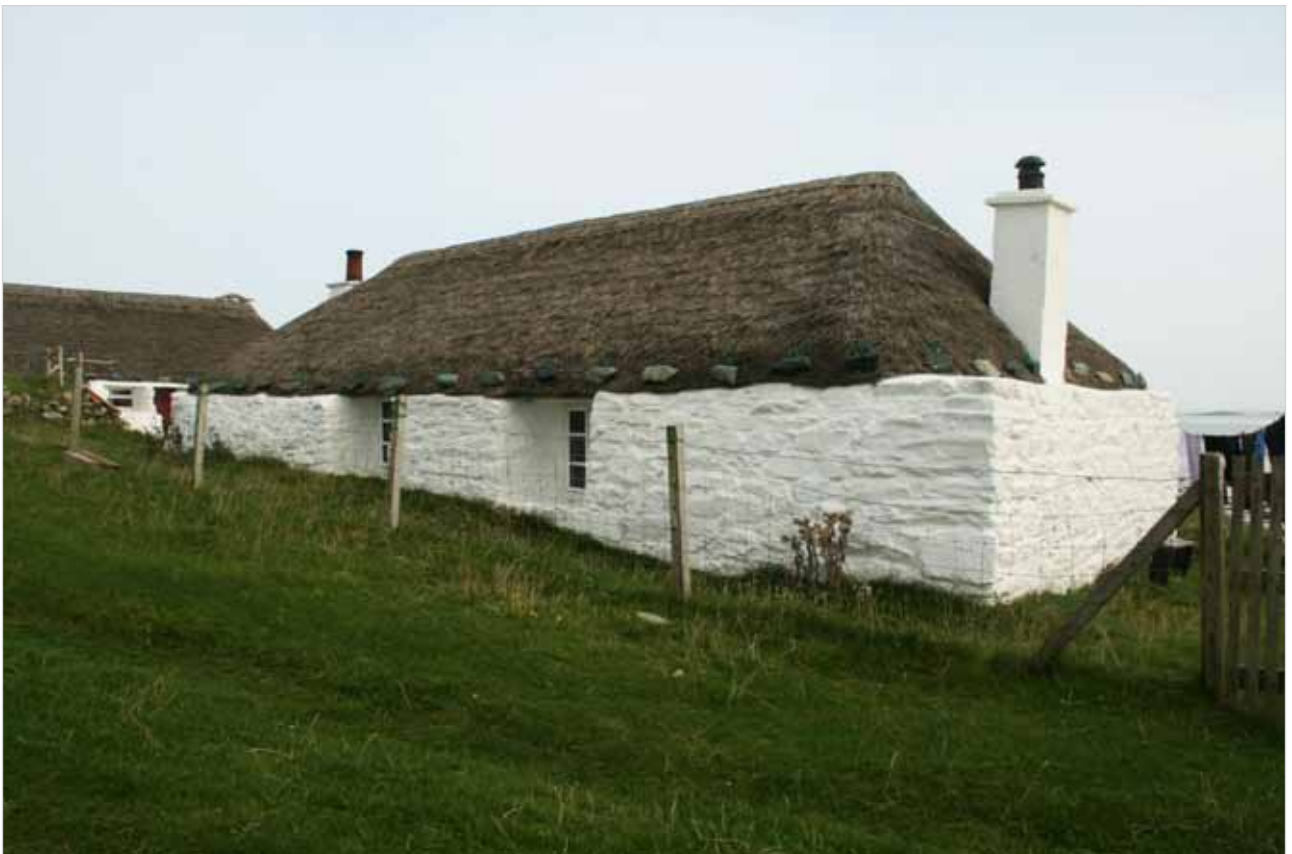
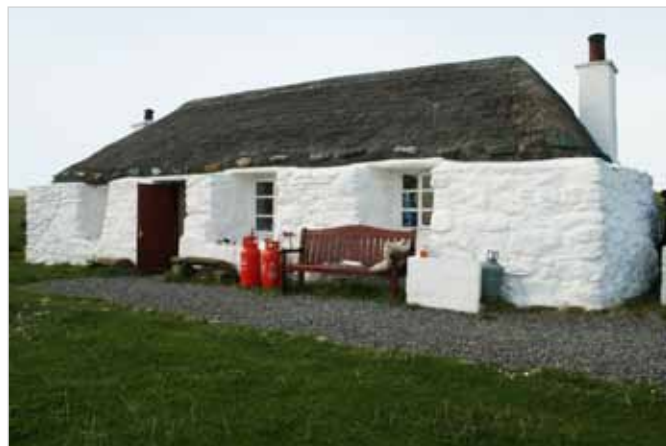
Berneray Hostel – Western Isles

exposed. The ridge is scobed with two horizontal

rows of hazel spars; however, this has become

slightly loose and is partially missing at the ends

of the ridge.

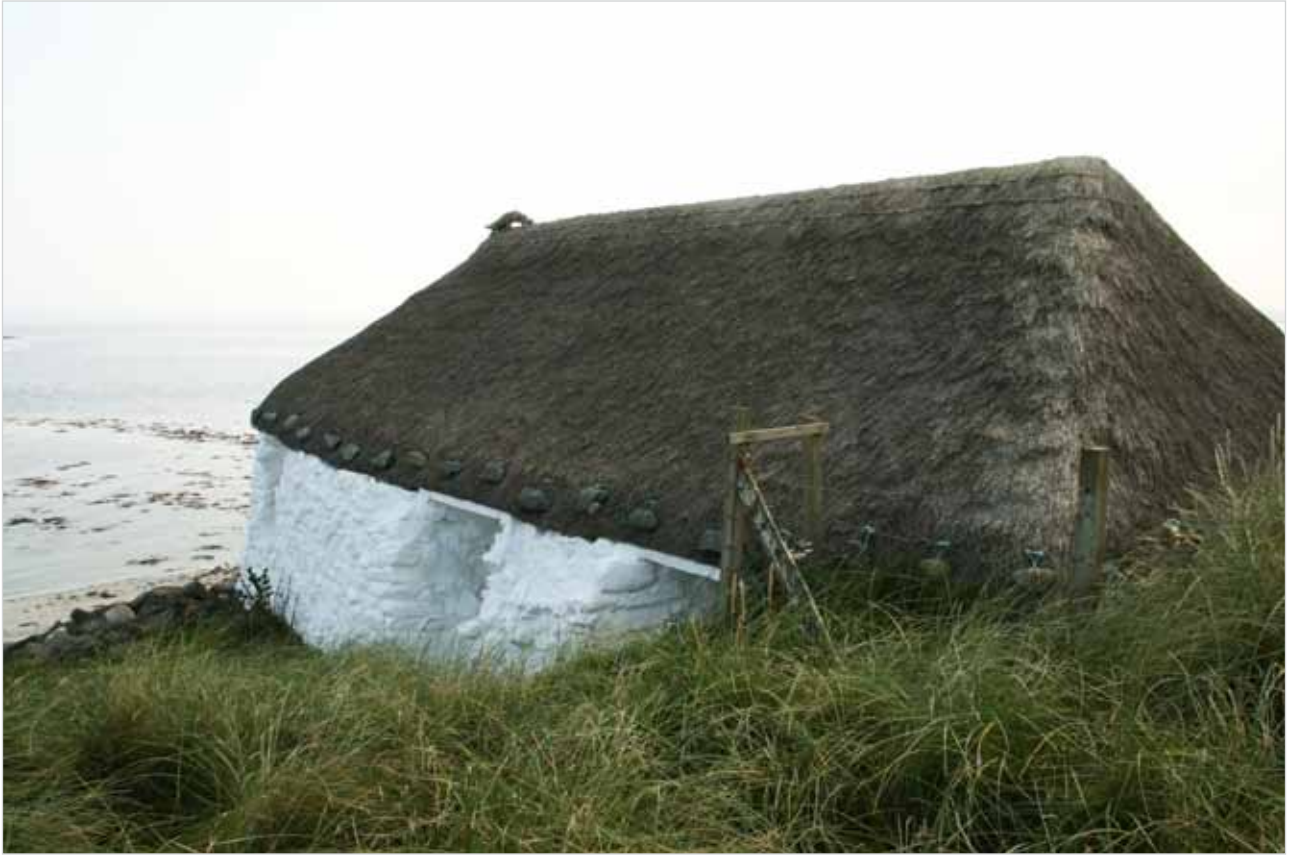
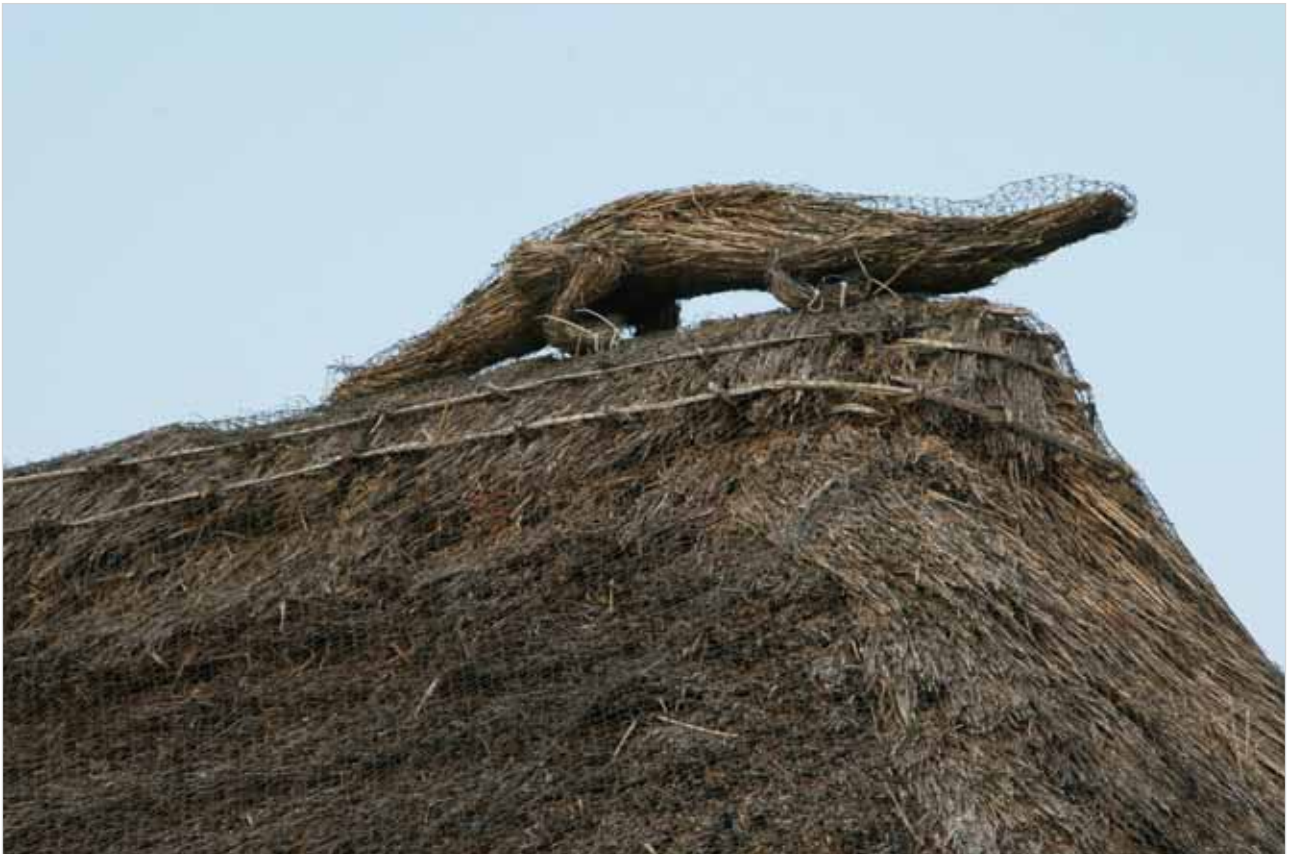
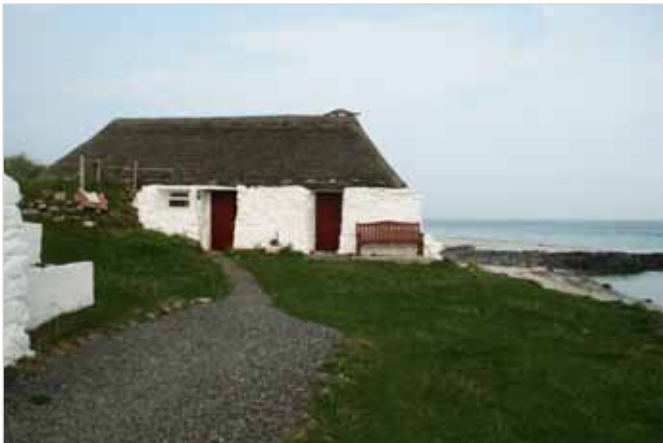
Berneray Hostel Annex – Western Isles

otter sculpture, which is secured in its shape by

netting, is missing. The adjacent thatched cottage,

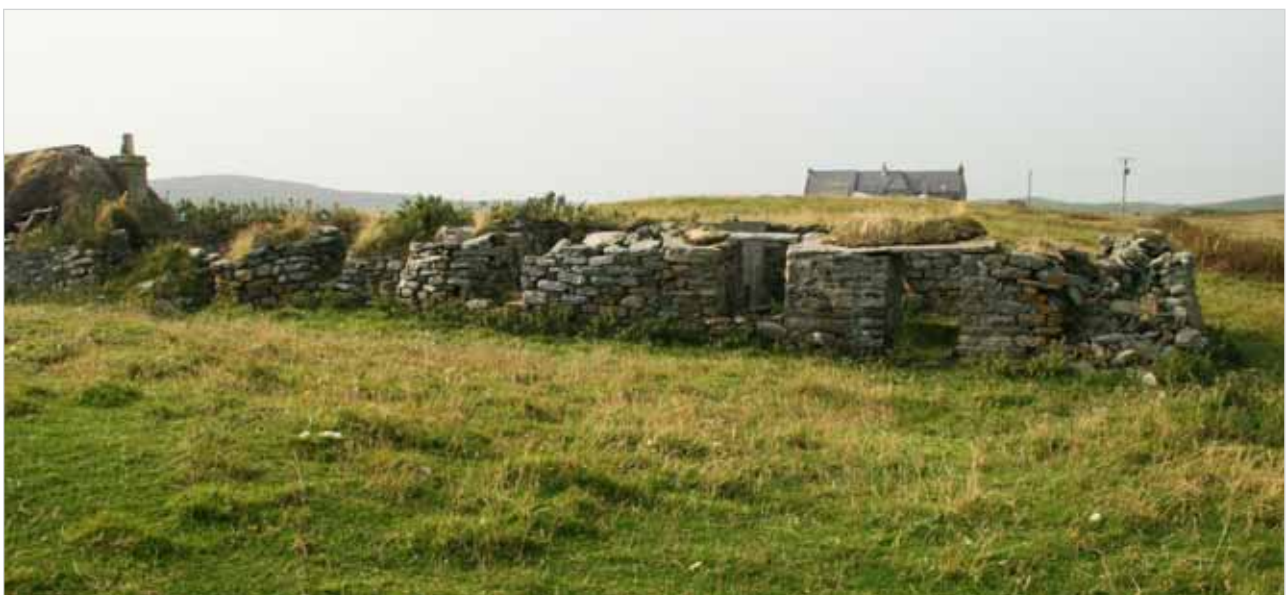
Additional Notes: The listed building description reads *'Probably 19th century, Hebridean-type thatched cottage (at north east end of row of 3 adjoining). Single storey; 3-bays. South east front: door to right with slab lintel; small-paned windows in splayed reveals. Massively thick battered, rubble-built walls with curved angles; central axial flue; muran thatch roof, secured with netting, some stone weights over inner wall head'*. The building is now a roofless ruin and has been on the Buildings at Risk (BAR) register since 2009 (BAR reference number 3740). BAR inspection notes reveal the roof of the building to have collapsed between 2000 and 2009. The listing description for the building should be updated accordingly.

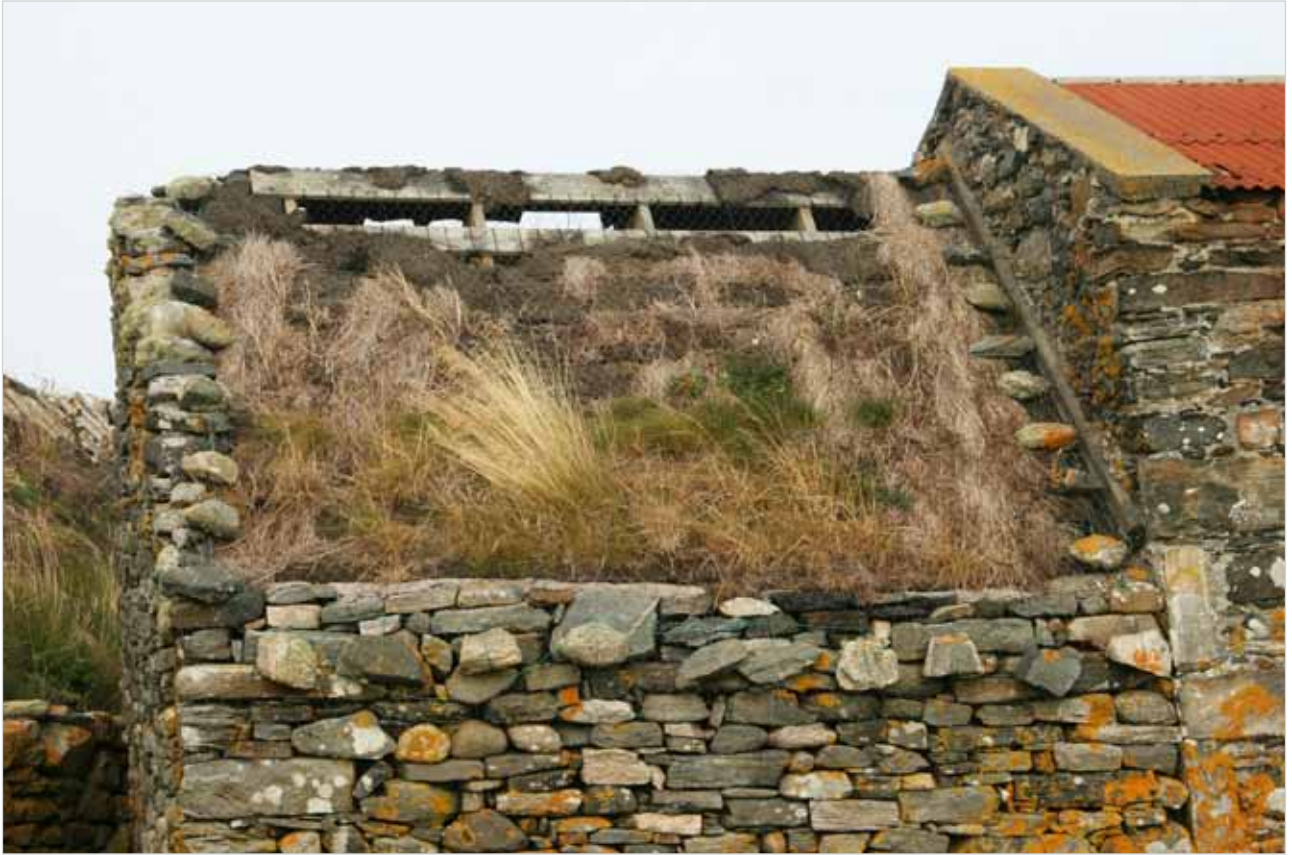
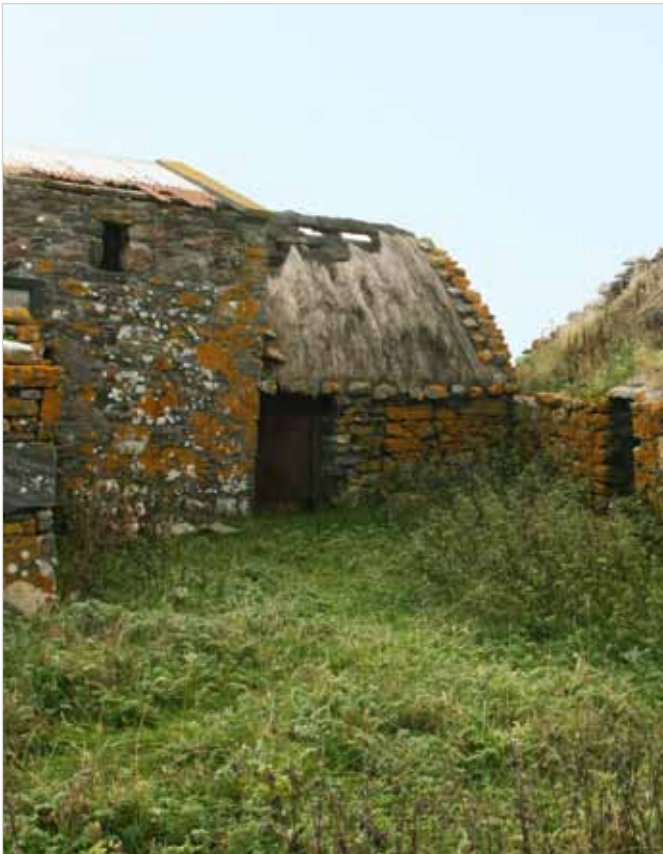
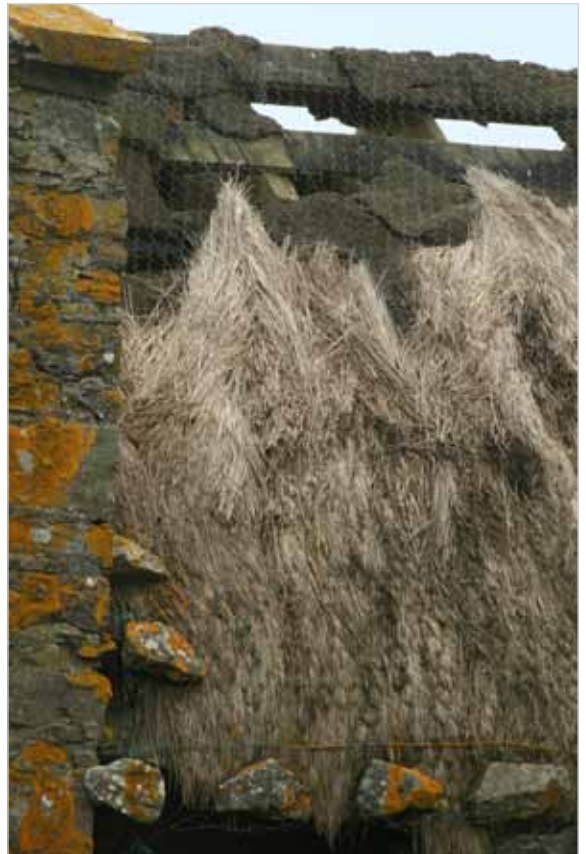
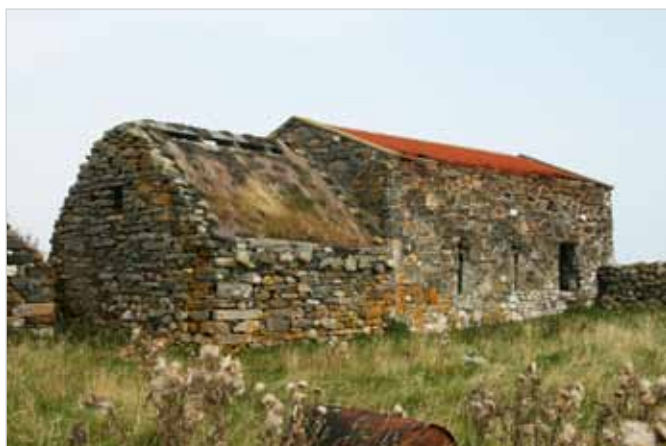
Ruisgarry Barn – Western Isles

Thatch Type: Marram
 Ridge Type: n/a
 Condition of Thatch: Poor

Additional Notes: Thought to be 18th-century, the listed building description reads '*corrugated iron roof (presumably thatched formerly); roofless additions beside door and on north west gable*'. The part of the building that is currently thatched is that described as being roofless. Although some of the marram thatch remains, the building is vacant and in a severe state of deterioration. Much of the thatch is still intact on the north roof pitch; however, there are large holes in the thatch at the top, leaving the interior and the roof structure exposed. The south pitch is missing much more of its thatch and is overgrown with vegetation. None of the ridge remains

and the turf underlay is exposed in many places. The roof remains netted, held in place by stones that are secured to the netting by string along the wallhead and skews. The building is located next to a thatched byre under the same listing (survey number 248). The barn has been on the Buildings at Risk Register since 2009 (BAR reference number 3744).

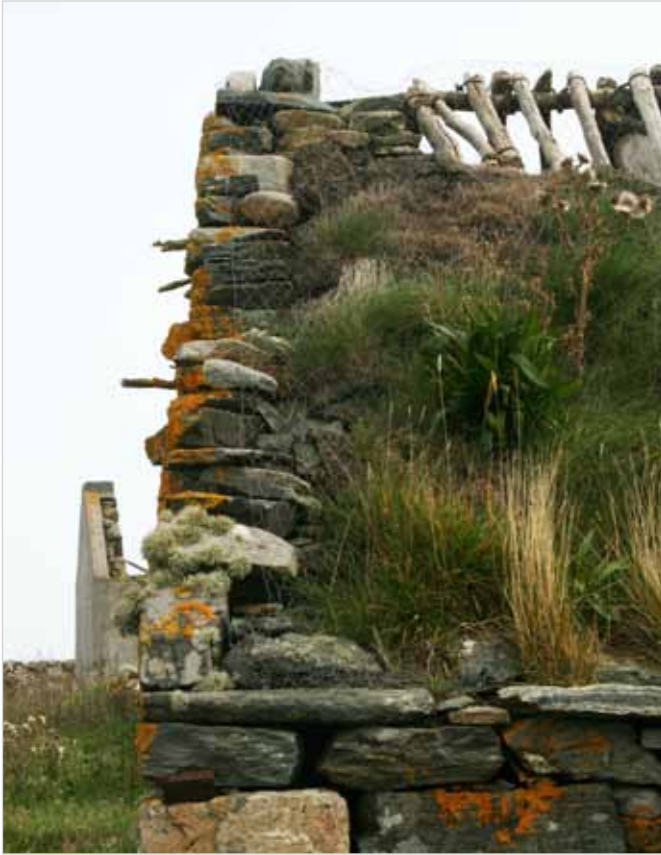
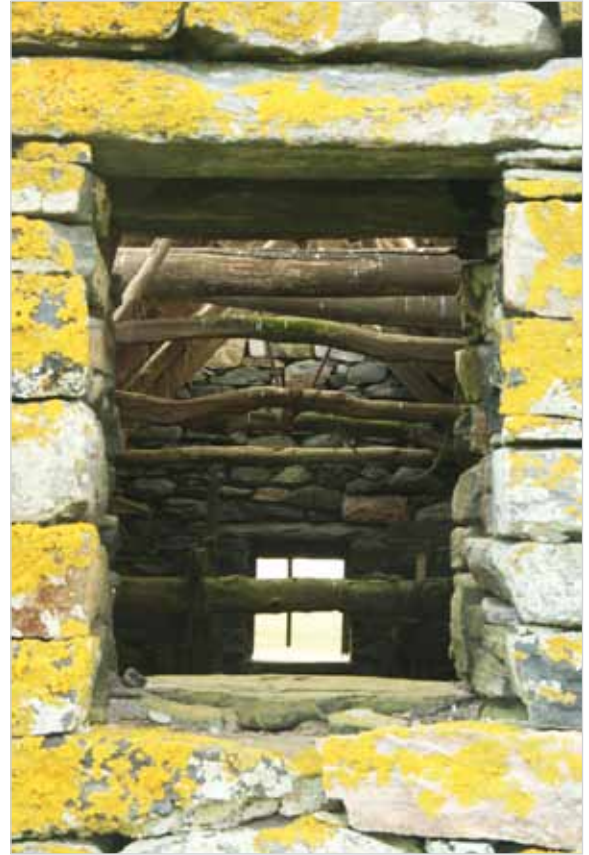
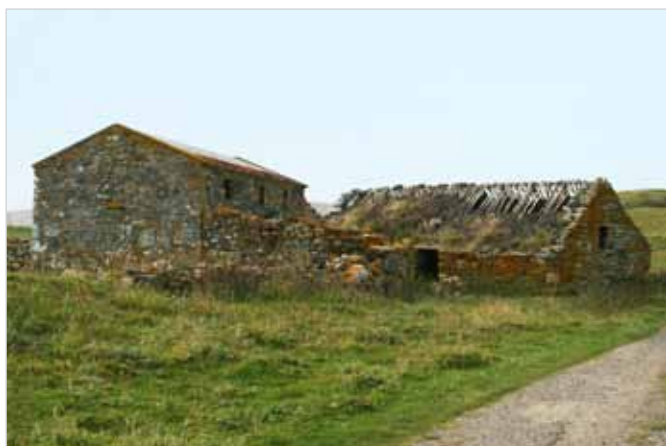
Ruisgarry Byre – Western Isles

Address: Ruisgarry Byre
 Baile Listing Category: B
 Isle of Berneray Date Listed: 05/10/1971
 Listed Building Number: 46108
 Local Council: WESTERN ISLES Canmore ID: 238271
 Building Type: Byre
 Use: n/a
 Grid Reference: NF 93224 81525 Occupancy: Vacant
 Date of Visit: 21/09/2014 Buildings At Risk: Yes
 Thatch Type: Marram
 Ridge Type: n/a
 Condition of Thatch: Poor

Additional Notes: Thought to be 18th-century, the listed building description reads '*muran thatch roof, secured with ropes and netting, stone weights over inner wall head [and], pegs on gable head*'. The building is currently vacant and in a severe state of deterioration, particularly the roof, which has lost much of its thatch, leaving the roof structure and interior exposed. What is left of the marram thatch and turf underlay is overgrown with vegetation and the ridge has been completely lost. The entire roof remains netted, weighted down by stones and bricks that have been placed on top of the netting along the wallhead and down the skews. There is no

visible evidence of the ropes and stone weights described to secure the thatch and netting in the original listing description, or the pegs at the gable head. The building is located next to a thatched barn under the same listing (survey number 247). The byre has been on the Buildings at Risk Register since 2009 (BAR reference number 3745).

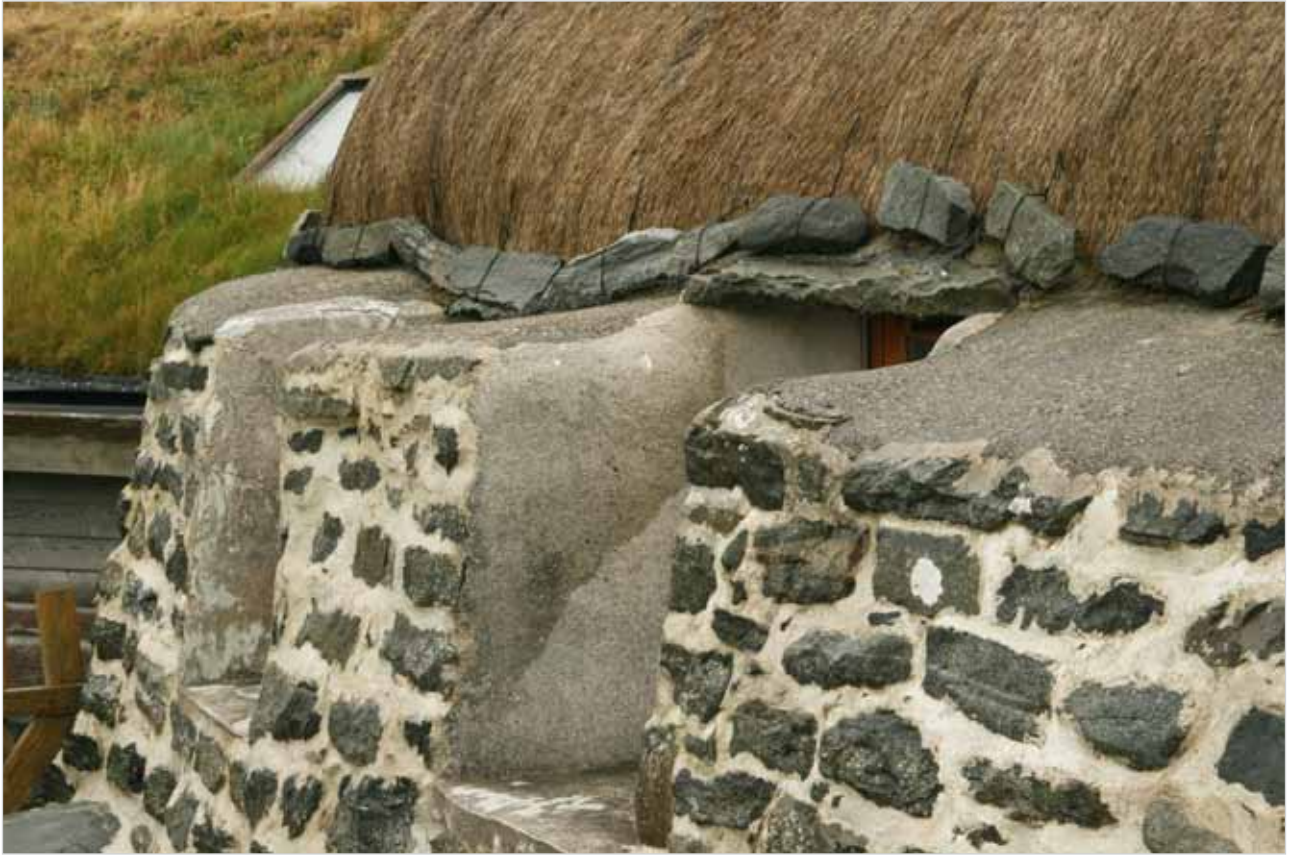
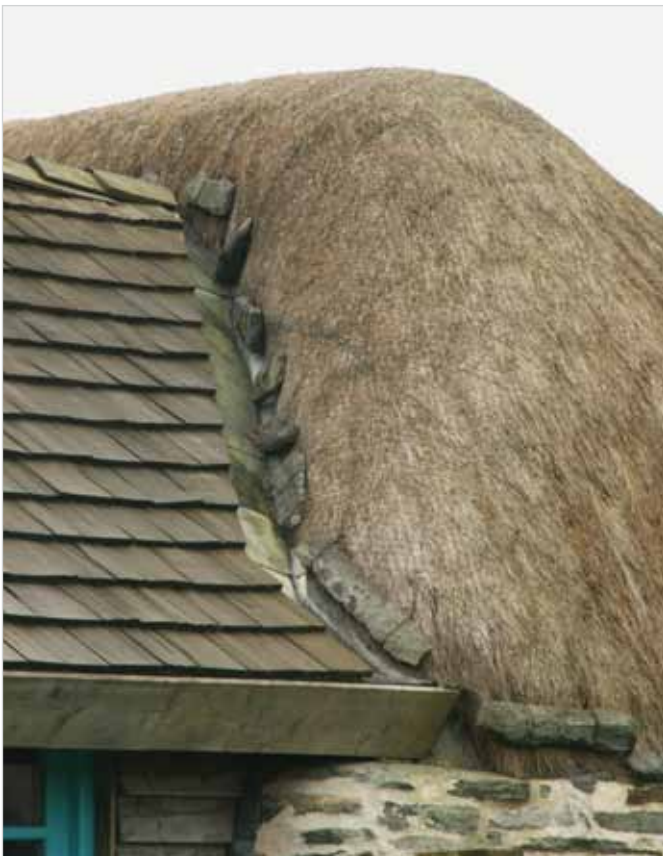
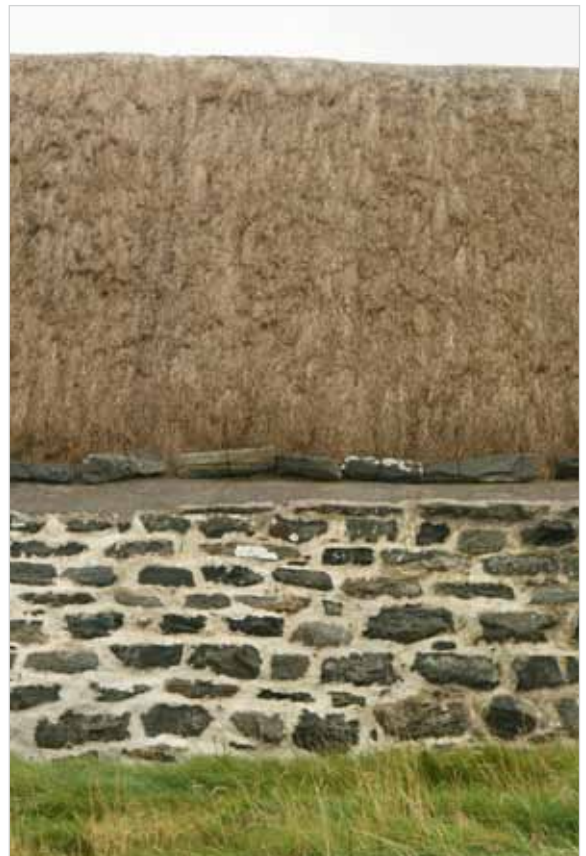
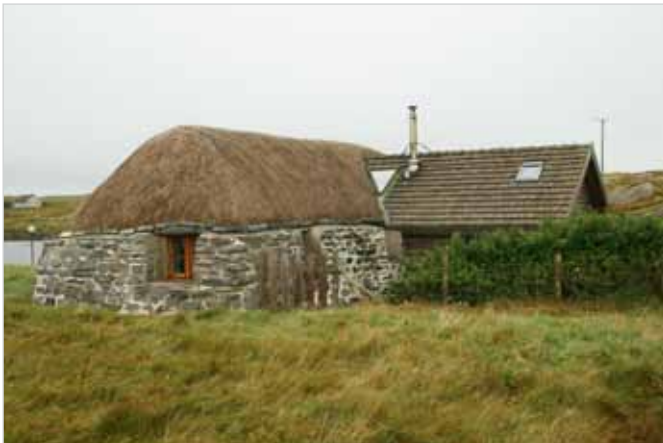
Laimrig Ruadh Thatched Cottage – Western Isles

Additional Notes: Probably 19th-century cottage with 'modern lean-to porch at right on south east front', listed as having a 'muran thatch roof, secured with netting and ropes, stone weights over inner wall head'. The modern porch extension has a slatted timber roof. The cottage is still thatched in marram and has a continuous marram ridge. The entire roof has been netted, weighted along the eaves, over the window openings and around the porch extension by stones secured to the netting by wire.

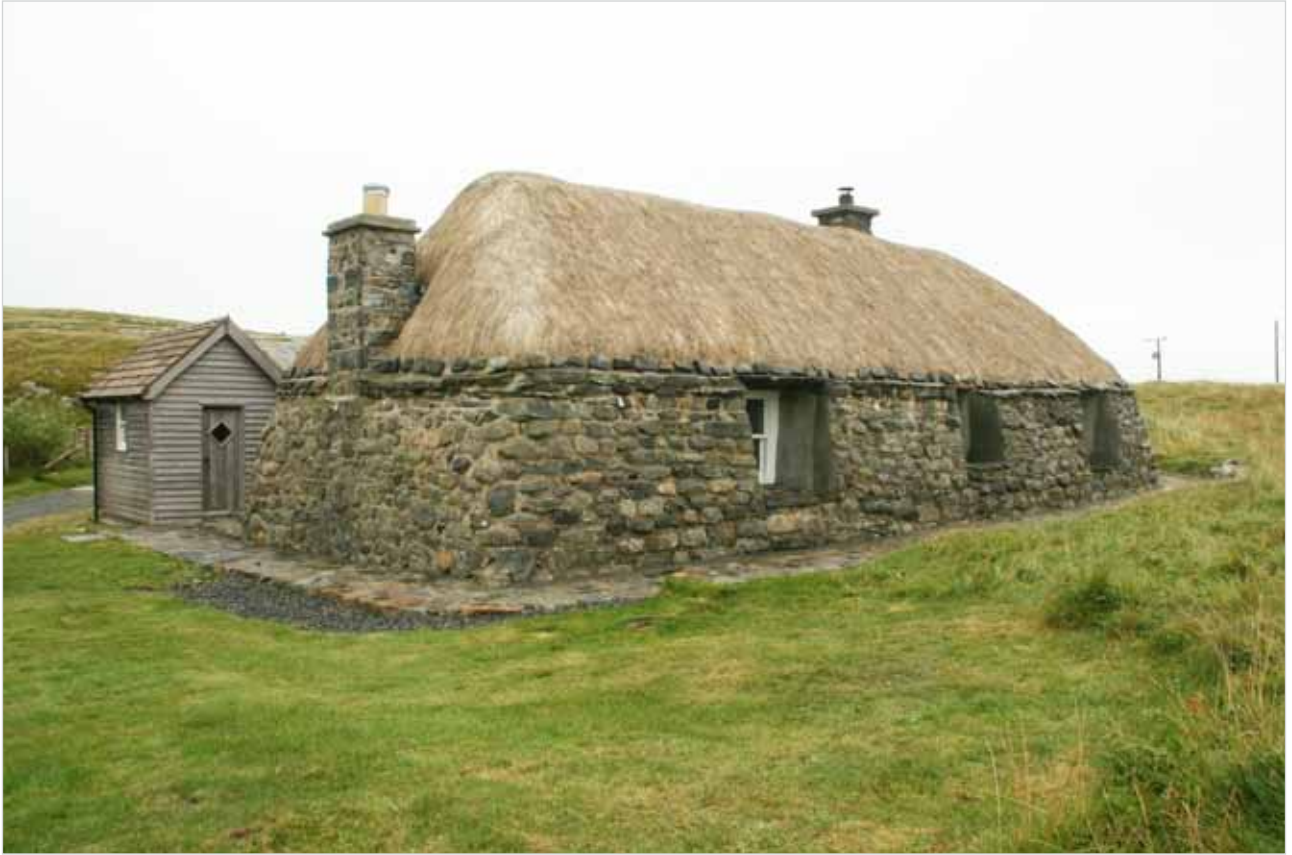
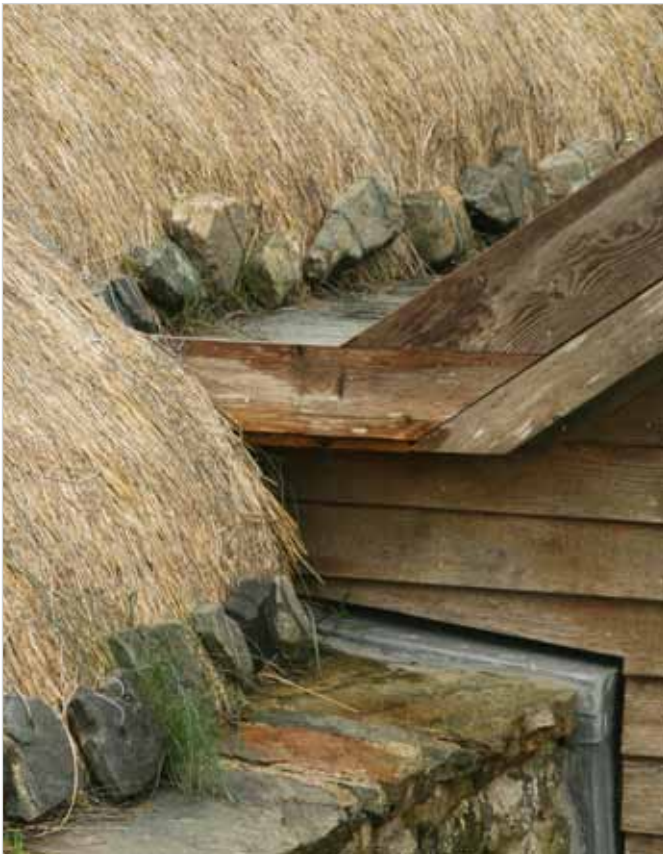
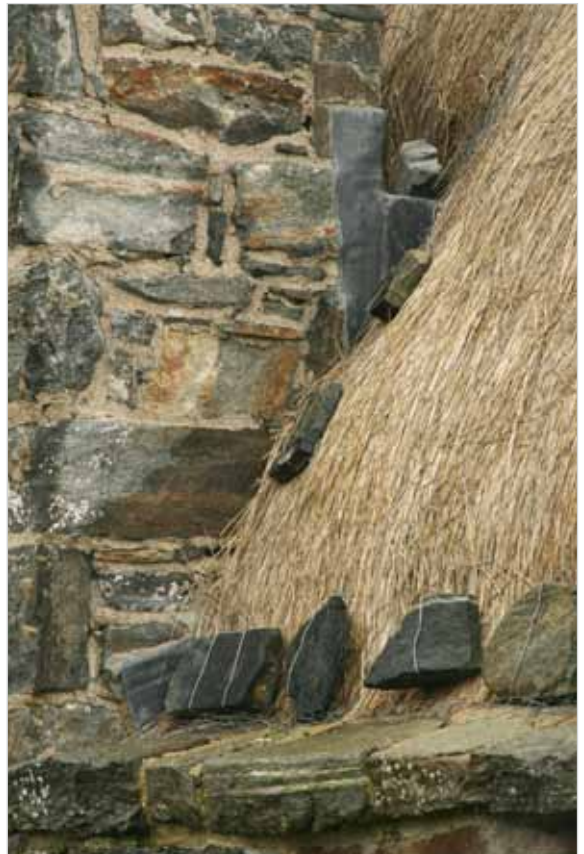
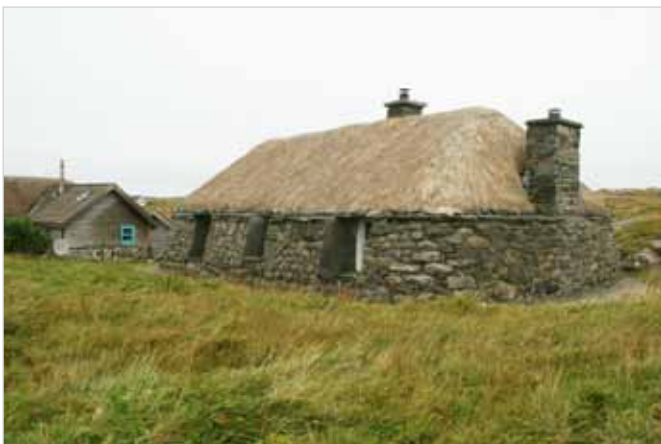
Laimrig Ruadh Thatched Cottage – Western Isles

Additional Notes: Probably 19th-century cottage with modern porch addition to east, listed as having a 'muran thatch roof, secured with netting and ropes, stone and wooden weights over inner wallhead'. The modern porch extension has a slatted timber roof. The cottage is still thatched in marram and has a continuous marram ridge. The entire roof has been netted, weighted along the eaves, over the window openings and around the porch extension and chimney stacks at either end by stones secured to the netting by wire.

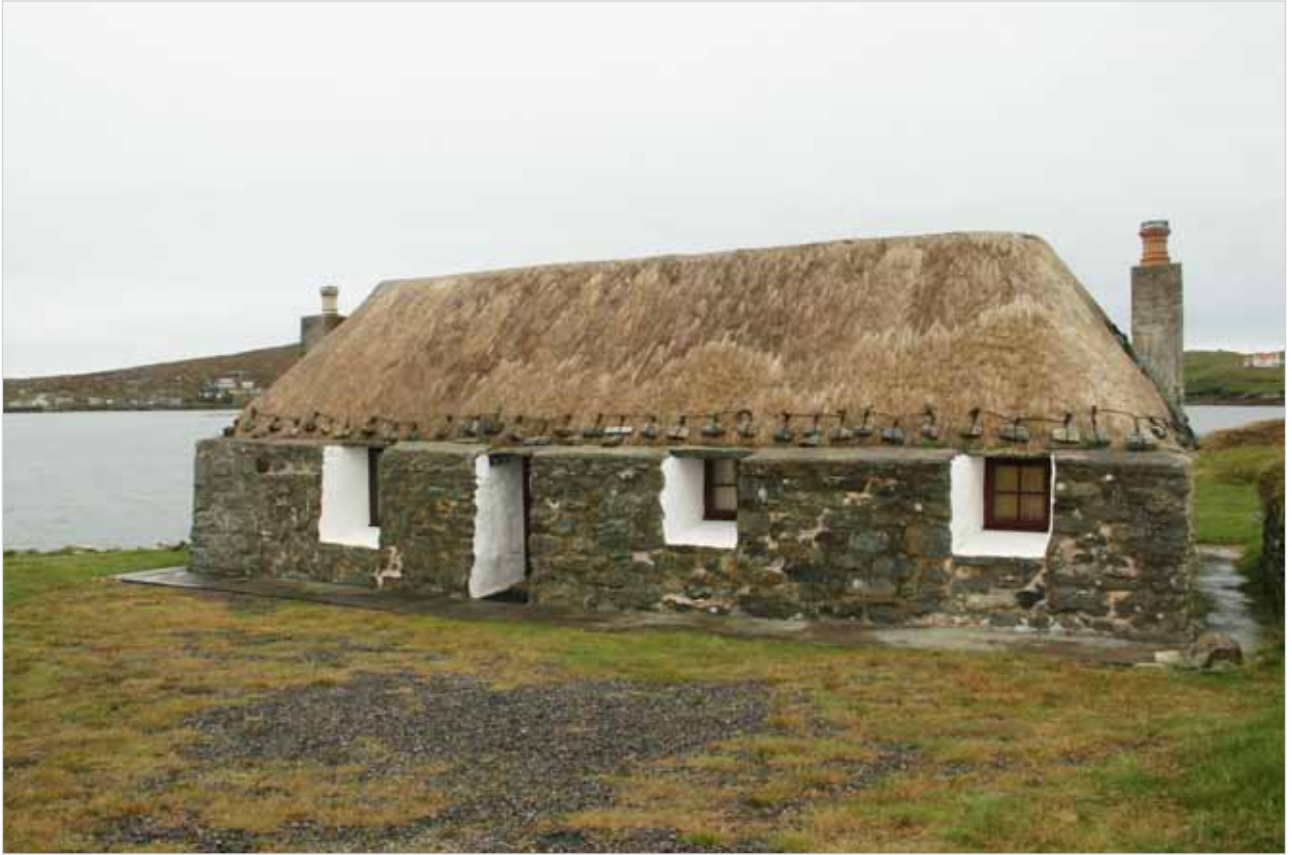
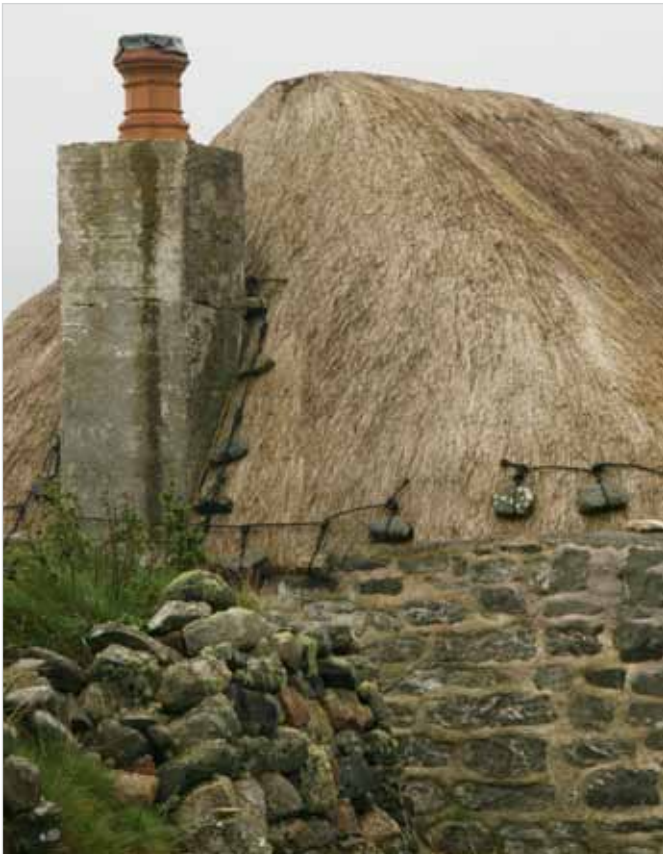
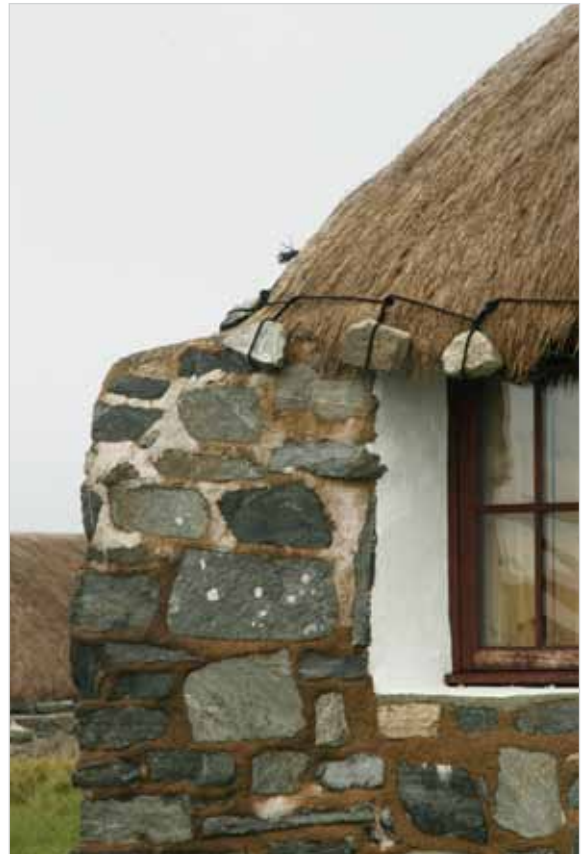
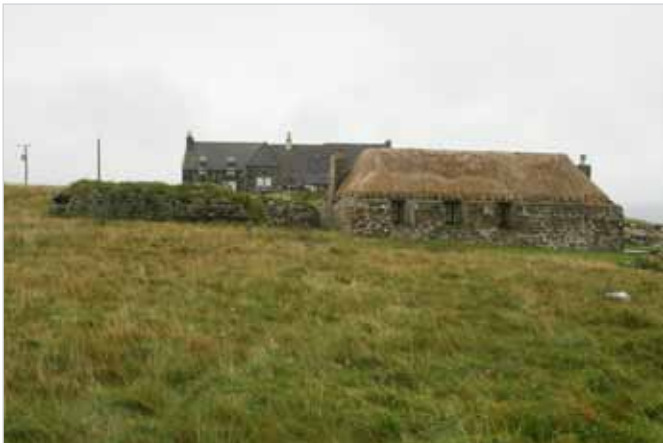
Laimrig Ruadh Thatched Cottage – Western Isles

Additional Notes: Probably 19th-century cottage, listed as having a '*muran thatch roof secured with netting and ropes, stone weights over inner wall head*'. The cottage is still thatched in marram and has a continuous marram ridge. The entire roof has been netted, weighted along the eaves and around the chimney stacks at either end by stones secured to the netting by a continuous string.

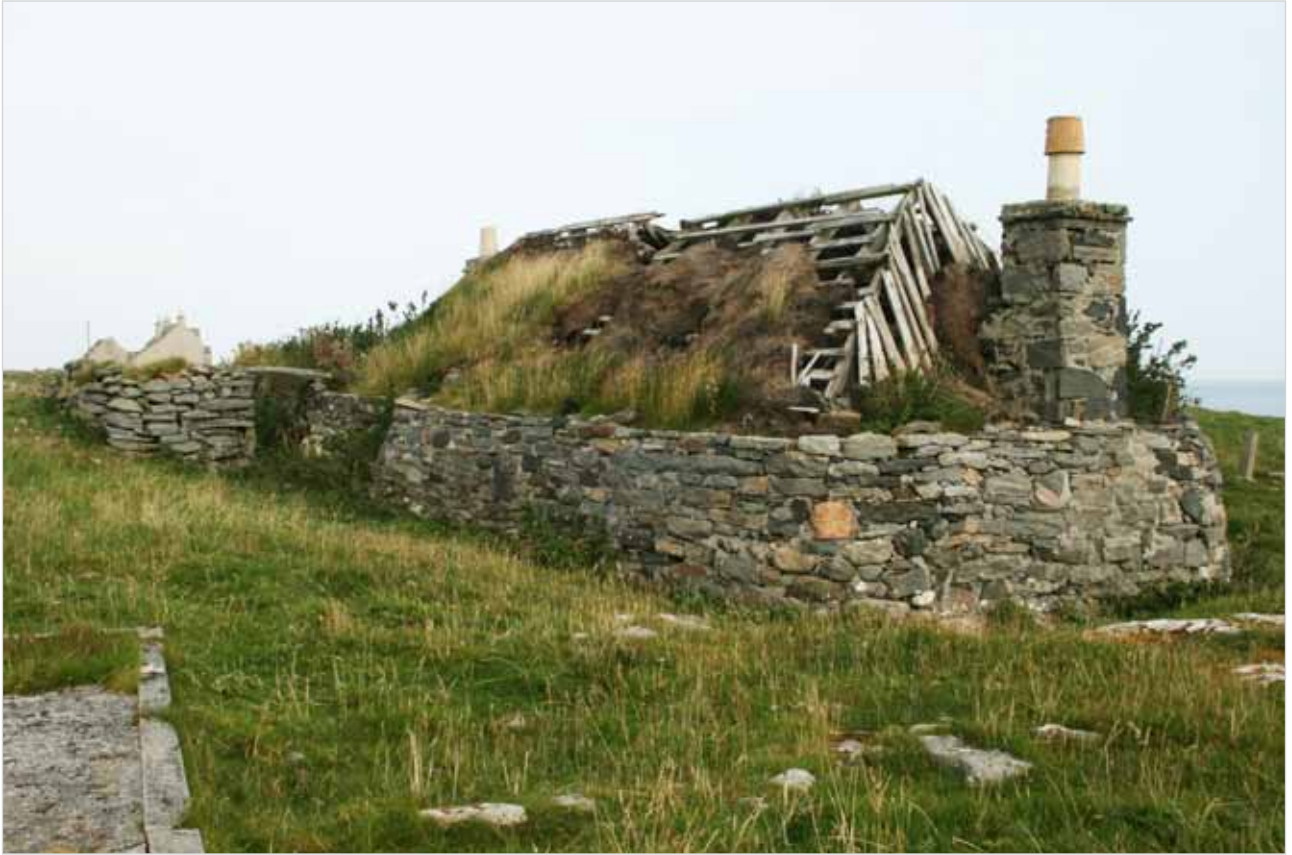
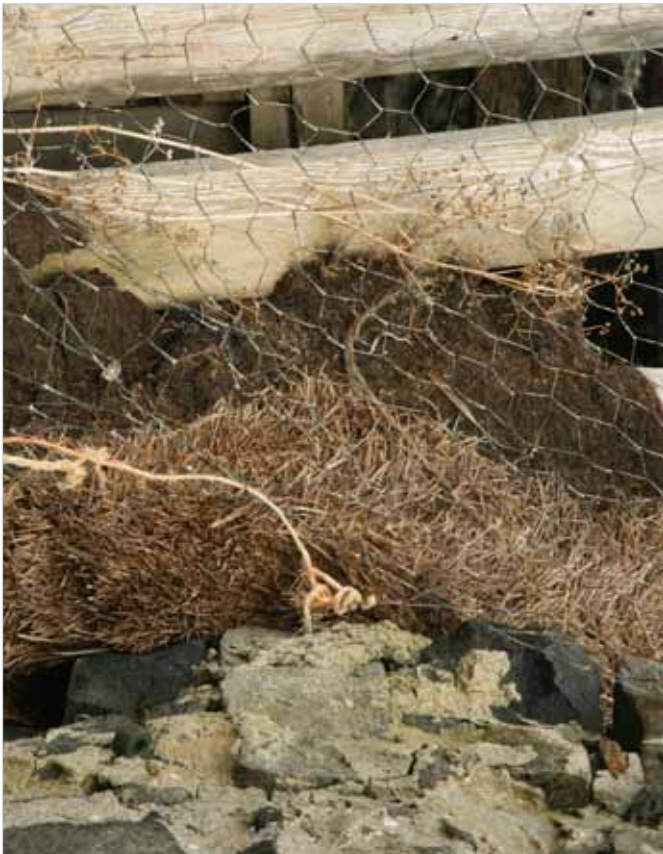
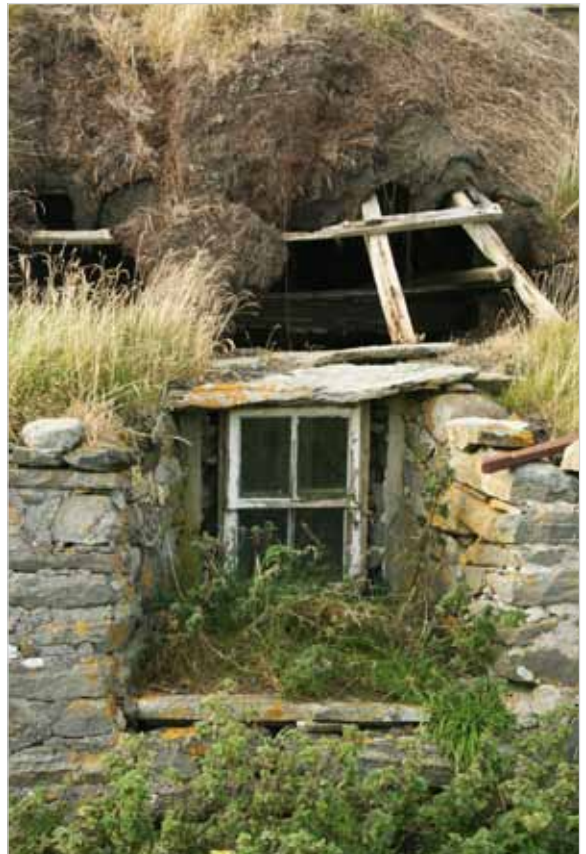
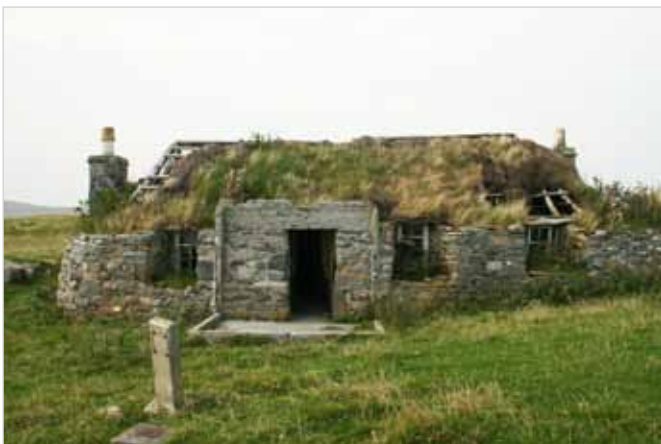
South West Cottage – Western Isles

South-west end cottage in a row of three, the middle and north-east cottages being roofless shells. The building's thatched roof is in a severe state of deterioration and the building has been on the Buildings at Risk (BAR) Register since 1998 (BAR reference number 1850). BAR inspections document the buildings' gradual decay since this time; however, it was recorded by BAR upon inspection in 2010 that Planning Permission and Listed Building Consent had been applied for for the renovation of the property. The current status of this planning application is unknown and the building remains in a derelict condition. There is some

marram thatch and turf underlay remaining on the roof, which is heavily overgrown with vegetation; however, there are large areas of thatch missing, exposing the roof structure and building's interior. There remains some visible evidence of the weighting stones and string, as well as the netting they would have once held in place.

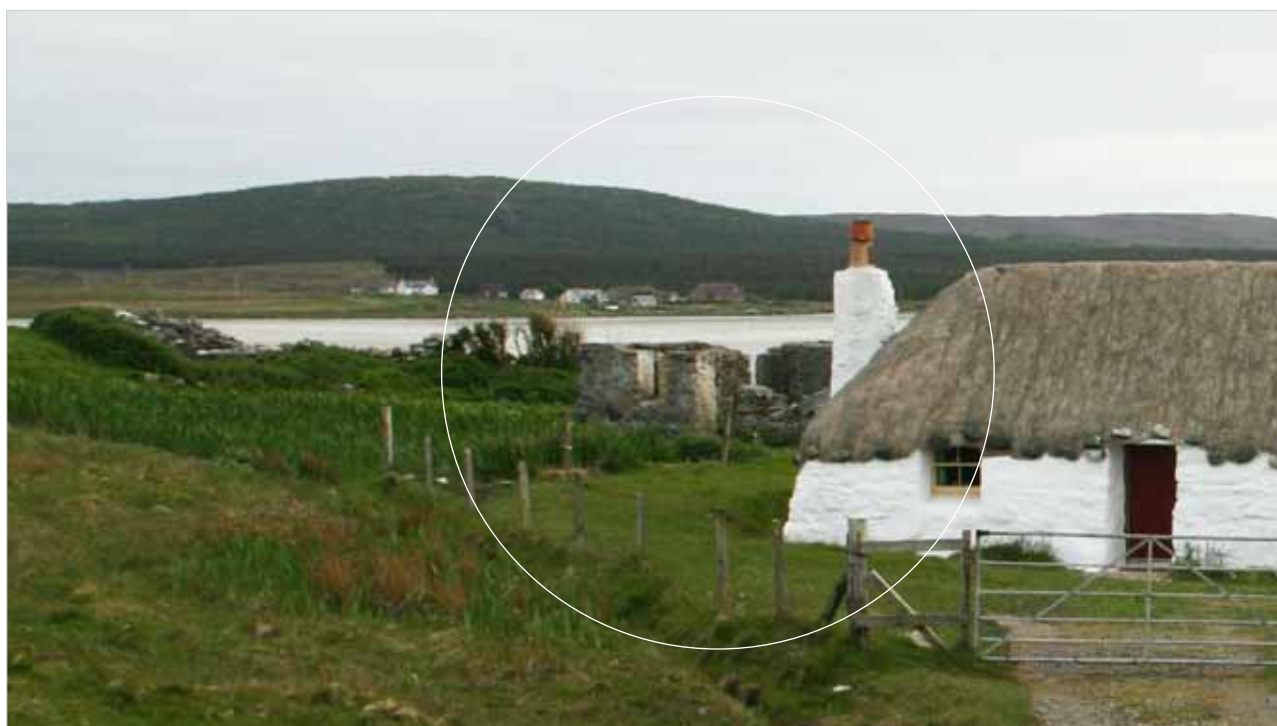
Address: Cottage to West of Struan Cottage

Additional Notes: Probably late 19th-century cottage, listed as having a '*muran thatch roof, secured above inner wallhead with stone weights*'. The cottage is now a roofless ruin and has been on the Buildings at Risk (BAR) register since 2009 (BAR reference number 3767), at which time it was already recorded as being roofless. The listed building description should be updated accordingly, as well as the name of the building, which states that the building is east of Struan Cottage, when it is in fact to the west.
