A Survey of Thatched Buildings in Scotland

Thatch Survey of Scotland
2014-15

A photographic survey of thatched buildings in Scotland, surveyed between May 2014 and August 2015 by Zoe Herbert (SPAB Scotland Officer), on behalf of the Society for the Protection of Ancient Buildings.

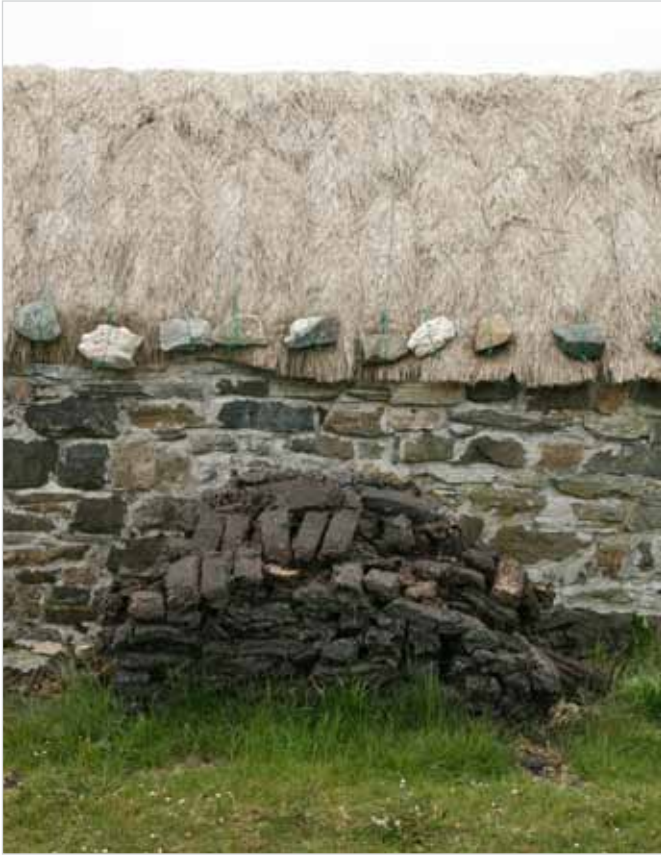
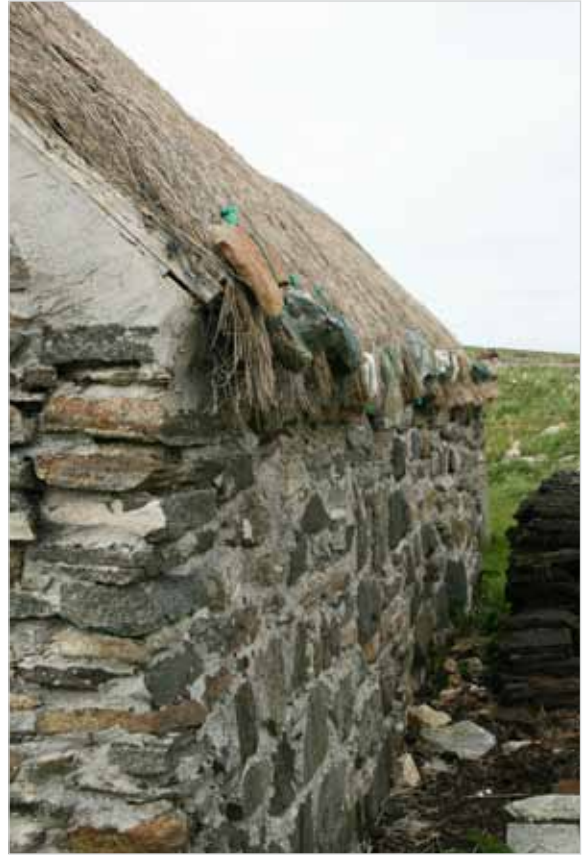
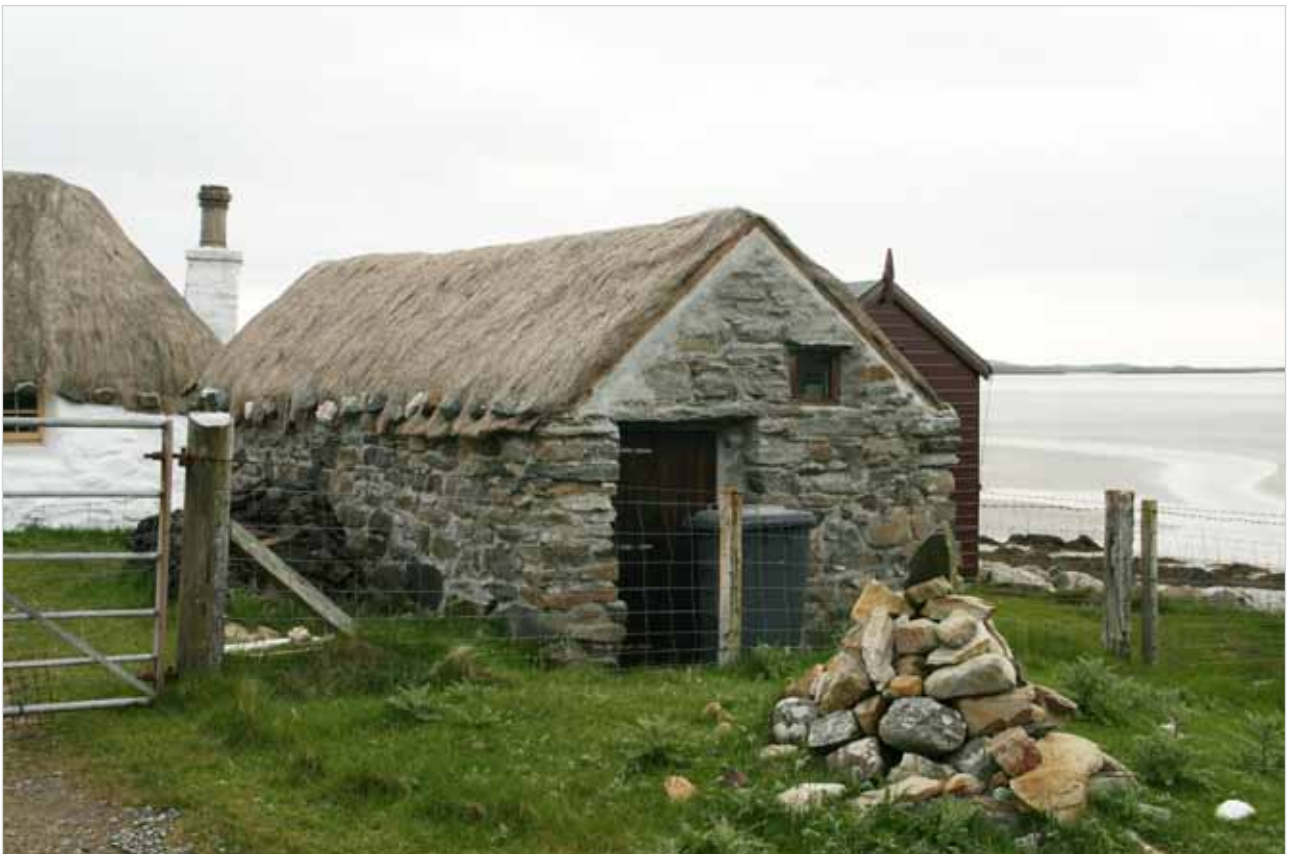
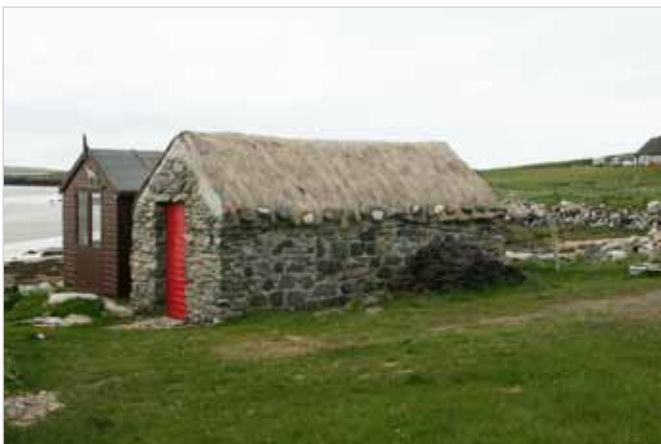
Struan Cottage Outbuilding – Western Isles

Additional Notes: Listed as part of a group listing along with 'Probably 19th century' cottage, Struan Cottage (survey number 254). The listing description notes its use as a garage; however, the building currently appears to be in use as a store for the cottage, which is used as holiday accomodation. The roof of the building is thatched in marram and has a continuous marram ridge. The entire thatch has been netted, and weighted at the eaves with stones secured to the netting by string, in the same manner as the cottage.

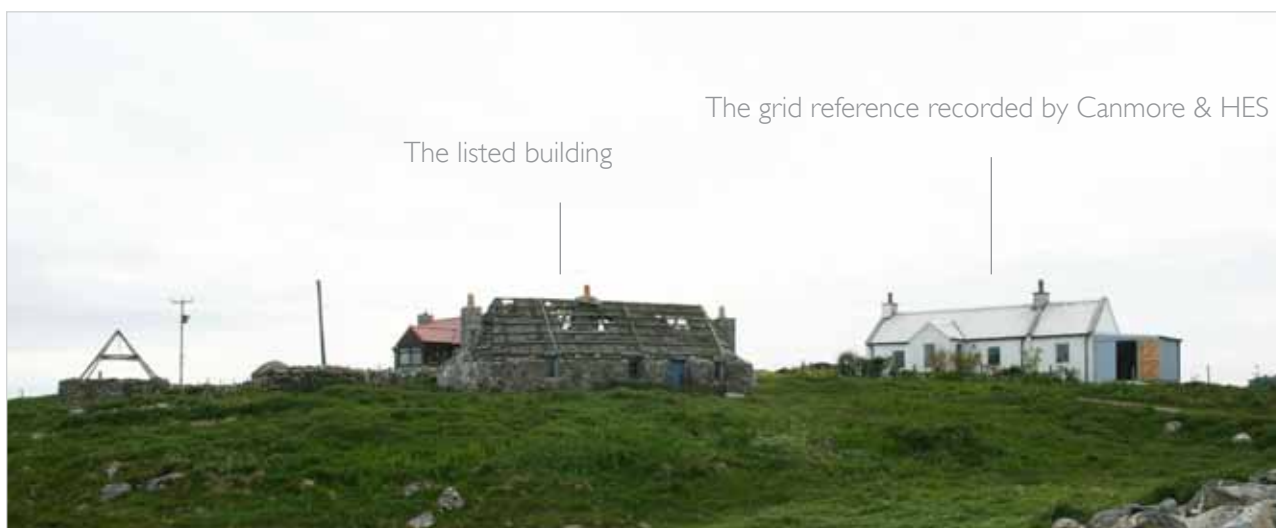
Additional Notes: The building is listed as having a '*muran thatch roof, secured by ropes and stones at inner wall head*'. The grid reference given by Canmore and Historic Environment Scotland for the building relates to the building on the right of the image below; however, from the listing description, and by a Buildings at Risk entry, the listed building is one shown below centre, which has been on the Buildings at Risk (BAR) register since 1997 (BAR reference number 1501). In 1996 upon inspection by BAR, it was recorded that the roof needs re-thatching. An image of the building on Canmore taken circa 2000 shows the cottage with a thatched roof. There is no longer any thatch left on the roof and the building's interior is exposed to the elements. The listed building description and grid reference should be updated accordingly.

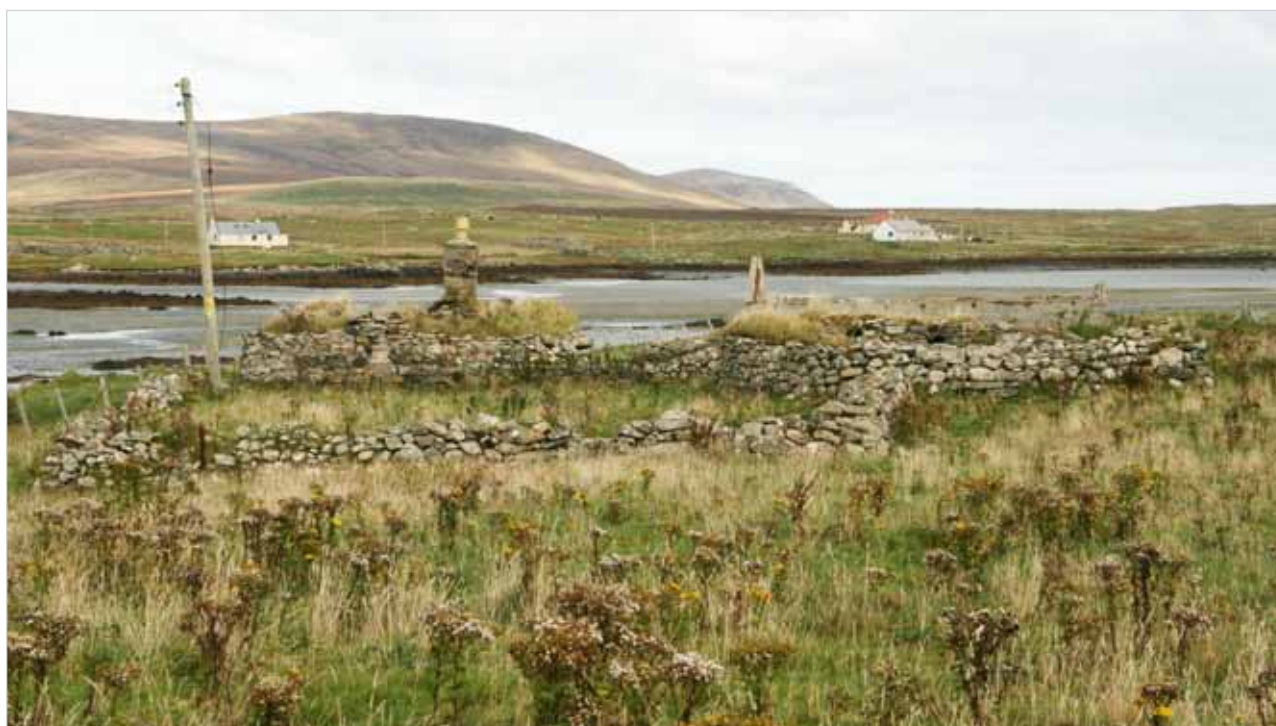
Additional Notes: 19th-century cottage, listed as having a '*muran thatch roof, secured with netting and ropes, stone weights over inner wallhead*'. The building is now a roofless ruin and has been on the Buildings at Risk (BAR) Register since 1996 (BAR reference number 1439), at which time it was recorded that the building was abandoned and that the roof was caving in. Upon the next visit by BAR in 2009 the roof was recorded as having caved in. The listing description for the building should be updated accordingly.....

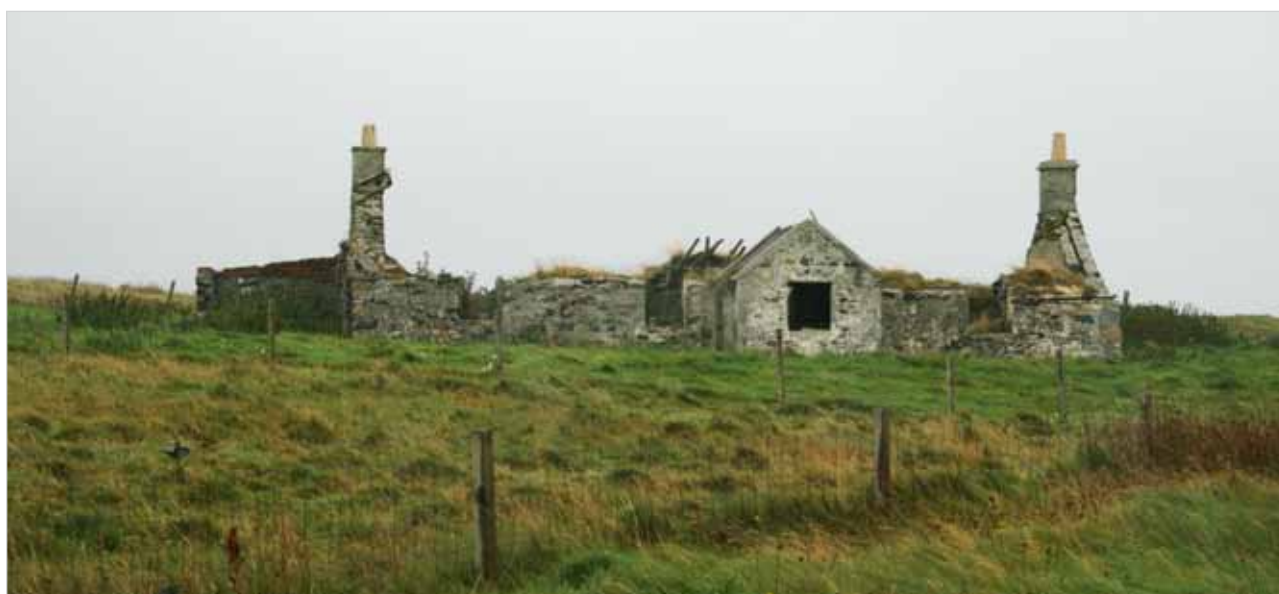
Additional Notes: Probably 19th-century, 'unusually long' cottage, listed as having 'muran thatch roof secured by netting, stone weights over inner wallhead'. The building has been on the Buildings at Risk (BAR) Register since 1996 (BAR reference number 1500), at which time the building was recorded as being 'vacant and decaying'. In 1996, the roof was recorded as having collapsed over the left-hand bay, yet by 2009 BAR recorded the whole thatched roof had collapsed. The cottage remains a roofless ruin, with what appears to be some heavily degraded thatching material on what is left of the wallheads. The listing description for the building should be updated accordingly.

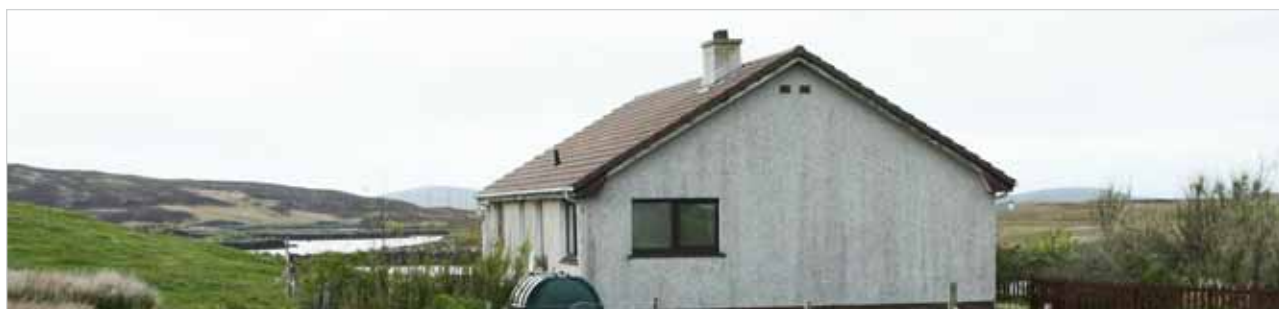
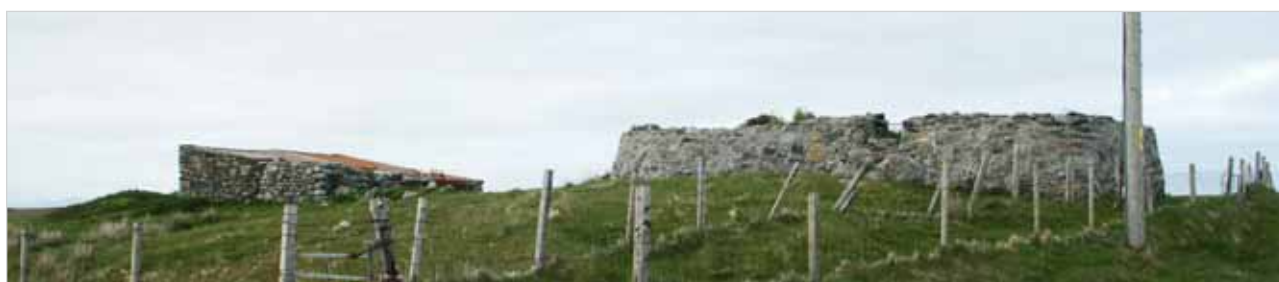
Address: 29 Locheport

Additional Notes: The grid reference recorded by this buildings' listing and by Canmore refers to a modern building on the site at 29 Locheport (grid reference NF 84910 63486); however, the BAR entry clearly identifies a ruin to the west of that as being the listed building. The 19th-century cottage is listed as having a '*heather thatch roof, secured with netting, stone weights over inner wall-head*'. The building has been on the Buildings at Risk (BAR) Register since 1996 (BAR reference number 1509), at which time it was already recorded to be a roofless shell. By inspection in 2008, BAR recorded that the interior had been cleared and only the external walls survived. The listing description and the grid reference for the building should be updated accordingly.....

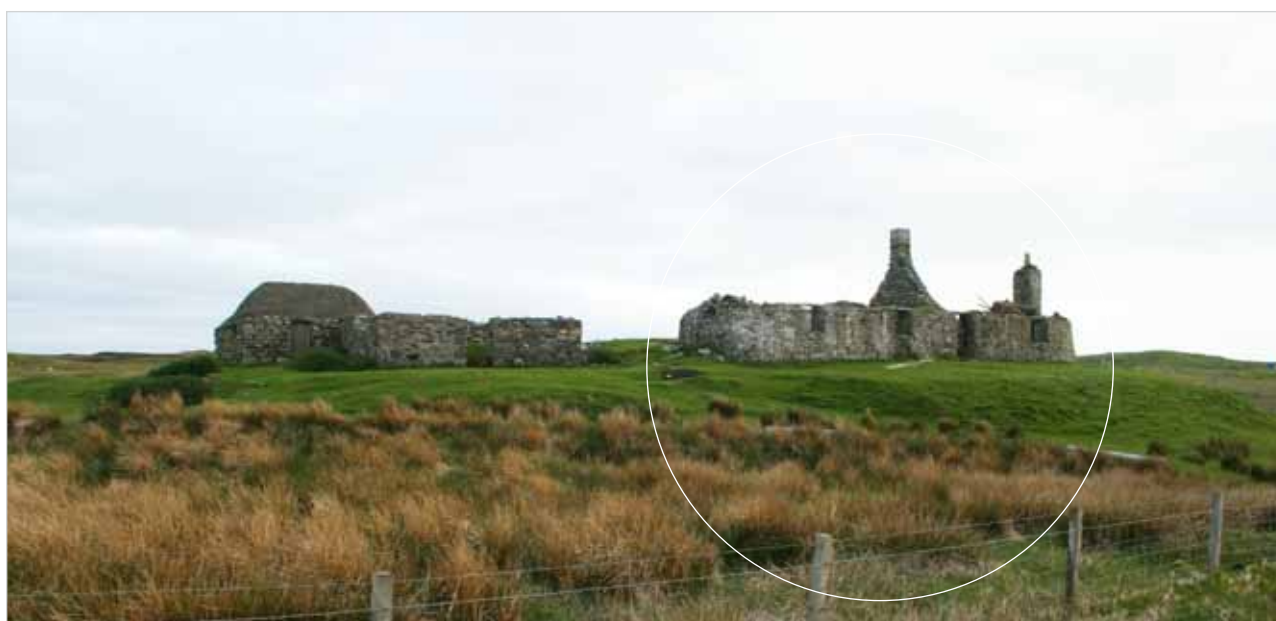
Address: 9 Locheport

Additional Notes: The cottage is listed as being a 'single storey 4-bay Hebridean-type thatched cottage' with a 'heather thatch roof secured with netting and stone weights; wallhead mainly covered by thatch'. The building is now a roofless ruin and has been on the Buildings at Risk (BAR) Register since 1996 (BAR reference number 1665), at which time it was recorded that the cottage had been unoccupied since 1983 and that part of the roof had caved in. By BAR inspection in 2009 most of the thatched roof had caved in and in 2010 BAR recorded the cottage to be roofless. Currently, there remains a small amount of collapsed roof structure and thatching material visible within the building shell. The listing description for the building should be updated accordingly.....

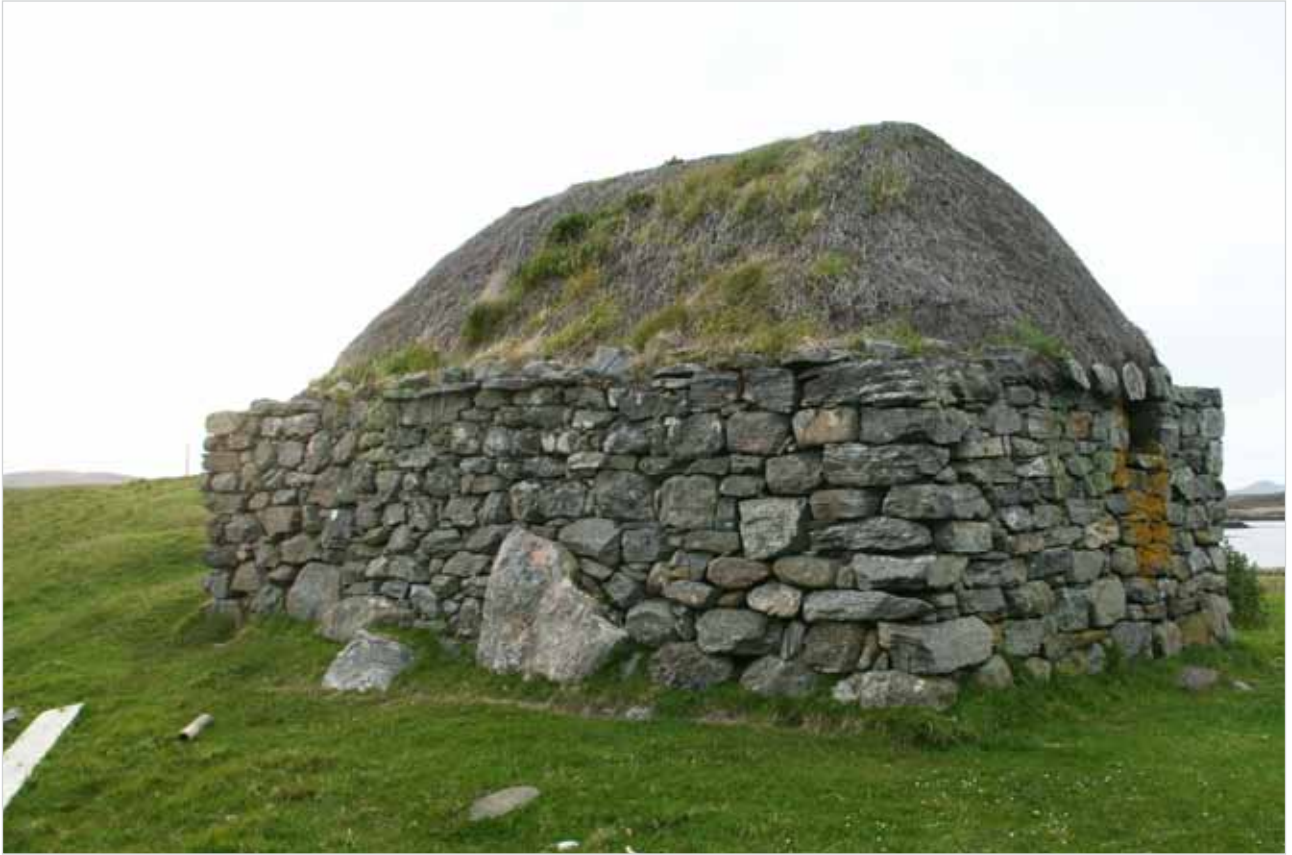
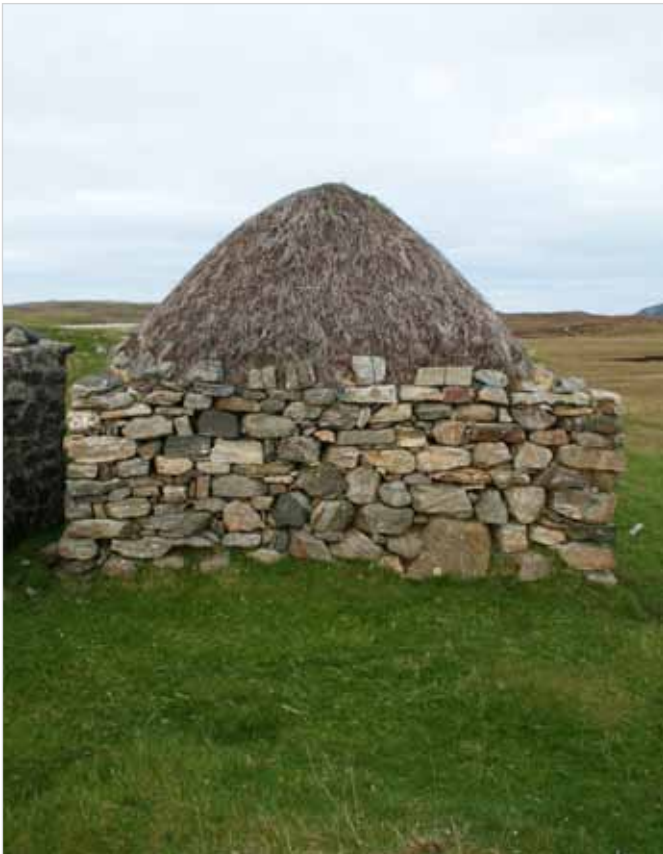
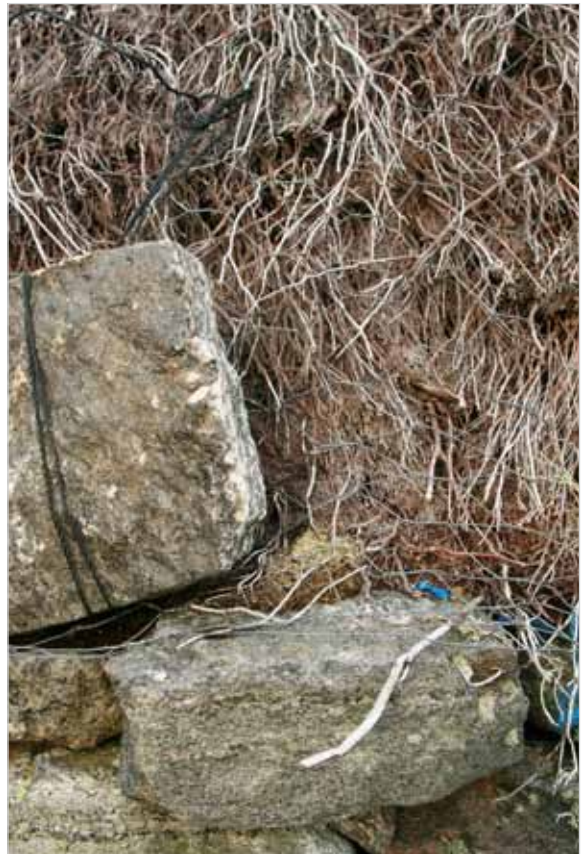
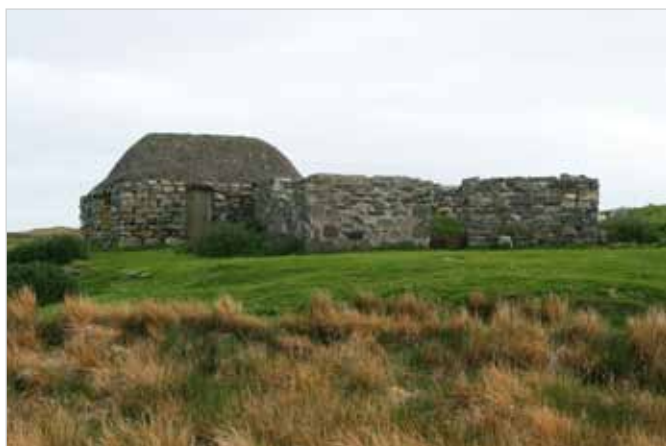
9 Locheport Outbuilding – Western Isles

Whilst this building is not listed along with the adjacent, and previously thatched, cottage at this site, it is mentioned in the Buildings at Risk entry for the cottage. In the inspection notes for the BAR visit to the cottage in 2009, it was recorded that 'one of the outbuildings has been renovated and re-thatched with heather thatch', whilst the notes from the 2010 visit state it has been 're-roofed in thatch'. The building, which has an entrance door located to the north and a small opening without any window frame or glazing to the east, is thatched in heather with a continuous heather ridge. The roof has been entirely netted, including over

the ridge, which has been weighted just above the wallhead by stones secured to the netting by string. The stones are partially suspended but in places rest upon the shallow wallhead of the building. There is a large amount of grassy vegetation growth across the surface of the thatch on the south elevation, and a small amount of moss growth on the north elevation.

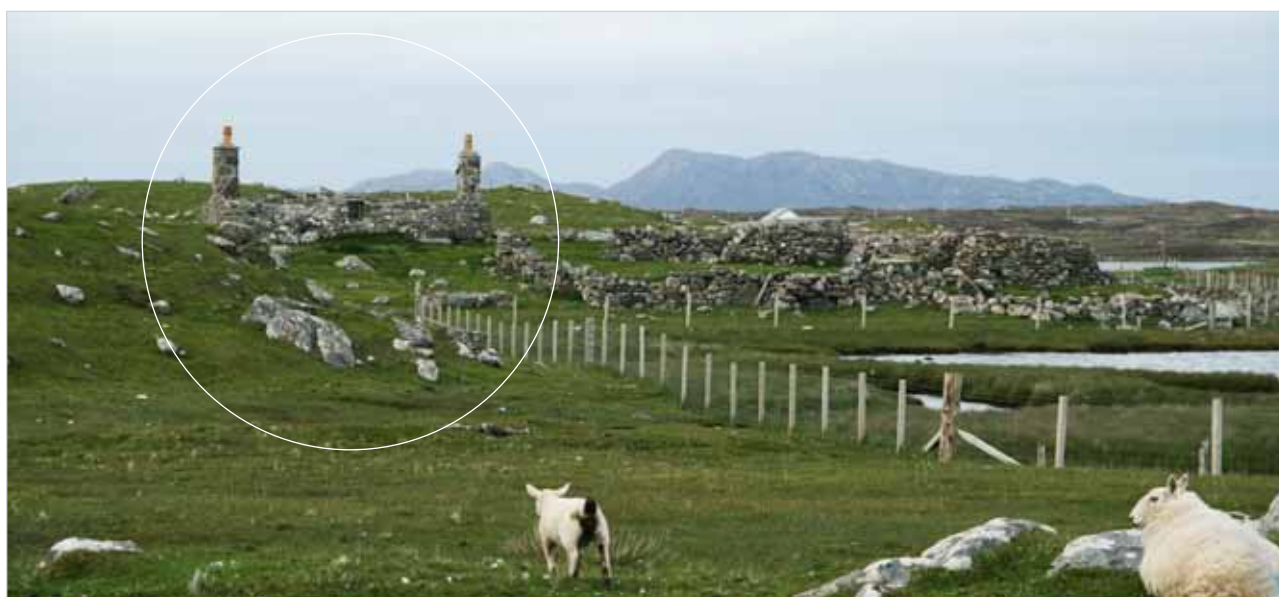
Address: 24 Claddach Baleshare

Additional Notes: Probably 19th-century cottage, listed as having a '*muran thatch roof, secured above inner wallhead with steel tubes, stones and bricks*'. The building is now a ruin and has been on the Buildings at Risk (BAR) Register since 1996 (BAR reference number 1449), at which time it was recorded to be '*empty and deteriorating*'. BAR inspections in 2009 record that the roof had collapsed, along with some of the chimney structure, and by 2010 '*external inspection finds the building remains a ruinous shell*'. Some of the roof structure, including netting that would once have secured the thatch, can currently be seen protruding upwards from within the ruined shell. The listing description for the building should be updated accordingly.

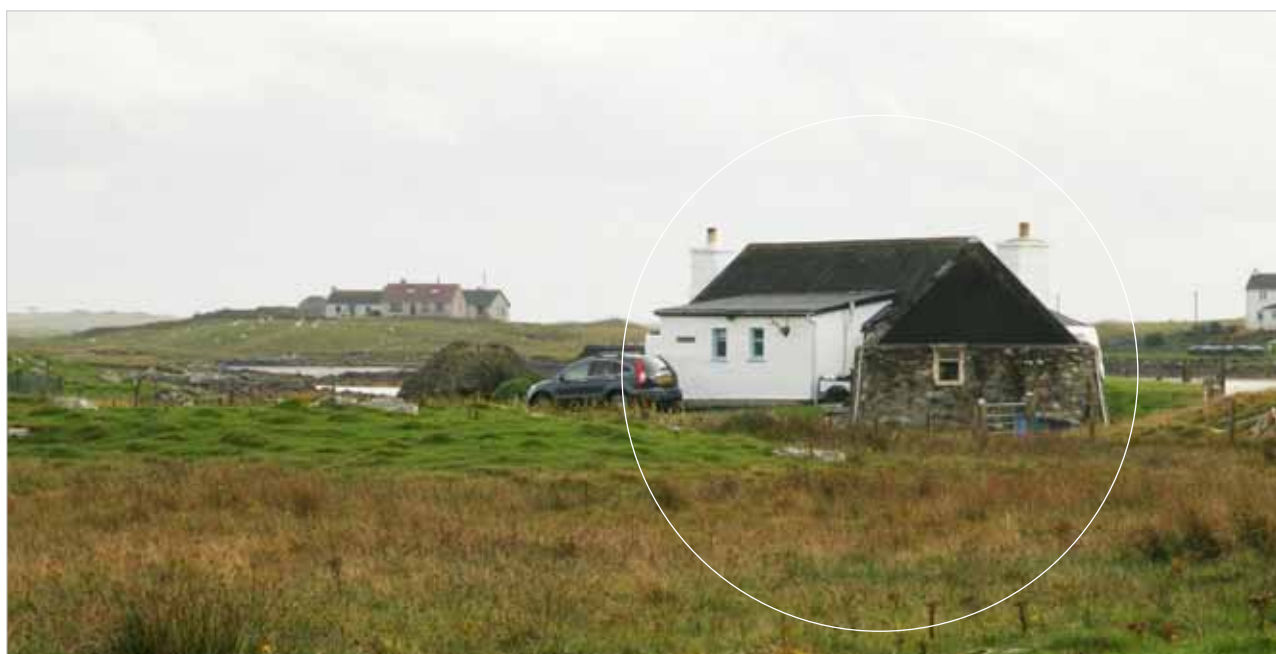
Address: Claddach Baleshare Thatched Cottage

Additional Notes: Probably 19th-century cottage (the white building in the below image), listed as having a 'muran thatch roof, secured with netting, stone weights at inner wallhead'. The byre/shed to the north-east of the cottage (exposed rubble building in the foreground of the below image) is also part of the group listing, and is also listed as having a thatched roof. Neither of the buildings are thatched any longer and both have a corrugated roof covering. There is a small thatched outbuilding to the south (left in the image below) that isn't listed or mentioned in the listing description (survey number 265). The listing description should be updated accordingly.....

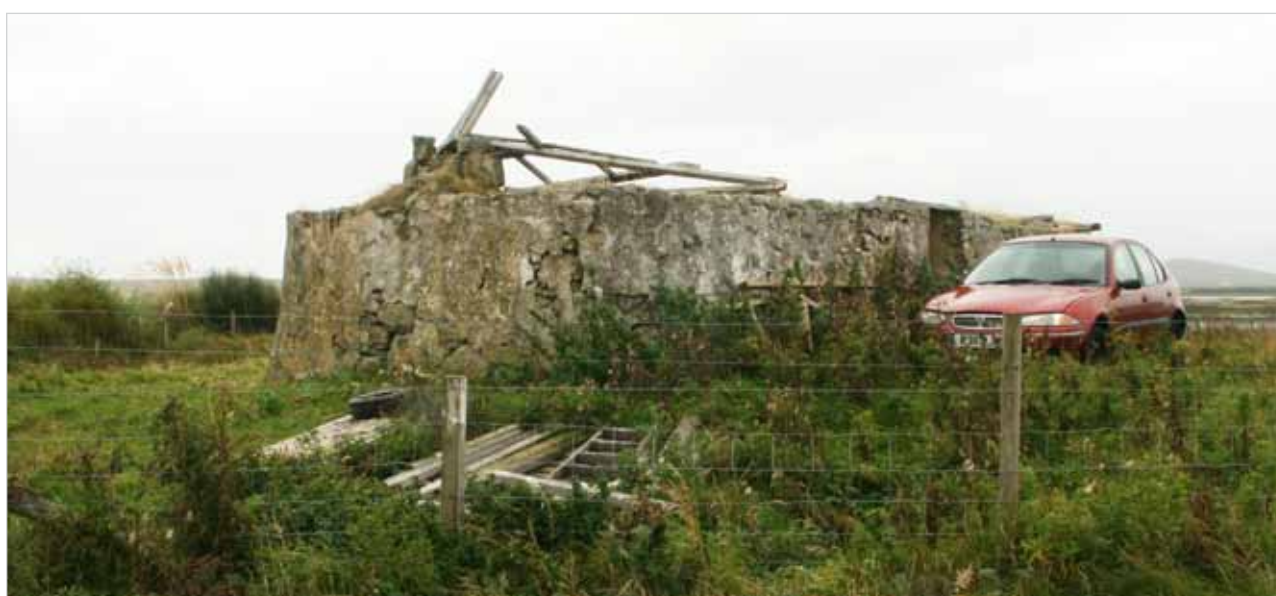
Additional Notes: Listed as a 'Skye-type thatched cottage' with 'muran thatch roof, reaching over eaves, and secured with stone, weights'; however, this building is now a roofless ruin and no thatch remains. The building has been on the Buildings at Risk (BAR) Register since 1996 (BAR reference number 1430). Upon BAR inspection in 1998 the building was recorded as being 'empty and becoming derelict, though it retains its thatched roof'; however, by the next BAR inspection in 2009 the building was recorded as being 'a roofless ruin'. The Canmore maps shows the wrong grid reference for the building (NF 85230 58996), yet BAR have the building's location correct. The listing description should be updated accordingly.....

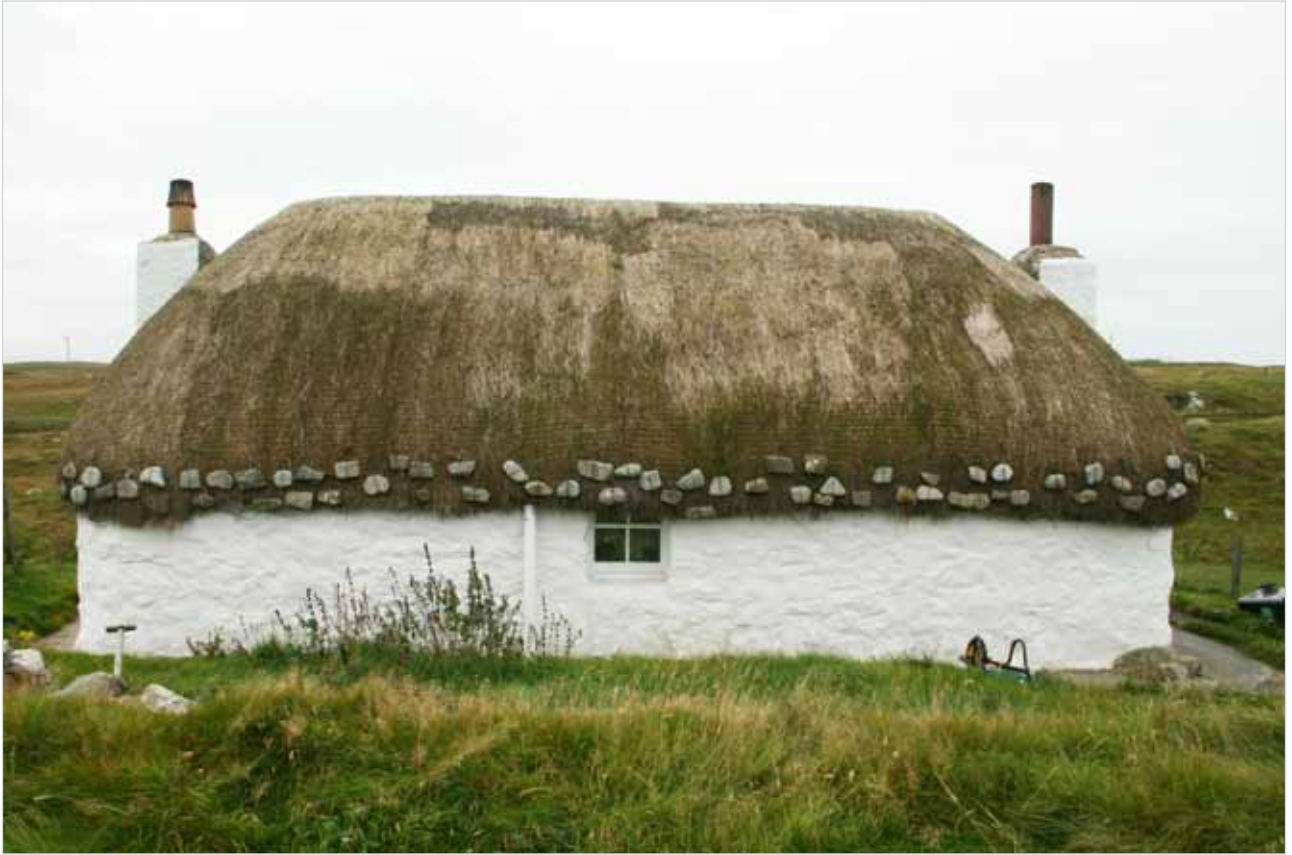
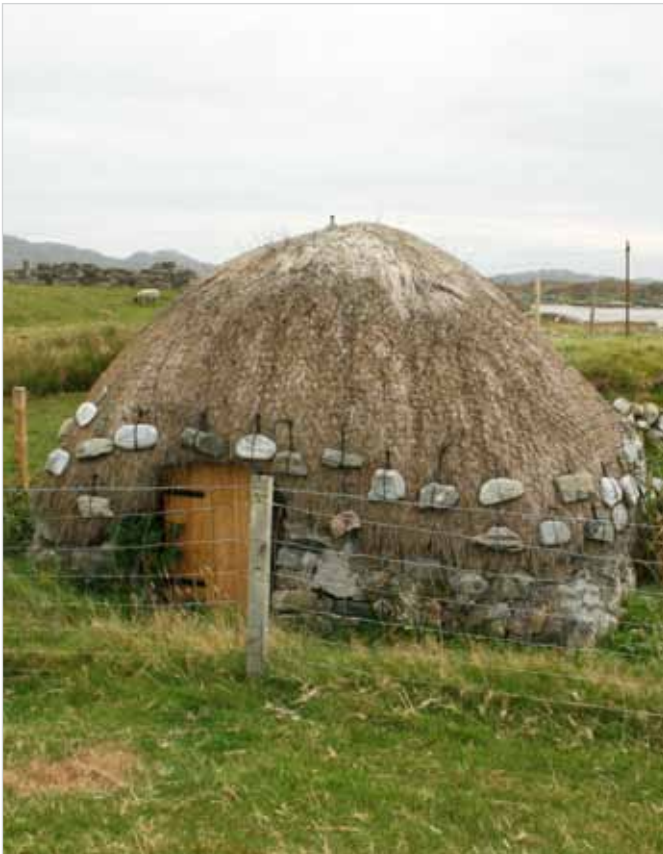
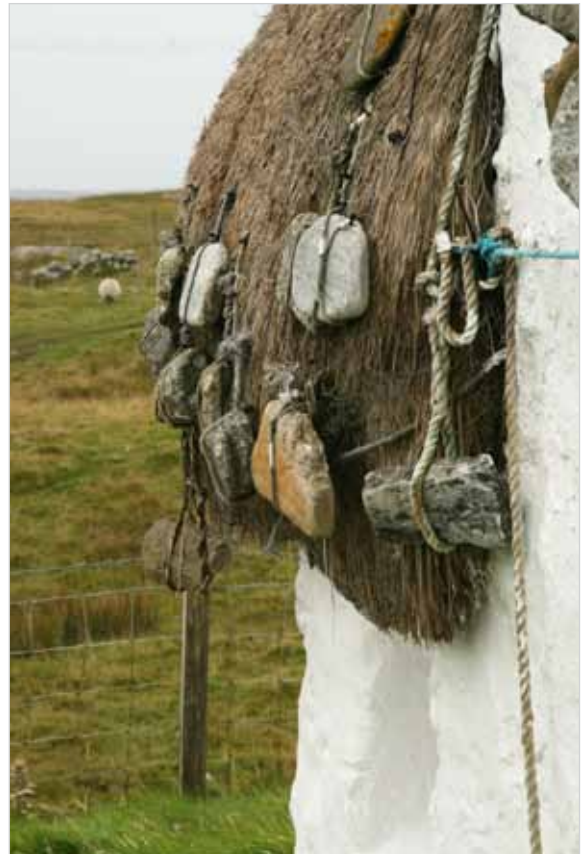
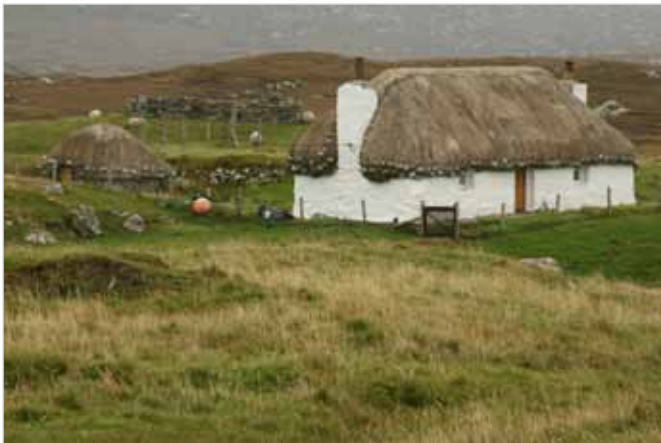
Thatched Cottage – Western Isles

Additional Notes: Late 19th/early 20th-century cottage, listed as having a 'muran thatch roof reaching over eaves, secured with netting and stone weights'. There is also a 'thatch-roofed outbuilding to north', which is also part of the listing. Both roofs are thatched in marram and have continuous marram ridges, as well as being entirely netted, including across the ridge. The netting has been weighted on both buildings by two rows of stones just above the eaves, and a single row of stones around the chimney stack at either end of the cottage, which have been secured to the netting by metal wire and string. There is a small amount of green algae-like

vegetation growth to the surface of the thatch on the rear elevation of the cottage and some thatch replacement/repairs appear to have taken place in the past, made apparent by the obvious difference in colour of the thatch in places.

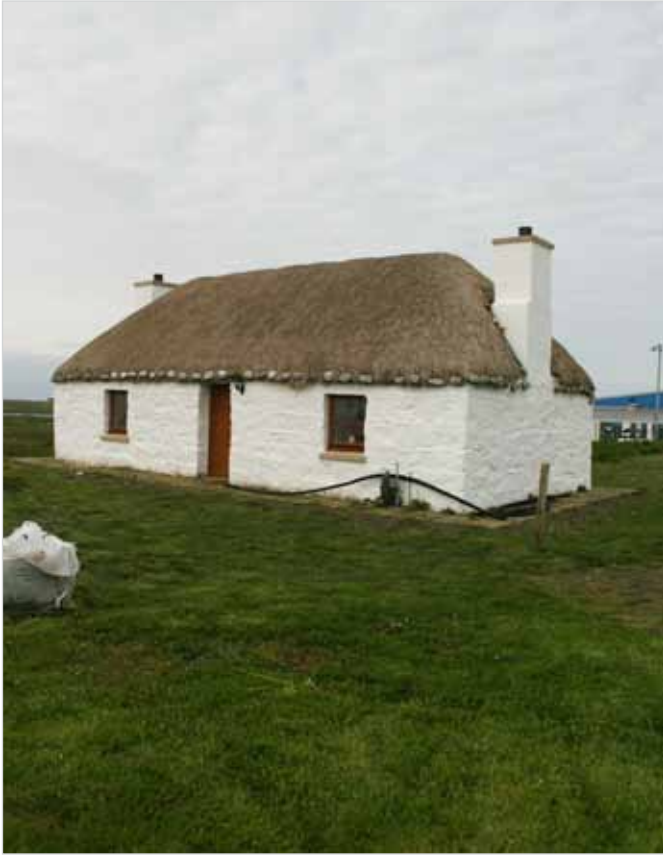
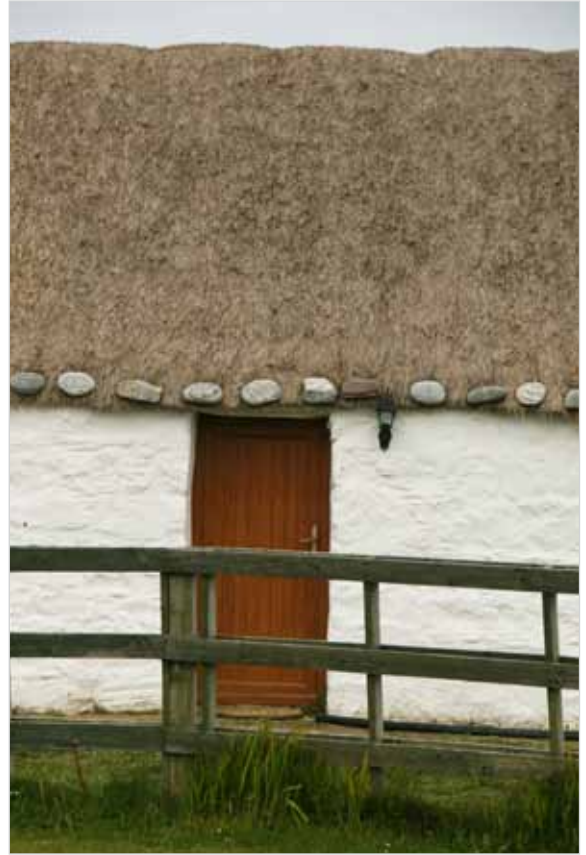
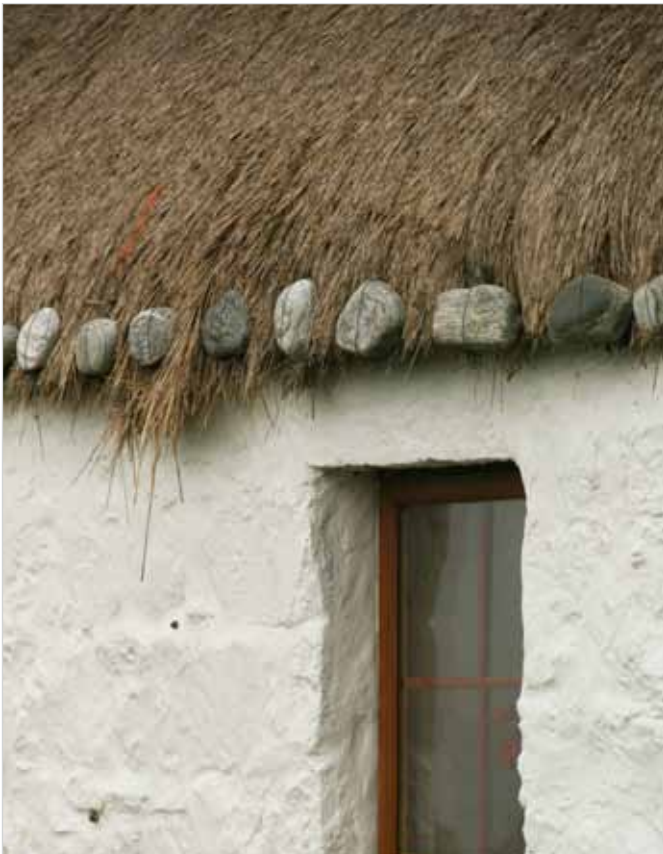
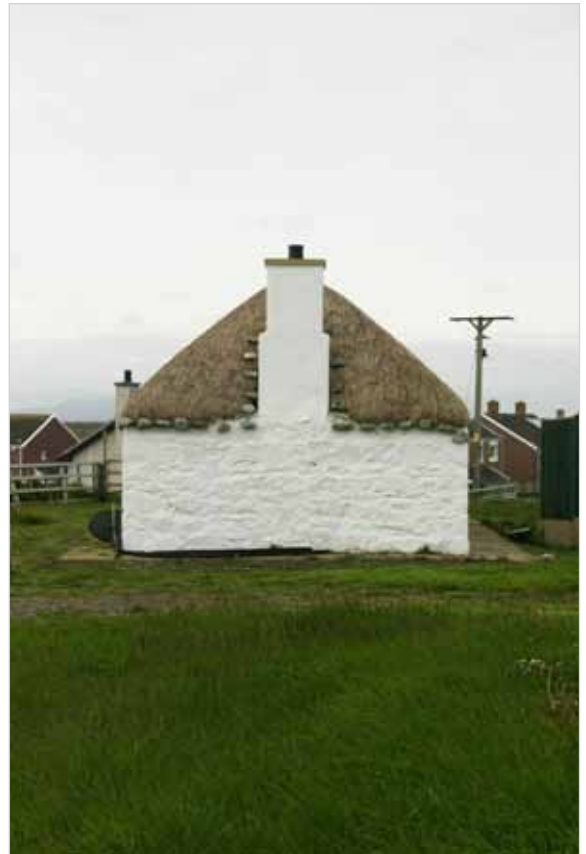
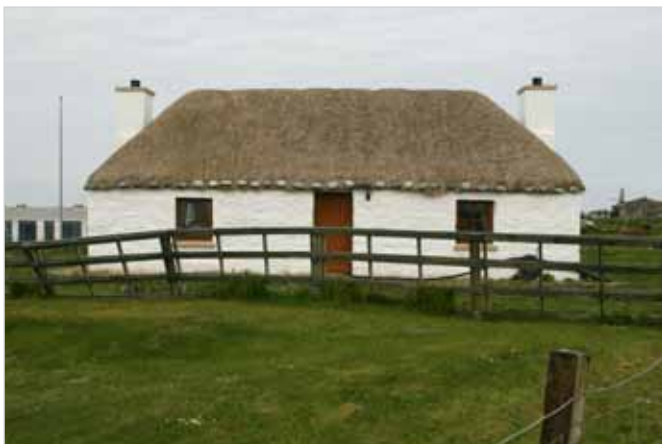
Thatched Cottage – Western Isles

Located near to the centre of the largest settlement on the Isle of Benbecula, and close to the airport and north coast of the island. The cottage is newly renovated from a ruin (confirmed by web-based satellite imagery), and has a marram-thatched roof with a continuous marram ridge. The roof has been entirely netted, including across the ridge, which has been weighted along the eaves and around the chimney stacks at either end with stones secured to the netting with wire.

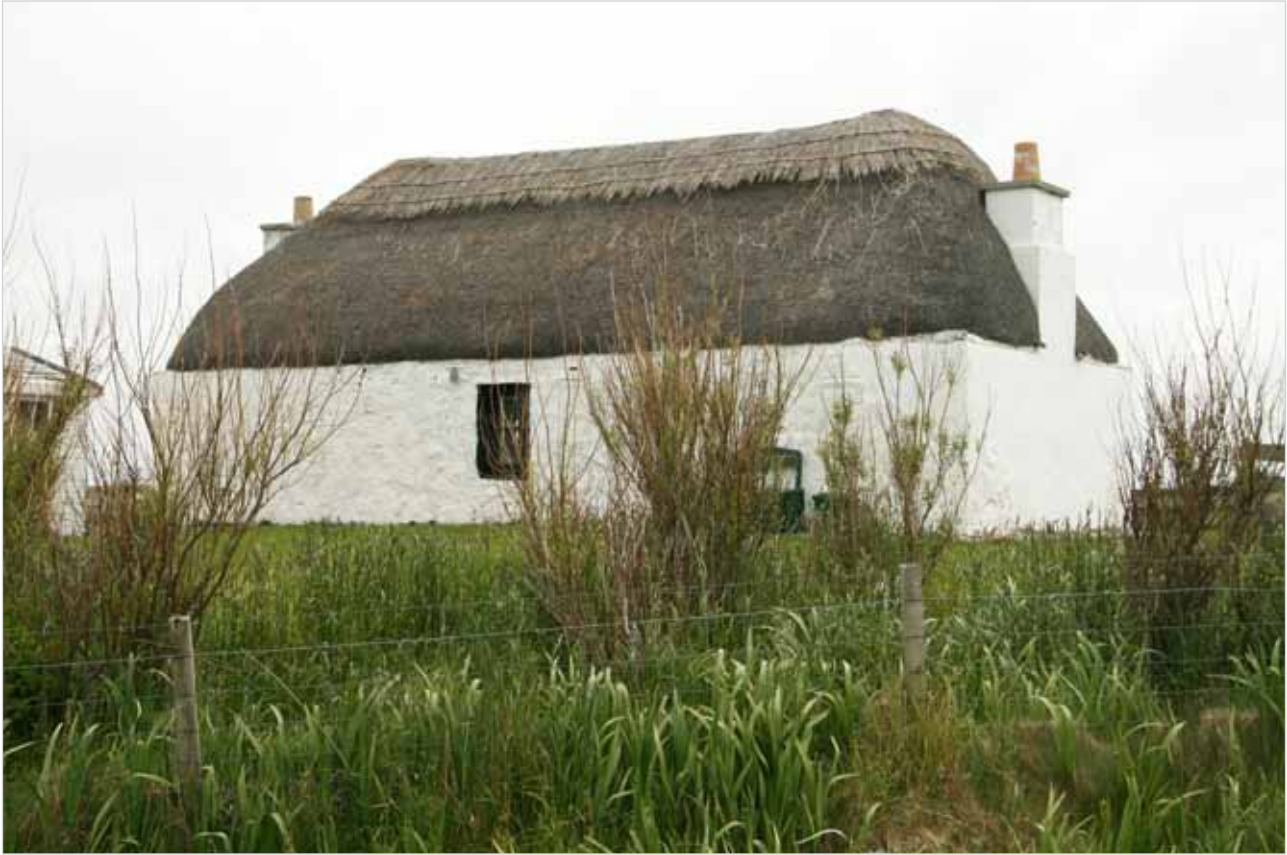
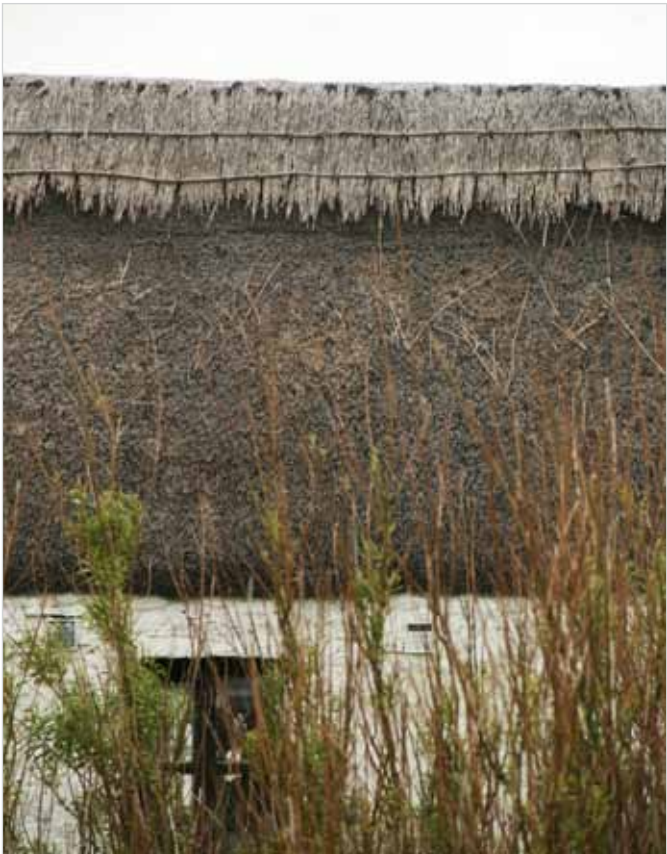
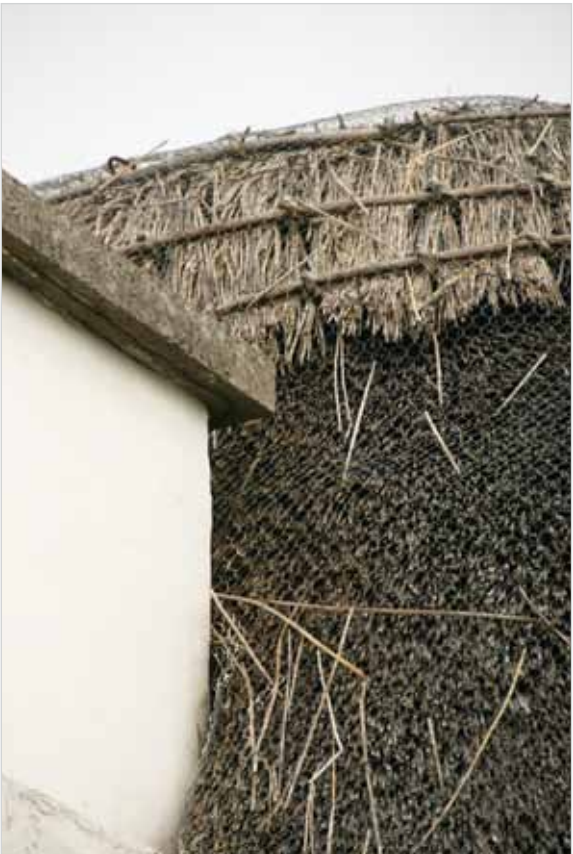
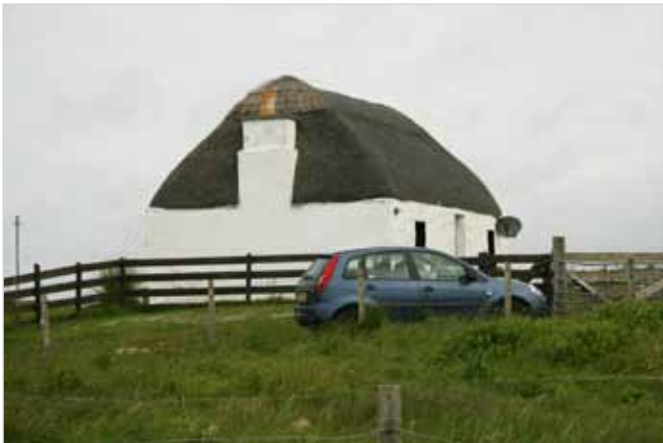
Taigh Violet Rose – Western Isles

Thatch Type: Reed
 Ridge Type: Thatched (Straw)
 Condition of Thatch: Good

Additional Notes: Late 19th/early 20th-century cottage, listed as having a 'muran thatch roof secured with ropes and modern bricks as weights'. The roof is now thatched in reed and has what appears to be a straw ridge, which has been scobed with hazel spars. The roof has been entirely netted, including across the ridge. The thatch is in a good condition; however, there are some pieces of dislodged thatch from the ridge that have fallen down the roof within the netting. The grid reference recorded for this building in the listing description and by Canmore is incorrect and identifies an empty piece of land in another part of the island (grid reference NF 80099 52242).

These databases should be updated accordingly with the correct location as recorded here.

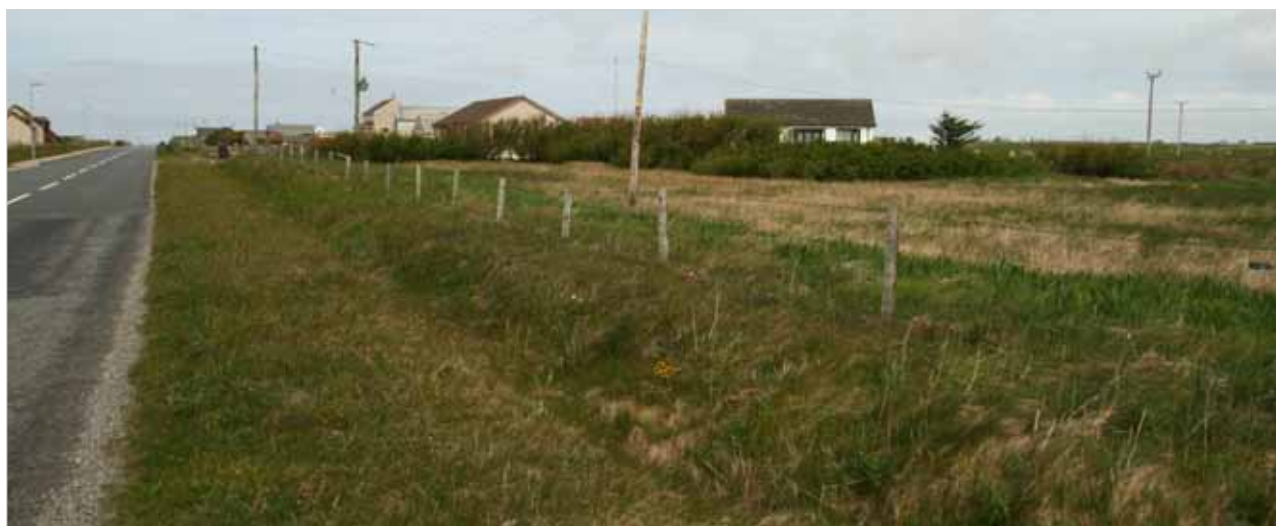
Additional Notes: The listed building description reads 'Late 19th/early 20th century, Skye-type thatched cottage. Single storey, Rubble-built with battered wall and curved angles. Long east front, with door off-centre north & diminutive window off-centre south; 2 west-facing windows, single window to short south wall. Single end stack; muran thatch roof secured with ropes and stone weights'. The grid reference identified by Historic Environment Scotland and Canmore shows an empty field, which has no visible signs of any building remains. It is unclear whether the location identified is incorrect or whether the building has been completely removed and the site grown over with grass, as there is no building or building remains nearby that matches the listed building description for this building. Further research is required and the listing description should be updated accordingly.
