A Survey of Thatched Buildings in Scotland

Thatch Survey of Scotland
2014-15

A photographic survey of thatched buildings in Scotland, surveyed between May 2014 and August 2015 by Zoe Herbert (SPAB Scotland Officer), on behalf of the Society for the Protection of Ancient Buildings.

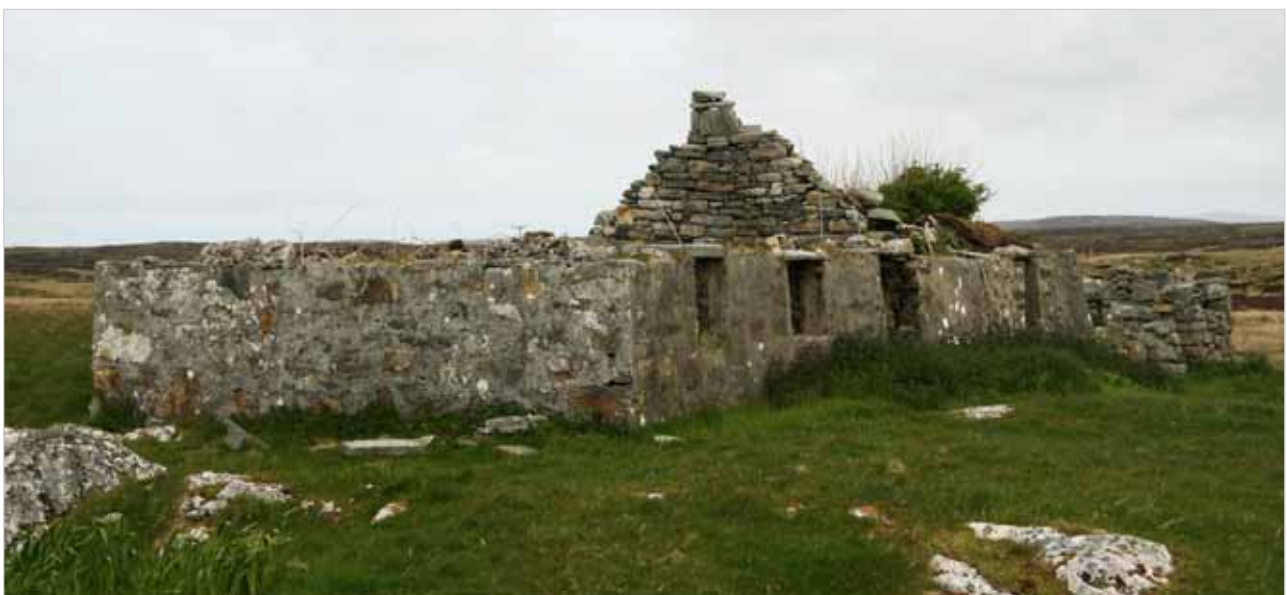
Additional Notes: Probably 19th-century cottage listed as having a '*muran thatch roof secured with ropes and stone weights*'. The building is now a roofless ruin and has been on the Buildings at Risk (BAR) Register since 1996 (BAR reference number 1784), at which time it was recorded as being '*abandoned and derelict with its roof caving in*'. BAR inspection in 2010 found the building to be a '*roofless shell in the slow process of collapse*'. There is visible evidence of what appears to be thatching material slumped over the wallhead on part of the north section of the cottage, as well as evidence of the ropes used for weighting. The listing description for this building should be updated accordingly.

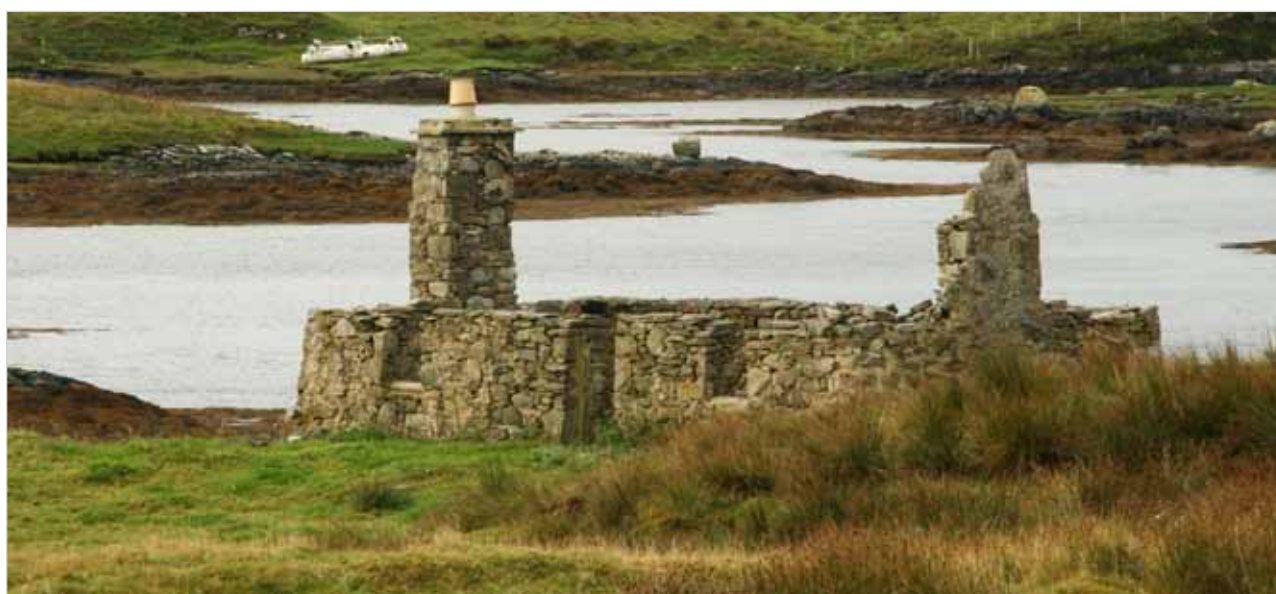
Additional Notes: The listed building description reads '*Late 19th/early 20th century, Skye-type thatched cottage*' with '*muran thatch roof, secured with ropes and stone weights*'. The building is now a roofless ruin and has been on the Buildings at Risk (BAR) Register since 1996 (BAR reference number 1917), at which time it was recorded that it was being used for hay storage, was in a decaying condition and that '*its grass-covered roof appear[ed] in danger of collapse*'. In 2000 an application was submitted to convert the building into a holiday home, which was granted permission in 2001. In 2002, BAR recorded that the cottage had been damaged by fire and the roof had now gone. The listing description for this building should be updated accordingly.

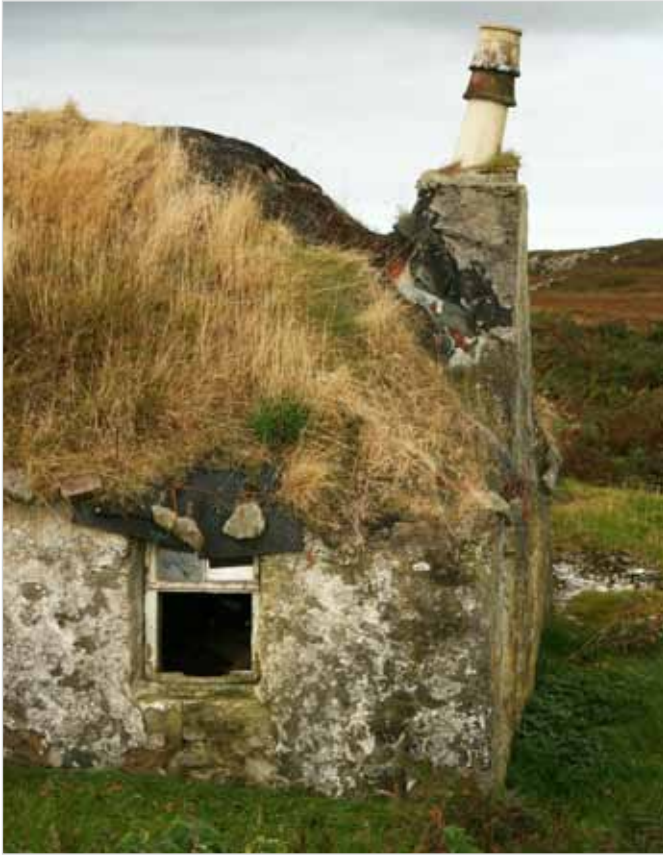
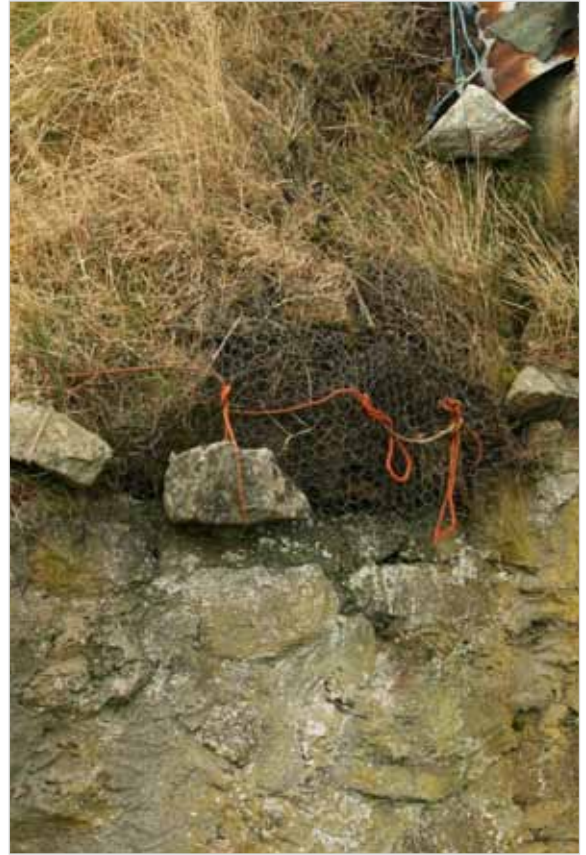
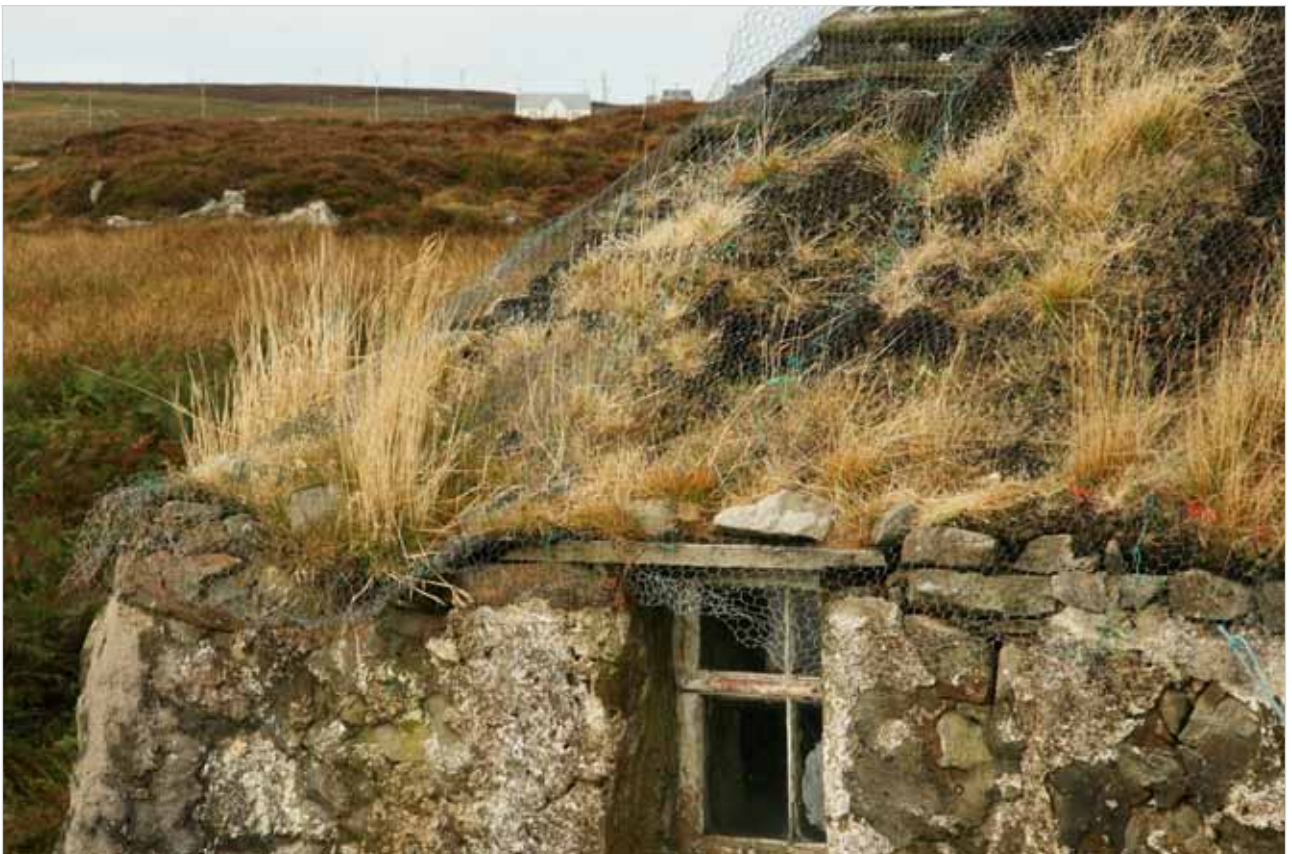
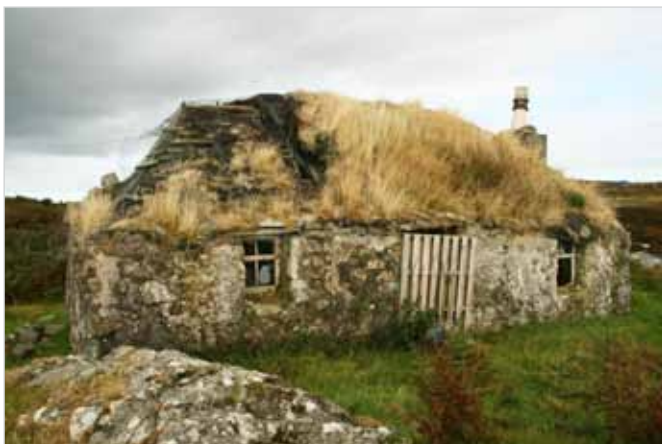
I Aird Cumhang – Western Isles

Grid Reference: NF 83196 47894
 Date of Visit: 24/09/2014
 Thatch Type: Marram
 Ridge Type: n/a
 Condition of Thatch: Poor

Additional Notes: Late 19th/early 20th-century thatched cottage, listed as having a 'muran thatch roof, secured with ropes and stone weights'; however, the building is now vacant and is in a severe state of deterioration. The roof is in a particularly poor condition; large areas of thatch are missing, exposing the roof structure and building's interior beneath. The thatch appears to have been marram grass with a turf underlay, yet the little thatch that remains has heavily deteriorated and is overgrown with vegetation. The netting over the top of the thatch, and across the now partially thatched ridge, is still mostly intact, and the remains of weighting stones attached to

the netting by string are still visible in places along the wallhead and around the chimney stack at the north-east end. The building is abandoned and has been on the Buildings at Risk (BAR) Register since 1996 (BAR reference number 1681).

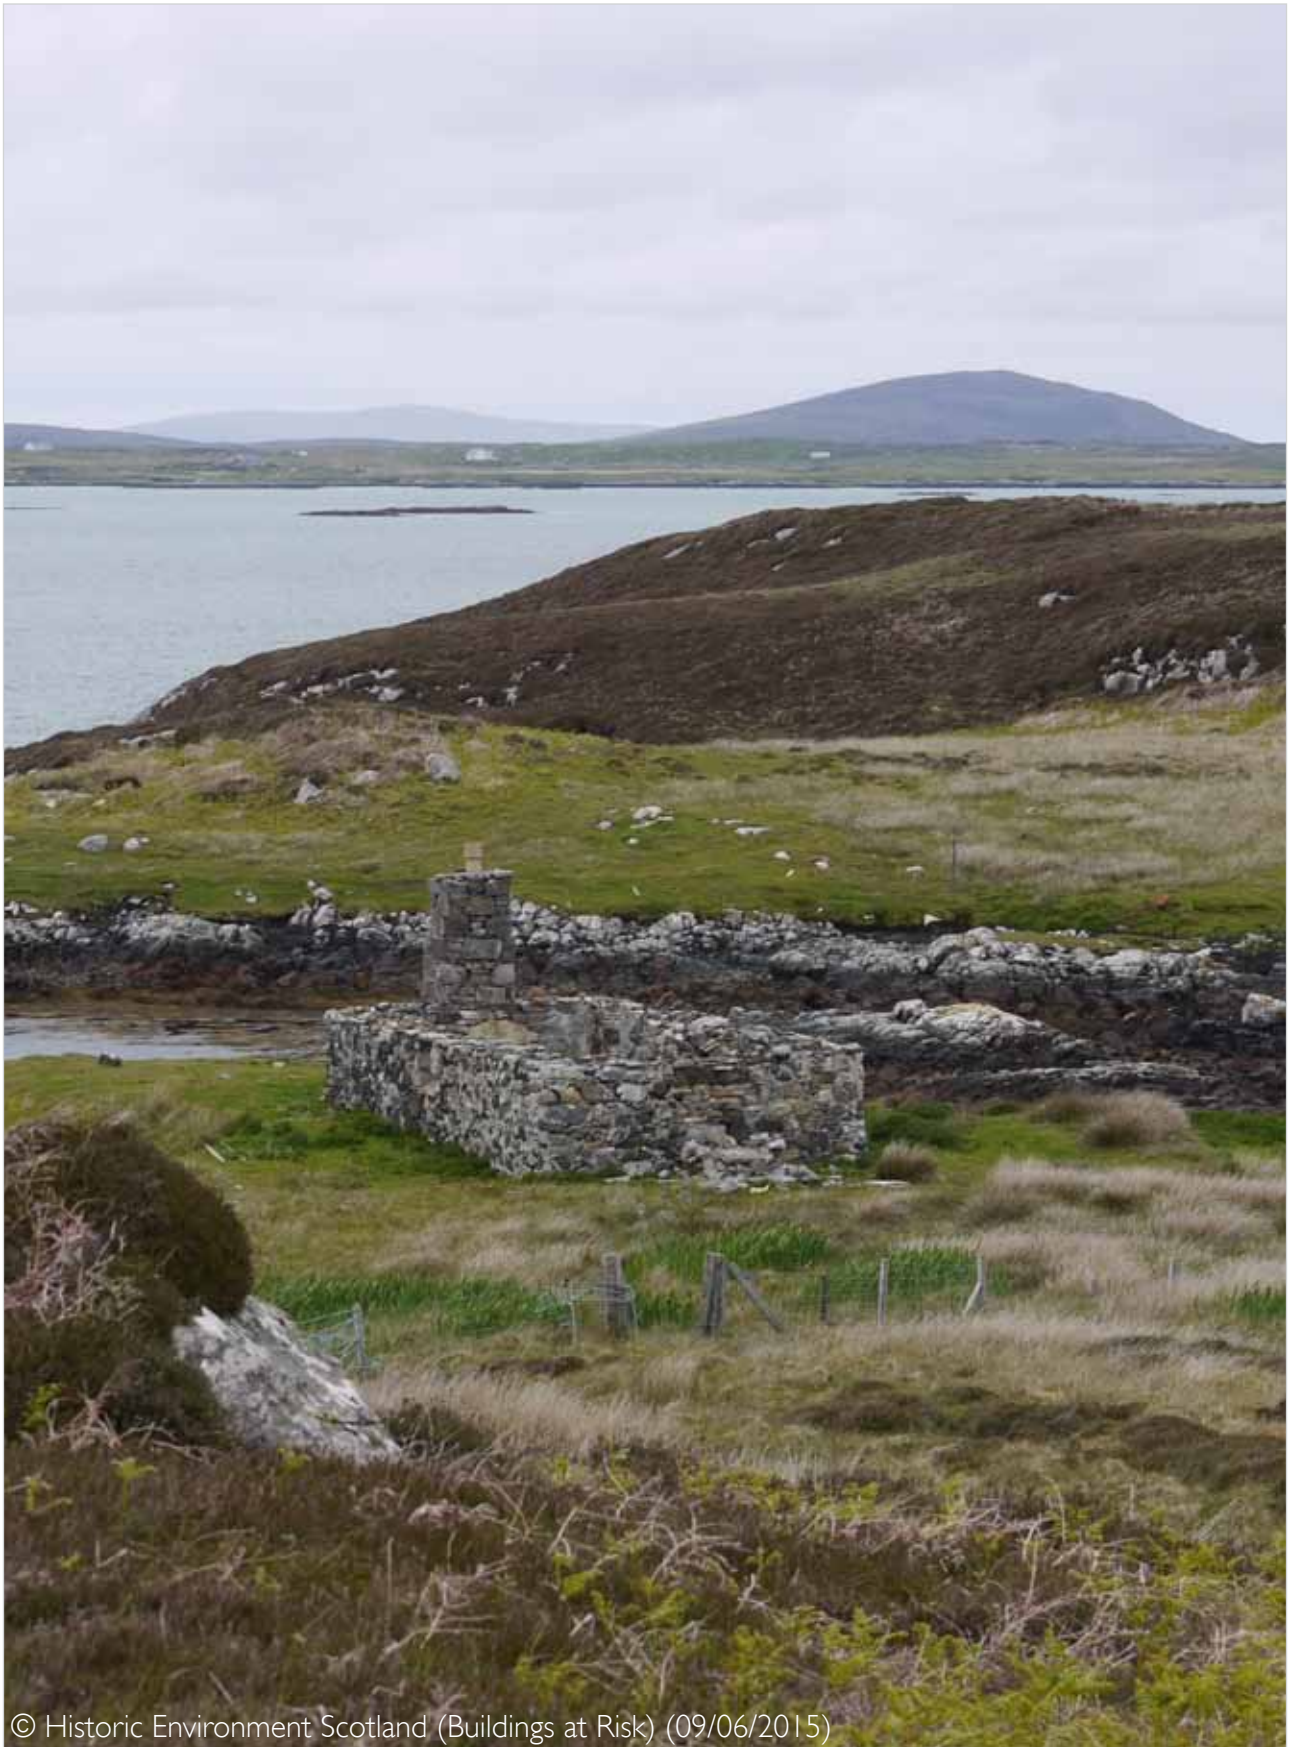
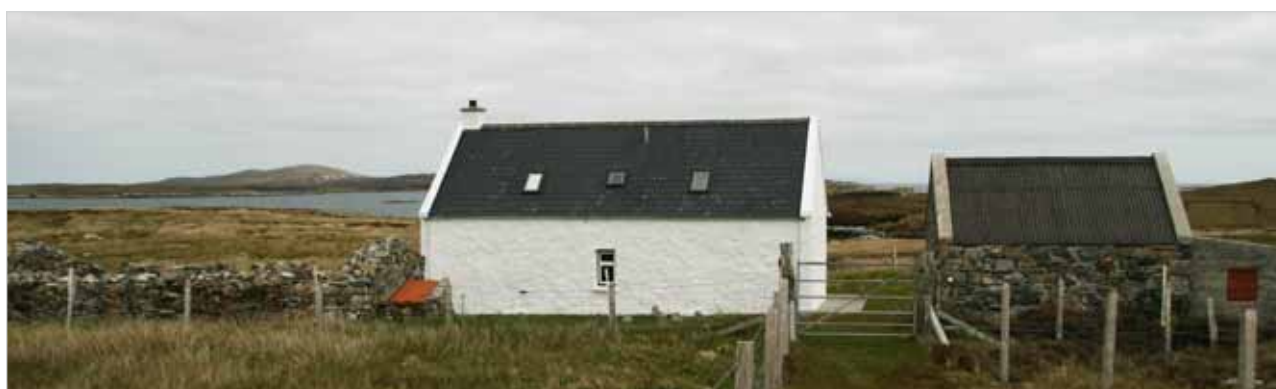
Flora MacLeod's Cottage – Western Isles

Additional Notes: Circa 1900 cottage, listed as being a thatched cottage with 'end stacks; *muran* thatch roof, secured with netting, ropes and stone weights'. The grid reference for this site is different on both the listing and that held by Buildings at Risk; in the listing the grid reference refers to the white building shown in the middle of the image below, as does Canmore. However, a building with the same listed building number has been on the Buildings at Risk (BAR) Register since 1996 (BAR reference number 1819) and they identify a site approximately 500 metres to the west of that in the listing (grid reference NF 82195 44844). Canmore hold a separate record for this site (Canmore ID 126070). BAR recorded that in May 1996 'SCT understands the cottage has been gutted by fire and is now a shell'. Although the site identified by BAR was inaccessible upon visiting, satellite imagery confirms that the building identified by BAR is indeed a shell. The location of this building should be confirmed, the grid references on all databases amended and the listing description updated accordingly.

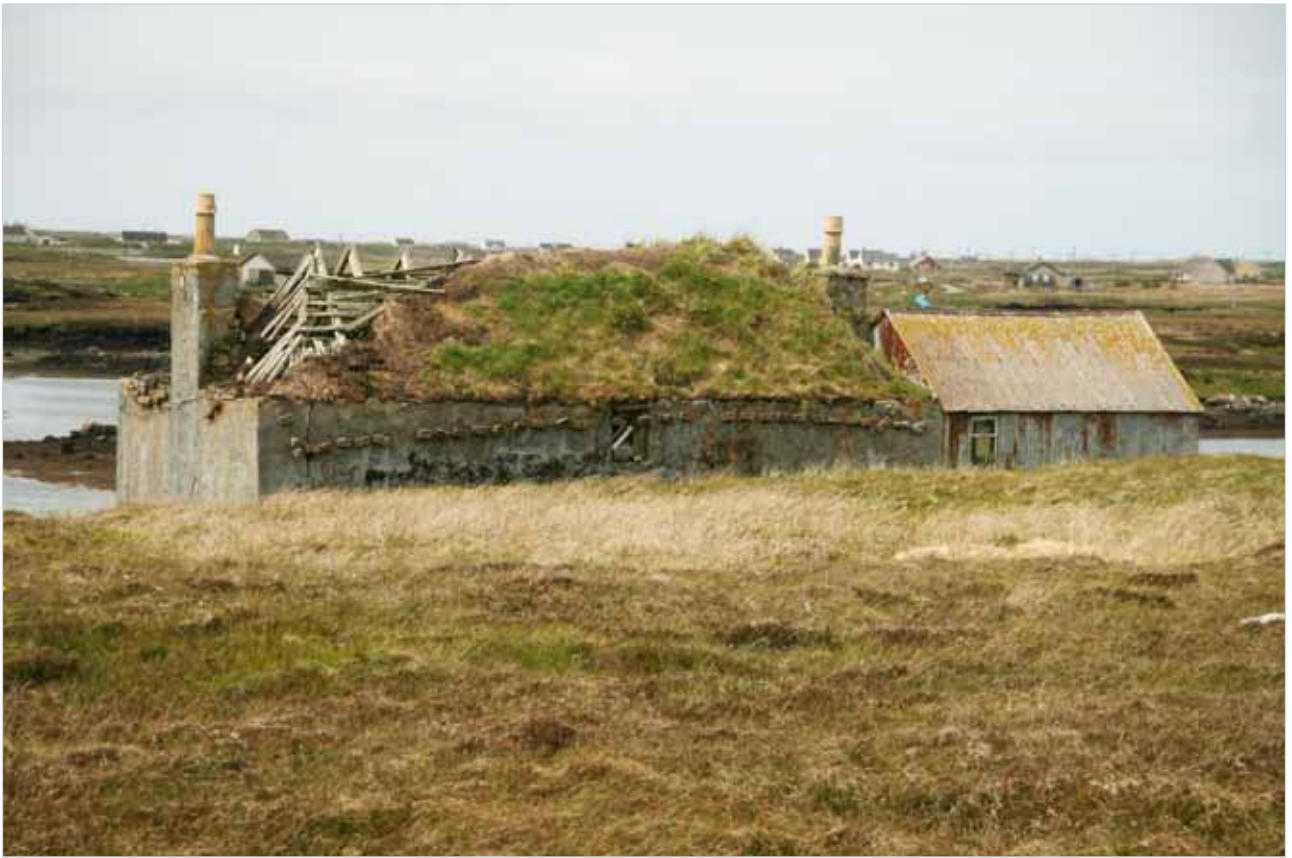
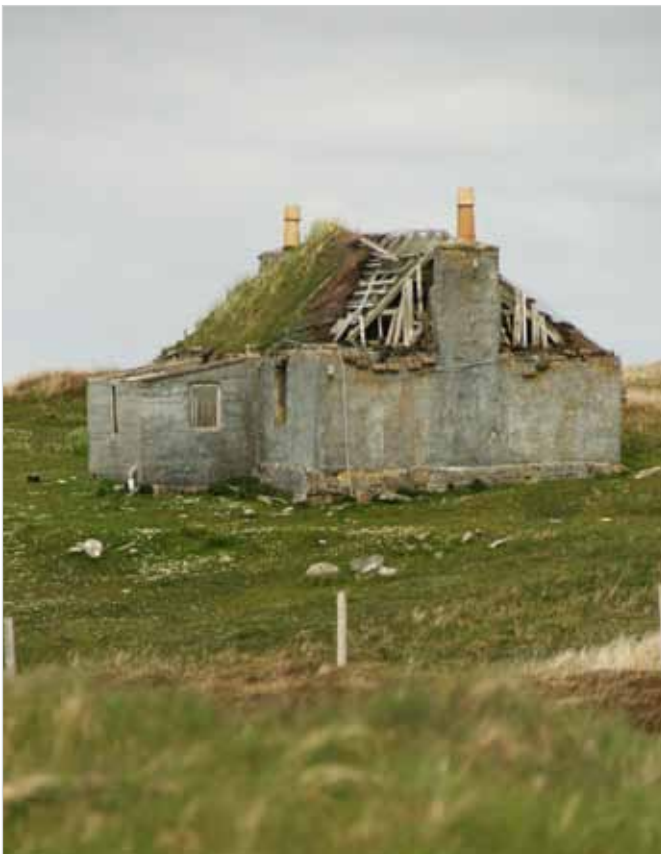
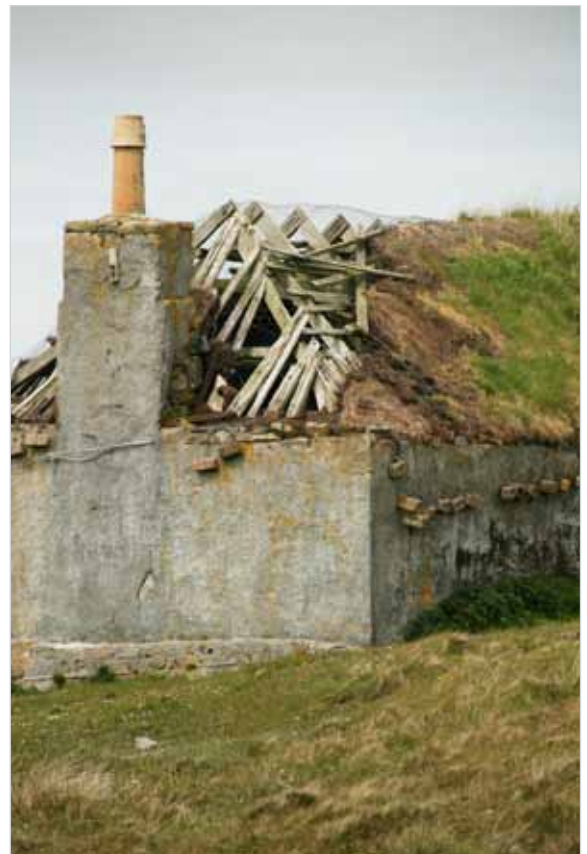
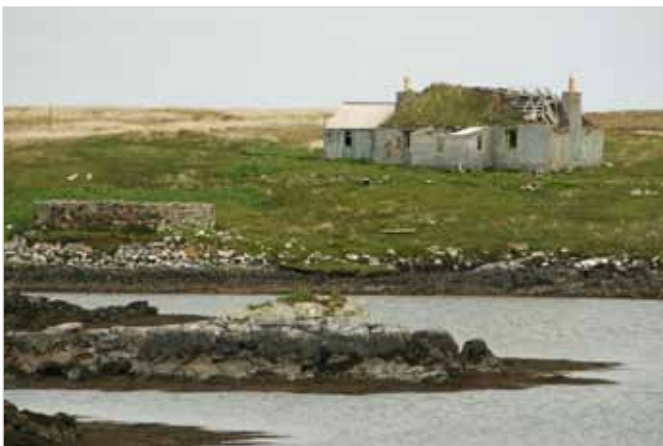
Rhughasinish Thatched Cottage – Western Isles

Condition of Thatch: Poor

Additional Notes: Single-storey cottage made from concrete with adjoining corrugated iron roof outbuilding to the north gable. The cottage, which appears to be thatched in marram with a continuous marram ridge, is in a derelict condition and much of the thatch is missing, exposing the interior of the building. The remaining thatch is heavily overgrown with grassy vegetation growth and there is visible evidence of netting, which is weighted down at the eaves with bricks secured to the netting with string. Many of the weighting bricks have fallen to the ground or are hanging much lower than they originally would have. The south end of the roof, which is in the poorest condition, appears to be close to collapse.

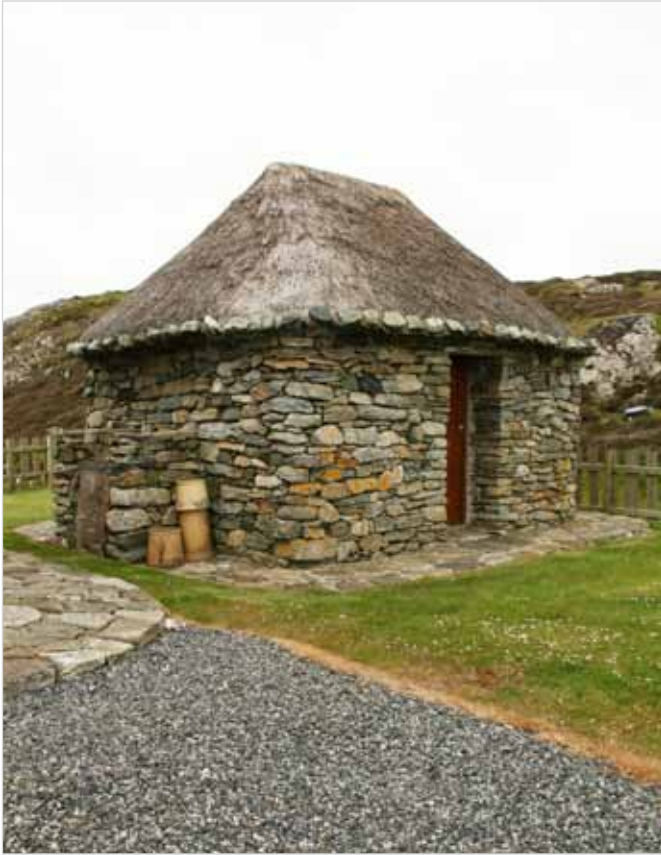
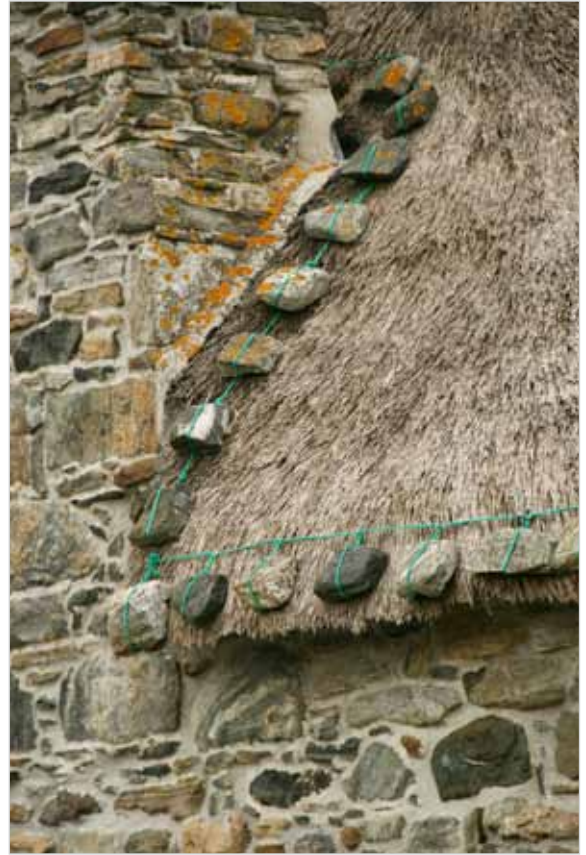
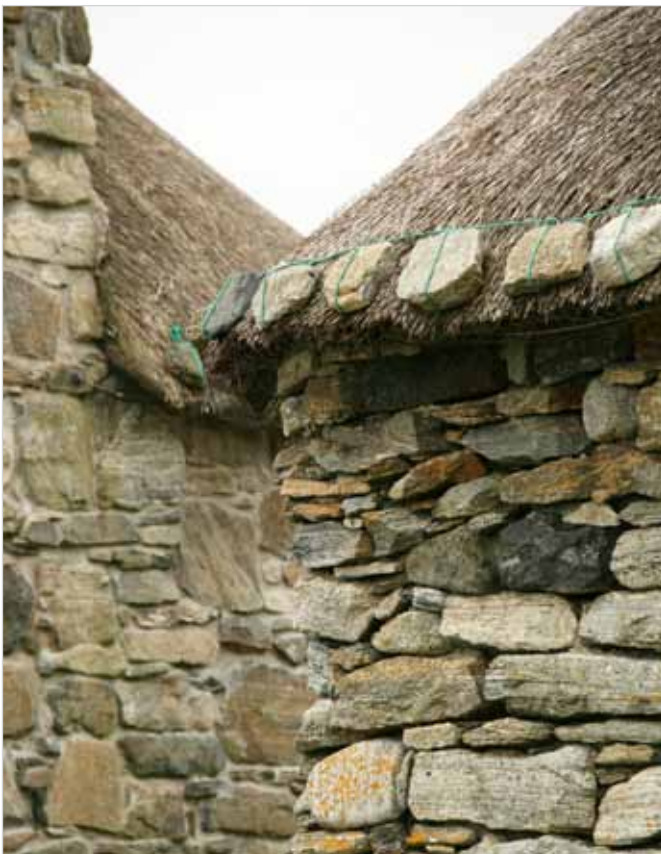
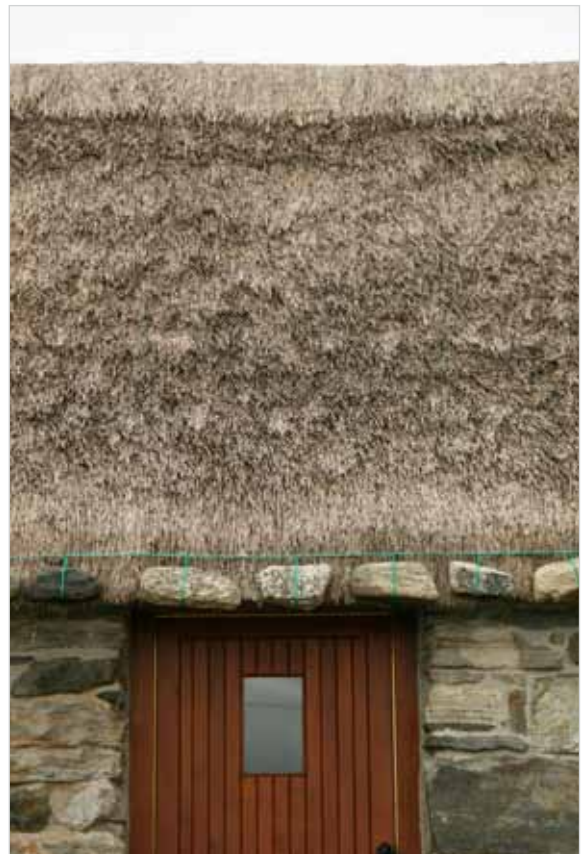
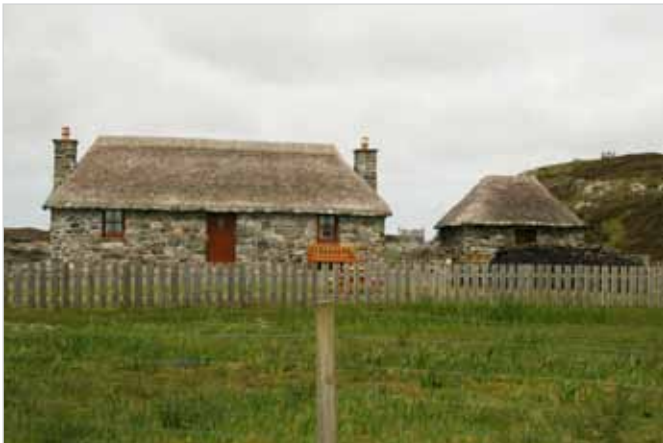
The Shieling by the Bay – Western Isles

Single-storey cottage built in 1908 and listed as having a 'muran thatch roof, secured with ropes and stone weights'. The cottage has been renovated and is now used as holiday accommodation. There is also a small outbuilding to the north, and both buildings are thatched in marram with a continuous marram ridge. The thatch on both buildings has been netted, weighted down along the eaves with stones secured to the netting by string. On the cottage, the string of stones continues around the edge of the chimney stacks at either gable end.

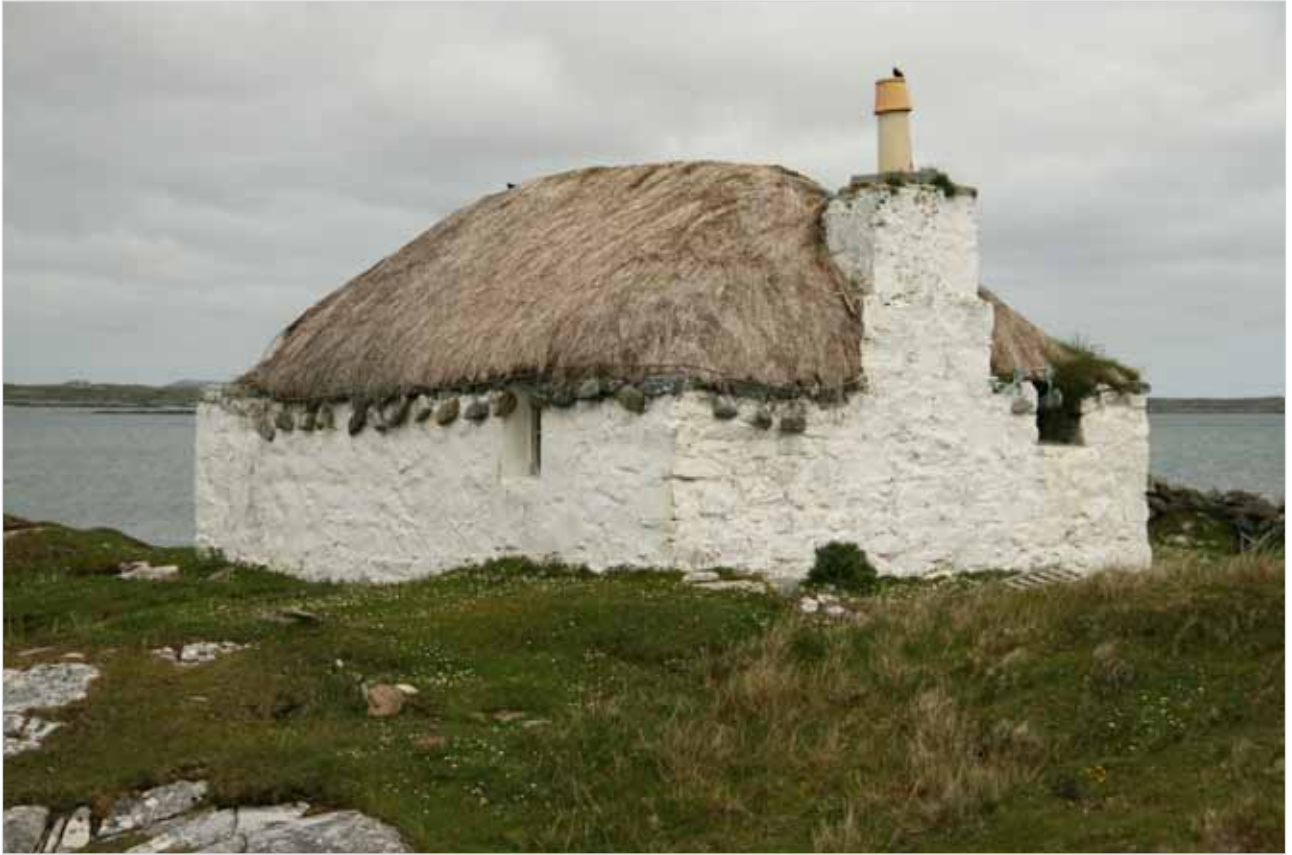
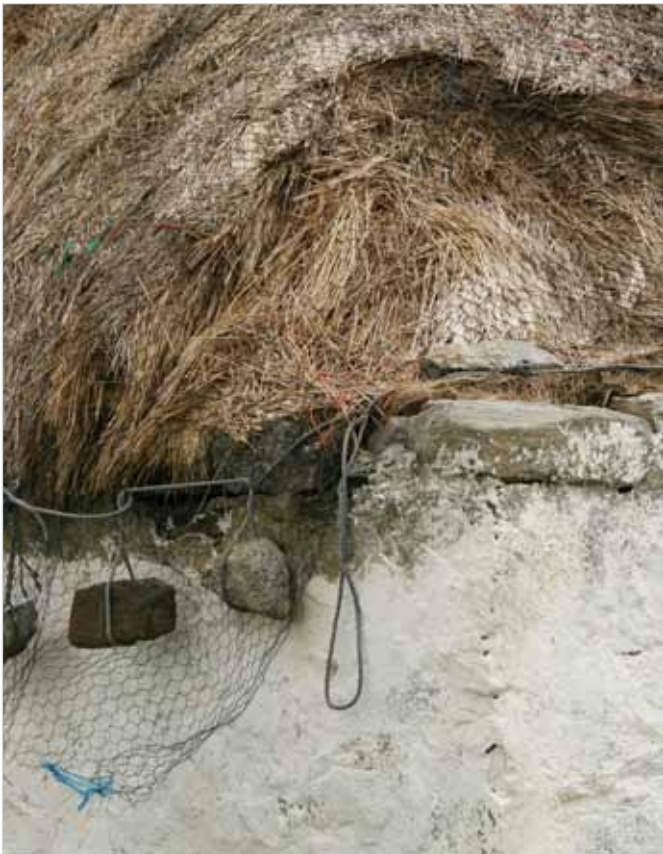
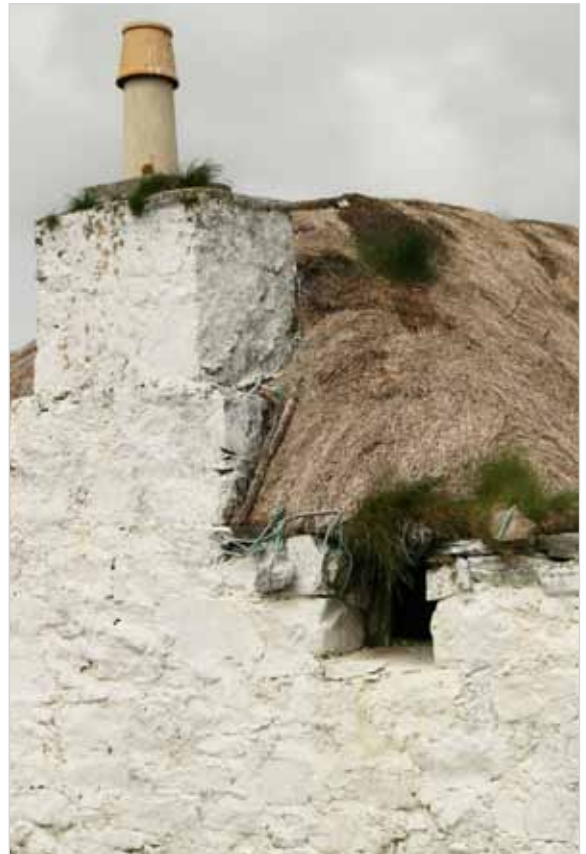
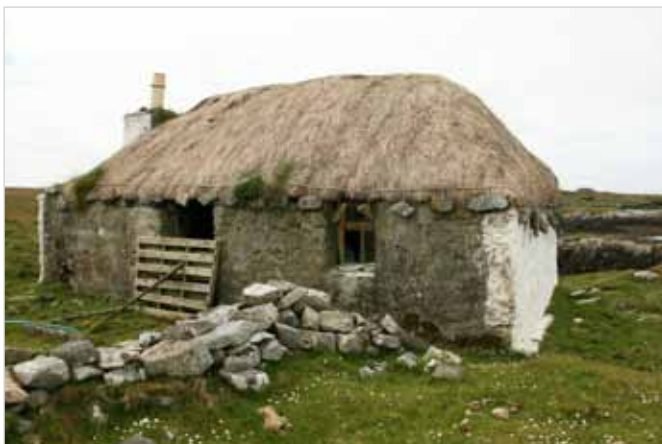
11 Rhughasinish – Western Isles

Thatch Type: Marram
Ridge Type: Thatched (Marram)
Condition of Thatch: Poor

Additional Notes: Probably 19th-century cottage, listed as having a 'muran thatch roof secured with ropes and stone weights'. The building is in an exposed location on the north coast of South Uist and is quite some distance from any roads, now being located on the owner's land, which is used for farming. The building is currently not in use but the owner maintains the thatched roof. The marram-thatched roof has a continuous marram ridge and has been entirely netted, including across the ridge. The netting has been weighted along the eaves by stones that have been secured to the netting by a continuous piece of thin rope passed through the holes in the net. The

netting is weighted down the sides of the chimney stack to the south by metal tubes, secured to the netting with the same thin rope. There are a few areas of thatch missing or dislodged across the roof and some grassy vegetation growth in places, particularly on the east elevation. The owner plans to re-thatch the roof within the next year.

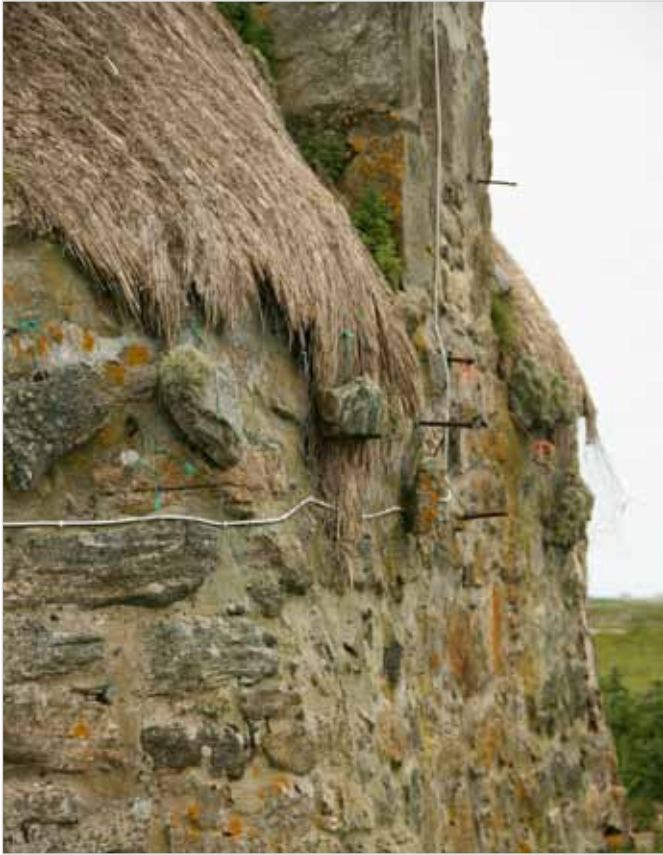
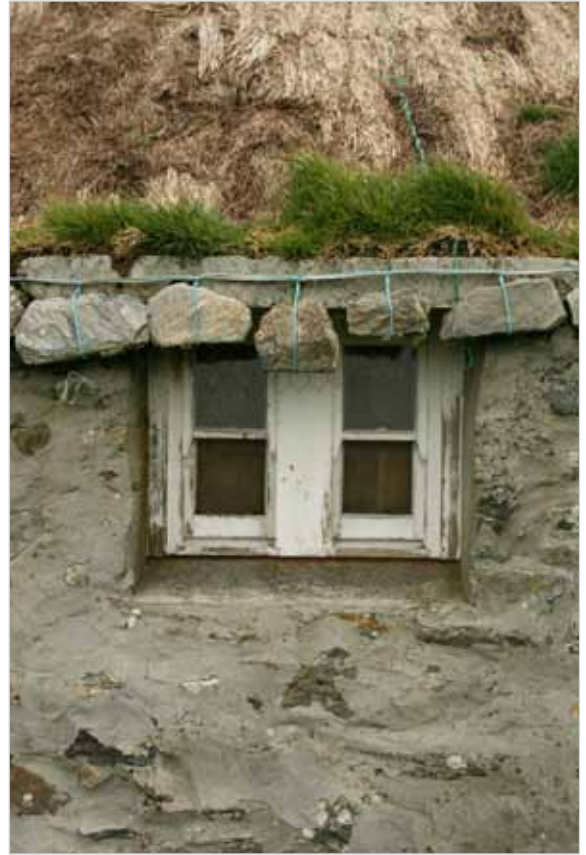
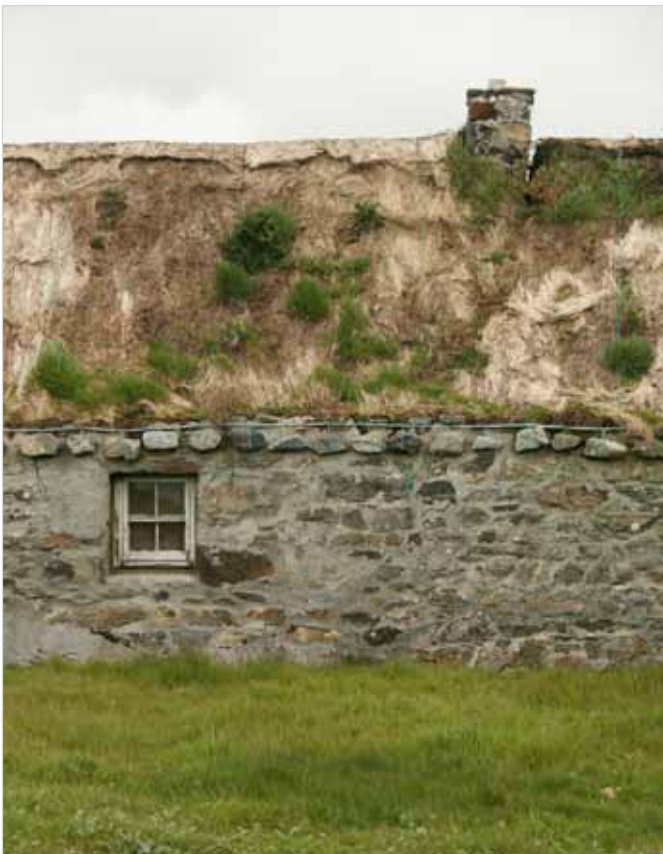
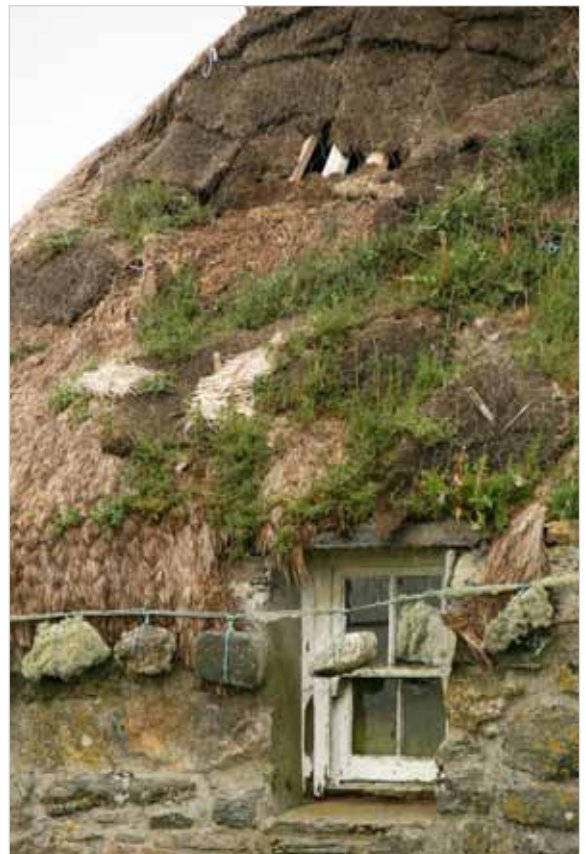
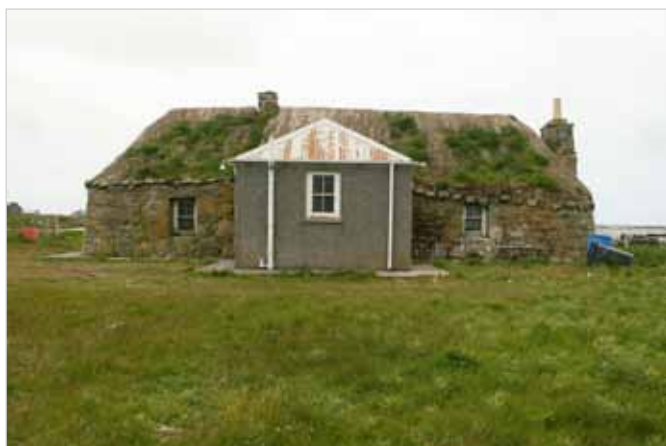
Thatch Type: Marram
Ridge Type: Thatched (Marram)
Condition of Thatch: Poor

The building retains a marram-thatched roof with a marram ridge; however the building is vacant and the roof is in a poor condition. There are some areas where the thatch is missing, exposing the interior of the building and the layer of turf underneath the marram, as well as having a significant opening around the chimney stack along the ridge. The surface of the thatch is also heavily overgrown with grassy vegetation. The roof has been entirely netted,

including across the ridge, which is weighted along the eaves by stones secured to the netting by a continuous string passed through the holes in the net. The stones and netting remain intact; however, some of the stones appear to be sagging and loose in places. The cottage has a modern porch extension to the east with a corrugated iron roof.

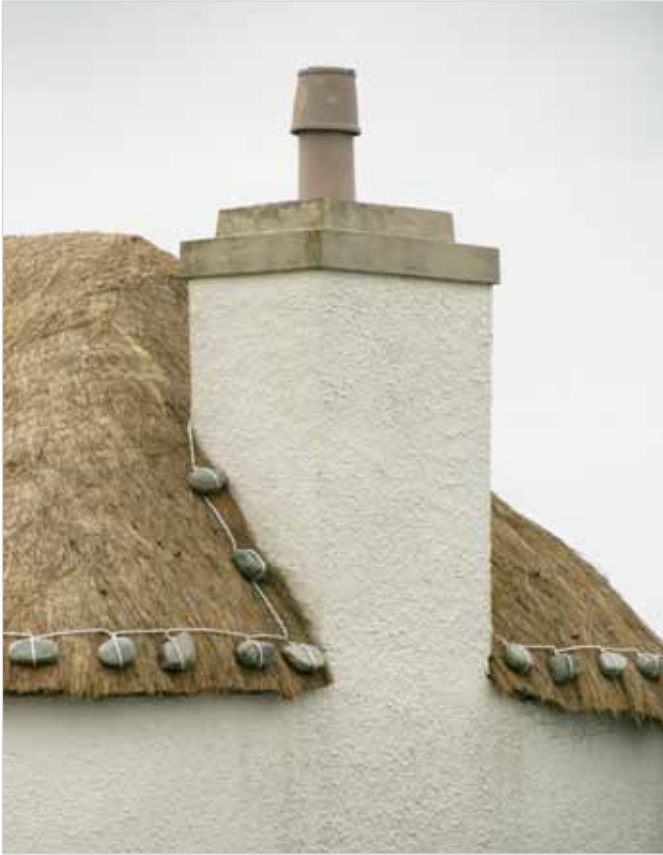
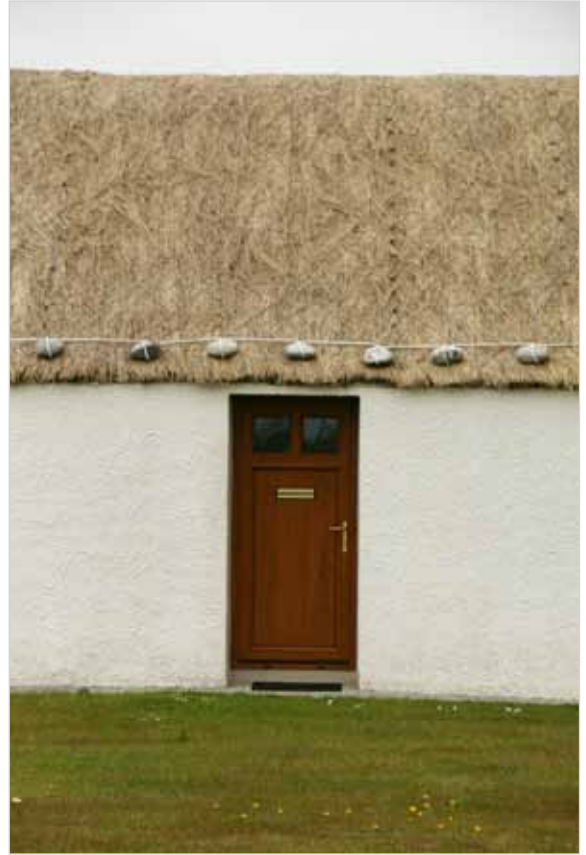
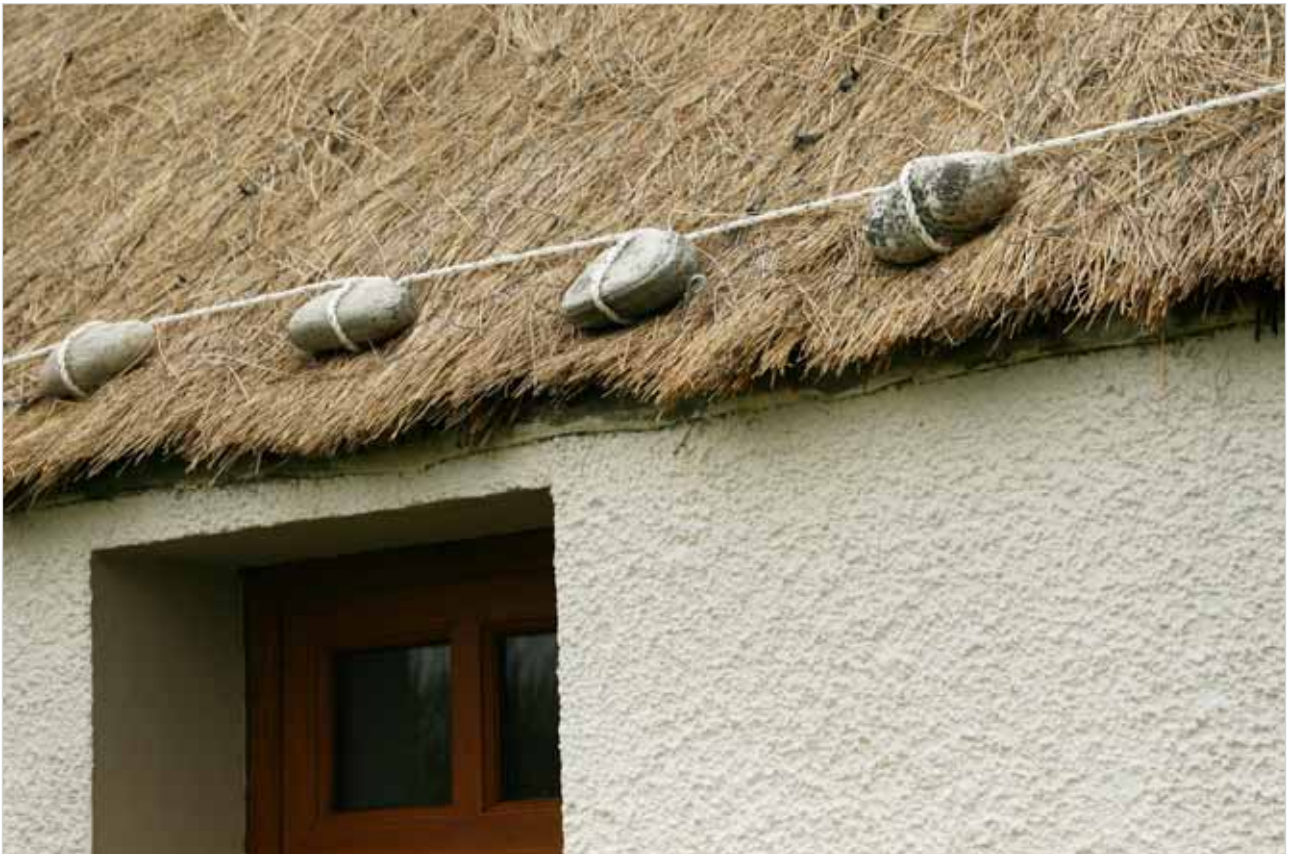
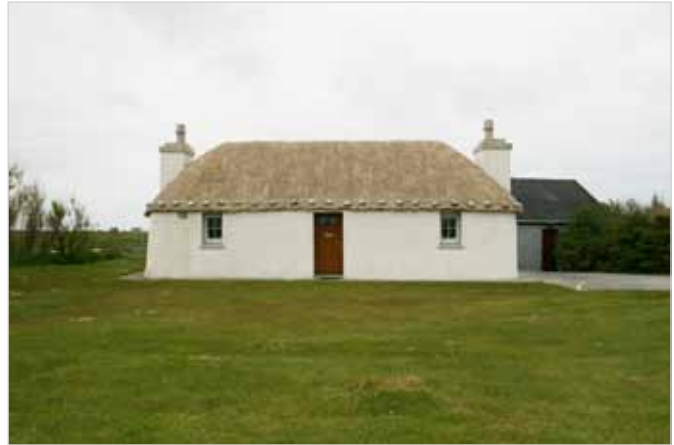
Bualadubh Thatched Cottage – Western Isles

Cottage of unknown date, currently has a marram-thatched roof with continuous marram ridge. The roof is entirely netted, including across the ridge, which is weighted just above the eaves and around the chimney stacks at either end with stones secured to the netting along a continuous string of thin rope passed through the holes of the net.
