A Survey of Thatched Buildings in Scotland

Thatch Survey of Scotland
2014-15

A photographic survey of thatched buildings in Scotland, surveyed between May 2014 and August 2015 by Zoe Herbert (SPAB Scotland Officer), on behalf of the Society for the Protection of Ancient Buildings.

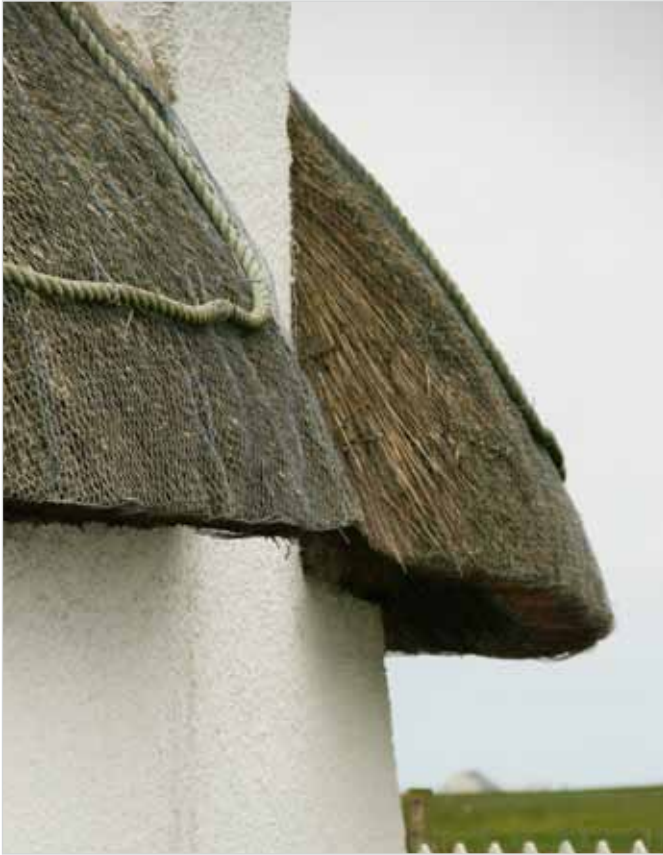
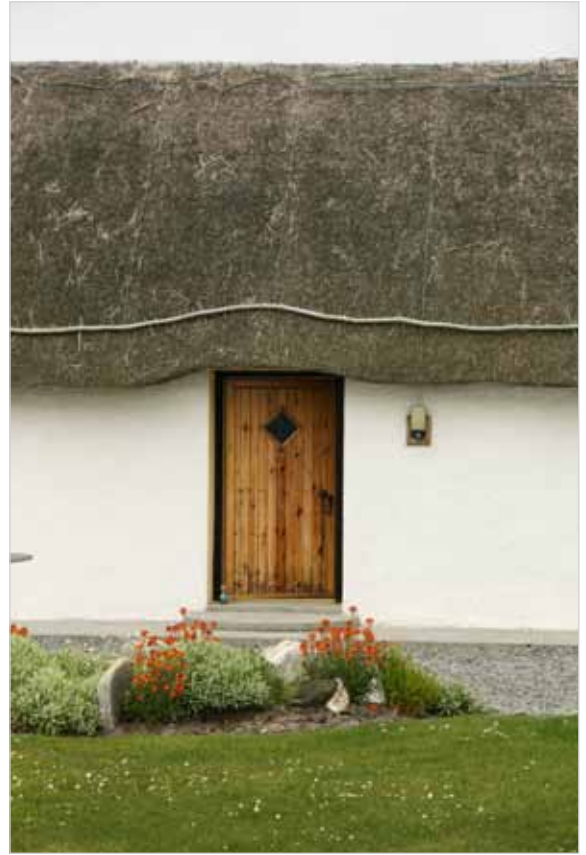
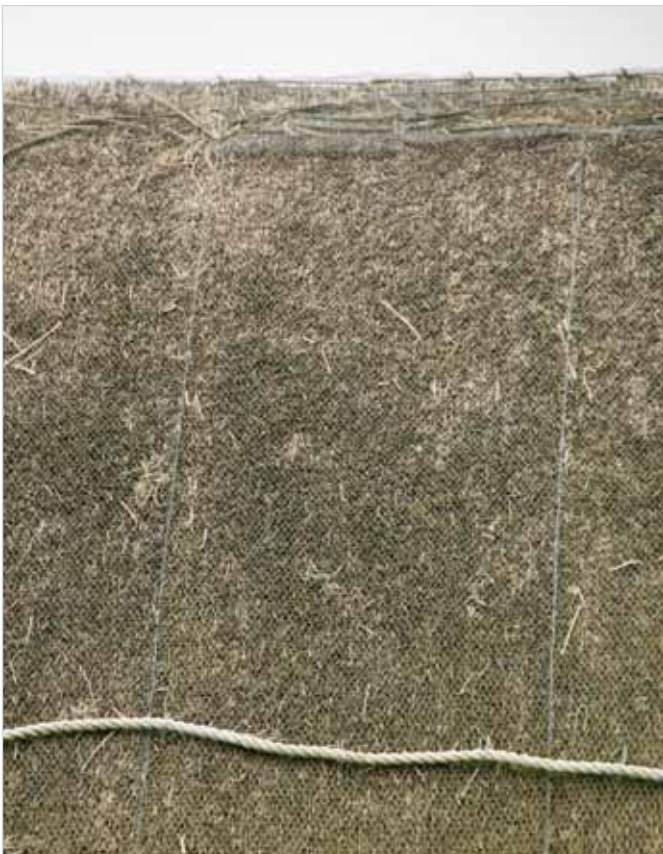
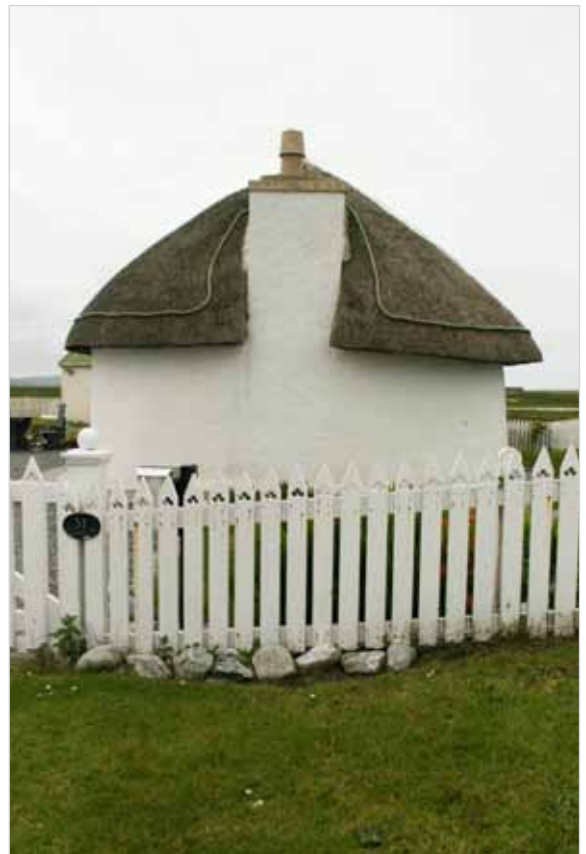
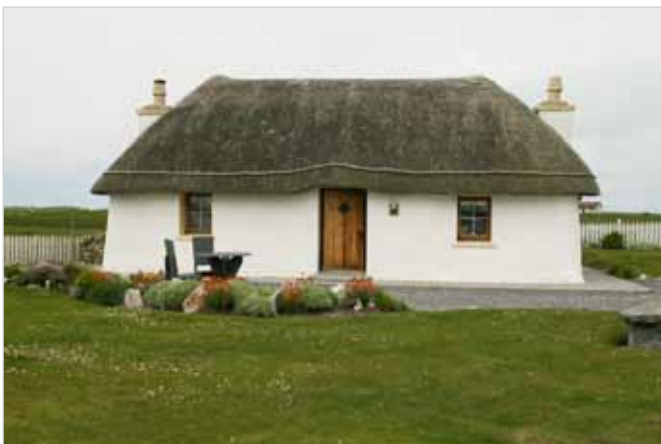
51 Balgarva – Western Isles

Thatch Type: Reed or Straw
Ridge Type: Thatched
Condition: Good

Additional Notes: Probably 19th-century cottage, listed as having a 'muran thatch roof, secured with ropes and netting; modern brick weights to east, stones used on other elevations' It is unclear what the thatch material currently is – it appears to be thatched in either reed or straw. Due to the condition of the thatch along the ridge, it is also unclear the manner and material in which it is scobed. The entire roof has been netted, and the netting has been secured underneath the eaves. There is a single thick rope secured to the surface of the netting around

a foot above the eaves, around the entire building and the chimney stacks. The rope is primarily used for decorative purposes but also provides a secondary weighting for the netting. The thatch is generally in a good condition; however, there are a few loose sections of thatch underneath the netting.

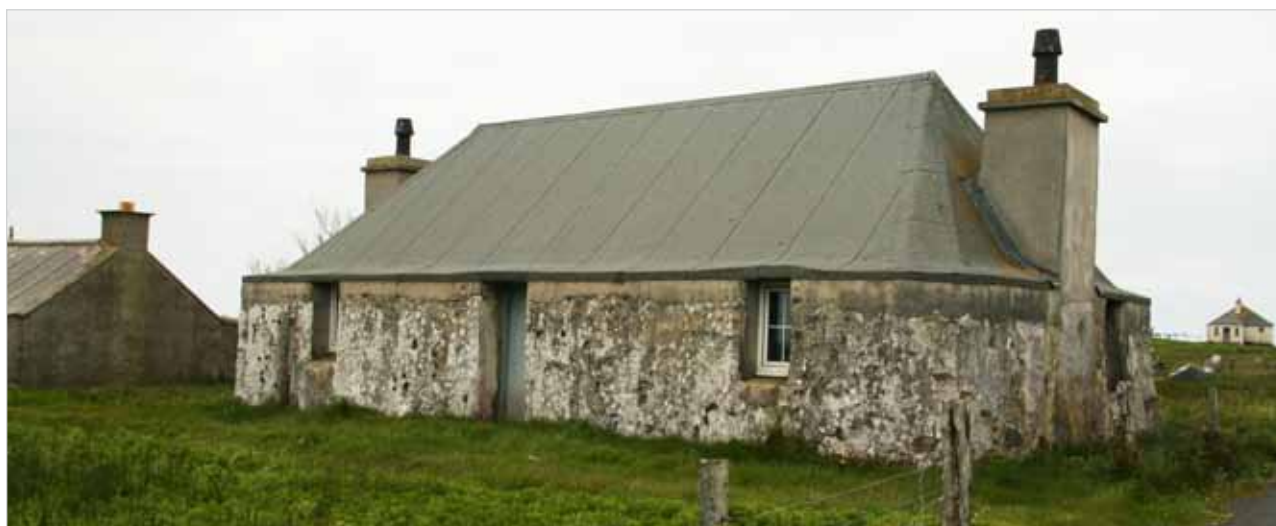
Address: Bualadubh Cottage

Additional Notes: Probably 19th-century cottage, listed in 1980 as having a '*muran thatch roof secured with ropes, netting and stone weights*', is no longer thatched and the roof is currently covered in felt. The cottage has been on the Buildings at Risk (BAR) Register since 1996 (BAR reference number 494) after being left vacant following the death of the occupant. At this time, the thatch was described as 'decaying', and by 1998 BAR record that the roof had been felted. It was also recorded in 1998 that the building had been repaired and appeared habitable and was subsequently removed from the Register; however, it remains on the BAR register currently. Whether the building is currently in use is unclear; however, BAR recorded in 2009 and 2010 that it was vacant. The listing description should be updated accordingly.

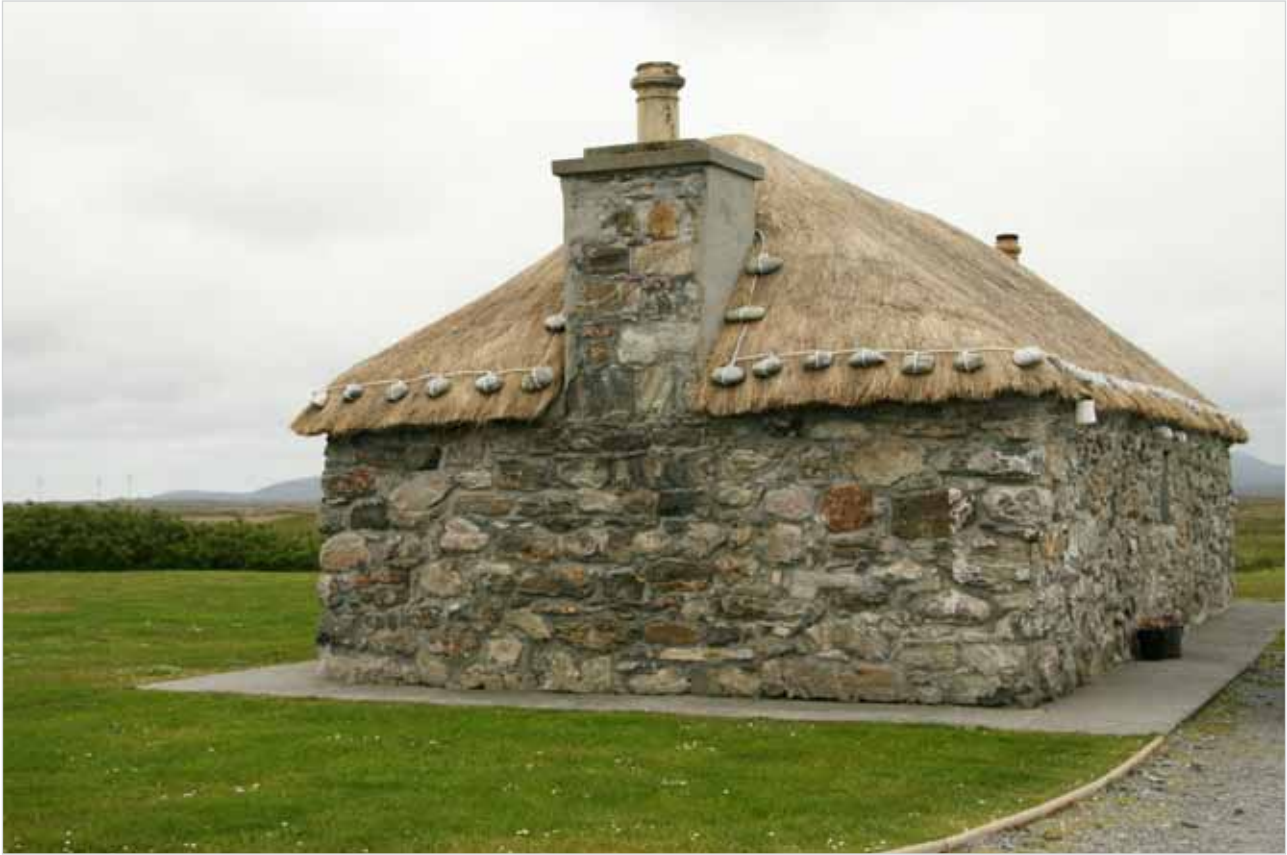
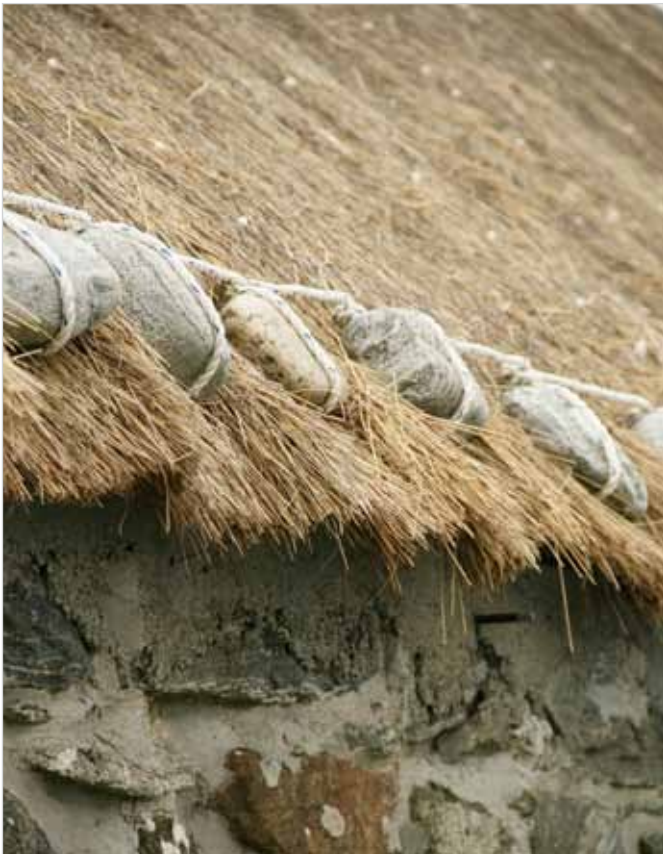
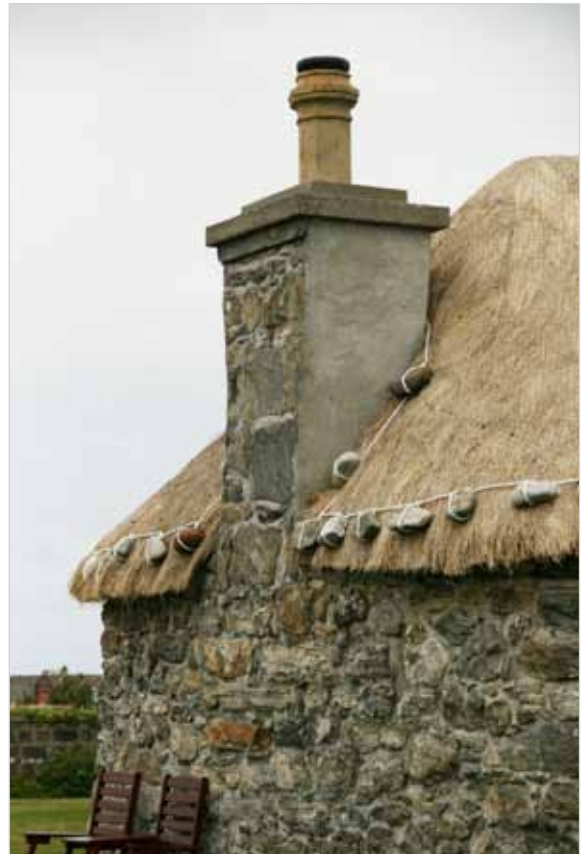
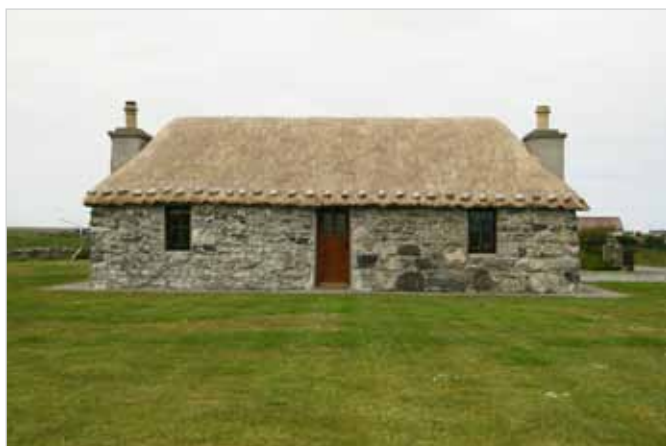
Corrodale Cottage – Western Isles

Thatch Type: Marram
Ridge Type: Thatched (Marram)
Condition of Thatch: Good

Additional Notes: Probably 19th-century cottage, listed as having a 'muran thatch roof, overhanging eaves, secured with netting and stone weights'. The cottage has been renovated for use as holiday accommodation but retains a marram-thatched roof with continuous marram ridge. The entire roof has been netted, including across the ridge, which is weighted just above the eaves and around the chimney stacks at either end by stones secured in a continuous string by thin rope passed through the holes in the netting. The listing description for the building notes that a 'shed to north (beside road) [is] also thatched; similar outbuilding to south now derelict'.

The shed to the north that is listed as being thatched is no longer there, though web-based satellite imagery that is now out of date confirms its former existence. The listing description should be updated accordingly.

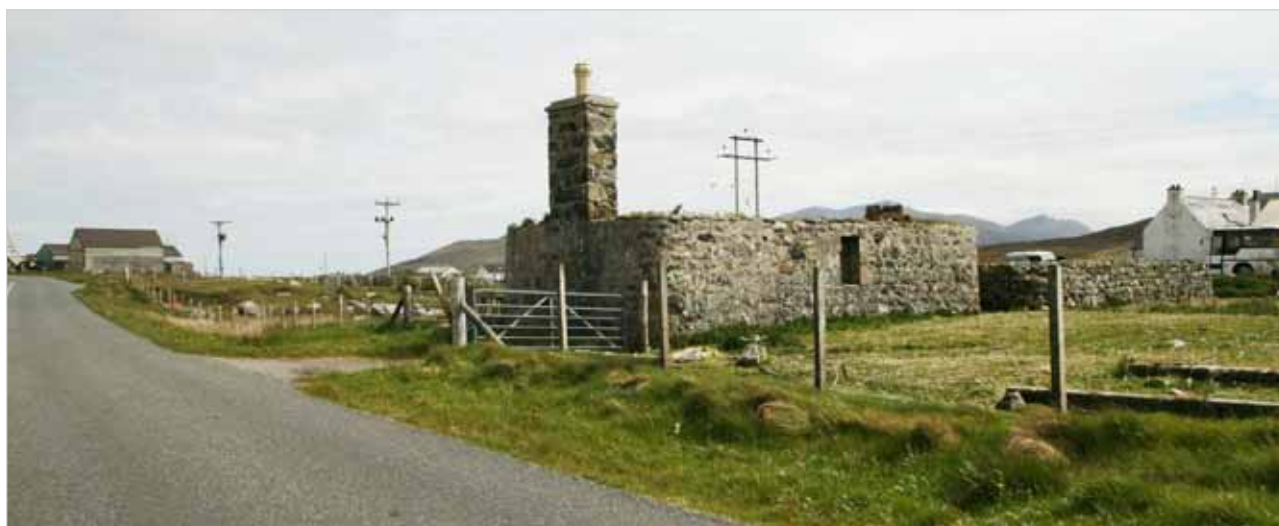
Address: 7 West Gerinish

Additional Notes: The location for this building is incorrect on its list entry. Both Canmore and Buildings at Risk identify the correct location for the building, which is a few metres east of that in the listing. (listed as NF 77570 41841). This late 19th/early 20th-century cottage is listed as having a '*muran thatch roof secured with netting, ropes and stone weights*'. Although planning permission for restoration was granted in 1998, the building is now a roofless ruin and has been on the Buildings at Risk (BAR) Register since 1996 (BAR reference number 1869). In 1998, BAR record the cottage to be abandoned with the roof in decay, and in 2010 they record the cottage to be a roofless ruin. The location on the listing should be corrected and the listing description updated accordingly.

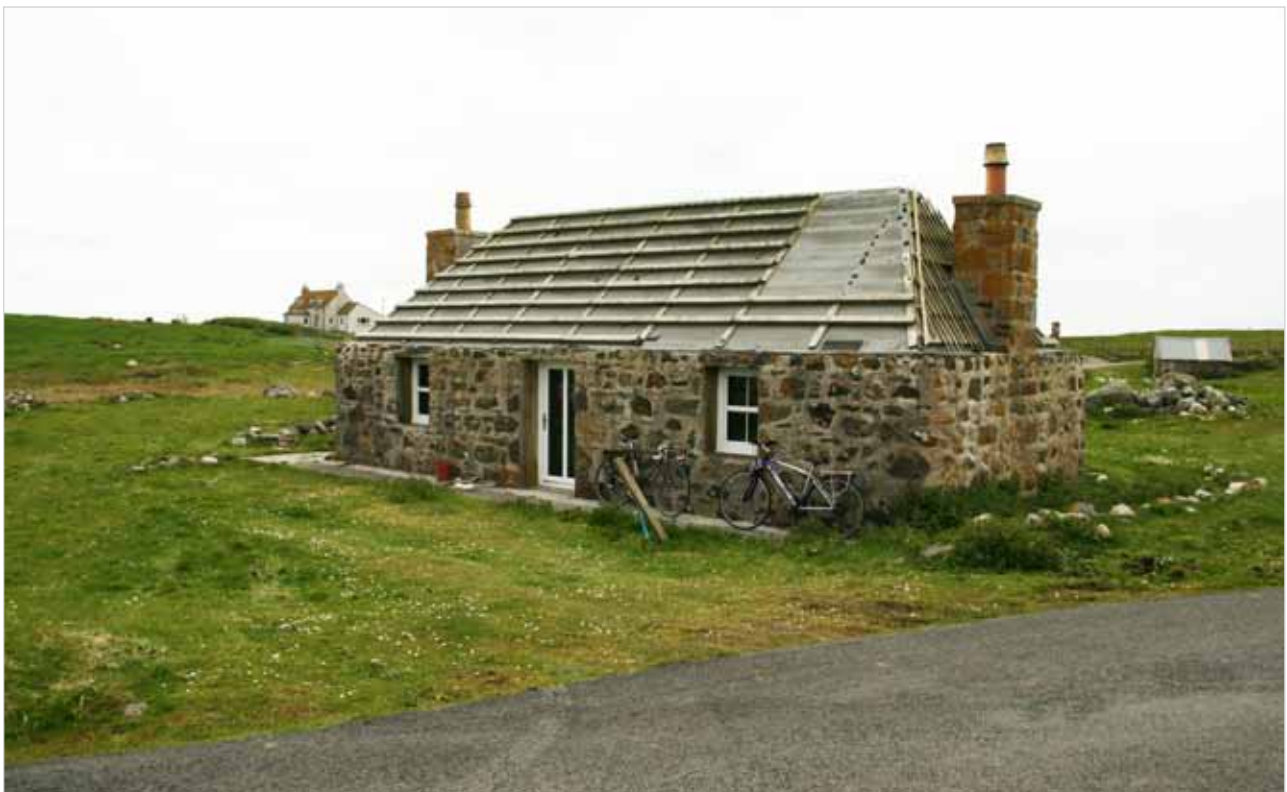
Additional Notes: 19th-century cottage, listed as having a '*muran thatch roof, secured with ropes and stone weights*'. The thatch has since been removed and currently appears to be in the process of having a new roofing material installed. There is no sign of any thatching material remaining anywhere on site. The listing description for the building should be updated accordingly.

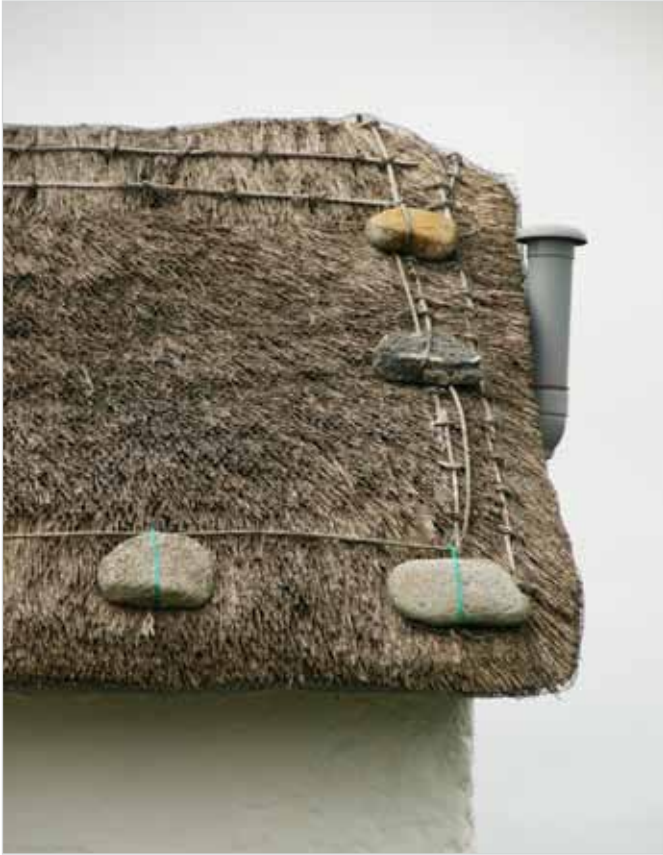
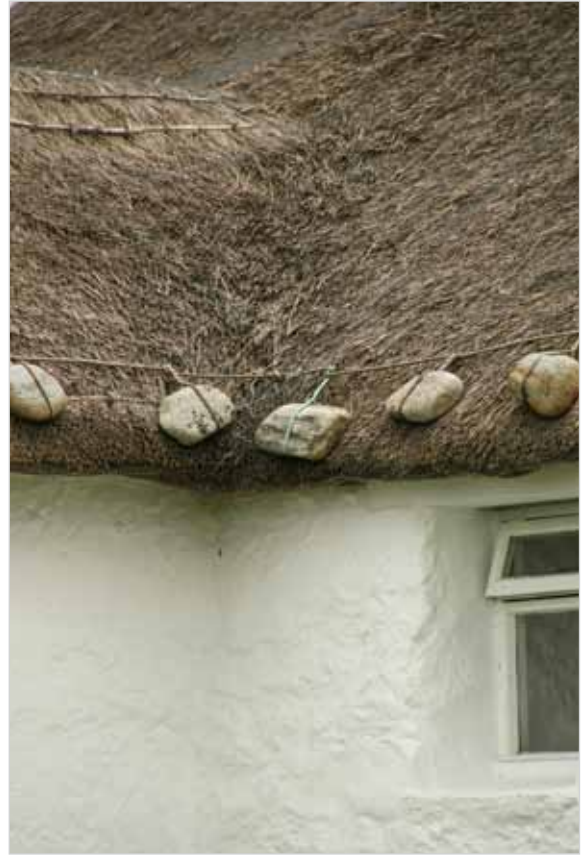
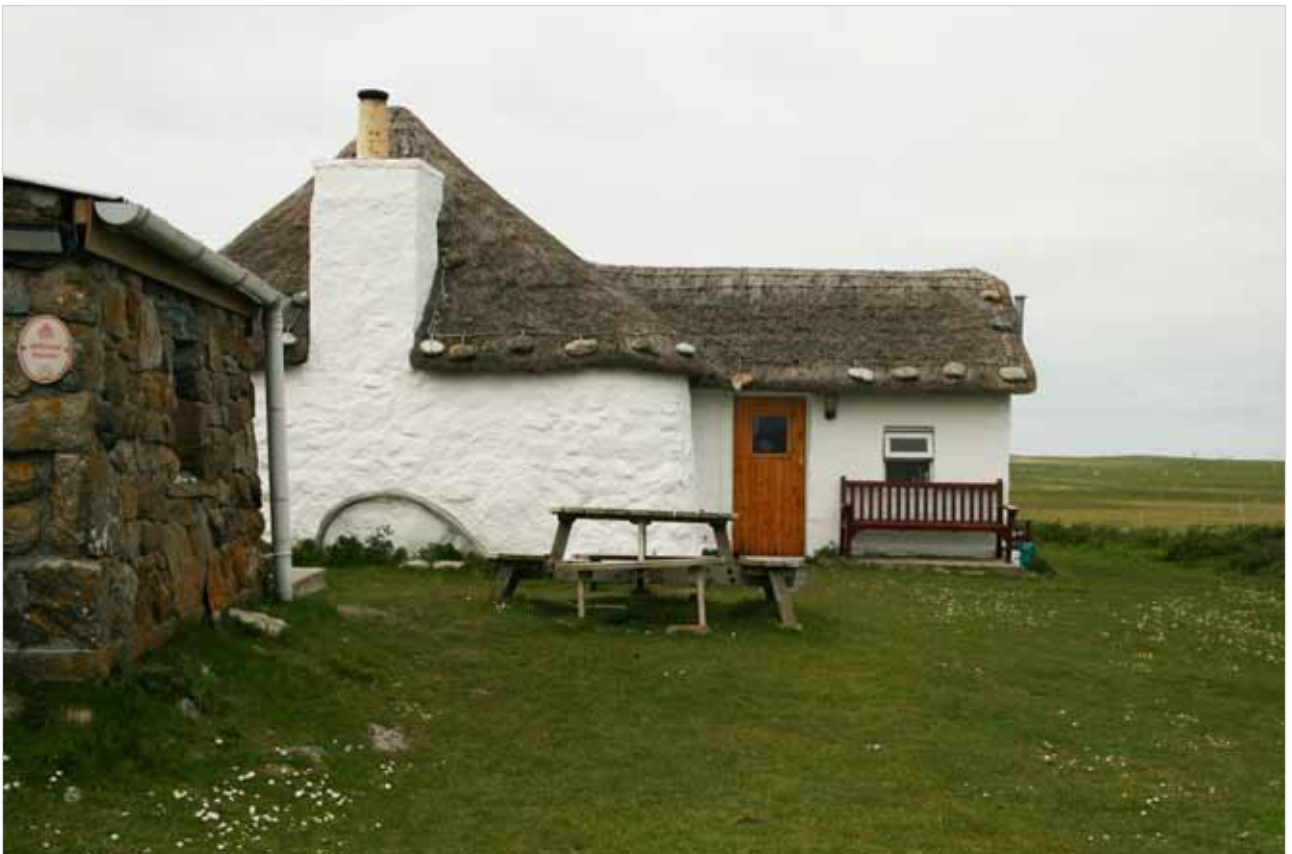
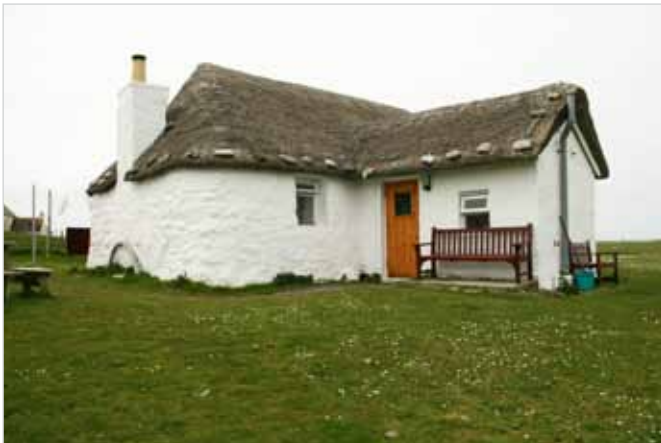
Howmore Hostel – Western Isles

Single-storey cottage with projecting wing to the front (north-east) elevation. According to the Gatliff Hebridean Hostels Trust website (www.gatliff.org.uk) the hostel at Howmore opened as a hostel in 1966. The roof of both the main cottage and the projecting porch wing are thatched in marram and have a continuous marram ridge. The ridge has been scobed using hazel spars, continued vertically down the skewes on the projecting wing. The entire roof has been netted, and weighted along the eaves and around the chimney stacks at either end of the cottage with stones. The stones have been hung by thin rope in a continuous string,

which has been pegged into the thatch with metal pegs above each of the stones.

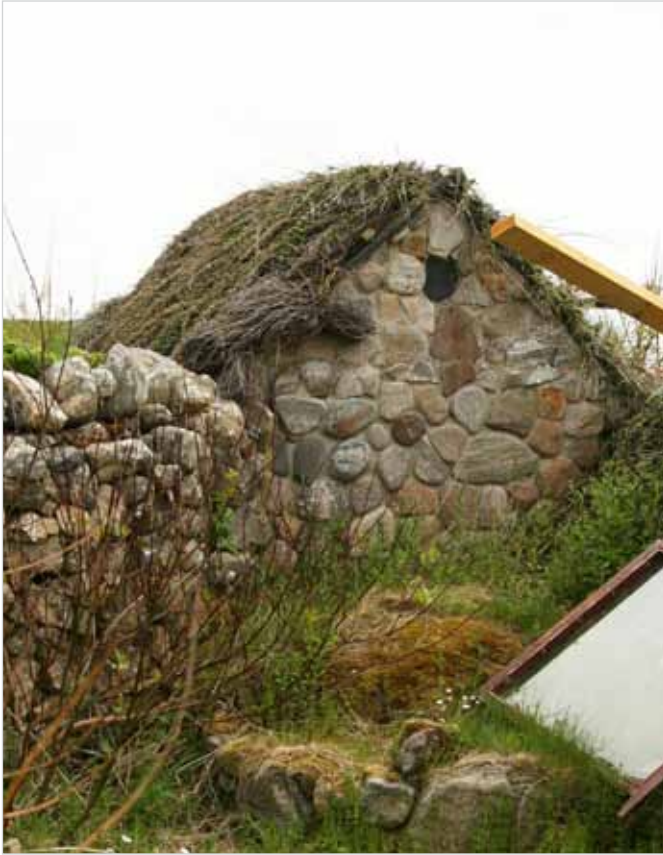
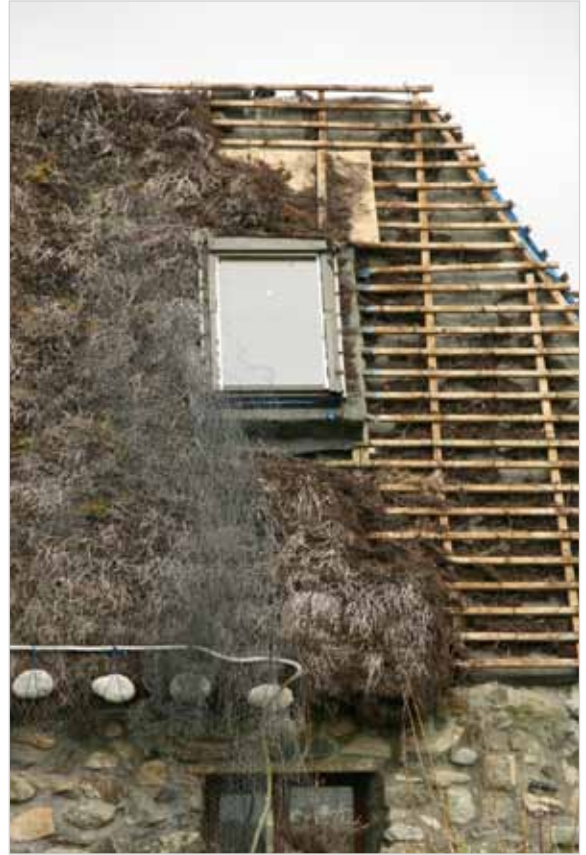
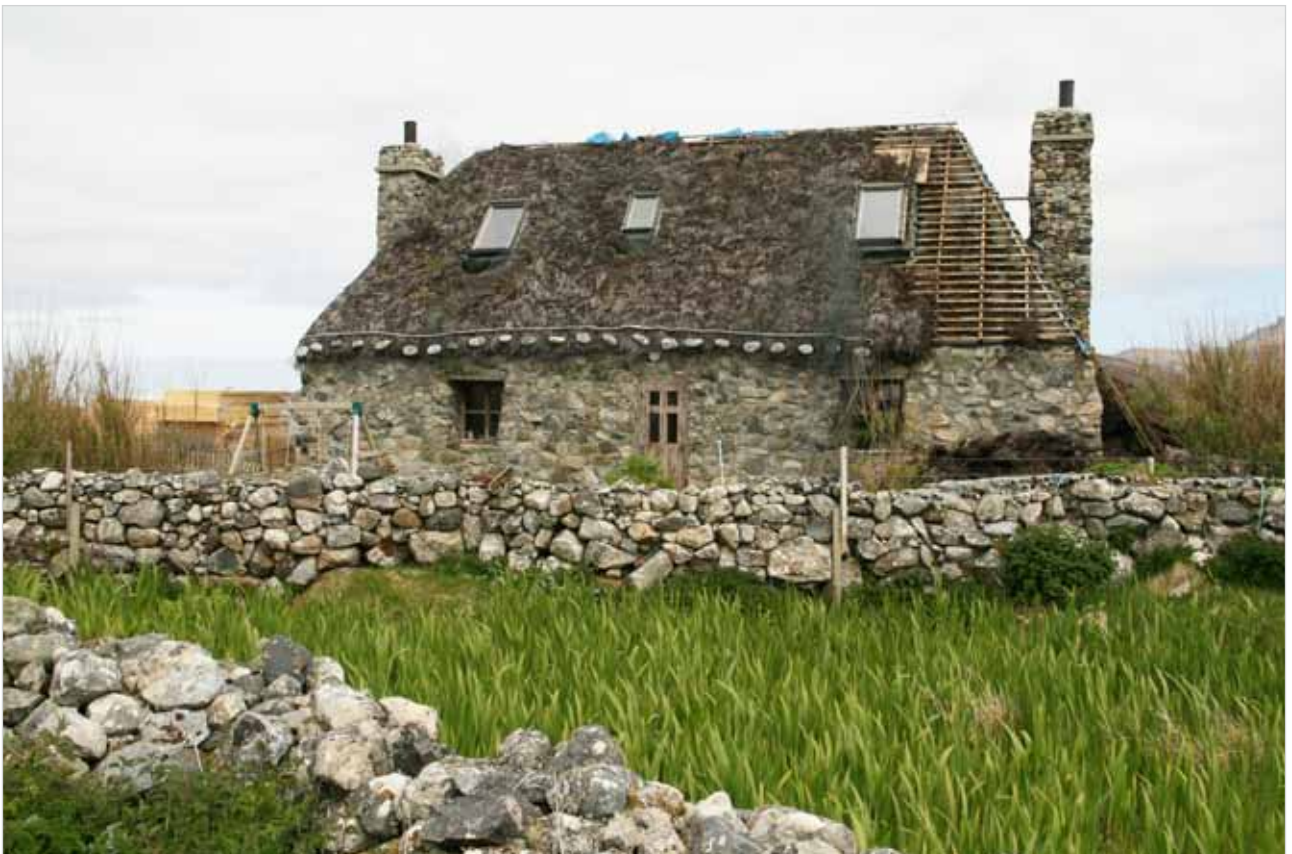
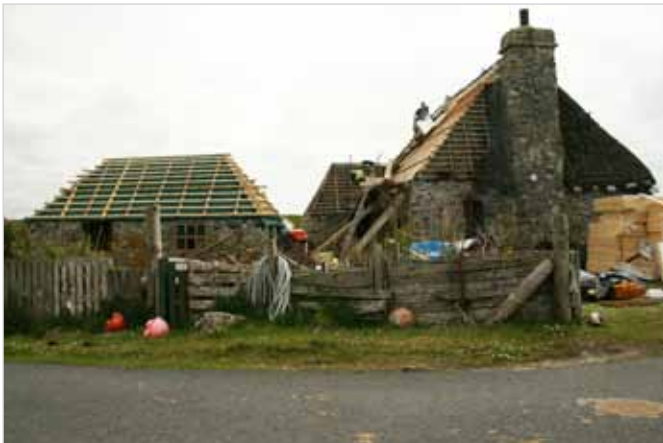
Howmore Thatched House – Western Isles

Large single-storey with attic cottage and two outbuildings to the east. At the time of visiting, the cottage as well as one of the outbuildings was having the heather thatch removed from the building in preparation for a complete re-thatch. The outbuilding had had the heather completely removed, whilst the cottage retained some of the heather thatch to the west elevation. The ridge had been completely removed, but visible evidence of netting over the heather could be seen, which was weighted down above the eaves and around the chimney stacks at either end with stones secured to a rope that had been strung through the

netting with metal wire. A small outbuilding to the east currently retains its heather roof, though this appears to be in fairly poor condition. The owner plans to re-thatch all roofs in heather.

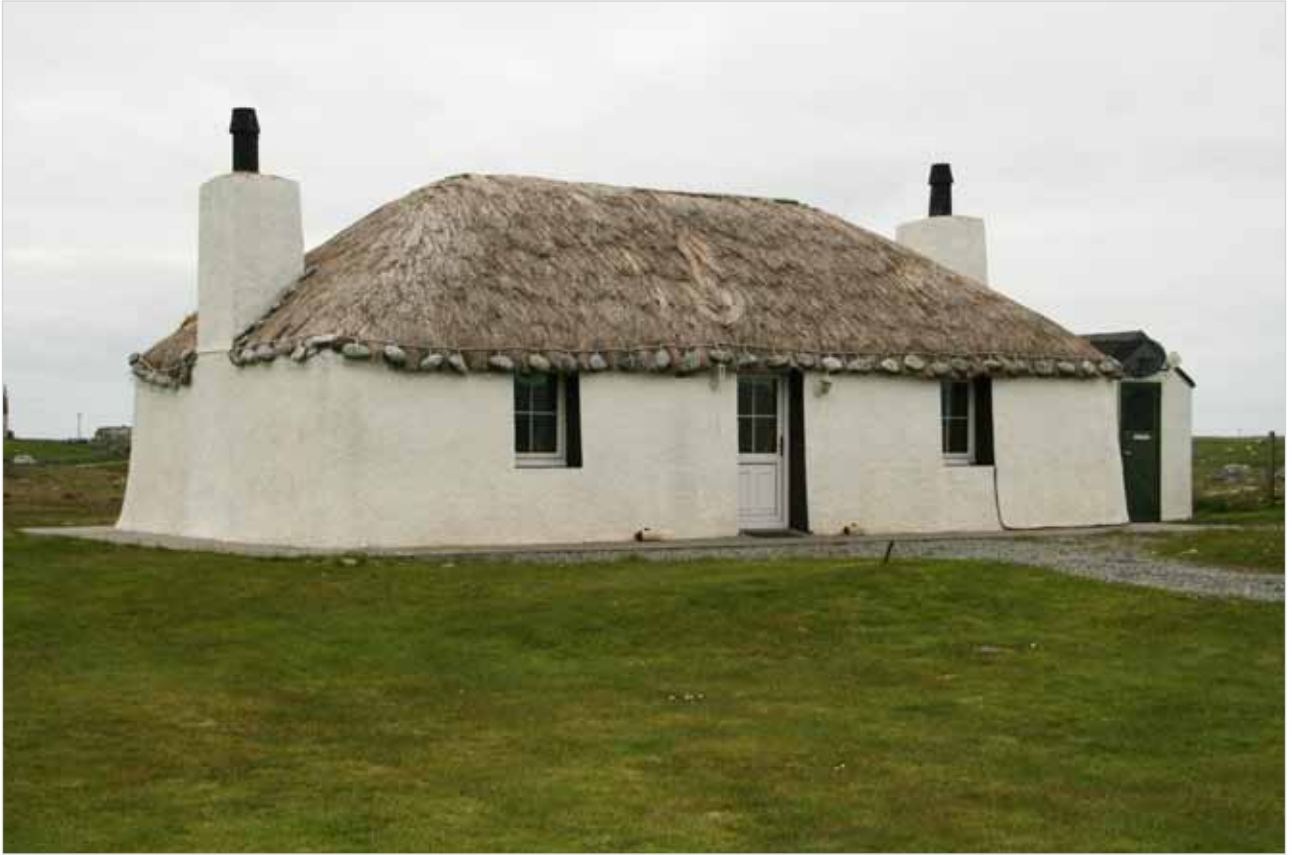
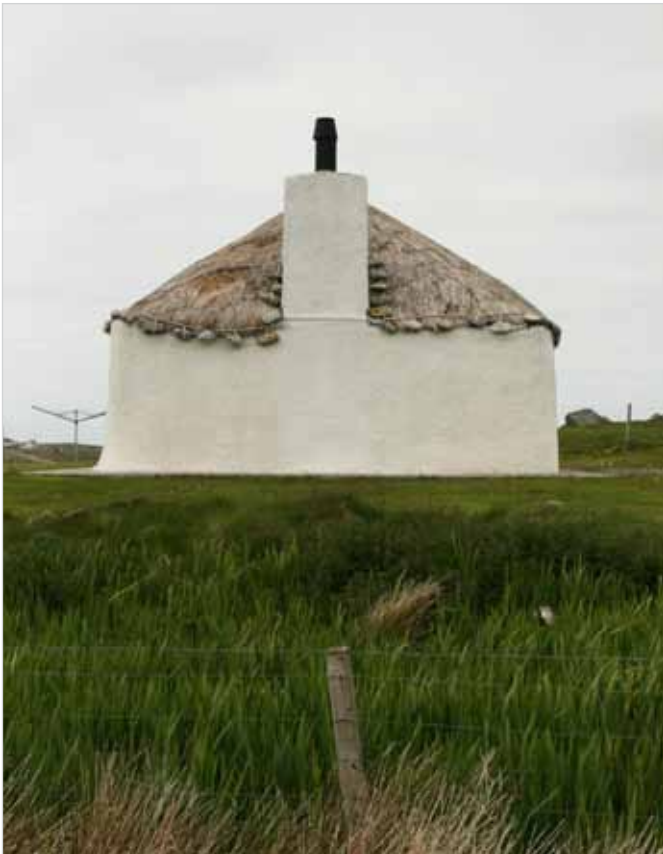
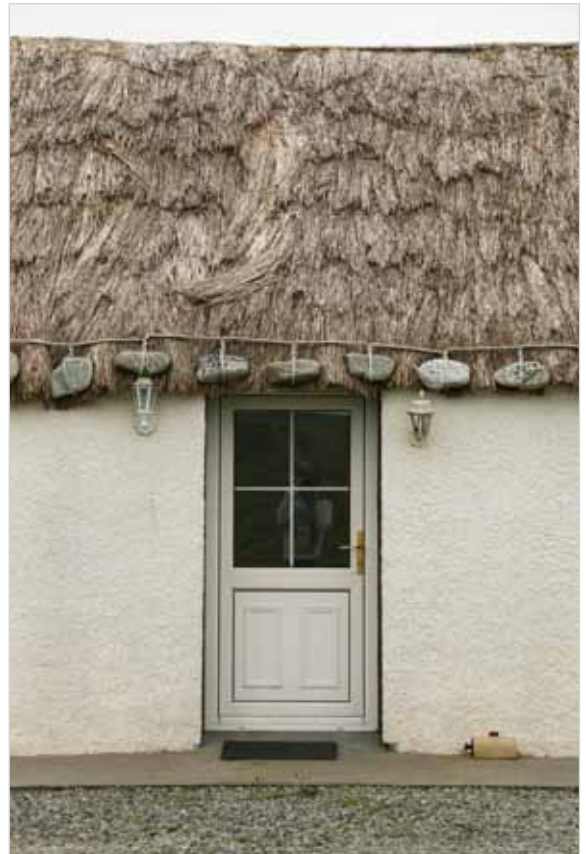
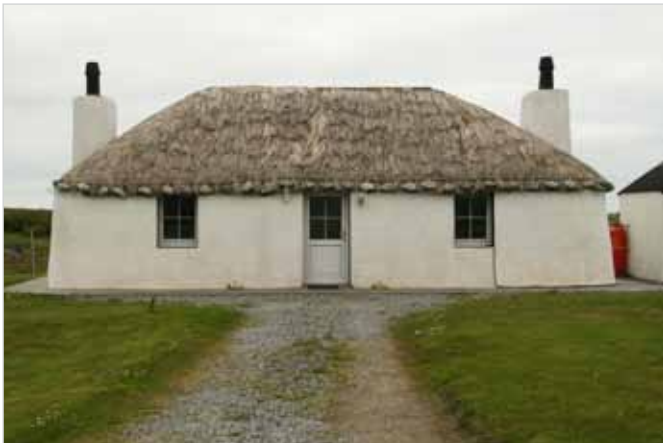
Taigh an t-Saoir – Western Isles

Fair

Single-storey cottage of unknown date, currently in use as holiday accomodation. The roof is thatched in marram and has a continuous marram ridge. The entire roof has been netted, including across the ridge, which has been weighted just above the eaves and around the chimney stacks at either end by a continuous string of stones secured to the netting by thin rope passed through the holes of the net. There are a few patches where the thatch has become slightly dislodged, but it doesn't appear to be compromising the coverage of the roof.

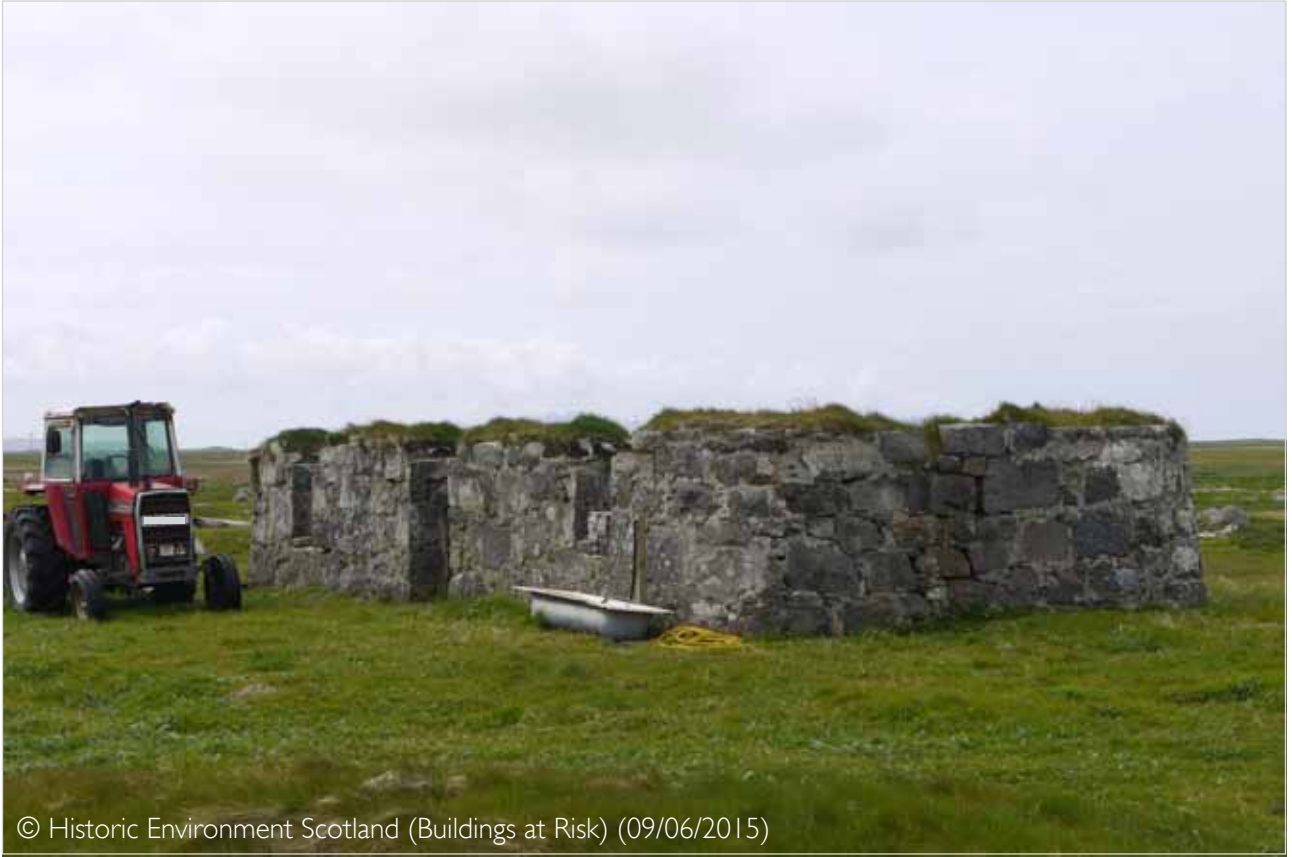
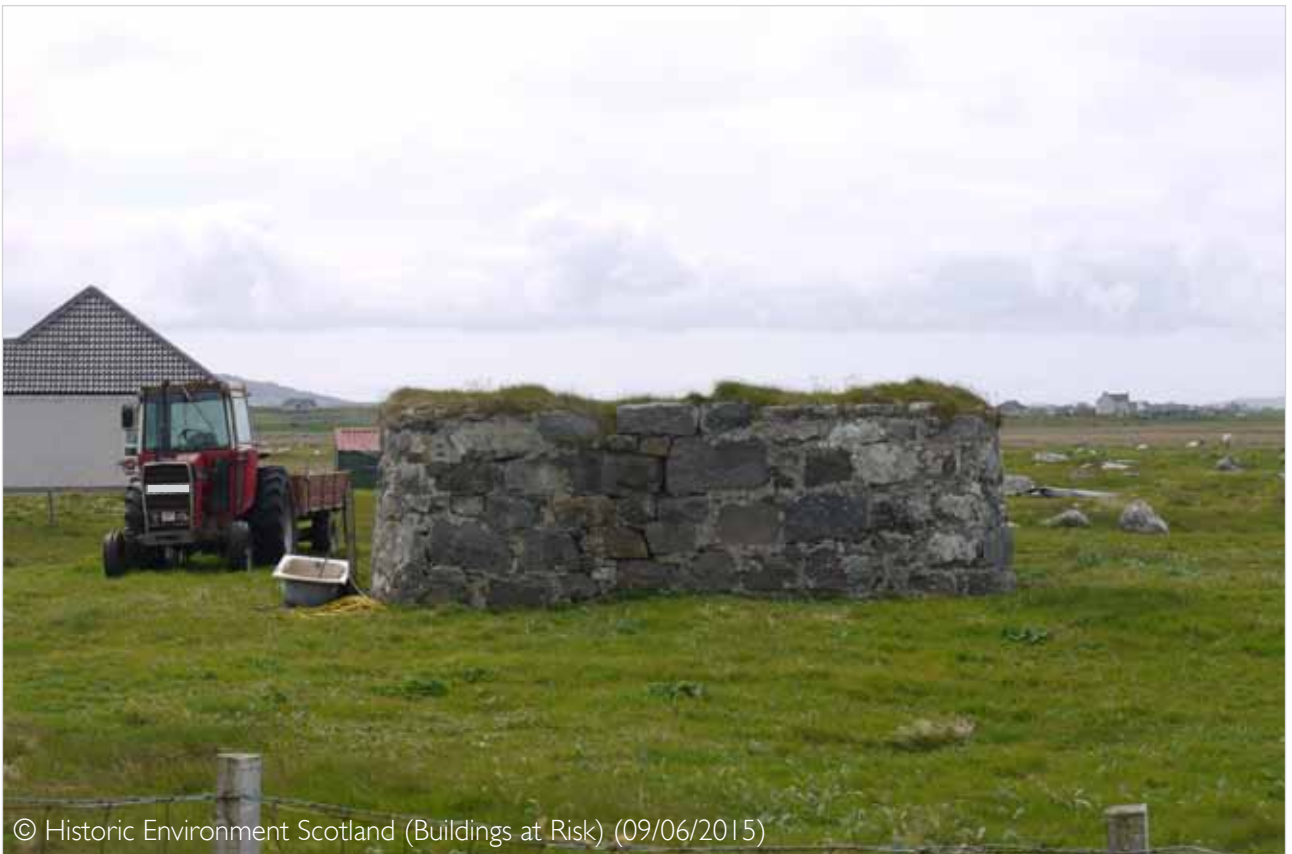
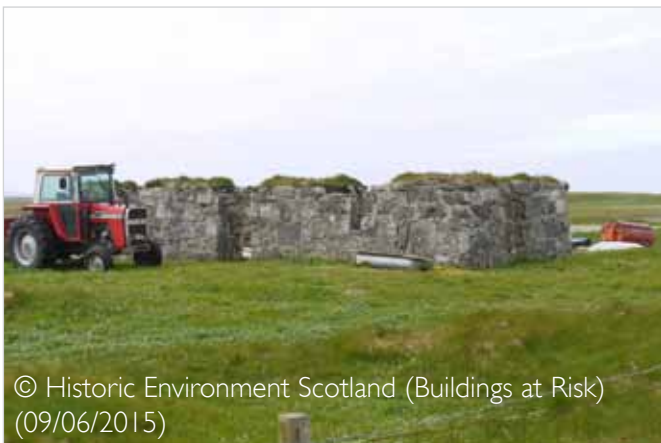
Daliburgh Thatched Cottage – Western Isles

Additional Notes: Whilst the name of the building for the listing records it at one location (grid reference NF 74124 21016), the grid reference held by the listing shows another (grid reference NF 74166 21086). The actual building under this listing, confirmed by its Buildings at Risk (BAR) entry, is on the opposite side of the road to the south. The cottage, listed as having a '*muran thatch roof, secured with netting, ropes and stone weights*', is a roofless ruin and has been on the Buildings at Risk Register since 2010 (BAR reference number 4786). The grid reference and listing description should be updated accordingly.

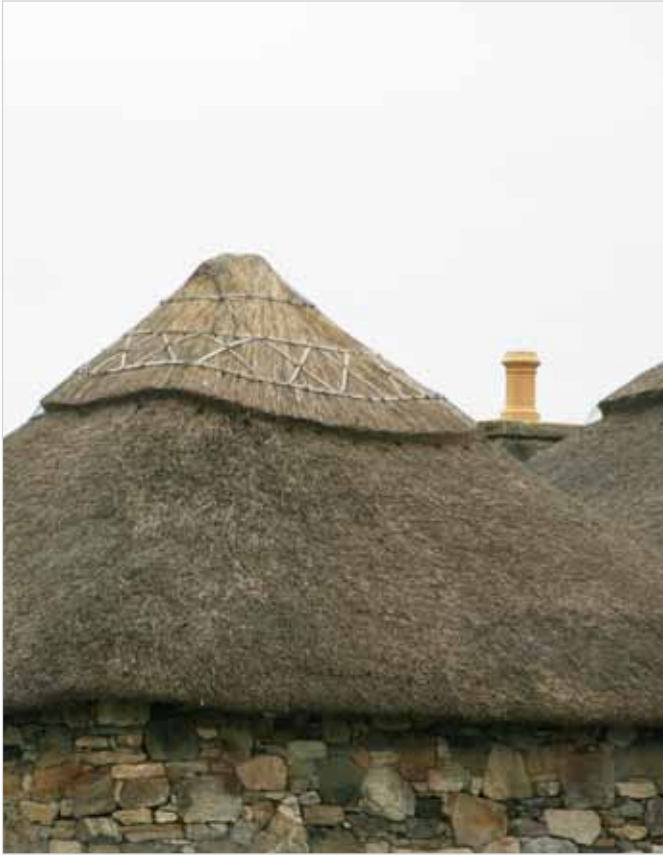
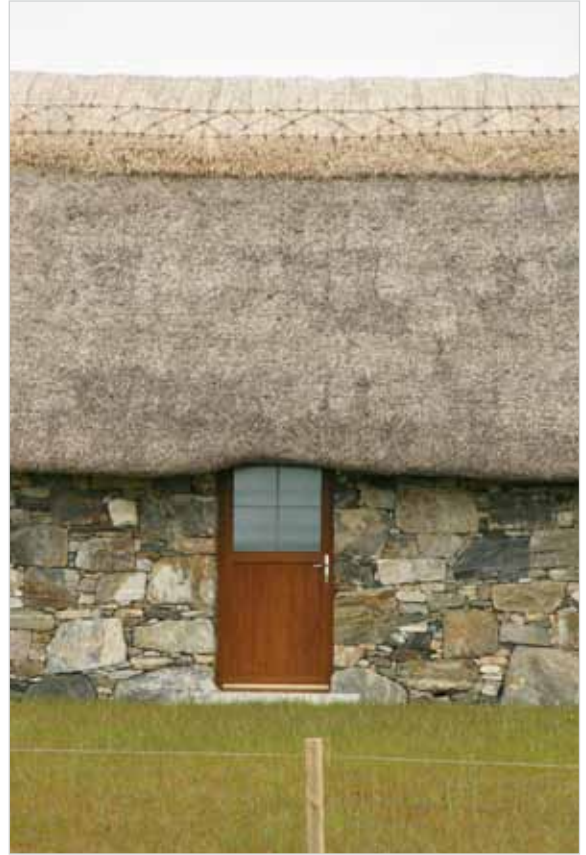
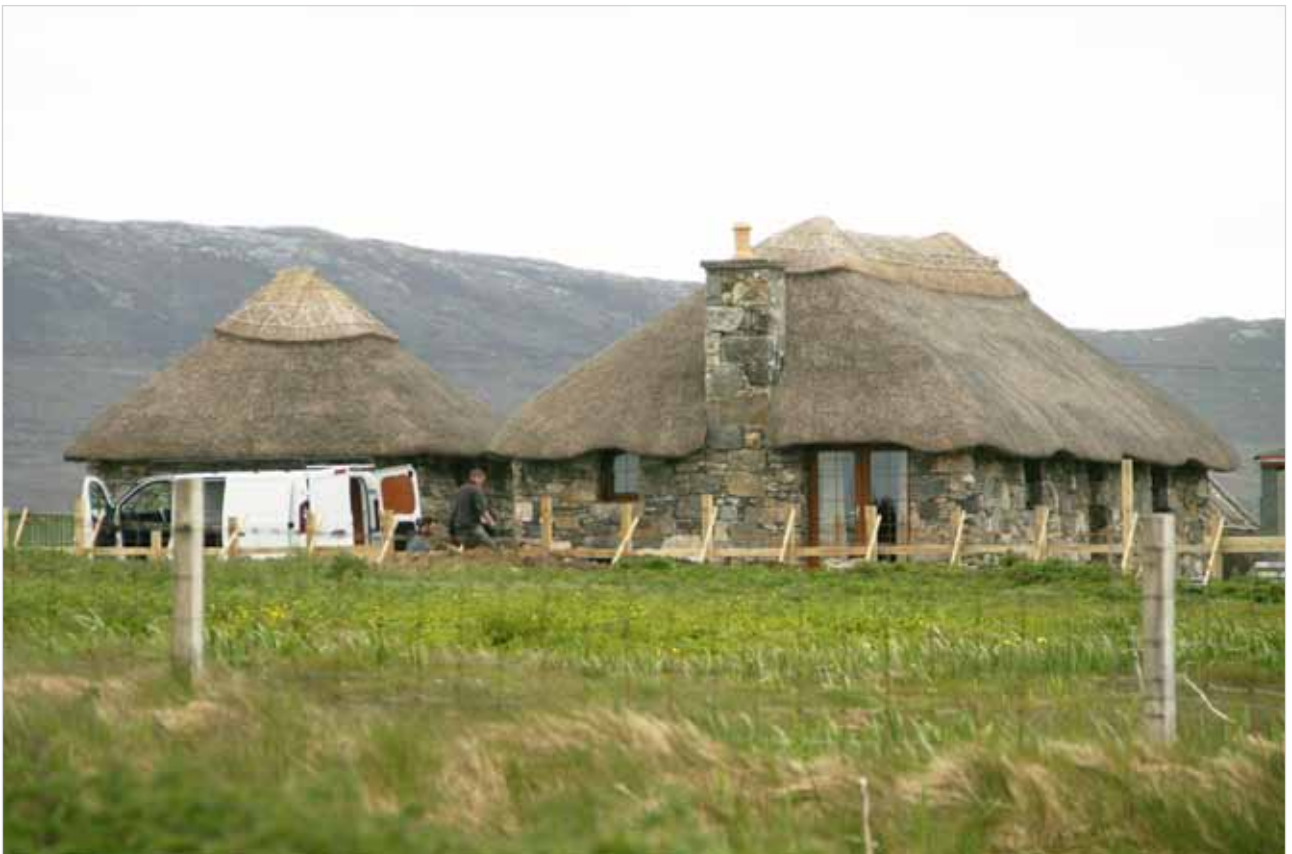
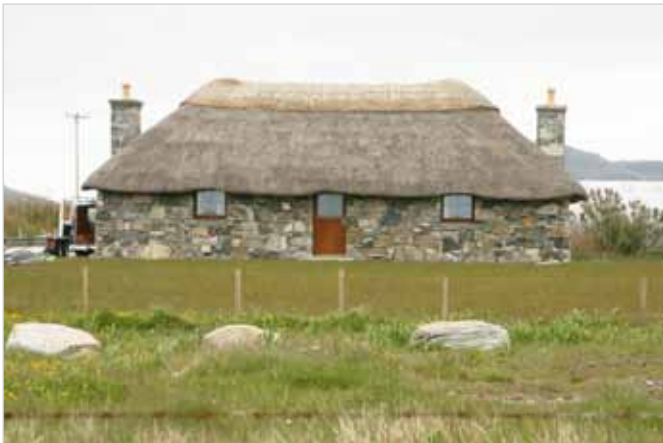
Kilpheder Thatched Cottage – Western Isles

Good

New build cottage with outbuilding, both with thatched roofs. Neither building appears on the current web-based satellite imagery, of unknown date, suggesting that they were constructed fairly recently. Both the roof of the cottage and the outbuilding appear to be thatched in reed with either straw or marram ridges. The ridge comes down particularly low in comparison to other raised ridges in Scotland, and has been scobed using what appears to be hazel spars. Both roofs have been entirely netted, including across the ridge. The thatch has been sculpted slightly above the window and door openings at the eaves.

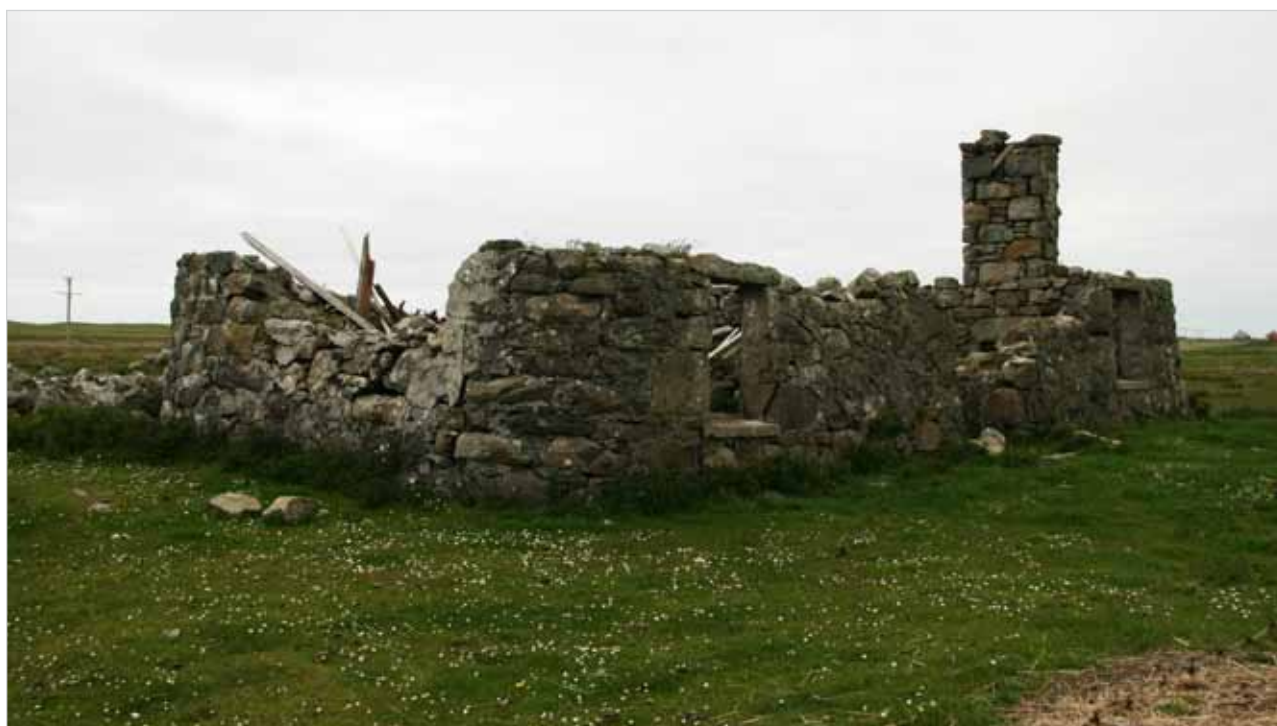
Additional Notes: Probably 19th-century cottage, listed as having a 'muran thatch roof, secured with ropes and stone weights; "spar feannag" at south end of roof. The building has been on the Buildings at Risk (BAR) Register since 2010 (BAR reference number 4785), at which time it was recorded that 'the former thatched cottage now a ruinous shell'. The building remains in the same condition and there are no visible signs of any thatching material left. The listing description for the building should be updated accordingly.
