A Survey of Thatched Buildings in Scotland

Thatch Survey of Scotland
2014-15

A photographic survey of thatched buildings in Scotland, surveyed between May 2014 and August 2015 by Zoe Herbert (SPAB Scotland Officer), on behalf of the Society for the Protection of Ancient Buildings.

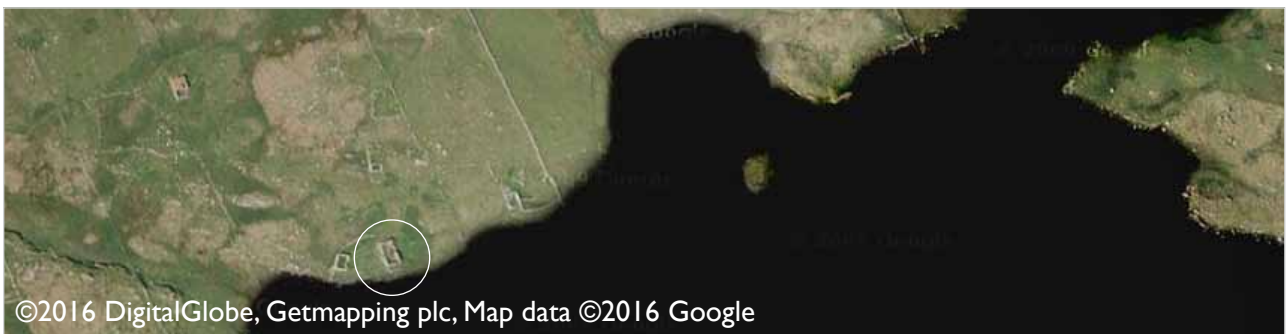
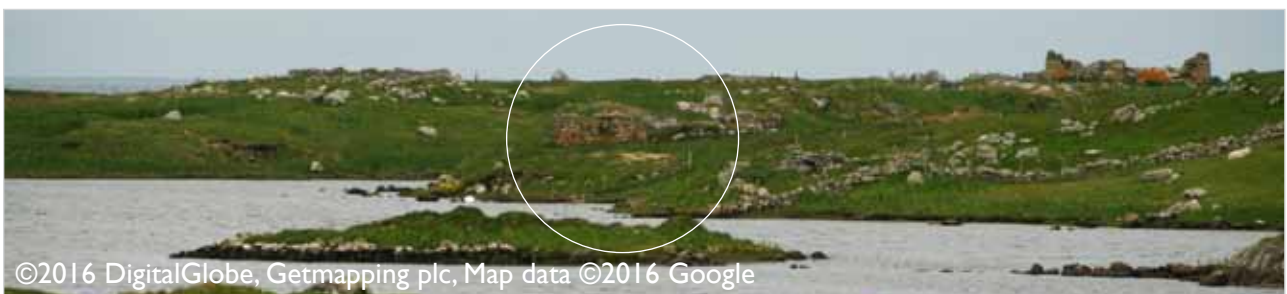
Additional Notes: The listed building description reads '*built 1907 or 1908. Skye-type thatched cottage on north shore of Loch an Eilean*' and it is described as having a '*muran thatch roof, secured with ropes, netting and stone weights*'. The site was inaccessible when visiting; however, photographs taken from nearby show a group of ruined cottages in that location, the one believed to be that of this listing clearly seen in a ruinous condition. Web-based satellite imagery confirms that the building identified by the listing is a shell with no roof. The listing description should be updated accordingly.

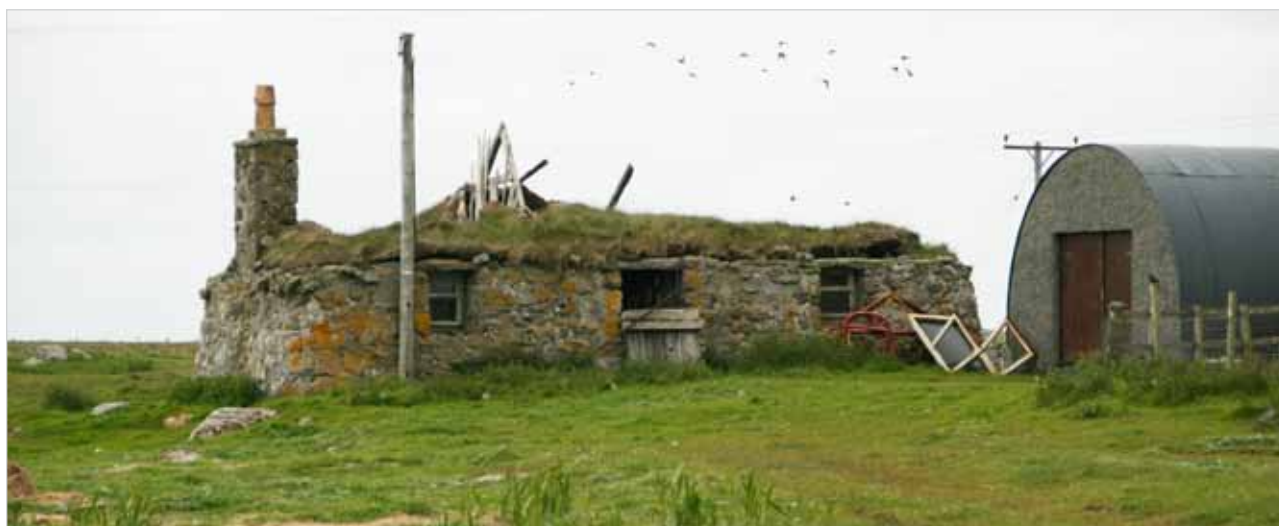
Additional Notes: Rebuilt/re-roofed late 19th/early 20th-century cottage, listed as having a '*muran thatch roof, secured with ropes and stone weights*'. The roof of the building has collapsed, though visible evidence of thatching material can be seen still resting upon the wallheads. The building has been on the Buildings at Risk (BAR) Register since 1996 (BAR reference number 1477), at which time it was recorded that the cottage was '*unoccupied and deteriorating rapidly*'. Upon BAR inspection in 2009, it was recorded that the thatched roof had '*collapsed over the north section*' and that the '*rest of the roof has failed and is caving in*'. At some point between 2010, when BAR last visited, and now, the south section of roof has also collapsed. The listing description for the building should be updated accordingly.

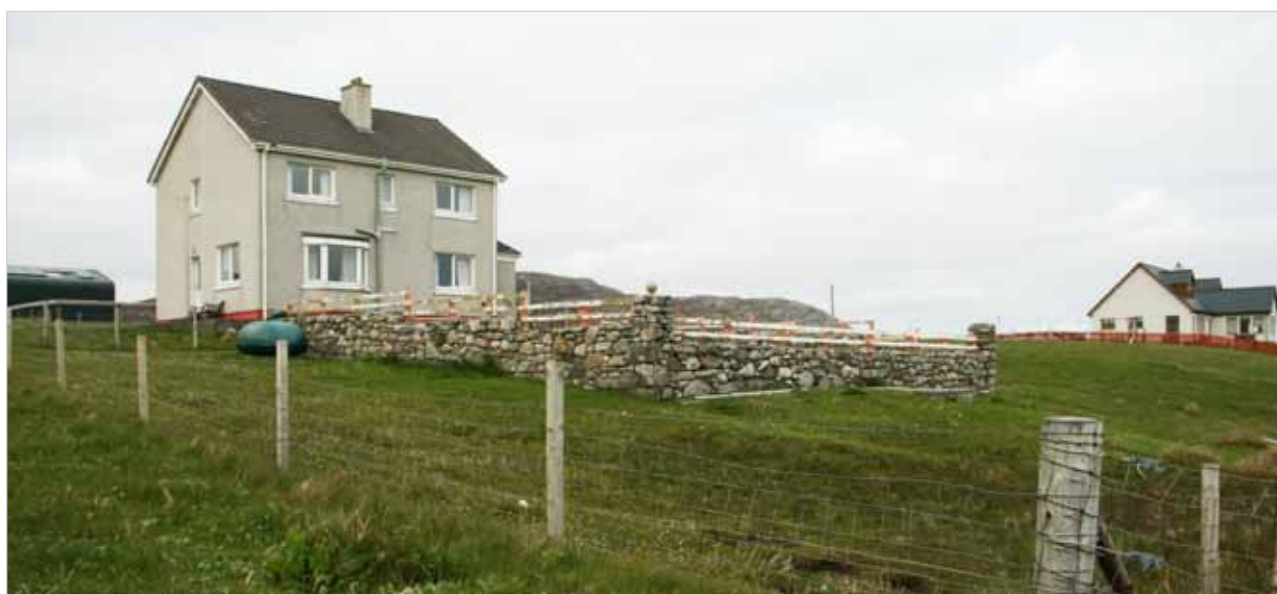
Address: West Kilbride Byre

Additional Notes: There is no building matching the listed building description for this building at the location recorded on the list entry or by Canmore (grid reference NF 75500 14500). There is only a modern two-storey house, which has rubble stone boundary garden walls in the general location of what should be the byre. The 'byre' is listed as having a '*muran thatch roof, secured with ropes and netting, weighted with stones and long steel tubes*'. The listing description notes read that it was re-thatched in 1982 and was in good condition when it was listed in 1985. Either the location is incorrect or the building has now gone; this should be verified and the listing description for the building updated accordingly.....

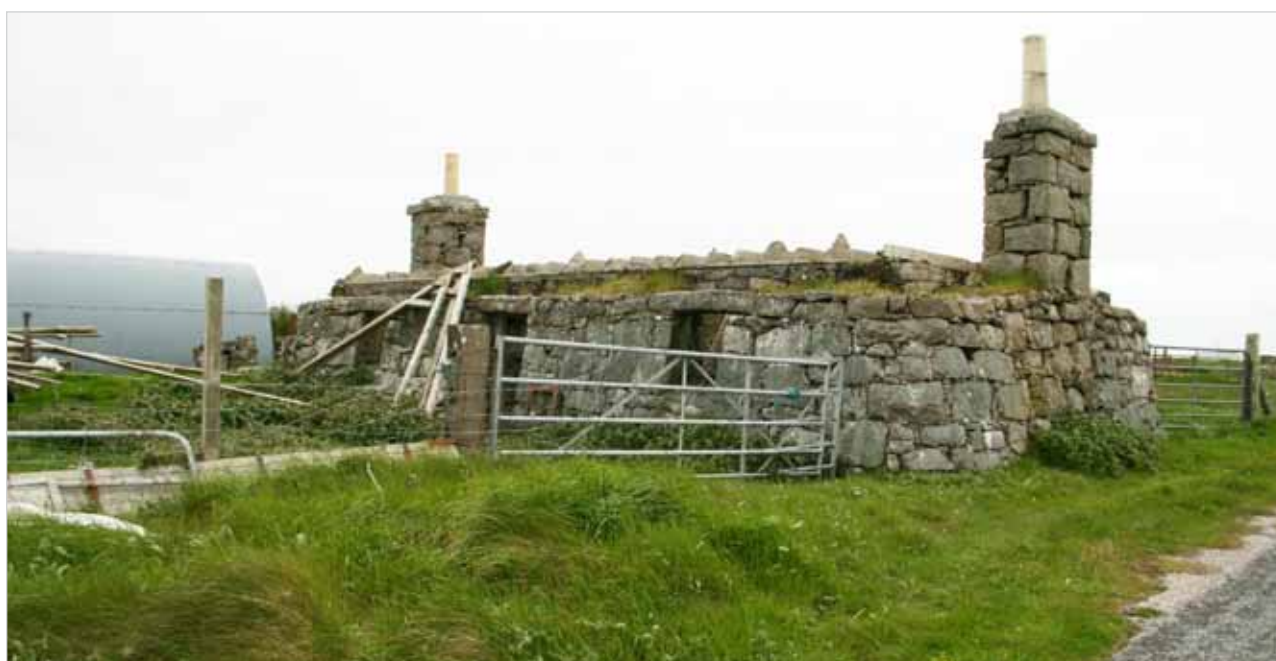
Address: North Smerclate Cottage

Additional Notes: Group listing for a 19th-century cottage and two adjoining outbuildings, with all three structures listed as having '*muran thatch roofs, secured with ropes and stone weights*'. The outbuildings, which are supposed to be located to the south-east of the cottage, appear to no longer be there. The cottage is now a roofless ruin and there are no visible signs of any thatch remaining. The notes of the listed building description state that the buildings were unoccupied in 1983, three years after it was listed in 1980. The listed building description should be updated accordingly.....

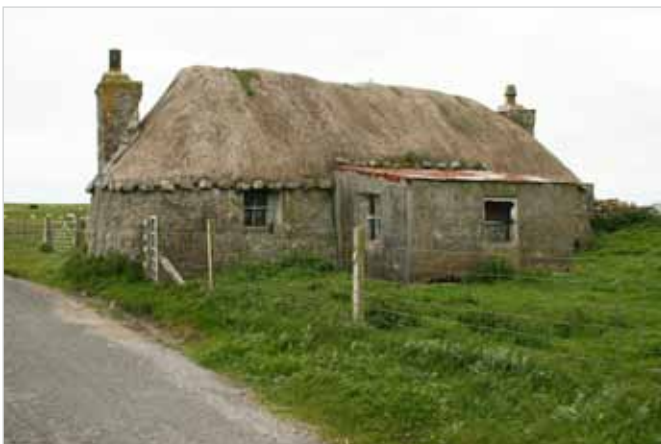
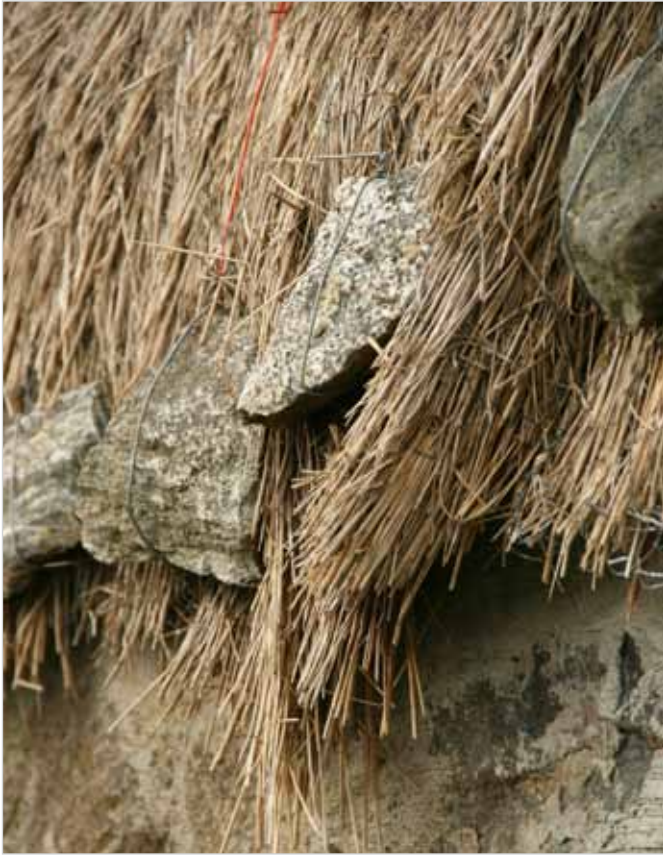
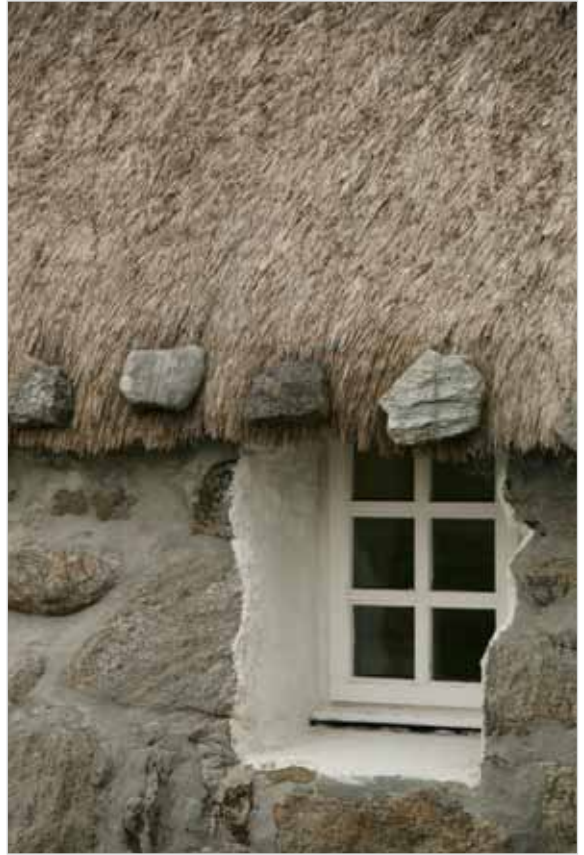
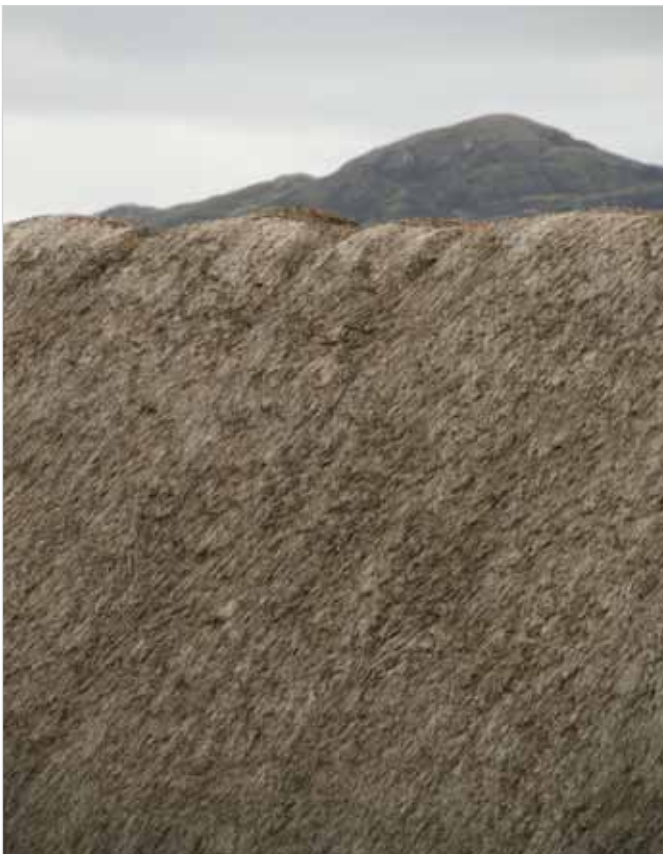
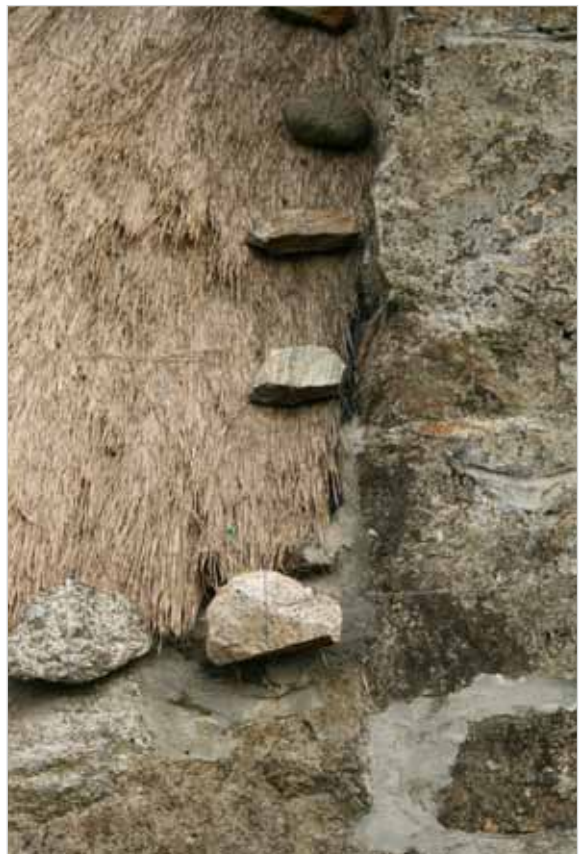
Garrynamonie Thatched Cottage – Western Isles

Condition of Thatch: Poor

Additional Notes: Single-storey cottage of unknown date, currently vacant. The roof is thatched in marram and has a continuous marram ridge. The entire roof has been netted, including across the ridge, which is weighted along the eaves and around the chimney stacks with stones, in addition to small metal tubes around the stacks, secured to the netting with wire. There is some missing/deteriorated thatch on the rear elevation of the building. As well as this area of damaged thatch there is a small amount of grassy vegetation growth in places throughout the roof. The condition of the thatch is likely to deteriorate further if the building remains unoccupied.

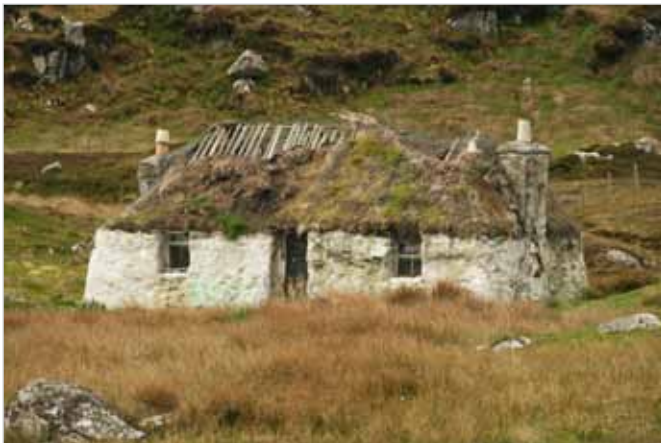
472a South Lochboisdale – Western Isles

Poor

Probably 19th-century cottage is listed as having a 'muran thatch roof, secured with ropes, netting and stone weights'. Large sections of marram thatch are still in place on the building; however, the building is derelict and much of the roofing material has been lost, leaving the interior of the building exposed. The site could not be accessed when visited, yet photographs taken from nearby show visible signs of netting still in place and a few weighting stones left intact around the chimney stacks only. A small section of thatch remaining along the ridge suggests it was thatched continuously across; however, this cannot be determined for certain.

The roof appears close to collapse as many of the timber beams can be seen to be damaged. There are large areas of grassy vegetation growth on the surface of the remaining thatch.

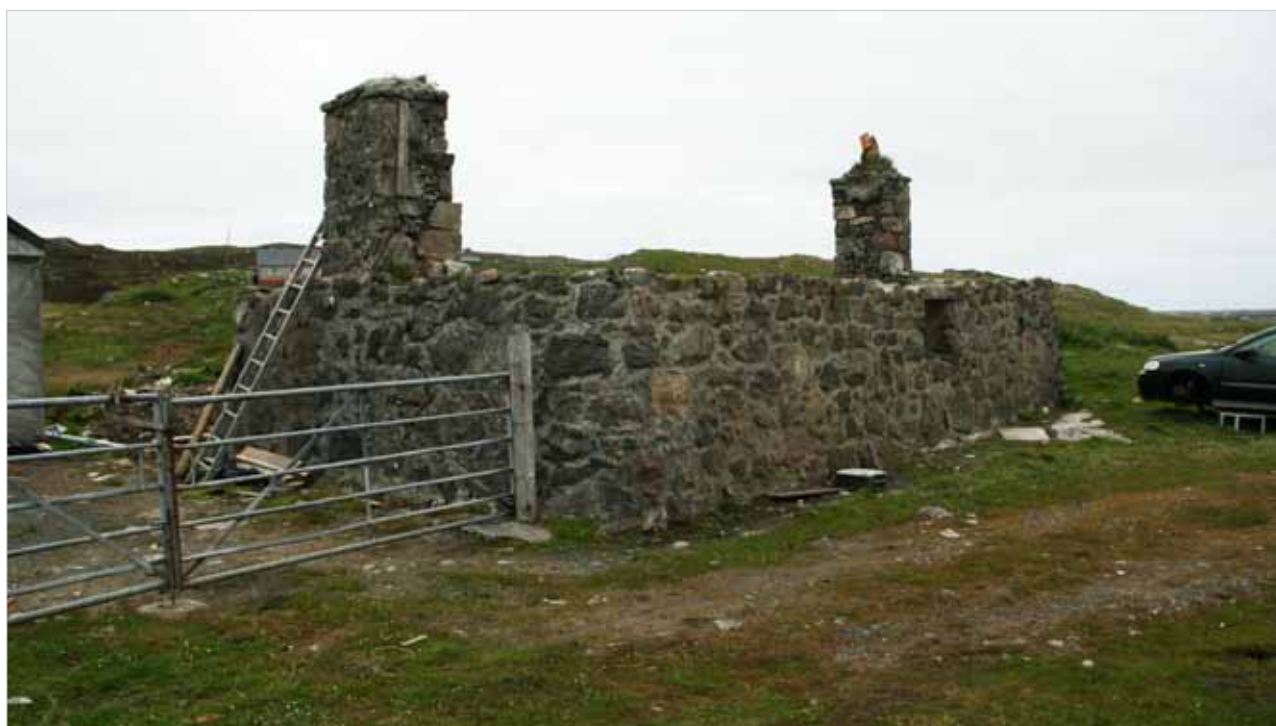
Additional Notes: Group listing for a 'Probably 19th century' thatched cottage and 'byre and shed to north and to south also thatched'. The cottage is listed as having a 'muran thatch roof, partly renewed in straw, and secured with netting ropes and stone weights'. There are no visible signs of anything that could clearly be identified as the byre and shed, and the cottage itself is now a roofless ruin with no visible signs of any thatch remaining. The listing description for the building should be updated accordingly.....
