# The Pleasance, Edinburgh

Insulation of coom ceiling, attic space & lightwell

This publication should be quoted as:  
Historic Scotland Refurbishment Case Study 5

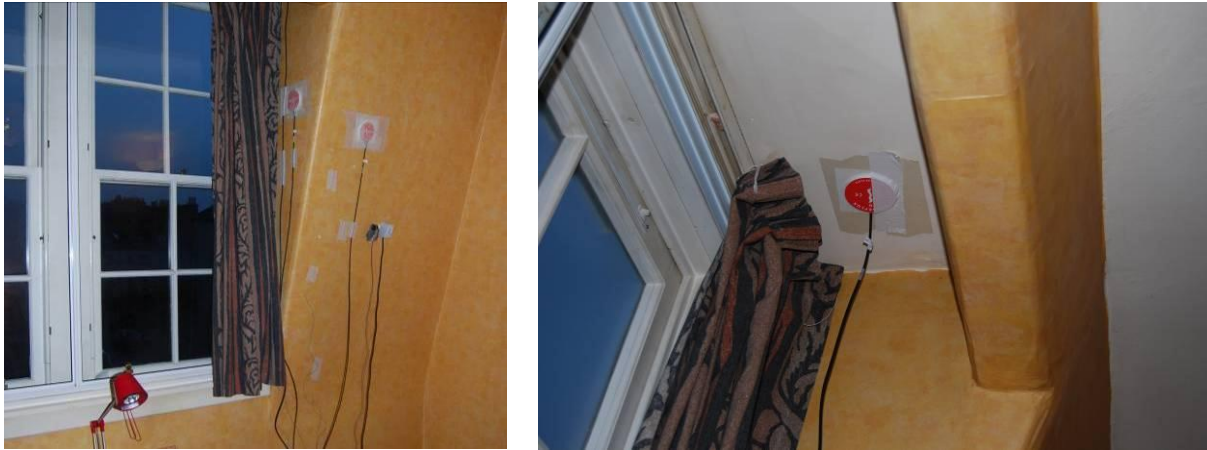
Fig. 9. U-value and humidity monitoring equipment whilst in place on coom ceiling, dormer and dormer roof

Building element	U-value (W/m <sup>2</sup> K)*	Notes
Coom ceiling	1.5	Slate and sarking, 120 mm void, lath and plaster lining
Dormer roof	1.5	Lead on sarking with lath and plaster lining
Dormer cheek	0.9	Lead on sarking with lath and plaster lining

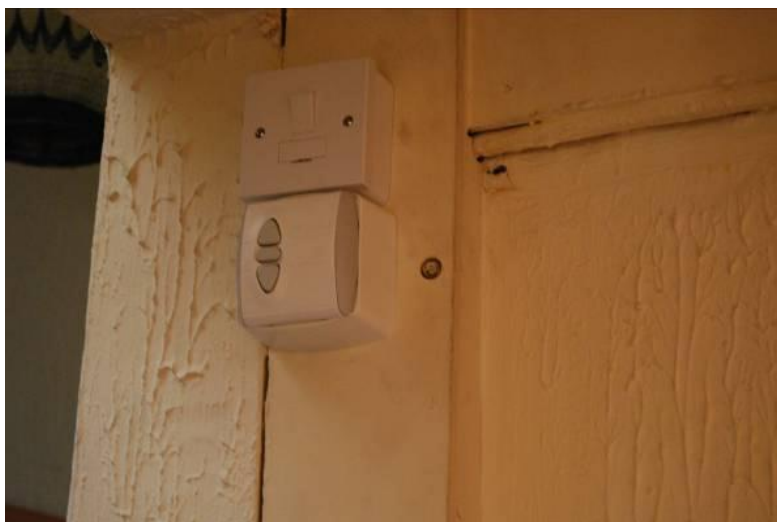
Fig. 11. The tenant can easily operate the roof light

The existing roof light was removed and replaced with a double glazed roof light (Fig. 10) with a motorised opening mechanism (Fig. 11). This was to allow cooling of the building during the summer months and controlled ventilation throughout the year. As the building fronts onto a busy road, and the rear faces the Pleasance Courtyard (a principal Edinburgh Fringe venue), noise pollution was an issue, so providing ventilation without opening the front and rear windows improved the internal conditions.

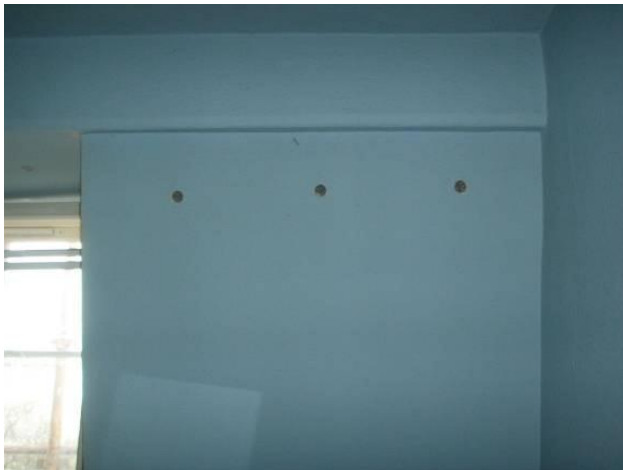
Fig. 18. Drill holes in the bedroom. Image by Adam Dudley Architects

During the installation, some bead escaped through small gaps between the wall head and the bottom edge of the sarking. With the scaffolding in place, these gaps were plugged with sheep's wool packing.

All drill holes through the lath and plaster were filled with expanding foam filler, to provide a 'backing' for flush filling. The filler to the holes in the kitchen linings were given a textured finish, to match the existing and the entire coom ceiling and dormer linings in the kitchen and rear bedrooms were painted with emulsion to match the adjacent walls. The existing wallpaper to the external coom and dormer linings was stripped back to the plaster. The plaster was filled, rubbed down, prepared and papered with 120 gauge lining paper, and painted with three coats of clay-based paint (Fig. 21).

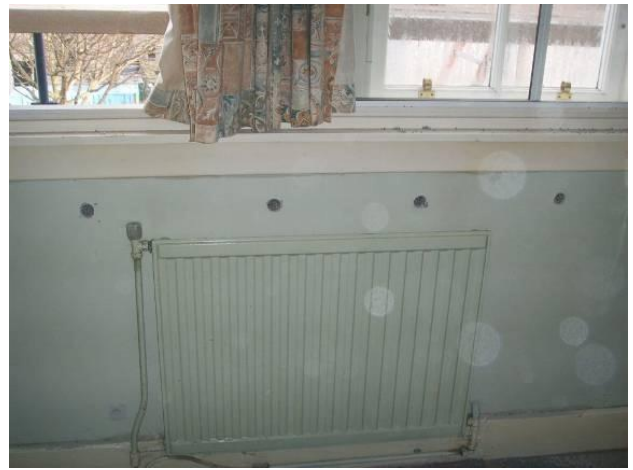
Fig. 19. Drill holes. Image by Adam Dudley Architects

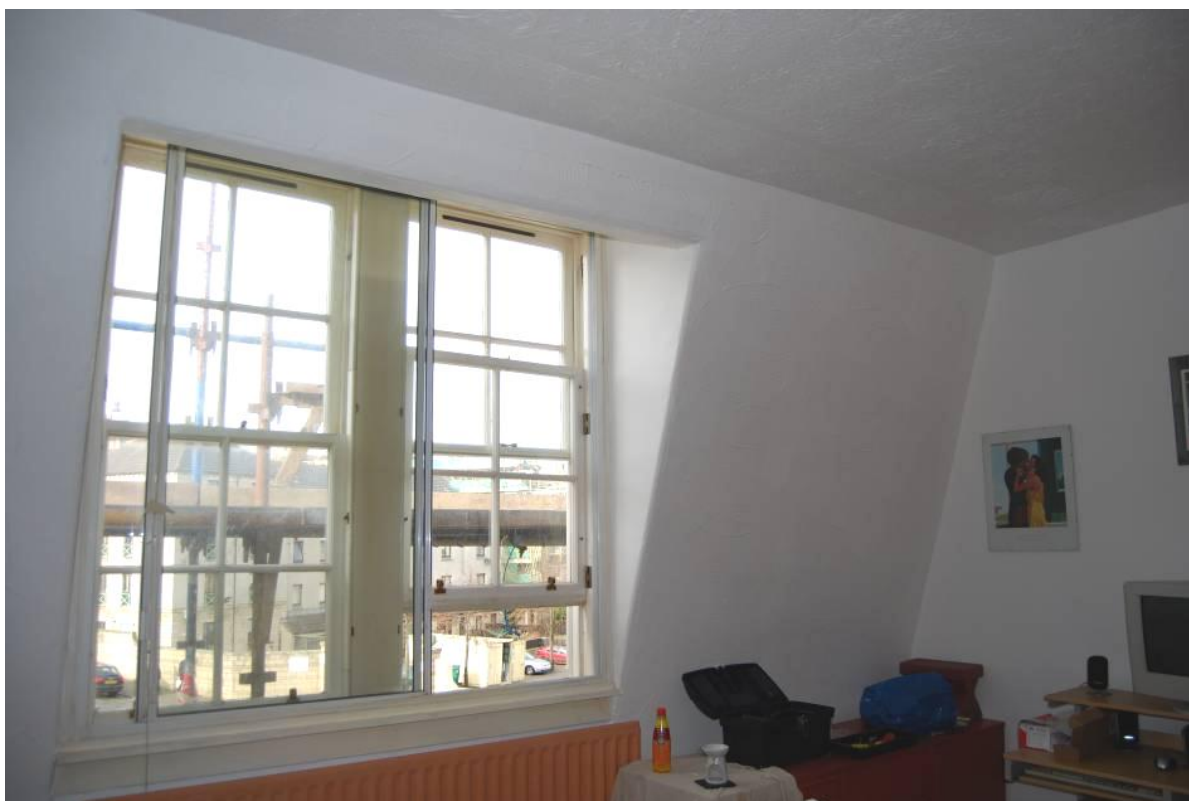
Fig. 21. Completed bedroom. Image by Adam Dudley Architects
