TECHNICAL PAPER 29

REVIEW OF HOT-MIXED EXTERNAL LIME
COATINGS IN SCOTLAND 1997-2016

HISTORIC
ENVIRONMENT
SCOTLAND

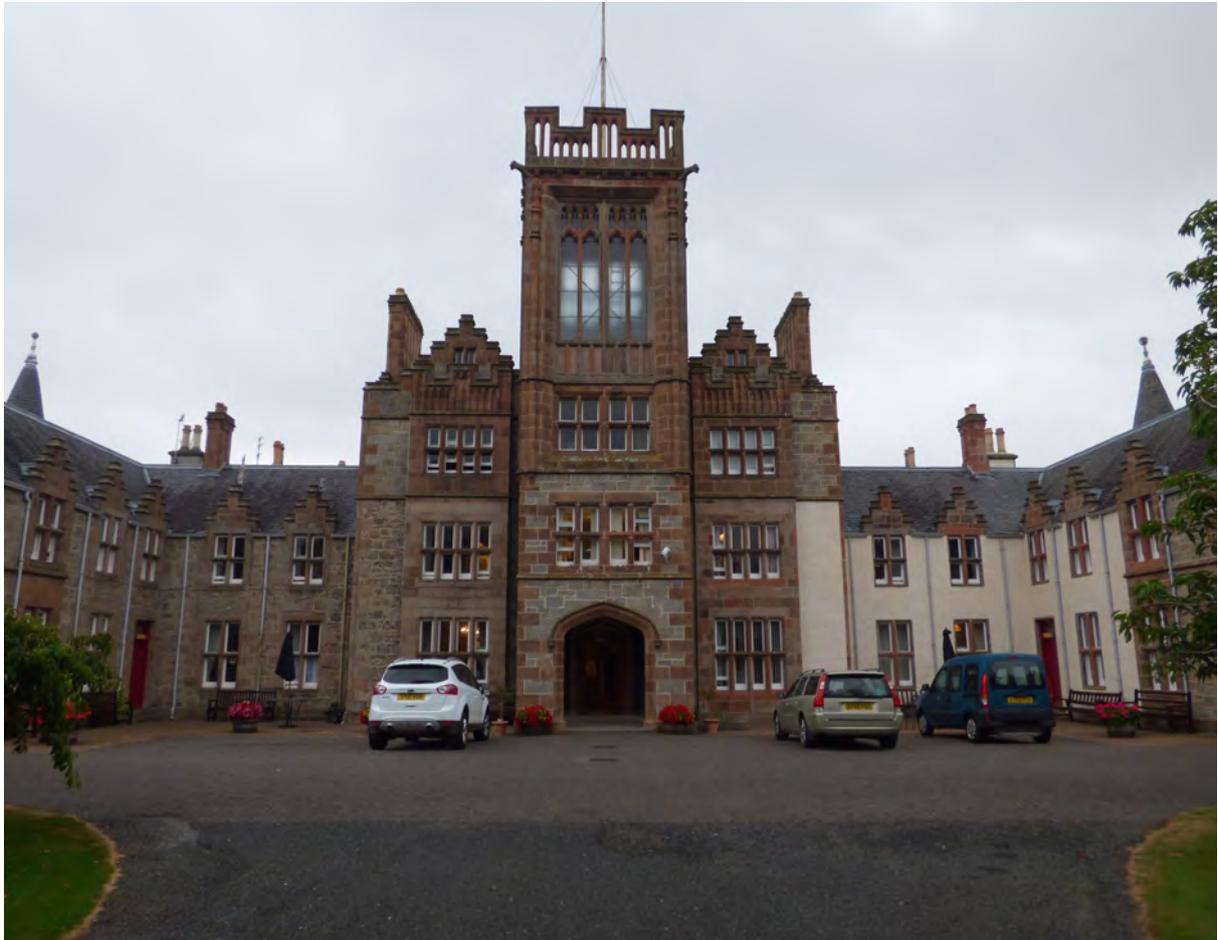
Figure 1.1 Main entrance, south-facing elevation.

The work on the hospital was supported by a grant from Historic Environment Scotland. The building has lime harling to the front, gable (side elevation), rear elevation (east side) and rear recess. The harling is an NHL gauged hot-mixed lime mortar, with traditional hand-cast finish throughout, and is consistent in terms of its texture and general appearance. It is finished with a limewash which also seems consistent in terms of its colouring. The harling appears to be well bonded to its substrate with no cracking observed, and is neatly feathered into the stone dressings. There is little evidence of any erosion or disruption, even below the window cills, where the harl is slightly proud of the stone. Locally, at ground level terminations, the harl is affected, though not significantly, by rising damp. No bossed harl was detected at these locations. Minor algae and water staining is apparent on the gable and rear elevations, with this particularly noticeable within the "L shaped" recess on the rear elevation, where air flow is restricted.

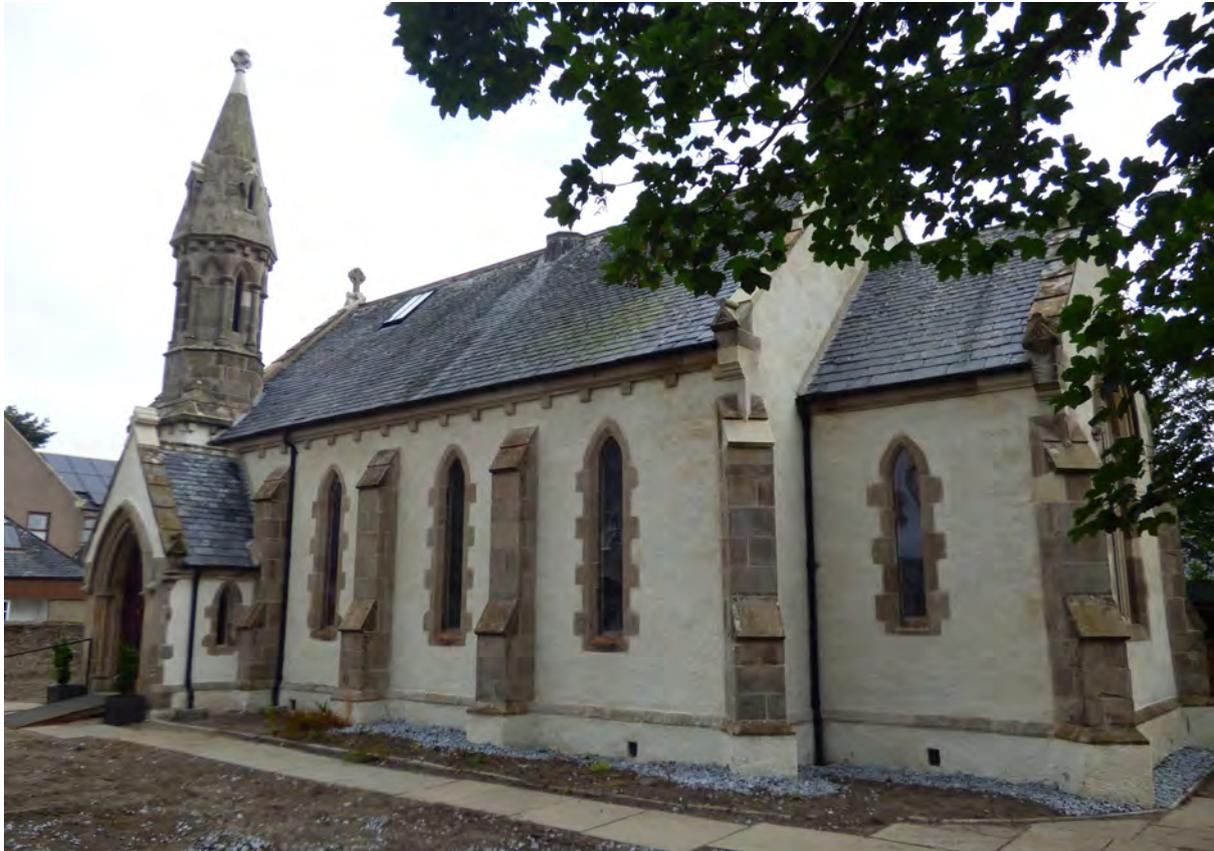
Figure 2.1 The front elevation, viewed from the south-east.

The harling appears to be well bonded to its substrate with no cracking observed. It is neatly finished into exposed stone window/door dressings, buttresses and quoins, feathered in where appropriate. A few areas of moisture within the harling and/or limewash were observed, particularly to the west gable. These areas generally have the appearance of moisture within the harl itself, due to its recent application and completion, or residual moisture within the wall fabric drying out, as would be expected.

Some water staining to the harling was also observed adjacent to the downpipe at the porch, possibly due to overspill or leakage from the rainwater goods.

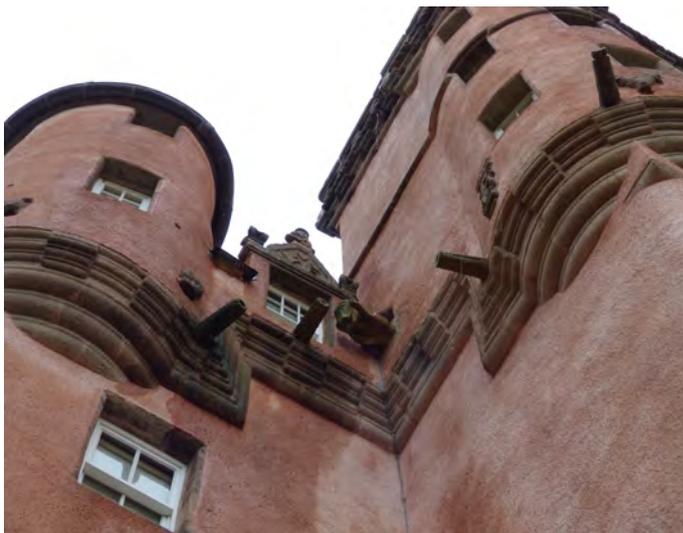
The harl appears generally sound as confirmed, where accessible, by tapping. In addition to the wetting of the walls by windblown spray, water shed from high level spouts is landing close to the base of the wall with splash back damage observed on the low level limewash.

Figure 3.3 View of water spouts at third floor level all contributing to water discharge that is impacting on this corner at ground level.

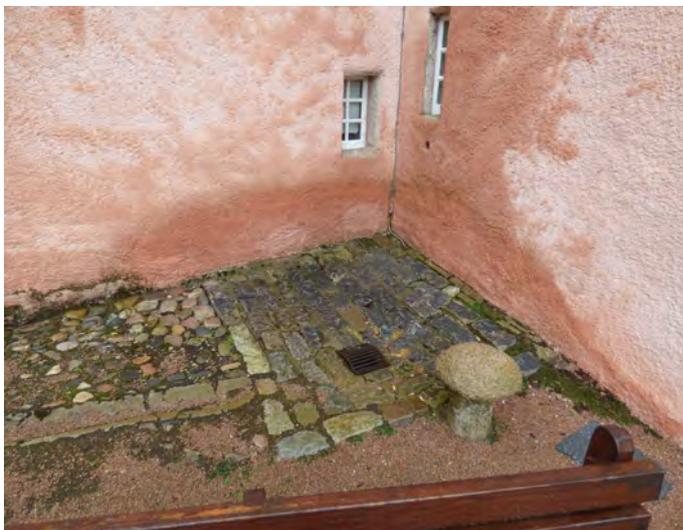
Localised patch repairs and re-limewashing were observed at ground level. In an attempt to address erosion and pitting of the ground surface, granite sets have been laid. These have resulted in splash back affecting the harl at ground level.

Figure 3.4 Impact of water discharged from the high level area.

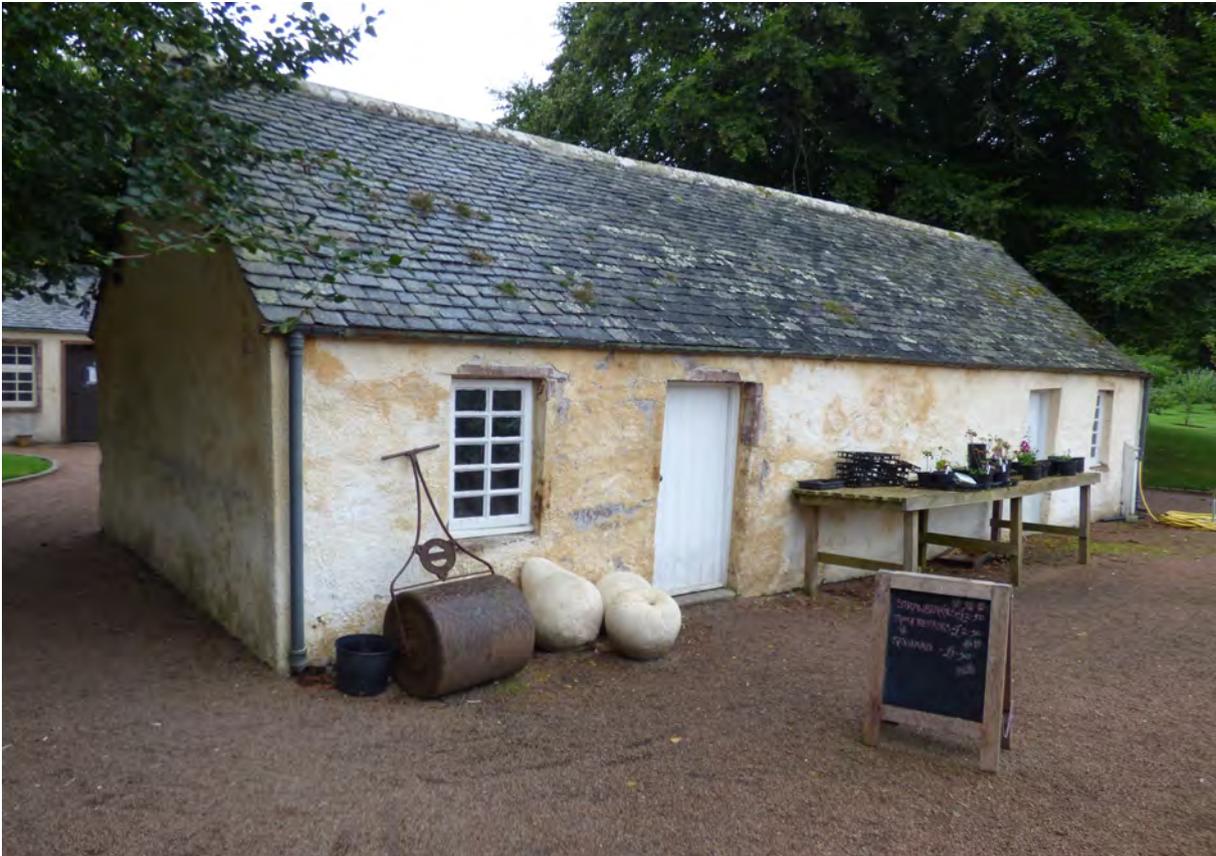
Figure 5.1 Front (north) elevation, viewed from the north-east.

The building is constructed from sandstone rubble finished with a lime harl which has been limewashed. It is understood that an NHL gauged hot-mixed mortar was used for the harling. The work was supported by Historic Environment Scotland's Annual Repair Grant to the National Trust for Scotland. From tapping the coating and visual inspection, the harl appears to be generally sound and well bonded to the substrate. However, adjacent to the openings there is local damage from impact and abrasion; water damage has arisen from faulty rainwater goods and rising damp or water splash against the walls.

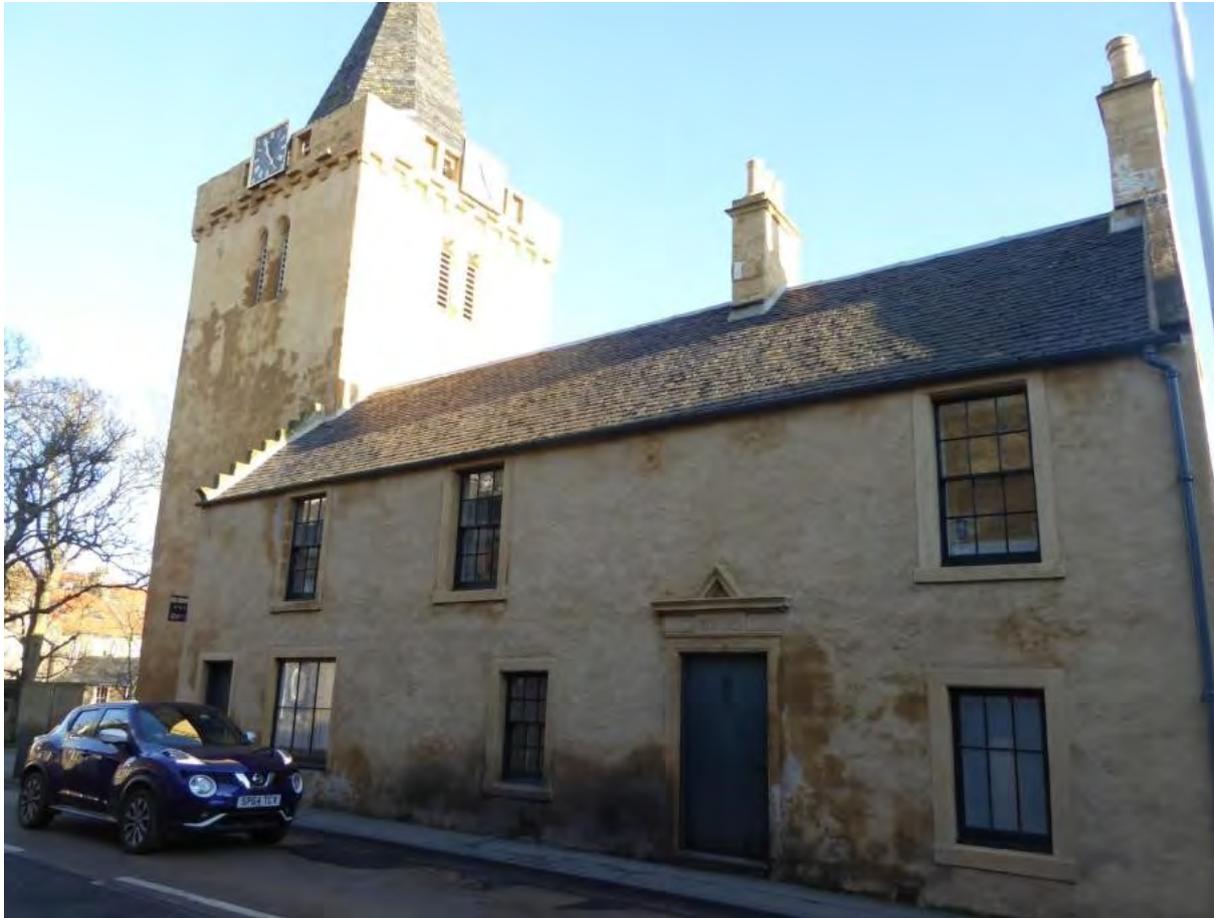
Figure 7.1 The front (west) elevation.

The harling on this building is a traditional hand-cast finish over rubble stone masonry that was mixed using an NHL gauged hot-mixed lime mortar. Works were supported by funding from Historic Environment Scotland. The harl is painted with a pigmented limewash and it appears to be generally sound and well bonded to the masonry, with a few localised exceptions.

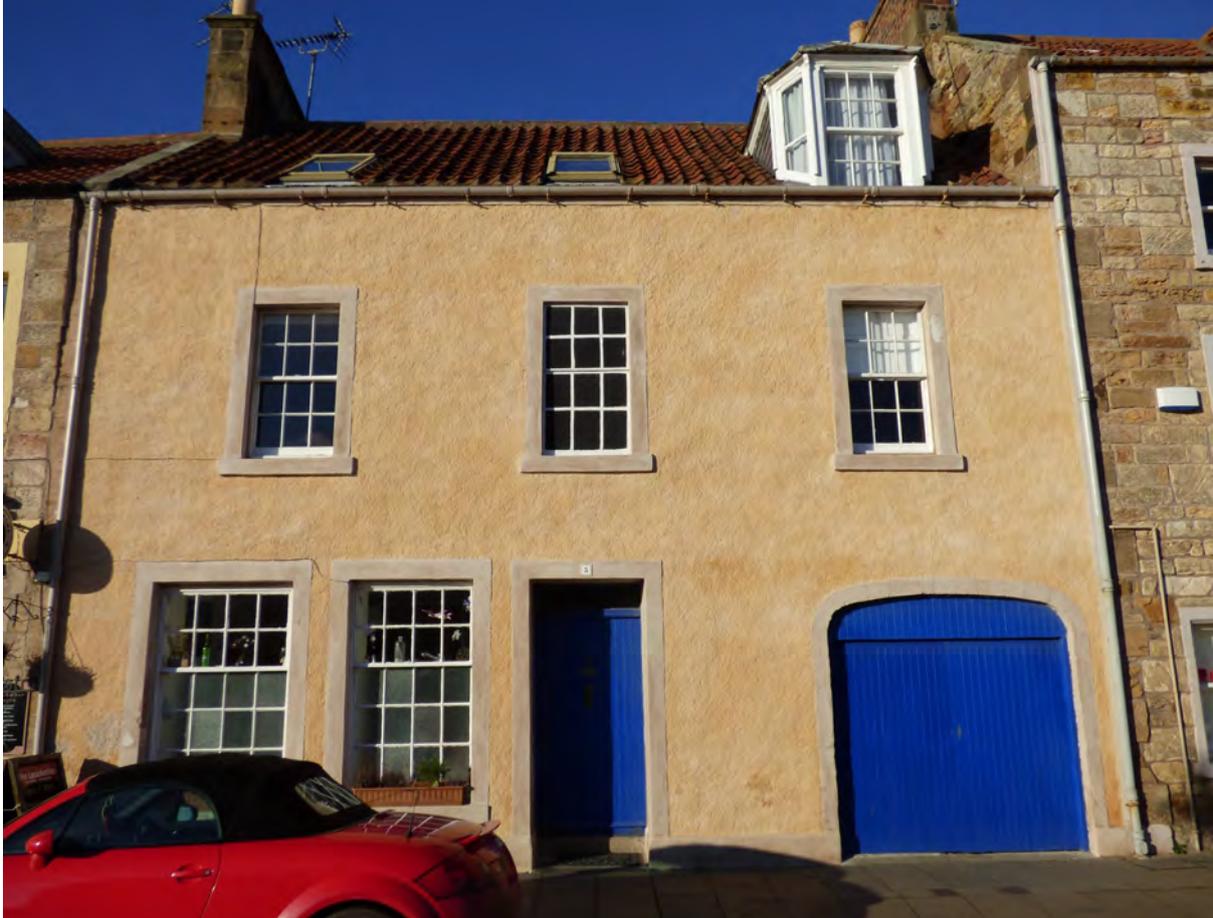
Figure 8.1 Front (south-east) elevation, showing the uniform appearance of the limewashed harl over the full elevation.

This relatively recently applied harl and limewash appear to be in good condition, surviving well in the coastal location. Some very localised erosion to the harl and limewash was observed on the south-west side, which appears to be due to water run-off, apparently channelled from a gap at the end of the gutter. This has been further aggravated by water draining down off the skew and missing the gutter.

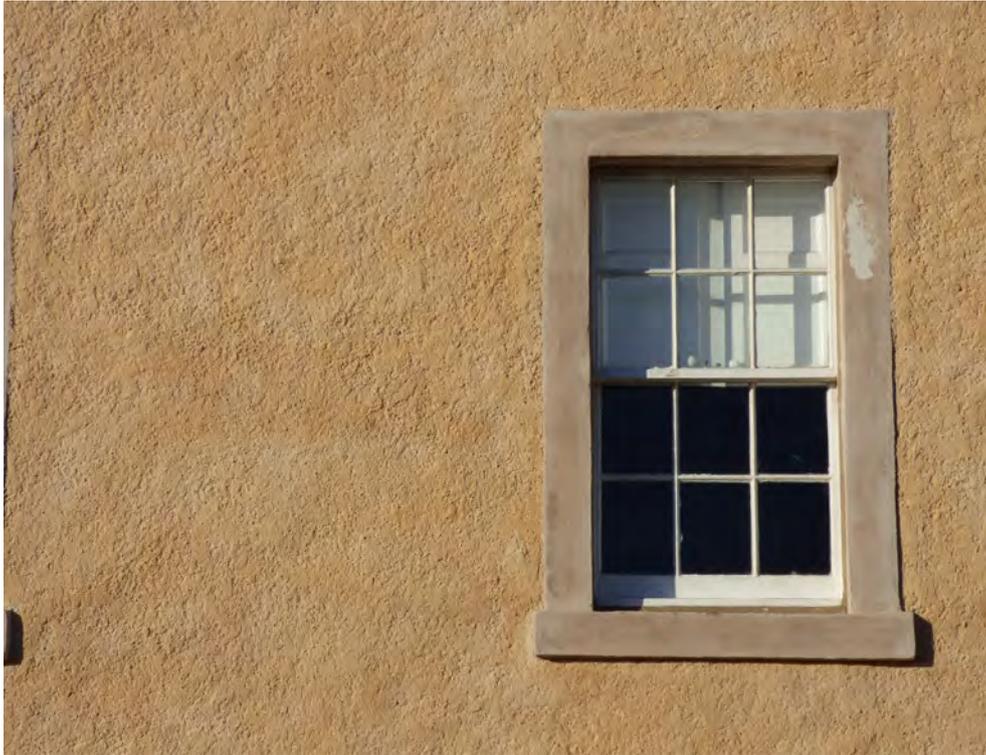
Figure 8.2 View of an area of harl, to the west of the easternmost window, at first floor level. Here the subtly undulating profile and texture of the harl can be seen to be enhanced by the warmth of the limewash coating.

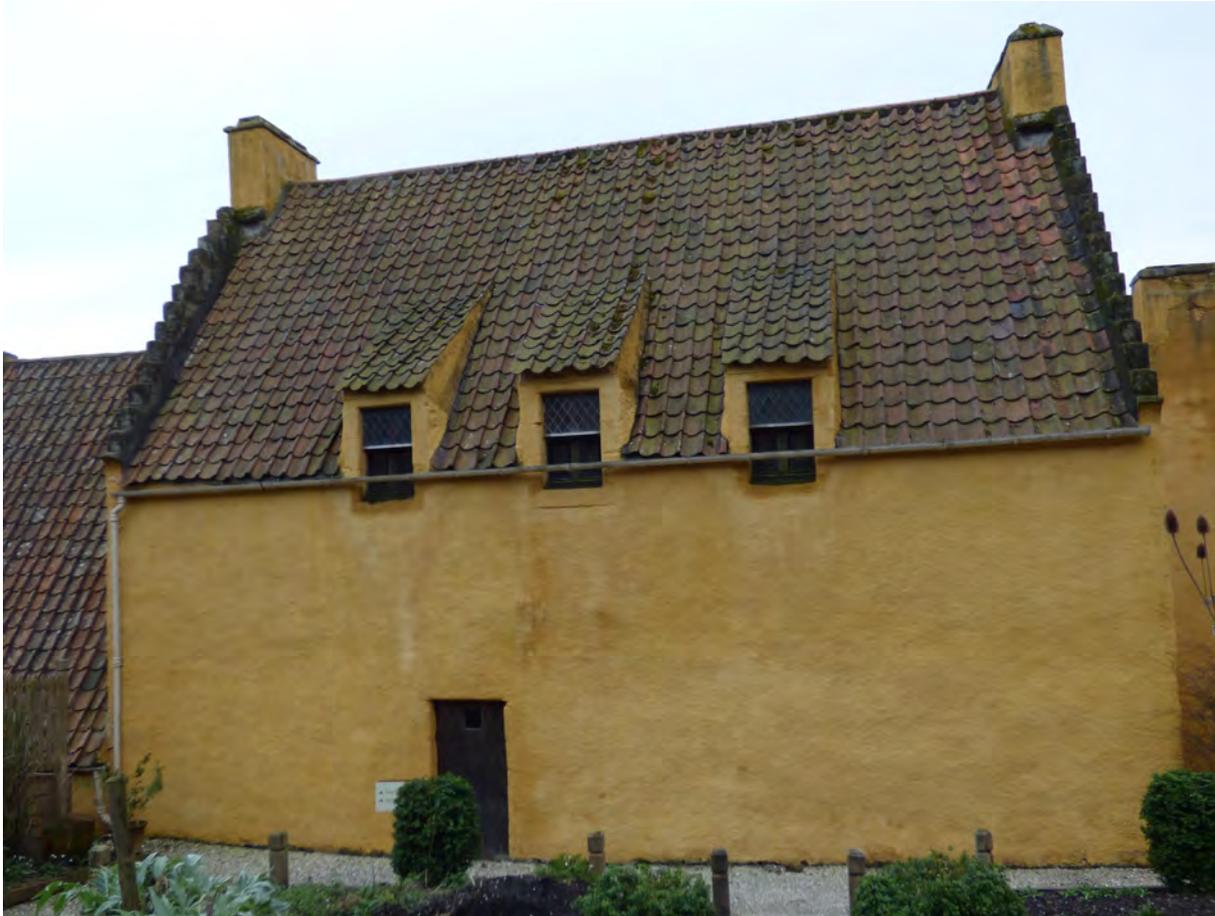
Figure 10.1 View of the north range, rear elevation.

The north range of Culross Palace was harled in an NHL gauged hot-mixed mortar. The works were supported by the Annual Repair Grant given to the National Trust for Scotland by Historic Environment Scotland. The harling has been limewashed with a pigmented limewash. On these elevations, the harl has the appearance of a traditional hand-cast application that has been lightly pressed back, producing a tight, relatively uniform surface texture. It is visually uniform and appears to be well bonded to the substrate.

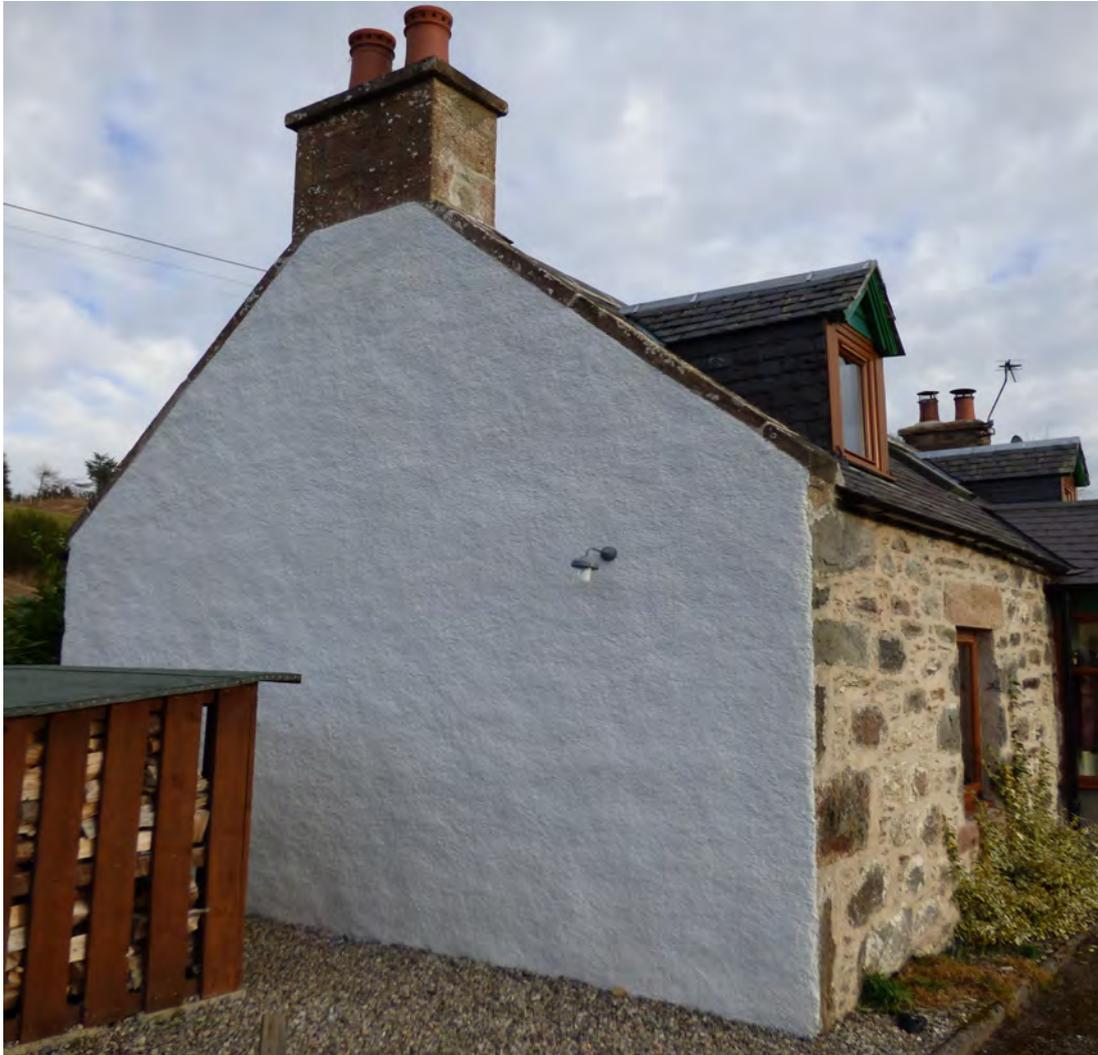
Figure 11.1 The west gable of the cottage.

The harling finish is consistent and well executed, and appears to be sound and fully bonded to its substrate. The limewash has been thinly applied and well burnished with no evidence of chalking. The harling has been neatly finished to the underside of the skew copes and chimney stack base. The absence of any staining is likely due to the care of the copes. Lower down, the good condition of the harling at ground level is a result of the gravel minimising splash back.

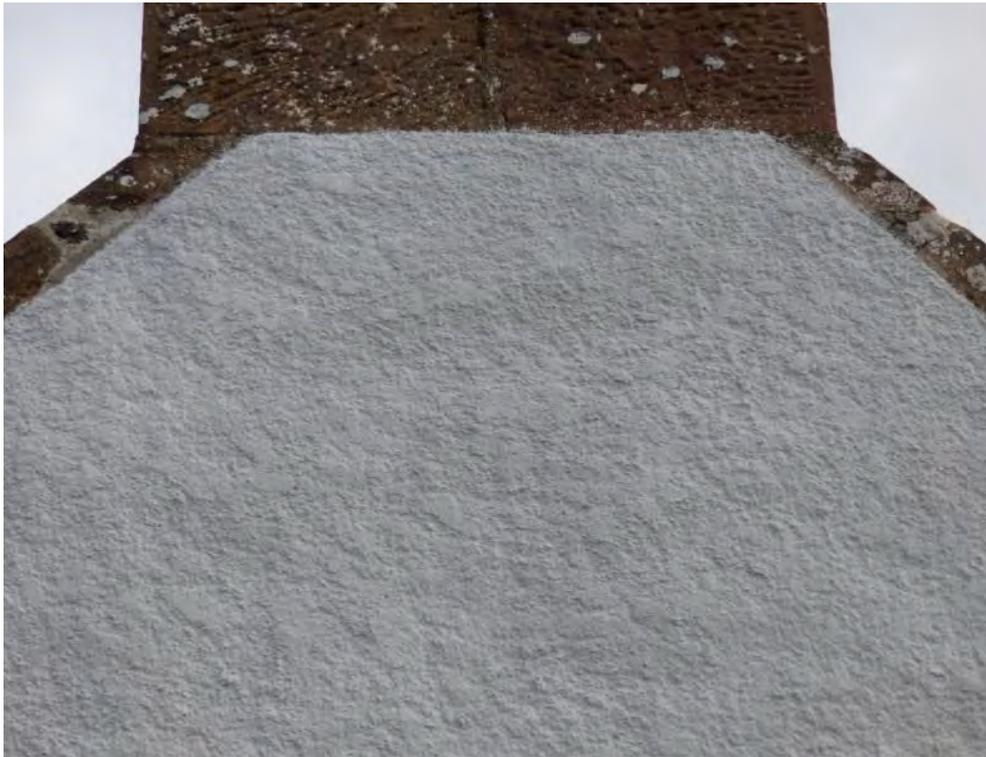
Figure 11.2 Close-up of the harling termination at the chimney.

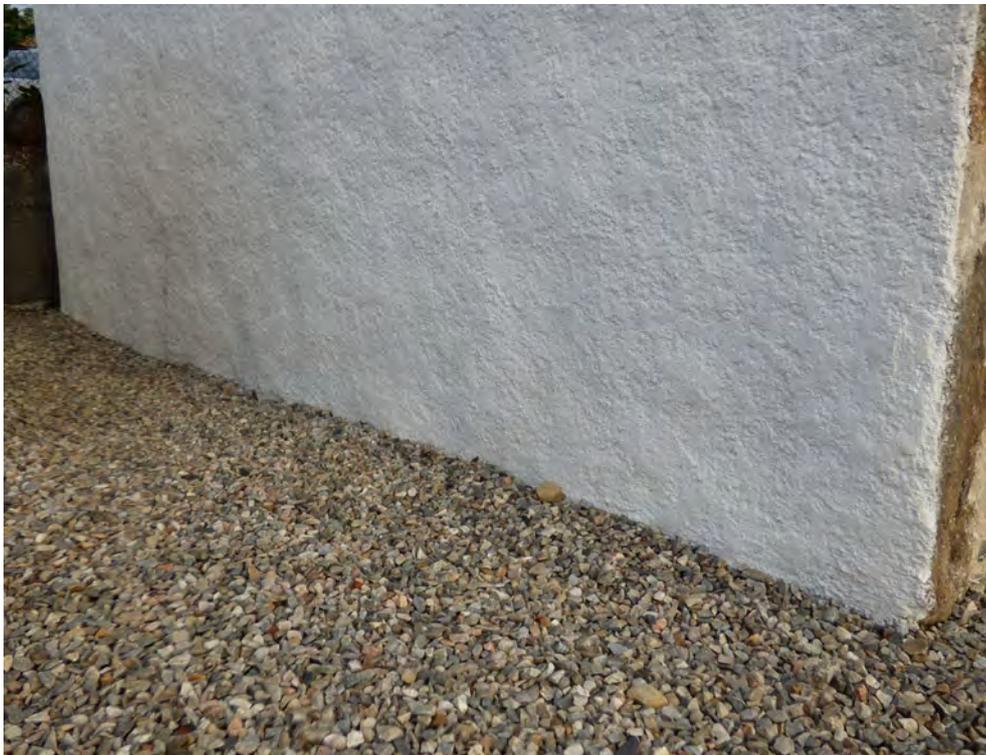
Figure 11.3 Base of the wall, showing harling carried on down to ground level.

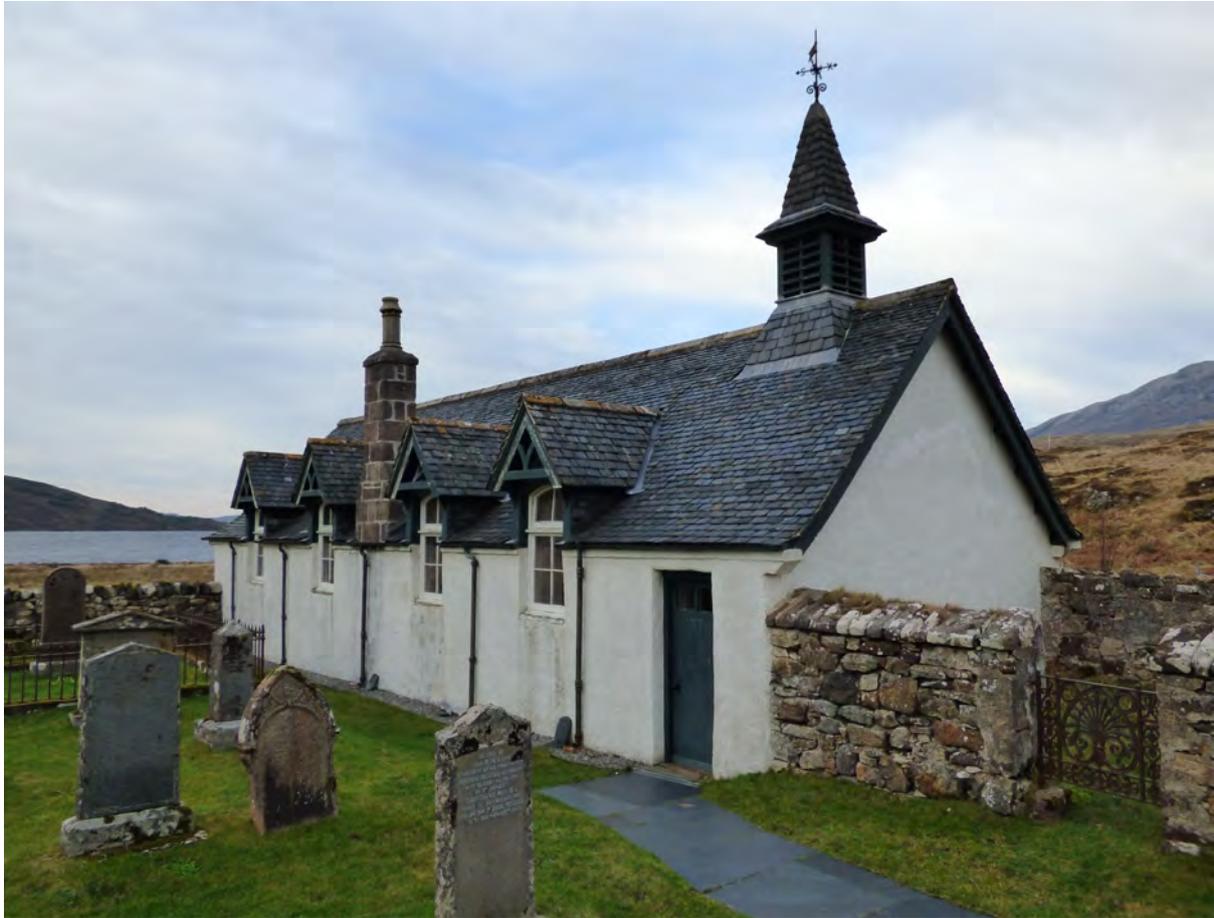
Figure 12.1 Front (south) elevation.

This 19th-century church was renovated during 2003 when it was re-harled and limewashed; it has not been re-limewashed since. The works were supported by a grant from Historic Environment Scotland. Some areas of earlier harling remain to the east gable and north elevation, and these were patched into with an NHL gauged hot-mixed mortar. The harling appears to be generally sound. Given the location and extreme exposure of the building, both the limewash and harl are performing well. Minor bossed areas and localised disruption was also apparent at ground level on the rear (north) elevation.

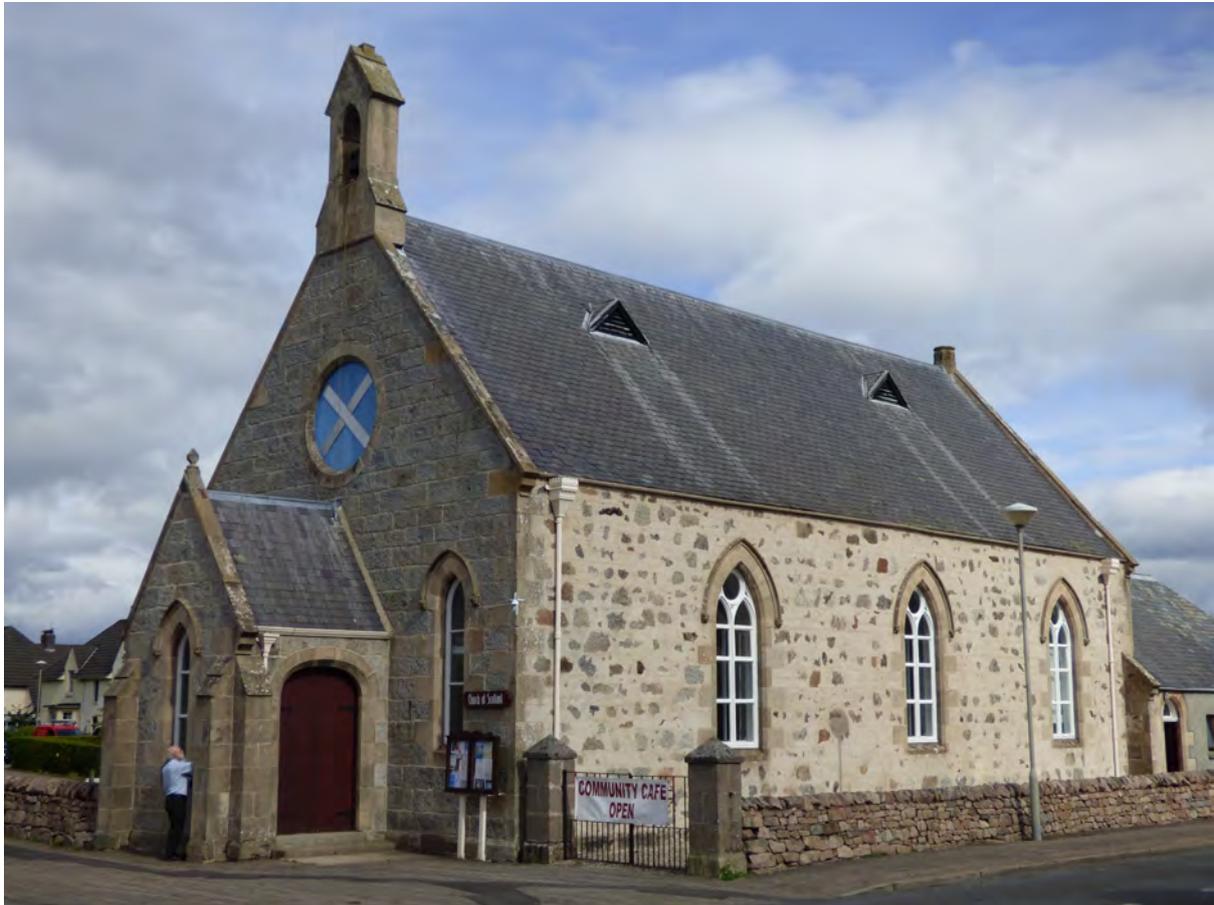
Figure 13.1 General view from the south-west.

This granite church was repointed around 2004. The finish to all except the front (west) elevation is a fully-flush or slaister pointing with a relatively flat, but scraped, finish which has been subtly lined-out. Whilst not a full coating, as in the case of a harling, the overall mortar surface area is considerable and will perform, in some respects, in a similar way to a thin harl coating. The mortar is generally well bonded to the stone, particularly where it is feathered onto the surface of the masonry.

causing localised spalling and surface erosion. Although the mortar is mostly well bonded, there was a higher incidence of small bossed areas detected, which is perhaps due to the effects of solar gain acting on this elevation.

However, generally the pointing was well executed and is performing effectively. In particular it was observed that the junction between the mortar pointing and the granite stone was tightly sealed with no evidence of cracking. This indicates the effectiveness of a hot-mixed mortar in forming a successful bond with a hard stone type.

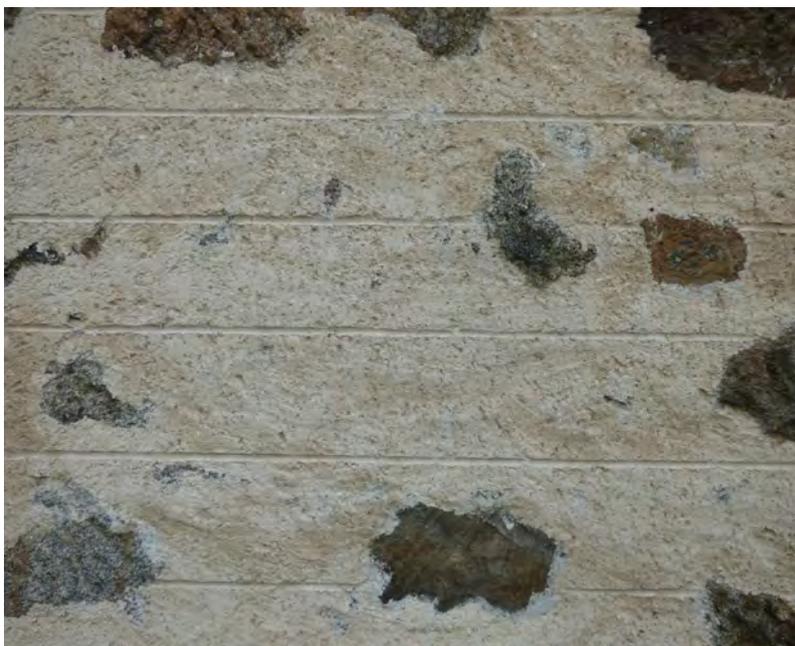
Figure 13.2 Close-up of an area of the pointing, showing a generally tight finish with a relatively uniform texture and finish.

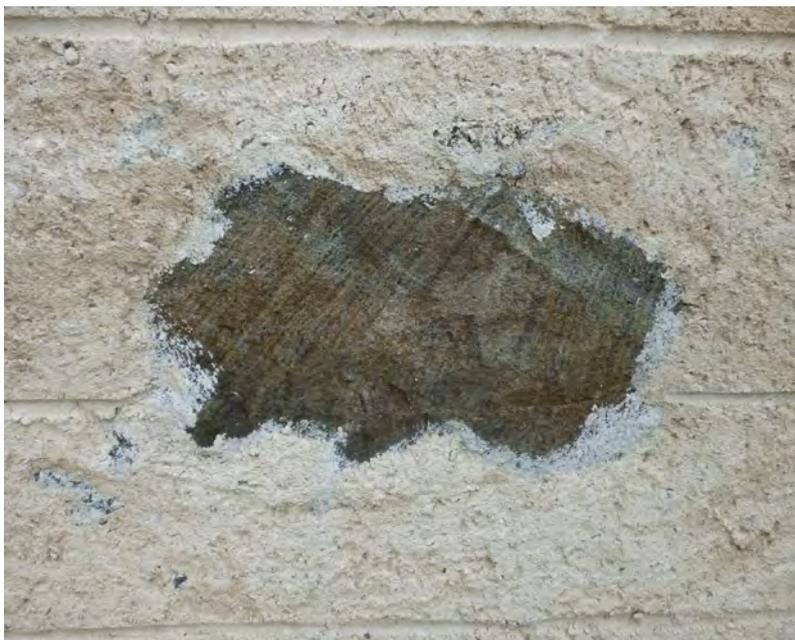
Figure 13.3 Close-up of one stone showing the mortar feathered over the edges of the stone, both effectively flattening the wall surface and displaying good adhesion to the masonry.

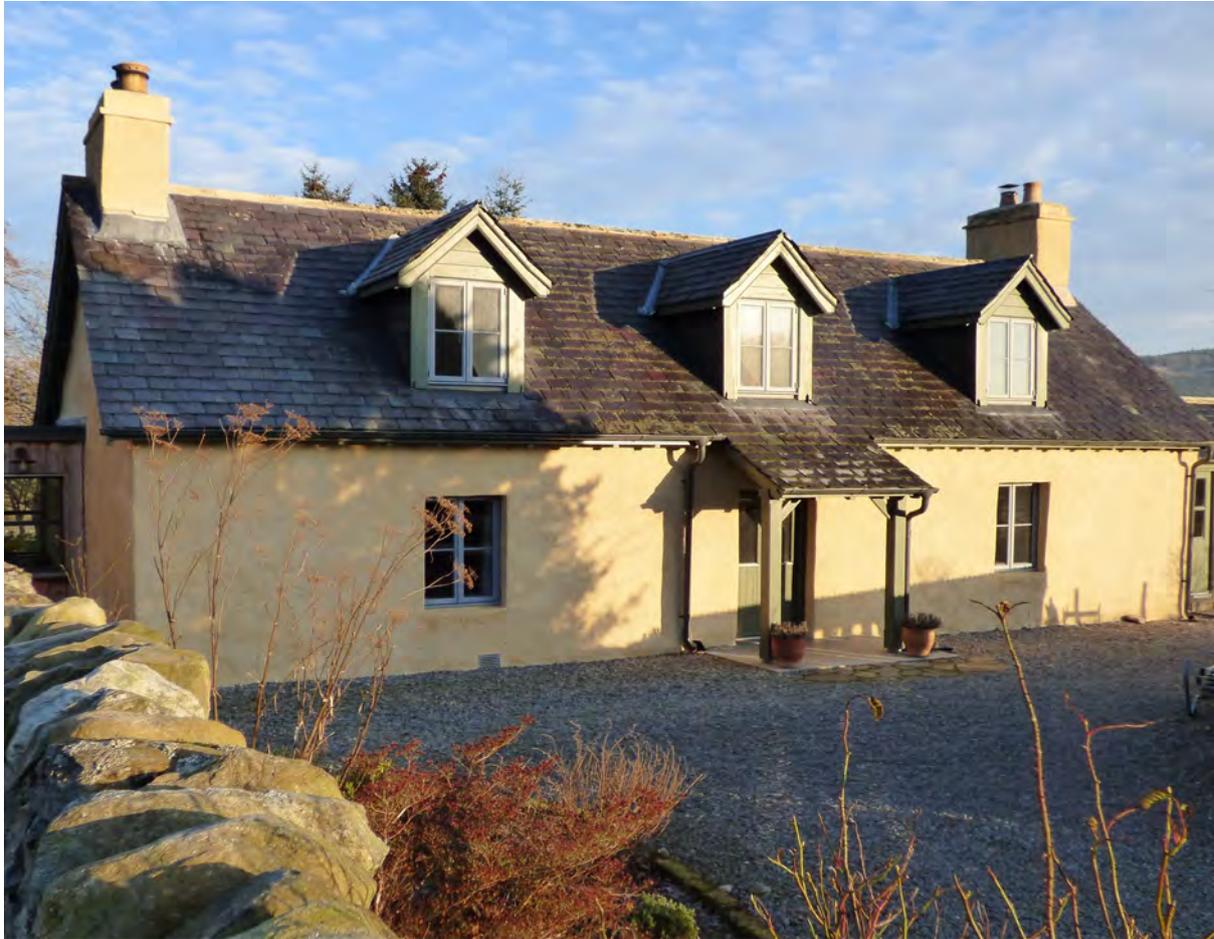
Figure 14.1 The front elevation, viewed from the south.

The harl and limewash are both in good condition. The harl appears to be well bonded and applied to a consistent finish, pressed back slightly. The limewash is evenly applied and well burnished into the harling with no evidence of chalking or cracking observed. There is slight discolouration of the limewash at the window cills to the south elevation caused by rainwater run-off. There is some minor and localised loss of limewash from the copes on both chimneys due to an eroded cope edge on the north and west sides.

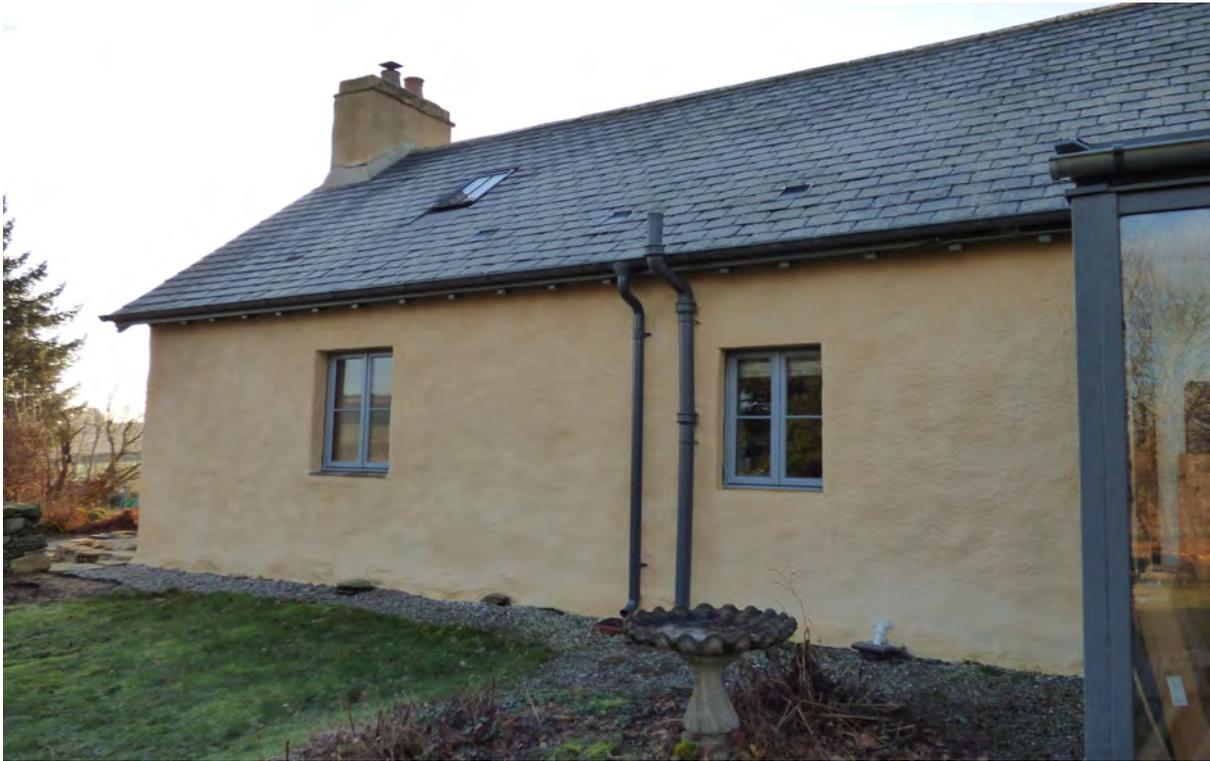
Figure 14.2 North elevation, west side. The harling is slightly textured and undulating following, to some degree, the profile of the masonry.

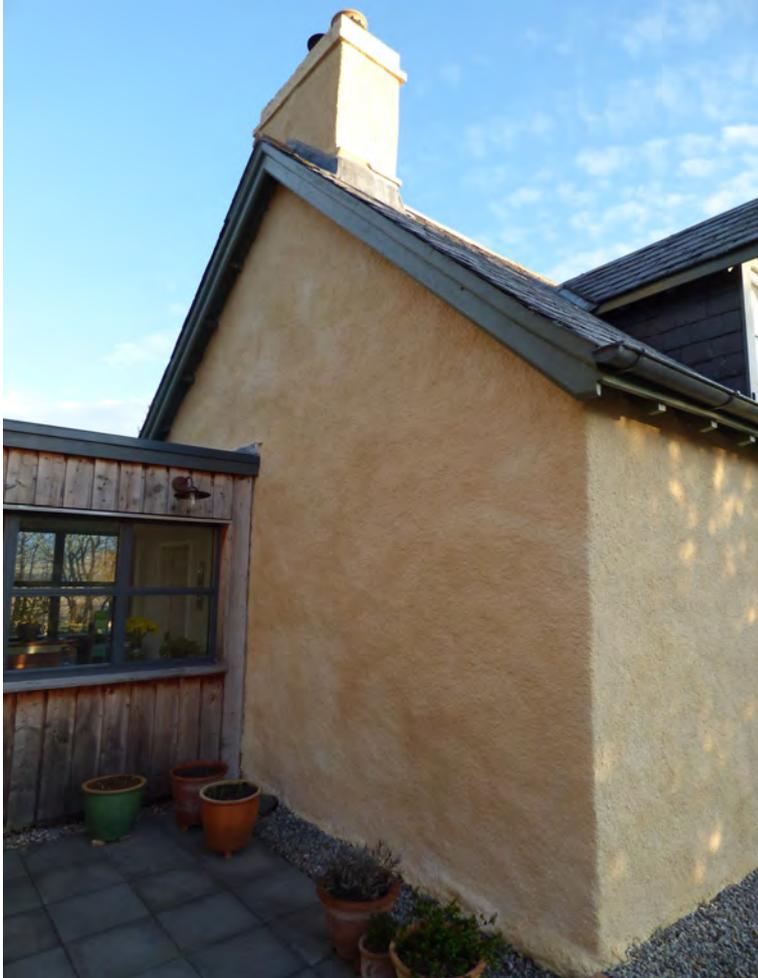
Figure 14.3 West gable, showing the natural variation in colour that is achieved with a well burnished pigmented limewash.

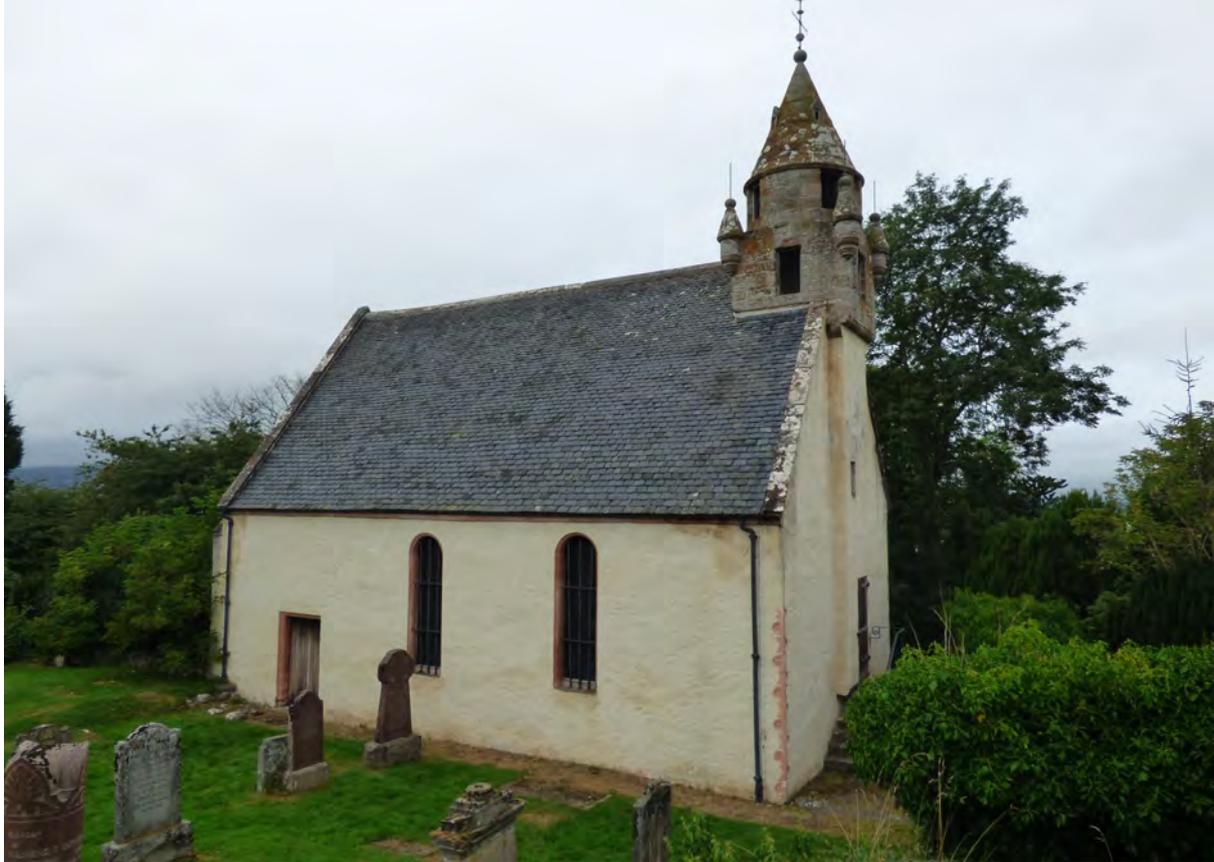
Figure 15.1 General view of the Wardlaw Mausoleum, viewed from the south-east.

The Wardlaw Mausoleum originally dates from the early 17th century. It was refurbished between 1997-98 and the harling was repaired as part of these works. The works were supported by grant funding from Historic Environment Scotland. Existing lime harling was patched with new matching lime harling, all of which was then limewashed. The building has not been limewashed since. The new harling and patch repairs were composed of a lime putty: sand coarse stuff to prepare backgrounds, and a hot-mixed coarse stuff for the harling; both mixes were gauged with an NHL. The quicklime for the harling was locally sourced and burnt on site in a small kiln. The sand for the harling was sourced from a local river bank. The hot-mixed mortar component was used cold after maturing on site for a few weeks. A hot-mixed grout (used hot) was also used to fill and consolidate areas of wallhead.

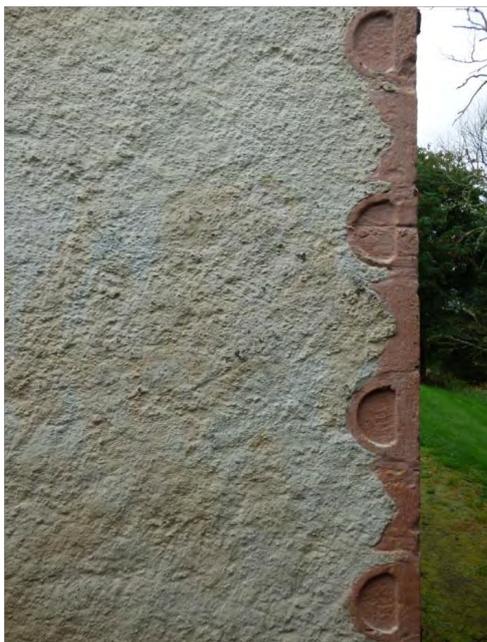
Figure 15.3. The east corner showing the well feathered junction with the sandstone quoins.

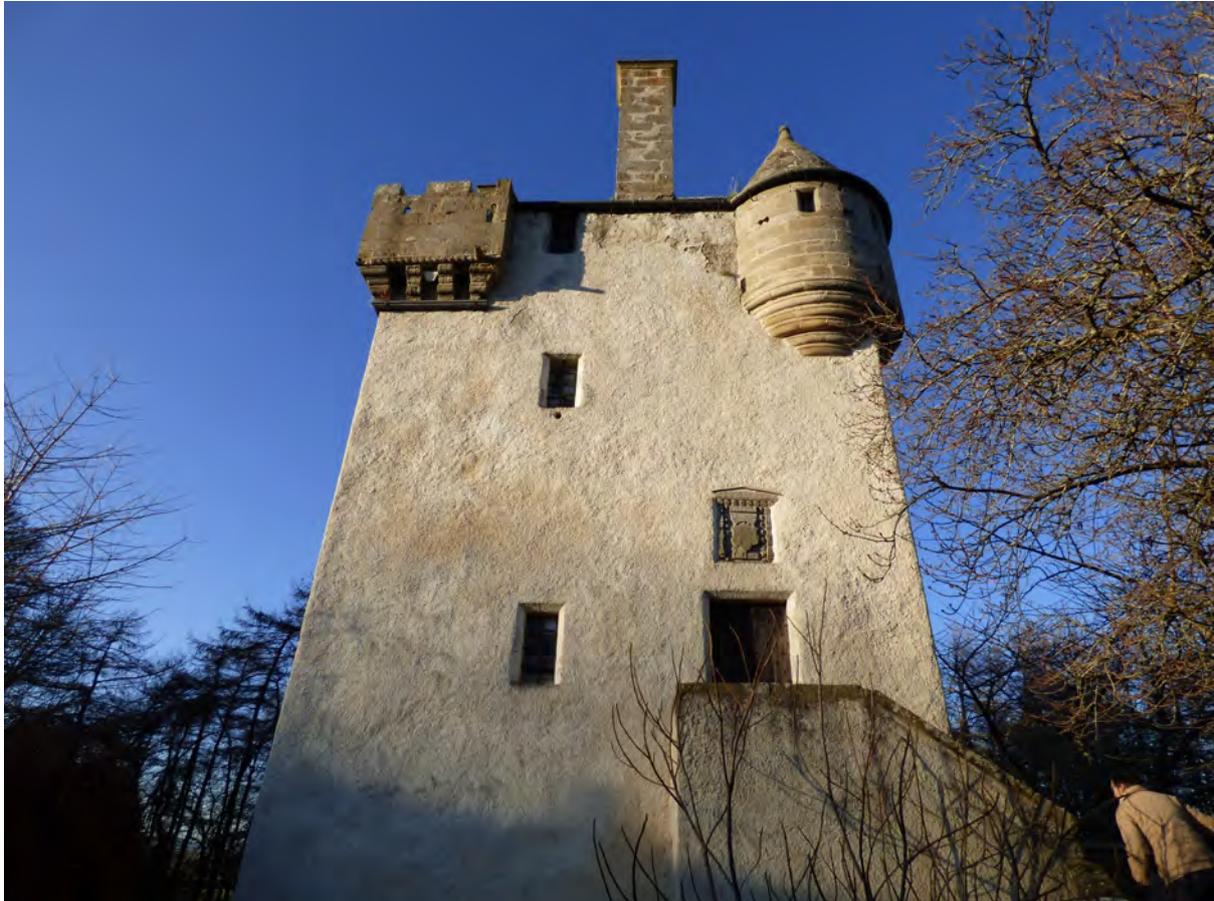
Figure 16.1 Front elevation viewed from the south-east.

The tower was re-harled in 2010 with a hydraulic hot-mixed harling, and also limewashed. Unlike most other projects within this report, the quicklime had a hydraulic component. This type of material is hard to procure but the contractor had access to supplies. The limewash was made from an NHL2 and was not pigmented; the warm colouring is the natural colour of the lime and its constituent minerals.
